Outbuildings at Rainsford Farm Crookham Hill, Thatcham, West Berkshire

Historic Building Record

Ref: 89920.01
May 2013

**Planning Appeal ref: APP/W0340/A/10/2134713
Original Planning Application ref: 09/02370/OUTMAJ**

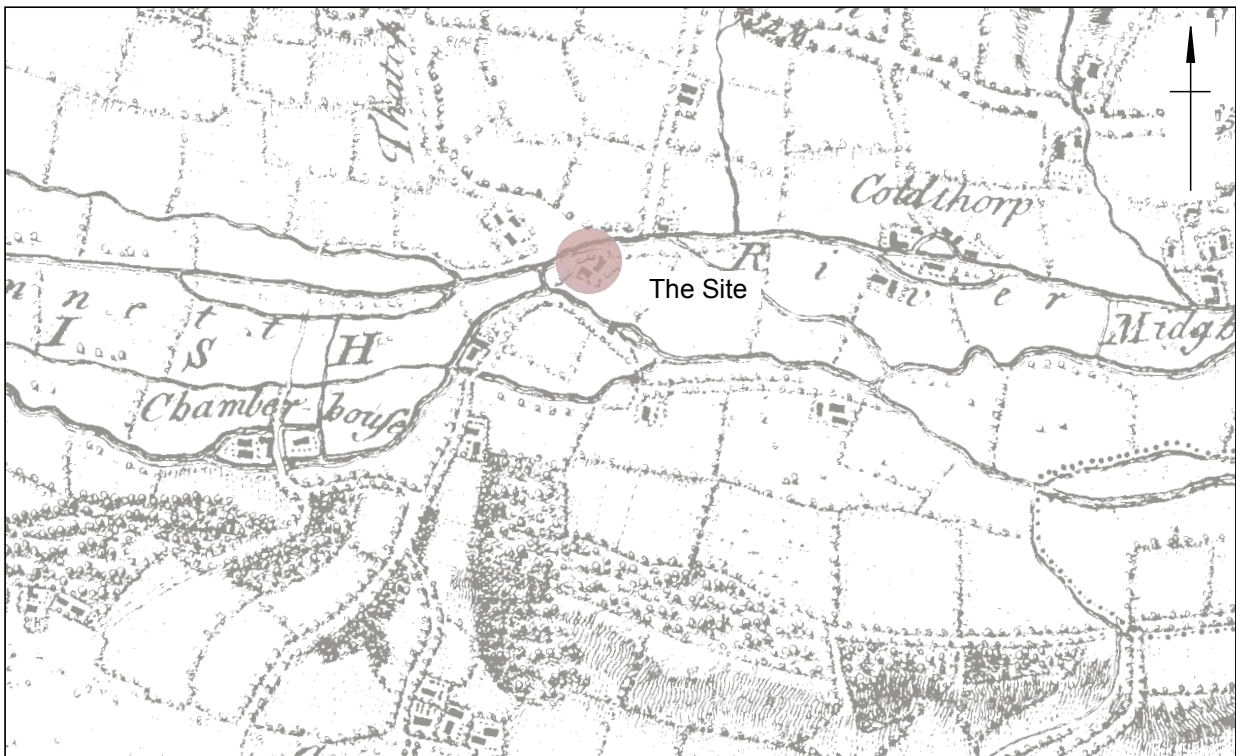
1761 'A Topographical Survey of the County of Berkshire' by John Rocque

3.2.1 Rainsford Farm has existed since at least the 17th century when it was in possession of the Tull family (VCH 1923). On John Rocque's 'Topographical survey of the county of Berkshire' 1761 (**Figure 2**) the farm is depicted as a curved triangular plot with two buildings, neither of which survive today. A building which spans the river Kennet is shown on the Chamberhouse Mill site to the south. Rocque's map records Thatcham as being 6 acres in length, 5½ in breadth, 23 in circumference and 11491 in acreage.

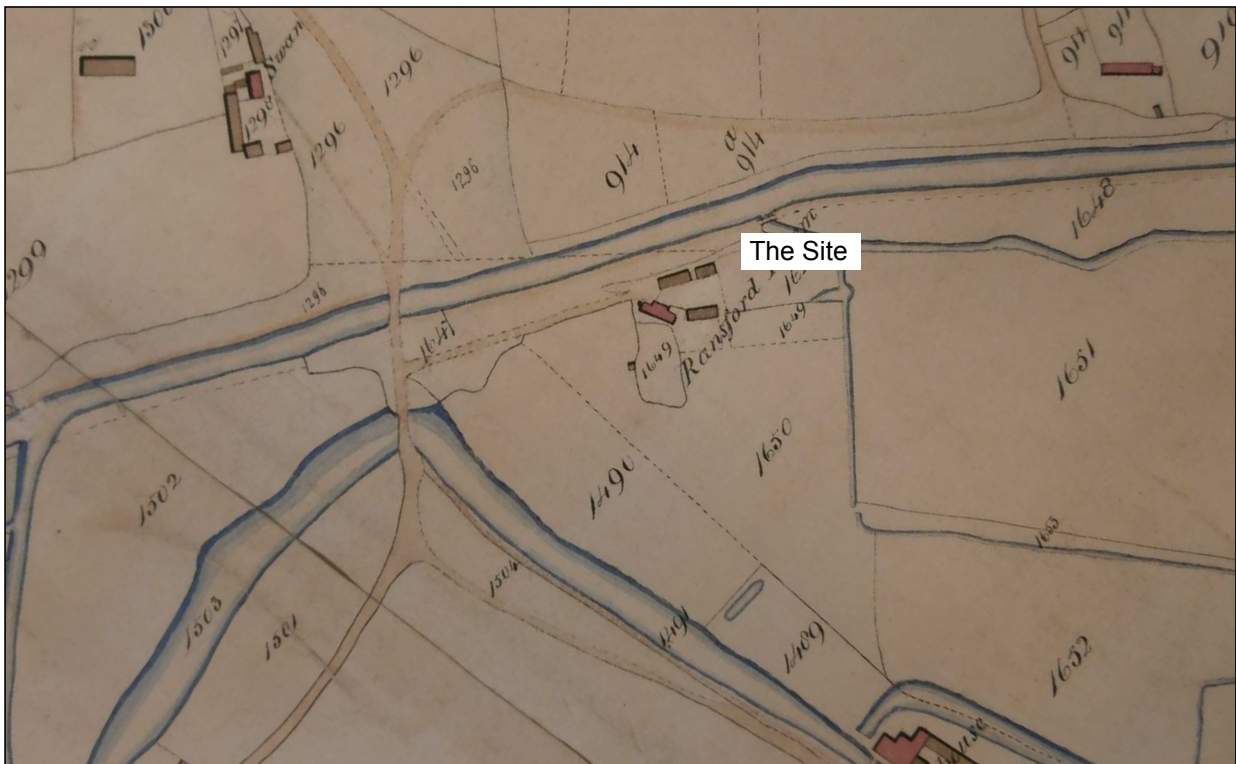
1841 Tithe map of Thatcham parish

- 3.2.3 The 1817 Enclosure map (not reproduced) does not delineate the Rainsford Farm property but does label the area as belonging to George White Esq. The 1841 Tithe map (**Figure 2**) and award confirm White's ownership of 'Ransford Farm', which is described as a house, gardens and buildings plot (number 1649). White also owned associated field, road and river plots 1650 – 1656, 1658 and 1659a, all of which (including the Ransford Farm house, gardens and buildings) were occupied by *Ellanor Botham*. The Tithe award indicates that the path leading from Crookham Hill road to the farm complex was common marshland (plot 1647) and that two land plots (1689 and 1690) between the Rainsford Farm complex and the river to the west were part of Chamberhouse Mill owned by Richard Tull Esq.. The Tithe map shows four buildings at Rainsford Farm: a farmhouse to the west, one subsidiary building to the east of the house and two to the north-east. The latter have their long axis aligned parallel to the canal and are probably the existing study buildings, however in 1841 the structures were not conjoined and the eastern one did not form an L-shape in plan, instead both had rectangular plans and were separate from each other.

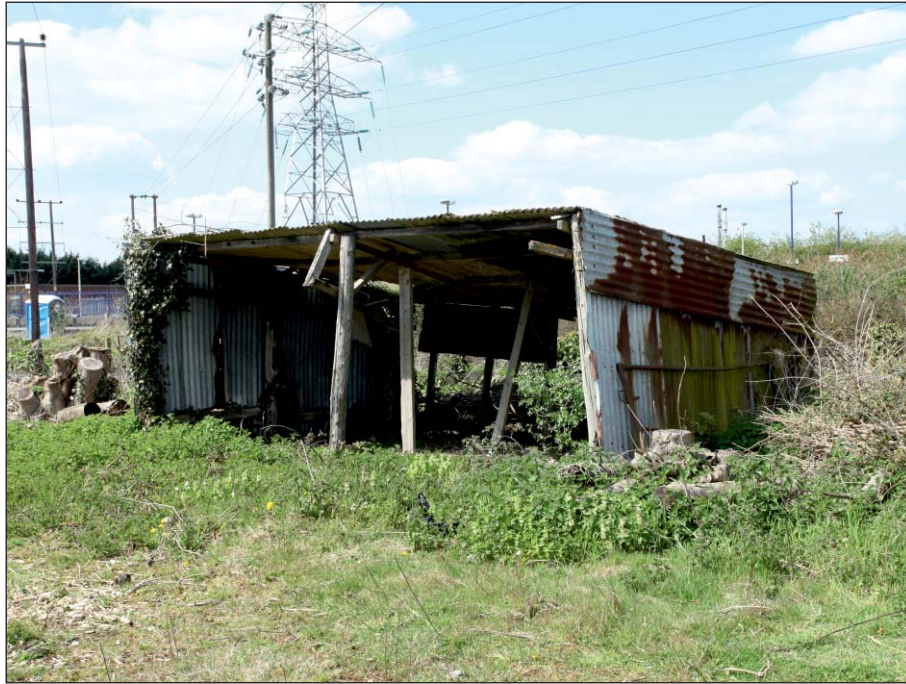
Plate 7: Corrugated iron lean-to

Also, a small corrugated iron lean-to was added to the north-east of the L-plan building (**Plate 7**). Finally, the garden plot to the south of the farmhouse that had existed since at least 1841 was truncated to form a boundary with the pigsties (**Plate 8**) and enlarge the meadow south of the house.

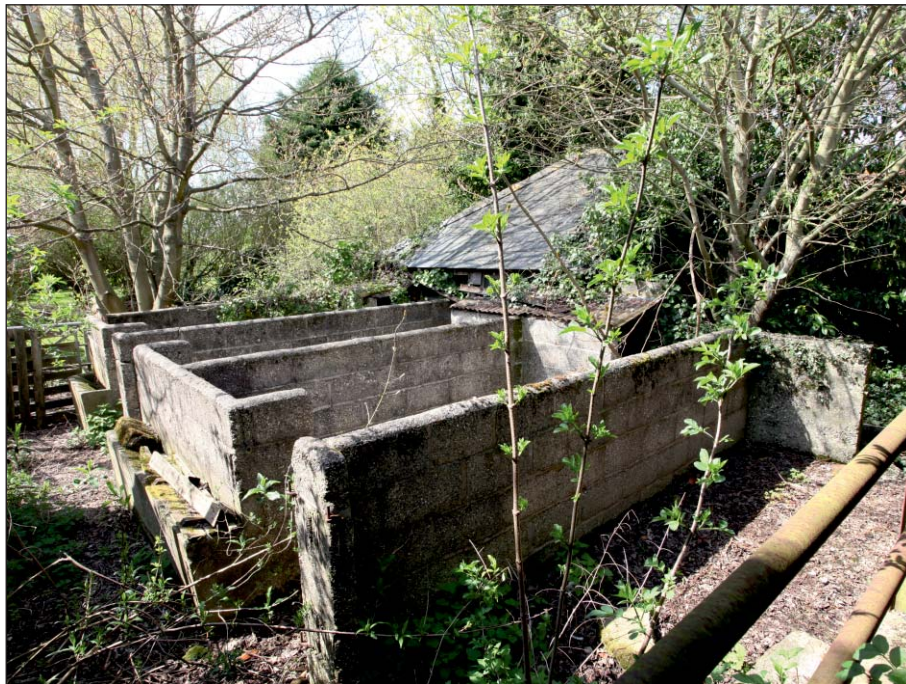
Plate 8: Pigsties

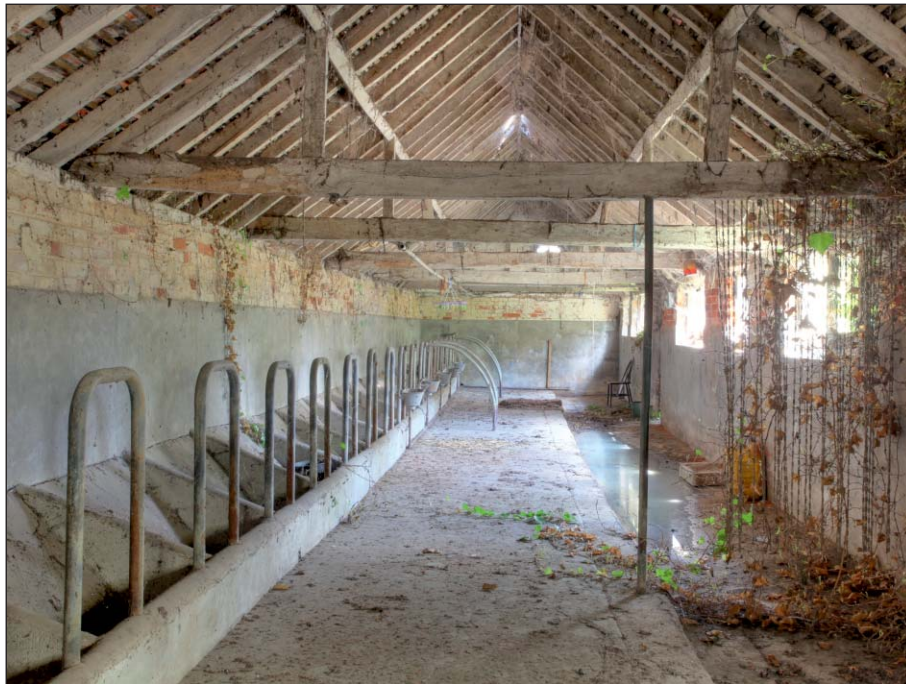
Plate 15: Western study building: interior

- 4.2.2 Internally, the building forms a single volume (**Plate 15**). The roof structure comprises a 7-bay queen post timber frame of regular sawn timbers which have limewashed. The concrete floor has an off-centre step that runs the full west-east length of the structure; the ground level is lower to the south. The brick walls have been rendered in concrete at low level which conforms to farming health regulations implemented in the 1920s - 30s (Harvey 1970). Adjacent to the north wall is a concrete trough subdivided into 20 feeding bays - most likely for young cattle. A series of metal T-plan frames separate each feeding bay although in the majority of cases, only the head of the 'T' remains. The frames are inscribed with the maker's mark 'YOUNG'. Some are fitted with metal buckets made by 'GEO. W. KING LTD. STEVENAGE'. This company operated a factory in Stevenage between 1940-1990 and produced cranes, hoists, pulleys, mechanical handling gear and sliding door gear as well as agricultural equipment (Our Stevenage website).
