# Bulmershe Campus Reading, Berkshire

Archaeological Evaluation Report

Ref: 103070.01  
February 2014

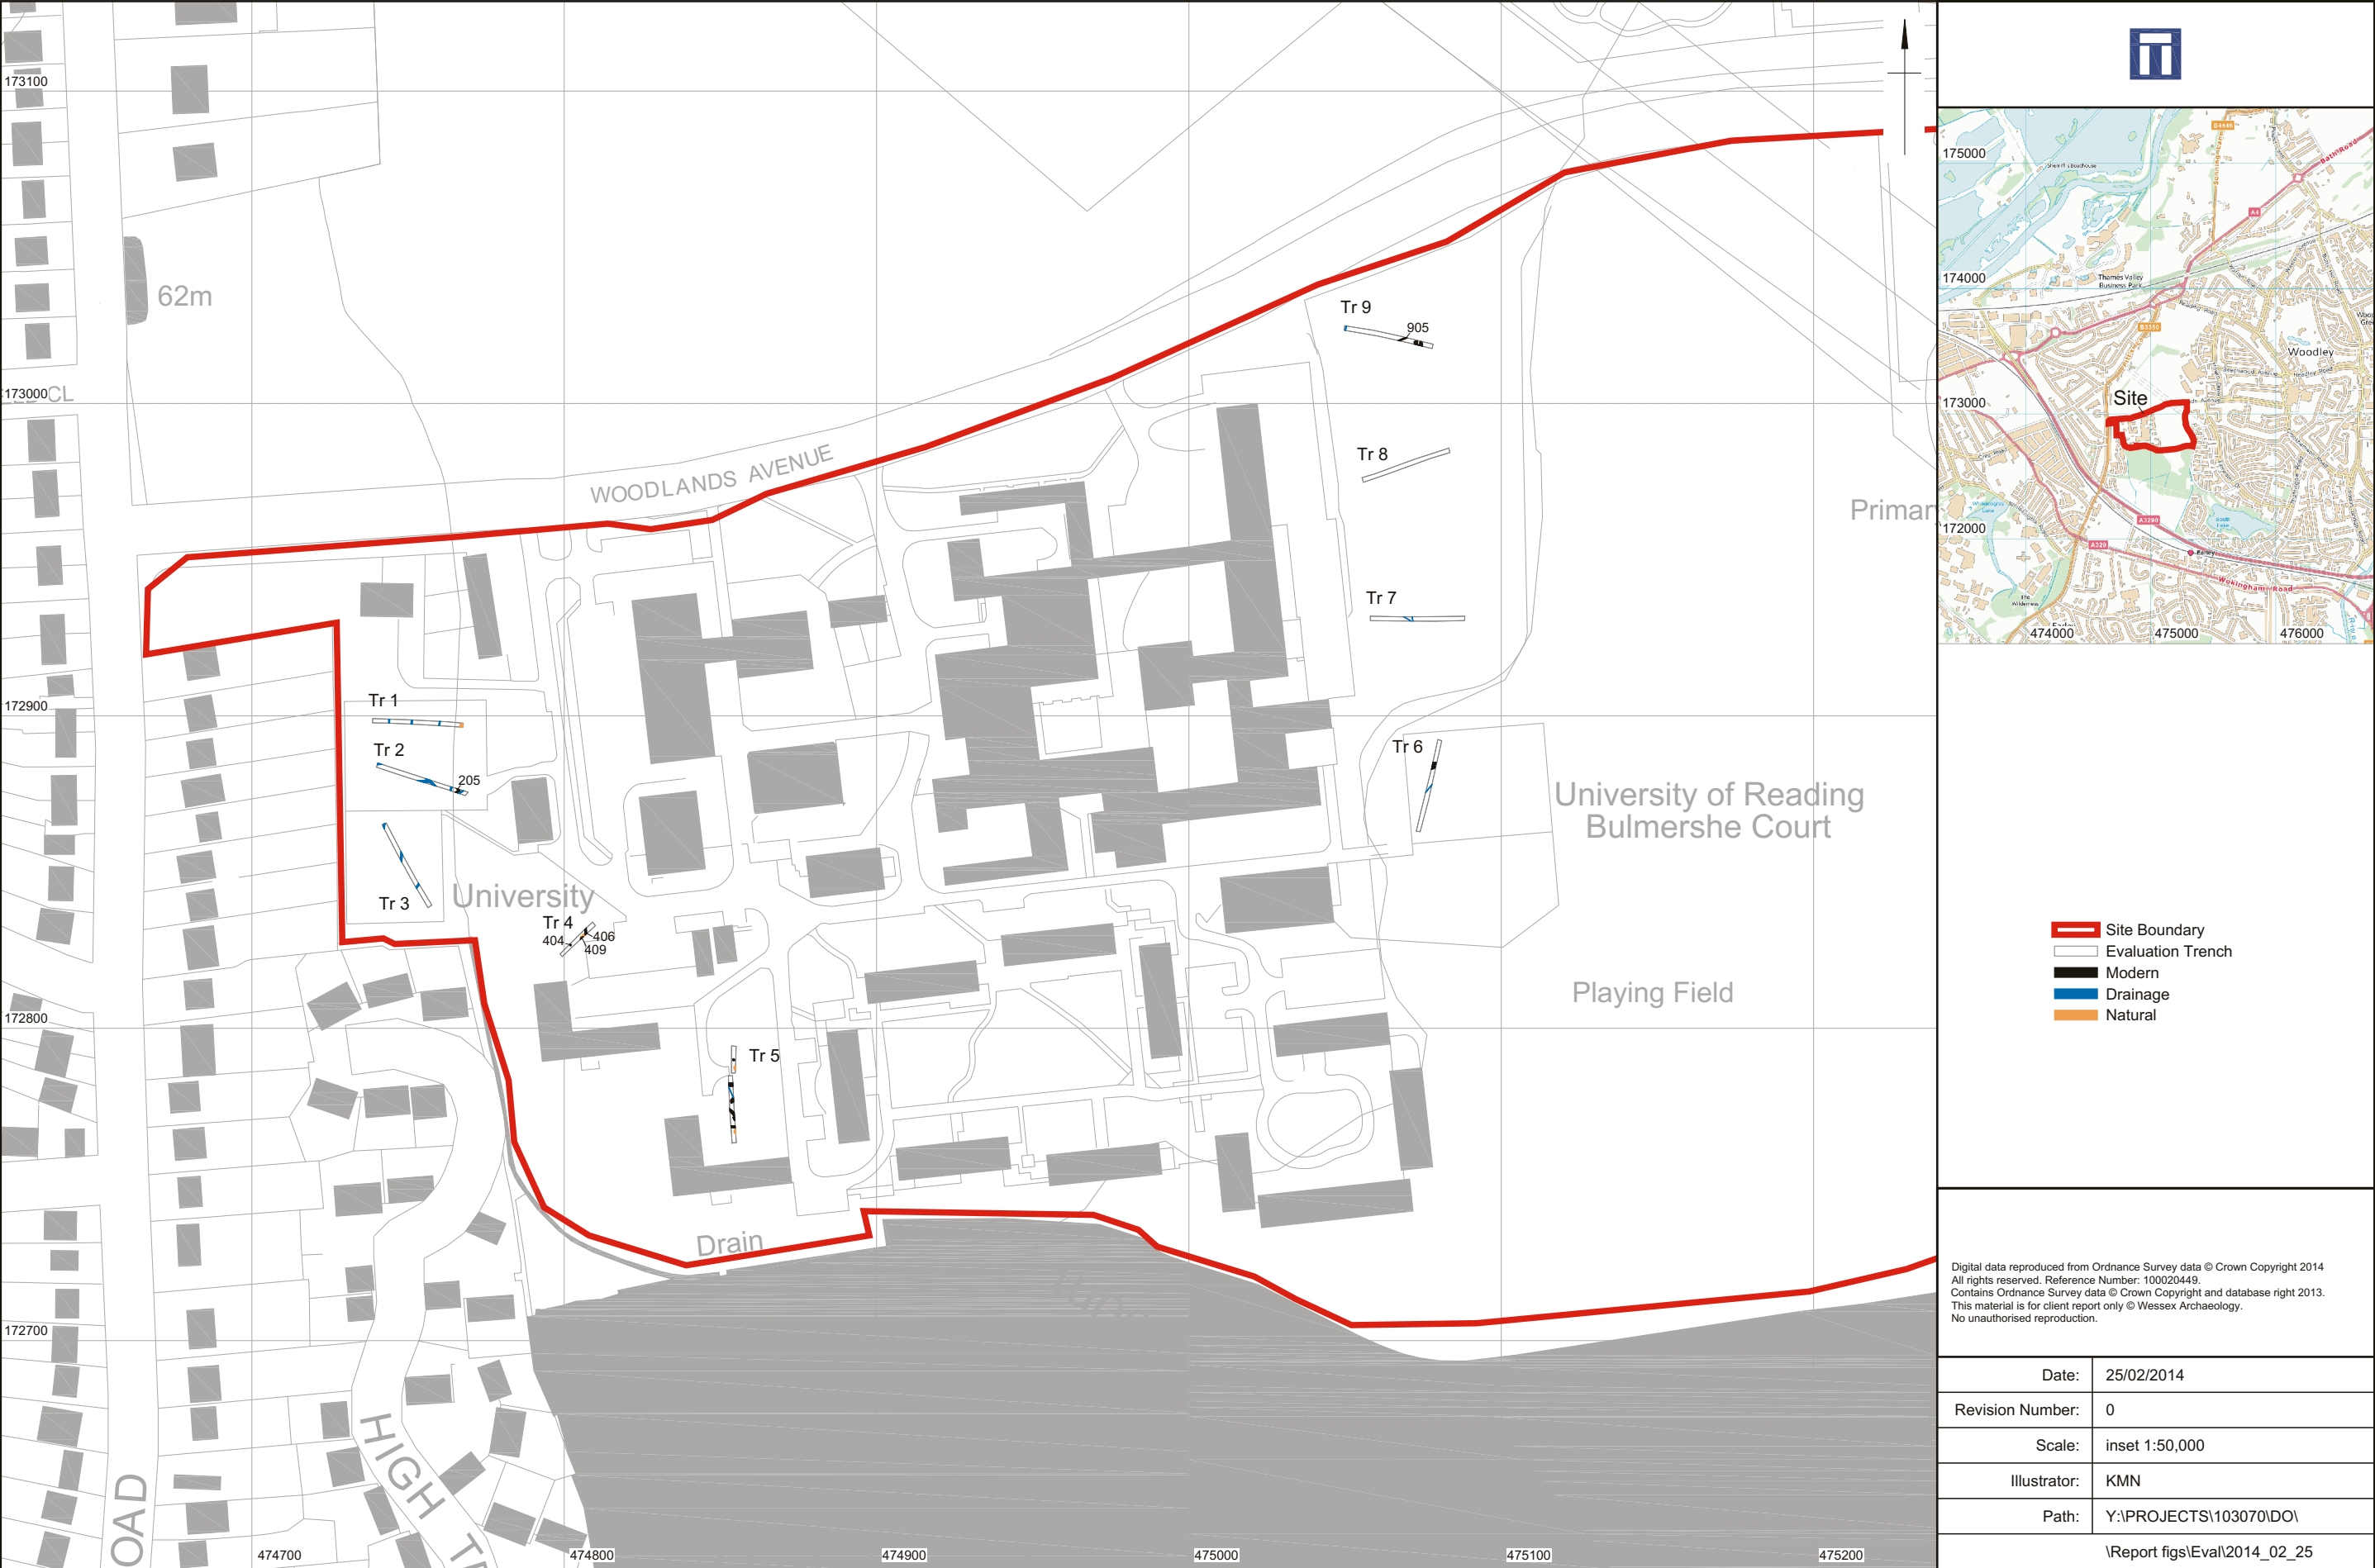
Figure 1

Location of site and evaluation trenches

3.2.2 The evaluation comprised the mechanical excavation of nine trenches, eight measuring between 30m long and 1.6m wide and one 15m long and 1.6m due to constraints on Site. The trenches were positioned within the proposed areas of development (**Figure 1**).

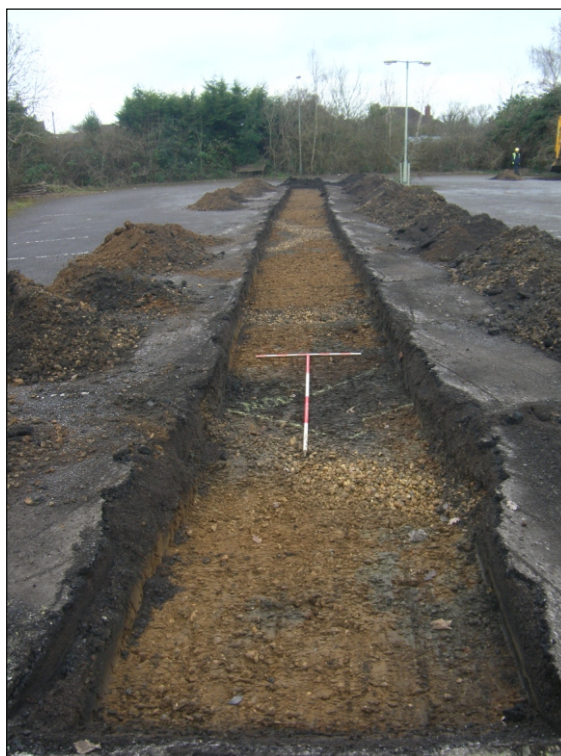
Plate 1: View of Trench 2, from the east

4.2.1 **Trenches 1, 2 and 3** were situated in the former tennis court and adjacent car park in the western part of the Site. These trenches encountered between 0.11-0.19m of tarmac and underlying sub-base laid directly onto the natural, which was a sandy gravel. In **Trenches 1 and 2** a thin layer of discoloured, contaminated material was also seen (**103, 203**) while in **Trench 3** some patches of discolouration were visible. The interface with the natural geology was sharp and clean with no trace of any buried soil indicating that the ground has been previously stripped and potentially truncated. A number of French drains were also noted, as well as a modern ditch near the south-eastern end of **Trench 2 (205) (Plate 1)**.

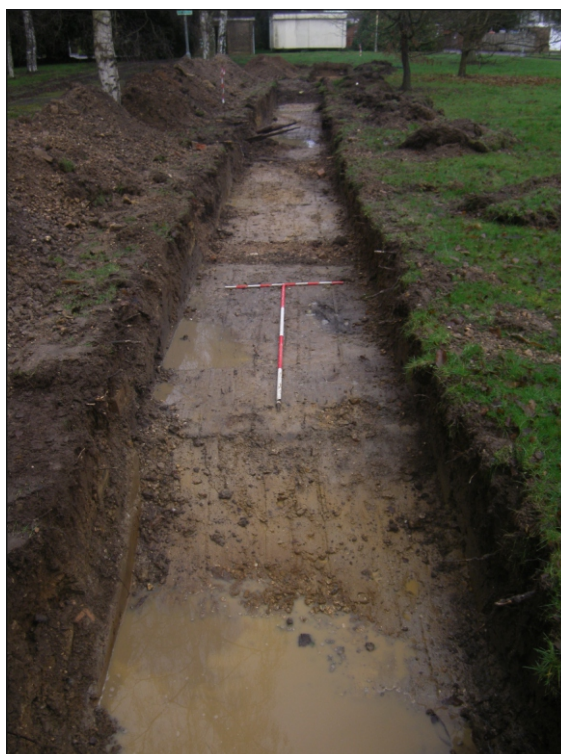
Plate 2: View of Trench 5, from the south

4.2.2 **Trenches 4 and 5** were situated in the south-western part of the Site in areas of landscaping. Within **Trench 4**, approximately 0.10m of topsoil (**401**) overlay 0.15m of subsoil (**402**), while in **Trench 5** the soil profile was much deeper with 0.20m of topsoil (**501**) overlying 0.24m of subsoil (**502**), suggesting the ground may have been built up. A

number of modern features were found in both trenches indicative of considerable disturbance (**Plate 2**).
