Shaw Lodge to Knapp Cottage Wiltshire

Archaeological Watching Brief Report

Ref: 100120.03
March 2014

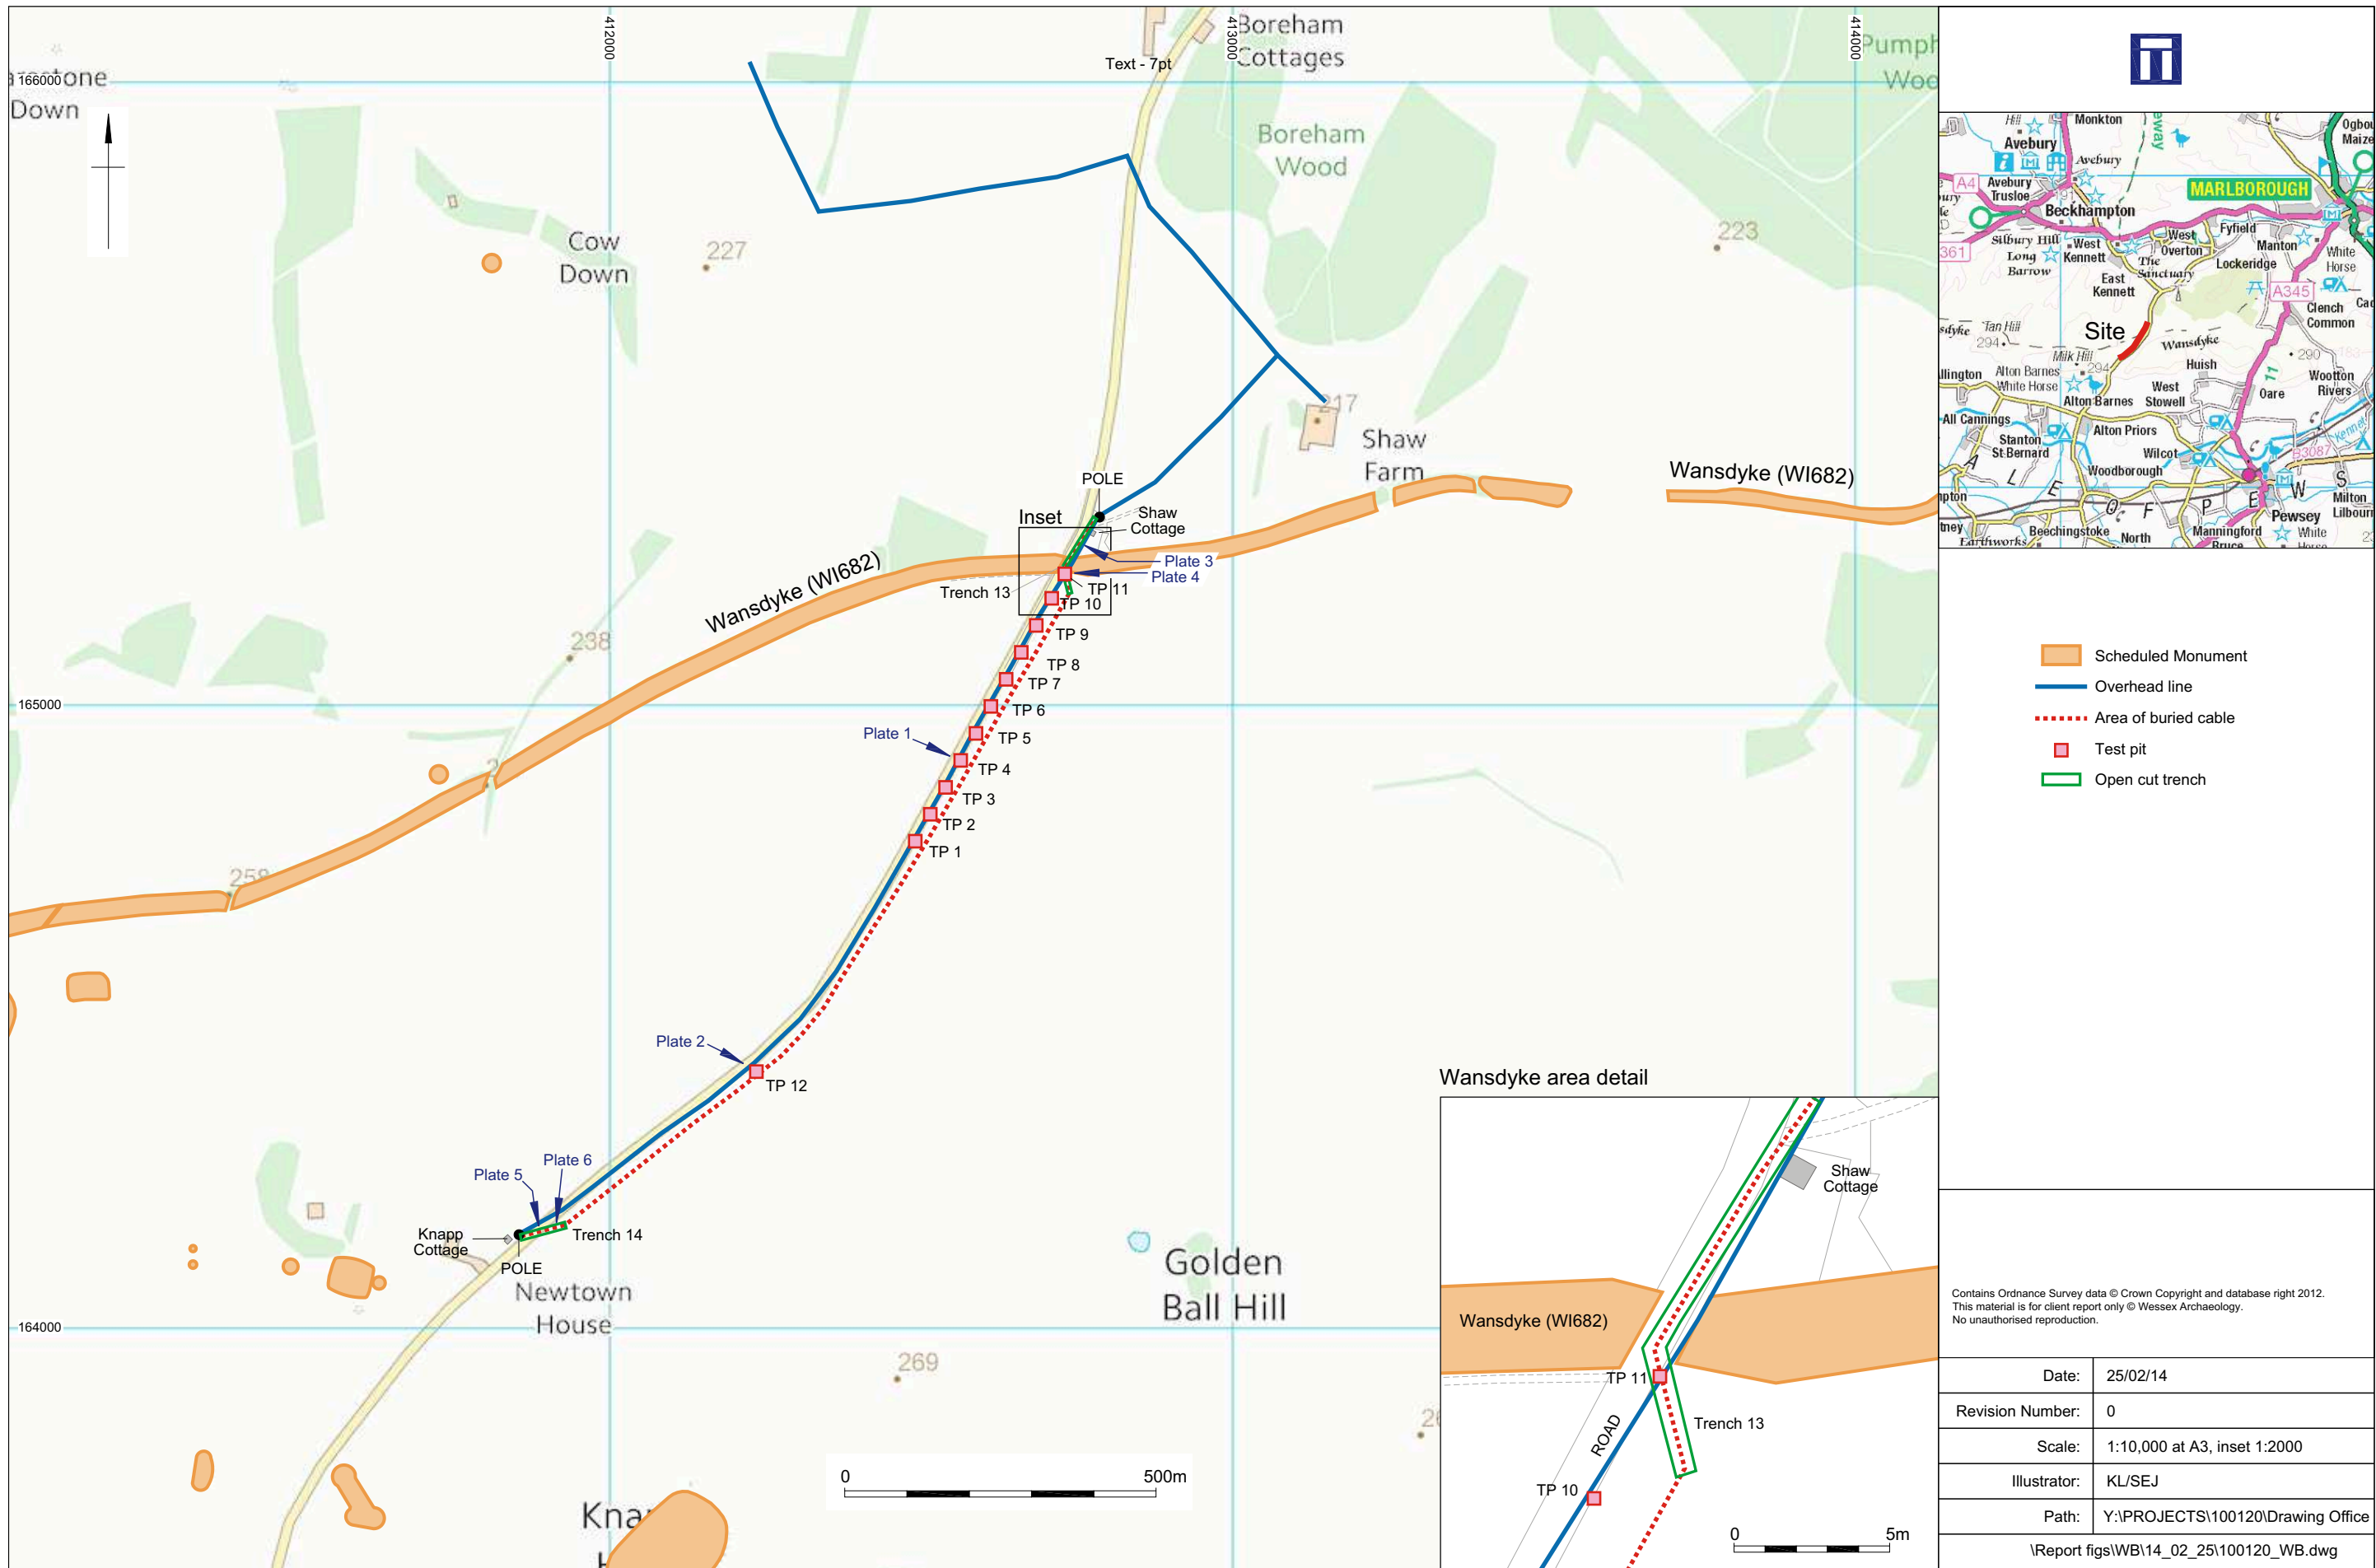
Figure 1

Location of the Site and monitored areas

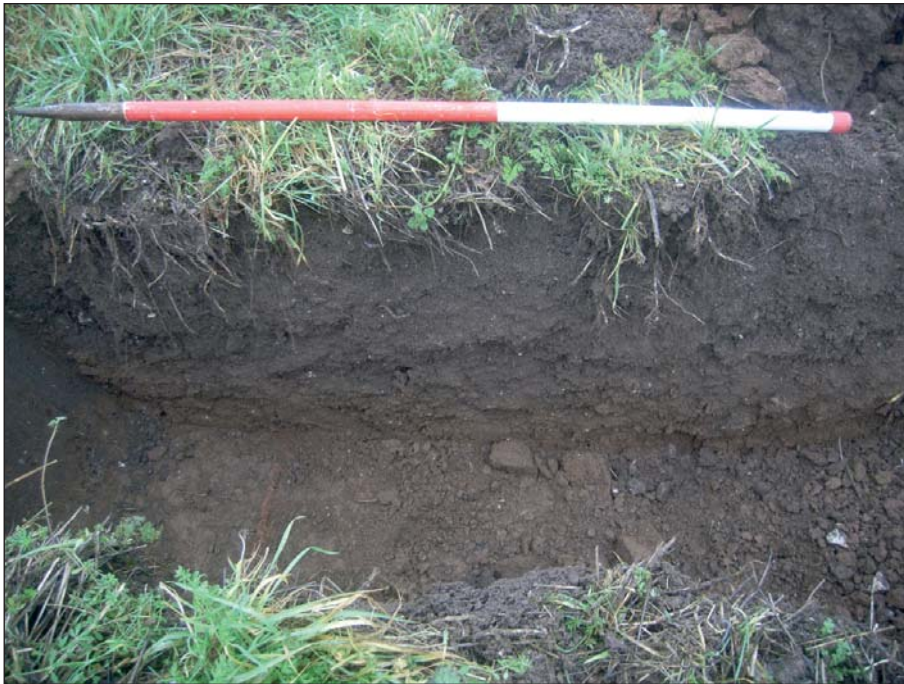
4.2.1 **Test Pits 1 – 11** (located between NGR 412486 164781 and 412730 165211) were evenly spaced along the northern part of the route at 50m intervals. Each test pit measured approximately 2.80m in length by 0.60m wide and 0.70m deep. The stratigraphic sequence of each test pit was similar, and comprised a mid-brownish grey topsoil (**101**) measuring approximately 0.3m in depth overlying a mid-reddish brown silty clay alluvial/colluvial deposit (**102**), and was recorded down to the base of the test pits (**Plate 1**). The natural geology was not encountered in any of the eleven test pits.

Plate 1: South-west facing section of Test Pit 4.

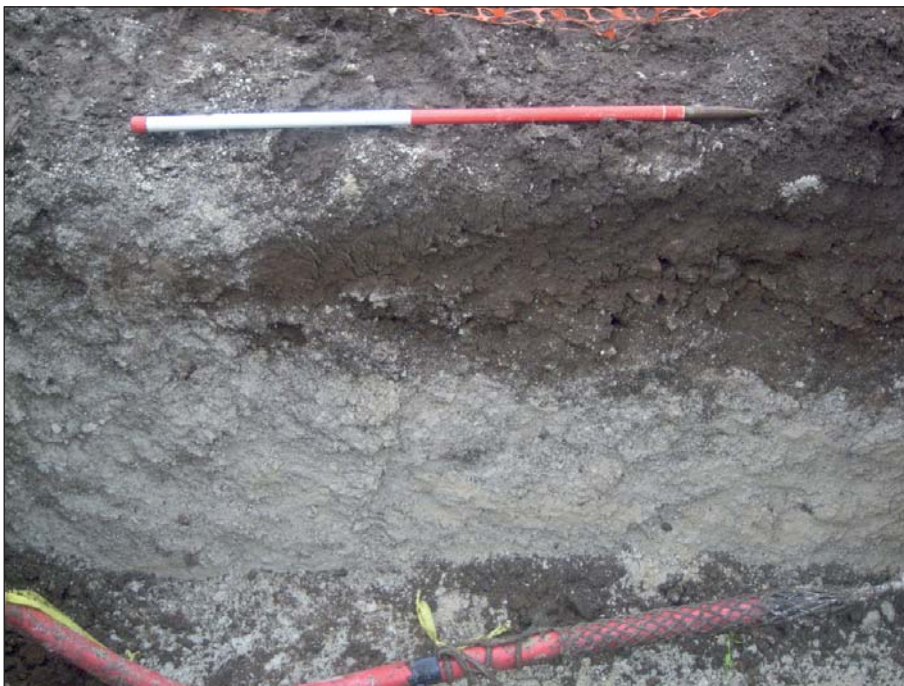
4.3.1 **Test Pit 12** (located at NGR 412235 164412) was required to facilitate the installation of the cable plough mole, and measured 3.00m in length by 1.50m wide and 1.50m deep. The same stratigraphic sequence was recorded, although, degraded Upper Chalk geology (**103**) was encountered at a depth of approximately 0.80m below the current ground level (**Plate 2**). No archaeological features or artefacts were encountered.

Plate 2: North-west facing section of Test Pit 12.

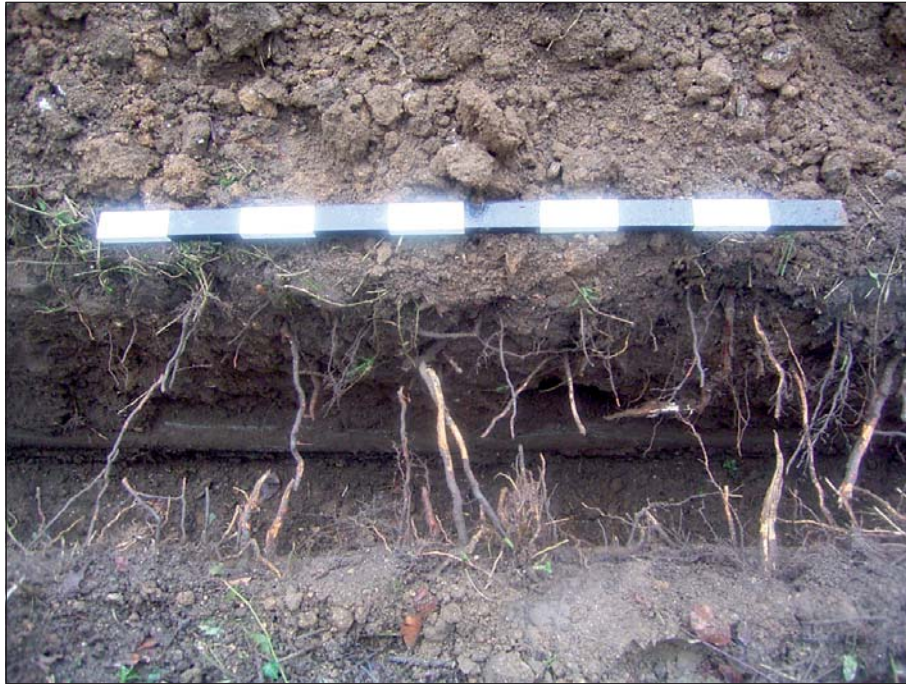
4.4.2 During the excavation it was noted that the trench ran on a parallel course to an existing water pipe (**104**; **Plate 3**). Given the disturbance caused by the existing pipe and road, no archaeological features or artefacts were encountered during the excavation of the trench, and chalk natural (**103**) was only encountered after the trench doglegged to the south of the Wansdyke (**Plate 4**).

Plate 3: South-east facing section of Trench 13 showing the water pipe.

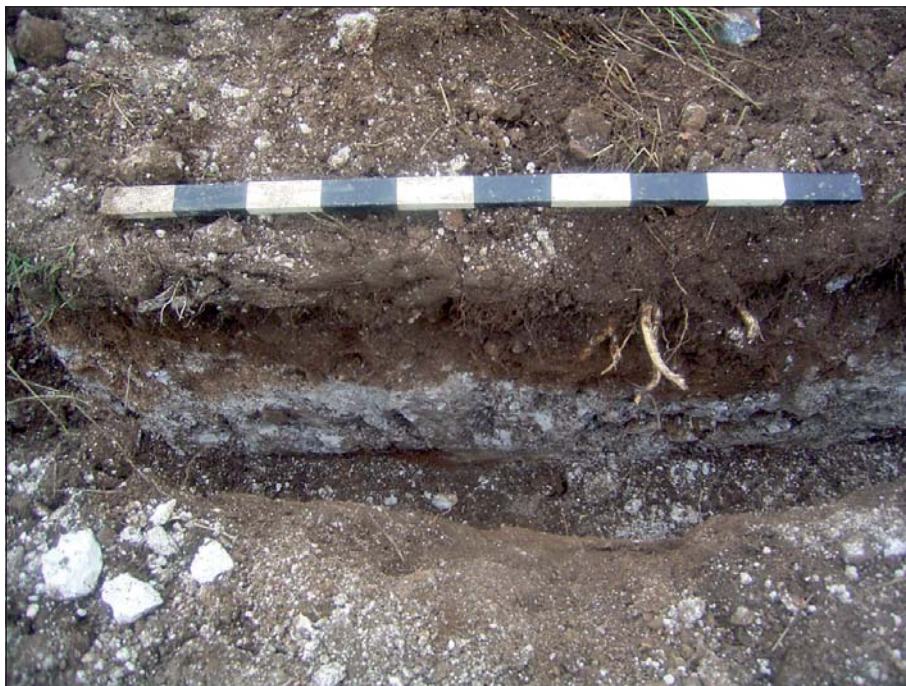
Plate 4: South-west facing section of Trench 13.

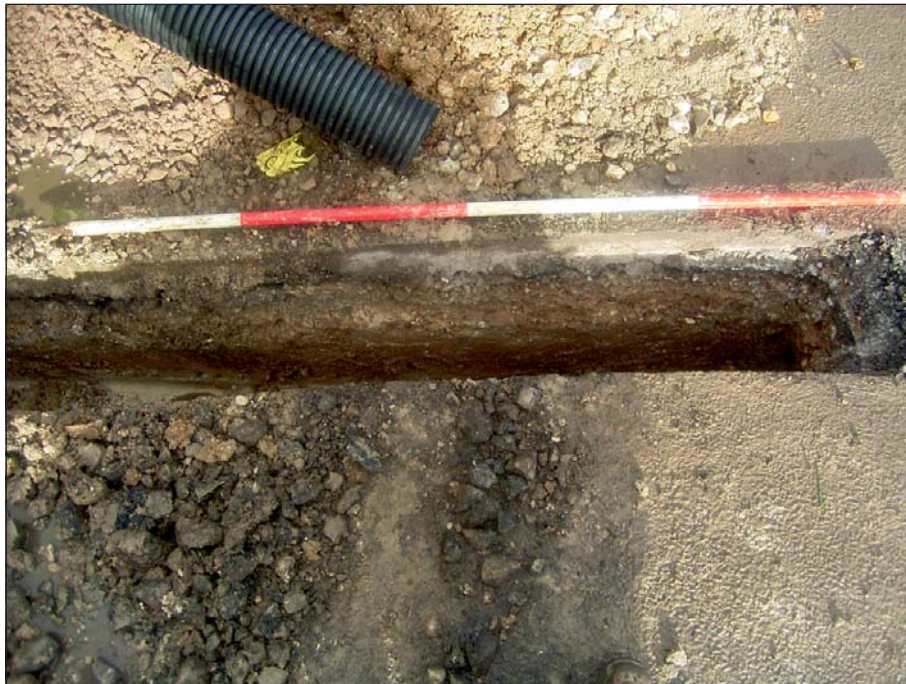
4.5.2 Within the road itself, a 0.20m thick layer of tarmac (**105**) overlaid 0.32m of hard core material (**106**) which was used as bedding for the road. The hard core layer was located above a mid-reddish brown silty clay colluvium (**102**; **Plate 5**). Elsewhere, the stratigraphy returned to the sequence observed across the rest of the Site, with a 0.30m thick silty clay topsoil (**101**) covering a mid-reddish brown subsoil/colluvium (**102**). As with the other observed sections, the natural chalk (**103**) was only identified as the cable trench moved away from the bottom of the valley and up the slope (**Plate 6**).

Plate 5: North-east facing section of Trench 14 through the road.

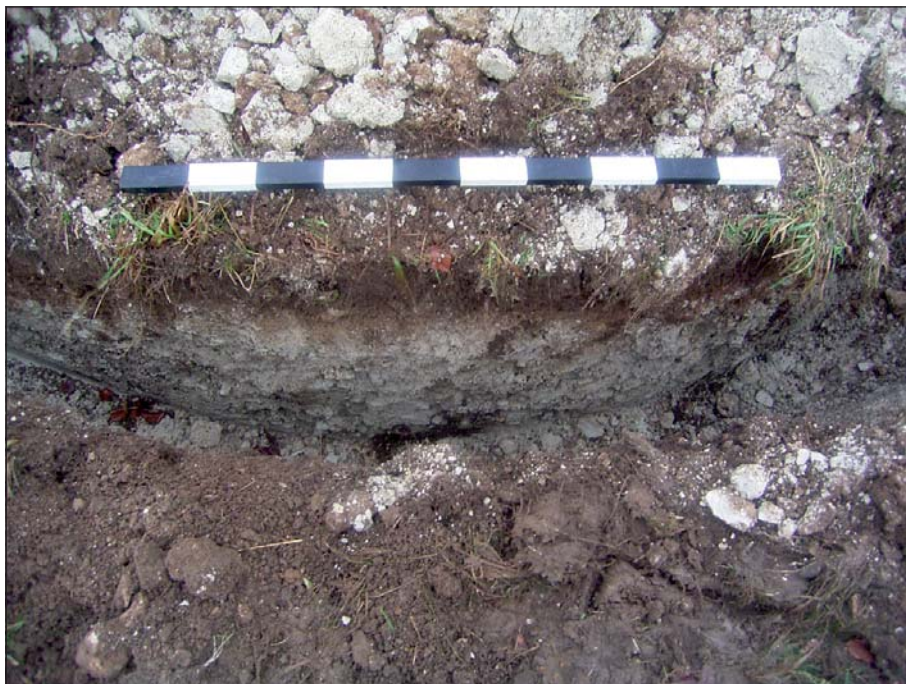
Plate 6: North-east facing section of Trench 14.
