Mattersey Priory Gilbertine Monastery Scheduled Monument 1012495 Nottinghamshire

Archaeological Watching Brief

Ref: 89180.01 July 2013

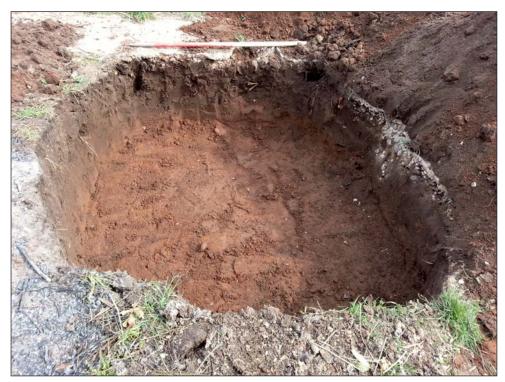
Plate 1: Remains of Mattersey Priory refectory

4.2.1 The stratigraphy observed in the inspection pit consisted of natural deposits overlain by subsoil and topsoil (**Plate 1**). The natural (**1003**) was loose mid orange-brown sand containing occasional rounded stone. The subsoil (buried soil **1002**) and topsoil (**1001**) were mid grey-brown sandy silts; the topsoil contained some complete and fragmented handmade red bricks. The topsoil was 0.25m deep and the base of the subsoil was 0.55m below ground level. Hand excavation and archaeological monitoring ceased at a depth of 0.70m below ground level. No archaeological deposits, features or artefacts were present.

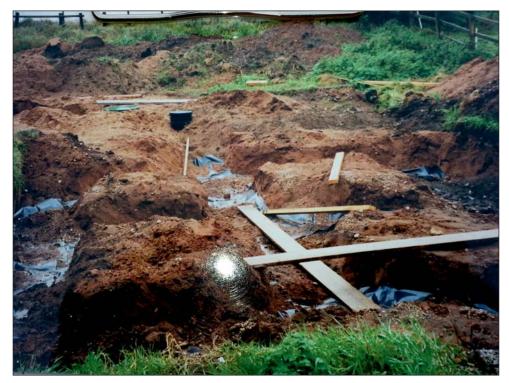
- 5.1.1 The original installation of the sewage system had clearly caused significant ground disturbance; this was evident from the bricks observed in the topsoil and from the stratigraphy of the excavated trench. The extent of this previous disturbance was visible in two photographs taken during those works, provided by the Client during fieldwork (**Plates 2** and **3**). The original ground disturbance appeared to cover the whole area that was to be affected by the construction of the new sewage and drainage system.
- 5.1.2 No archaeological finds, features or deposits were identified during the excavation of the inspection pit. Given the extent of previous disturbance indicated by the photographs, the proposed works impacted only on previously disturbed ground.

Plate 2: Site during construction of original sewage and drainage system, looking northwest

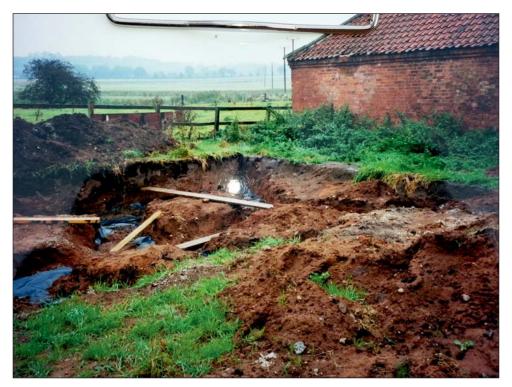
Plate 3: Site during construction of original sewage and drainage system, looking northeast
