MOORGATE MILL, BLACKBURN, LANCASHIRE

Strip, Map and Record Excavation Report

Report reference: 86931.04

January 2013

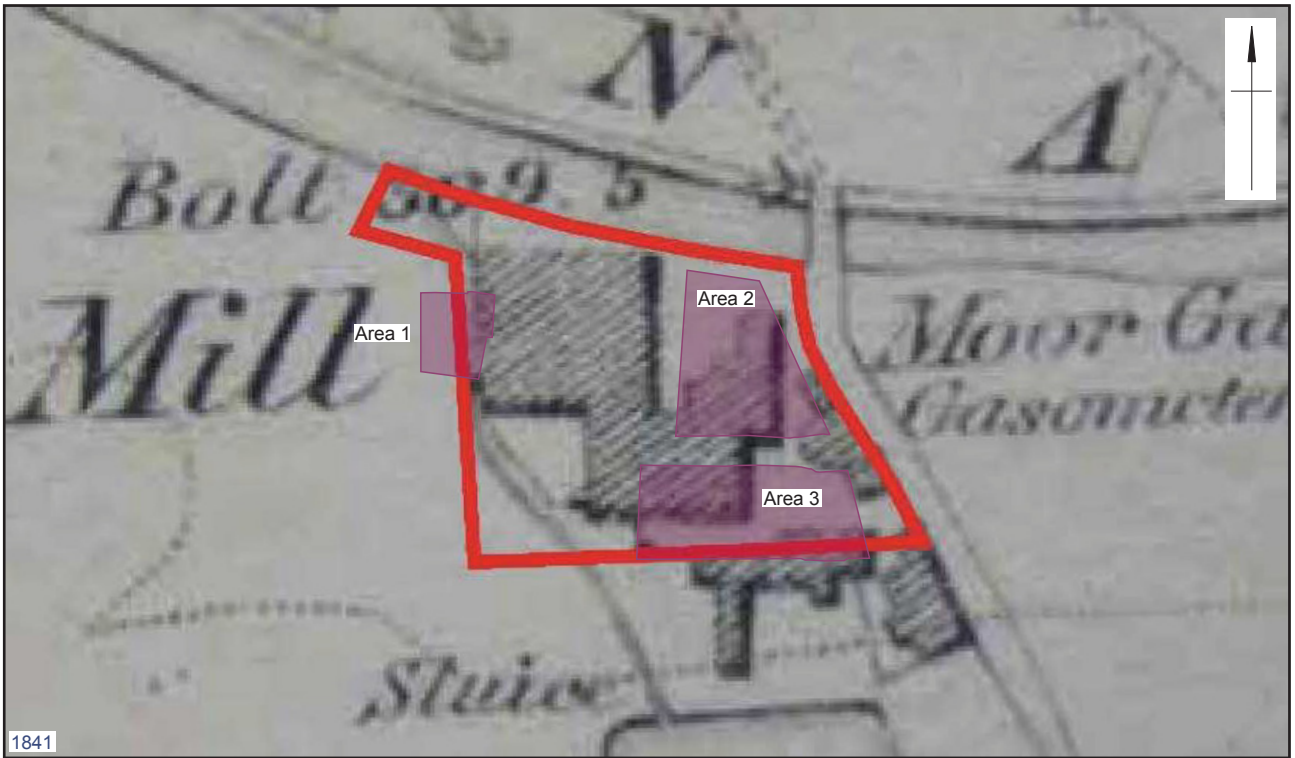
Figure 2

Excavation areas overlain on the 1841 and 1896 OS Maps

7.1.3 In **Area 2** the general outline of the original warehouses coursed rubble stone wall footings appeared to have survived; these can be speculatively tied in with the 1841 OS map. The building foundations on the eastern side of the mill building most likely enclosed the steam engine and boiler room. The 1841 map also shows a gas holder on the Moorgate Street frontage in the early phases of development. Firebrick, possibly from a gas retort arch, was found in this area. This indicates that originally gas may have been produced in this part of the Site, most likely for lighting in the Mill and associated buildings. Further foundations were identified in the south east of the area relating to buildings on the Moorgate Street frontage.

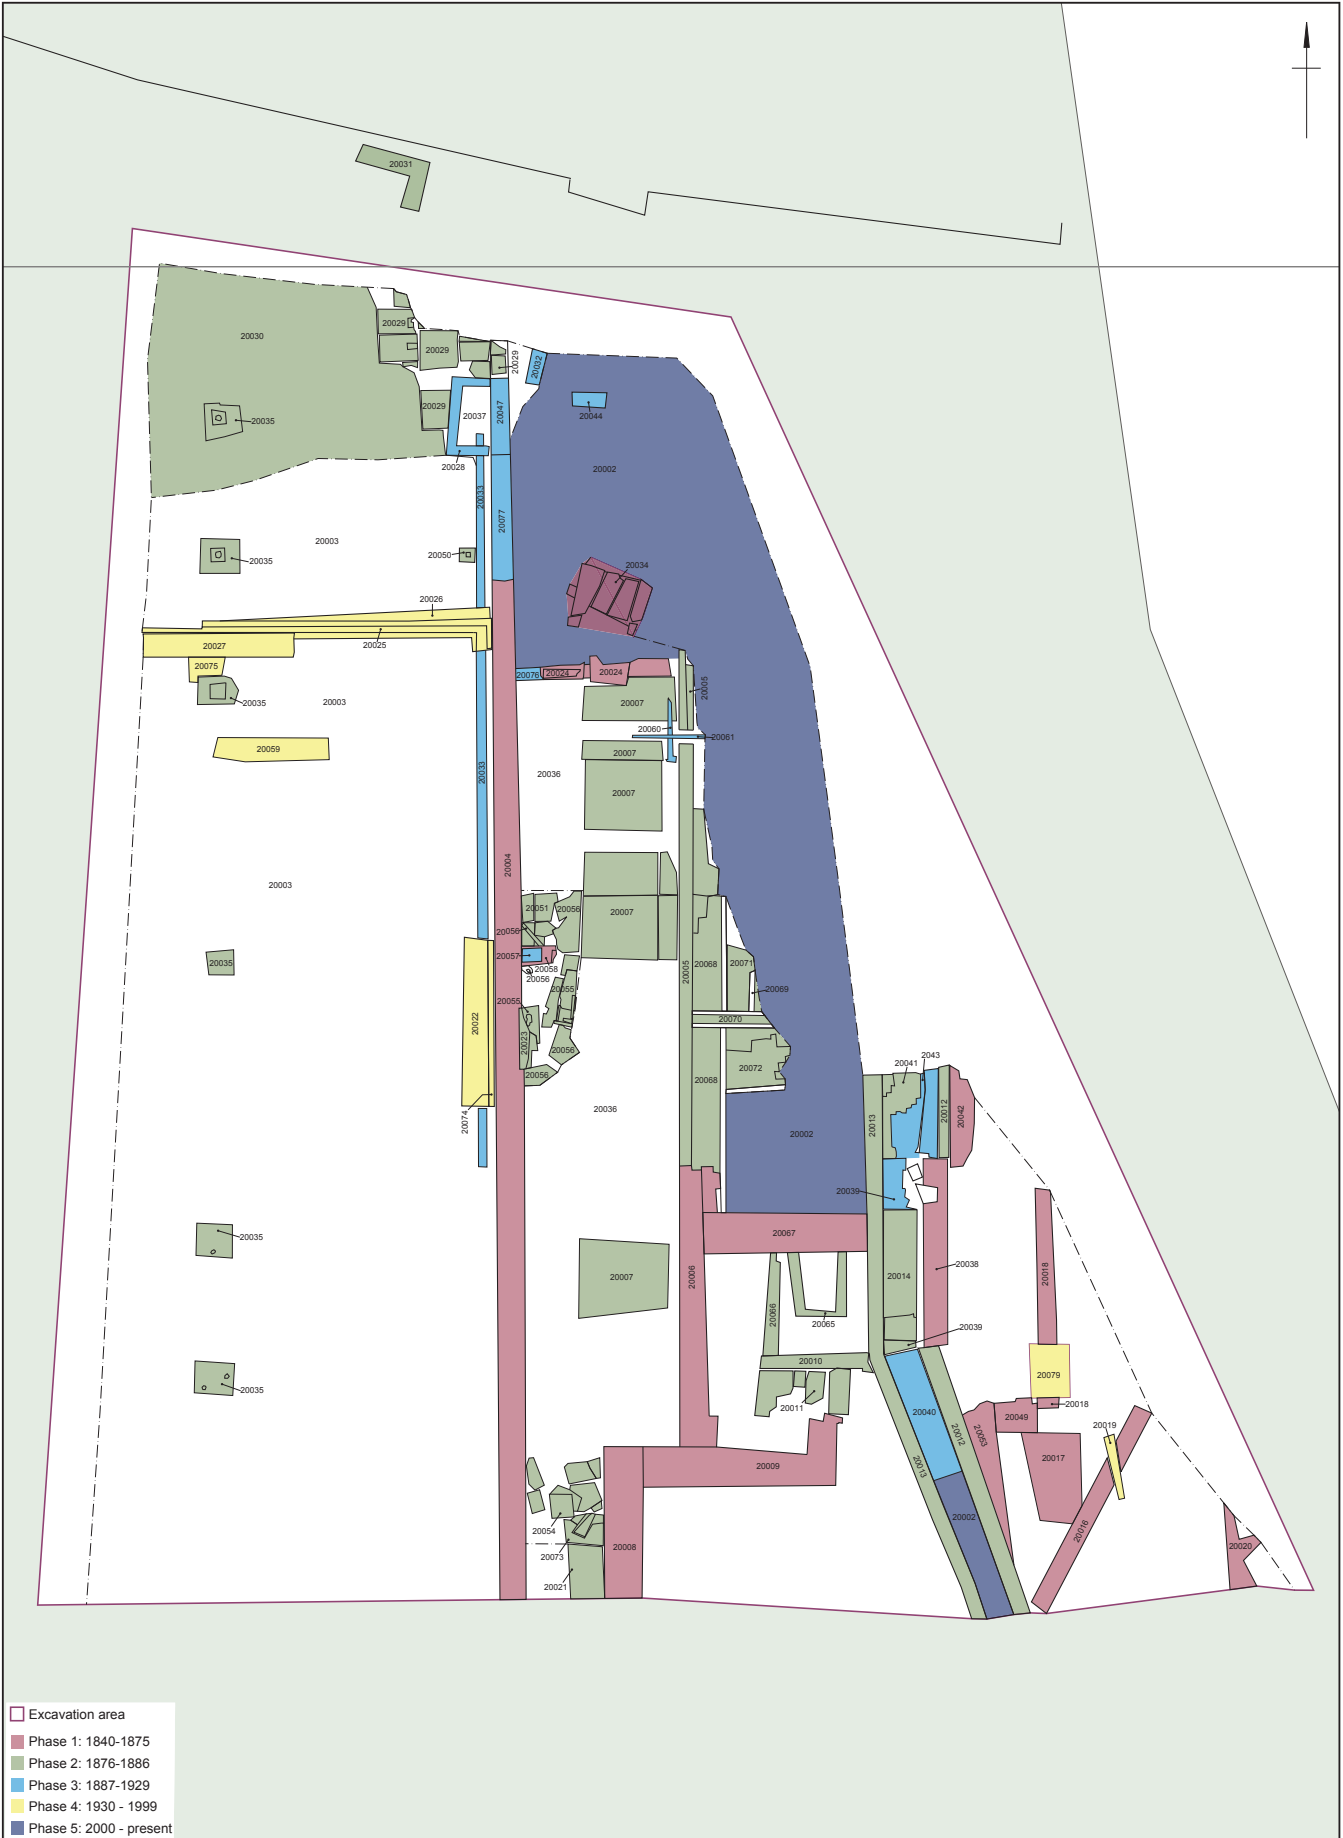
Figure 5

- Excavation area
- Phase 1: 1840-1875
- Phase 2: 1876-1886
- Phase 3: 1887-1929
- Phase 4: 1930 - 1999
- Phase 5: 2000 - present

Plan of identified features in Area 2

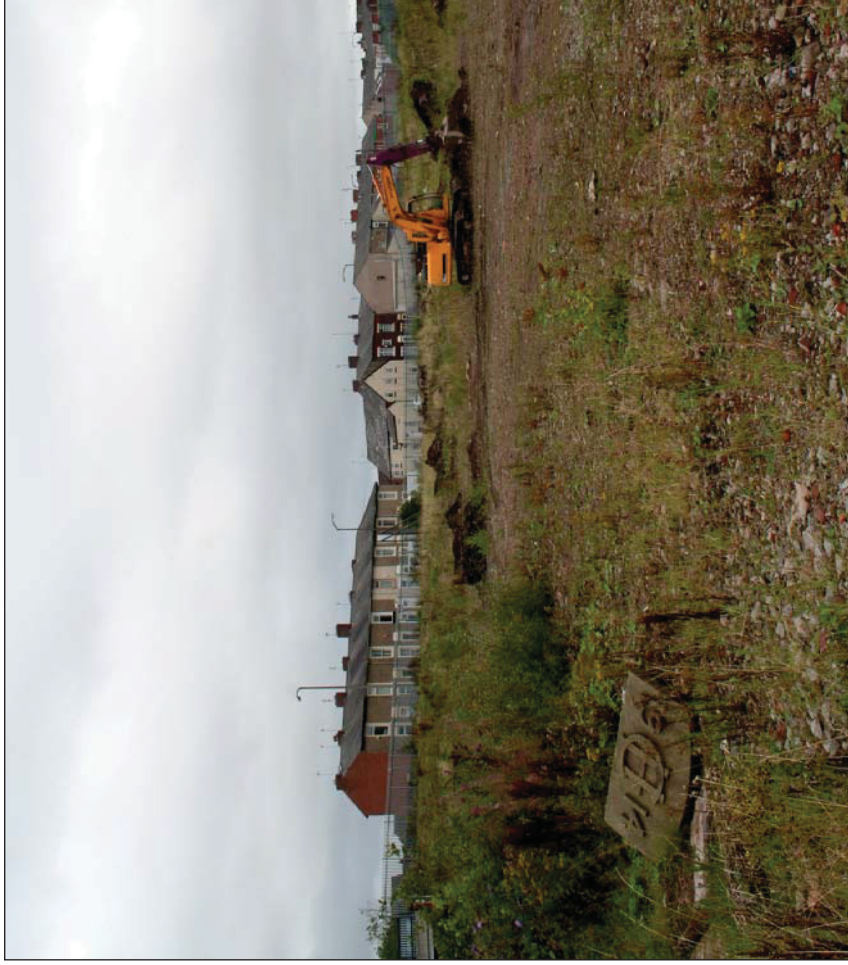
Figure 6
Plan of identified features in Area 3

- 5.4.1 **Area 3** was located to the south east of the Site across buildings shown on the 1841 OS map and later mapping (**Figure 2**). Over half of the stripped area (the western half) was completely free of archaeology, with no sign of mill structures.

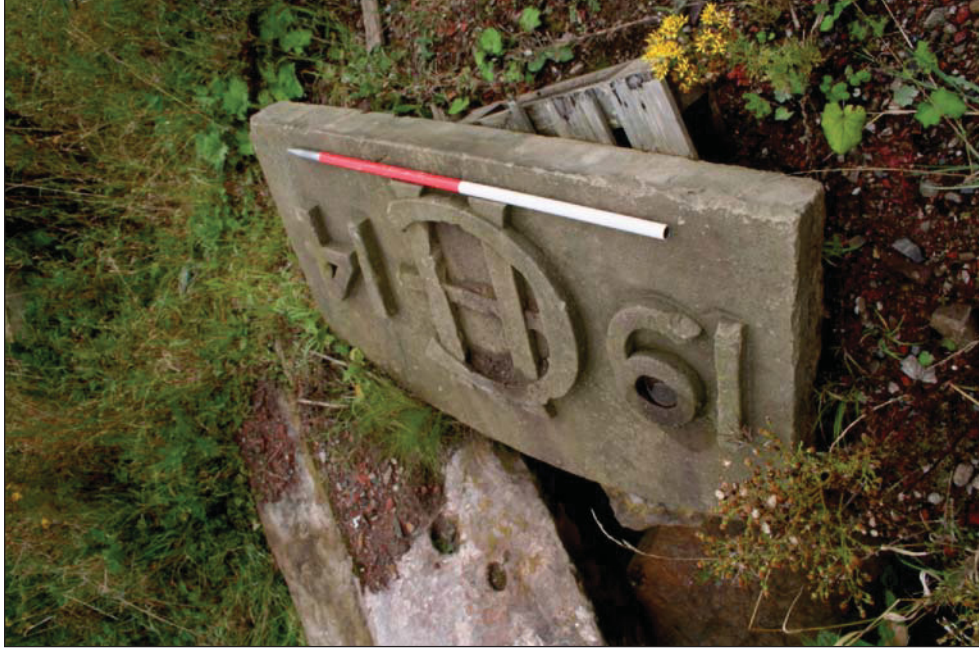
Plate 1: General shot of the Site, prior to excavation.

1.2.2 The Site (**Plate 1**) is approximately 0.78 hectares in extent, bounded by the Leeds and Liverpool Canal to the north, late 19th century terraced houses along Moorgate Street to the east, public space to the south, and modern detached houses along Tresco Close and Bentham Close to the south west and west, respectively.

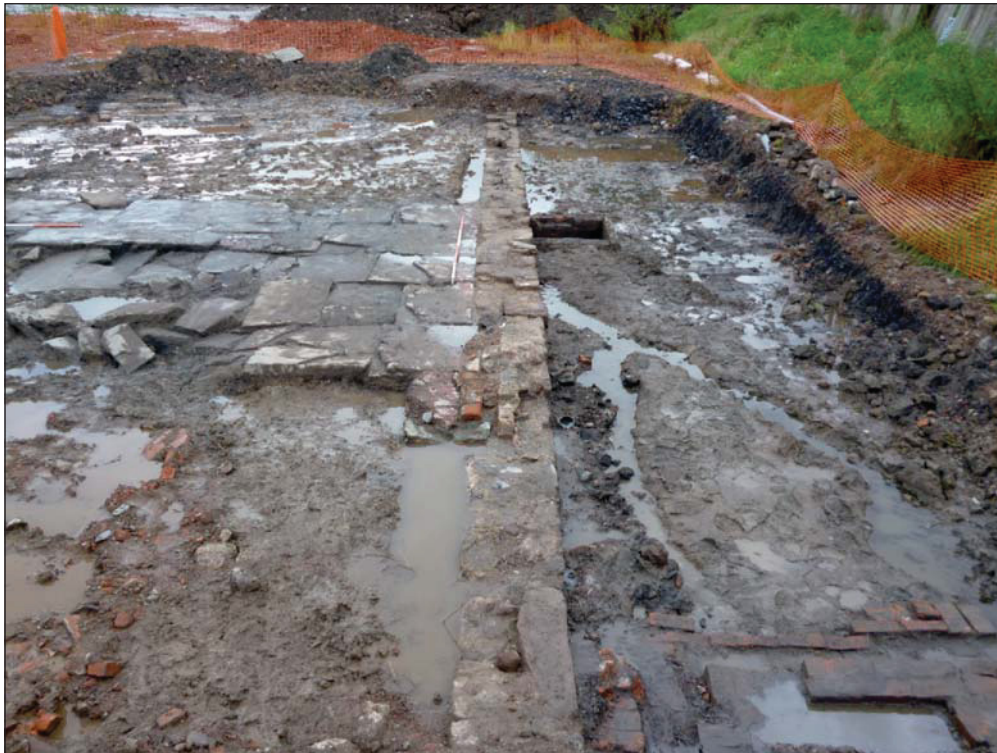
Plate 3: Area 1. General view, looking south, showing wall **10002** and floor **10011**.

- 5.2.5 A partial flagstone floor **10001** covering an area of approximately 5m² (**Plate 3**) is likely to date from the renovation of the weaving sheds in 1876. Occasional broken flagstones were observed in the demolition rubble **10008** beyond the floor.

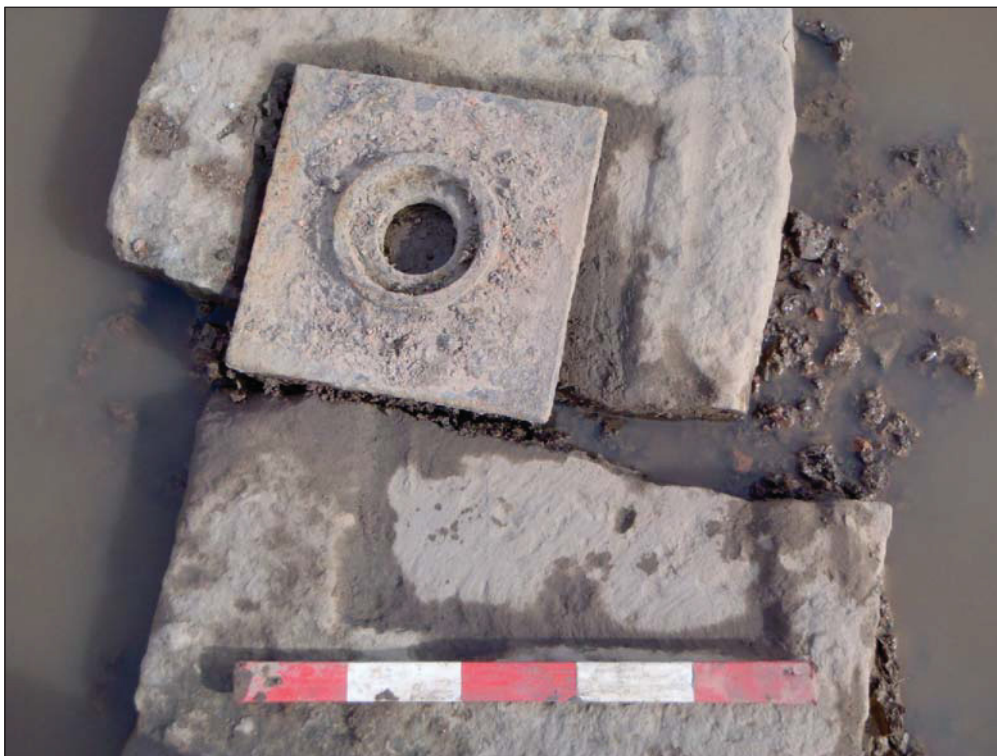
Plate 4: Area 1. Stone plinth with cast iron base plate for roof support **10010**.

10009	Layer/Deposit	Clay natural	Mid-yellowish brown clay natural. Has occasional inclusions pressed into the surface. Same as 20003 and 30002 .	0.5m + below ground surface (Unexcavated)
10010	Masonry	Stone plinths x4	Four sub rectangular sandstone plinths with various details and metal stains, probably bases for roof struts in the weaving sheds; plinth number 2 has the square metal plate still present. Very similar to 20035 in Area 2 .	Approx. size is 0.60m x 0.95m. Thickness is a minimum of 0.1m.

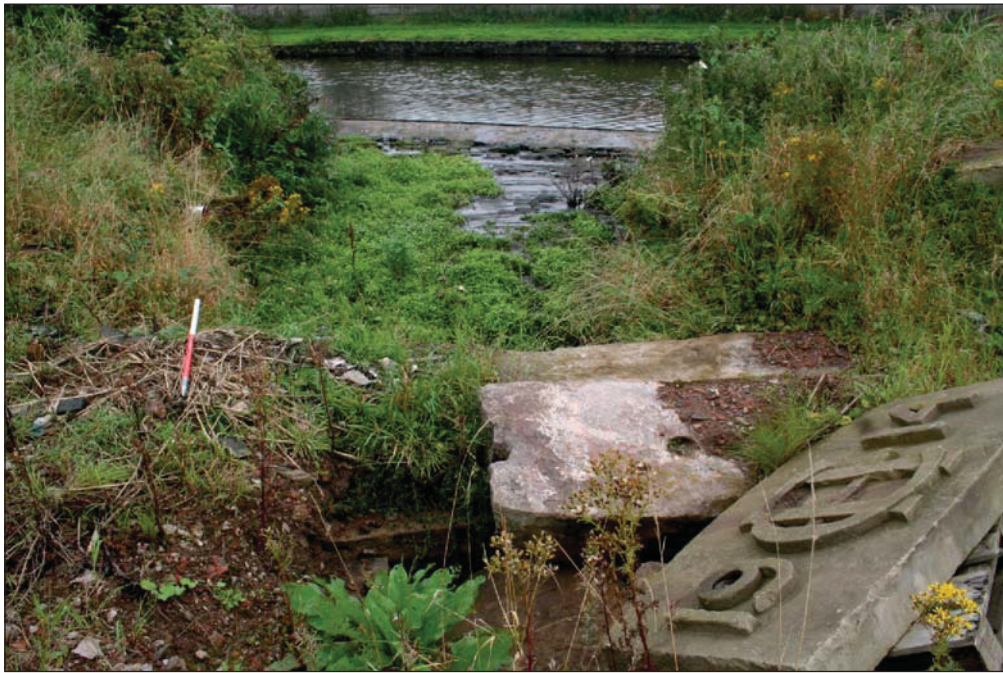
Plate 5: Area 1. Overflow channel observed during watching brief.

5.2.10 The later internal chamber was aligned roughly with the north north west to south south east running overflow channel from the canal observed during the earlier watching brief (**Plate 5**), and presumably fed into this channel under the building.

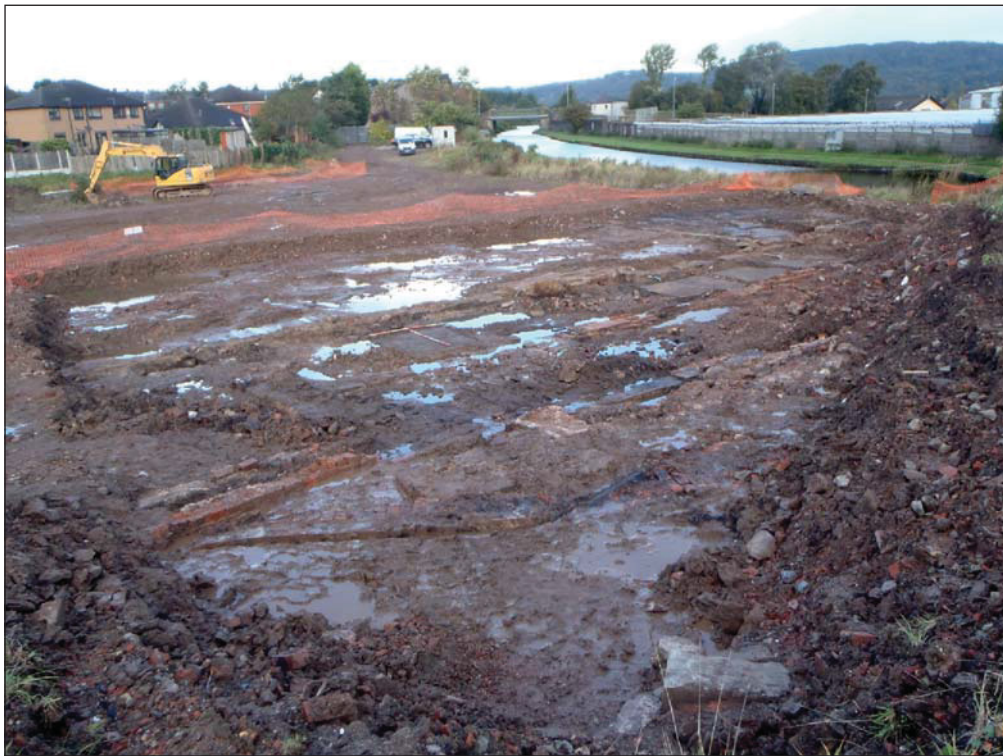
Plate 6: Area 2 General view looking north-west.

5.3.1 **Area 2** was located to the east of the Site (**Plates 6 and 7**) across the eastern side of the mill complex close to Moorgate Street and along the western side of buildings on the street frontage, including the area of a 'Gasometer' shown on the 1841 OS map (**Figure 2**). Natural clay geology **20003** was encountered particularly to the west of the area.

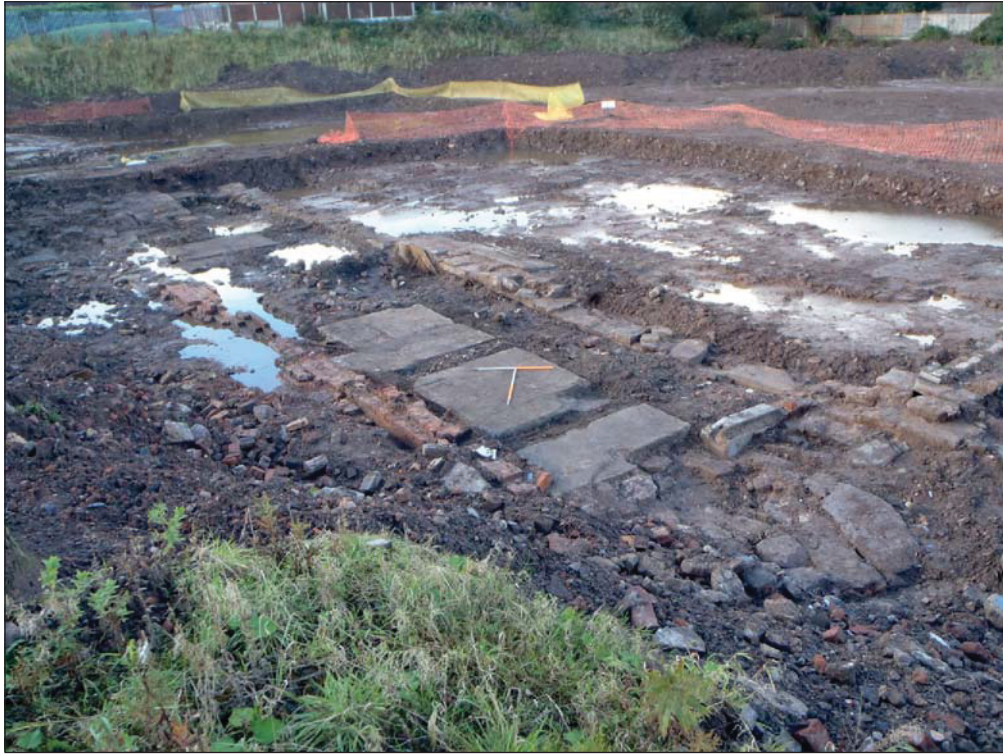
Plate 7: Area 2. General view looking south-west.

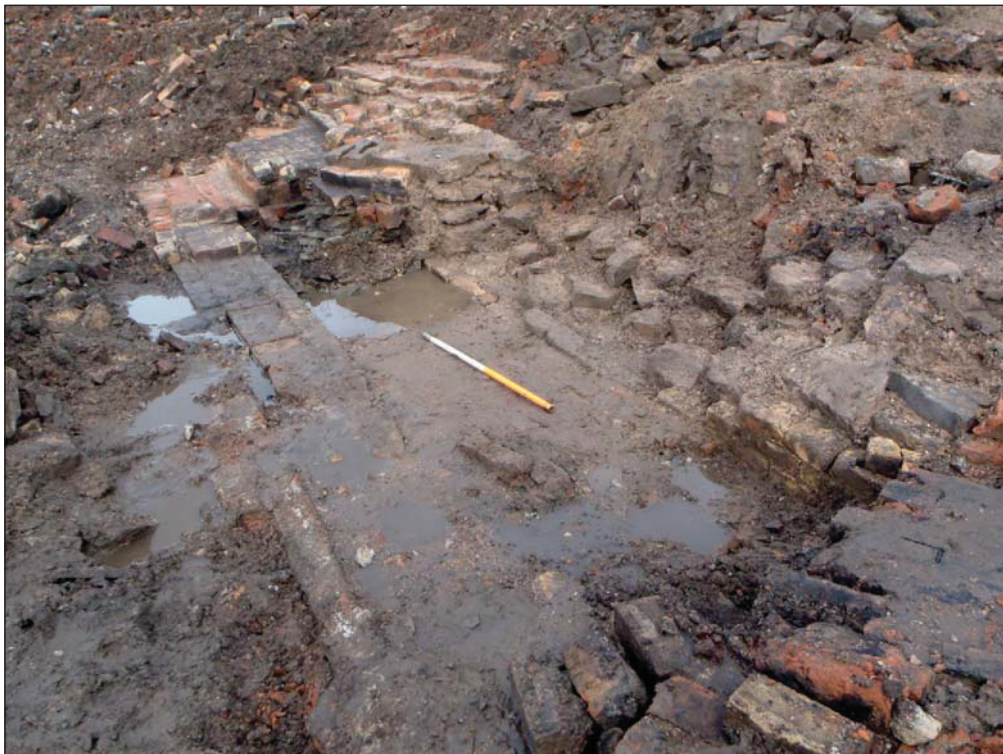
Plate 8: Area 2. Detail of flue structure including early stone wall **20038** and floor alterations.

- 5.3.17 The eastern wall of the flue **20012** was constructed around existing stone walls **20038**, and brick walls **20042** and **20053**.
- 5.3.18 The floor surface within the flue has seen at least two levelling phases, the lowest excavated layer observed was reddish orange sand packing **20041**, this was overlain by red irregular sized handmade bricks **20014** arranged on edge in a stretcher formation. There was a huge variation in the brick types which the lower layers were constructed from, including frogged/unfrogged/handmade/machine made, this suggests re-use of bricks already to hand.

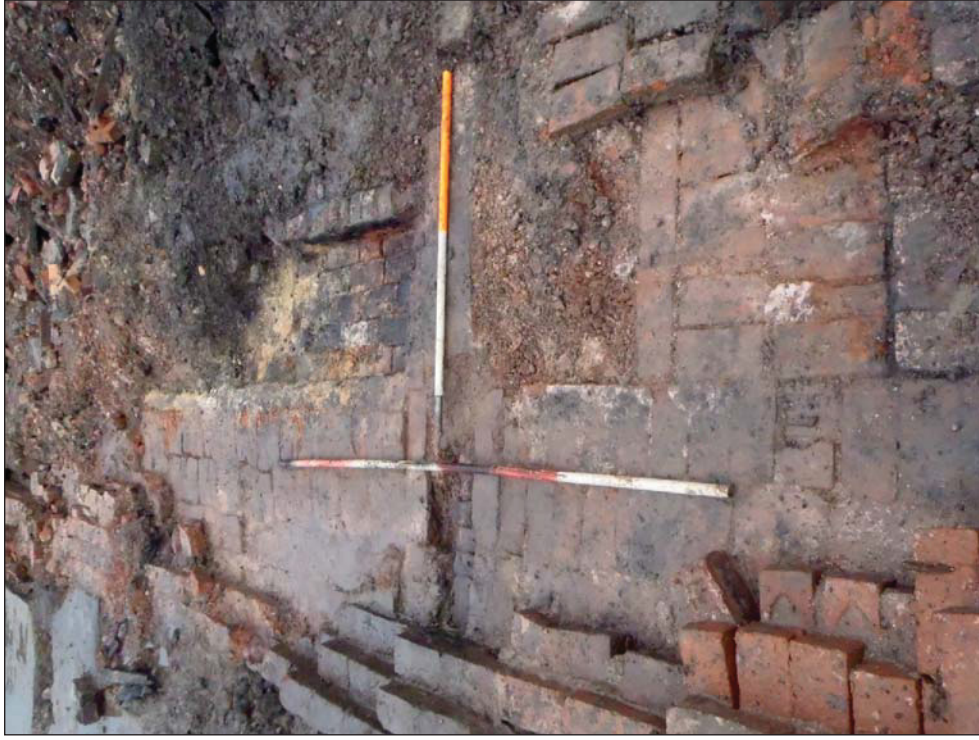
Plate 9: Area 2. Wall **20005** and fire brick boiler structure **20072**.

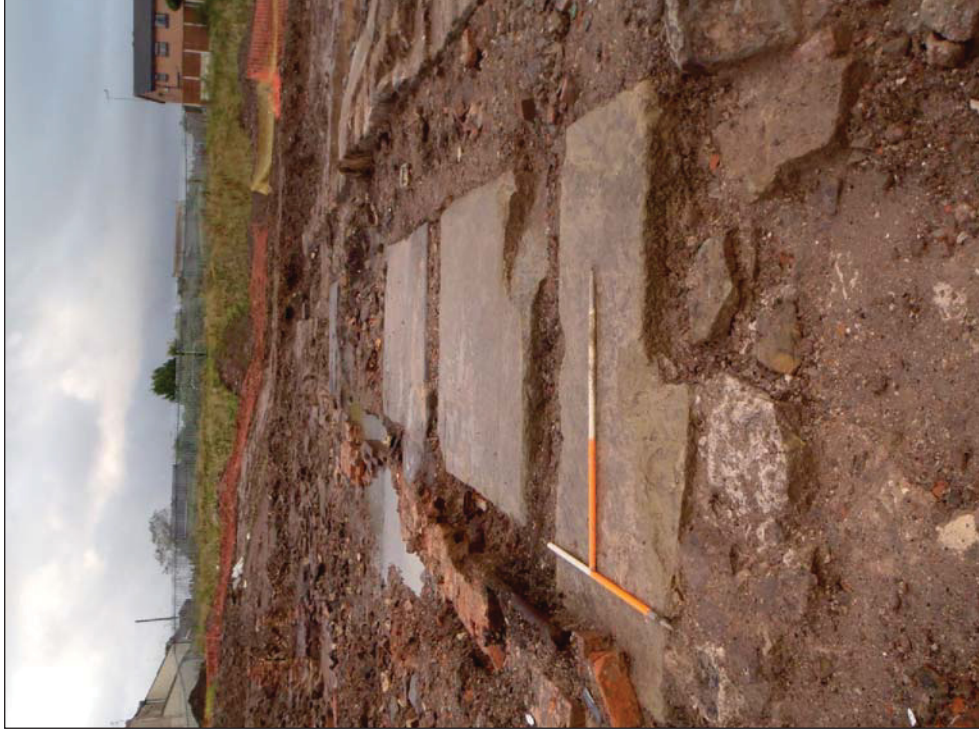
Plate 10: Area 2. Pad stones **20007**.

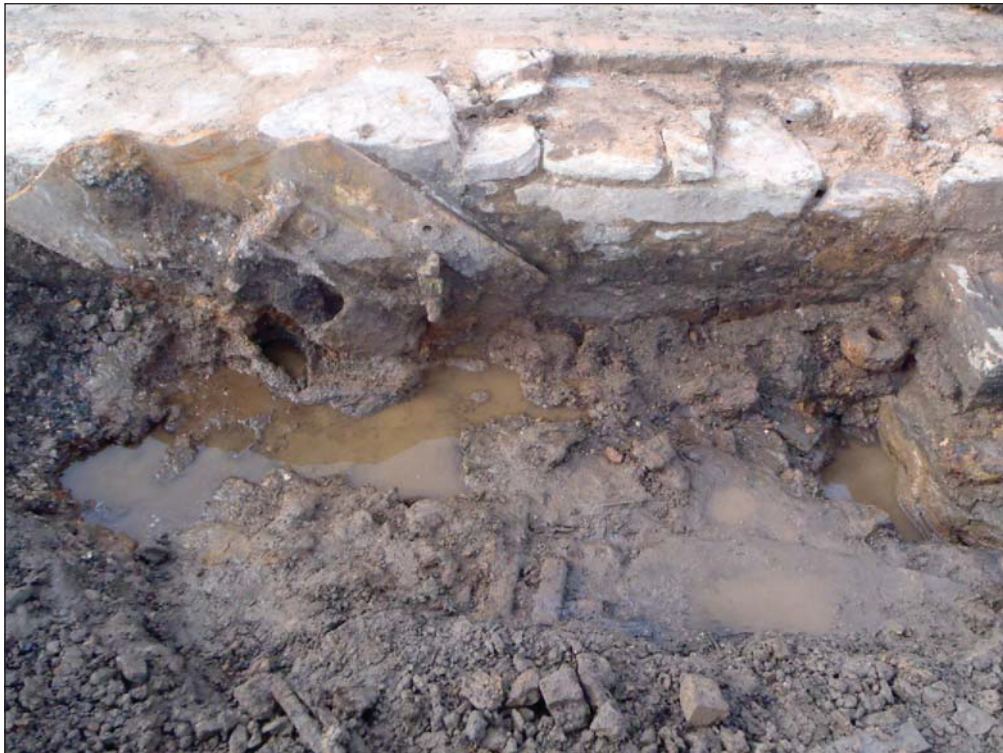
Plate 11: Area 2. Machinery plate **20023**.

- 5.3.14 A sondage was excavated in the sooty clinker deposit **20036** between **20007** and large metal plate **20023 (Plate 11)** riveted to wall **20004**; this was excavated down to a depth of approximately 0.8m and a thick layer of corroded ferrous material was encountered **20056** sitting on top of possible stone floor **20051/20055 (Plate 12)**. The metalwork found beneath layer **20036** was potentially from boiler/steam engine components rusted *in situ*, perhaps they were damaged during one of the fires (there was a high proportion of ash/soot within deposit **20036**).

20023	Fitting	Metal plate	Metal plate with attachments bolted to wall 20004 . Bracket for a large piece of machinery. Probably contemporary with corroded metal fragments 20056 .	1.63m x 0.23m. Approx. 0.80m max depth excavated.
20024	Masonry	Stone wall	Rubble stone wall with lime mortar butting brick wall 20005 . Adjacent to brick buttress (?) 20076 , possibly including a door jamb. Very haphazard with little definition. Not fully excavated.	3.32m x 0.40m. 0.30m depth excavated to.
20025	Masonry	Brick wall	Two single courses of pink brick, a bricks width apart, sitting on top of concrete surface 20026 . Associated with 20027 . Majority of bricks are frogged or have	8.7m x 0.30m Bricks are approx. 0.22m x 0.10m. 0.07m thick.

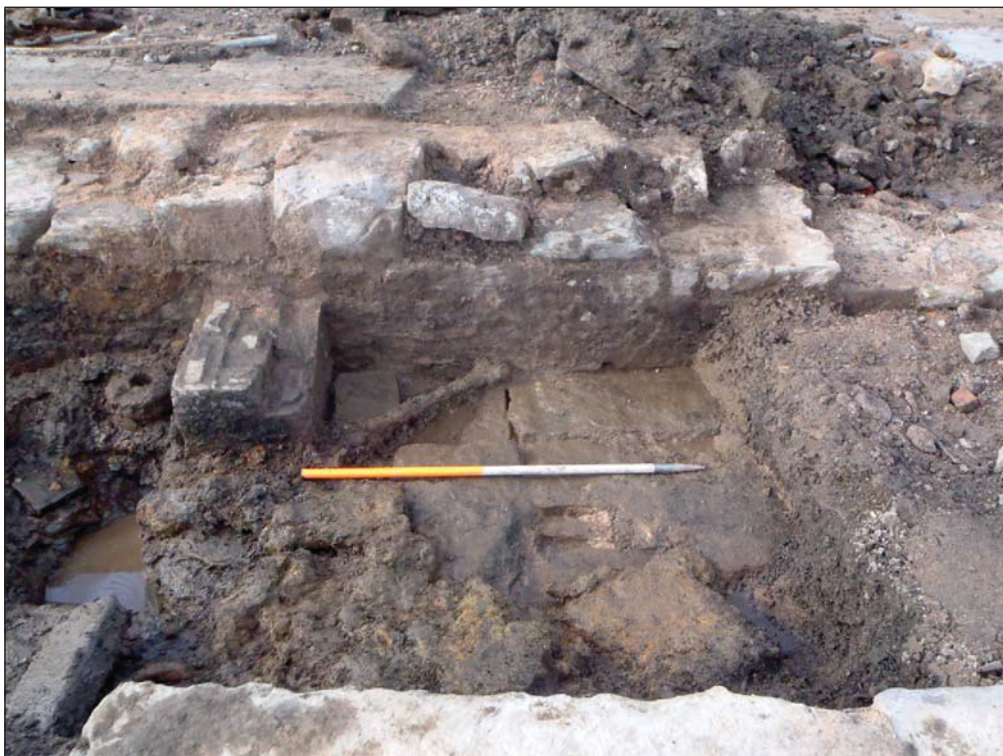
Plate 12: Area 2. Original floor **20051** & partition **20058**.

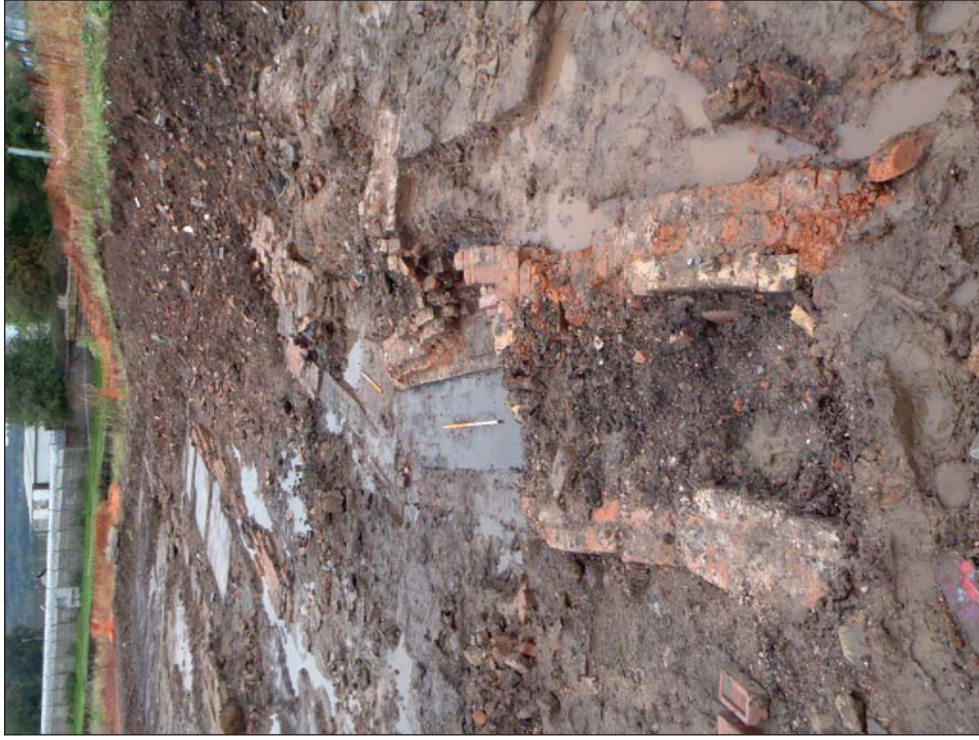
Plate 13: Area 2. Overall view of flue looking north.

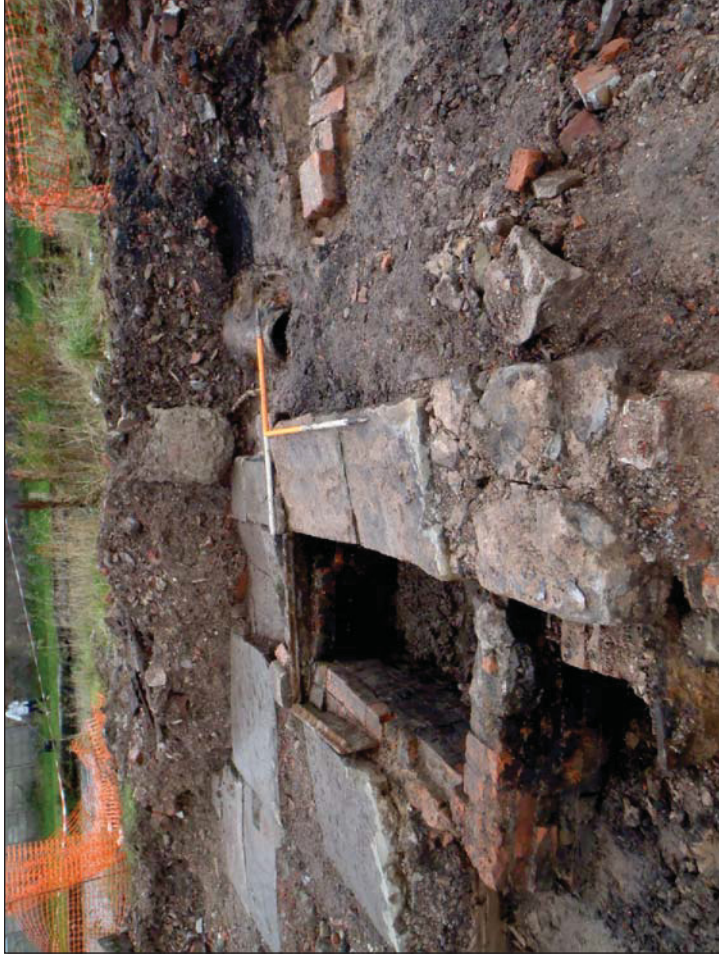
Plate 14: Area 2. Wall 20047.

- 5.3.24 There are two new structures visible on the 1911 OS map located in the northern part of the Site which could account for alterations in this area. Visible developments on-site included the sections of wall **20047** and **20077** at the end of **20004**, forming the eastern wall of tank **20028** (**Plates 14/15**). This was a sub rectangular structure, roughly 1.7m x 1.4m, built of red bricks, including air bricks, bonded with a black ash mortar and backfilled with silty sand **20037**. Below this was silt with a pungent odour **20048**.

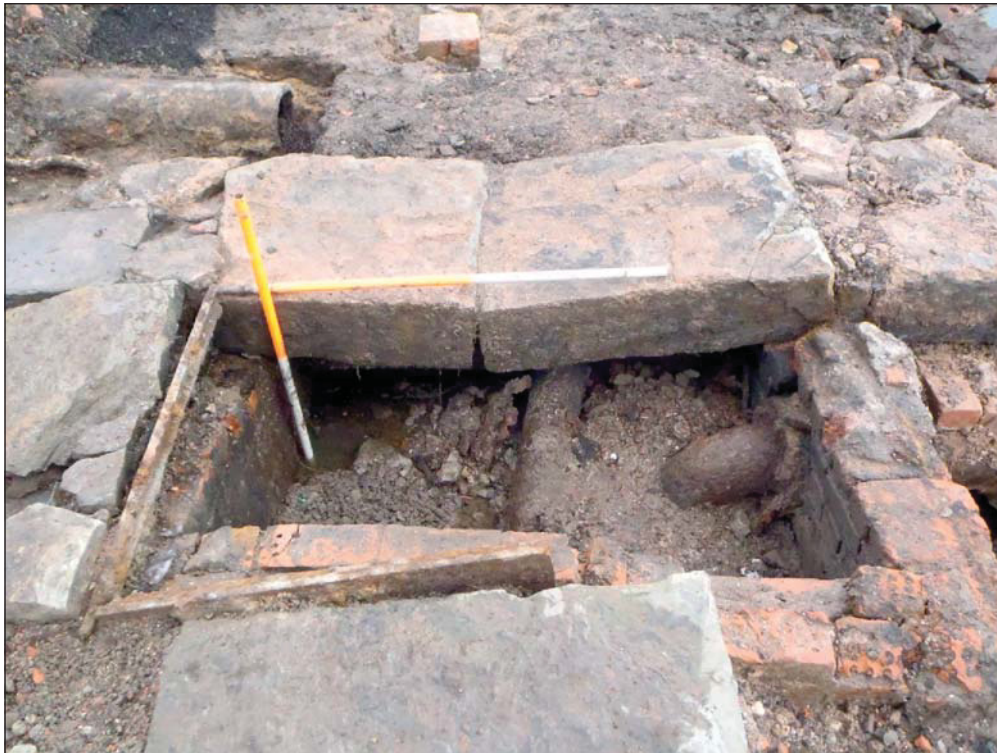
Plate 15: Area 2. Tank structure **20028**.

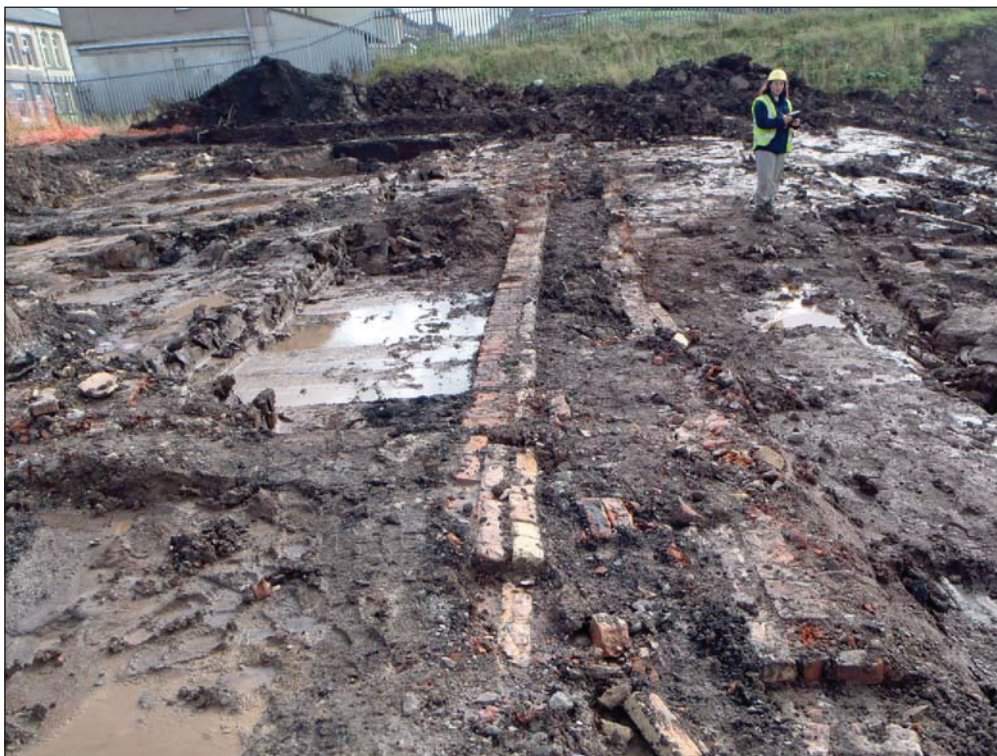
Plate 16: Area 3. Continuation of flue.

30005	Masonry	Red brick	Eastern red brick flue tunnel wall with sandy lime mortar aligned N-S. Three courses thick, the inner skin is composed of heat affected yellow fire bricks. Same as 20012 in Area 2 .	> 18m x 0.36m. Bricks same as above.
30006	Masonry	Stone plinth	Sandstone plinth with rusted metal plate attached to it – roof strut? Located on the NE corner of concrete structure 30003 .	0.8 x 0.7m
30007	Masonry	Stone plinth	Sandstone plinth with brick and slate inclusions. Located on the NW corner of concrete structure 30003 .	1.04 x 1.2m
30008	Masonry	Stone surface	Remains of irregular shaped stone flags arranged against the south wall of concrete structure 30003 .	2.6 x 0.74m
30009	Masonry	Stone buttress	E-W aligned rubble stone section of wall with sandy lime mortar, to the west of wall 30004 . One of several buttresses along the flue walls.	1.10 x 0.77m
30010	Masonry	Stone buttress	E-W aligned rubble stone section of wall, to the west of 30004 , also west of buttress 30011 . One of	0.7 x 0.93m

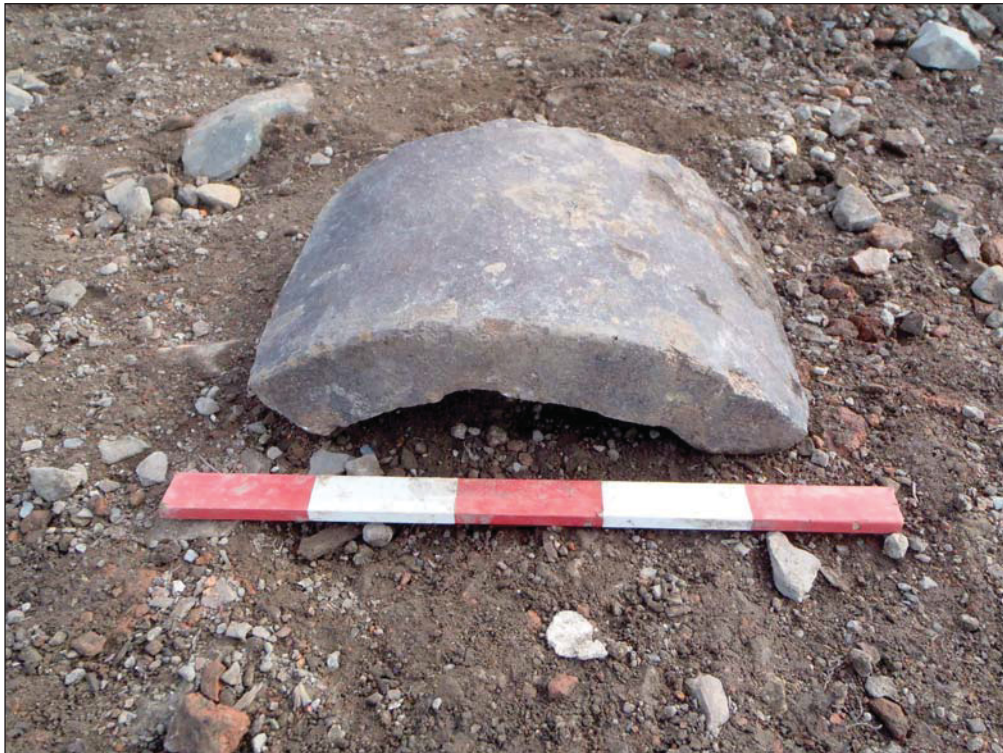
Plate 17: Area 2. Firebrick retort arch.

- 6.4.1 This category consists exclusively of wall tiles, mainly small, flat whiteware tiles, sometimes with transfer-printed designs (examples came from **Areas 2** and **3**), but also including a glazed terracotta decorative tile from a dado rail or similar horizontal architectural detail (context **30019**).
- 6.4.2 A number of maker's marks were noted on bricks, detail of which is provided in **Appendix 3**. In addition, a large arched section of firebrick (**Plate 17**) may be the surround for a gas retort.
