Canon Street Car Park, Taunton, Somerset

Archaeological Watching Brief Report

Ref: 103190.02
June 2014

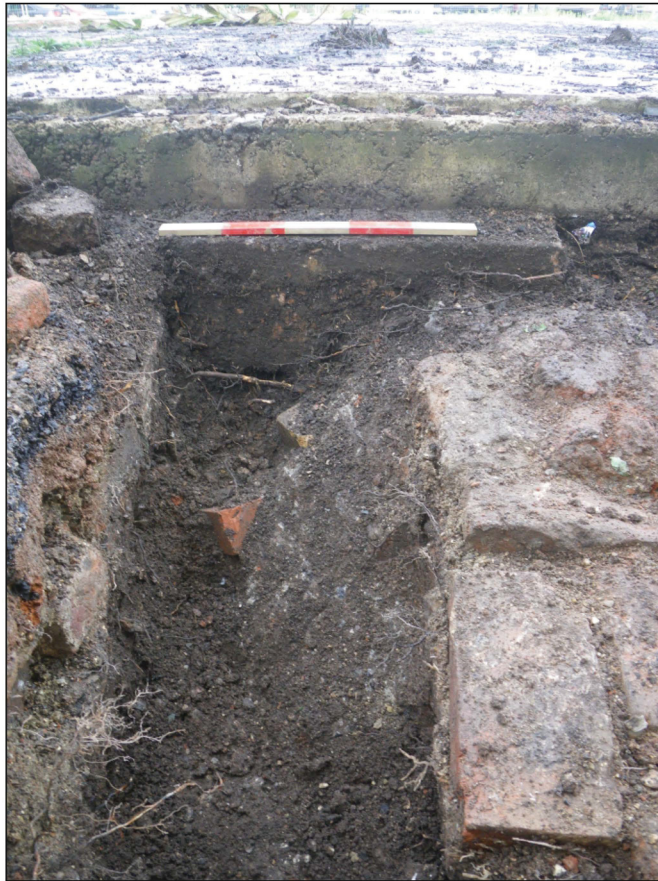
Plate 1: SW facing section of test pit 1

4.2.5 The surviving remains of the former 'The Chestnut Tree' building consist of 3 layers of concrete (**110**), (**111**) and (**112**). These deposits are found at the northeastern end of the test pit and were contained within construction cut (**116**) which cuts into the top of the post-medieval deposit **106** (**Plate 1**). A modern water pipe service (Feature 113 and fill 102) lay immediately adjacent to the concrete foundation base (**Plate 1**).

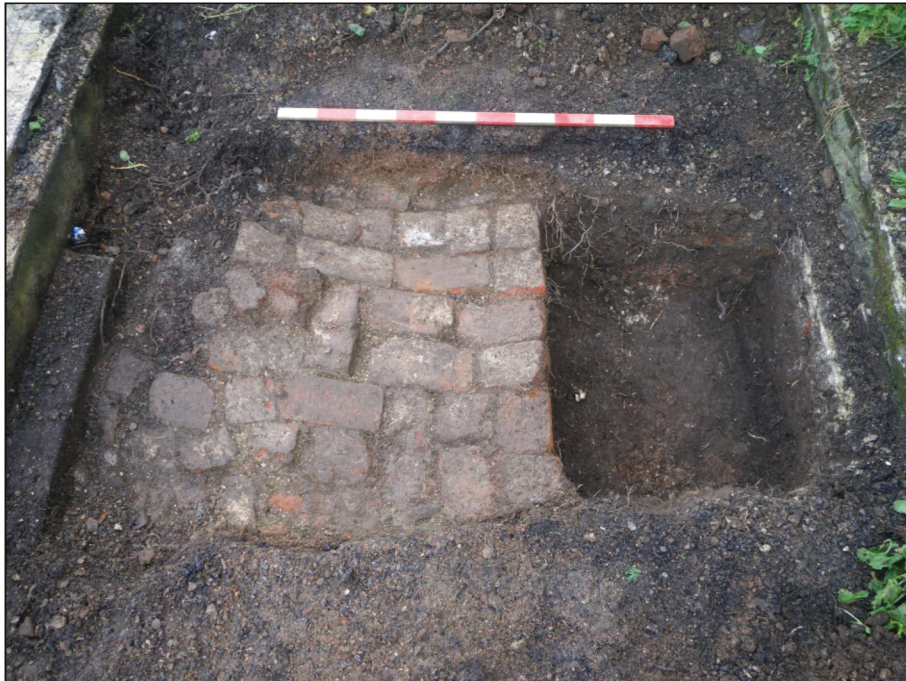
Plate 2: NW facing section of test pit 1

4.2.6 The southwestern end of the test pit is formed by a modern wall (**108**) which supports the extant remains of the Borough Bank. This wall was constructed of large slate stone and concrete and sits on concrete foundations (**109**) which are contained within construction cut (**115**) (**Plate 2**).

4.2.7 Surface (**105**) is a single layer of regularly lain bricks (one course thick) with no bonding agent that has likely been laid down as a pathway or a shallow platform (**Figure 2, Plate 2**). The bricks appear to have been re-used from another structure. This surface immediately cuts into the post-medieval layer (**106**). The surface that these bricks form is slightly slumped in the centre which is probably the result of settling of the underlying levelling layer/backfill (**106**) and the presumed deeper Borough ditch fills (not observed during these excavations).

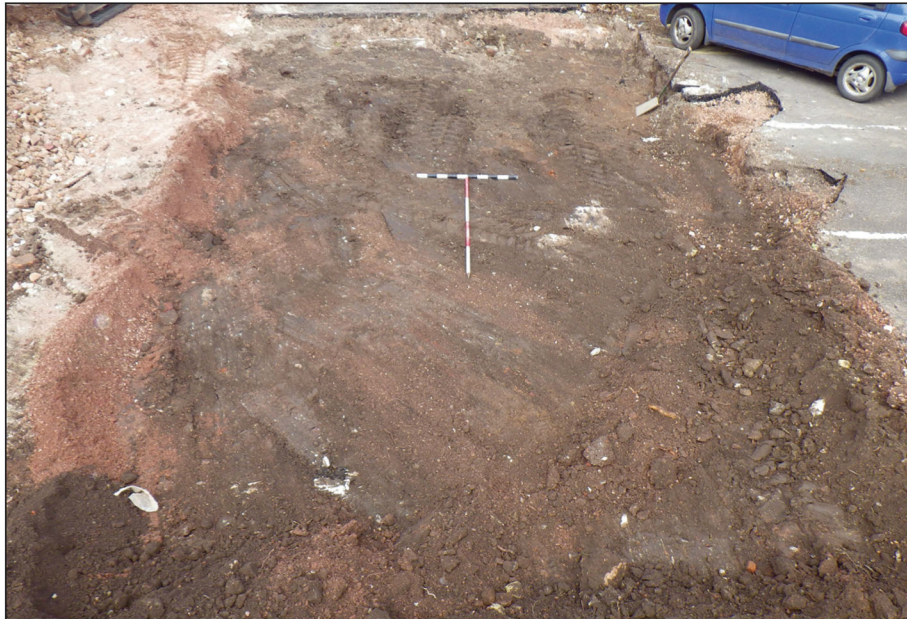
Plate 3: View from SE of layer (122) in Area 1

4.3.5 Layer(**122**) was observed in plan across all of Area 1 at 0.45m below the present car park ground level and underlay modern overburden (**Plates 3 and 4**). It consisted of a fairly compact layer of dark grey brown silty clay loam with mixed patches of yellowish brown clay (in the north east extent) and sparse charcoal, mortar and coal. Recovered finds from this layer included post-medieval pottery, tile fragments, animal bone, shell, clay pipe and glass.

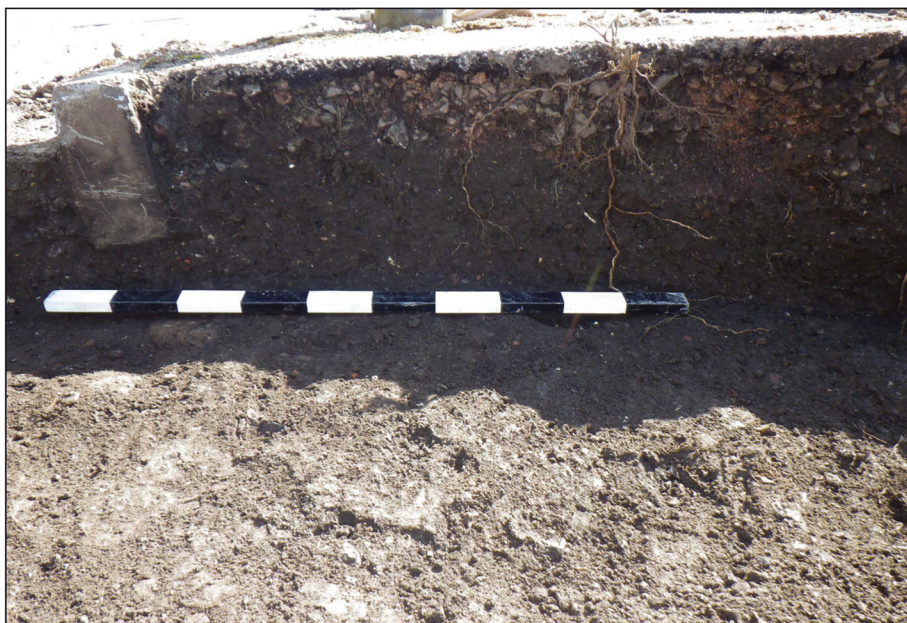
Plate 4: SW facing representative section in Area 1 showing modern overburden overlying layer (122)

4.3.2 The ground reduction required in Areas 1 and 2 was very limited, with a maximum depth of excavation of approximately 0.50m below the ground surface (**Plates 4 and 5**).

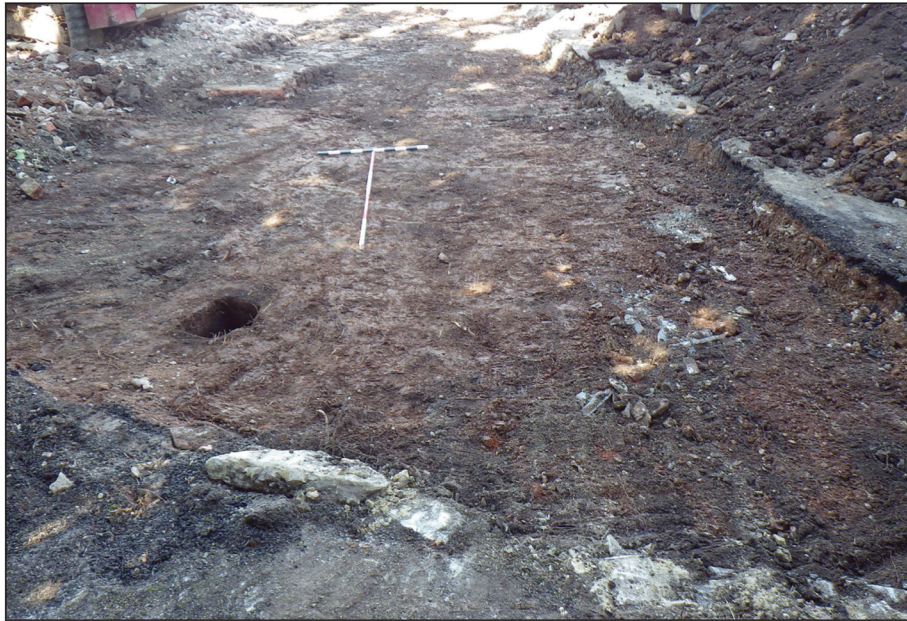
Plate 5: View from S of layer (123) with sondage in Area 2

4.3.6 Layer (**123**) was observed in plan across all of Area 2 at 0.15m to 0.20m below the present car park ground level and underlay modern overburden (**Plate 5**). It consisted of a compact layer of dark yellowish brown sandy clay loam. No artefacts were retrieved from this deposit. A small sondage was excavated by hand through this deposit which revealed it to be 0.25m deep and confirmed the presence of underlying archaeological deposits, layer (**124**).
