Waterfront Site, Mumby Road Gosport, Hampshire

Archaeological Evaluation Report

Ref: 86261.02

June 2014

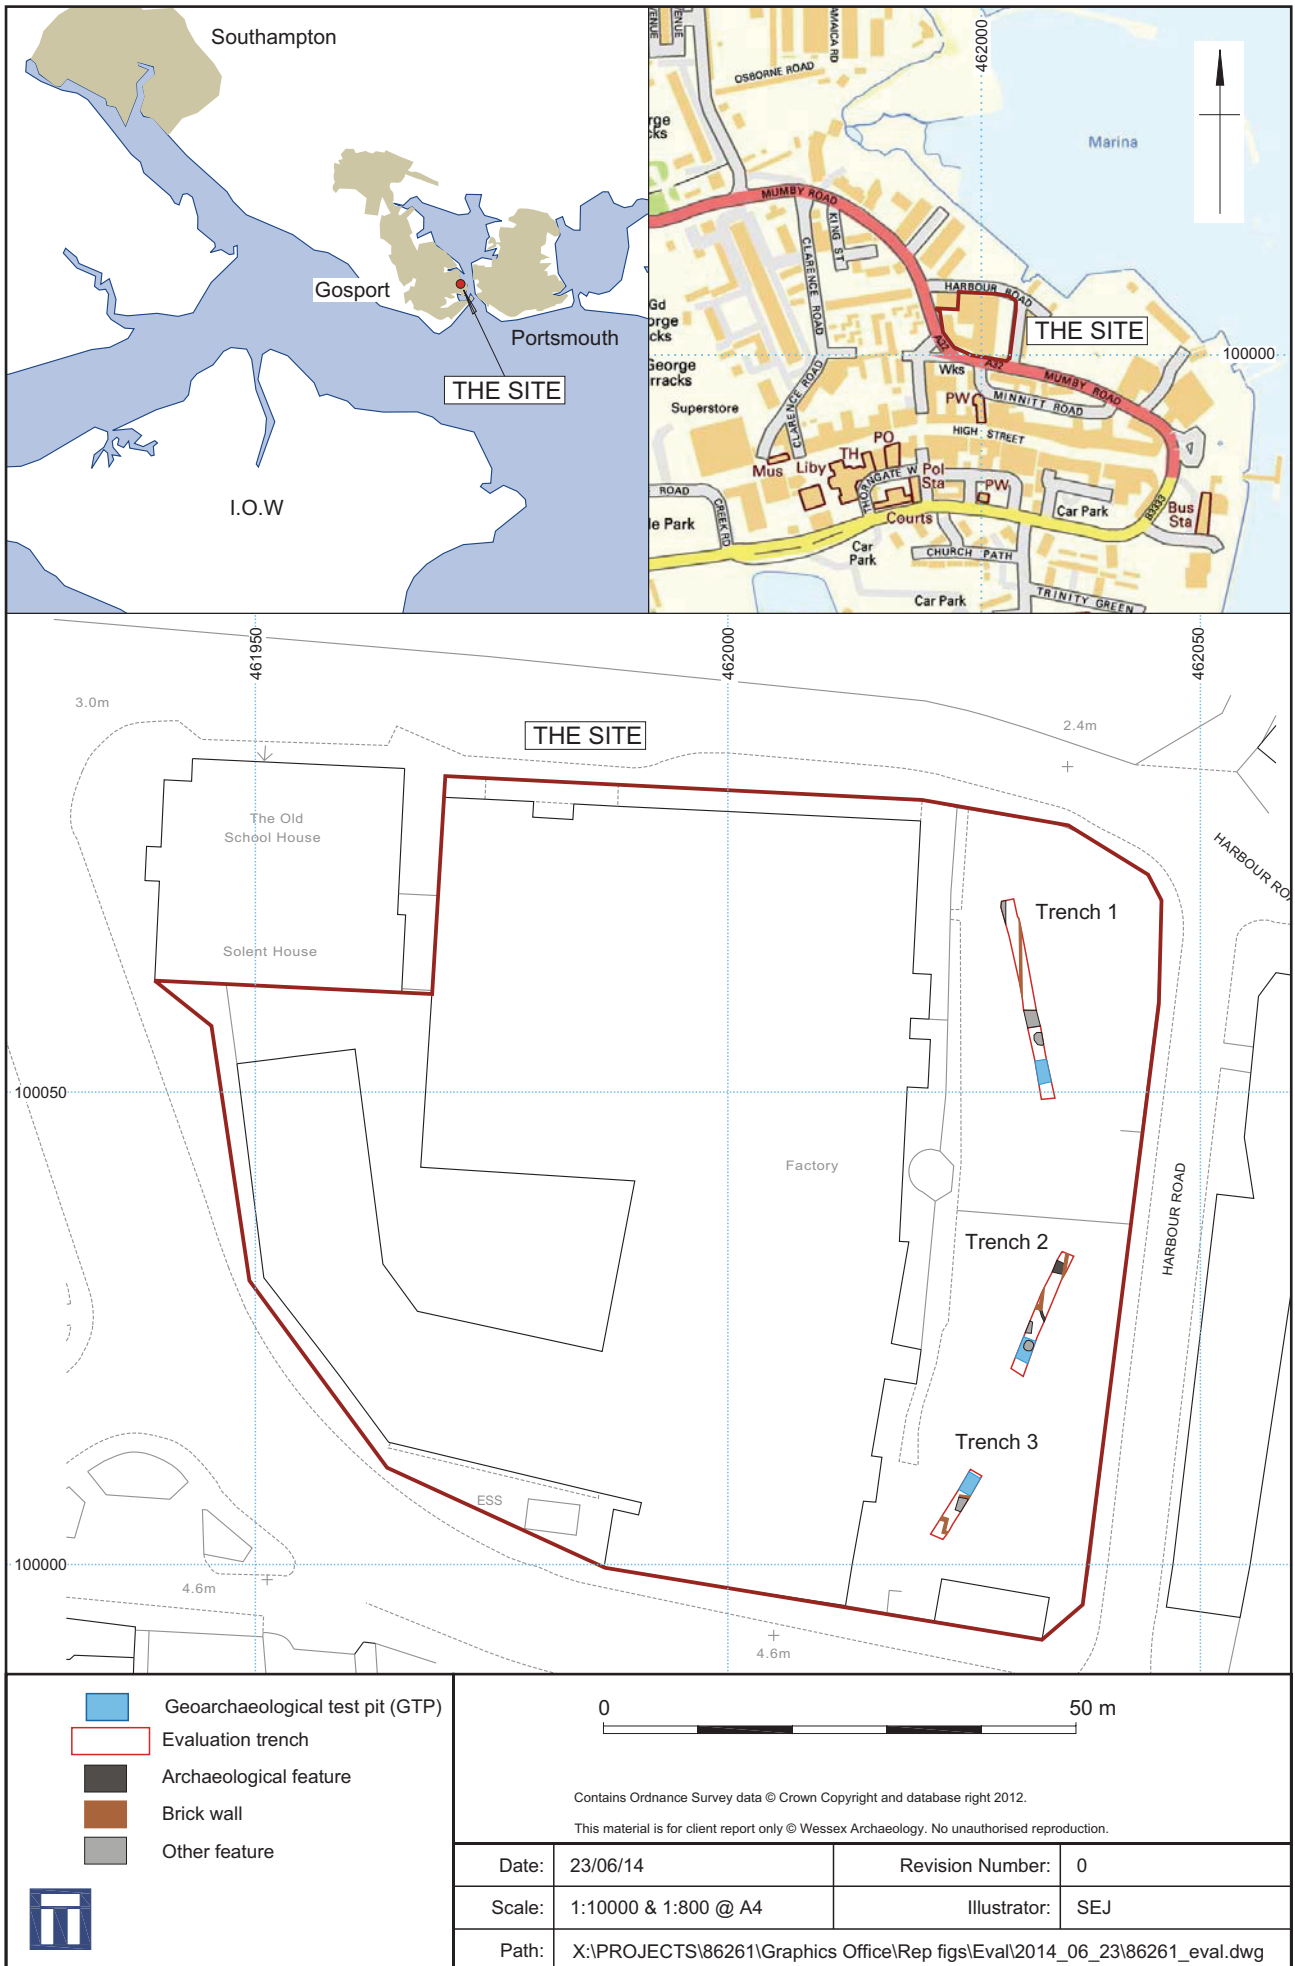
Figure 1

Site location and excavation area

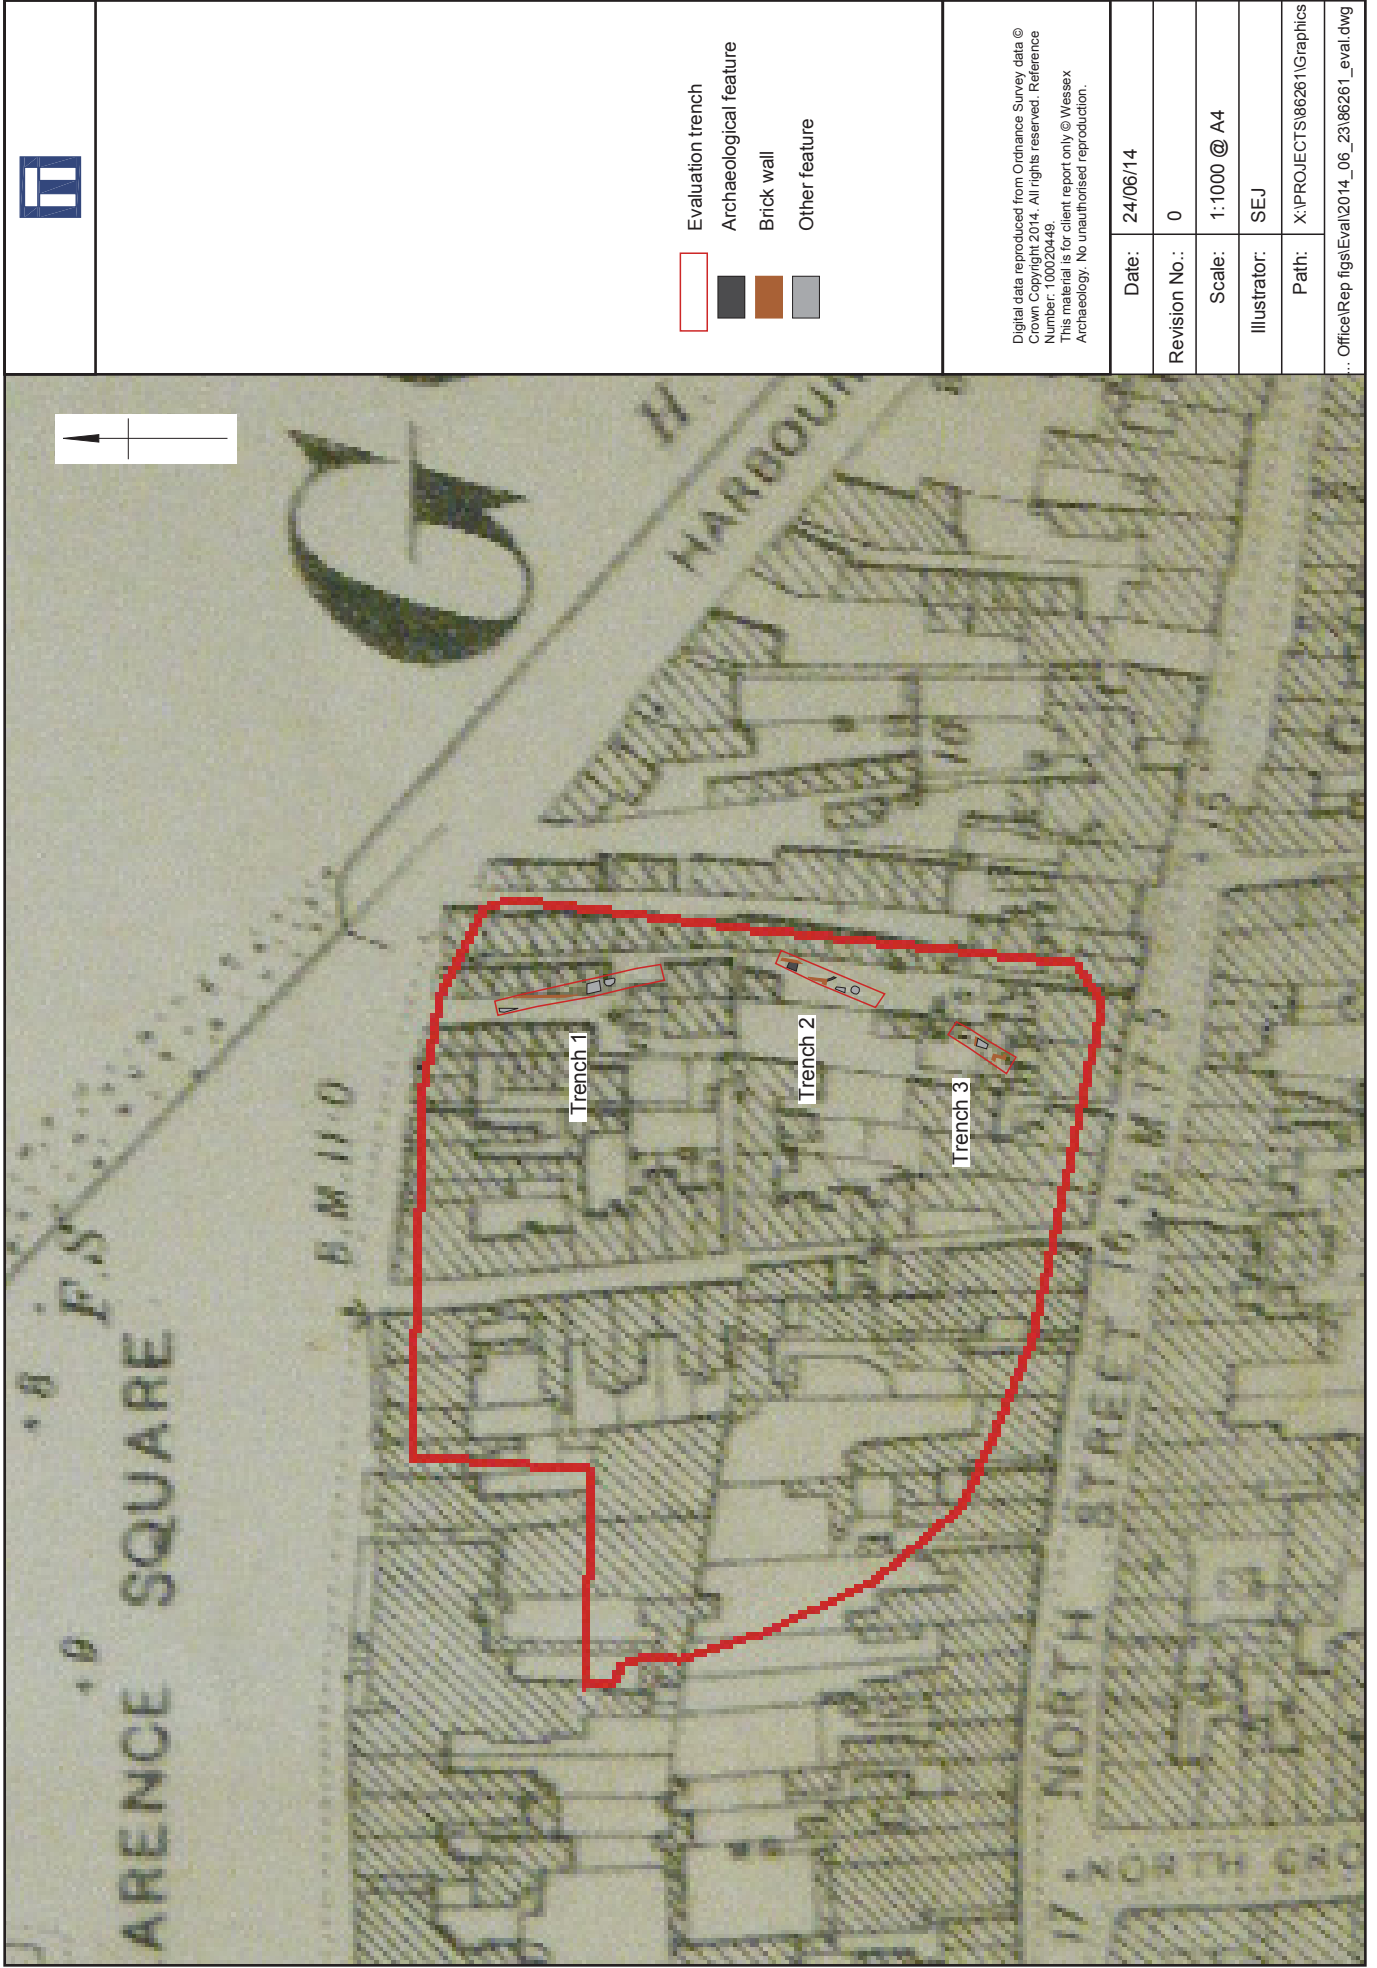
Figure 3

1898 Ordnance Survey map showing the site boundary and trenches overlain

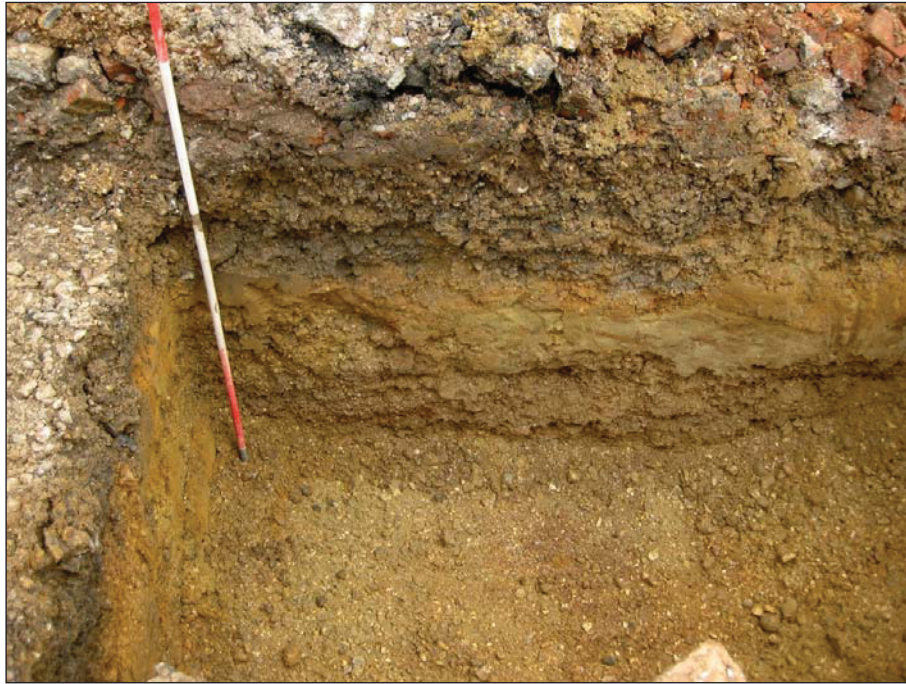
Plate 1: Geoaerchaeology Test Pit 1 taken from the west

4.3.8 A geoarchaeological test-pit (**TP1**) was excavated at the southern end of **Trench 1** (**Plate 1**) and is described in **Section 6** of this report and **Appendix 1**.

- 6.2.2 Beneath the made ground in **TP1**, the upper gravel deposits were unbedded and mixed, with some post-depositional iron and manganese staining. Beneath these upper gravels were layers indicative of fluvial deposition, comprising a sand lens approximately 0.3m in thickness, below which weakly bedded gravels were recorded. There was no indication of stand-still phases, land surfaces, or other layers with archaeological or palaeoenvironmental potential. At 1.70 depth, the gravels became fairly compact and, due to the unstable sides and the limited reach of the machine, no further excavation was undertaken.

TEST PIT 1		Machine excavated
Depth (Mbg)	Sediment description	Interpretation
0.00-0.50	Tarmac and made ground, rubble, crushed mortar and brick.	Made ground
50.00-1.00	5YR 4/4 reddish brown sandy gravel with some iron and manganese staining. Matrix supported and poorly sorted, rounded to sub-rounded. Clast size up to 15cm. Clear boundary	Upper gravel
1.00-1.40	10YR 5/8 yellowish brown medium sand with iron stained patches. Clear boundary.	Sand lens
1.40-1.70	7.5YR 4/6 strong brown sandy gravel. Matrix supported, rounded to sub-rounded, iron stained, poorly sorted, and weakly horizontally bedded. Clast size up to 5cm. Bottom of the test pit is fairly compact but beyond the reach of the machine.	Fluvial deposits. Weakly bedded gravels and sands.

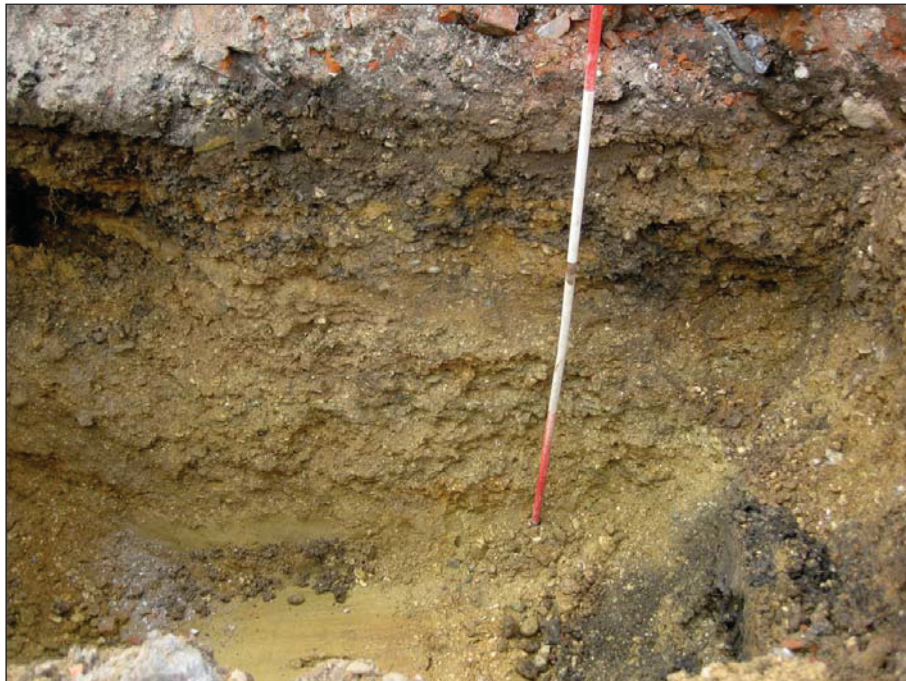
Plate 2: Geoaerchaeology Test Pit 2 taken from the east

- 6.2.3 The sequences in **TP2** and **TP3** were very similar, although a subsoil was observed between 0.70-0.80m below ground level (bgl) in **TP2** and 0.70-0.90m bgl in **TP3**. This subsoil immediately overlies the bottom fluvial gravels with no upper gravel apparent. The fluvial gravels were almost identical to those in **TP1**. The bottom of **TP2** consisted of a sand lens similar to that in **TP1**.

TEST PIT 2		Machine excavated
Depth (Mbg)	Sediment description	Interpretation
0.00-0.70	Tarmac and made ground, rubble, crushed mortar and brick. Clear boundary.	Made ground
0.70-0.80	10YR 4/3 brown sandy loam subsoil with some roots visible and occasional small to medium gravel. Clear boundary.	Subsoil
0.80-1.90	10YR 5/6 yellowish brown sandy gravel. Matrix supported, rounded to sub-rounded, iron stained, poorly sorted with slight horizontal bedding apparent. Clast size up to 10cm. Clear boundary.	Fluvial deposits. Weakly bedded gravels and sands.
1.90-2.00	10YR 5/8 yellowish brown medium sand with iron stained patches. Maximum safe reach of machine at 2.00m.	Sand lens.

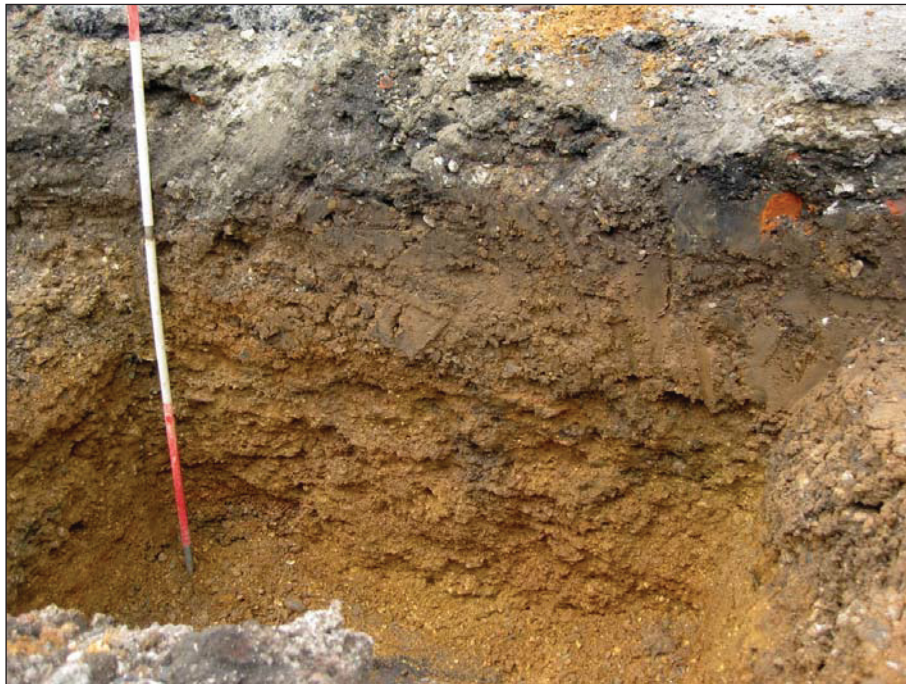
Plate 3: Geoaerchaeology Test Pit 3 taken from the east

- 4.3.16 A geoarchaeological test-pit (**TP3**) was excavated at the southern end of **Trench 3** (**Plate 3**) and is described in **Section 6** of this report and **Appendix 1**.

TEST PIT 3		Machine excavated
Depth (Mbg)	Sediment description	Interpretation
0.00-0.70	Tarmac and made ground, rubble, crushed mortar and brick. Clear boundary.	Made ground
0.70-0.90	10YR 4/3 brown sandy loam subsoil with some roots visible and occasional small to medium gravel. Clear boundary.	Subsoil.
0.90-1.85	7.5YR 4/6 strong brown sandy gravel. Matrix supported, rounded to sub-rounded, iron stained, poorly sorted, and weakly horizontally bedded. Clast size up to 5cm. Maximum safe reach of machine at 1.85m.	Fluvial deposits. Weakly bedded gravels and sands.

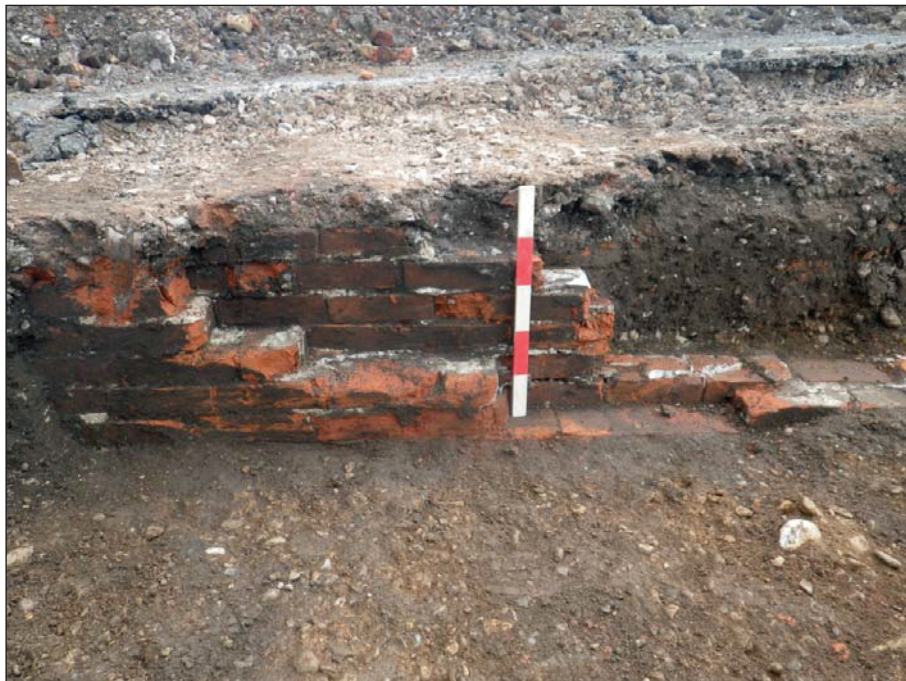
Plate 4: Trench 1 west facing section showing wall 106

4.3.5 **Trench 1** (23m x 1.4m x 0.6m) was located at the northern end of the car park (**Figure 2**) and aligned on a north to south orientation. A similarly aligned wall **106** (**Plate 4**) was present at the northern end of the trench, and was composed of two parallel brick courses of unfrogged mid orange brick and white cementitious mortar. The wall was constructed in either Stretcher or Flemish stretcher bond, and is thought to date to the later 19th century.

106	Structure	Fill of 105 . Wall formed of two parallel brick courses. Bricks unfrogged mid orange (0.21m x 0.1m x 0.065m) bonded by a white coarse sand cementitious mortar. Very little of the walls survived however the brick bonding appeared to be either stretcher Flemish stretcher bond	0.3m+
107	Deliberate backfill	Fill of 105 . Reworked subsoil with brick fragments used to backfill foundation trench	0.3m+
108	Foundation trench	E-W aligned construction trench. Cuts 101 . Modern	0.1m+
109	Structure	Fill of 108 . Comprised large angular stone blocks typical of that used as capping for probable drainage/sewer pipe. Left in situ	0.1m+
110	Pit	Sub-square Modern pit/robber cut. 1.3m (N-S) 0.9m (E-W). Extends beyond eastern trench baulk. Cut of pit visible within layer 102 suggesting it resulted from the removal of a footing during the demolition of the 19 th century buildings on the Site.	0.4m+
111	Deliberate backfill	Fill of 110 . Loose compaction. Mid brown sandy loam and sandy gravel. Abundant brick and mortar fragments. Predominately unfrogged brick though several frogged bricks were noted.	0.4m+

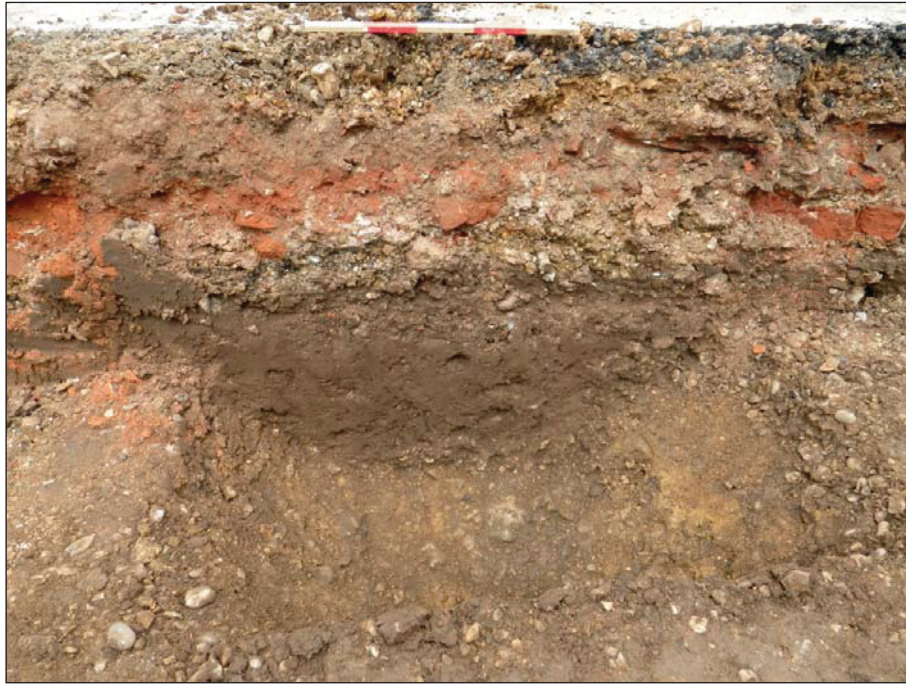
Plate 5: Trench 2 ditch **206** taken from the south-east

- 4.3.9 **Trench 2** (15m x 1.4m x 0.6m) was located in the centre of the area of car park (**Figure 2**) and aligned northeast to southwest. Two features thought to predate the late 19th century development of the Site were recorded in **Trench 2**, and both were found to cut subsoil layer **205**. A 0.8m length of ditch **206** (**Plate 5**) was recorded at the northeast end of the trench, and aligned east to west. It measure 1.2m wide and 0.4m deep, and exhibited steep concave sides and a broadly flat base. The eastern end of the ditch had been cut away by wall **219**. The location of ditch **206** within the centre of the Site corresponds to an area of garden/paddocks associated with the properties facing onto Mumby and Harbour Roads respectively, as shown on the 1678 map of Gosport by De Gomme (WA 2012).

- 7.3.1 No artefacts were recovered from the fills of ditch **206** and gully **209**, however the presence of eroded brick flecking noted within these deposits is suggestive of a post-medieval date. It is considered likely these features are associated with the use of the area as gardens or paddocks prior to the major development of the area undertaken in the 19th century.

206	Ditch	E-W aligned field ditch. Broadly parallel with Mumby Rd to south. Steep concave sides and flat base. 1.2m wide 0.4m deep. Cuts 205 .	0.65-0.95m
207	Secondary fill	Fill of ditch 206 . Reworked subsoil with pockets of collapsed gravel. Mid-dark brown sandy loam. Occasional red brick flecks evident throughout. No charcoal flecking noted.	0.65-0.95m
208	Layer	Superficial geology: Orange brown sandy gravel. Rooting derived from overlying subsoil evident at interface (upper 0.05m)	0.6m+
209	Gully	NNE-SSW aligned shallow concave gully likely forming narrow field drainage. 0.3m wide and 0.1m deep (max). Concave sides with irregular base. Cuts 205	0.6-0.7m
210	Secondary fill	Fill of 209 . Reworked subsoil with pockets of collapsed gravel. Mid-dark brown sandy loam.	0.6-0.7m
211	Pit	1.1m diameter, 1m deep Post-medieval rubbish pit. Steep sides tapering to flat base.	0.55-1.5m
212	Deliberate backfill	Fill of 211 . Dark grey brown silty loam with abundant brick fragments, crushed cementitious mortar	0.55-1.5m

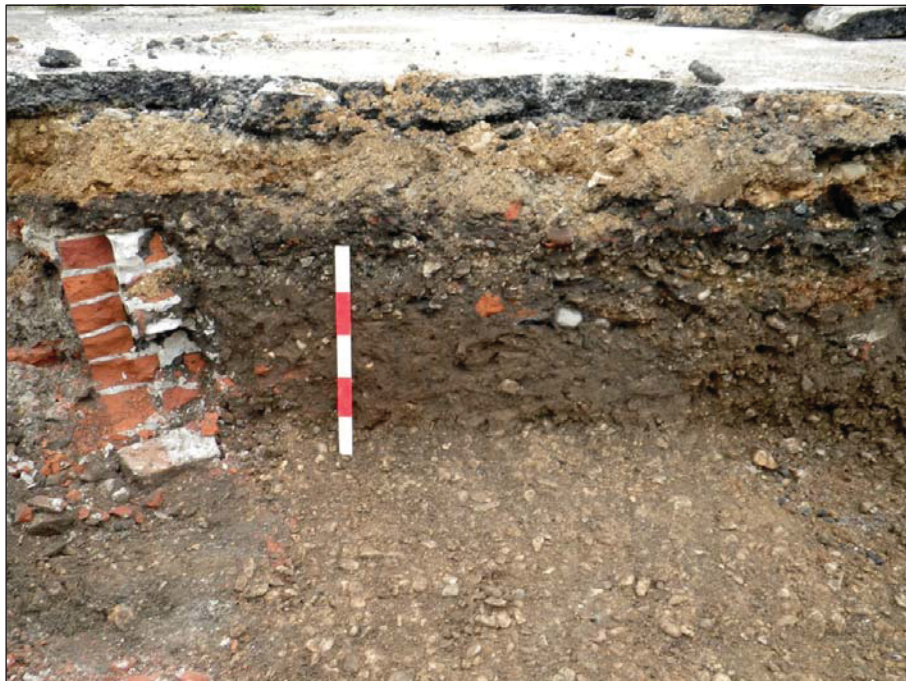
Plate 6: Trench 3 south-east facing section showing wall **307**

- 4.3.15 At the southern end of the trench, wall **307** (**Plate 6**) was of a similar construction to the walls recorded in **Trenches 1** and **2**. It had a dog-leg layout within the trench, and appeared to form a western and eastern return into the trench baulk. A further wall **309** was recorded in the centre of **Trench 3**, and aligned east to west. The wall measured 1m in length and had a greater lime content in the associated mortar, and appeared to have been constructed using English bond. It is thought the western end of the wall would have had a southern return however this had been subsequently cut away.

305	Layer	Superficial geology: Orange brown sandy gravel. Rooting derived from overlying subsoil evident at interface (upper 0.05m)	0.76m+
306	Foundation trench	N-S aligned wall foundation trench. Cuts 303	0.3m+
307	Structure	Fill of 306 . Wall formed of two parallel brick courses. Bricks unfrogged mid orange (0.21m x 0.1m x 0.0.65m) bonded by a white coarse sand cementitious mortar. Very little	0.3.m+

of the walls survived however the brick bonding appeared to be either stretcher Flemish stretcher bond	
308	Deliberate backfill	Fill of 306 . Reworked subsoil with brick fragments used to backfill foundation trench	0.3m+
309	Foundation trench	E-W aligned wall foundation trench. Cuts 303 .	0.45m+
310	Structure	Fill of 309 . Wall formed of two parallel brick courses. Bricks unfrogged mid orange to mid grey orange (0.21m x 0.1m x 0.065m) bonded by a white coarse sand cementitious mortar. Very little of the walls survived however the brick bonding appeared to be either English bond. Cut by 312 .	0.45m+
311	Deliberate backfill	Fill of 309 . Reworked gravel with brick fragments used to backfill foundation trench	0.45m+
312	Robber cut	Shape in plan suggests Structure 310 was originally formed a western corner. Robber cut 312 cut away the N-S return of the original structure.	0.25m+
313	Deliberate backfill	Fill of 312 . Comprised successive deliberately backfilled layers of dark grey black gravel including lenses of grey blue clay.	0.25m+
