# DRONFIELD GASWORKS, DERBYSHIRE

**Archaeological Watching Brief**

Ref: 84480.02 April 2012

Prepared for: URS Infrastructure & Environment UK Limited

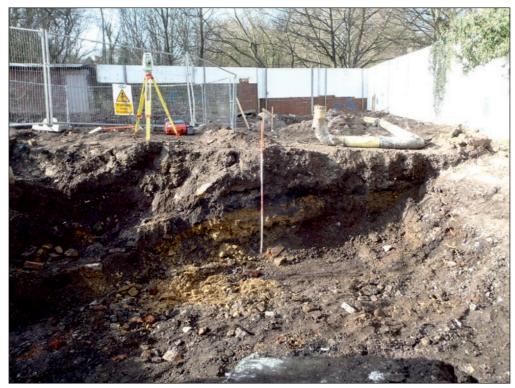
Plate 1: Southeast facing section of Trench 1, showing made ground deposits 100, 104, 105, 106 and 107.

- 3.2.2 Above the natural were numerous made ground deposits (**Plate 1**) of redeposited soils (contexts **104**, **106**, **107**, **204**, **206**, **306** and **411**) and ash rich deposits with fragments of construction material (contexts **105**, **203**, **303**, and **410**). Whilst structure **405** (see below) was observed to have been constructed within a cut made into these deposits (context **412**), it was not possible to identify the relationship between all deposits and structures due to the constraints of the methodology.
- 3.2.3 A further layer of made ground of mixed composition overlay the Site, with frequent inclusions of frogged and unfrogged red brick, squared masonry and general construction material throughout (contexts 100, 201, 202, 301, 302, and 407).

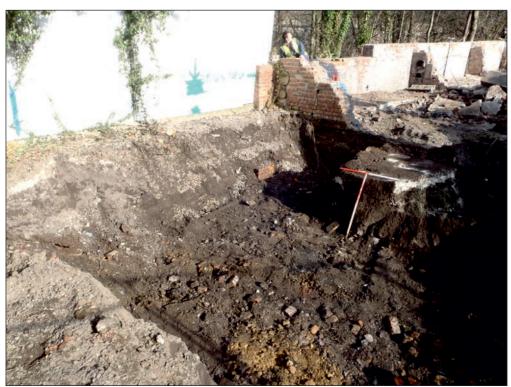
Plate 2: General view across Trench 1, showing standard remains of Quenching House, its sandstone foundations **103**, the short brick structure **102** and concrete foundations **101**.

- 3.3.2 Towards the northern end of the building a short two skin thick southeast-northwest aligned handmade red brick structure was observed (context **102**, **Plate 2**). The structure was not found to be associated with any larger structure and appeared to terminate at its western extent.

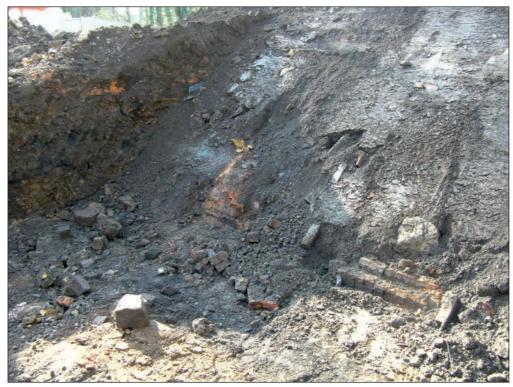
Plate 3: View showing brick structures **414** and **415** within southeast facing section of Trench 4.

- 3.3.3 In the southeast of the area was a substantial concrete foundation of indeterminate function (context **101**).
- 3.3.4 In the southern corner of the building's footprint an L-shaped section of brickwork was encountered (contexts **414** and **415**). This structure was four skins thick and constructed of handmade red brick with one course laid on edge (**Plate 3**).

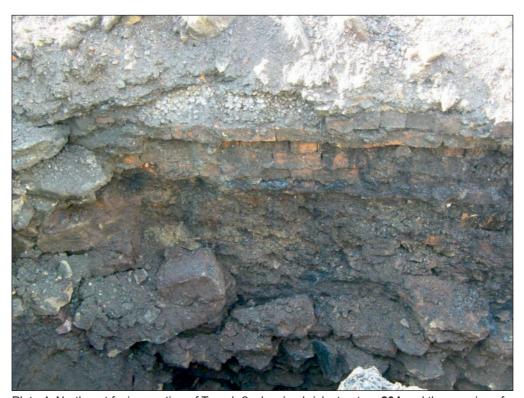
Plate 4: Northeast facing section of Trench 2, showing brick structure **204** and the remains of sandstone foundation **207/305/404**.

- 3.4.2 The foundations of the outer walls of the building comprised rough slabs of sandstone laid to courses (contexts 103/405, 404, 408, and 409; Plates 4-6).

- 3.4.3 A redbrick structure was observed abutting the northern face of the southwest wall foundation (context 204/304; Plates 4-5). This structure was likely associated with a large nine skin thick redbrick foundation (context 401 and 403; Plate 6) and associated cast iron pipe and tank (402) to its northeast, although any linking walls had been removed during the excavation for a modern plastic gas main extending northwest-southeast across the bottom of the monitored area. A plan produced of the works in 1913 (URS 2012) shows a structure within the vicinity of these observed features.

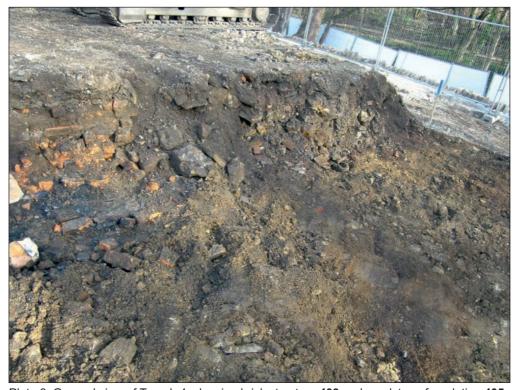
Plate 6: General view of Trench 4, showing brick structure **403** and sandstone foundation **405** in the section.
