Archaeological Watching Brief Report

Planning Reference: 2/2012/1519/PLNG-2/2012/1520/PLNG

Ref: 89220.03 July 2014

Project name Manston House, Manston, Dorset

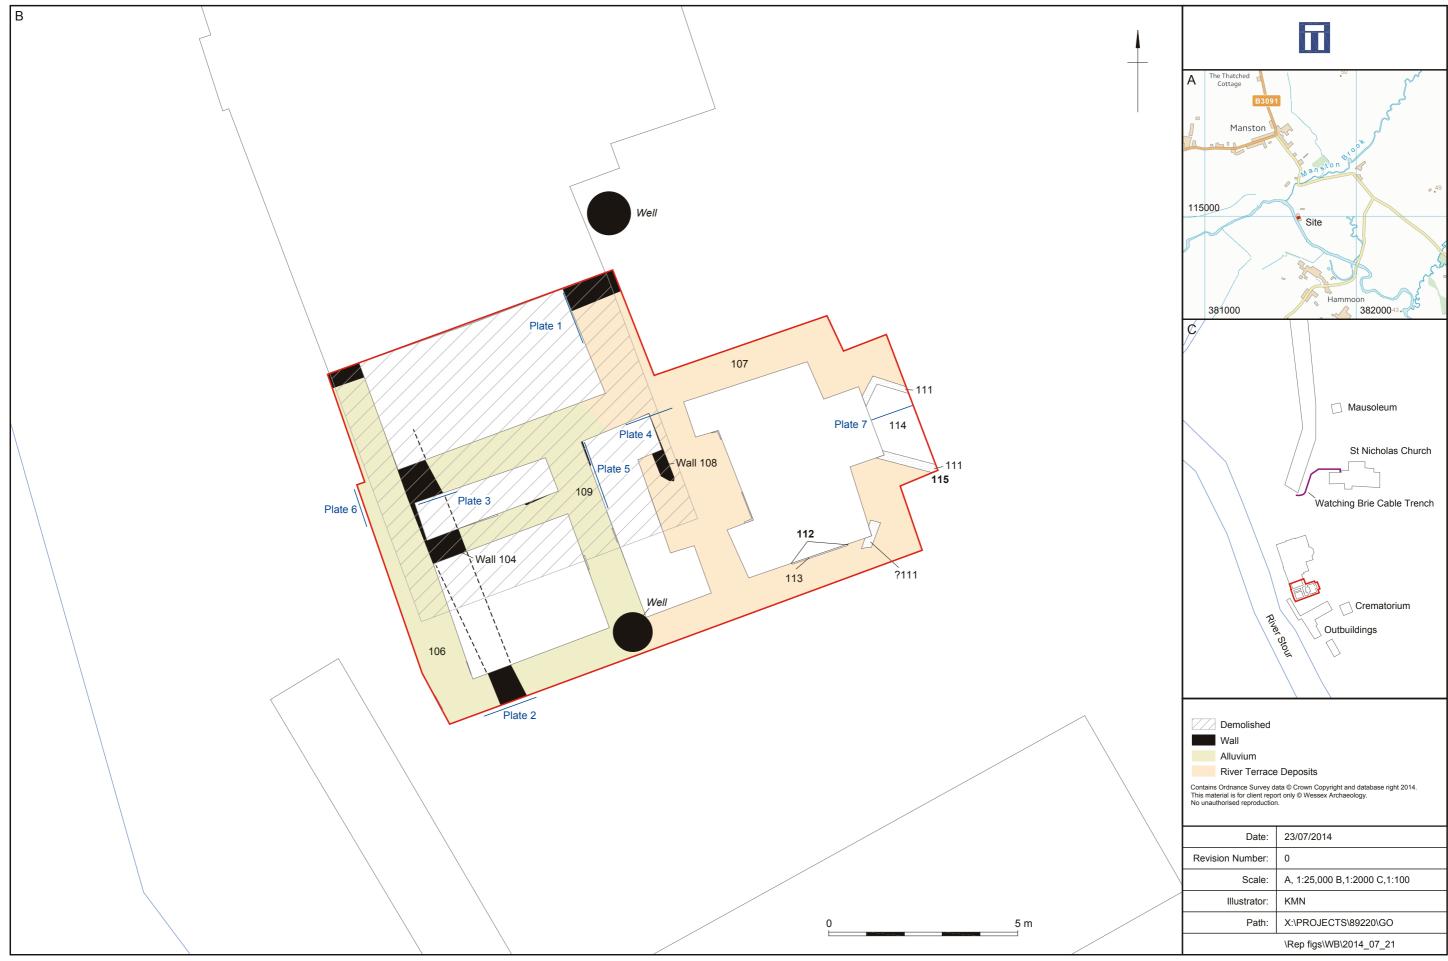
Site location and results of extension work

- 1.1.1 Wessex Archaeology was commissioned by Johnston Cave Associates acting on behalf of Mr and Mrs Swire to undertake an archaeological watching brief during a proposed development at Manston House, Manston, Sturminster Newton, Dorset, centred on National Grid Reference (NGR) 38515, 25650 (hereafter 'the Site') (**Figure 1A**).

4.1.1 The groundworks for the new extension encompass an area measuring approximately 14m by 9m and thus cover an area slightly larger than the footprint of the previous extensions (**Figure 1B**). Due to the underlying geology, which was alluvium on the western side of the Site (**106**) and river terrace deposits on the eastern side of Site (**107**), the foundations were required to be much deeper than originally planned and were generally between 1.9-2.0m in depth. This meant that the trenches were not safe for

- 4.1.4 Another wall **108**, of largely identical construction was observed on a north-east south-west alignment, potentially forming an internal division to the east of wall **104** (**Figure 1A**; **Plates 4** and **5**). The base of this wall was at a slightly shallower depth, perhaps supporting the idea that this is an internal division. At the north-east end of the wall a possible south-east return was observed though this had been largely truncated away by modern disturbance. In one section, adjacent to wall **108** but above layer **103** was a possible surface deposit **109** (**Plate 5**).

4.2.1 The groundworks in the churchyard comprised the hand excavation of a cable trench for the electrical cable (**Figure 1C**, **Plate 8**). The trench measured approximately 20m in length, 0.25m wide and was 0.5m deep. Up to 0.2m of disturbed topsoil characterised by a brownish grey alluvial sandy clay, was recorded. No archaeological evidence was recorded within the trench.

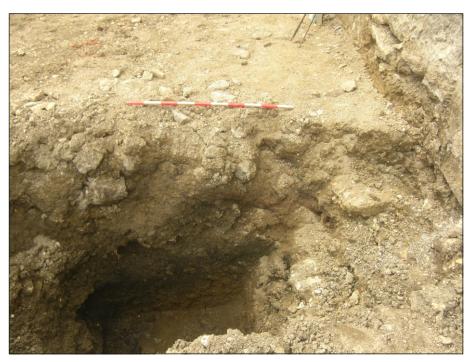
Plate 1: Footing adjacent to south-east corner of existing building, view from north-east

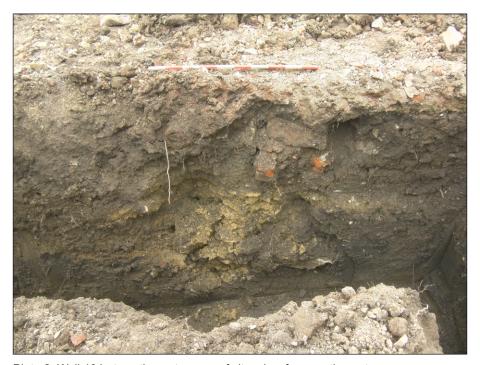
- 4.1.3 Within the western part of the Site a stone built north-north-west south-south-east aligned wall **104** was observed (**Plates 2** and **3**). This wall lay at a depth significantly below the current ground surface and is slightly misaligned with the adjacent 17th century wing (**Figure 1B**). Although of a similar, no doubt local stone to the 17th century wing it appeared to be constructed using more roughly shaped blocks than the fine ashlar stone work utilising in the upstanding remains (**front cover**). Given the shallow footings observed for the upstanding remains it seems unlikely that **104** only represents the foundation level. No construction cut for the wall could be seen and it apparently lay above a thin alluvial deposit **105**, which in turn overlay alluvium **106**. Abutting the wall was a dark, slightly mixed deposit **103**.

Plate 2: Wall 104 at south-west corner of site, view from north-west

- 6.1.1 The watching brief has indicated the presence of another structure to the south of the 17th century wing of the house, as suggested by wall **104**. The slight misalignment may suggest it pre-dates the 1690 building and indeed there are no indications of any original entrances within the south wall to suggest that it communicated with a more southerly wing. It seems likely, therefore, that these walls are of the pre-1690 house, mentioned in 1635, which was subsequently demolished however no positive dating evidence could be obtained for the structure.

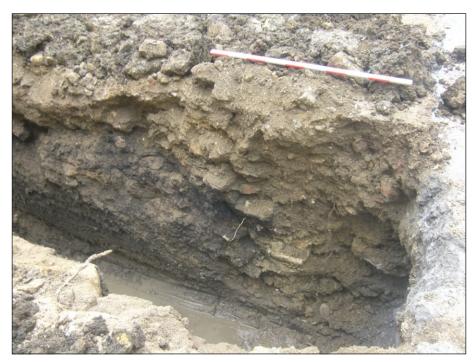
Plate 3: North-west facing section through wall 104 and adjacent deposits

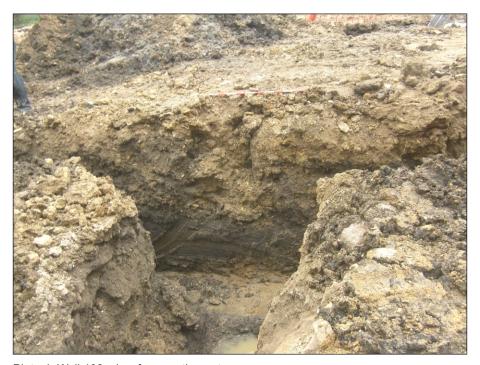
Plate 4: Wall 108, view from north-west

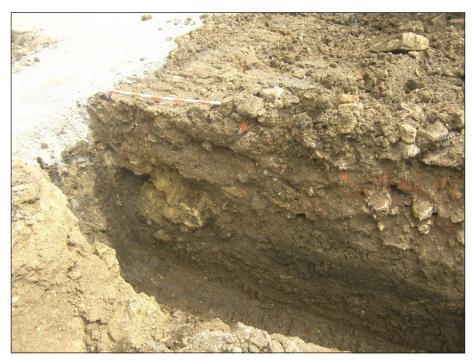
Plate 5: South-west facing section of wall 108 and layer 109

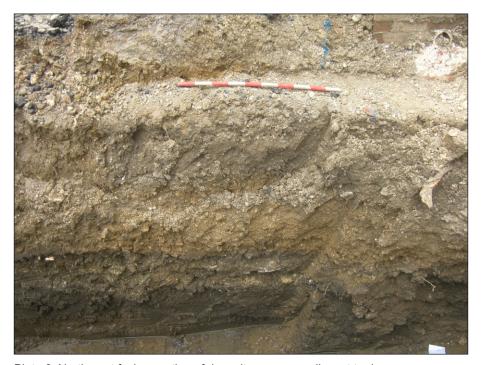
- 4.1.5 Although no clear variation of deposits on opposing sides of wall sections could be seen within the presumed building footprint a different deposition sequence was observed on the western side of wall **104**, adjacent to the river (**Plate 6**). Here a mixed sandy layer **116** was seen to overlie the alluvial layer **105**, in which fragments of stone could be seen perhaps indicative of construction or demolition. Above this was a layer of re-deposited river terrace material **116** which either may suggests natural but substantial flooding or a deliberate made ground.

Plate 6: North-east facing section of deposit sequence adjacent to river

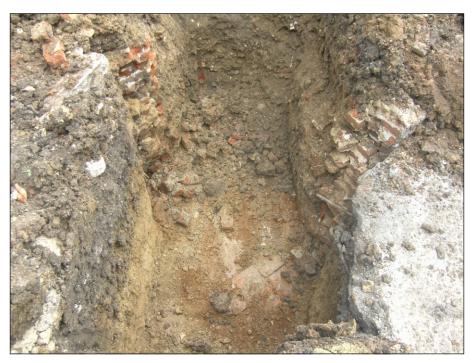
- 4.1.7 Also within the south-eastern part of the Site was red brick structure **111** (**Plate 7**). Nothing is shown on any of the historic mapping in this position, which in modern times was within a terraced area. It would seem to be most likely a cellar potentially of a similar date to the other outbuildings (late 18th/ early 19th century); its absence of the Ordnance Survey mapping may suggest that there was little or no above ground structure or that it pre-dates the First Edition map and was abandoned when the walled terrace (already shown on this edition) was constructed.

Plate 7: Brick structure 111, view from north-west

111	Structure	Red brick structure, possible cellar. Pale yellow grey mortar, regular jointing. Infilled with 114. Not fully seen in plan but likely rectangular. Fill of construction cut 115 .	0.40-2.00 brl
112	Cut	Vertical, straight sided cut. Not seen in plan. Filled with 113. Cuts 102.	0.50-2.00 brl
113	Deposit	Fill of 112 . Mid grey to mid blue-grey clay. No visible inclusions. Compact. Likely deliberate backfill.	0.50-2.00 brl
114	Layer	Infilling of brick structure 111. Mid brown grey silty clay loam. Slightly mixed, some bioturbation.	0.40-2.00 brl
115	Cut	Construction cut for brick structure 111. Not really seen but assigned for stratigraphic purposes.	0.40-2.00 brl
116	Layer	Possible levelling. Mid yellow-brown sandy silt loam. Mixed with diffuse mid grey patches. 2% stone, sub-angular, 2-10cm. Fairly compact. Overlies 105.	1.20-1.50 brl

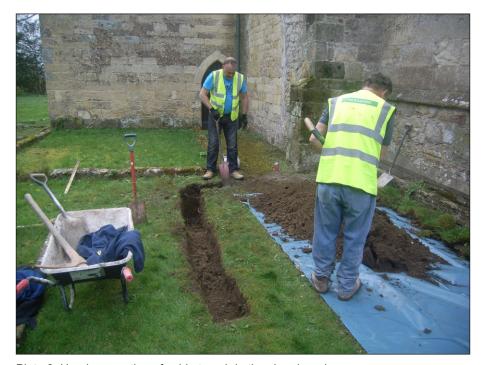
Plate 8: Hand excavation of cable trench in the churchyard

- 6.1.3 The trench in the churchyard was dug in direct proximity to the existing graves, yet no archaeological remains were recorded and no finds retained. This is due to the relatively small depth of the trench and the fact that ground was previously disturbed.
