NOSTELL PRIORY STABLES, NOSTELL, WAKEFIELD, WEST YORKSHIRE

Historic Building Recording and Structural Watching Brief

Planning Application Ref: 09/00701/FUL & 09/00705/LBC

72934.01_BDG_V0_4

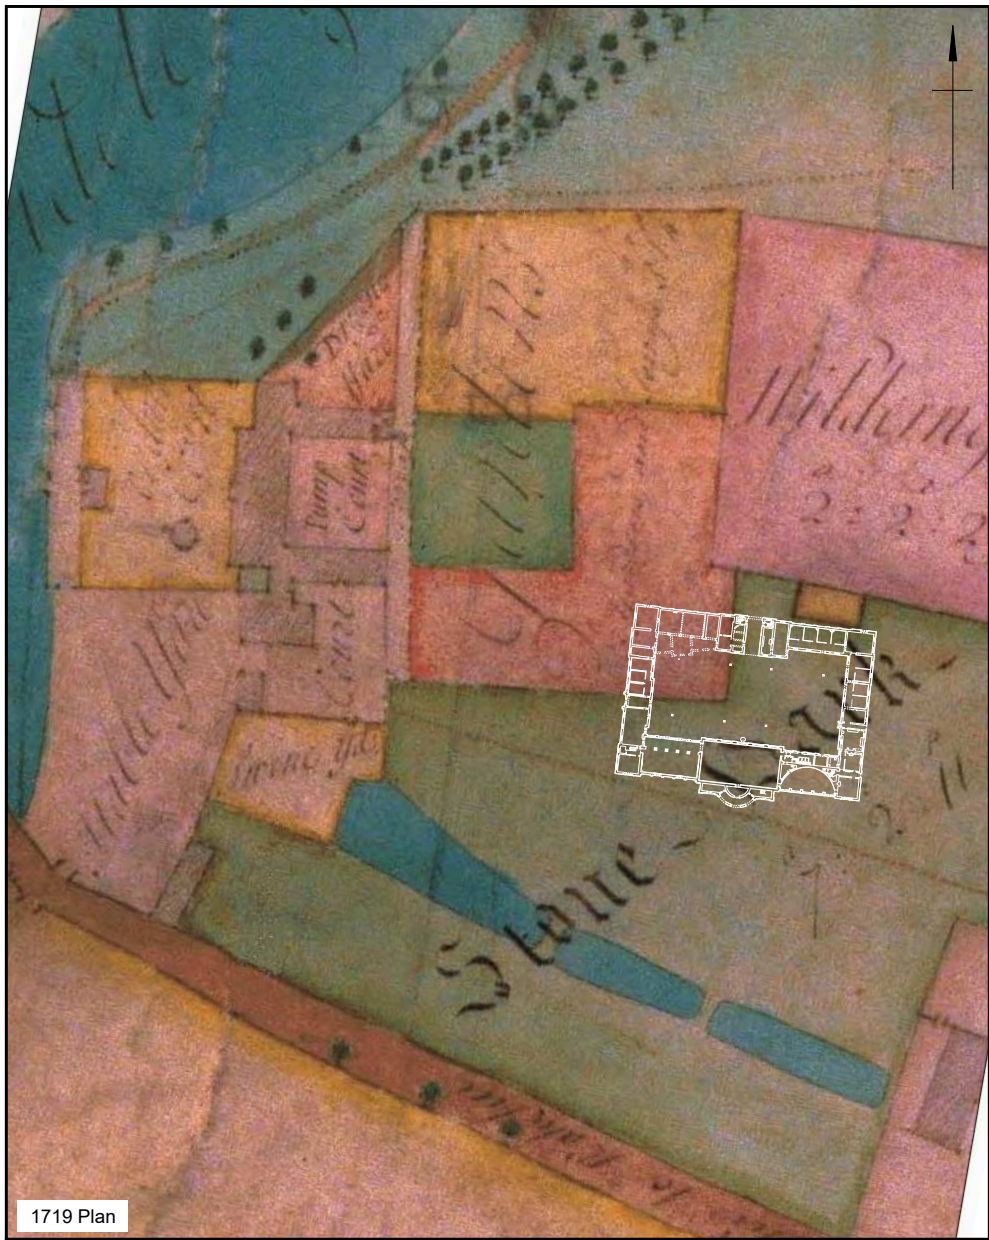
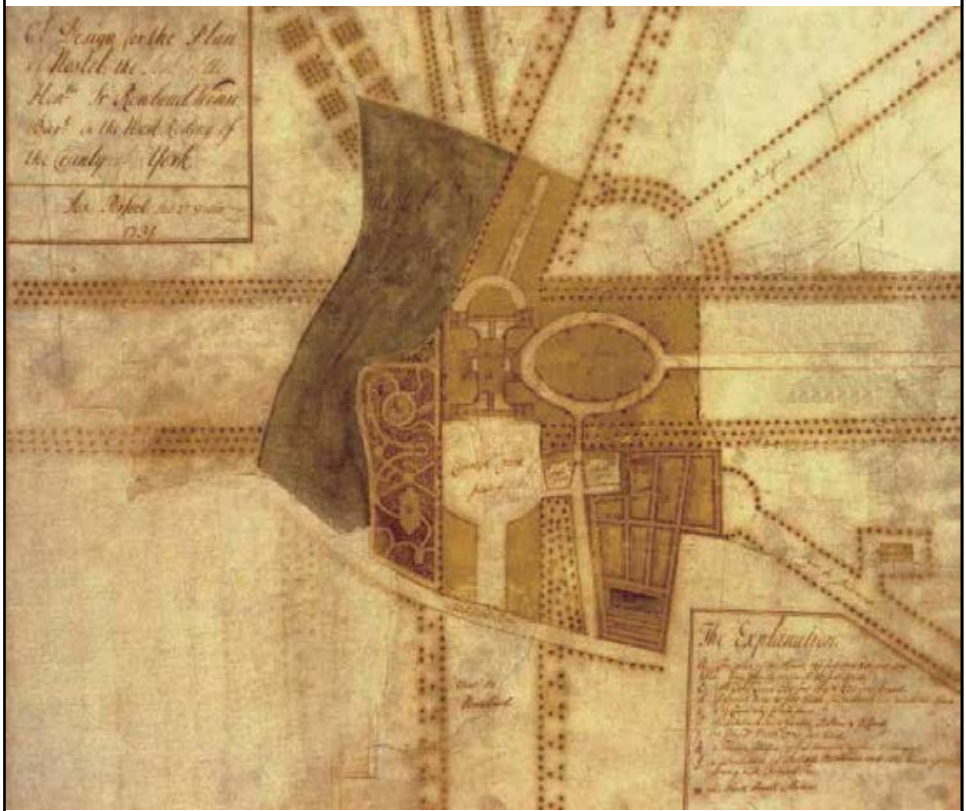
Figure 2

1719 Plan

1731 Map

Historic Plans: 1719 Marshal Plan and 1731 Prefect Map of Nostell Priory

- 4.2.1 Nostell Priory was founded by the Augustinian Order in the 12th century. Although the Augustinians were evicted from the priory during the Dissolution in 1539, elements of the Priory buildings survived until the late 1770s, and became known as Nostell Hall (a name the property maintained until the 1830s). In 1654, Nostell was sold to the Winn family, who have resided at Nostell ever since. The house which the Winn family bought comprised three ranges of the old Priory which had been previously converted. This was inhabited by the family until the 1730s when the 3rd Baronet, Sir Rowland, decided to build a new house (**Figure 2**).

- 4.3.1 The first recorded stables at Nostell were built between 1719 and 1721. This was a modest range which incorporated a central Coach House with seven stalls either side, and was constructed in alignment with Nostell Hall (**Figure 2**).

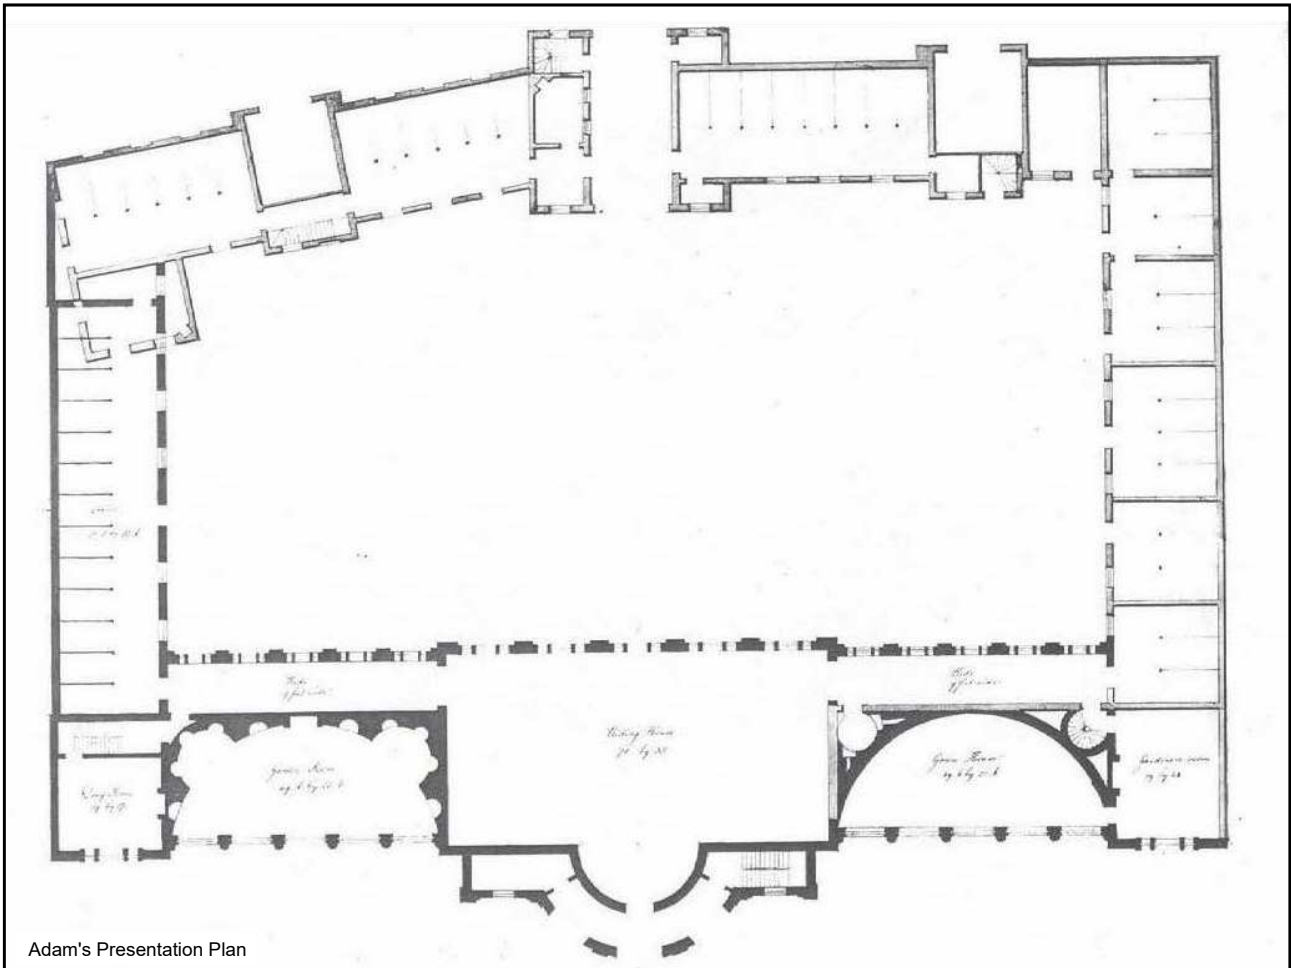
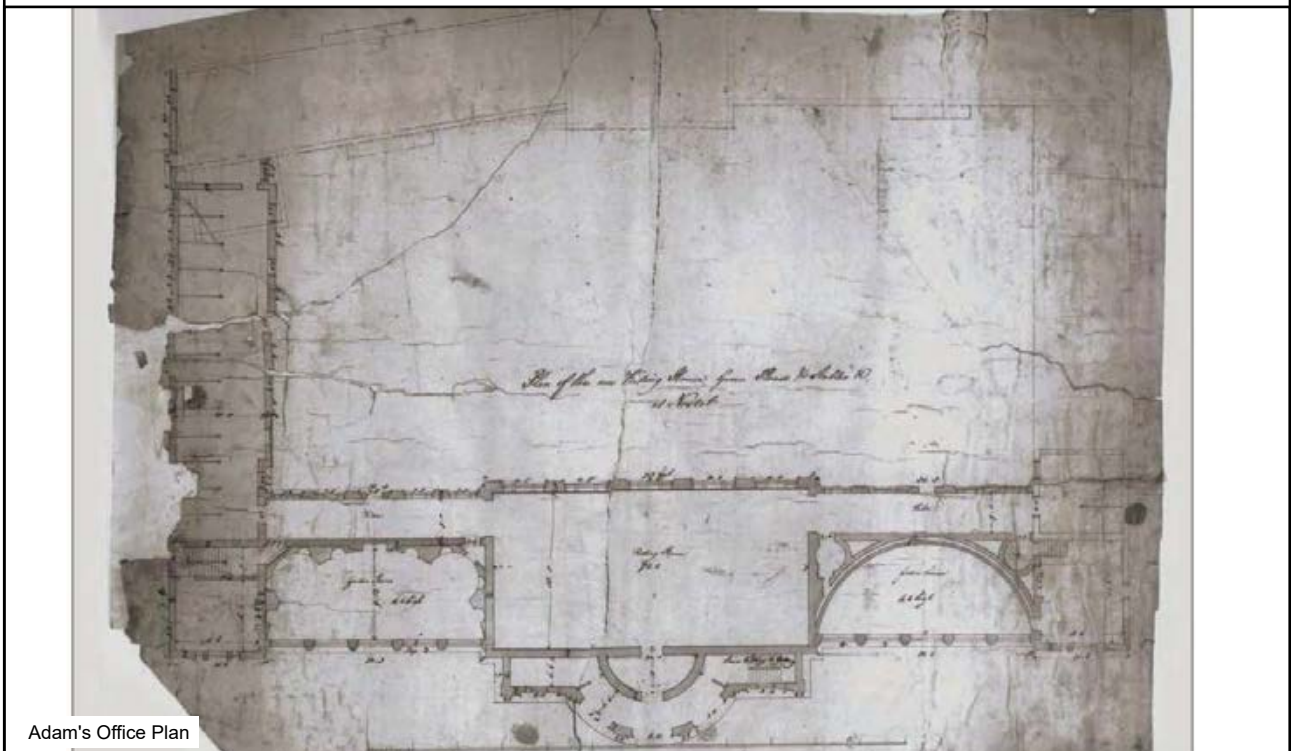
Adam's Presentation Plan

Adam's Office Plan

- 4.3.3 The quadrangle was not realised until the 1770s when the 5th Baronet commissioned Robert Adam to design a West Range with stalls and a South Range providing a Garden Room and Greenhouse, along with a large Riding House joining the two (**Figures 4, 5 and 7**).

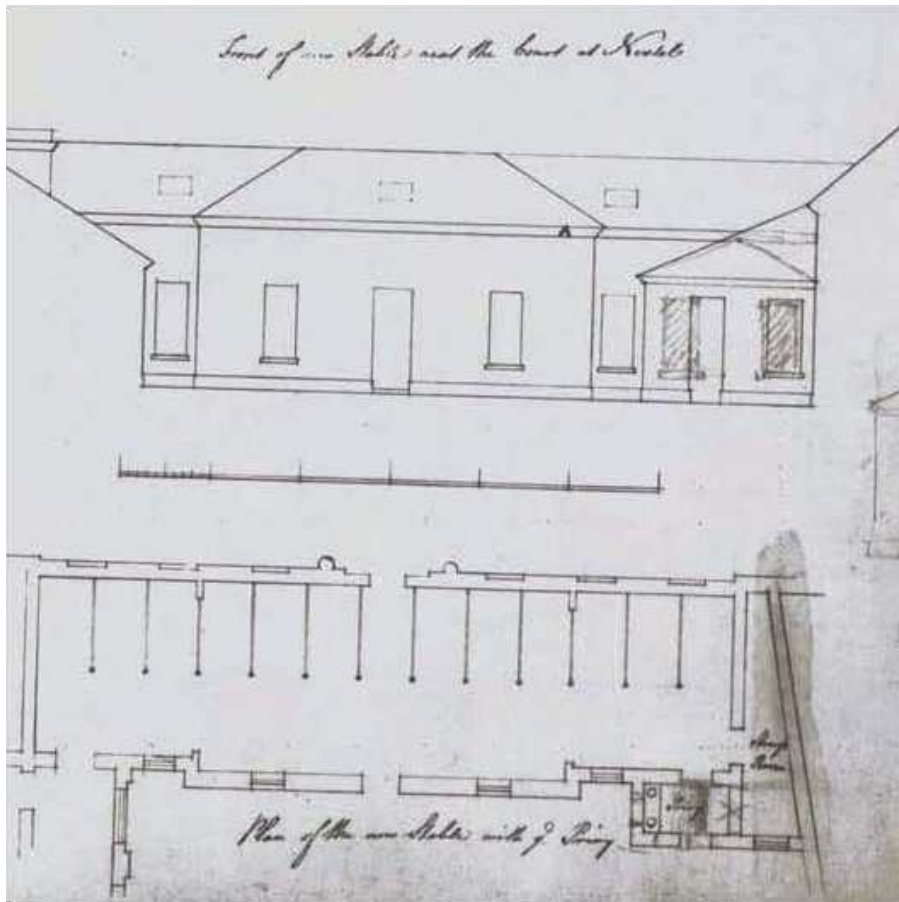
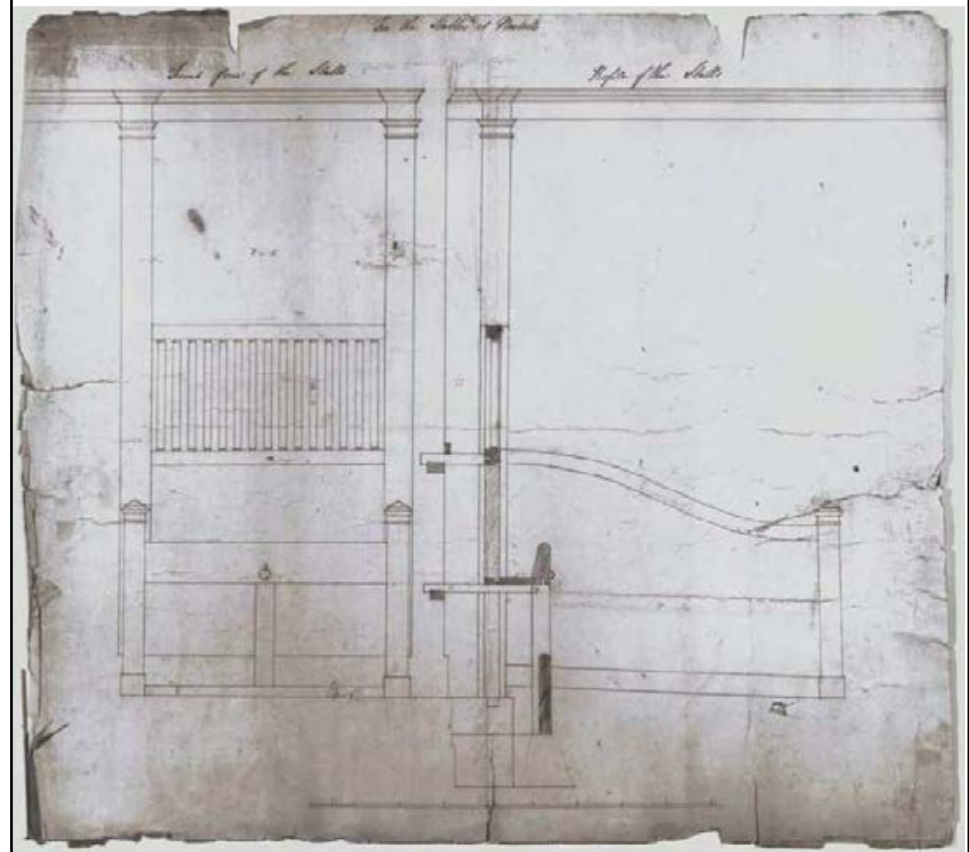
Adam's Proposal Drawing of West Range

Adam's design for West Range

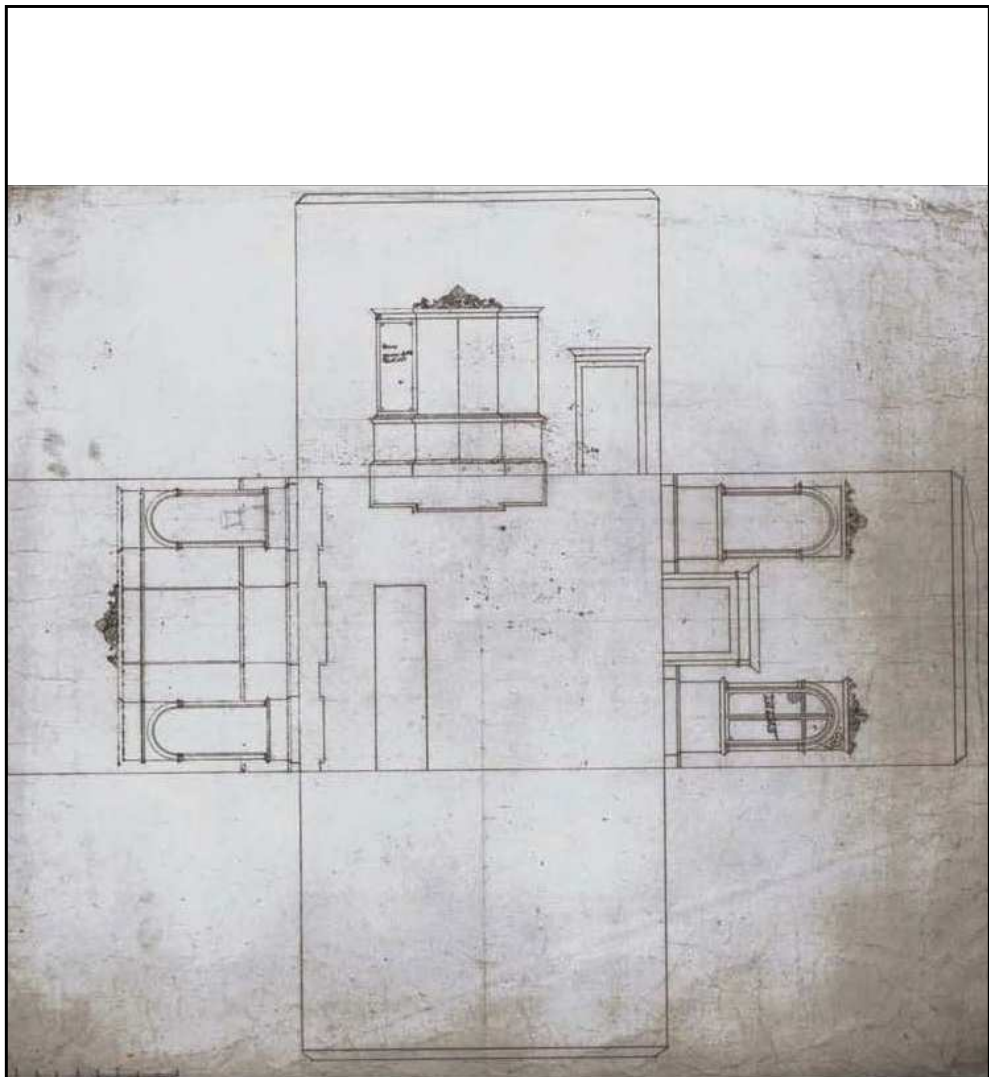
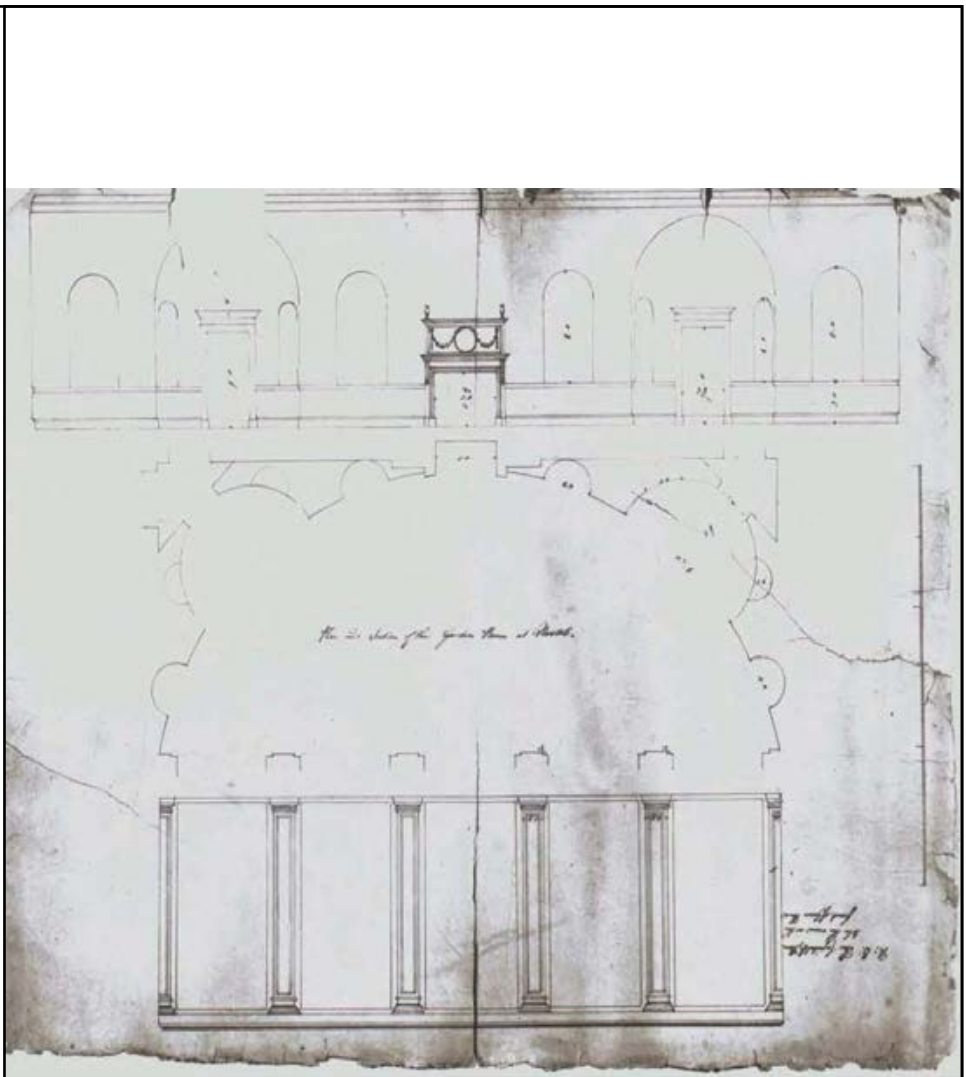
Figure 7

Nostell Drug Room (G27)

Garden Room (G28)

Historic Plans: Plan and elevation of Nostell Drug Room (G27) and Adam's Proposed Plan of Garden Room (G28)

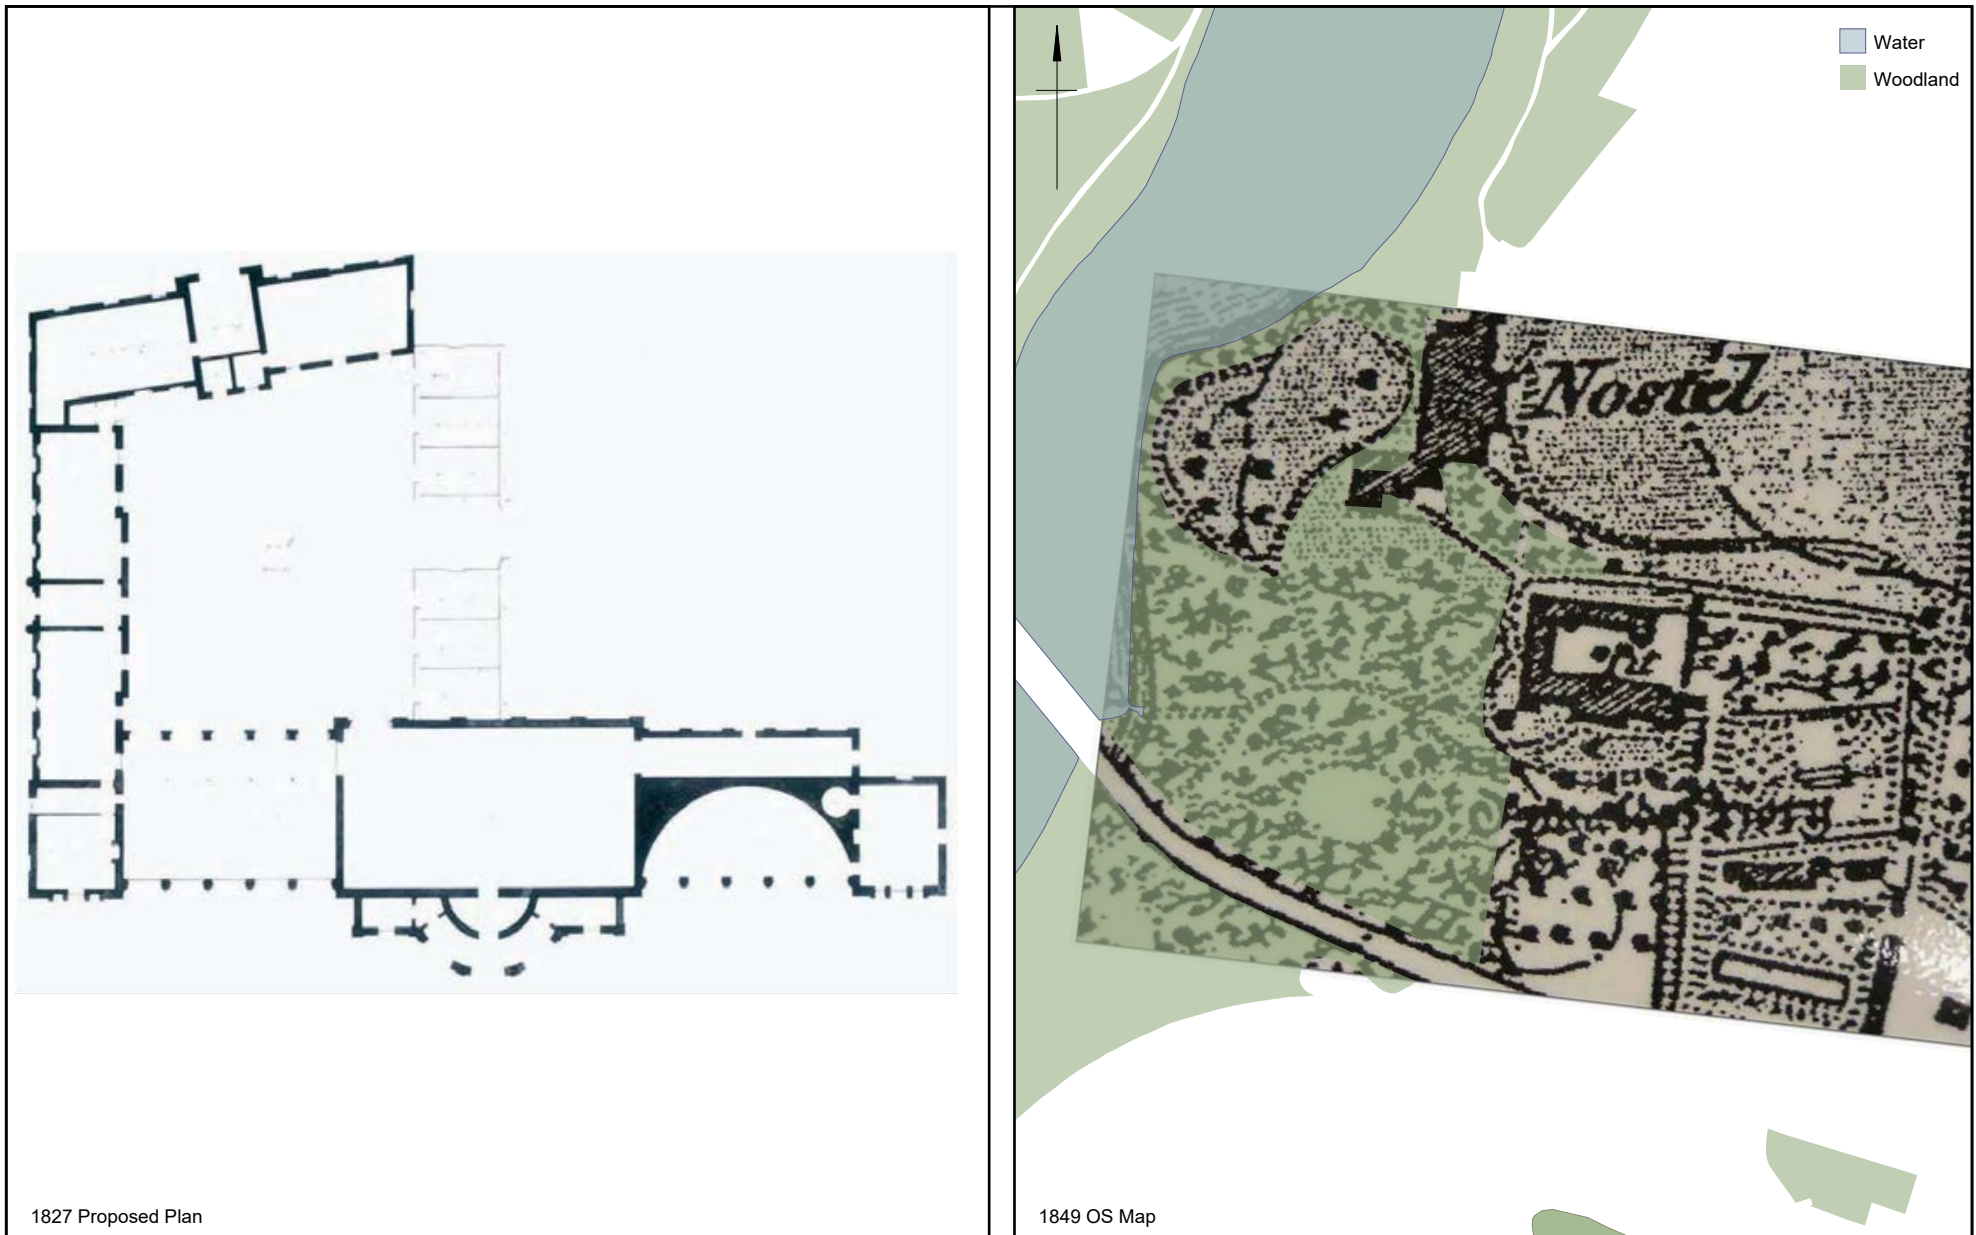
1827 Proposed Plan

1849 OS Map

- 4.3.4 During the 1820s, work to reduce the capacity of the stables saw Paine's East Range and the east end of the North Range demolished (**Figure 8**). This was undertaken by architects Watson Pritchett and Watson, who drew up proposals to enclose the yard with a range that ran from the Riding House to the east end of the 1719-21 (phase 1) range (**Figure 8**). This never came to fruition, however, a cupola was added to the West Range, over a new central entrance (**Figure 6**). The cupola was built to the designs of a former unrealised Adam proposal drawing. It is supposed that the construction of the new cupola brought about the removal of the cupola over Paine's pedimented entrance within the North Range.

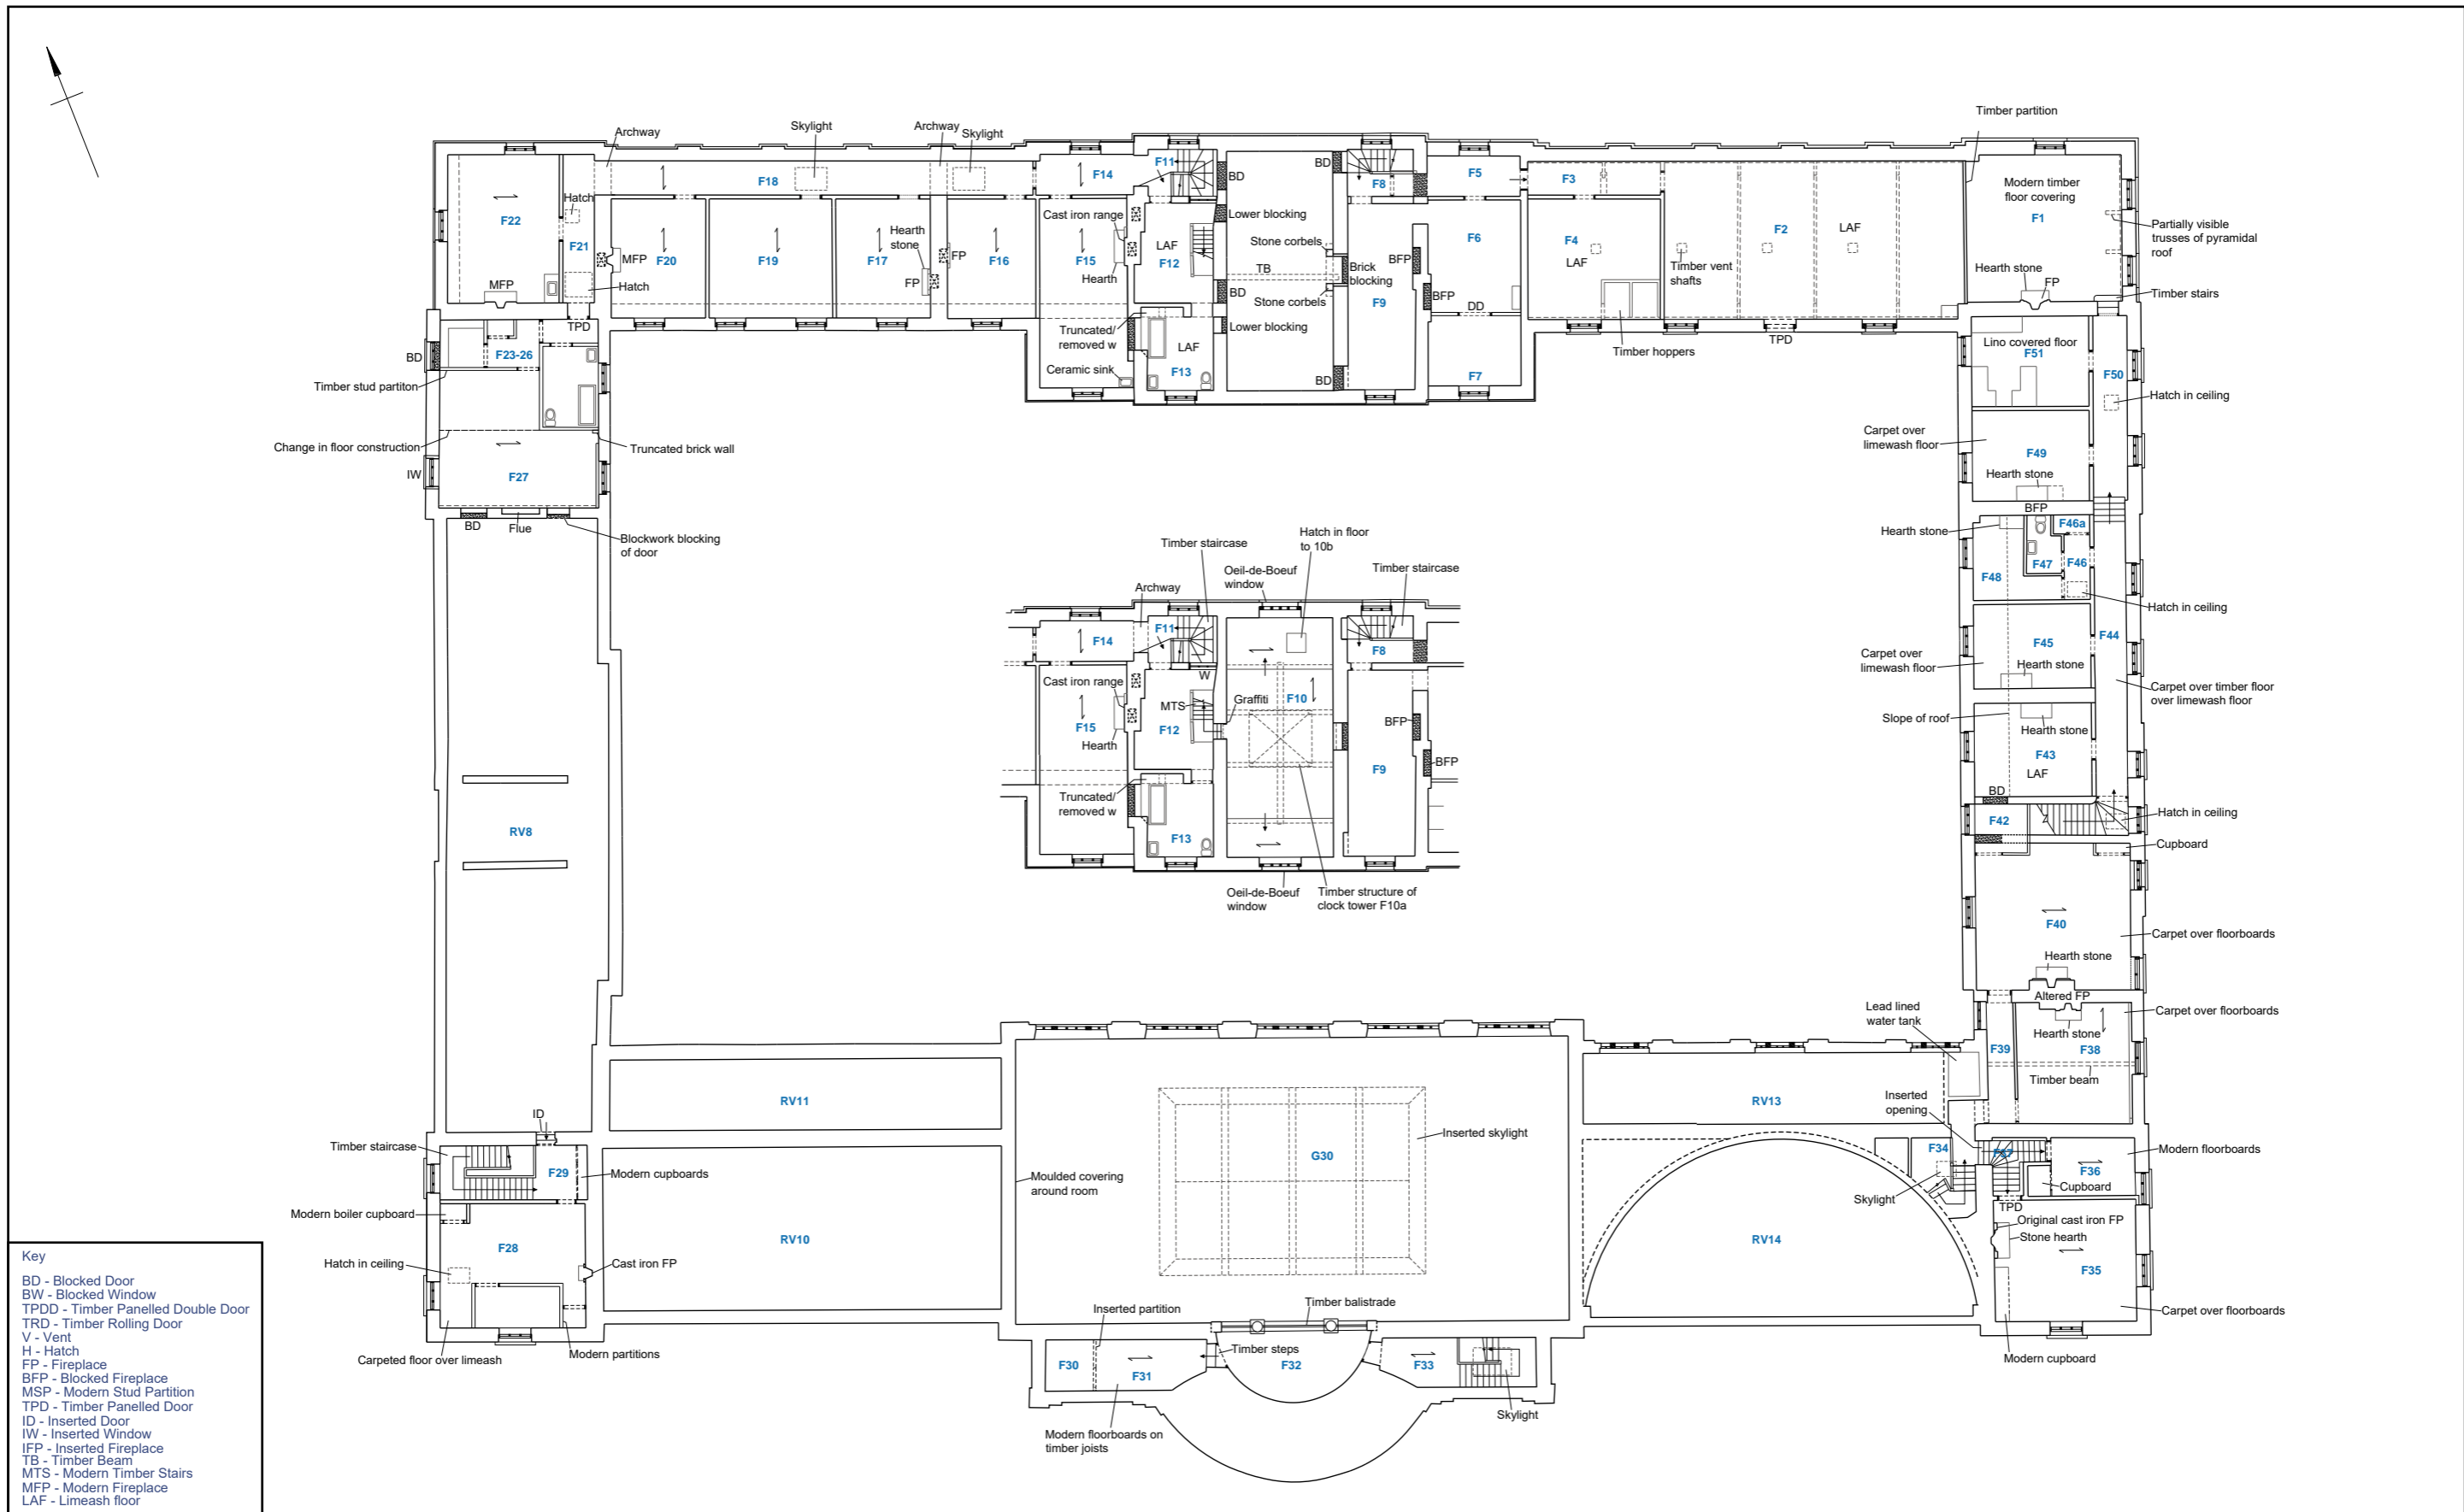
Figure 13

First floor plan

- Phase 1: 1719 - 1721
- Phase 2: 1750 - 1763
- Phase 3: 1769 - 1773
- Phase 4: 1822 - 1830
- Phase 5: 1849 - 1875
- Phase 6: 1875 - 1876
- Phase 7: 1904
- Phase 8: Post 1904

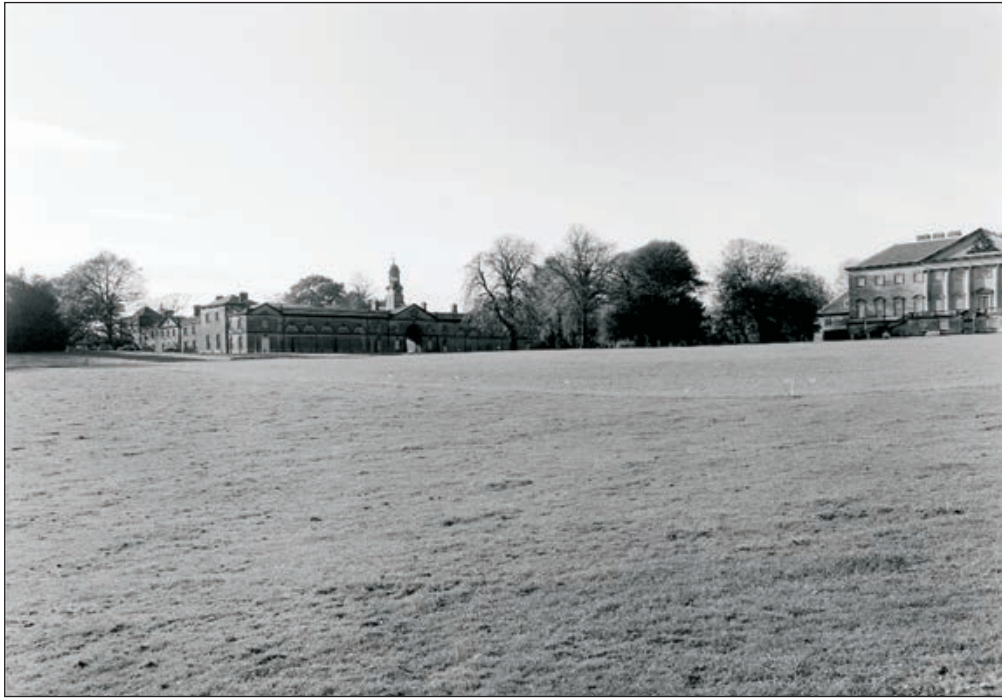
Plate 1: General view of Stable Block from the northeast, with the Mansion positioned to the northwest (Film 01.02)

- 5.1.1 The Site comprised a stable complex with four ranges set around a central courtyard (**Figure 1, Plates 1-7**). A cart passage within the North Range provided the main and vehicular access to the central yard of the complex (**Plate 8**). The North, South and East Ranges were all two-storeys in height, whilst the West Range was largely single-storey. All were constructed using a sandstone exterior with brick core and interior, with the exception of the earliest retained elements on site (phase 2) where some walls had been built entirely of sandstone. The stables were constructed between 1719 and 1904, and encompassed 8 identified main phases of construction.

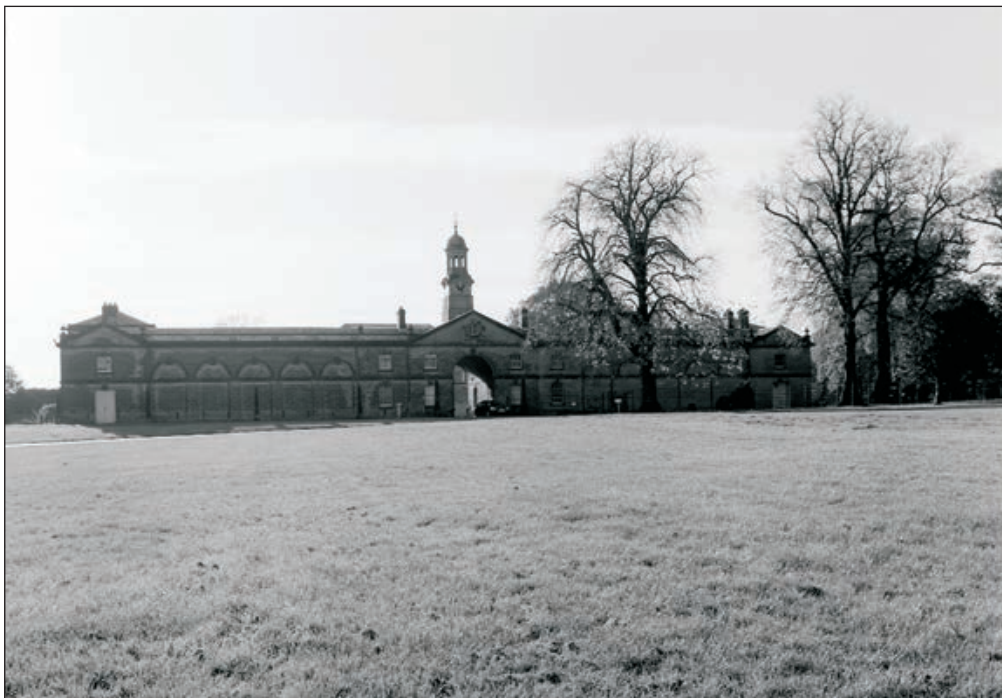
Plate 2: General view of the north elevation showing the entranceway of the Stable Block (Film 01.03)

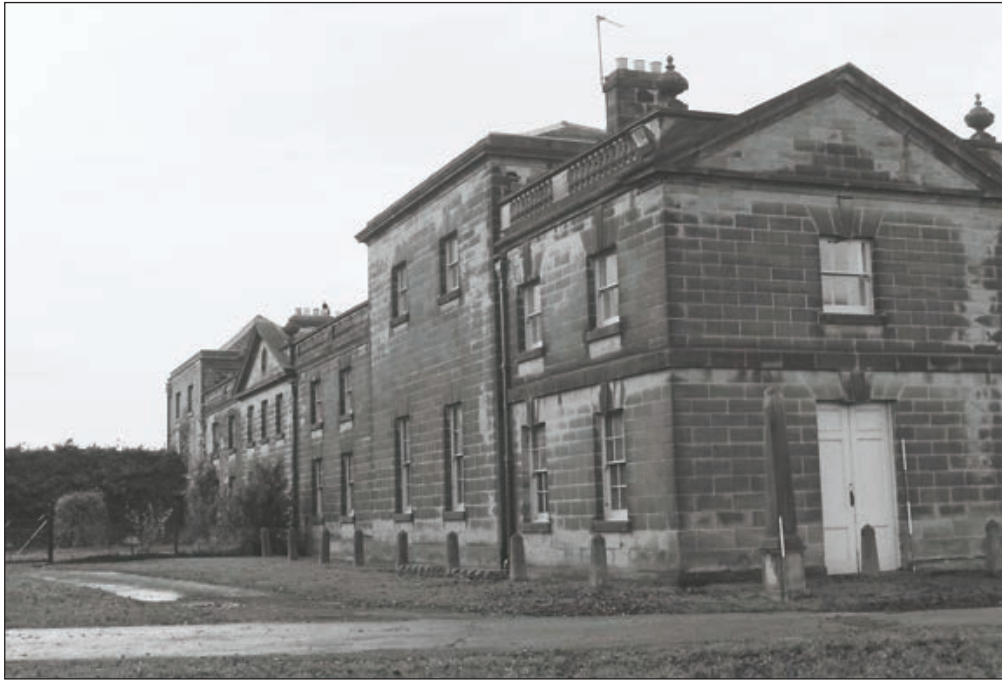
Plate 3 : General view of the east elevation of the East Range and northeast corner of the North Range from the northeast (Film 11.24)

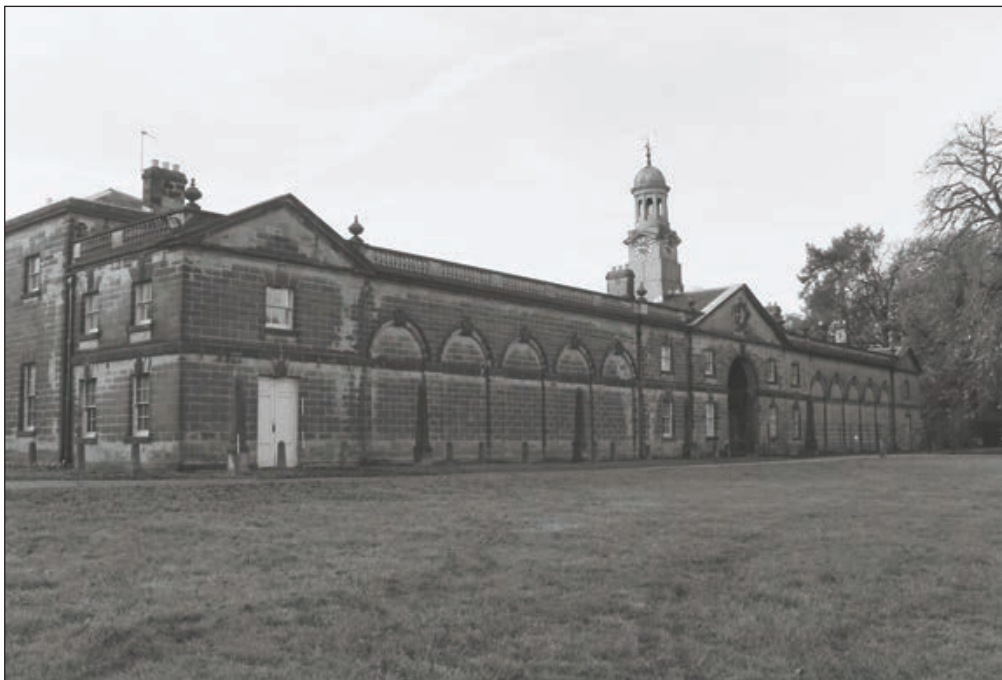
Plate 4: General view of the north elevation of the North Range from the northeast (Film 11.25)

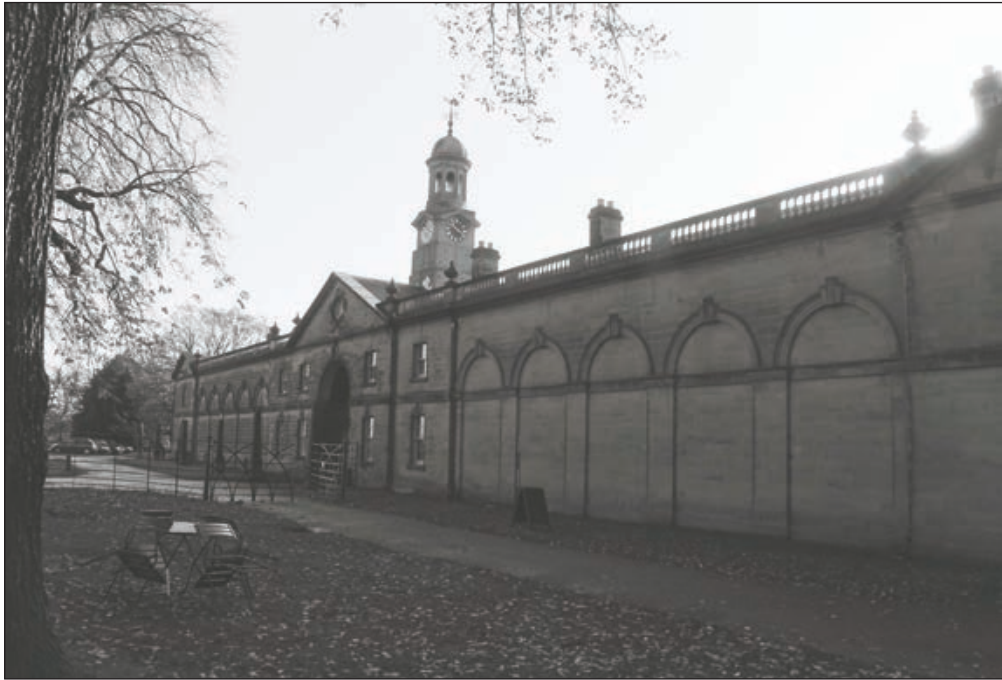
Plate 5: General view of the north elevation of the North Range from the northwest (Film 11.20)

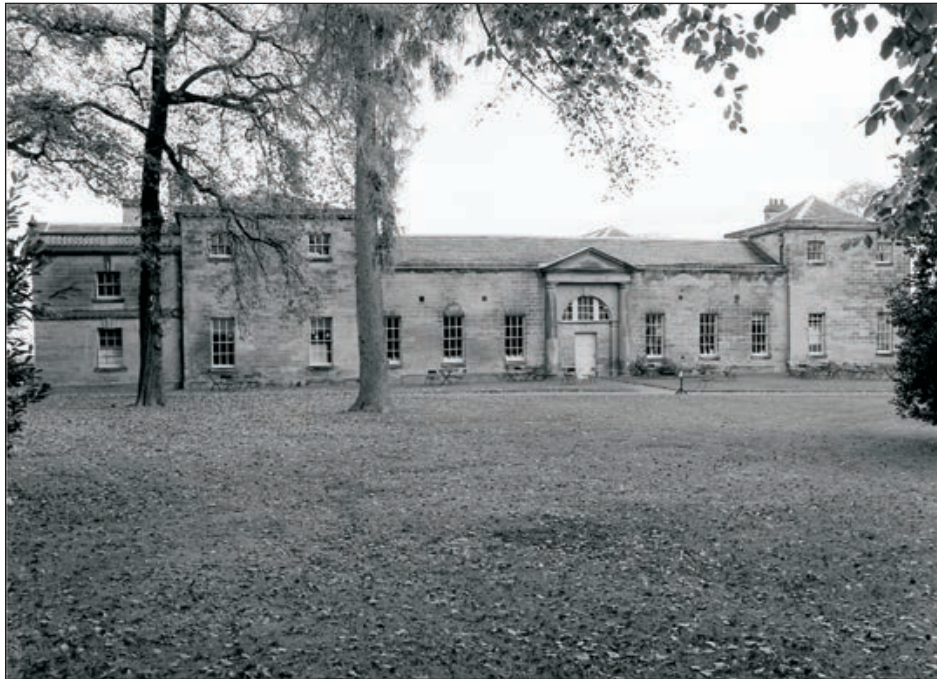
Plate 6: General view of west elevation of West Range from the northwest (Film 03.02)

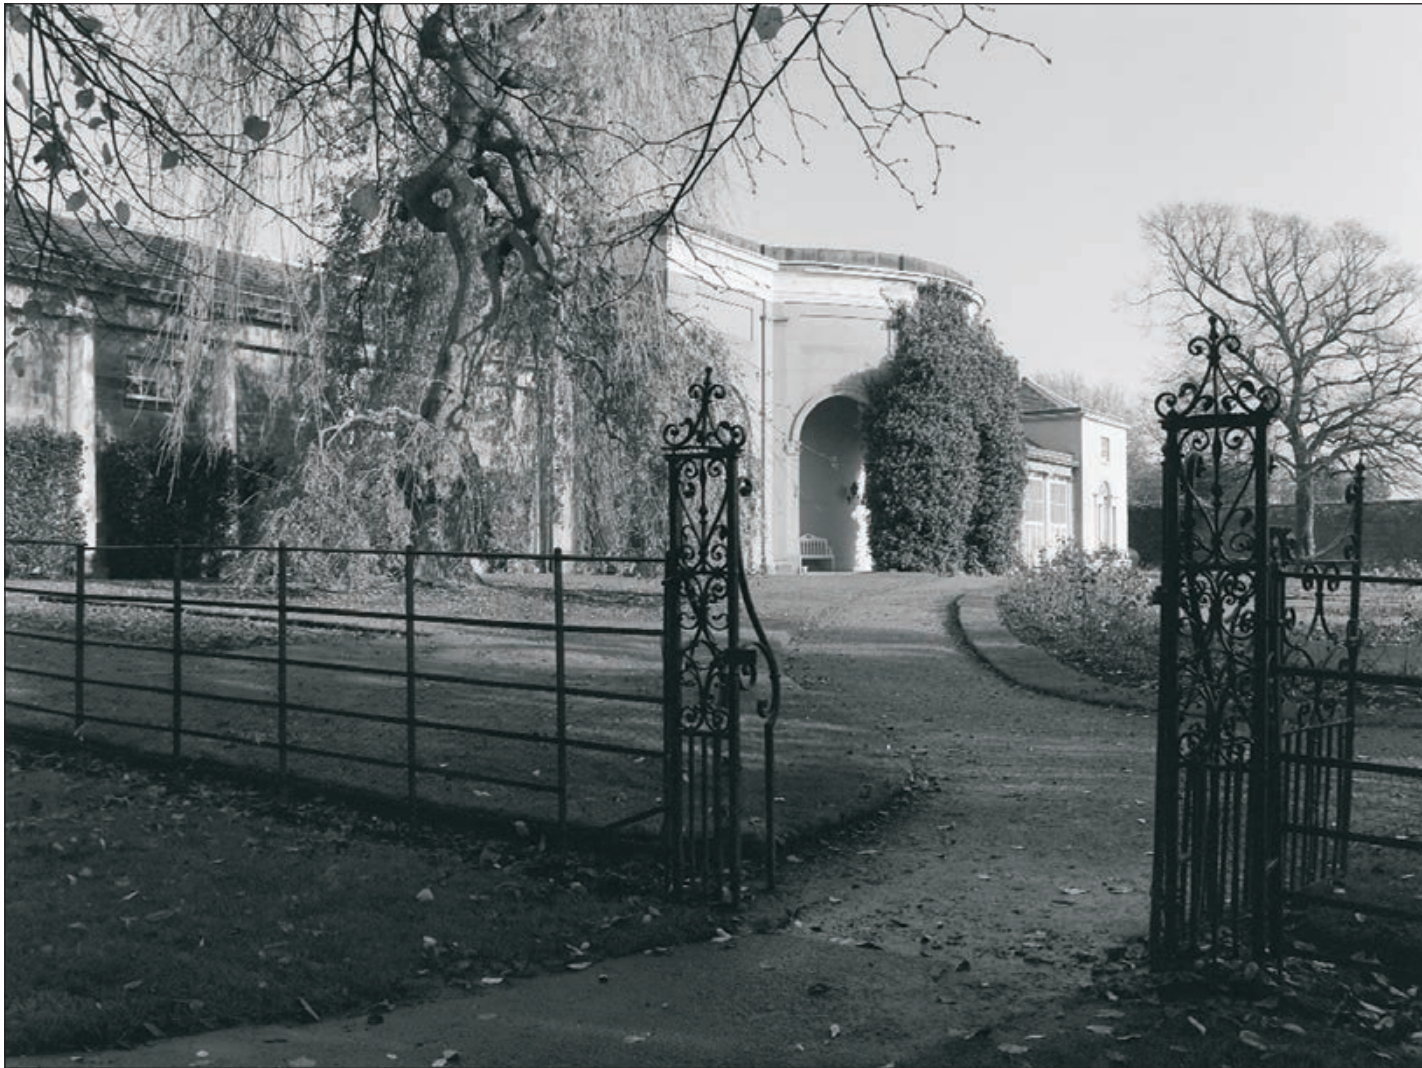
Plate 7: General view of the south elevation of the South Range, from the southwest (Film 02.01)

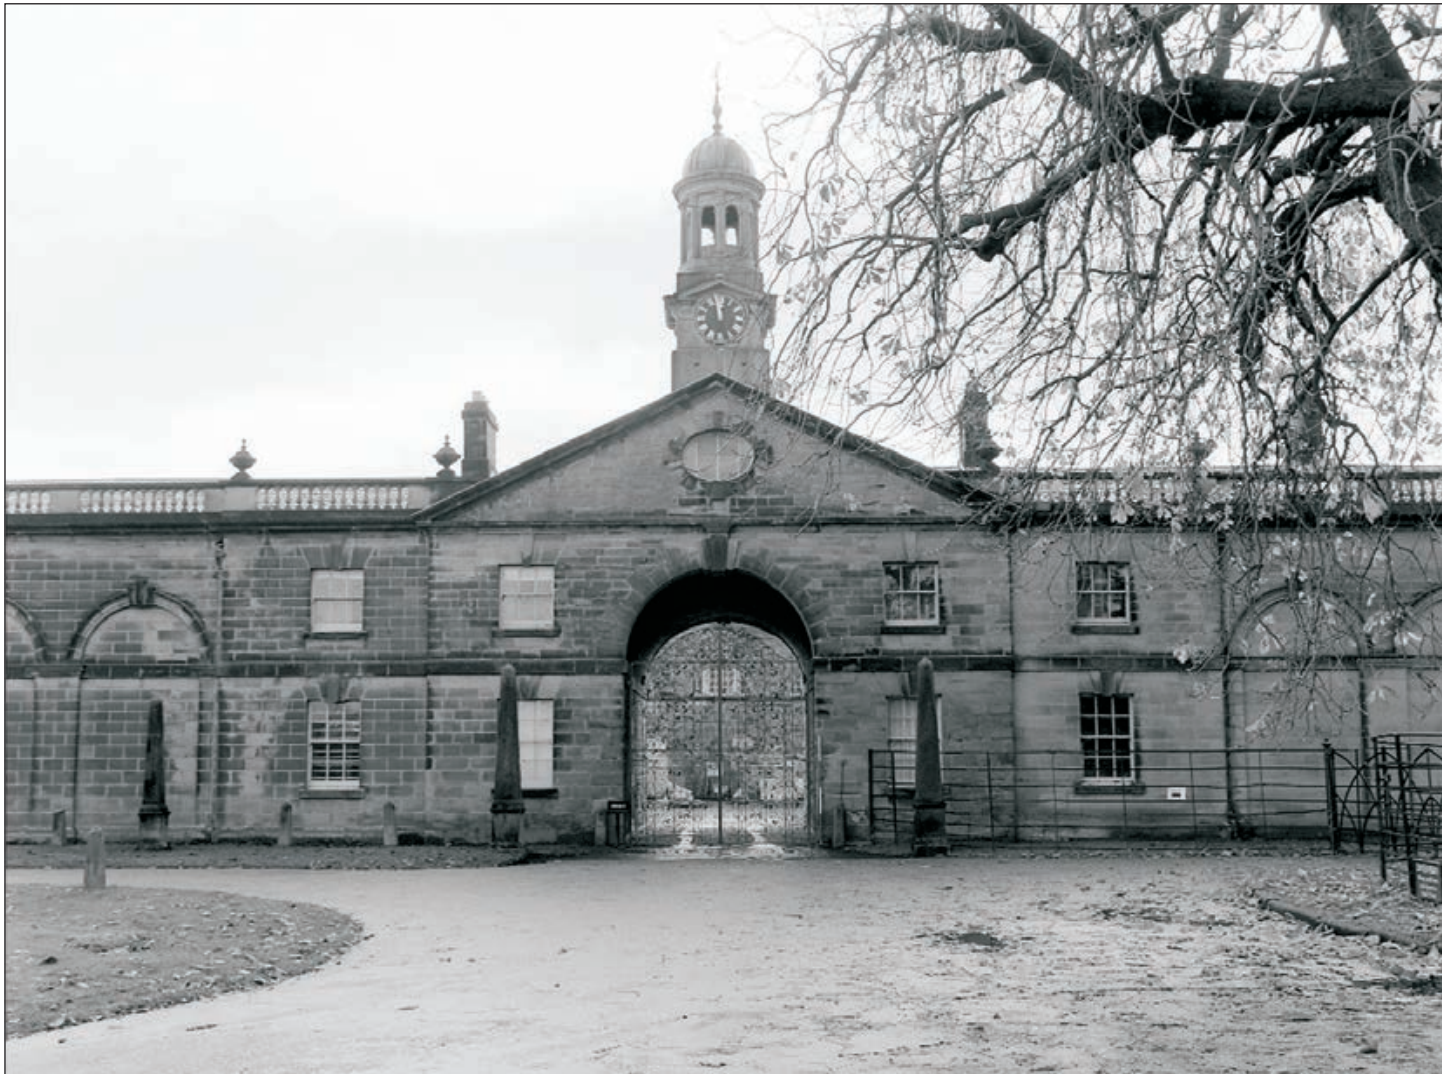
Plate 8: View of the north elevation of the central entranceway of the North Range, from the north (Film 03.07)

- 5.2.4 The majority of Paine's stable was subsequently demolished and replaced, however, the North Range has retained his three-storey, pedimented arched entranceway with later cupola above (**Plate 8**). Its projecting north elevation comprised a tall central archway, with flanking sash windows at both ground and first floor and a central third-storey oeil-de-boeuf window above the archway (**Plates 8 and 14**). The ground and first floors are broken by a projecting stone string course, whilst the pediment was framed with projecting moulded stone cornicing and copings. All windows had projecting stone sills and flat segmental stone arches with accented key stone (**Plates 15-17**). This detailing was also present around the archway and oeil-de-boeuf (**Plate 14**). Attached to the north elevation of the archway was a set of secondary decorative iron gates (**Plates 9-11**). The south elevation of the entranceway was essentially a mirror of the north (**Plate 13**).
