NOSTELL PRIORY STABLES, NOSTELL, WAKEFIELD, WEST YORKSHIRE

Historic Building Recording and Structural Watching Brief

Planning Application Ref: 09/00701/FUL & 09/00705/LBC

72934.01_BDG_V0_4

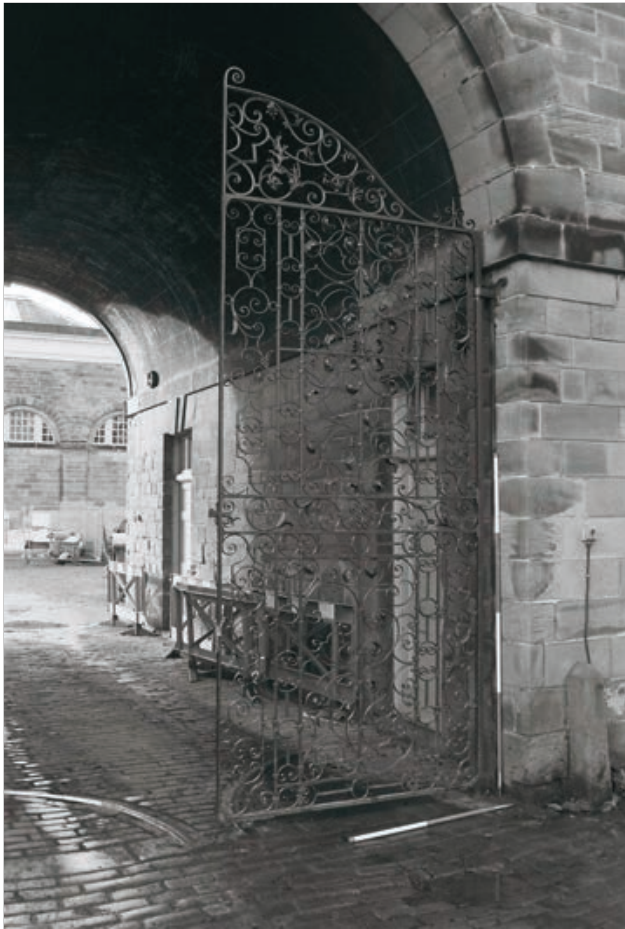
Plate 9: View of iron gates of the North Range cart passage entrance (Film 12.05)

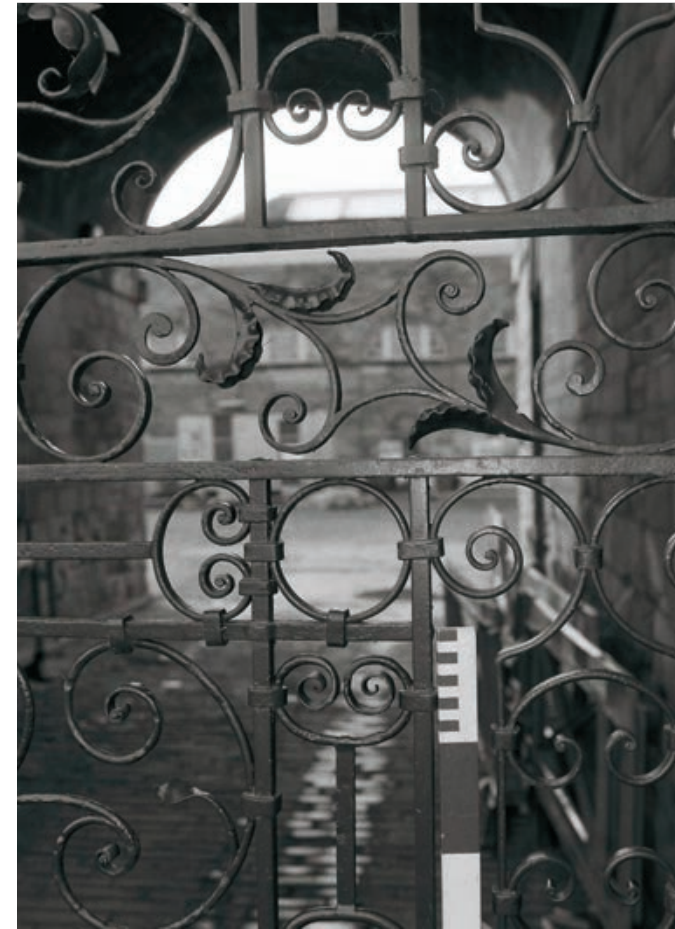
Plate 10: Detail of the North Range cart passage iron gates (Film 12.07)

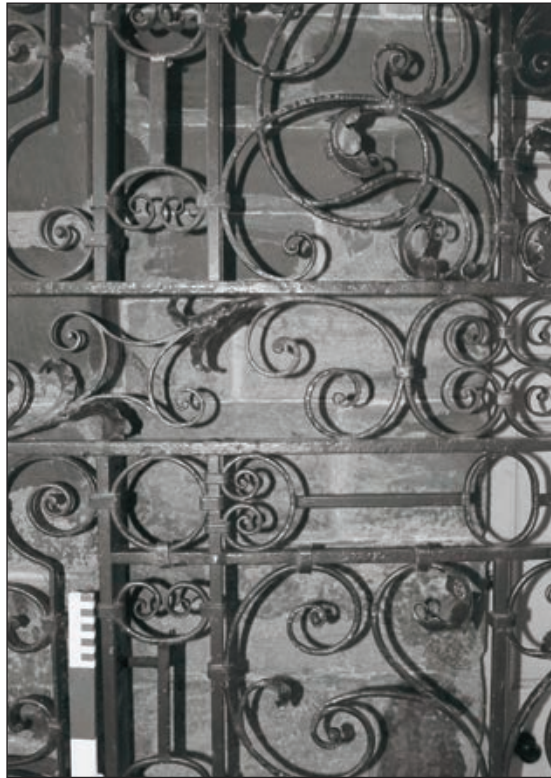
Plate 11: Detail of the North Range cart passage iron gate (Film 12.09)

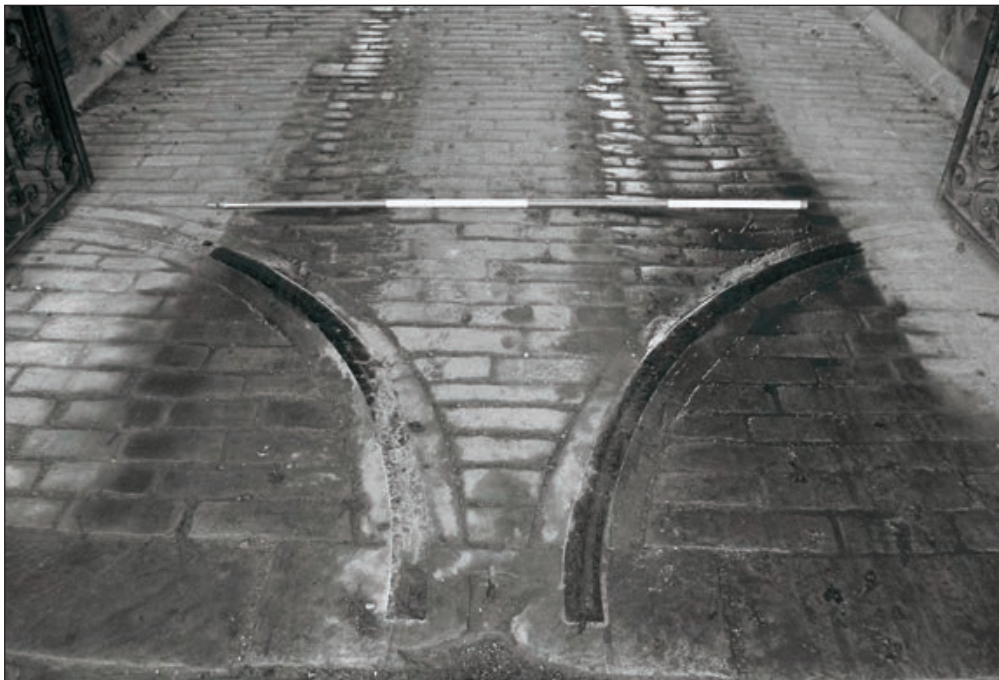
Plate 12: View of stone setted surface of cart passage and gate guides, North Range (Film 20.29)

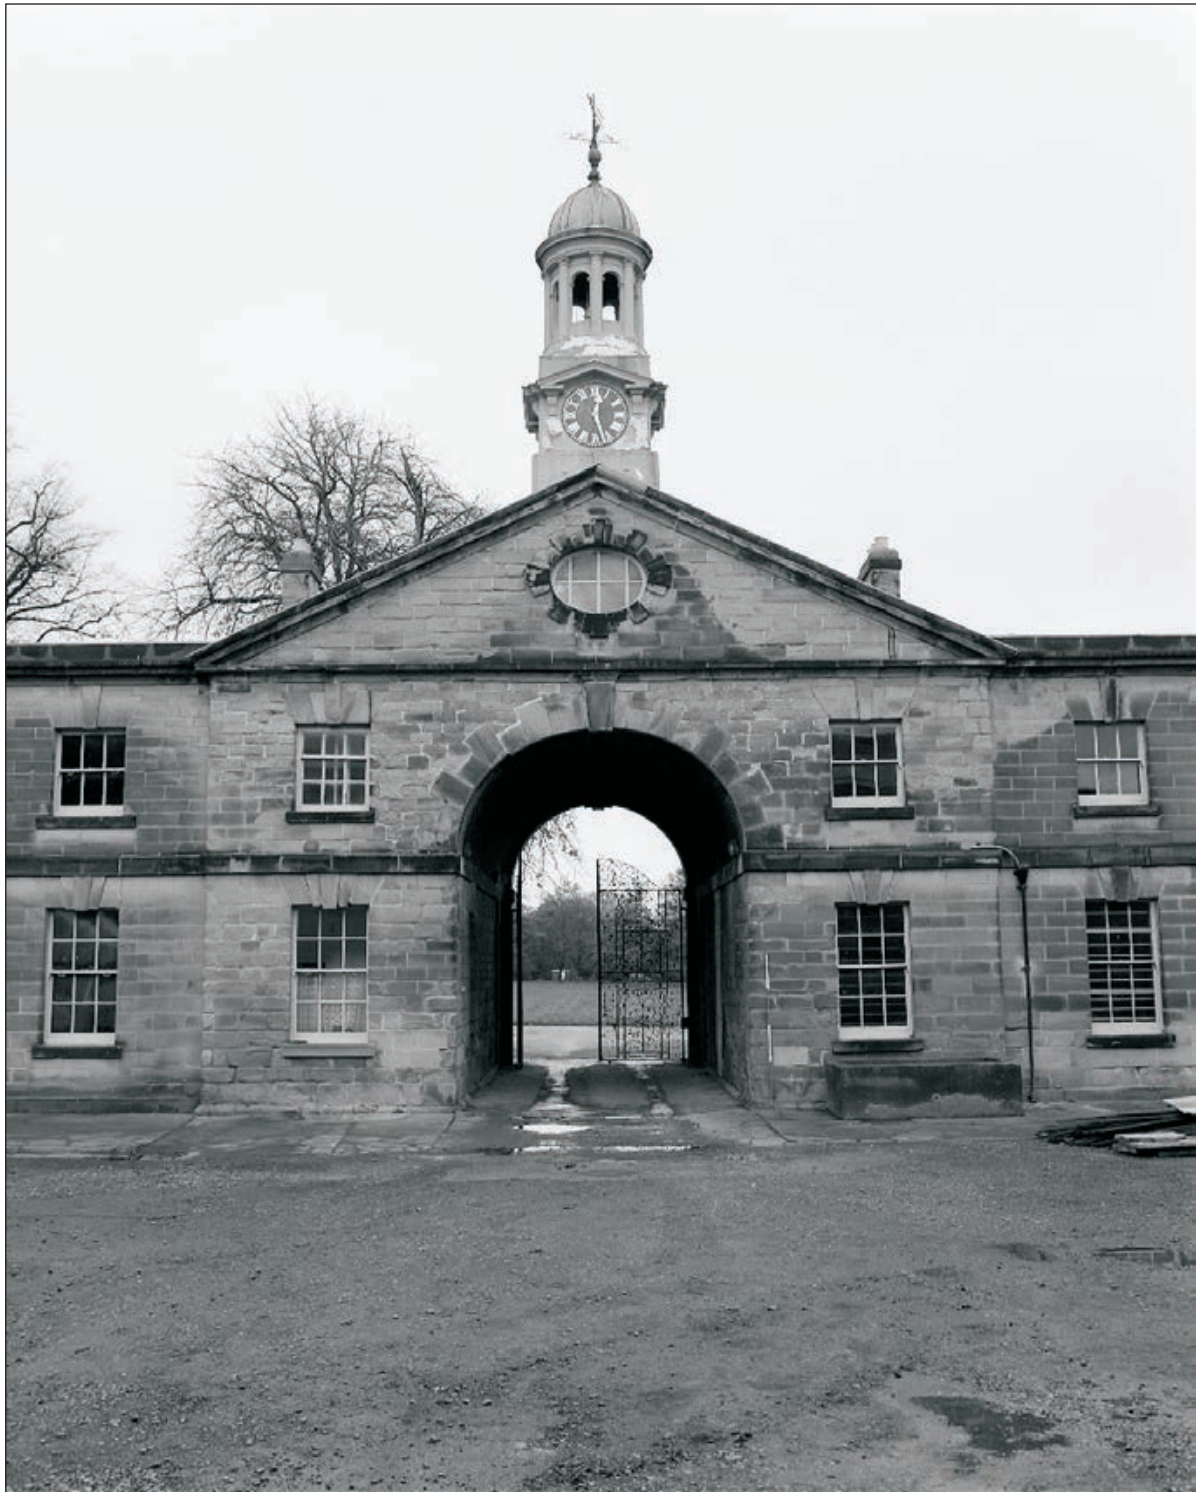
Plate 13: View of the south (courtyard) elevation of the entranceway of the North Range, from the south (Film 17.01)

- 5.2.4 The majority of Paine's stable was subsequently demolished and replaced, however, the North Range has retained his three-storey, pedimented arched entranceway with later cupola above (**Plate 8**). Its projecting north elevation comprised a tall central archway, with flanking sash windows at both ground and first floor and a central third-storey oeil-de-boeuf window above the archway (**Plates 8 and 14**). The ground and first floors are broken by a projecting stone string course, whilst the pediment was framed with projecting moulded stone cornicing and copings. All windows had projecting stone sills and flat segmental stone arches with accented key stone (**Plates 15-17**). This detailing was also present around the archway and oeil-de-boeuf (**Plate 14**). Attached to the north elevation of the archway was a set of secondary decorative iron gates (**Plates 9-11**). The south elevation of the entranceway was essentially a mirror of the north (**Plate 13**).

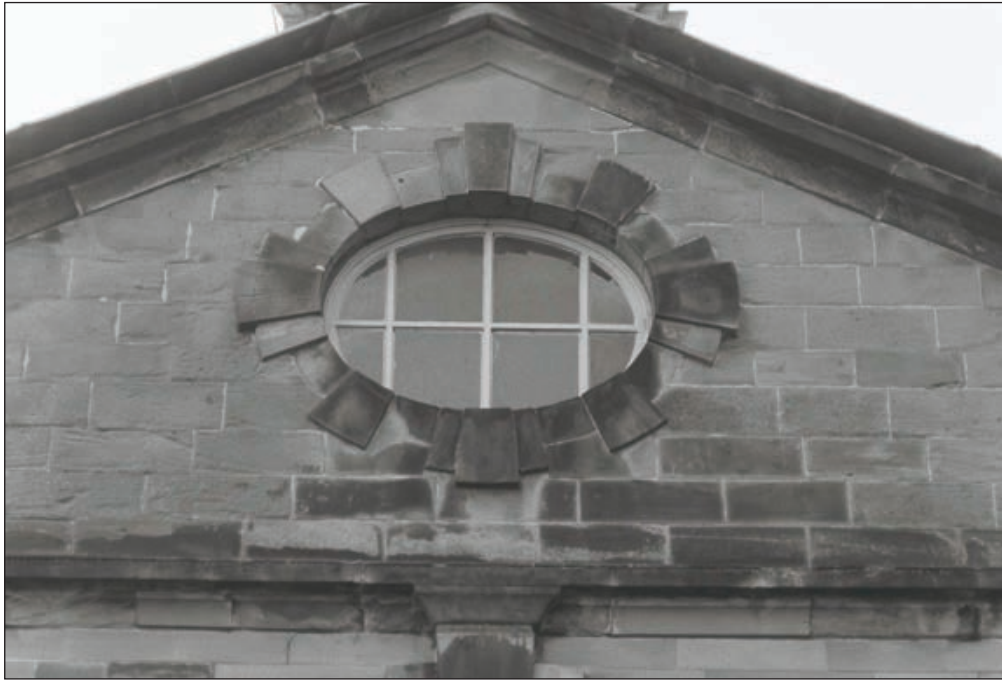
Plate 14: Detail of oeil-de-beuf window, north elevation of the North Range (Film 11.08)

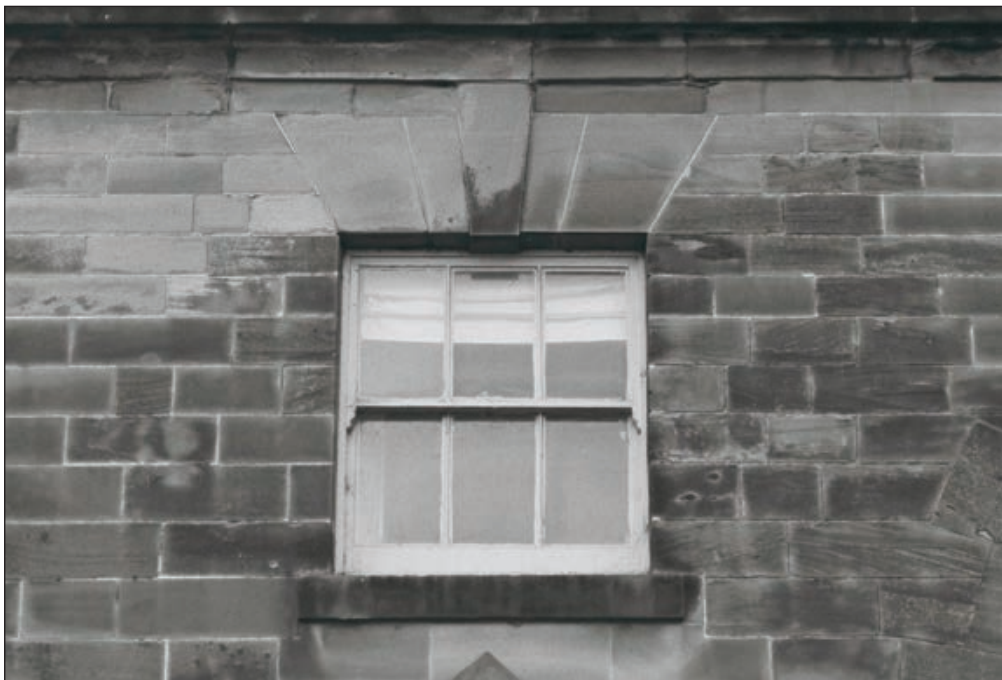
Plate 15: Detail of first floor window, north elevation of North Range (Film 11.06)

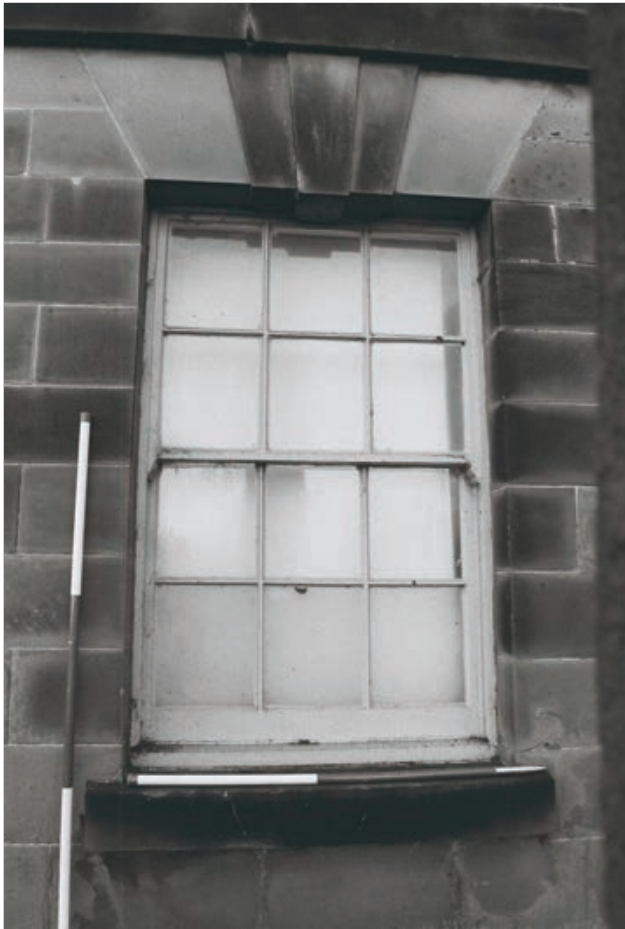
Plate 16: Detail of ground floor window, north elevation of the North Range (Film 11.05)

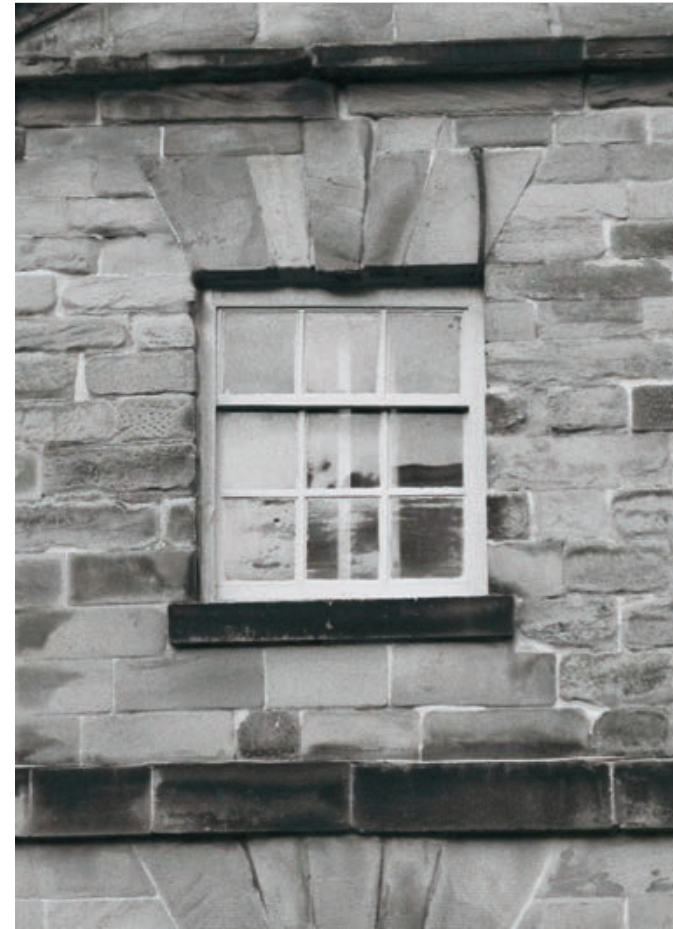
Plate 17: Detail of first floor window, south elevation of North Range (Film 16.35)

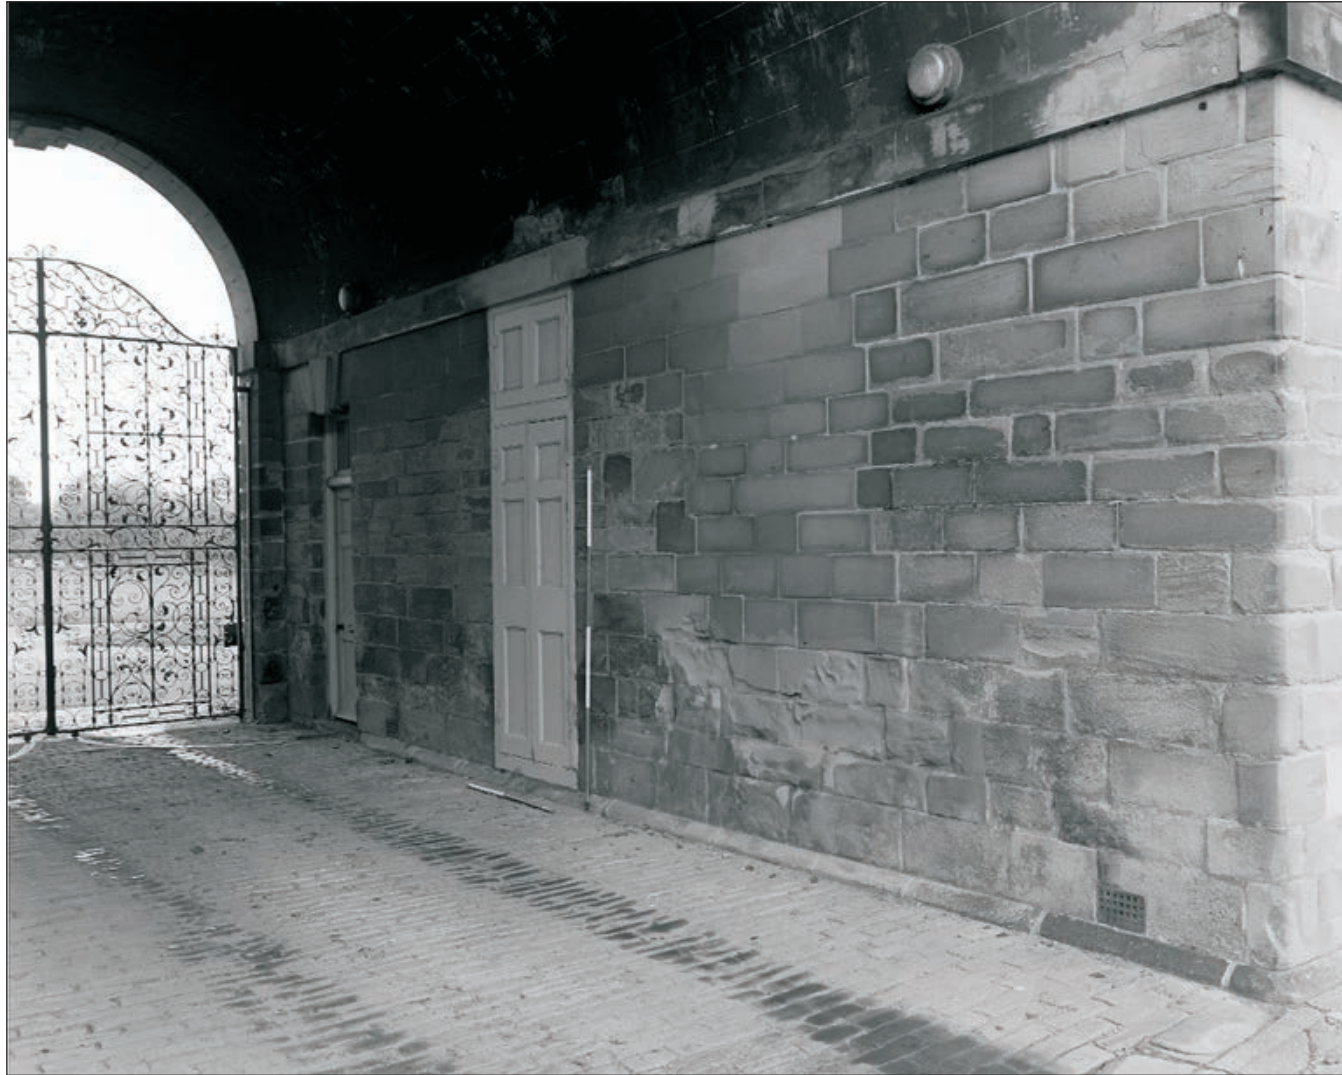
Plate 18: View of the west facing elevation of the cart passage (G7) of the North Range, from southwest (Film 04.06)

- 5.2.5 The cart passage itself (G7), within its east wall contained a primary doorway opening at the north end, a secondary central recessed opening with timber double doors, and a stone blocked arched opening at the south end (**Plate 18**). Present within the west wall of the cart passage were primary door openings at the north and south ends (**Plate 19**) and two stone blocked windows centrally positioned between the two doorways (**Plate 20**). The ground surface of the cart passage was made up of stone setts, likely a secondary surface (**Plates 12, 18 and 19**). The arched ceiling to the cart passage was a secondary insert, and was made up of lath and plaster with mock stone scoring (**Plate 21**).

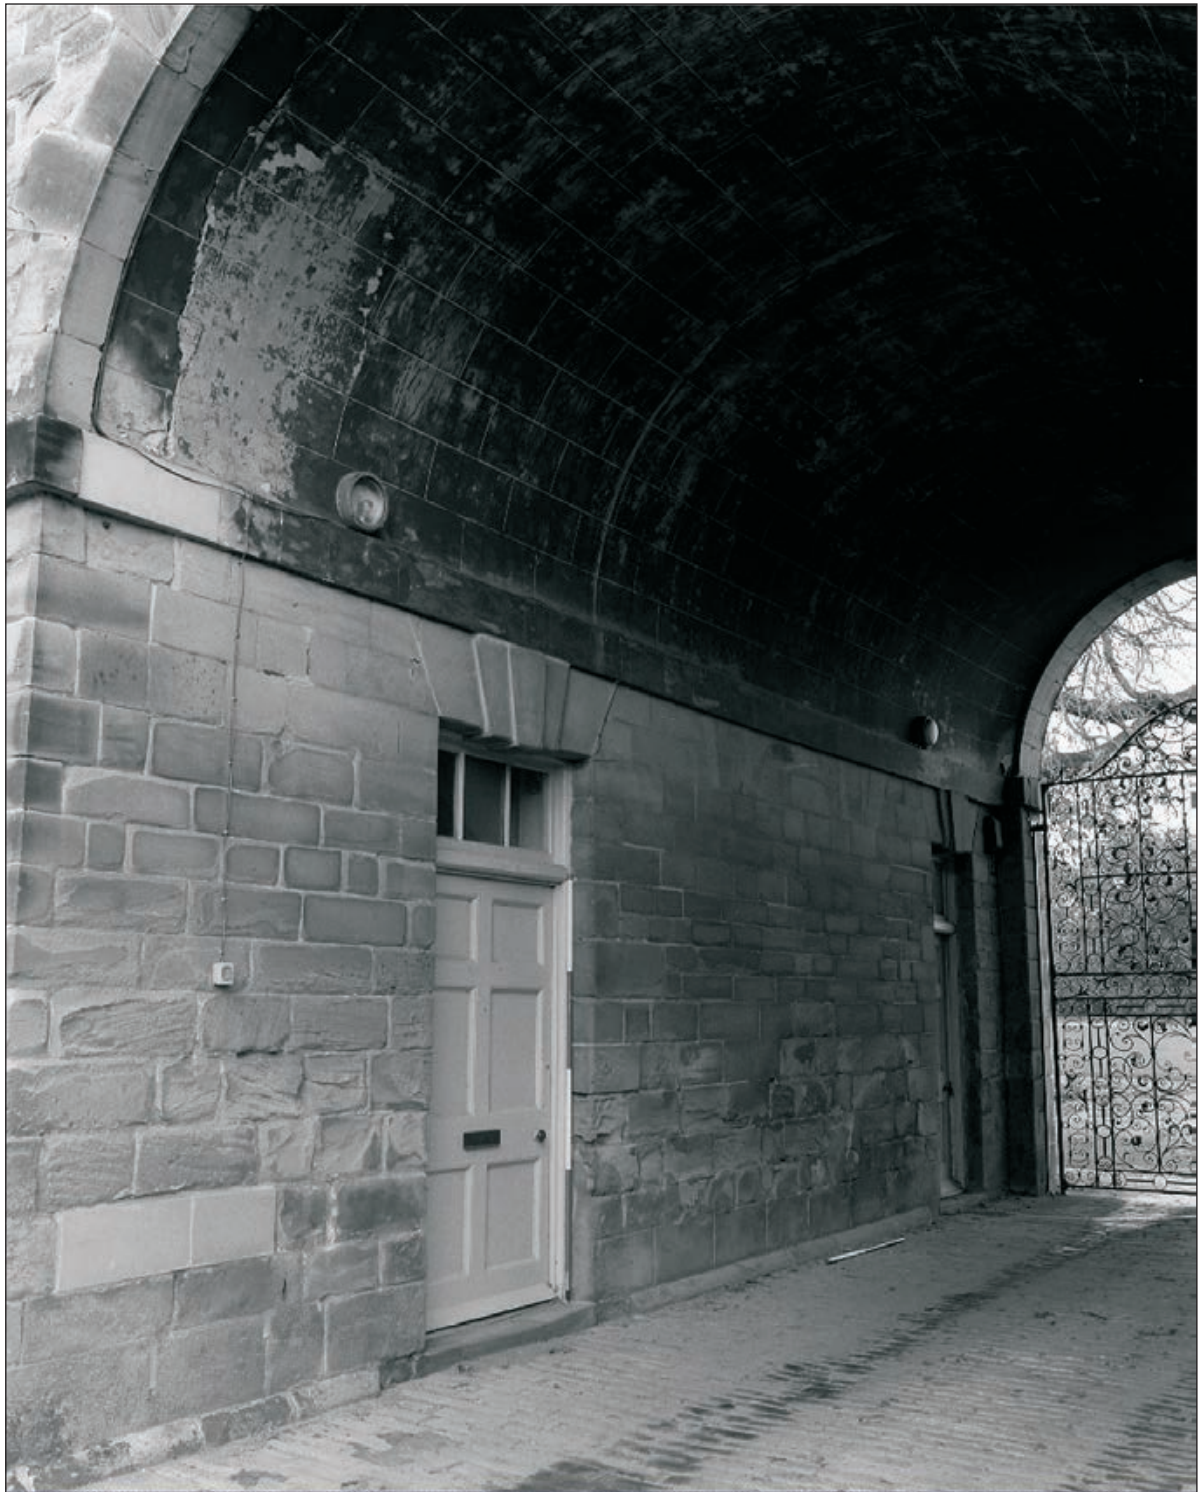
Plate 19: View of the east facing elevation of the cart passage (G7) of the North Range (Film 04.04)

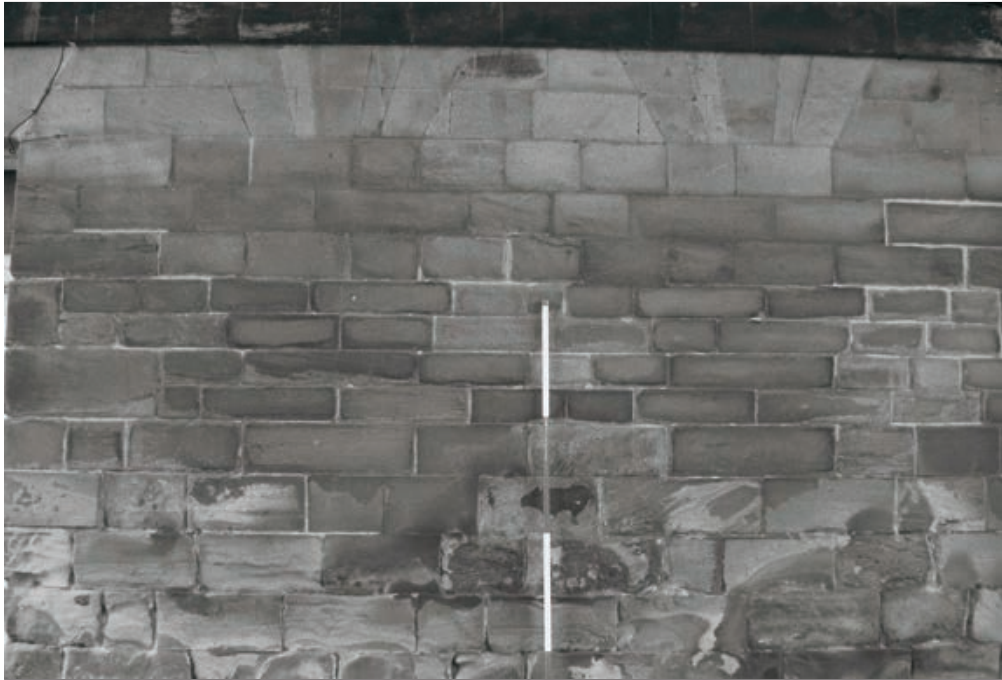
Plate 20: Detail of blocked windows within the east facing elevation of the North Range cart passage (G7) (Film 20.27)

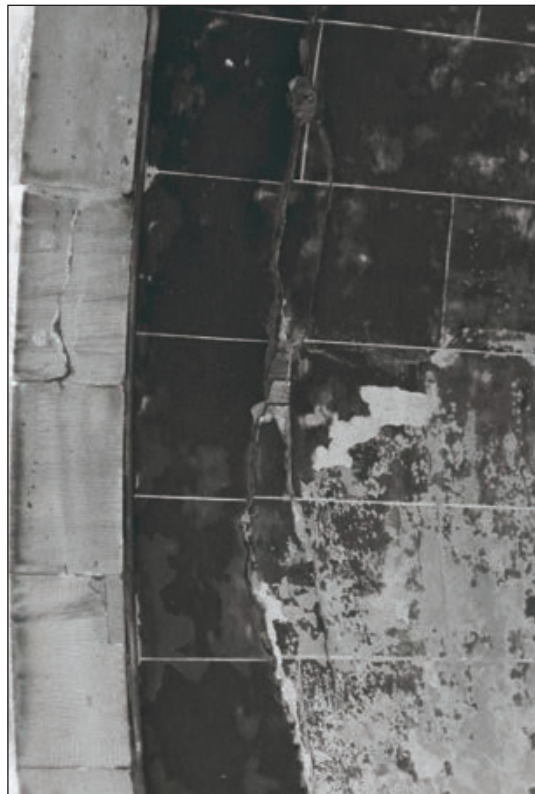
Plate 21: Detail of inserted lath and plaster arched ceiling of the North Range cart passage (G7) (Film 20.31)

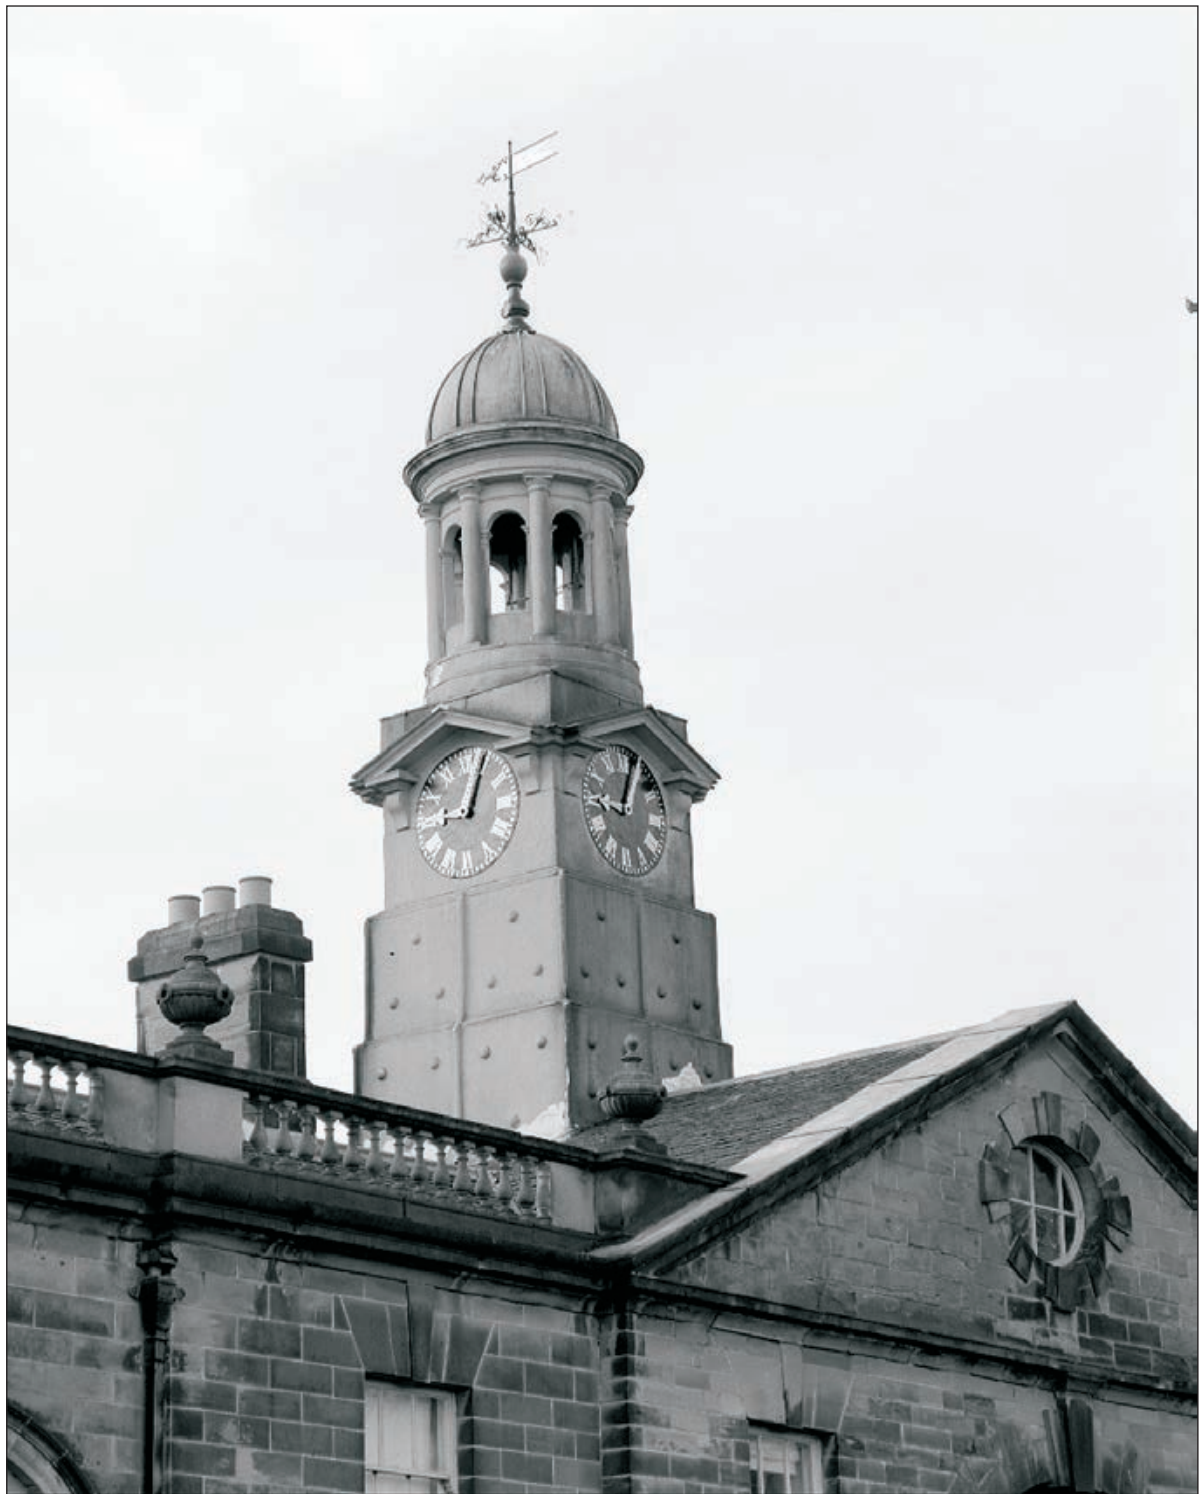
Plate 22: Detail of Clock Tower over entranceway of North Range, from northeast (Film 10.07)

- 5.2.6 Positioned centrally above the pedimented entranceway was a secondary cupola tower which was moved to its position over the North Range from the West Range in 1875 (**Plates 22 and 23**). It had a stepped square base with

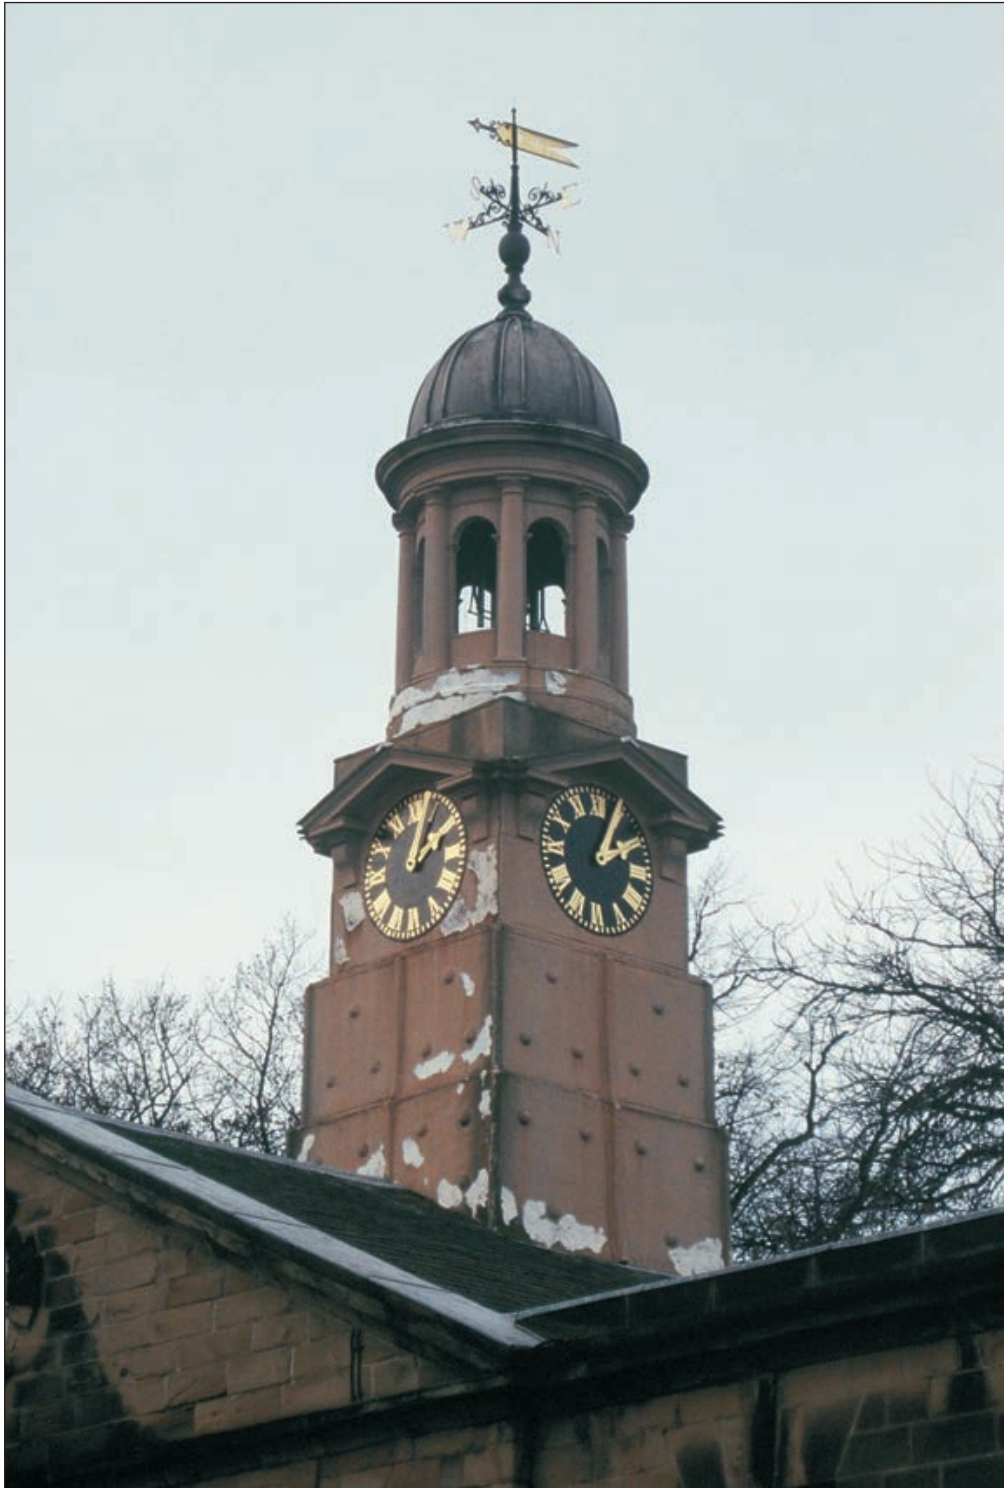
Plate 23: Detail of Clock Tower over entranceway of the North Range, from southeast (Film CS. 17)

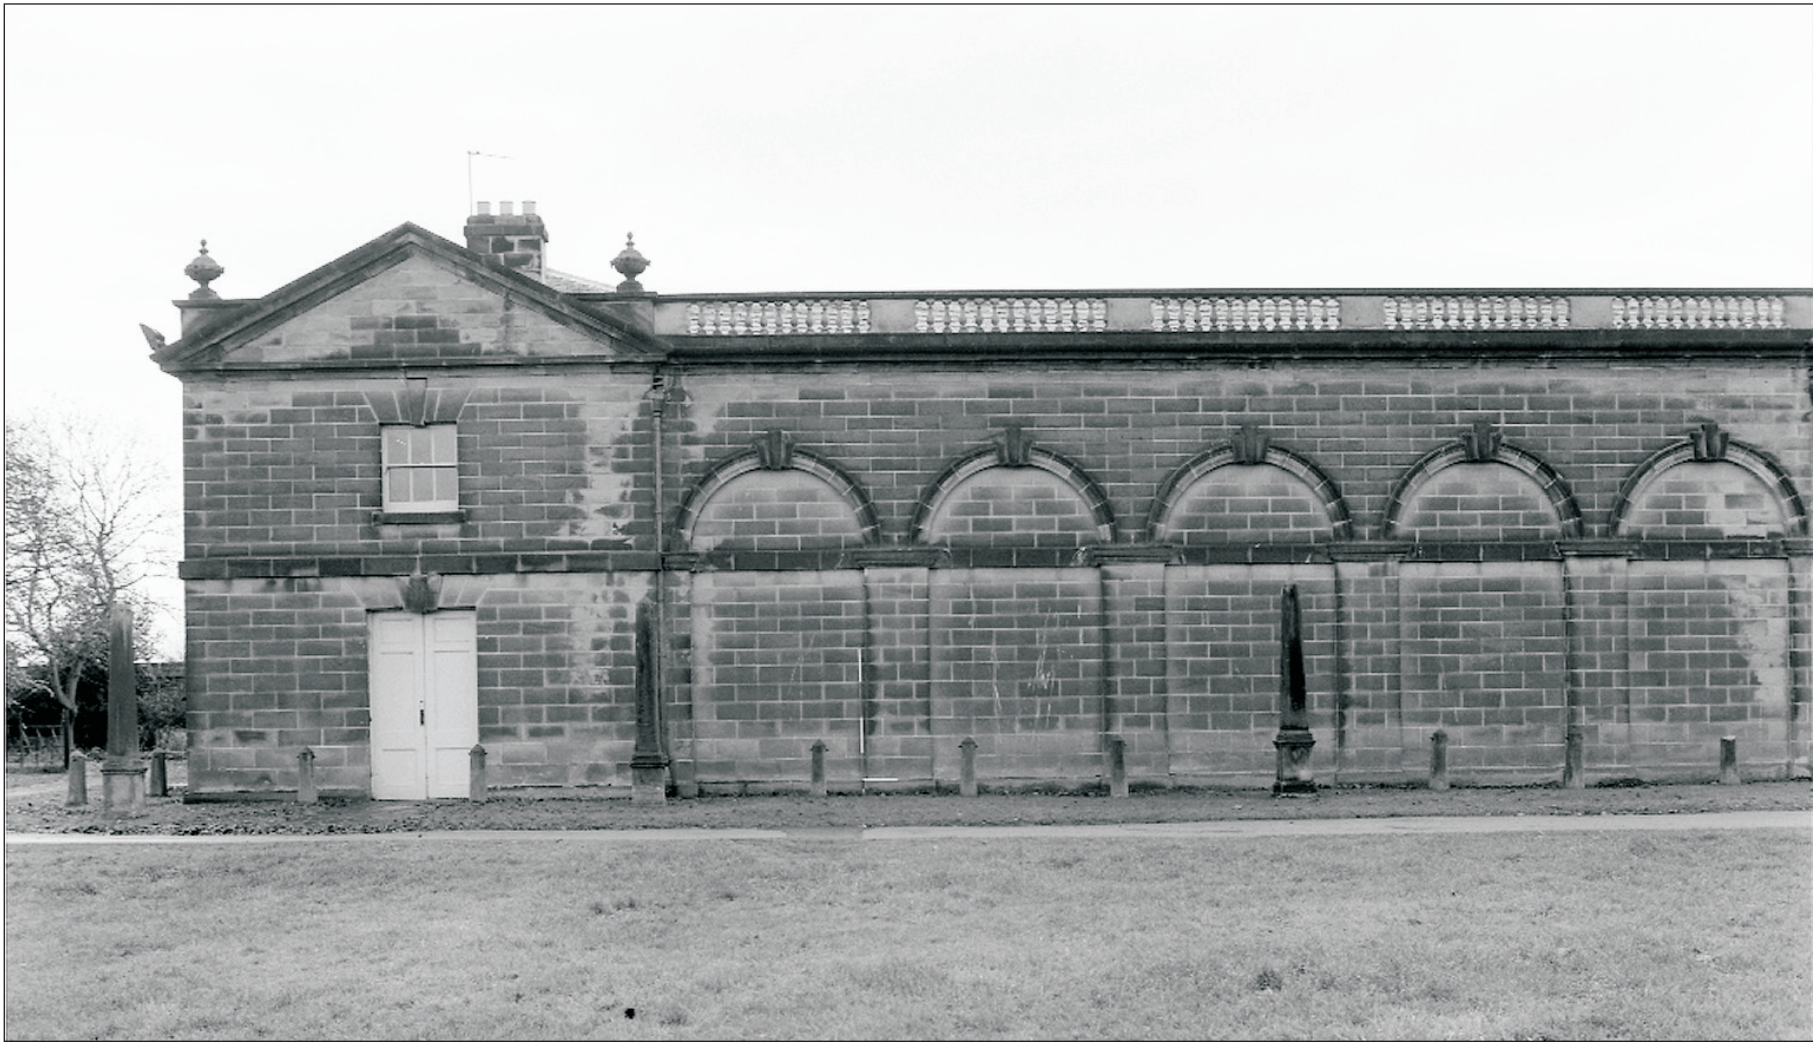
Plate 24: View of the east end of the north elevation of the North Range (Film 04.01)

- 5.2.7 The east side of the range was built in 1875-1876 (phase 6), by MacVicar Anderson. This comprised a stone built, two-storey structure with five recessed arched bays in the centre, a fenestrated west bay and a tall pedimented bay at the east end (**Plates 4 and 24**). The architectural design was clearly tailored to remain in keeping with the earlier Paine entranceway. The ground and first floor was divided by a projecting stone string course, whilst at the top of the five arched bays was a stone cornice with small parapet and balustrade. The western bay contained a timber sash window at both ground and first floor, whilst the eastern bay contained a wide ground floor doorway, a sash window at first floor – both centrally positioned – and moulded stone framed pediment. Two urns were positioned on both sides of the east and west bays on top of the balustrade (**Plate 24**).

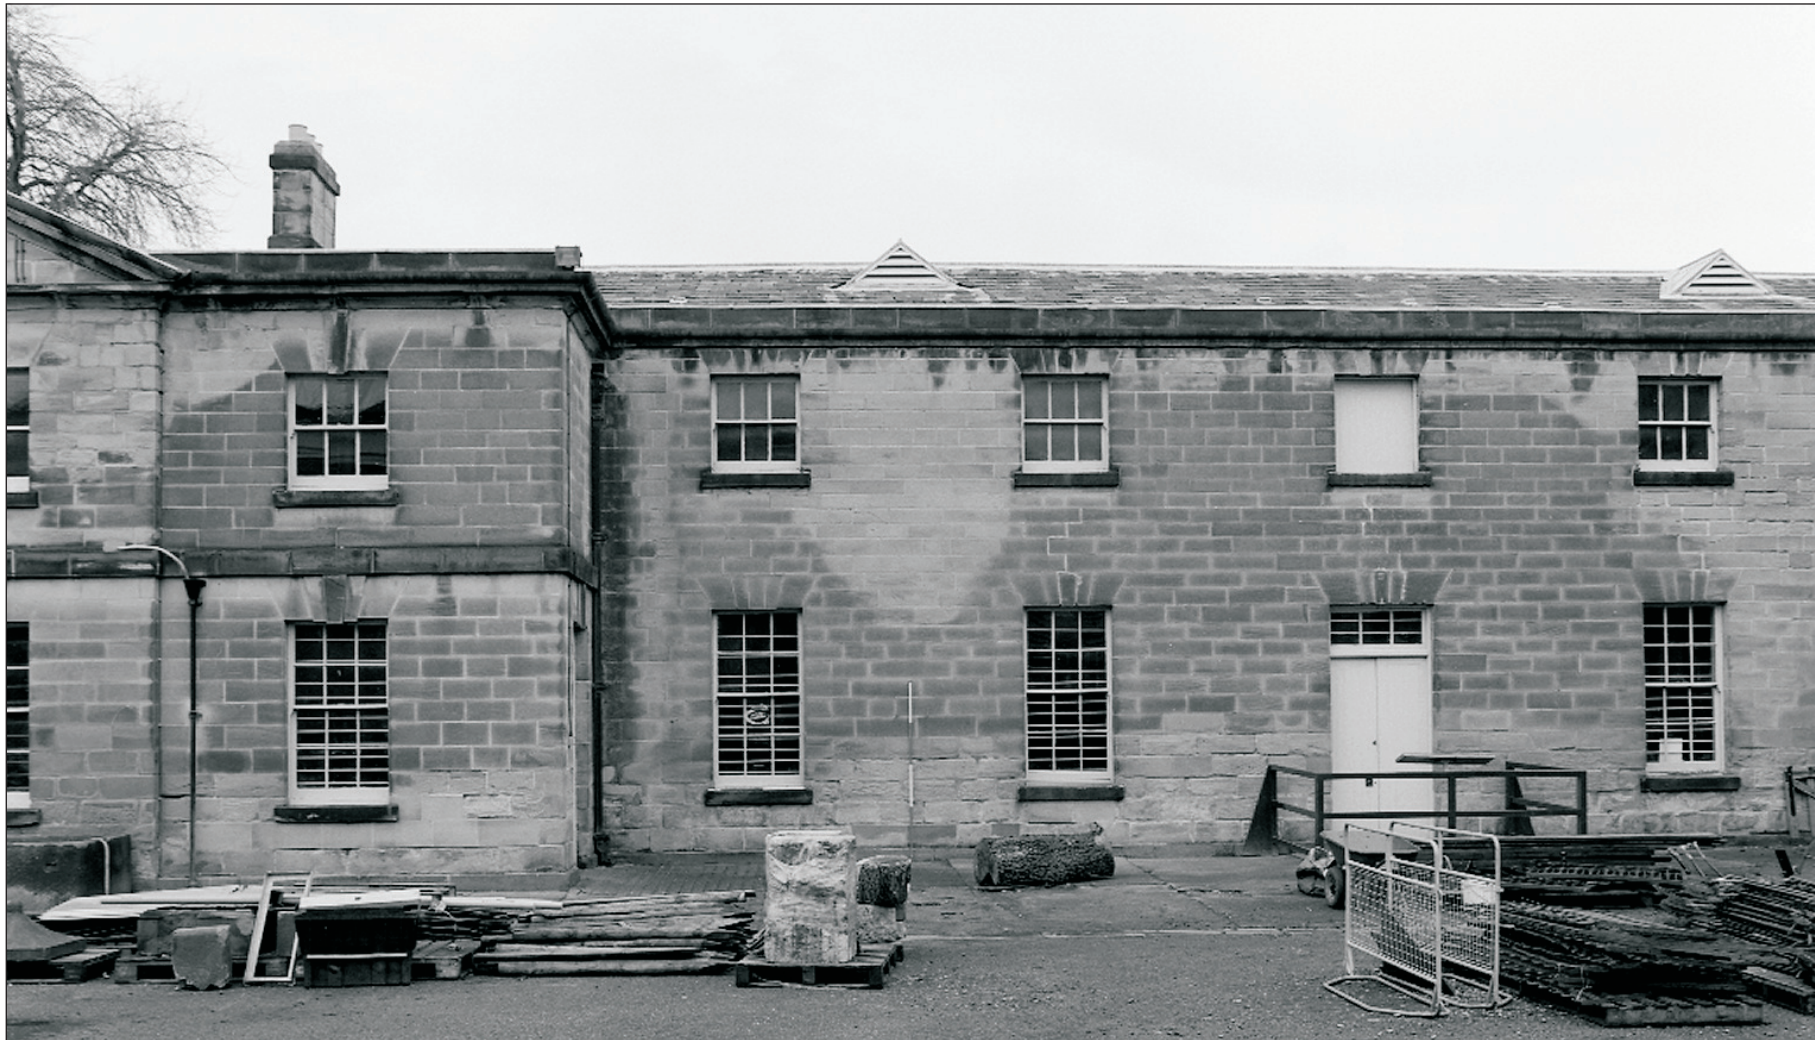
Plate 25: View of the south courtyard elevation of the east end of the North Range (Film 17.07)

- 5.2.8 The south elevation of the east side of the north range was much plainer in architectural detail. It comprised five bays, the west bay projecting into the courtyard almost in line with the earlier Paine entranceway (**Plate 25**). Each of the bays contained a central sash window with projecting stone sill and segmental flat arched heads at ground and first floor, with the exception of the fourth bay to the east which had a doorway at ground floor and a threshing door at first floor above (**Plate 25 and 26**). There was no parapet or balustrade around the roof within this elevation, leaving the stone tiled covered pitched roof visible with two projecting triangular wooden vents (**Plate 27**).

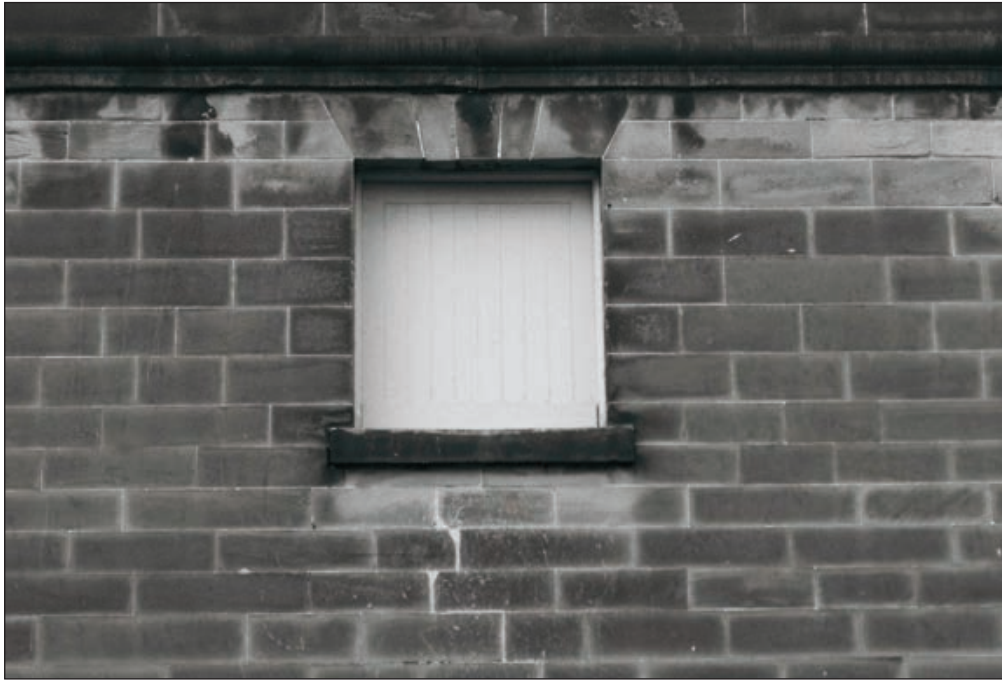
Plate 26: Detail of first floor threshing door within the south elevation of the east end of the North Range (Film 20.37)

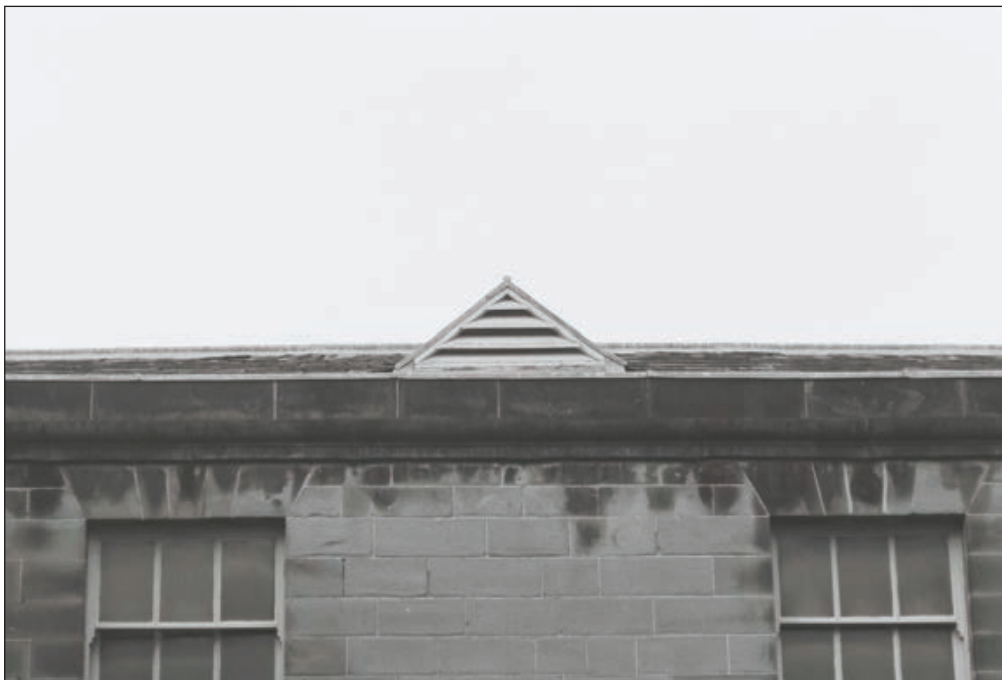
Plate 27: Detail of pitched timber louvered roof vents of the east end of the North Range (Film 20.34)

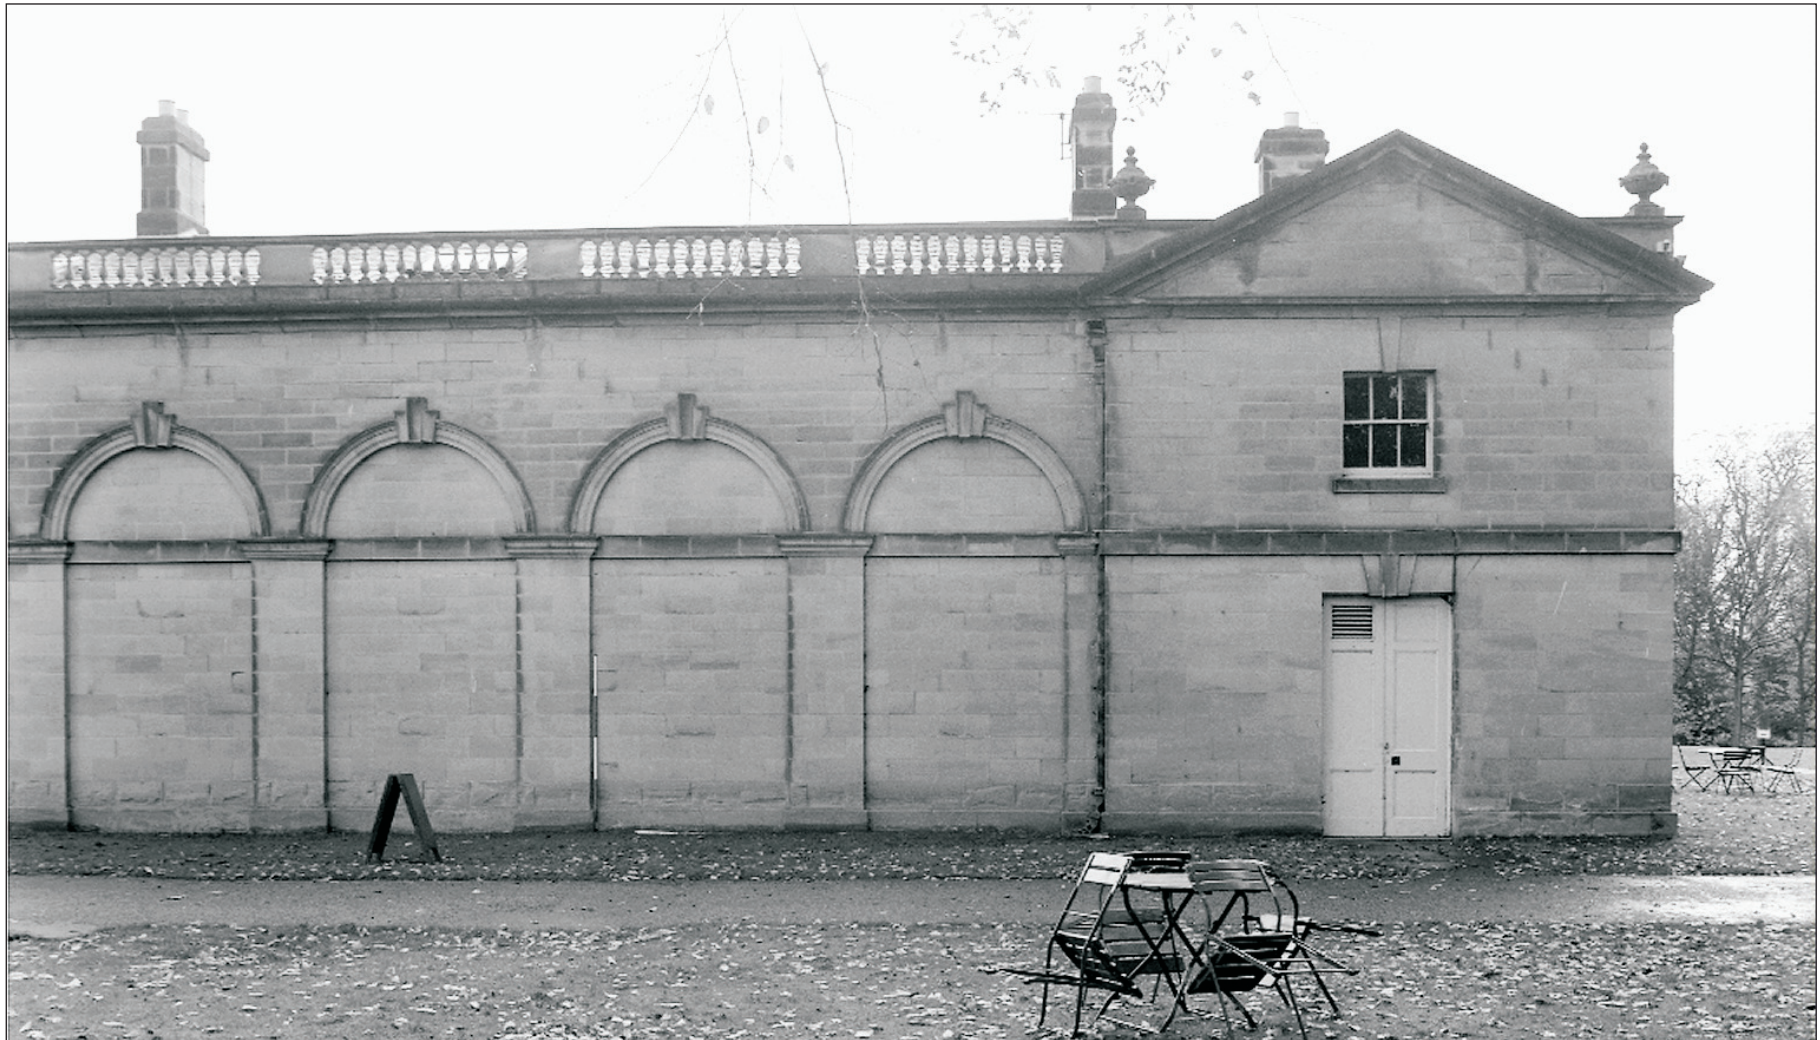
Plate 28: View of the west end of the north elevation of the North Range (Film 03.05)
