NOSTELL PRIORY STABLES, NOSTELL, WAKEFIELD, WEST YORKSHIRE

Historic Building Recording and Structural Watching Brief

Planning Application Ref: 09/00701/FUL & 09/00705/LBC

72934.01_BDG_V0_4

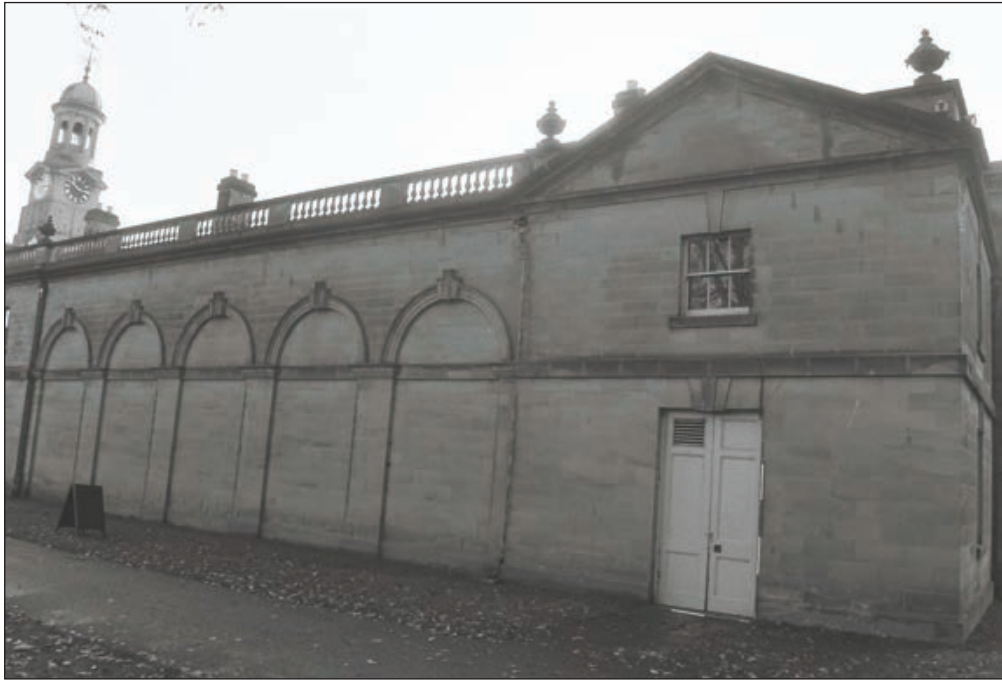
Plate 29: General view of the west end of the north elevation of the North Range (Film 11.18)

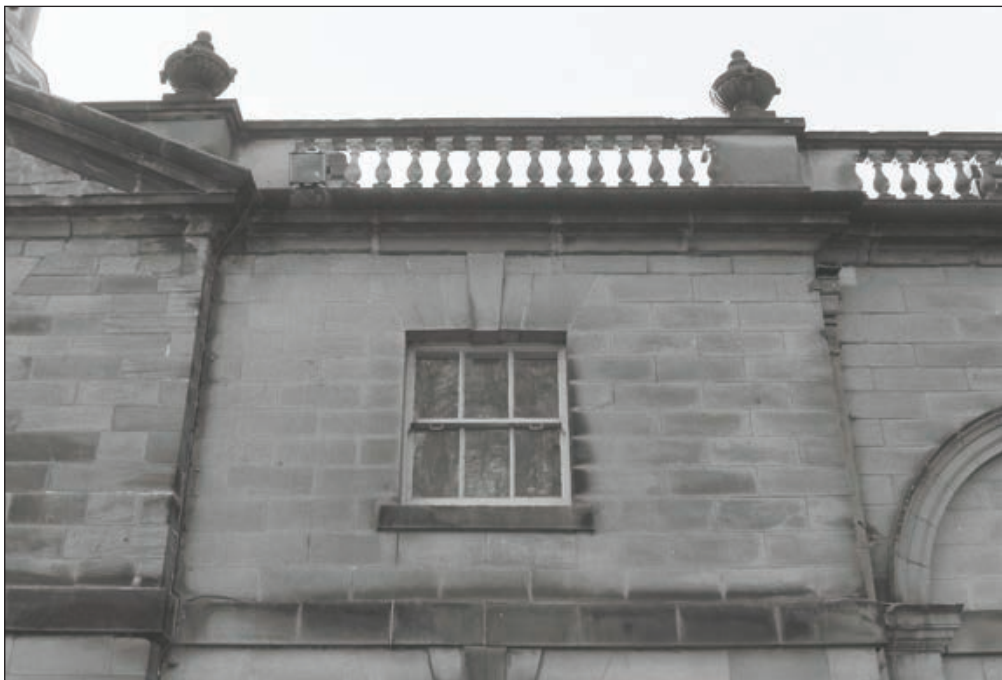
Plate 30: Detail of first floor window and upper balustrade, west end of the north elevation of the North Range, adjacent to the phase 2 Paine entranceway (Film 11.14)

- 5.2.9 The west side of the North Range was constructed in 1904 (phase 7), also by MacVicar Anderson, replacing the original phase 1 stable range. This replacement range contained a north elevation which mirrored the slightly earlier north elevation of the east side of the range, with a fenestrated two-storey bay at the east, a five-bay central section with recessed arches, and a pedimented west bay with ground floor doorway and first floor sash window (**Plates 28 and 29**). Urns again decorated either side of the pedimented bay, resting on a stone parapet. The timber sash windows at both ground and first floor had moulded horns, projecting stone sills and segmental flat arched heads, with accented key stones (**Plates 30-32**).

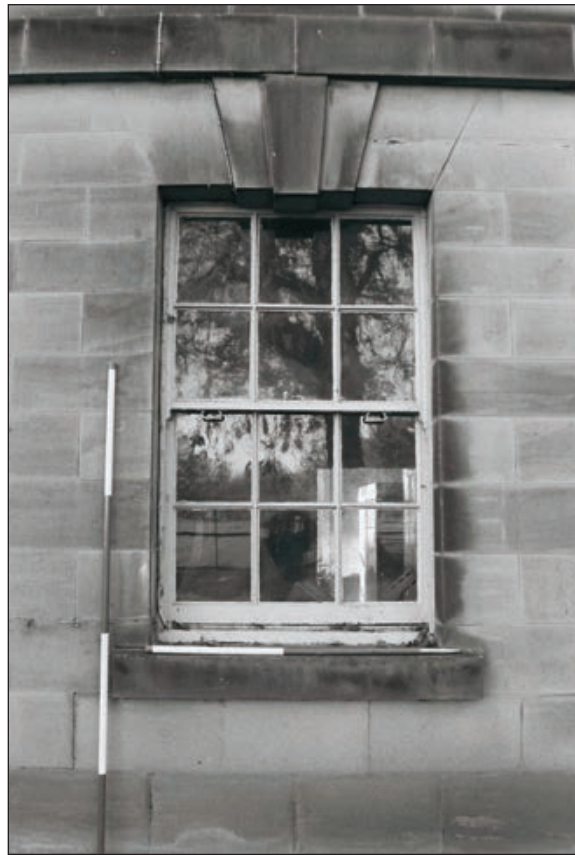
Plate 31: Detail of a ground floor window of the phase 7 west end of the north elevation of the North Range (Film 11.10)

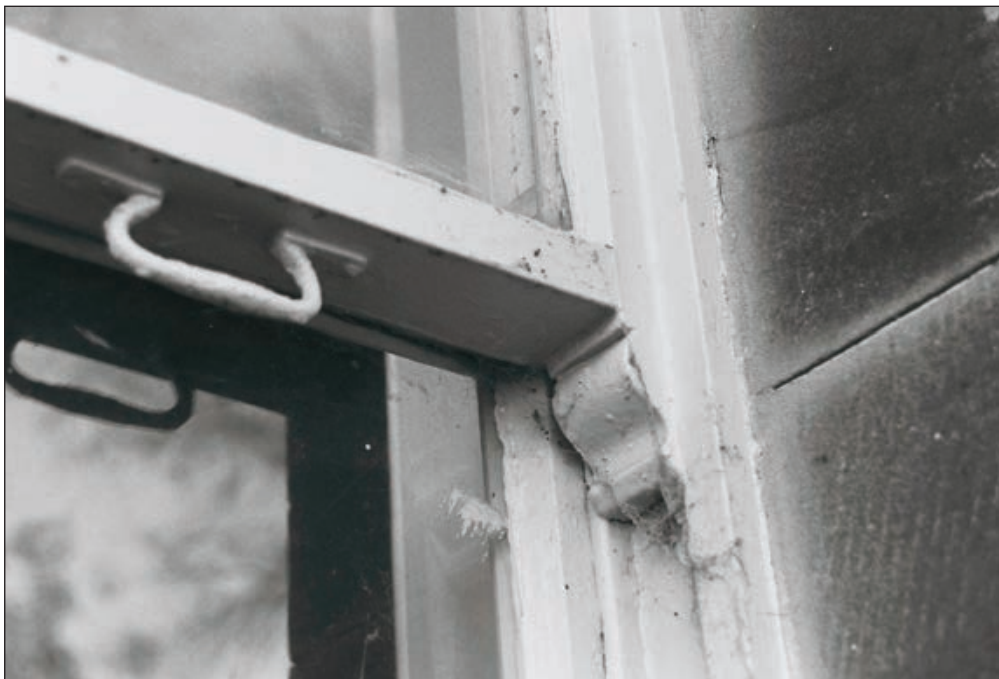
Plate 32: Detail of the moulded horn and attached handle of the ground floor timber sash window of the phase 7 west end of the north elevation of the North Range (Film 11.12)

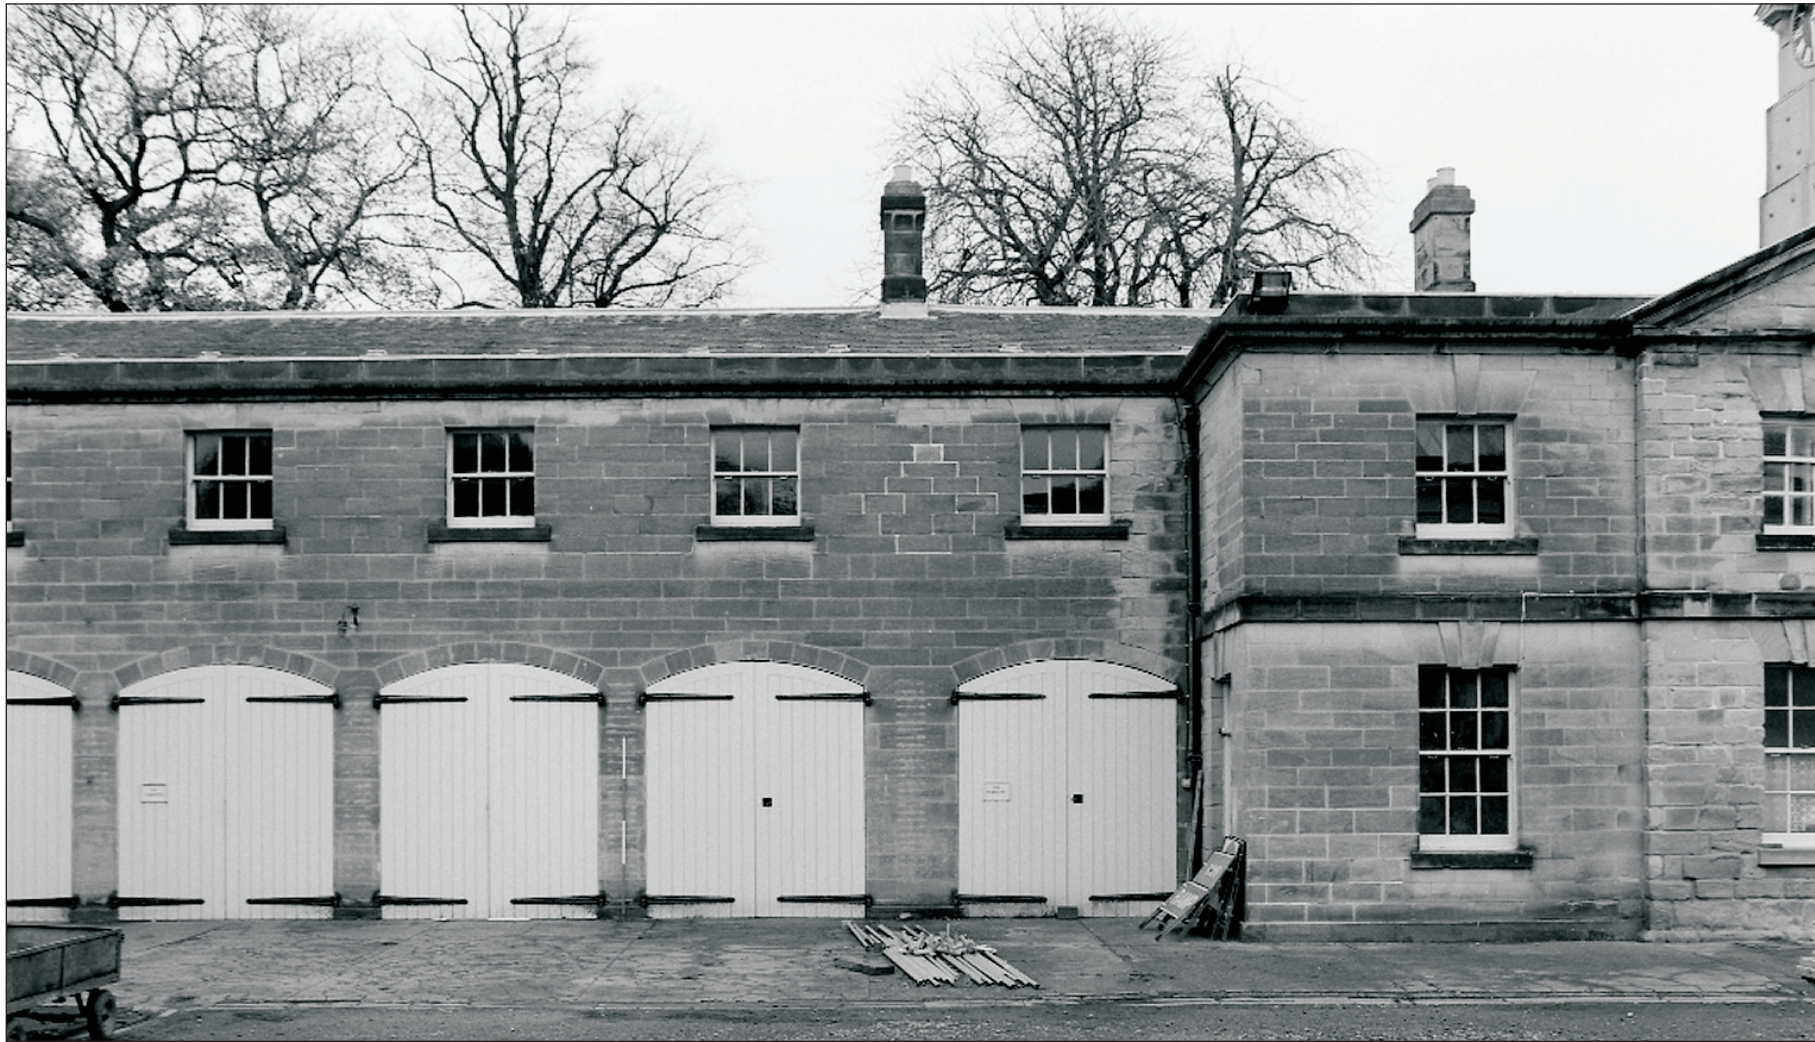
Plate 33: View of the phase 7 west end of the south (courtyard) elevation of the North Range (Film 17.03)

- 5.2.10 The south elevation of the phase 7 range contained a fenestrated projecting east bay, with timber sashes at ground and first floor (**Plate 33**), and a doorway within the west wall of the projecting bay (**Plate 34**). The remainder of the elevation, set back from the alignment of the wider central cart passage, had five bays each with a sash window at first floor, and an arched vehicular doorway with timber double doors at ground floor (**Plates 33 and 35**). Scars on the piers between the doorways indicated the position of a 1940s single-storey lean-to structure, which was positioned against the elevation.

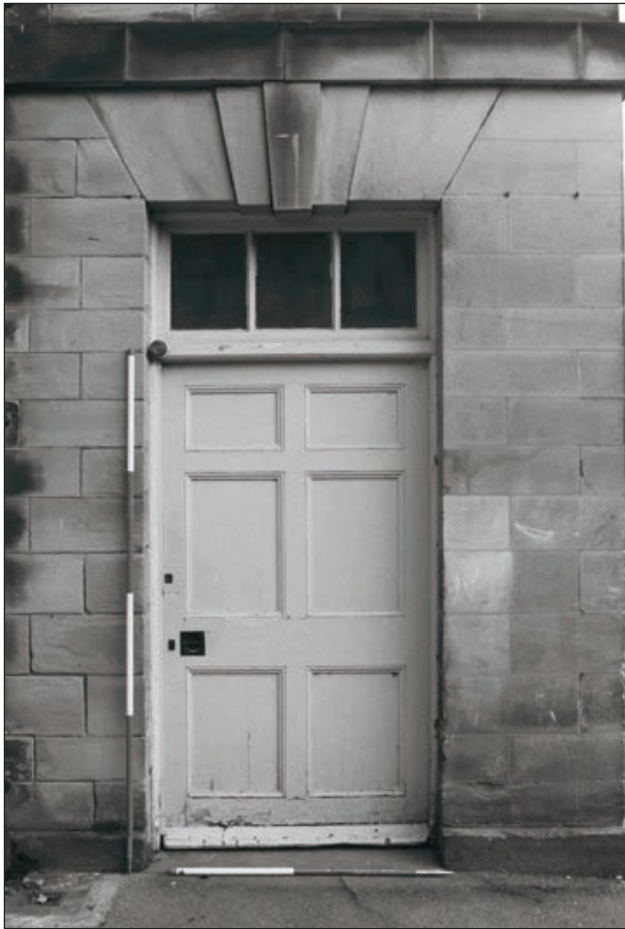
Plate 34: Detail of timber panelled doorway within the west elevation of the projecting section of the west end of the North Range (Film 20.26)

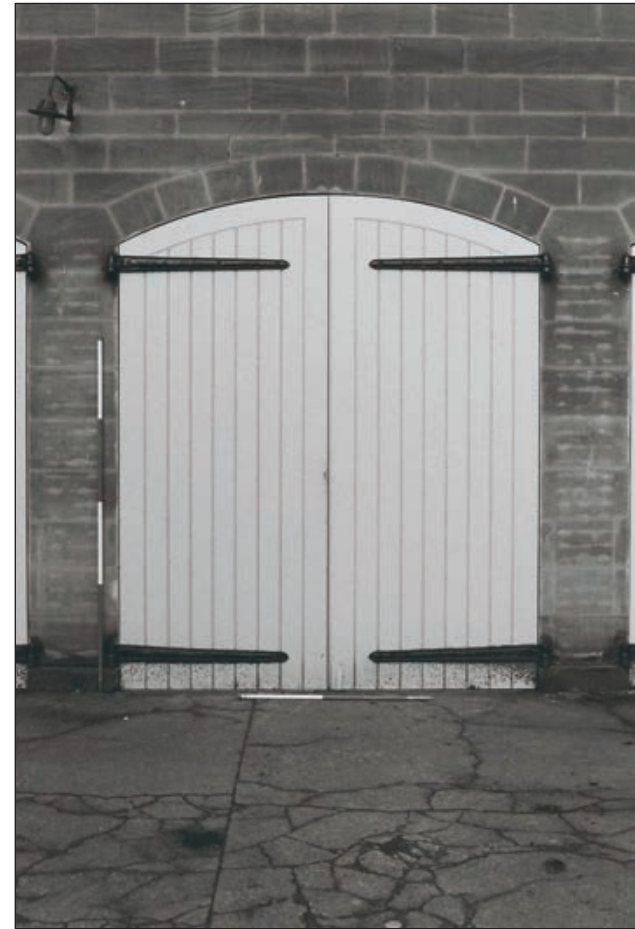
Plate 35: Detail of the ground floor timber double doors with adjacent mortar scars, south elevation of the west end of the North Range (Film 20.21)

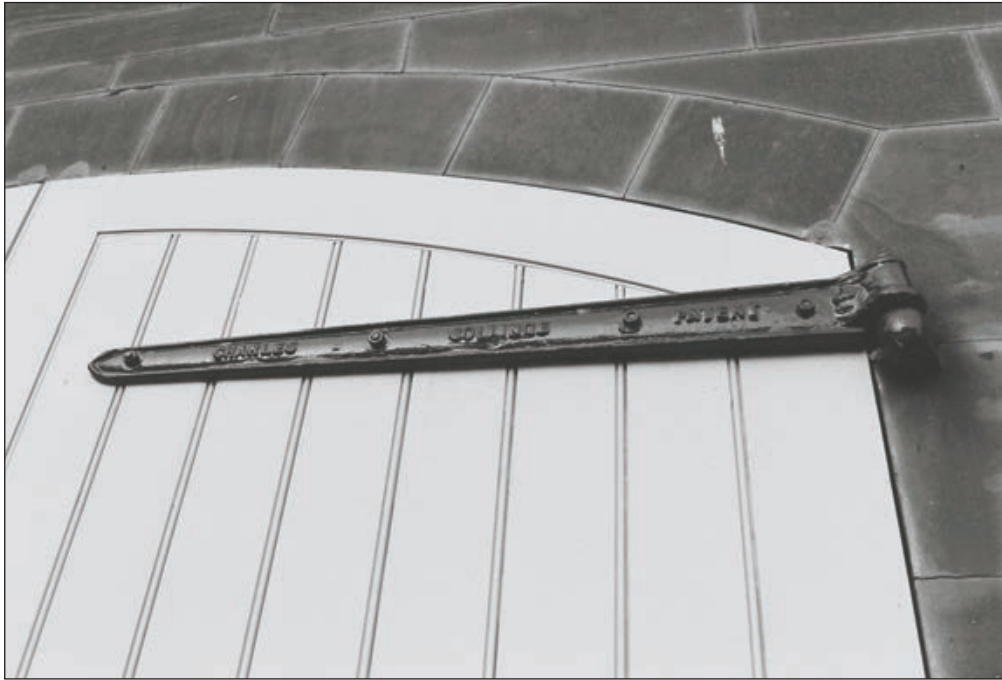
Plate 36: Detail of large cast iron hinges of the timber double doors of the west end of the south courtyard elevation of the North Range: 'CHARLES COLLINGS PATENT' (Film 20.23)

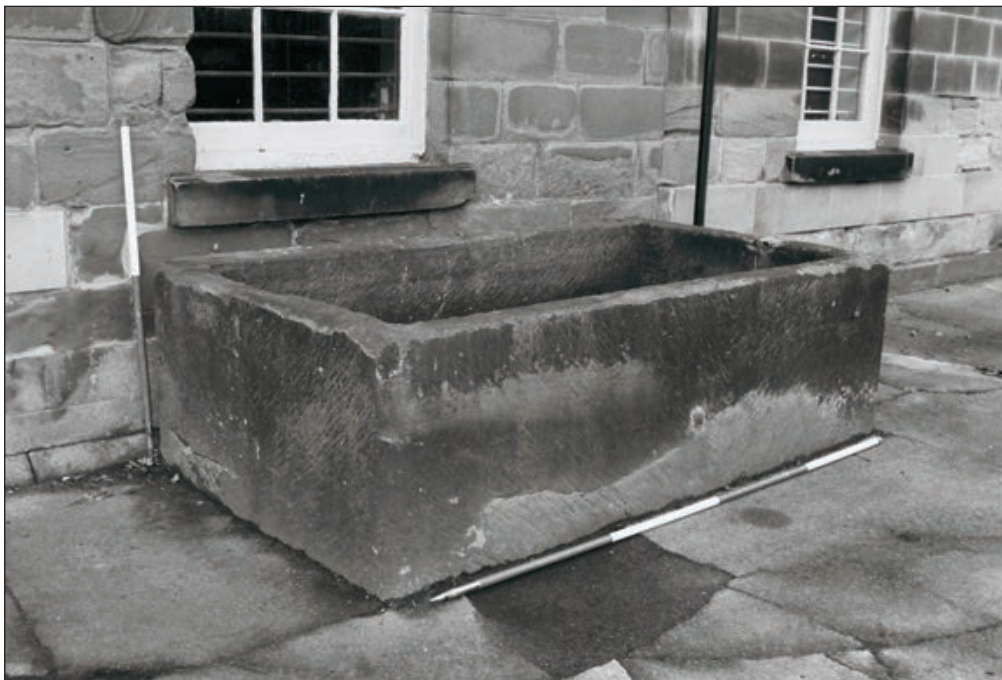
Plate 37: Detail of large stone trough against the south elevation of the North Range, within the courtyard of the Stable Block (Film 20.36)

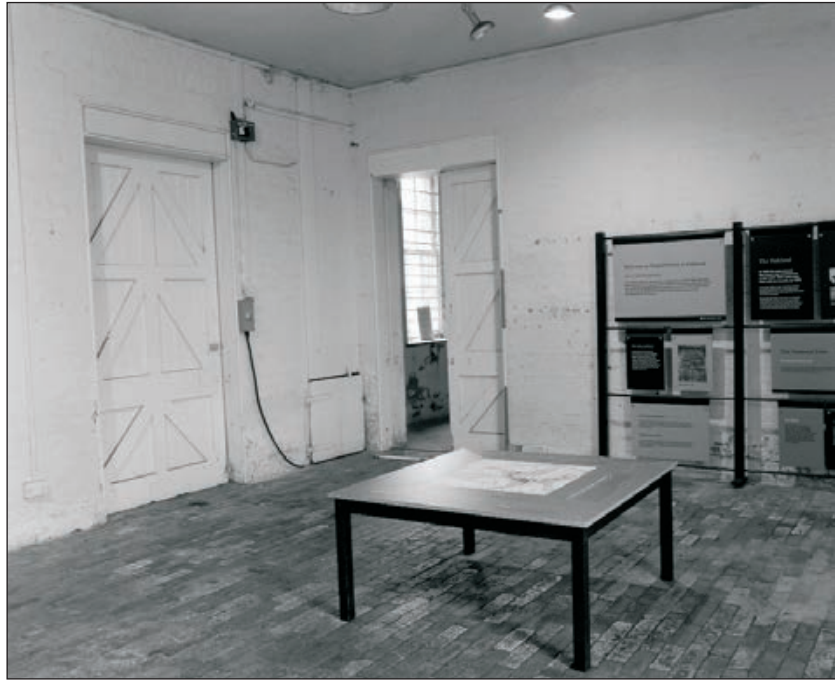
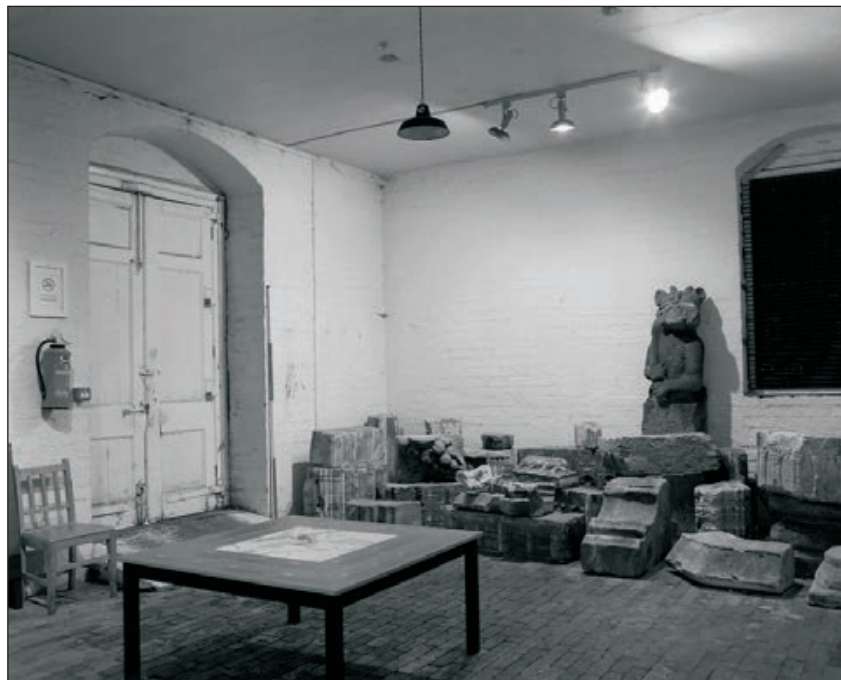
Plate 38: General view of room G1, East Side of the North Range (Film 06.05)

Plate 39: General view of room G1, East Side of the North Range (Film 06.08)

- 5.2.11 Room G1 was located at the east corner of the east end of the North Range (**Figures 11-12 & Plates 38-39**). This room connected the North and East Ranges. Direct access was gained from a doorway to the north (**Plate 44**), whilst internal sliding doors were positioned within the southwest corner of the room, in both the west and south walls (**Plates 38 and 40**). The east wall contained a blind window and a former blind window which had been opened up, and subsequently boarded, and the floor had a brick surface (**Plates 42-43**). Within the southwest corner of the room was a chute within the wall, leading from the hay loft above, with timber board covering (**Plate 41**). This would have provided quick movement of hay from the loft above to the stable loose boxes within the North and East Ranges.

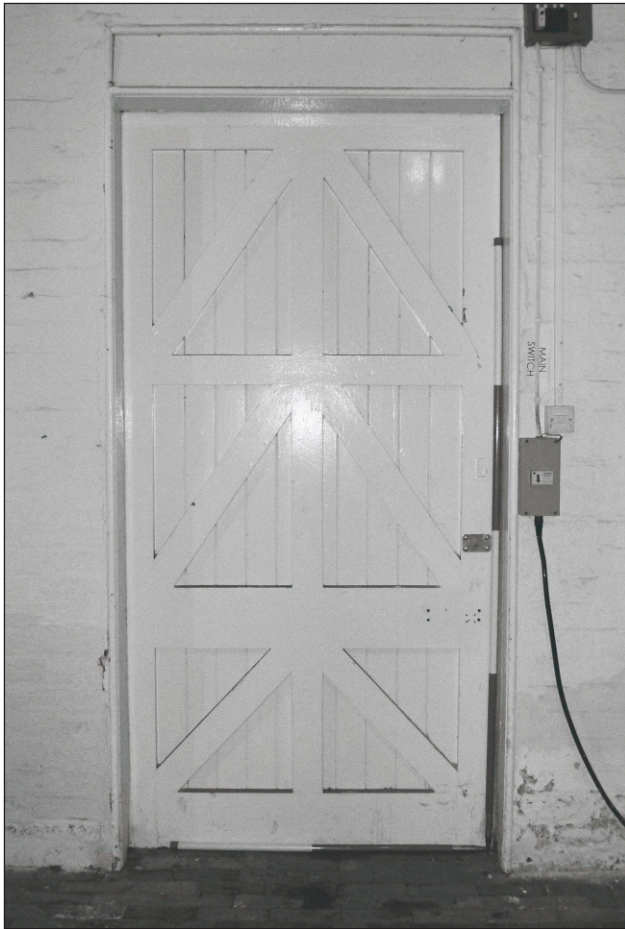
Plate 40: Detail of doorway in south wall of G1, East Side of the North Range, leading to G56 of the East Range (Film 14.06)

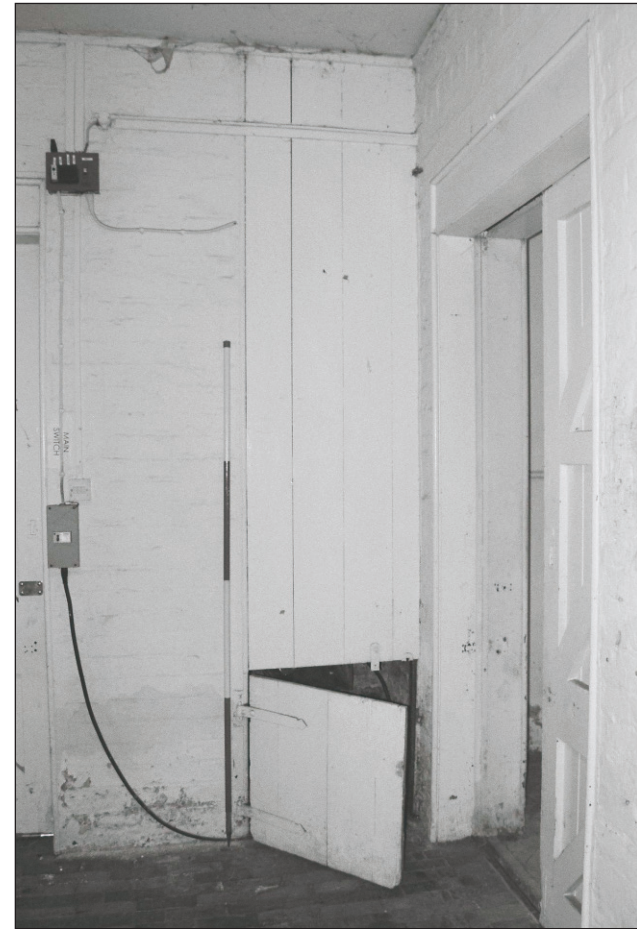
Plate 41: Detail of recessed chute from hay loft above, south wall of G1, East Side of the North Range (Film 14.09)

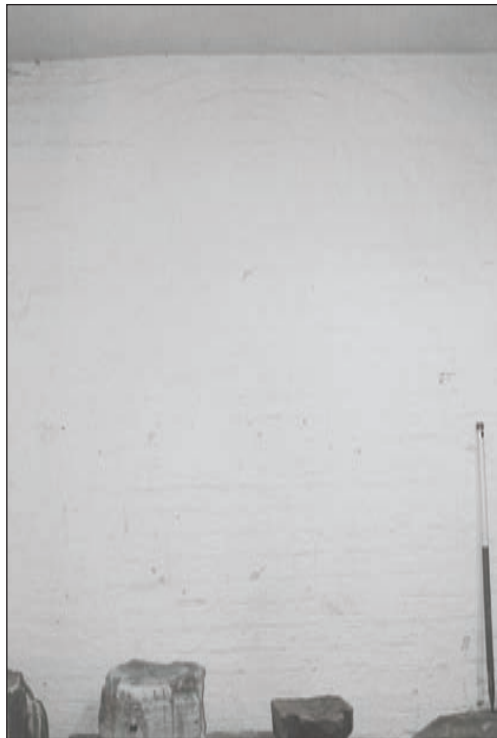
Plate 42: Detail of blind window within east wall of room G1, East Side of the North Range (Film 14.02)

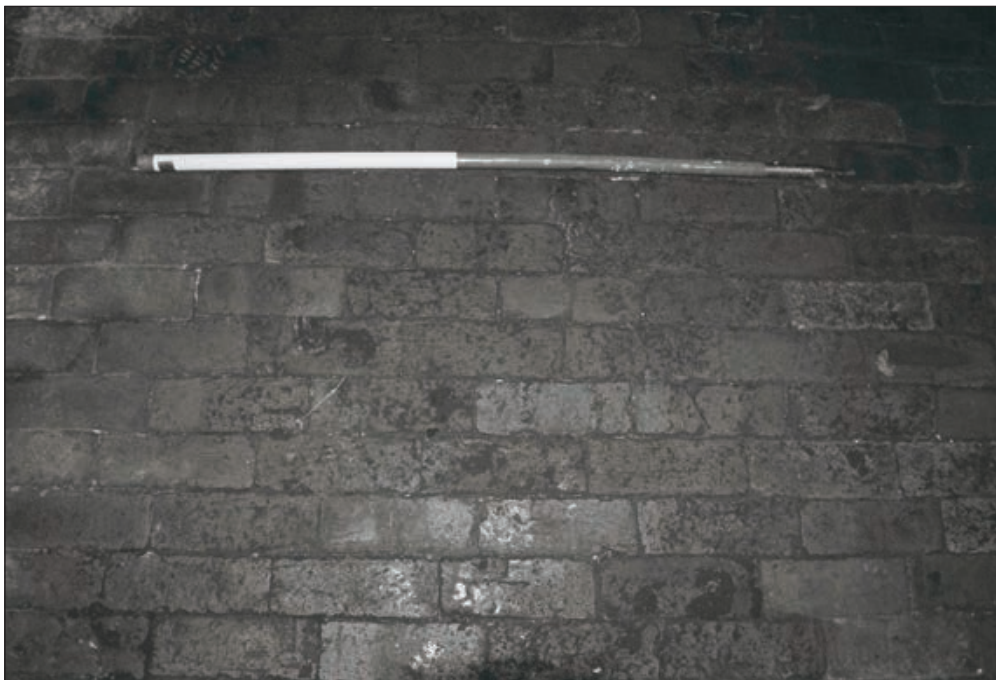
Plate 43: Detail of brick floor surface, room G1, East Side of the North Range (Film 14.05)

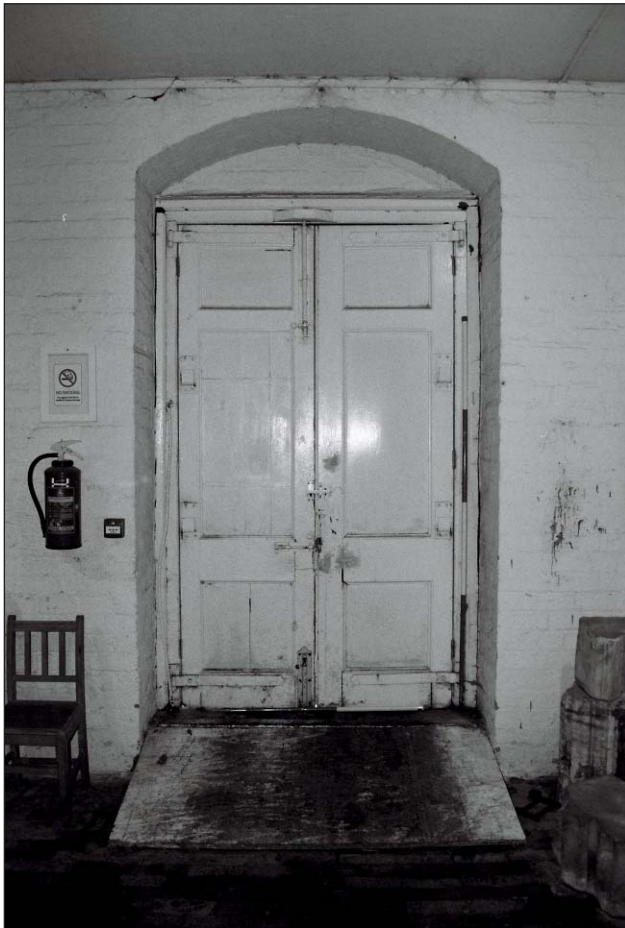
Plate 44: Detail of main doorway in north wall of G1, East Side of the North Range (Film 13.36)

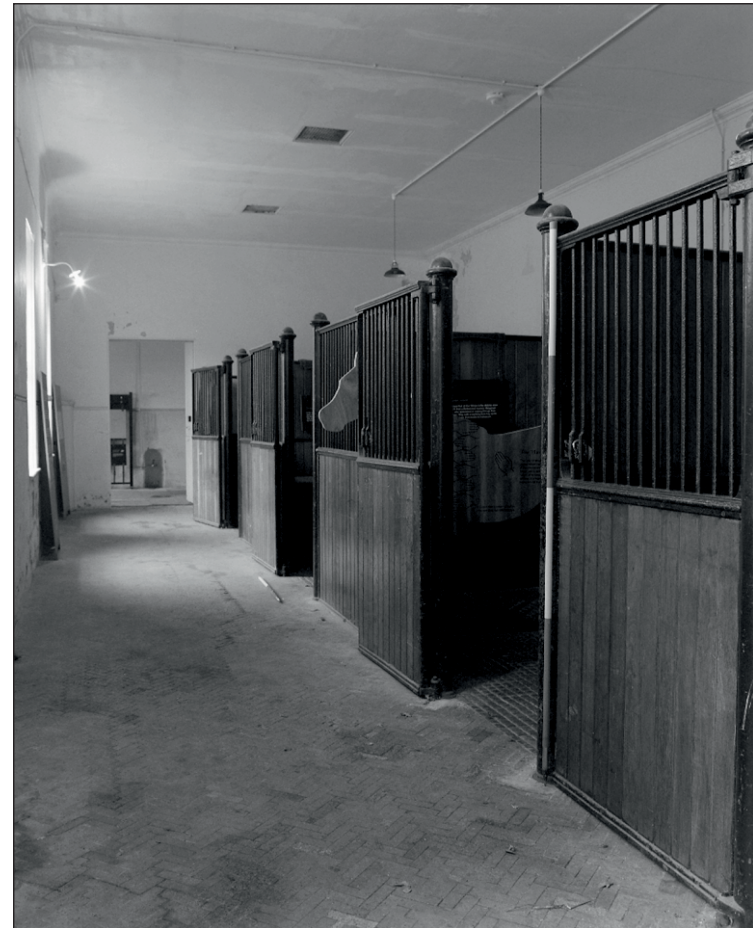
Plate 45: General view of room G2, East Side of the North Range, showing loose boxes (Film 06.09)

- 5.2.12 Positioned to the west was room G2. This was a long room with a high ceiling, containing four loose boxes against the north side (**Plate 45**). Sliding doors were located within the east and west walls, whilst the south wall contained three windows and a doorway. The loose boxes were all made up of primary phase 6 Musgrave fixtures and fittings, including the partitions, columns, tiling, mangers, hay racks, drainage, and stable brick flooring (**Plates 46-57**). The floor surface of the southern half of the room was of brick in a herringbone design (**Plate 52**). Above each loose box was a metal vent within the ceiling (**Plate 58**), leading into a timber vent, exiting through the roof of the range. Within the south wall of the room was an arched recess with drain in the floor (**Plate 60**), and a double recessed timber corn and bran chute (**Plate 61**) connected to two large timber hoppers within the hay loft above. This provided a quick and easy method of grain movement from the storage area above, to the mangers in the loose boxes, and allowed the precise measurement of corn and bran to be provided each time.

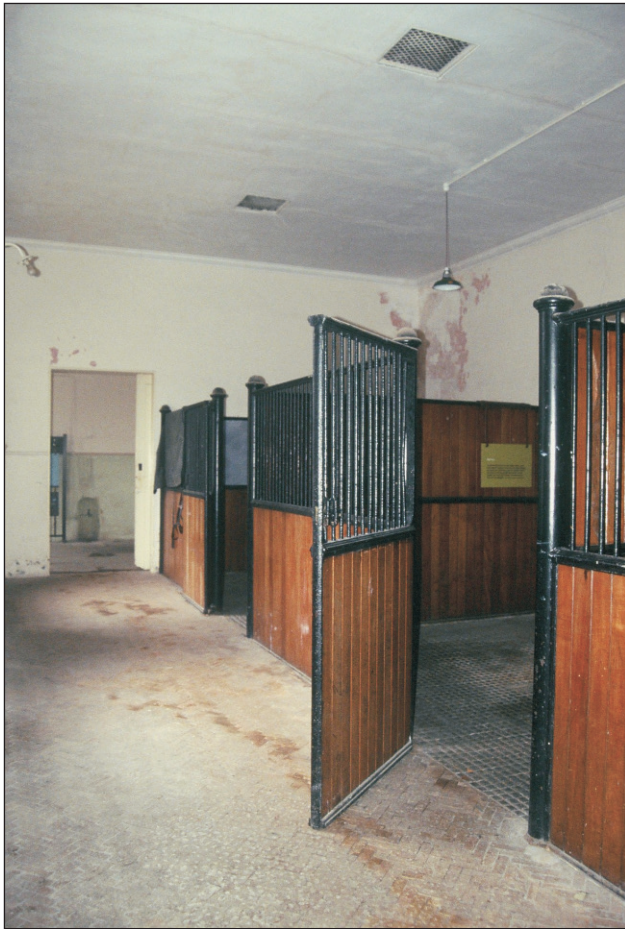
Plate 46: View of room G2 showing original loose boxes, East Side of the North Range (Film C.S. 16)

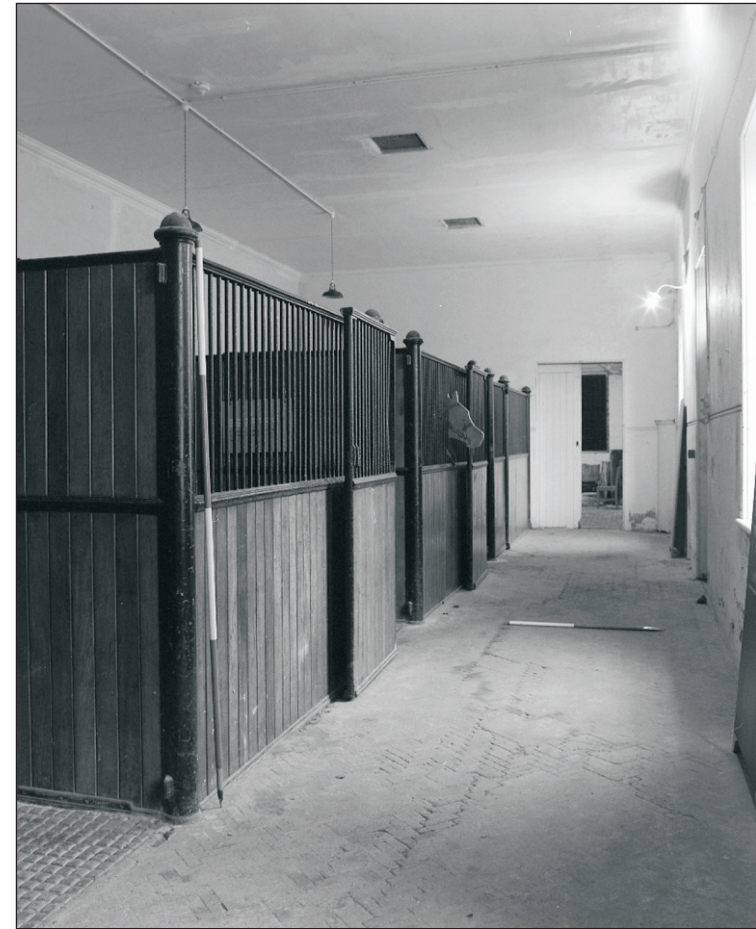
Plate 47: General view of room G2, East Side of the North Range, showing loose boxes (Film 07.05)

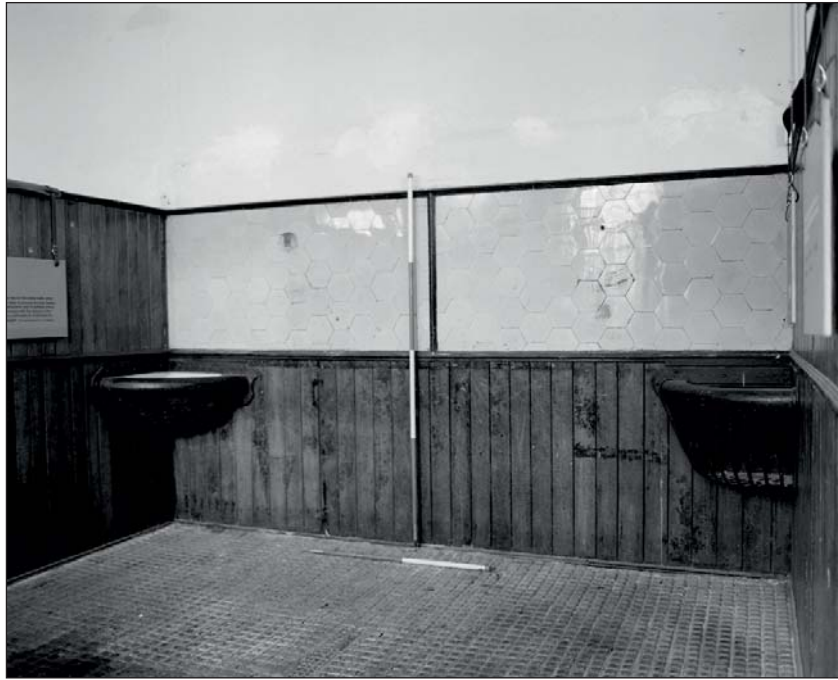
Plate 48: Detail of original loose box within room G2, East Side of the North Range, showing corner manger and trough (Film 07.02)

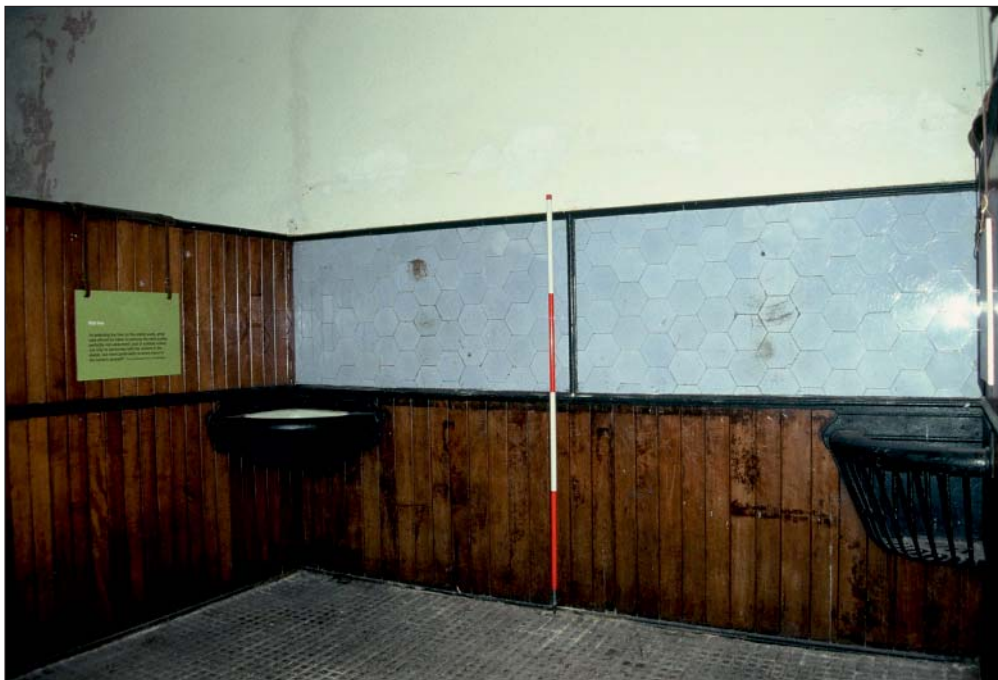
Plate 49: Detail of original loose box within room G2, East Side of the North Range, showing corner manger and trough and coloured hexagonal tiling (Film C.S. 11.)

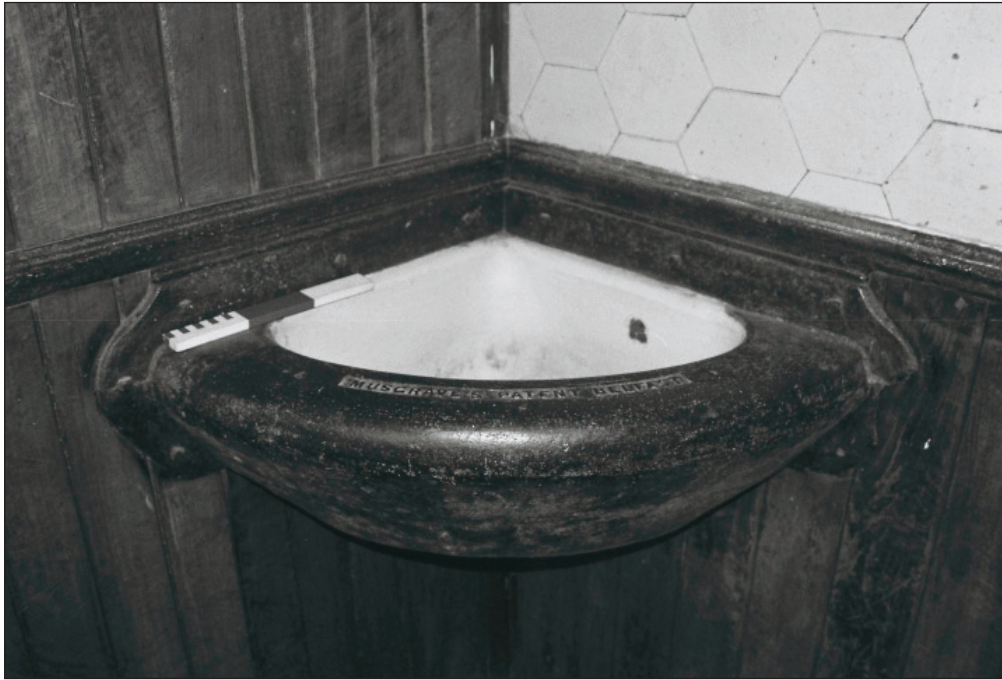
Plate 50: Detail of original Musgrave corner manger, room G2, East Side of the North Range (Film 14.20)

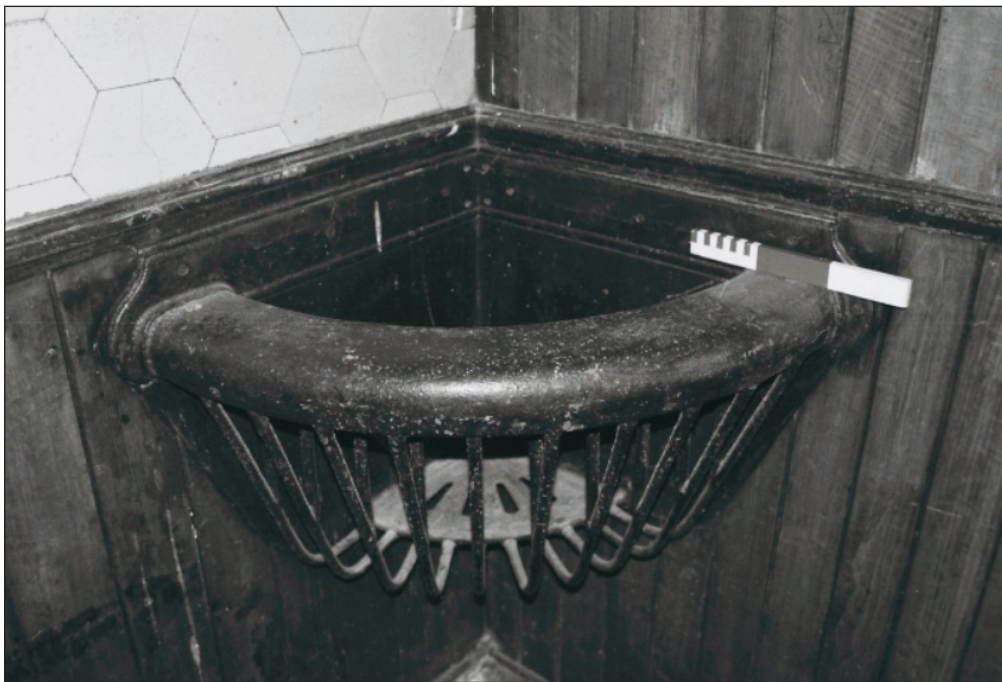
Plate 51: Detail of original Musgrave corner hay rack, room G2, East Side of the North Range (Film 14.22)

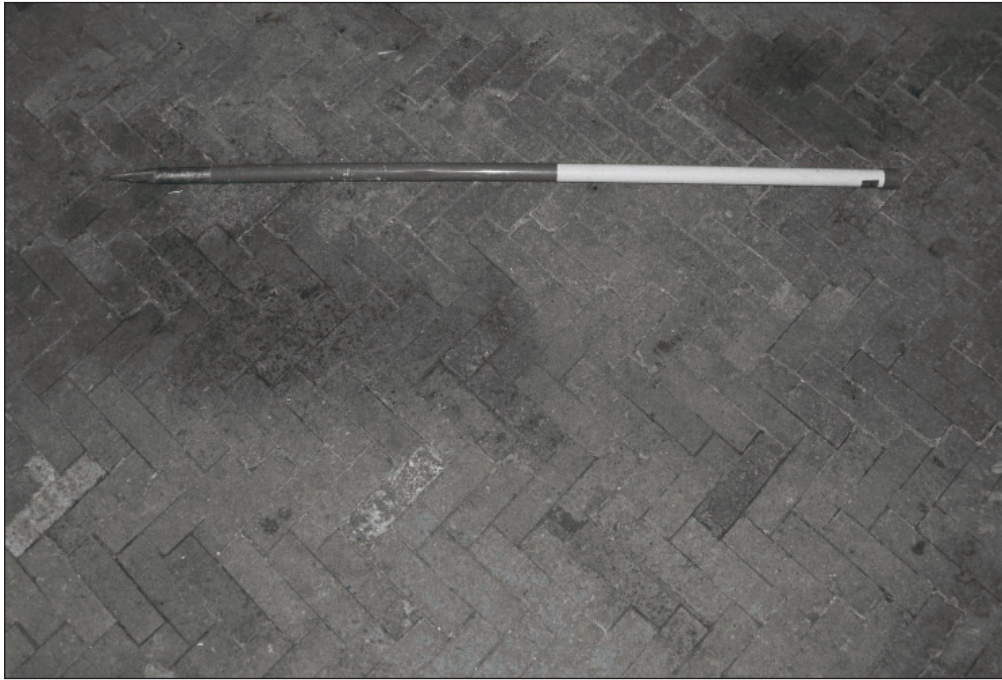
Plate 52: Detail of original herringbone brick floor of the southern half of room G2, East Side of the North Range (Film 14.14)

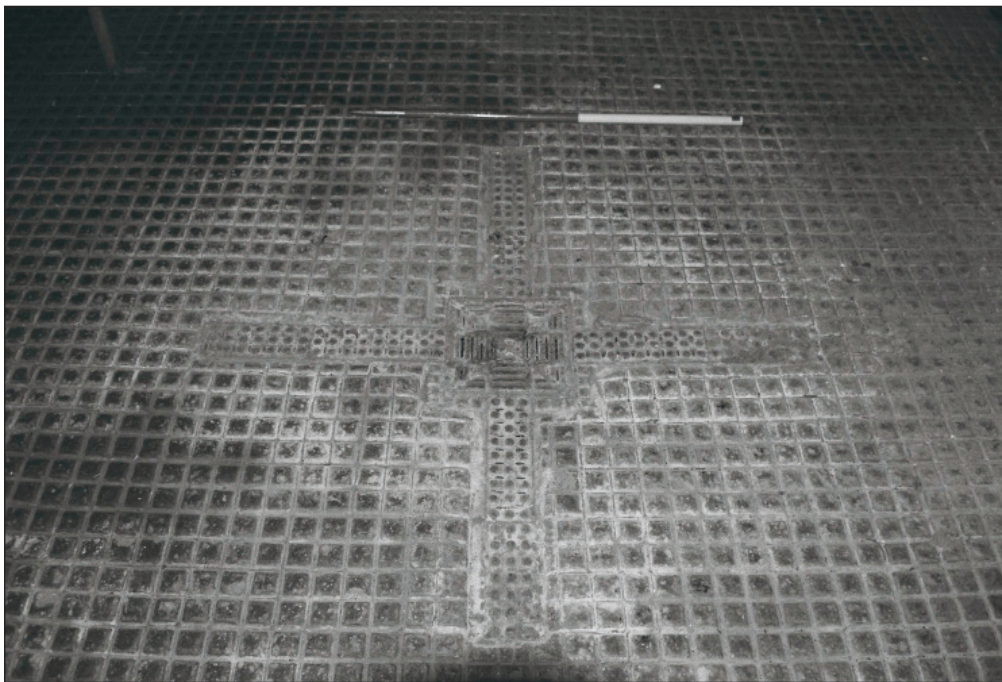
Plate 53: Detail of original stable brick floor and drains and stench trap within loose boxes of room G2, East Side of the North Range (Film 14.19)

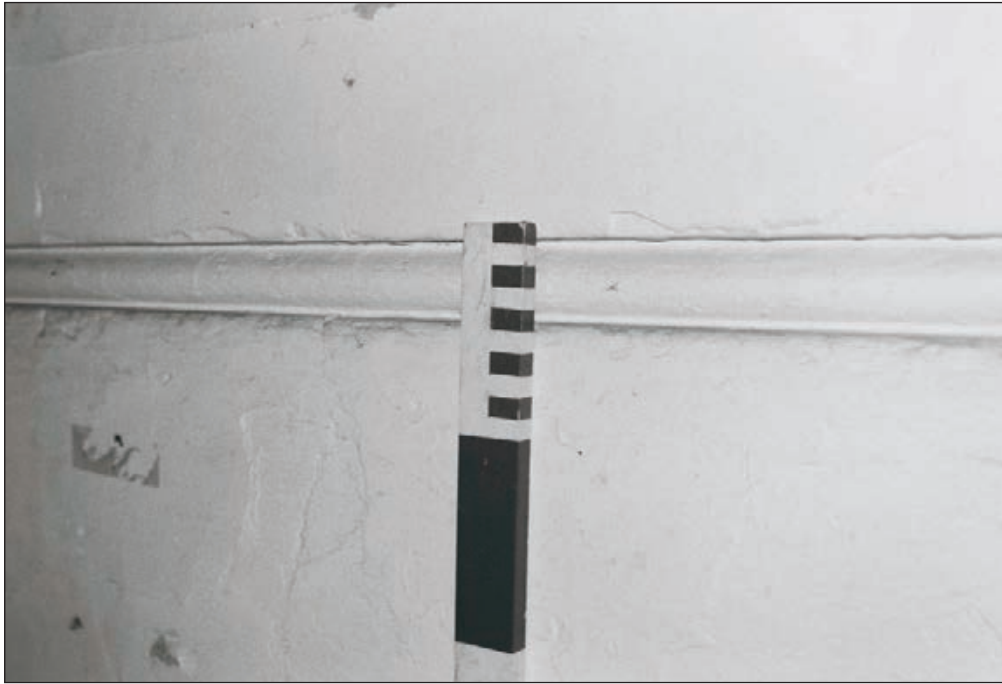
Plate 54: Detail of moulded plaster dado detailing around southern wall of room G2, East Side of the North Range (Film 14.10)

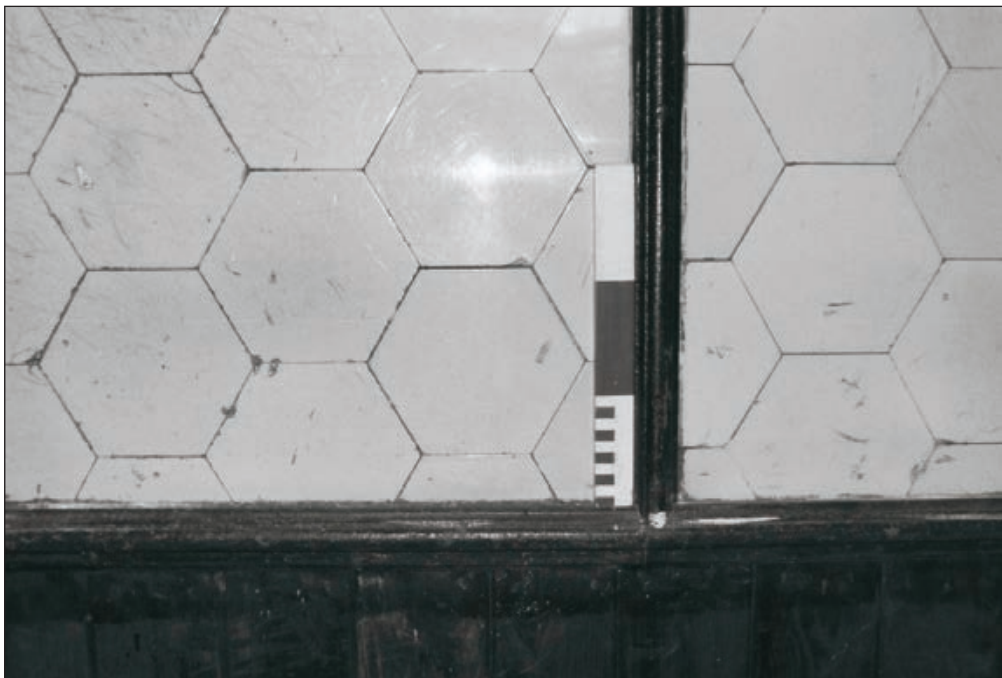
Plate 55: Detail of original stable tiling and cast iron moulded details, room G2, East Side of the North Range (Film 14.24)

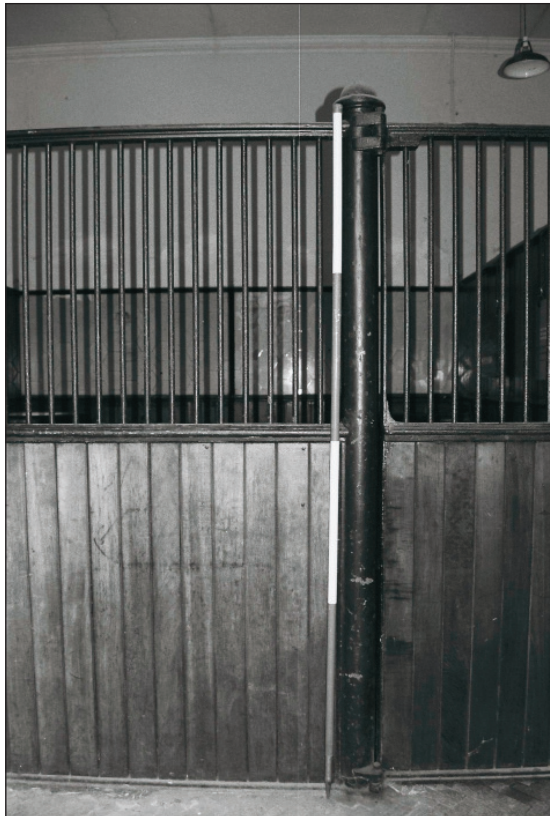
Plate 56: Detail of original cast iron column of loose boxes within room G2, East Side of the North Range (Film 14.29)

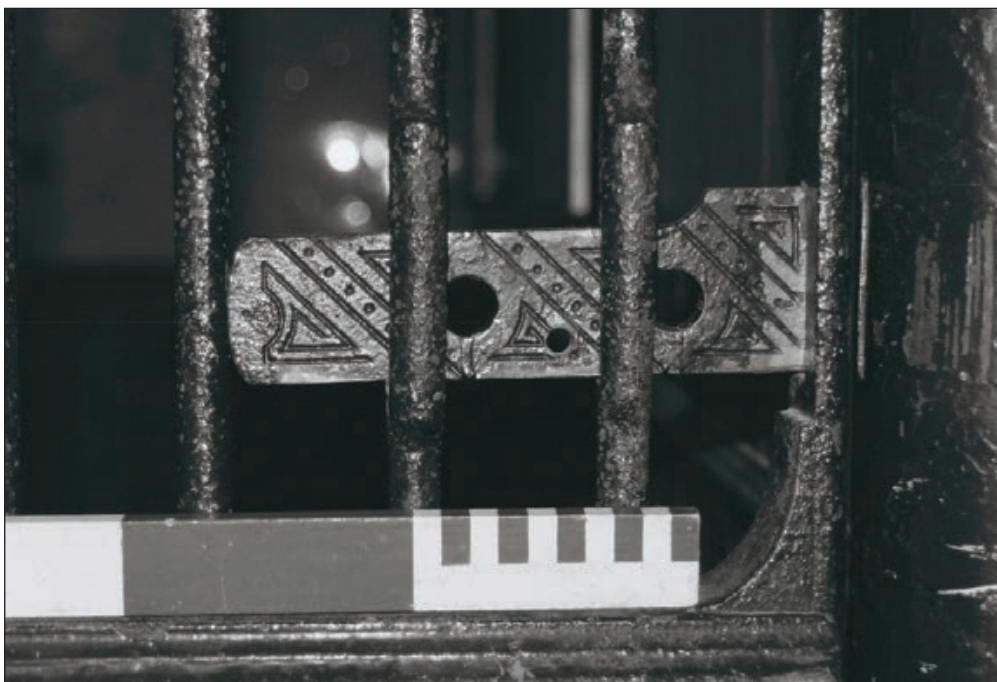
Plate 57: Detail of original decorative loose box door latch, room G2, East Side of the North Range (Film 14.27)

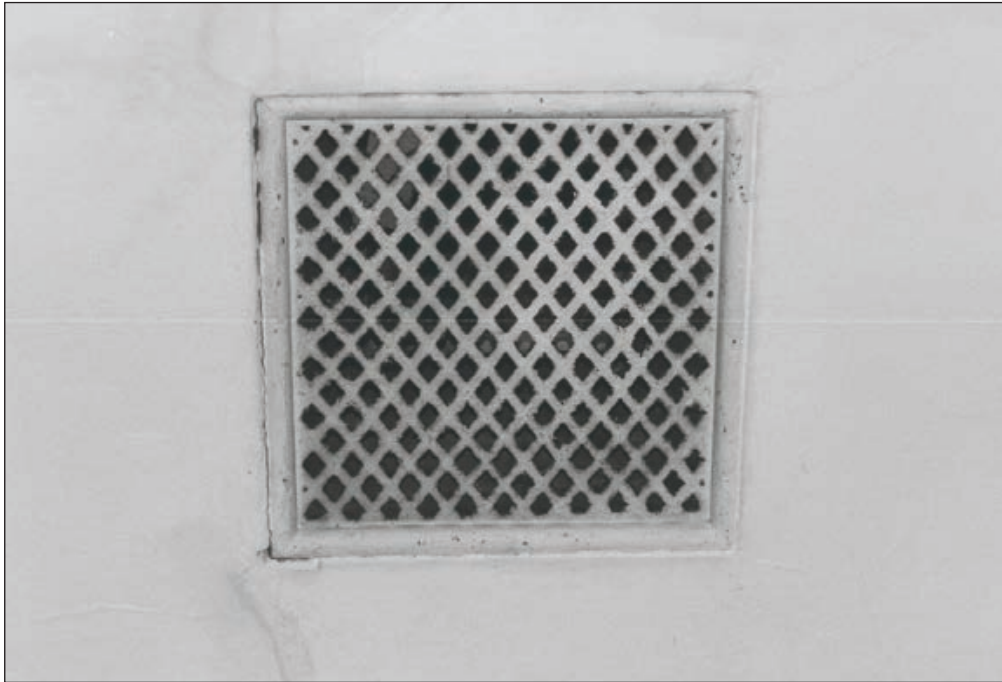
Plate 58: Detail of original cast iron vent in ceiling of room G2, East Side of the North Range (Film 14.30)

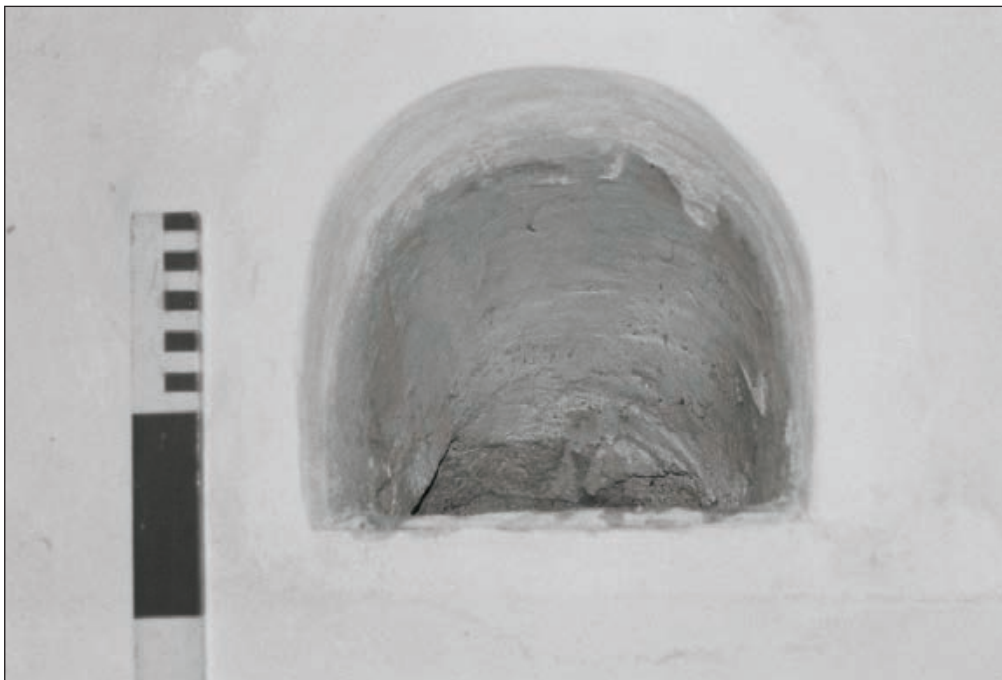
Plate 59: Detail of hole within south wall of room G2, East Side of the North Range (Film 14.17)
