NOSTELL PRIORY STABLES, NOSTELL, WAKEFIELD, WEST YORKSHIRE

Historic Building Recording and Structural Watching Brief

Planning Application Ref: 09/00701/FUL & 09/00705/LBC

72934.01_BDG_V0_4

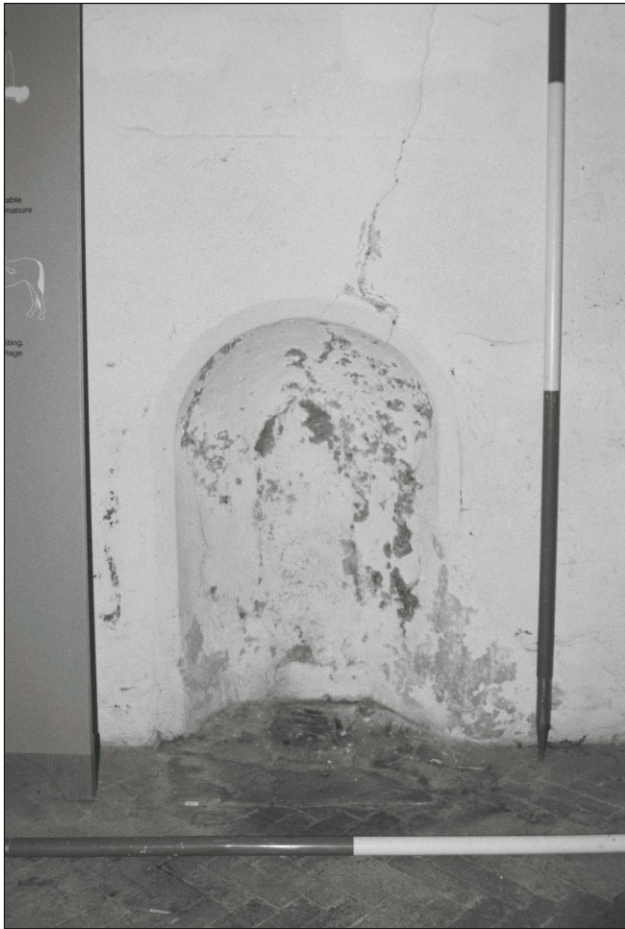
Plate 60: Detail of drainage recess within the south wall of room G2, East Side of the North Range (Film 14.13)

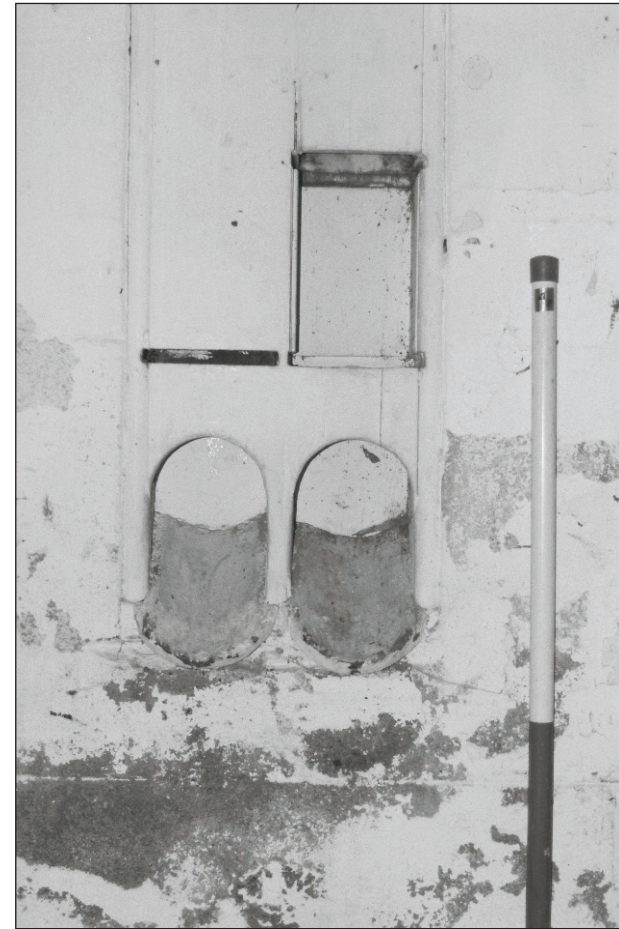
Plate 61: Detail of grain chutes from hay loft above, south wall of room G2, East Side of the North Range (Film 14.33)

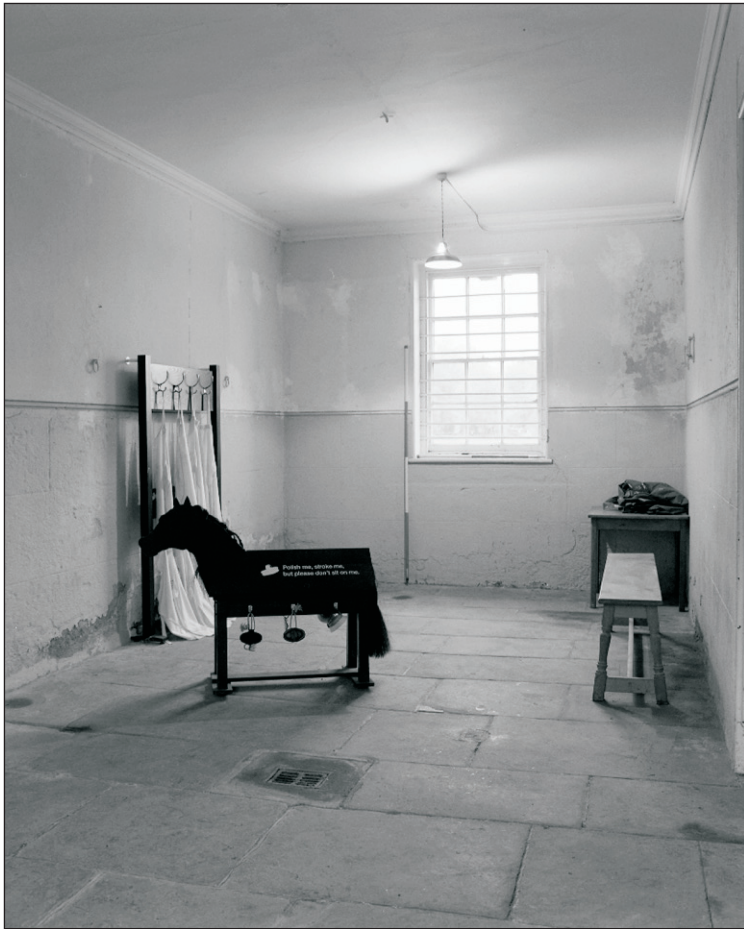
Plate 62: General view of room G3, 'Wash Room', East Side of the North Range (Film 07.07)

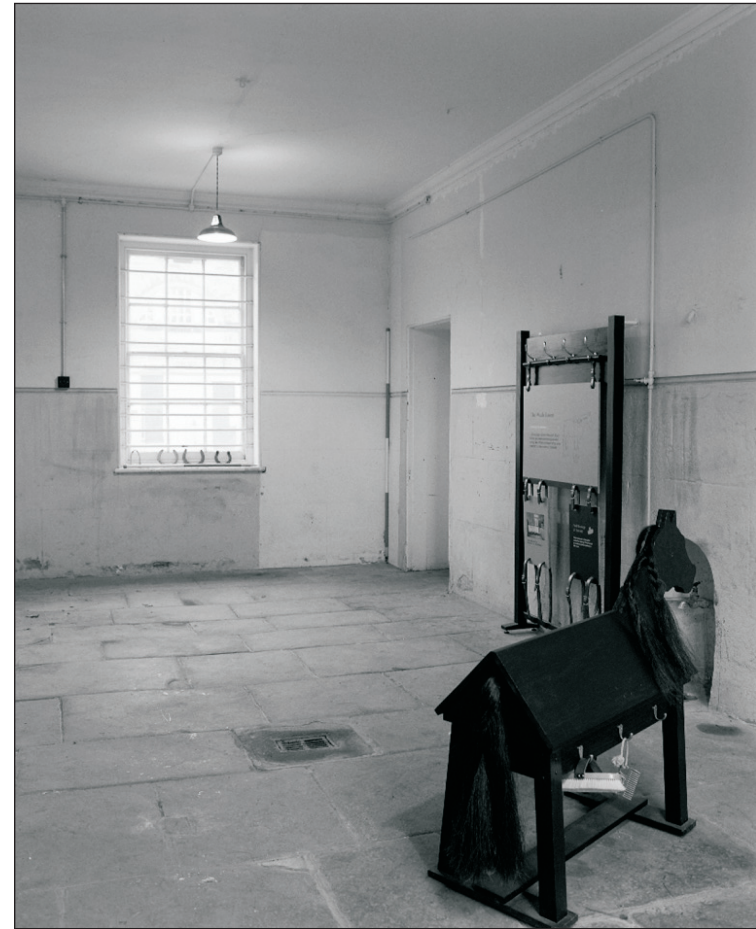
Plate 63: General view of room G3, 'Wash Room', East Side of the North Range (Film 07.09)

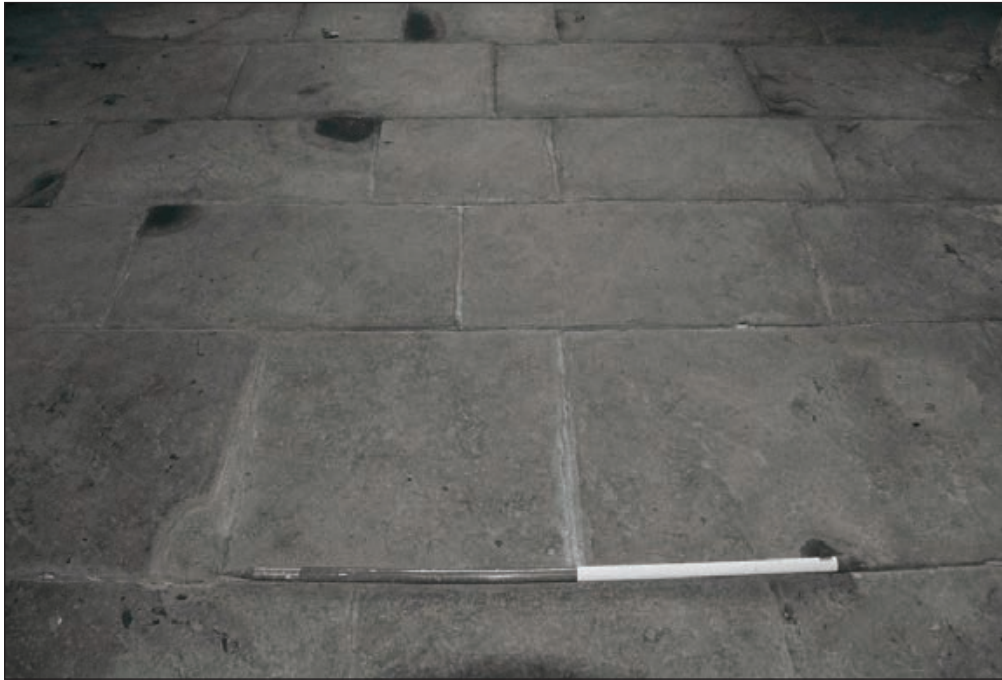
Plate 64: Detail of stone flag floor of room G3, 'Wash Room', East Side of the North Range (Film 15.02)

- 5.2.13 Room G3, located to the west of G2, was a wash room. This was a fairly plain room with stone flagged floor, plastered and painted walls with high moulded plaster dado, cornice and a window within the north and south walls (**Plates 62-64**). There was a drain set within the stone flagged floor of the room (**Plate 65**), and an arched recess with drain and tap in the west wall (**Plate 70**). Positioned on the east wall of the room were the remains of two original Musgrave folding brackets (minus the arms) (**Plates 66-67**), and two tether hooks within the west wall (**Plates 68-69**). A doorway within the south end of the east wall led directly outside to the courtyard, whilst an opposing doorway within the west wall led into room G4 (**Figures 11-12**).

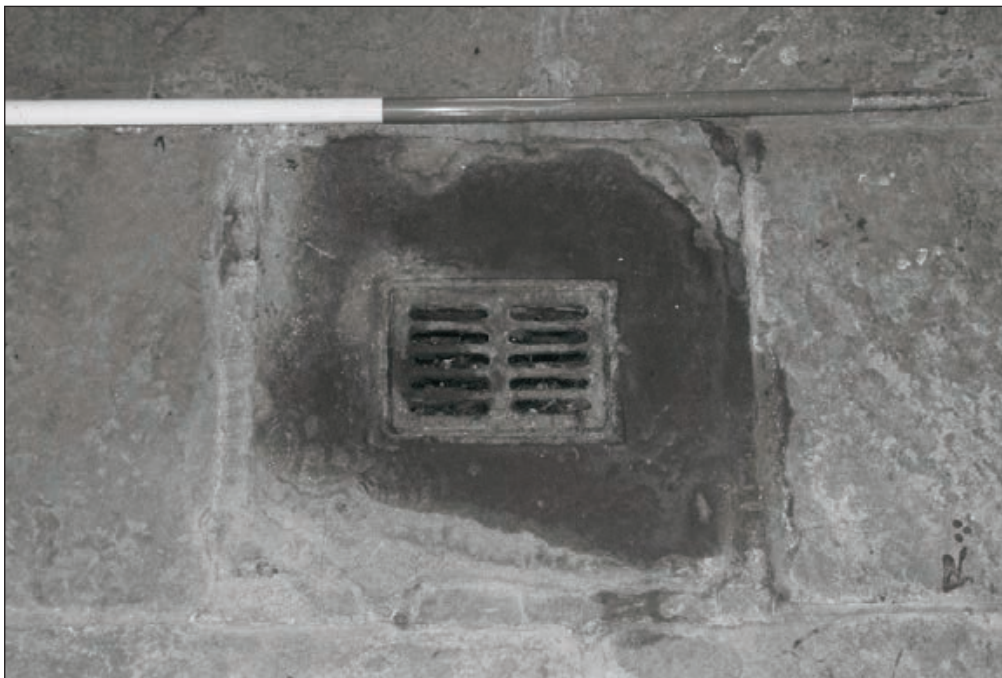
Plate 65: Detail of drain in floor of room G3, 'Wash Room', East Side of the North Range (Film 15.07)

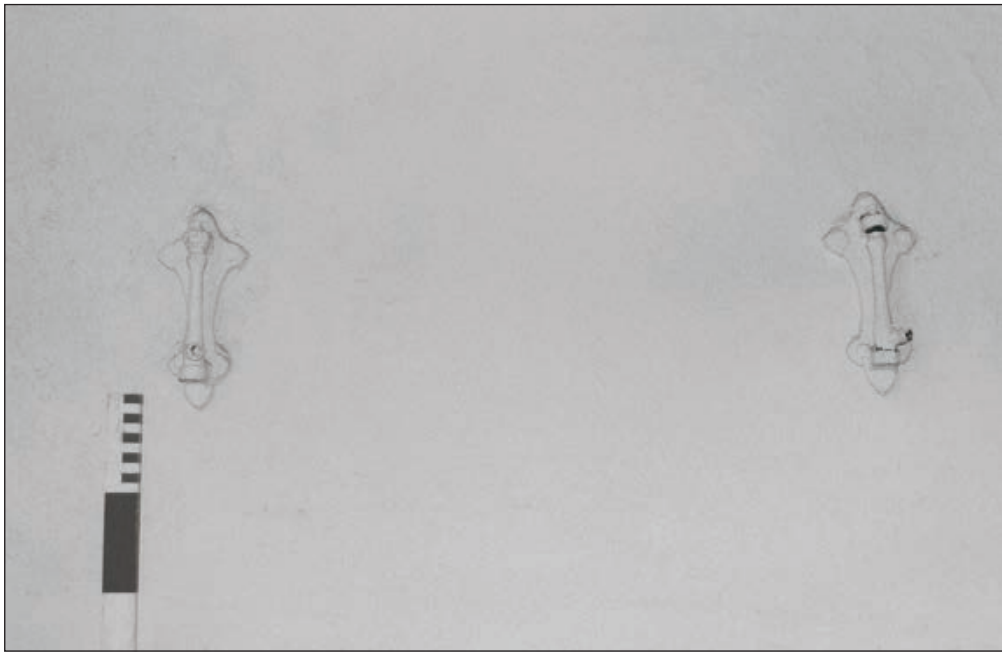
Plate 66: Detail of original Musgrave folding brackets, east wall of room G3, 'Wash Room', East Side of the North Range (Film 15.09)

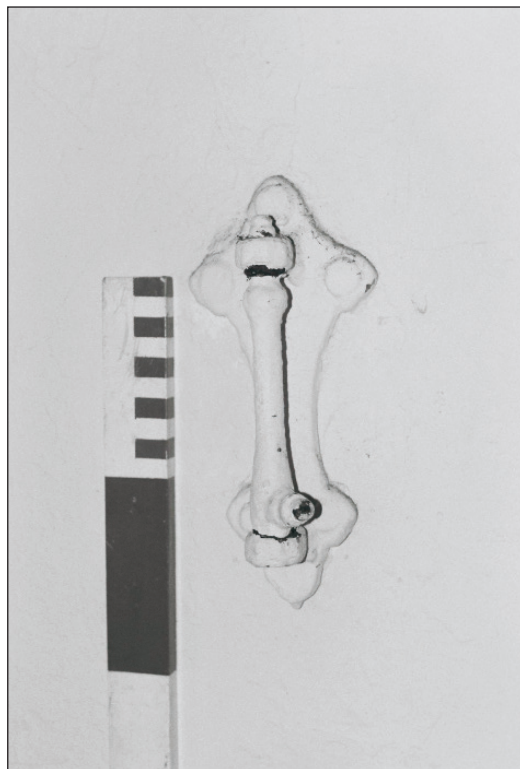
Plate 67: Detail of original Musgrave folding bracket, east wall of room G3, 'Wash Room', East Side of the North Range (Film 15.12)

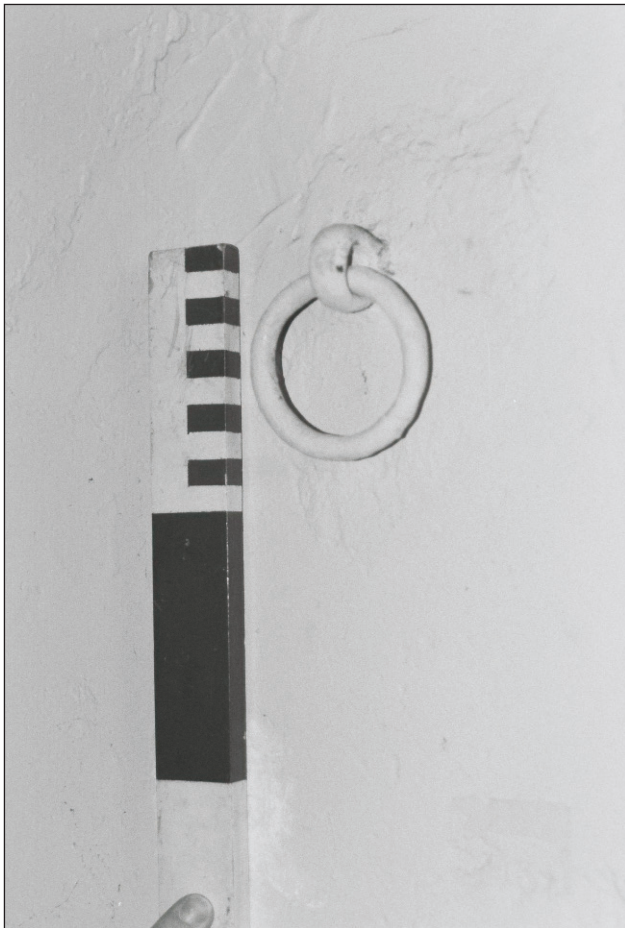
Plate 68: General view of tether hook, west wall of room G3, 'Wash Room', East Side of the North Range (Film 15.04)

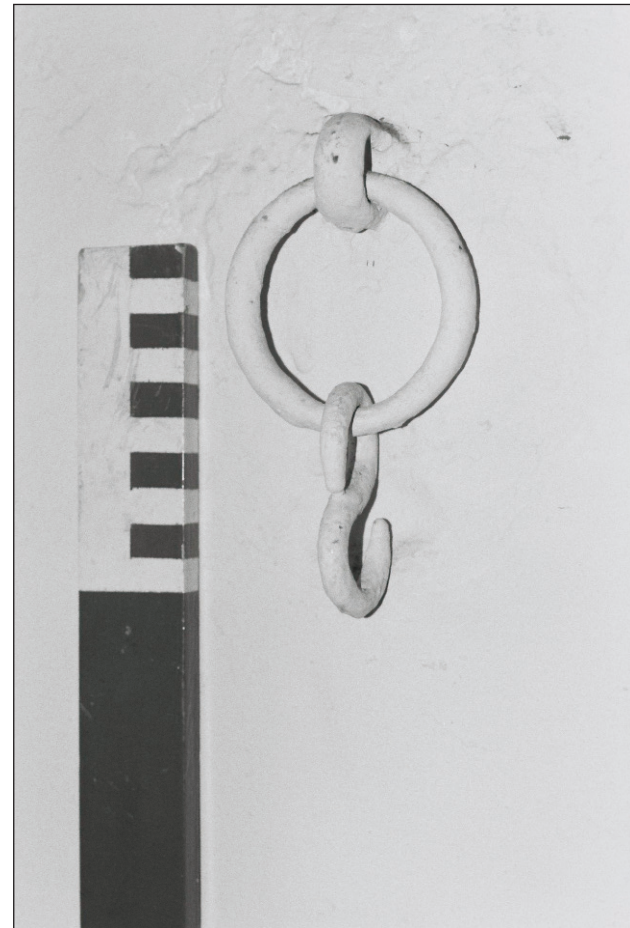
Plate 69: General view of tether hook, west wall of room G3, 'Wash Room', East Side of the North Range (Film 15.05)

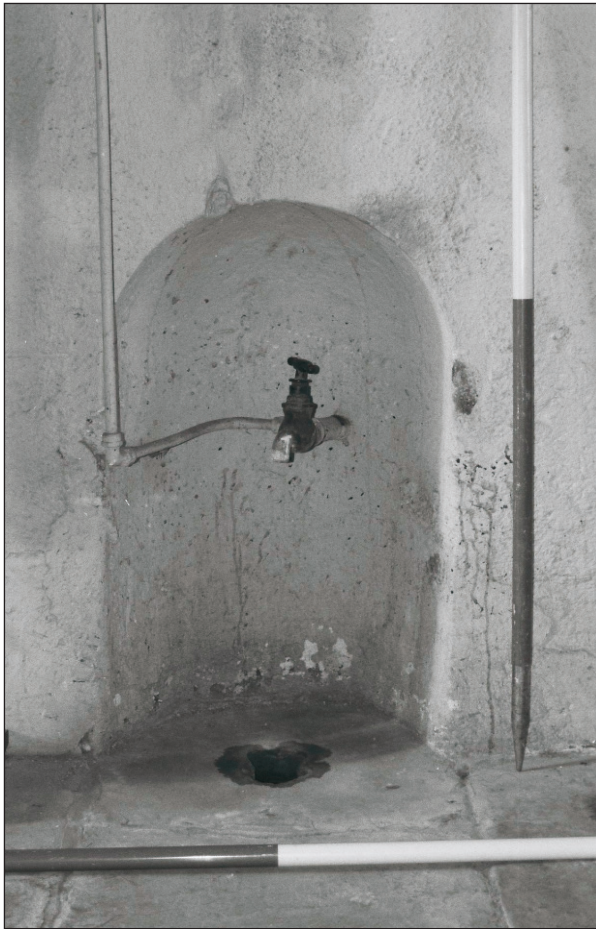
Plate 70: Detail of recessed drain and tap in west wall of room G3, 'Wash Room', East Side of the North Range (Film 14.36)

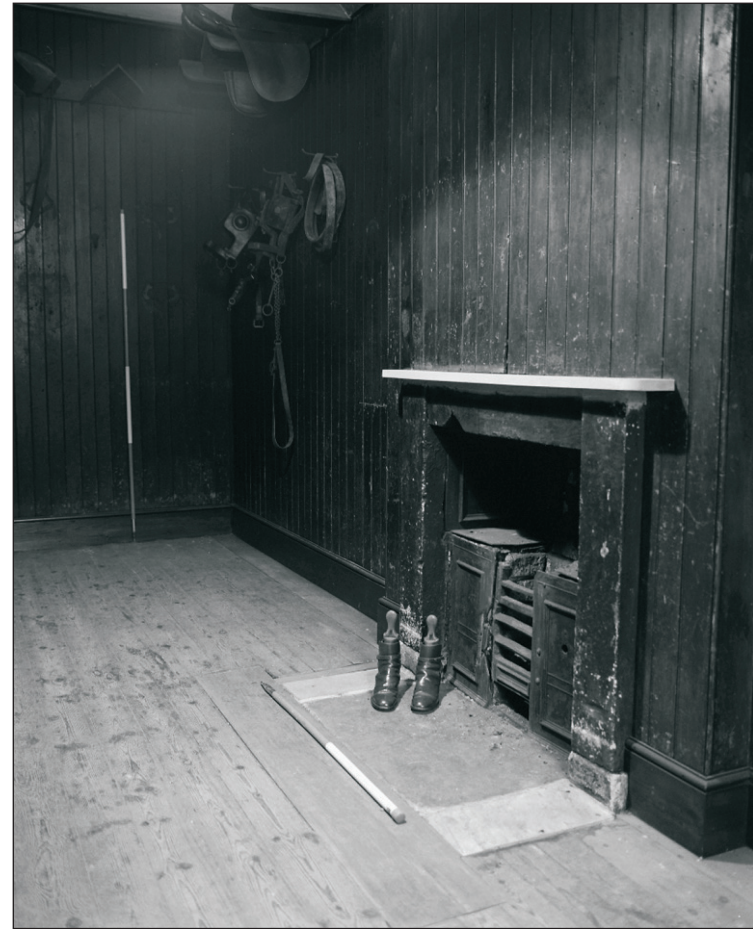
Plate 71: General view of room G4, 'Tack Room', Central Entranceway of the North Range (Film 08.02)

- 5.2.14 G4 was the 'Tack Room', and was located within Paine's phase 2 entranceway structure. Although the core fabric of the walls date to phase 2, the internal fixtures and fittings of the 'Tack Room' date to phase 6. The walls were covered with timber tongue and groove match boarding and moulded skirting and the floor was exposed timber floor boards (**Plates 71 and 73**). A phase 6 fireplace was positioned within the east wall (**Plate 72**), whilst a harness case, corner cupboard, and saddle and equipment brackets were also retained within the room (**Plates 73, 75-77**). The timber panelled

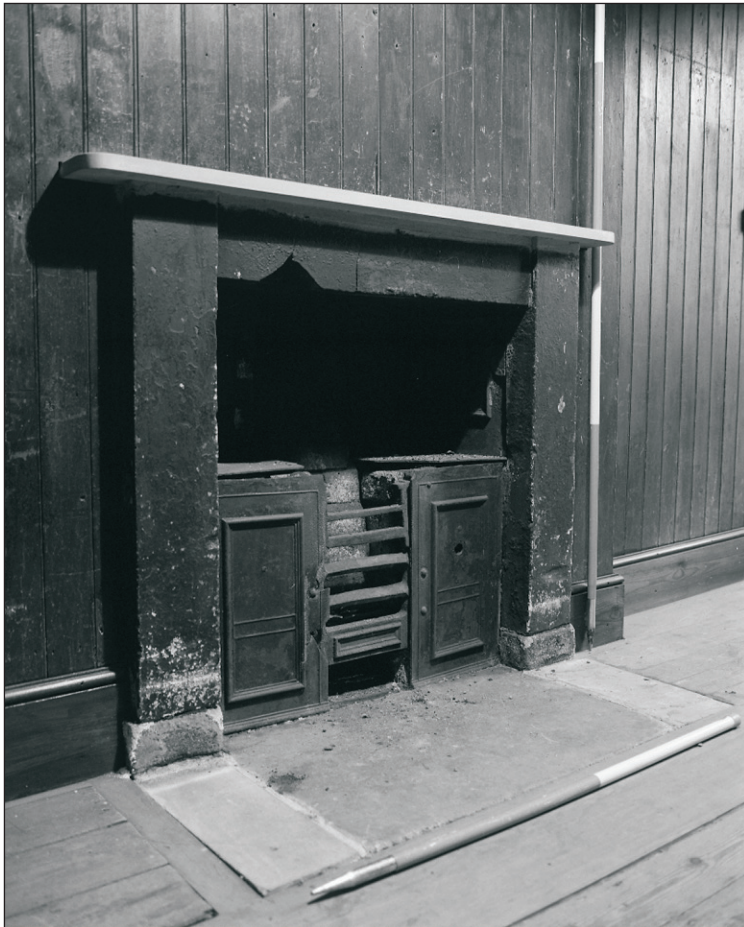
Plate 72: Detail of fireplace, east wall of room G4, 'Tack Room', Central Entranceway of the North Range (Film 08.05)

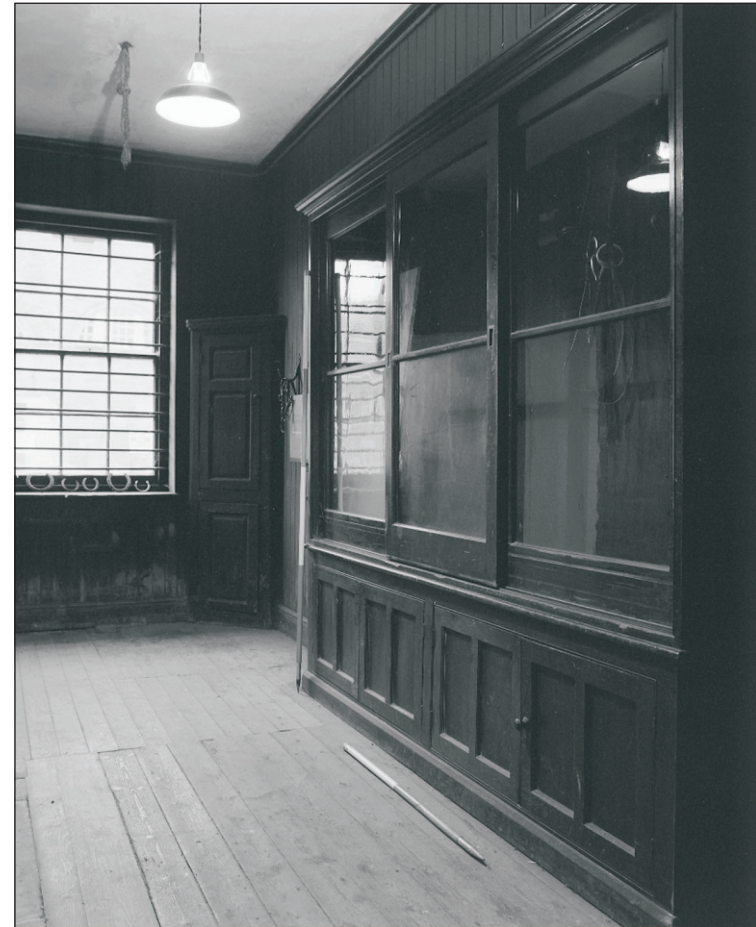
Plate 73: General view of room G4, 'Tack Room', Central Entranceway of the North Range, showing harness case (Film 08.03)

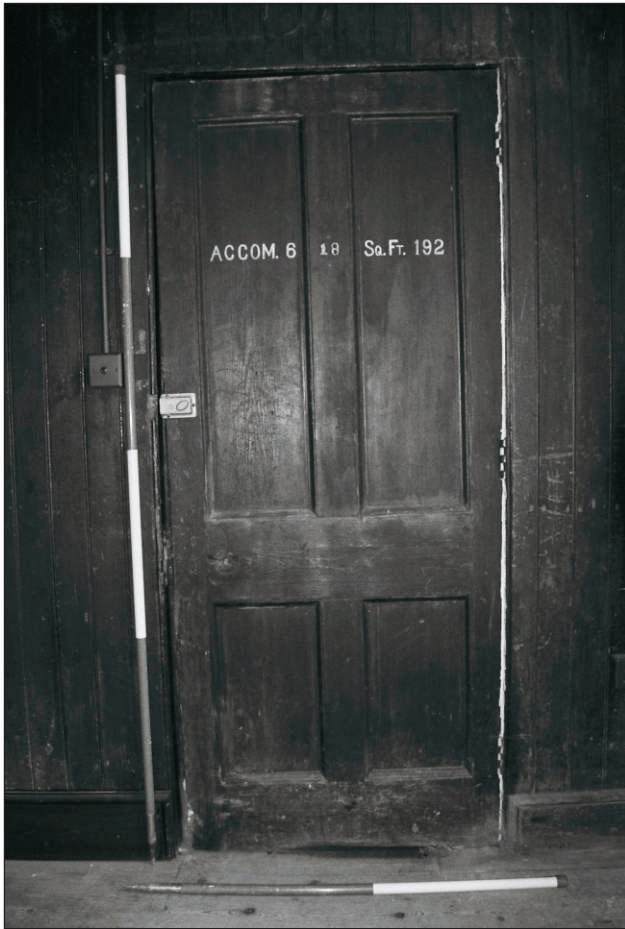
Plate 74: Detail of timber panelled door, room G4, 'Tack Room', Central Entranceway of the North Range (Film 15.25)

door of the room retained stencilled writing dating from the use of the stables by the army during World War II (**Plate 74**). Graffiti, also dating from this period, was noted etched into the tongue and groove match boarding (**Plate 78**). The ceiling was made up of painted lath and plaster which had an inserted rope fixing hanging down (**Plate 80**). It is not known what this rope was used for.

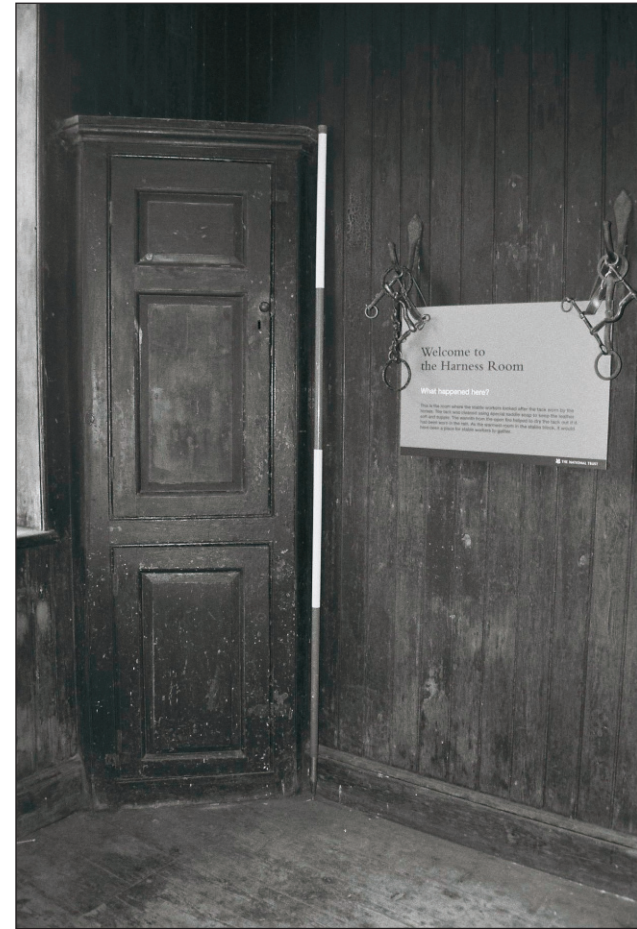
Plate 75: View of corner cupboard and brackets on wall of room G4, 'Tack Room', Central Entranceway of the North Range (Film 15.18)

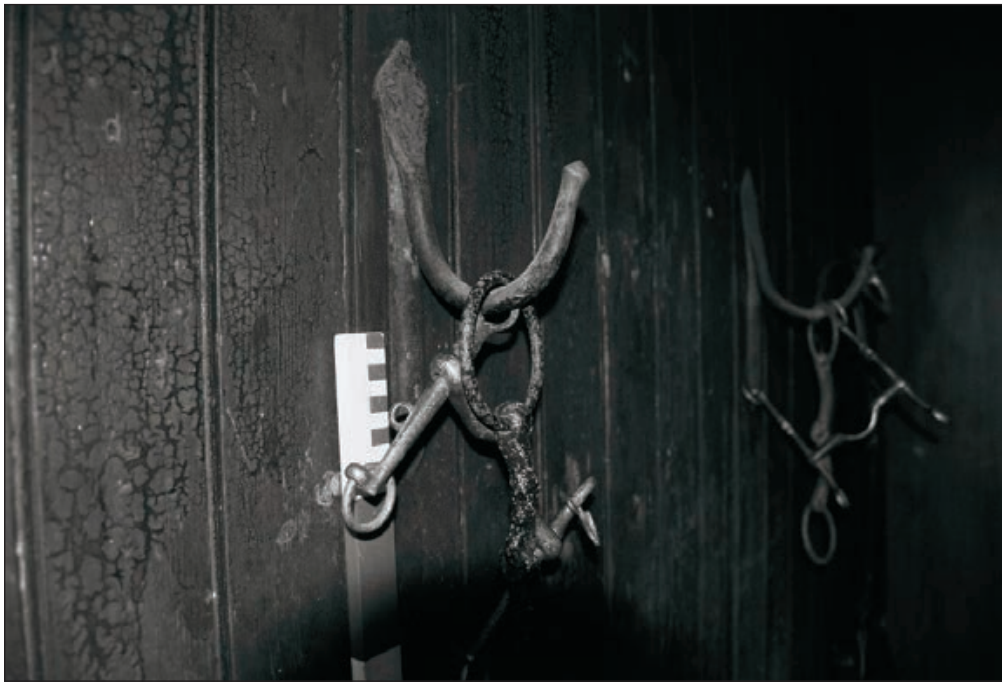
Plate 76: Detail of iron hooks on wall of room G4, 'Tack Room', Central Entranceway of the North Range (Film 15.19)

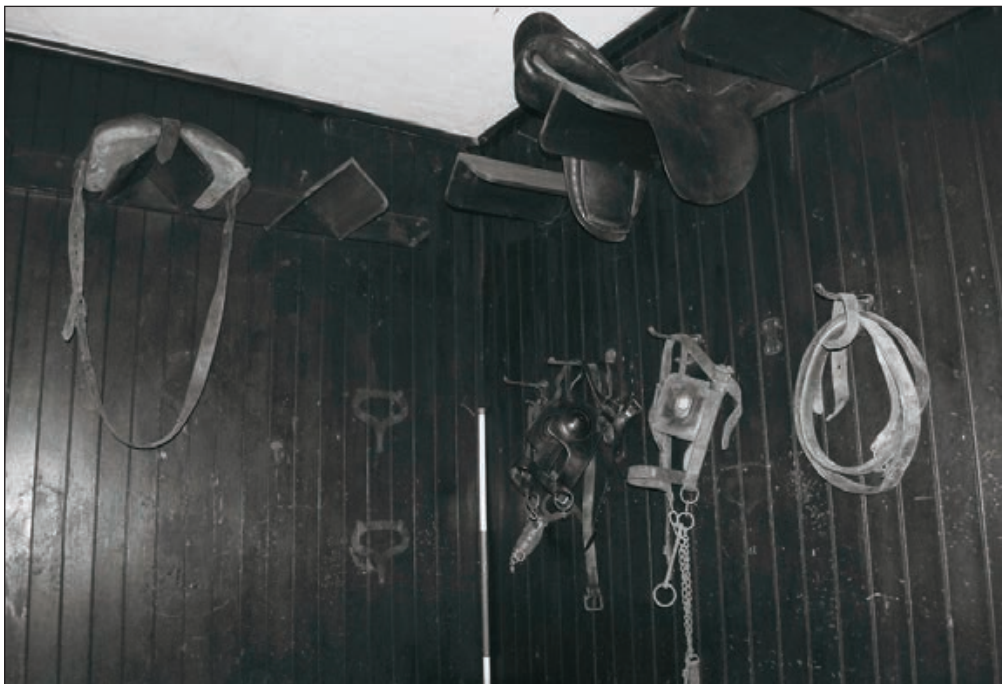
Plate 77: Detail of saddle brackets and hooks on wall of room G4, 'Tack Room', Central Entranceway of the North Range (Film 15.22)

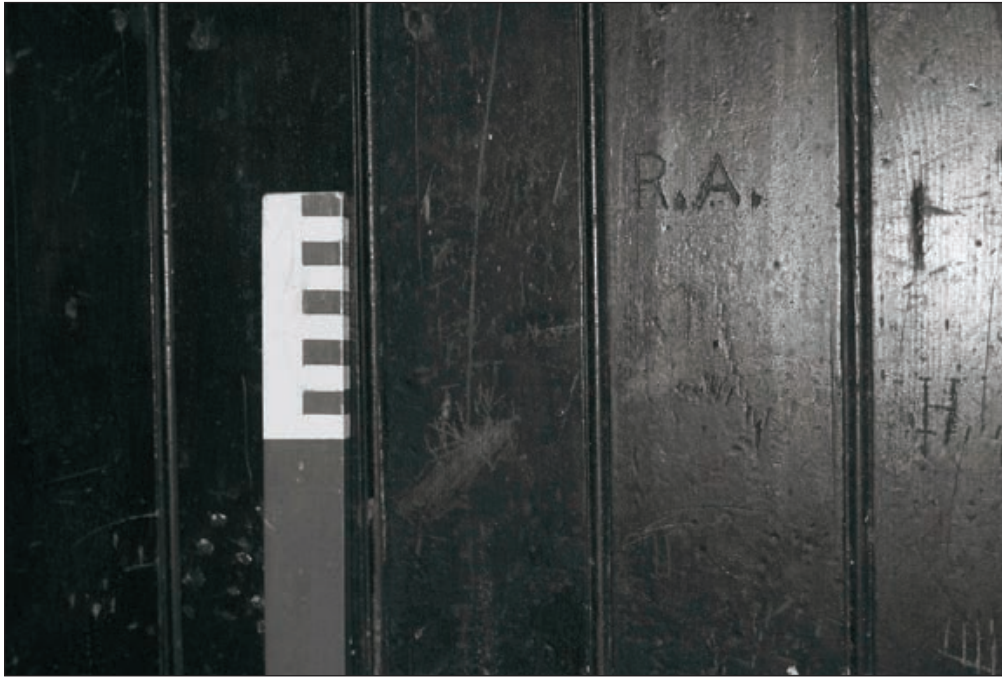
Plate 78: Detail of graffiti carved into tongue and groove match boarding on wall of room G4, 'Tack Room', Central Entranceway of the North Range (Film 15.28)

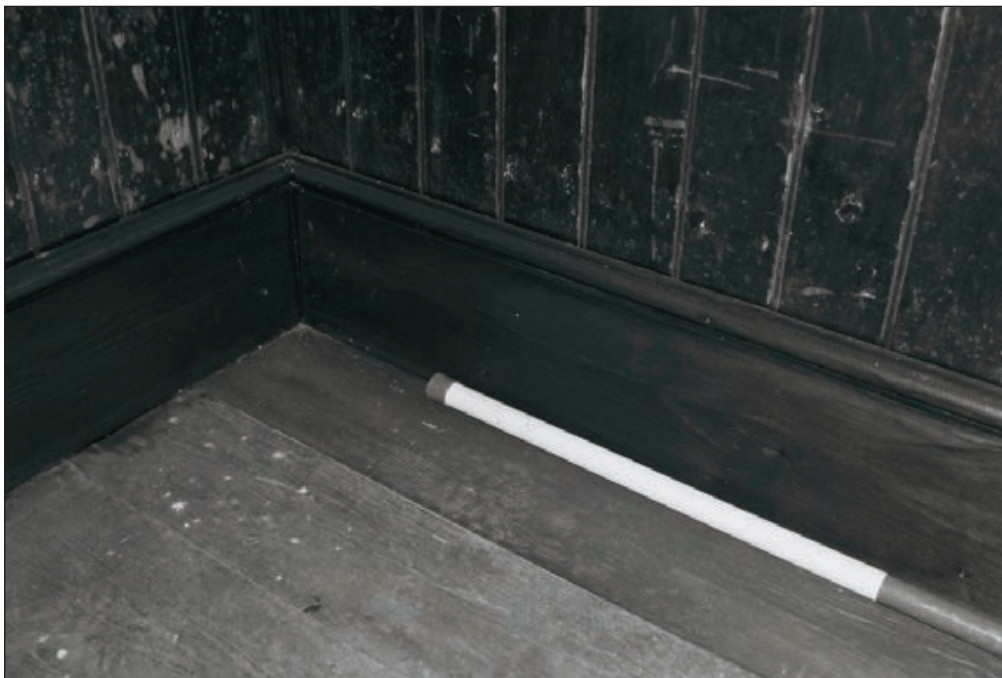
Plate 79: Detail of timber floor boards, skirting boards, match boarding, room G4, 'Tack Room', Central Entranceway of the North Range (Film 15.24)

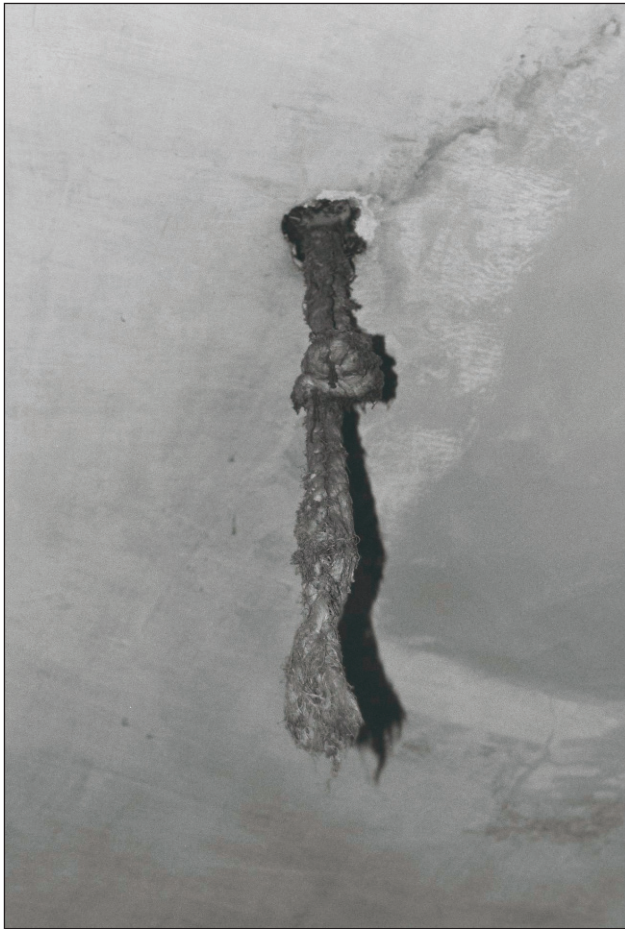
Plate 80: Detail of rope fixing from ceiling of room G4, 'Tack Room', Central Entranceway of the North Range (Film 15.14)

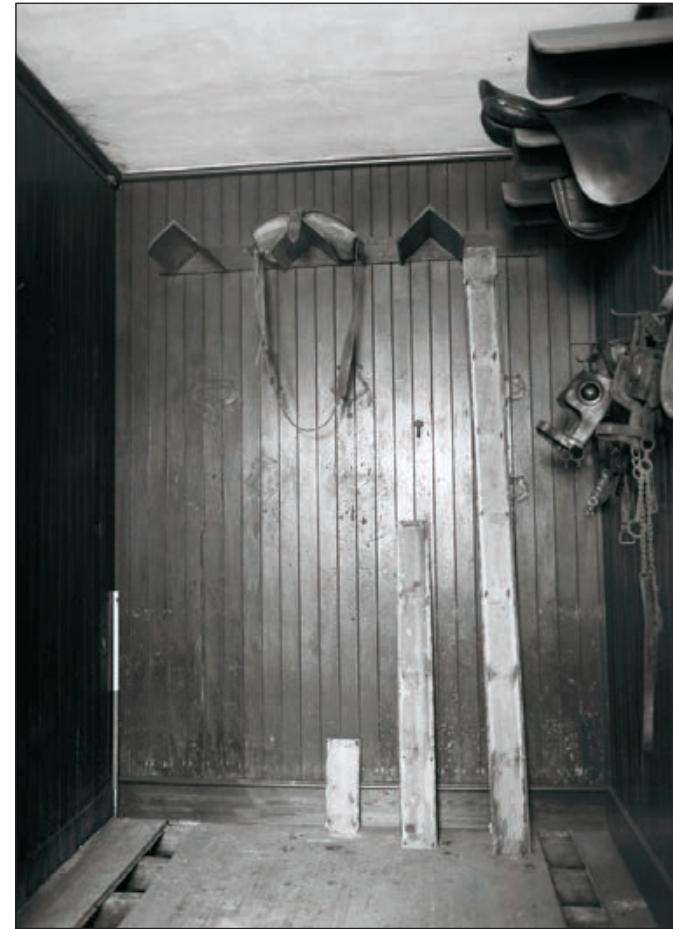
Plate 81: View of north wall of room G4, 'Tack Room', Central Entranceway of the North Range prior to removal of match boarding - OB. 33 & 71 (Film 50.13)

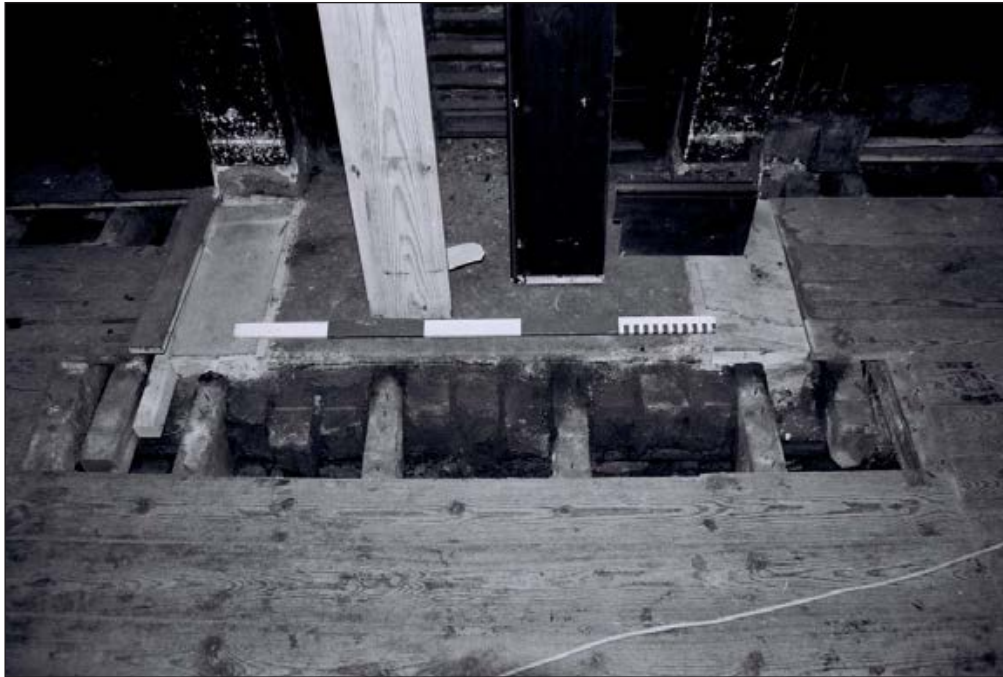
Plate 82: Detail of exposed fireplace structure, room G4, 'Tack Room', Central Entranceway of the North Range - OB. 34 (Film 43.14)

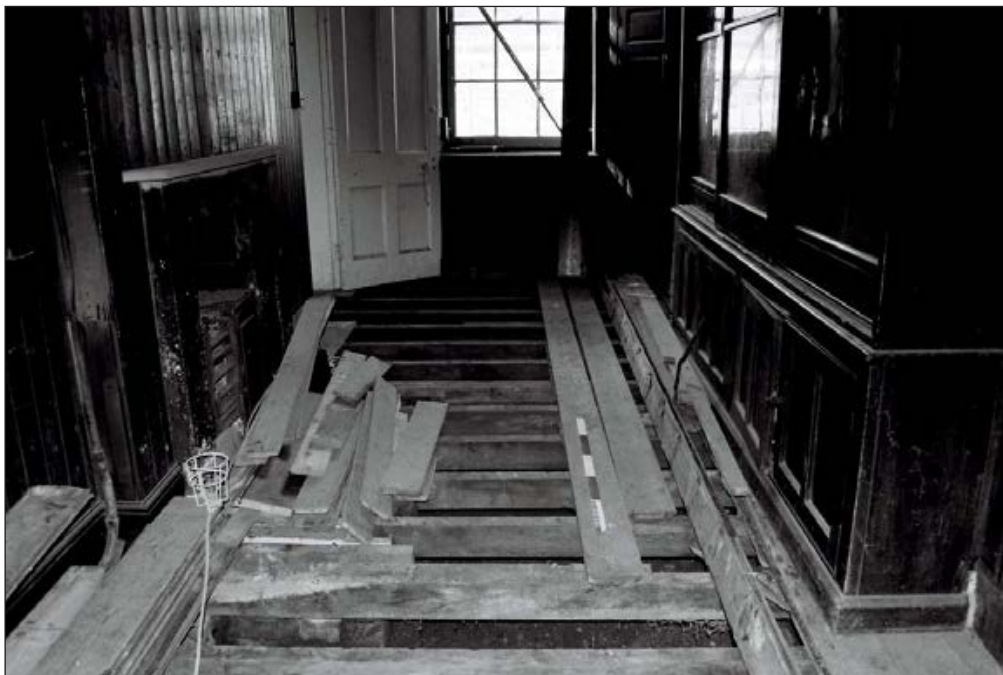
Plate 83: View of exposed floor structure, room G4, 'Tack Room', Central Entranceway of the North Range - OB. 34 (Film 52.29)

- 5.2.15 During the structural watching brief, all timber within G4 was removed for assessment and conservation. The lifting of the floor boards exposed timber joists resting on brick plinths along the west and east walls of the room (**Plate 83**). It could be seen that the fireplace hearth stone had been previously mended, and cut bricks supported the stone (**Plate 82**). These cut bricks may have been part of the primary floor of the room, prior to the phase 6 alterations and inserted suspended floor. The removal of the tongue and groove match boarding from the walls revealed phase 2 stone outer walls and a brick internal wall to the north. There were two blockings within the west wall: a stone blocked arched opening (**Plates 84-85**), mirroring that within the wall on the opposite side of the cart passage (G7) (**Figure 11**); and a brick blocked opening, the full height of the room, which originally accommodated part of the clock mechanism from the cupola above (**Plate 84**). Within the east wall, the original walls were covered with plaster with the remains of a typical paint scheme comprising a dark lower half, and a light upper half (**Plate 91**), whilst bare red brick delineated a blocked arched opening at the north end, and the inserted central fireplace and chimney breast (both likely phase 6) (**Plates 86-88**). The window within the south wall had been altered, appearing to have been narrowed slightly and the sill raised (**Plate 90**).

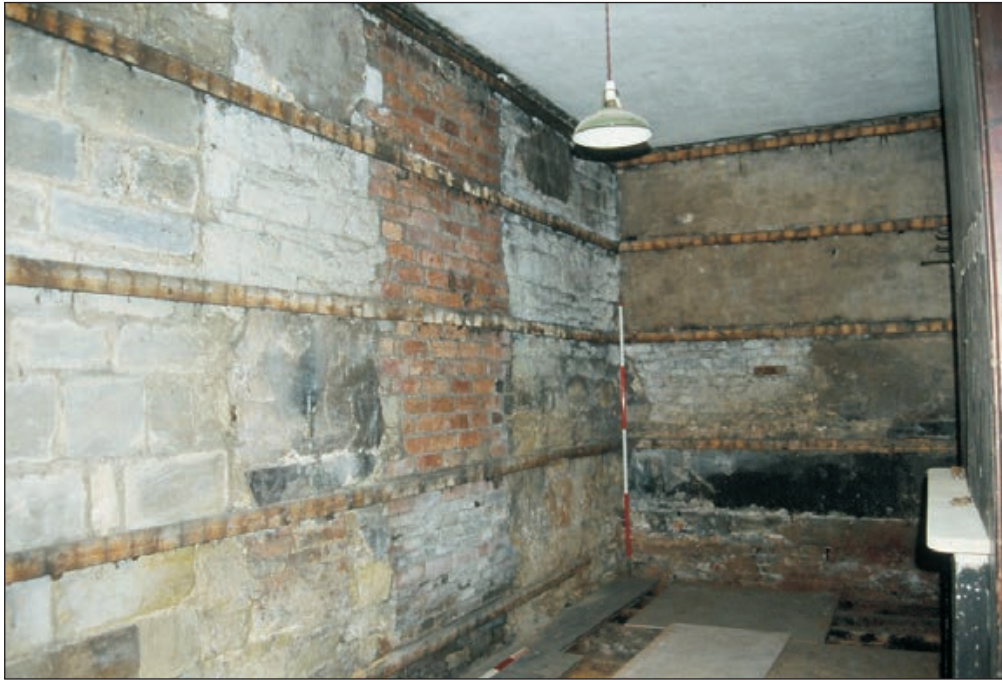
Plate 84: View of room G4, 'Tack Room', Central Entranceway of the North Range, after removal of match boarding, showing blocked openings - OB. 71 & 73 (Film C.S. 39)

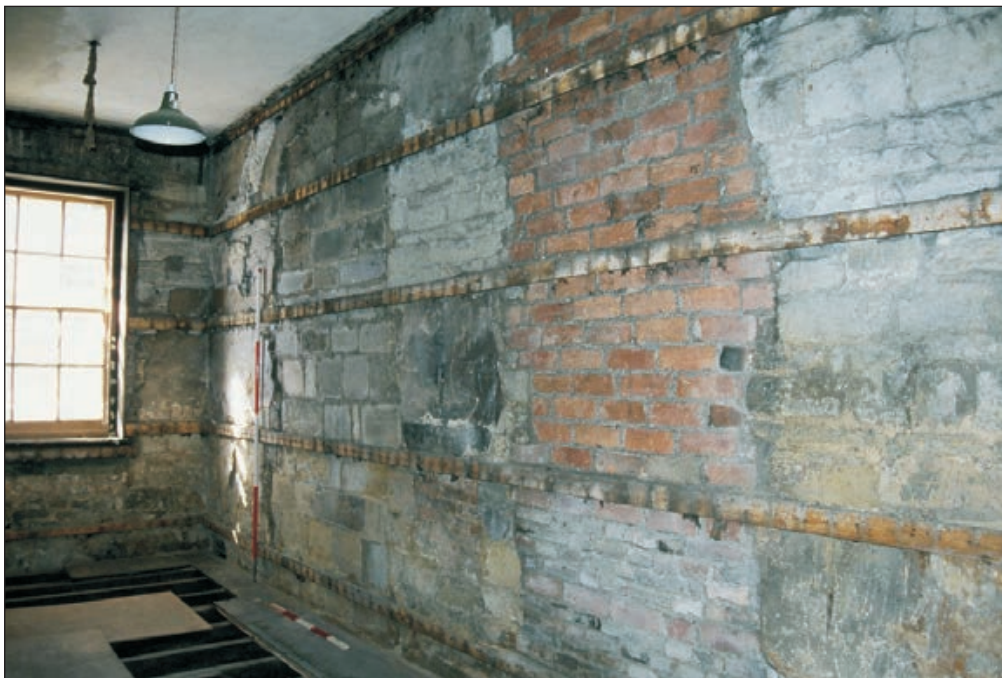
Plate 85: View of room G4, 'Tack Room', Central Entranceway of the North Range, after removal of match boarding, showing blocked openings - OB. 71 & 73 (Film C.S. 34)

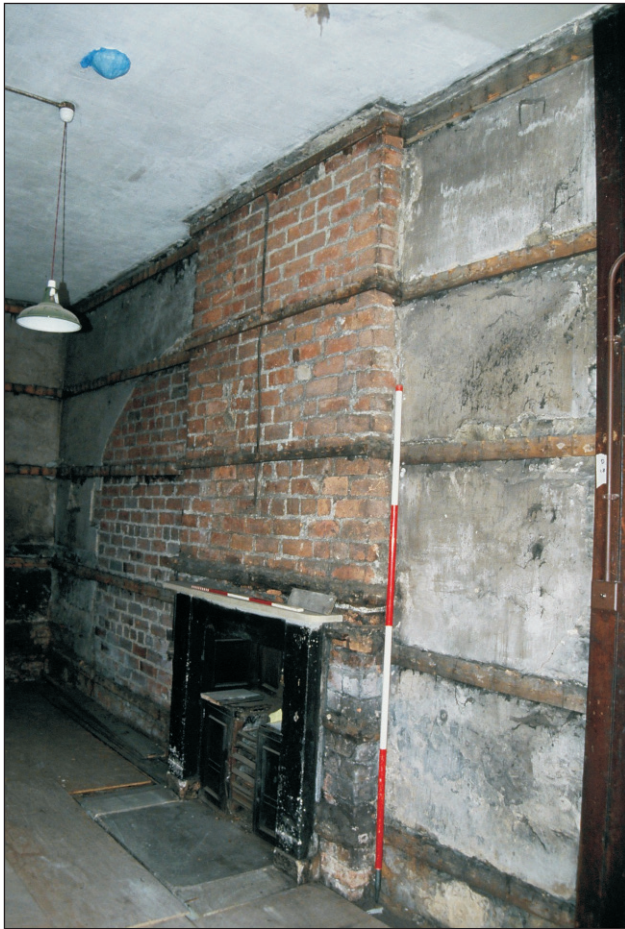
Plate 86: View of exposed east wall after removal of timber match boarding, room G4, 'Tack Room', Central Entranceway of the North Range, showing later brick blocking - OB. 71 & 75 (Film C.S. 32)

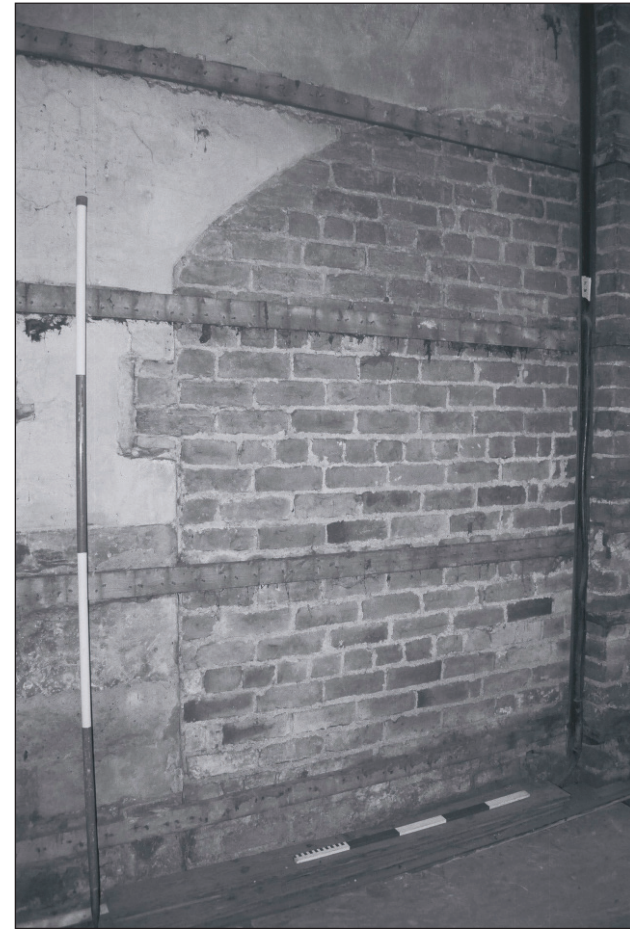
Plate 87: Detail of brick blocked arch, east wall of room G4, 'Tack Room', Central Entranceway of the North Range - OB.71 & 75 (Film 57.25)

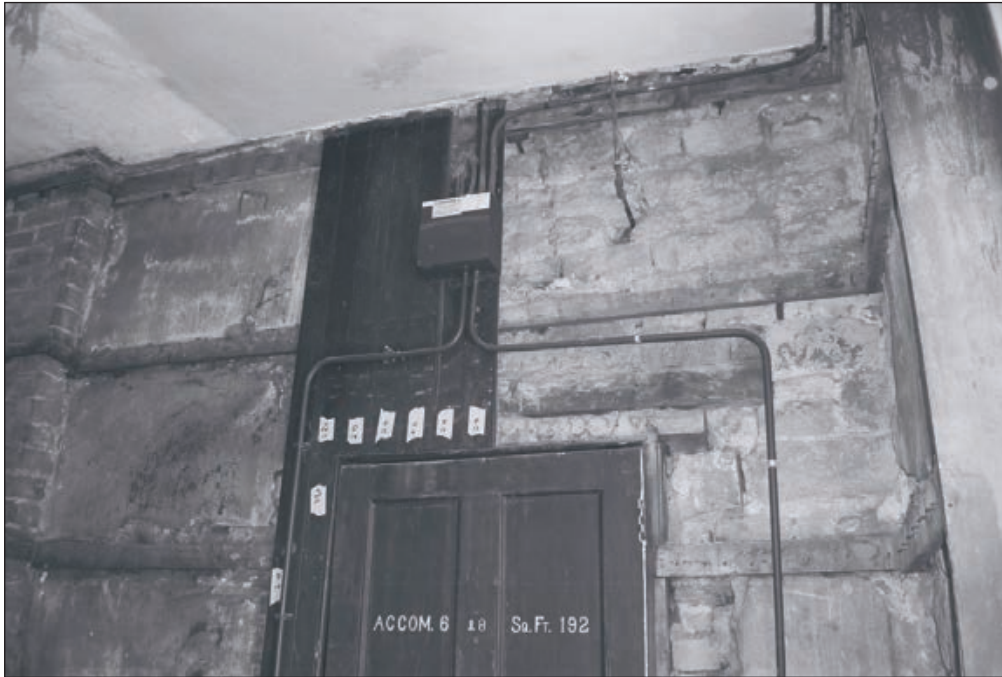
Plate 88: Detail of the south end of east wall showing phase 2 stonework, room G4, 'Tack Room', Central Entranceway of the North Range - OB. 71 & 75 (Film 57.15)

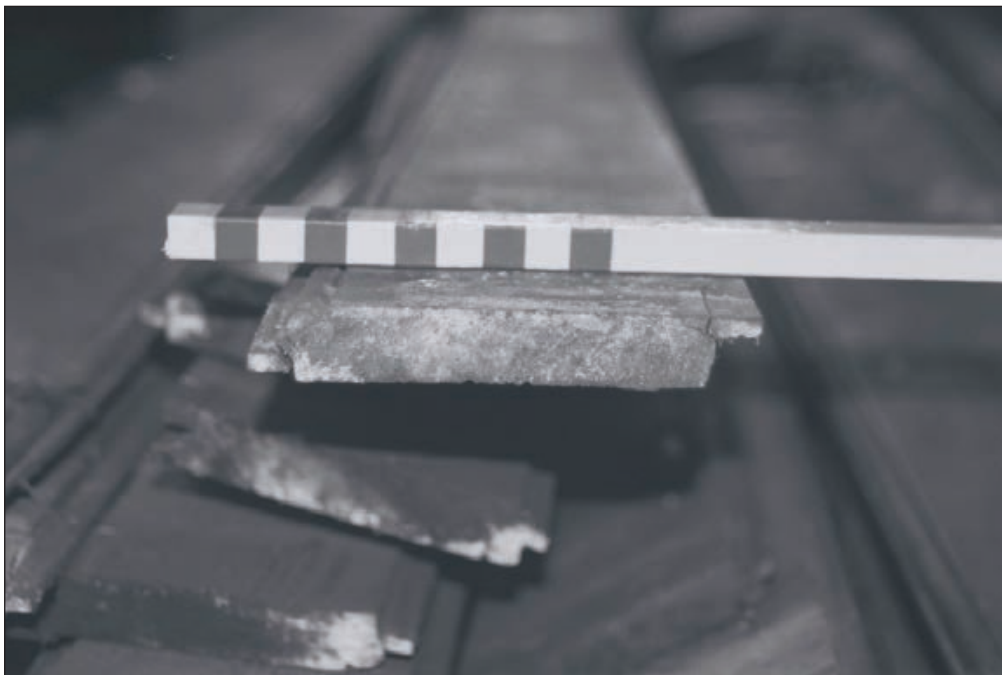
Plate 89: Detail of match boarding of room G4, 'Tack Room', Central Entranceway of the North Range - OB. 71 (Film 56.05)

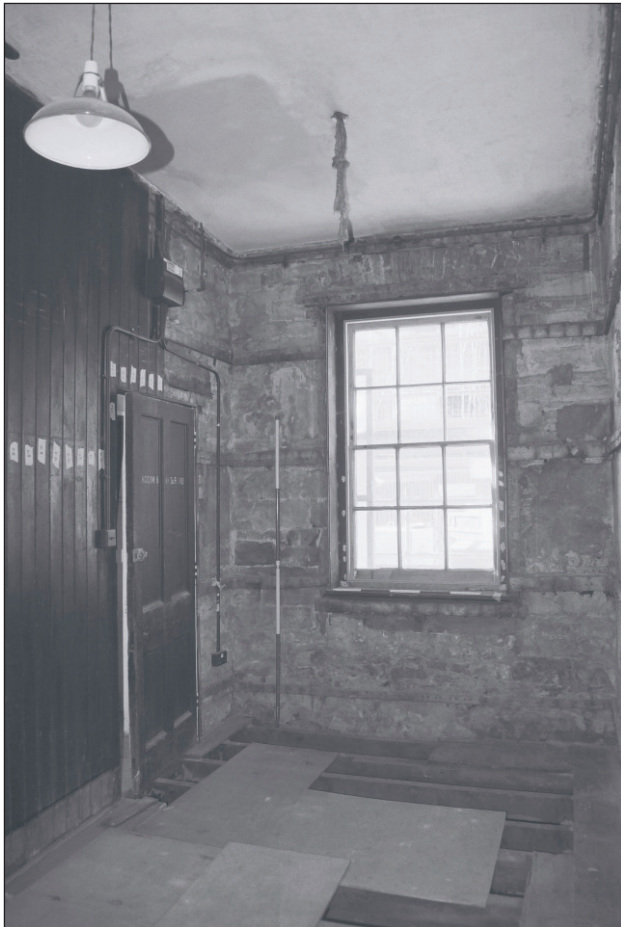
Plate 90: View of exposed south wall, room G4, 'Tack Room', Central Entranceway of the North Range, showing altered window - OB. 71 & 72 (Film 56.17)

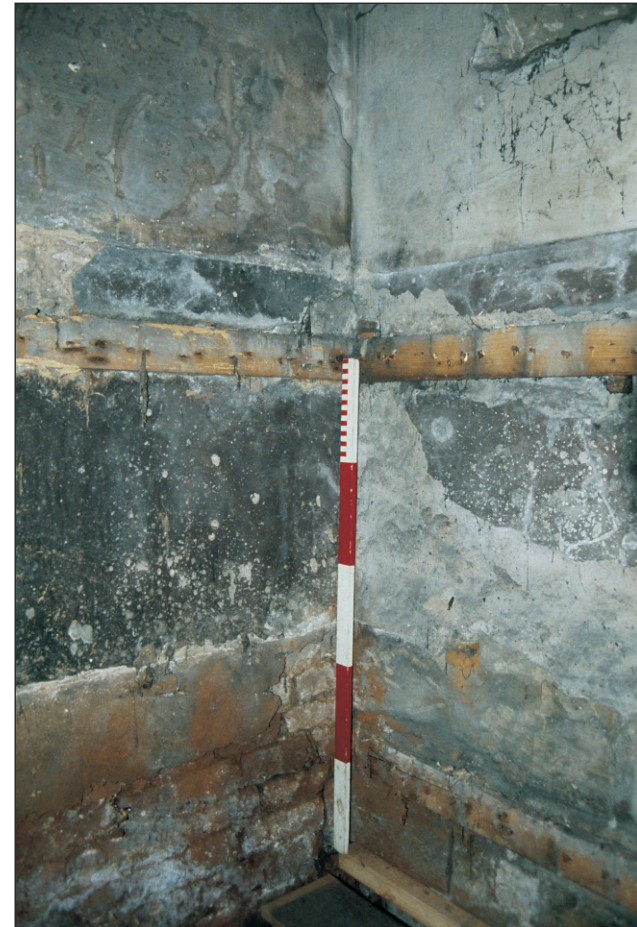
Plate 91: Detail of phase 2 paint scheme on exposed plastered walls of room G4, 'Tack Room', Central Entranceway of the North Range - OB. 73 & 76 (Film C.S. 37)
