NOSTELL PRIORY STABLES, NOSTELL, WAKEFIELD, WEST YORKSHIRE

Historic Building Recording and Structural Watching Brief

Planning Application Ref: 09/00701/FUL & 09/00705/LBC

72934.01_BDG_V0_4

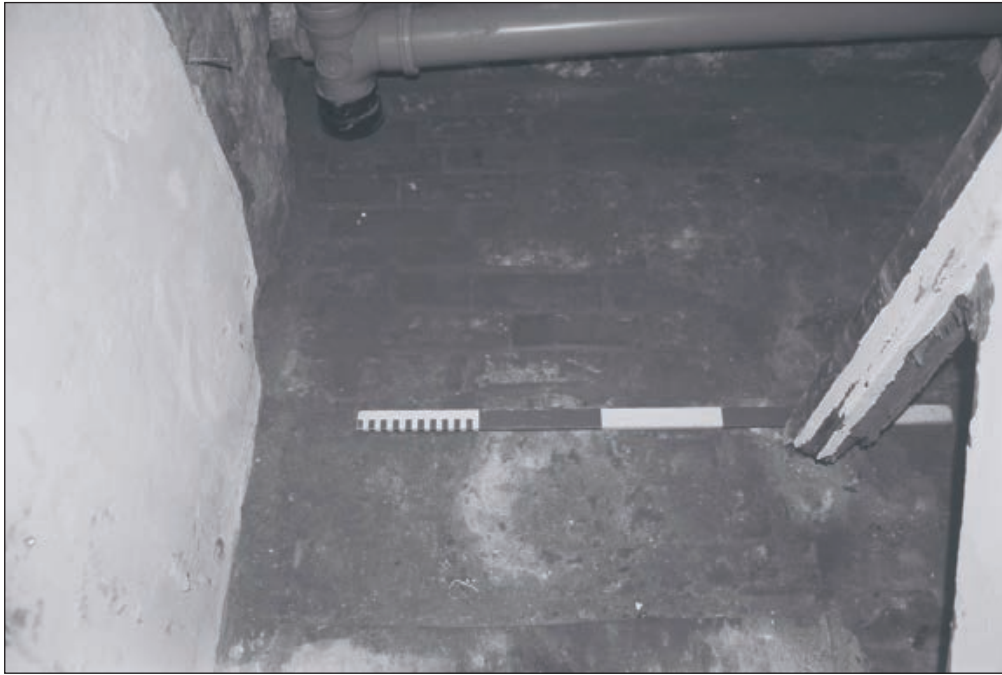
Plate 92: View of original brick floor of G5/6, Central Entranceway of the North Range - OB. 128 (Film 79.14)

- 5.2.16 To the north of G4 was G5/G6 which contained the staircase leading to the first floor of the eastern half of the range, accessed via a doorway within the west wall from the cart passage (G7). There was a sash window within the north wall, and the staircase was of simple design with winders. After the removal of later coverings and finishes, the original phase 2 brick floor could be seen (**Plate 92**).

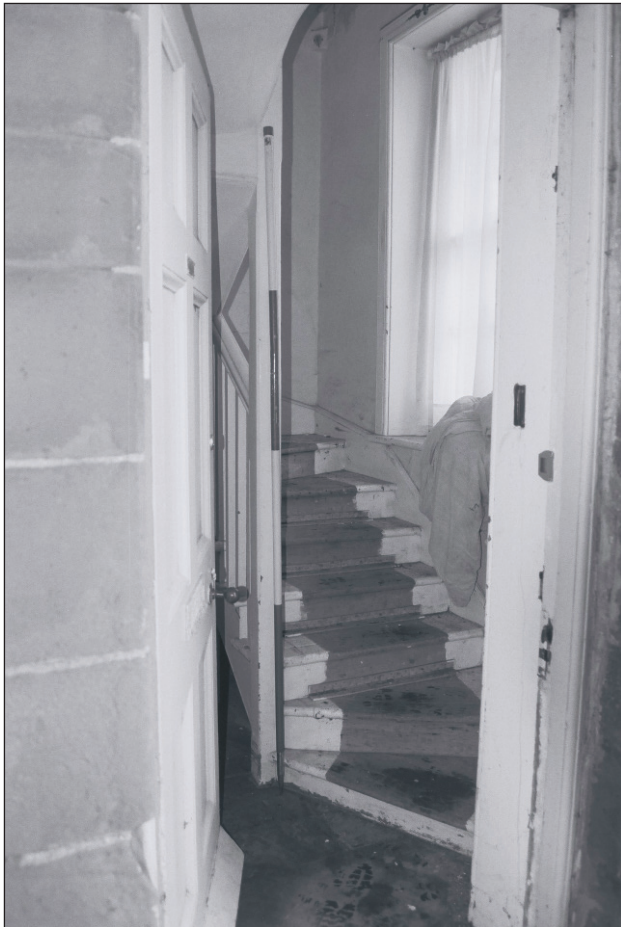
Plate 93: General view of staircase G8, Central Entranceway of the North Range (Film 42.34)

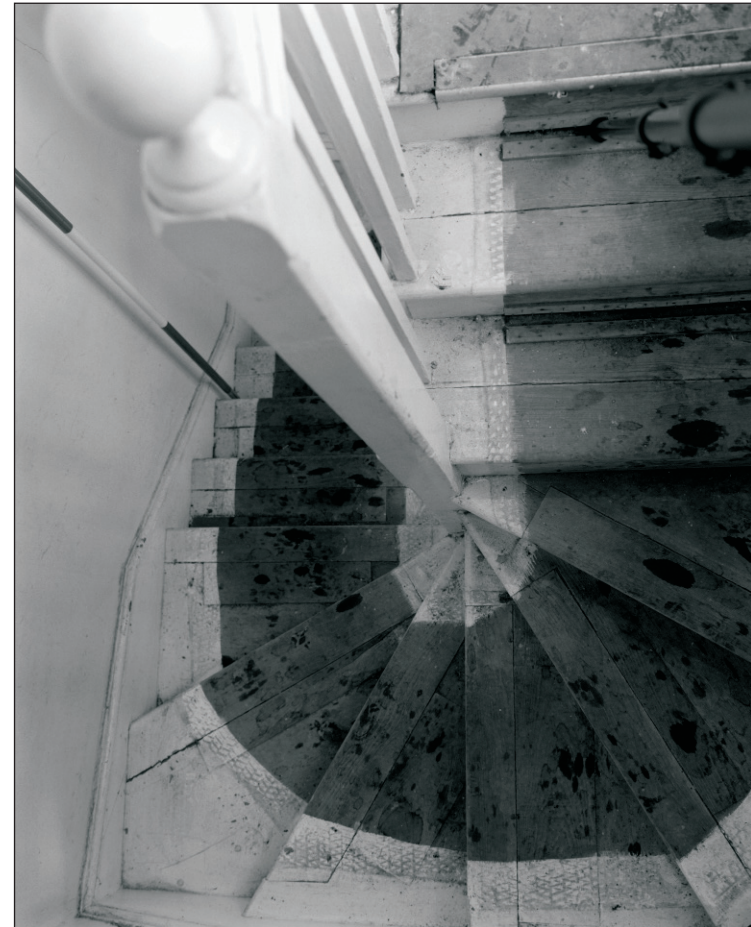
Plate 94: General view of staircase G8 to F11, Central Entranceway of the North Range (Film 32.02)

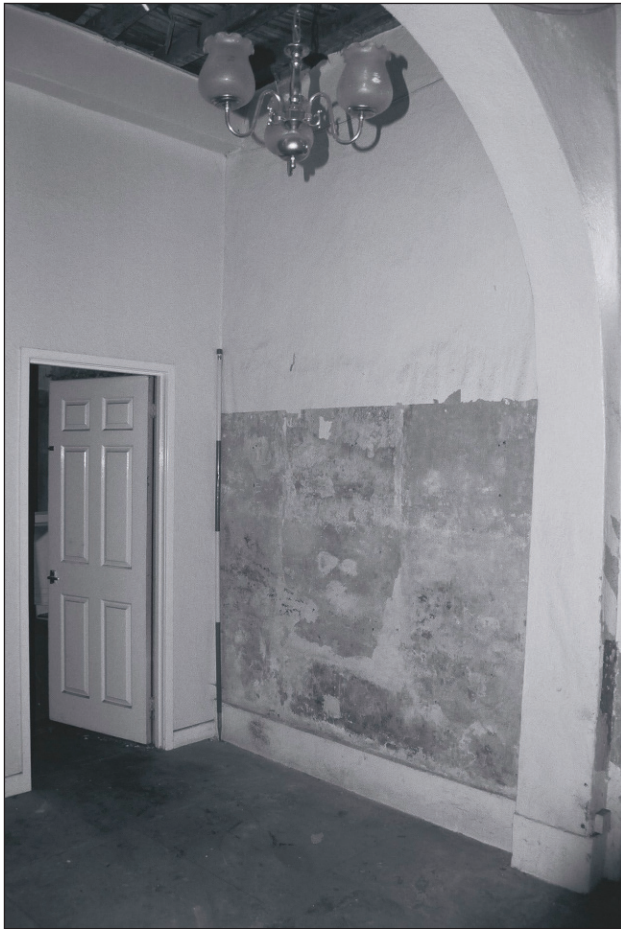
Plate 95: General view of room G10 showing modern partition with G9, Central Entranceway of the North Range (Film 26.04)

- 5.2.18 Positioned to the south of this were rooms G9, G10 and G11. Although at the initial time of survey, the rooms were separated by modern partitions, the space was essentially a single room (**Figure 11 and Plates 95-98**). Access would only have originally been gained via the large doorway opening to the east, directly from the adjacent cart passage (G7) (**Plate 97**). There were two inserted doorways, one within the north wall which connected the room with the staircase in G8, and another opposing the original main doorway to the west, joining the room with G12. Within the northwest corner of the room was an original phase 2 fireplace with cast iron range, of the name J. Holdsworth, Wakefield (**Plates 99-100**). An early paint scheme was still

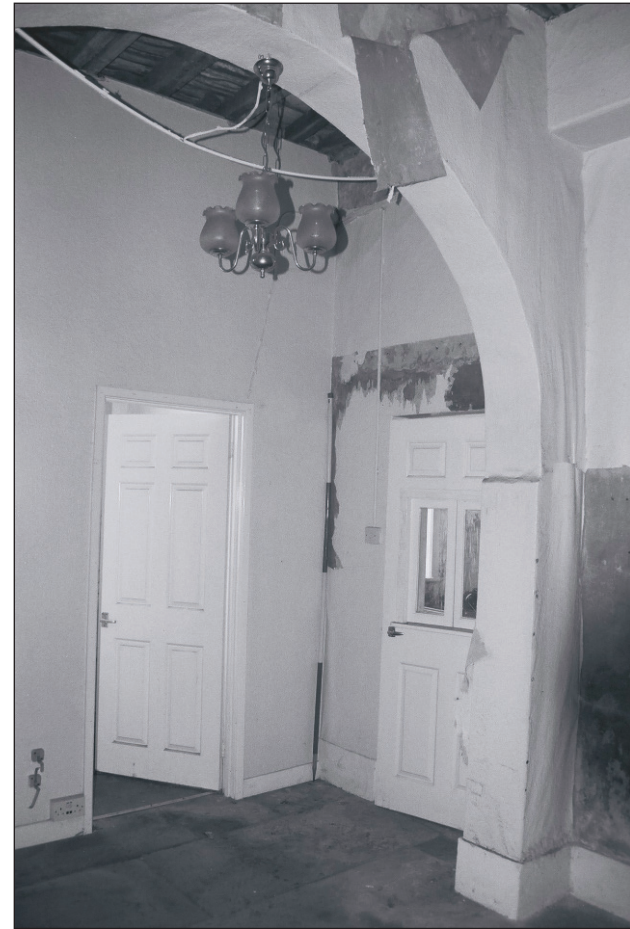
Plate 96: General view of room G10, Central Entranceway of the North Range, showing modern partition with G11 and doorway to G12 (Film 26.01)

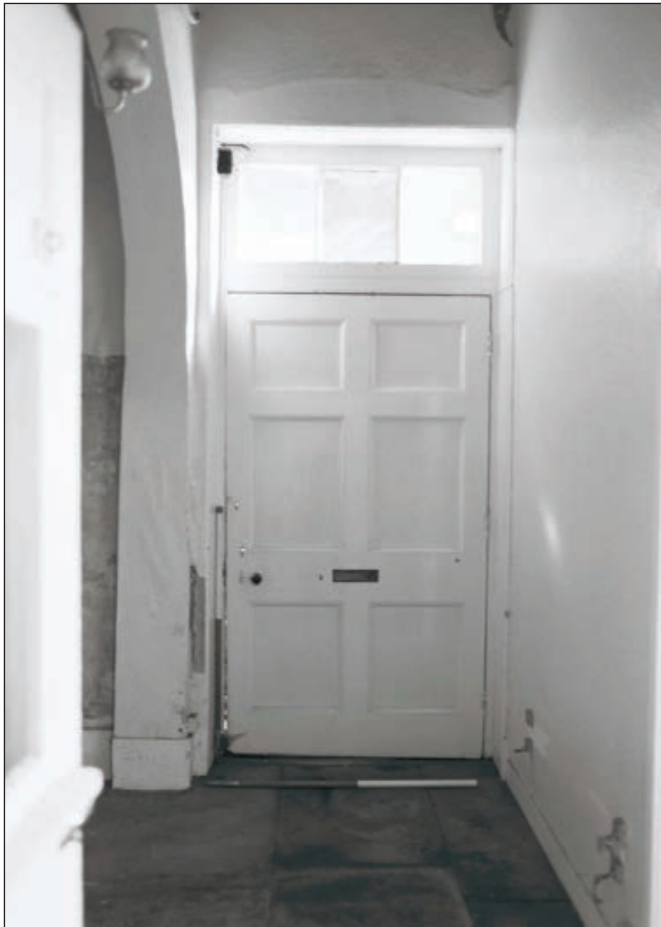
Plate 97: General view of corridor G10, Central Entranceway of the North Range, showing primary doorway from cart passage G7 (Film 50.02)

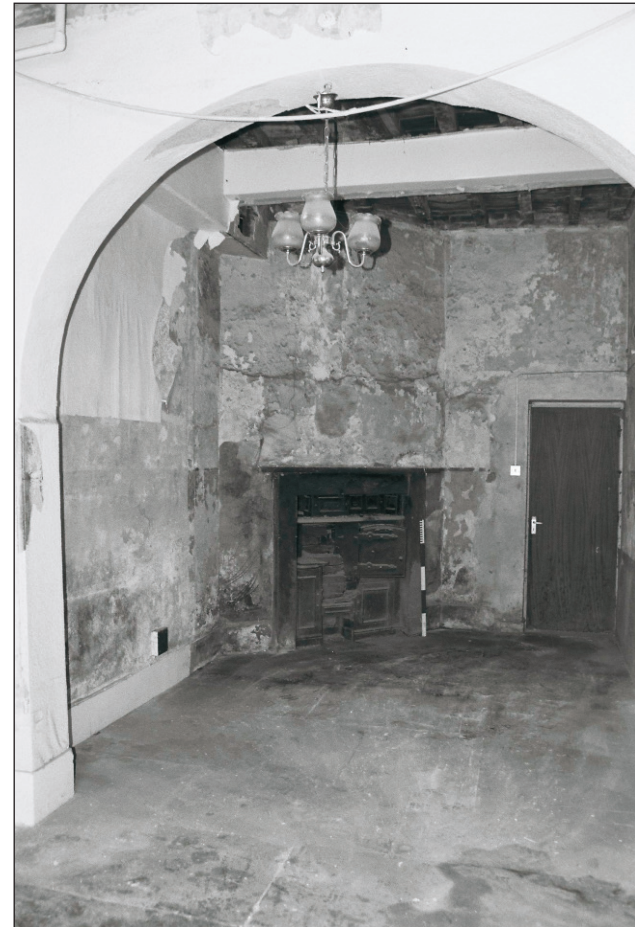
Plate 98: General view of room G9/10, Central Entranceway of the North Range, after the removal of modern partition (Film 52.20)

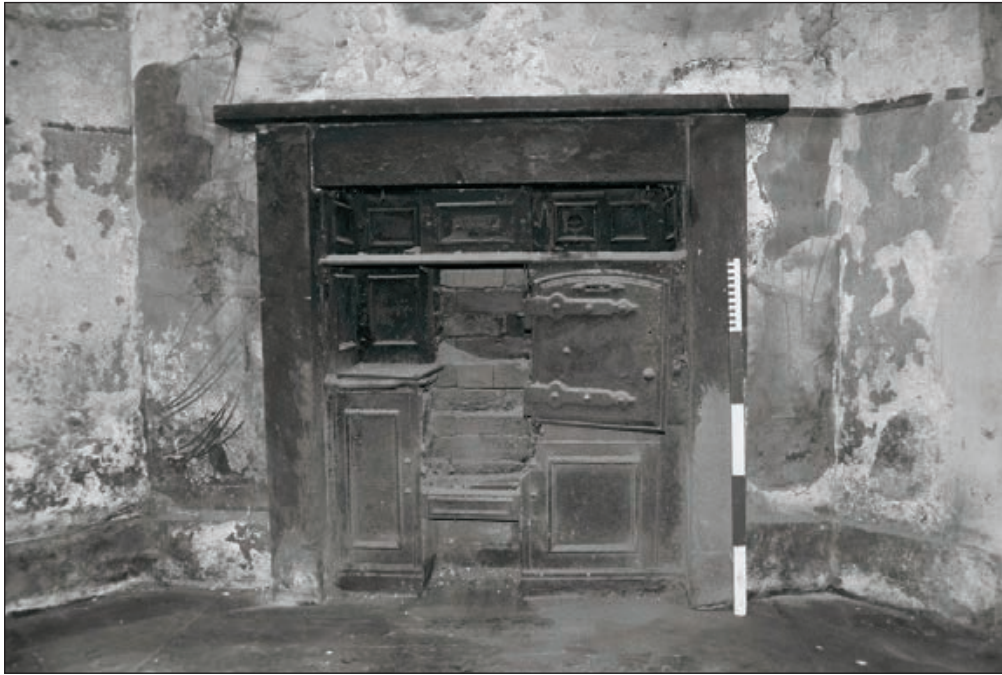
Plate 99: Detail of phase 2 corner fireplace, room G9, Central Entranceway of the North Range (Film 52.19)

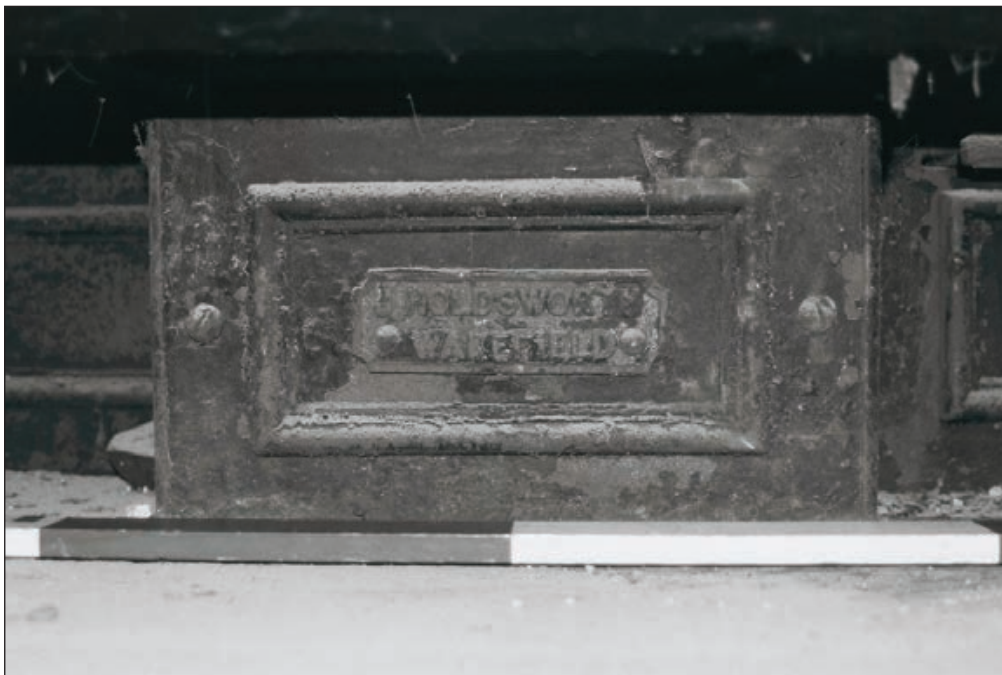
Plate 100: Detail of 'J. Holdsworth, Wakefield' name plate on corner fireplace, room G9, Central Entranceway of the North Range (Film 52.17)

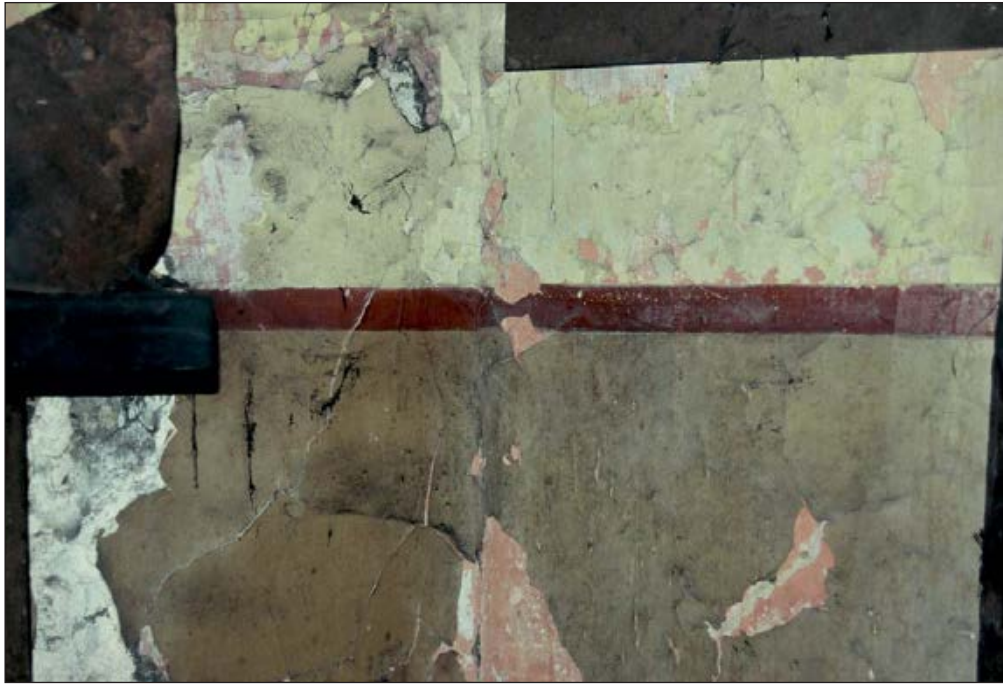
Plate 101: Detail of paint scheme, north wall of room G9, Central Entranceway of the North Range (Film C.S. 25.)

evident within G9, with a white upper half, and a brown lower half, divided by a red boarder (**Plate 101**). The floor was solid and covered with stone flags (**Plate 102**), whilst the ceiling comprised exposed timber joists with laths supporting a limeash floor above (**Plates 103-104**). Nail and plaster marks indicated the former presence of a lath and plaster ceiling, since removed. The walls had all been plastered and painted during phase 8, so the blocked windows within the east wall were not visible internally. Either side of the doorway within the east wall, running east to west were two archways (**Plate 105**), and within the south wall there was a sash window with raised sill (**Plates 105 and 108**). G11 had most latterly been utilised as a w.c. and store room. Timber hooks were positioned high on both the east and west walls (**Plate 106**).

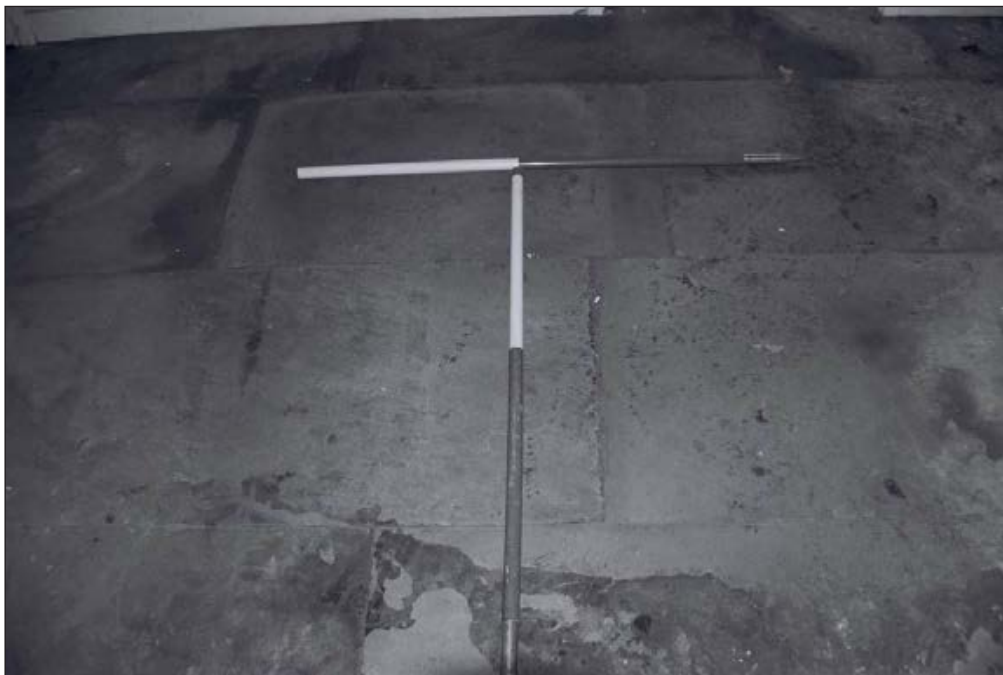
Plate 102: Detail of stone flag floor, room G9, Central Entranceway of the North Range (Film 41.35)

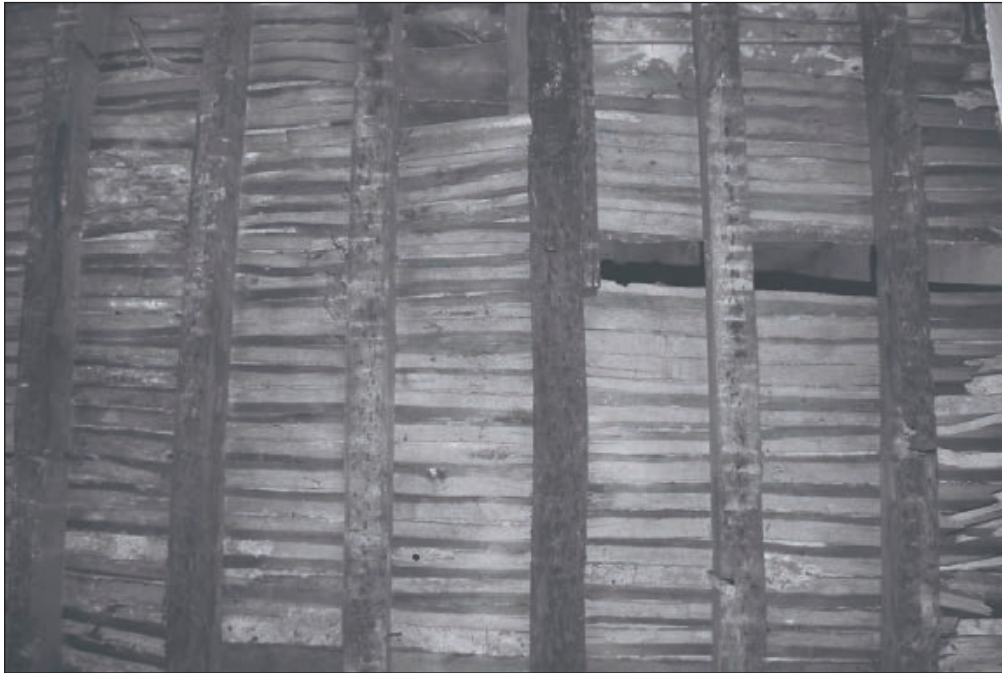
Plate 103: Detail of timber joists and laths of floor above, room G9/10, Central Entranceway of the North Range (Film 26.03)

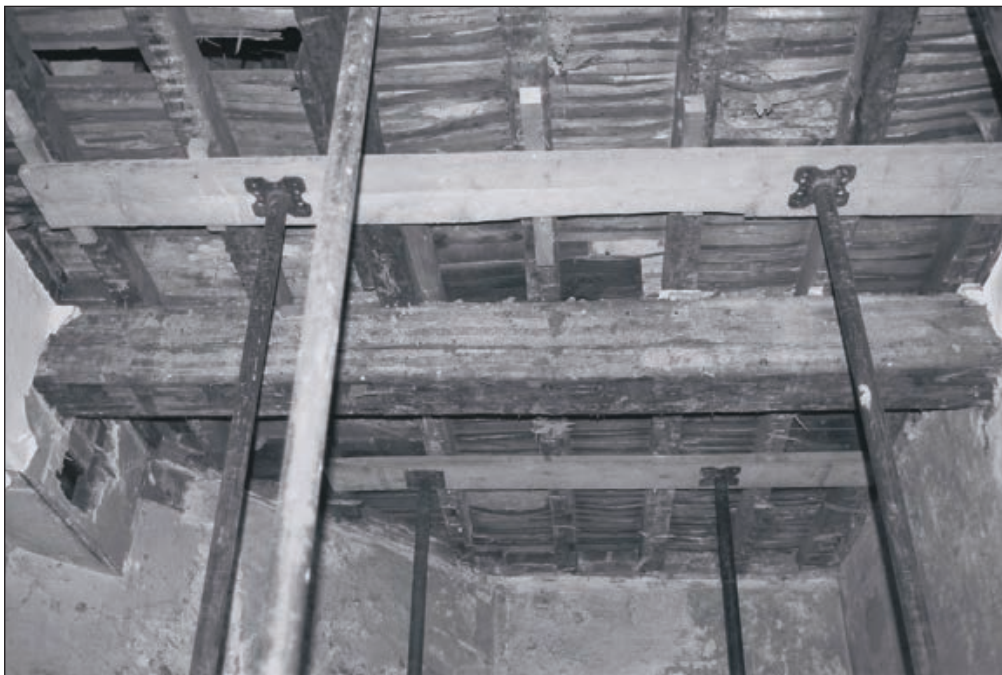
Plate 104: Detail of exposed reused timber beam and joists of floor above room G9/10, Central Entranceway of the North Range (Film 54.27)

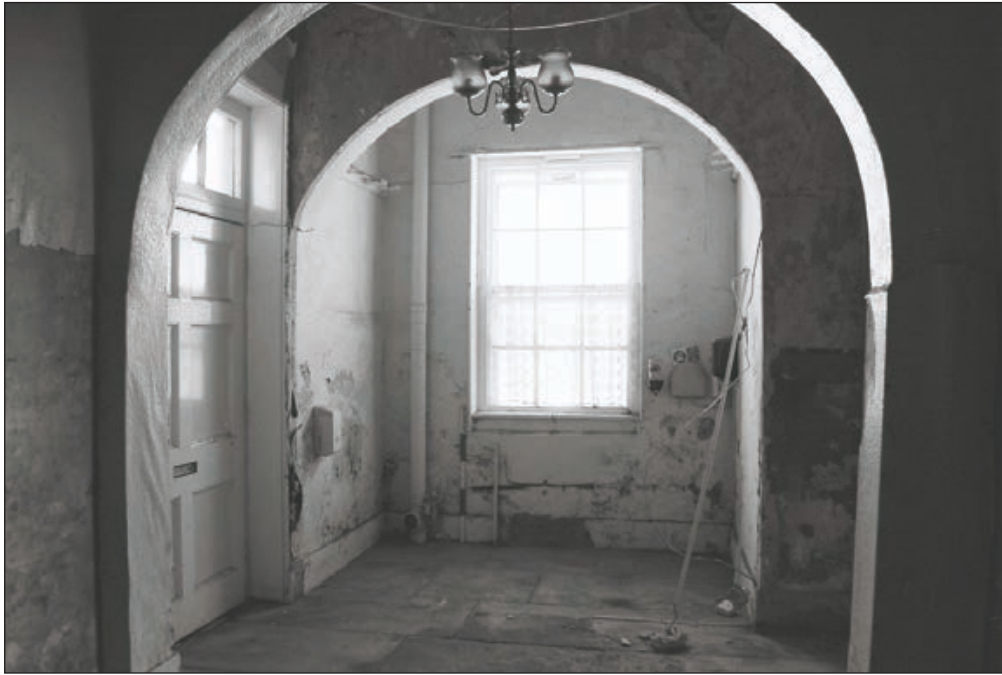
Plate 105: General view of rooms G10/11, Central Entranceway of the North Range, after removal of modern partitions (Film 52.15)

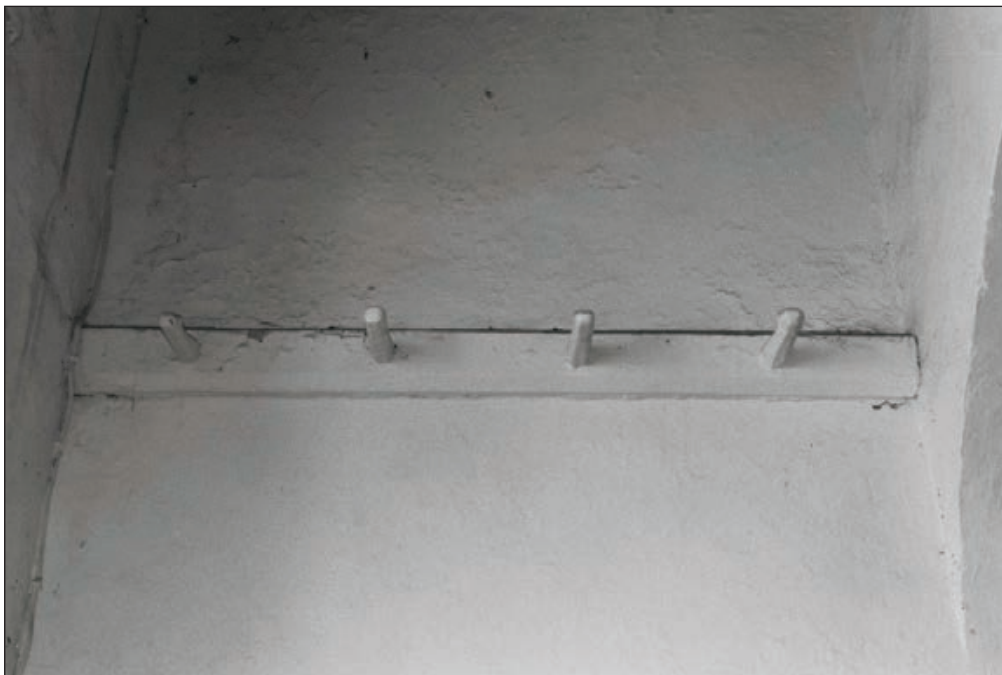
Plate 106: Detail of timber hooks, west wall of room G11, Central Entranceway of the North Range (Film 52.11)

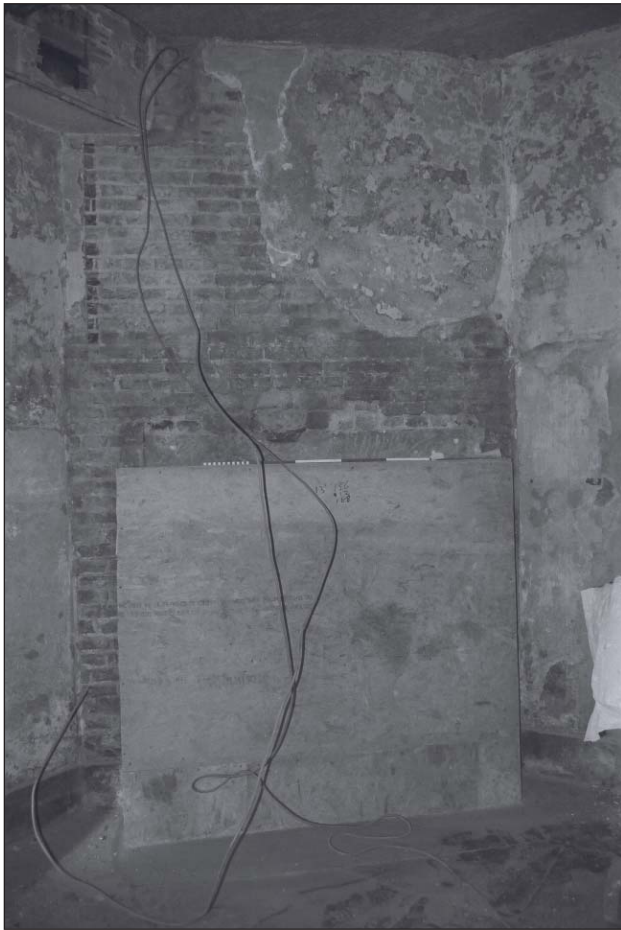
Plate 107: View of exposed brick fabric of corner fireplace, room G9, Central Entranceway of the North Range - OB. 114 (Film 76.36)

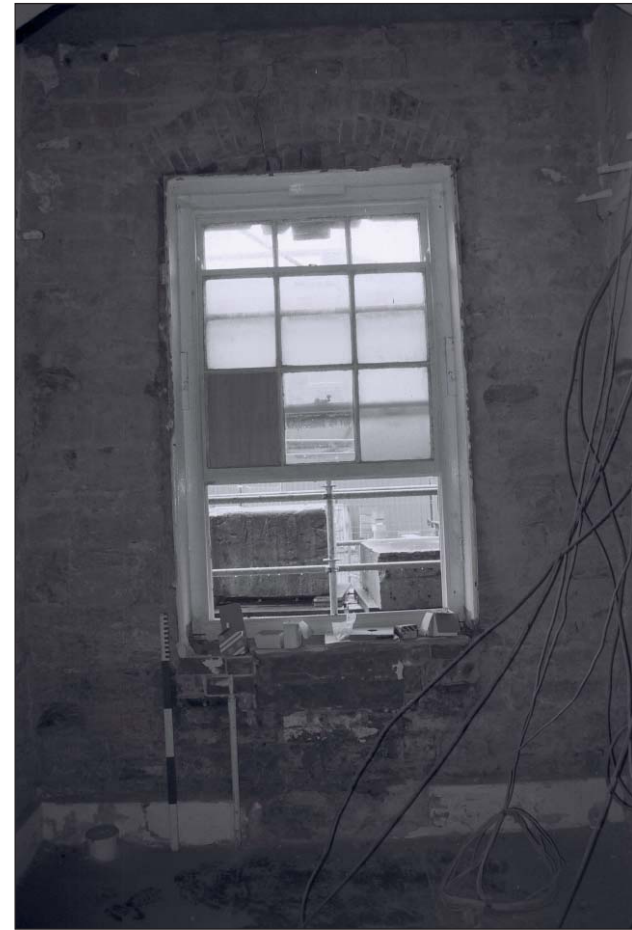
Plate 108: Detail of exposed stonework & raised sill of window, south wall of G11, Central Entranceway of the North Range - OB. 116 (Film 76.31)

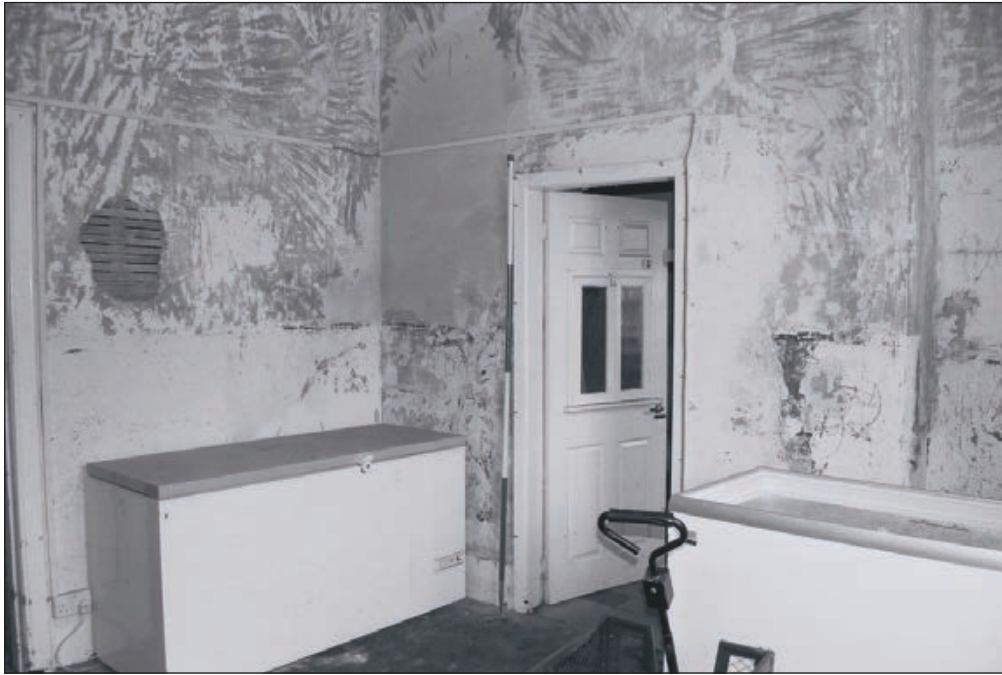
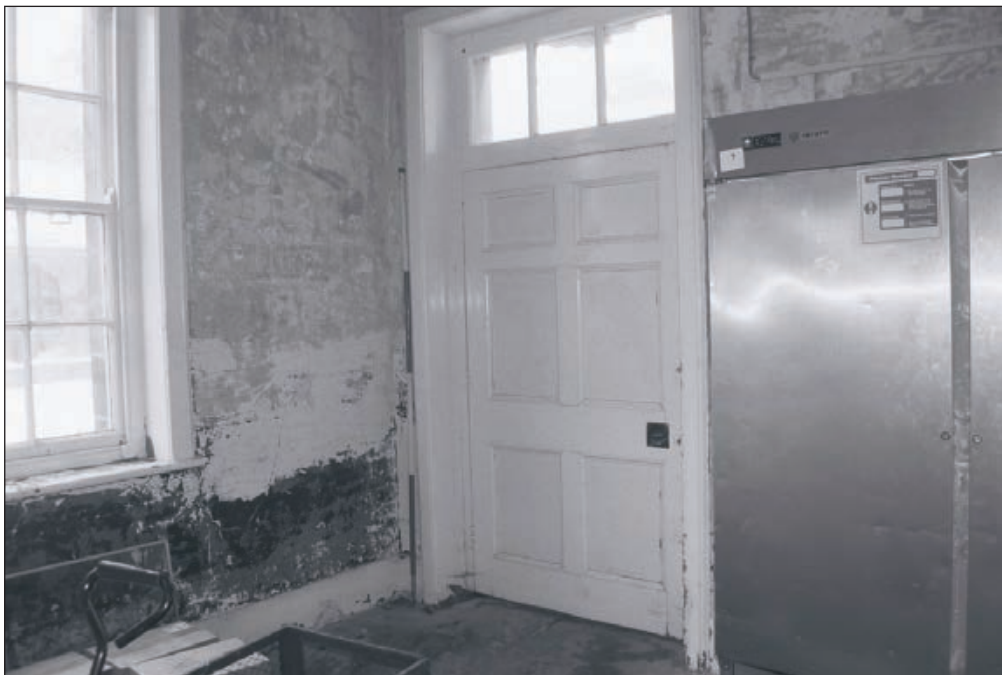
Plate 109: General view of room G12, West Side of the North Range (Film 26.09)

Plate 110: General view of room G12, West Side of the North Range (Film 26.07)

- 5.2.19 G12, positioned to the southwest of G9-G11, was part of the phase 7 west element of the North Range (**Figure 11**). This room was square in plan, and contained a doorway in the west wall, leading from the courtyard, and a modern inserted doorway to the east leading to G10 (**Plates 109-110**). There was also a sash window to the south. The main walls were covered in plaster and showed the remains of former paint schemes (**Plate 111**). The north wall was a timber stud with lath and plaster covering, dividing G12 and G13. Exposed during the watching brief, was a metal sign on the top of the door leading to G13, with the words 'THE "IRIS" CAR' (**Plate 112**). This is contemporary with the construction of the west end of the range, and the use of the ground floor as a coach house, housing motor cars.

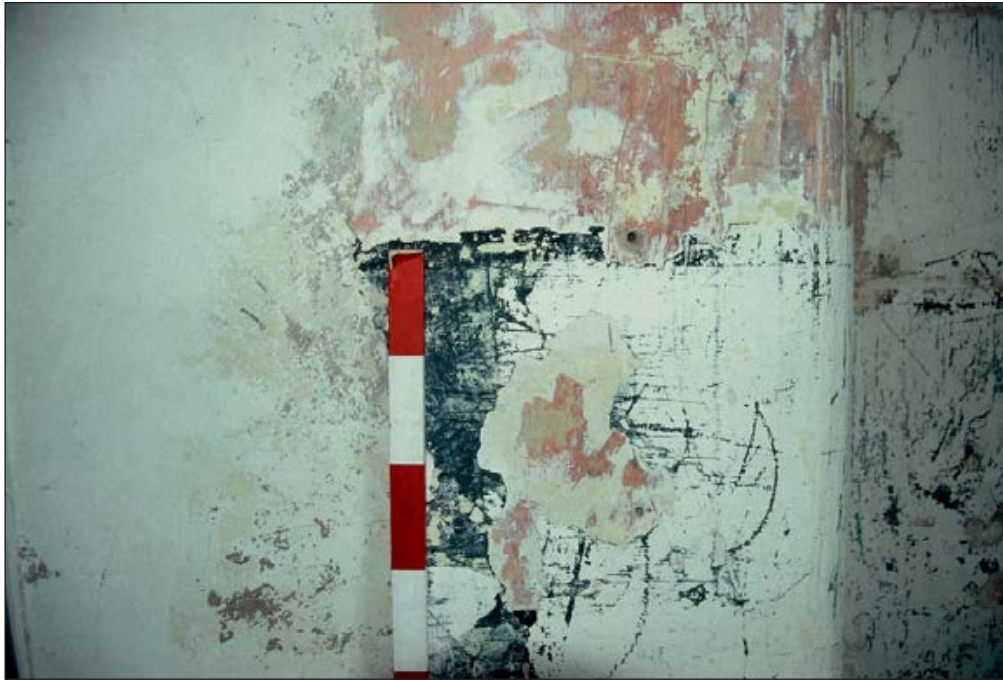
Plate 111: Detail of paint scheme, room G12, West Side of the North Range (Film C.S. 27.)

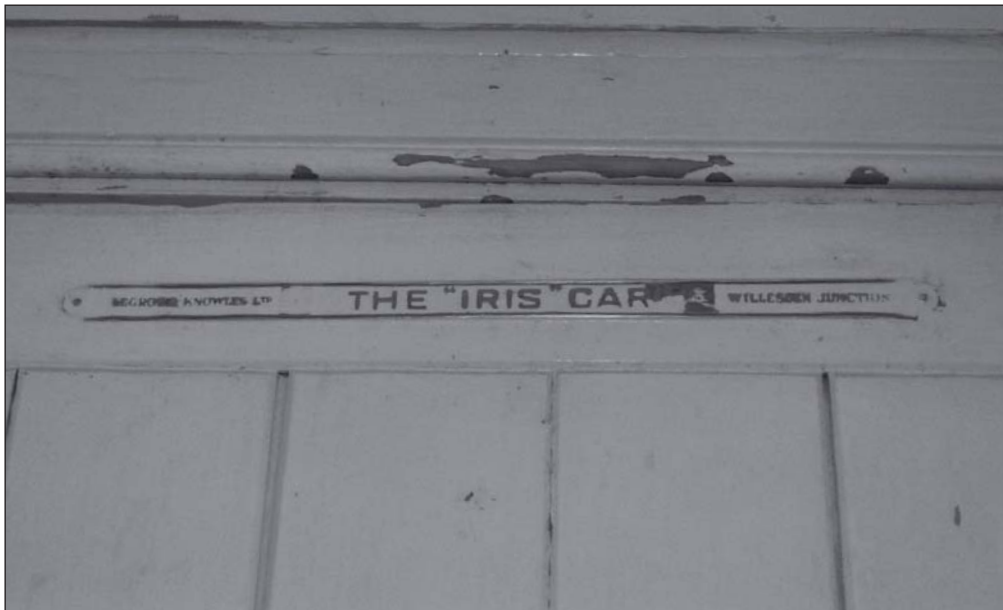
Plate 112: Detail of 'THE IRIS CAR' sign on door within room G12, West Side of the North Range (Film 77.08)

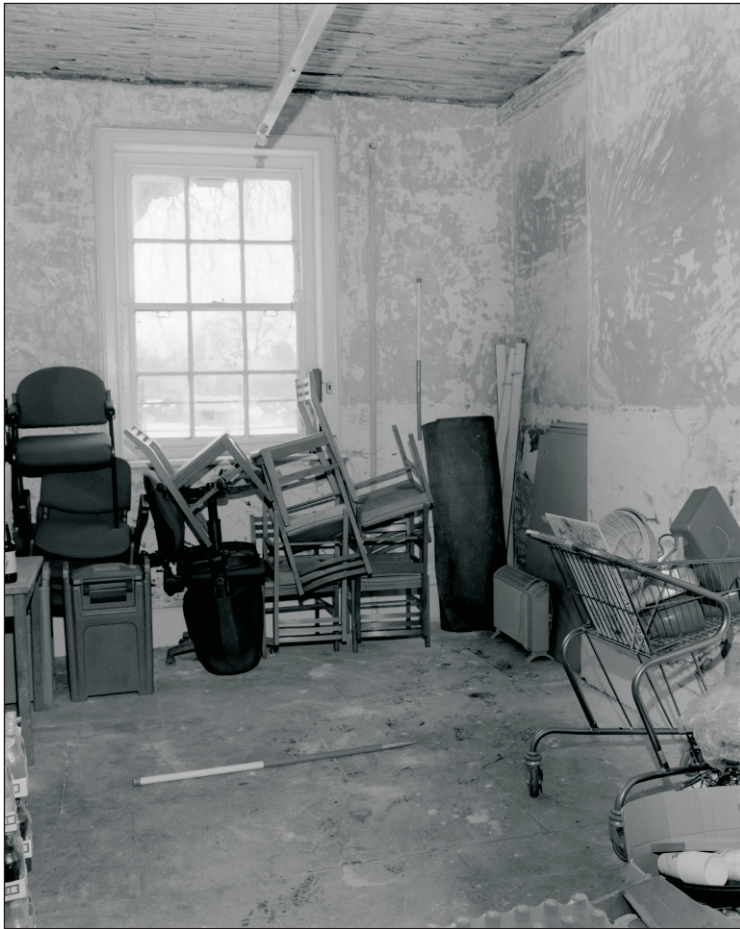
Plate 113: General view of room G13, West Side of the North Range (Film 40.08)

- 5.2.20 G13, to the north of G12, was a simple room, with sash window to the north (**Plate 113**). This room was most recently used as a store room. The floor was covered with stone flags, whilst the plaster from the ceiling had been removed, leaving the wooden laths exposed (**Plate 114**).

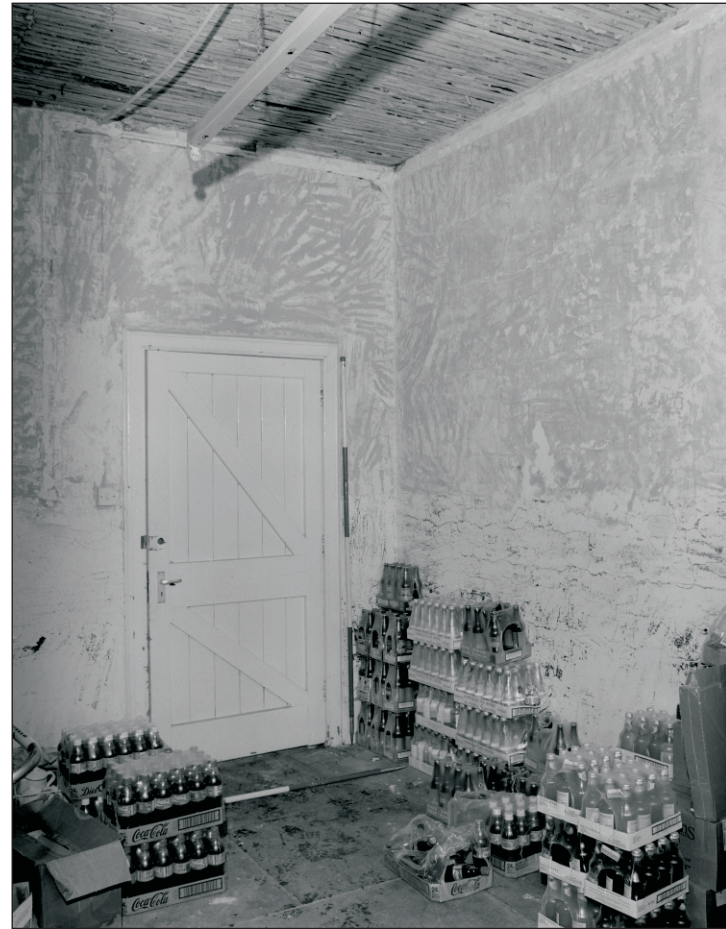
Plate 114: General view of room G13, West Side of the North Range (Film 40.10)

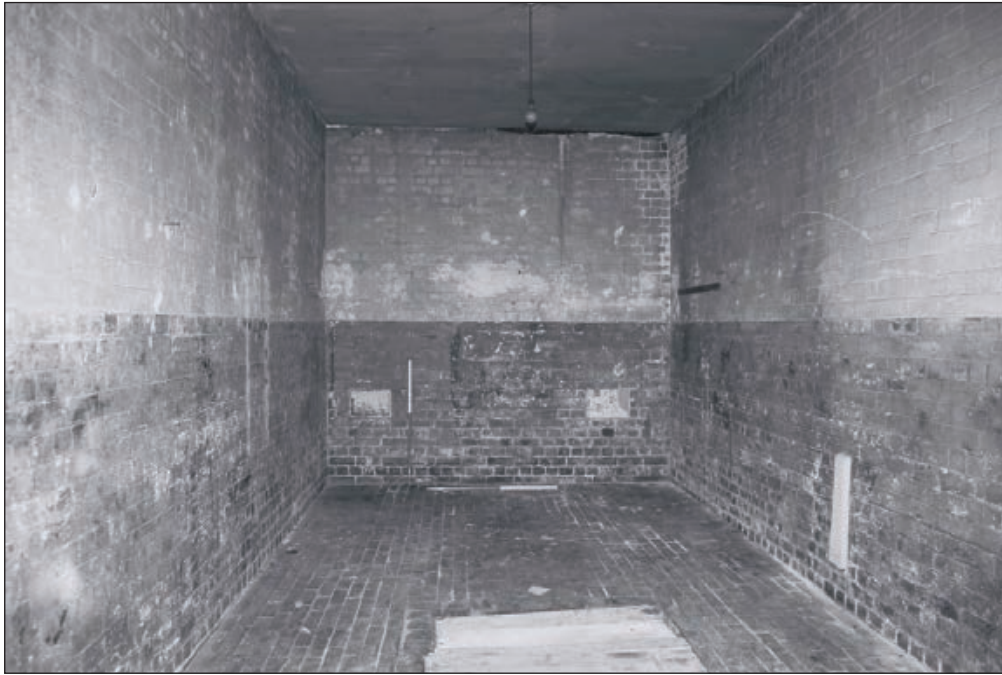
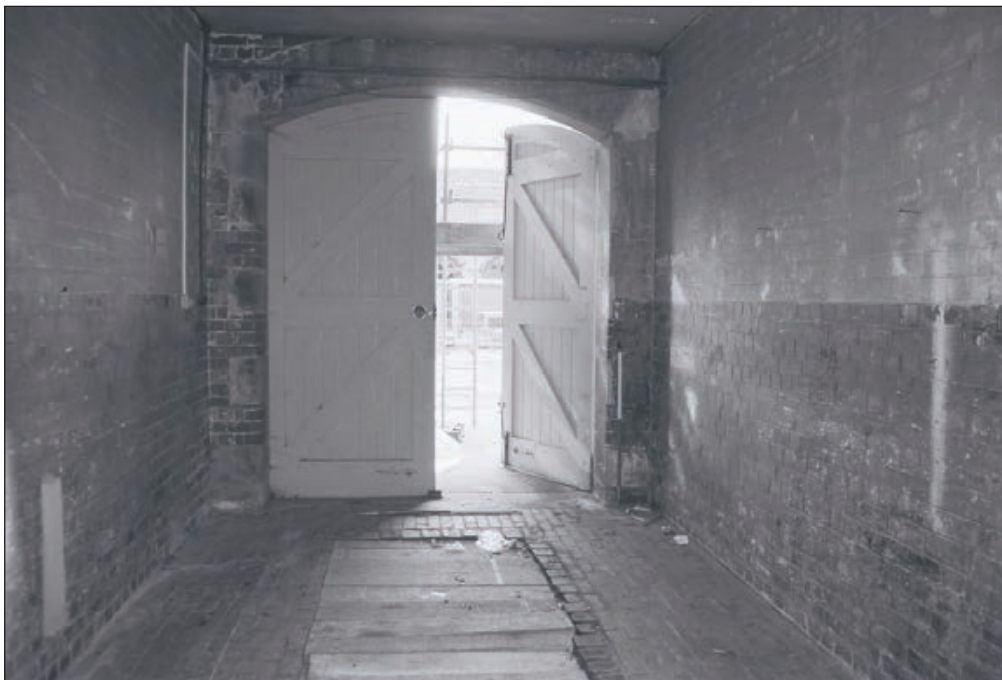
Plate 115: General view of room G14, West Side of the North Range (Film 48.12)

Plate 116: General view of room G14, West Side of the North Range (Film 48.14)

- 5.2.21 To the west was room G14. This was a very plain room accessed from large double doors within the south wall, from the courtyard. G14 was rectangular in plan with painted brick walls, a brick floor, and a lath and plaster ceiling (**Plates 115-116**). Within the brick floor was an inserted inspection pit with concrete base, with timber boards covering the opening (**Plate 117**). This most likely dated to the 1940s when the stables were occupied by the army.

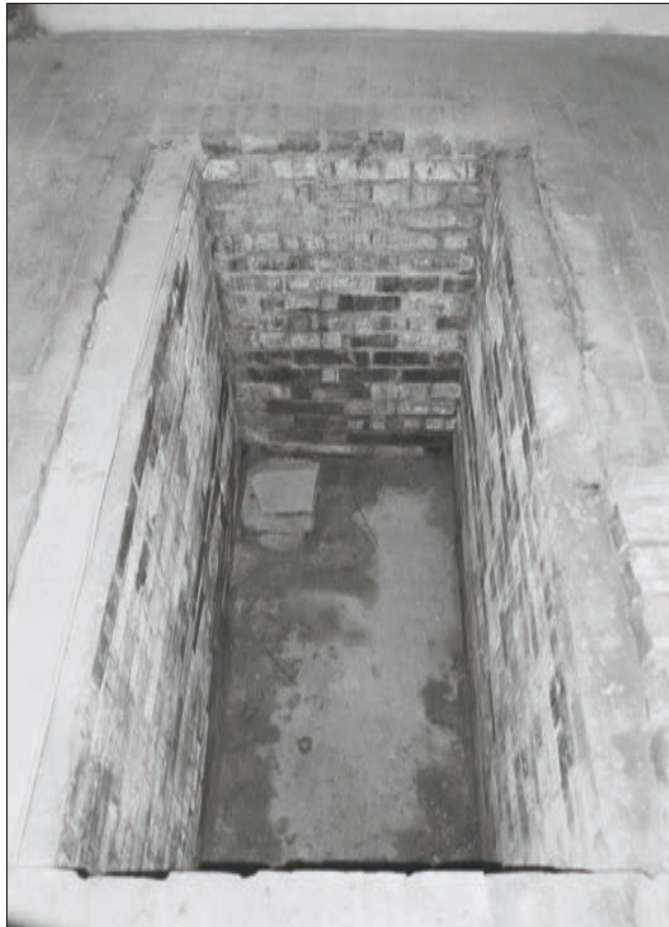
Plate 117: Detail of inserted inspection pit within the floor of room G13, West Side of the North Range (Film 73.15)

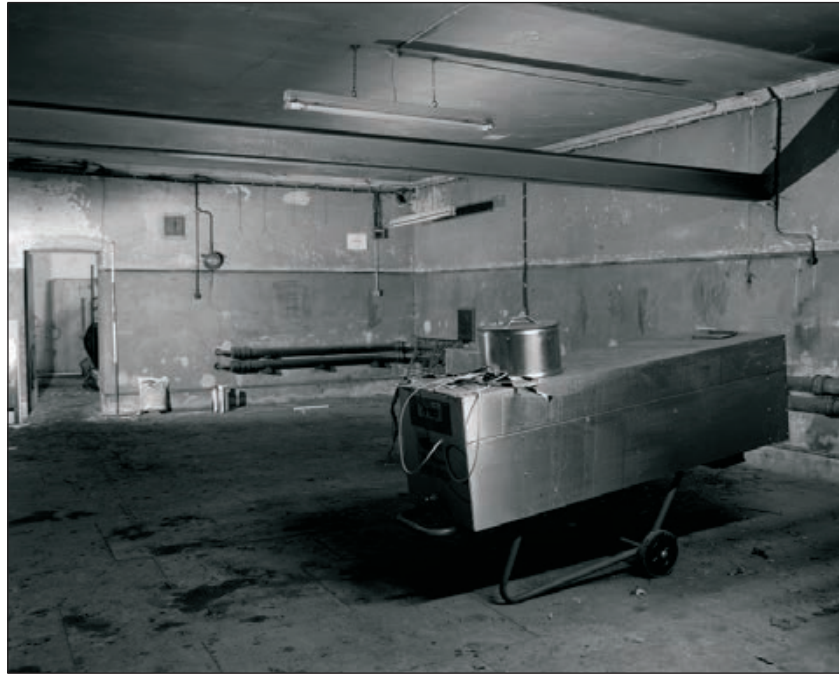
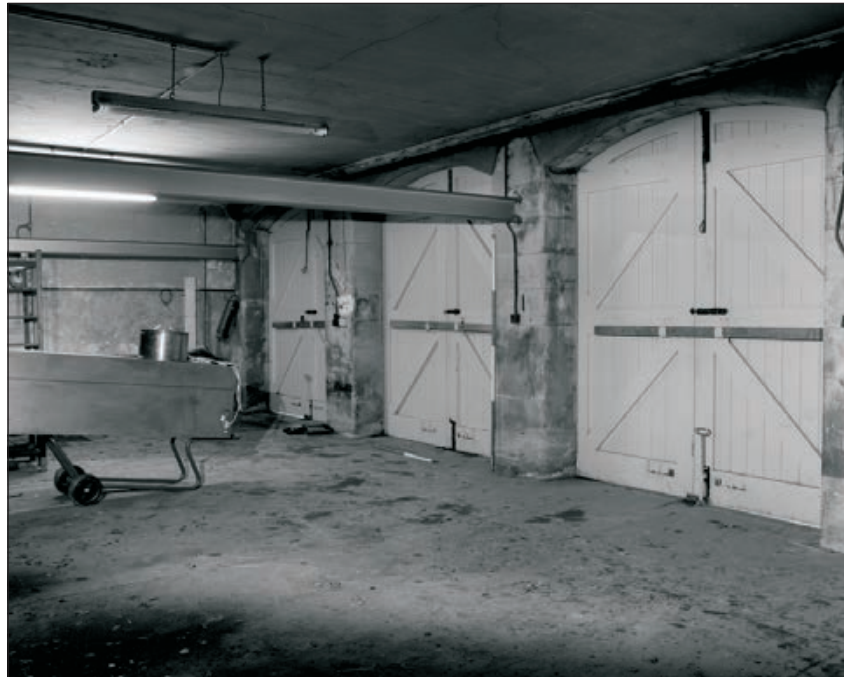
Plate 118: General view of room G15, West Side of the North Range (Film 40.06)

Plate 119: General view of room G15, West Side of the North Range (Film 40.03)

- 5.2.22 Room G15 to the west was a long room, accessed via four large double vehicular doorways to the south (**Plates 118-119**). The room had a stone flagged floor (**Plate 123**), plastered walls with moulded dado and typical paint scheme (**Plates 121-122**). A primary doorway was positioned within the west wall, providing access to the adjacent G16. Positioned within the floor of the easternmost bay of the room was a large inspection pit, covered with timber slats, and concrete steps leading down to its base (**Plates 124-125**). This may have been a 1940s insert. Two inserted RSJ running transversely across the room also likely date from the 1940s, whilst positioned on the east wall of the room was a 1944 fire extinguisher (**Plate 120**). A doorway was inserted at the north end of the west wall during the refurbishment works, exposing the red brick fabric of the walls (**Plate 126**).

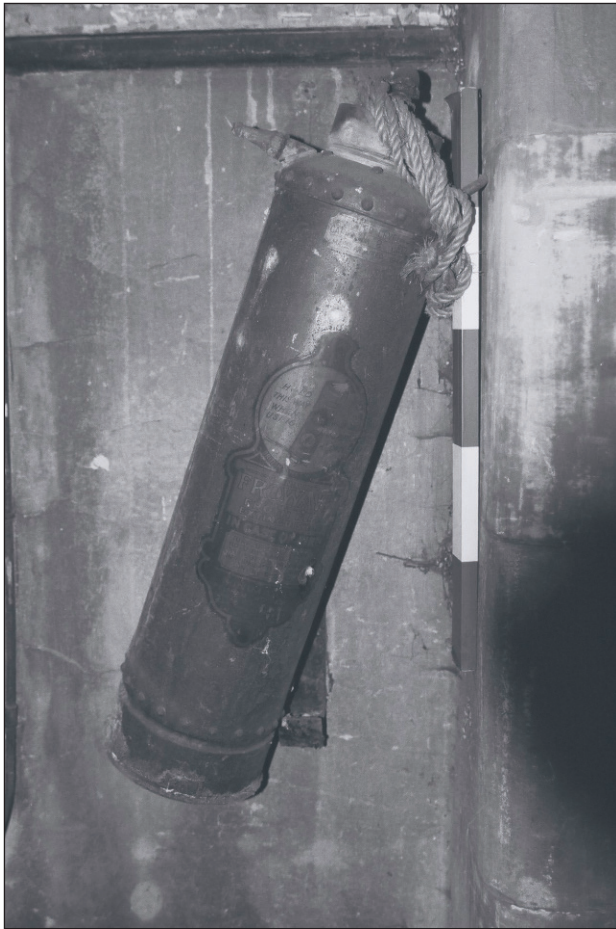
Plate 120: Detail of 1944 fire extinguisher, room G15, West Side of the North Range (Film 26.15)

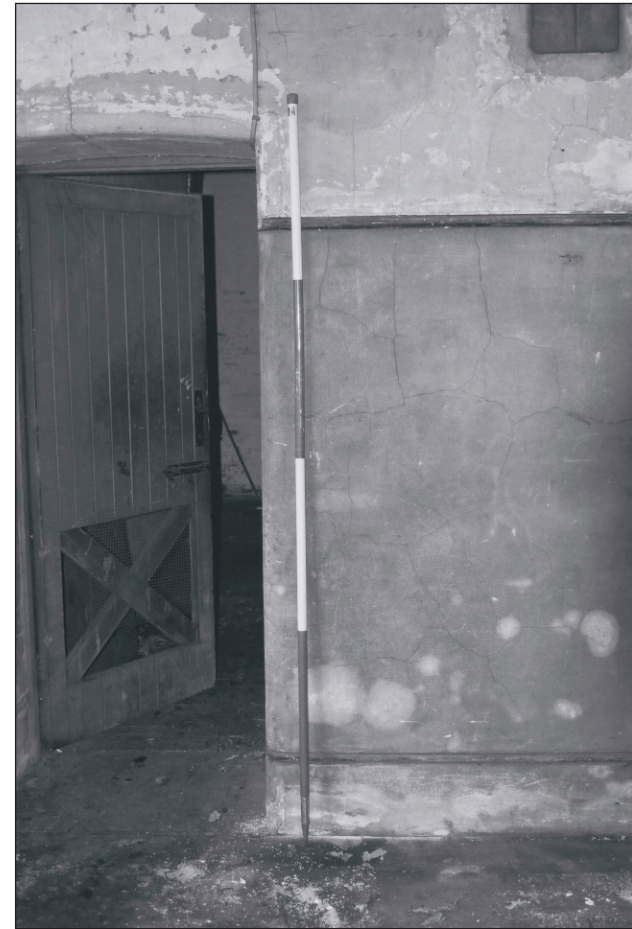
Plate 121: View of moulded plaster skirting and dado with paint scheme, G15, West Side of the North Range (Film 26.10)

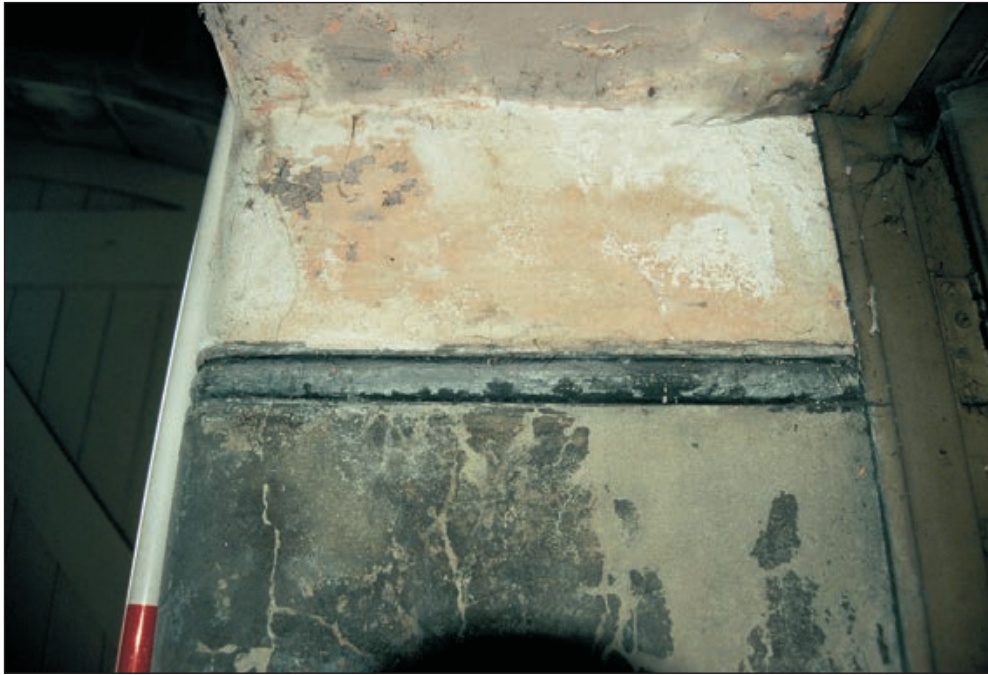
Plate 122: Detail of moulded plaster dado and paint scheme of room G15, West Side of the North Range (Film C.S. 24)

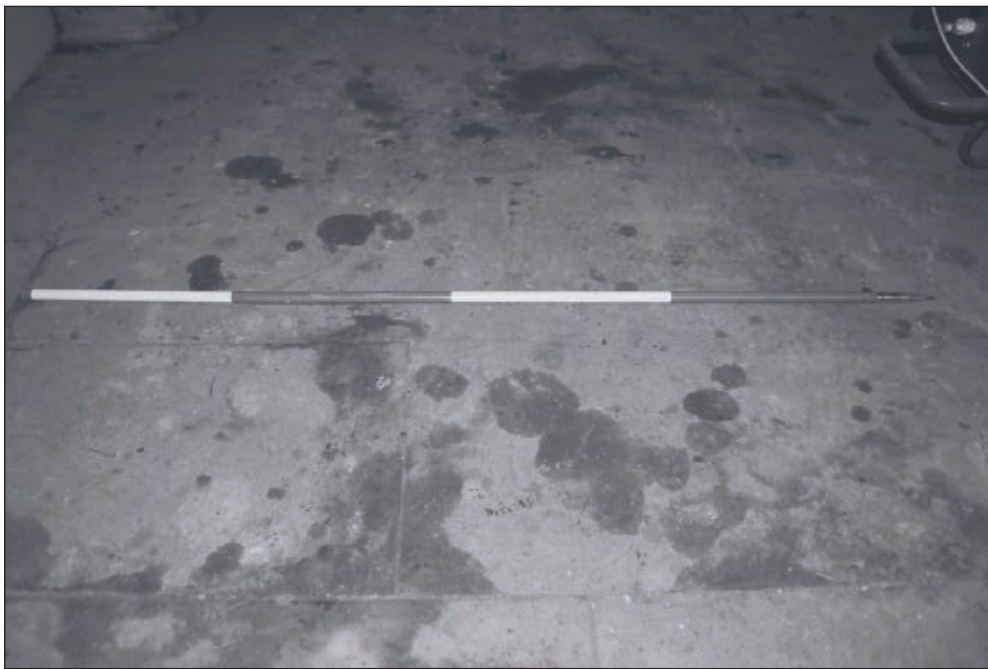
Plate 123: Detail of stone flag floor of room G15, West Side of the North Range (Film 26.13)
