NOSTELL PRIORY STABLES, NOSTELL, WAKEFIELD, WEST YORKSHIRE

Historic Building Recording and Structural Watching Brief

Planning Application Ref: 09/00701/FUL & 09/00705/LBC

72934.01_BDG_V0_4

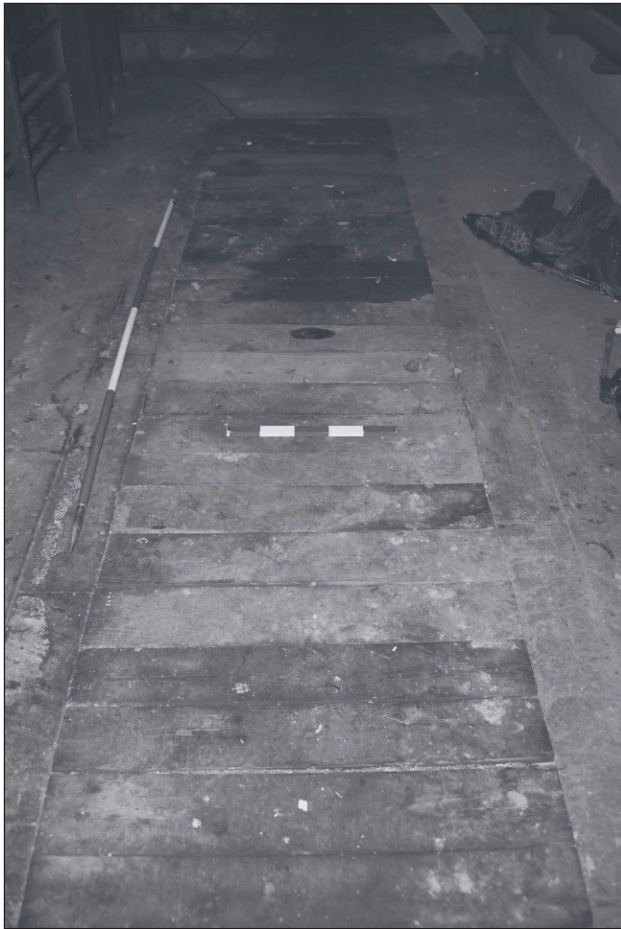
Plate 124: View of inspection pit within the floor of G15, West Side of the North Range (Film 26.17)

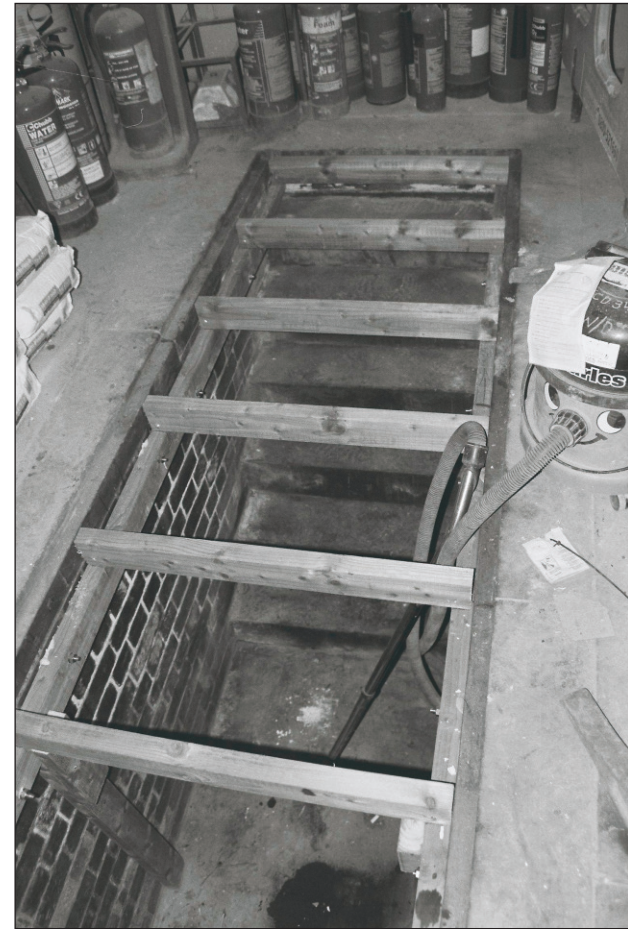
Plate 125: View of inspection pit with floor of G15, West Side of the North Range, showing steps leading down into pit - OB. 107 (Film 73.17)

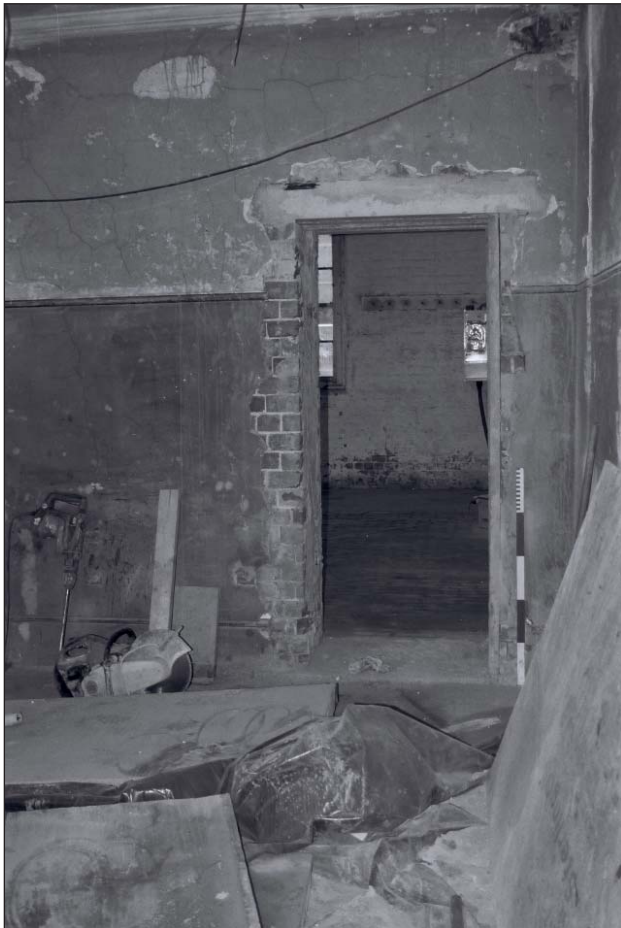
Plate 126: View of inserted door within west wall of G15 showing exposed phase 7 brickwork, West Side of the North Range - OB.68 (Film 56.35)

- 5.2.22 Room G15 to the west was a long room, accessed via four large double vehicular doorways to the south (**Plates 118-119**). The room had a stone flagged floor (**Plate 123**), plastered walls with moulded dado and typical paint scheme (**Plates 121-122**). A primary doorway was positioned within the west wall, providing access to the adjacent G16. Positioned within the floor of the easternmost bay of the room was a large inspection pit, covered with timber slats, and concrete steps leading down to its base (**Plates 124-125**). This may have been a 1940s insert. Two inserted RSJ running transversely across the room also likely date from the 1940s, whilst positioned on the east wall of the room was a 1944 fire extinguisher (**Plate 120**). A doorway was inserted at the north end of the west wall during the refurbishment works, exposing the red brick fabric of the walls (**Plate 126**).

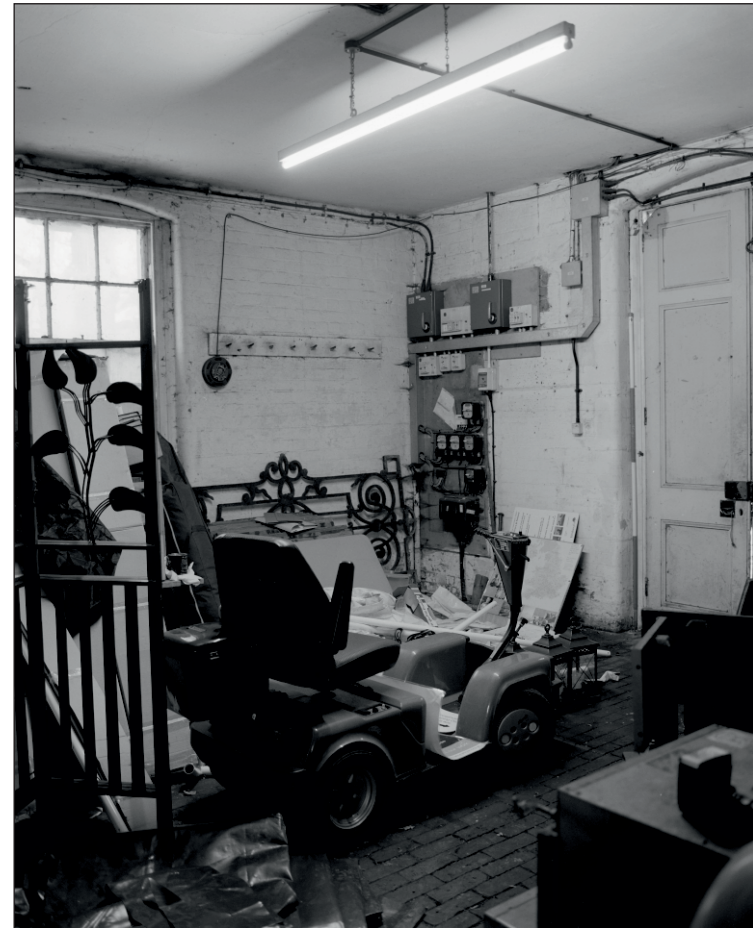
Plate 127: General view of room G16, West Side of the North Range (Film 39.10)

- 5.2.23 Room G16, positioned at the far west of the North Range was a square room with large doorway to the north, sash window to the west (**Plate 127**),

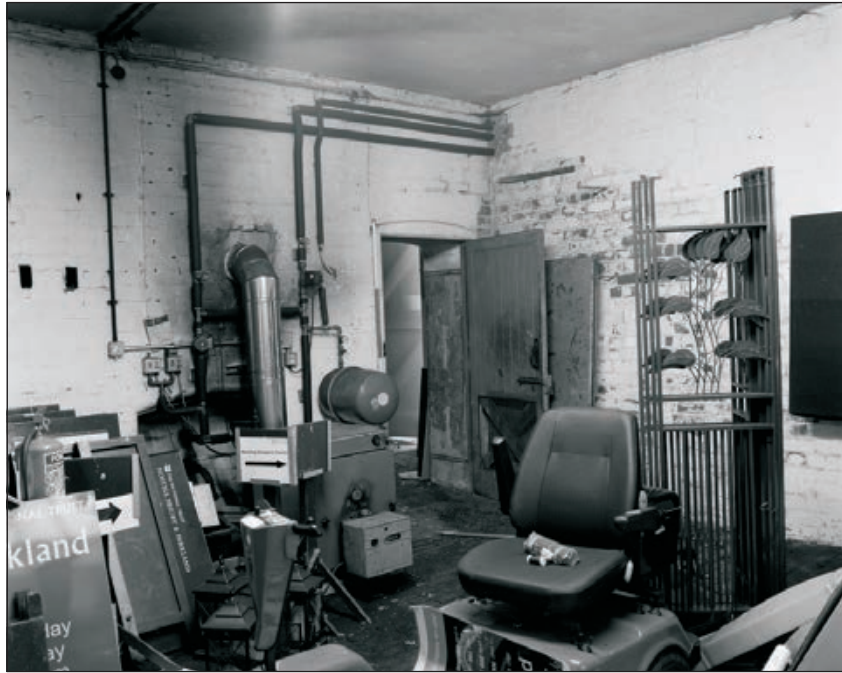
Plate 128: General view of room G16, West Side of the North Range (Film 40.01)

former fireplace to the east and adjacent doorway connecting with G15 (**Plate 128**). The walls were painted brick, the ceiling was lath and plaster, and the floor was red brick (**Plate 129**). After the removal of a modern boiler, a former fireplace with recessed hearth was revealed within the east wall of the room (**Plate 130**). The door to the east was a timber battened door with simple lath and ornate box lock (**Plates 131-132**).

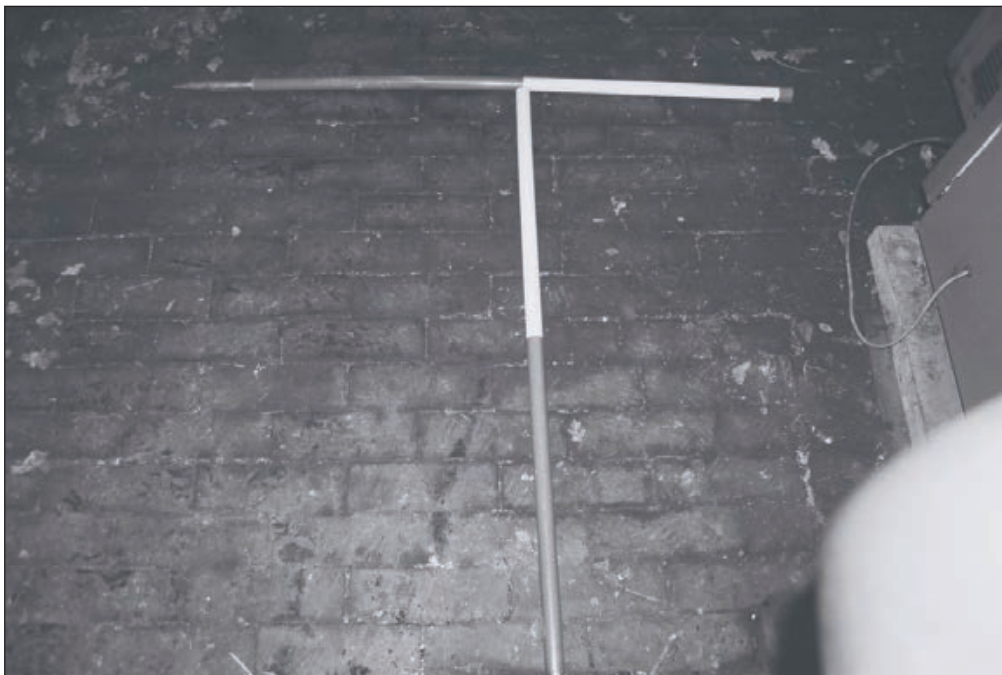
Plate 129: Detail of brick floor of room G16, West Side of the North Range (Film 26.23)

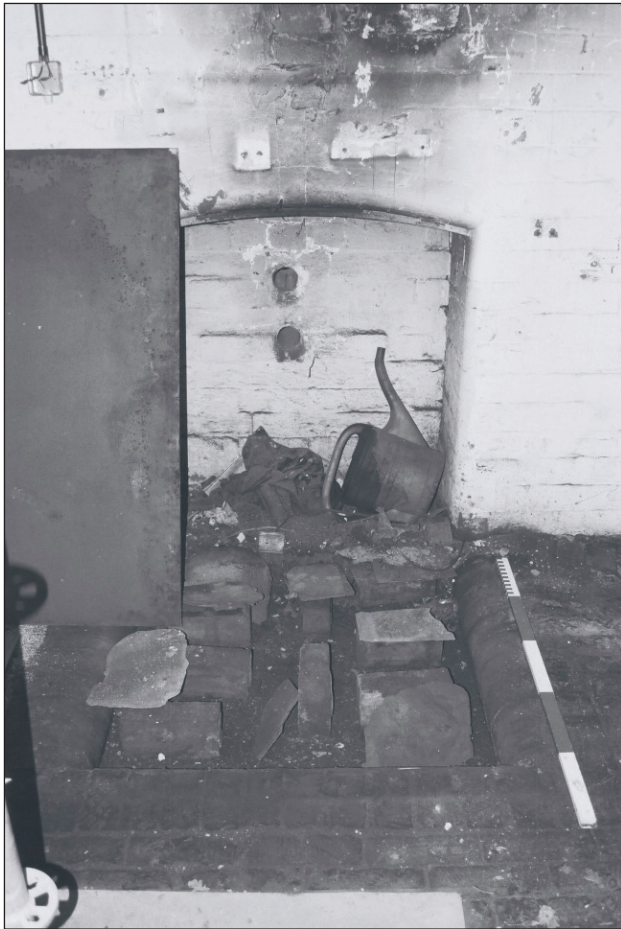
Plate 130: View of fireplace and recessed hearth in east wall of room G16, West Side of the North Range (Film 54.31)

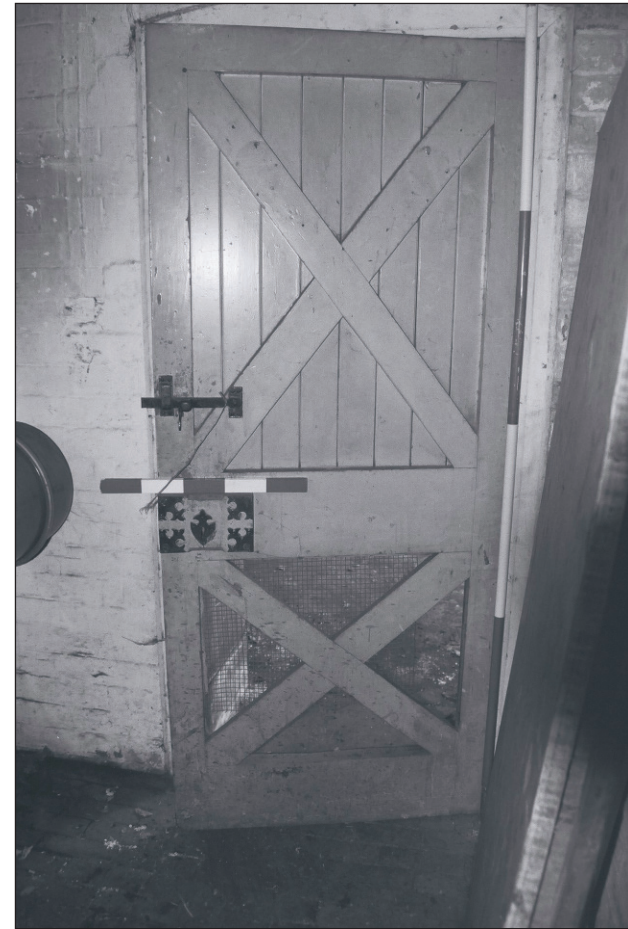
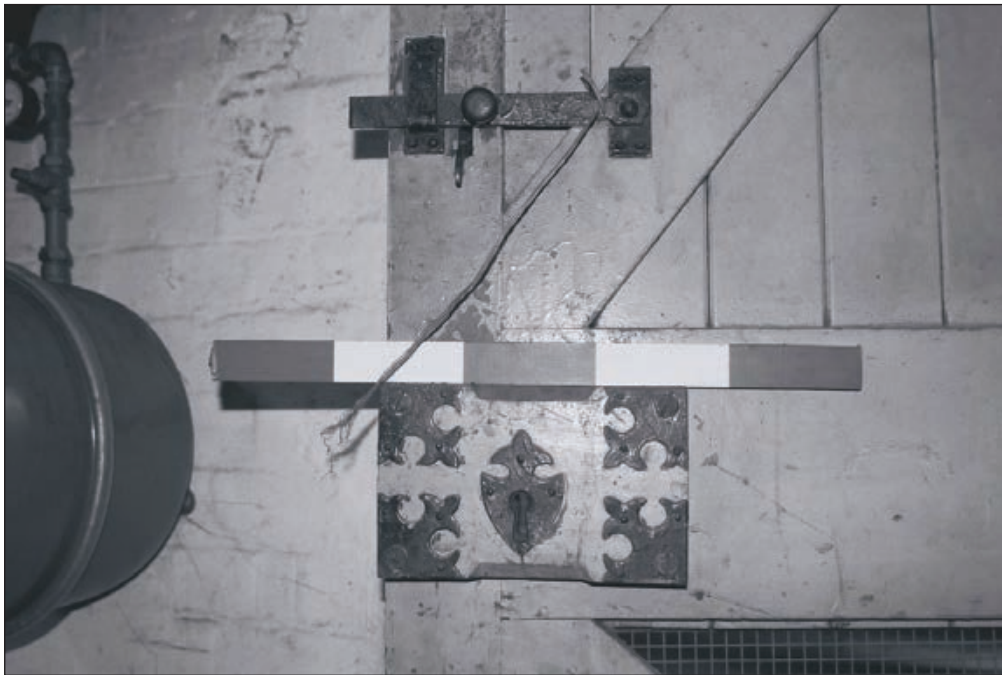
Plate 131: Detail of door, G16, West Side of the North Range (Film 26.21)

Plate 132: Detail of door furniture, room G16, West Side of the North Range (Film 26.19)

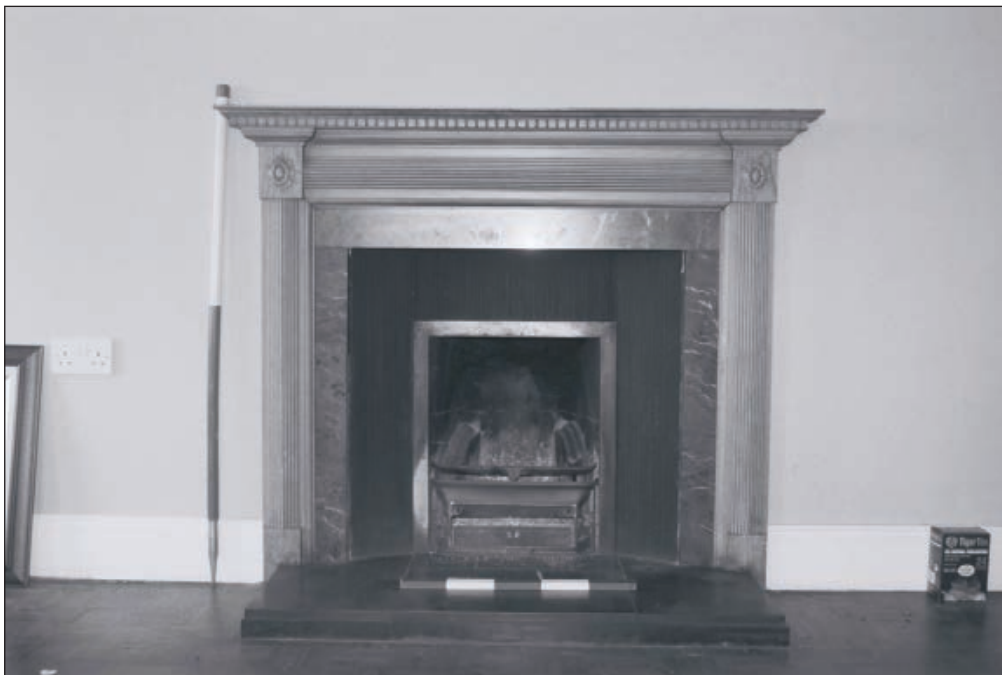
Plate 135: Detail of fireplace, room F1, East Side of the North Range (Film 21.30)

- 5.2.24 Room F1, located at the east end of the phase 6 east side of the North Range (**Figure 13**), was square in plan, and was part of the living accommodation on the first floor of the East Range. It was accessed from corridor F50 within the East Range, via a doorway within the south wall, although a difference in floor level between the North and East Ranges, meant timber steps led down into the room. The room had one sash window to the north and two to the east (**Plates 133-134 and 136**), whilst to the south was a central fireplace (**Plate 135**). The room had modern finishes throughout.

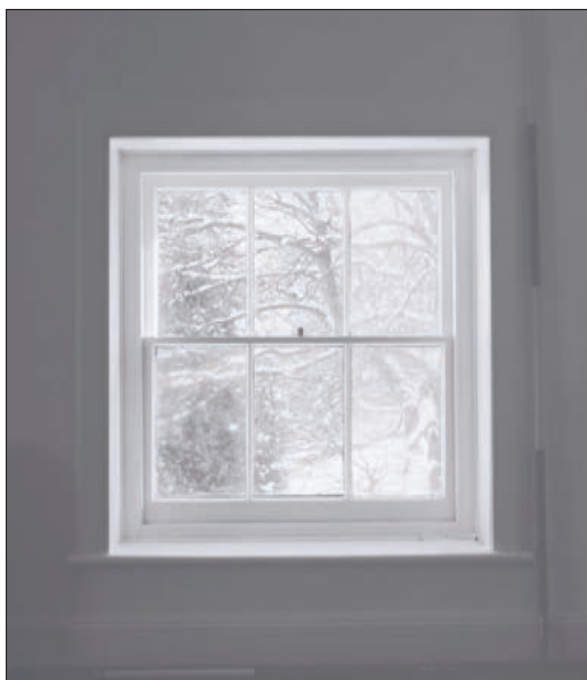
Plate 136: Detail of sash window, room F1, East Side of the North Range (Film 21.29)

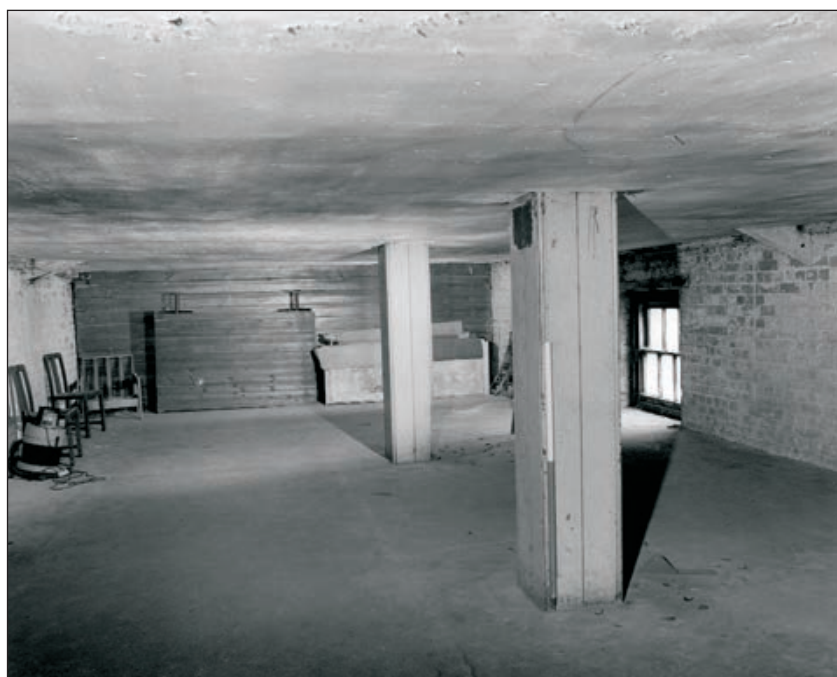
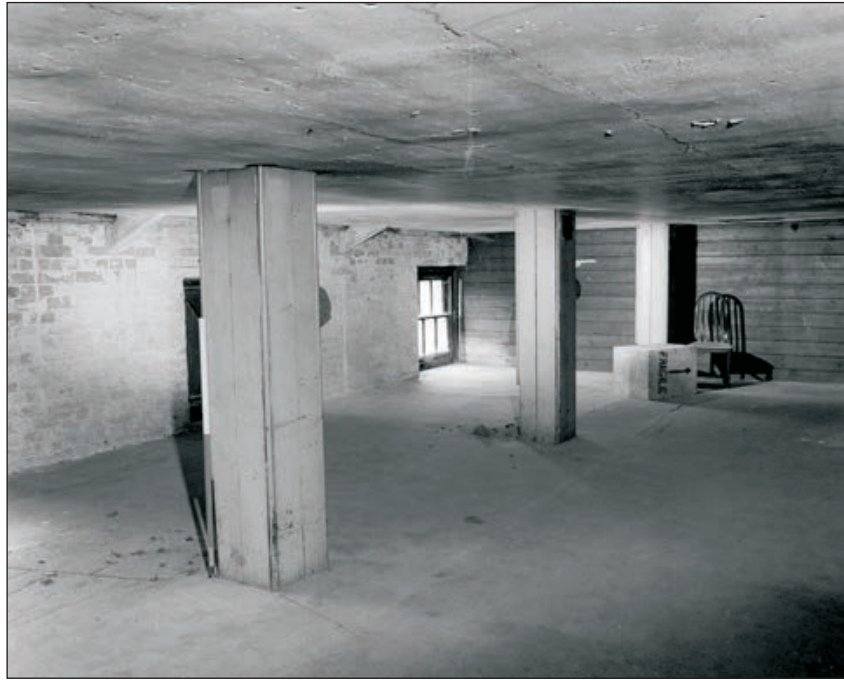
Plate 137: General view of room F2, East Side of the North Range (Film 05.10)

Plate 138: General view of room F2, East Side of the North Range (Film 06.02)

- 5.2.25 To the west was hayloft F2 (**Plates 137-138**). The room was very plain with low lath and plaster ceiling, limeash floor, and painted brick walls. There were two low sash windows and a threshing door within the south wall (**Plates 140-141**). Running through the room into and out of the roof were three timber vents which served the loose boxes below. These had a cast iron grille/vent set within the floor (**Plate 142**), were of timber construction, and continued up into the roof space above before exiting through a triangular raised louvered roof vent (**Plates 143-145**). The roof structure of this element of the range comprised joggled King-Post trusses with iron strapping, and timber purlins and common rafters (**Plate 144**). At the southeast corner of the room, set within the limeash floor was a hatch for the chute leading down to room G1 below (**Plate 139**).

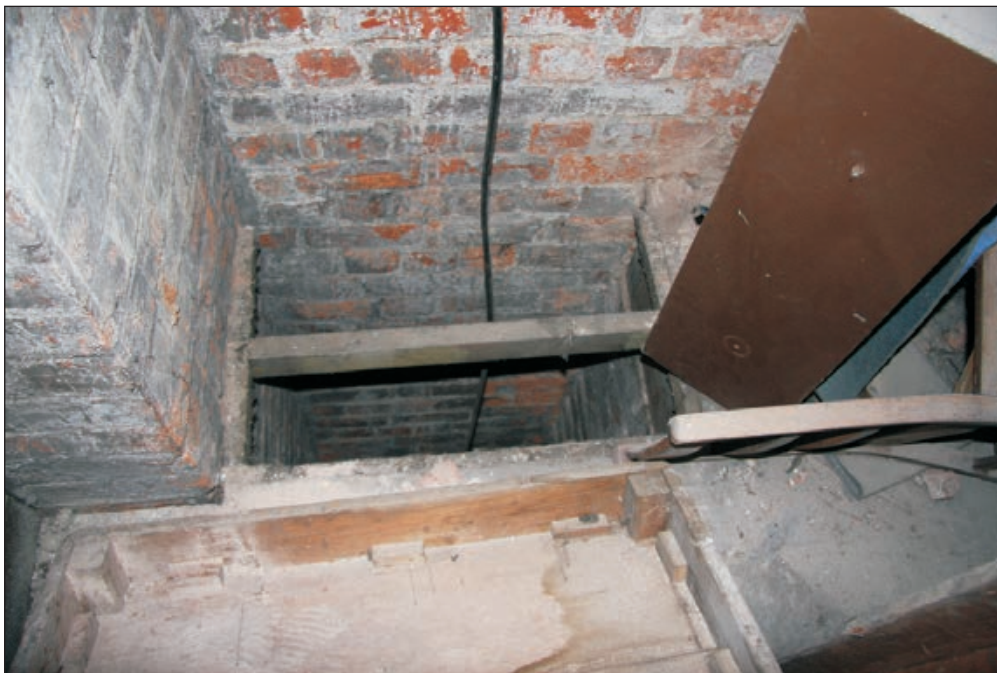
Plate 139: View of chute in floor of room F2, East Side of the North Range, leading to G1 below - OB. 59 (Film D. 14.10.10 1640)

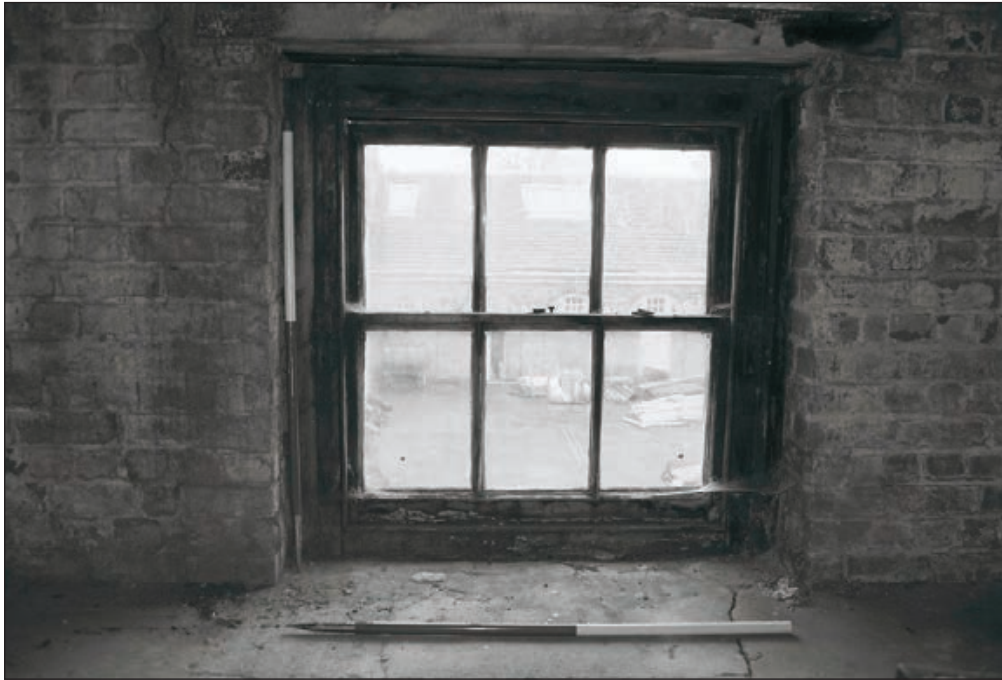
Plate 140: Detail of window, room F2, East Side of the North Range (Film 16.19)

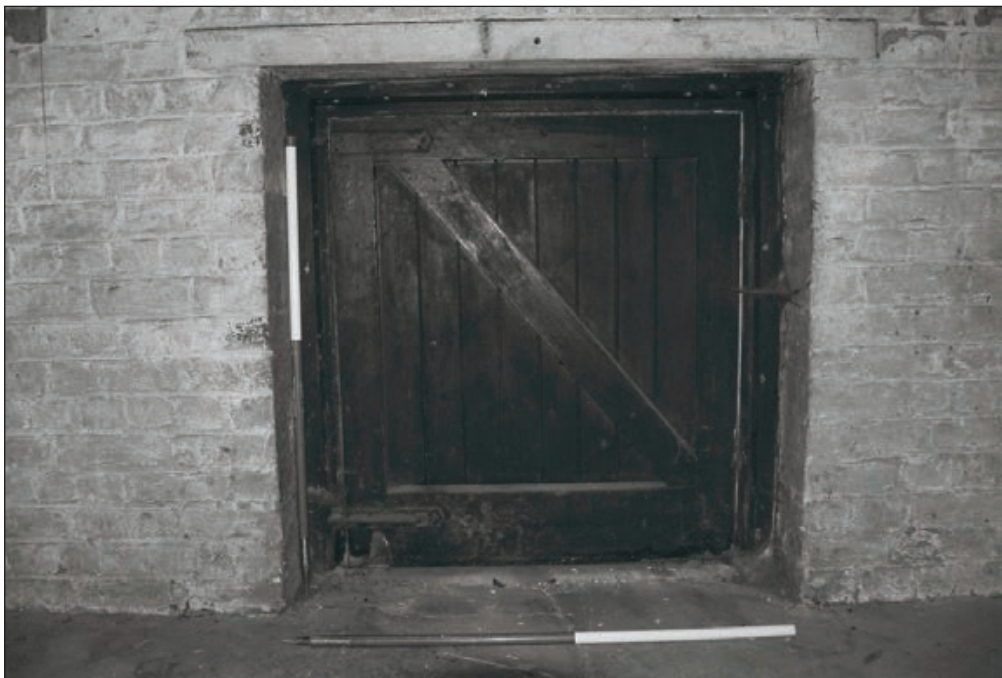
Plate 141: Detail of threshing door, room F2, East Side of the North Range (Film 16.14)

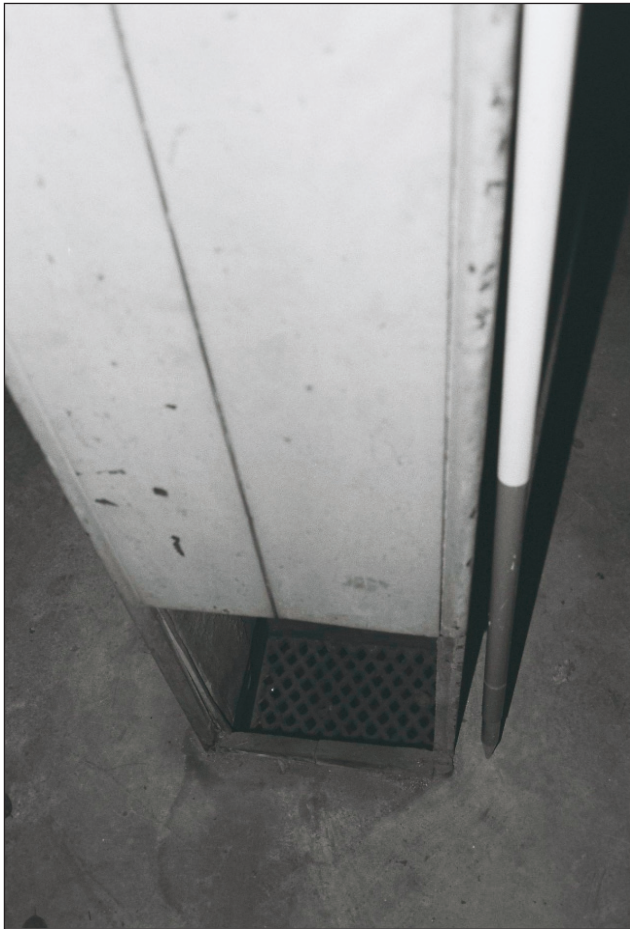
Plate 142: Detail of vent from ceiling of G2 through room F2, East Side of the North Range (Film 16.16)

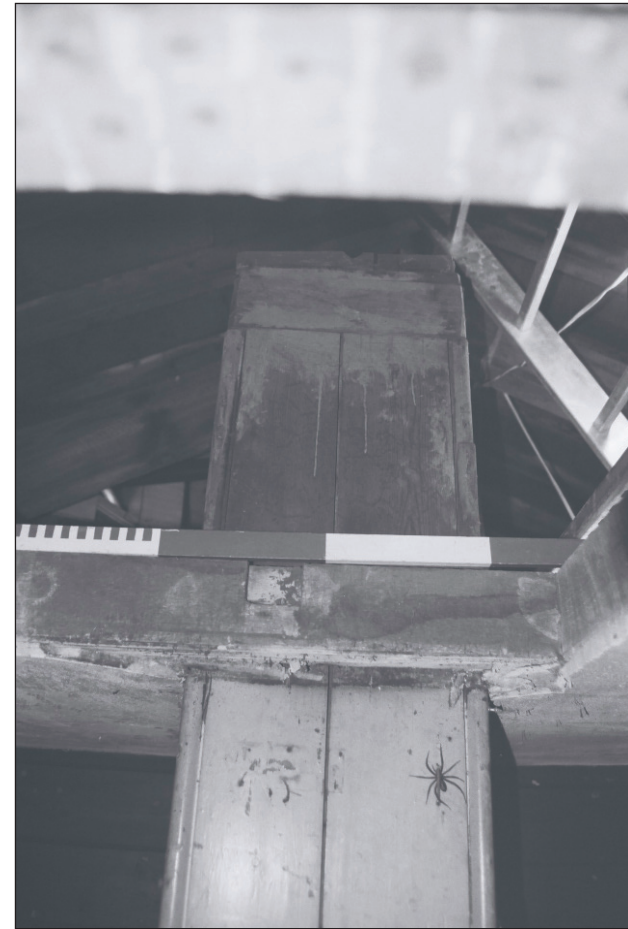
Plate 143: Detail of vent running into the roof void above F2, East Side of the North Range - also note lath and plaster ceiling - Observation 18 (Film 47.27)

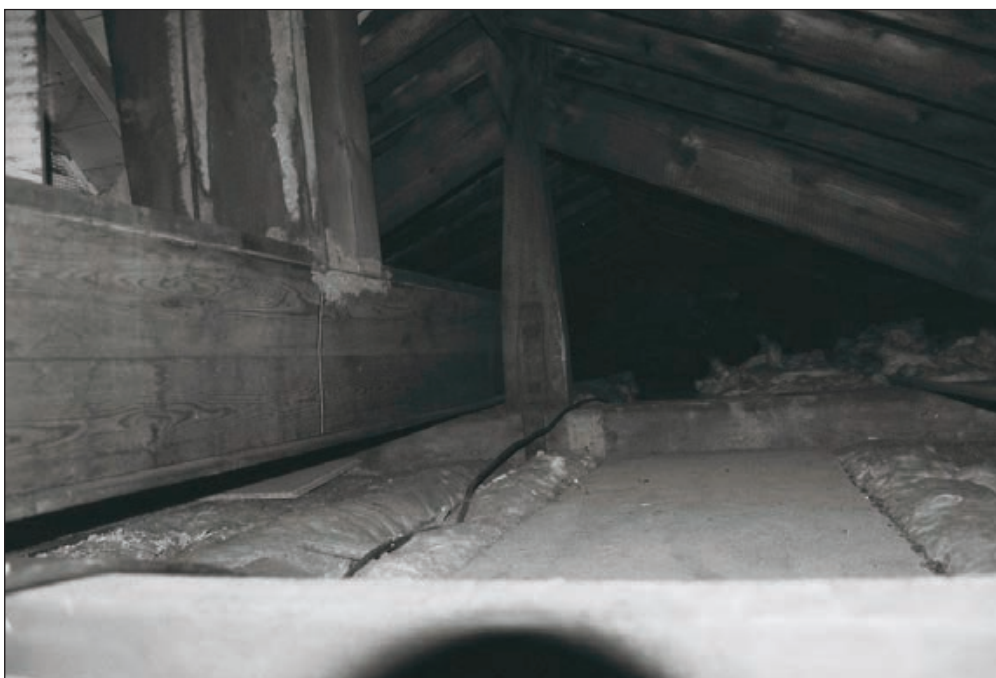
Plate 144: View of King-Post roof trusses and vents within roof void above room F2, East Side of the North Range (Film 16.13)

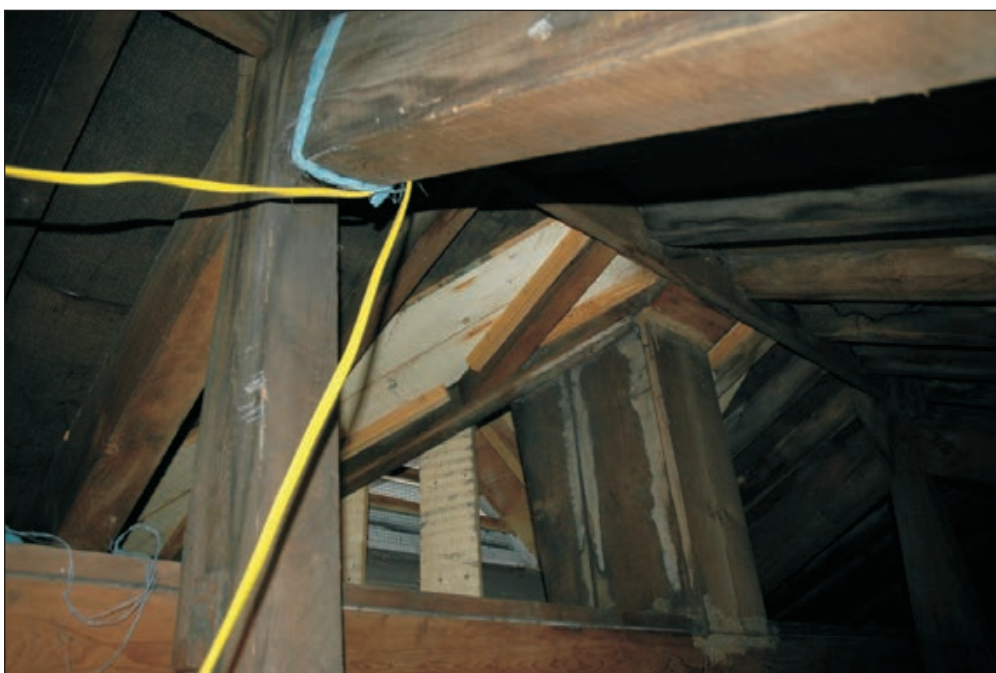
Plate 145: Detail of vent leading to raised roof vent in roof void above room F2, East Side of the North Range (Film D. 25.02.10 7533)

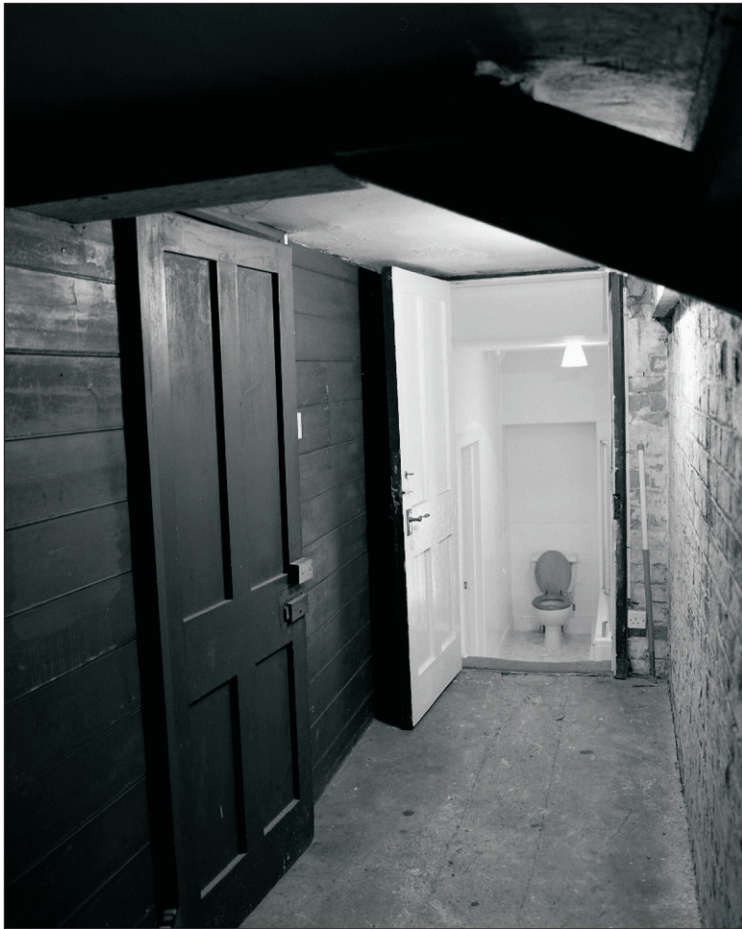
Plate 146: General view of room F3, East Side of the North Range, with F5 beyond (Film 06.04)

- 5.2.26 To the west, a small corridor: F3 (**Plates 146-148**) provided access to the hay loft F2/F4 and room F5.
- 5.2.27 Leading off F3 to the south, room F4 (**Plate 149**) was square in plan, and contained a single sash window to the south, a central timber vent, and two large timber hoppers in the southeast corner (**Plate 150**). These joined with the chutes within the wall of G2 below. The floor was made up of limeash laid directly onto timber laths (**Plate 151**), which was the same throughout rooms F2, F3 and F4.

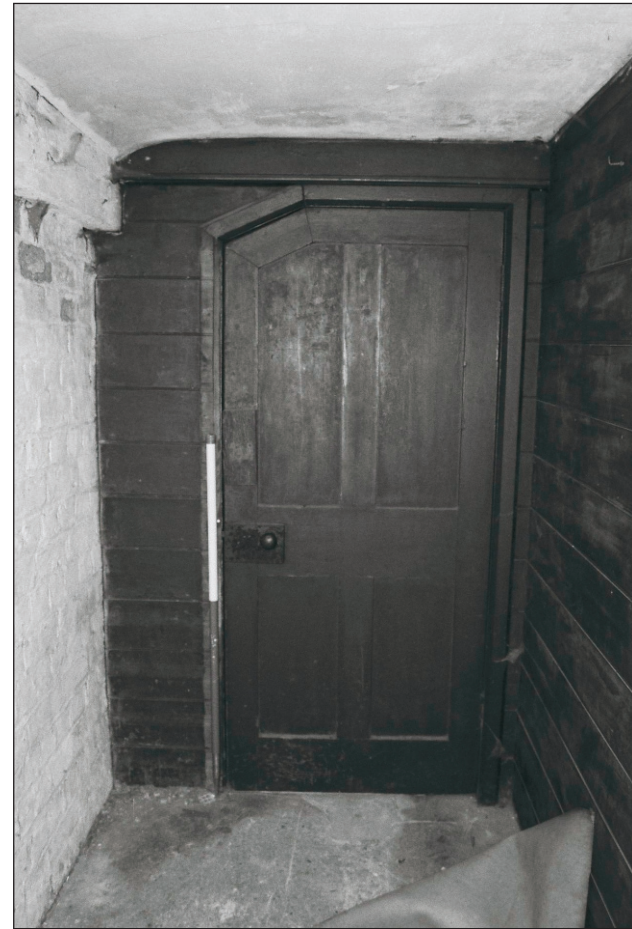
Plate 147: View of room F3 showing doorway to F2, East Side of the North Range (Film 15.36)

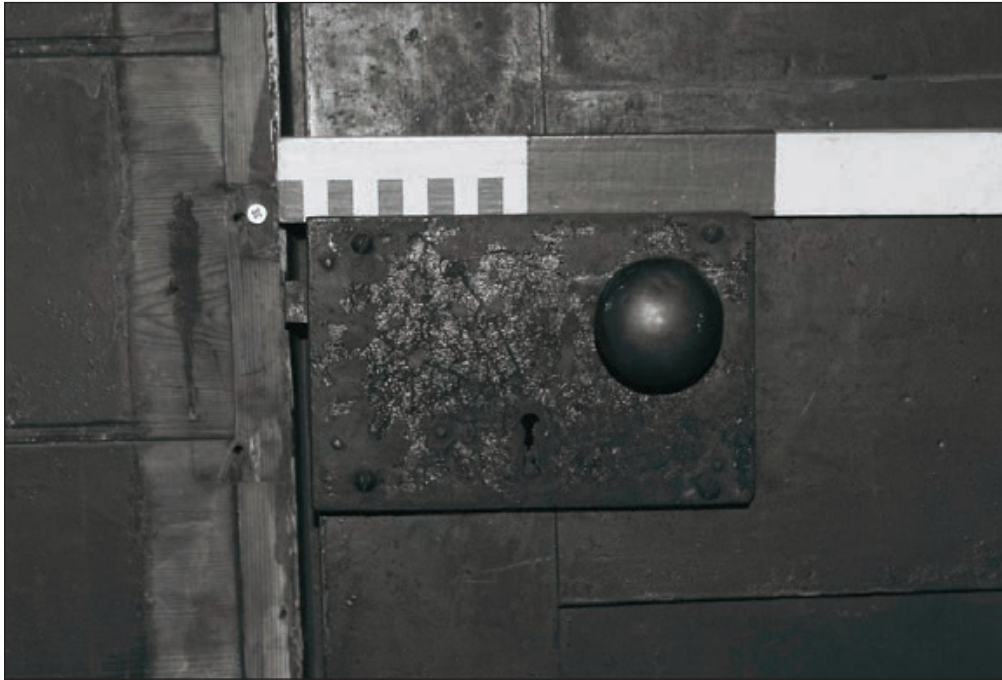
Plate 148: Detail of box lock on door between F3 and F4, East Side of the North Range (Film 16.09)

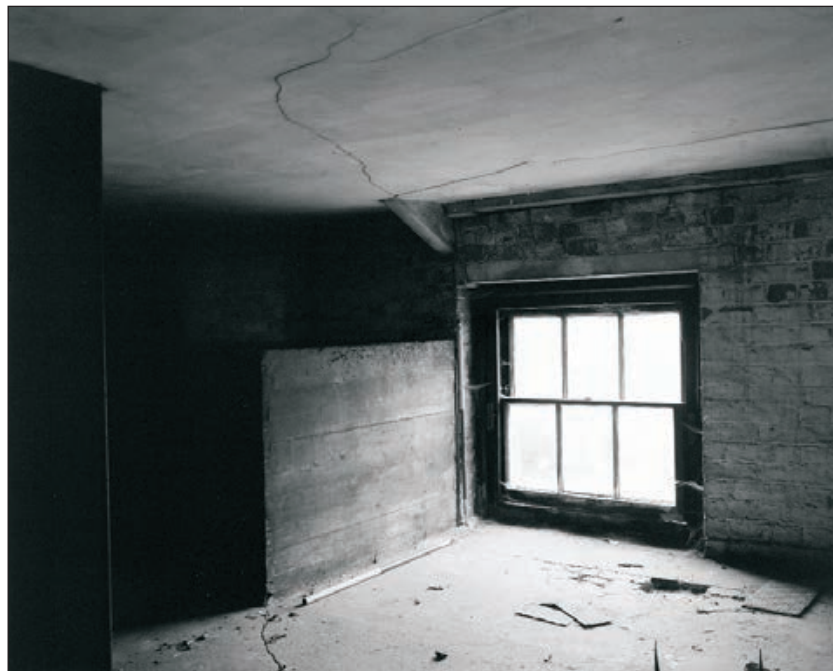
Plate 149: General view of room F4, East Side of the North Range, showing window and timber hoppers (Film 05.05)

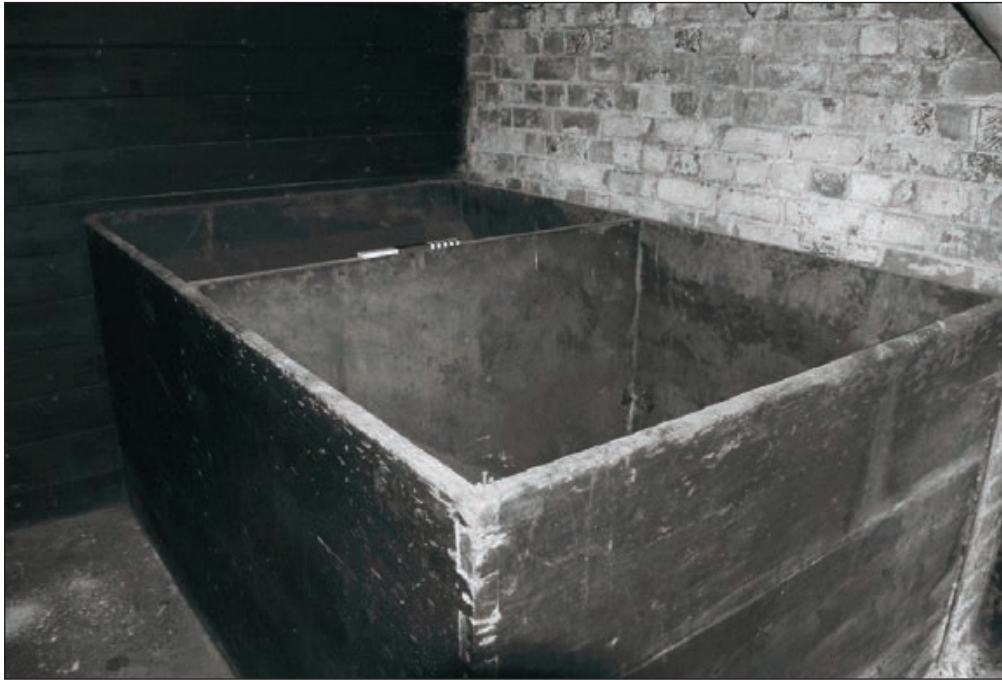
Plate 150: Detail of timber grain hoppers leading to chutes within G2 below, room F4, East Side of the North Range (Film 16.03)

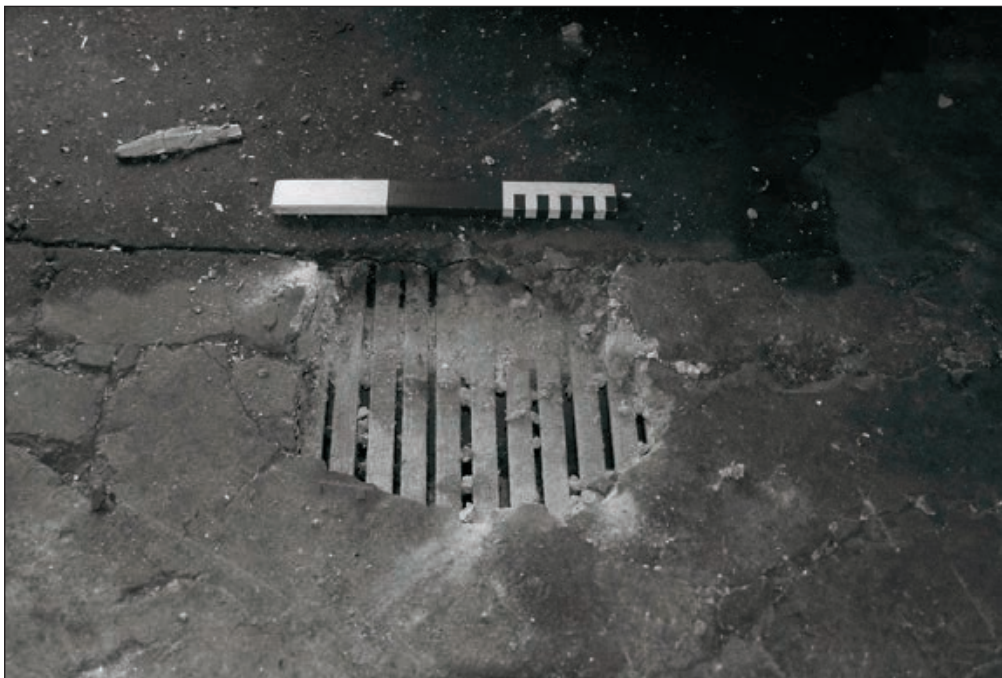
Plate 151: Detail of limeash floor on timber joists and laths, room F4, East Side of the North Range (Film 16.06)

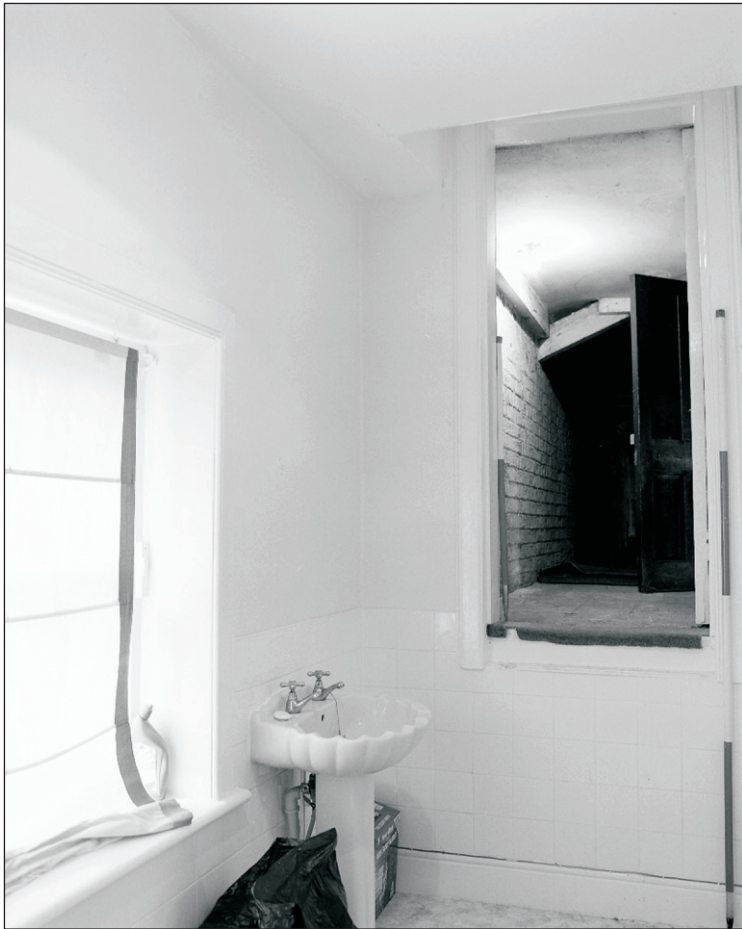
Plate 152: General view of room F5, East Side of the North Range, with F3 beyond (Film 05.03)

- 5.2.28 To the west was room F5, a modern bathroom with high doorway to the east providing access to the hayloft (**Plate 152**). The difference in floor level between the two areas, suggests the removal of former steps directly in front of the doorway. The presence of former steps is also suggested by a break in the limeash floor within F5, with timber boarding directly in front of the doorway (**Plate 153**). There was a sash window to the north and doorway leading to F6 to the south.

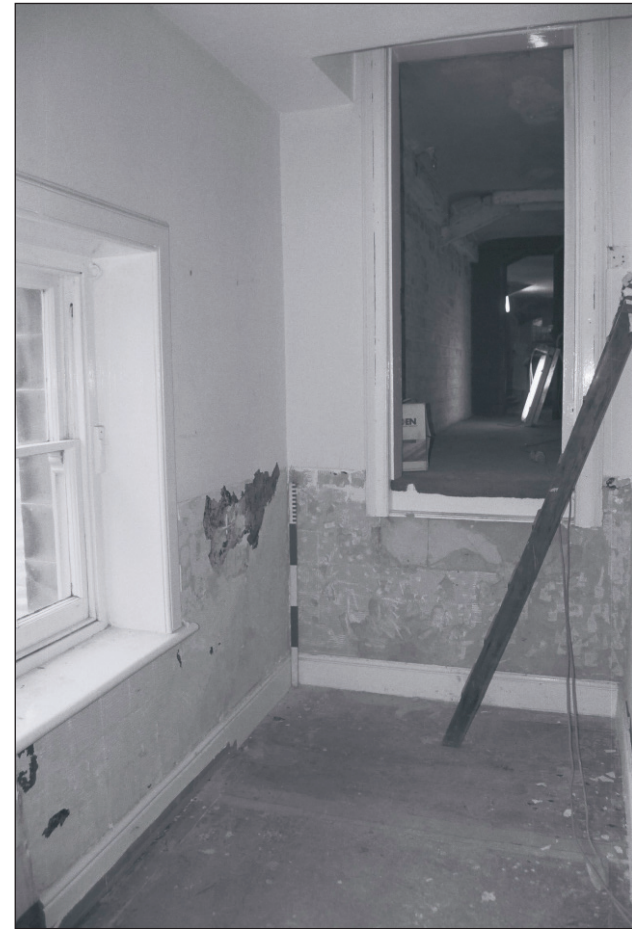
Plate 153: View of room F5, East Side of the North Range, showing break in limeash floor - OB. 124 (Film 77.10)

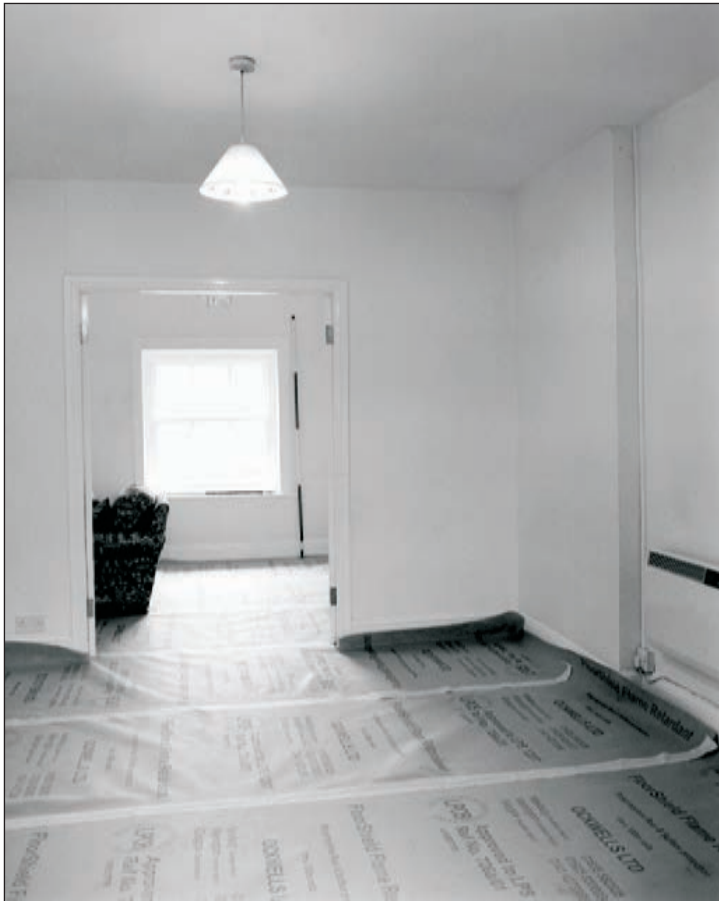
Plate 154: General view of room F6 with F7 beyond, East Side of the North Range (Film 05.01)

- 5.2.29 Rooms F6 and F7 were originally a single space, and only relatively recently divided by modern partitioning (**Plate 154**). The room was rectangular in

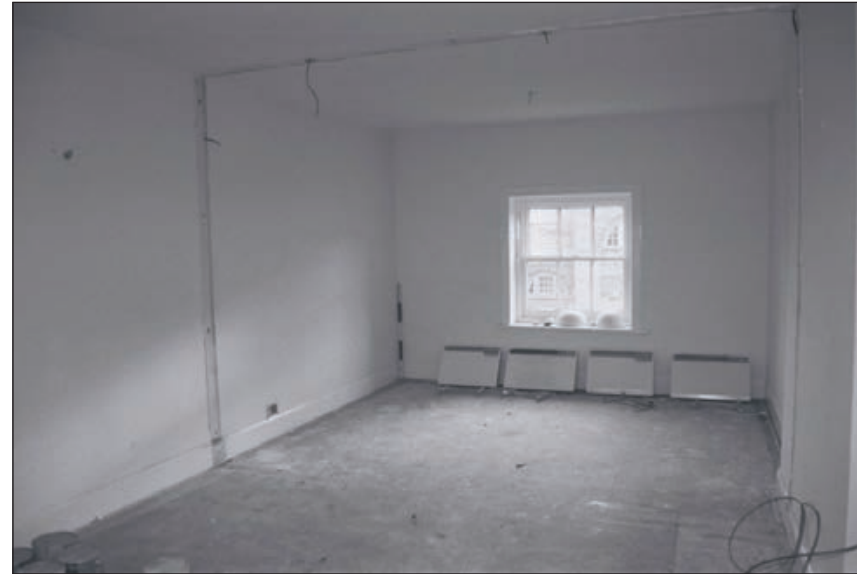
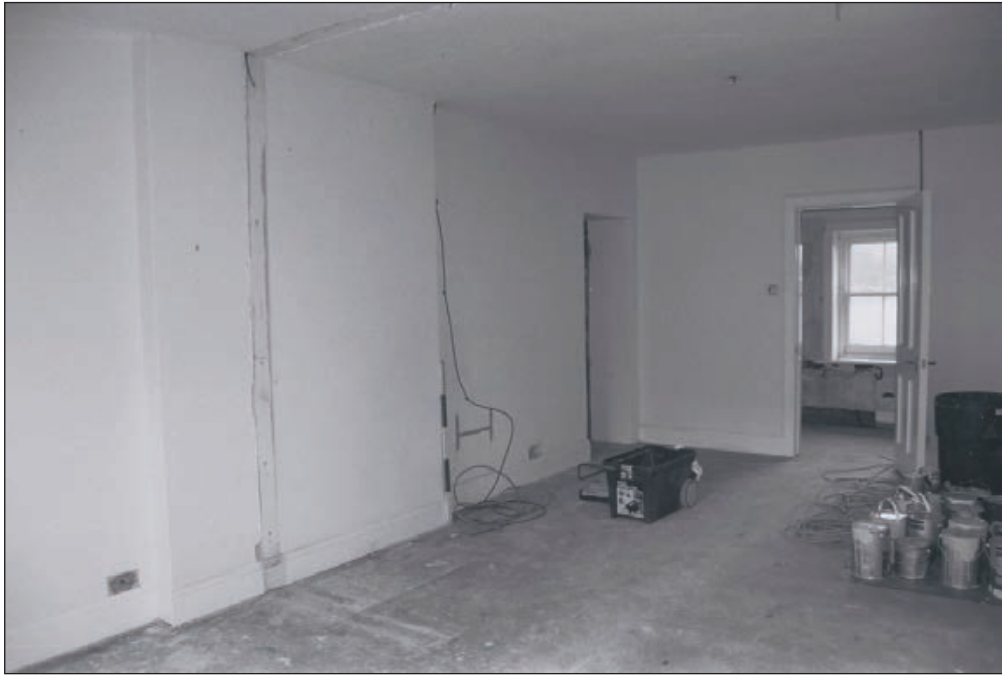
Plate 155: General view of rooms F6 and F7, East Side of the North Range, after removal of modern partitions - OB. 123 - showing limeash floor and blocked fireplace (Film 77.20)

Plate 156: General view of rooms F7 and F6, East Side of the North Range, after removal of modern partitions - OB. 123 - showing limeash floor and blocked fireplace (Film 77.18)

plan, with modern finishes throughout. There was a sash window to the south (**Plate 157**), a limeash floor, and blocked fireplace within the west wall (**Plate 155-156**). The hearth stone was visible, set within the limeash floor.

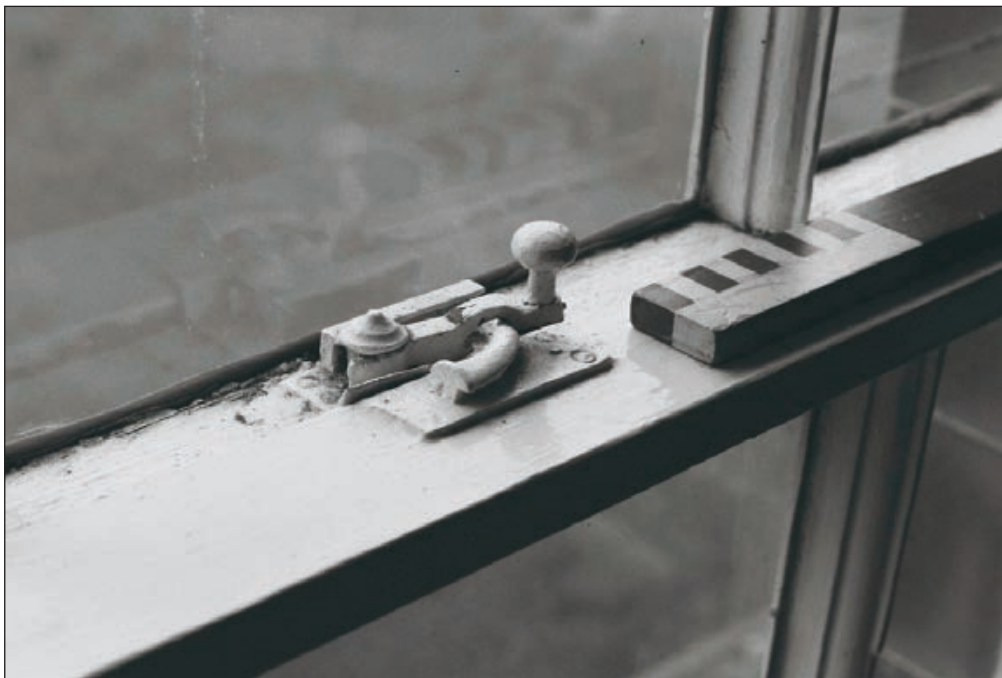
Plate 157: Detail of sash window lock, room F7, East Side of the North Range (Film 15.33)

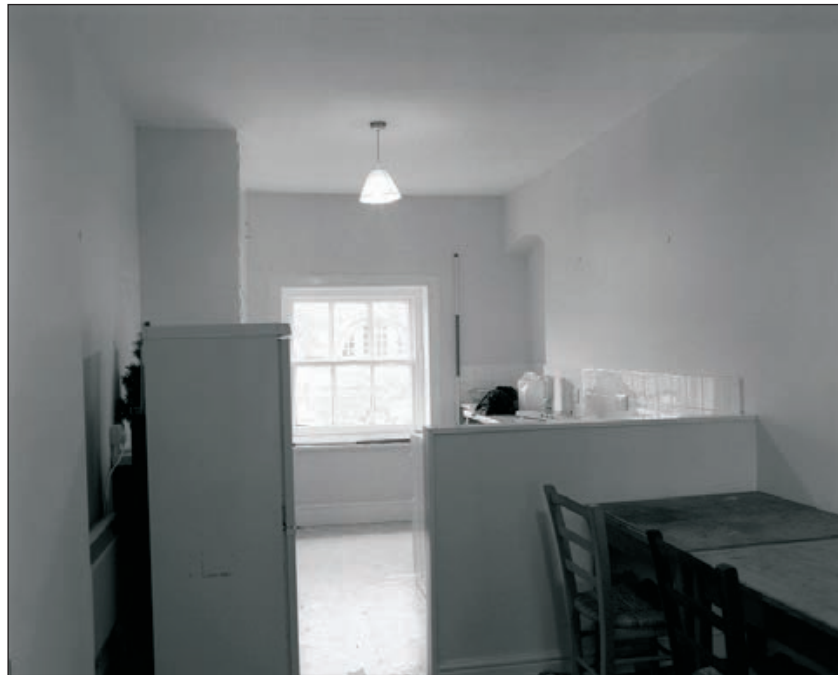
Plate 158: General view of room F9, Central Entranceway of the North Range (Film 04.08)

- 5.2.30 To the west of F6/F7, room F9 was a long and narrow rectangular room, which was once open to F8 to the north. The two were divided during phase 6. F9 contained a sash window to the south and modern finishes throughout (**Plate 158**). There was a blocked doorway at the south end of the west wall (**Plate 159**), which would have originally connected to F10b, above the cart passage. Within the east wall was a blocked fireplace, which was inserted during phase 6. The floor was timber boards laid on joists (**Plates 160-162**), however this was likely a secondary floor after the phase 6 works to the range, possibly replacing an original limeash floor. Although not visible from within F9, the west wall also contained a central brick blocking, continuing upwards from G4 below.
