NOSTELL PRIORY STABLES, NOSTELL, WAKEFIELD, WEST YORKSHIRE

Historic Building Recording and Structural Watching Brief

Planning Application Ref: 09/00701/FUL & 09/00705/LBC

72934.01_BDG_V0_4

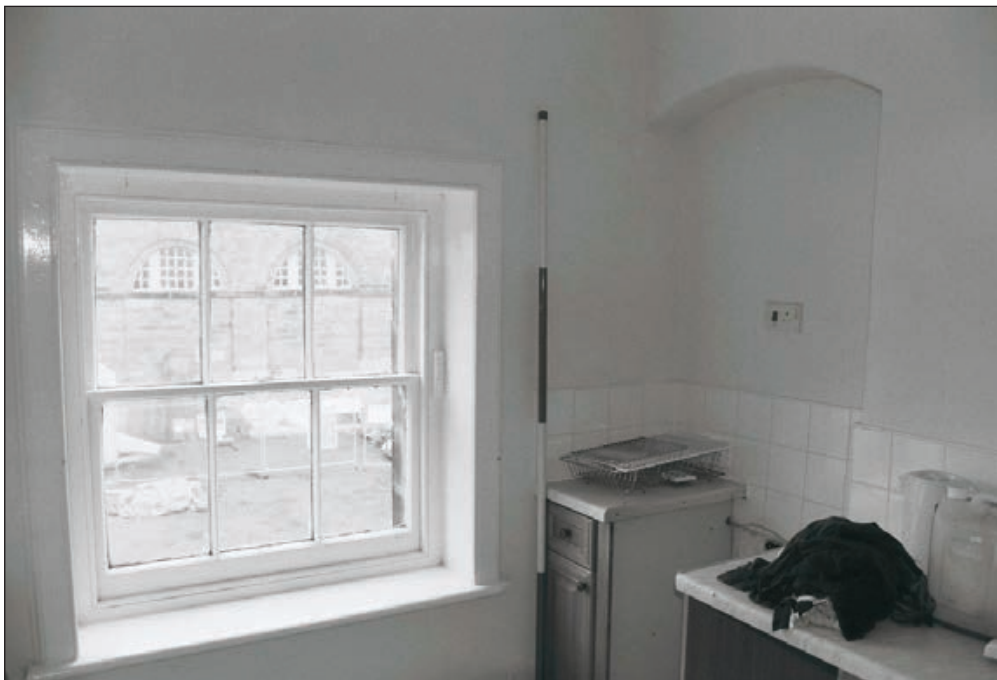
Plate 159: View of the southwest corner of room F9, Central Entranceway of the North Range, showing window and blocked doorway (Film 15.29)

- 5.2.30 To the west of F6/F7, room F9 was a long and narrow rectangular room, which was once open to F8 to the north. The two were divided during phase 6. F9 contained a sash window to the south and modern finishes throughout (**Plate 158**). There was a blocked doorway at the south end of the west wall (**Plate 159**), which would have originally connected to F10b, above the cart passage. Within the east wall was a blocked fireplace, which was inserted during phase 6. The floor was timber boards laid on joists (**Plates 160-162**), however this was likely a secondary floor after the phase 6 works to the range, possibly replacing an original limeash floor. Although not visible from within F9, the west wall also contained a central brick blocking, continuing upwards from G4 below.

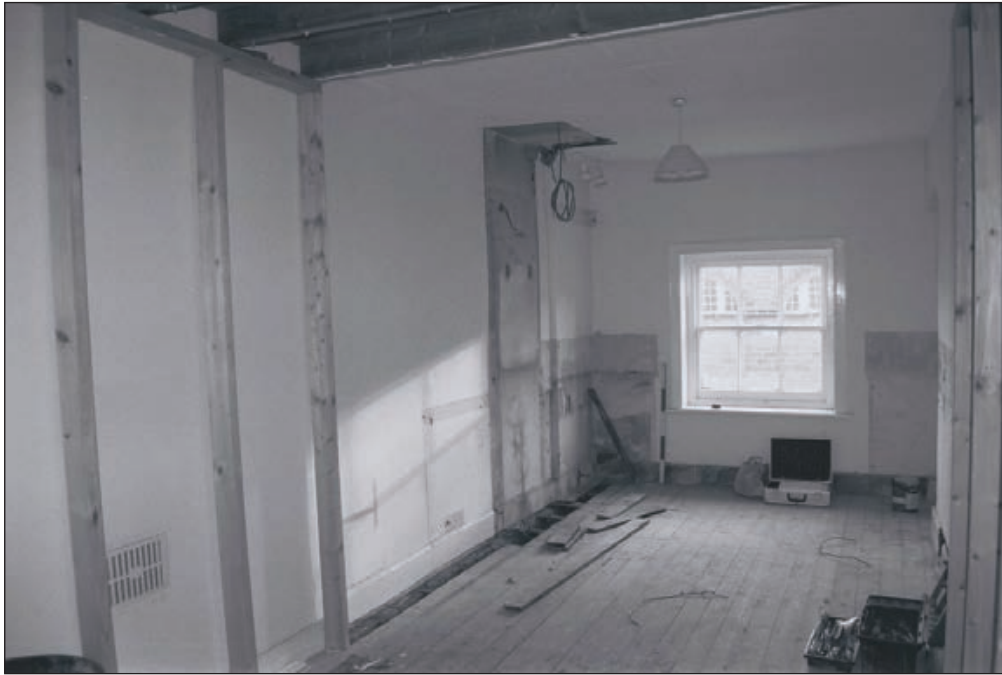
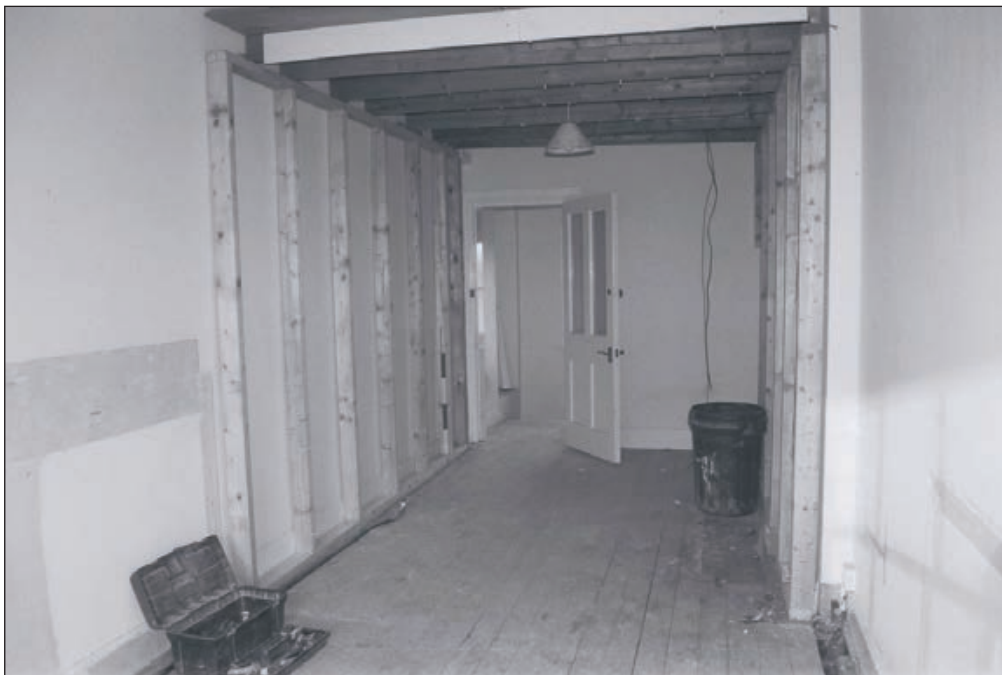
Plate 160: General view of room F9, Central Entranceway of the North Range, after the removal of modern partitions etc. - OB. 122 (Film 77.15)

Plate 161: General view of room F9, Central Entranceway of the North Range after the removal of modern partitions etc. - OB. 122 - showing timber boarded floor and blocked fireplace (Film 77.12)

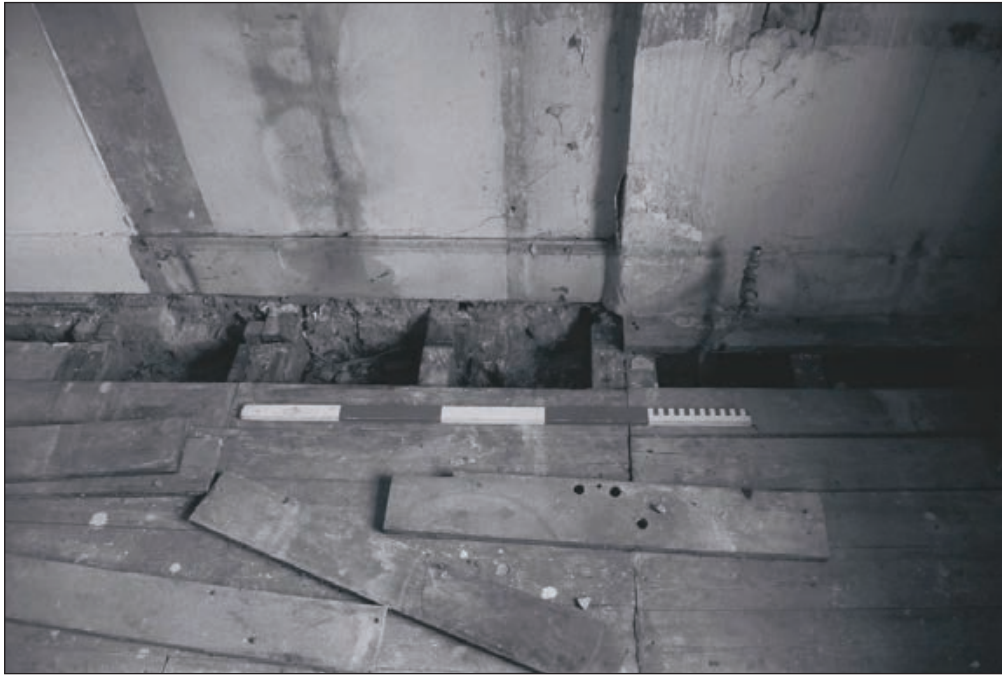
Plate 162: Detail of removed floorboards, exposed timber joists and east wall, room F9, Central Entranceway of the North Range - OB. 122 (Film 77.13)

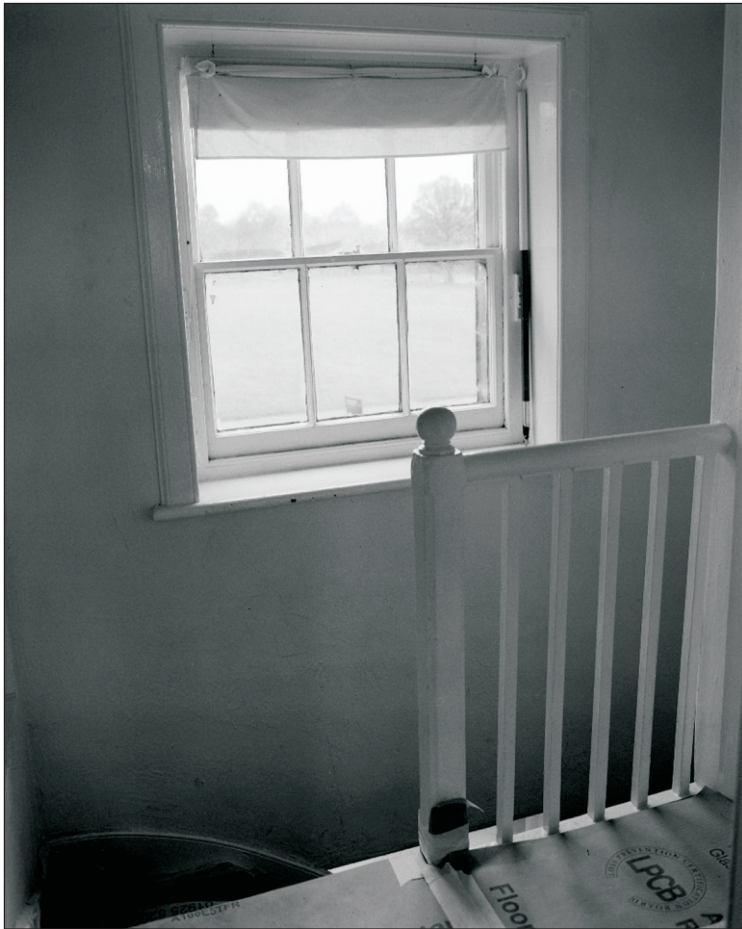
Plate 163: General view of room F8, Central Entranceway of the North Range (Film 04.10)

- 5.2.31 F8, located to the north of F9 contained the top of the staircase leading from G5/G6 below (**Plate 163**). There was a small landing with cupboard to the east, sash window to the north and a blocked doorway to the west (**Plate 164**). This would have also originally led into F10b.

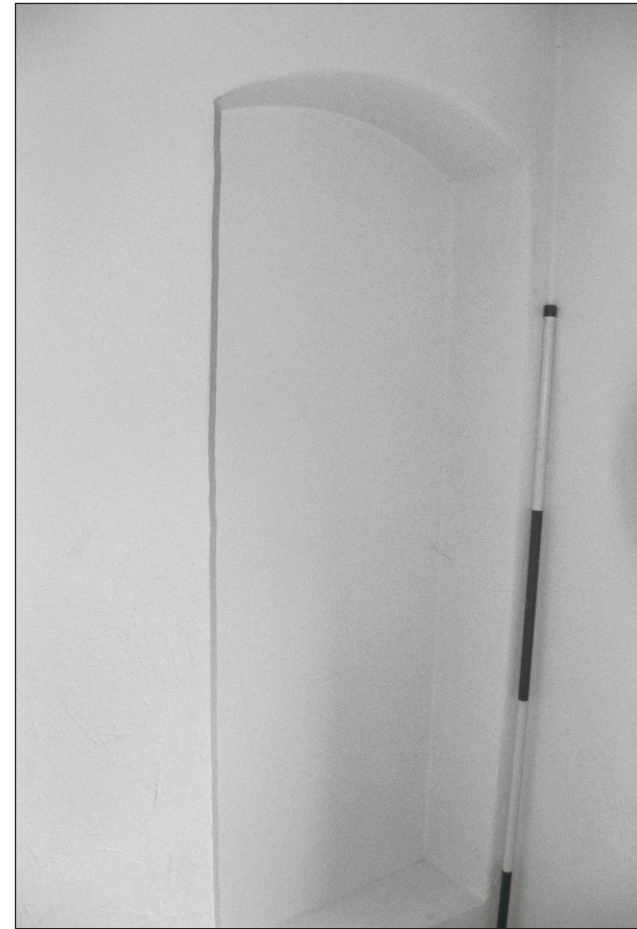
Plate 164: View of blocked door in west wall of room F8, Central Entranceway of the North Range (Film 15.30)

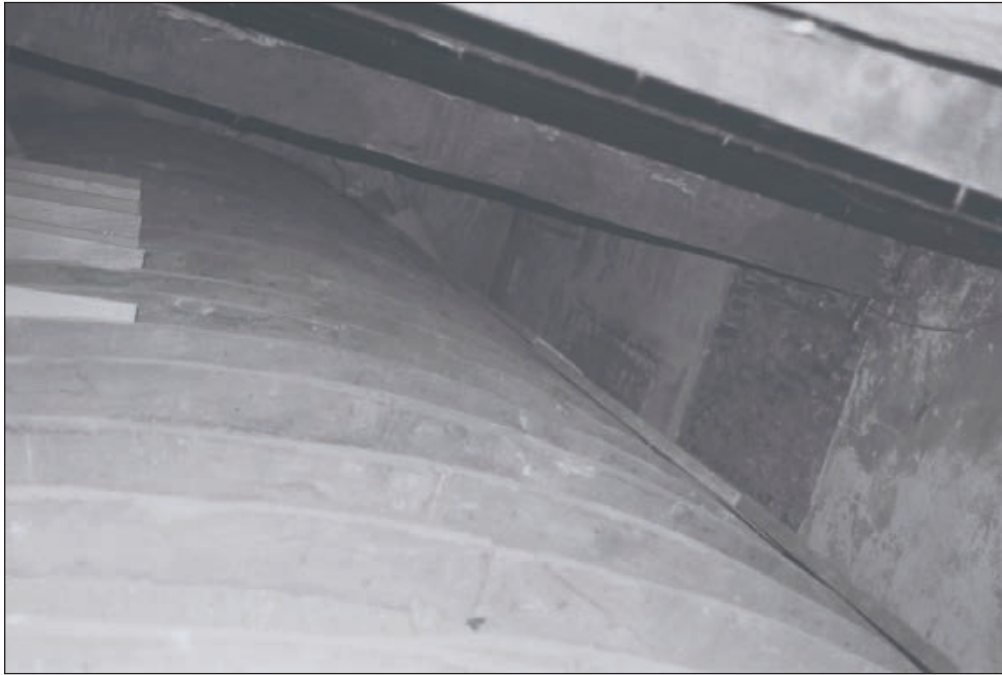
Plate 165: View of floor void F10b, Central Entranceway of the North Range - OB. 87 - showing inserted arch and blocked openings in west wall (Film 75.22)

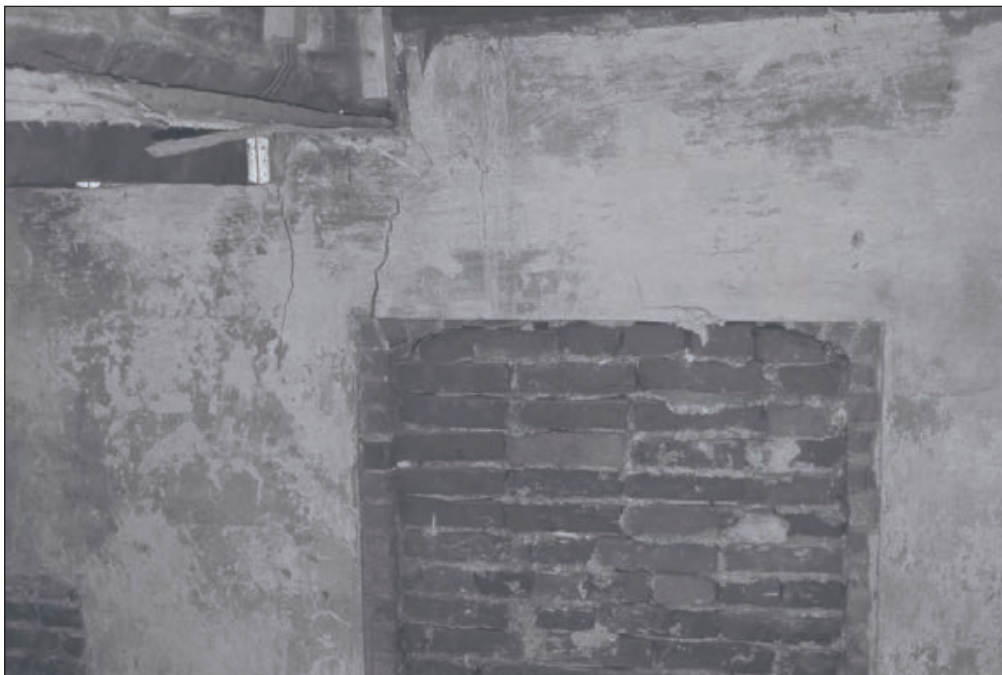
Plate 166: View of blocked doorway with F11 in west wall of F10b, Central Entranceway of the North Range - OB. 87 (Film 75.29)

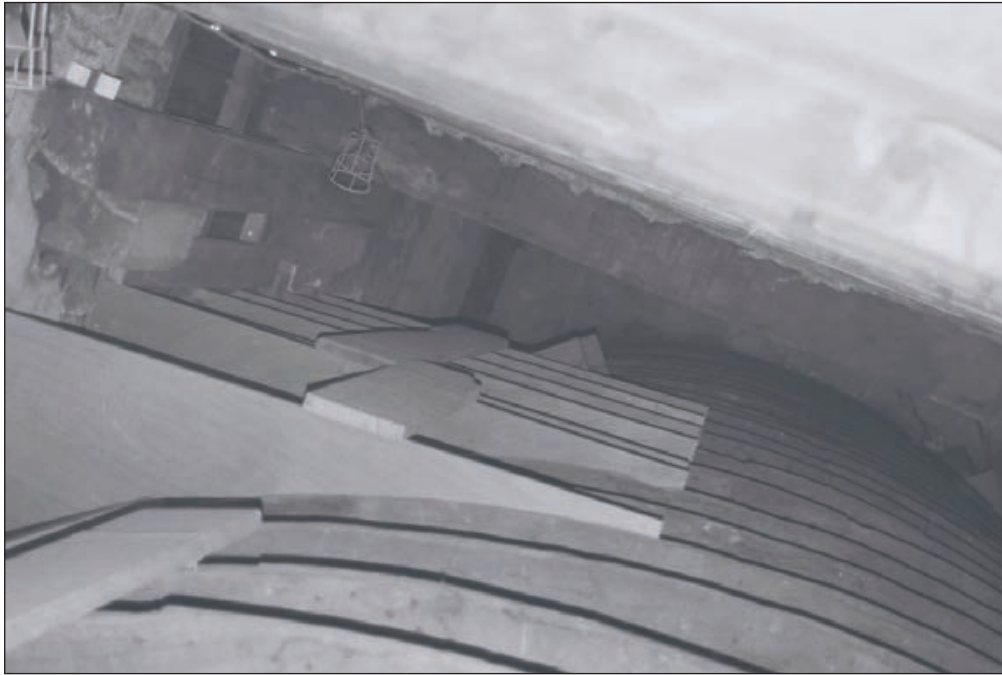
Plate 167: View of floor void F10b, Central Entranceway of the North Range - OB. 87 - showing inserted arch, timber beams and recess in east wall (Film 75.27)

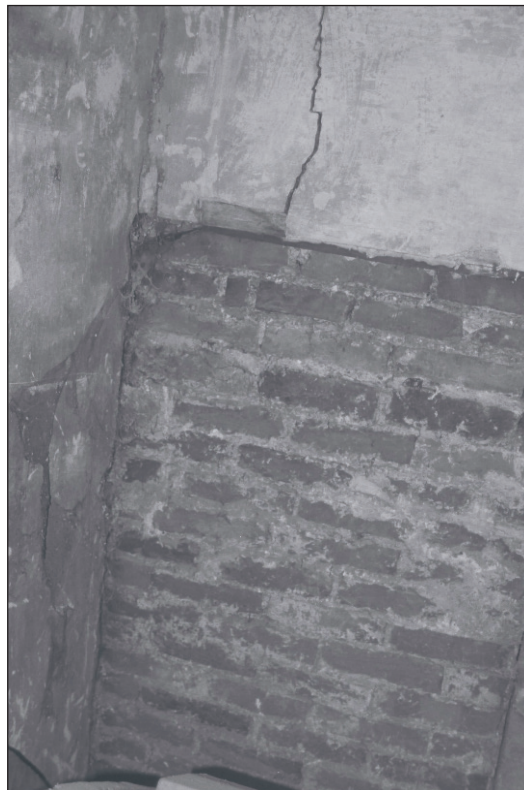
Plate 168: View of blocked doorway with F8 in east wall of F10b, Central Entranceway of the North Range - OB. 87 (Film 75.35)

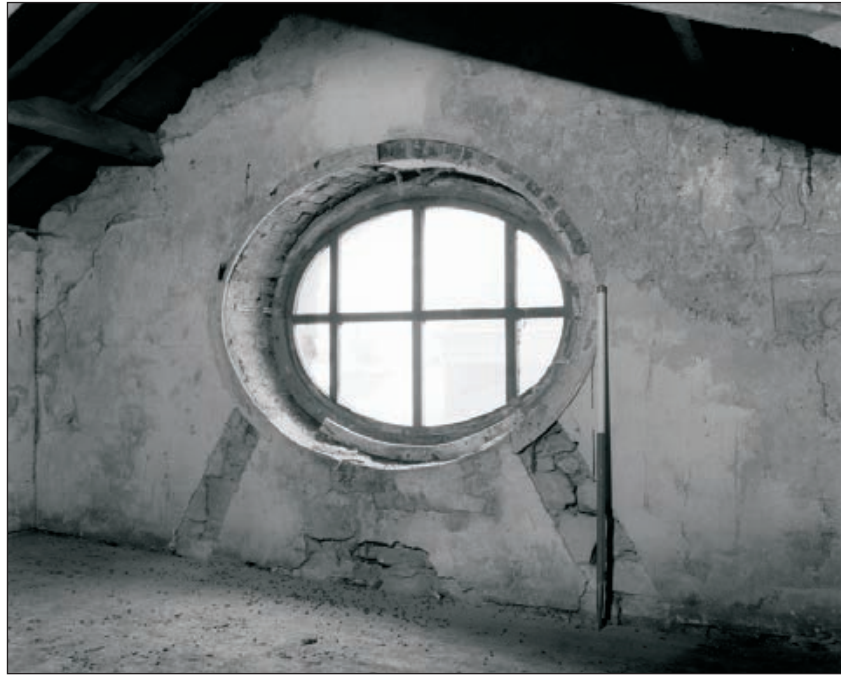
Plate 169: General view of the south side of F10, Central Entranceway of the North Range, showing oeil-de-boeuf window (Film 33.01)

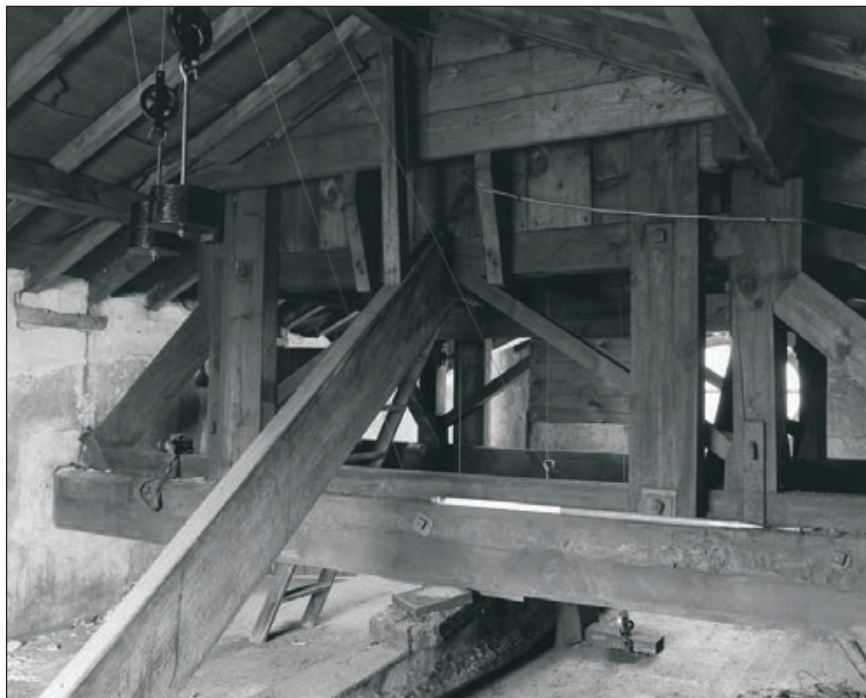
Plate 170: General view of F10, Central Entranceway of the North Range, showing clock tower structure (Film 33.03)

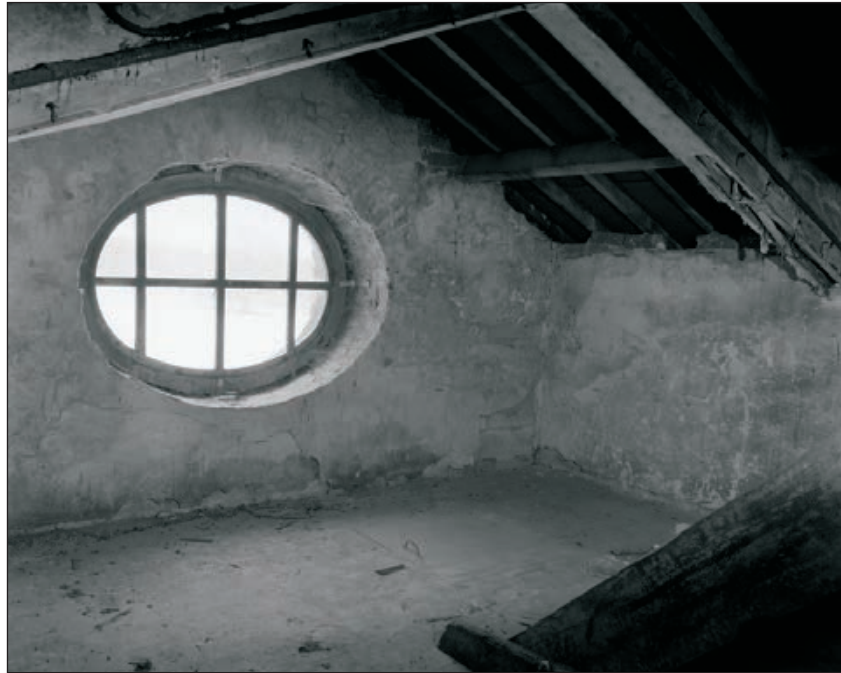
Plate 171: General view of the north side of F10, Central Entranceway of the North Range, showing oeil-de-boeuf window and hatch in floor to F10b below (Film 33.06)

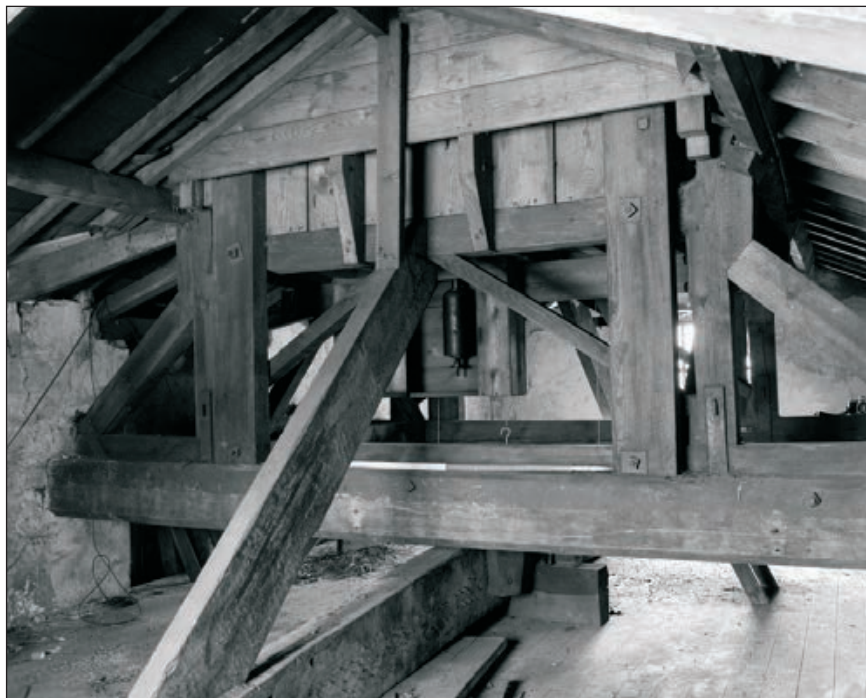
Plate 172: General view of F10, Central Entranceway of the North Range, showing clock tower structure (Film 33.08)

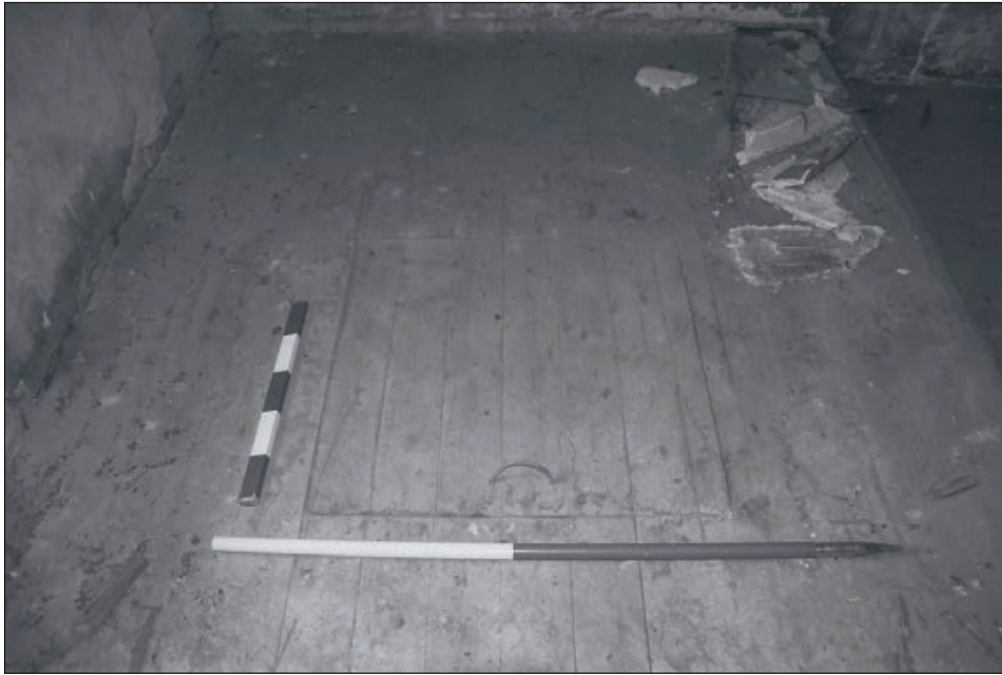
Plate 173: Detail of hatch within the floor of the north side of F10, Central Entranceway of the North Range, leading to F10b (Film 42.16)

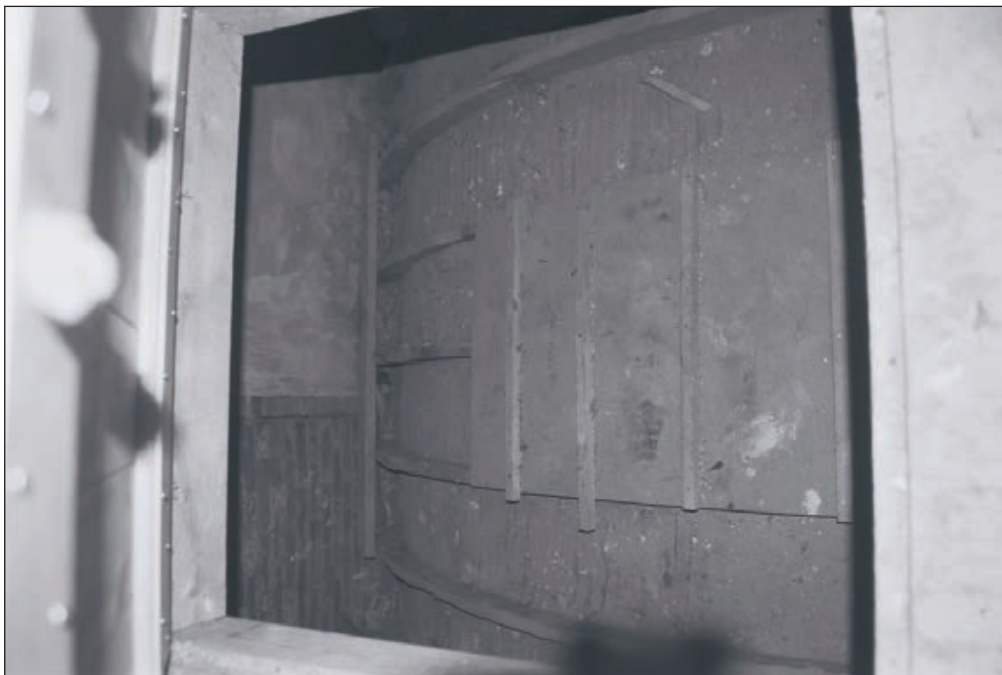
Plate 174: View into F10b down hatch within the floor of F10, Central Entranceway of the North Range, showing inserted arch (Film 42.13)

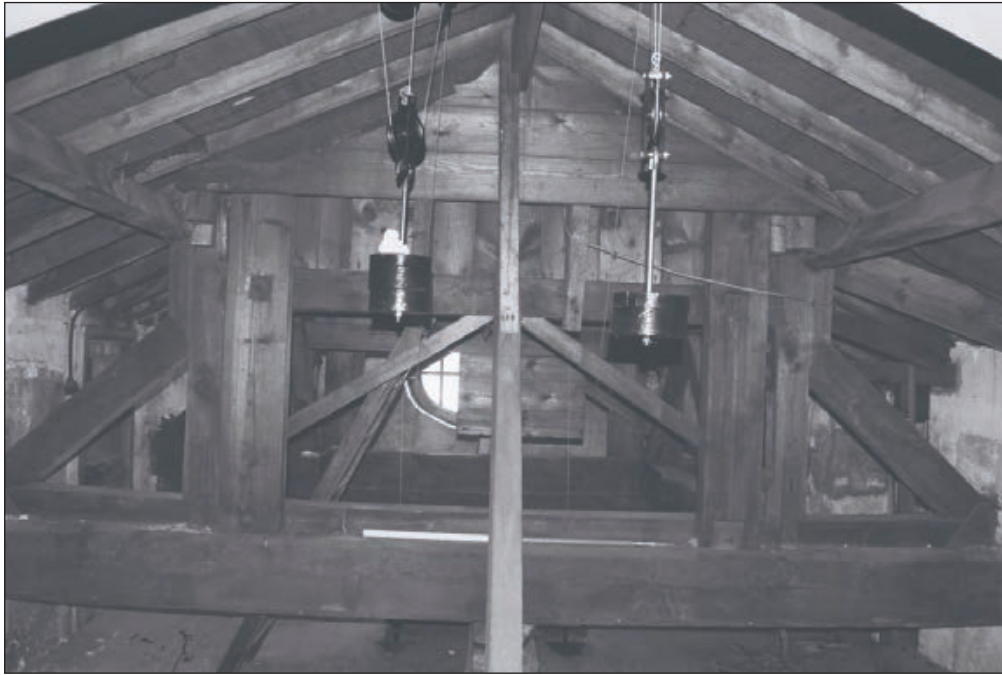
Plate 175: View of timber clock tower structure, F10, Central Entranceway of the North Range (Film 42.20)

- 5.2.33 Room F10 above was a rectangular space, accessed from a modern staircase within F12, via a small doorway within the west wall. This room contained the timber structure for the cupola/clock tower above (F10a). The walls were all of phase 2 date, and retained their plaster covering. Both to the north and south were oeil-de-boeuf windows (**Plates 169, 171**) lighting the room, with raised timber flooring beneath them. In the centre of the room the floor was lower, with the main timber framing of the cupola (**Plates 170, 172**). Within the raised floor to the north there was the hatch providing access to the void F10b below (**Plates 173-174**). It would appear that the timber cupola structure contained several phases of timberwork, suggesting the presence of a former cupola, prior to the adding of the current clock tower in 1875 (**Plates 175-180**). Surrounding the doorway in the west wall

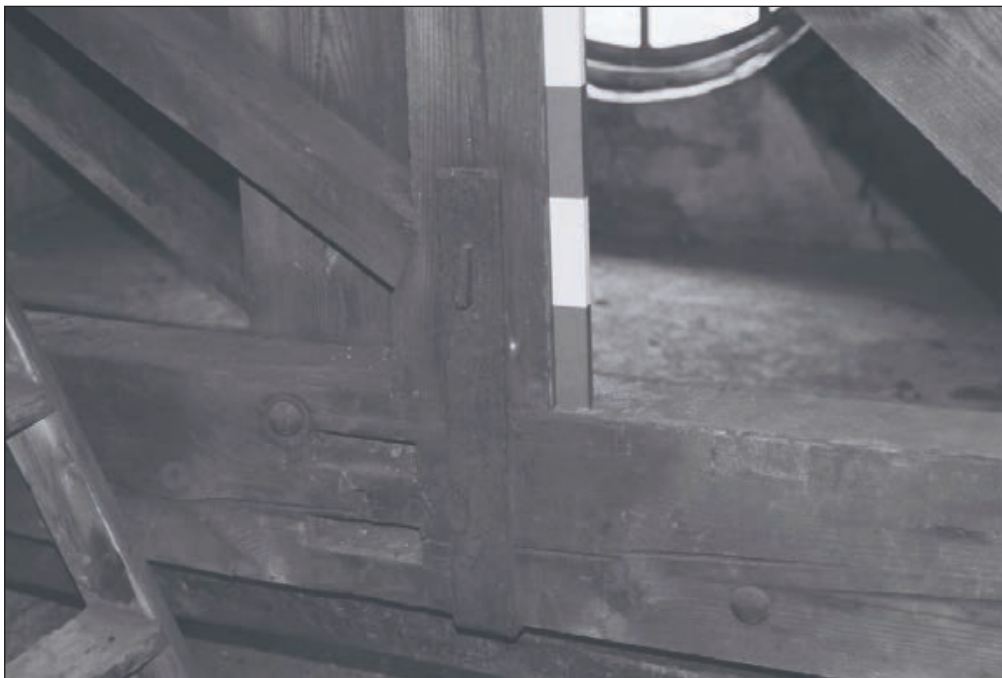
Plate 176: Detail of iron strapping and former joint in timbers of clock tower structure, F10, Central Entranceway of the North Range (Film 42.18)

- Plate 176** *Detail of iron strapping and former joint in timbers of clock tower structure, F10, Central Entranceway of the North Range (Film 42.18)*

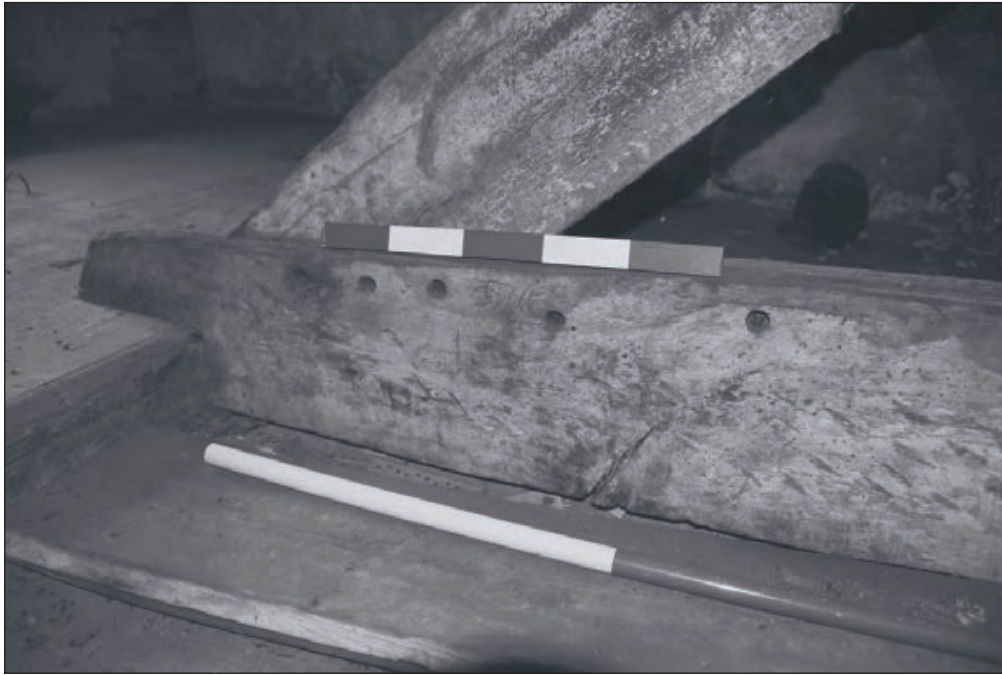
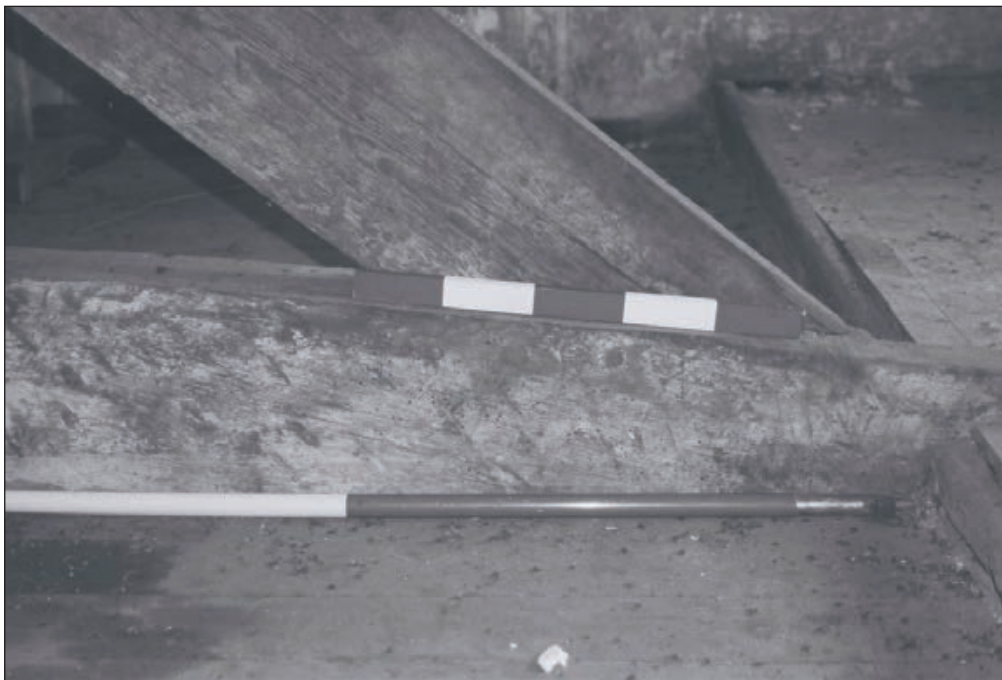
Plate 177: Detail of pegged trusses of timber clock tower structure, F10, Central Entranceway of the North Range (Film 42.15)

Plate 178: Detail of pegged trusses of timber clock tower structure, F10, Central Entranceway of the North Range (Film 42.24)

- Plate 177** *Detail of pegged trusses of timber clock tower structure, F10, Central Entranceway of the North Range (Film 42.15)*
- Plate 178** *Detail of pegged trusses of timber clock tower structure, F10, Central Entranceway of the North Range (Film 42.24)*

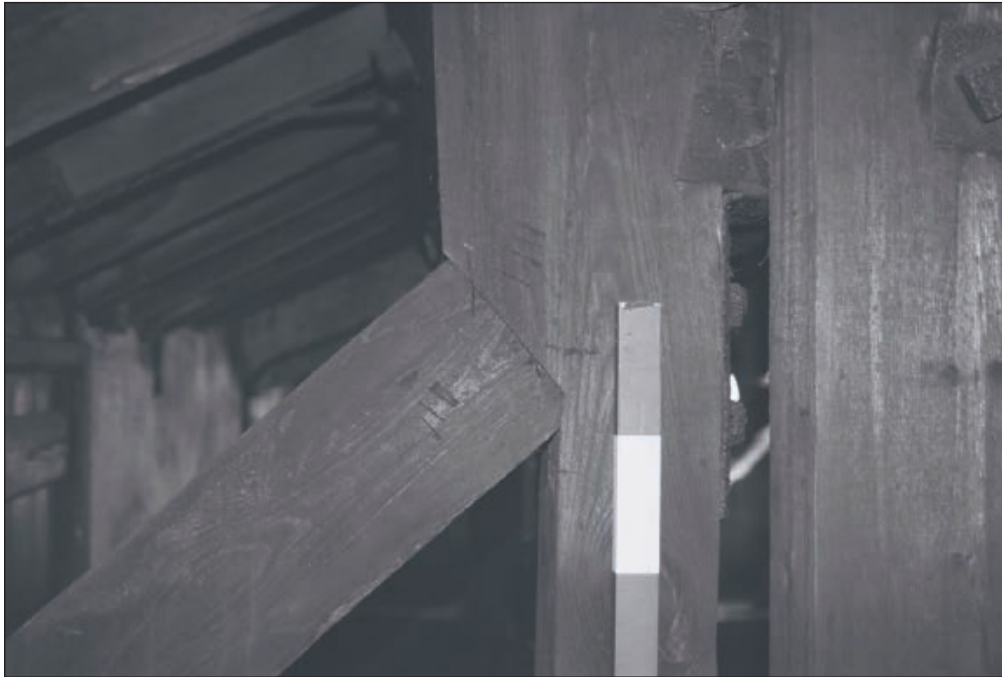
Plate 179: Detail of construction marks on timber clock tower structure, F10, Central Entranceway of the North Range (Film 42.26)

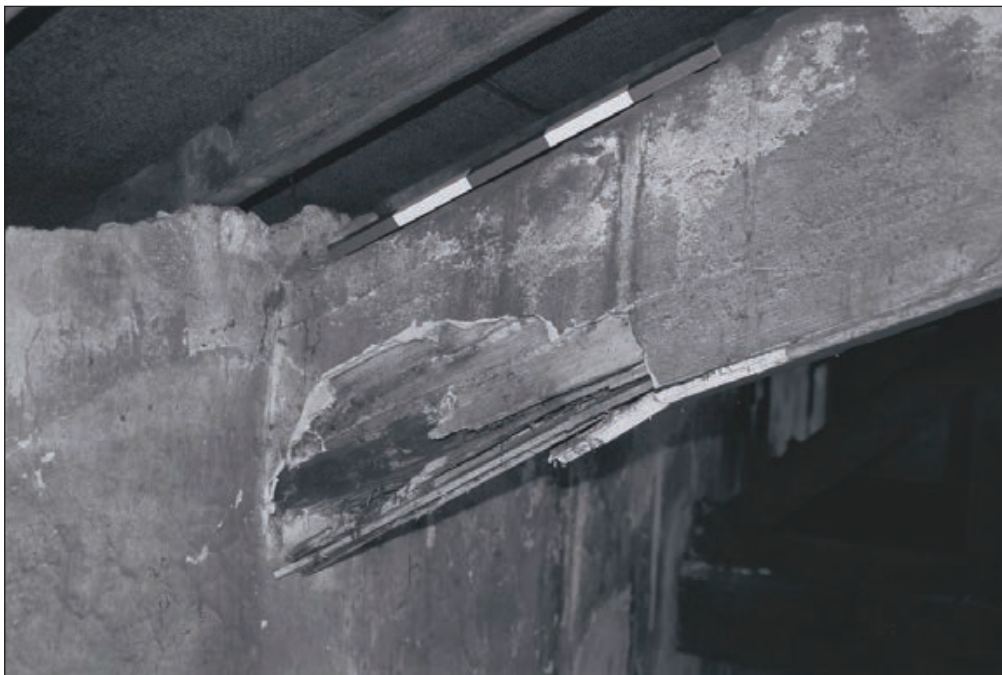
Plate 180: Detail of original phase 2 timber truss with lath and plaster covering, F10, Central Entranceway of the North Range (Film 42.23)

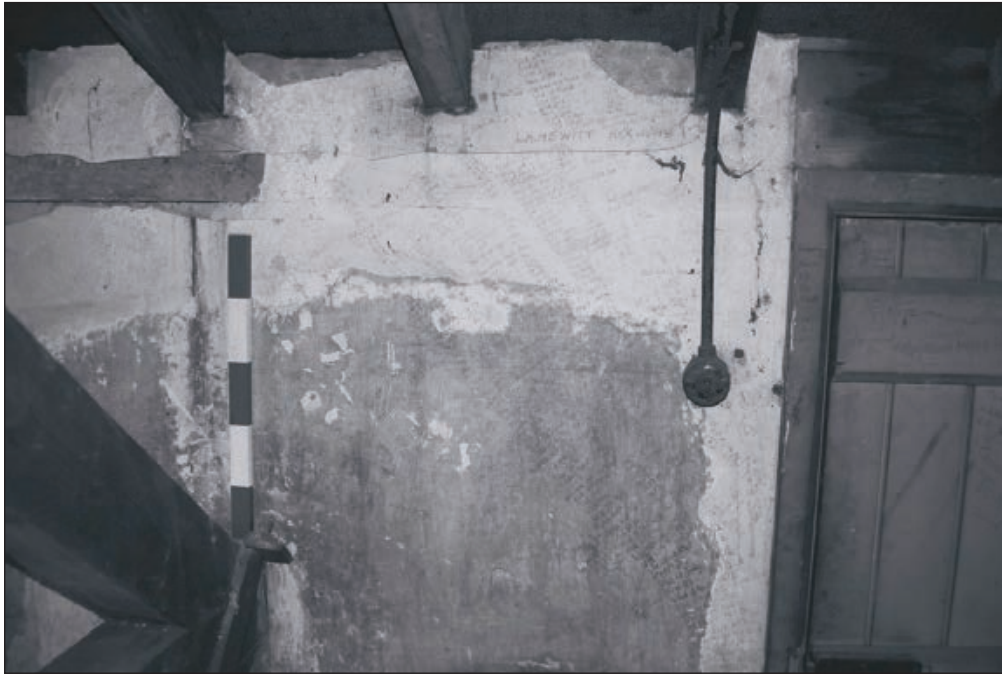
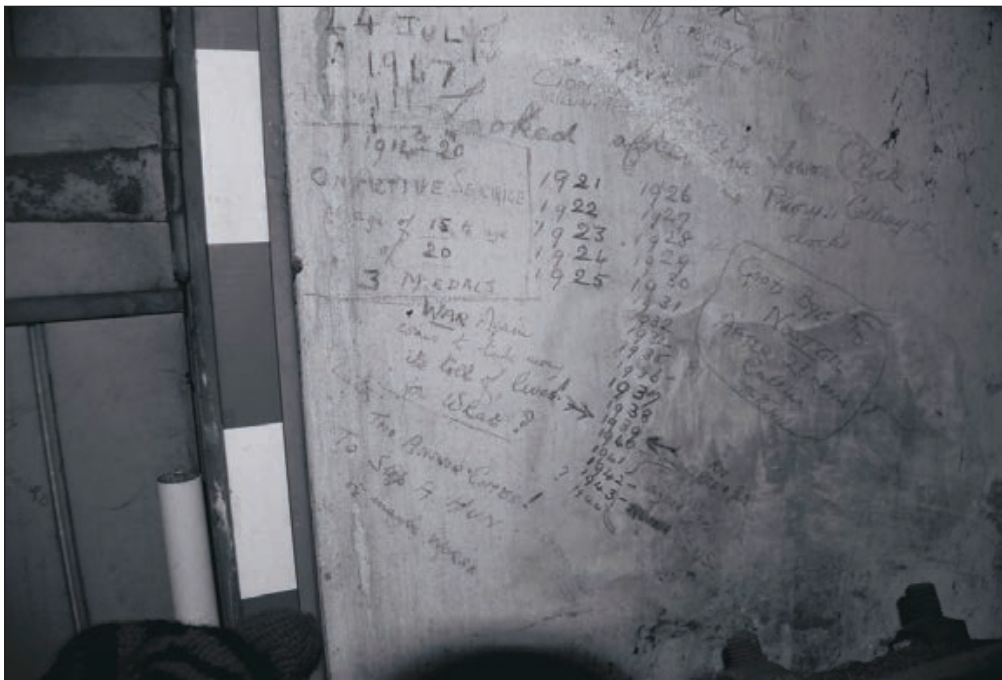
Plate 181: View of graffiti on west wall of F10, Central Entranceway of the North Range (Film 42.30)

Plate 182: Detail of section of graffiti on west wall of F10, Central Entranceway of the North Range (Film 42.29)

was an area of graffiti, which spanned from the early to late 20th century, and covered several subjects including maintenance of the clock, World Wars I and II, and members of the Nostell Estate staff (**Plates 181-182**). During the structural watching brief openings were made within the east and west walls. This work exposed the fabrics of the walls, with the east wall being constructed with stone (**Plates 183, 185**), and the west being of red brick (**Plates 184, 186**). An opening was also inserted into the recessed/blocked opening in the centre of the east wall (a continuation of the blocking within G4 and F9/F10b), leading into the roof space above F9 (**Plate 187**).

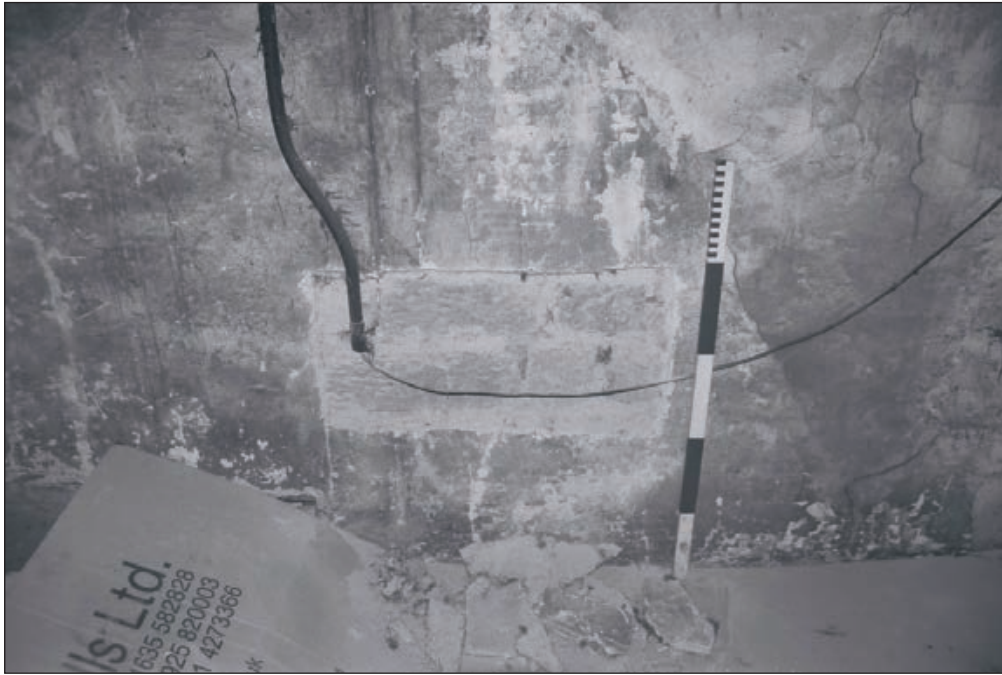
Plate 183: Detail of removed plaster on east wall of F10, Central Entranceway of the North Range, showing exposed stone fabric of wall - OB. 20 (Film 47.23)

- Plate 183** *Detail of removed plaster on east wall of F10, Central Entranceway of the North Range, showing exposed stone fabric of wall - OB. 20 (Film 47.23)*

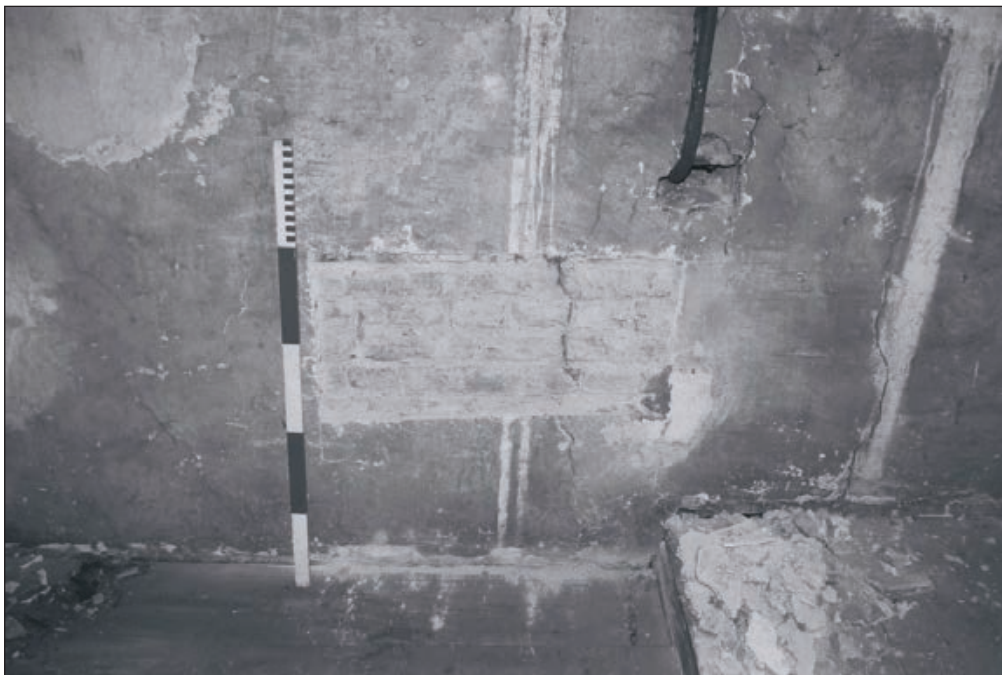
Plate 184: Detail of removed plaster on west wall of F10, Central Entranceway of the North Range, showing exposed brick fabric of wall - OB. 19 (Film 47.24)

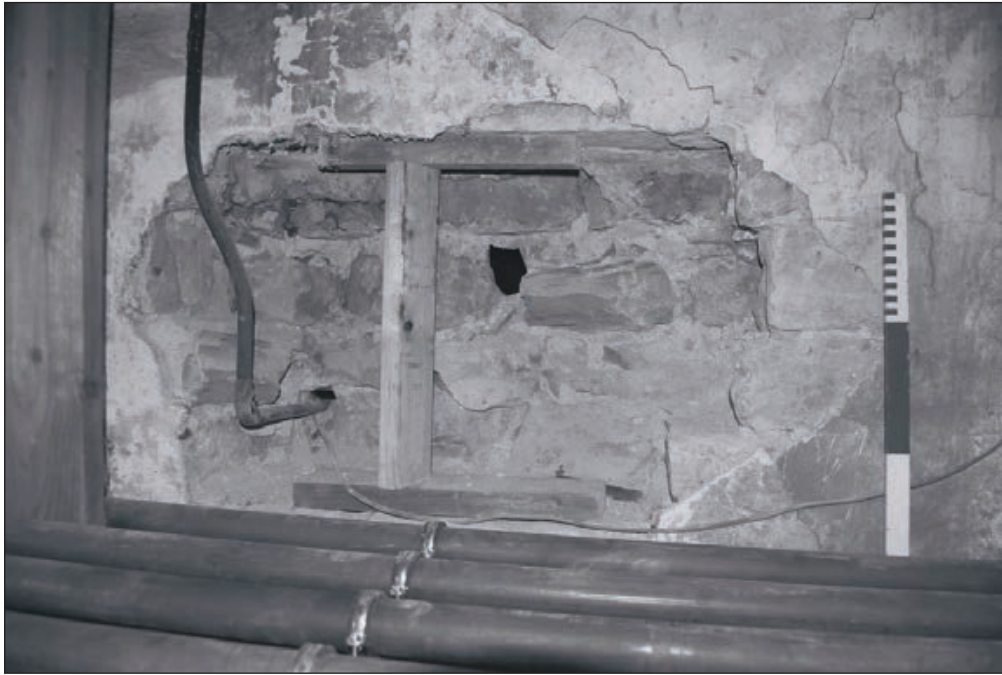
Plate 185: Detail of inserted opening within the east wall of F10, Central Entranceway of the North Range, showing exposed stone fabric of wall - OB. 20 (Film 51.30)

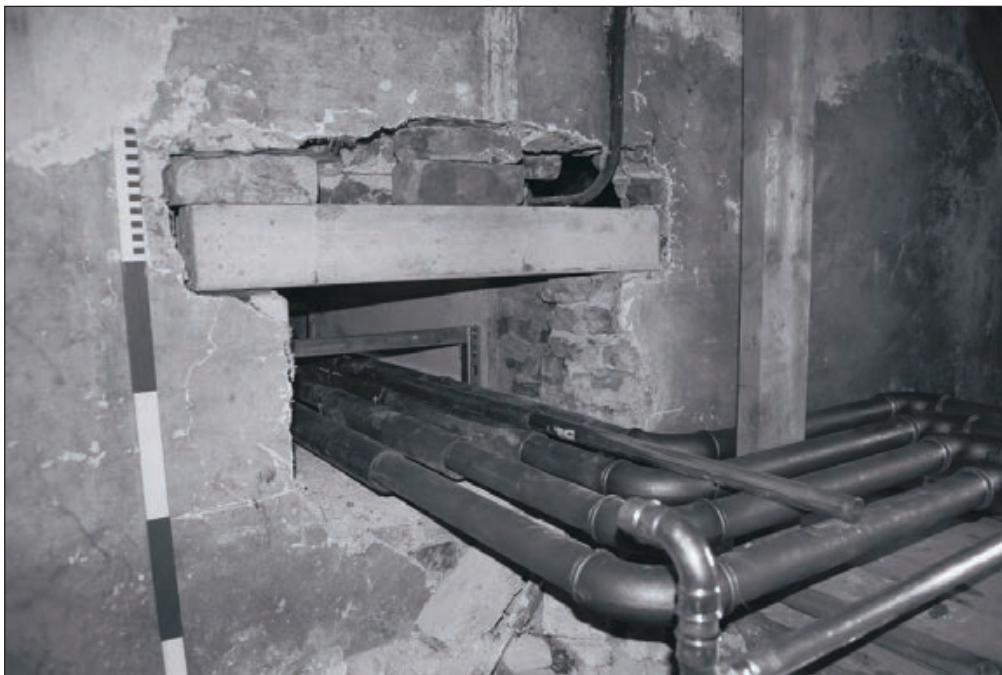
Plate 186: Detail of inserted opening within west wall of F10, Central Entranceway of the North Range, showing exposed brick fabric of wall - OB. 19 (Film 51.34)

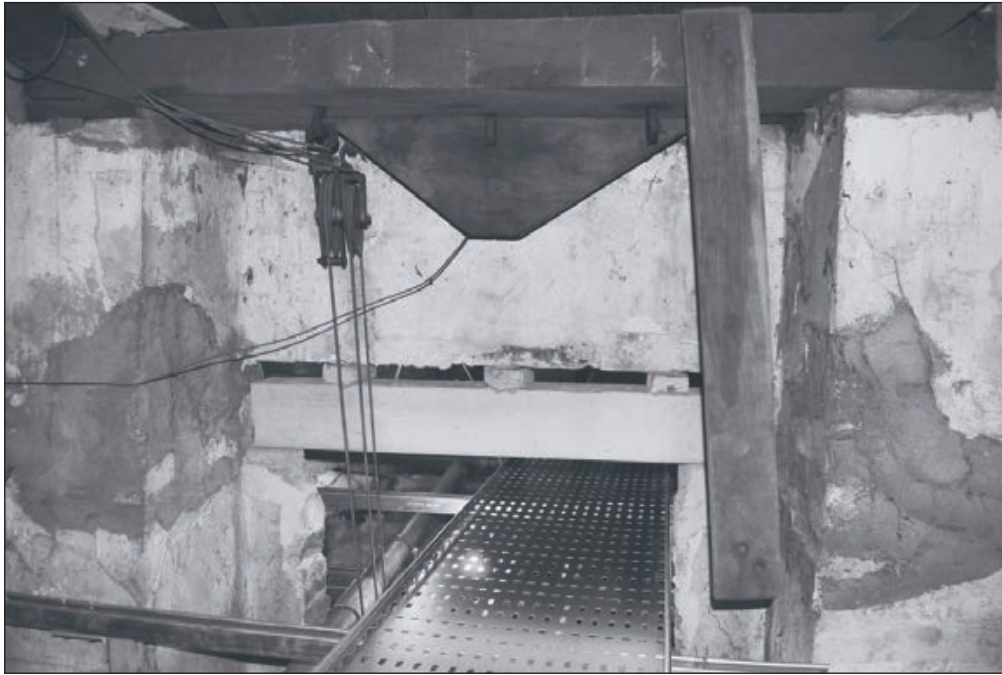
Plate 187: Detail of inserted opening within the recess in the east wall of F10, Central Entranceway of the North Range, showing exposed brick fabric of wall - OB. 29 (Film 51.26)

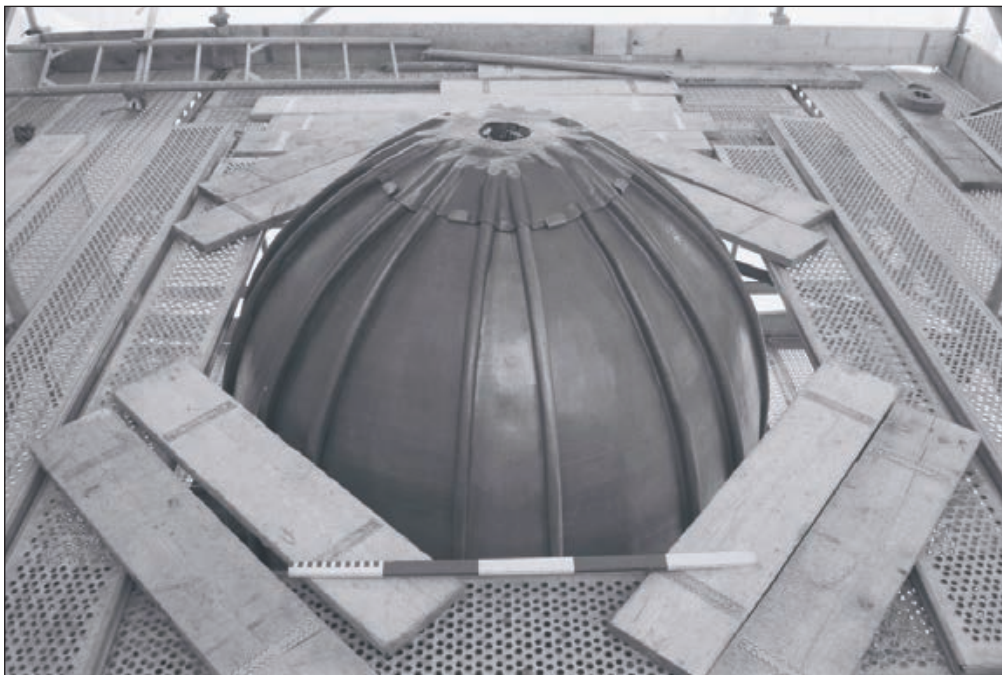
- 5.2.34 The Clock Tower/Cupola itself (F10a), positioned above the entranceway was constructed of wood, with lead covering. The top was domed and covered with lead (**Plate 188**), below which was a decorative loggia finished with moulded corncicing (**Plates 189, 190**). Beneath the loggia, the tower was square with pediments on moulded corbels, over clock faces (removed) on each facet (**Plates 191, 192**). Inside the loggia, graffiti dating from the 1870s to the late 20th century was observed (**Plates 193-196**).

Plate 188: Detail of domed top of clock tower, F10a, Central Entranceway of the North Range - OB. 84 (Film 68.28)

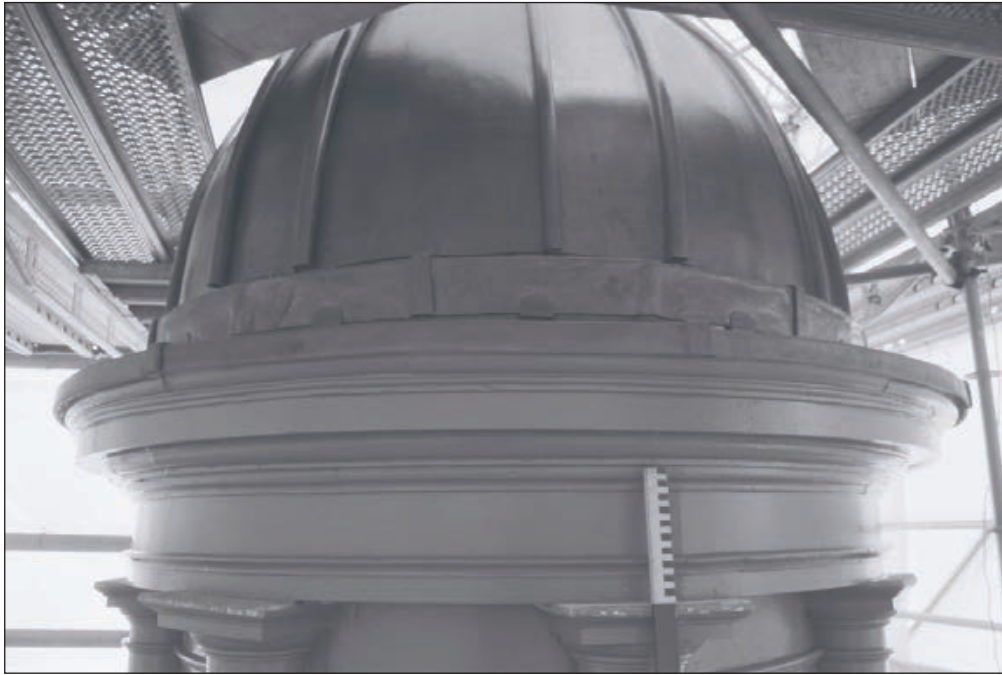
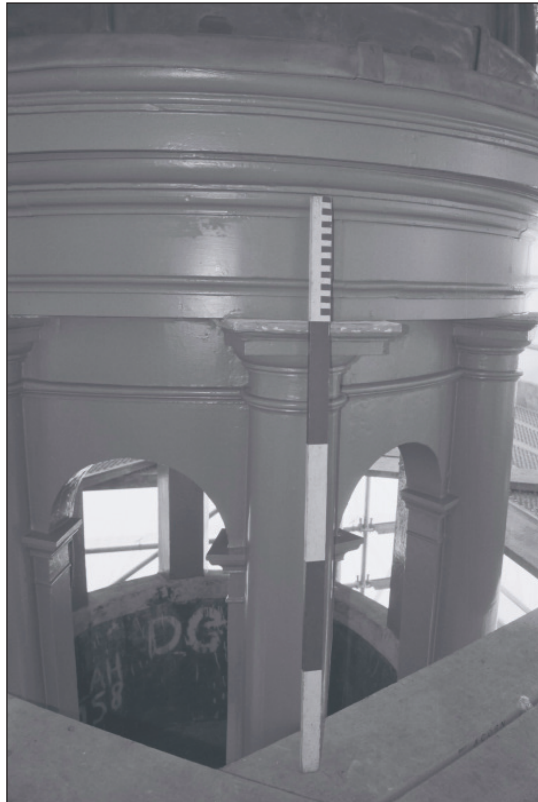
Plate 189: Detail of clock tower, F10a, Central Entranceway of the North Range - OB. 84
(Film 68.23)

Plate 190: Detail of loggia of clock tower, F10a,
Central Entranceway of the North Range - OB. 84
(Film 68.25)
