NOSTELL PRIORY STABLES, NOSTELL, WAKEFIELD, WEST YORKSHIRE

Historic Building Recording and Structural Watching Brief

Planning Application Ref: 09/00701/FUL & 09/00705/LBC

72934.01_BDG_V0_4

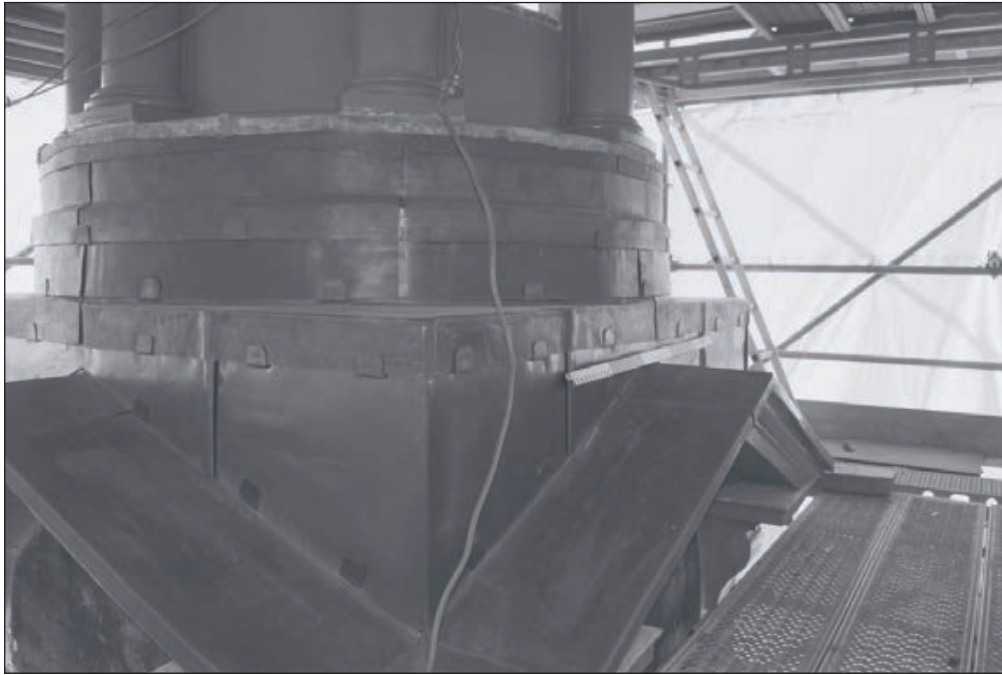
Plate 191: Detail of clock tower, F10a, Central Entranceway of the North Range - OB. 84 (Film 68.19)

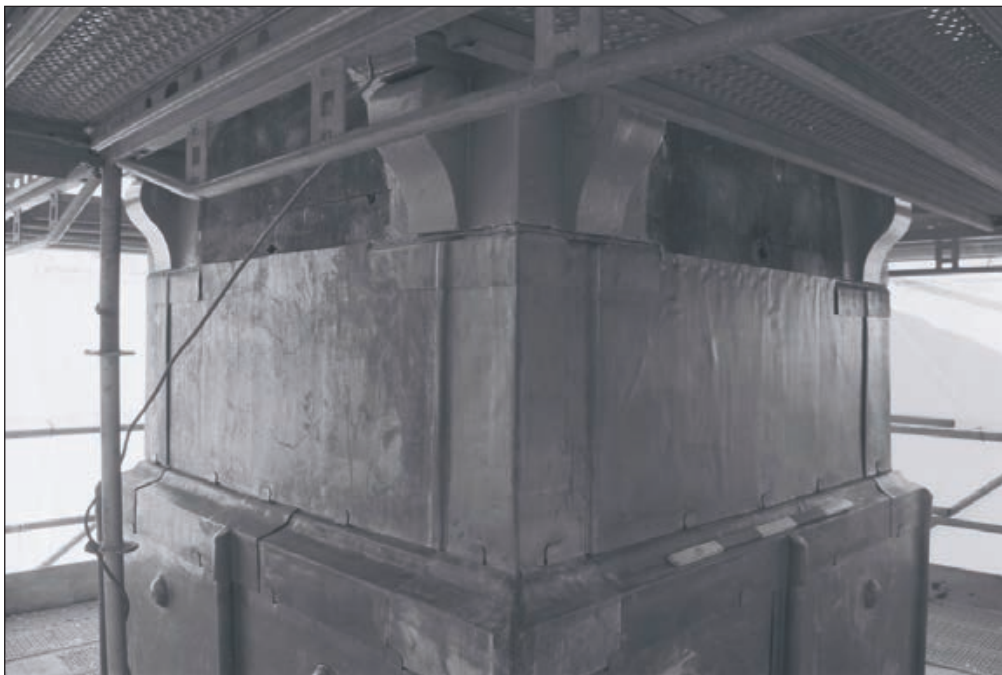
Plate 192: Detail of clock tower, F10a, Central Entranceway of the North Range - OB. 84 (Film 68.09)

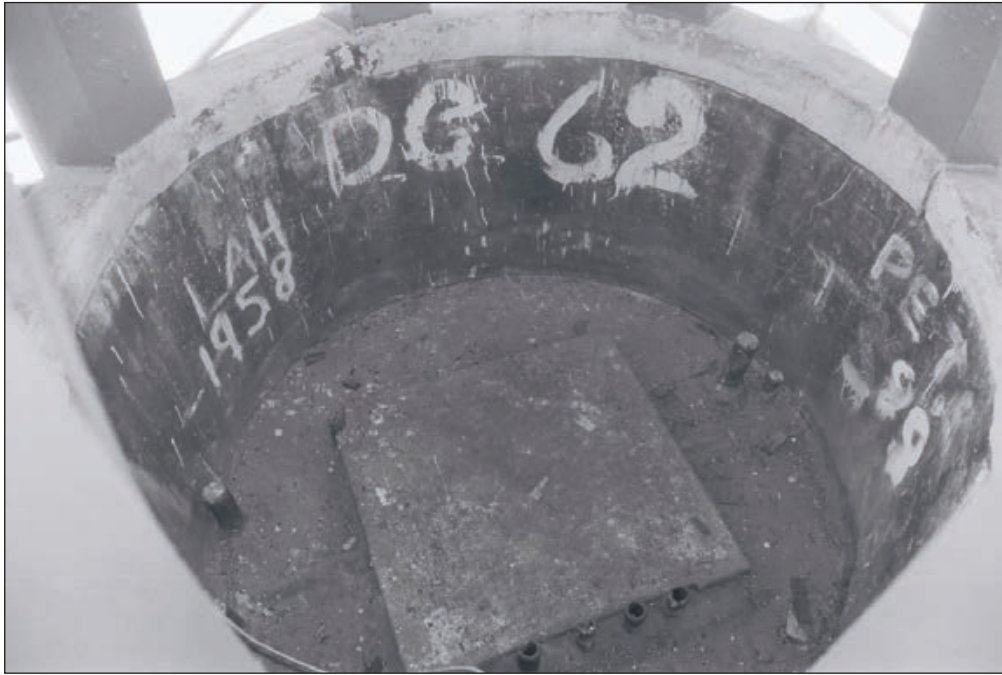
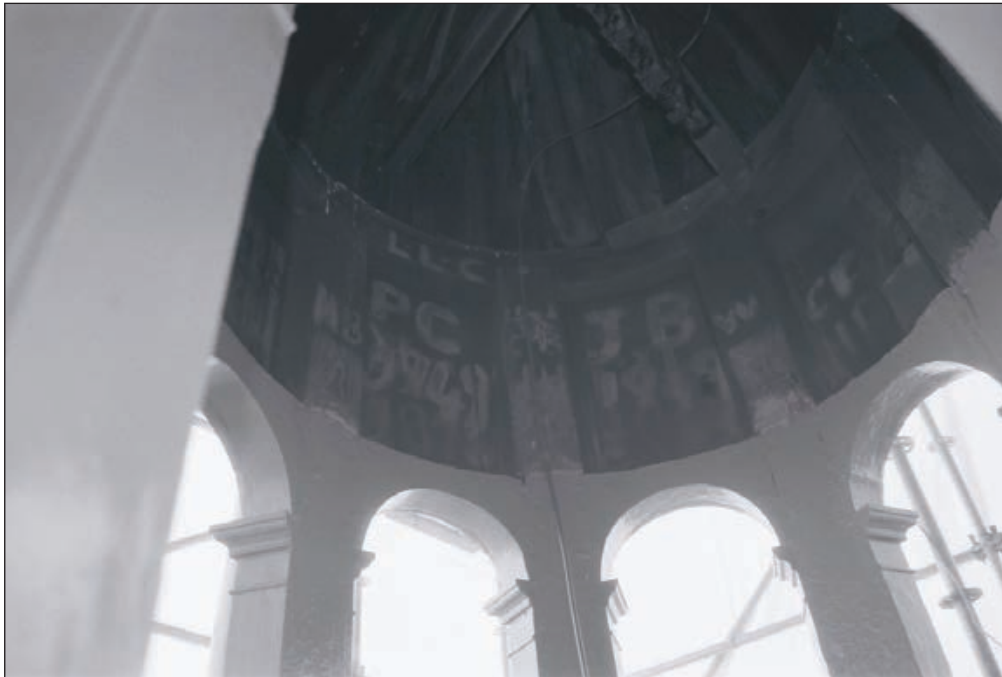
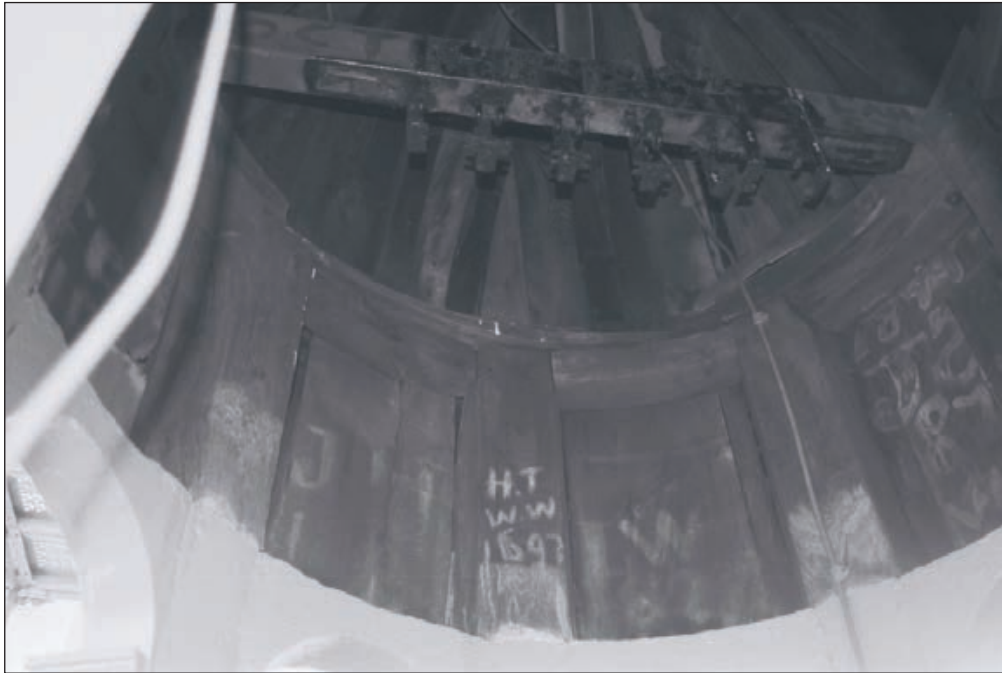
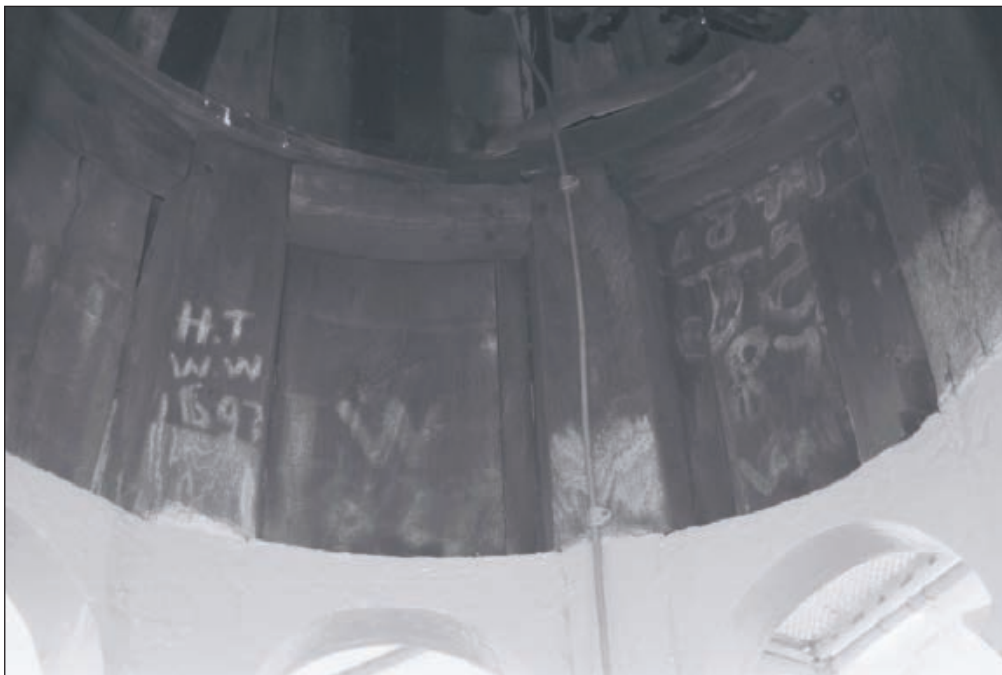
- 5.2.34 The Clock Tower/Cupola itself (F10a), positioned above the entranceway was constructed of wood, with lead covering. The top was domed and covered with lead (**Plate 188**), below which was a decorative loggia finished with moulded corncicing (**Plates 189, 190**). Beneath the loggia, the tower was square with pediments on moulded corbels, over clock faces (removed) on each facet (**Plates 191, 192**). Inside the loggia, graffiti dating from the 1870s to the late 20th century was observed (**Plates 193-196**).

Plate 193: Detail of graffiti in clock tower, F10a, Central Entranceway of the North Range - OB. 84 (Film 68.22)

Plate 194: Detail of graffiti within clock tower, F10a, Central Entranceway of the North Range - OB. 84 (Film 68.17)

Plate 195: Detail of structure and graffiti in clock tower, F10a, Central Entranceway of the North Range - OB. 84 (Film 68.15)

Plate 196: Detail of graffiti within clock tower, F10a, Central Entranceway of the North Range - OB. 84 (Film 68.13)

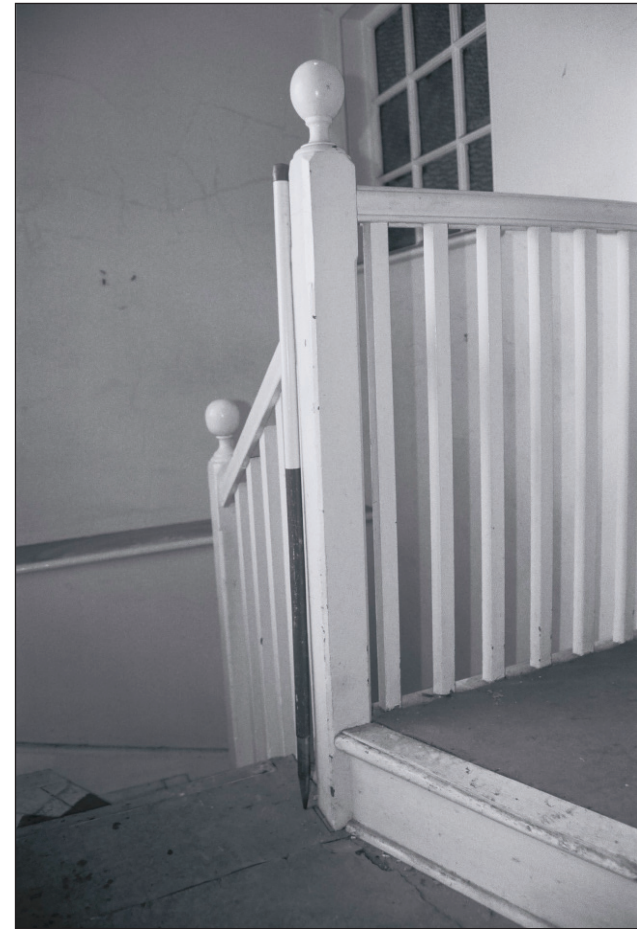
Plate 198: General view of staircase, F11, Central Entranceway of the North Range (Film 25.34)

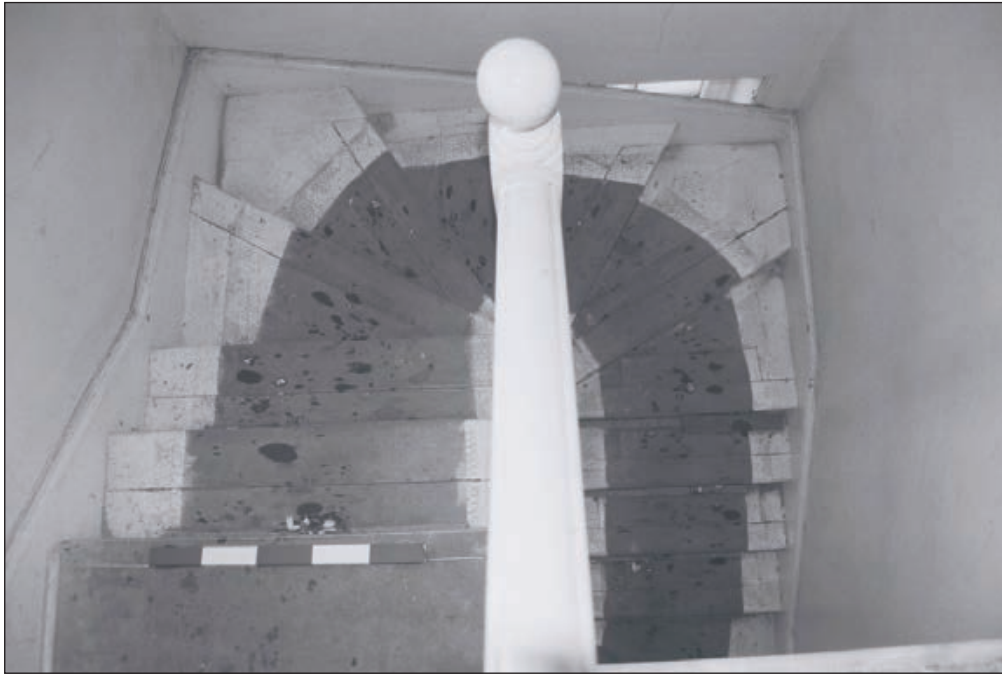
Plate 199: View of staircase, F11, Central Entranceway of the North Range (Film 25.32)

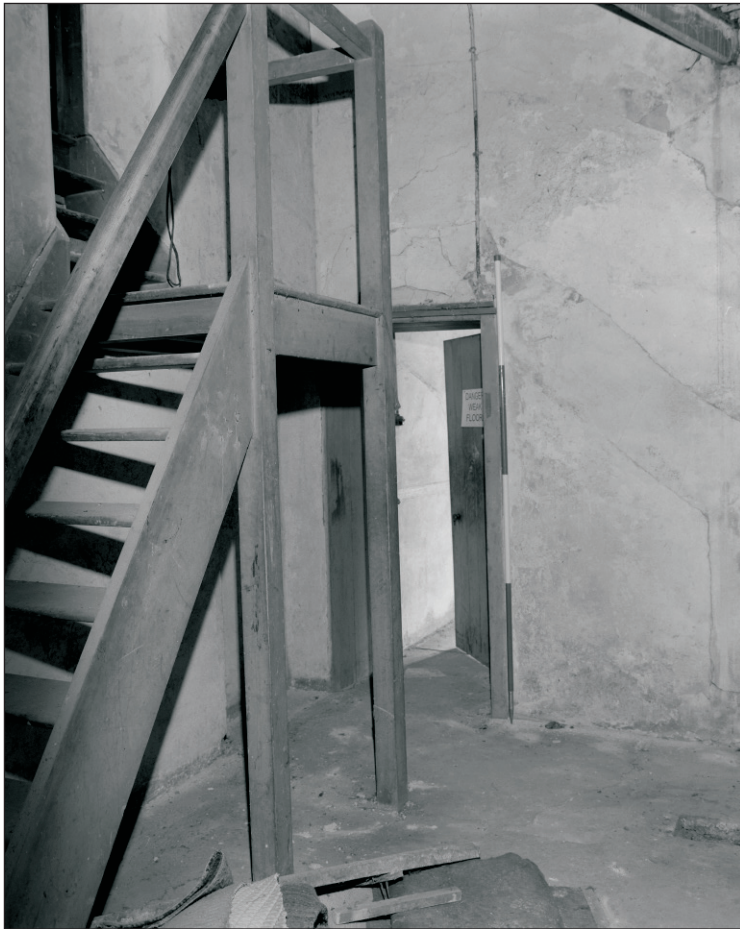
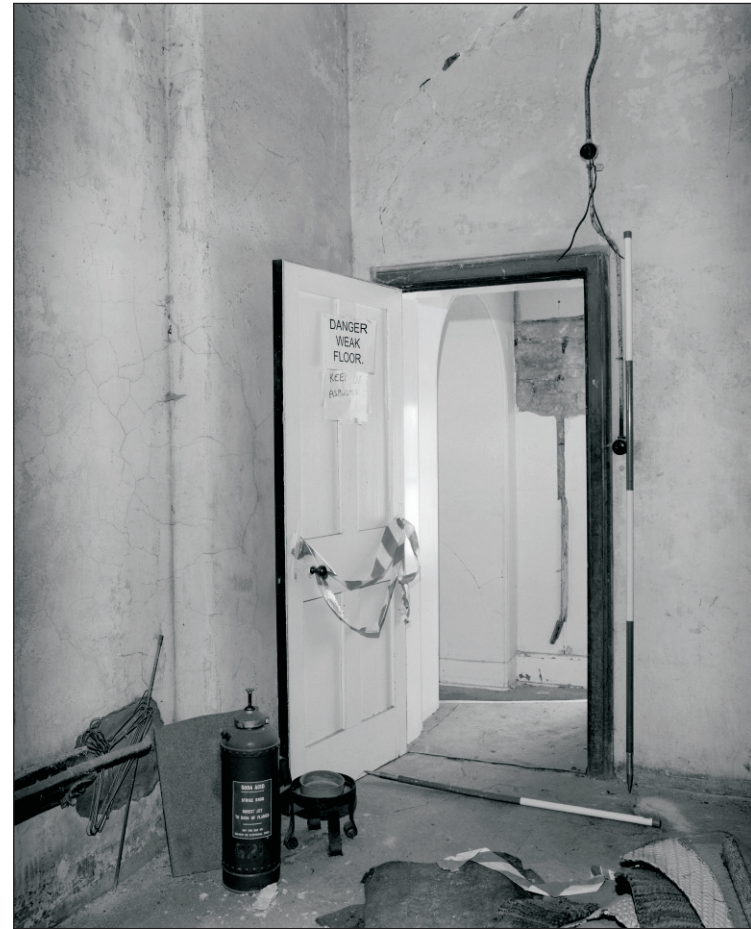
- 5.2.36 Room F12 to the south (**Plates 200-201**) had an inserted phase 6 north partition wall, with multipaned light sharing window. The walls were all painted plaster, with the south wall bearing the scars of a former staircase leading to the high doorway within the east wall. A modern timber staircase was positioned at the northeast side of the room, leading to the doorway with F10. The ceiling had exposed timbers and a lath and plaster covering (**Plate 202**), whilst the floor was limeash, laid on timber joists with timber laths set between the joists, and a layer of straw over the top (**Plate 203**). Within the east wall was a blocked doorway would have led into the adjacent F10b (**Plate 204**), and in the south wall, a doorway led to room F13. During the structural watching brief, the original limeash floor, and laths were removed, exposing the phase 2 timber joists (**Plate 205**). Openings were also inserted high into the east and west walls of the room, exposing both walls to be constructed from red brick (**Plates 206-207**).

Plate 200: General view of F12, Central Entranceway of the North Range (Film 32.03)

Plate 201: General view of F12, Central Entranceway of the North Range (Film 32.05)

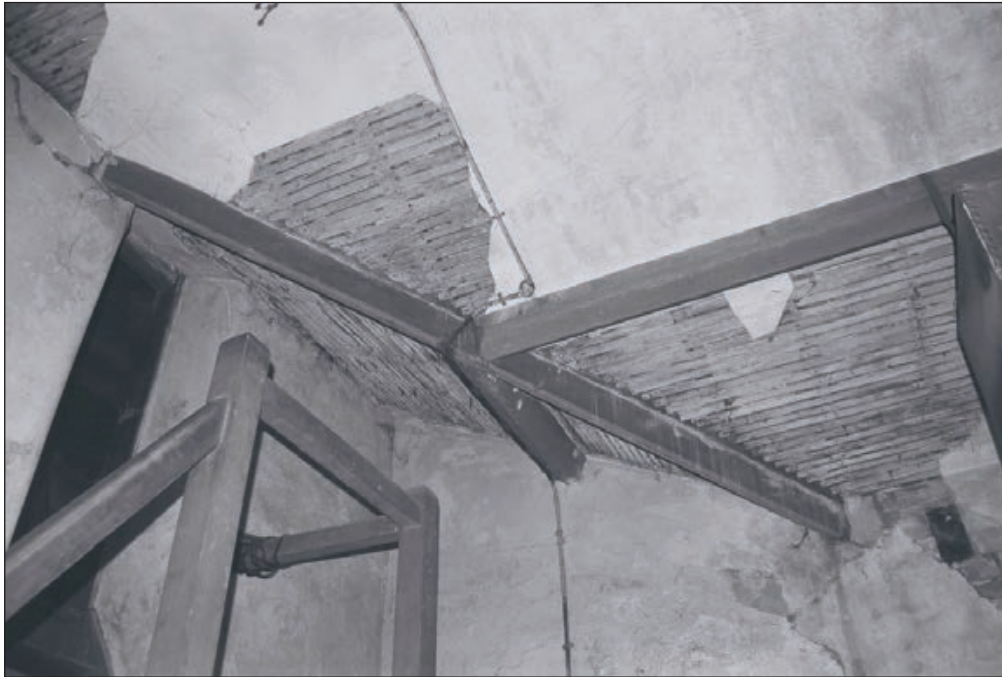
Plate 202: View of ceiling/roof structure of F12, Central Entranceway of the North Range (Film 42.01)

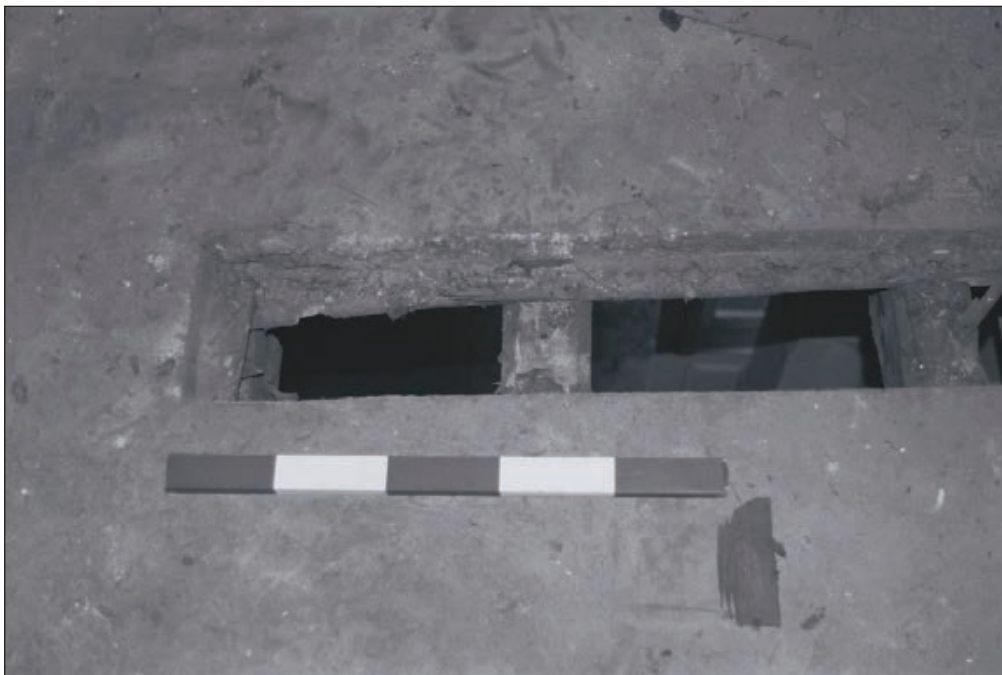
Plate 203: Detail of limeash floor on timber joists and laths, F12, Central Entranceway of the North Range (Film 42.11)

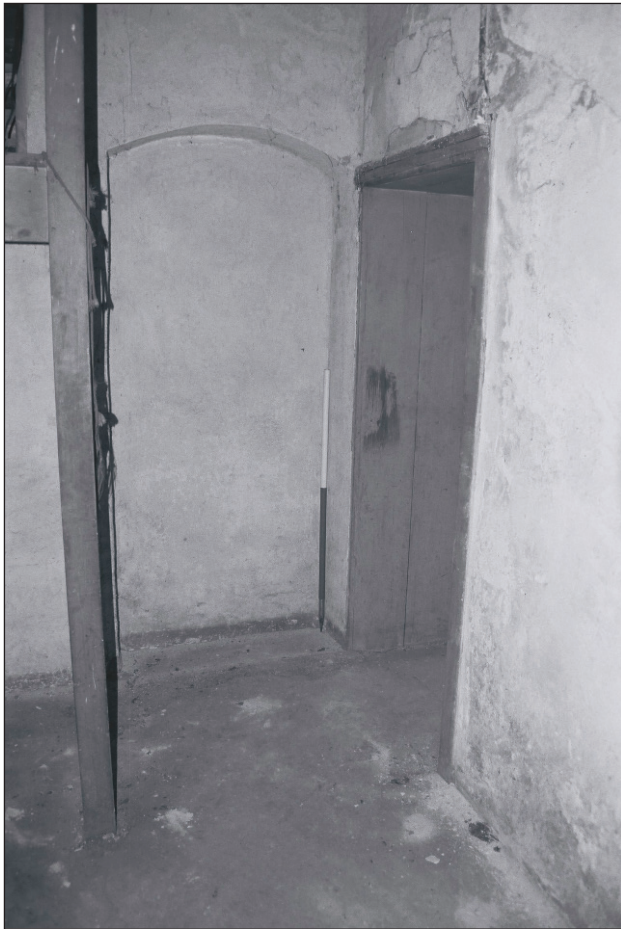
Plate 204: View of blocked doorway to F10b and doorway to F13, southeast corner of F12, Central Entranceway of the North Range (Film 42.08)

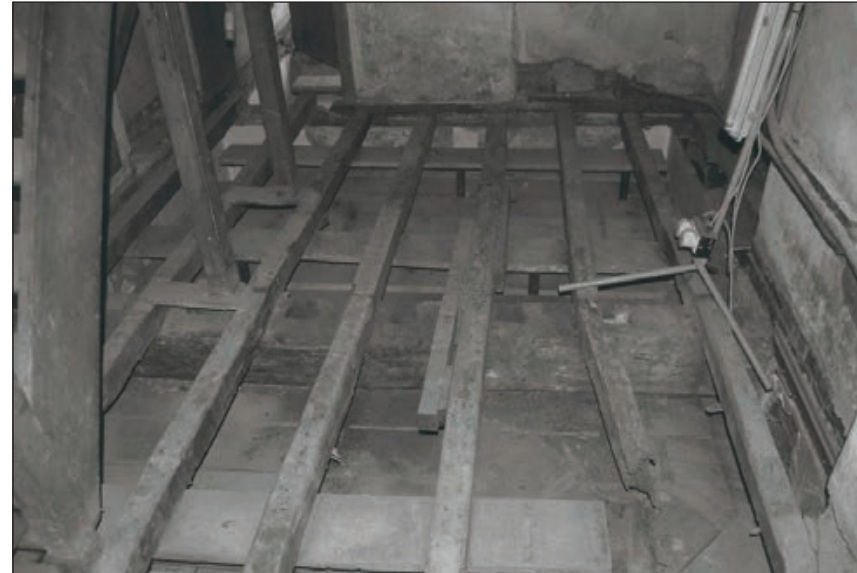
Plate 205: General view of exposed floor joists and beam after removal of limeash, F12, Central Entranceway of the North Range (Film 69.03)

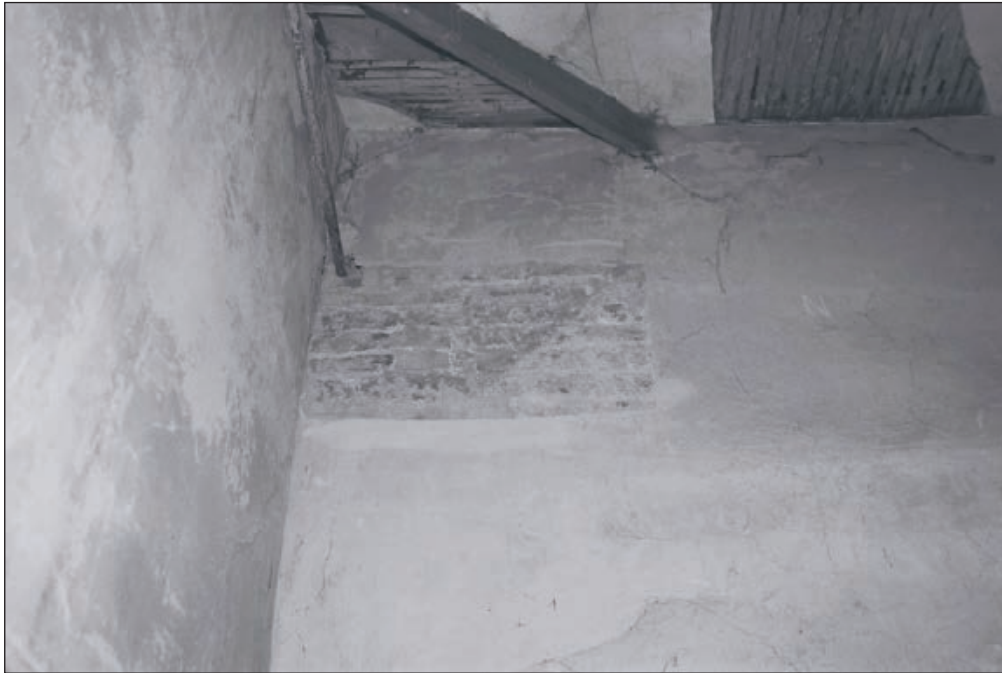
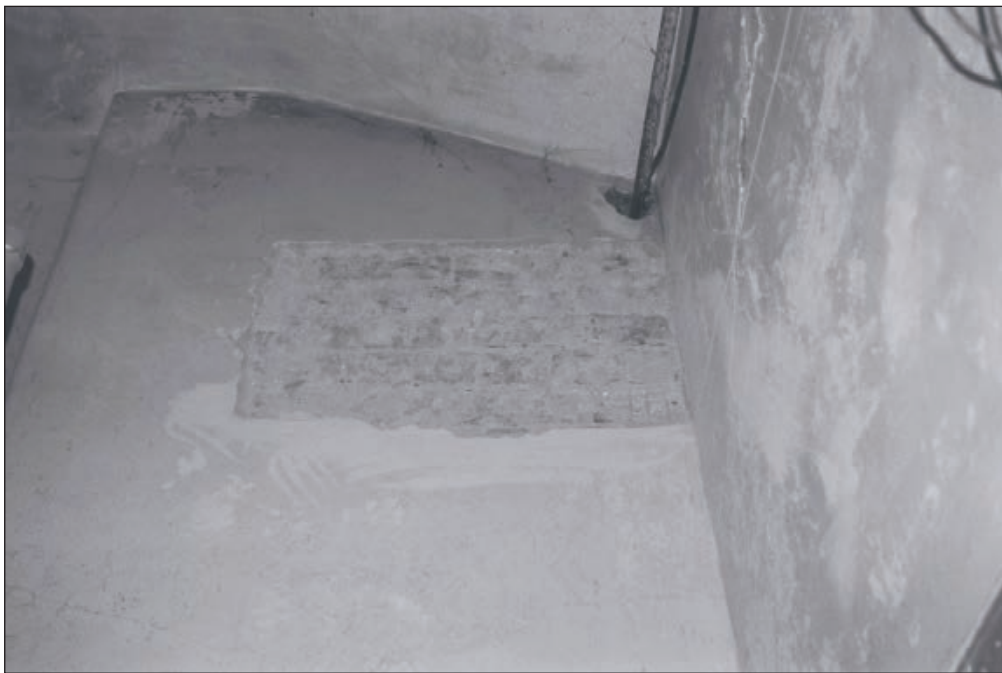
Plate 206: View of area of removed plaster exposing brick fabric, east wall of F12, Central Entranceway of the North Range - OB. 26 (Film 48.19)

Plate 207: View of area of removed plaster exposing brick fabric, west wall of F12, Central Entranceway of the North Range - OB. 27 (Film 48.17)

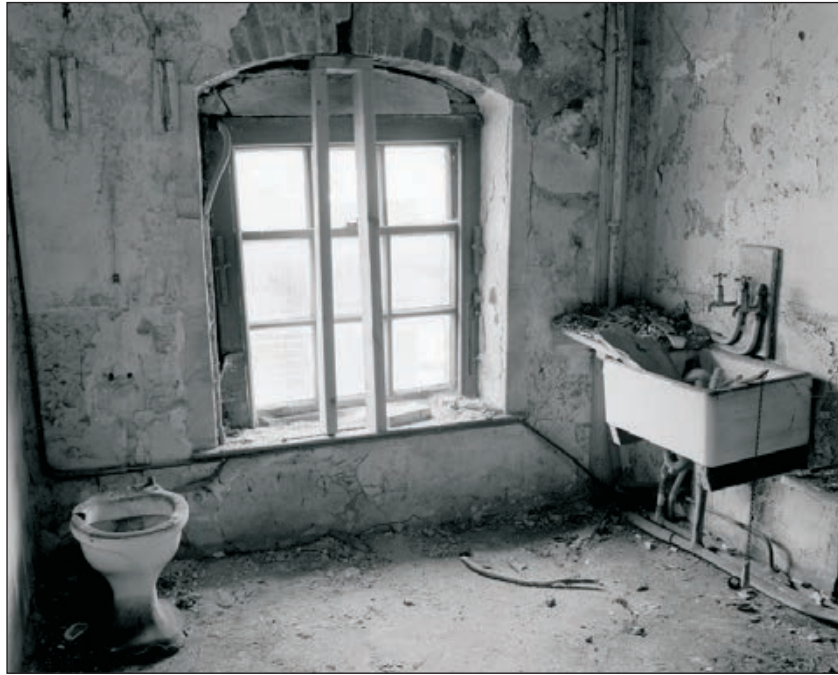
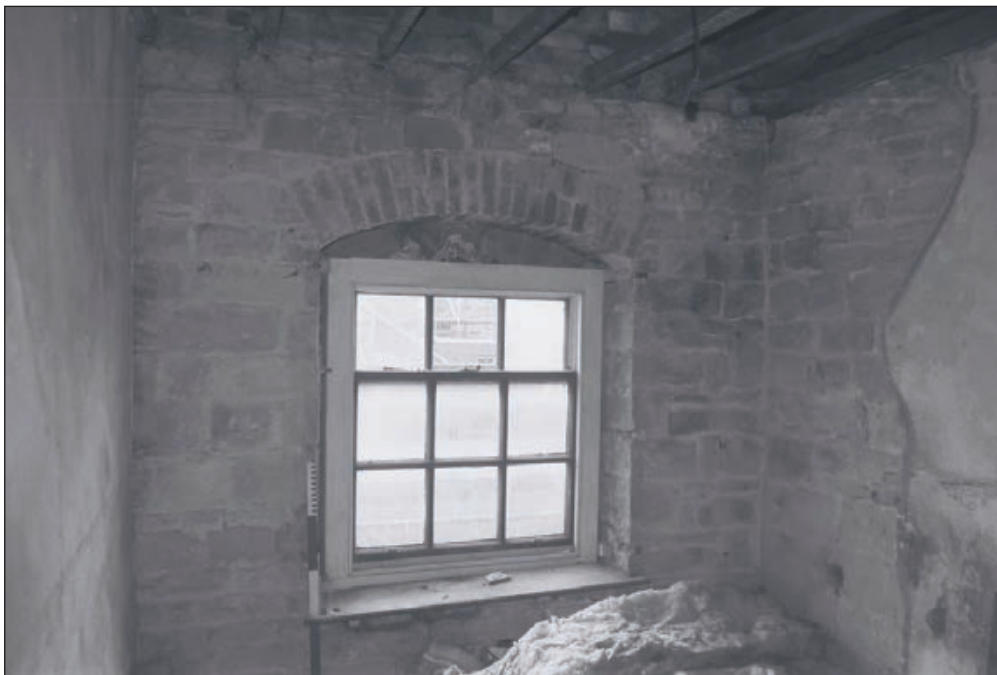
- 5.2.37 Accessed from F12 only, to the south room F13 appeared to have functioned most latterly as a bathroom in the 1940s/50s, with a sash window to the south, toilet, basin and bath (**Plates 208, 209**). The south wall and the southern half of the west wall were constructed from stone, whilst the remaining walls were all of a brick construction. The northern half of the west wall contained a brick arched blocked doorway or recess (**Plates 210-211**), and the north wall contained a doorway to F12 and two adjacent brick blocked windows (**Plates 212-215**), all with segmental brick arched heads. The ceiling was lath and plaster, the removal of which exposed the end of a

Plate 208: General view of room F13, Central Entranceway of the North Range (Film 32.07)

Plate 209: General view of F12 after removal of bathroom fittings and plaster from walls, Central Entranceway of the North Range (Film 76.22)

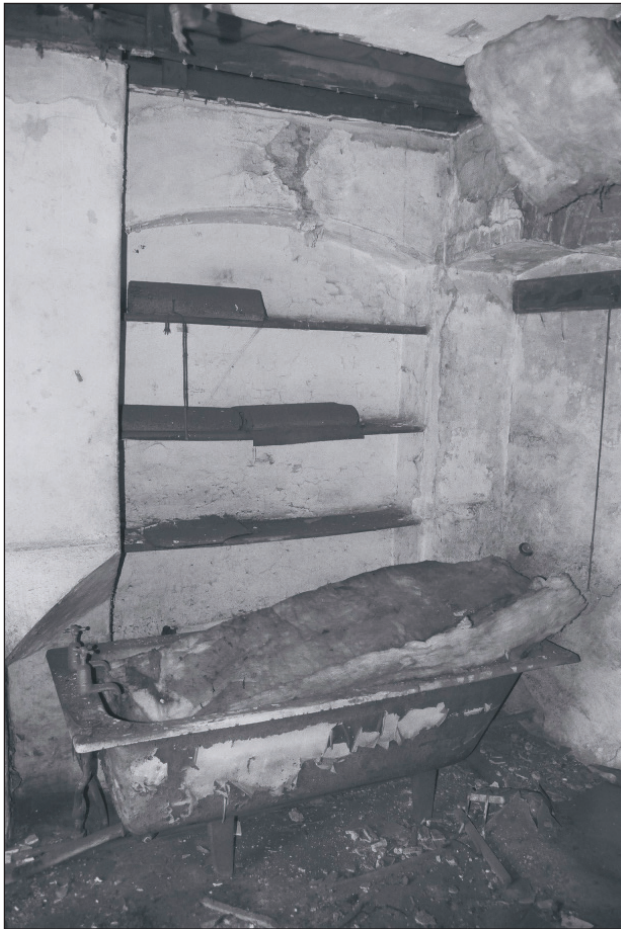
Plate 210: General view of northwest corner of F13, Central Entranceway of the North Range, showing blocked opening (Film 42.03)

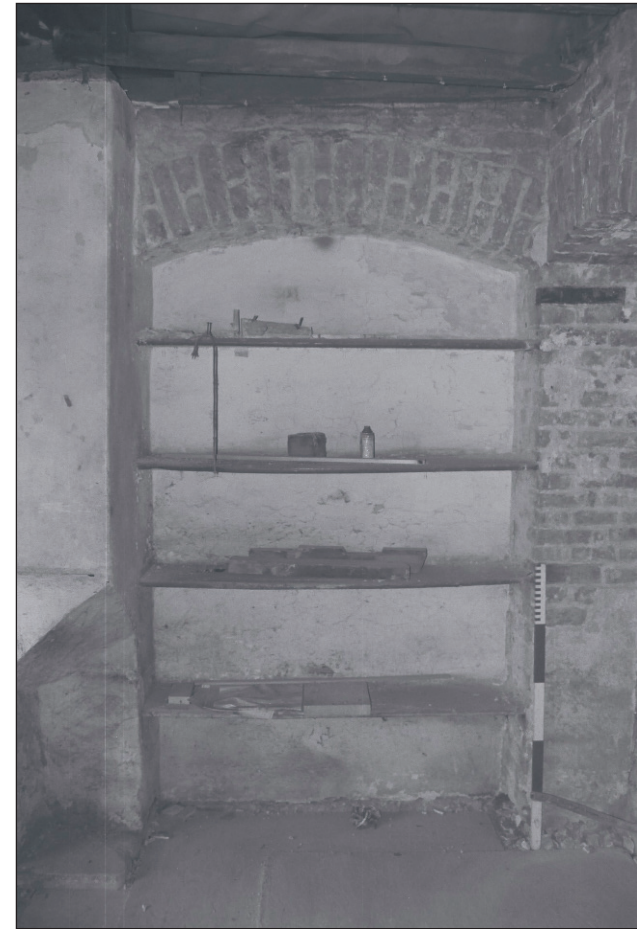
Plate 211: General view of the northwest corner of F12, Central Entranceway of the North Range, after removal of bathroom fittings and plaster (Film 76.24)

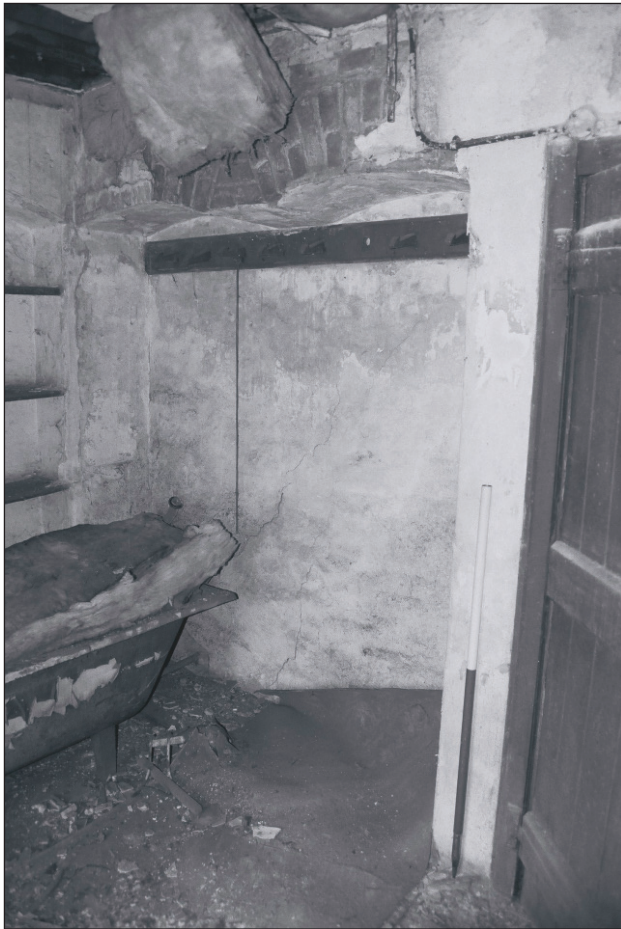
Plate 212: General view of north wall of F13, Central Entranceway of the North Range, showing blocked opening (Film 42.05)

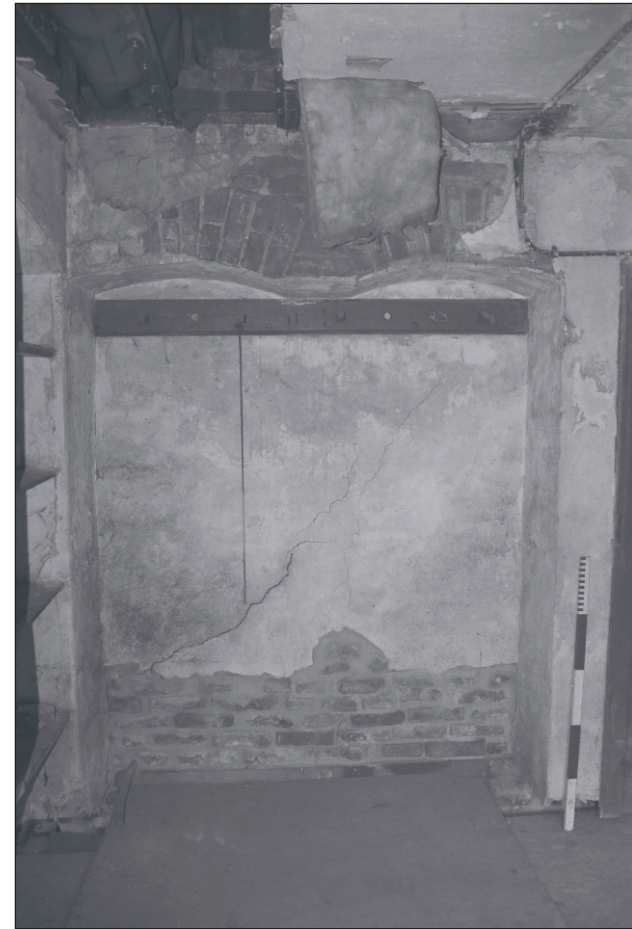
Plate 213: View of the north wall of F12, Central Entranceway of the North Range, showing blocked opening (Film 74.12)

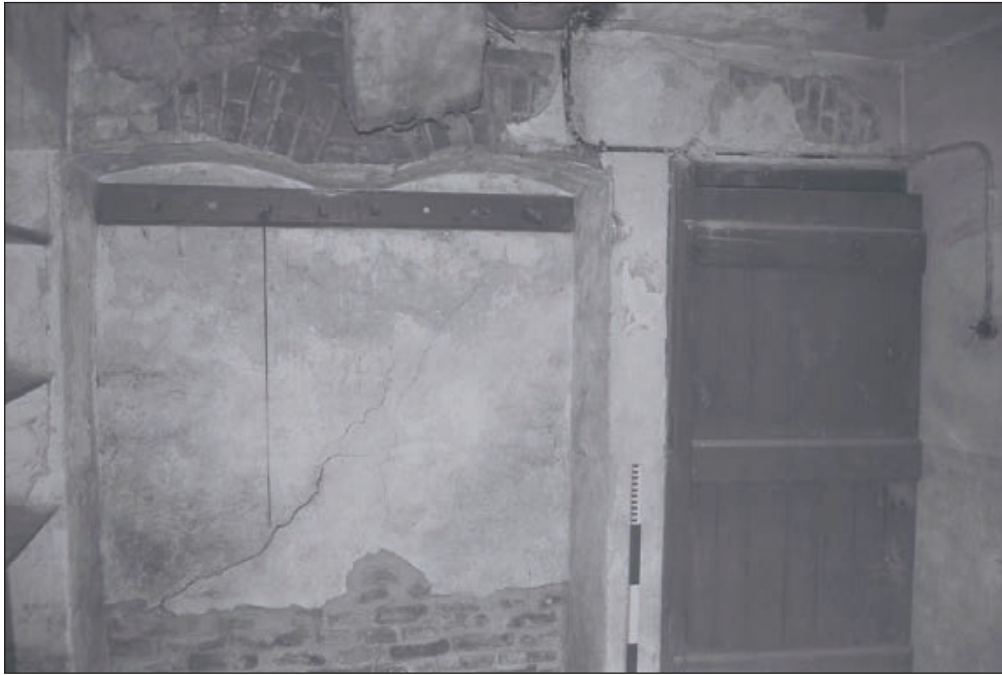
Plate 214: General view of north wall of F13, Central Entranceway of the North Range, showing blocked opening and doorway (Film 74.15)

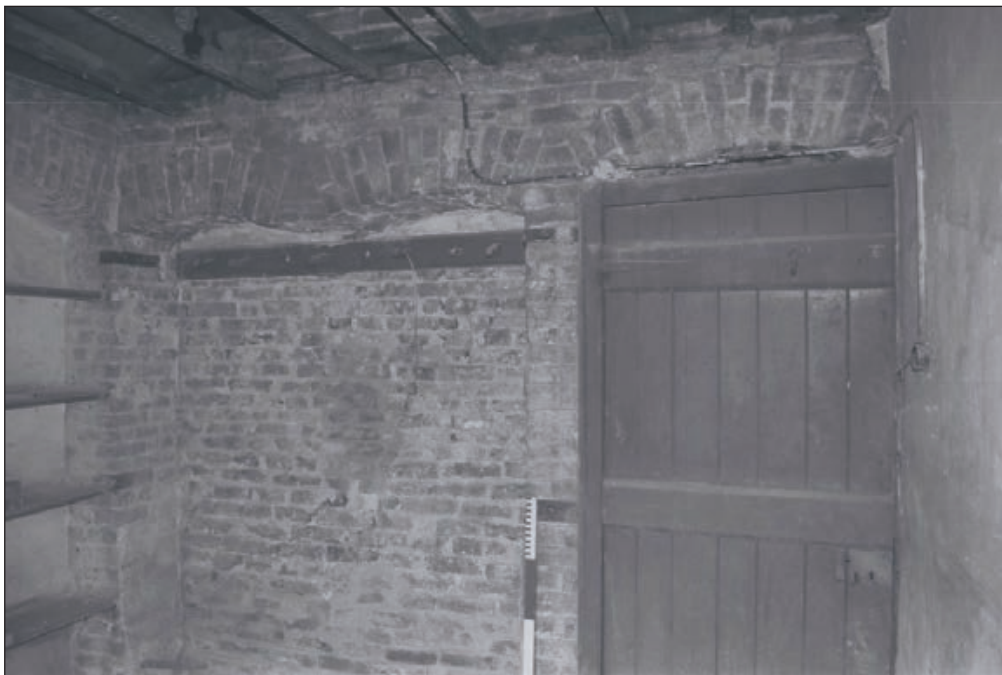
Plate 215: General view of F12 after removal of bathroom fittings and plaster from walls, Central Entranceway of the North Range (Film 76.25)

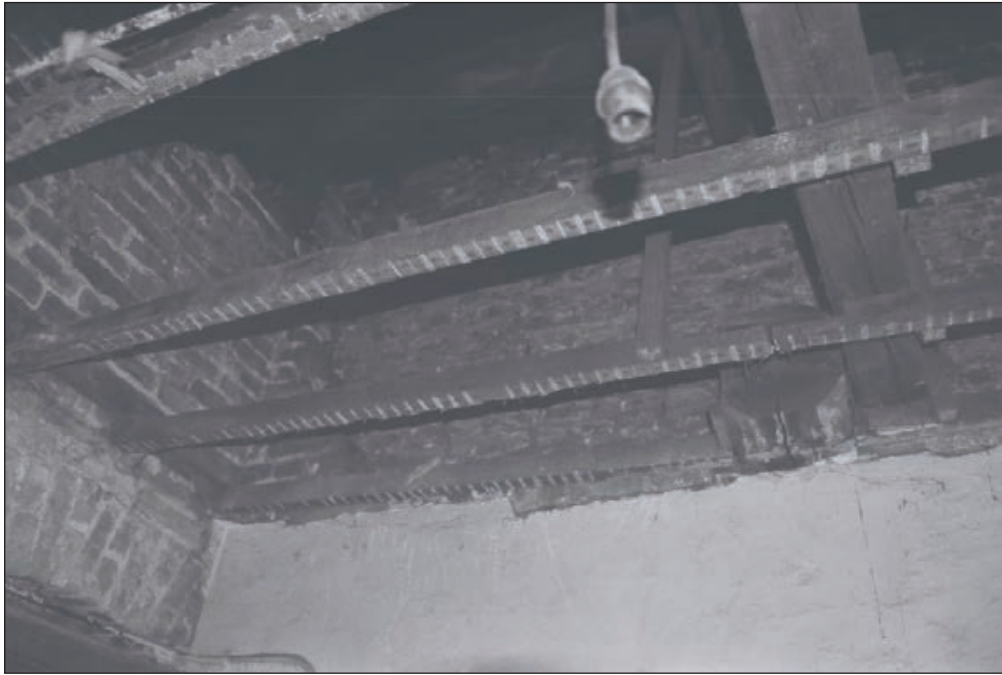
large timber beam from F10, and possibly several phases of brickwork above (**Plate 216**). The floor was a continuation of the limeash within F12, the removal of which again exposed the original phase 2 timber joists (**Plate 217, 219**), some with visible construction marks (**Plate 218**), whilst all had dovetail jointed ends and wooden pegged joints (**Plates 220-221**).

Plate 216: View of exposed ceiling structure, brick fabric of upper walls and timber beams from F10, room F13, Central Entranceway of the North Range (Film 76.19)

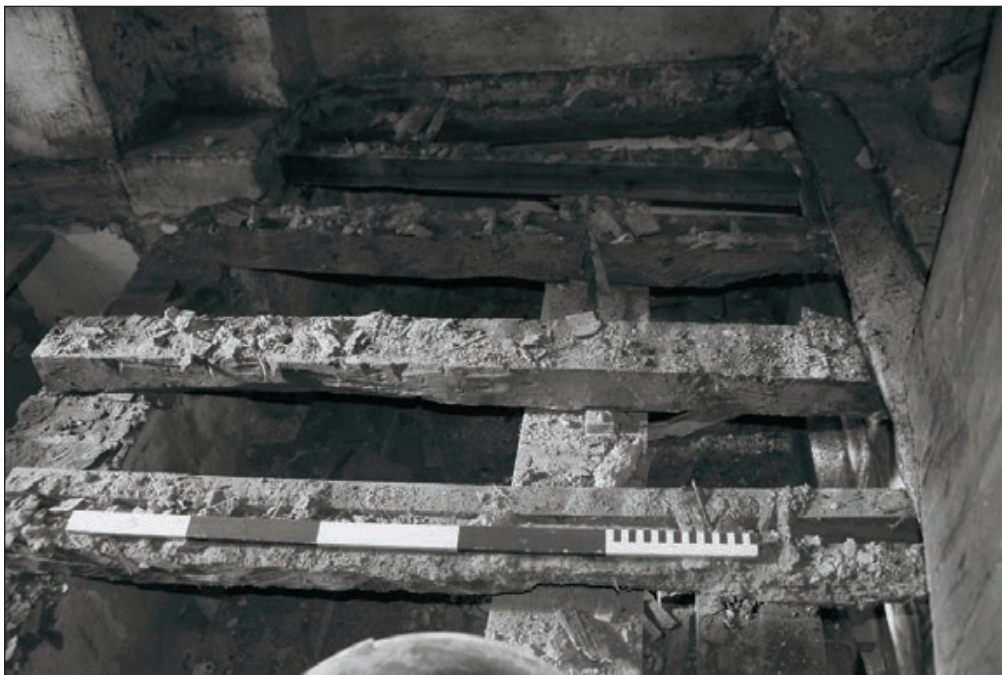
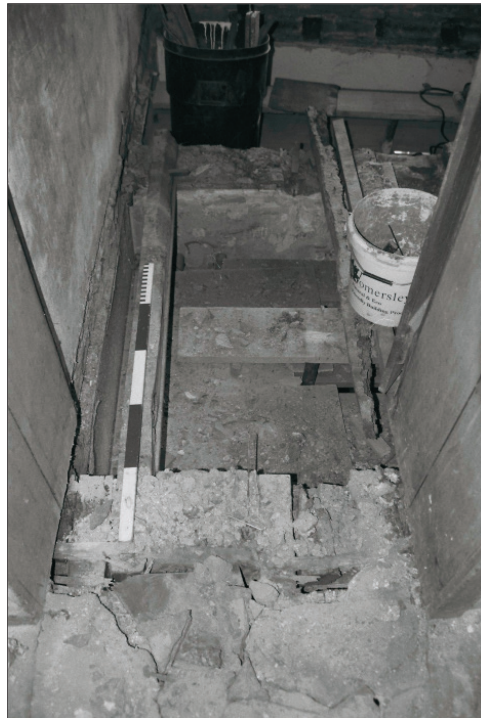
Plate 217: General view of exposed timber floor joists, room F13, Central Entranceway of the North Range, after removal of limeash (Film 69.33)

Plate 219: General view of exposed timber floor joists, room F13, Central Entranceway of the North Range, after removal of limeash (Film 69.35)

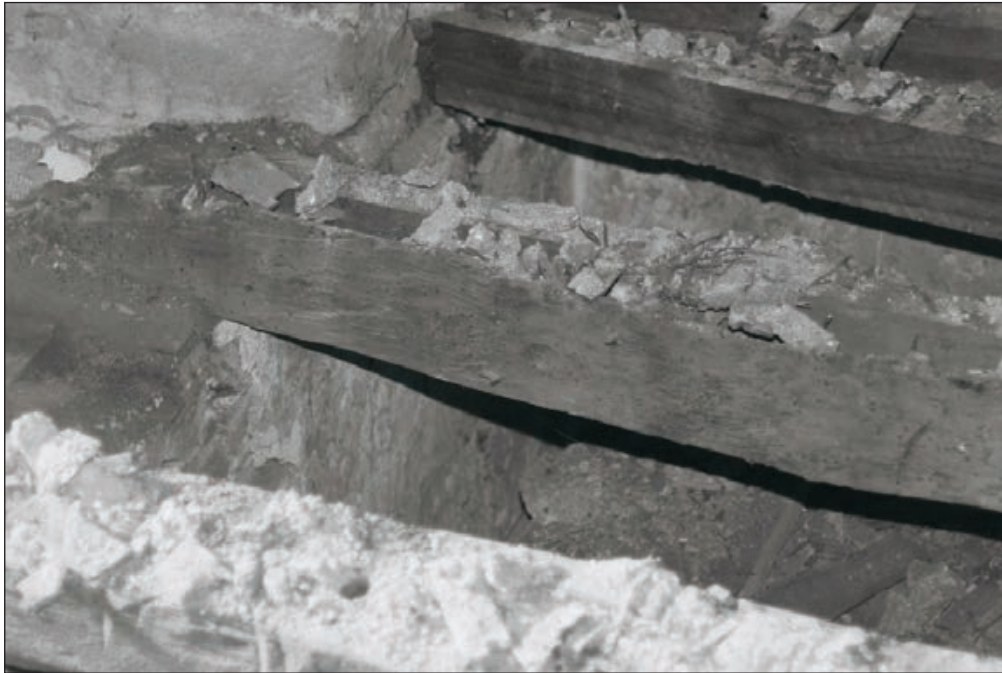
Plate 218: Detail of exposed timber floor joists, room F13, Central Entranceway of the North Range, after removal of limeash, showing construction marks (Film 69.30)

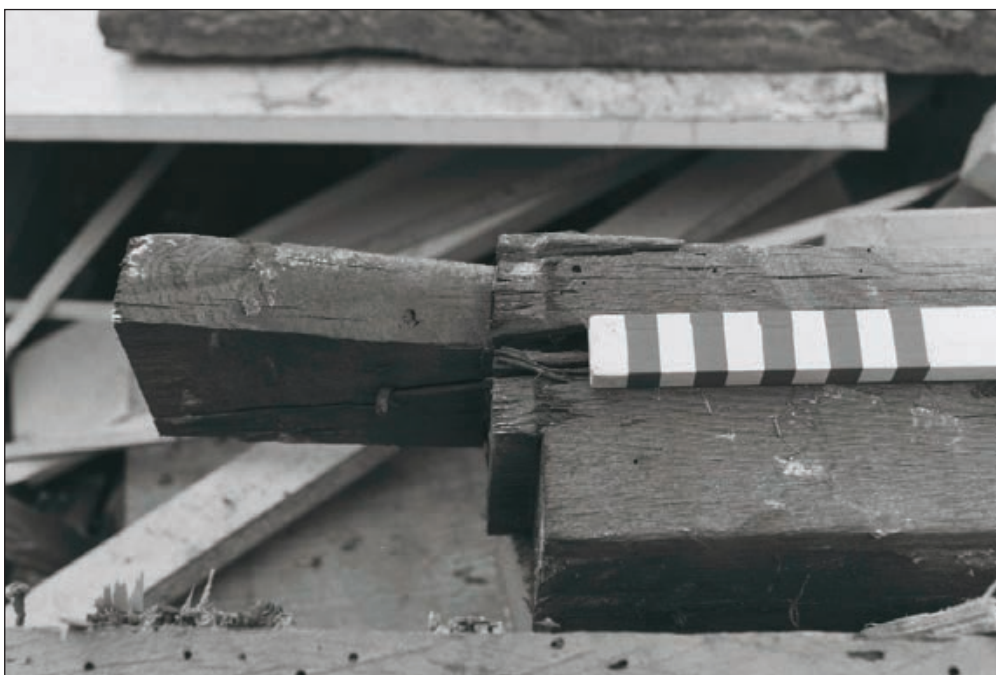
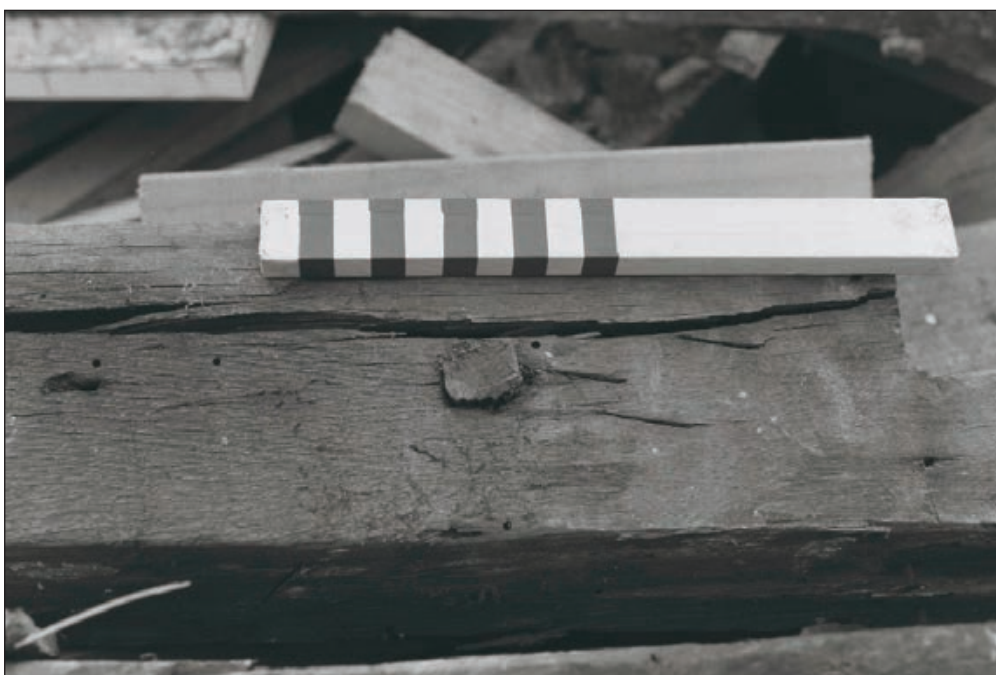
Plate 220: Detail of removed timber floor joists from room F13, Central Entranceway of the North Range, showing dovetail joint (Film 69.16)

Plate 221: Detail of pegged joint of removed timber joists from room F13, Central Entranceway of the North Range (Film 69.15)

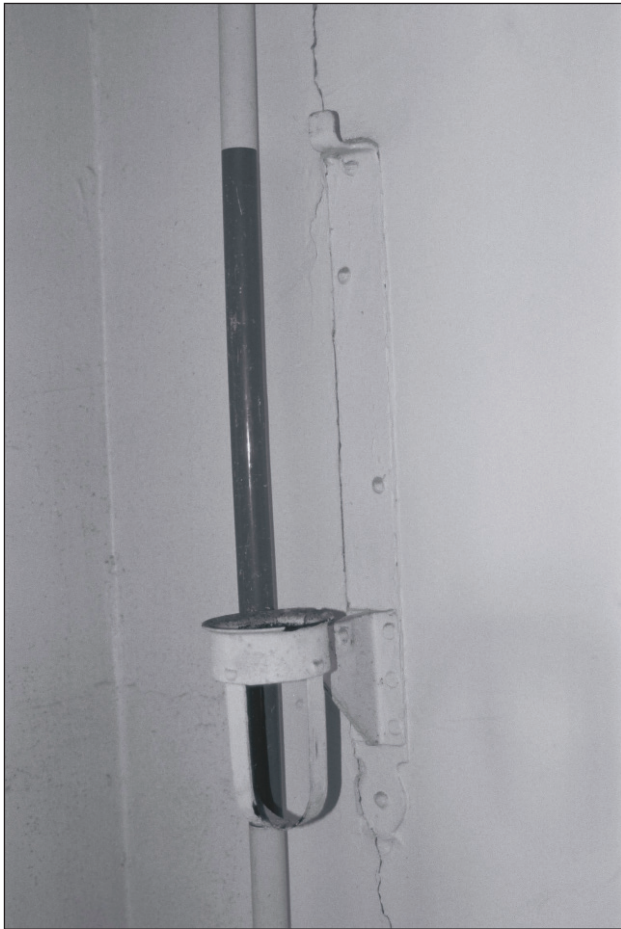
- 5.2.38 Room F14 was a small corridor/landing area leading from F11 to the east, to F18 to the west (**Figure 13**), part of the phase 7 western element of the North Range. There was a window to the north, whilst to the south there was a break in the wall (brick and lath and plaster stud) delineating the position of the join between the phase 2 and phase 7 elements of the structure (**Plate 223**). Also positioned on the wall was a metal bracket (**Plate 222**).

Plate 222: Detail of metal bracket on south wall of corridor F14, West Side of the North Range (Film 25.29)

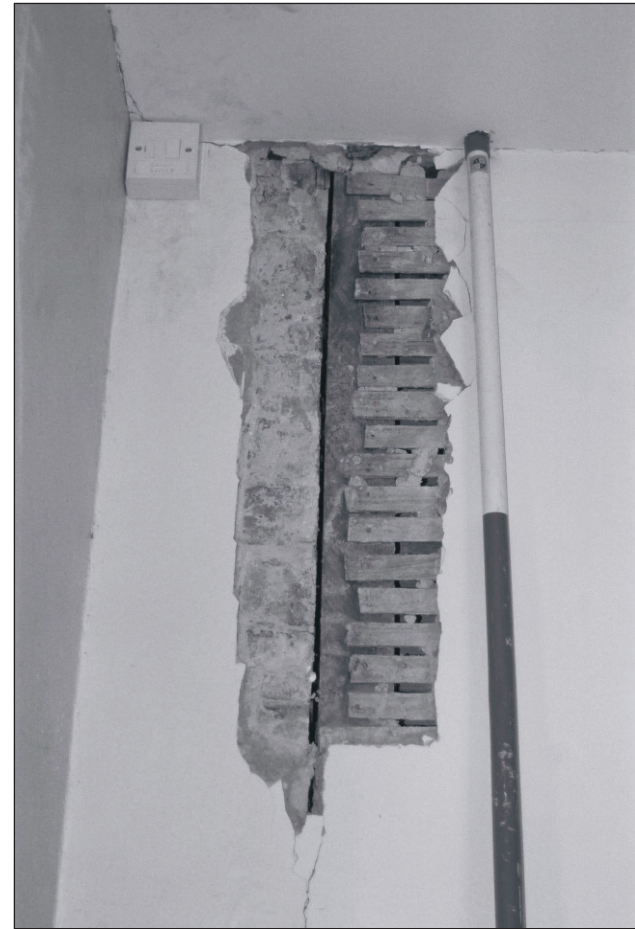
Plate 223: Detail of exposed join in brick and stud wall, south wall of corridor F14, West Side of the North Range (Film 25.30)

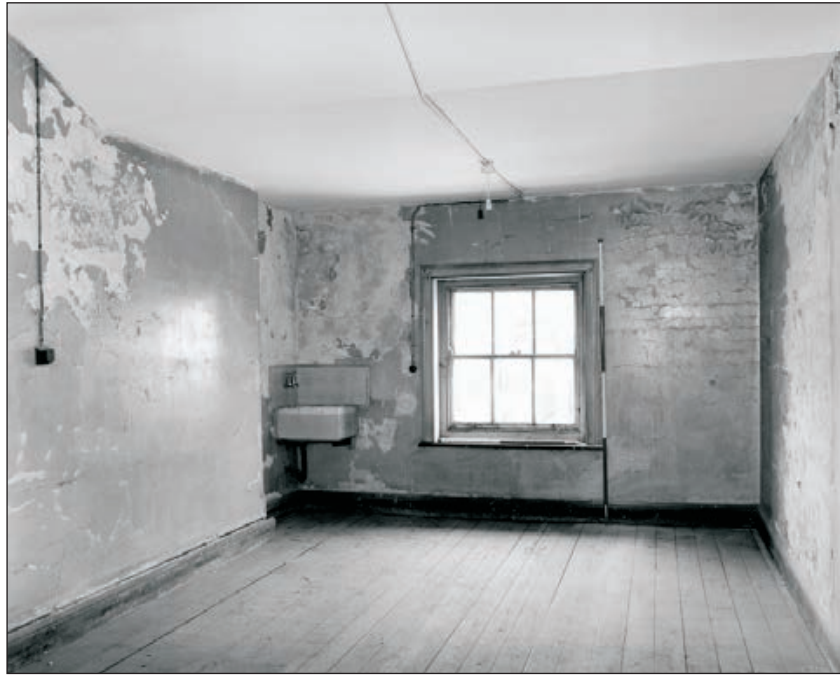
Plate 224: General view of room F15, West Side of the North Range (Film 31.03)

- 5.2.39 Leading off to the south of F14 was room F15 (**Plates 224-225**), a fairly plain room, rectangular in plan, with painted plastered walls, timber boarded floor, and lath and plaster ceiling. There was a fireplace in the east wall with cast iron range (**Plate 226**), and original phase 7 moulded skirting surrounded the room (**Plate 227**). To the north was the doorway from F14 with a timber panelled door (**Plate 228**) and to the south was a sash window (**Plate 229**). Positioned within the southeast corner of the room was a ceramic sink (**Plate 230**). Its removal exposed the stone phase 2 east wall (**Plate 231**). The lifting the floor boards revealed double timber joists with a lath a plaster ceiling attached below (**Plate 232**).
