NOSTELL PRIORY STABLES, NOSTELL, WAKEFIELD, WEST YORKSHIRE

Historic Building Recording and Structural Watching Brief

Planning Application Ref: 09/00701/FUL & 09/00705/LBC

72934.01_BDG_V0_4

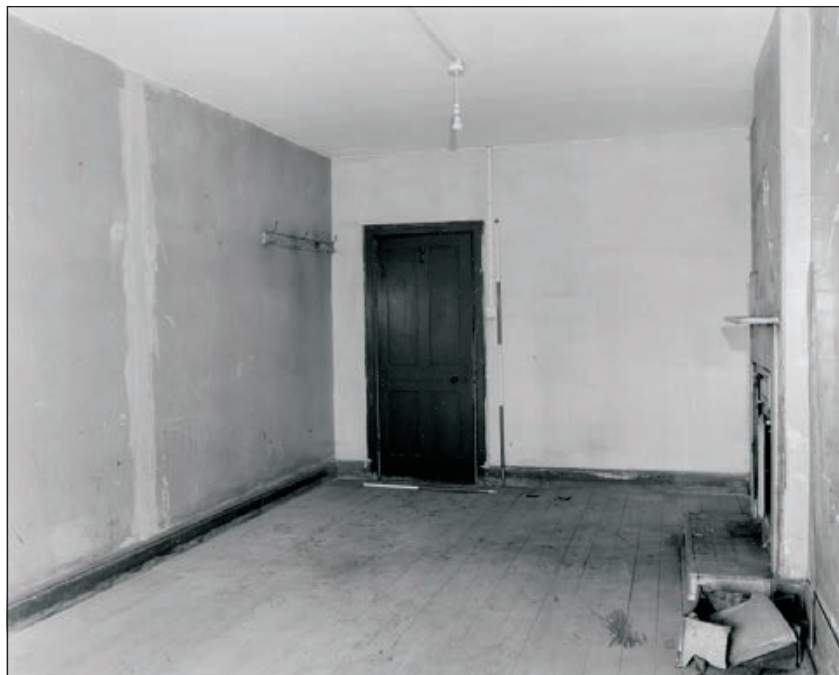
Plate 225: General view of room F15, West Side of the North Range (Film 31.05)

- 5.2.39 Leading off to the south of F14 was room F15 (**Plates 224-225**), a fairly plain room, rectangular in plan, with painted plastered walls, timber boarded floor, and lath and plaster ceiling. There was a fireplace in the east wall with cast iron range (**Plate 226**), and original phase 7 moulded skirting surrounded the room (**Plate 227**). To the north was the doorway from F14 with a timber panelled door (**Plate 228**) and to the south was a sash window (**Plate 229**). Positioned within the southeast corner of the room was a ceramic sink (**Plate 230**). Its removal exposed the stone phase 2 east wall (**Plate 231**). The lifting the floor boards revealed double timber joists with a lath a plaster ceiling attached below (**Plate 232**).

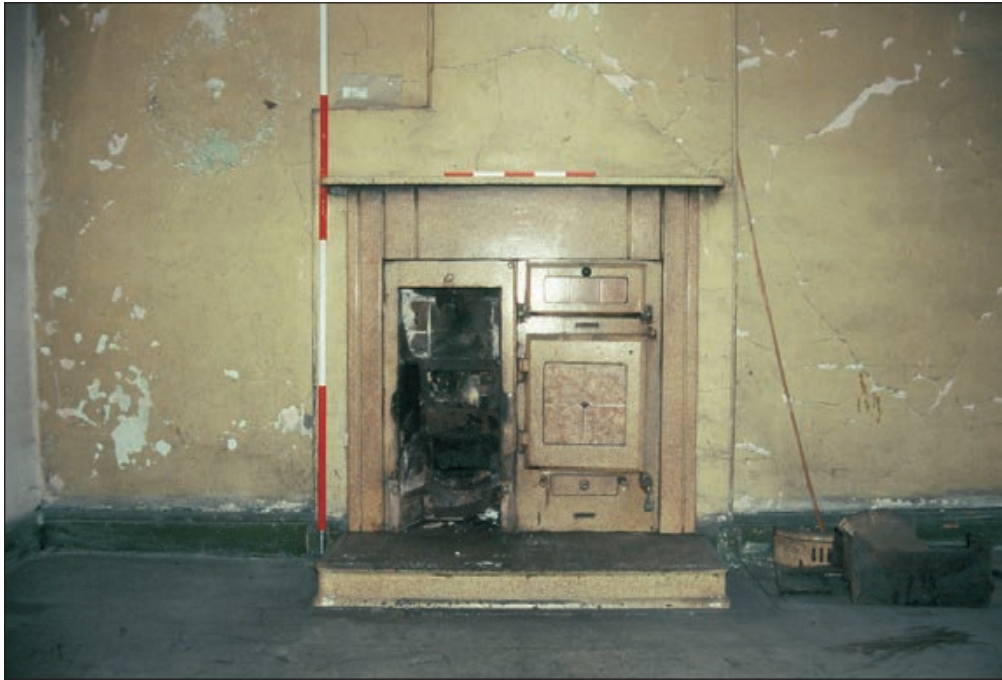
Plate 226: View of range, east wall of room F15, West Side of the North Range (Film C.S. 28)

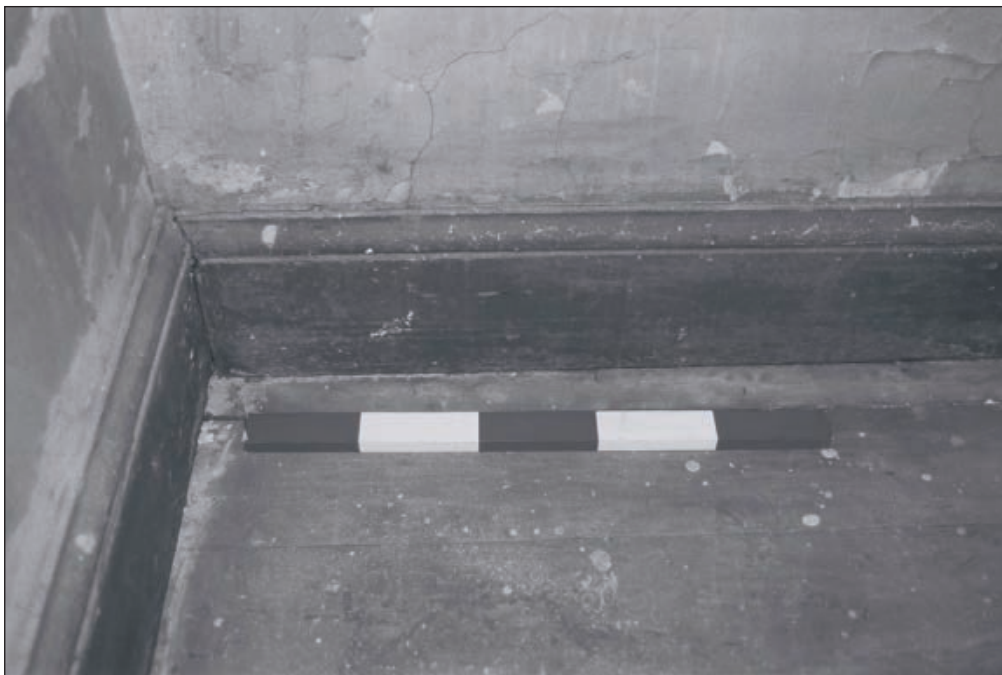
Plate 227: Detail of skirting boards, room F15, West Side of the North Range (Film 25.20)

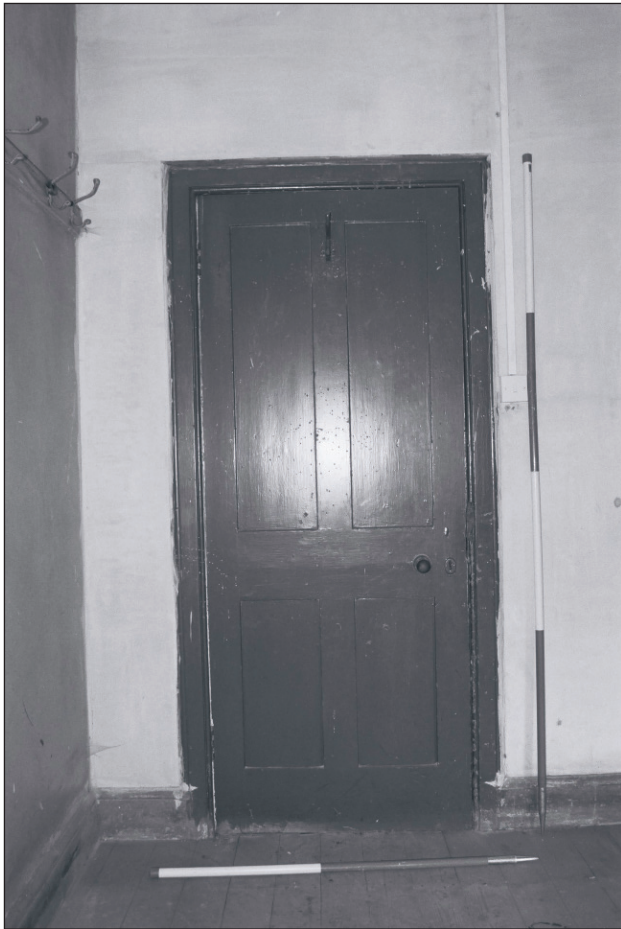
Plate 228: Detail of door from corridor F14, north wall of room F15, West Side of the North Range (Film 25.19)

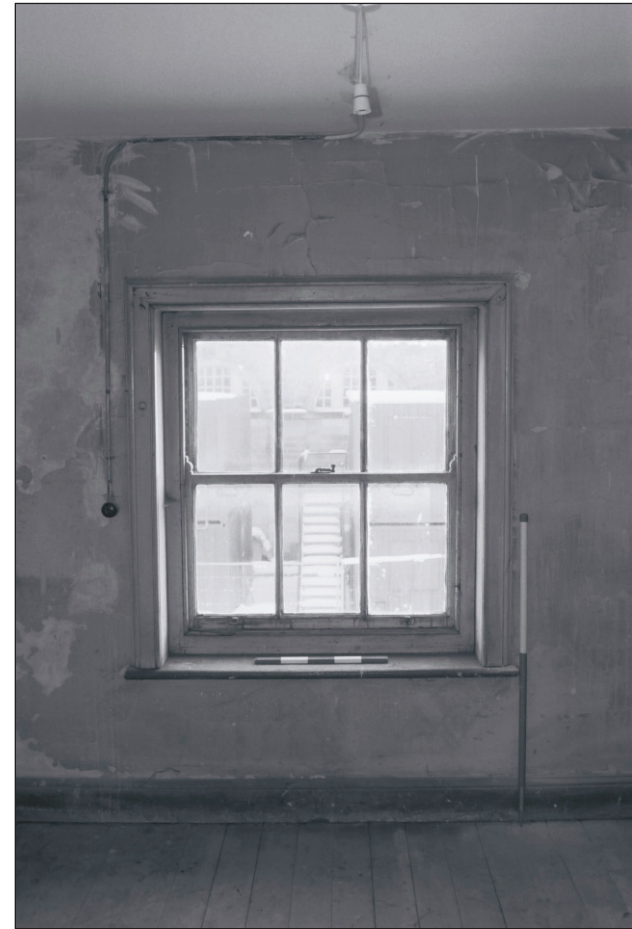
Plate 229: Detail of sash window in south wall of room F15, West Side of the North Range (Film 25.22)

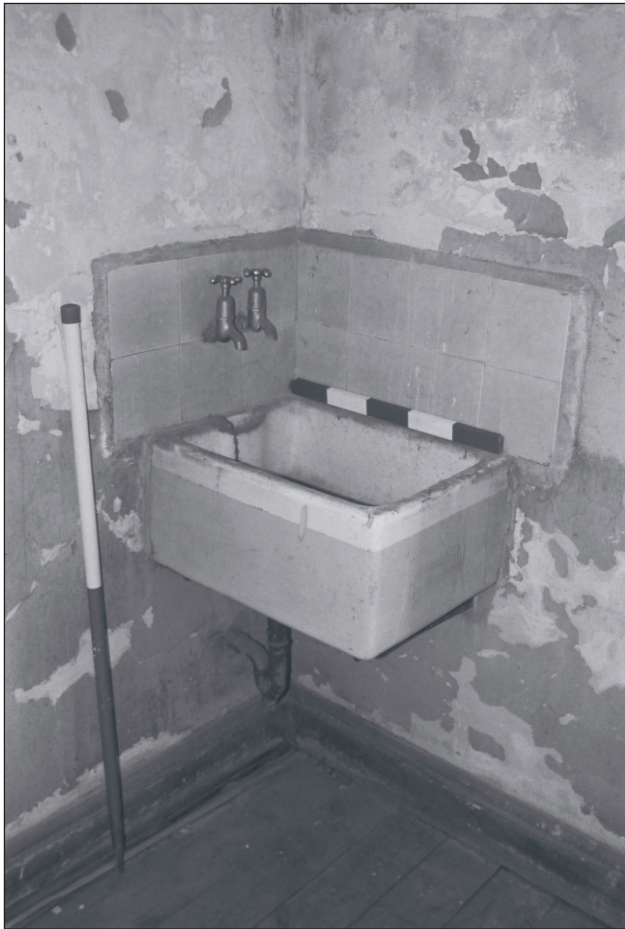
Plate 230: Detail of door ceramic sink in southeast corner of F15, West Side of the North Range (Film 25.25)

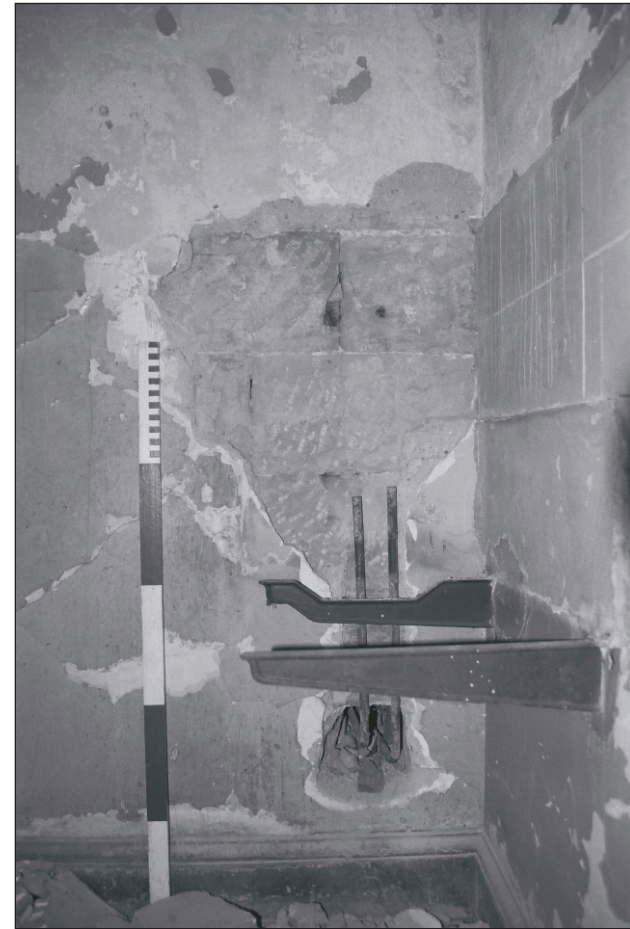
Plate 231: Detail southeast corner of room F15, West Side of the North Range, showing exposed stonework - OB. 30 (Film 51.24)

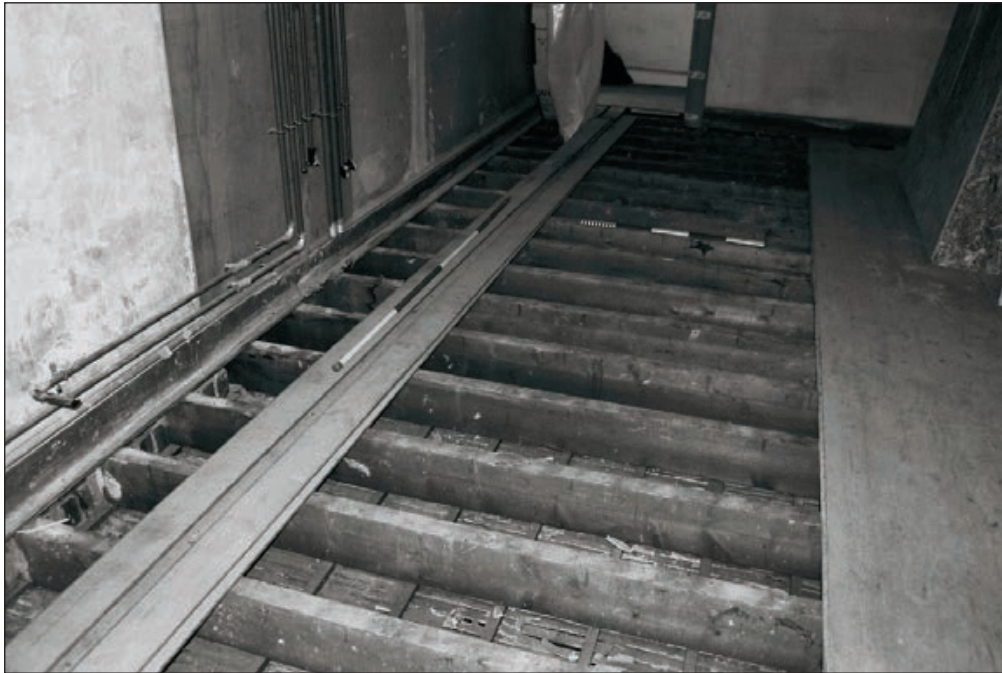
Plate 232: View of exposed timber floor structure, room F15, West Side of the North Range - OB. 43 (Film 53.17)

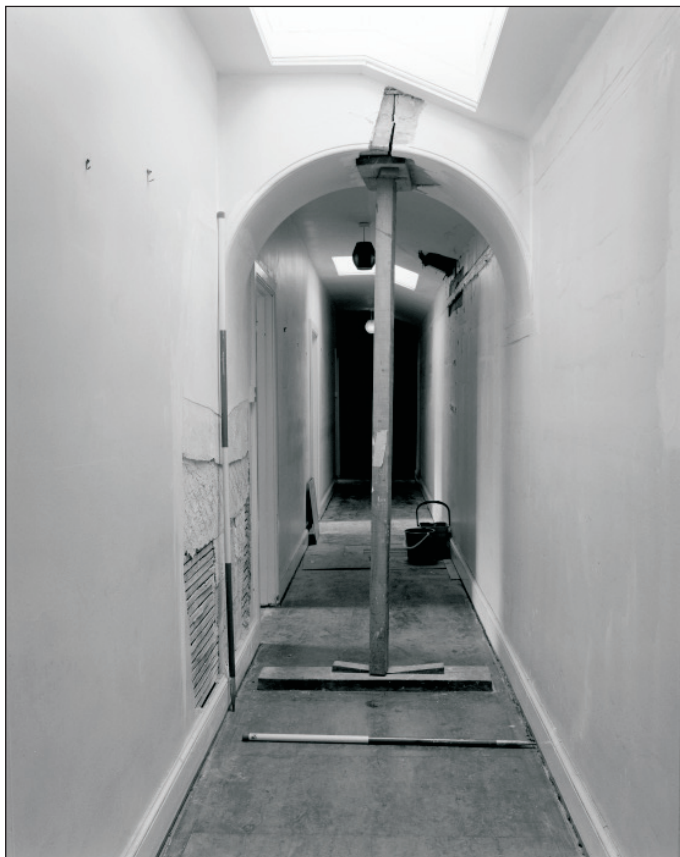
Plate 233: General view along corridor F18, West Side of the North Range (Film 33.09)

- 5.2.40 To the west of F14, running along the north side of the range was corridor F18 (**Plate 233**). This had a timber boarded floor, picture rail (**Plate 234**) and two skylights (**Plate 235**). Four rooms (F16-17 and F19-20) were positioned off to the south of F18 (**Figure 13**).

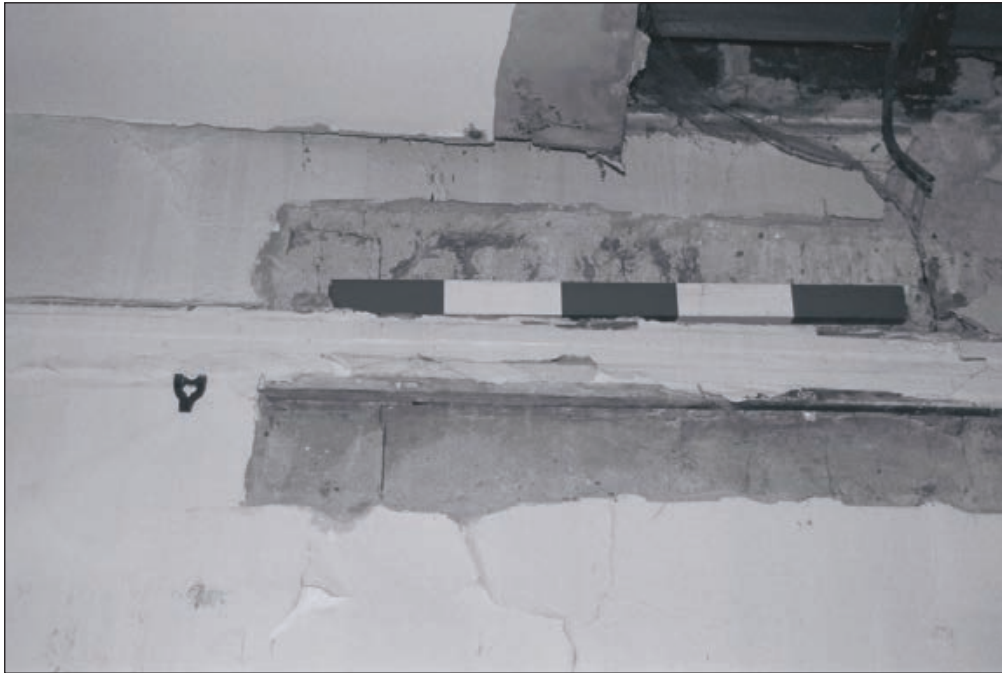
Plate 234: Detail of picture rail, north wall of corridor F18, West Side of the North Range (Film 25.13)

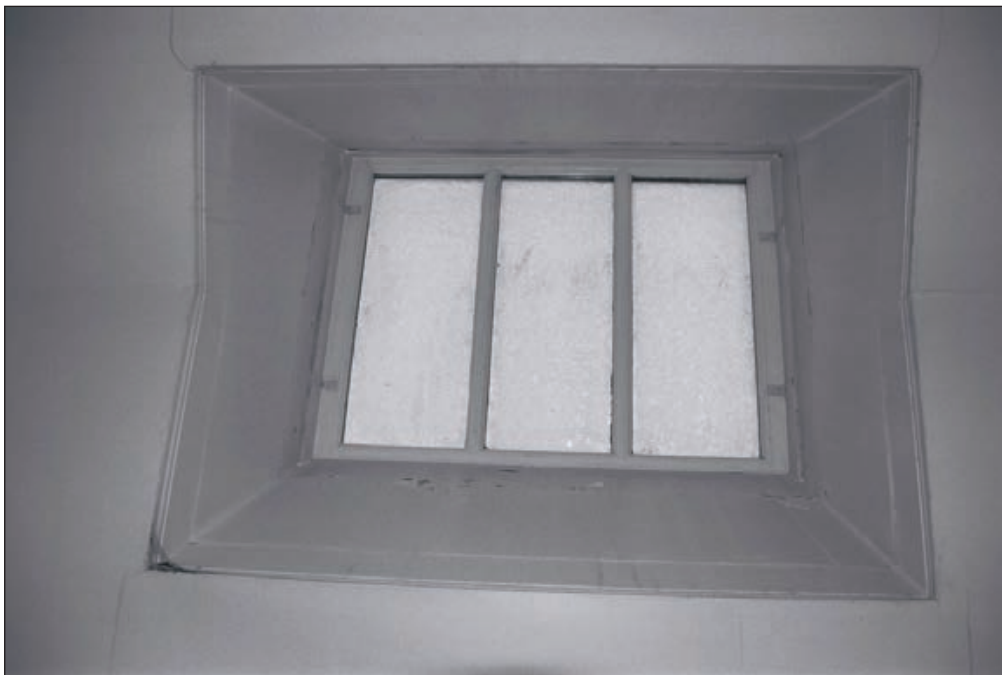
Plate 235: Detail of skylight in ceiling of corridor F18, West Side of the North Range (Film 25.10)

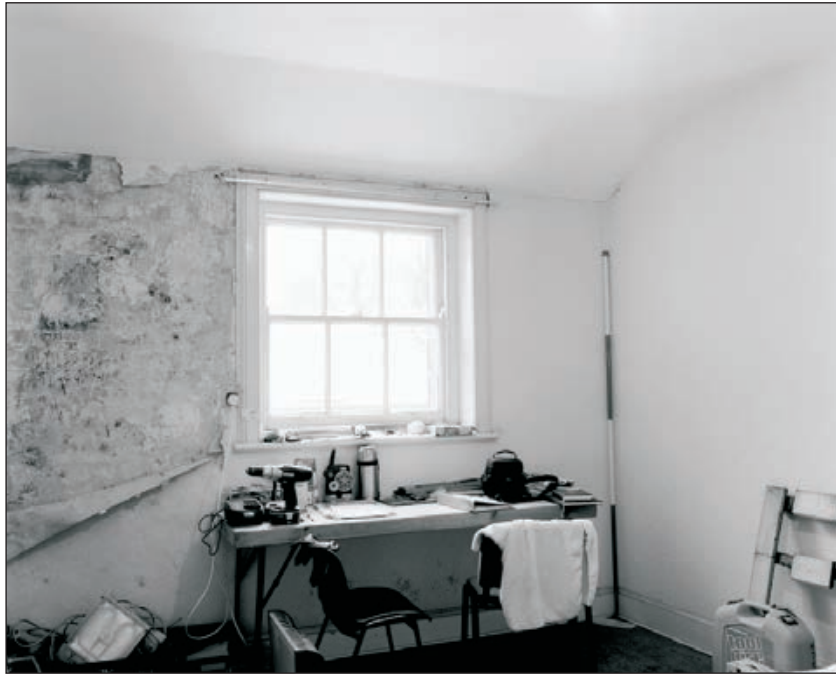
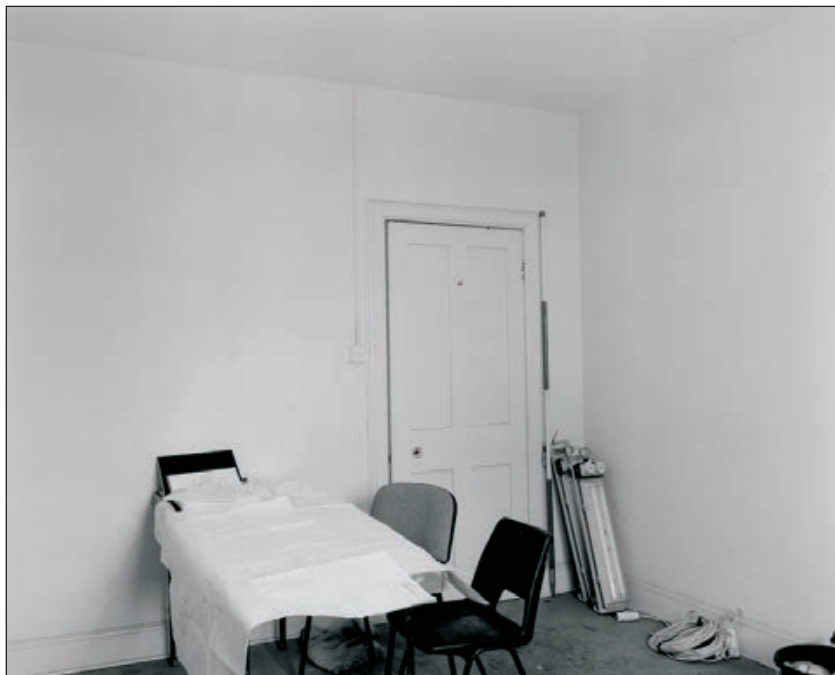
Plate 236: General view of room F16, West Side of the North Range (Film 30.07)

Plate 237: General view of room F16, West Side of the North Range (Film 30.10)

- 5.2.41 Room F16 was to the west of F15, accessed from corridor F18. This was a small rectangular room, with window to the south, timber panelled door and boarded floor (**Plates 236-237**). There was a cast iron fireplace with plain wooden surround in the west wall (**Plate 238**). The lifting of the floor boards exposed double timber joist floor construction and a lath and plaster ceiling (**Plate 239**).

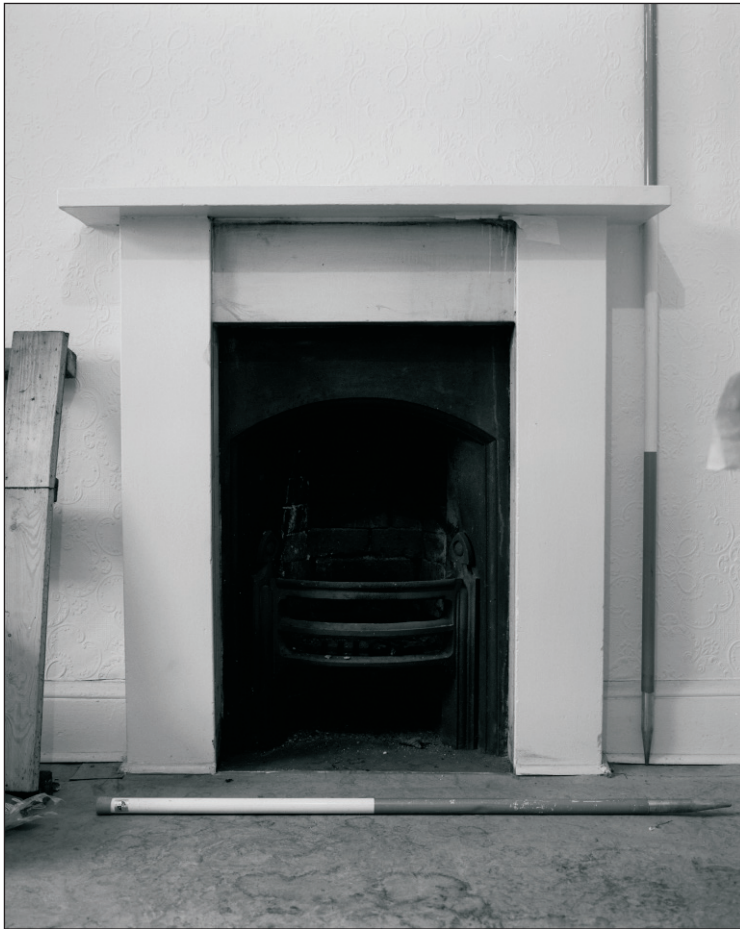
Plate 238: Detail of fireplace, west wall of room F16, West Side of the North Range (Film 31.01)

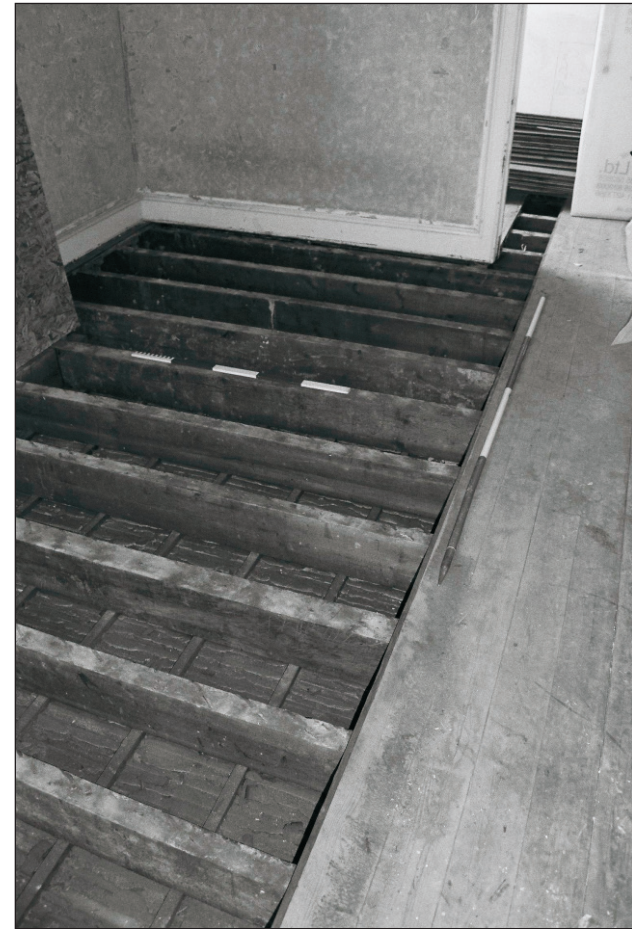
Plate 239: Detail of exposed timber floor structure, room F16, West Side of the North Range - OB. 42 (Film 53.20)

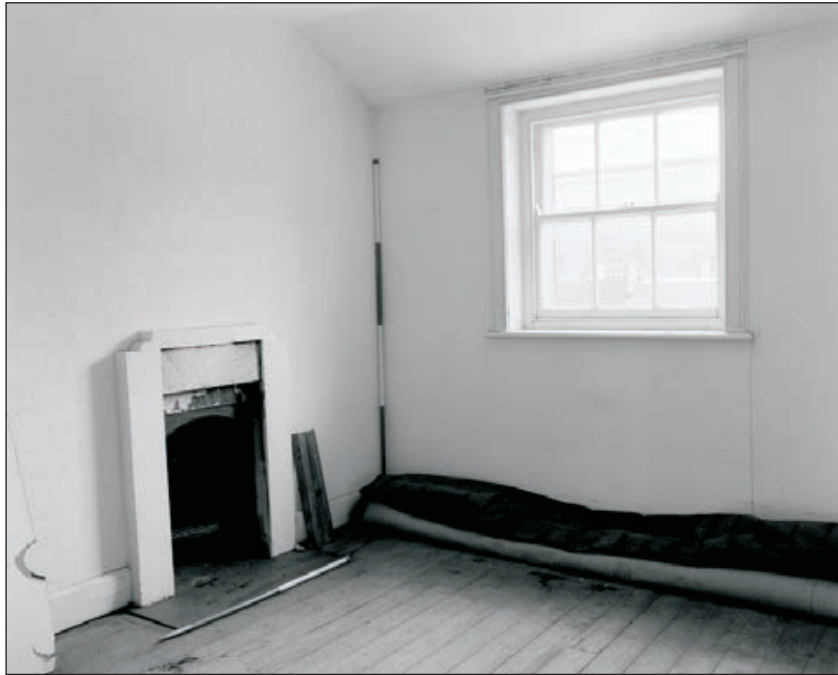
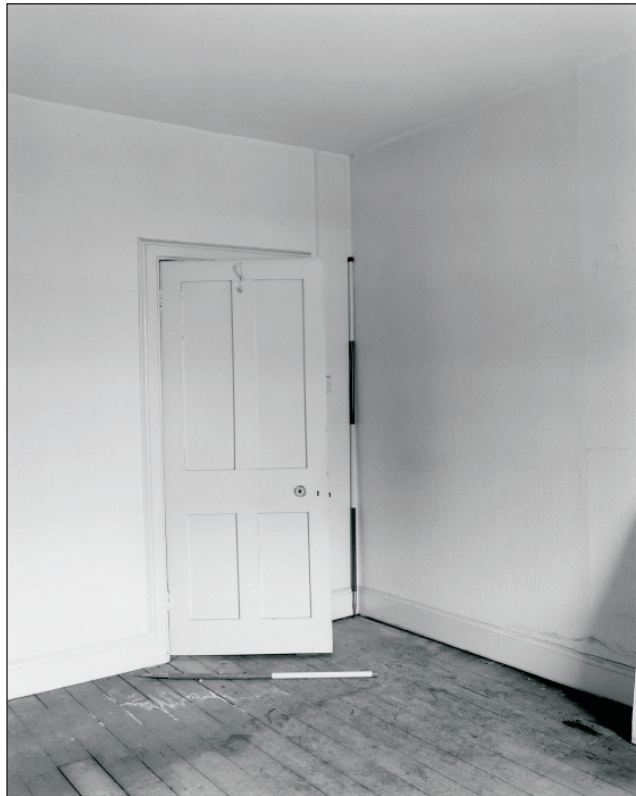
Plate 240: General view of room F17, West Side of the North Range (Film 34.01)

Plate 241: General view of room F17, West Side of the North Range (Film 34.03)

- 5.2.42 To the west was room F17 (**Plates 240-241**), which had a window to the south, timber panelled door to F18, and cast iron fireplace with later surround within the east wall (**Plate 242**).

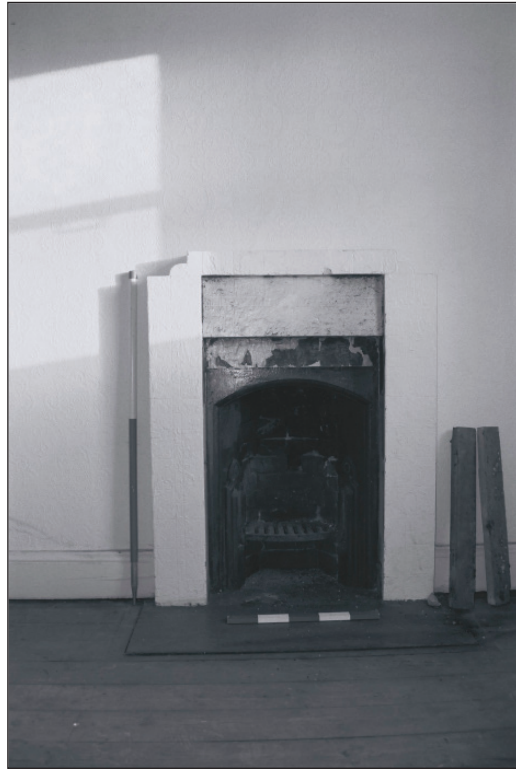
Plate 242: Detail of fireplace, room F17, West Side of the North Range (Film 25.15)

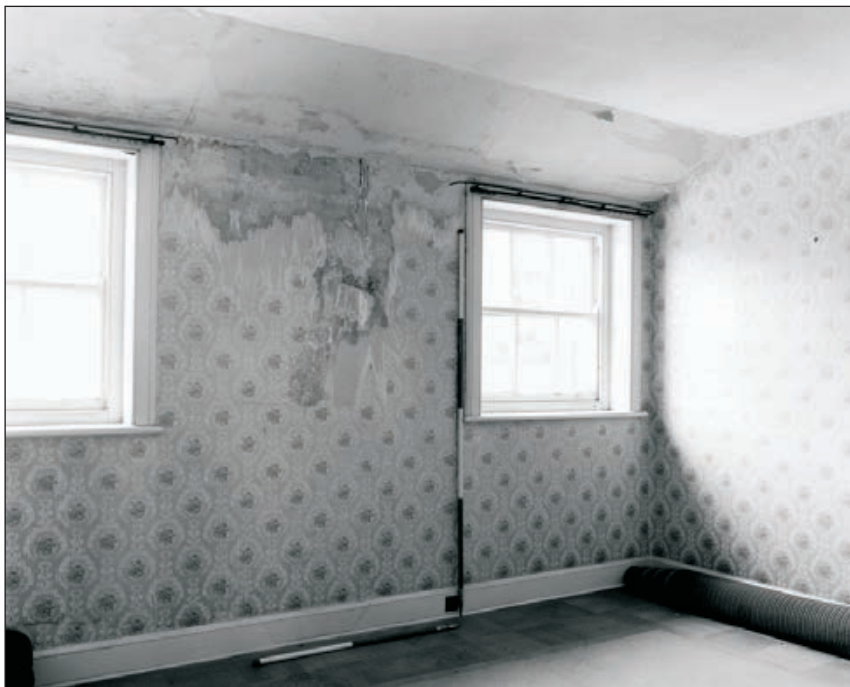
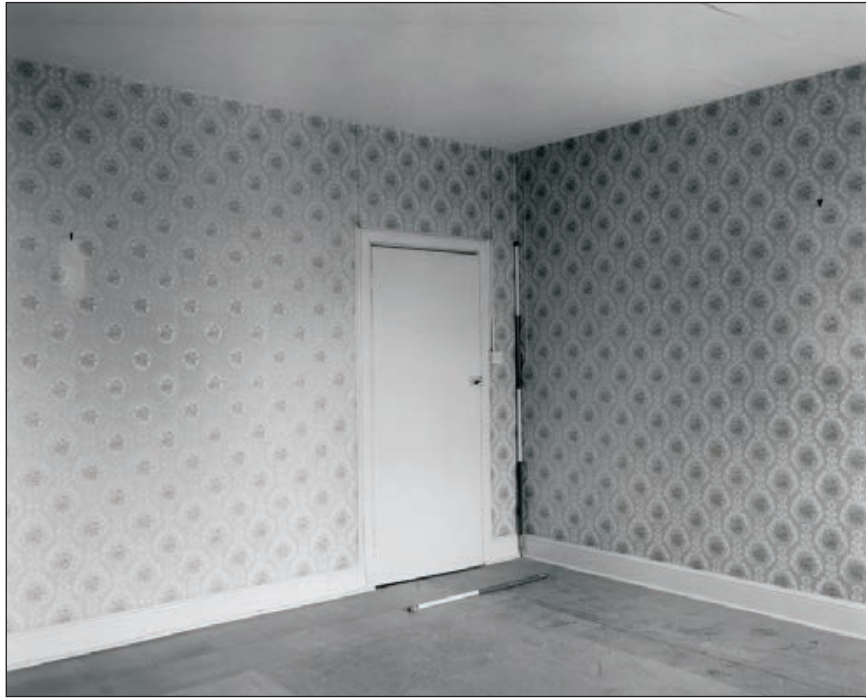
Plate 243: General view of room F19, West Side of the North Range (Film 34.05)

Plate 244: General view of room F19, West Side of the North Range (Film 34.08)

- 5.2.43 F19 to the west of F17, was a simple square room, with two sash windows to the south (**Plate 243**), and a panelled door leading from F18 (**Plate 244**). The walls to the east, west and north were all of timber stud construction with a lath and plaster covering (**Plate 245**), which meant the room contained no form of original heating. During the structural watching brief the partition between F19 and F17 was removed, making a single larger room (**Plate 246**). This confirmed that all stud walling was of phase 7. The timber floor boards were also lifted within F17/19, revealing a double joist structure carried on RSJs running north-south across the range, and a lath and plaster ceiling below (**Plate 247**). This floor structure was the same throughout the western element of the first floor of the North Range.

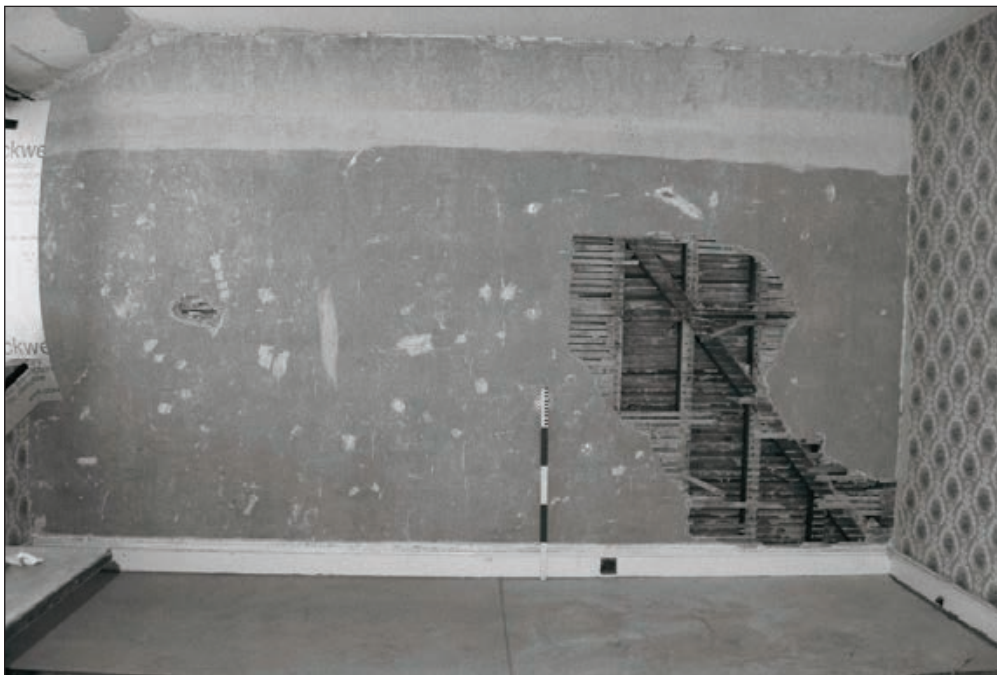
Plate 245: View of removed lath and plaster on west wall of room F19, West Side of the North Range - OB. 37 (Film 52.09)

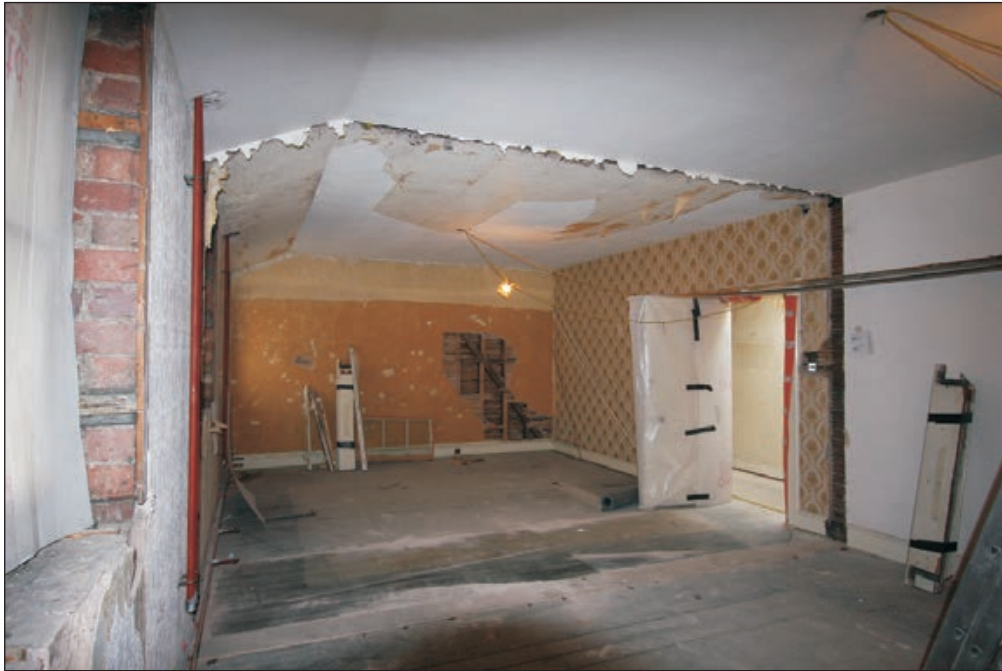
Plate 246: General view of rooms F17/19, West Side of the North Range, after removal of dividing partition - OB. 51 (Film D. 14.06.10 0013)

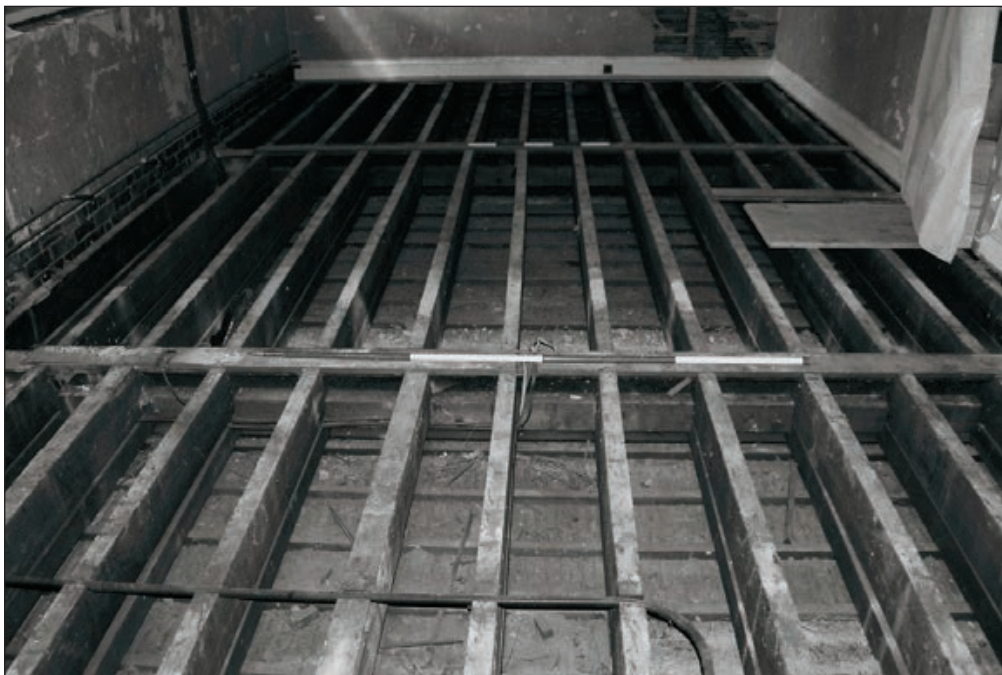
Plate 247: View of exposed timber and RSJ floor structure of rooms F17/19, West Side of the North Range - OB. 41 (Film 53.29)

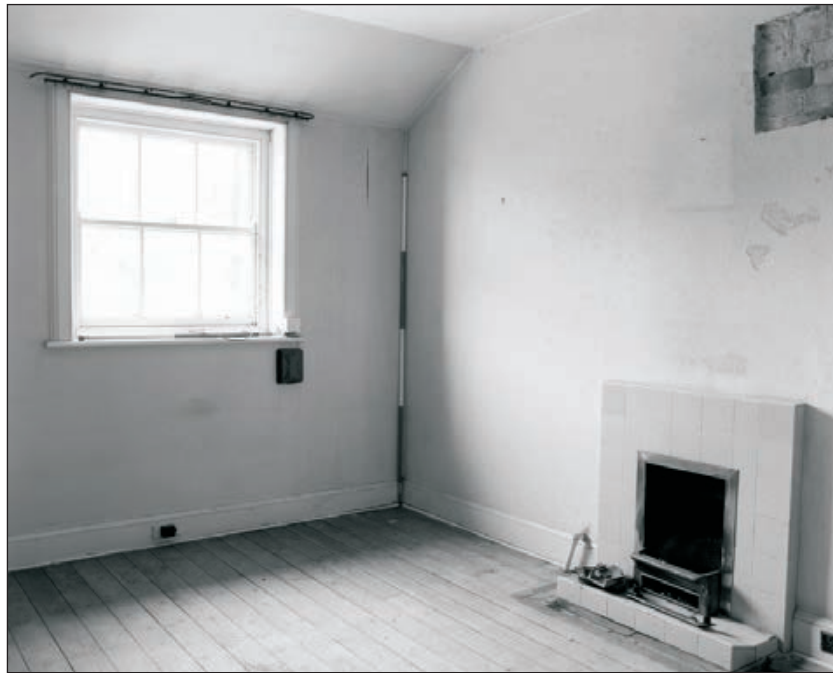
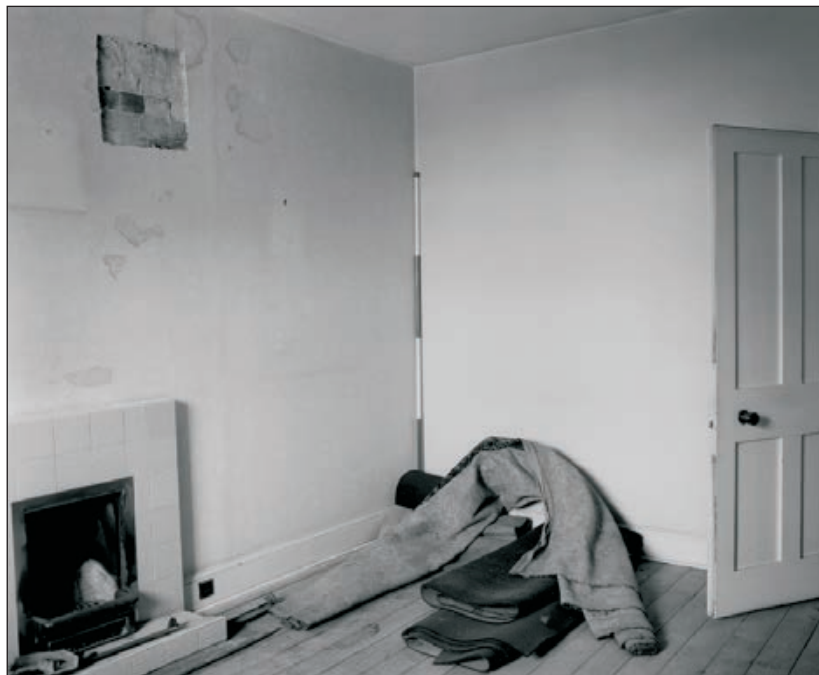
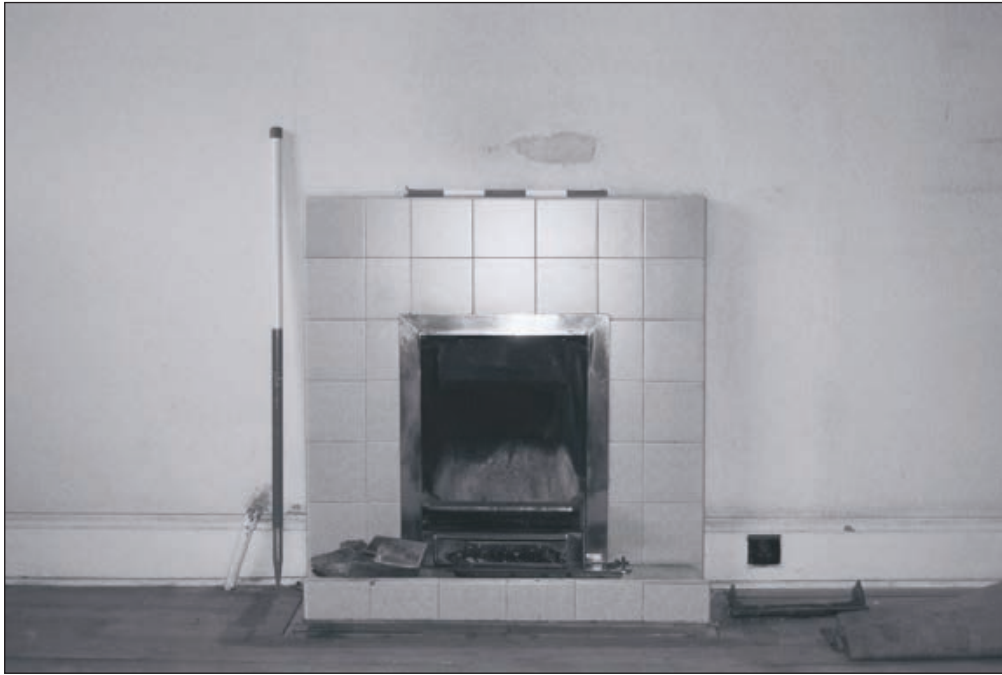
Plate 248: General view of room F20, West Side of the North Range (Film 34.09)

Plate 249: General view of room F20, West Side of the North Range (Film 35.01)

Plate 250: Detail of fireplace, room F20, West Side of the North Range (Film 25.06)

- 5.2.44 The fourth room leading off from F18 was F20, at the west end of the corridor. This was a rectangular room with window to the south, panelled door to the north and a cast iron fireplace with modern surround within the west wall (**Plates 248-250**). A section of removed plaster on the west wall exposed the brick fabric (**Plate 251**), whilst the lifting of the floor boards showed the construction to be the same as that within the rest of the phase 7 range (**Plate 252**).

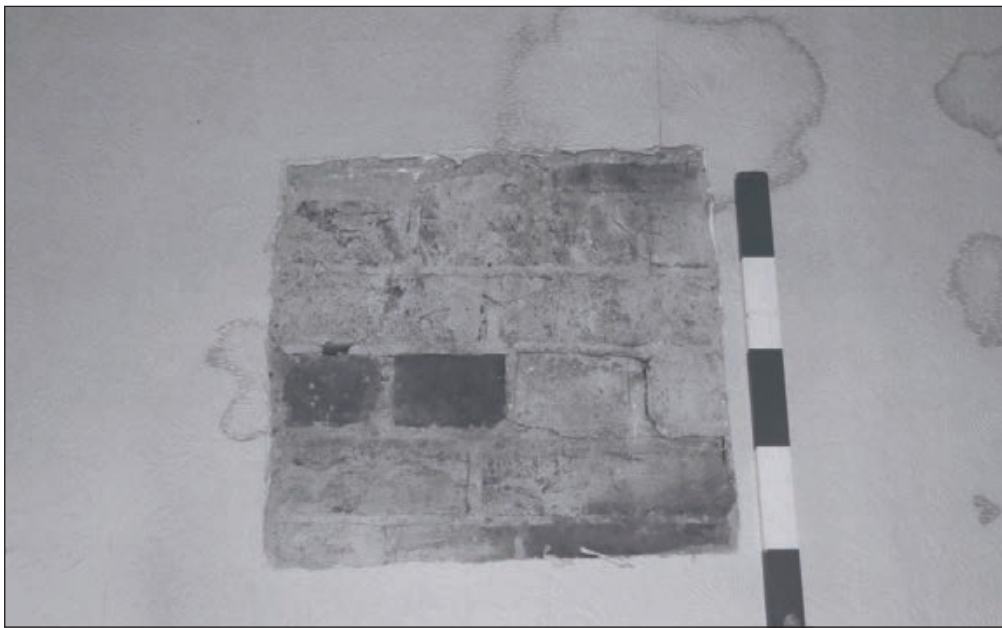
Plate 251: Detail of removed plaster exposing brickwork, west wall of room F20, West Side of the North Range (Film 25.04)

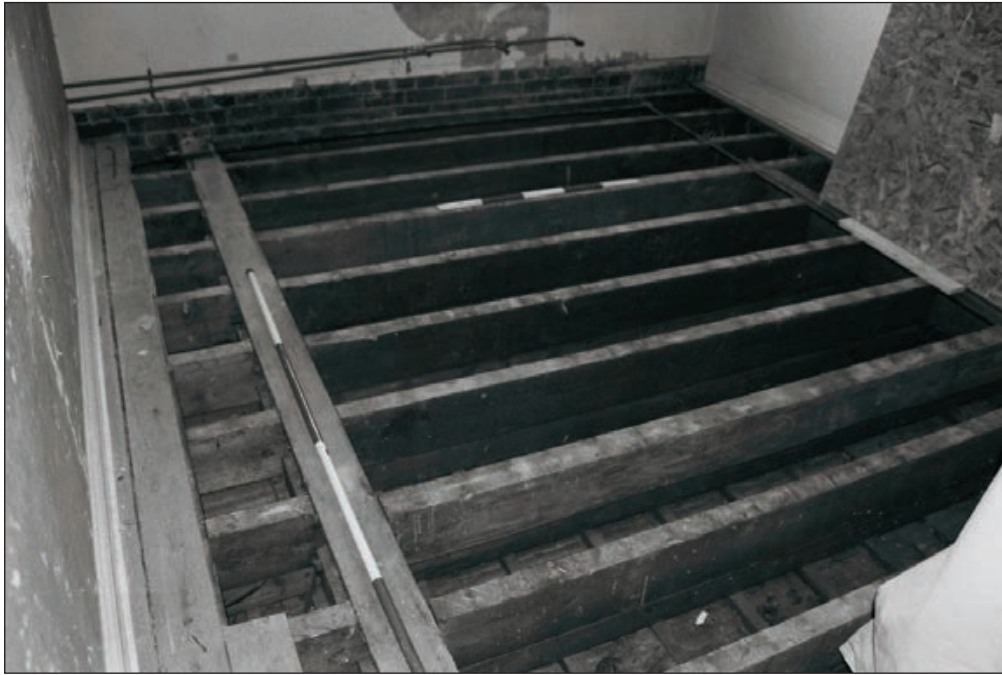
Plate 252: View of exposed timber and RSJ floor structure of room F20, West Side of the North Range - OB. 40 (Film 53.35)

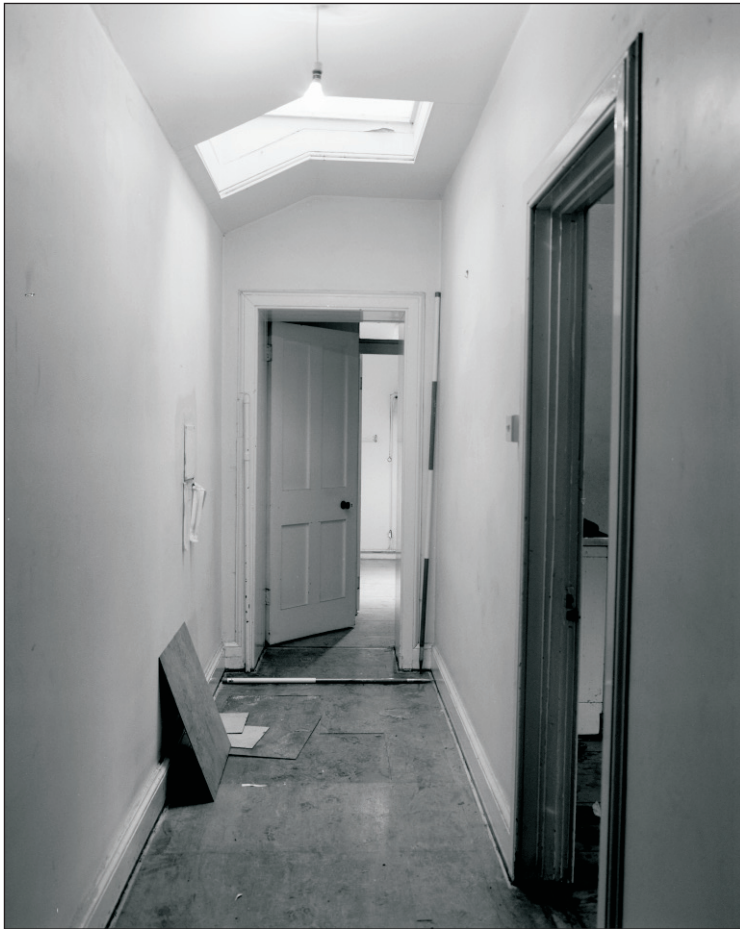
Plate 253: General view of corridor F21, West Side of the North Range (Film 35.03)

- 5.2.45 At the west end of corridor F18, F21 was a small corridor running north-south and led to room F22 to the west, and the first floor of the West Range to the south (**Figure 13 and Plate 253**). There was a skylight in the ceiling, serving the corridor, along with a hatch which allowed access into the roof space above the range. An area of removed plaster had exposed the brickwork of the east wall of F21 (**Plate 254**). The roof structure of the northwest end of the range comprised timber King-Post roof trusses with metal strapping and bolts, with a timber and lath and plaster skylight structure (**Plates 255-256**).

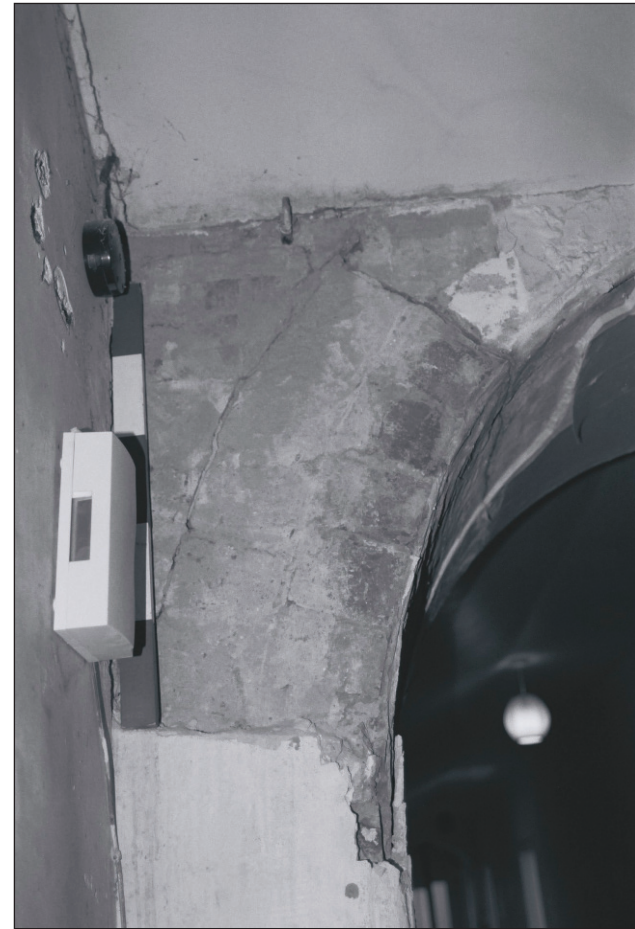
Plate 254: Detail of removed plaster exposing brickwork beneath, corridor F21, West Side of the North Range (Film 25.01)

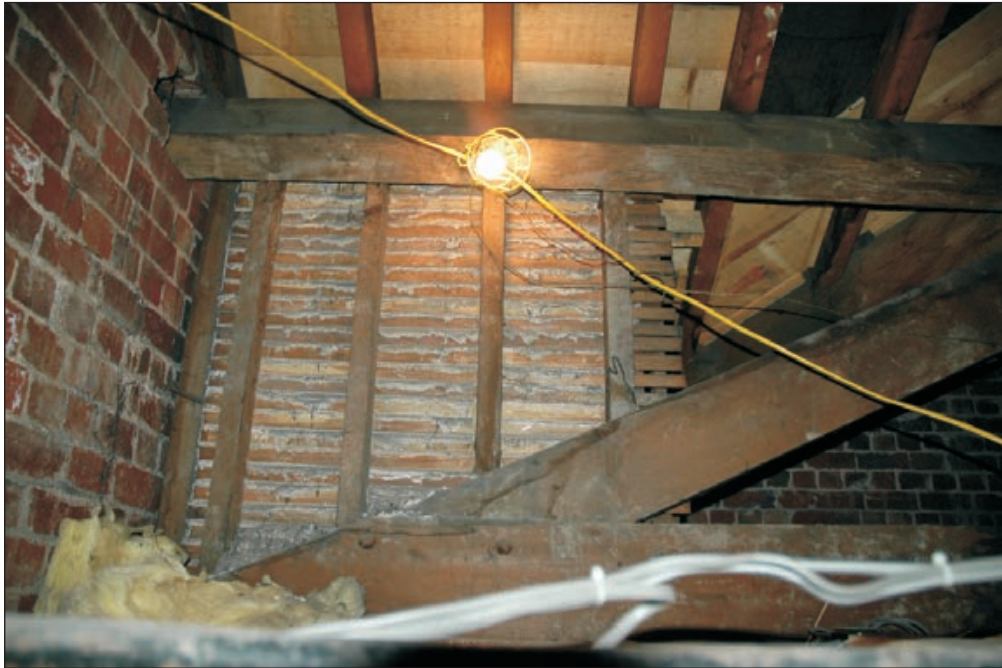
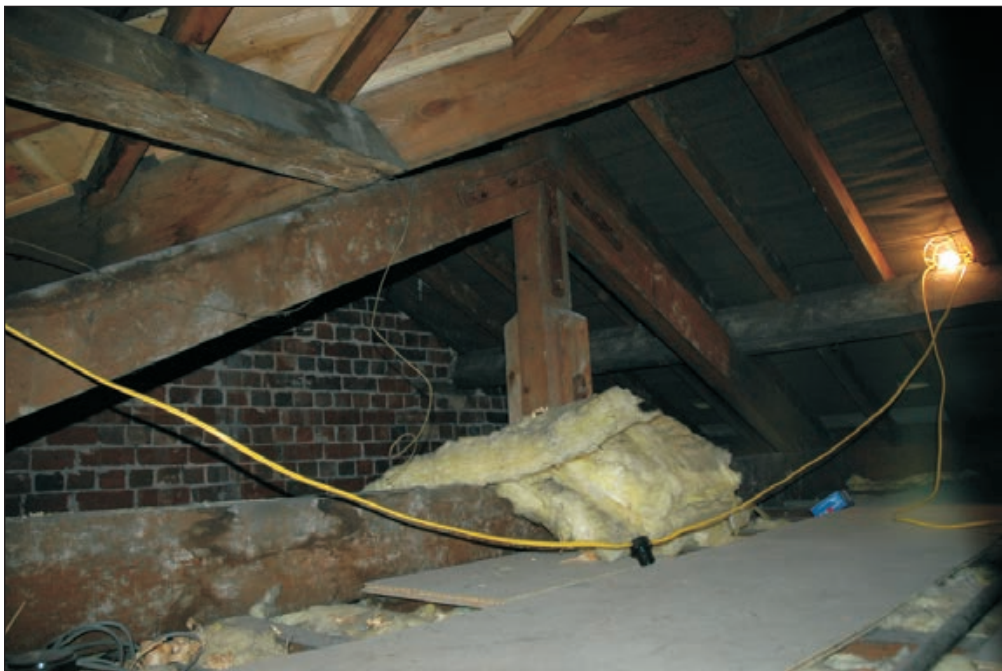
Plate 255: View of skylight construction, roof void above F21, West Side of the North Range (Film D. 18.02.10 7028)

Plate 256: View of timber trusses, roof void above F21 and F22, West Side of the North Range (Film D. 18.02.10 7029)

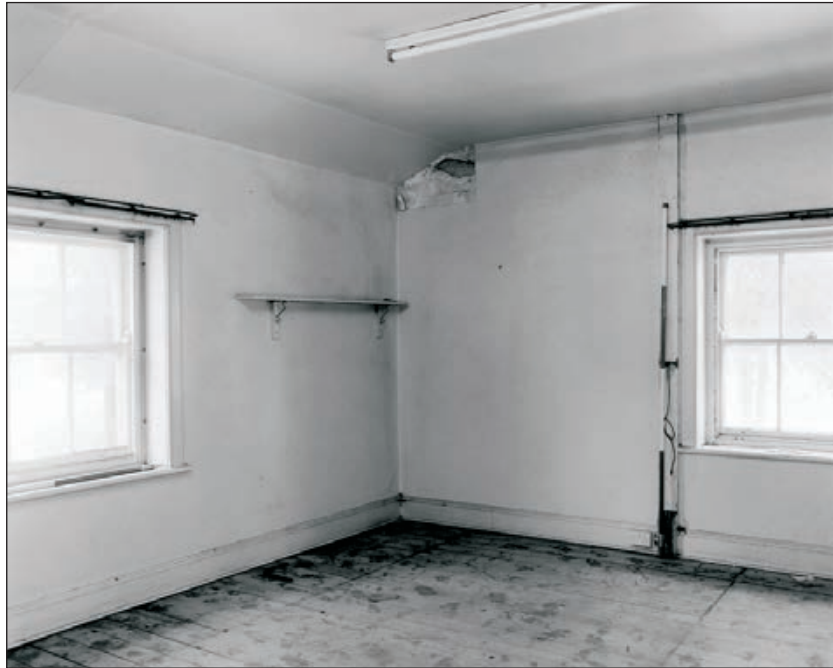
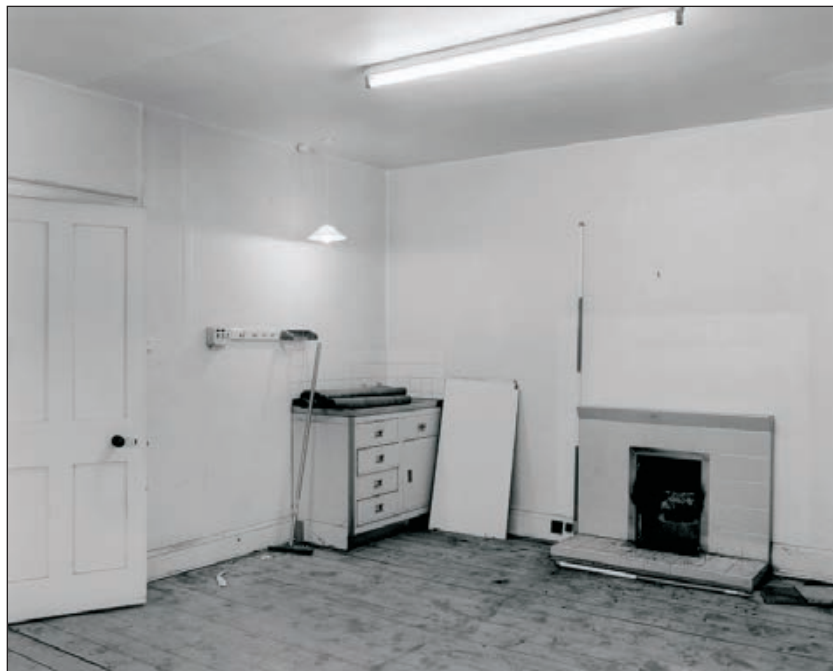
Plate 257: General view of room F22, West Side of the North Range (Film 35.05)

Plate 258: General view of room F22, West Side of the North Range (Film 35.08)

- 5.2.46 Leading off F21 to the west, room F22 (**Plates. 257-258**), was accessed via a central doorway within a timber stud partition to the east. There was a sash window to the north and west (**Plate 257**) and a fireplace with modern surround to the south (**Plates 258-259**). The floor boards were lifted, exposing the double timber joisted and RSJ floor structure (**Plate 260**) and floor boards with writing on the underside saying 'FU Paul Gringley-on the-Hill' and 'Mr C R Blackwell New Market' (**Plates 261-262**).
