NOSTELL PRIORY STABLES, NOSTELL, WAKEFIELD, WEST YORKSHIRE

Historic Building Recording and Structural Watching Brief

Planning Application Ref: 09/00701/FUL & 09/00705/LBC

72934.01_BDG_V0_4

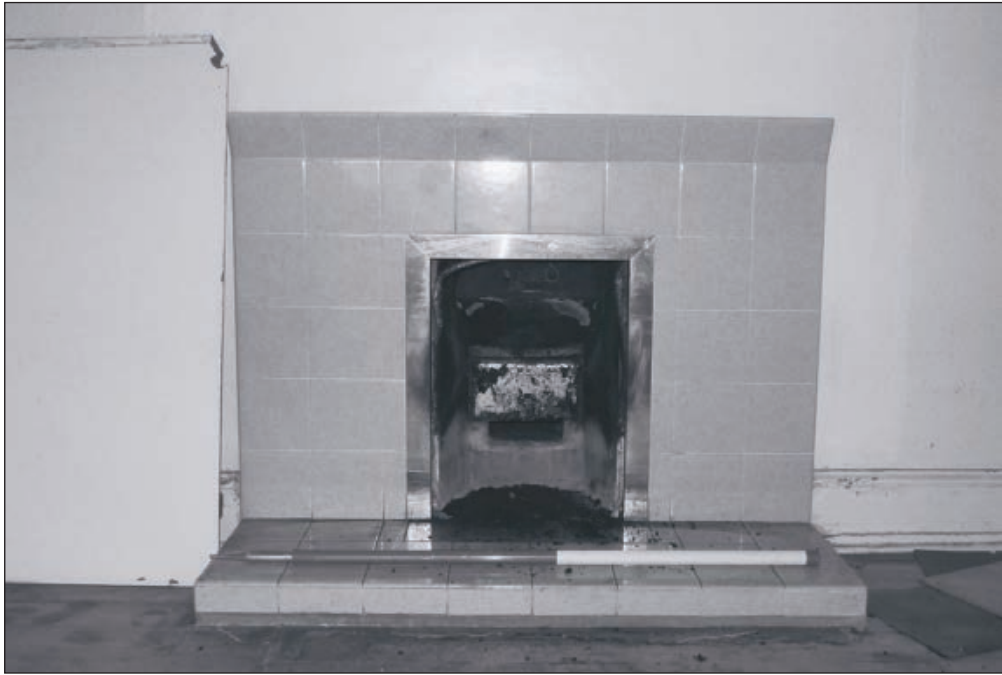
Plate 259: Detail of fireplace, south wall of F22, West Side of the North Range (Film 26.34)

- 5.2.46 Leading off F21 to the west, room F22 (**Plates. 257-258**), was accessed via a central doorway within a timber stud partition to the east. There was a sash window to the north and west (**Plate 257**) and a fireplace with modern surround to the south (**Plates 258-259**). The floor boards were lifted, exposing the double timber joisted and RSJ floor structure (**Plate 260**) and floor boards with writing on the underside saying 'FU Paul Gringley-on the-Hill' and 'Mr C R Blackwell New Market' (**Plates 261-262**).

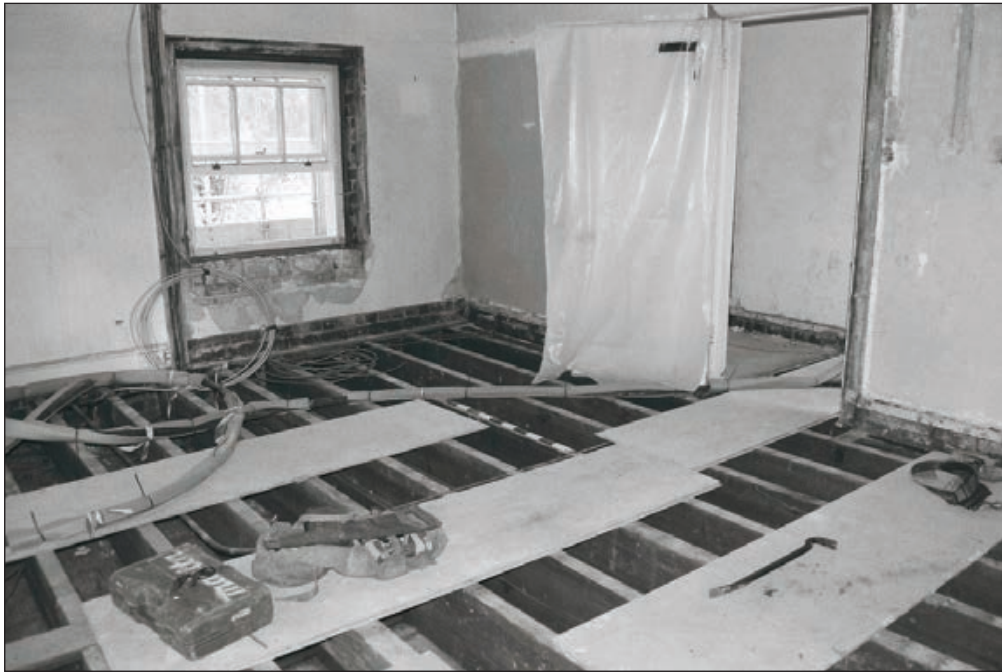
Plate 260: General view of exposed timber and RSJ floor structure, room F22, West Side of the North Range - OB. 58 (Film 72.34)

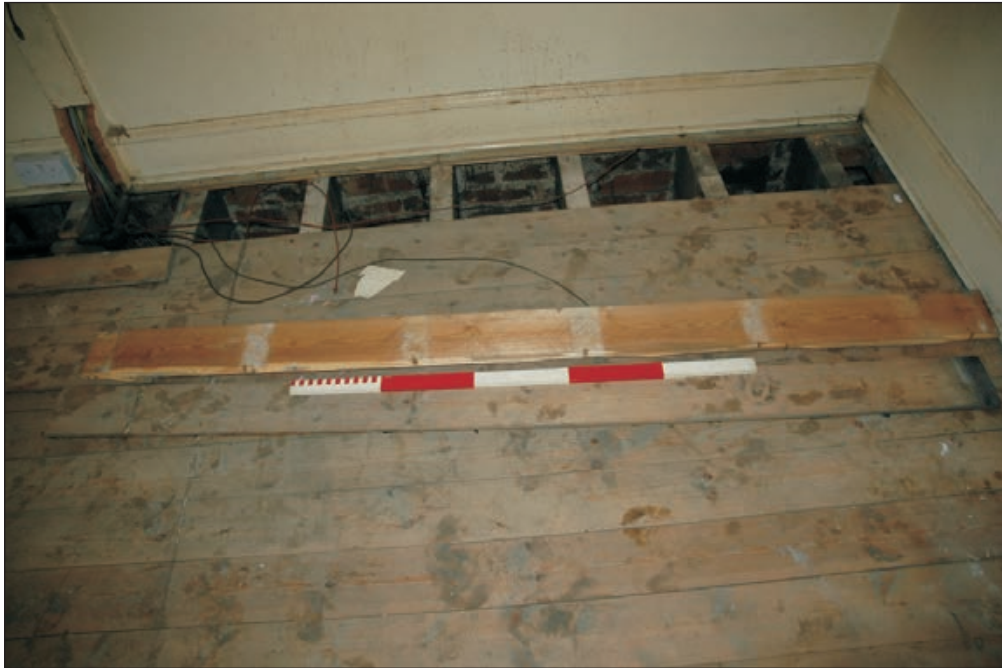
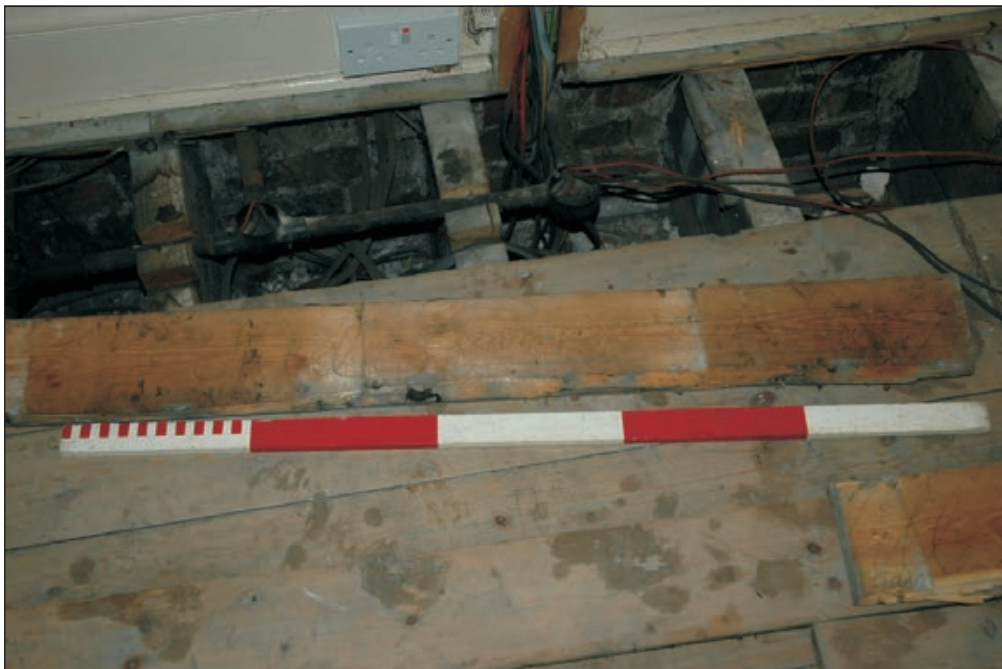
Plate 261: Detail of writing on back of lifted floor boards, F22, West Side of the North Range - OB. 58 (Film D. 18.02.10 7050)

Plate 262: Detail of writing on back of lifted floor boards, F22, West Side of the North Range - OB. 58 (Film D. 18.02.10 7055)

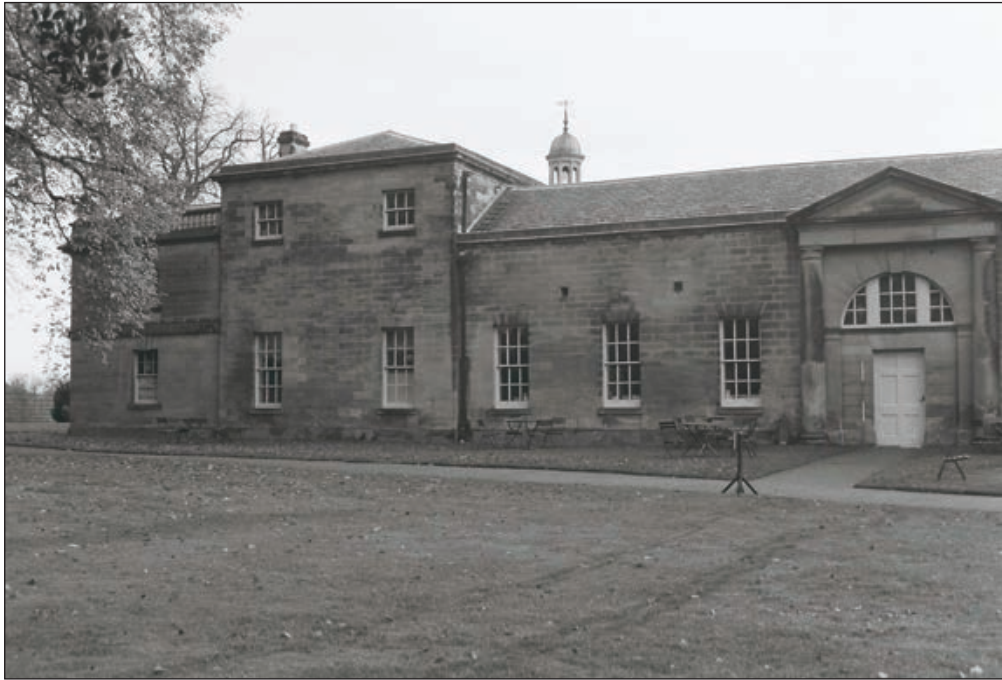
Plate 263: General view of the north end of the west elevation of the North and West Ranges (Film12.21)

- 5.3.1 The majority of the West Range was constructed between 1769 and 1773 (phase 3) by Robert Adam, along with the South Range. The west elevation of the stable block also encompassed the west elevations of the North and South Ranges at each end. The north end of the west elevation was two-storeys in height and formed part of the phase 7 North Range. There was a central sash window at both ground and first floor, with stone string coursing dividing the elevation (**Plate 263**).

- 5.3.2 To the south of this was a taller phase 3, two-storey pavilion element with pyramidal roof. The elevation contained two tall sash windows at ground floor (**Plate 263, 266**) and two small sashes at first floor (**Plate 263, 267**). Of these two first floor windows, the north window was blind (**Plate 267**) whilst the south window was a phase 7 insertion (**Figure 13**).

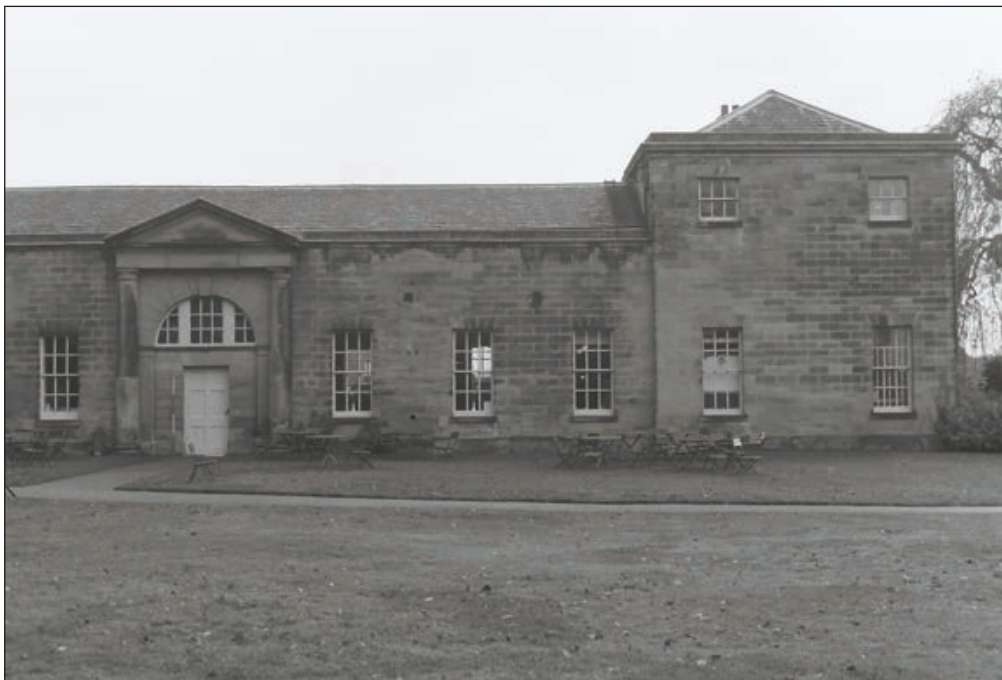
Plate 264: General view of the south end of the west elevation of the West and South Ranges (Film 12.19)

- 5.3.4 The south end of the elevation contained a two-storey pavilion which was part of the South Range and contemporary with the West Range. This elevation had two tall sash windows at ground floor and two smaller sashes at first floor (**Plate 264**), the same as the pavilion element at the north end of the West Range.

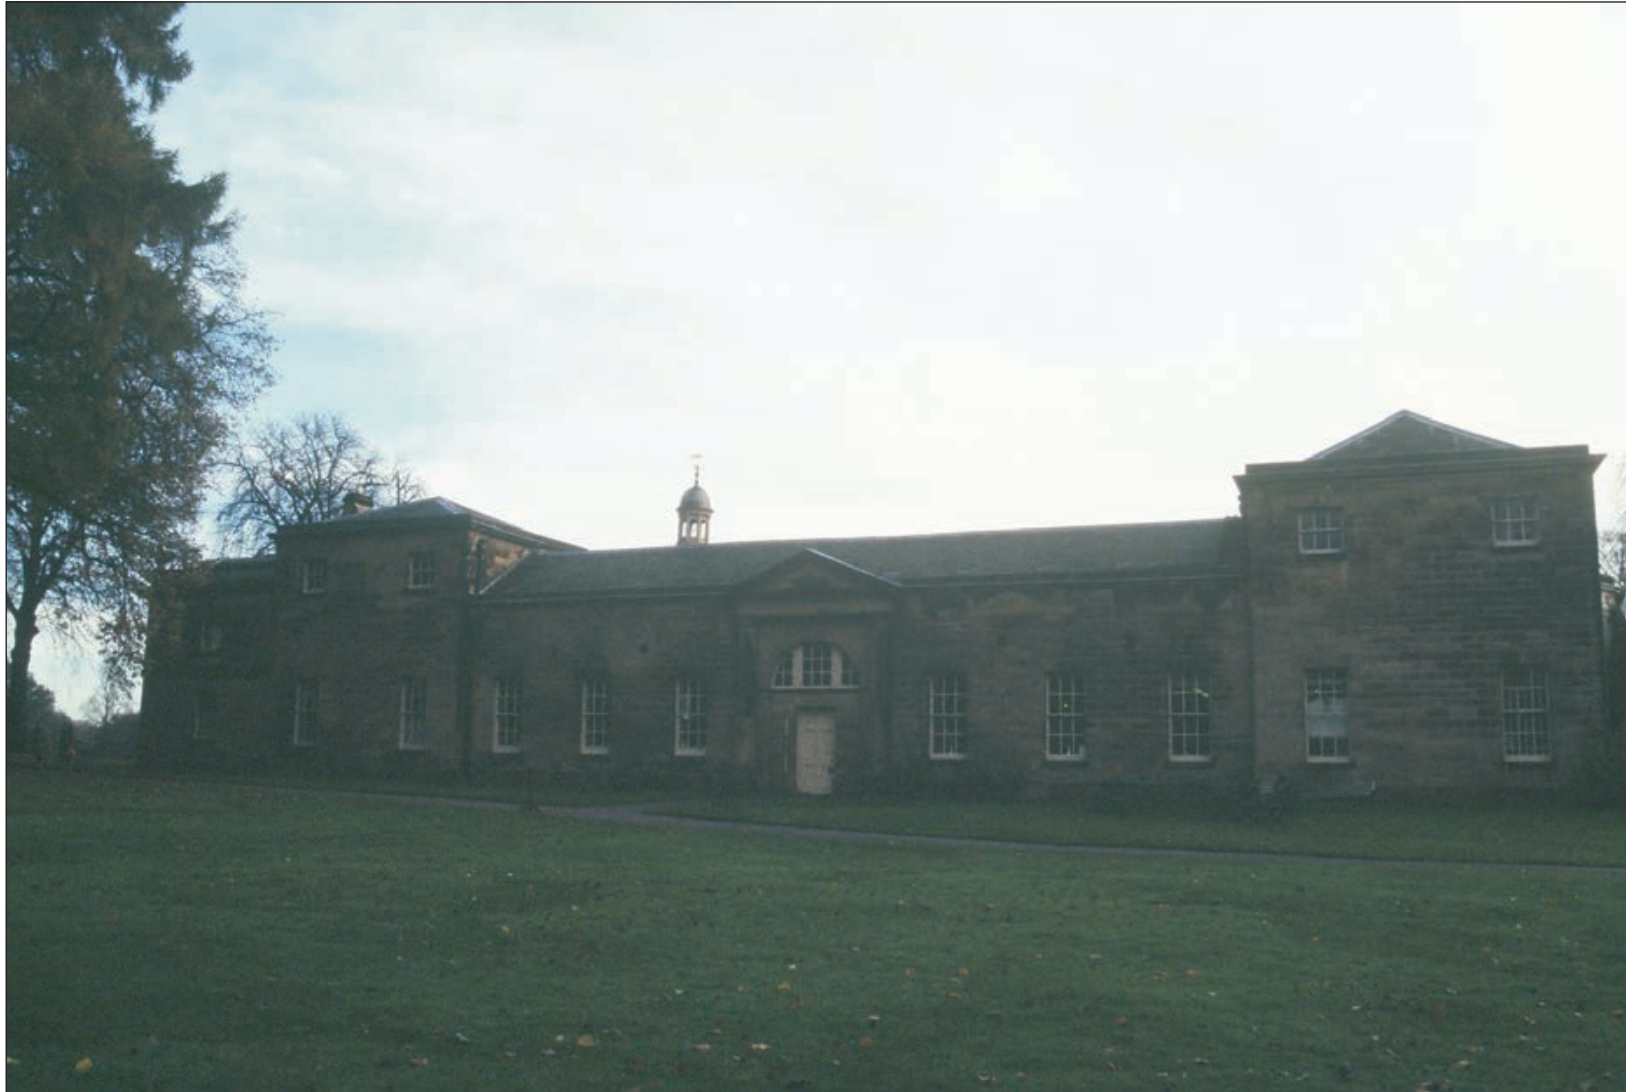
Plate 265: General view of the west facing elevation of the West Range (Film CS.03)

- 5.3.3 The phase 3 central section of the range was single-storey, comprising seven bays within the west elevation (**Plates 263-265**). The central bay contained a doorway with large tripartite fanlight above, and stone pediment carried on stone columns (**Plate 268**). There were three bays either side of the central doorway, each with a tall sash window, originally blind. A pitched roof with stone tile covering was visible above the elevation (**Plates 263-265**).

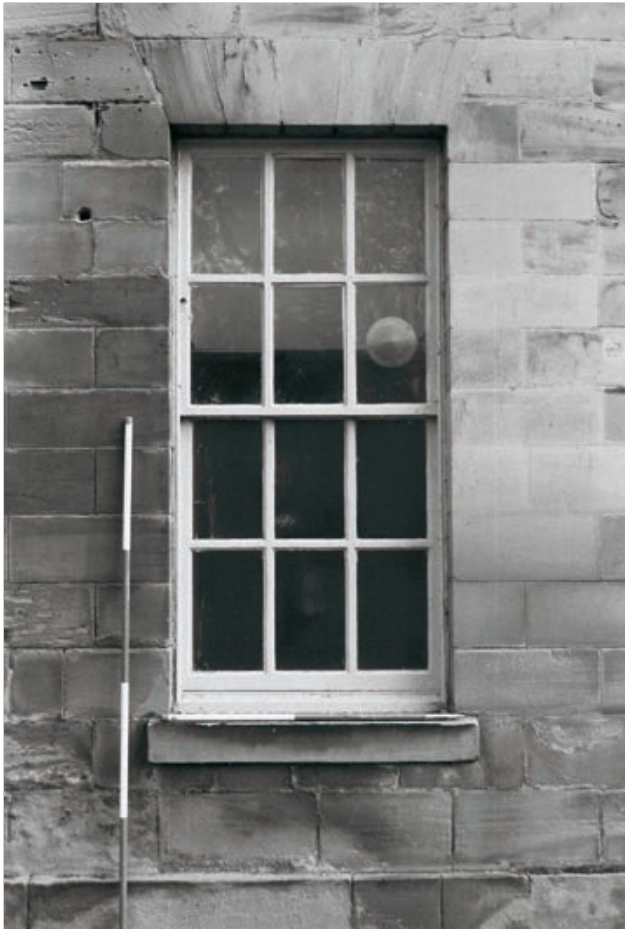
Plate 266: Detail of ground floor window, west elevation of the West Range (Film 12.11)

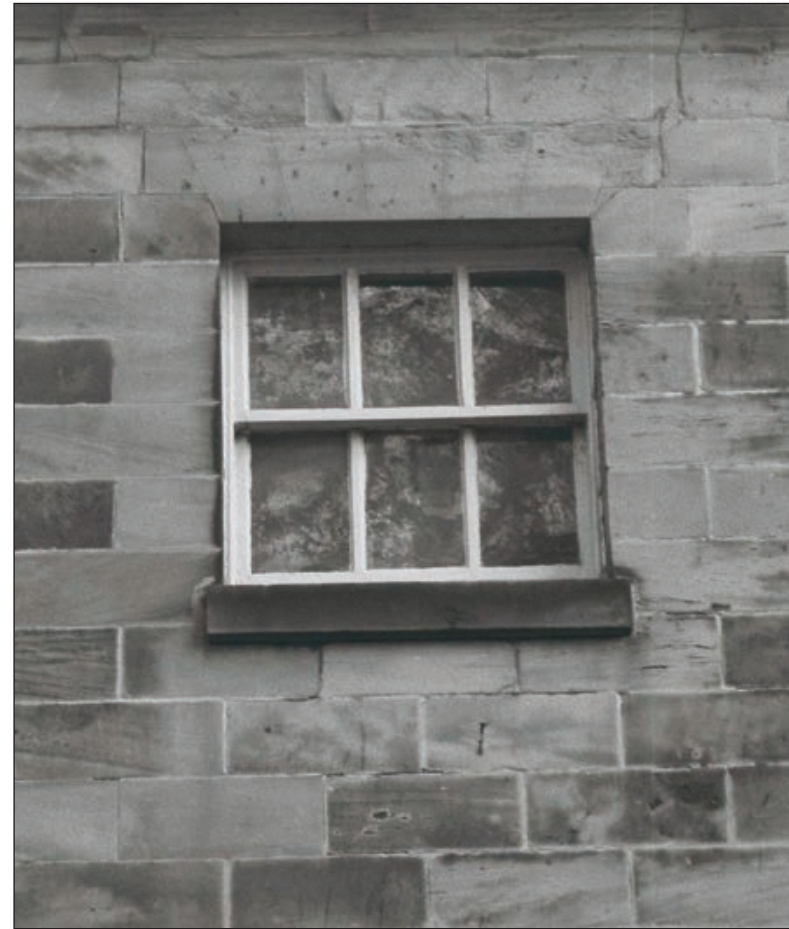
Plate 267: Detail of first floor window, west elevation of the West Range (Film 12.14)

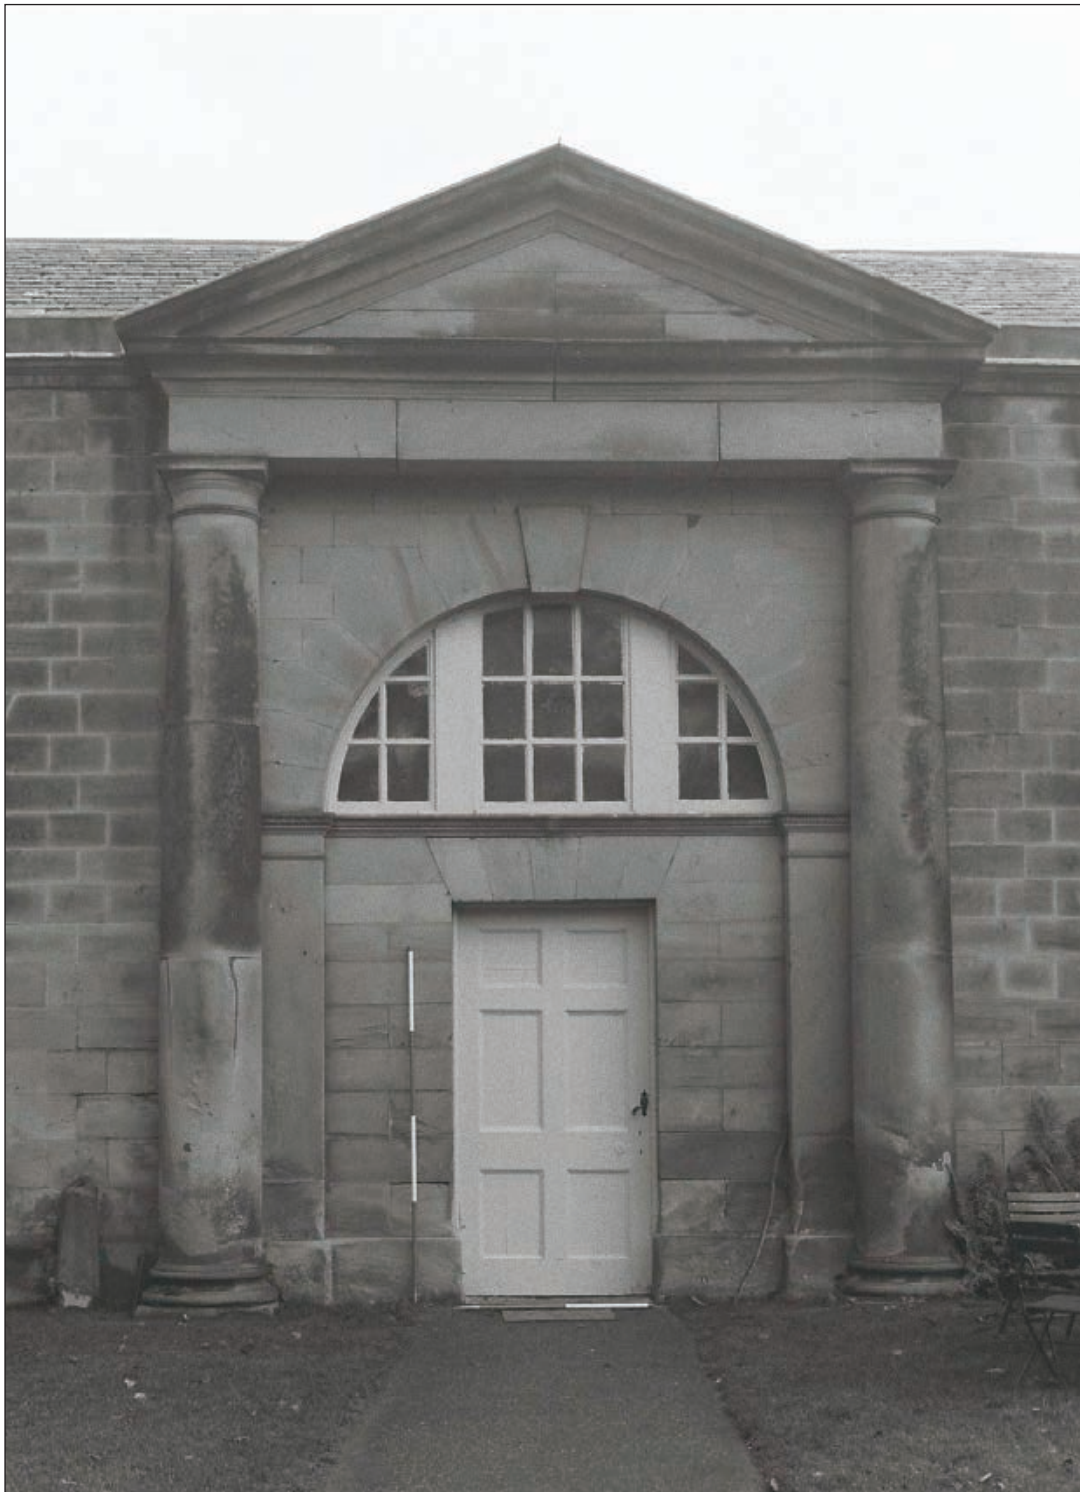
Plate 268: View of the west entrance, west elevation of the West Range (Film 12.15)

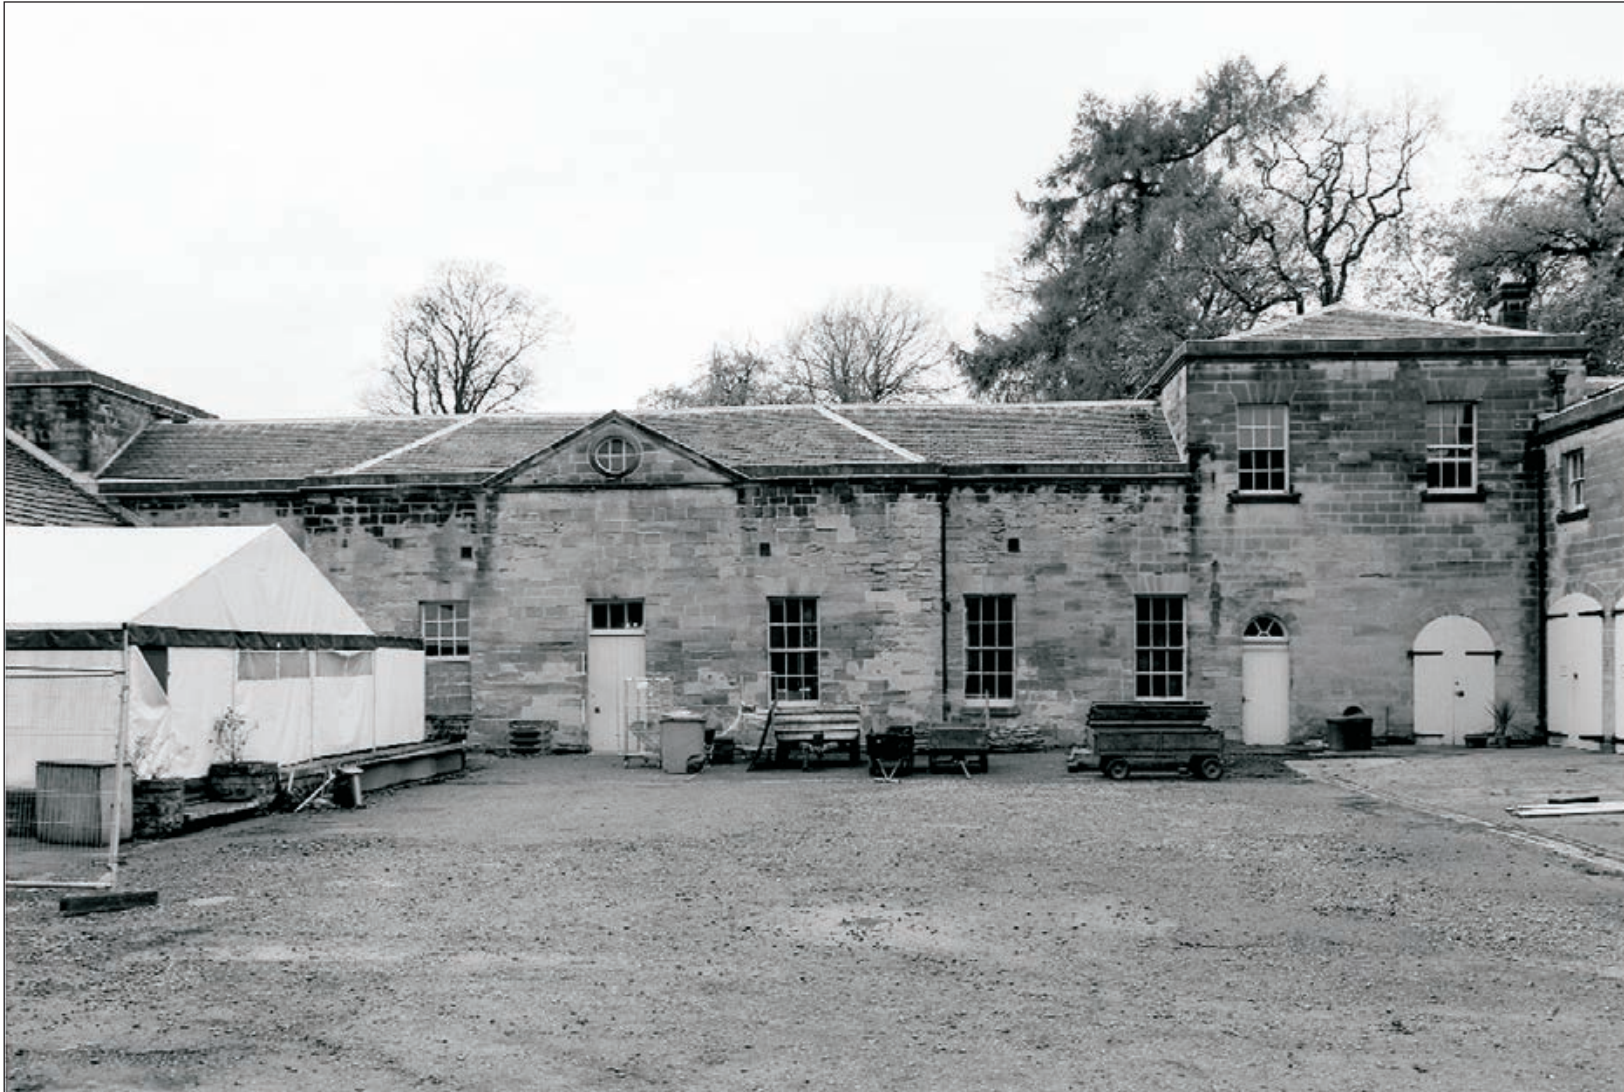
Plate 269: View of the east facing courtyard elevation of the West Range (Film 18.03)

- 5.3.5 The east elevation of the West Range fronted the central courtyard of the stables. Only two elements of the range made up the east elevation, comprising the phase 3 and 7 two-storey north pavilion of the Range, and the central single-storey phase 3 element (**Plate 269**). The east elevation of the north two-storey pavilion, was largely phase 7 in date, and contained a wide double door and a single pedestrian doorway with a small recessed drain and tap positioned between them at ground floor (**Plate 270-271**). Two sash windows were positioned at first floor.

- 5.3.6 The single-storey central section of the range had three projecting bays with central pedestrian doorway with later pediment above, containing an oeil-de-boeuf window (**Plates 269, 272-273**). To the north were three full height sash windows, whilst to the south were two half sash windows, the lower section being recessed stone.

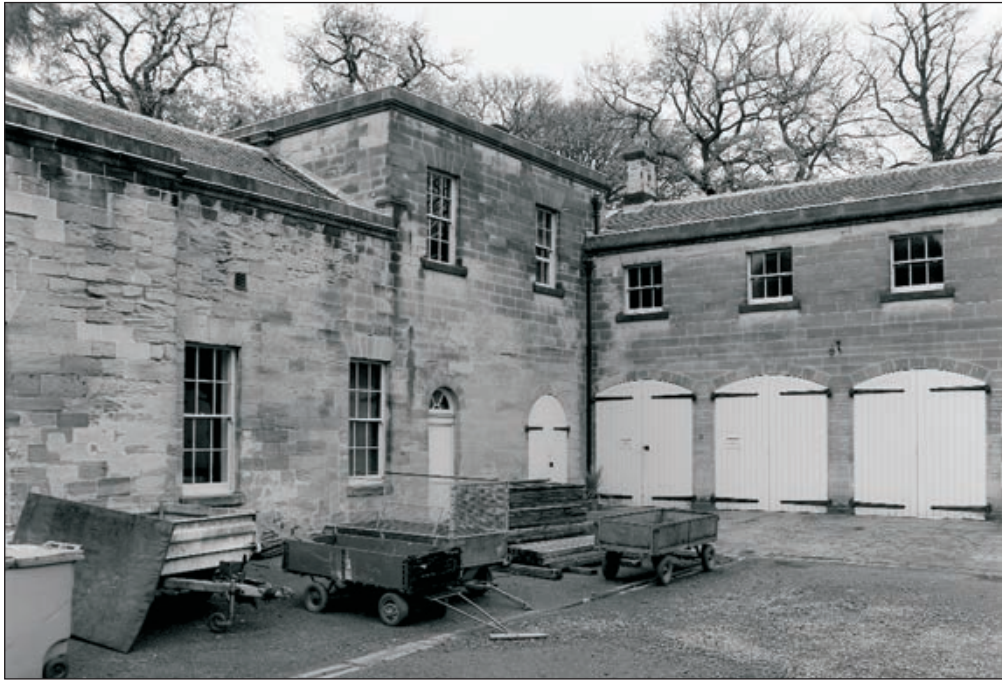
Plate 270: View of the north end of the east facing courtyard elevation of the West Range (Film 17.06)

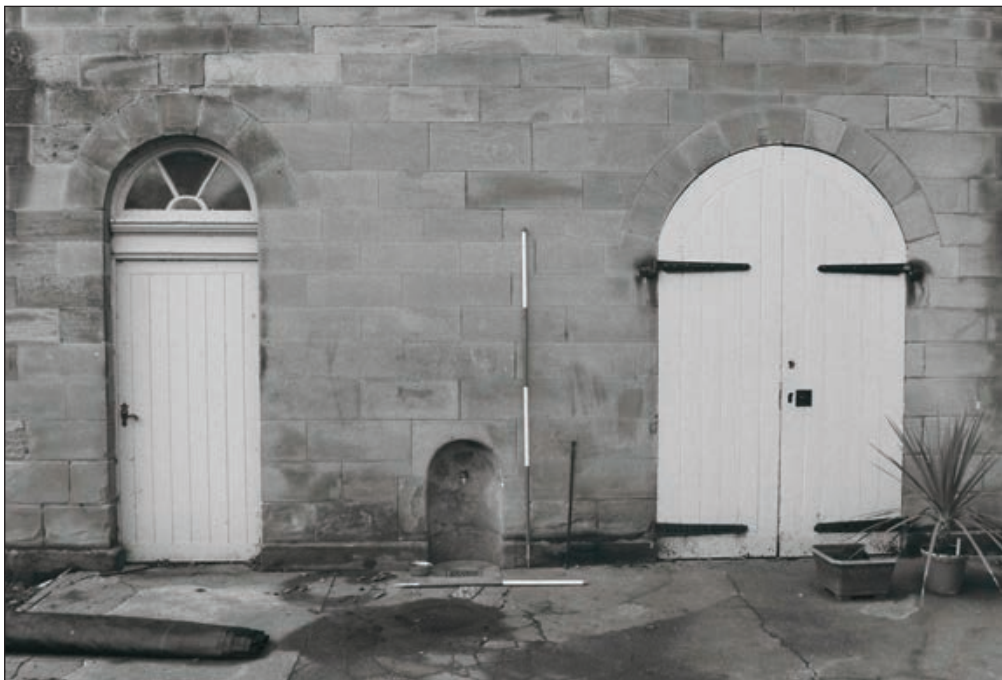
Plate 271: Detail of ground floor doorways at the north end of the east facing courtyard elevation of the West Range (Film 20.19)

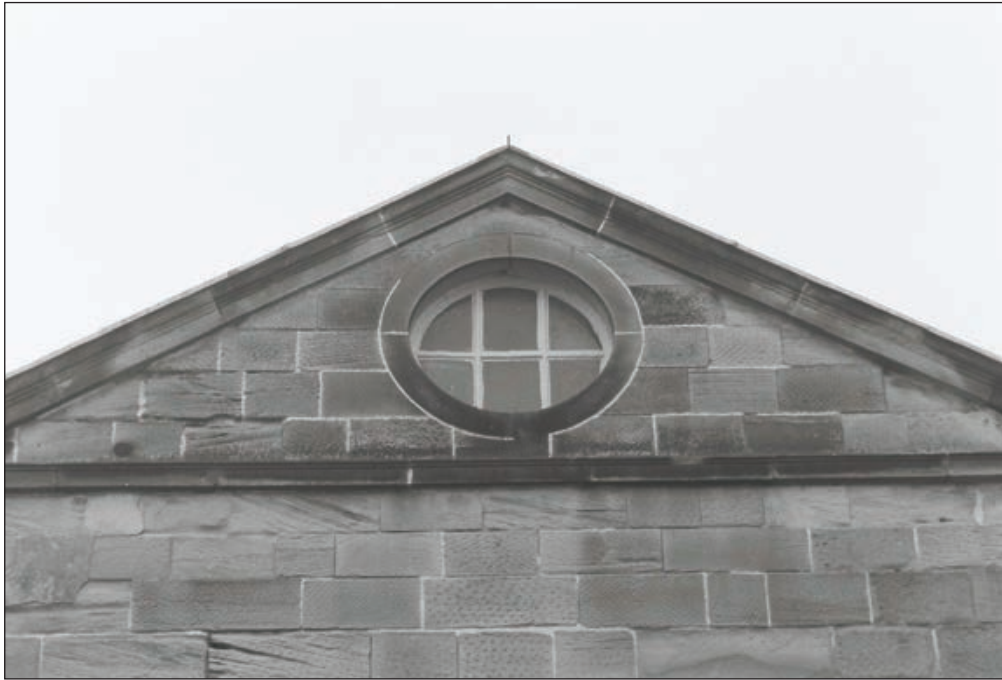
Plate 272: Detail of the oeil-de-boeuf window within the pedimented entrance of the east facing courtyard elevation of the West Range (Film 20.13)

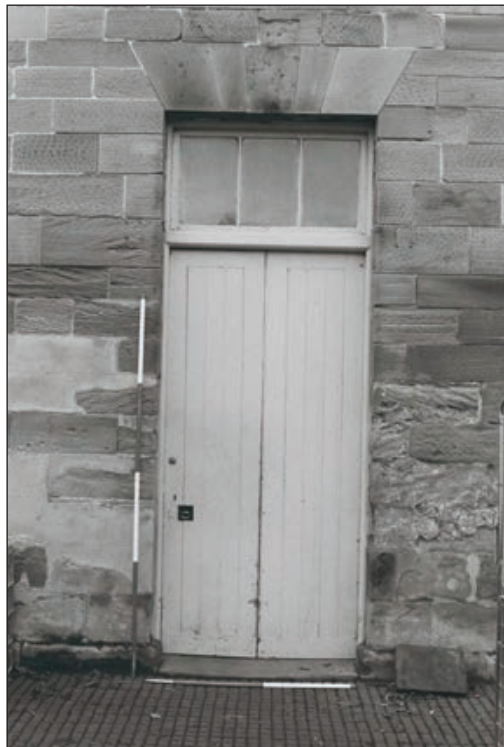
Plate 273: Detail of ground floor central doorway, east facing courtyard elevation of the West Range (Film 20.15)

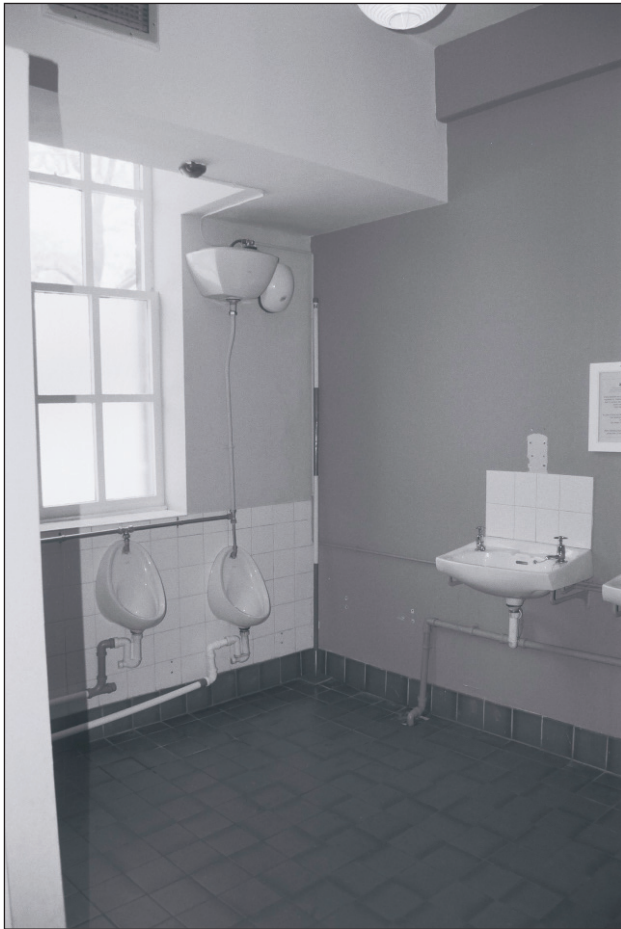
Plate 274: General view of G17, West Range (Film 41.26)

- 5.3.8 Internally the north end of the West Range had been highly modernised with partitions creating modern (phase 8) toilets serving the visitor café. Room G17, at the north of the range functioned as male w.c., with modern facilities, fittings and finishes throughout, and a sash window to the west (**Plate 274**).

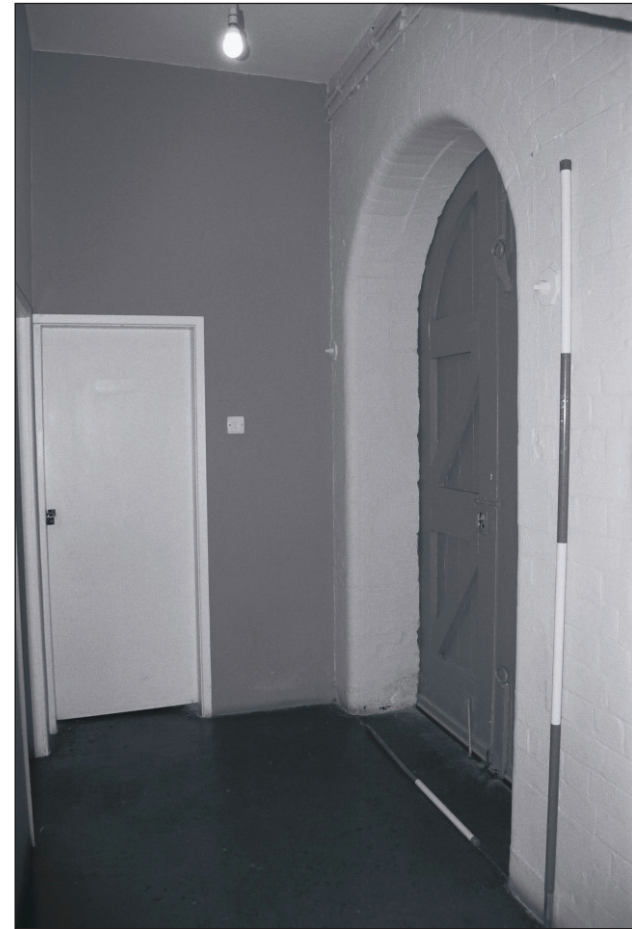
Plate 275: General view of G19, West Range (Film 23.08)

- 5.3.9 This room was accessed from a small lobby/corridor to the east, G19 (**Plate 275**). Positioned within the east wall was a large arched doorway with timber battened doors (**Plate 276**). To the north of G19 and G17 was a small partitioned walk-in cupboard. During the structural watching brief, the modern partitions dividing these rooms were removed, creating a single room. The lath and plaster ceiling across this space was also removed, exposing the floor structure above (**Plate 277**). The exposed joists were supported at the south end by timber beams running adjacent to the south wall (**Plate 278**). However, this beam was missing in the centre of the space, suggesting the removal of a supporting structure, such as a pier or chimney stack, requiring additional supports to be added to the central joists (**Figure 15**). A high opening was also inserted within the west end of the south wall of the room, exposing the brick fabric of the wall (**Plate 278**).

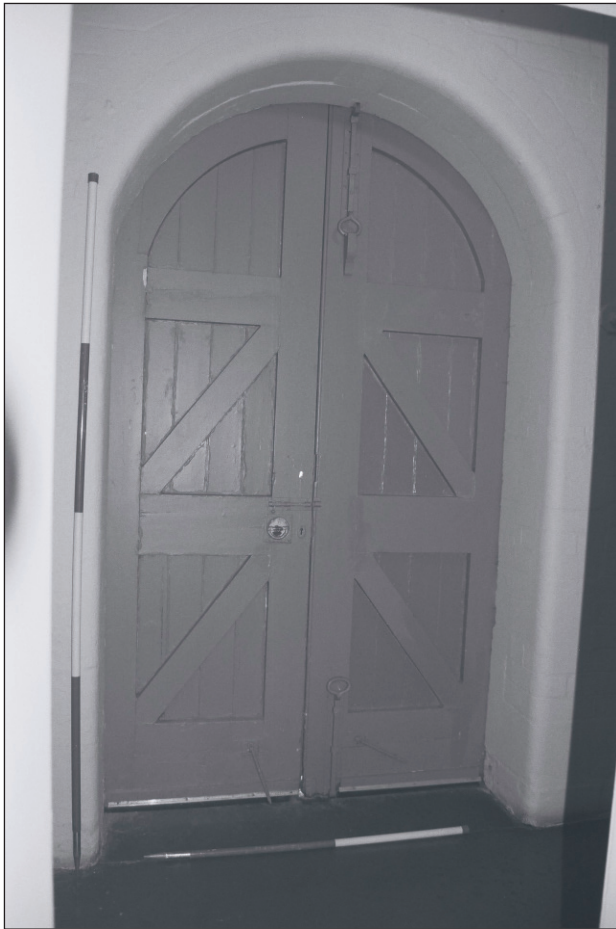
Plate 276: General view doorway, east wall of G19, West Range (Film 23.05)

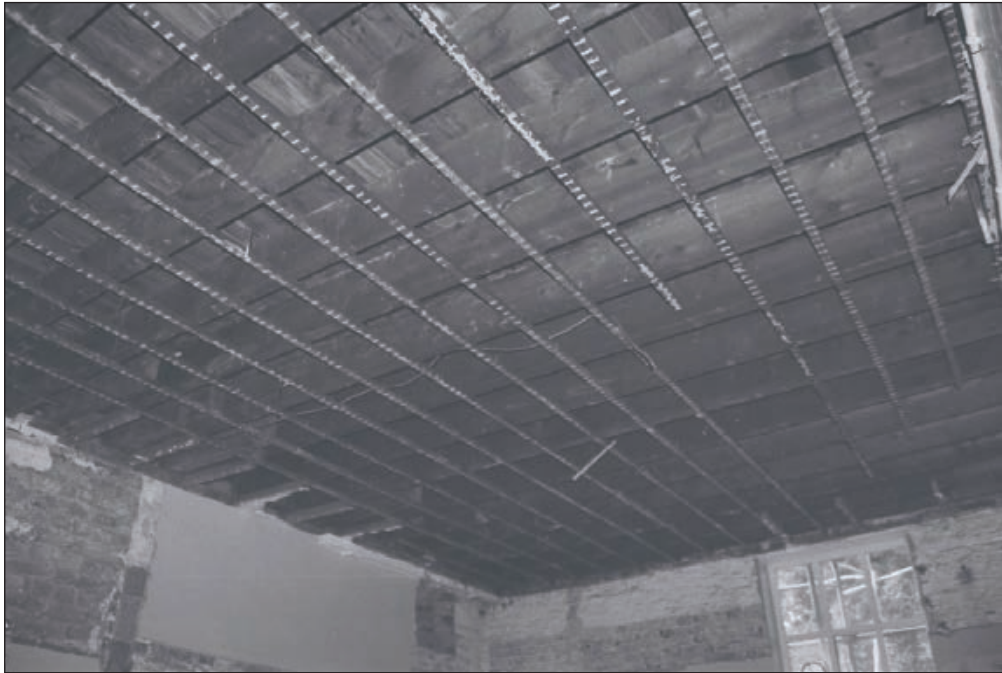
Plate 277: View of floor structure above G17/19, West Range, after removal of ceiling (Film 67.19)

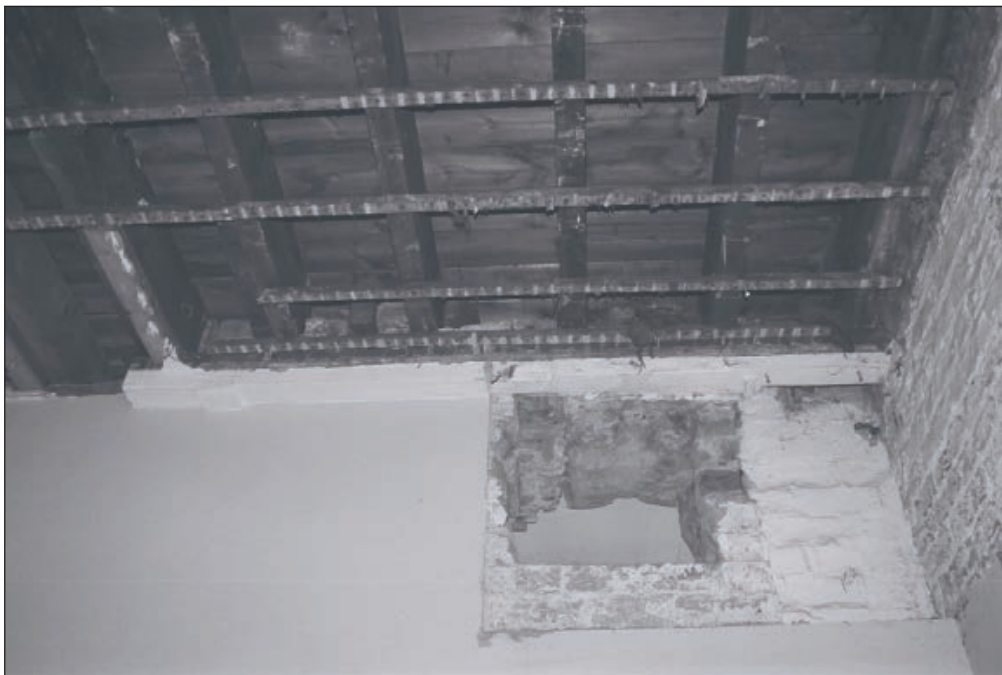
Plate 278: Detail of floor and ceiling structure above G17/19, West Range, after the removal of ceiling and - OB. 80, and inserted opening within wall - OB. 83 (Film 67.17)

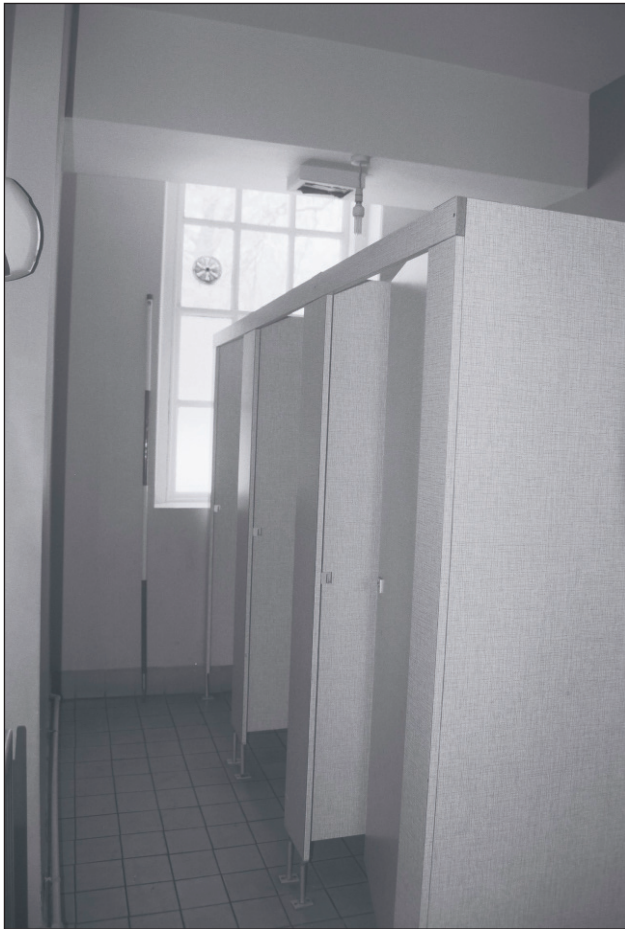
Plate 279: General view of G21, West Range (Film 41.29)

- 5.3.10 To the south of G17 room G21 functioned as ladies' lavatories and contained modern toilets and sink units, with a sash window to the west (**Plate 279**). This was accessed via a small lobby/corridor to the east, G20 (**Plate 280**). This contained a pedestrian doorway with fanlight within the east wall leading to the central courtyard of the stables (**Plate 281**), and an inserted doorway to the north and south, connecting to G29 to the north and G22 to the south. The dividing partition between G20 and G21 was removed during the structural watching brief, creating a single space (**Plates 282-283**). The ceiling of both rooms, made up of modern plaster board, was removed, exposing the floor structure above. This comprised irregular inserted RSJ and timber joists, with modern floor boards above (**Plate 284**).

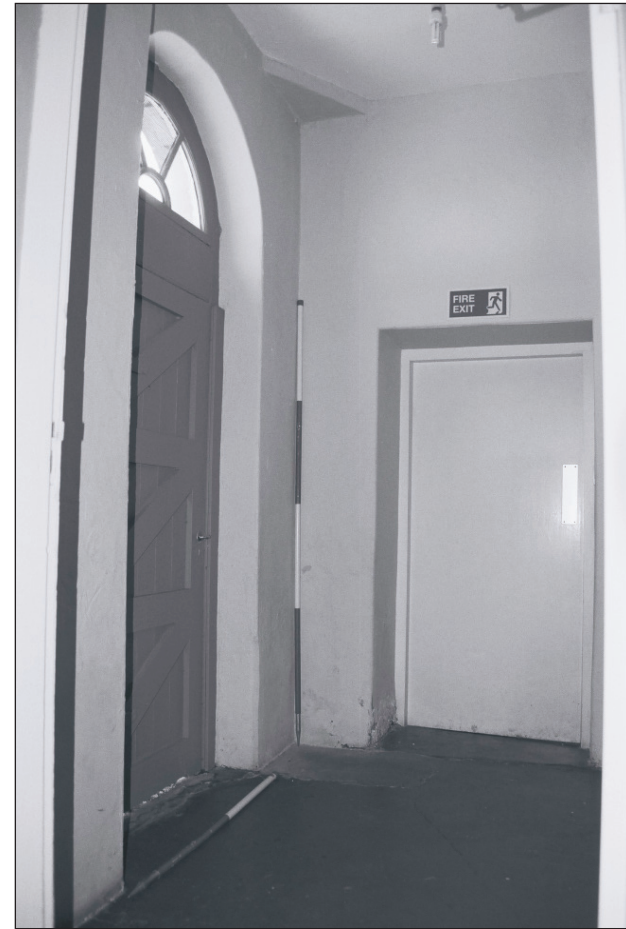
Plate 280: General view of G20, West Range (Film 23.11)

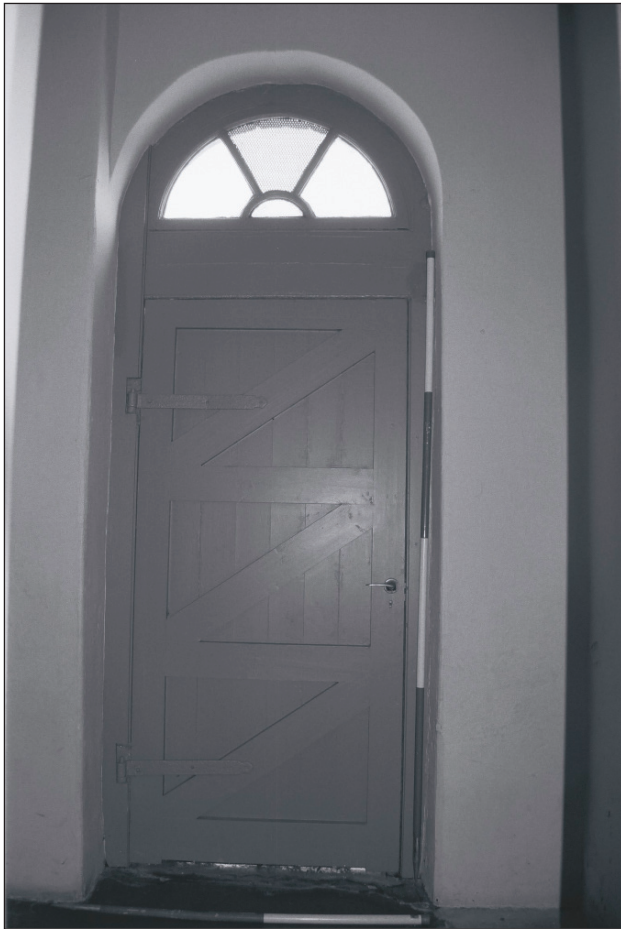
Plate 281: View of doorway, east wall of G20, West Range (Film 23.09)

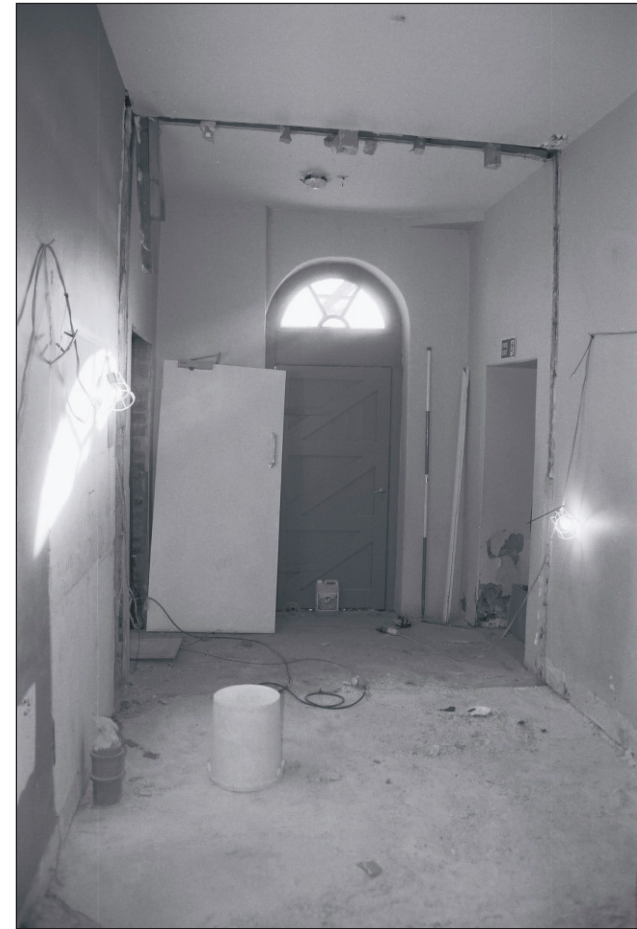
Plate 282: General view of G20/21, West Range, after removal of modern partitions (Film 67.33)

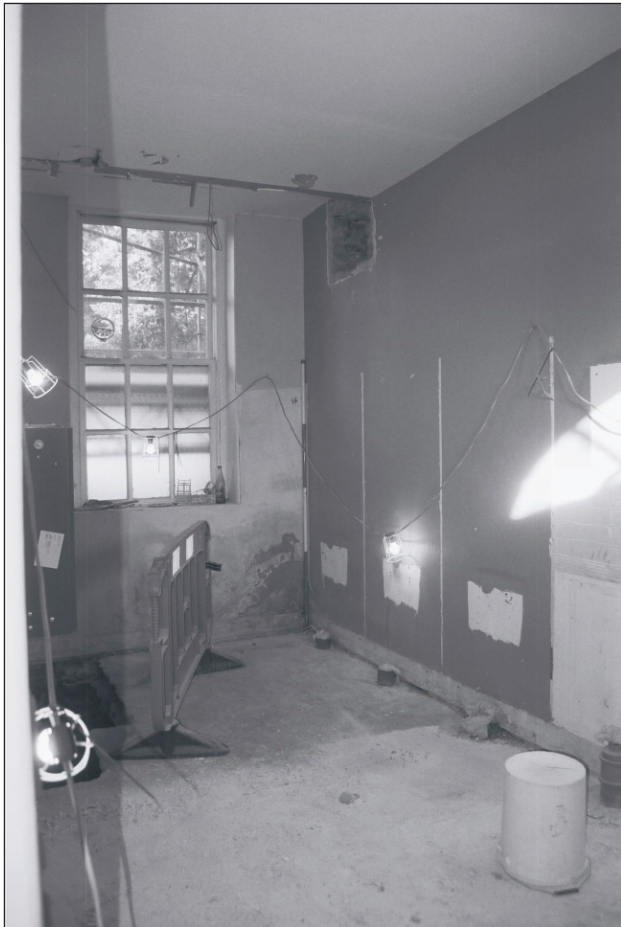
Plate 283: General view of rooms G20/21, West Range, after the removal of modern partitions (Film 67.35)

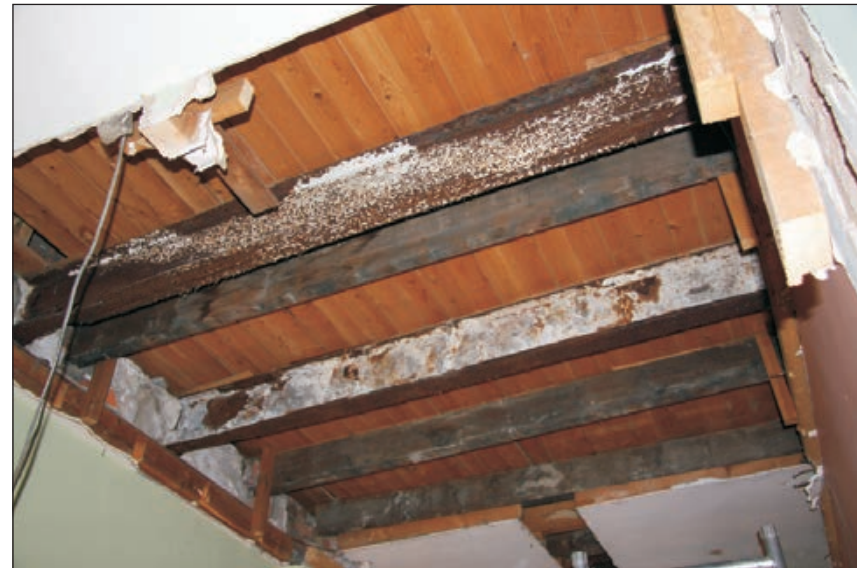
Plate 284: View of exposed modern timber and RSJ joists of ceiling and floor above G20/21, West Range - OB. 81 (Film D. 14.10.10. 1596)

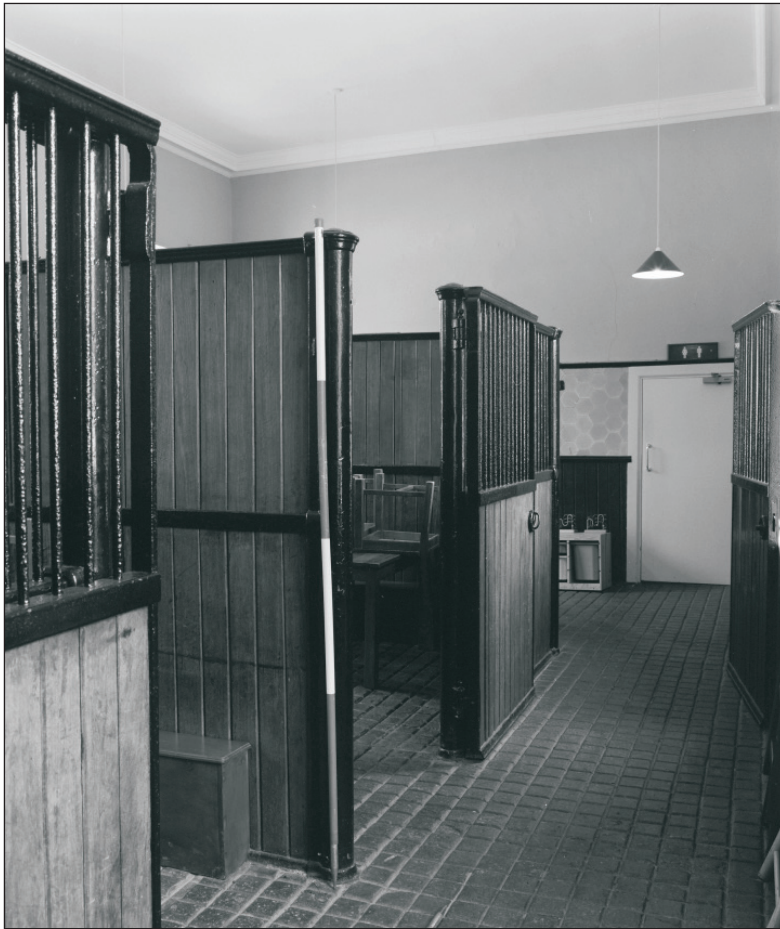
Plate 285: General view of G22, West Range (Film 39.03)

- 5.3.11 Located within the single-storey section of the West Range were rooms G22, G23 and G24 (**Figure 11**). G23 was a central through entrance with loose boxes positioned within G22 to the north, and a modern café to the south. G22 was most latterly used as a seating area for the visitor café at Nostell Priory. The room (**Plates 285-286**) contained three sash windows to the west, formerly blind windows, and two full sashes and a blind/blocked window to the east. G22 contained three 1904 (phase 7) loose boxes, fixtures and fittings, which replaced any earlier stalls. These were very similar to those retained within the east element of the North Range, and include Musgrave cast iron and timber partitions, hexagonal turquoise wall tiles, stable brick flooring, and tether rings (**Plates 287-289, 291, 294**). Former stench traps within the floor had been blocked (**Plate 290**) and the Musgrave cast iron hay racks and mangers have been previously removed (**Plate 292**). A moulded cornice was present surrounding the room (**Plate 293**).
