NOSTELL PRIORY STABLES, NOSTELL, WAKEFIELD, WEST YORKSHIRE

Historic Building Recording and Structural Watching Brief

Planning Application Ref: 09/00701/FUL & 09/00705/LBC

72934.01_BDG_V0_4

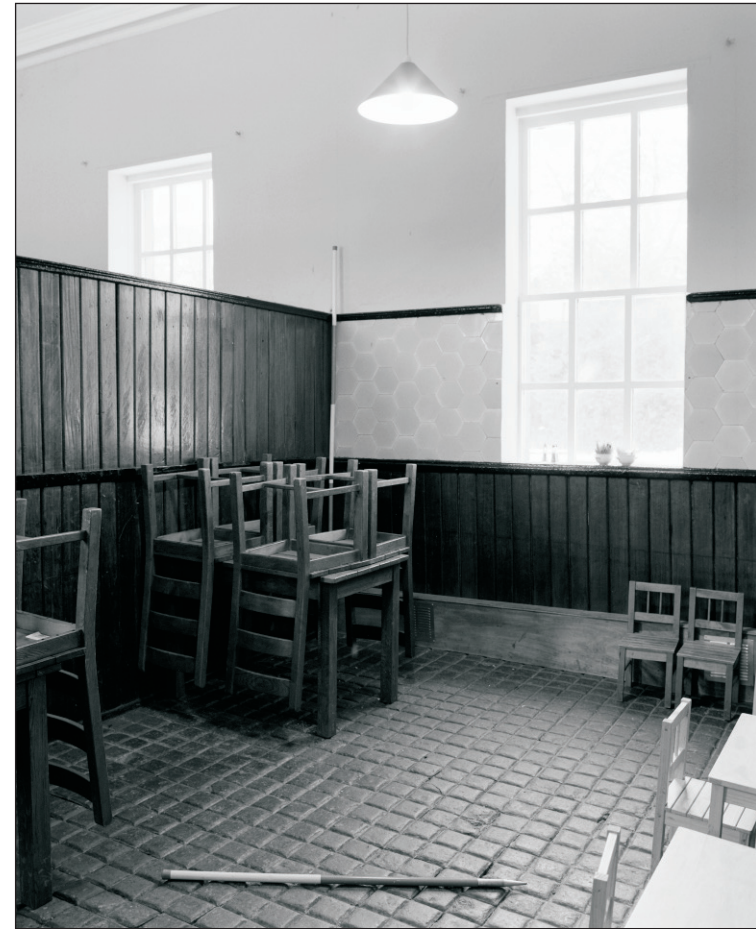
Plate 286: General view of G22, West Range (Film 39.07)

- 5.3.11 Located within the single-storey section of the West Range were rooms G22, G23 and G24 (**Figure 11**). G23 was a central through entrance with loose boxes positioned within G22 to the north, and a modern café to the south. G22 was most latterly used as a seating area for the visitor café at Nostell Priory. The room (**Plates 285-286**) contained three sash windows to the west, formerly blind windows, and two full sashes and a blind/blocked window to the east. G22 contained three 1904 (phase 7) loose boxes, fixtures and fittings, which replaced any earlier stalls. These were very similar to those retained within the east element of the North Range, and include Musgrave cast iron and timber partitions, hexagonal turquoise wall tiles, stable brick flooring, and tether rings (**Plates 287-289, 291, 294**). Former stench traps within the floor had been blocked (**Plate 290**) and the Musgrave cast iron hay racks and mangers have been previously removed (**Plate 292**). A moulded cornice was present surrounding the room (**Plate 293**).

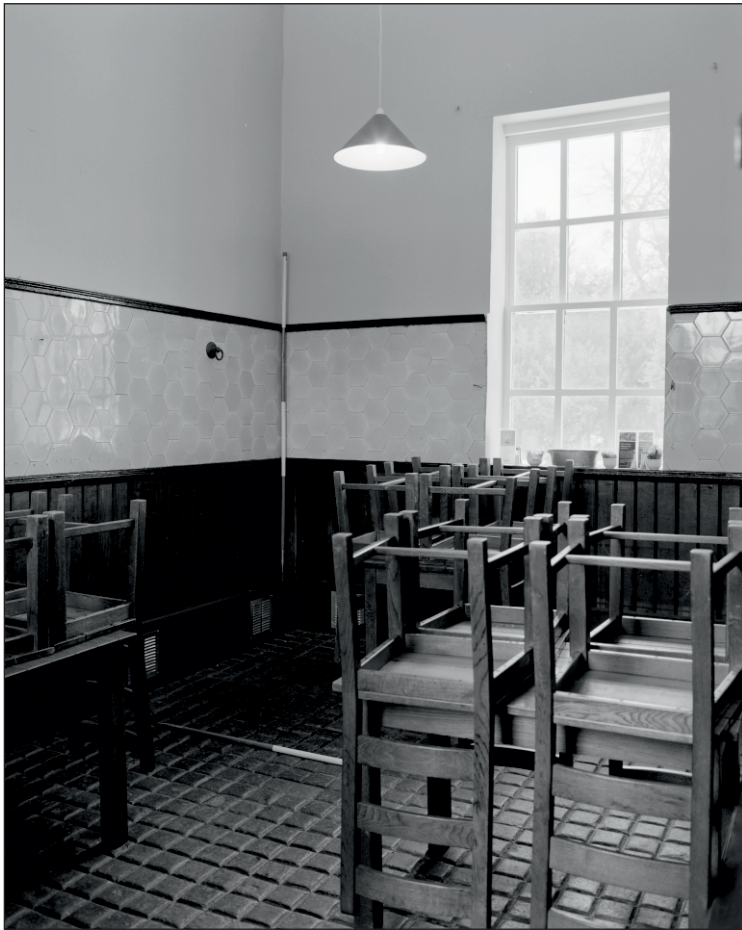
Plate 287: General view of loose box in G22, West Range (Film 39.05)

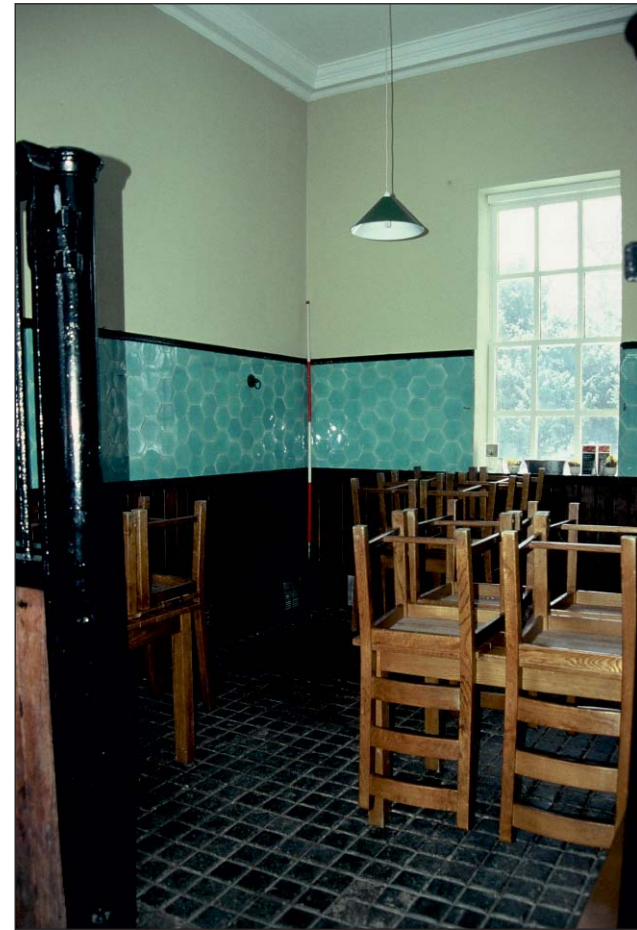
Plate 288: General view of loose box in G22, West Range (Film C.S. 22.)

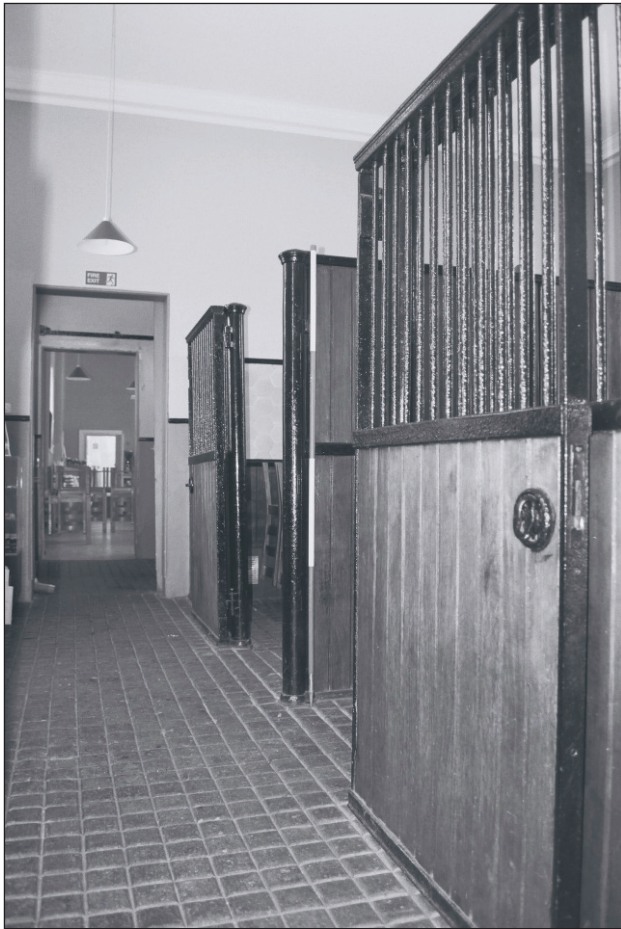
Plate 289: General view of loose boxes in G22, West Range (Film 23.14)

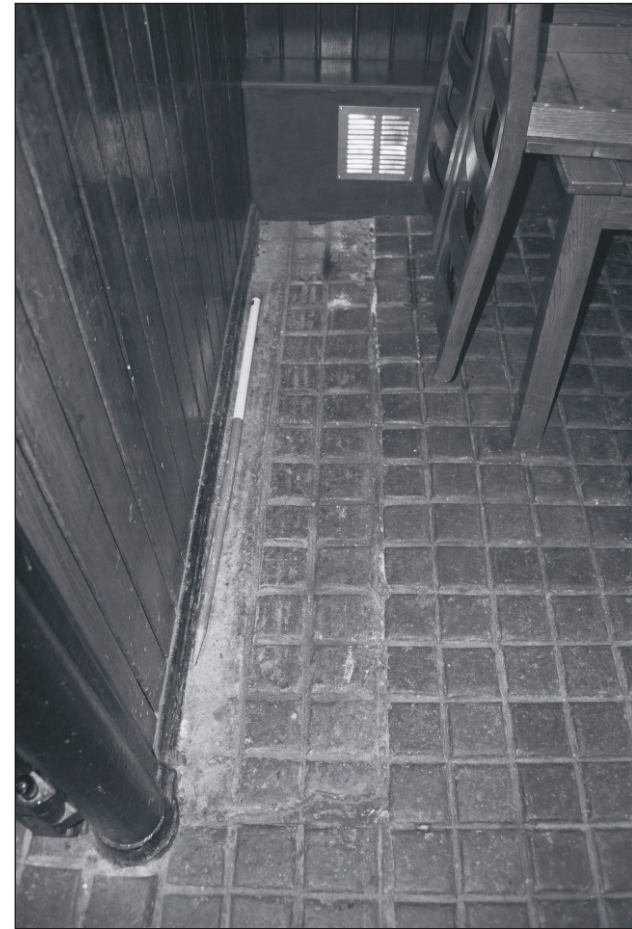
Plate 290: View of blocked stench trap surface drains in floor of loose box in G22, West Range (Film 23.19)

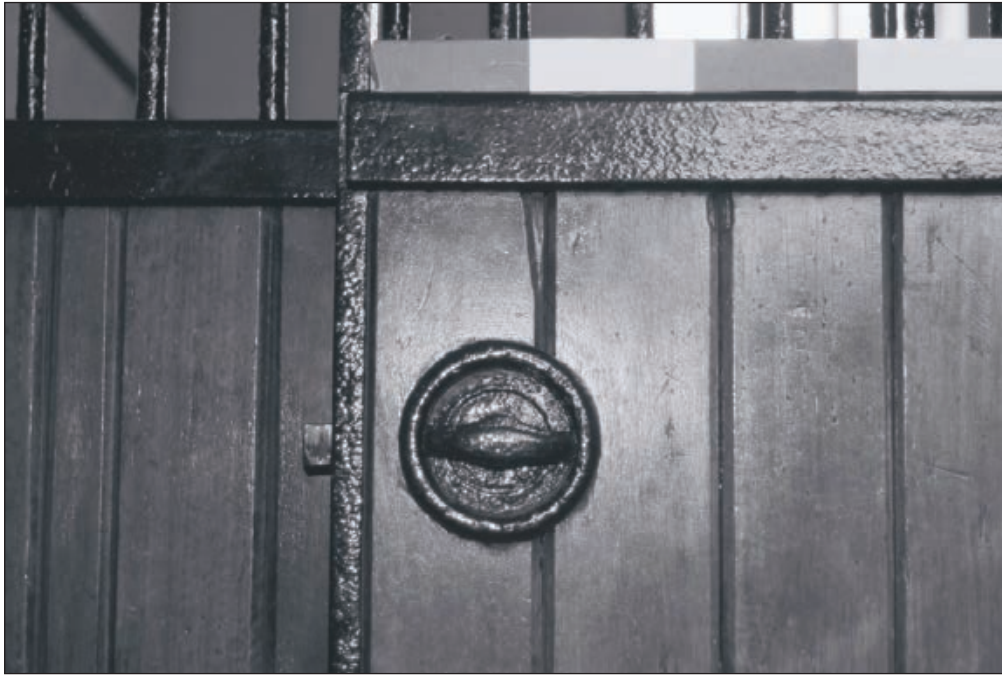
Plate 291: Detail of loose box iron latch, G22, West Range (Film 23.15)

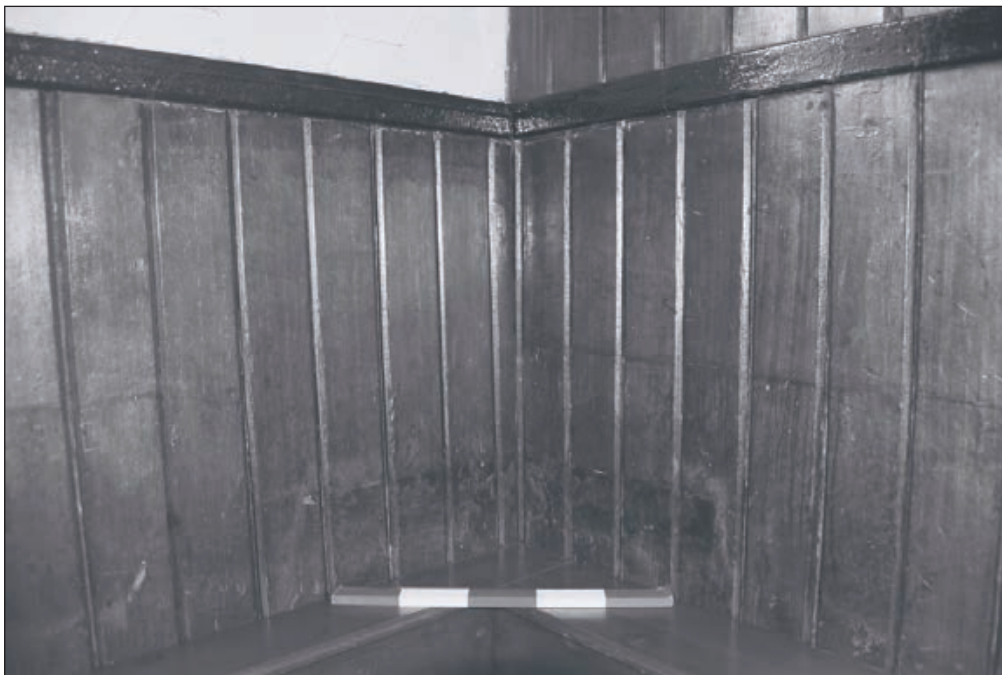
Plate 292: Detail of scar from removed trough or manger, northwest corner of loose box within G22, West Range (Film 23.22)

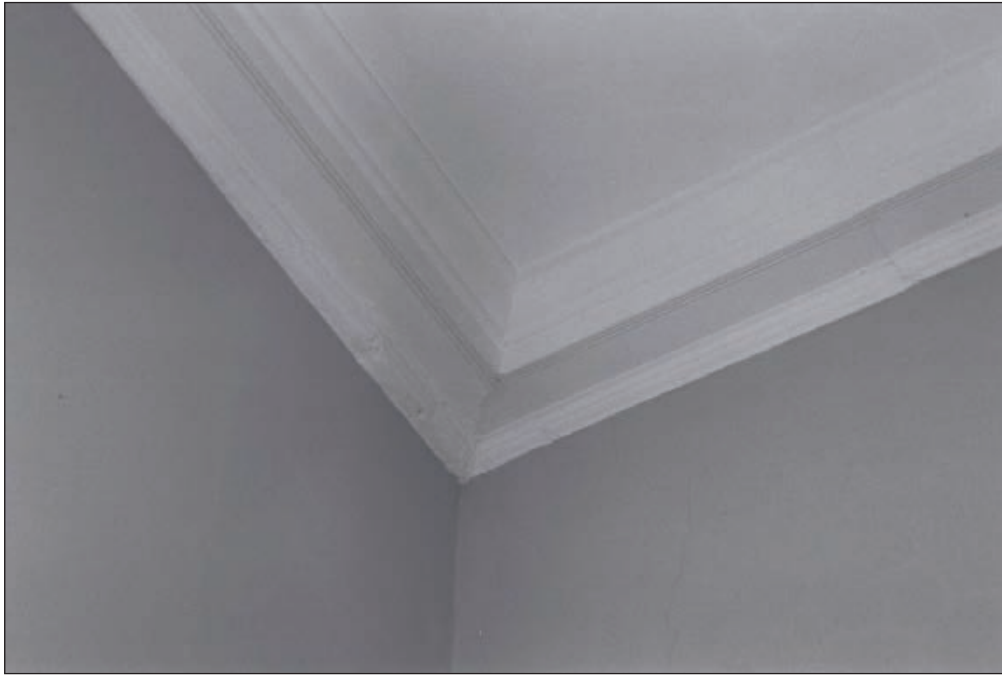
Plate 293: Detail of cornice, G22, West Range (Film 23.18)

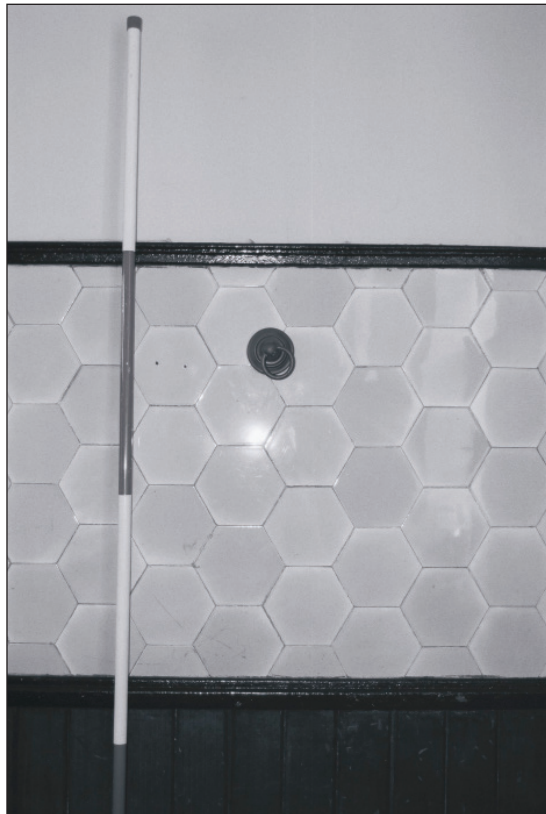
Plate 294: Detail of tiling and tether hook, south wall of loose box, G22, West Range (Film 23.23)

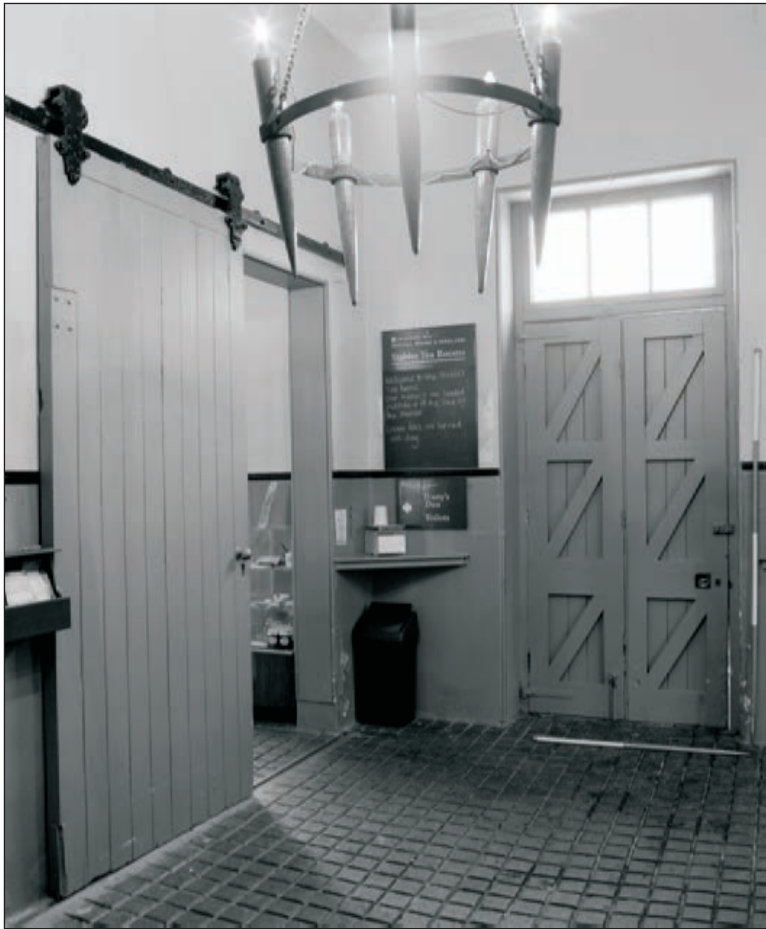
Plate 295: General view of G23, West Range (Film 39.01)

- 5.3.12 G23 (**Plate 295**) was a central through entrance, inserted within the range in phase 4. There was a single doorway within the west wall (**Plate 296**), and a double doorway with rectangular fanlight to the east (**Plate 297**). To the north and south were sliding/rolling timber doors (**Plates 298-299**), providing access to former stabling within G22 and G24. The floor was of stable brick, the same as that within G22 to the north, with a blocked central drain (**Plate 300**). Within the north wall was a low arched recessed drain (**Plate 301**) and tether hook (**Plate 302**).

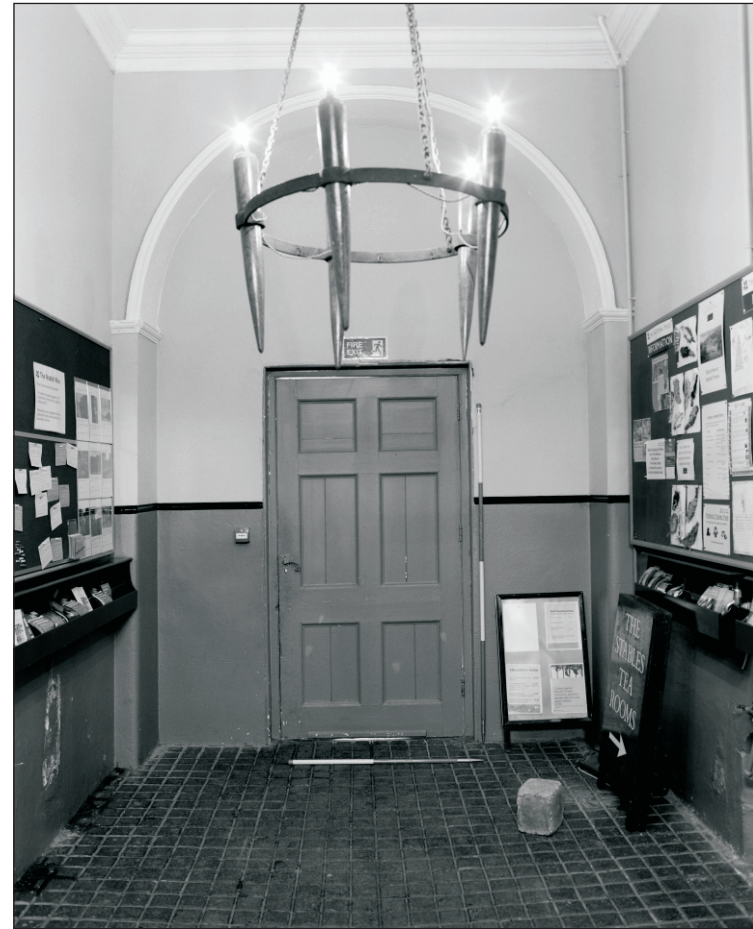
Plate 296: General view of G23, West Range (Film 38.09)

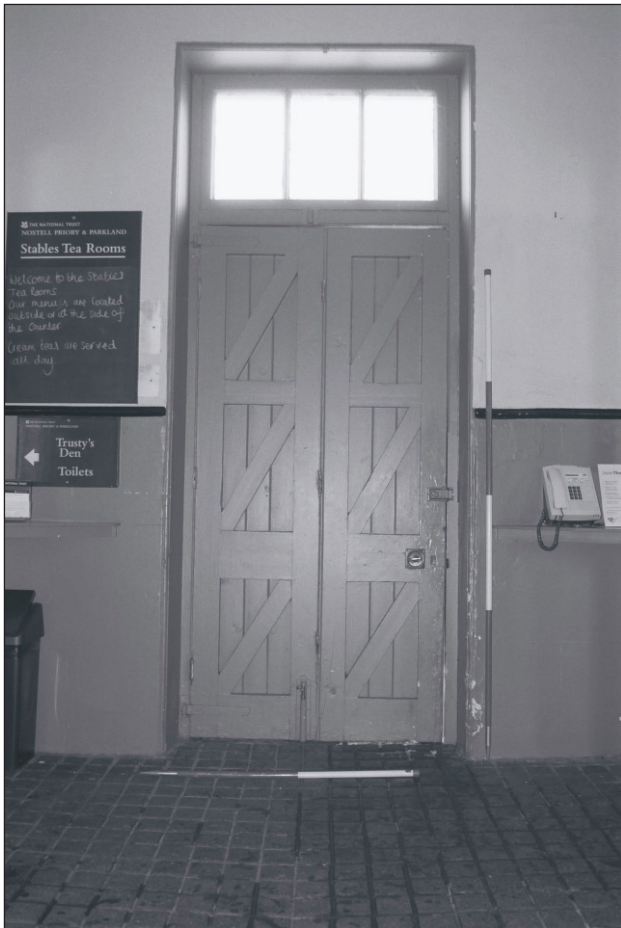
Plate 297: Detail of eastern door, G23, West Range (Film 23.32)

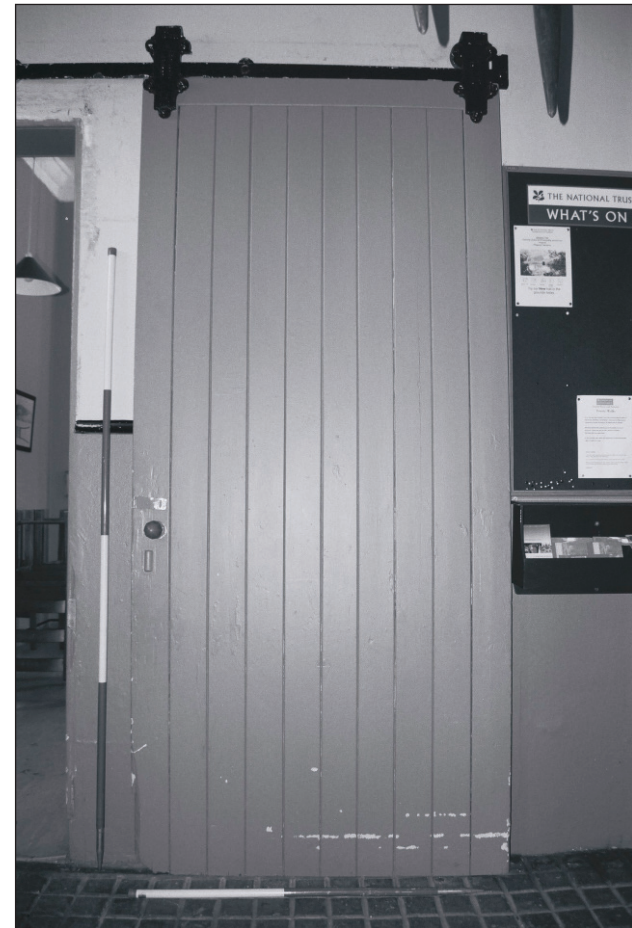
Plate 298: Detail of sliding/rolling door, G23, West Range (Film 22.01)

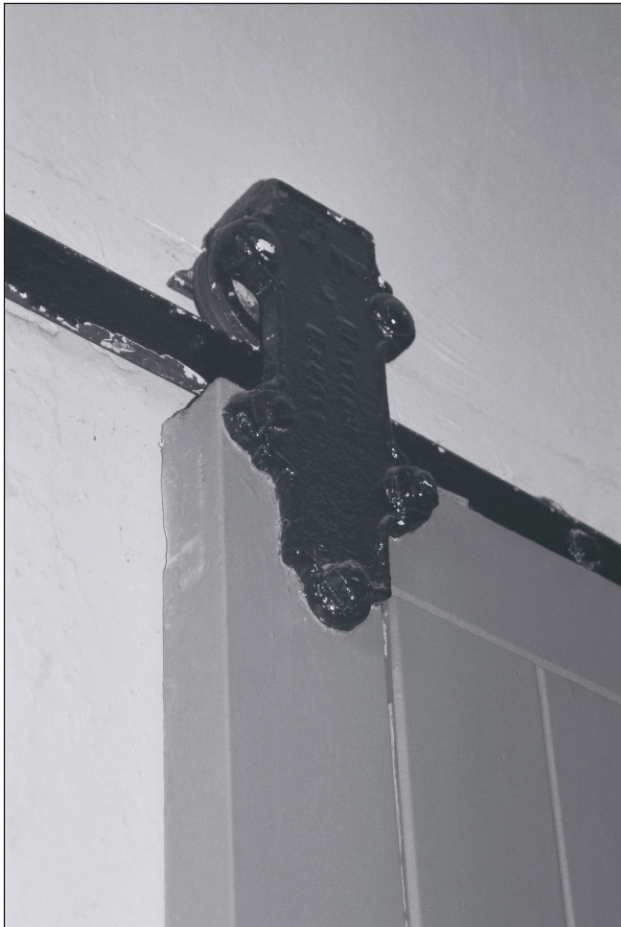
Plate 299: Detail of iron bracket and roller on rolling door, G23, West Range (Film 23.33)

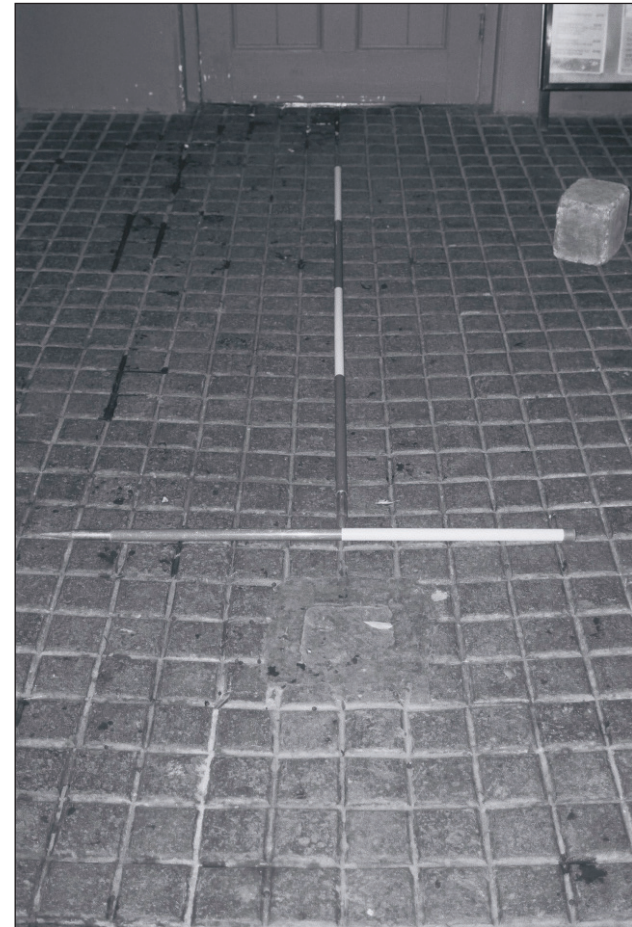
Plate 300: Detail of stable brick floor, G23, West Range (Film 23.30)

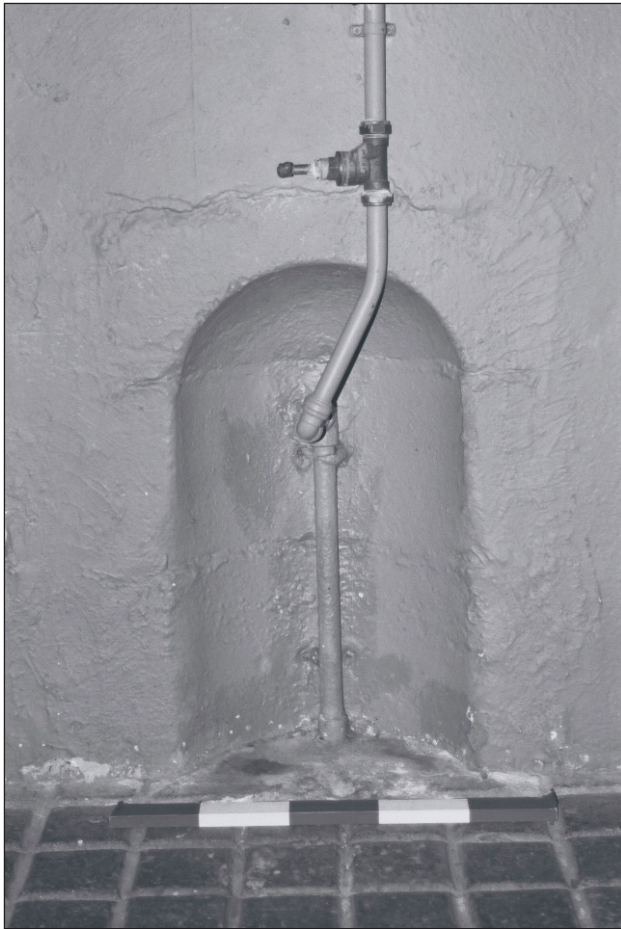
Plate 301: Detail of recessed drain, north wall of G23, West Range (Film 23.28)

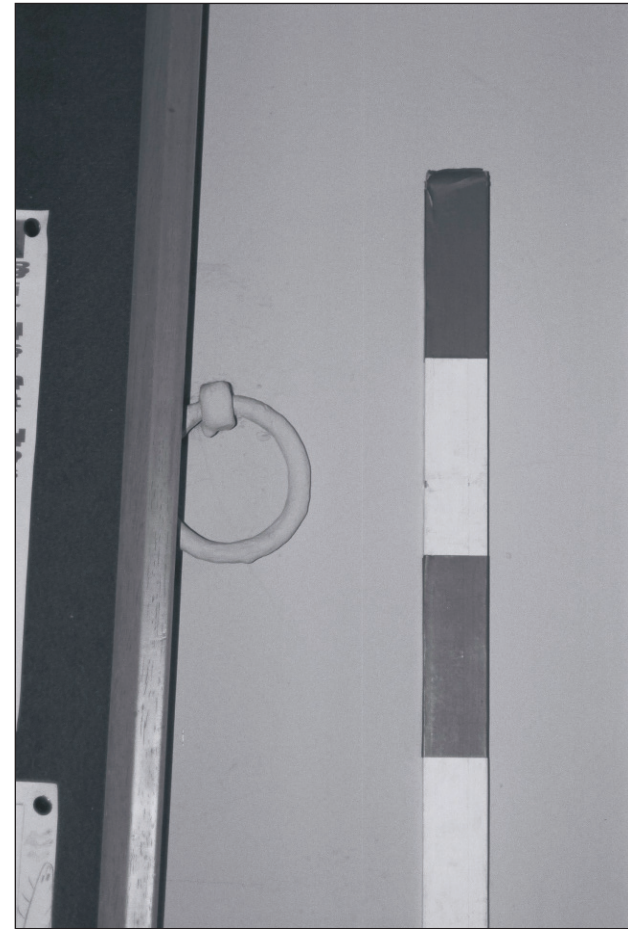
Plate 302: Detail of tether hook, north wall of G23, West Range (Film 23.26)

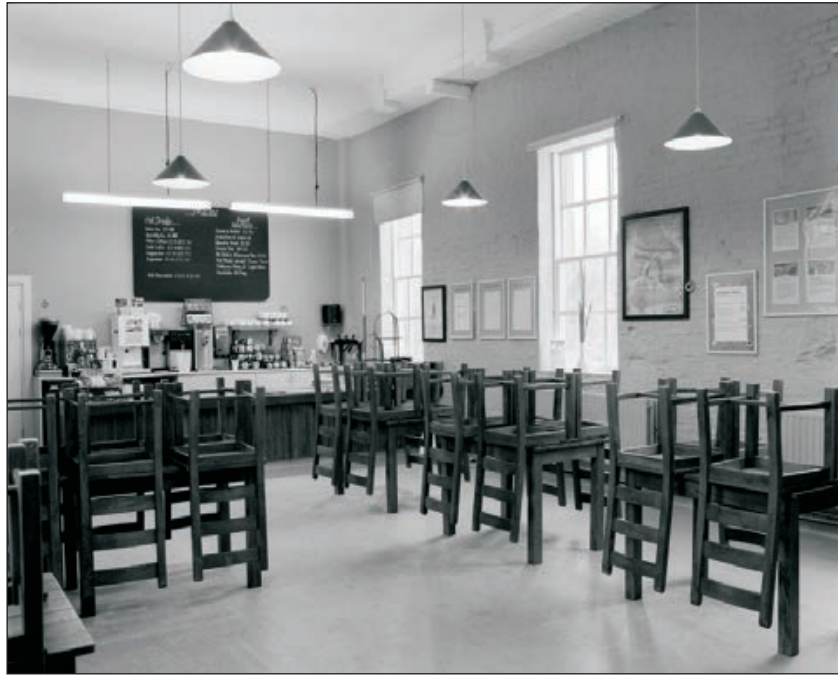
Plate 303: General view of G24, West Range (Film 38.07)

- 5.3.13 To the south G24 latterly functioned as a café with modern seating, counter and modern finishes (**Plates 303-305**). To the south were three former blind windows (**Plates 304, 309**), two original high windows to the north (**Plate 305, 310**), and access to the south range via two doorways in the southeast corner. Attached to the ceiling, along the west wall were remnants of the original phase 3 stalls and grain chutes which had been truncated and consolidated (**Plate 306**). The remainder of the ceiling retained original corning (**Plate 307**) and two ceiling roses (**Plate 308**).

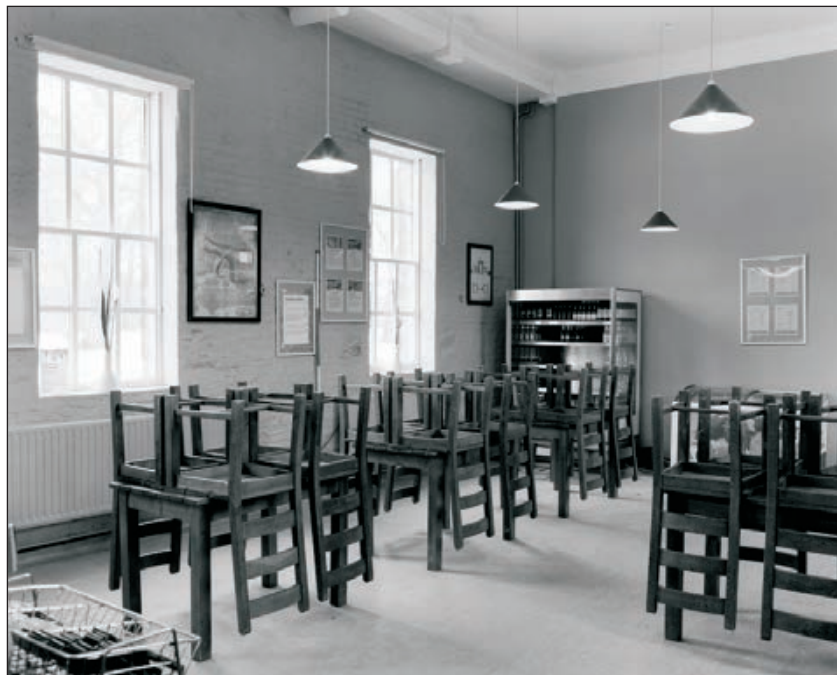
Plate 304: General view of G24, West Range (Film 38.03)

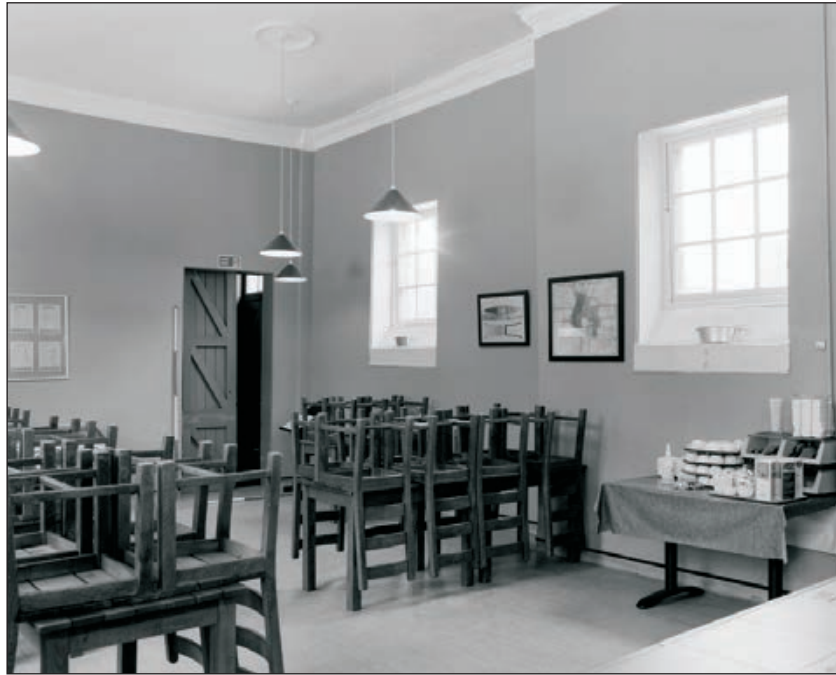
Plate 305: General view of G24, West Range (Film 38.05)

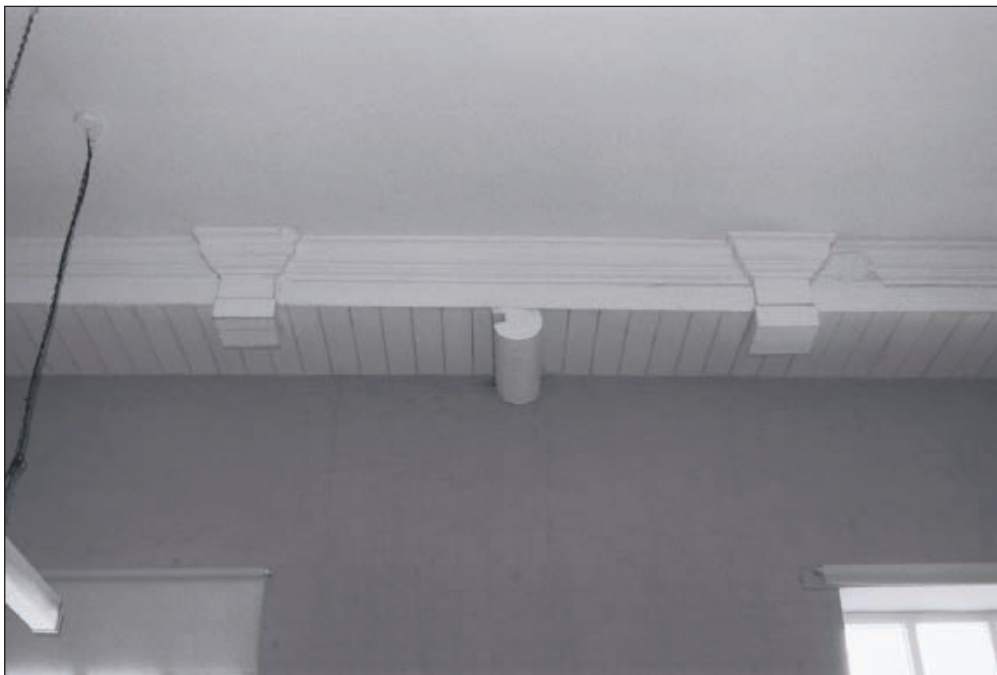
Plate 306: Detail of cornice indicating original positions of stalls, west wall of G24, West Range (Film 22.15)

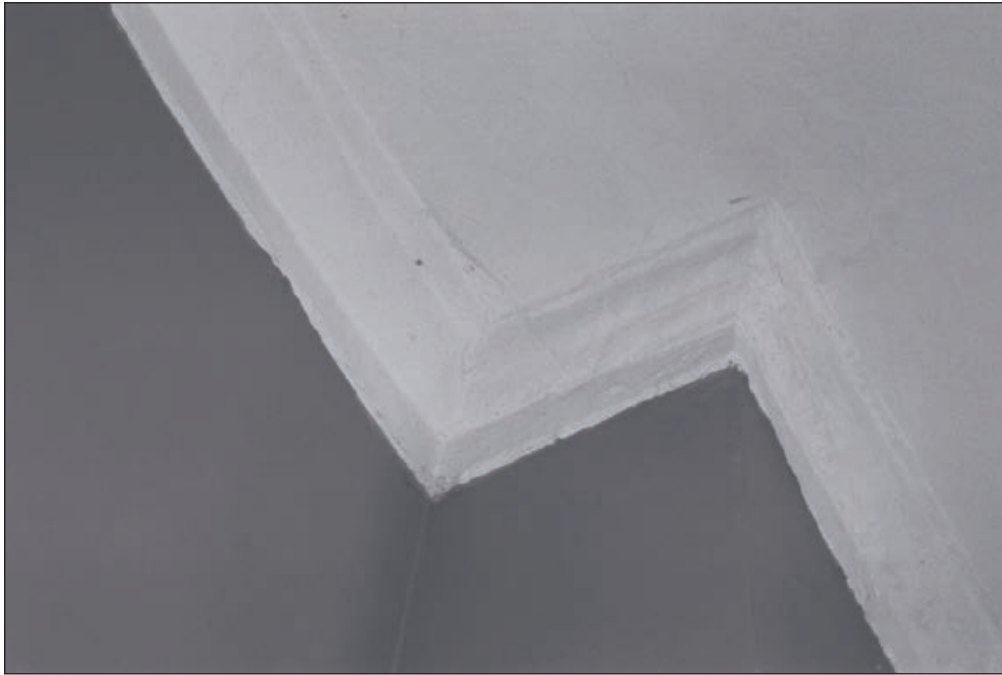
Plate 307: Detail of cornice, G24, West Range (Film 22.10)

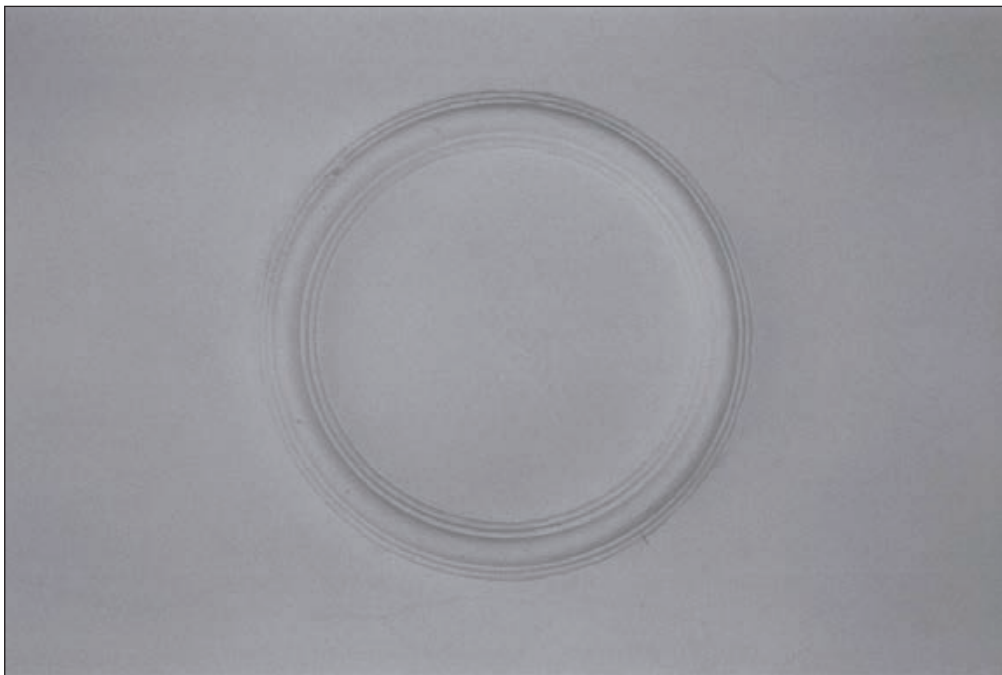
Plate 308: Detail of ceiling rose, G24, West Range (Film 22.12)

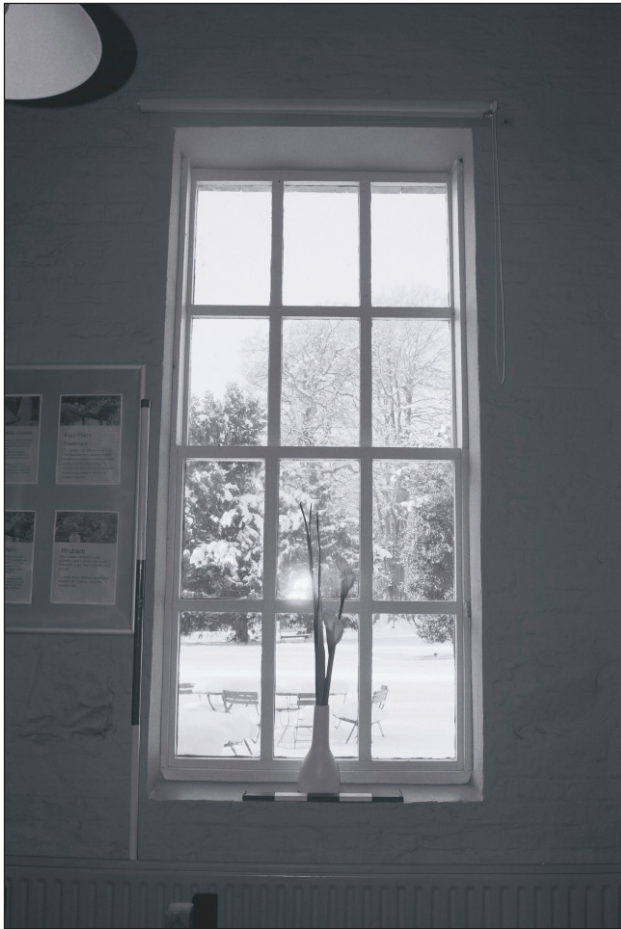
Plate 309: Detail of former blind window, west wall of G24, West Range (Film 22.06)

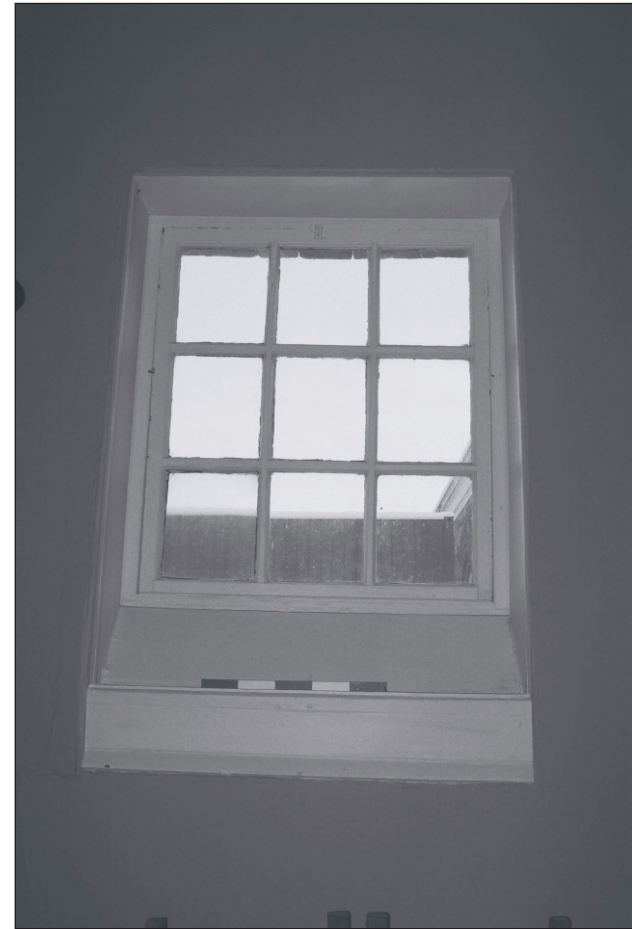
Plate 310: Detail of high window, east wall of G24, West Range (Film 22.09)

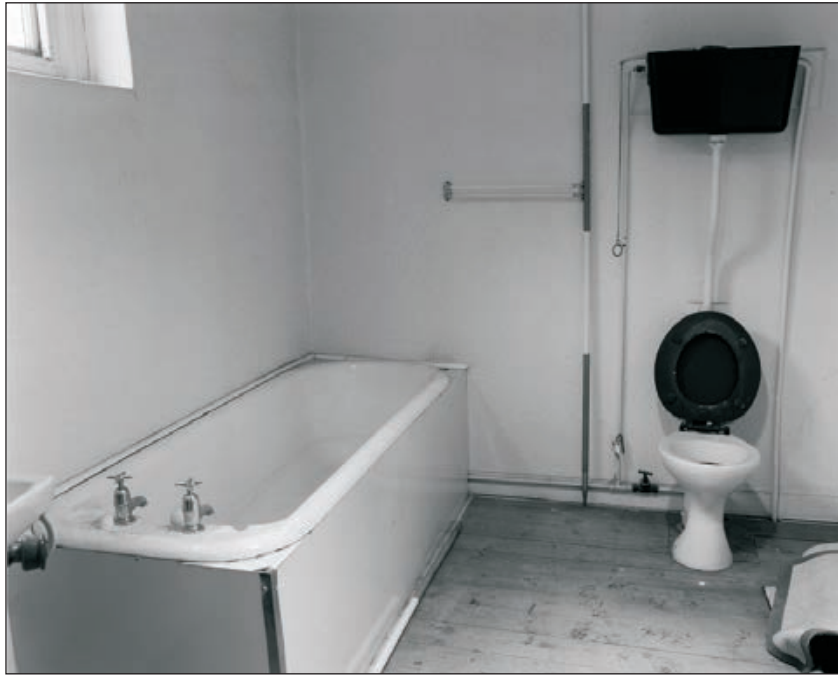
Plate 311: General view of room F26, West Range (Film 35.10)

- 5.3.14 The first floor of the north end of the West Range was essentially a single room, with rooms inserted during the mid-20th century, creating rooms F23-F26 (**Figure 13**). Access to the area was via F21 in the North Range. The 20th-century inserted rooms included a bathroom, F26 (**Plate 311**), a small

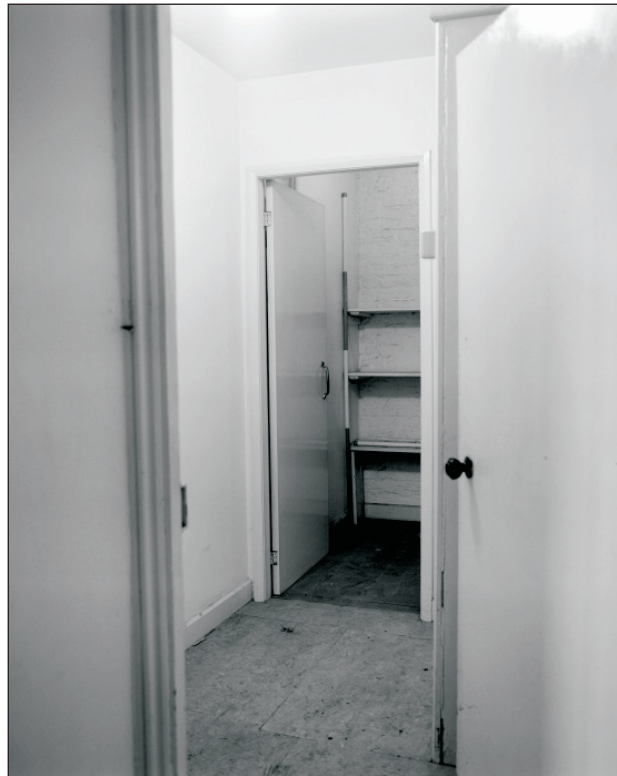
Plate 312: General view of corridor F25 towards F23, West Range (Film 36.01)

corridor F25 (**Plate 312**), a pantry, F23 (**Plate 314**), and cupboard F24. The room to the south, within which F23-F26 were inserted, F27 (**Plate 315**), was a large open space utilised as a store, with several phases of construction, representing the join between the original phase 1 North Range, the phase 3 West Range, and the phase 7 North Range. The north and east walls dated to phase 7, the south wall and the south end of the west wall dated to phase 3 and the north end of the west wall contained phase 1 stone fabric. The south wall contained several exposed features including blocked openings, flues and doorways (**Plates 316-317**). It is possible that these are related to the former phase 1 North Range. Projecting westwards from the east wall is a truncated section of brick walling, in line with a dividing wall below (**Plate 318**). This also delineated a change in timber floor boards, with those to the south being modern. The windows within the east wall both dated to phase 7 (**Plate 319**), and those to the west were much higher and comprised a phase 7 window inserted within a phase 3 wall (**Plate 320**), and a blind window at the junction of phase 1 and phase 3 fabric.

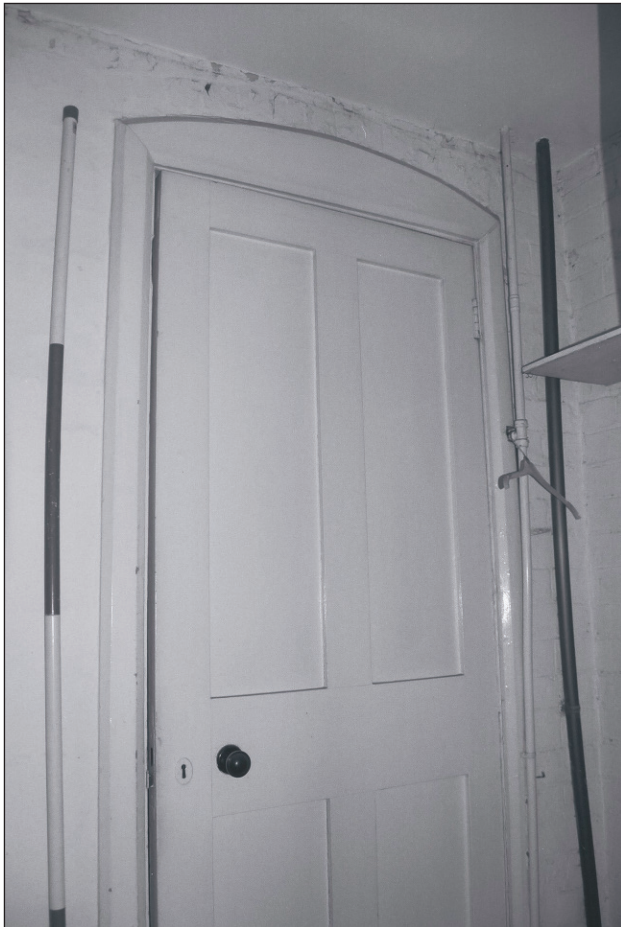
Plate 313: Detail of doorway in F25 from F21, West Range (Film 26.31)

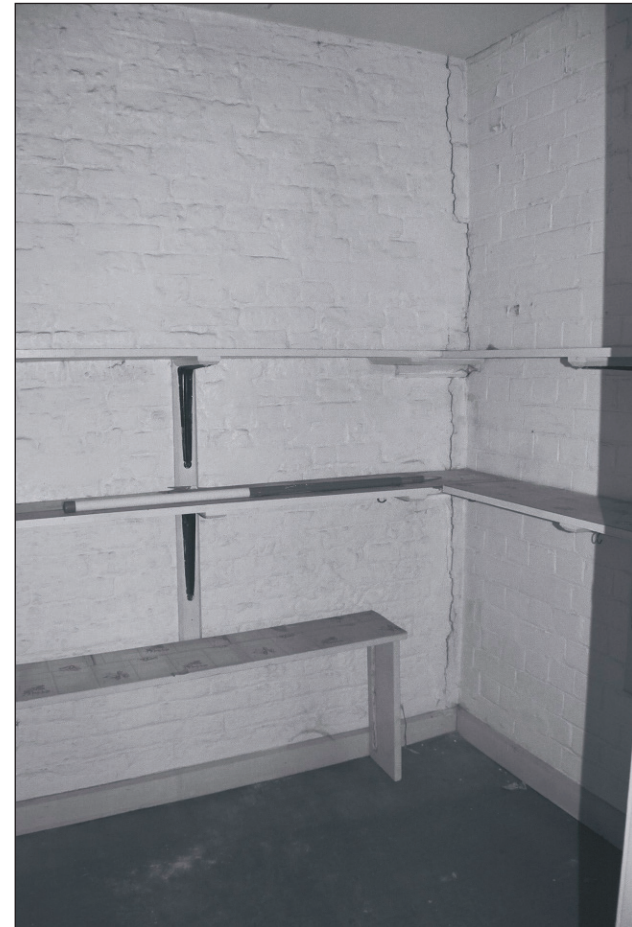
Plate 314: View into F23, West Range (Film 26.33)

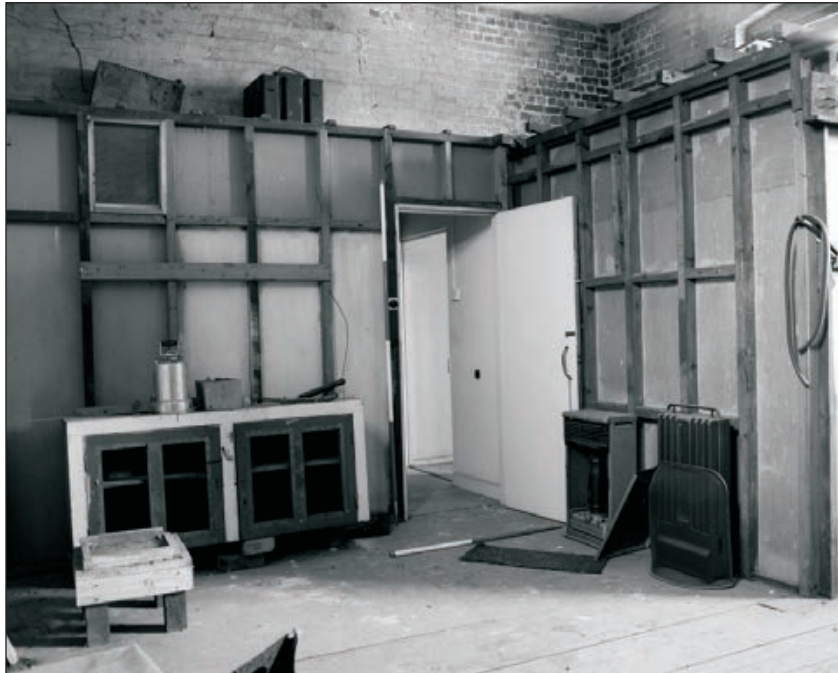
Plate 315: General view of inserted rooms F23-F26, within room F27 West Range (Film 36.04)

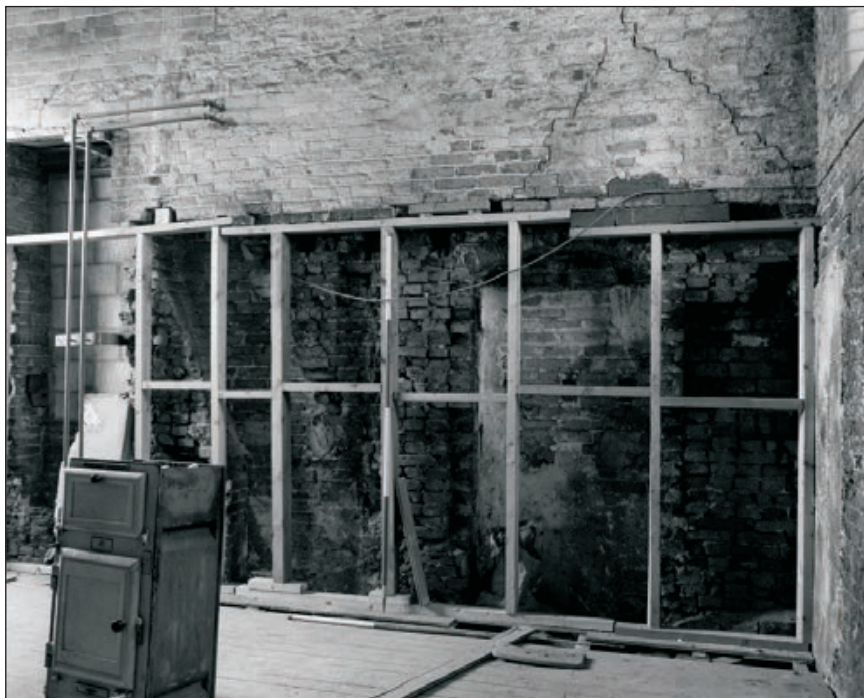
Plate 316: General view of earlier south wall of F27, West Range, showing blocked door and flue (Film 36.06)

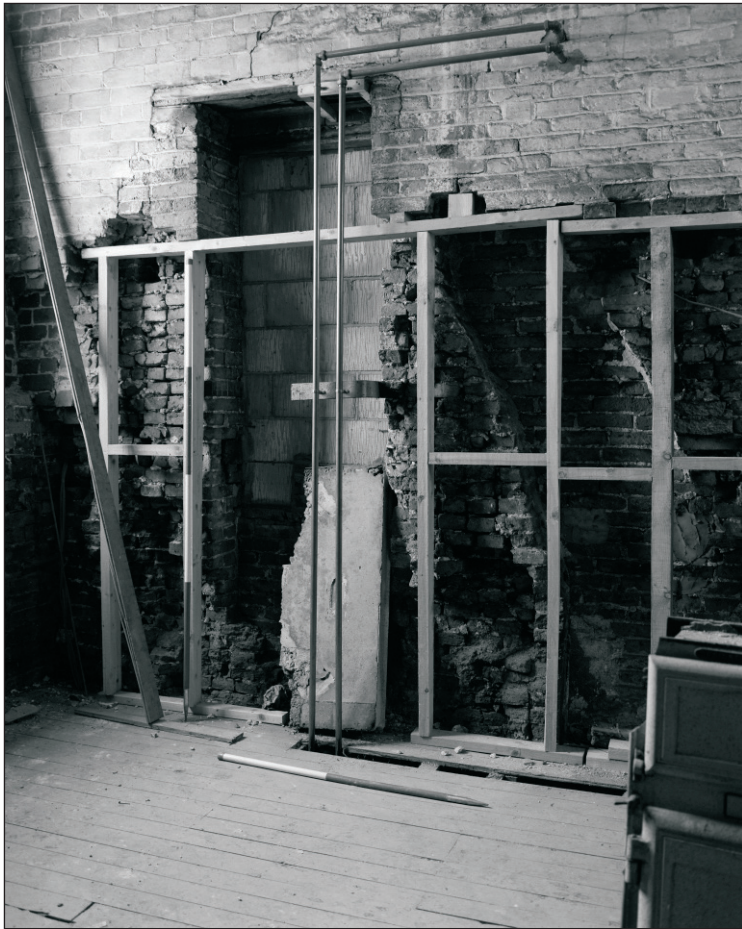
Plate 317: View of earlier south wall of F27, West Range, showing join with later north range, blocked doorway and flue (Film 36.08)

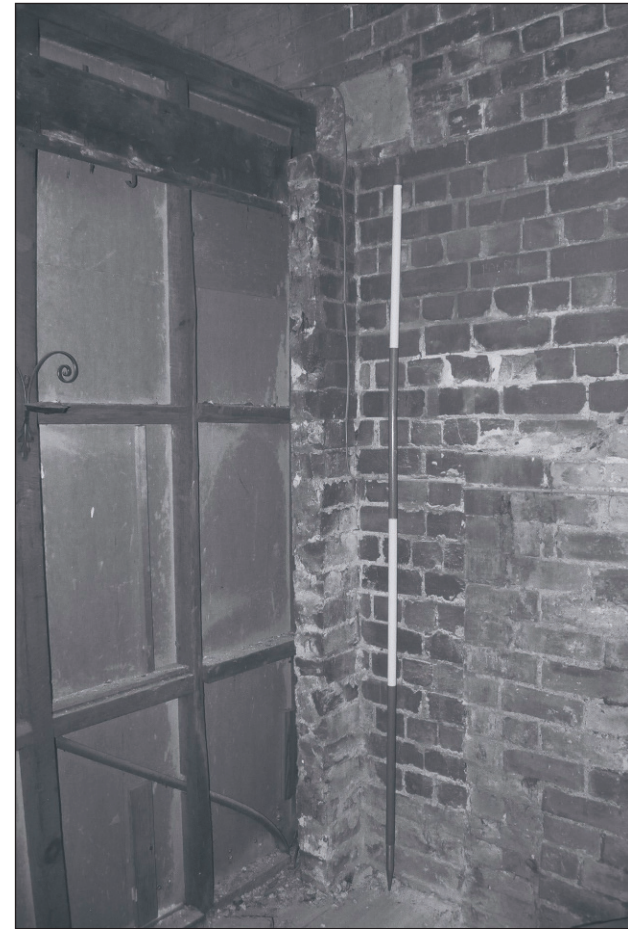
Plate 318: View of join between phase 3 and 6 brickwork, and truncated partition, east wall of F27, West Range (Film 26.24)

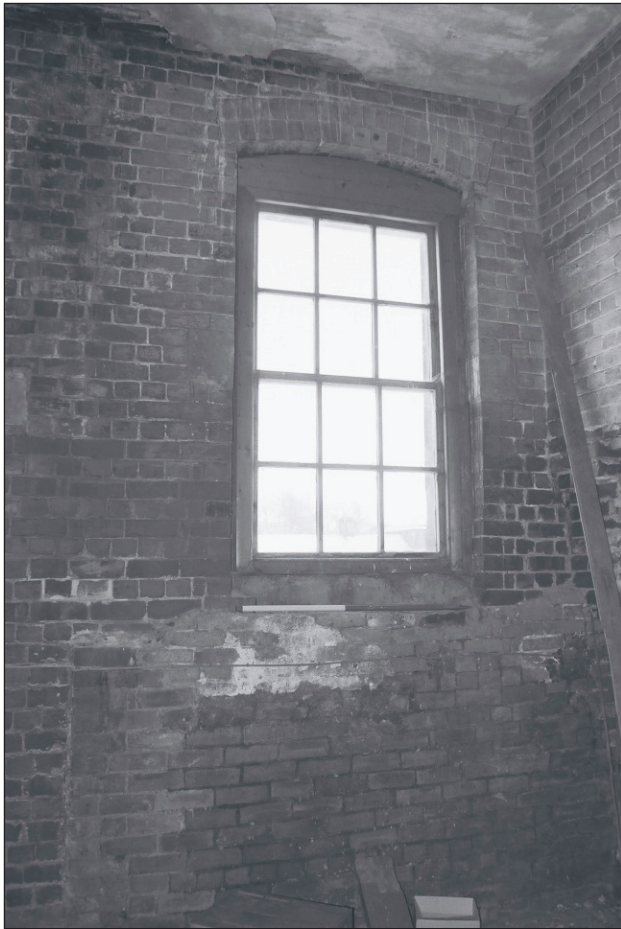
Plate 319: View of sash window, east wall of F27, West Range, showing earlier brick below (Film 26.26)
