NOSTELL PRIORY STABLES, NOSTELL, WAKEFIELD, WEST YORKSHIRE

Historic Building Recording and Structural Watching Brief

Planning Application Ref: 09/00701/FUL & 09/00705/LBC

72934.01_BDG_V0_4

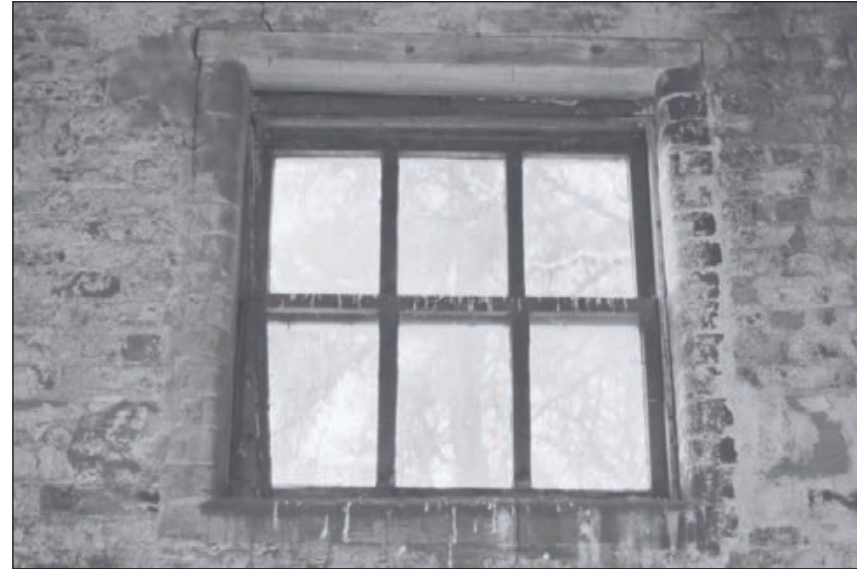
Plate 320: View of inserted window in phase 3 west wall of F27, West Range (Film 26.29)

corridor F25 (**Plate 312**), a pantry, F23 (**Plate 314**), and cupboard F24. The room to the south, within which F23-F26 were inserted, F27 (**Plate 315**), was a large open space utilised as a store, with several phases of construction, representing the join between the original phase 1 North Range, the phase 3 West Range, and the phase 7 North Range. The north and east walls dated to phase 7, the south wall and the south end of the west wall dated to phase 3 and the north end of the west wall contained phase 1 stone fabric. The south wall contained several exposed features including blocked openings, flues and doorways (**Plates 316-317**). It is possible that these are related to the former phase 1 North Range. Projecting westwards from the east wall is a truncated section of brick walling, in line with a dividing wall below (**Plate 318**). This also delineated a change in timber floor boards, with those to the south being modern. The windows within the east wall both dated to phase 7 (**Plate 319**), and those to the west were much higher and comprised a phase 7 window inserted within a phase 3 wall (**Plate 320**), and a blind window at the junction of phase 1 and phase 3 fabric.

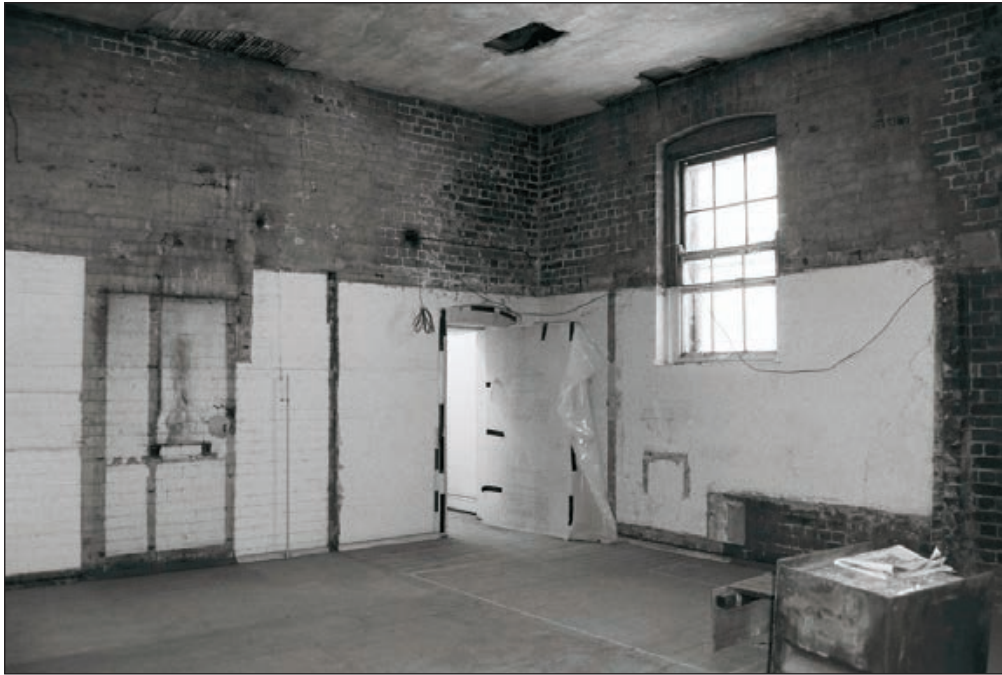
Plate 321: General view of F27 after removal of inserted rooms F23-F26, West Range (Film 52.04)

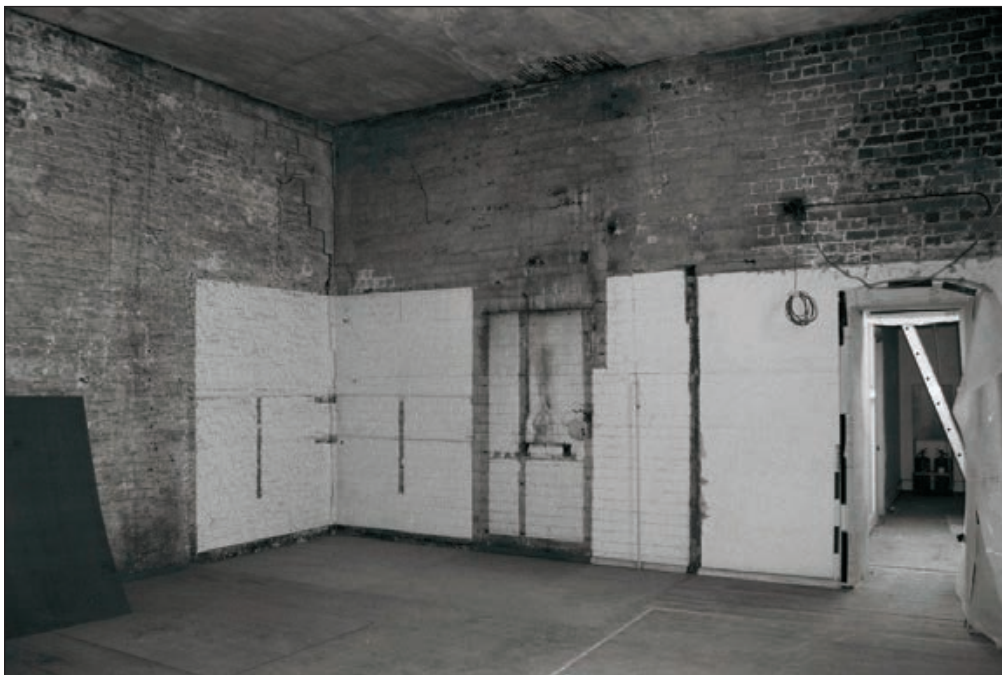
Plate 322: General view of F27 after removal of inserted rooms F23-F26, West Range (Film 52.03)

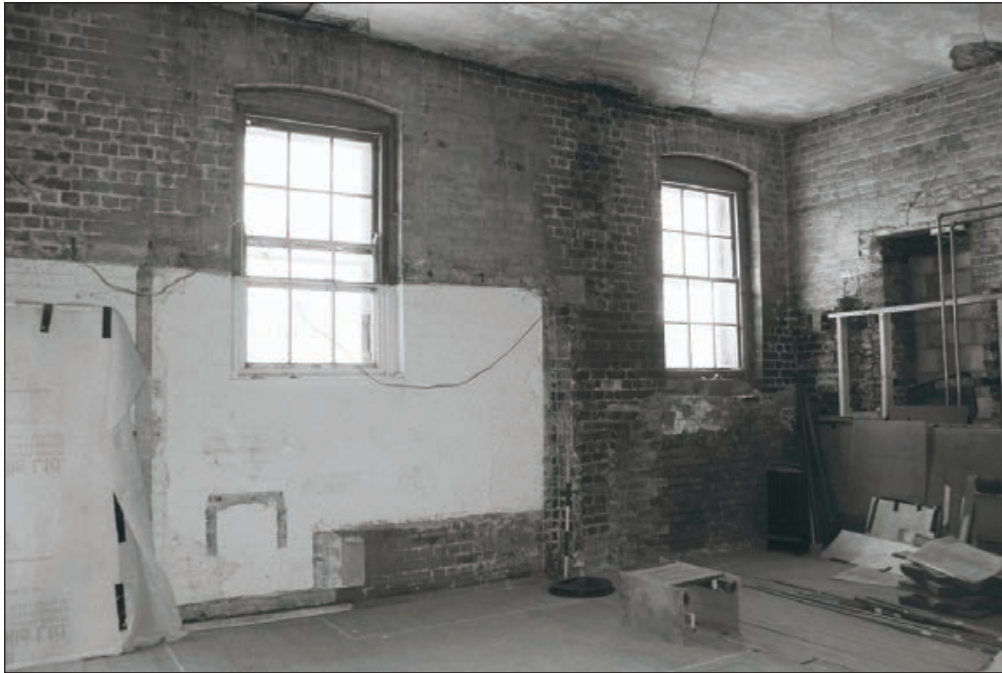
Plate 323: General view of F27 after removal of inserted rooms F23-F26, West Range (Film 52.01)

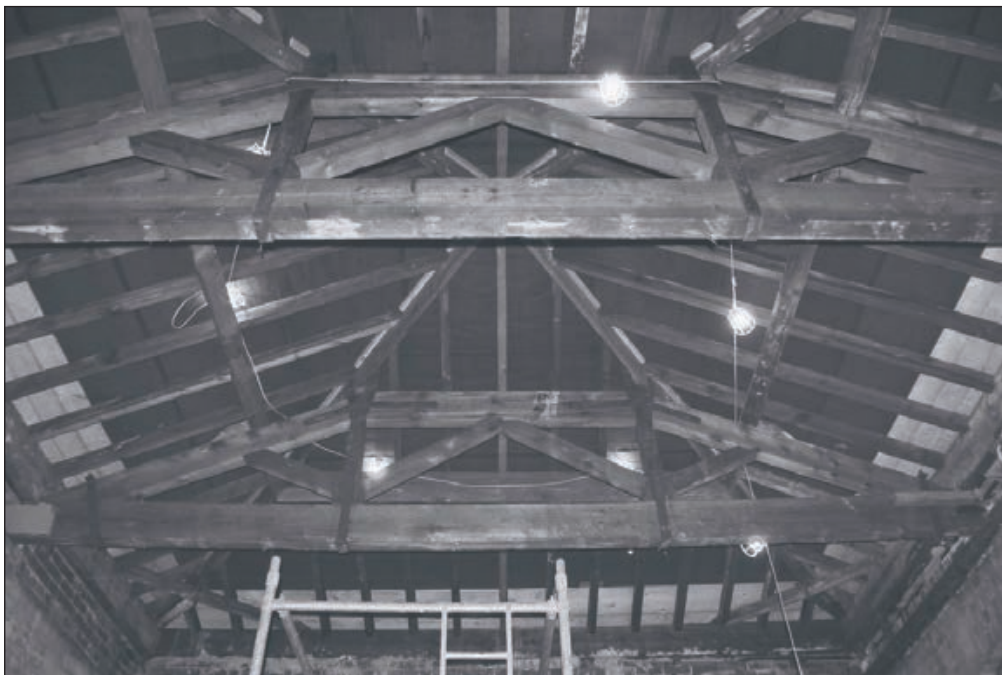
Plate 324: General view of exposed timber Queen-Post trusses, F27, West Range - OB. 56 (Film 67.08)

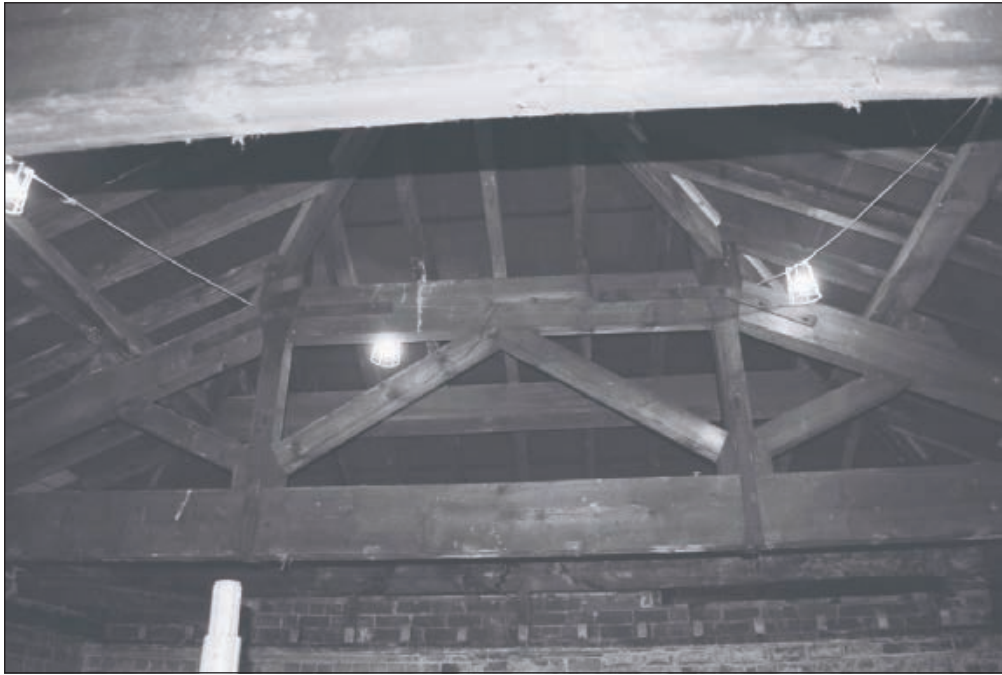
Plate 325: Detail of timber Queen-Post truss, F27, West Range - OB.56 (Film 67.02)

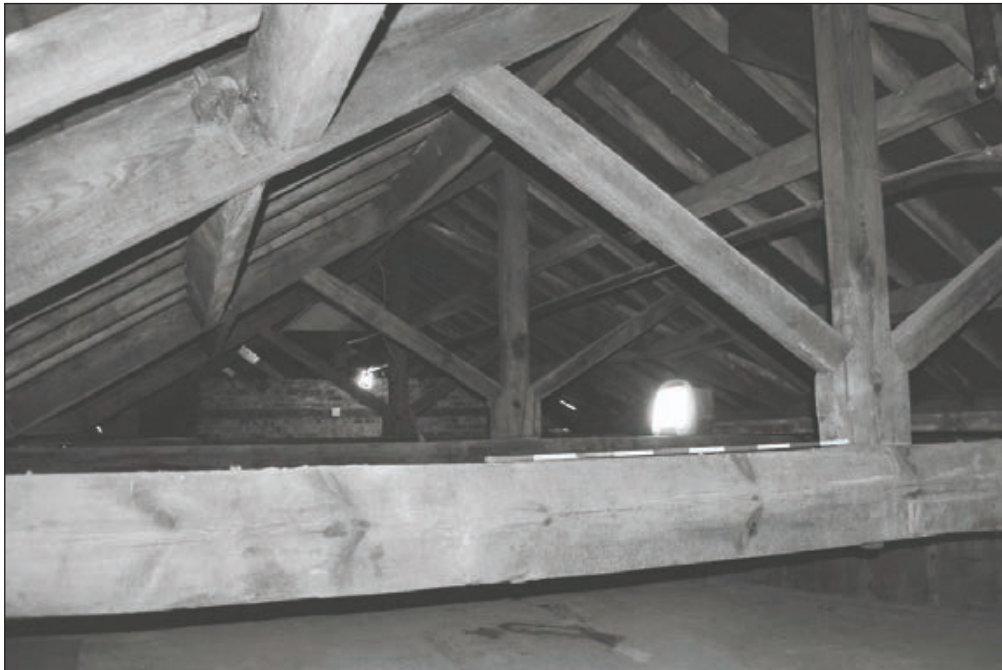
Plate 326: General view of Roof Void 8, West Range - OB. 98 (Film 71.19)

- 5.3.16 Located above the single-storey, central section of the range was roof void 8. This appeared to have functioned as a hayloft serving the stabling below. The roof was supported on 8 timber joggled King-Post trusses with pegged trenched purlins and visible construction marks and Baltic timber marks (**Plates 326-327**). Access to the roof was via a small inserted doorway within the south gable wall of the range, from F29 within the South Range (**Plate 328 and Figure 13**). There were the remains of a timber vent, which would have led from G24 below, and exited through the roof. This metal upper vent had largely been removed (**Plate 329**). The floor comprised a limeash covering laid on a timber joisted floor with laths and straw base for the limeash. Positioned along the west side of the room, set within the limeash floor were hatches (**Plates 330-332**) which would have provided direct access to chutes leading to the mangers within the stalls below. Two brick walls were positioned within the centre of the room, which were part of the through entrance of G23 below, inserted during phase 4 for the addition of the external pediment and cupola tower by Watson Pritchett and Watson. The limeash floor between these inserted walls was removed during the watching brief, exposing the timber joisting below (**Plates 333-334**).

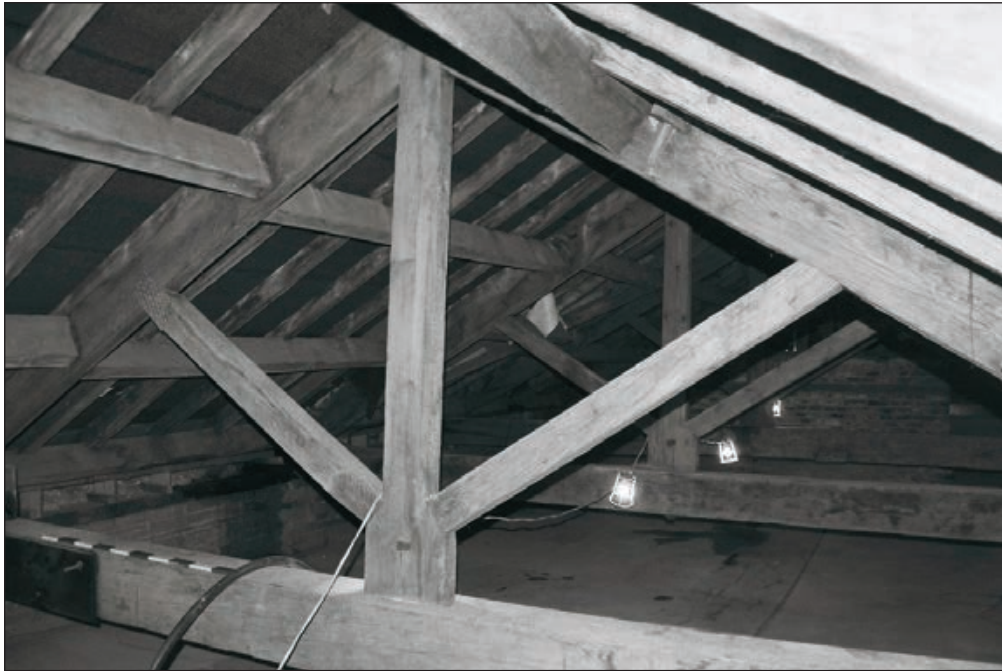
Plate 327: General view of Roof Void 8, showing timber King-Post truss, West Range - OB.98 (Film 71.10)

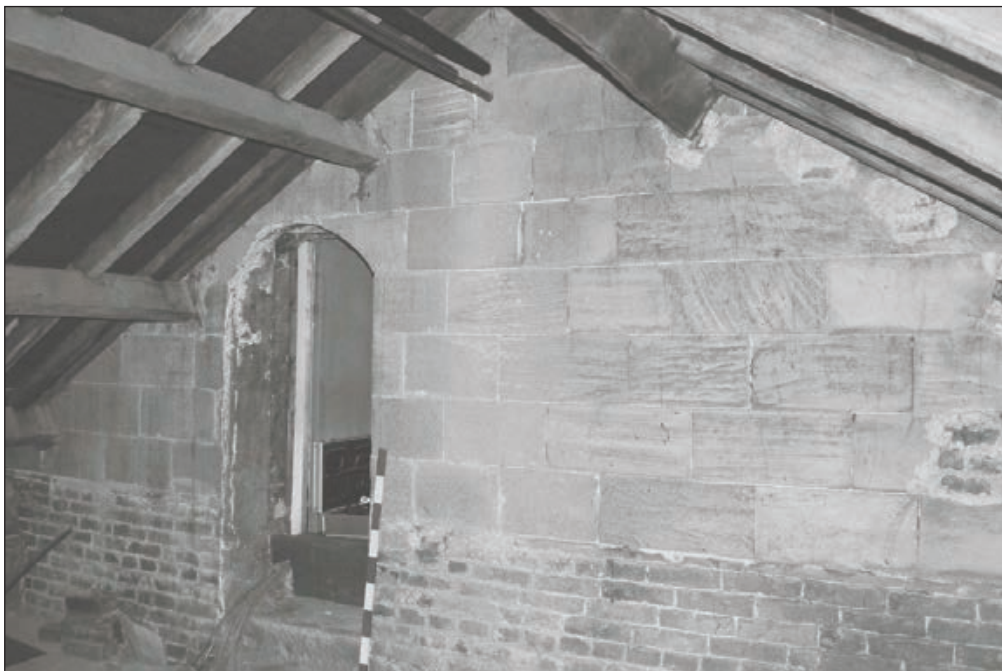
Plate 328: View of south gable wall of Roof Void 8, West Range - OB. 98 (Film 71.15)

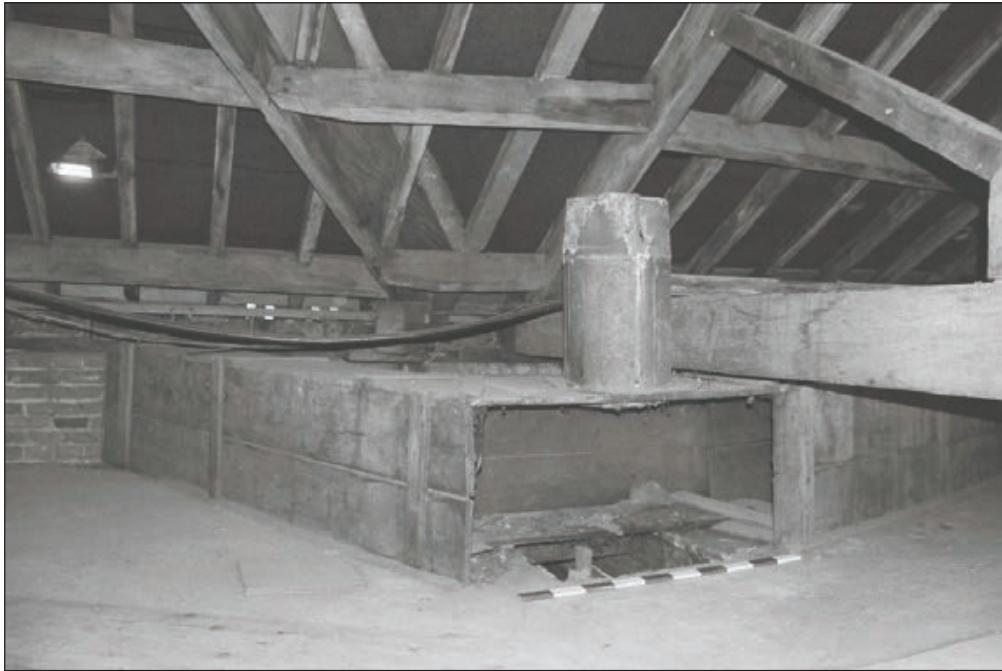
Plate 329: View of inserted timber vent within Roof Void 8, West Range - OB.98 (Film 71.07)

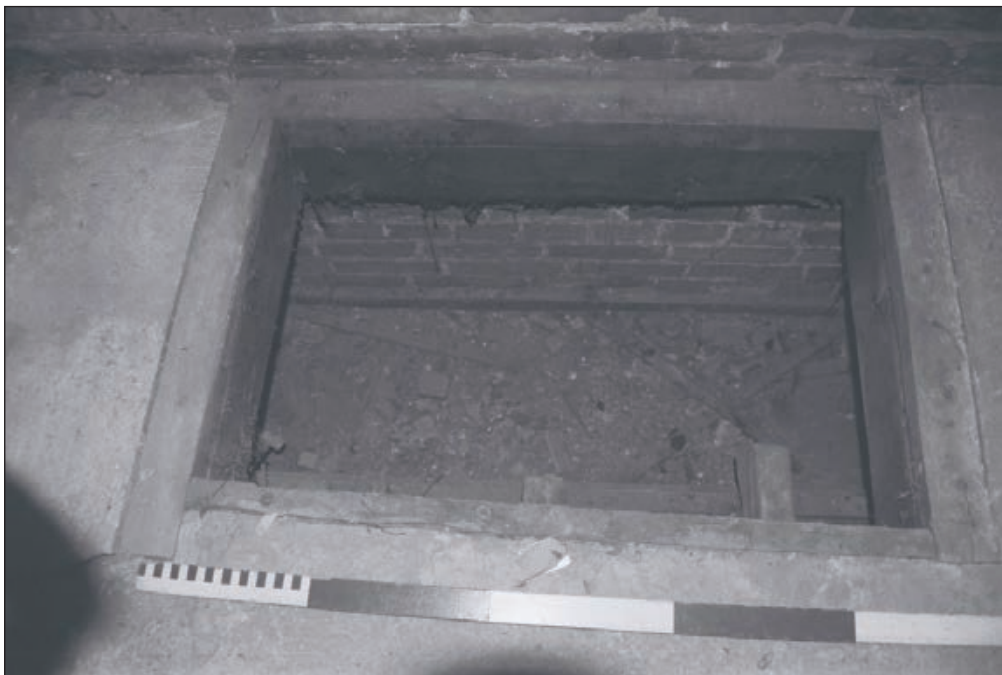
Plate 330: View of hatch in floor of Roof Void 8, West Range - OB. 98 - former grain chute (Film 78.22)

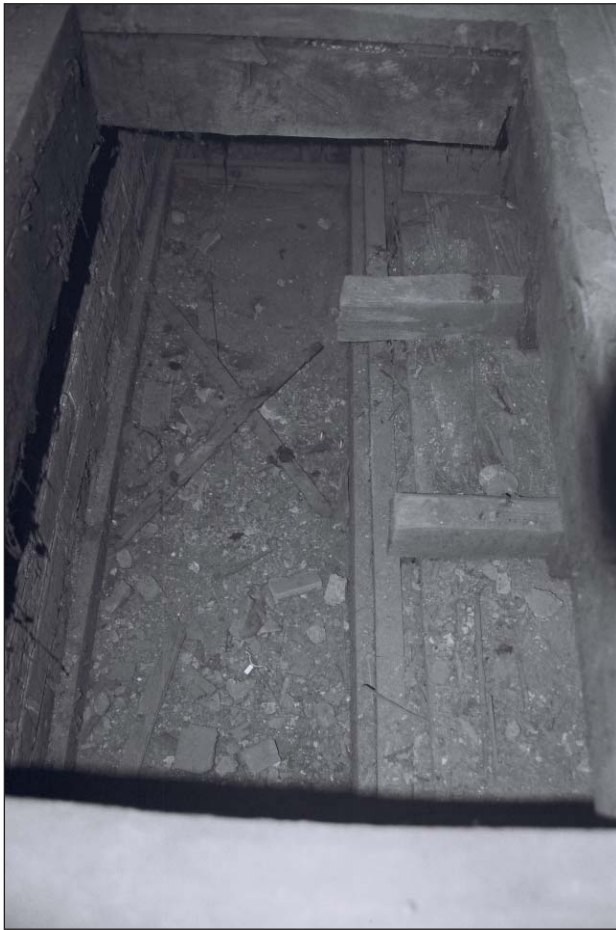
Plate 331: View of into hatch in floor of Roof Void 8, West Range - OB. 98 - showing ceiling construction and former chute (Film 78.17)

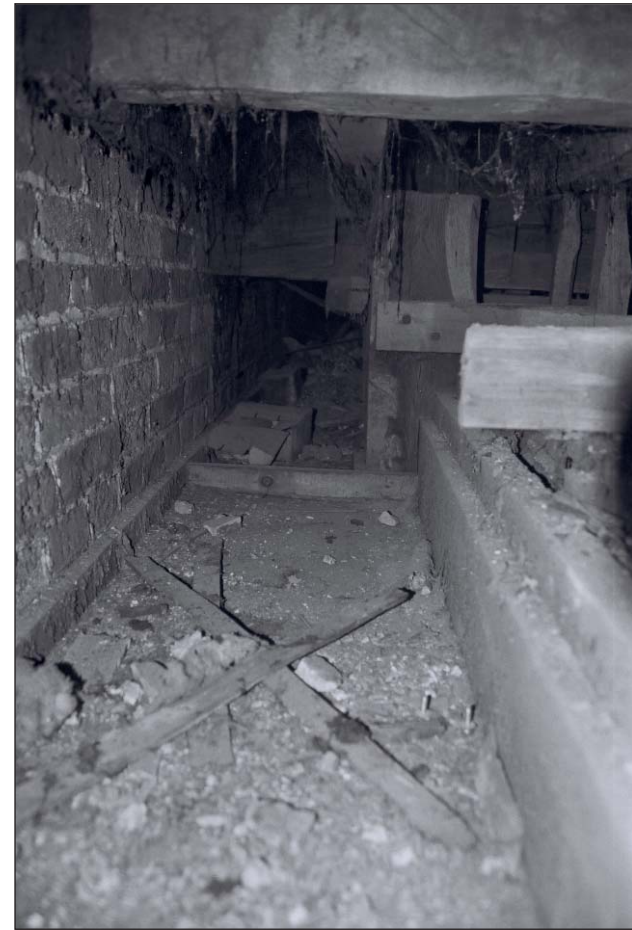
Plate 332: View below hatch in floor of Roof Void 8, West Range - OB. 98 - showing floor and ceiling construction and location of former grain chute (Film 78.20)

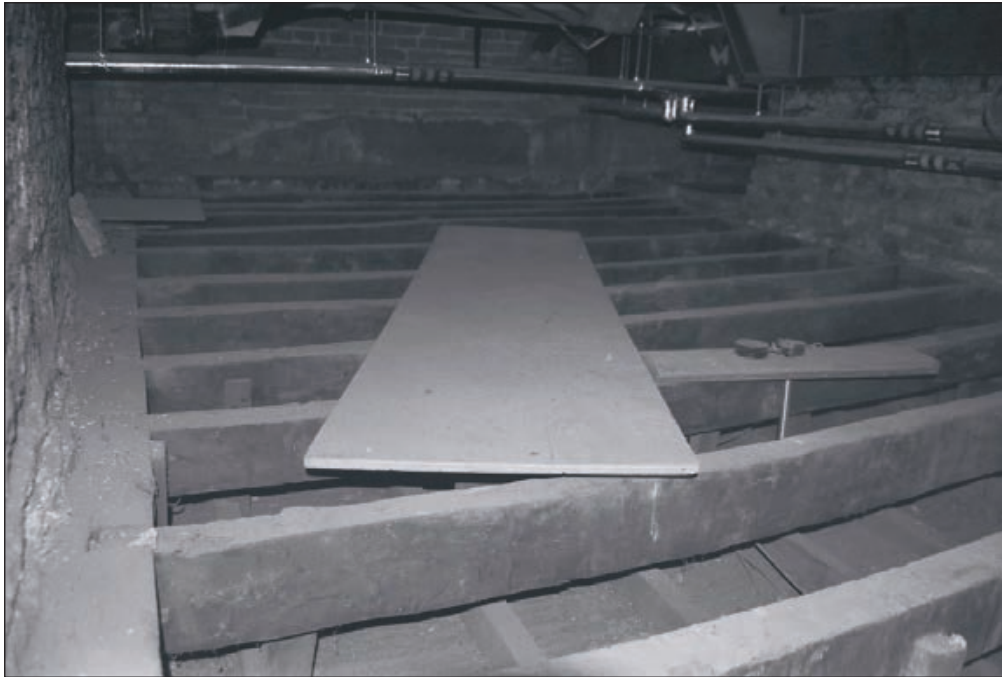
Plate 333: View of timber floor structure within Roof Void 8, West Range - OB.98 - after removal of limeash covering (Film 79.31)

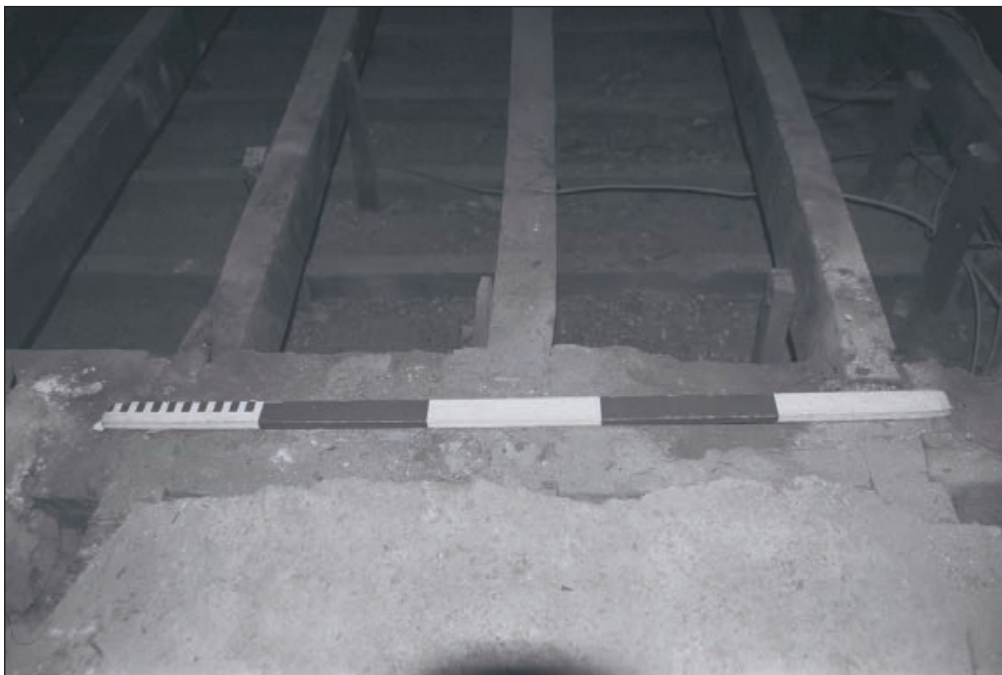
Plate 334: View of timber floor structure within Roof Void 8, West Range - OB.98 - after removal of limeash covering showing join of joists with timber beam (Film 79.36)

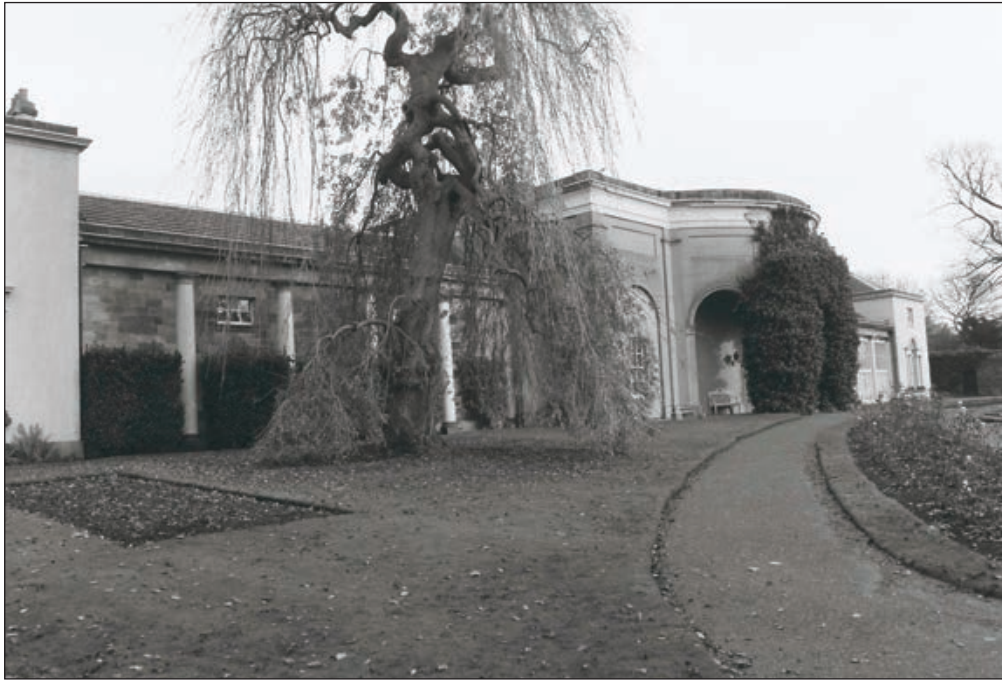
Plate 337: General view of the south elevation of the South Range (Film 13.34)

- 5.4.3 The south elevation of the range clearly defined each of the five sections making up the South Range (**Plate 337**).

- 5.4.5 To the east was the south elevation of the former Garden Room. This comprised five bays divided by four timber columns (with brick core), on a stone base supporting stone lintels above (**Plates 337-339**). The panel bays between the columns were later stone infills of former large window openings (**Plate 344**). Positioned high within the second and fourth bays was a central pivoting window (**Plate 342**). A stone tile covered pitched roof was visible above the elevation.

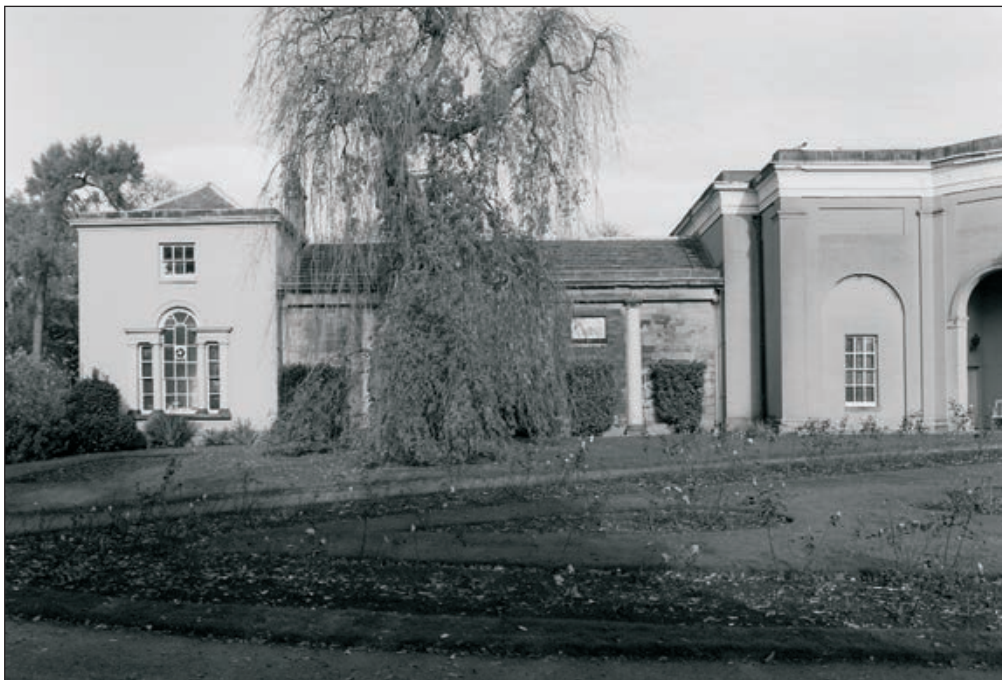
Plate 338: View of the west end of the south elevation of the South Range (Film 02.07)

- 5.4.4 At the west end is a two-storey pavilion which had a painted render covering the elevation (**Plate 338**). At ground floor there was a large central Venetian window (**Plate 339, 340**) and small sash at first floor. A small parapet around the top of the elevation partially obscured the pyramidal roof above (**Plates 338-339**).

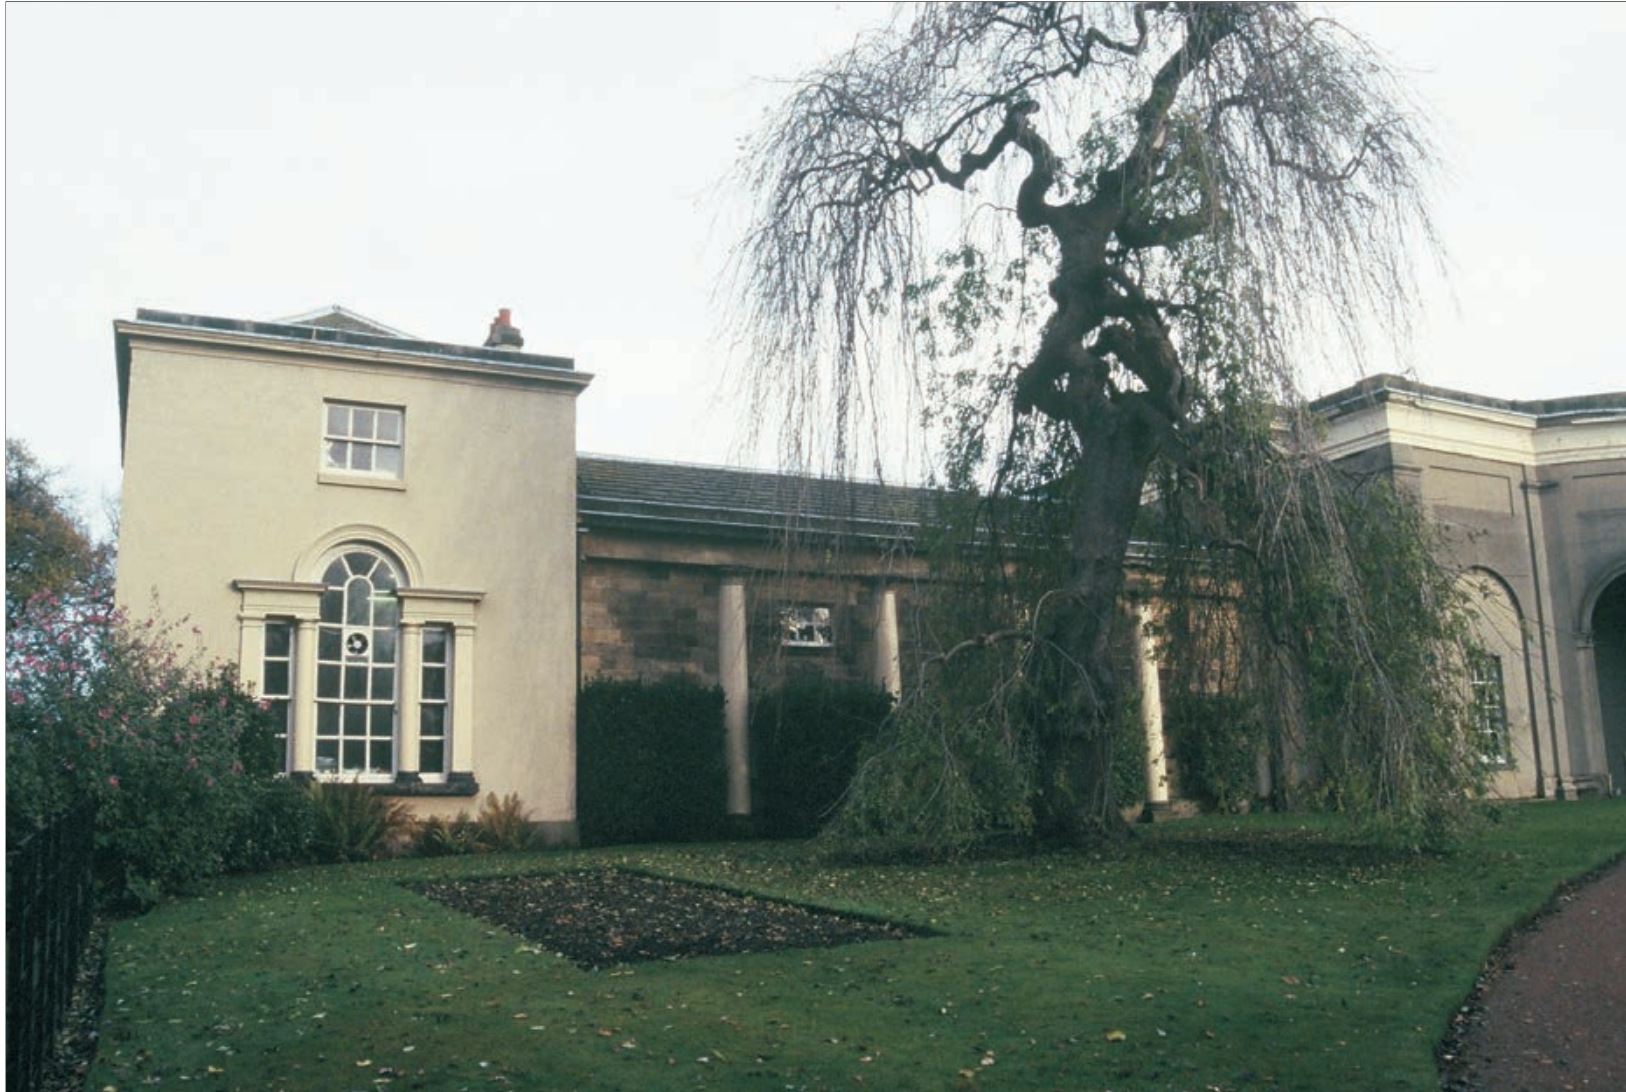
Plate 339: General view of the west end of the south facing elevation of the Garden Room and adjacent West Pavilion, of the South Range (Film CS.09)

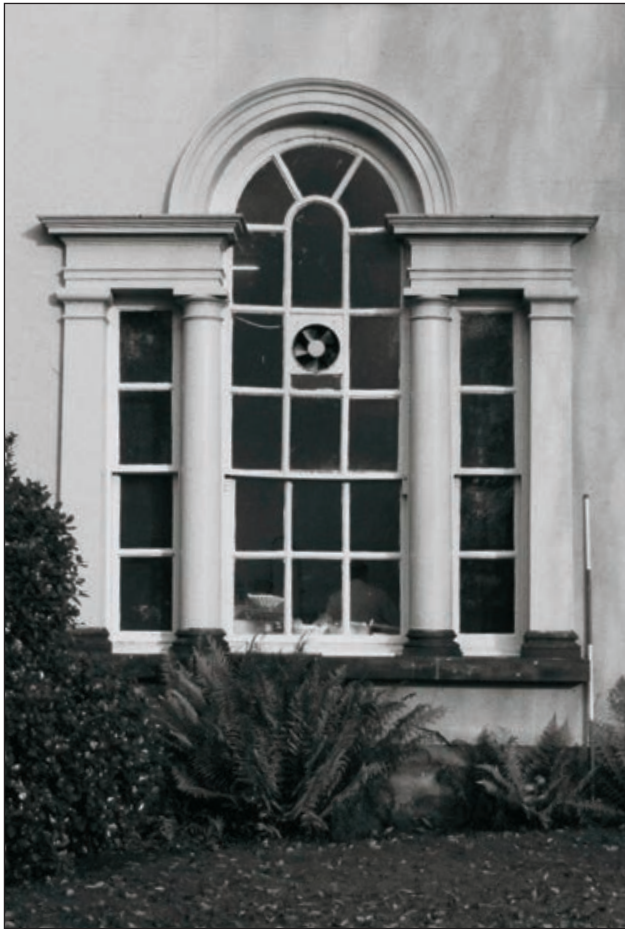
Plate 340: Detail of ground floor window with blind outer lights, south elevation of the West Pavilion of the South Range (Film 12.27)

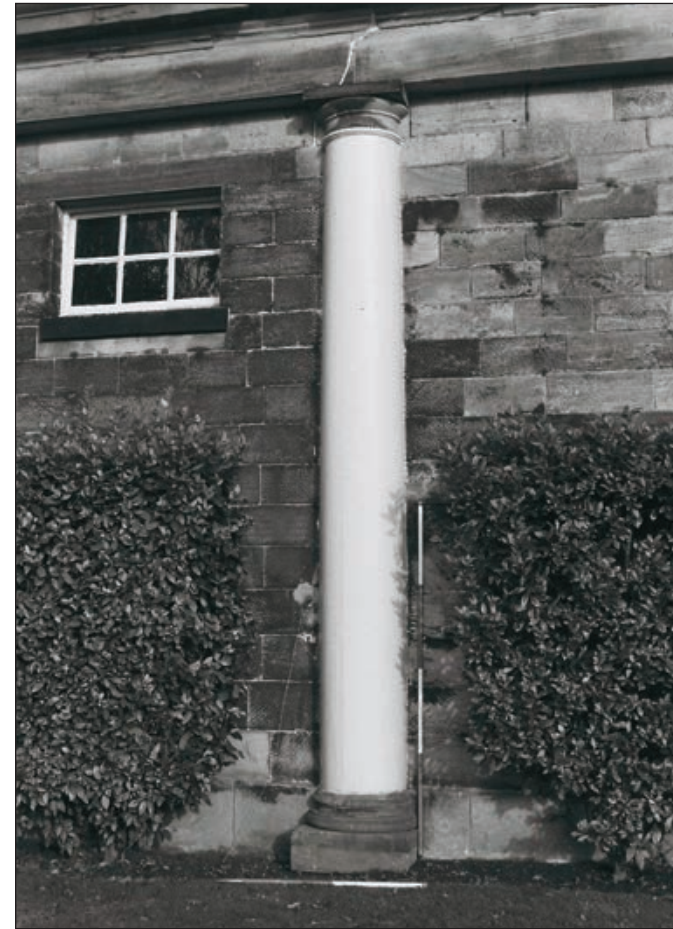
Plate 341: Detail of column with adjacent stone infills, south elevation of the Garden Room, South Range (Film 12.29)

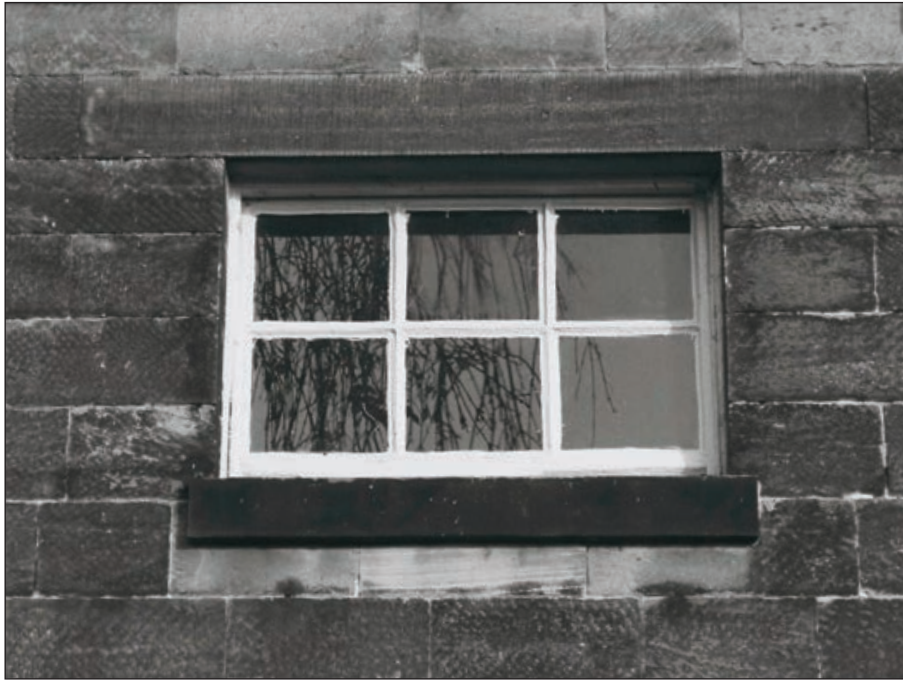
Plate 342: Detail of high window in the south elevation of the Garden Room, South Range (Film 12.31)

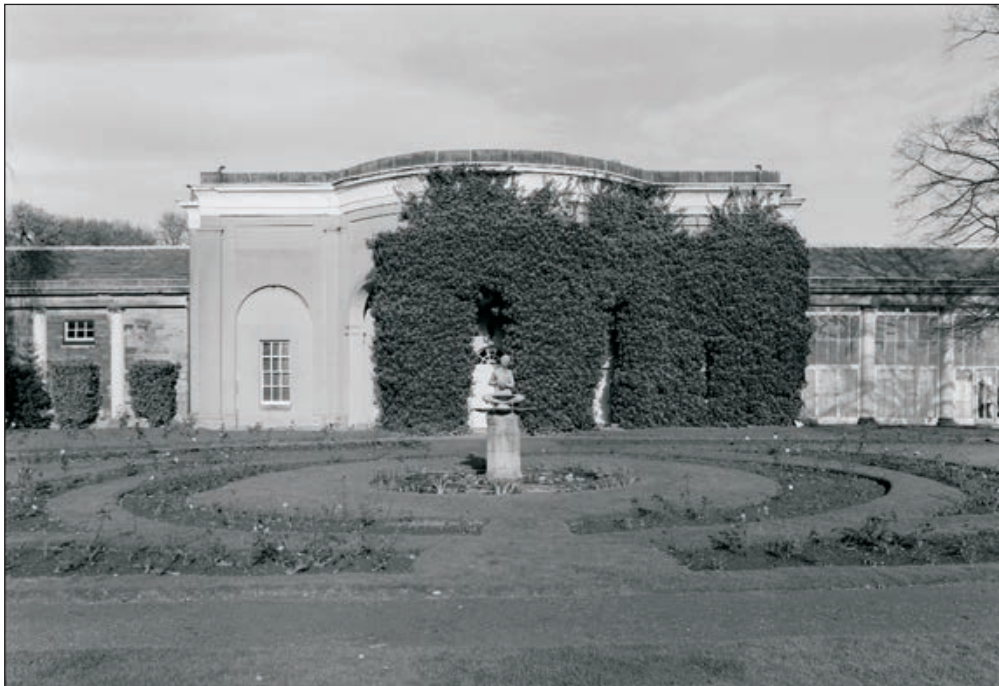
Plate 343: View of the south elevation of the centrally positioned Riding House, South Range (Film 02.03)

- 5.4.6 The central Riding House was a very large, two-storey structure, with bowed central loggia (**Plate 343**). The elevation was covered with a cement render scored to imitate stone, whilst the eastern two thirds of the elevation were obscured by ivy. Flanking the central loggia were recessed bays with central sash window (**Plate 344, 348, 349**). A large cornice and parapet finished the top of the elevation, fully obscuring the roof beyond (**Plate 347**).

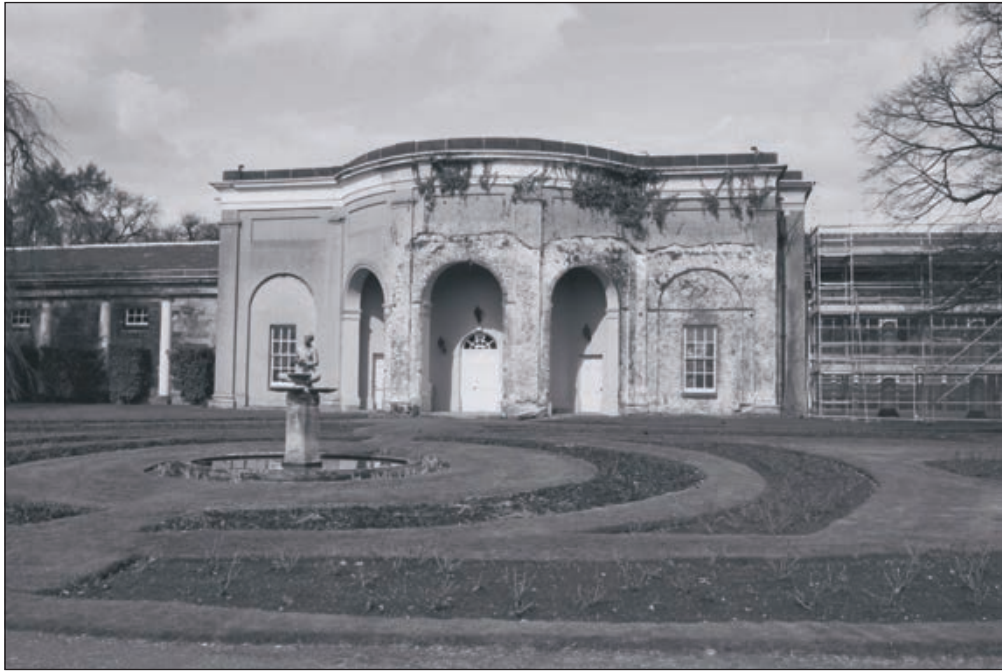
Plate 344: View of the south elevation of the South Range after the removal of vegetation, exposing the fabric of the building - OB. 32 (Film 51.16)

- 5.4.7 During the structural watching brief, the ivy was removed from the elevation, revealing the brick construction of the range (**Plates 344-345**), with weathered stone plinths at the base of the decorative columns (**Plate 346**). It was also observed that timber was set into the walls for the attachment of moulded corncicing.

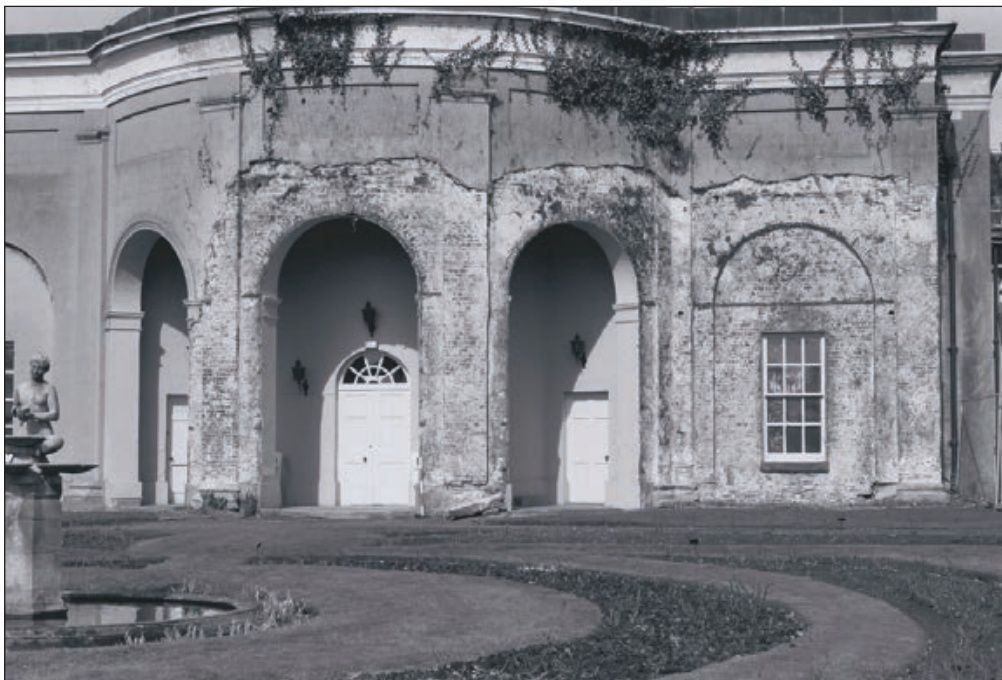
Plate 345: Detail of exposed brick fabric of the south elevation of the South Range - OB. 32 (Film 51.15)

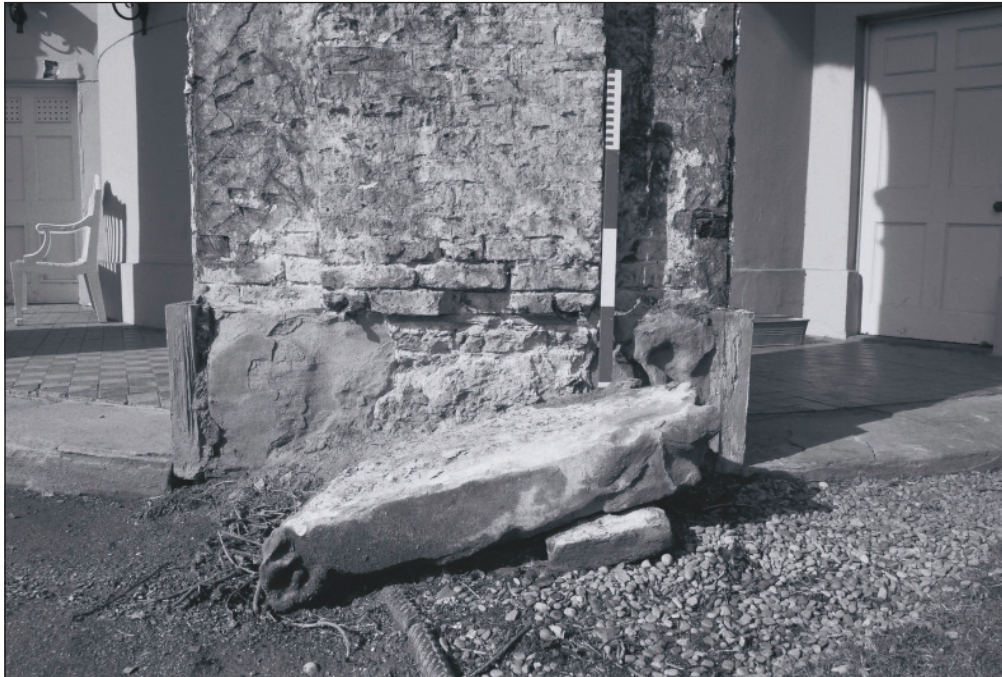
Plate 346: Detail of the exposed brick and stone fabric of the south elevation of the South Range - OB. 32 (Film 51.12)

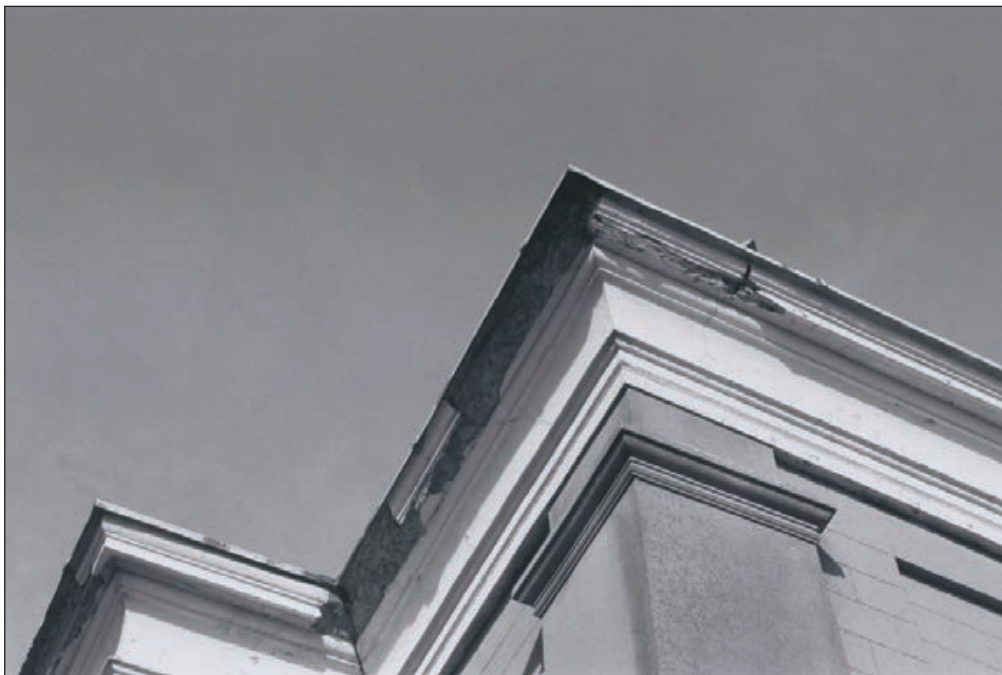
Plate 347: Detail of the cornice of the south elevation of the South Range - OB. 32 (Film 51.09)

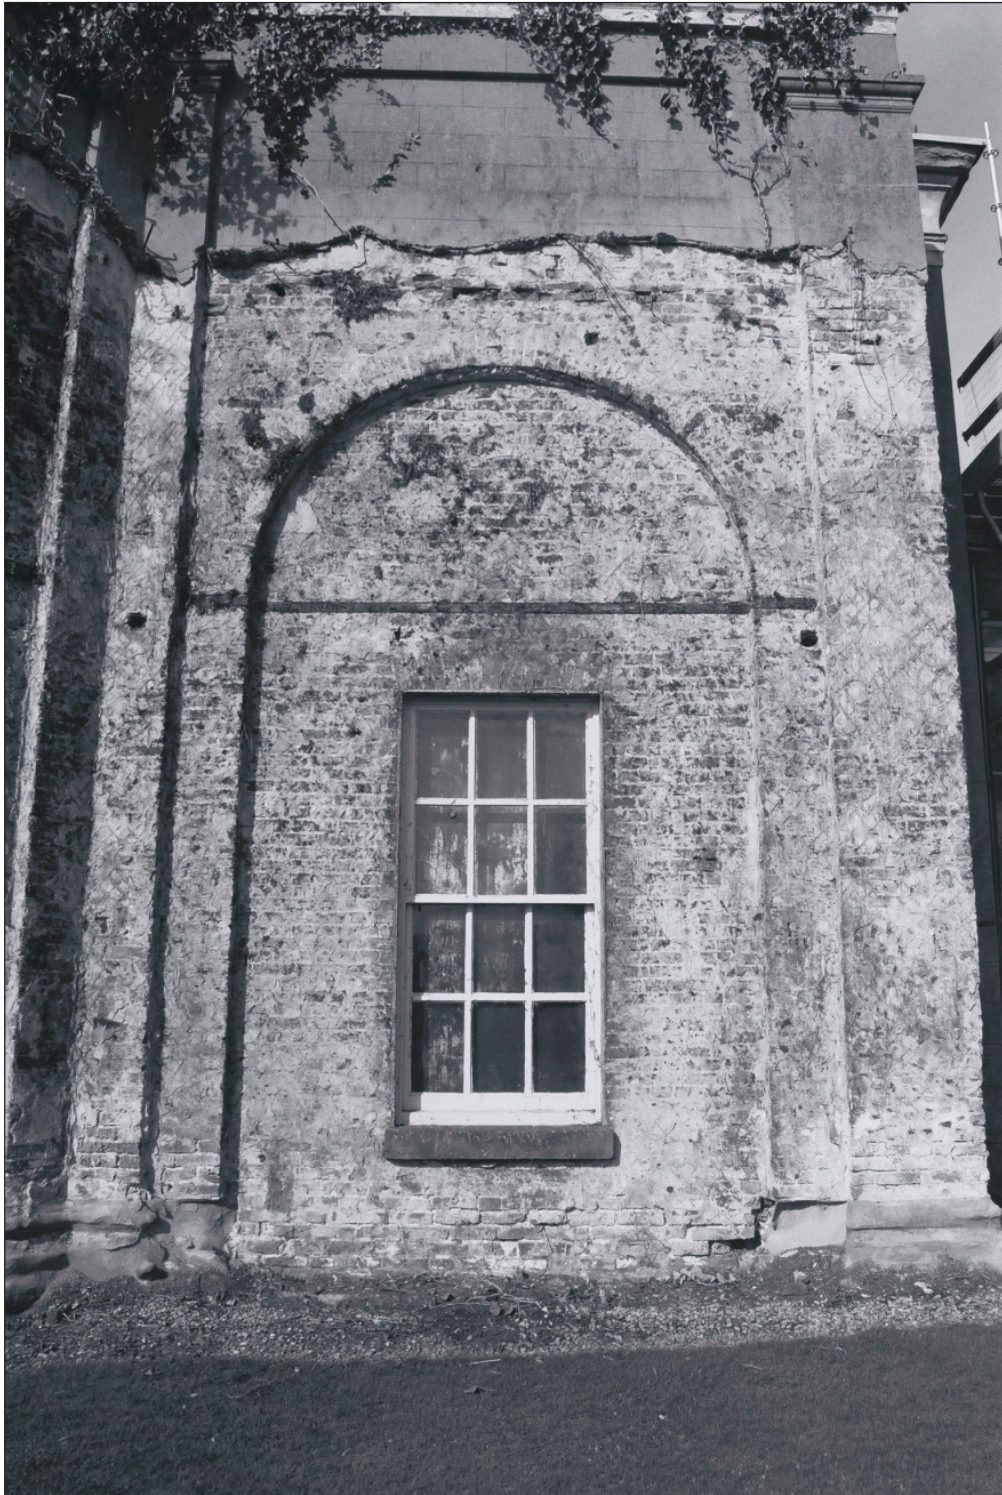
Plate 348: Detail of the exposed brick and stone fabric of the south elevation of the South Range, after the removal of vegetation - OB. 32 (Film 51.10)

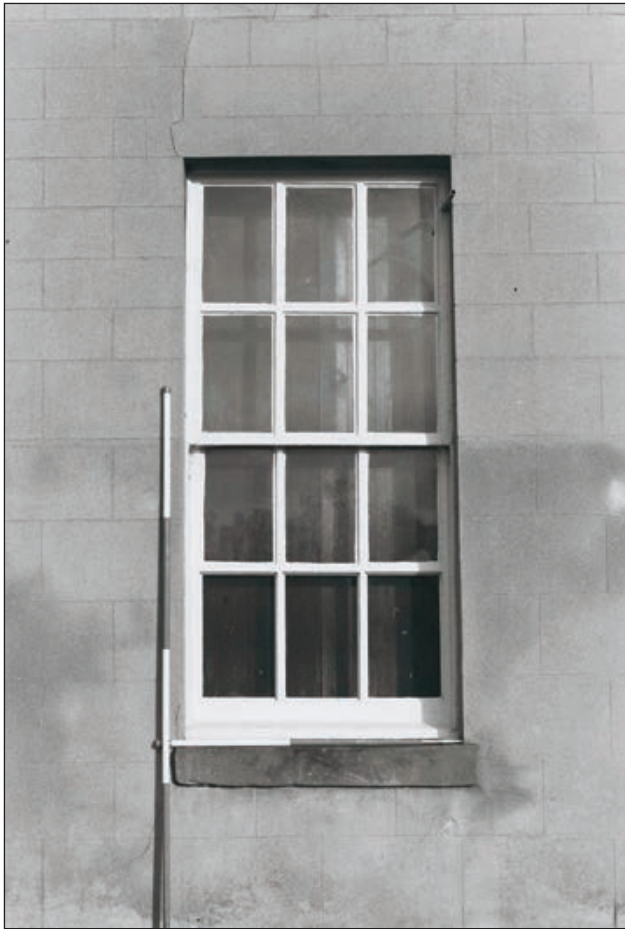
Plate 349: Detail of ground floor window, south elevation of the Riding House, South Range (Film 12.33)

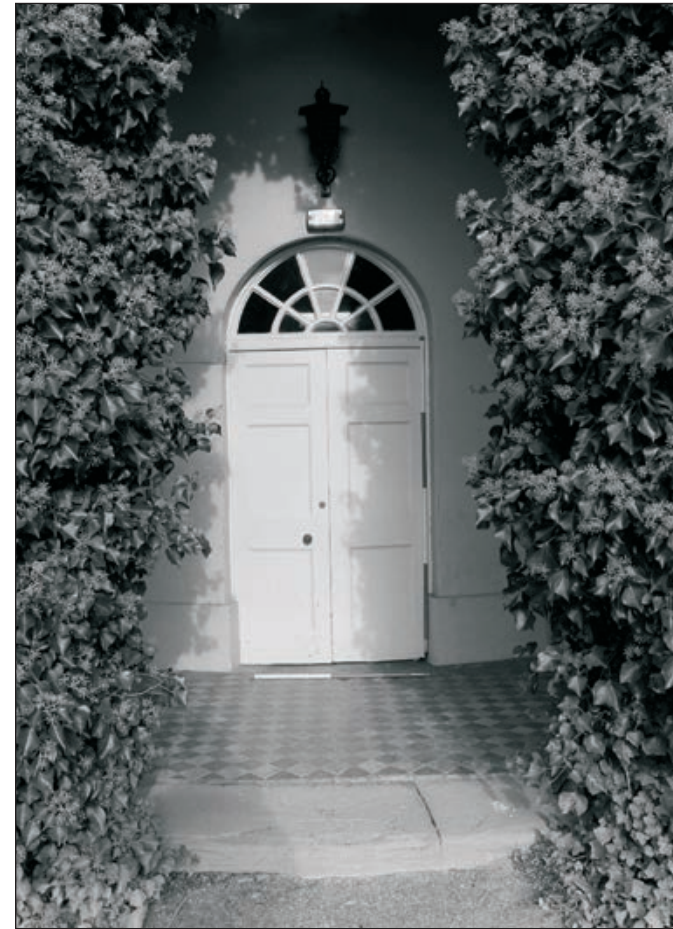
Plate 350: Detail of ground floor doorway within the bowed south elevation of the Riding House, South Range (Film 02.09)
