NOSTELL PRIORY STABLES, NOSTELL, WAKEFIELD, WEST YORKSHIRE

Historic Building Recording and Structural Watching Brief

Planning Application Ref: 09/00701/FUL & 09/00705/LBC

72934.01_BDG_V0_4

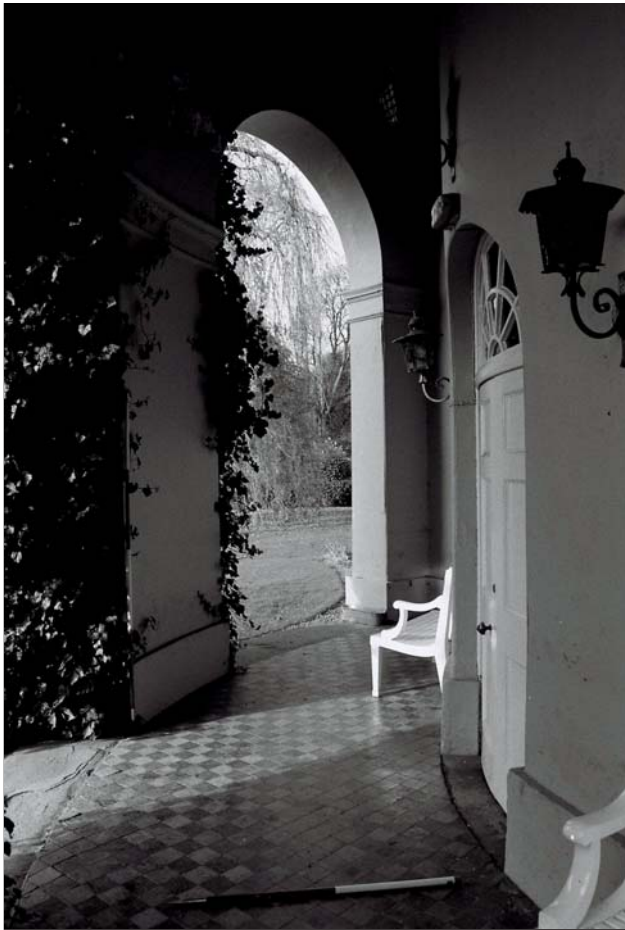
Plate 351: View of bowed/curved loggia (G34), of the south elevation of the Riding House, South Range, looking south-west (Film 13.08)

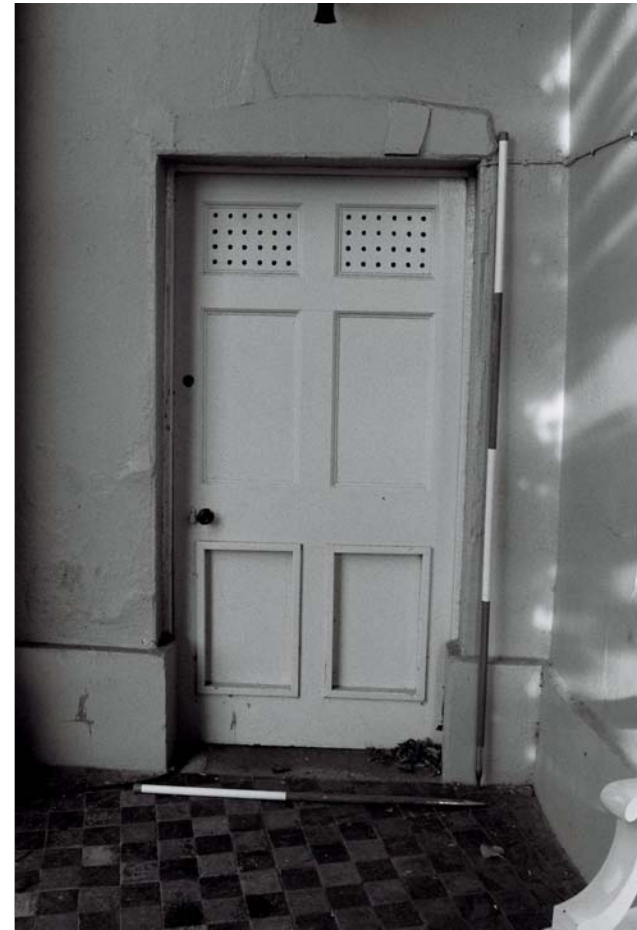
Plate 352: Detail of ground floor doorway within the west wall of the Riding House loggia (G34), south elevation of the South Range (Film 13.03)

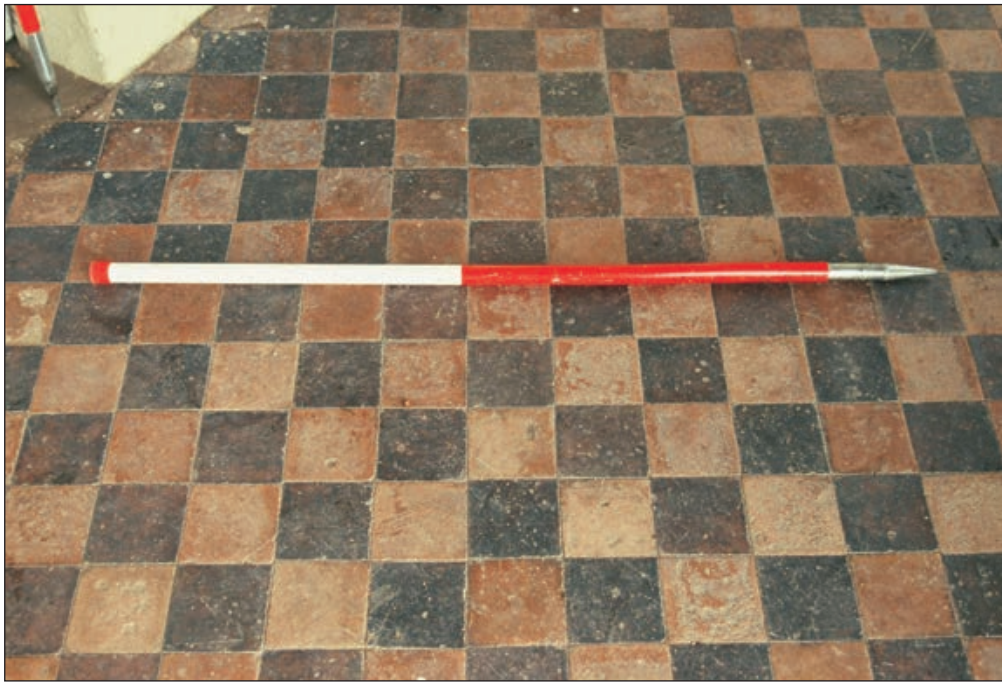
Plate 353: Detail of tiled floor of the Riding House loggia (G34), South Range (Film CS.04)

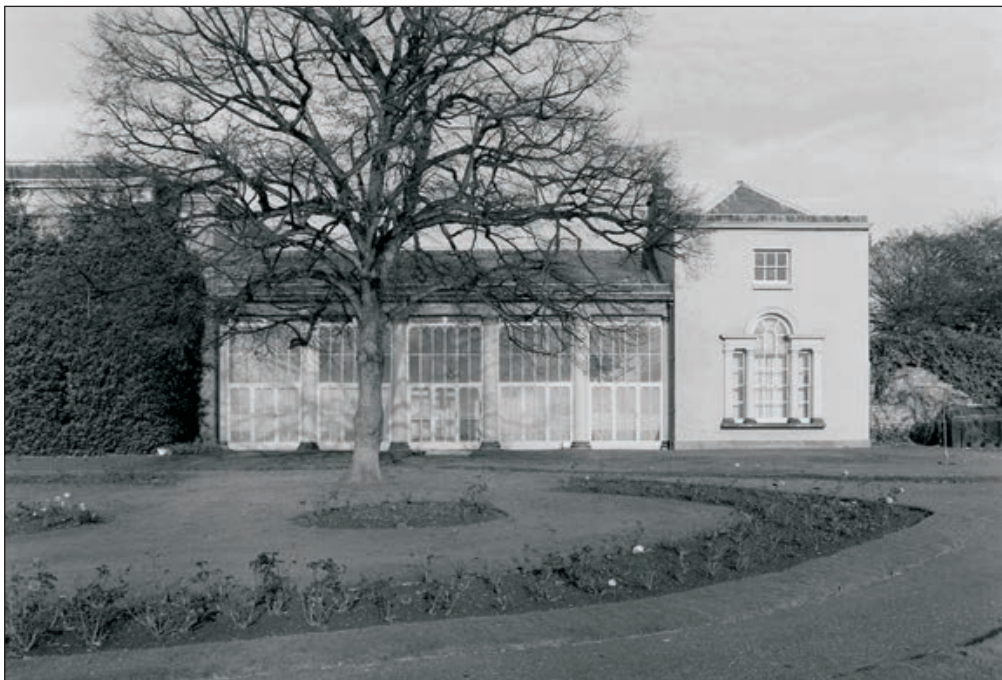
Plate 354: View of the east end of the south elevation of the South Range, showing the Greenhouse and East Pavilion (Film 02.06)

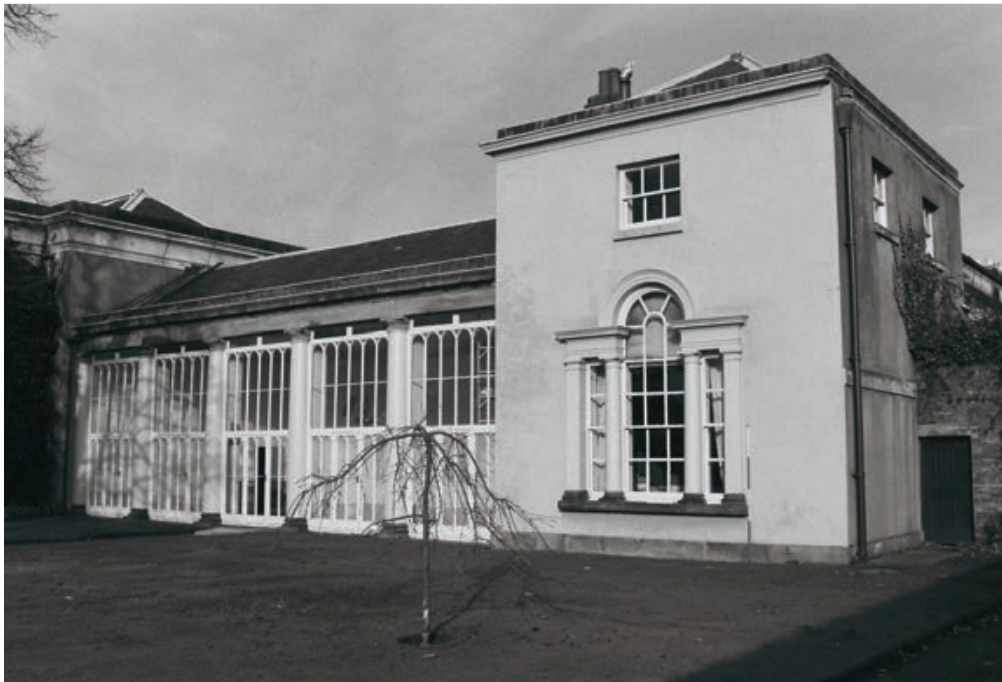
Plate 355: View of the southeast corner of the South Range, showing the south elevation of the Green House and adjacent East Pavilion (Film 13.14)

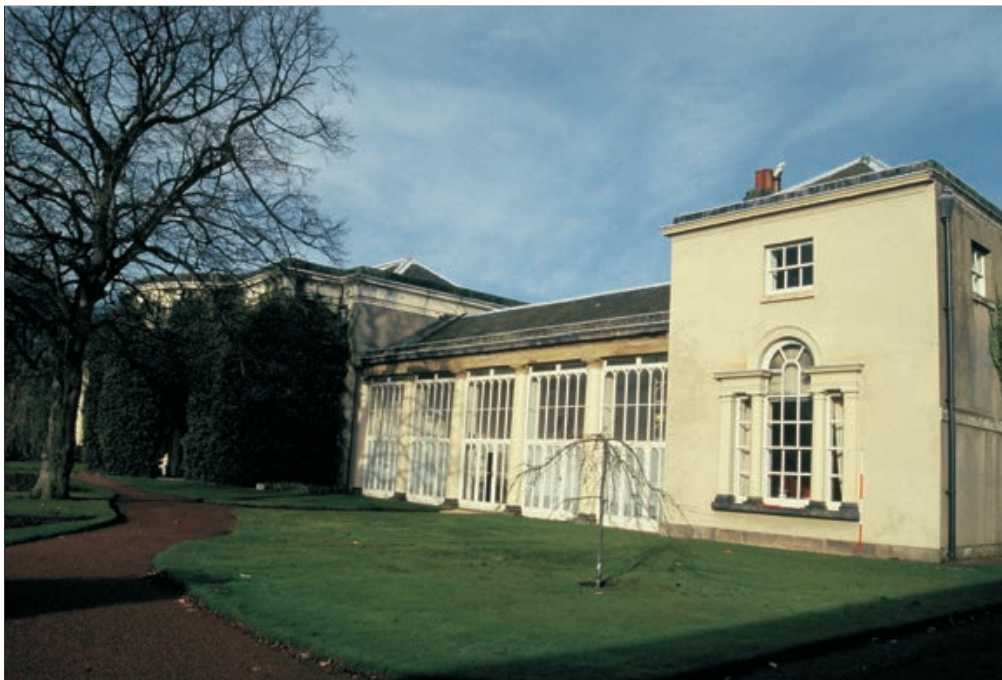
Plate 356: View of the southeast corner of the South Range, showing the south elevation of the Greenhouse and adjacent East Pavilion (Film CS.05)

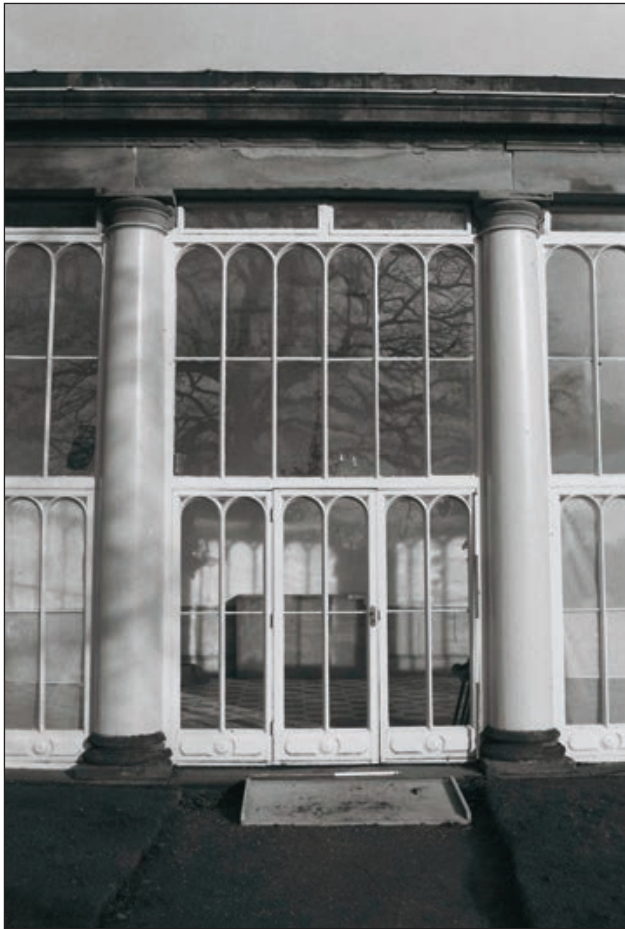
- 5.4.10 Attached to the east is the second end pavilion, mirroring that of the pavilion at the west end, also covered with a render (**Plates 357-359**) and containing a large venetian window at ground floor and small sash at first floor (**Plate 358**).

Plate 357: View of columns and fenestration of the south elevation of the Greenhouse, South Range (Film 13.10)

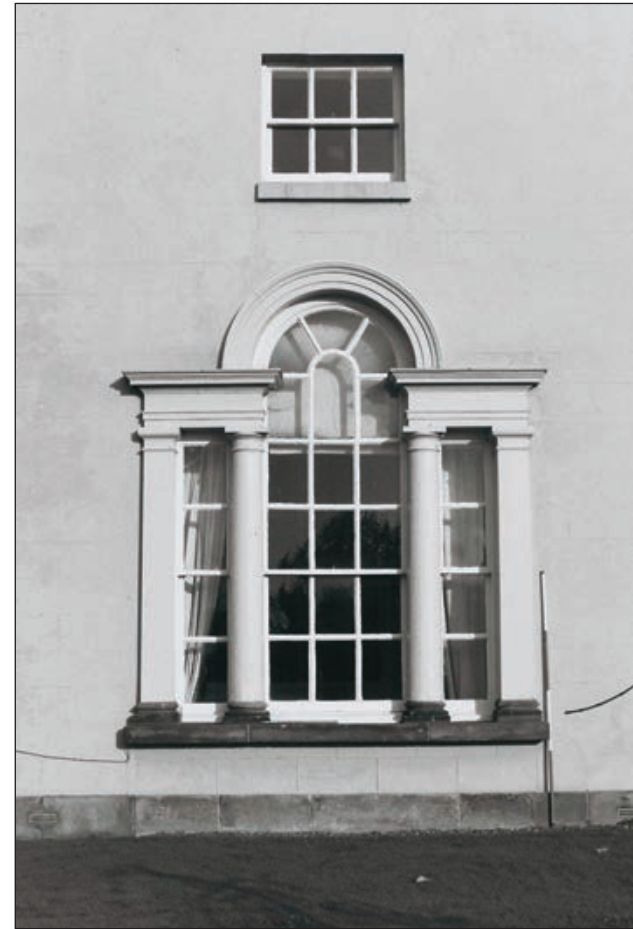
Plate 358: Detail of the fenestration of the south elevation of the East Pavilion, South Range (Film 13.12)

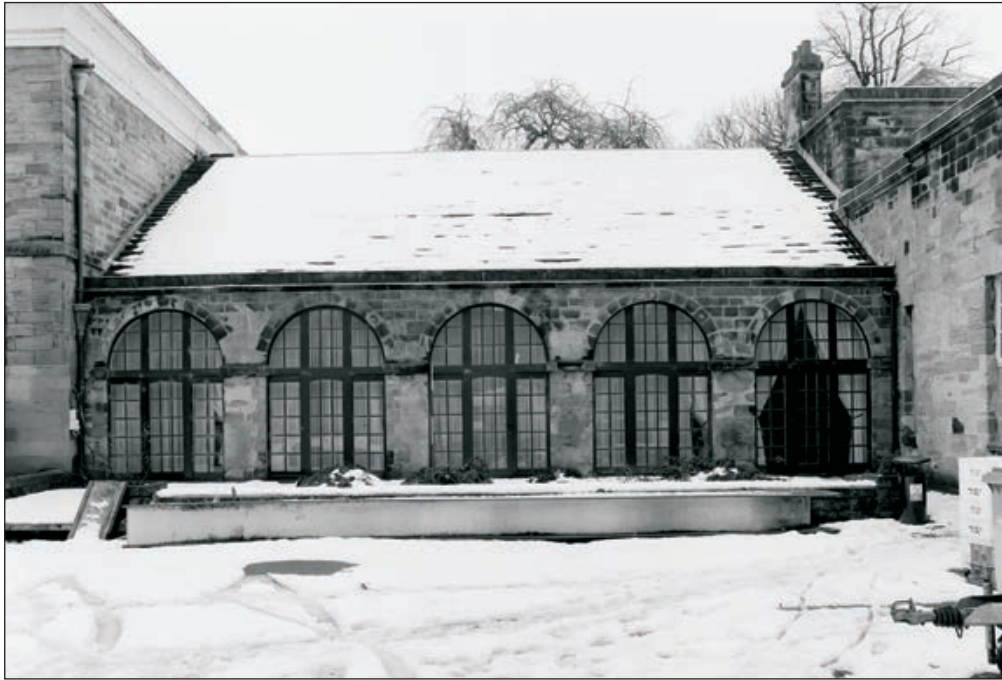
- 5.4.12 The north elevation of the former garden room to the west was single-storey in height and comprised five stone arched bays (**Plate 359**), each with modern windows and glazed doors set within them (**Plate 360**). The roof above was pitched with stone tile covering.

Plate 359: View of the north courtyard elevation of the Garden Room, South Range (Film 36.09)

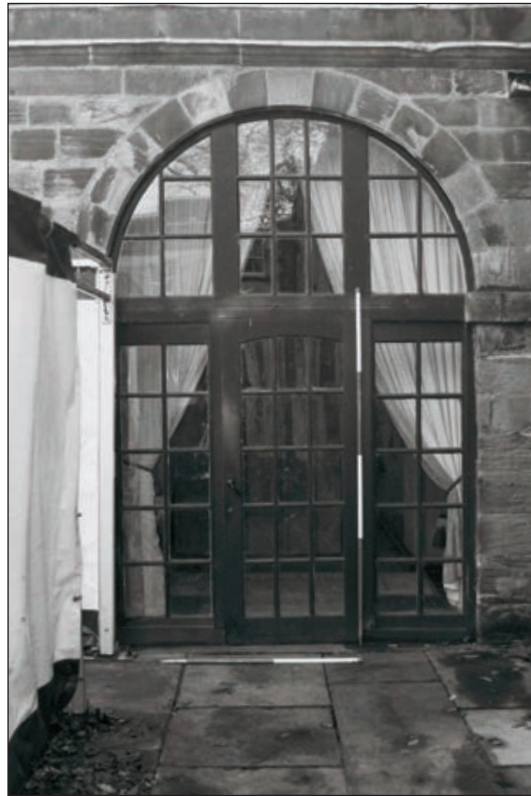
Plate 360: Detail of archway and modern glazing within the north courtyard elevation of the Garden Room, South Range (Film 20.17)

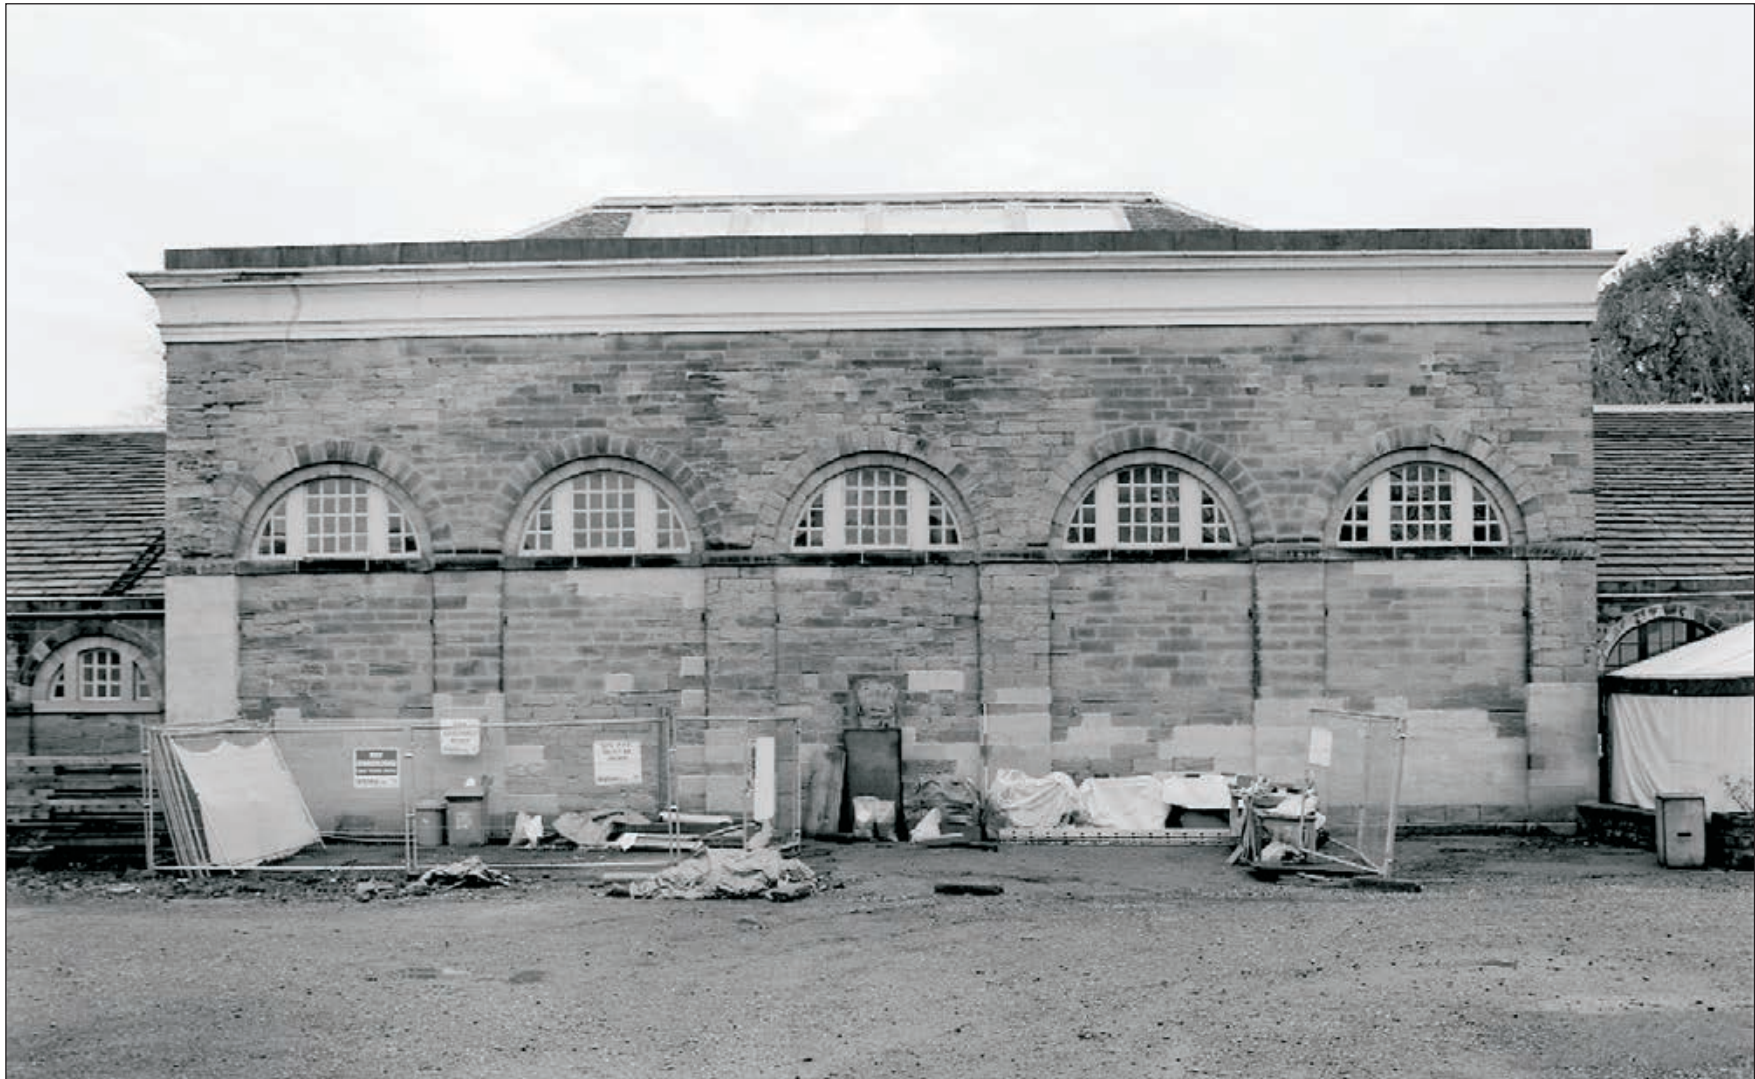
- 5.4.13 The central Riding House had a tall stone built north elevation, with five arched recessed bays (**Plate 361**), each with a tripartite window within the arch of the bays (**Plate 362**). The top of the elevation was decorated with a large cornice and parapet wall. The top of the hipped roof of the riding house, with skylights and stone tile covering was just visible above the parapet. Positioned directly in front of the north elevation were the remains of the Robert Adam water pump (**Plate 363**). Beneath this within the courtyard, uncovered by On Site Archaeology, was a large brick built cistern or well which would have served the water pump.

Plate 361: General view of the north courtyard elevation of the central Riding House, South Range (Film 18.08)

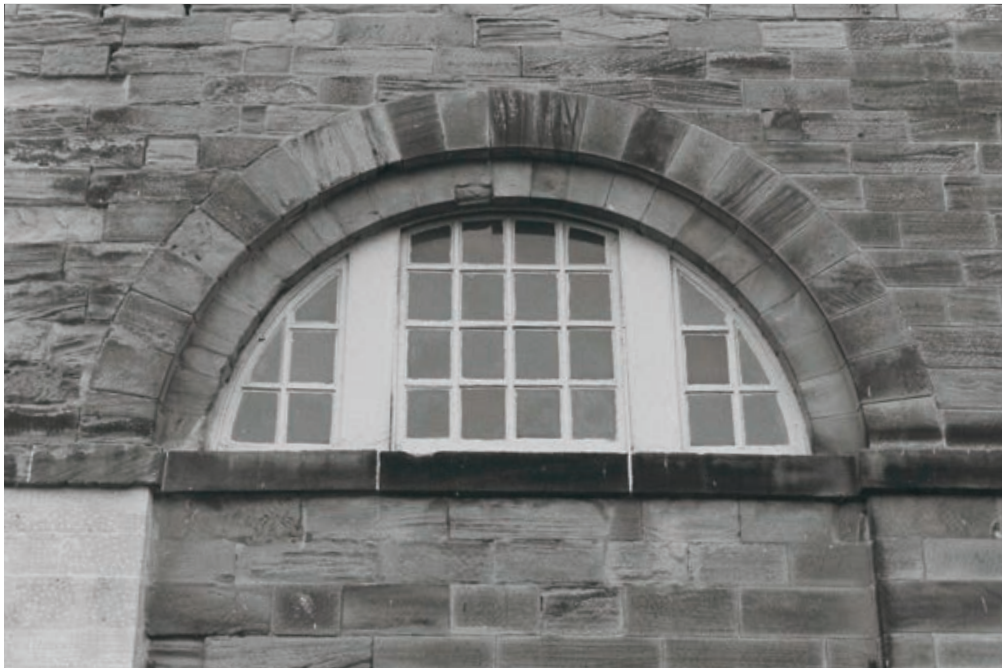
Plate 362: Detail of the high arched windows of the north courtyard elevation of the Riding House, South Range (Film 20.08)

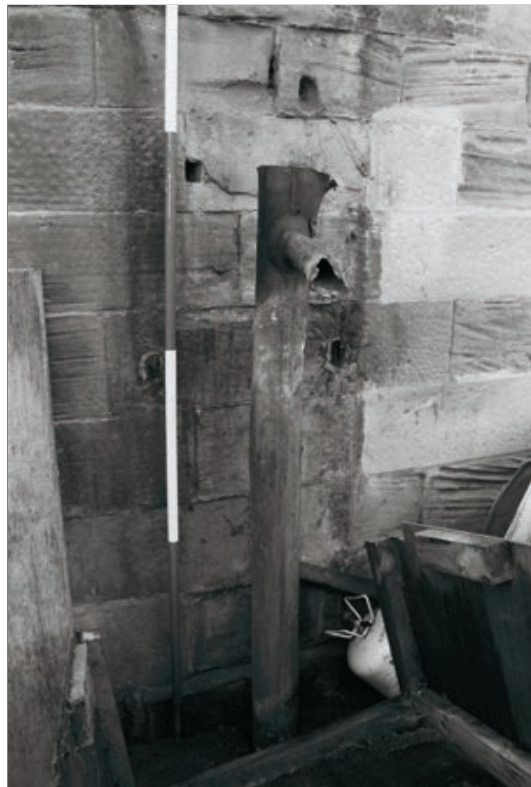
Plate 363: Detail of the pipework of the Adam designed water pump against the north elevation of the Riding House, South Range (Film 20.10)

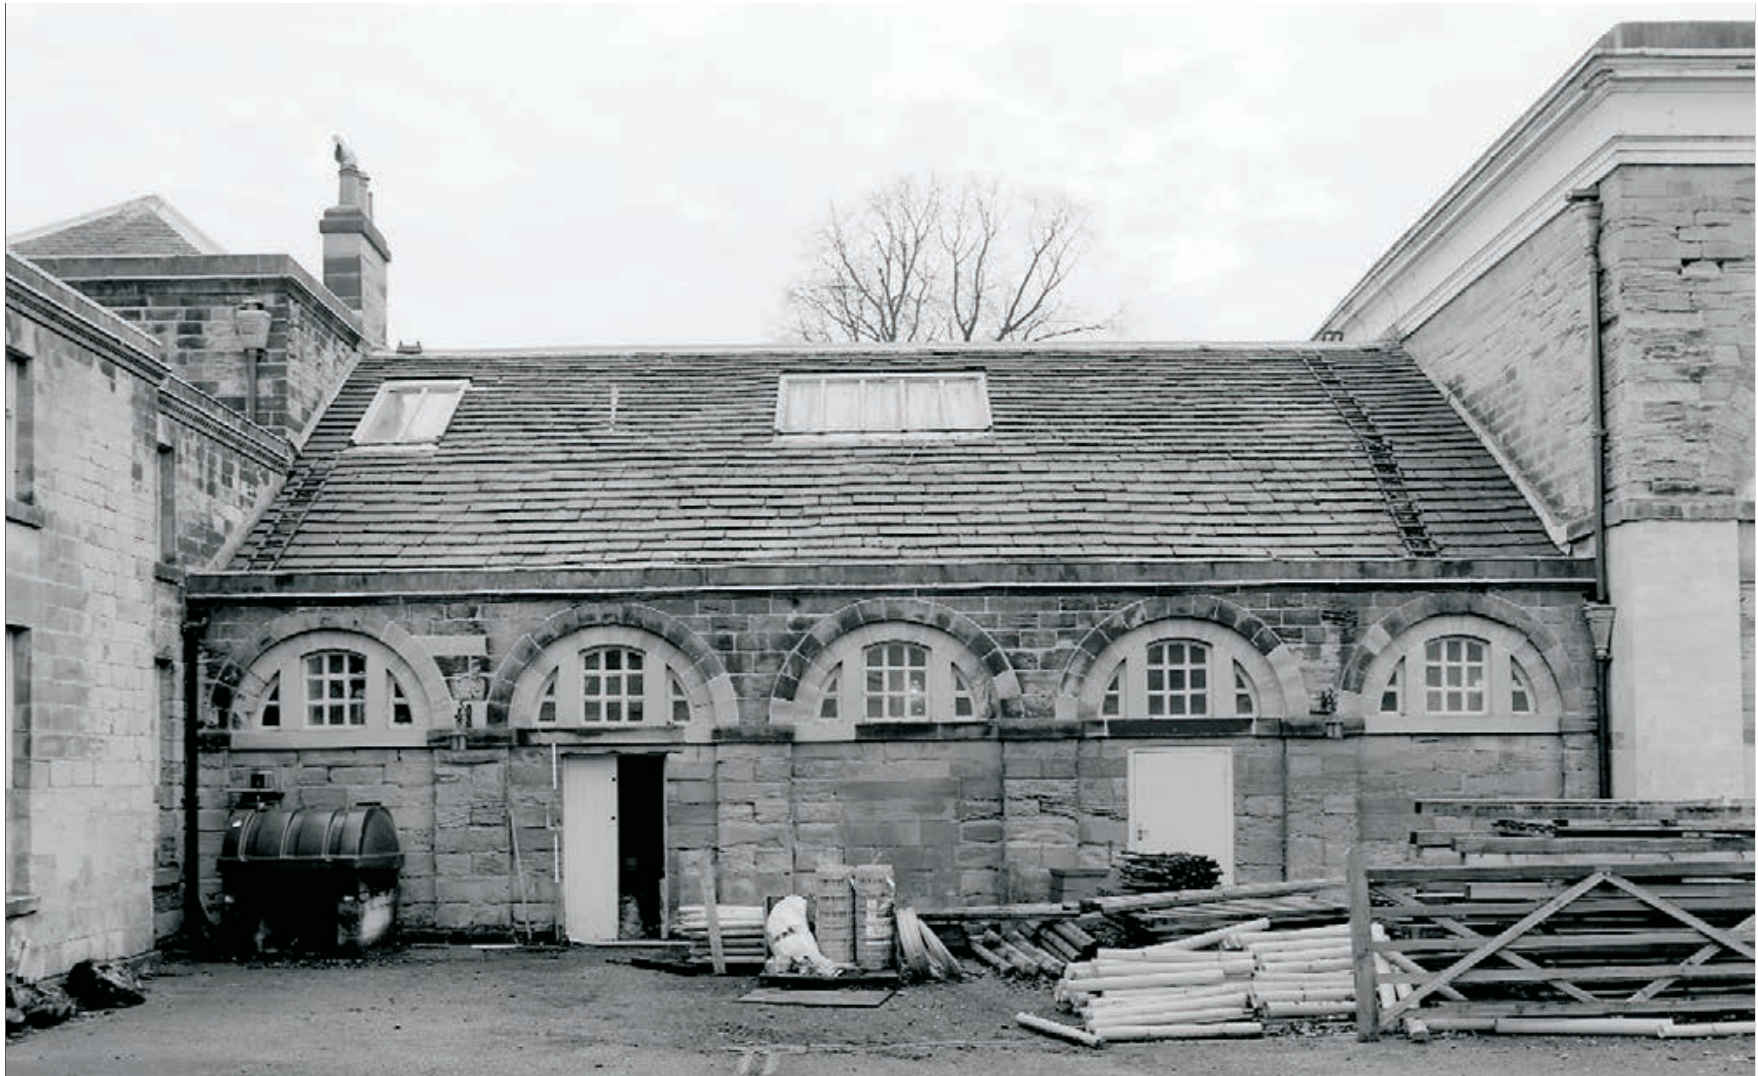
- 5.4.14 To the east was the north elevation of the Greenhouse block. This rear section of the building was originally a corridor leading from the stables in the East Range, to the Riding House. This north elevation was of single-storey, constructed of stone, with five recessed arched bays, and a high pitched roof with stone tile covering and two inserted skylights (**Plate 364**). Each bay contained a tripartite window within the archway (**Plate 365**), just as within the north elevation of the Riding House. The central bay contained a stone blocked doorway, whilst the flanking bays contained an inserted door (**Plate 365**).

Plate 364: General view of the north courtyard elevation of the former corridor to the rear of the Greenhouse, South Range (Film 18.06)

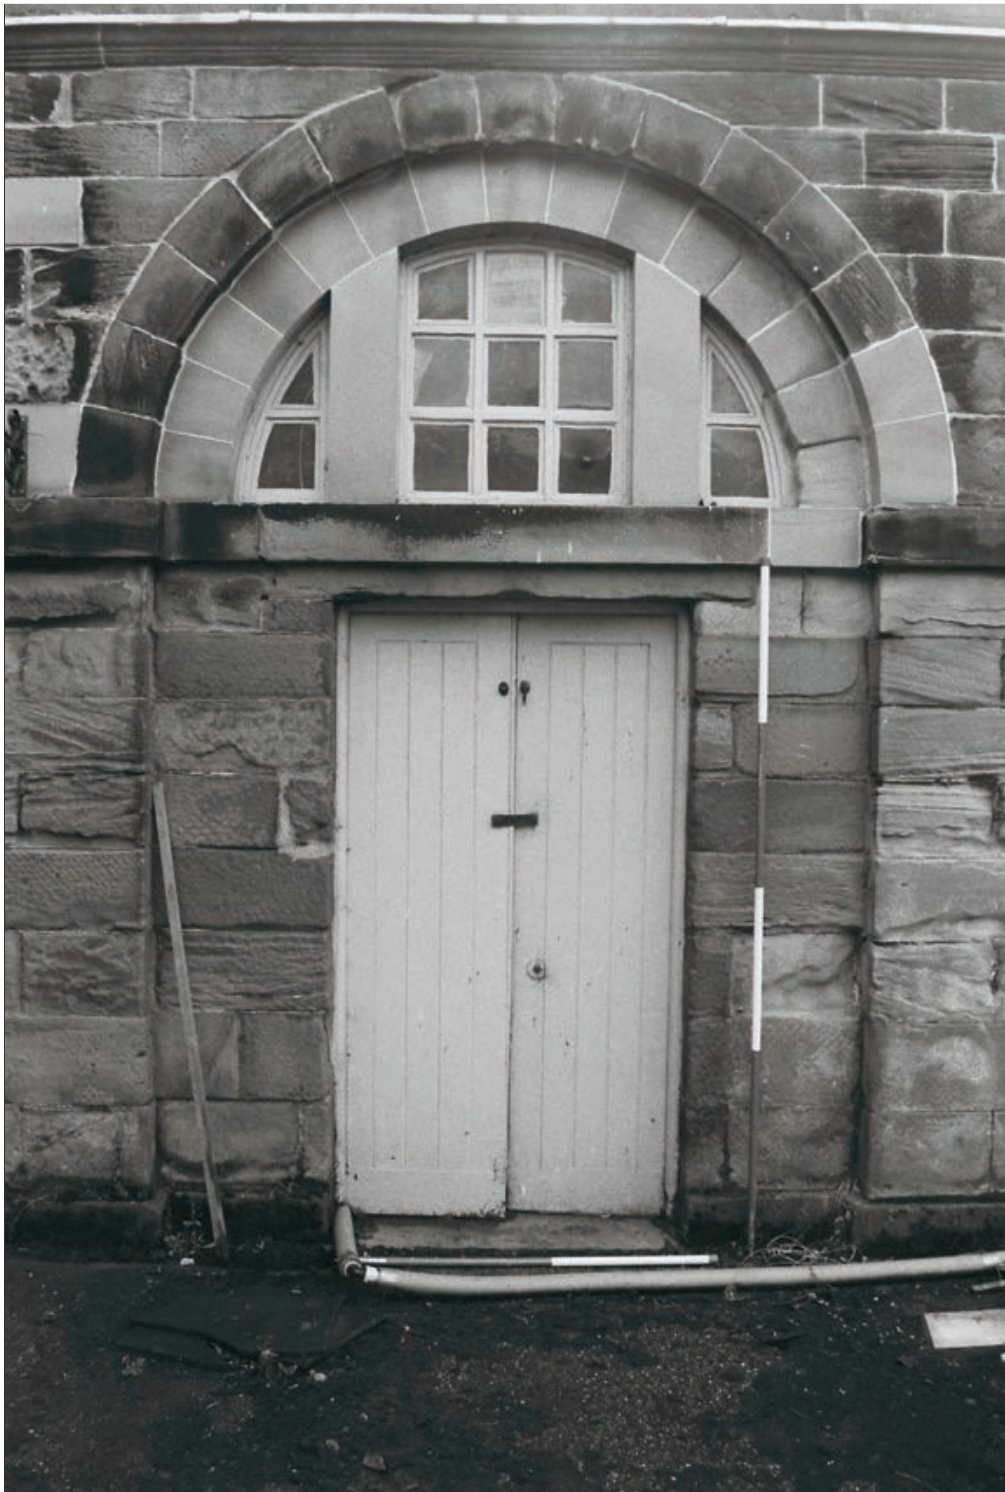
Plate 365: Detail of arched window and inserted doorway of former corridor, north (courtyard) elevation of the South Range (Film 20.07)

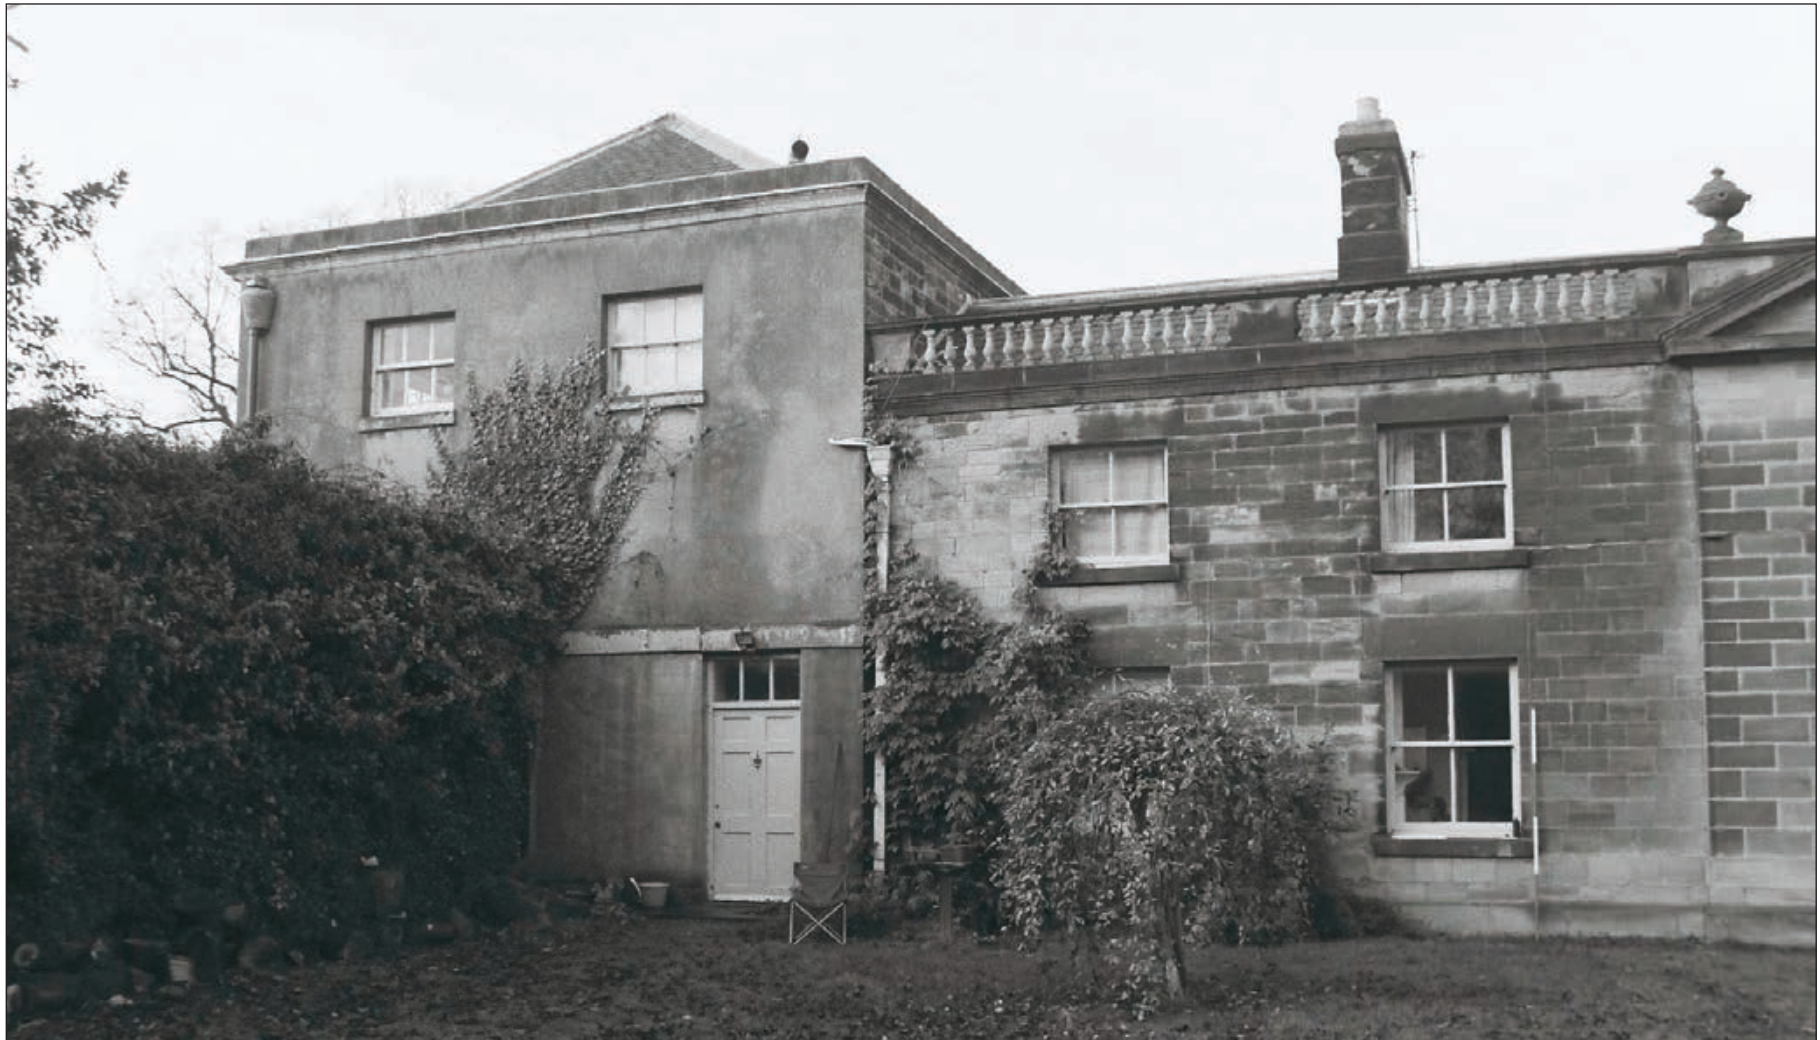
- 5.4.16 The east elevation of the Agent's House encompassed the east elevation of the South Range's East Pavilion, which had a rendered east elevation, and abutting garden wall (**Plate 366**). To the north of this at ground floor was a doorway with rectangular fanlight above, and stone string course dividing the ground and first floors. At first floor are two small sash windows. A small parapet partially obscured the pyramidal roof of the pavilion above (**Plate 366**). To the north the east elevation is made up of several phases of construction, with a pedimented and projecting three bayed section, with flanking set back double bays to either side. The southern four bays of this are incorporated into the Agent's House (South Range), whilst the northern three bays are part of the phase 6 East Range. This multiphased elevation contains two bays to the north of the pavilion, with two sash windows at ground and first floor, each with flush stone lintels and projecting stone sills (**Plates 367-368**). At the top of the elevation is a stone balustrade and cornice (**Plate 366**). To the north of this, the elevation is pedimented and steps outwards over three bays. This projecting, pedimented section appears to have been largely of phase 6 in date, with the southernmost two bays making up part of the Agent's House (South Range) with sash windows at both ground and first floor each with segmental stone lintels and projecting stone sills. The remaining northernmost bay, and the rest of the east elevation to the north are all part of the East Range (**Plate 563-564**).

Plate 366: General view of the south end of the east elevation of the South and East Ranges (Agent's House), looking southwest (Film 11.34)

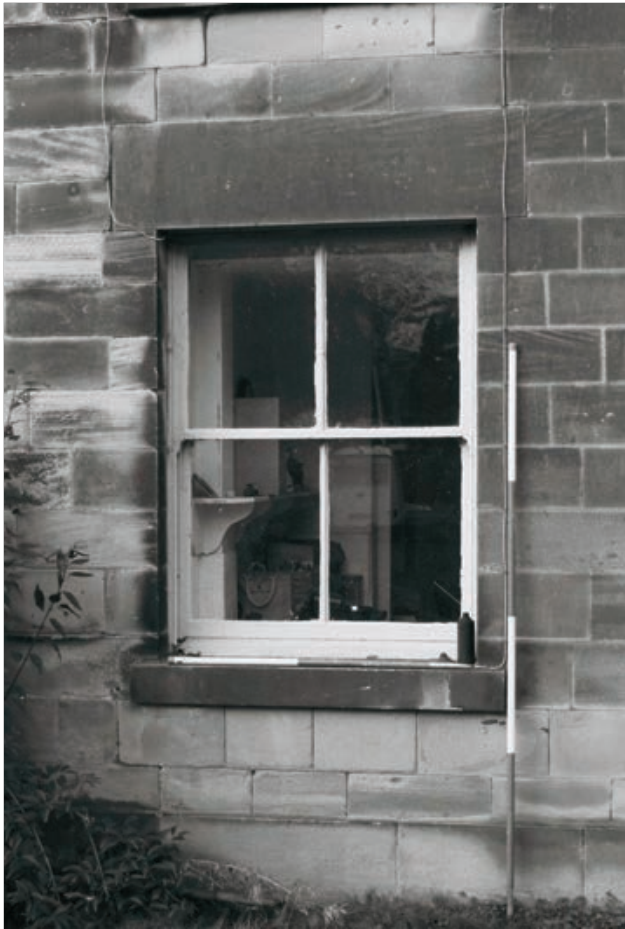
Plate 367: Detail of a ground floor window at the south end of the east elevation of the South/East Range (Agent's House) (Film 11.28)

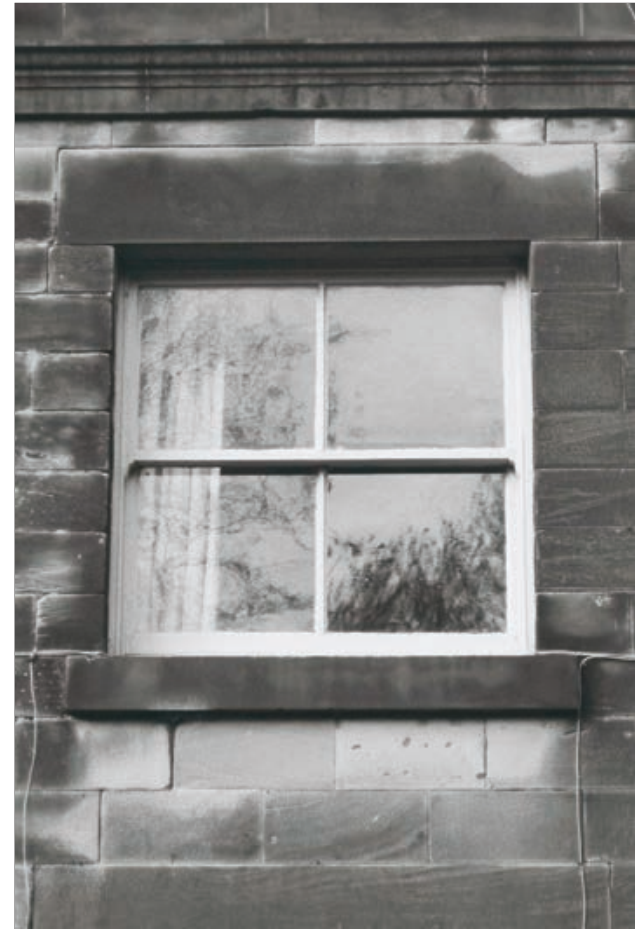
Plate 368: Detail of a first floor window at the south end of the east elevation of the South/East Range (Agent's House) (Film 11.30)

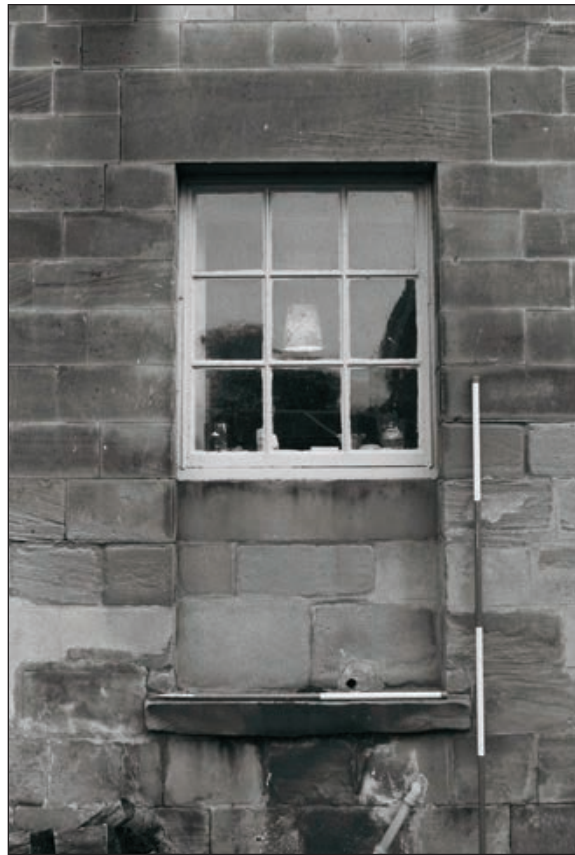
Plate 369: Detail of a ground floor window at the south end of the west elevation of the South/East Range (Agent's House) (Film 20.02)

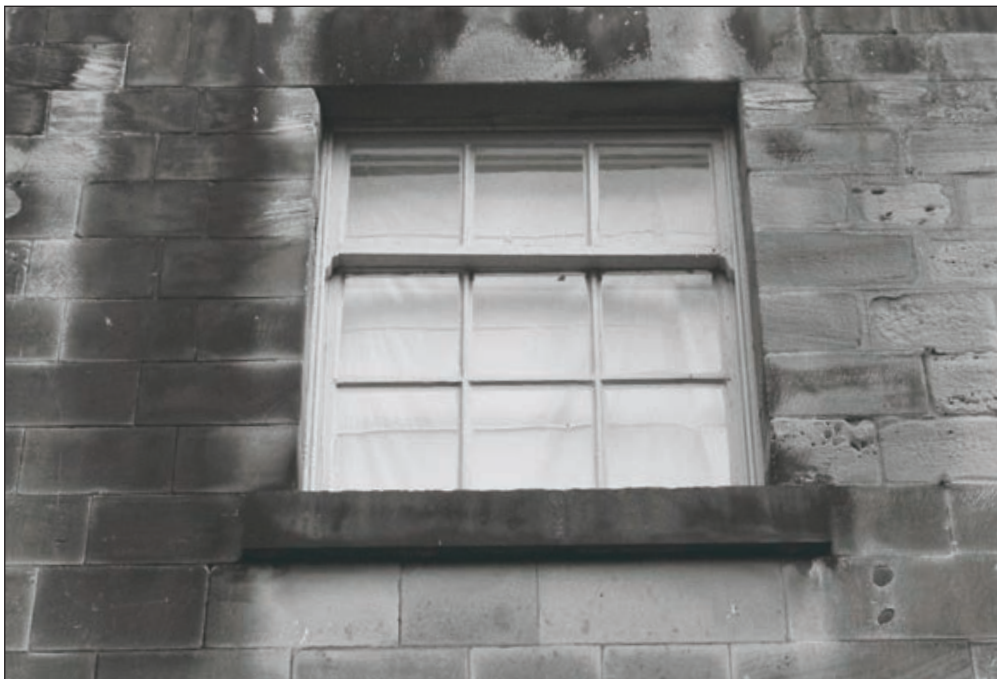
Plate 370: Detail of a first floor window at the south end of the west courtyard elevation of the South/East Range (Agent's House) (Film 20.04)

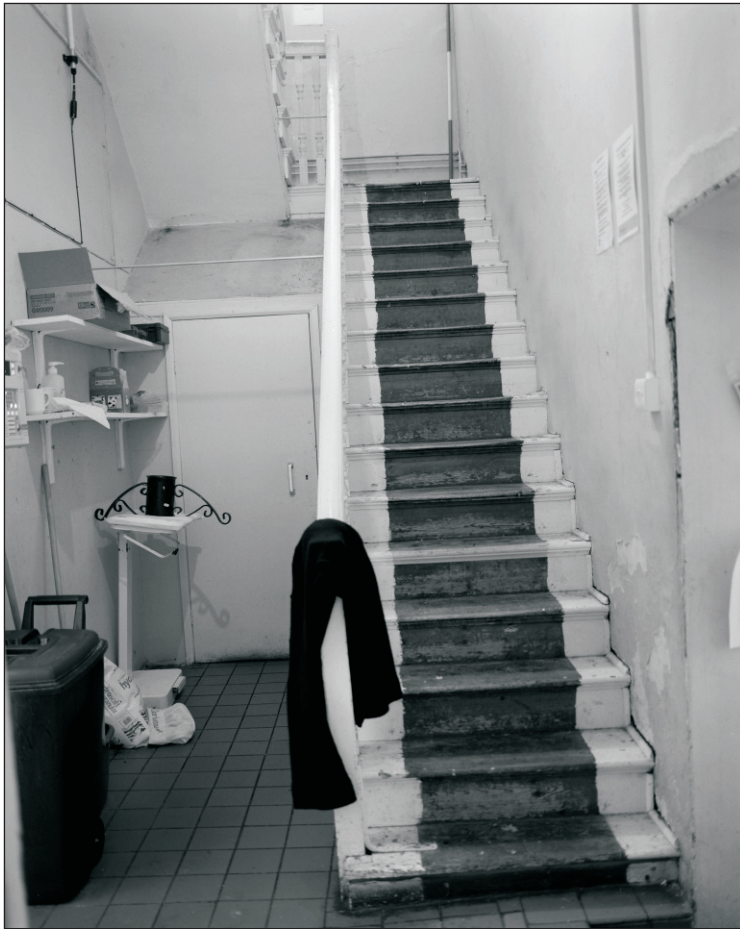
Plate 371: General view of G25, South Range (Film 37.06)

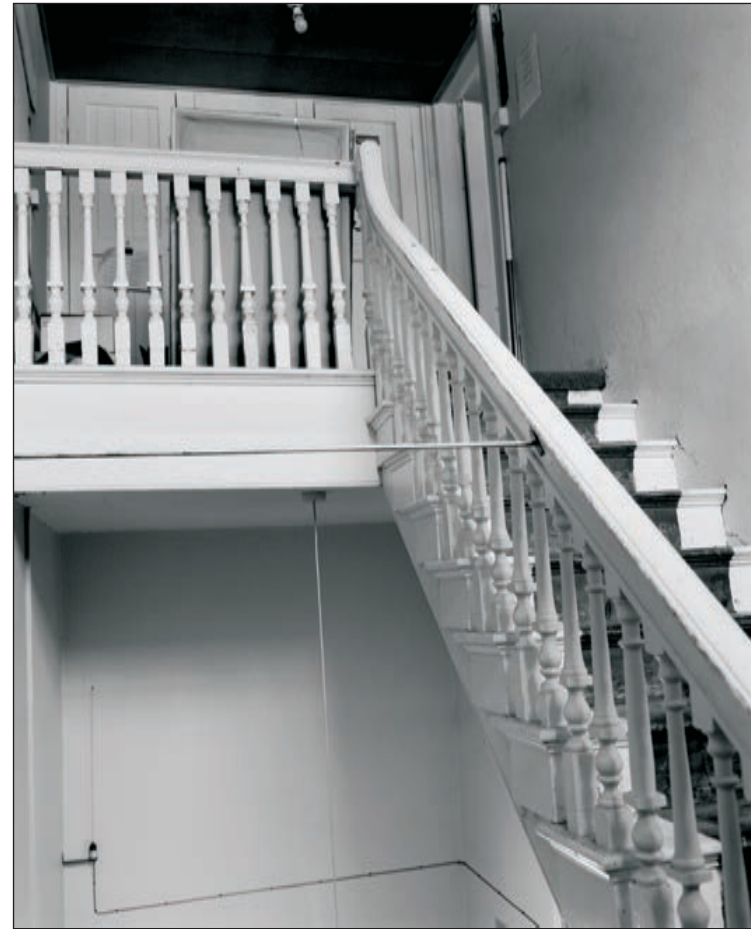
Plate 372: General view from half landing on staircase G25 towards F29, South Range (Film 37.07)

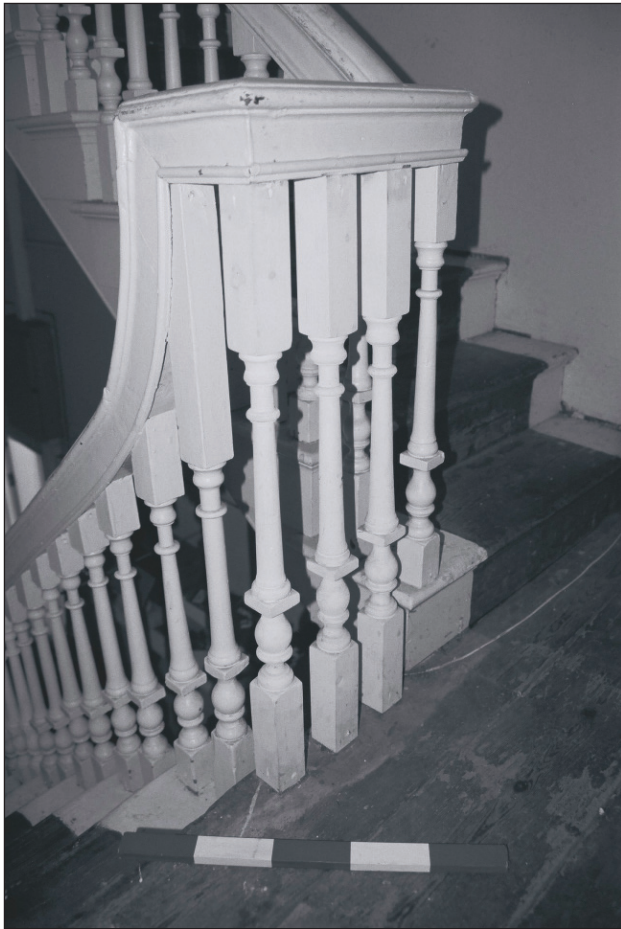
along each edge up the stairs. The balustrade had painted turned balusters and moulded handrail (**Plate 373**).

Plate 373: Detail of staircase balustrade G25, South Range (Film 22.22)

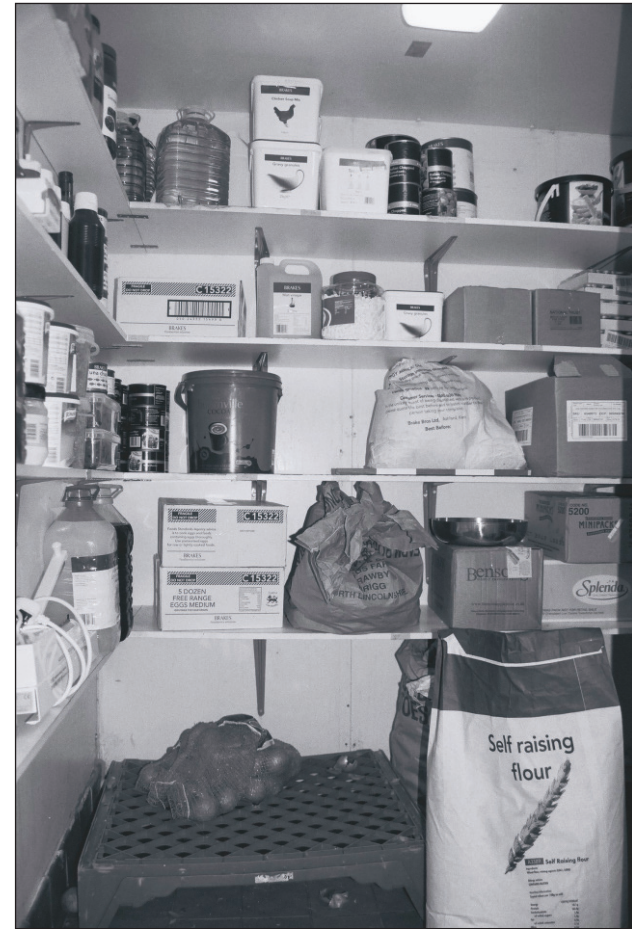
- 5.4.20 To the west of the hallway G25, was G26, a modern partitioned understair cupboard. This was utilised as a pantry, with the window in the west wall boarded over and modern shelving attached to the walls (**Plate 374**). The removal of the modern fittings exposed the sash window behind (**Plate 375**).

Plate 374: General view of G26, South Range - understair cupboard (Film 22.16)

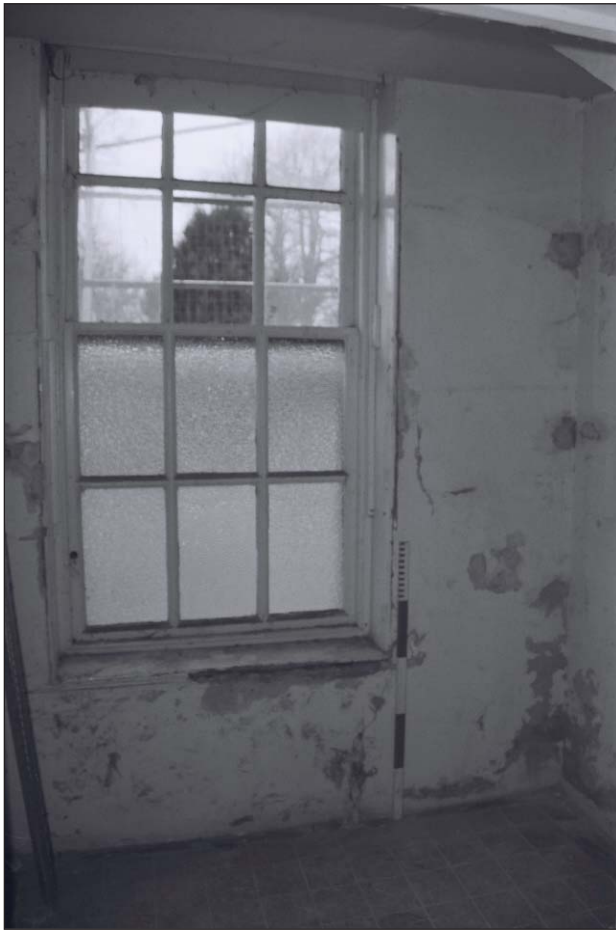
Plate 375: View of G26, South Range, after the removal of modern shelving - OB. 129 (Film 79.17)
