NOSTELL PRIORY STABLES, NOSTELL, WAKEFIELD, WEST YORKSHIRE

Historic Building Recording and Structural Watching Brief

Planning Application Ref: 09/00701/FUL & 09/00705/LBC

72934.01_BDG_V0_4

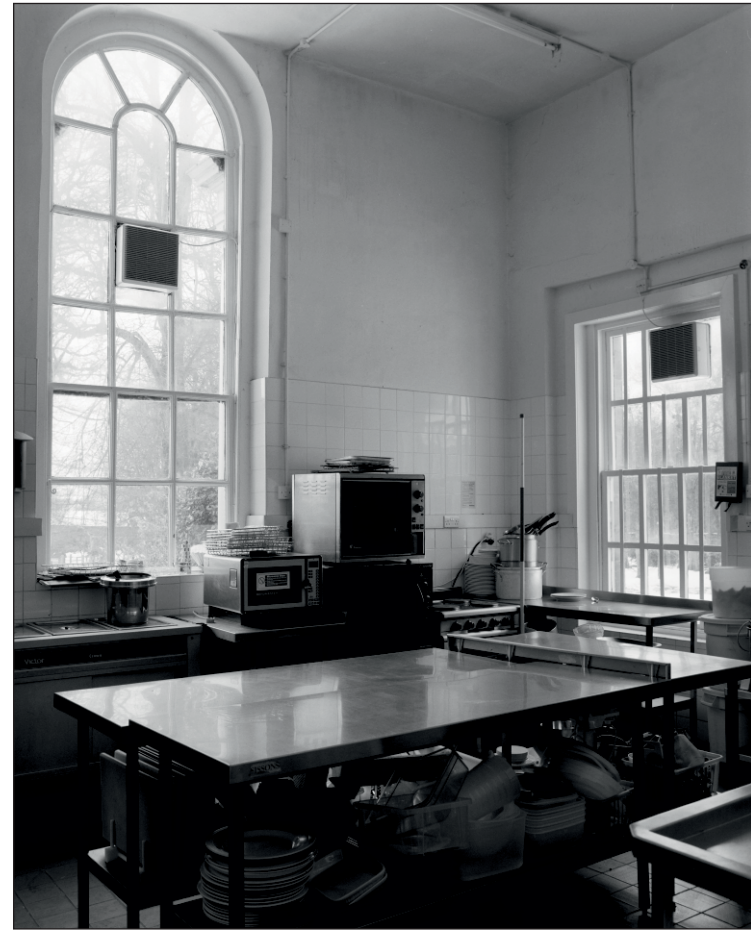
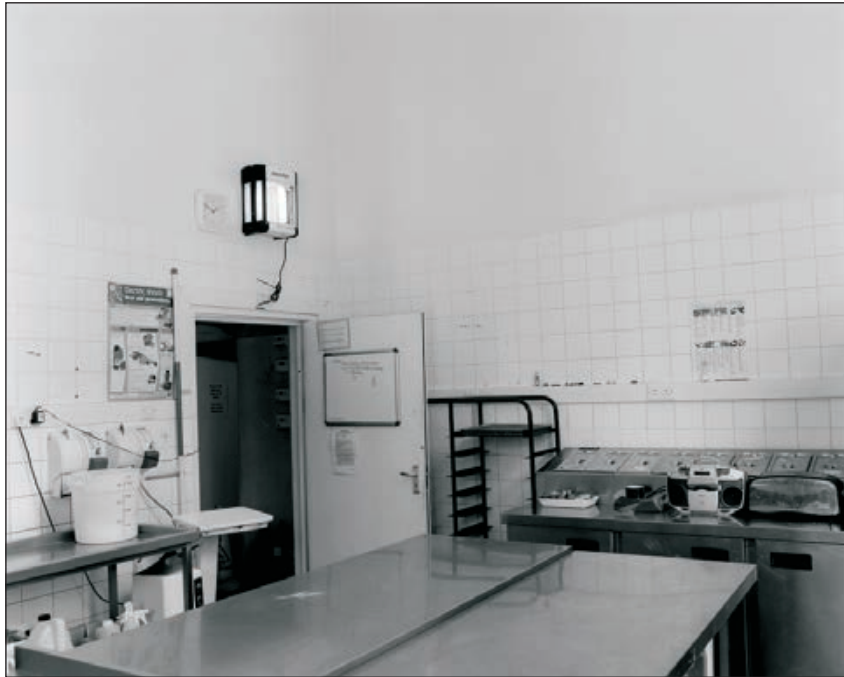
- 5.4.21 G27, housing modern kitchen fixtures and fittings, was located to the south (**Plate 376-377**). To the south was the central tall arched light of the venetian window within the elevation. The two flanking lights were blind internally. There was also a window to the west (**Plate 378**). The room was covered with modern finishes throughout, obscuring all historic fabric (**Plates 376-378**). These were removed as part of the refurbishment works, although little further information was observed, with the exception of the likely insertion of the doorway to the north from G25 (**Plates 379-380**).

Plate 376: General view of G27, South Range (Film 37.01)

Plate 377: General view of room G27, South Range (Film 37.03)

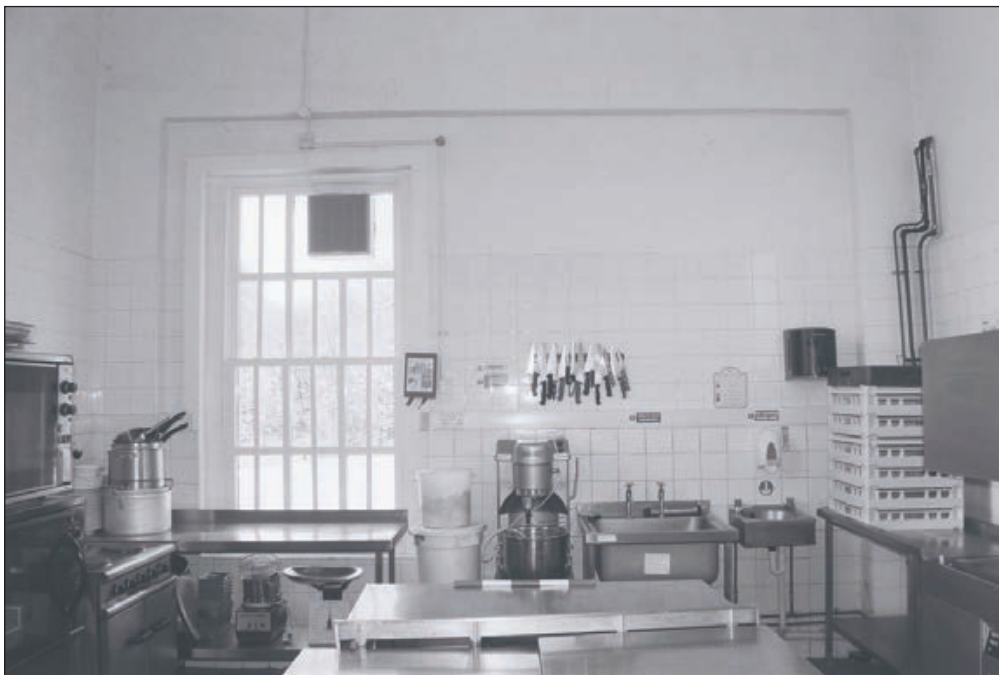
Plate 378: General view of G27, South Range (Film 22.26)

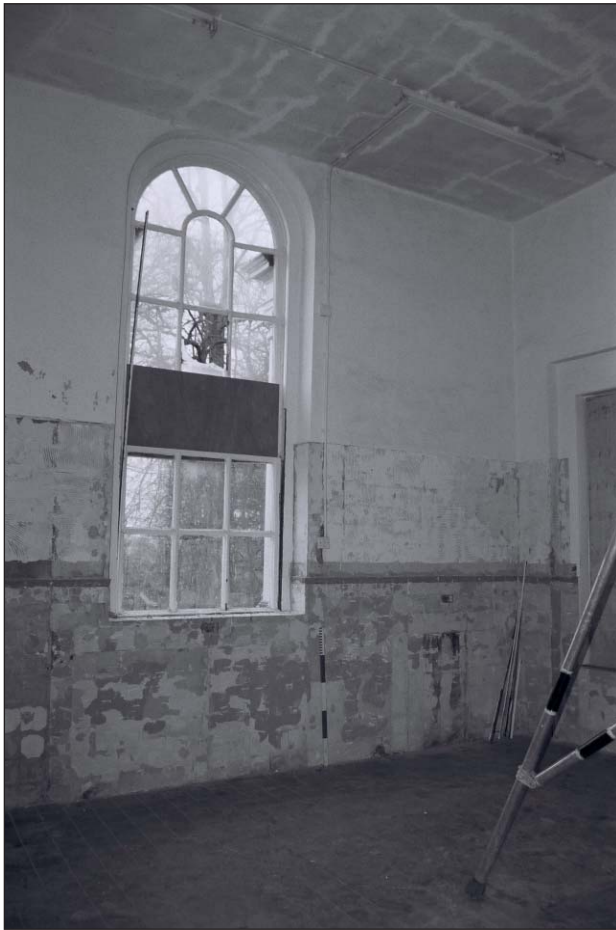
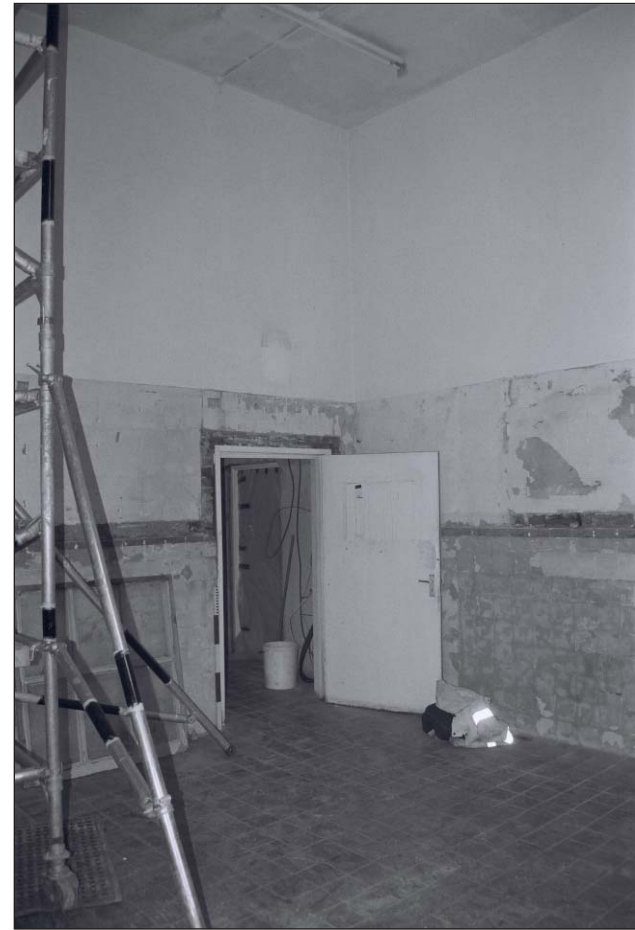
Plate 379: General view of G27, South Range, after the removal of modern kitchen fittings - OB. 130 (Film 79.20)

Plate 380: General view of G27, South Range, after removal of modern kitchen fittings (Film 79.18)

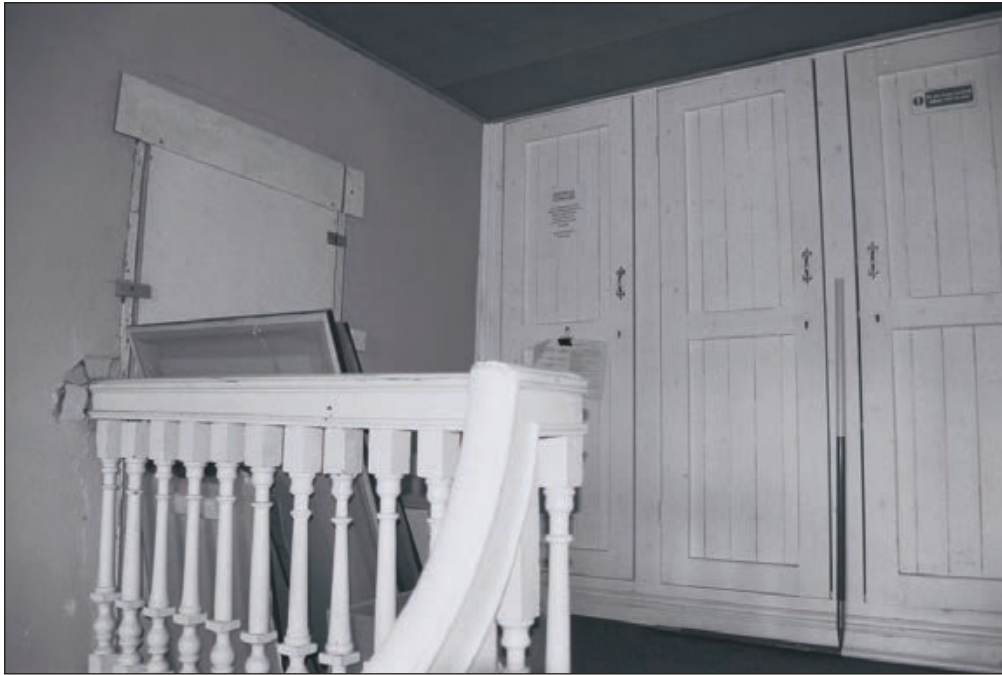
- 5.4.22 The first floor of the pavilion could only be accessed via the staircase from G25. This comprised F29, a small landing at the top of the staircase (**Plate.. 381**) and room F28. Landing F29, had a limeash floor, modern built-in cupboards along the east wall, and an inserted opening to the north providing access into Roof Void 8 in the West Range.

Plate 381: General view of F29, South Range - showing modern cupboards and inserted doorway to Roof Void 8, West Range (Film 22.19)

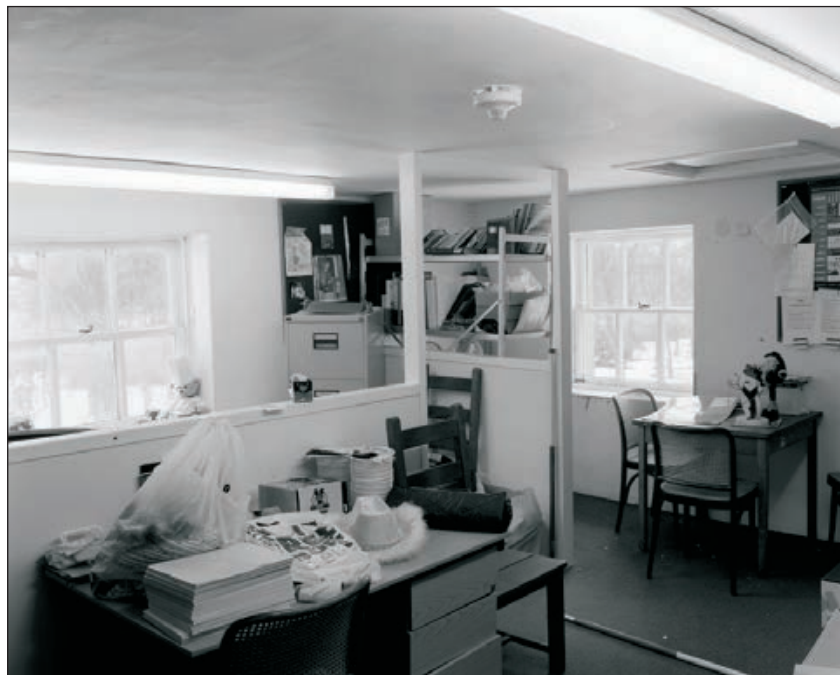
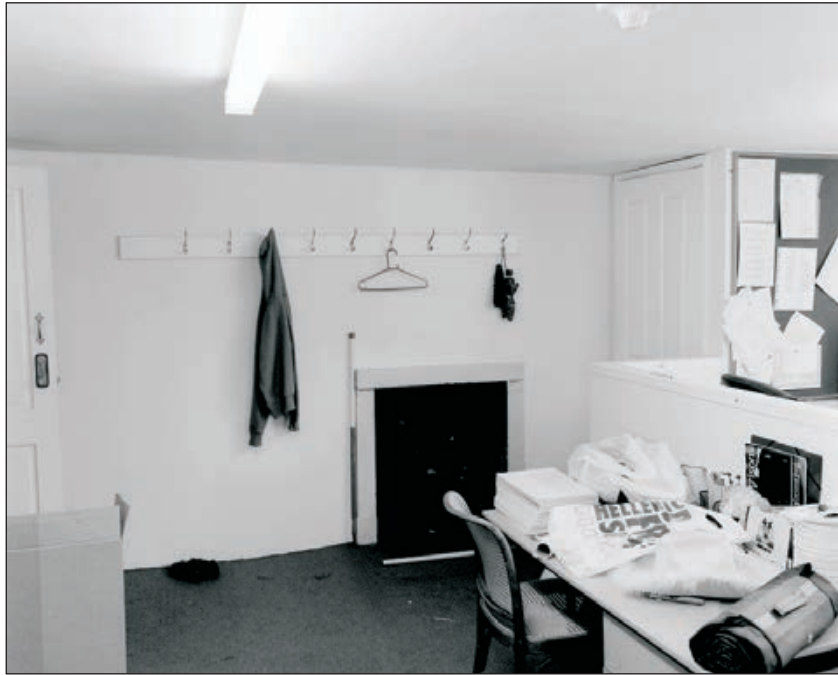
- 5.4.23 Room F28, to the south of F29, was rectangular in plan, with modern finishes and inserted partitions. The room functioned as a staff room most latterly (**Plates 382-383**). There was a simple cast iron fireplace with plain stone surround, within the east wall (**Plate 384**) and a sash window to the west and south (**Plates 385**). All modern fittings and finishes were removed during the structural watching brief, exposing the original limeash flooring (**Plates 385-386**). A hatch within the ceiling of F29, provided access into the pavilion roof space. The roof structure was made up of a timber King-Post in the centre, with radiating struts and principal rafters (**Plate 387**). The purlins were all timber trenched and pegged (**Plate 388**). Some modern repairs were evident within the structure, whilst the whole ceiling was of modern plaster board.

Plate 382: General view of F28, South Range (Film 37.09)

Plate 383: General view of F28, South Range, showing fireplace (Film 38.01)

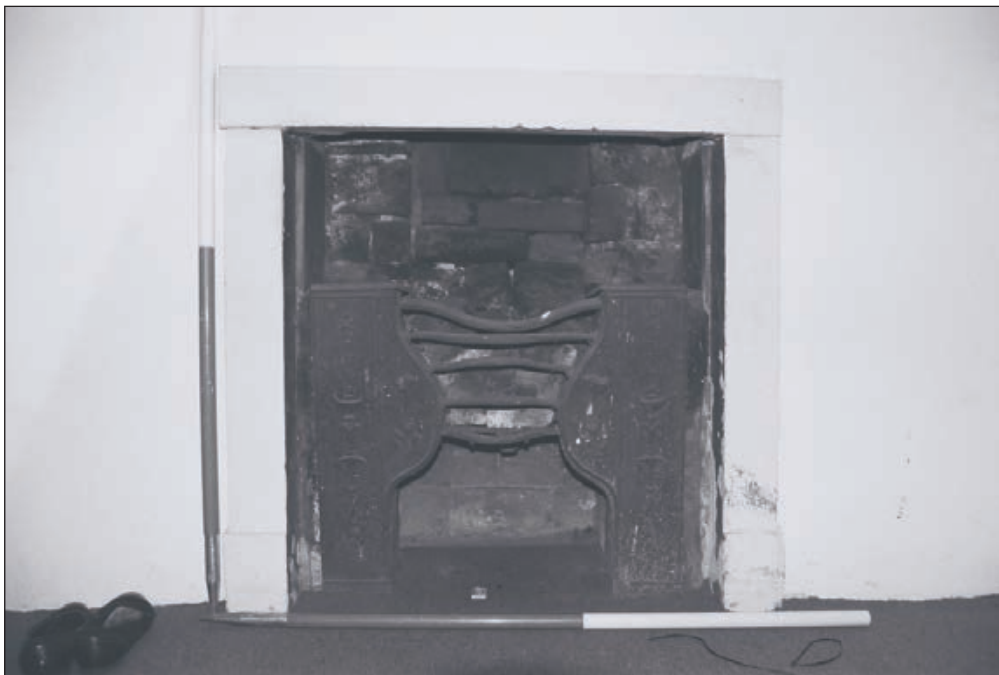
Plate 384: Detail of fireplace, east wall of F28, South Range (Film 22.20)

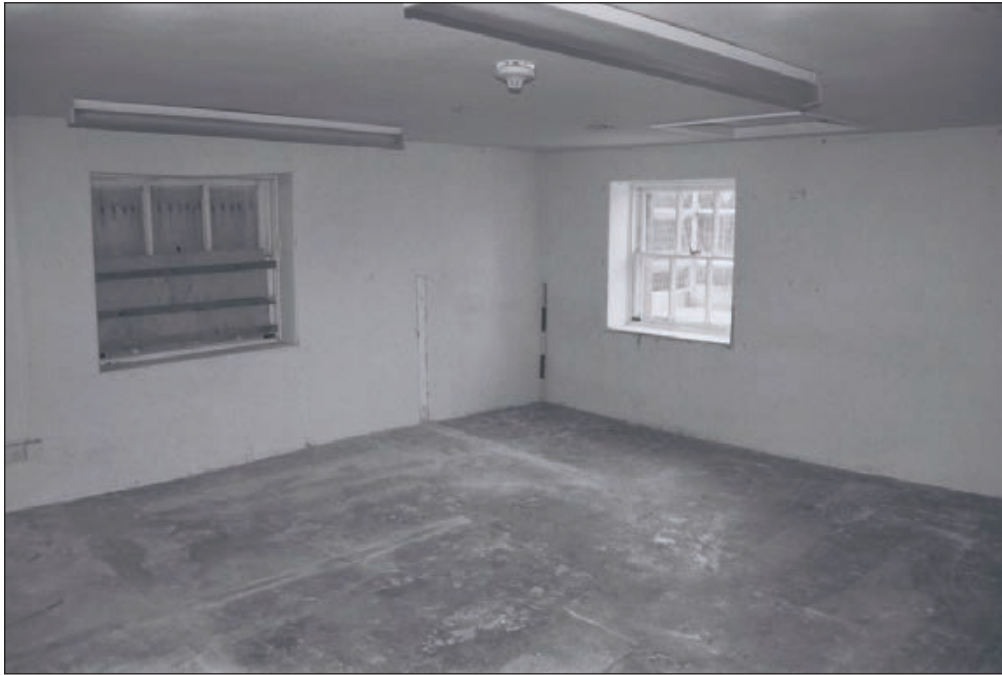
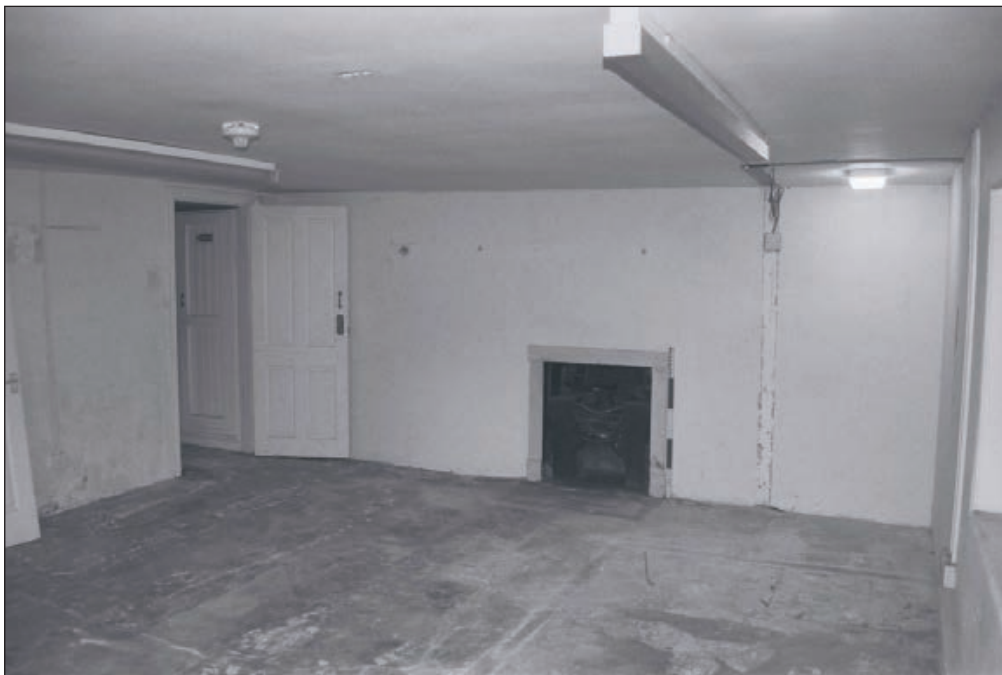
Plate 385: General view of F28, South Range, after removal of modern partitions and fittings - OB. 126 (Film 77.01)

Plate 386: General view of F28, South Range, after removal of modern partitions and fittings - OB. 126 (Film 77.03)

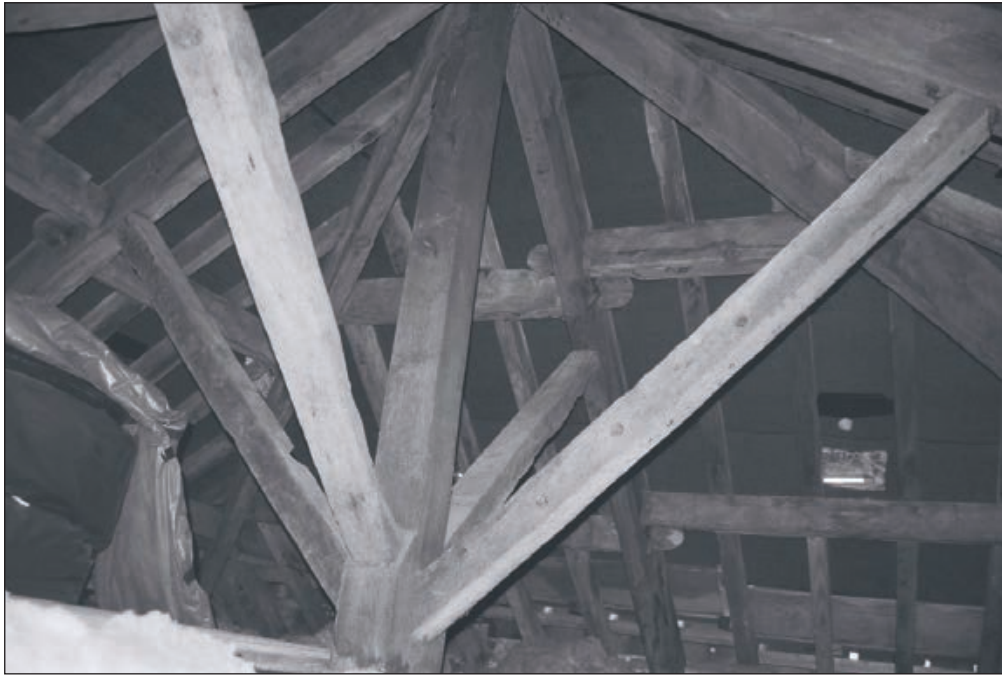
Plate 387: General view of timber trusses, roof void above F28, South Range, - OB. 127 (Film 78.26)

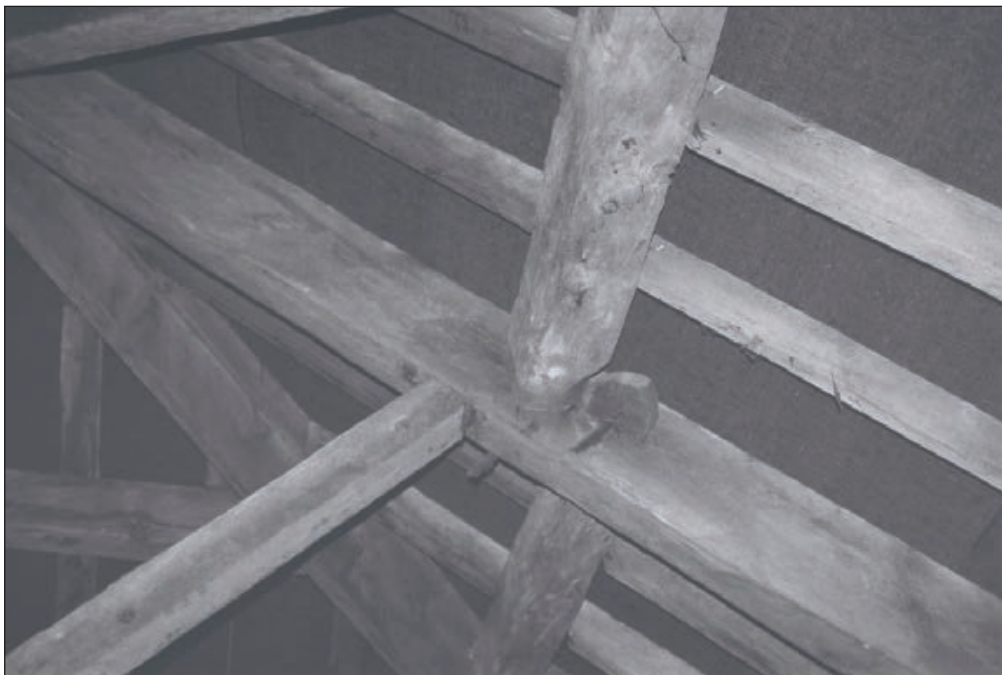
Plate 388: Detail of pegged timber purlins and trusses, roof void above F28, South Range - OB. 127 (Film 78.31)

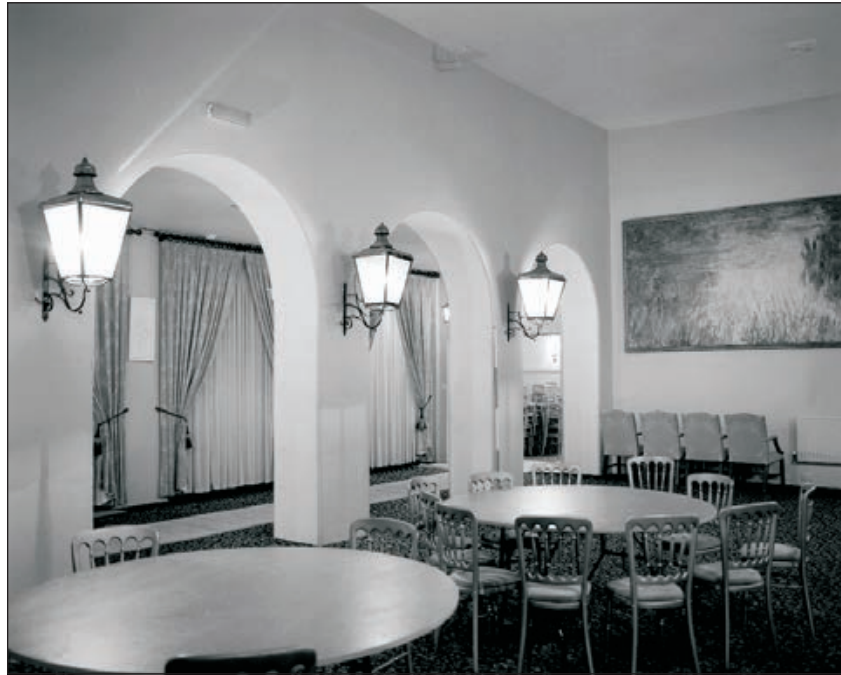
Plate 389: General view of G28, South Range (Film 10.01)

- 5.4.24 To the east of the pavilion was the former Garden Room, G28. This was a tall double height room, with few or no original features retained. The room had modern function suite finishes throughout and a bar to the west (**Plates 389-390**). The north wall had been completely altered and five arches inserted, opening it up with G29 to the north (**Plate 389**). The original fenestrated south wall has been infilled, and contains two high pivot windows (**Plate 390**). Positioned high above the arches of the north wall was a timber bracket (**Plate 391**) which was likely associated with the use of the room as a grain store in the 1960s. A hatch within the ceiling of the rooms provided access into Roof Void 10 above. The roof structure was of four joggled King-Post trusses with trenched and pegged purlins (**Plate 392**).

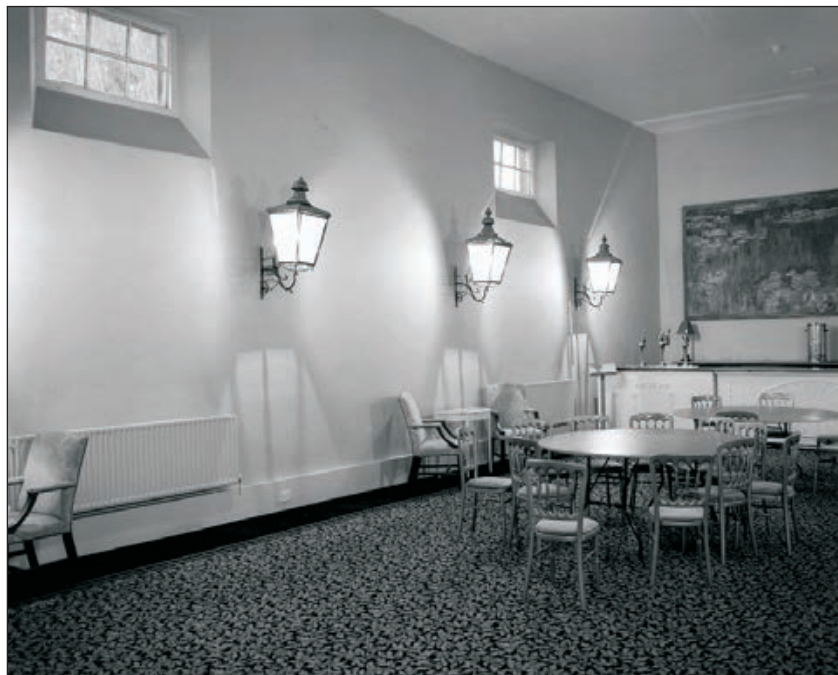
Plate 390: General view of G28, South Range (Film 10.03)

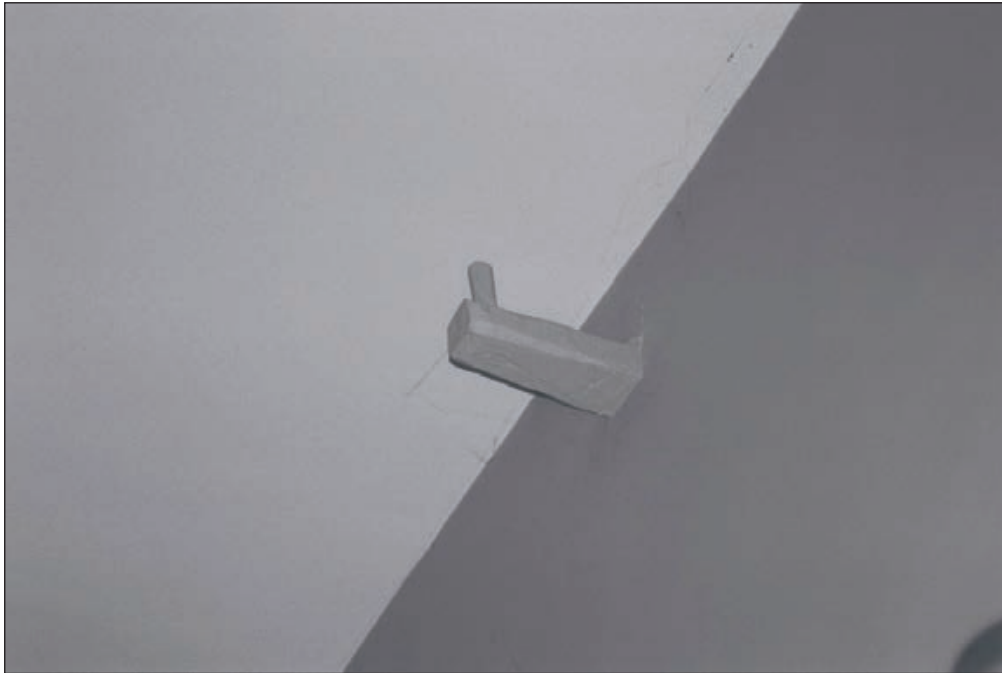
Plate 391: Detail of high timber bracket within east wall of G28, South Range (Film 24.01)

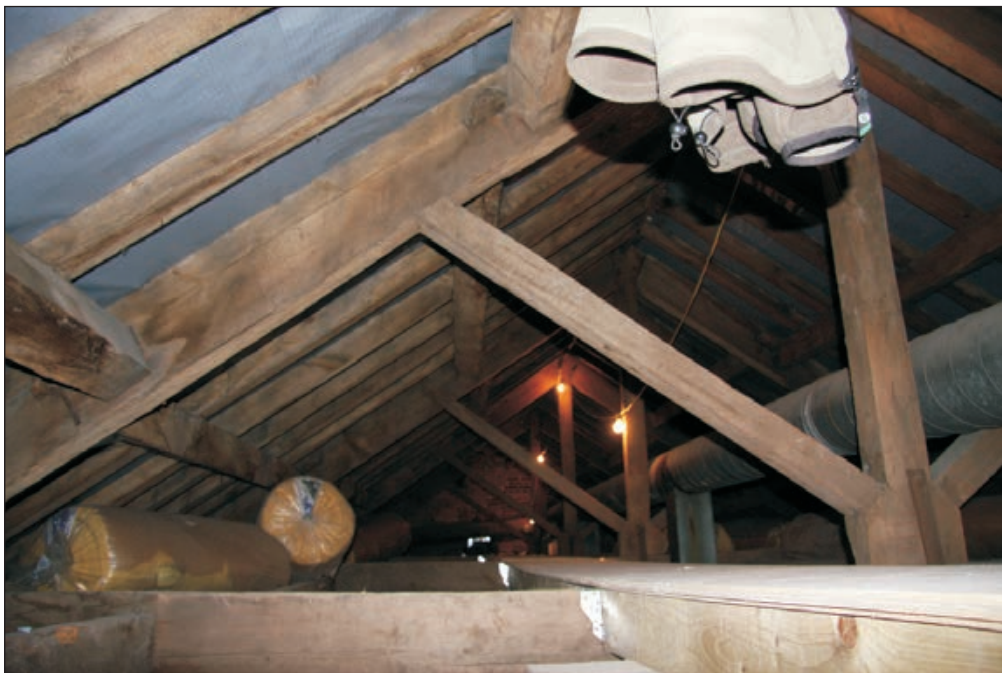
Plate 392: General view of roof void above G28, South Range, showing timber King-Post trusses - OB. 112 (Film D. 21.10.11 5072)

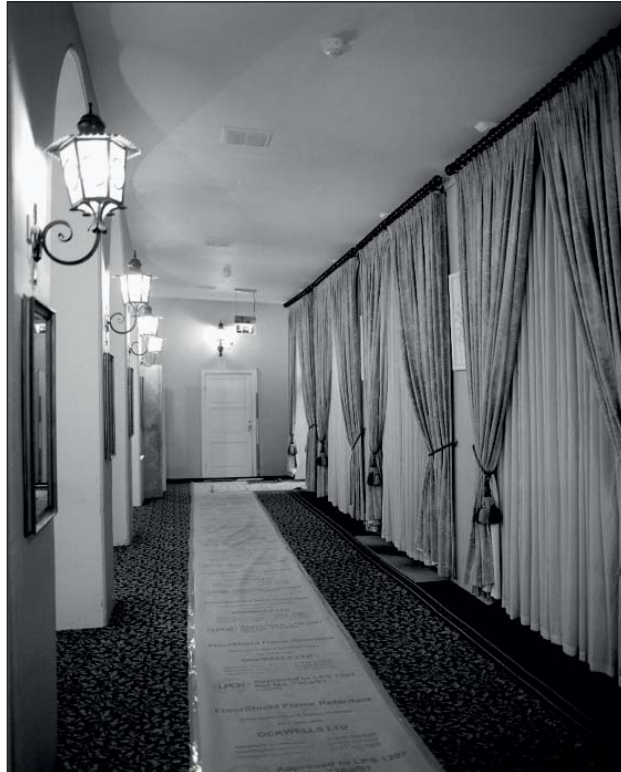
Plate 393: General view of G29, South Range (Film 10.05)

- 5.4.25 Room G29, positioned to the north of G28, was a former corridor providing access from the stables of the West Range to the Riding House. This had been substantially altered, with both the north and south walls being arched, whilst those to the north contained modern windows and doors (**Plates 393-**

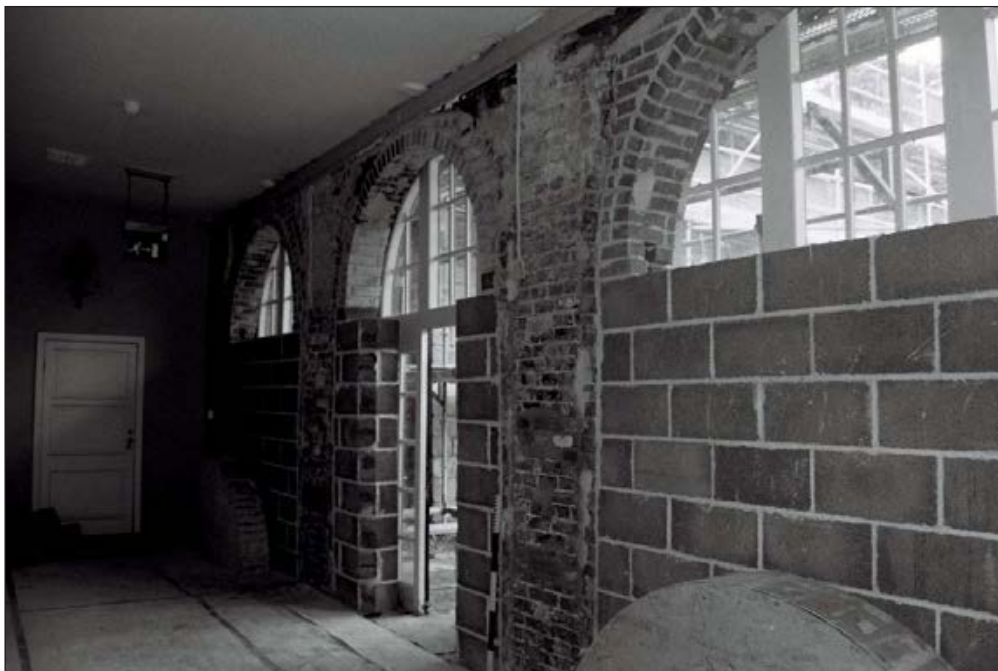
Plate 394: View of exposed brickwork, north wall of G29, South Range - OB. 105 (Film 72.07)

394). A doorway at the west end of the room provided access with G24 of the West Range, whilst to the east was an opening into the Riding House G30. The plaster on the north wall was removed and the arched wall modified. The original phase 3 brick cores of the piers were exposed (**Plate 394**).

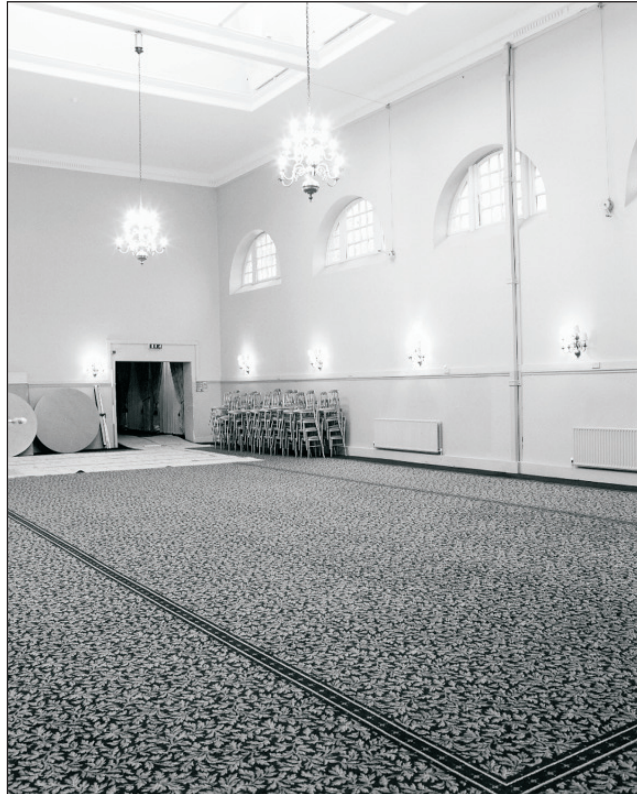
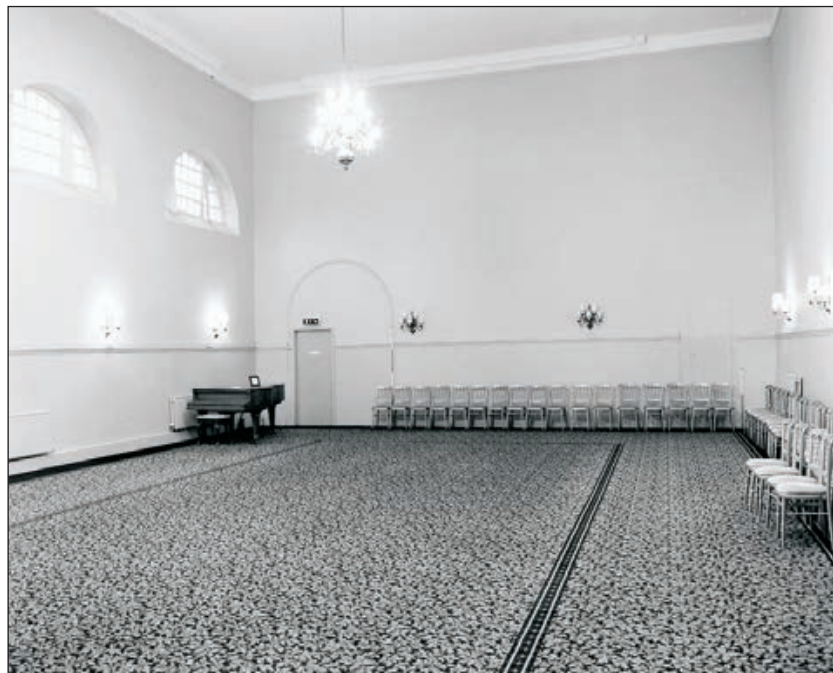
Plate 395: General view of G30, South Range (Film 09.03)

Plate 396: General view of G30, South Range (Film 09.10)

- 5.4.26 The central Riding House was largely a single space, G30. This was a large and very tall room, with modern décor suitable for functions (**Plates 395-396**). The entrance into the room from G29 had been widened during the 1960s, whilst the entrance from the former corridor to the east had been blocked with a small modern pedestrian doorway within the opening (**Plates 397-398, 401**). An inserted doorway positioned at the south end of the east wall (**Plate 402**), provided internal access to the adjacent former Greenhouse. All the original tongue and groove match boarding around the lower third of the walls had been boarded over, although small areas were exposed and recorded within the north wall (**Plate 410**). The room contained five very high tripartite arched windows within the north wall, to light the room (**Plate 403**). However, these must not have been sufficient, and within the roof, large skylights were inserted during the 19th century (**Plate 400**). These had pulley mechanisms with winders attached to the north wall in order for the skylights to be opened (**Plate 404**). Also positioned against the north wall was an internal downpipe possible serving the external cistern/well (**Plate 405**). Within the centre of the south wall was an opening to room G33, and an elaborate viewing balcony above at first floor (F32) (**Plate 399**), with decorative columns (**Plate 406**). The original dentil cornice was in a poor state of repair, with large sections missing (**Plate 407**). During the renovation of the cornice, its structural detail was observed, with simple timber moulded brackets, nailed laths, and two types of plaster (**Plates 408-409**). The dentils were probably fixed with small hidden nails. The floor was a solid concrete surface (**Plate 411**).

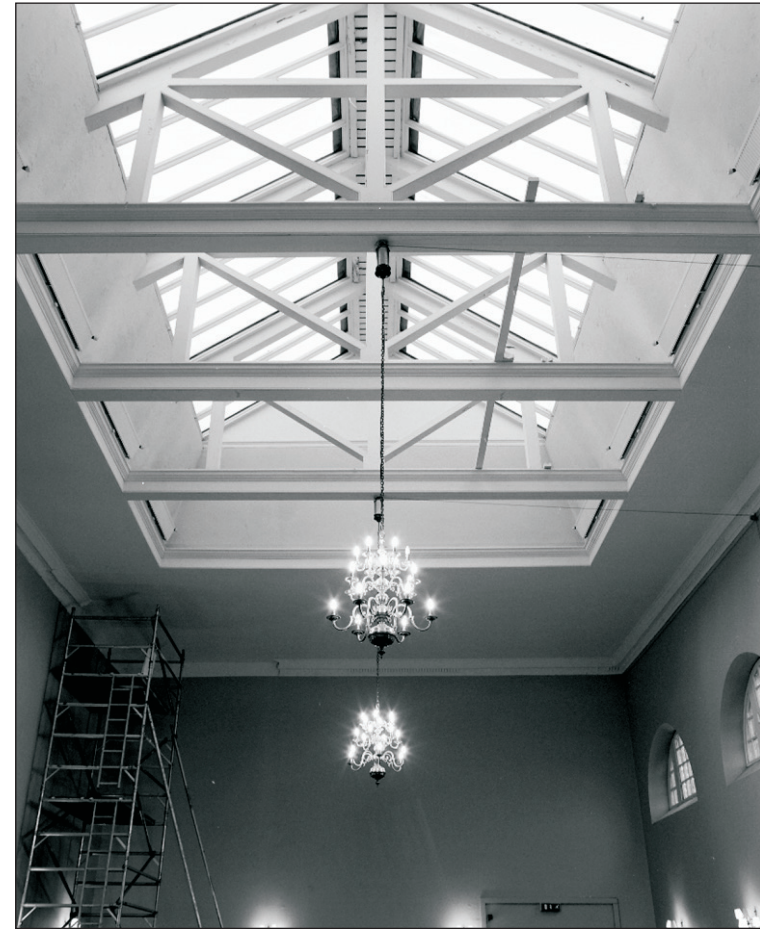
Plate 400: View of King-Post roof trusses and inserted skylights, G30, South Range (Film 09.06)

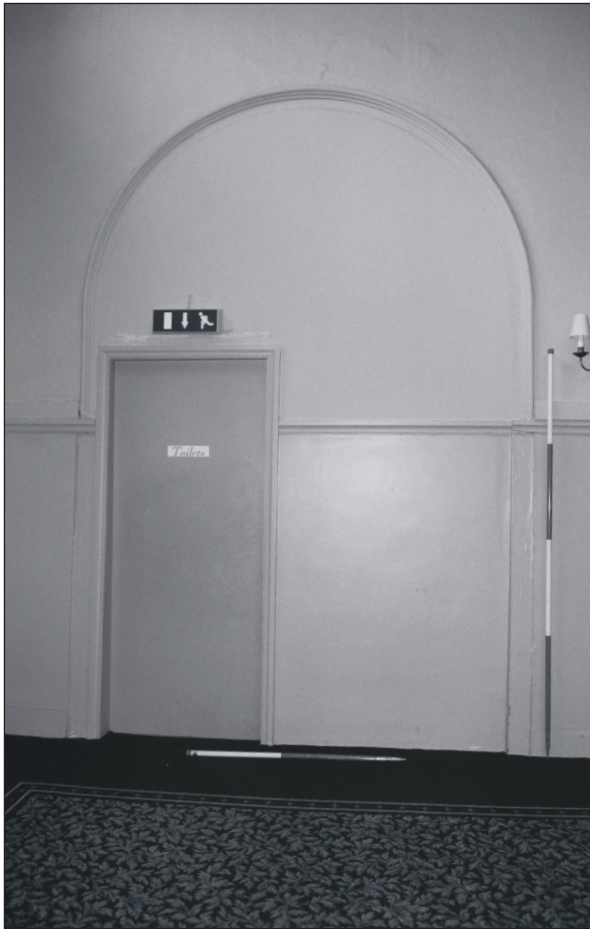
Plate 401: View of blocked arched opening, east wall of G30, South Range (Film 24.22)

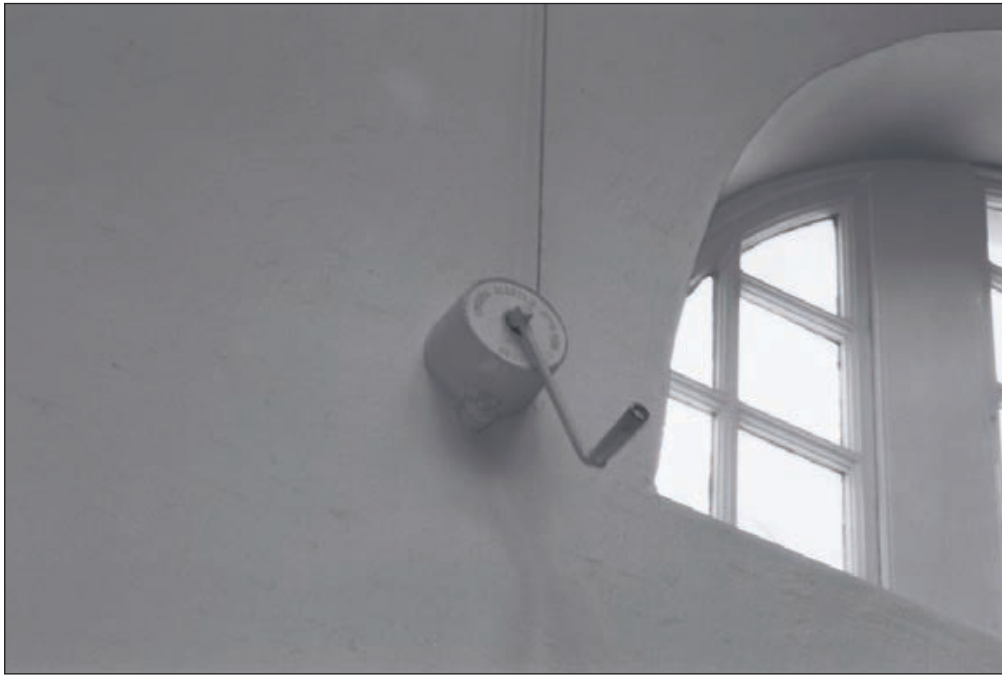
Plate 404: Detail of pulley mechanism for opening inserted skylights within roof, G30, South Range (Film 24.16)

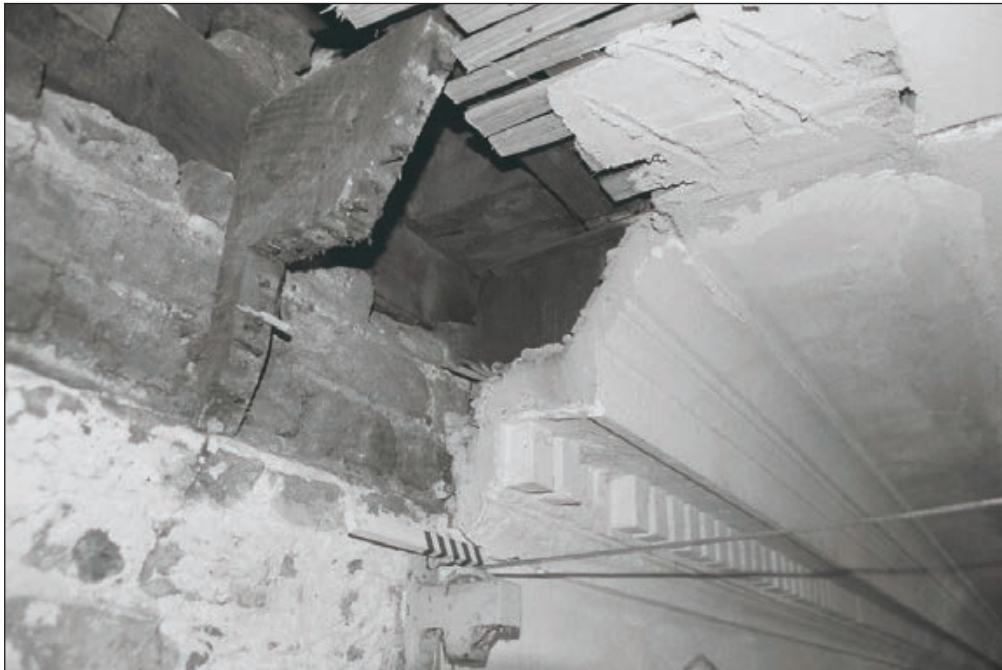
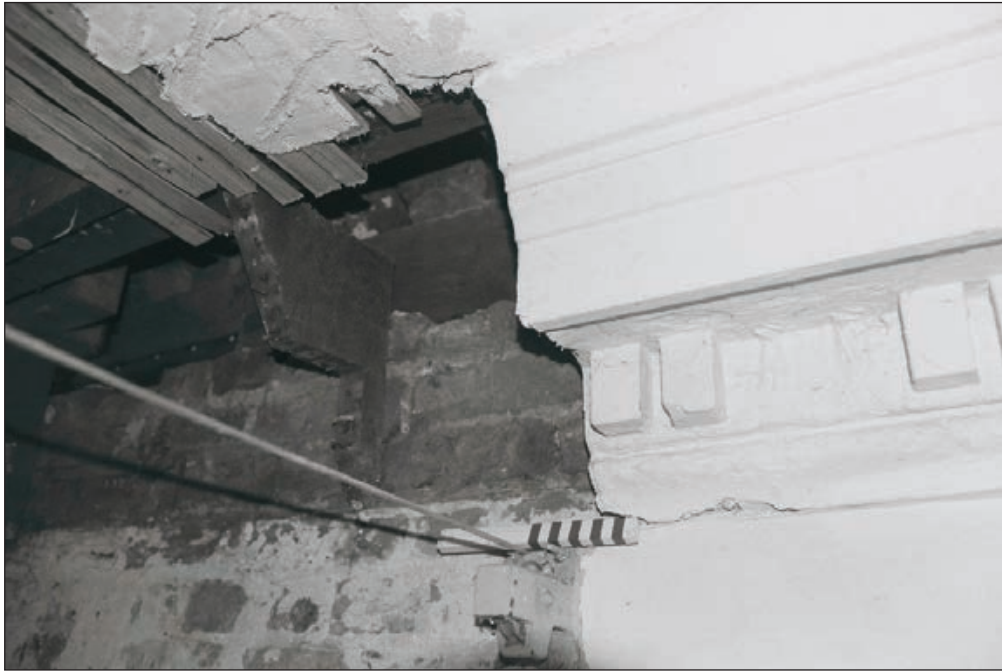
Plate 408: Detail of cornice structure, G30, South Range - OB. 104 (Film 72.12)

Plate 409: Detail of cornice structure, G30, South Range - OB. 104 (Film 72.14)

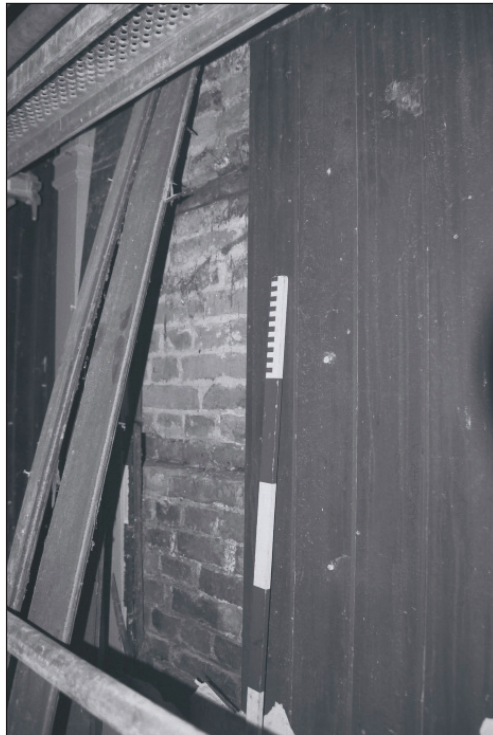
Plate 410: Detail of tongue and groove timber match boarding around lower half of G30 walls, South Range - OB. 69 (Film 56.32)

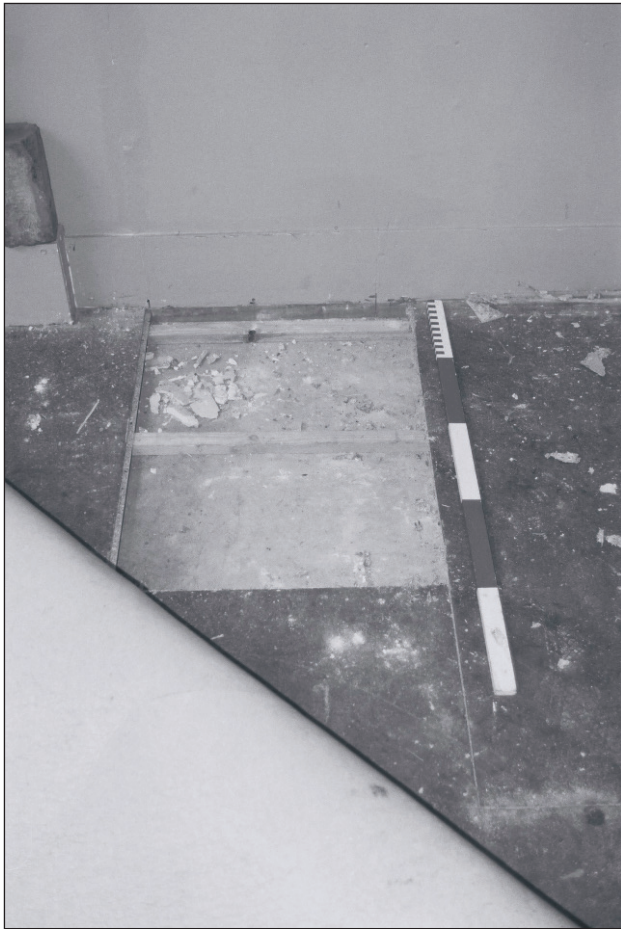
Plate 411: Detail of exposed concrete floor of G30, South Range - OB. 15 (Film 46.16)

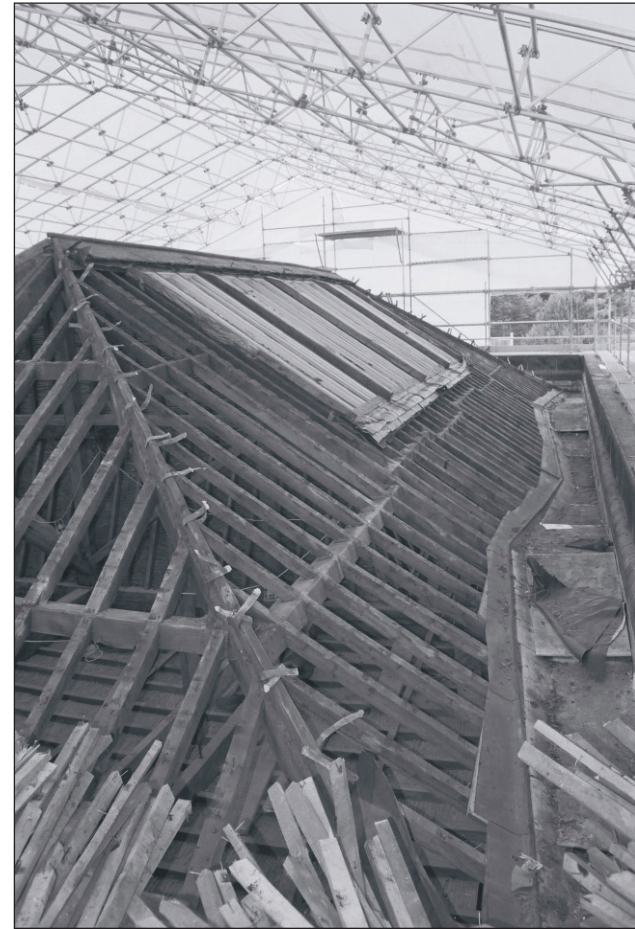
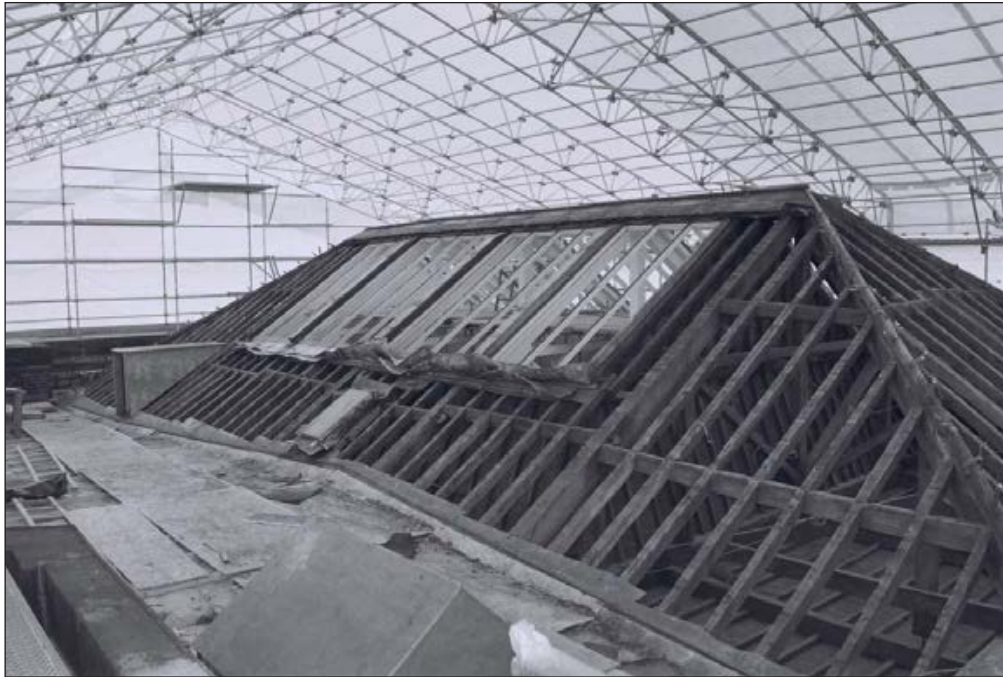
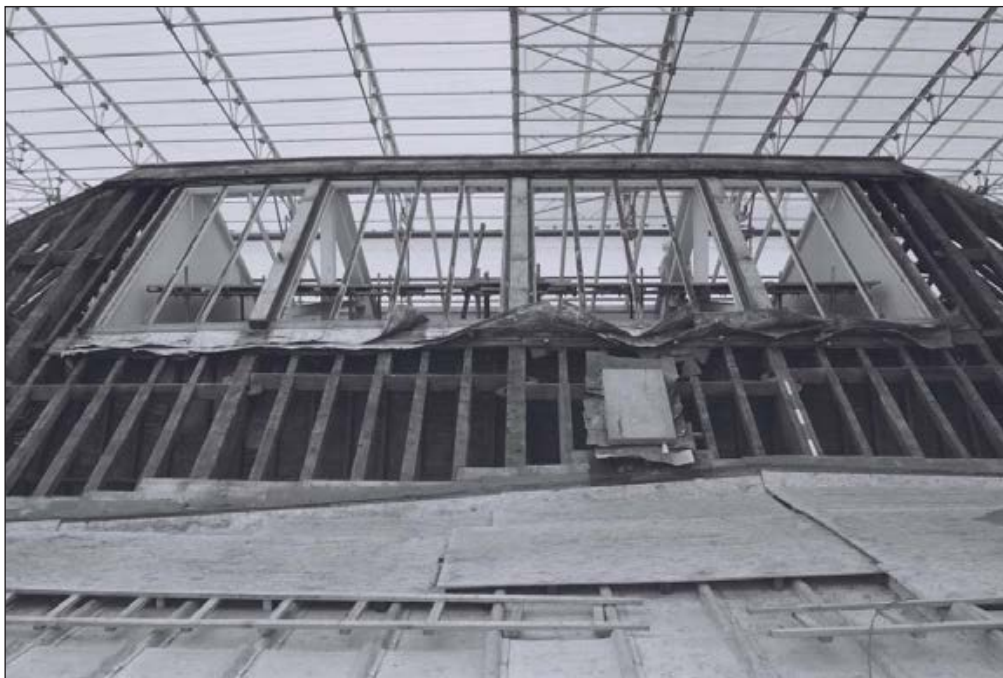
Plate 412: View of timber roof structure of the Riding House above G30, South Range - OB. 67 (Film 54.20)

Plate 413: View of exposed timber roof structure of the Riding House above G30, South Range - OB. 67 (Film 54.05)

Plate 414: View of timber roof structure of the Riding House, above G30, South Range - OB. 104 - showing inserted skylights (Film 55.08)

- 5.4.27 The roof of G30 was a pitched timber structure, hipped to the east and west, with inserted skylights and stone tile covering. The stone tiles were removed and the timber structure revealed (**Plates 412-416**). The original roof structure had five timber King-Post trusses with trenched and pegged purlins. Many of the timbers making up the south pitch, especially the common rafters, had construction marks. The skylights were clearly of a later date, and with their insertion, the hips to the east and west required two secondary trusses at each end (**Plate 416**). Modern repairs had also been undertaken on the roof, including the insertion of steels.

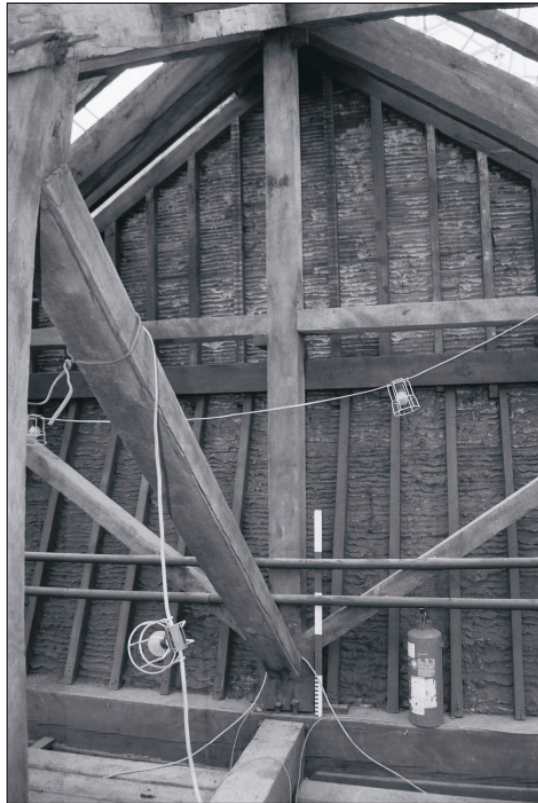
Plate 415: View of original hipped truss, roof structure of the Riding House above G30, South Range - OB. 67 (Film 55.35)

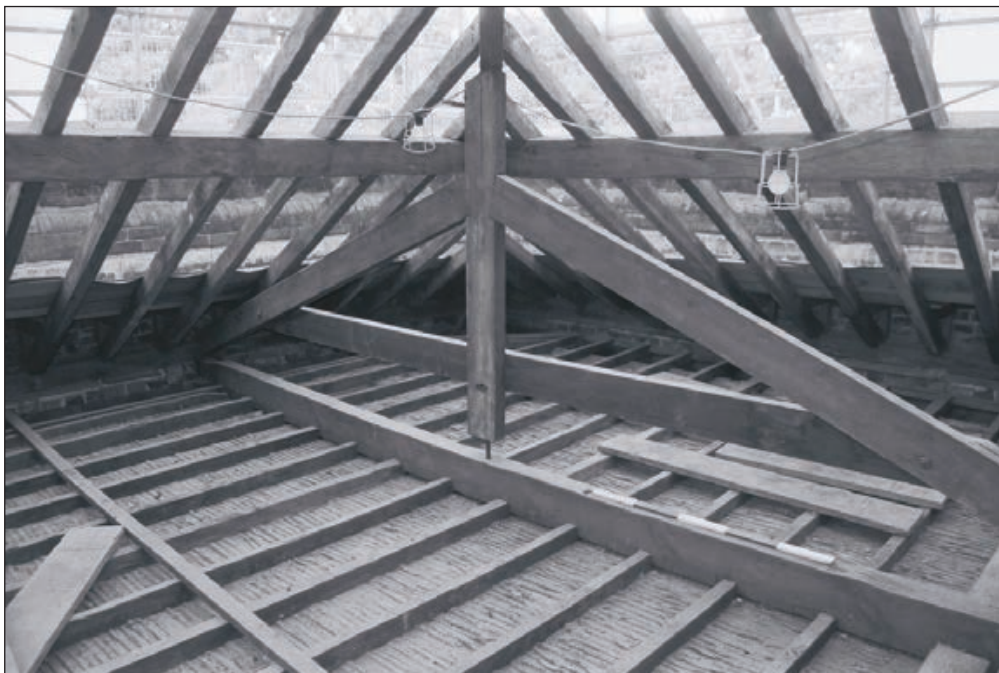
Plate 416: View of secondary roof truss of hipped roof structure of the Riding House, above G30, South Range - OB. 67 (Film 55.30)
