NOSTELL PRIORY STABLES, NOSTELL, WAKEFIELD, WEST YORKSHIRE

Historic Building Recording and Structural Watching Brief

Planning Application Ref: 09/00701/FUL & 09/00705/LBC

72934.01_BDG_V0_4

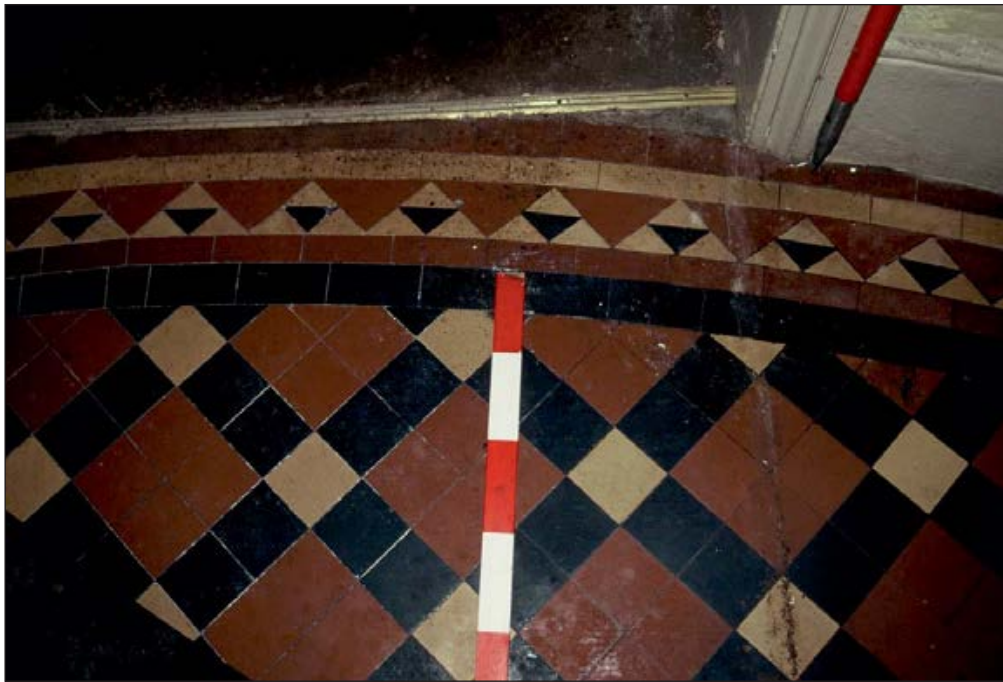
Plate 418: Detail of pattern tiled floor of G33, South Range (Film C.S. 19.)

- 5.4.28 To the south of G30 were a range of rooms which projected southwards from the Riding House. These included room G33, a small semi-circular lobby area which connected the external loggia G34 with the Riding House G30 (**Figure 11**). To the north, the lobby had a double door opening with steps leading down into G30 (**Plate 417**) and within the curved south wall a large double doorway providing access to the loggia G34 and rose gardens beyond. This door had an elaborate etched gold box lock (**Plate 419**). The floor was covered with coloured tessellated patterned tiles (**Plate 418**).

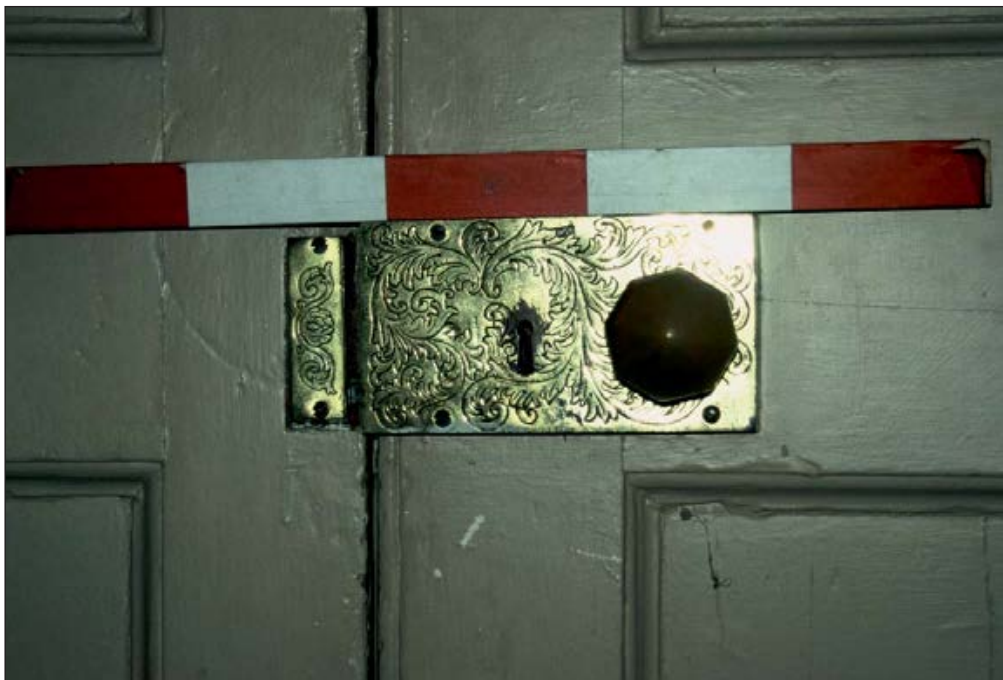
Plate 419: Detail of decorative etched box lock on doorway in south wall of G33, South Range (Film C.S. 20.)

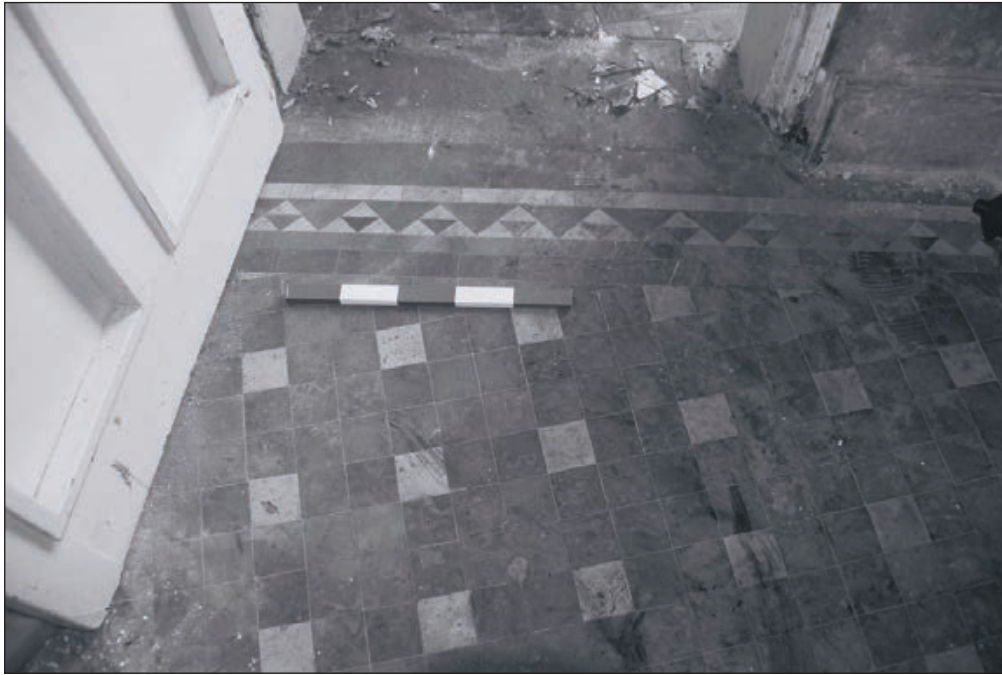
Plate 422: Detail of pattern tiled floor of G32, South Range (Film 41.21)

(**Plate 420**). These small rooms contained a boiler within G31 (**Plate 421**), whilst G32 was used as a store. Some original cornice had been retained (**Plate 423**), along with coloured tessellated patterned tiled floor (**Plate 422**), the same as that within G33. A sash window was positioned within the south wall, and had retained its moulded architrave, and some elements of a former shutter (**Plate 424**).

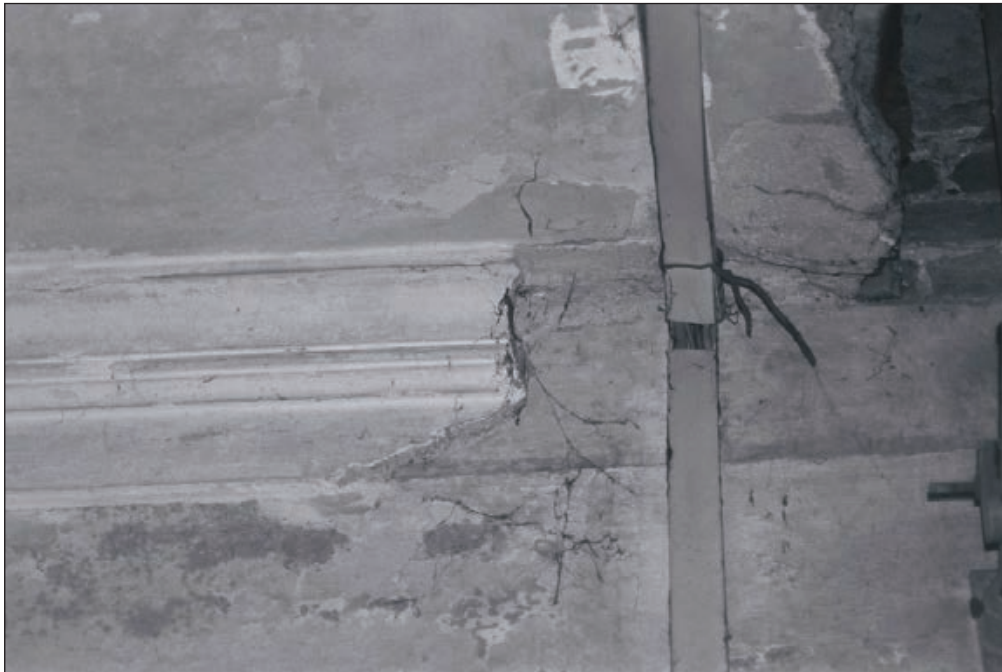
Plate 423: Detail of original cornice, G31, South Range (Film 41.15)

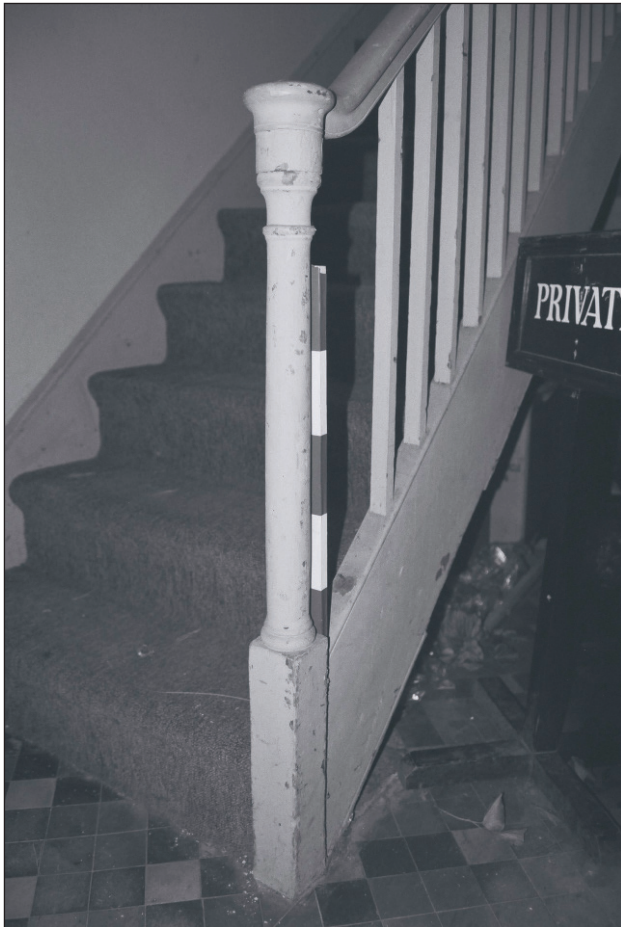
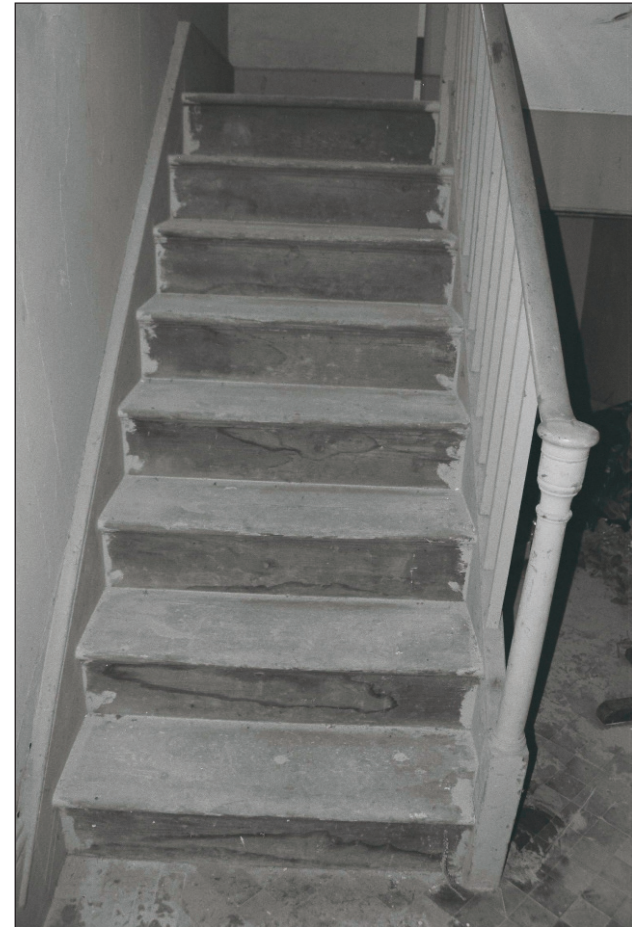
Plate 426: Detail of staircase, G35, South Range (Film 41.10)

Plate 427: General view of staircase, G35, South Range, showing timber treads (Film 70.15)

- 5.4.30 This space was mirrored to the east of G33, also accessed via G34, making room G35. This was a rectangular hallway, with staircase leading to the first floor, and a blind window to the south (**Plate 425**). Again original floor tiling and cornice was retained, and the staircase was a simple timber design with stick balusters (**Plates 426-430**) and half landing. This staircase led to the first floor of the Riding House, including a small landing area (F33), which had a skylight serving the staircase, and original cornice, and timber boarded floor (**Plates 428, 430-431**). A doorway to the west led to F32, the viewing balcony (**Plate 432**). This was semi-circular in plan, and had four decorative columns, with simple balustrade between, doorways to the east and west, and original dentil cornicing (**Plates 432-433, 435**). Rooms F30 and F31, could only be accessed from the balcony F32. This was originally a single space, but had been divided by modern partitioning (**Plates 436-437**). Within the northwest corner of F30 was piping from the boiler in G31 below, and inserted hatches within the ceiling above (**Plates 438-439**). The floor was covered with timber boards. These were lifted revealing rotting timber joists (**Plate 440**). The lath and plaster ceiling of the room was also removed, exposing the ceiling and cornice structure (**Plate 441**).

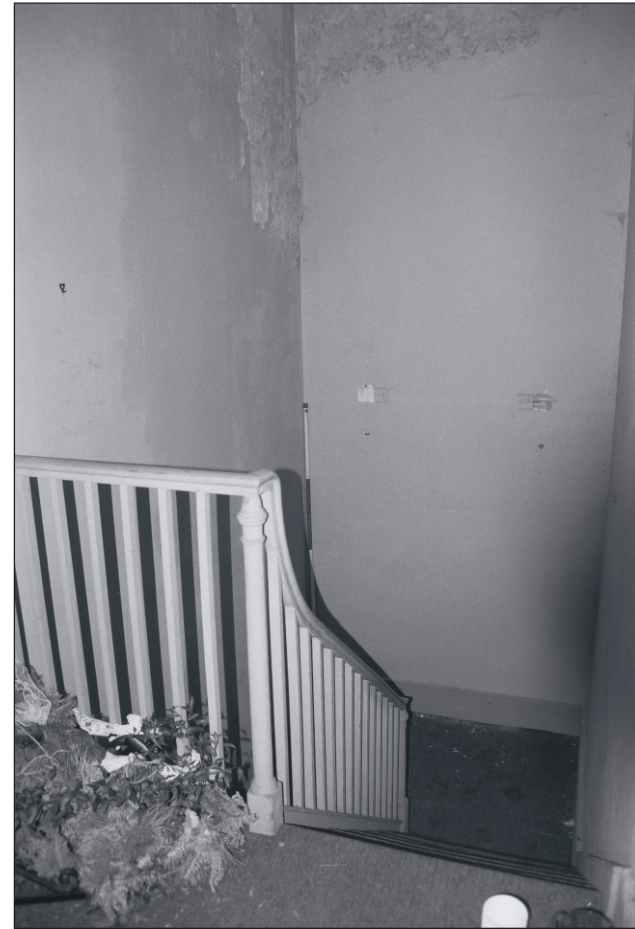
Plate 429: General view of staircase from F33, South Range, showing half landing (Film 41.09)

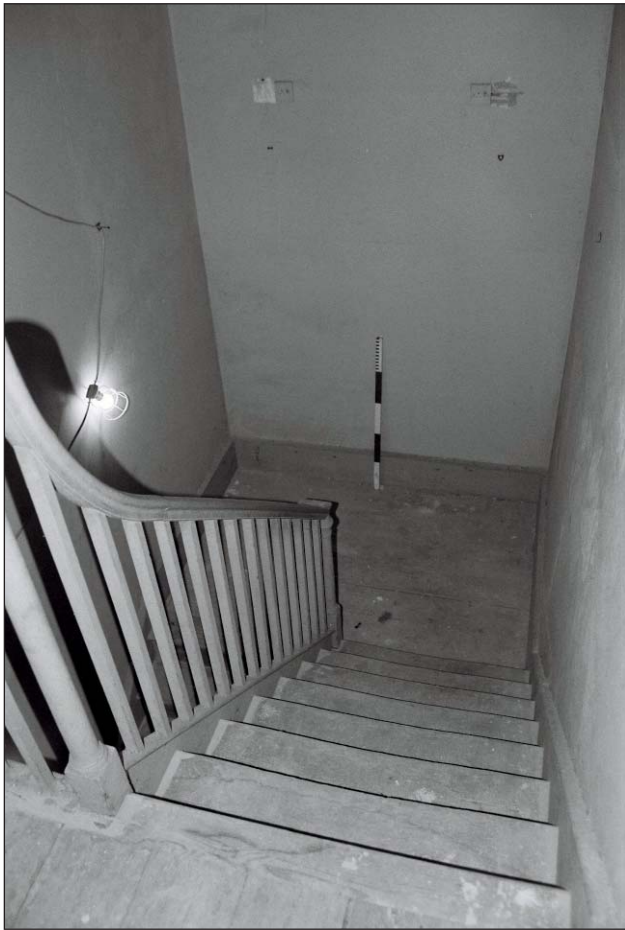
Plate 430: View of staircase from F33, South Range, showing timber treads and half landing ,South Range (Film 70.17)

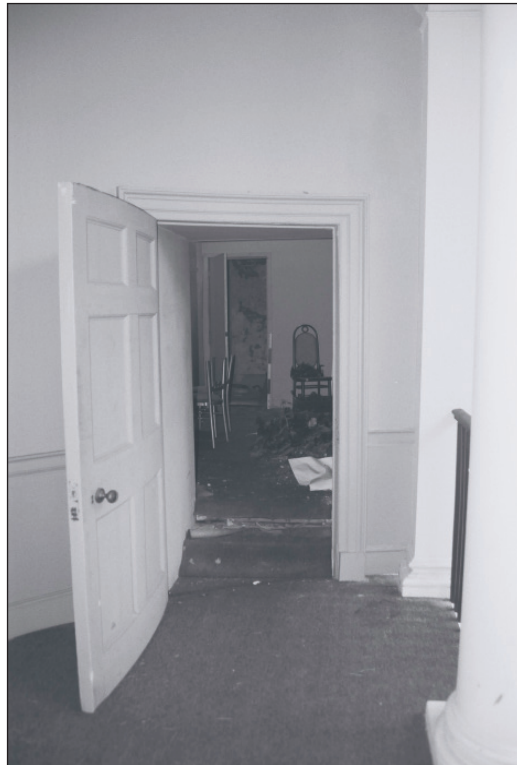
Plate 434: View of curved door, F32 with F31 beyond, South Range (Film 46.29)

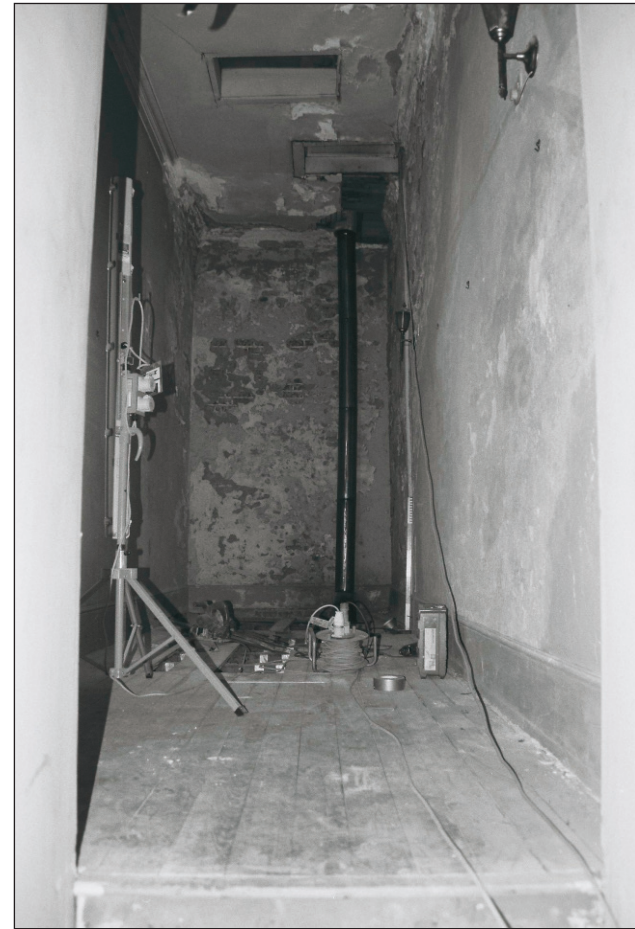
Plate 439: General view of F30 and F31, South Range, after the removal of the modern partition (Film 69.05)

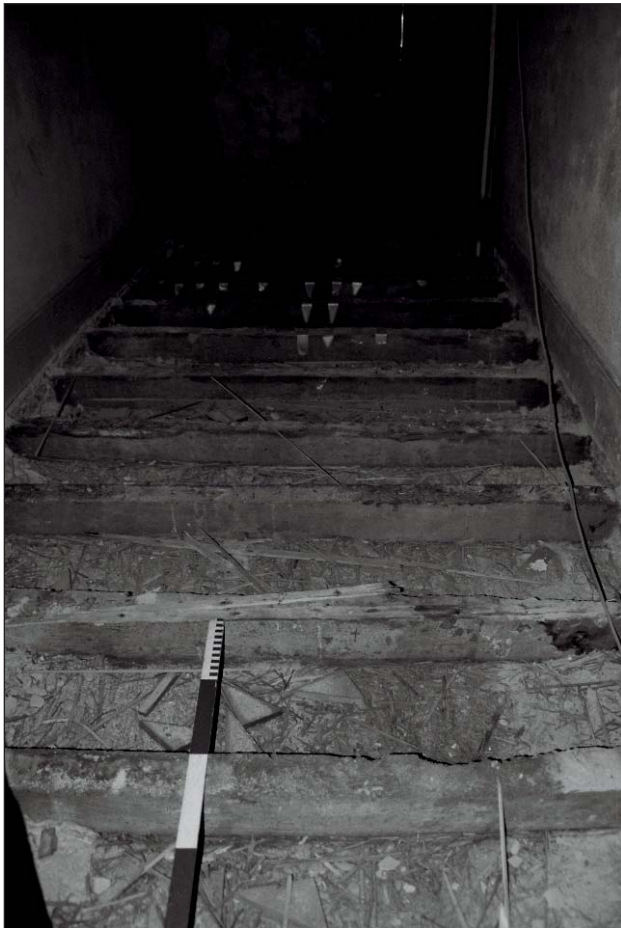
Plate 440: View of exposed timber joists, F30/31, South Range - OB. 90 (Film 70.21)

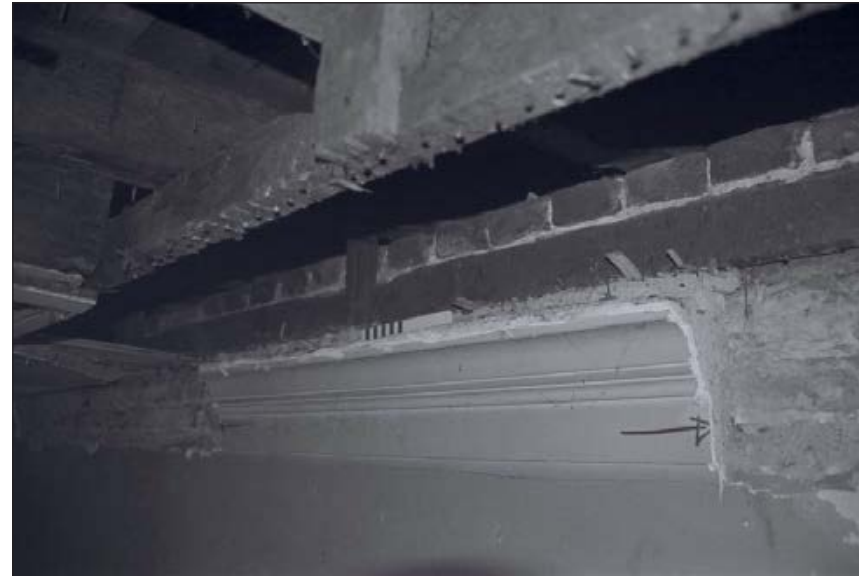
Plate 441: Detail of cornice and ceiling structure, F30/31, South Range - OB. 109 (Film 74.28)

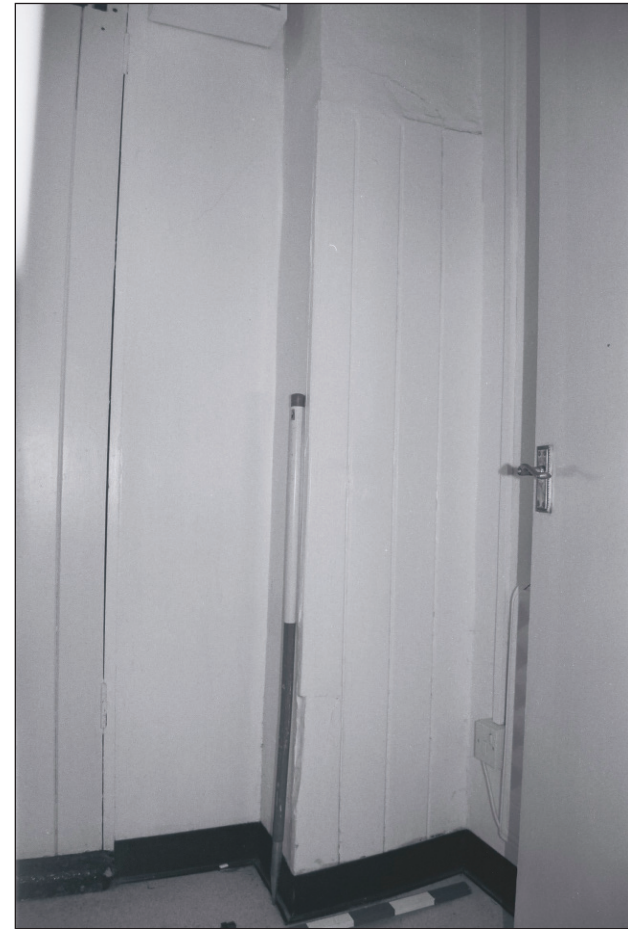
Plate 443: Detail of original tongue and groove match boarding on south wall of G38, South Range (Film 24.29)

- 5.4.31 To the east of the Riding House, was a former corridor which would have led from the stables in the East Range to G30 of the Riding House. This had been divided up into rooms G37-G40 and G42-G43 (**Figure 11**). Rooms G37-G40, were all modern toilets (**Plates 442-447**). A small section of original timber tongue and groove match boarding had been retained on the south wall of G38 (**Plate 443**).

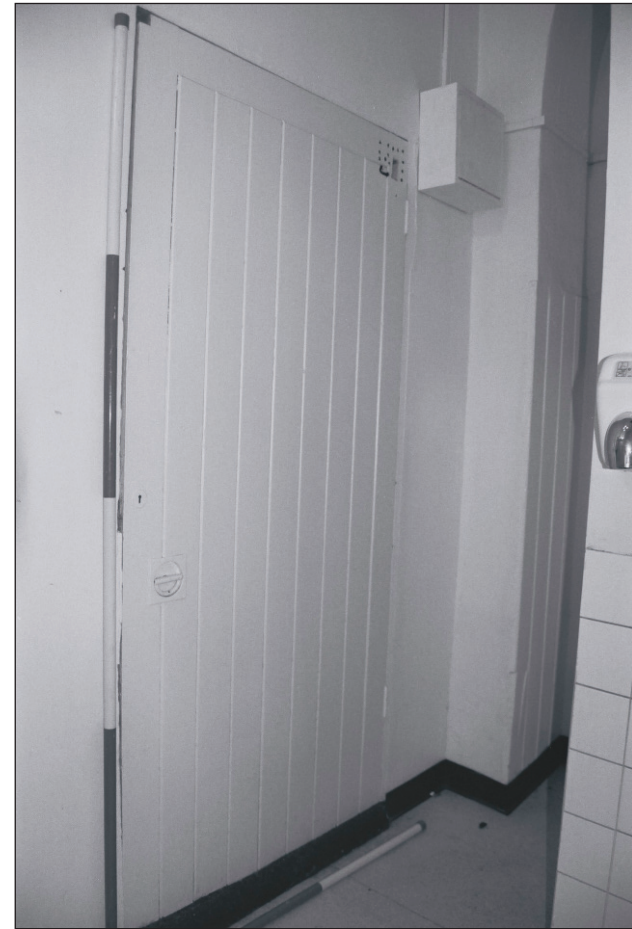
Plate 445: View of doorway in south wall of G38, leading to G36, South Range (Film 24.30)

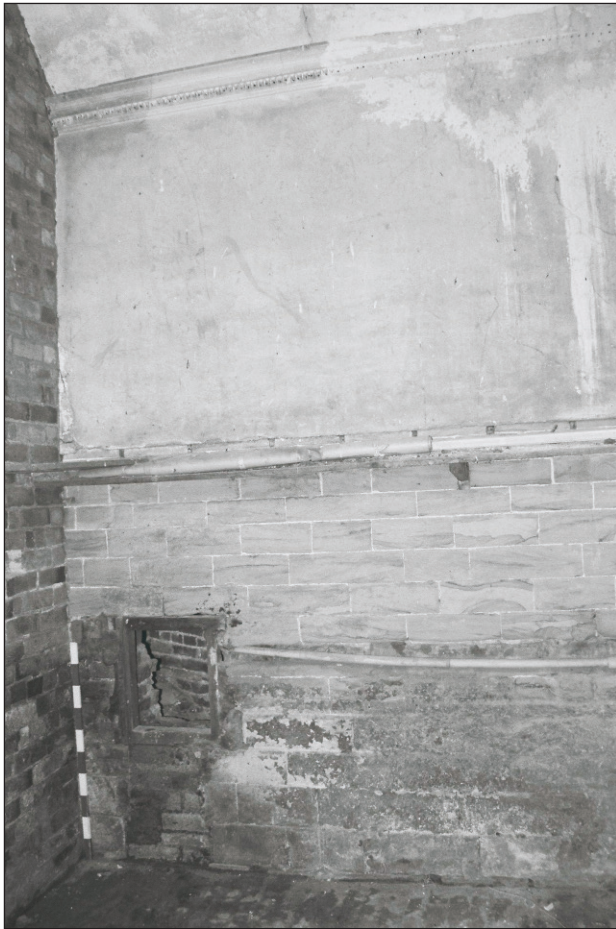
Plate 448: General view of G42, South Range, showing small inserted opening within the south wall - OB. 45 (Film 71.36)

- 5.4.32 Room G42 (**Plates 448-449**), to the east of the modern toilets was a small square room, used as a store, with inserted doorway in the north wall leading from the courtyard (**Plate 450**). This section of the former corridor was the only surviving part which had retained the original plastered upper walls, plastered arched ceiling, and moulded dentil cornice (**Plates 448-455**). Both the east and west walls were inserted brick partitions. The original timber tongue and groove match boarded lower half of the wall had not survived, revealing a stone constructed south wall, and a brick built north wall (**Plates 448, 450**). The plaster on the upper section of the walls had survived however, along with the arched straw and plaster ceiling (**Plates 454-455**) and moulded cornice with dentil detailing (**Plates 452-453**). To the north was an inserted double door, above which is a primary tripartite arched window (**Plate 450**), and the floor had retained its primary brick surface (**Plate 451**).

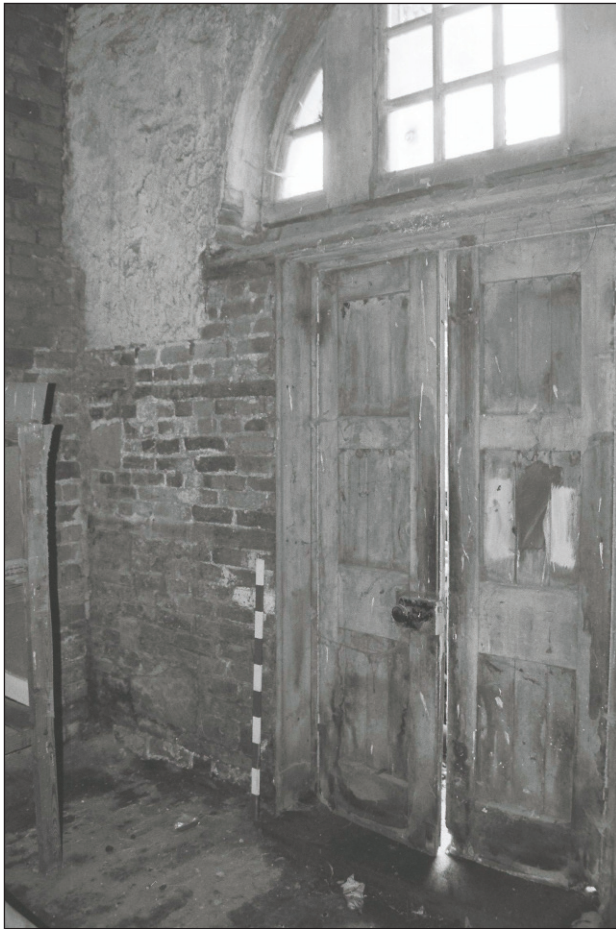
Plate 450: General view of G42, South Range, showing inserted doorway and primary window in north wall (Film 71.32)

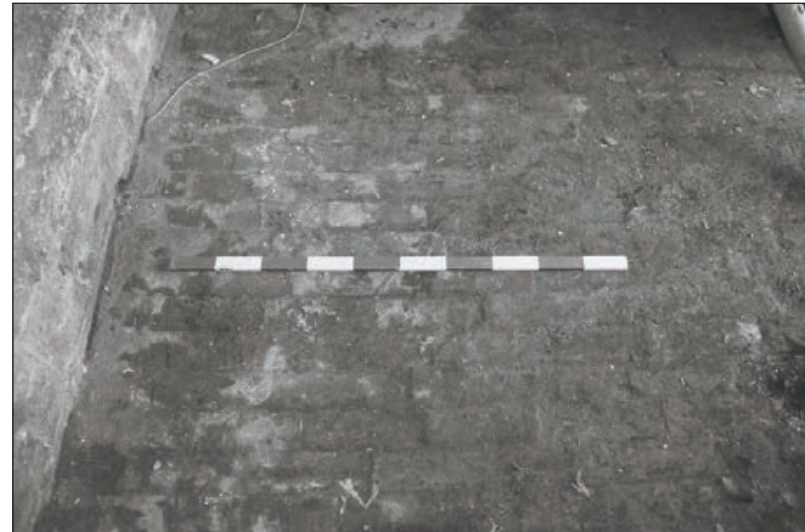
Plate 451: Detail of original brick floor of G42, South Range (Film 71.24)

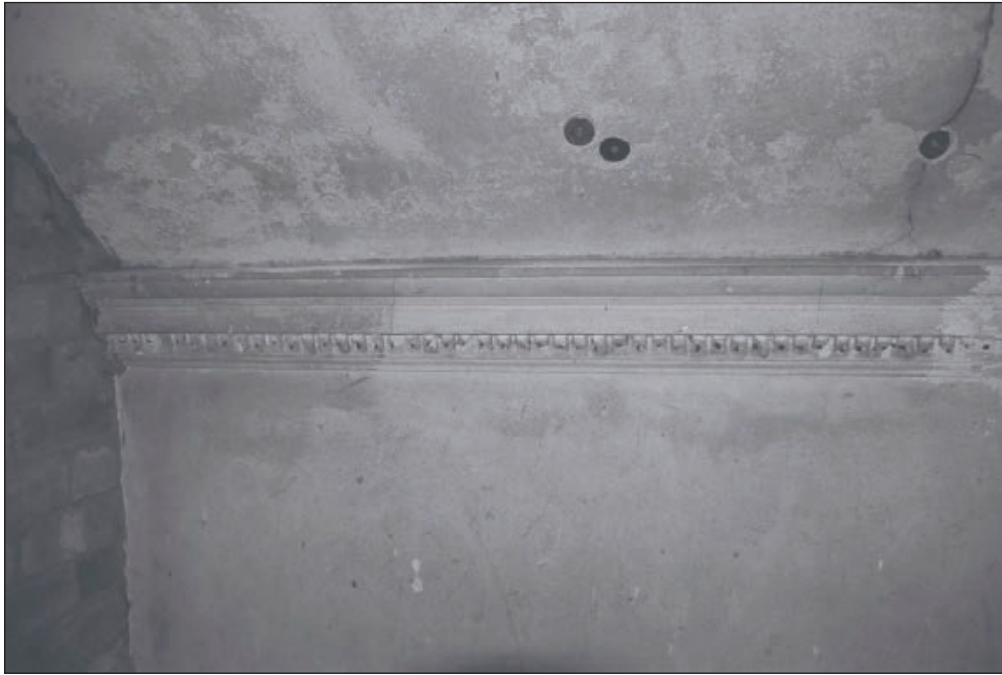
Plate 452: Detail of original plaster and cornice, G42, South Range (Film 74.36)

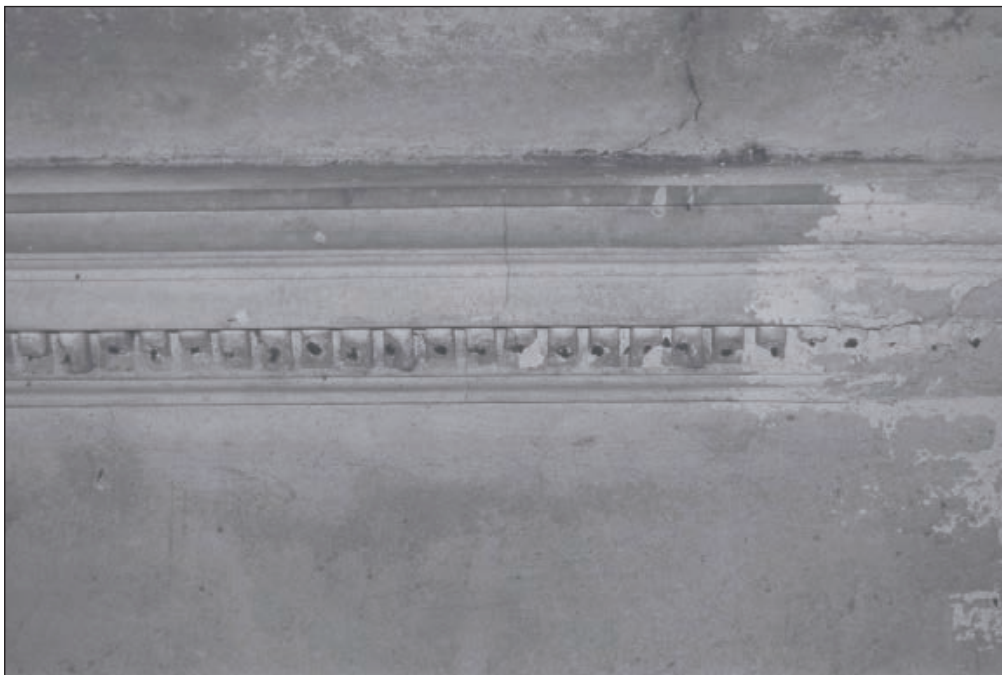
Plate 453: Detail of original cornice, G42, South Range (Film 74.33)

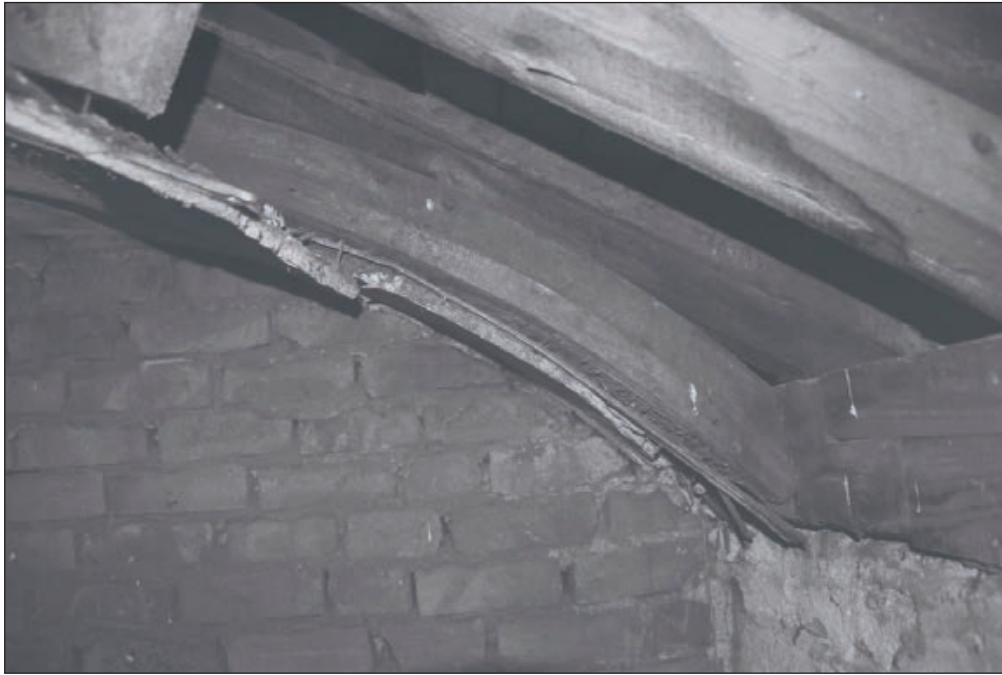
Plate 454: Detail of original ceiling construction, G42, South Range - OB. 97 (Film 74.31)

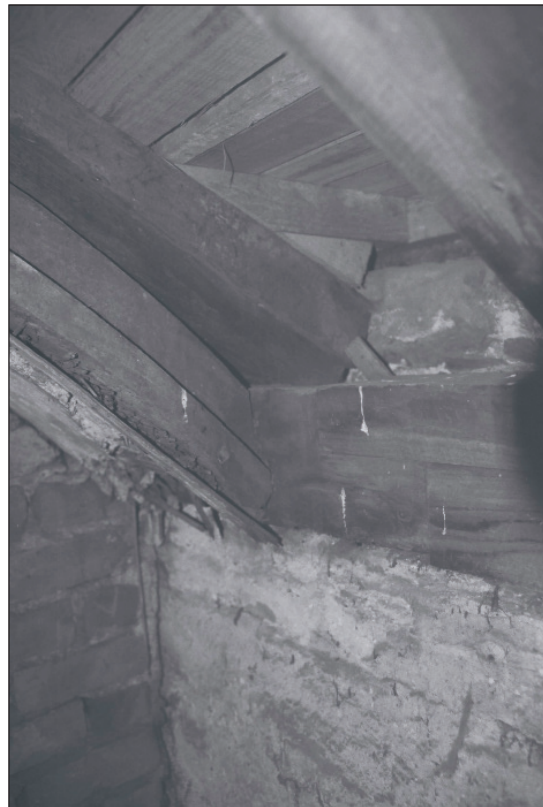
Plate 455: Detail of original ceiling construction, G42, South Range - OB. 97 (Film 74.30)

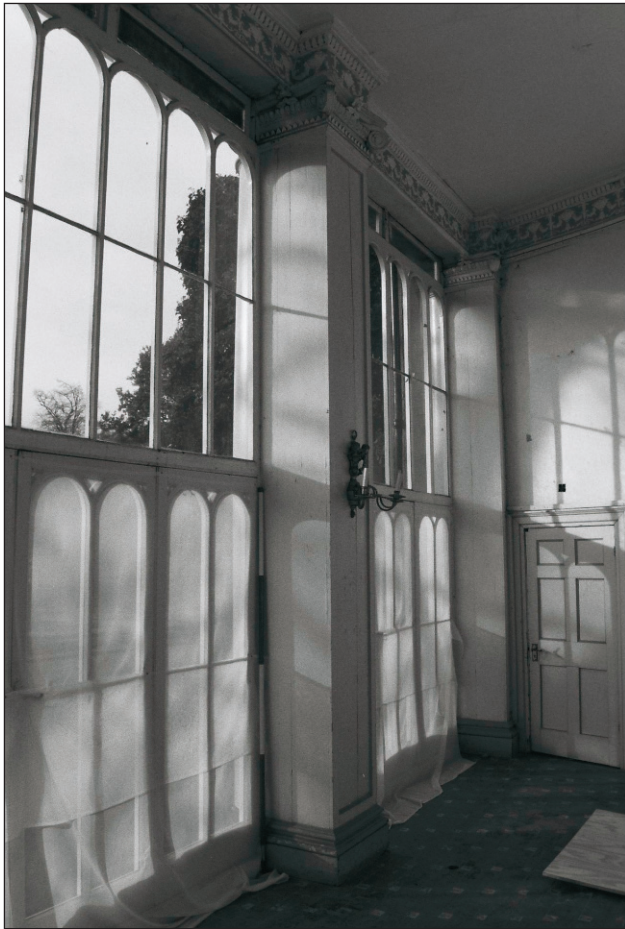
Plate 458: General view of windows, G41, South Range (Film 13.20)

456-457). The large windows were a secondary replacement (**Plate 458**), whilst the floor was a modern tile covering. To the west were two inserted doors, one to G30 (**Plate 459**), and another with G36. To the east was a primary doorway leading to G47. The ceiling contained an inserted skylight alongside an original plaster ceiling rose (**Plate 460, 465**) and the curved north wall had retained high deep moulded skirting and moulded dado rail (**Plate 461**) and the original cornice has been retained throughout (**Plates 462-464**). The refurbishment works required the removal of the skirting and timber surrounds of the columns of the south wall. This exposed the brick cores of the columns (**Plates 466, 467**), with some showing evidence of crude alterations (**Plate 468**). The removed timber surrounds were made up from long, wide timber boards which had been pegged and hinged together (**Plates 469, 470**), along with deep moulded plinth base surrounds (**Plate 471**). Also revealed during the works, within the floor of the door reveal between G41 and G47, was original coloured tessellated tiles (**Plate 472**).

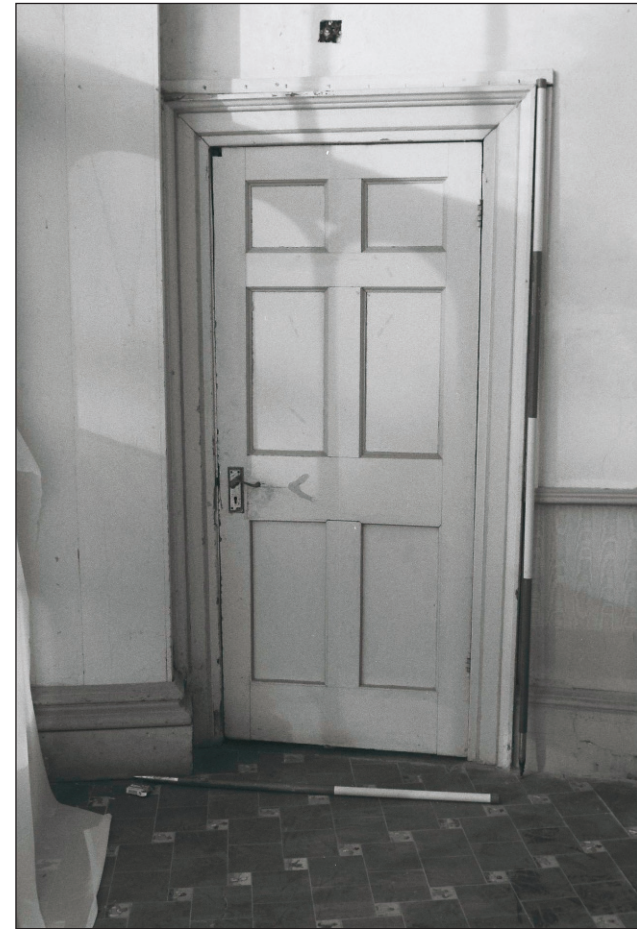
Plate 459: View of inserted door, west side of G41, South Range (Film 13.16)

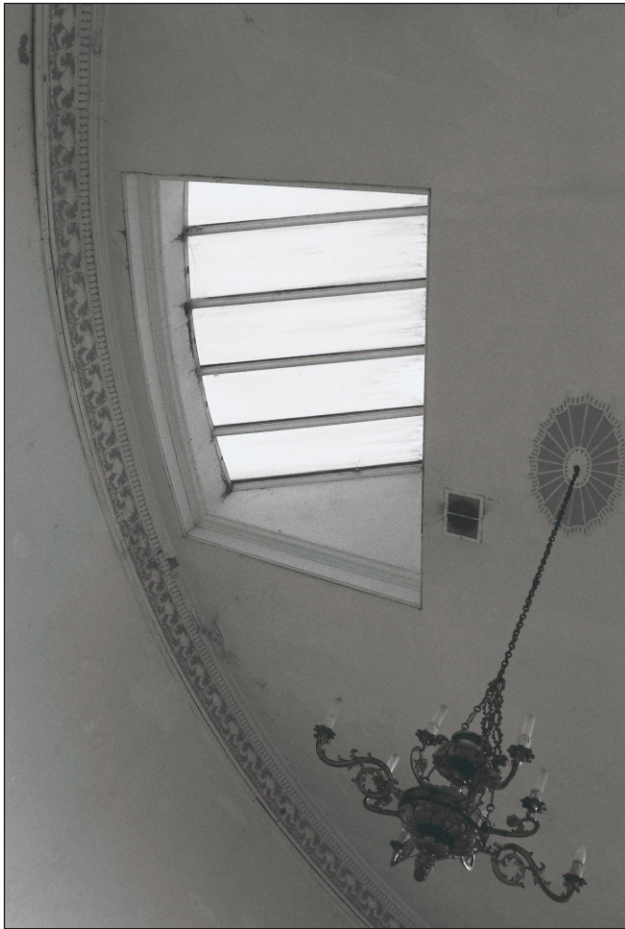
Plate 460: View of inserted skylight, ceiling of G41, South Range (Film 13.29)

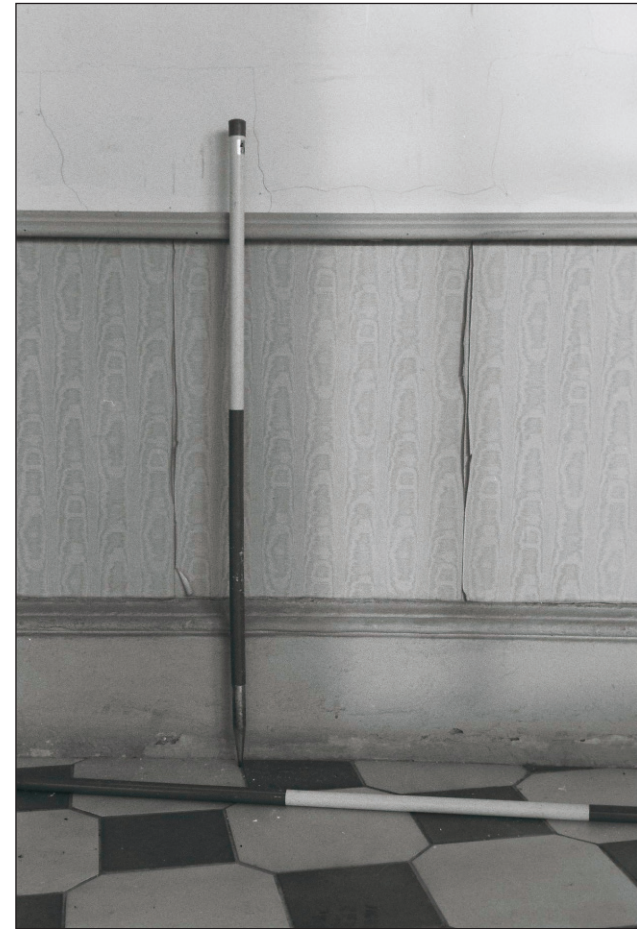
Plate 461: View of high skirting and dado rail, G41, South Range (Film 13.33)

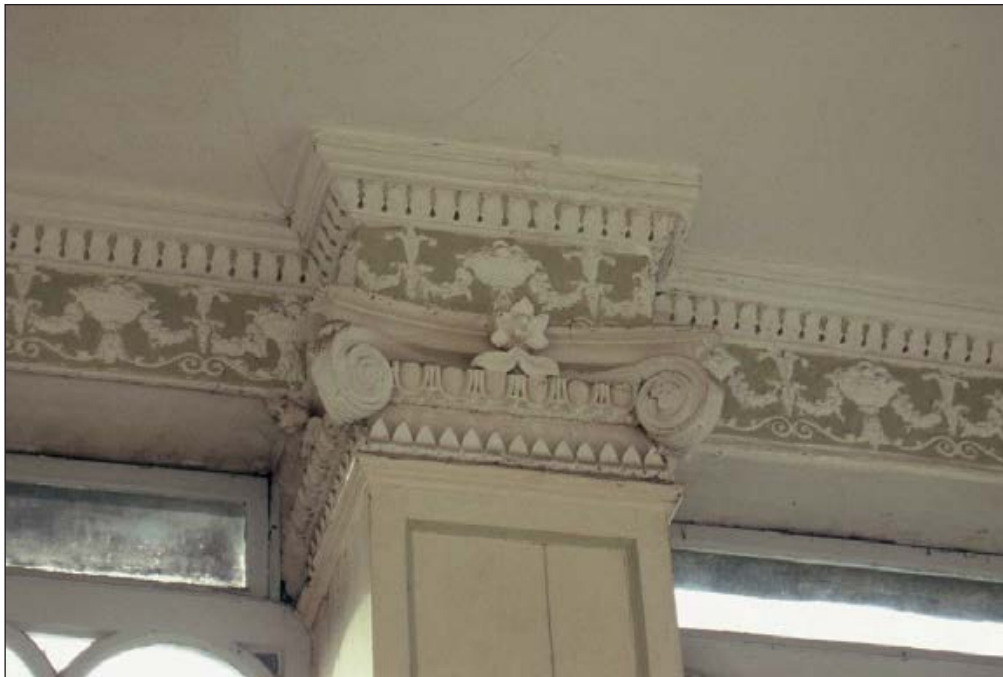
Plate 462: Detail of original cornice and column head, G41, South Range (Film C.S. 6.)

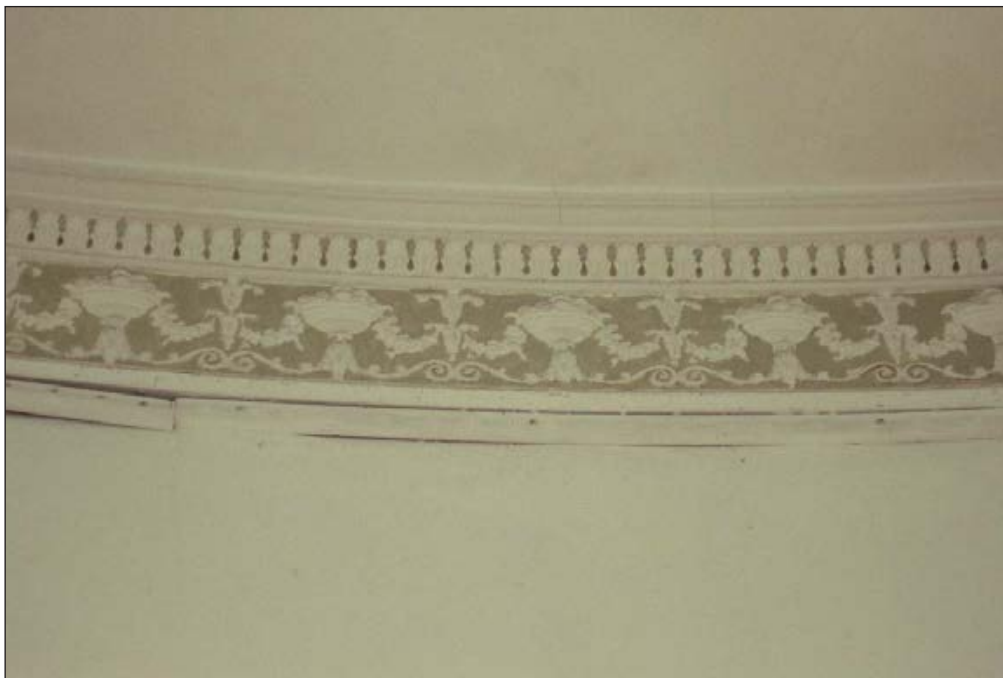
Plate 463: Detail of original cornice, G41, South Range (Film C.S. 7.)

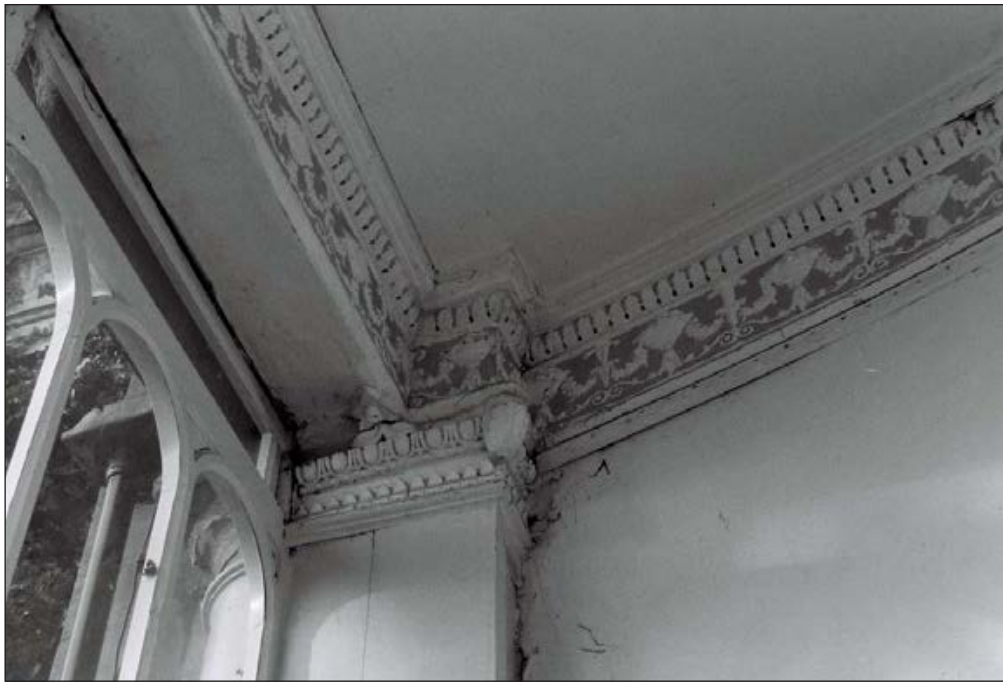
Plate 464: Detail of original cornice and column head, G41, South Range (Film 13.19)

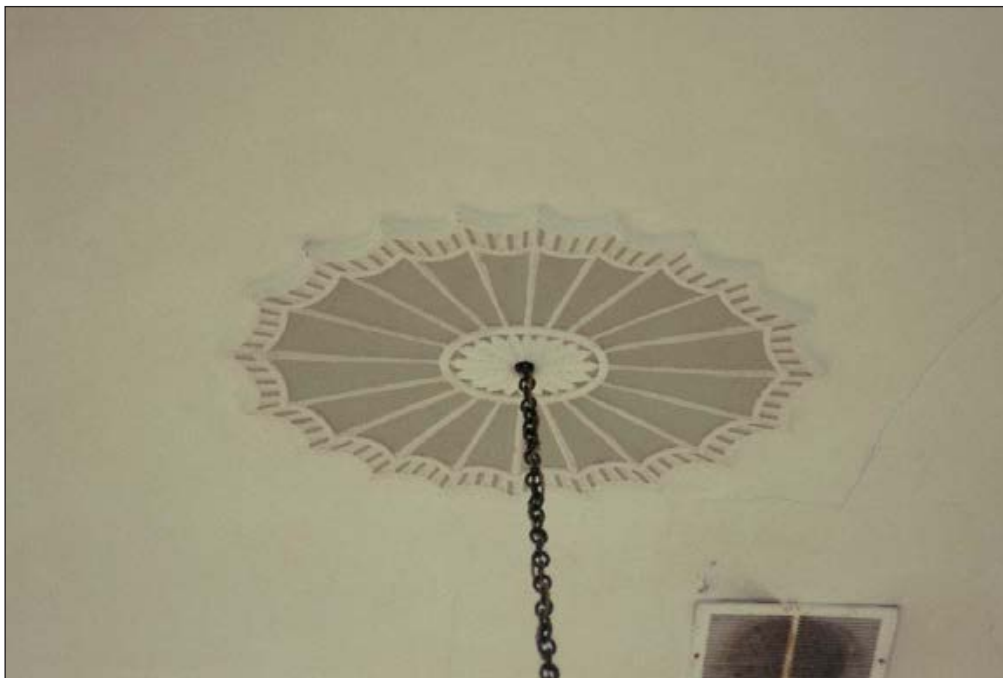
Plate 465: Detail of original ceiling rose, G41, South Range (Film C.S. 8.)

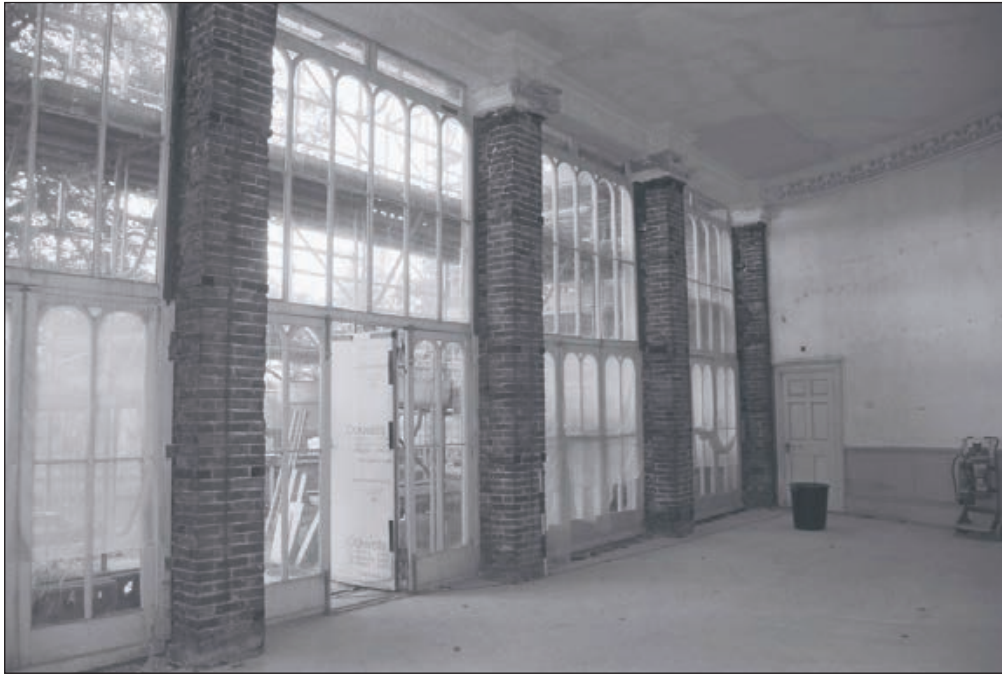
Plate 466: General view of G41, South Range, after removal of timber column surrounds - OB. 106 (Film 74.17)

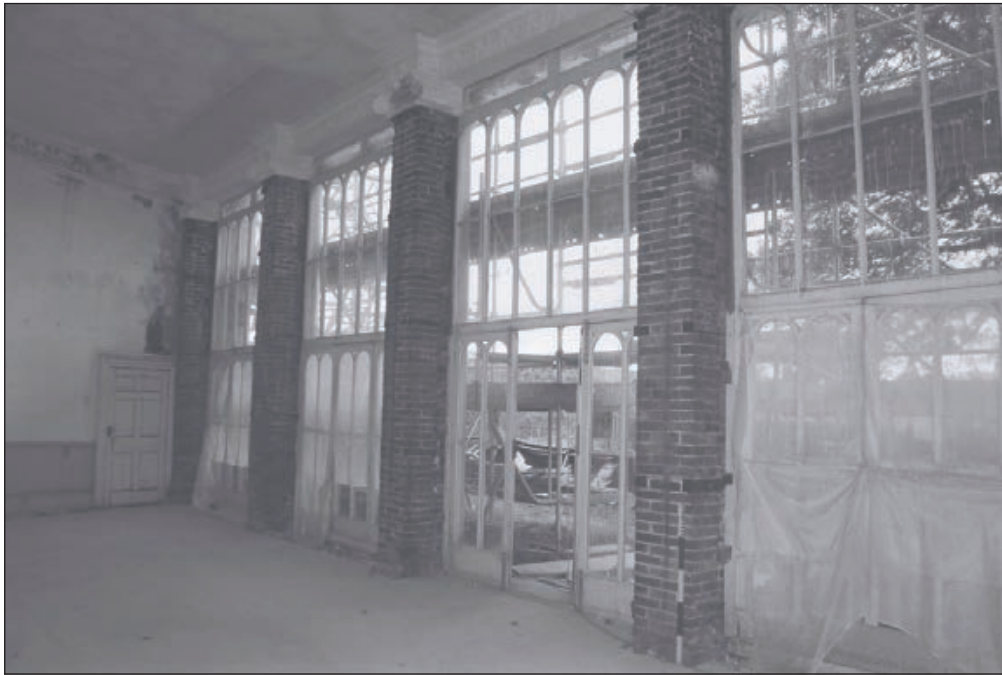
Plate 467: General view of G41, South Range, after removal of timber column surrounds - OB. 106 (Film 74.20)

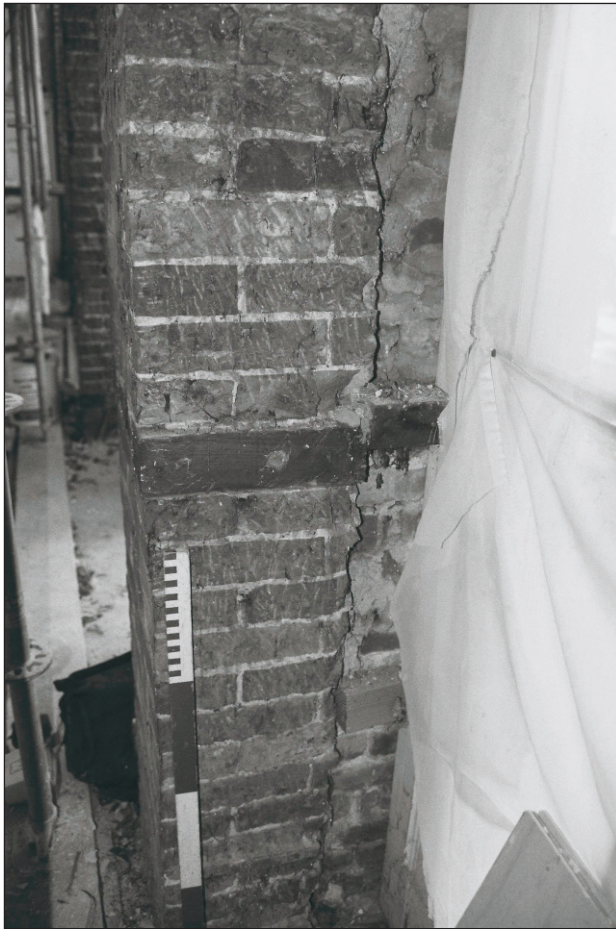
Plate 468: Detail of cut brick of columns, G41, South Range - OB. 106 (Film 73.23)

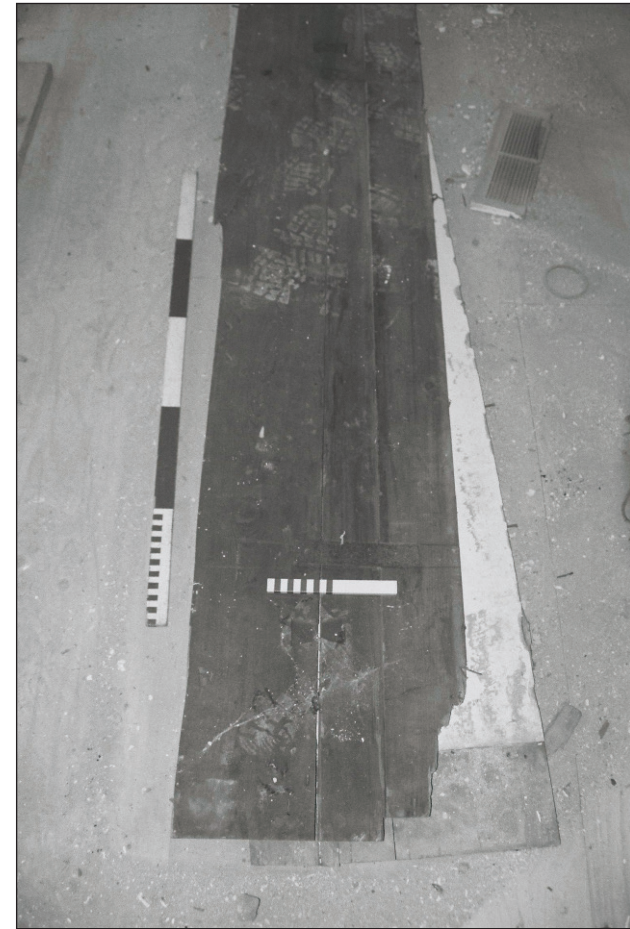
Plate 469: Detail of removed timber panelling of columns, G41, South Range - OB. 106 (Film 73.36)

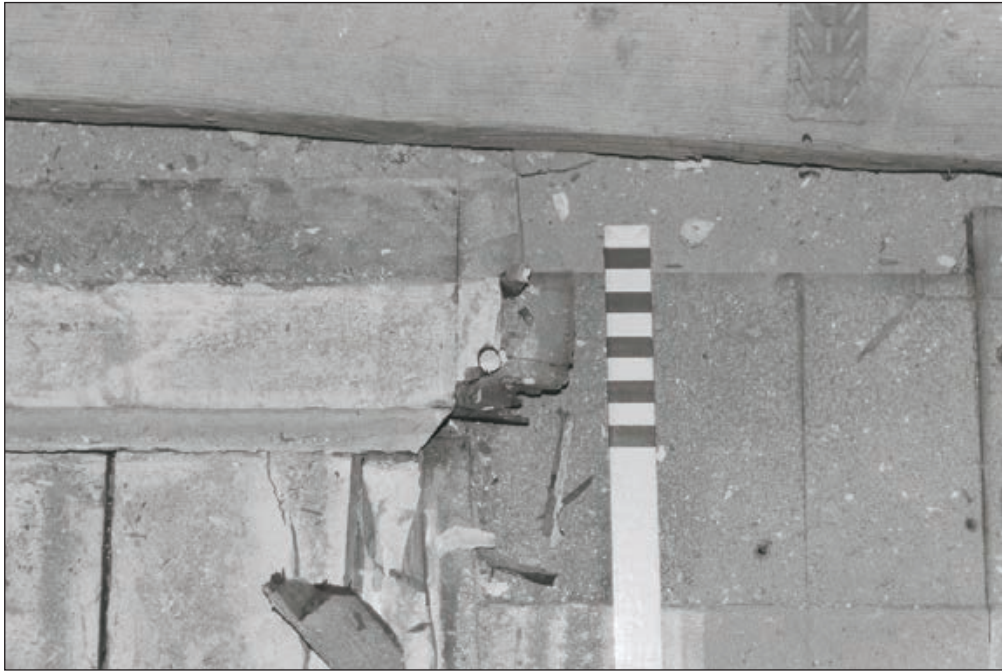
Plate 470: Detail of timber pegged joints of removed column panelling, G41, South Range - OB. 106 (Film 73.30)
