NOSTELL PRIORY STABLES, NOSTELL, WAKEFIELD, WEST YORKSHIRE

Historic Building Recording and Structural Watching Brief

Planning Application Ref: 09/00701/FUL & 09/00705/LBC

72934.01_BDG_V0_4

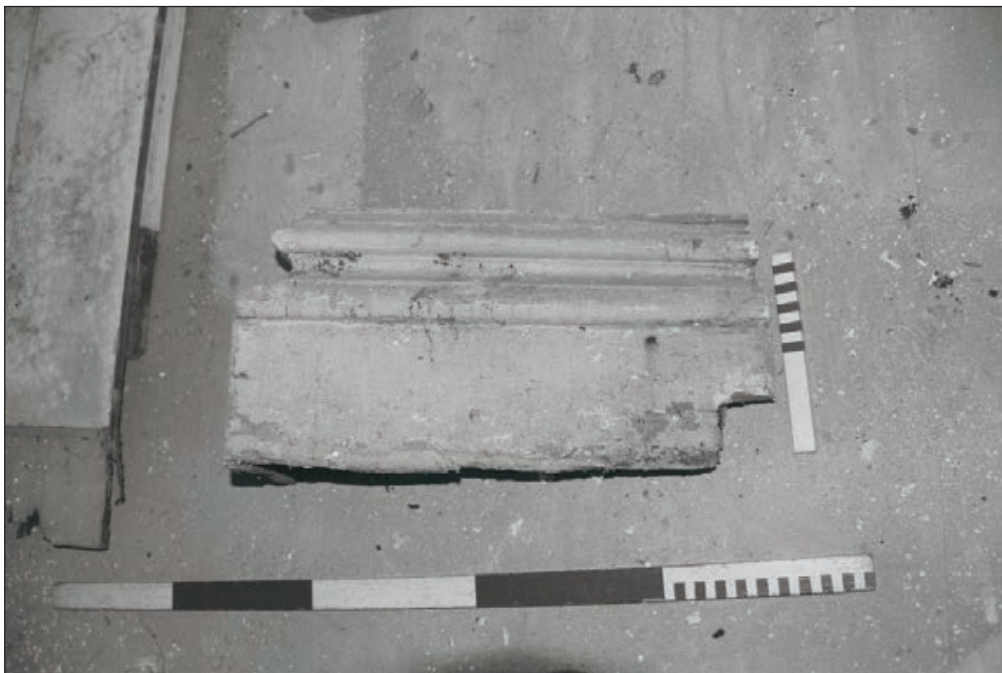
Plate 471: Detail of removed moulded skirting from base of columns, G41, South Range - OB. 106 (Film 73.21)

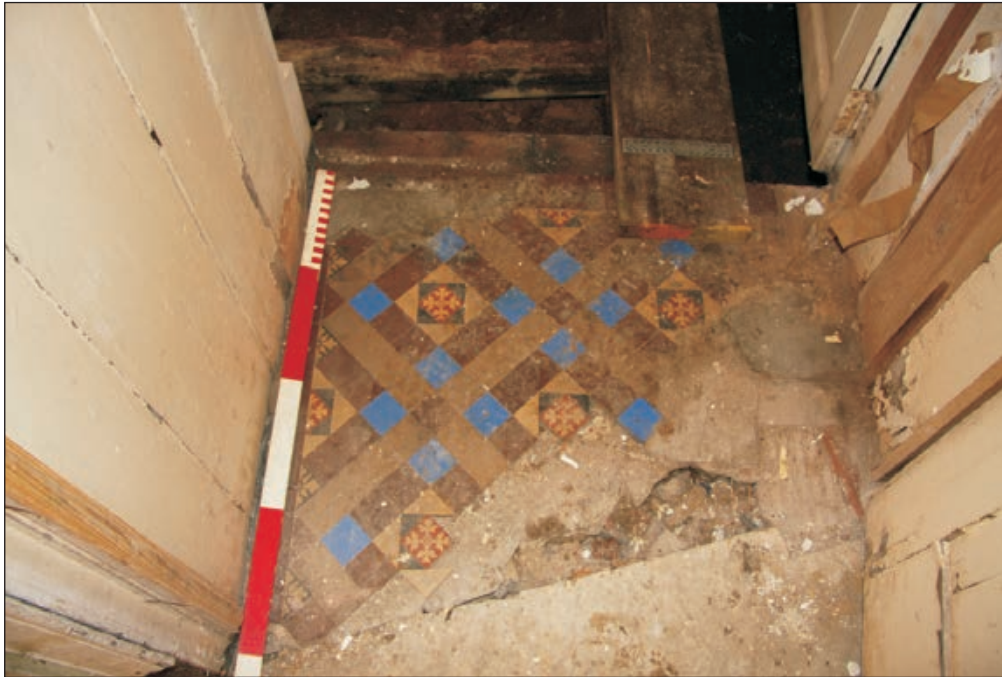
Plate 472: Detail of original colour tiled floor of door reveal between G41 and G47, South Range - OB. 117 (Film D. 04.11.11 5245)

456-457). The large windows were a secondary replacement (**Plate 458**), whilst the floor was a modern tile covering. To the west were two inserted doors, one to G30 (**Plate 459**), and another with G36. To the east was a primary doorway leading to G47. The ceiling contained an inserted skylight alongside an original plaster ceiling rose (**Plate 460, 465**) and the curved north wall had retained high deep moulded skirting and moulded dado rail (**Plate 461**) and the original cornice has been retained throughout (**Plates 462-464**). The refurbishment works required the removal of the skirting and timber surrounds of the columns of the south wall. This exposed the brick cores of the columns (**Plates 466, 467**), with some showing evidence of crude alterations (**Plate 468**). The removed timber surrounds were made up from long, wide timber boards which had been pegged and hinged together (**Plates 469, 470**), along with deep moulded plinth base surrounds (**Plate 471**). Also revealed during the works, within the floor of the door reveal between G41 and G47, was original coloured tessellated tiles (**Plate 472**).

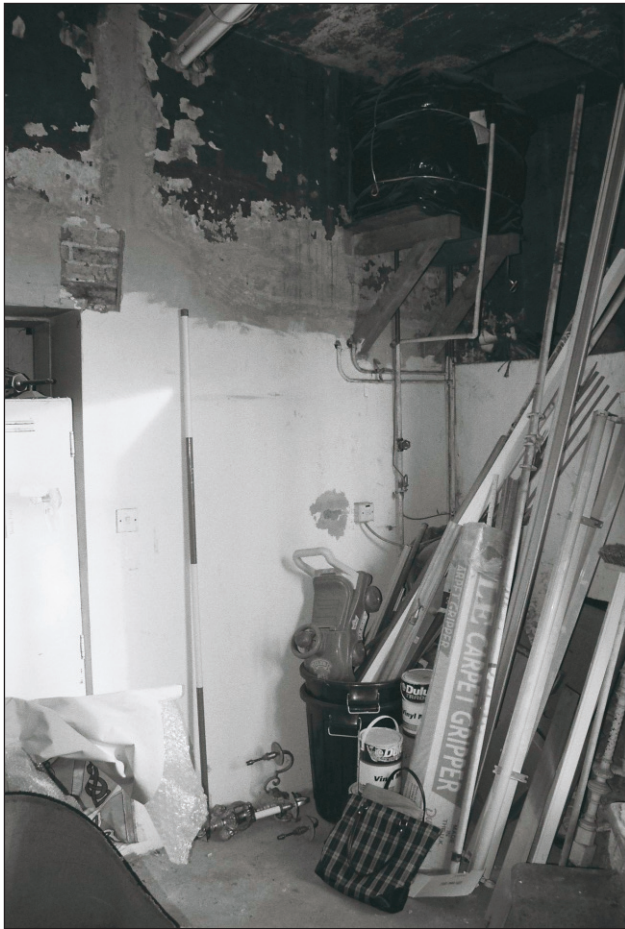
Plate 473: General view of G36, South Range (Film 13.26)

- 5.4.34 To the northwest of G41, accessed via an inserted door within the curved wall of the greenhouse was room G36. This was a triangular room in plan, used as a store room (**Plate 473**) with inserted brick flue in the southwest corner (**Plate 475**). A large opening within the west wall of the structure was observed through a hole in the lath and plaster ceiling of the room (**Plate 474**). This is likely to date to the use of the Range as a grain store in the 1960s. Observations of the roof space above G41 and G36 indicate a timber King-Post roof truss structure, with trenched and pegged timber purlins (**Plate 476**).

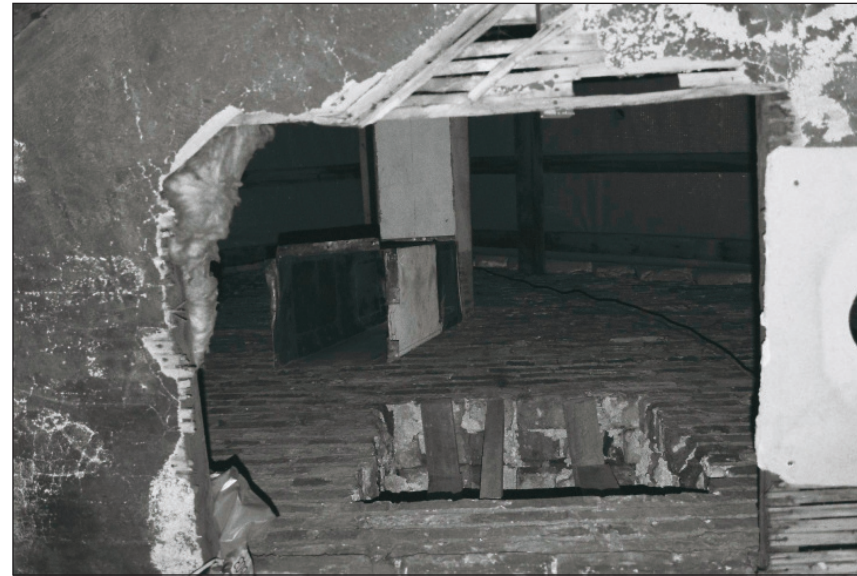
Plate 474: Detail of ceiling construction and inserted opening within west wall, roof void above G36, South Range (Film 13.24)

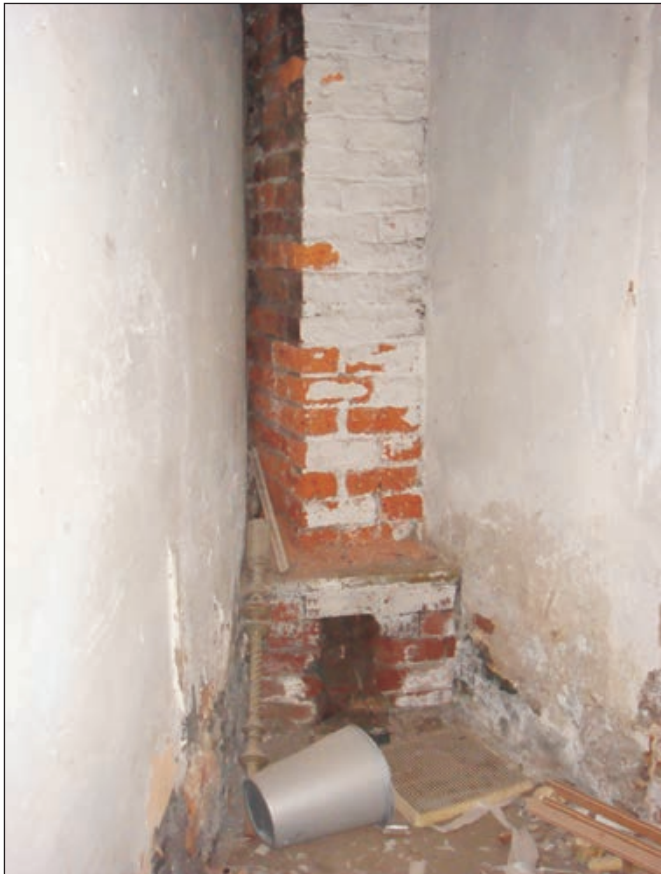
Plate 475: View of inserted brick flue within the south corner of G36, South Range - OB. 60 (Film D. 05.05.10 05166)

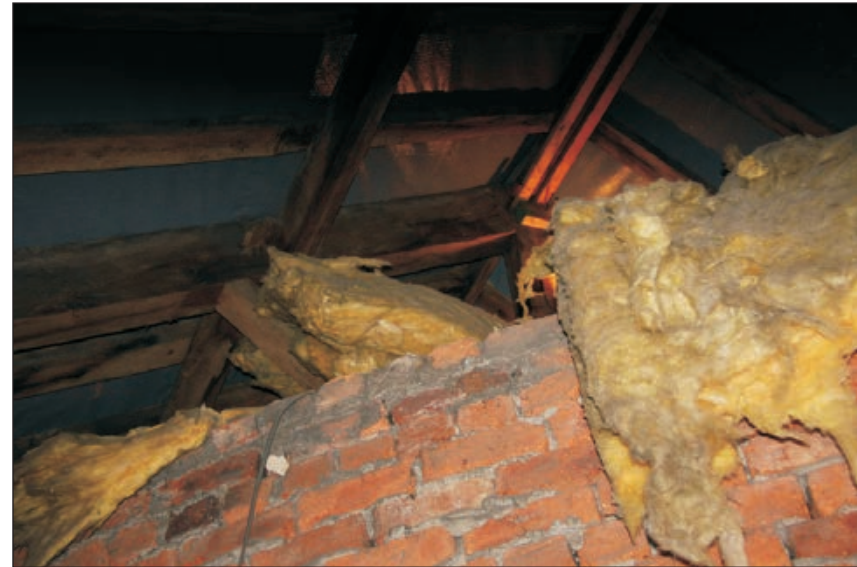
Plate 476: View of curved brick wall and timber King-Post roof trusses above, from roof void above G36, South Range - OB. 111 (Film D. 21.10.11 5051)

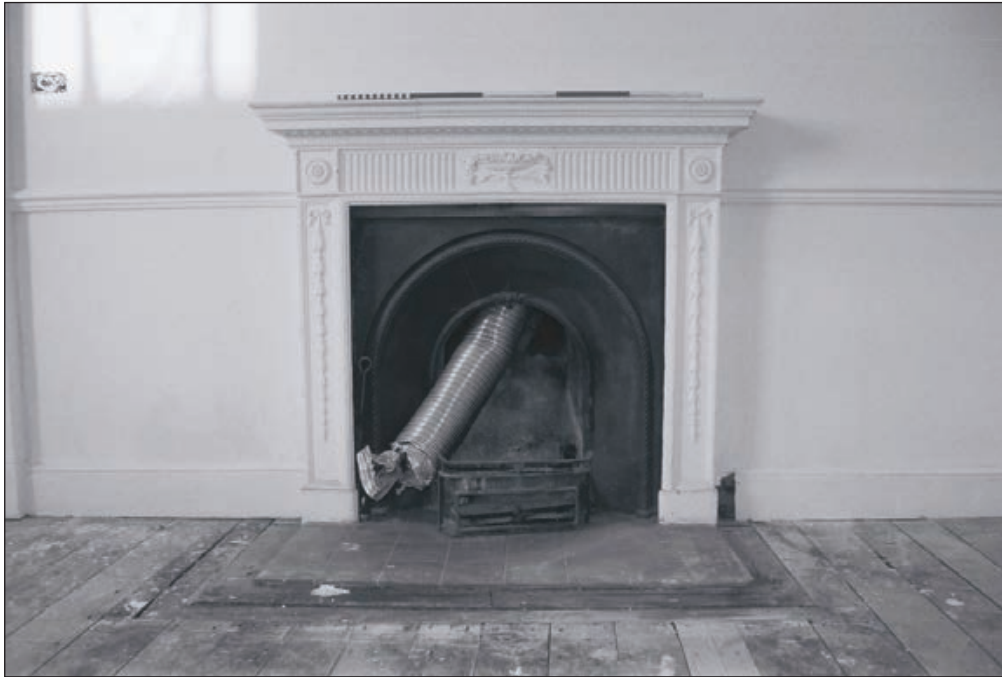
Plate 479: Detail of fireplace, west wall of G47, South Range - Agent's House (Film 77.35)

- 5.4.36 Room G47 (**Plates 477-478**), located at the southeast corner of the range, was a square room, accessed from G41 to the west and G48 to the north. The room contained a phase 3 doorway at the south end of the west wall and central cast iron fireplace (**Plates 478, 479**). Within the south wall was a large venetian window. The north wall of the room is phase 5 in date with a contemporary doorway (**Plates 477, 480-481**). The timber floor boards were lifted exposing a timber joist floor, carried on small brick plinths (**Plate 482**). The joists were nearly all reused beams, with decorative chamfers and stops (**Plate 483**). Visible below the floor line at the north end of the west wall was a possible brick blocking (**Plate 484**). The central light of the venetian window within the south wall was removed, exposing the sash box and weights (**Plates 485-486**).

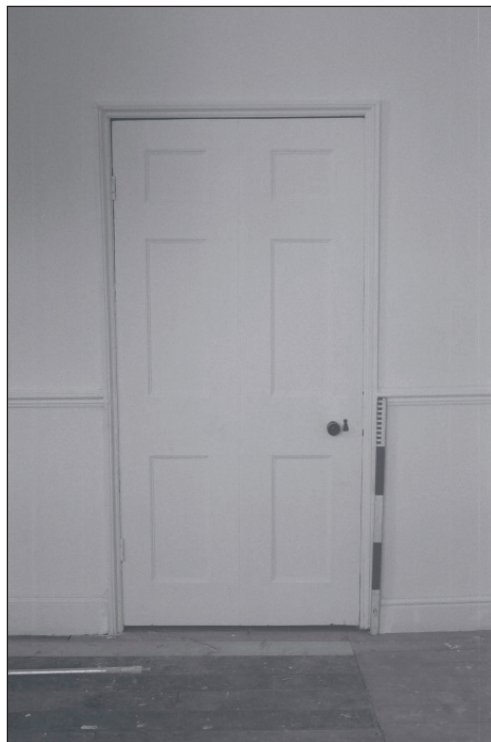
Plate 480: Detail of doorway to corridor G48, north wall of G47, South Range - Agent's House (Film 77.30)

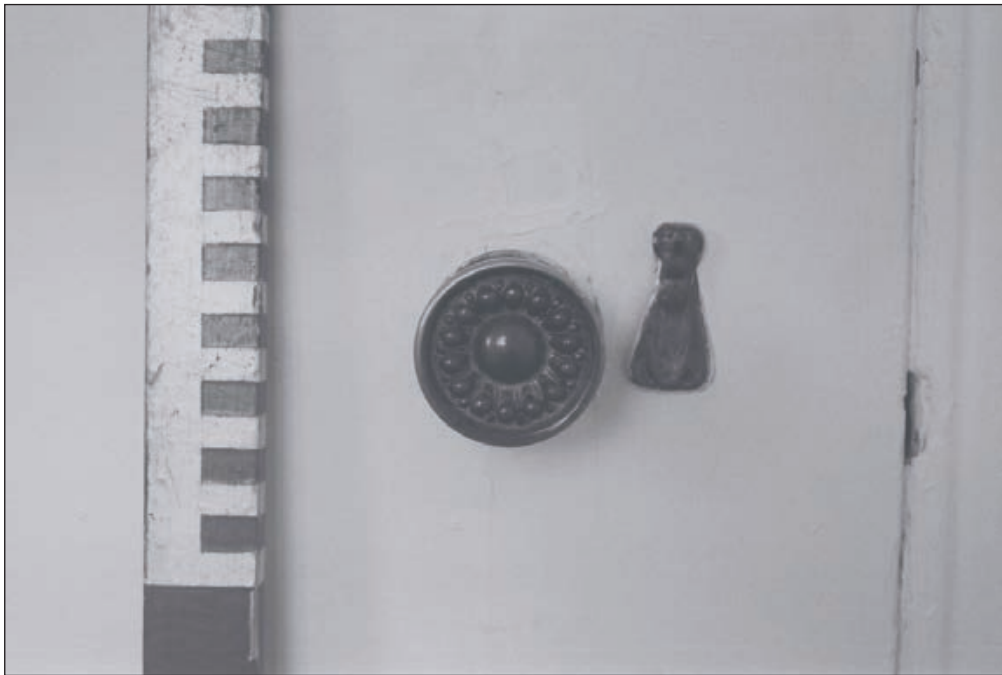
Plate 481: Detail of door furniture of door in north wall of G47, South Range - Agent's House (Film 77.25)

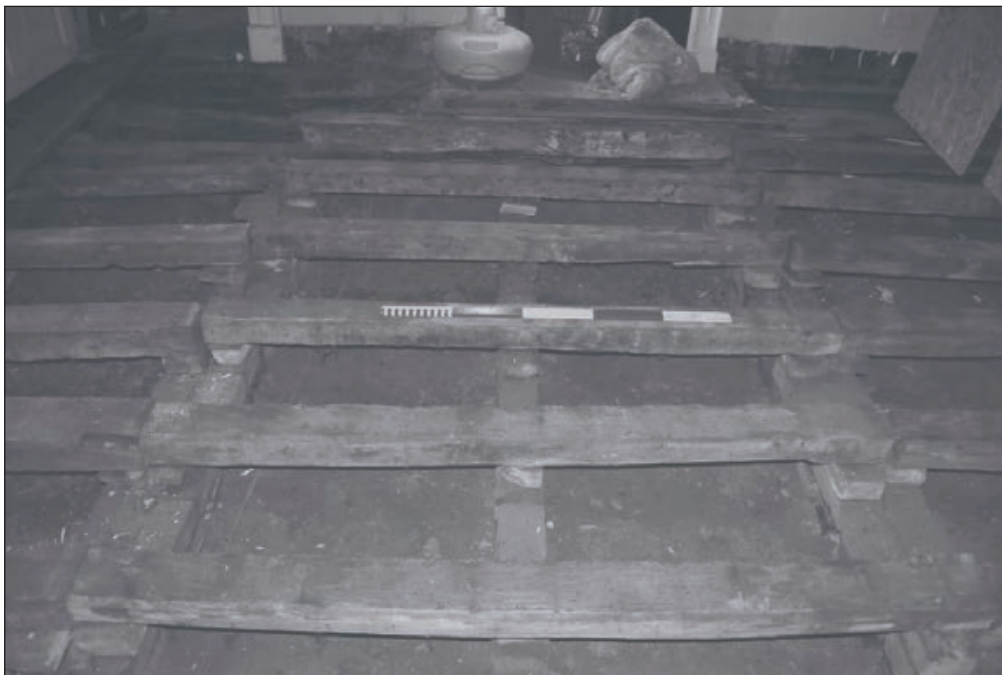
Plate 482: General view of exposed floor structure, G47, South Range - Agent's House - OB. 118 (Film 75.12)

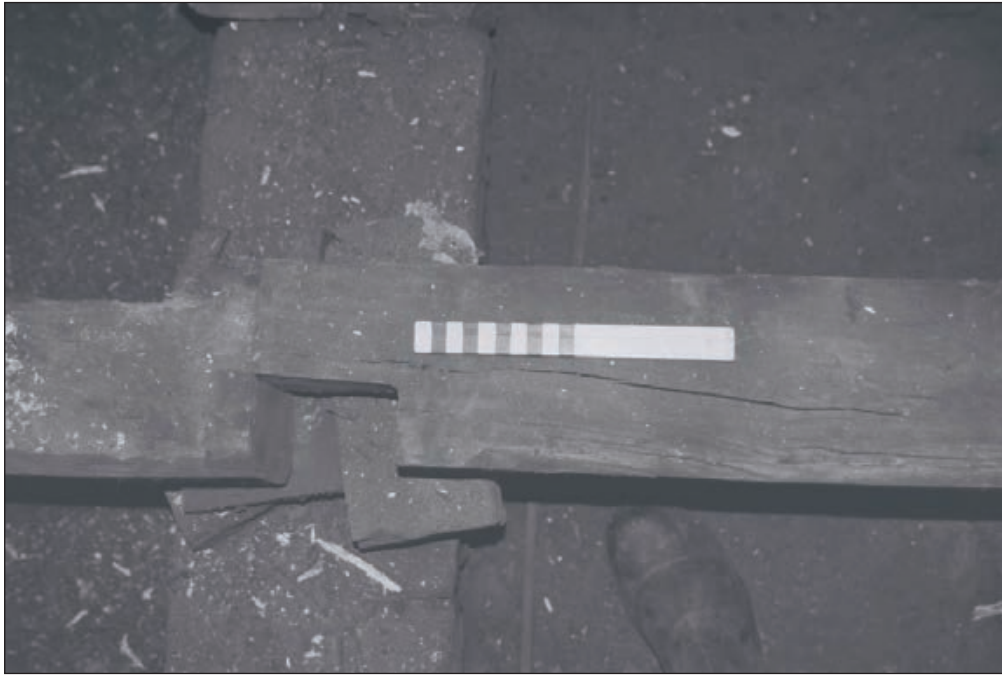
Plate 483: Detail of reused timber beam as floor joist, G47, South Range - Agent's House - OB.118, showing chamfer and stop (Film 75.10)

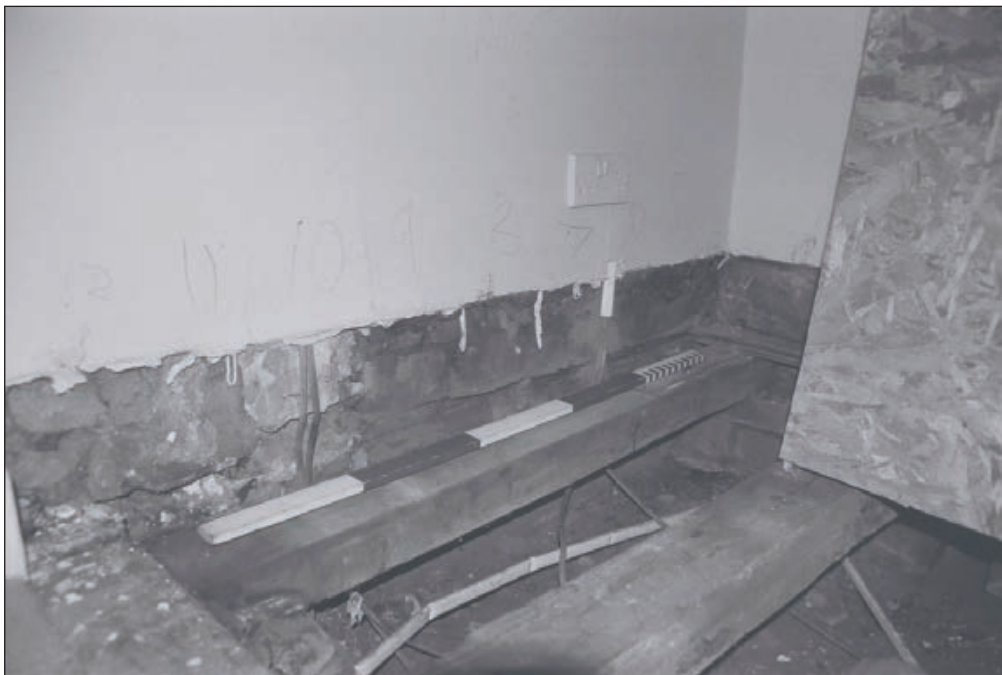
Plate 484: Detail of probable blocking within the west wall of G47, South Range - Agent's House - OB. 118 (Film 75.07)

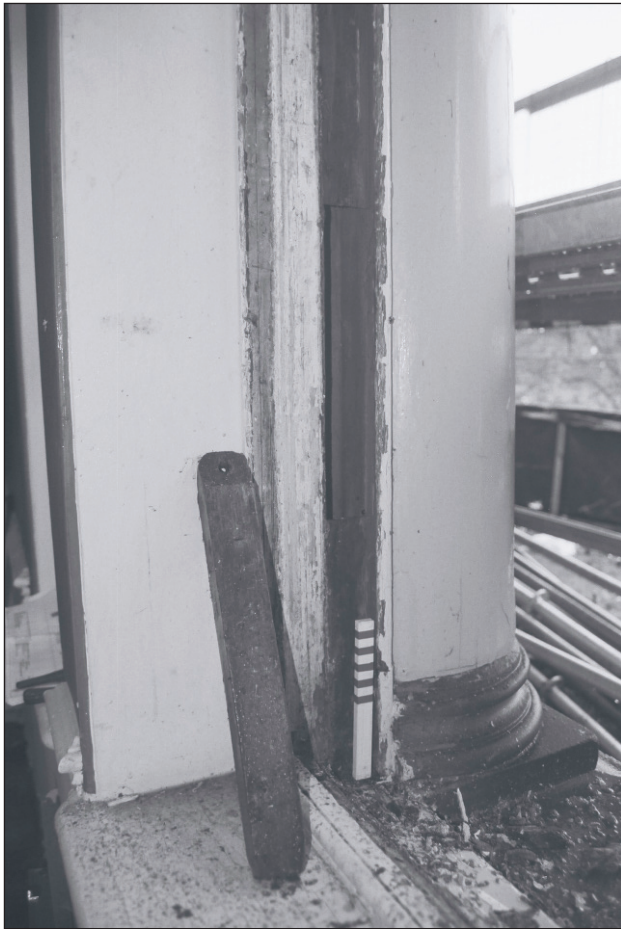
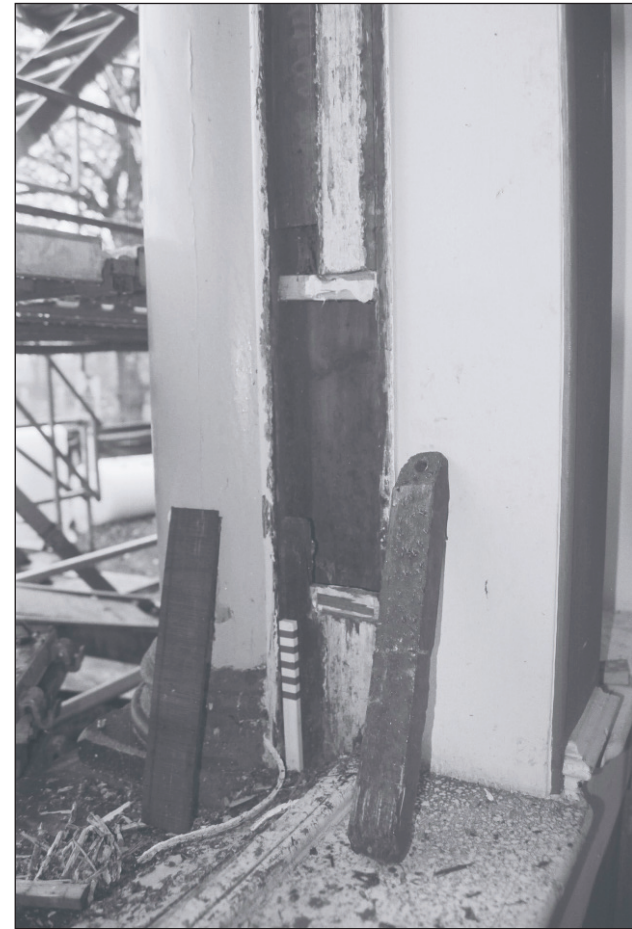
Plate 485: Detail of timber sash window with weight, G47, South Range - Agent's House - OB. 118 (Film 75.05)

Plate 486: Detail of timber sash window with weight, G47, South Range - Agent's House - OB. 118 (Film 75.02)

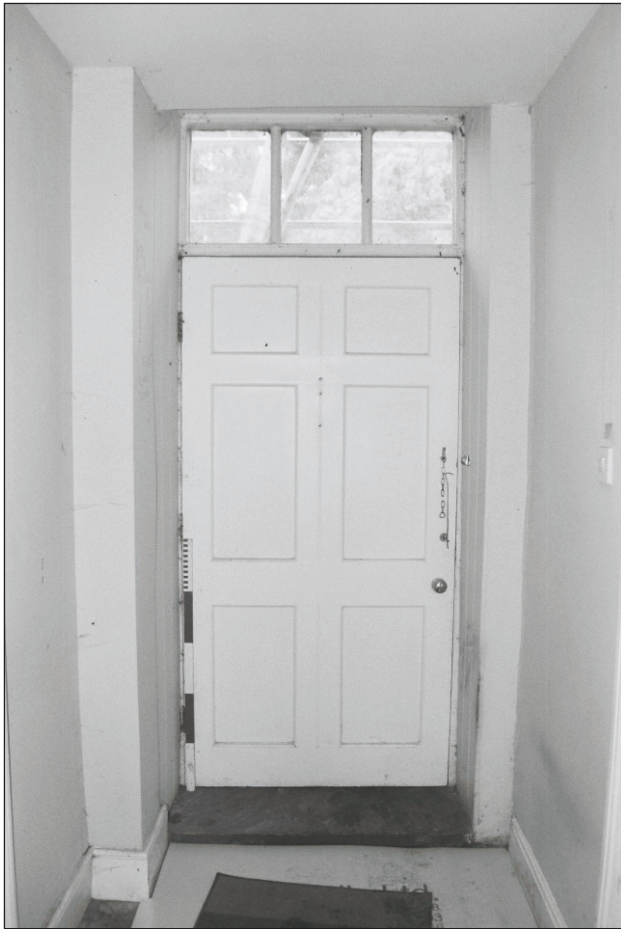
Plate 489: Detail of east entrance with timber panelled door and overlight, G48, South Range - Agent's House (Film 65.20)

- 5.4.37 To the north was corridor G48 (**Plates 487, 488**). This corridor was created during phase 5, and contained a separate main entrance to the Agent's House to the east (**Figure 11**). This entrance had a timber panelled door with rectangular fanlight (**Plates 488, 489**). The corridor had two doorways leading off to the north (G49 and G50), one to the south (G47) and one at the west end leading to G45. The floor had a stone flag covering, whilst the ceiling was a modern insert (**Plates 487, 488**). This modern ceiling was removed revealing a high phase 3 lath and plaster ceiling with moulded cornice (**Plate 490**).

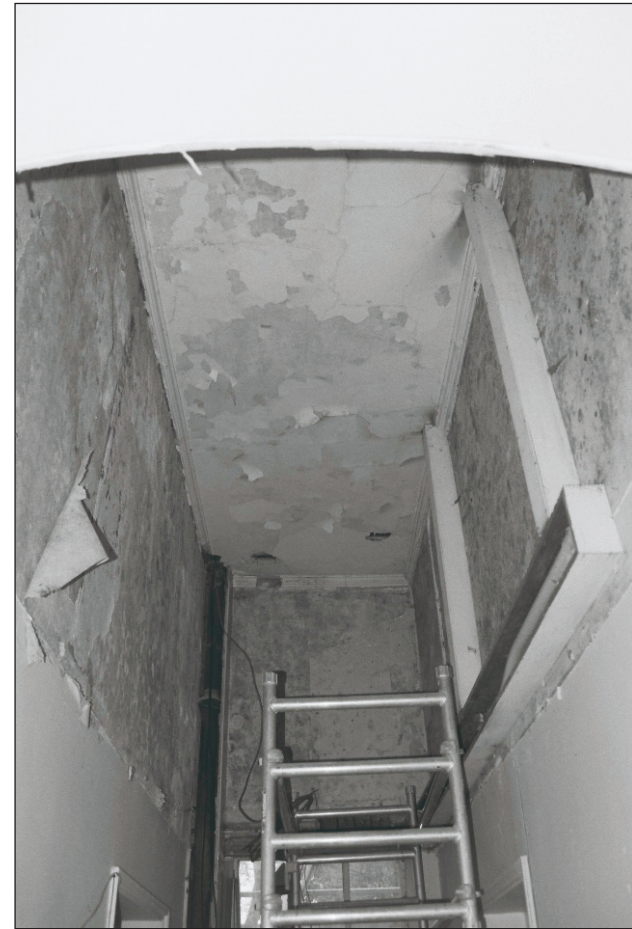
Plate 490: View of original ceiling after removal of modern insert, G48, South Range - Agents House (Film 70.33)

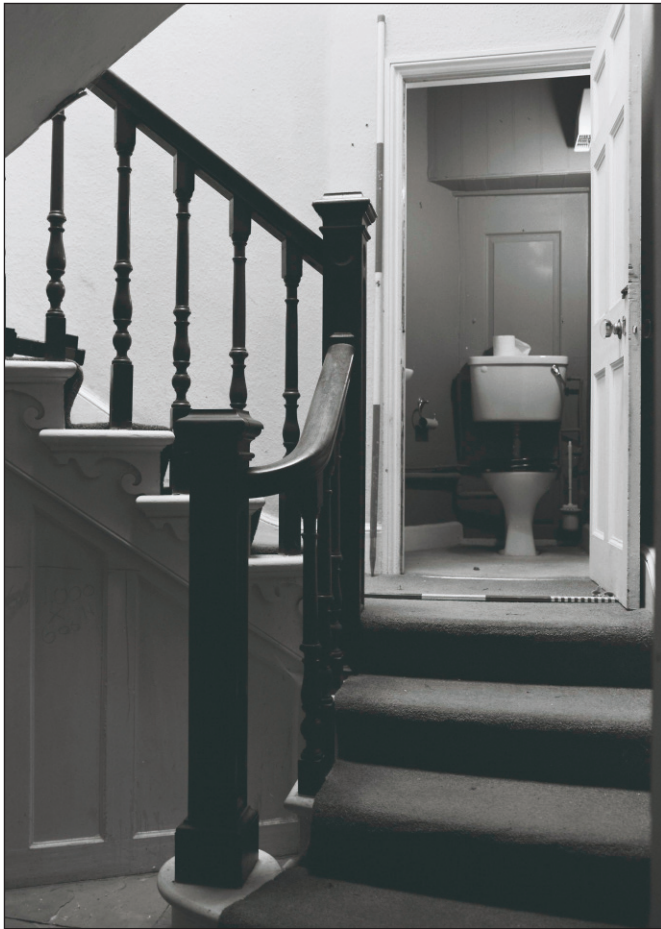
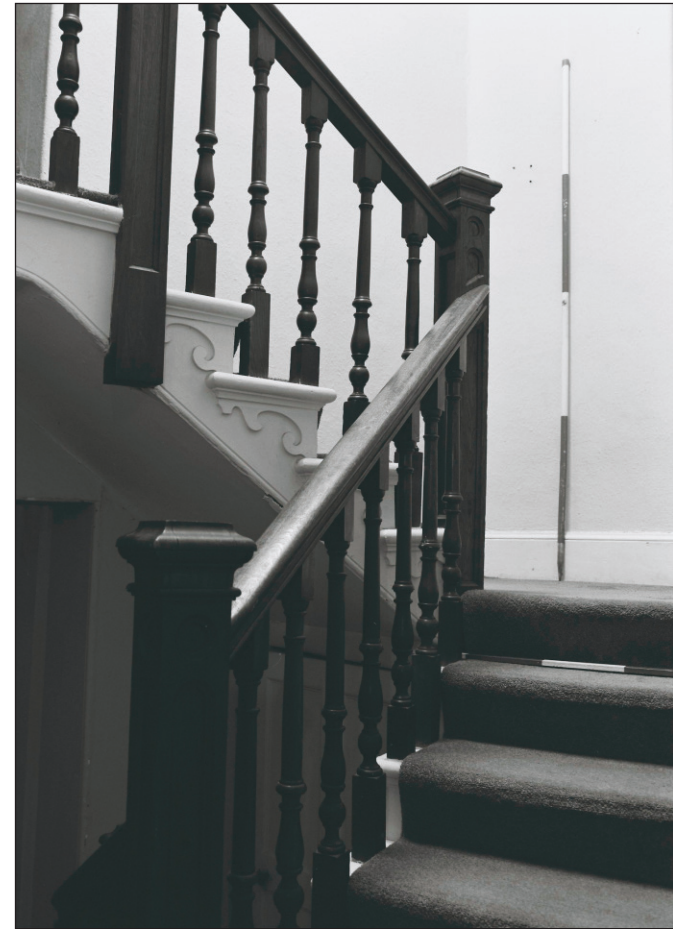
Plate 491: General view of staircase G45, South Range - Agent's House, with G44 beyond (Film 61.05)

Plate 492: View of staircase G45, South Range - Agent's House (Film 61.10)

- 5.4.38 To the west was G45, a small hallway with irregular shaped staircase leading up to the first floor (F34). This staircase dated to phase 5, although the balustrade may be later, appearing to be more early 20th-century in date (**Plates 491-494**). To the south, beneath the staircase was a small cupboard, G46 (**Plate 495**). This had a stone flagged floor and shelving attached to the walls. A small w.c was positioned to the west of G45, at half landing, creating room G44 (**Plate 496**).

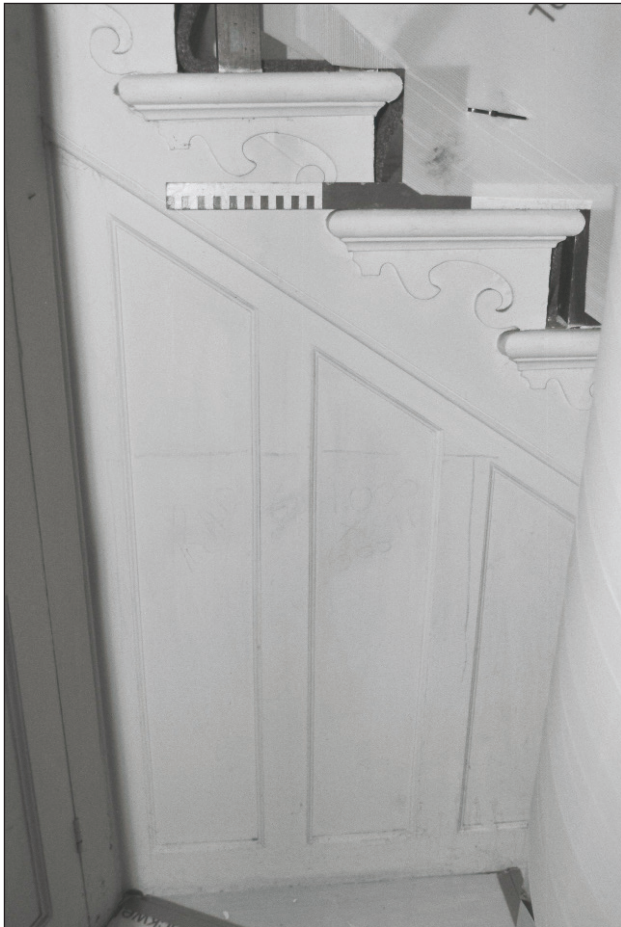
Plate 493: Detail of decorative panels and stair-ends of staircase, G45, South Range - Agent's House (Film 65.16)

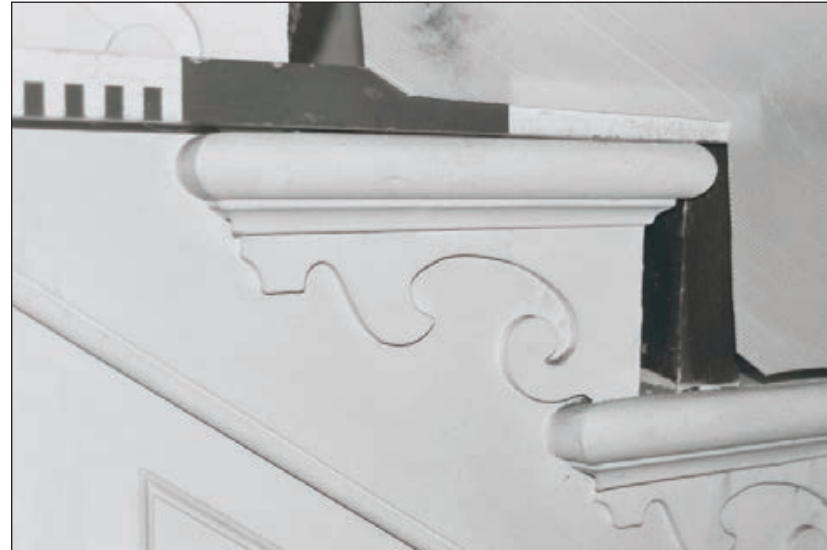
Plate 494: Detail of moulded stair ends, G45, South Range, Agent's House (Film 65.17)

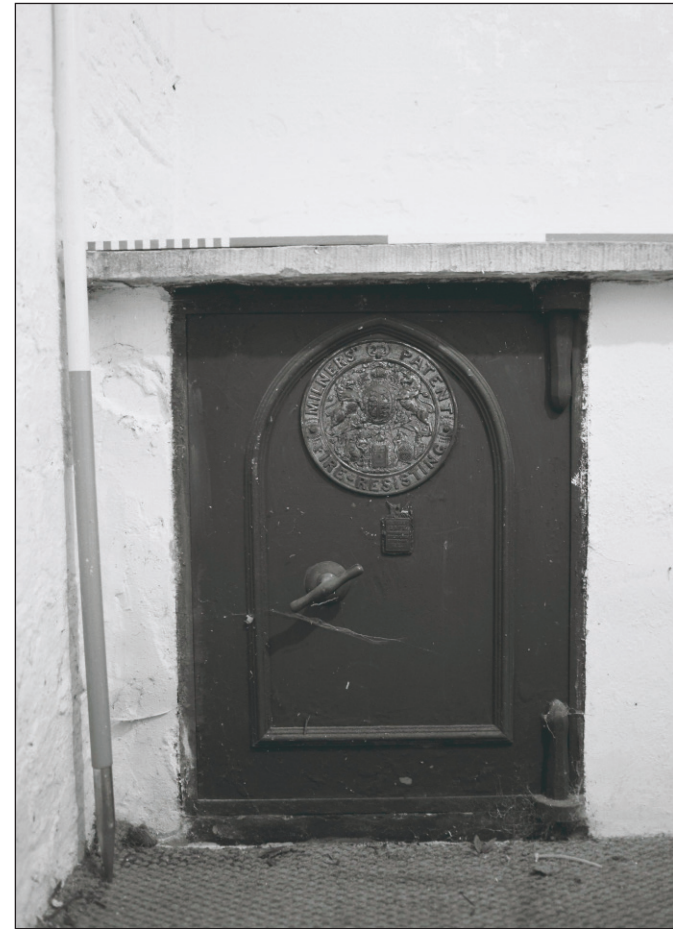
Plate 500: Detail of safe within G43, South Range, Agent's House (Film 61.04)

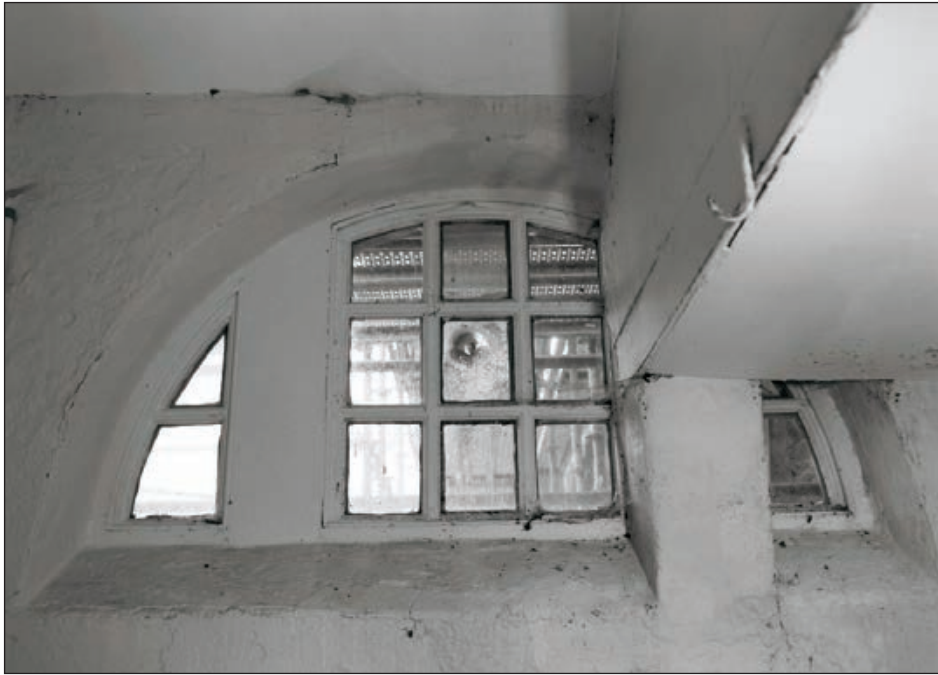
Plate 501: View of high window, north wall of G43, South Range - Agent's House - showing inserted tank above (Film 61.02)

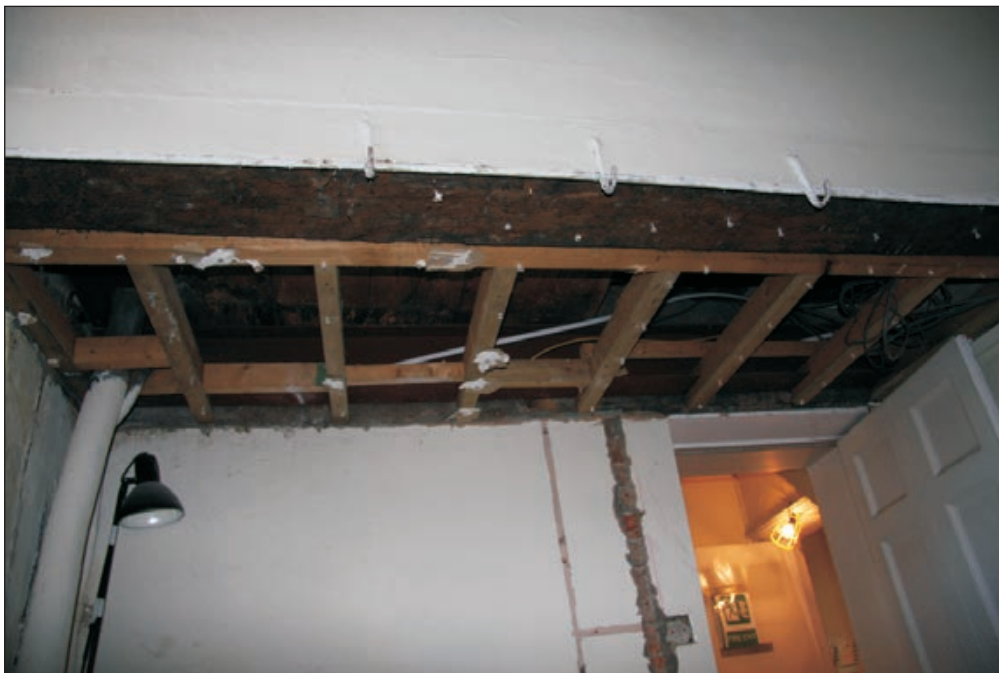
Plate 502: View of exposed reused timber beam and RSJ within G43, South Range - Agent's House - OB. 95 - for inserted floor and tank above (Film D. 20.10.10 1782)

- 5.4.40 Room G43, to the west of G50, was the eastern end of the former corridor linking the East Range stables with the Riding House. The floor level was much lower within the room, in comparison with the remainder of the ground floor of the Agent's House. The room had been converted to a pantry store, with inserted stone topped table on brick piers against the west wall (**Plate 499**), and a safe beneath the south end of the table (**Plate 500**). The north wall contained an original tripartite arched window (**Plate 501**), although a brick pier had been constructed in front, which carried a large inserted reused timber beam above. An RSJ had also been inserted above along the east side of the ceiling (**Plate 502**). This was to support an inserted corridor and water tank above.

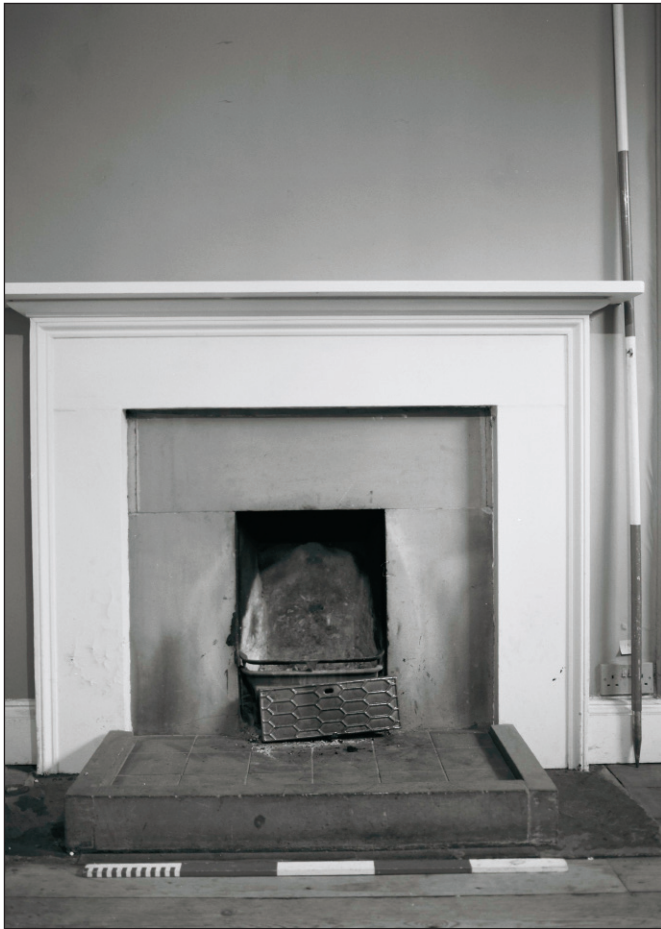
Plate 505: Detail of fireplace, G49, South Range - Agent's House (Film 64.10)

- 5.4.41 Room G49 (**Plate 503**), to the east of G50, and north of G48, could be accessed from both corridors. It was a rectangular room with fireplace to the north, with adjacent built-in cupboard (**Plates 504, 505**) and timber sash window to the east (**Plate 506**). This timber sash window originally had a shutter housed below which would pull upwards covering the window. This had been boarded over. This boarding was removed during the work, revealing only the remains of the shutter box intact, whilst the shutter itself had not survived (**Plate 507**). The lifting of the timber floor boards exposed timber joists resting on brick plinths (**Plate 508**). Many of the original joists had been replaced in recent years.

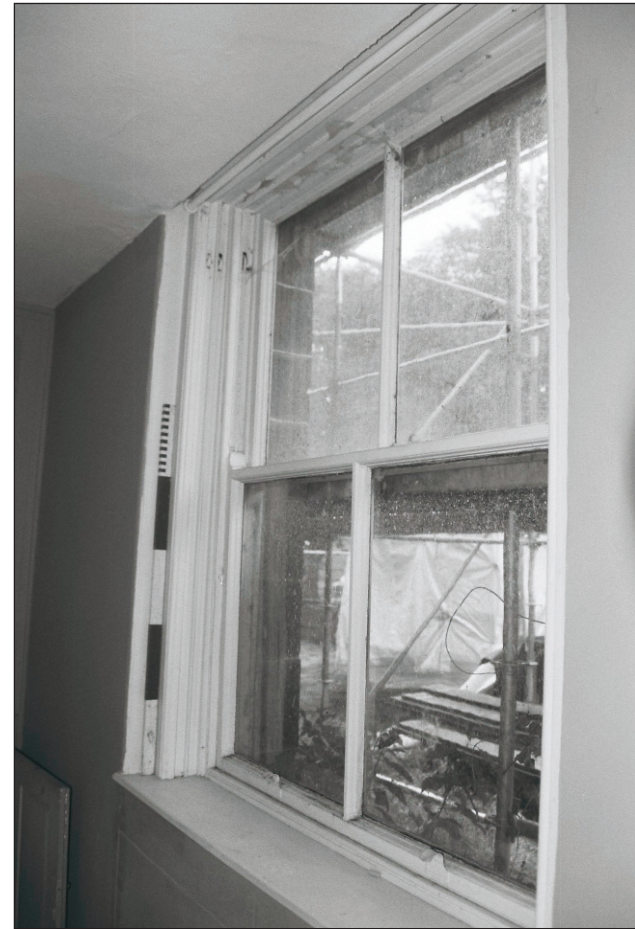
Plate 506: Detail of sash window with former lifting shutter, G43, South Range, Agent's House (Film 65.23)

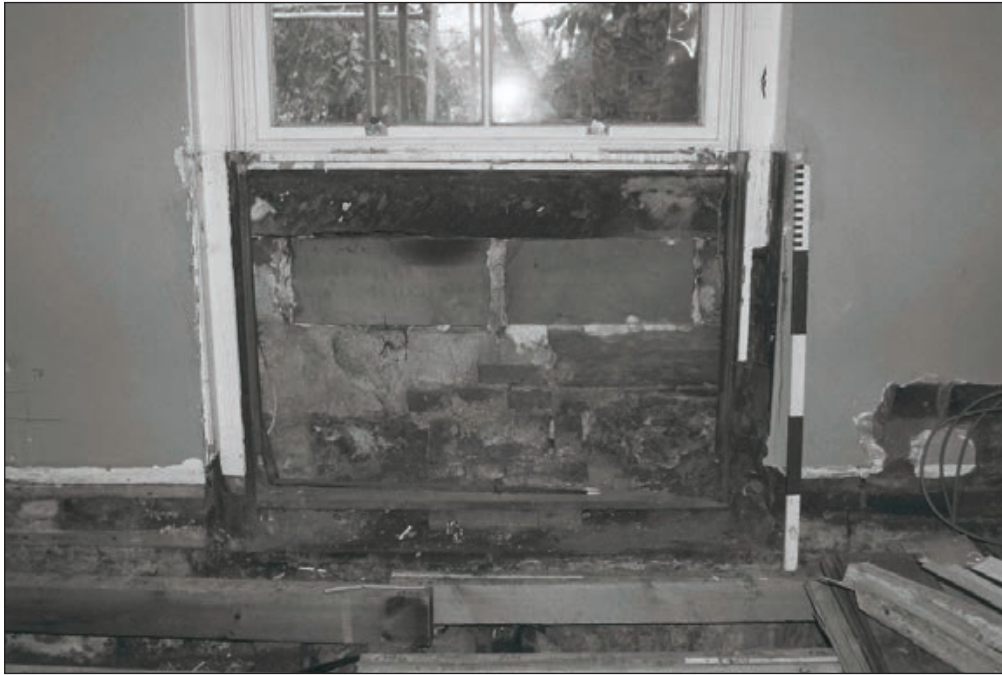
Plate 507: Detail of exposed former sash window shutter frame and east wall of G49, South Range - Agent's House - OB. 94 (Film 70.27)

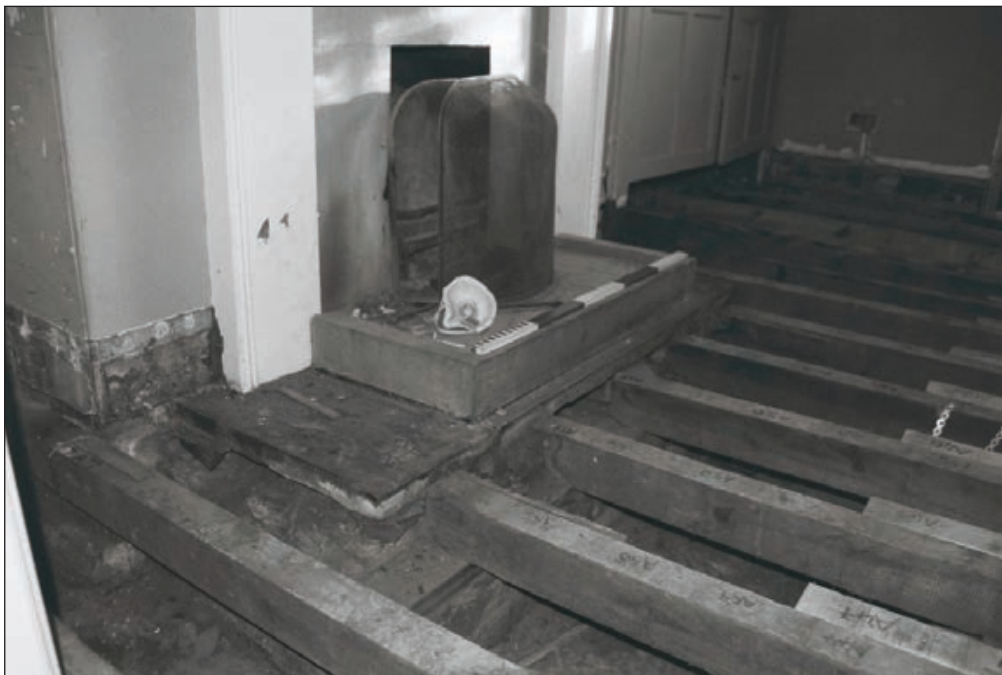
Plate 508: View of exposed timber joists and floor structure of G49, South Range - Agent's House - OB. 86 (Film 69.09)

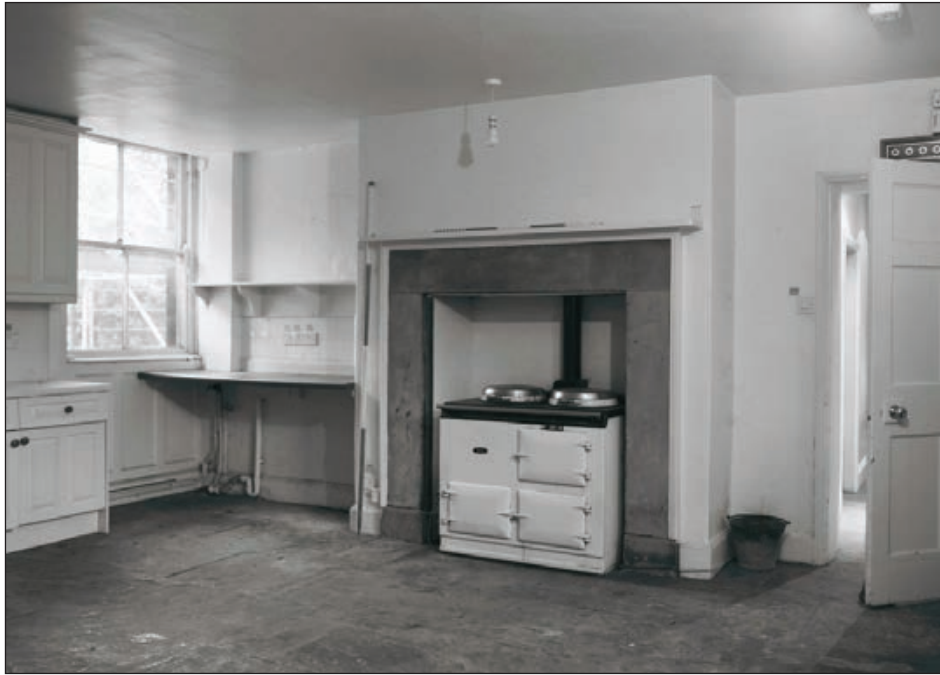
Plate 509: General view of G51, South Range - Agent's House (Film 59.01)

- 5.4.42 Room G51 was the kitchen of the Agent's House, positioned to the north of G49 and G50. To the south was a central large fireplace which would have once housed a large range (**Plate 509**). To the east were two sash windows (**Plate 510**), the northernmost of which had retained its pull up shutter (**Plates 513, 514**). To the north were two doorways, one to the east which opened up into an understair pantry (G52), and one to the west which led to staircase G53. There was a single sash window to the west, centrally positioned within the room (**Plate 511**). Above the doorway to G50 to the south was an original electric servant indicator board (**Plate 512**). The floor was made of stone flags, resting on brick plinths running east-west across the room (**Plate 515**). Modern kitchen fixtures and fittings were present throughout the room.

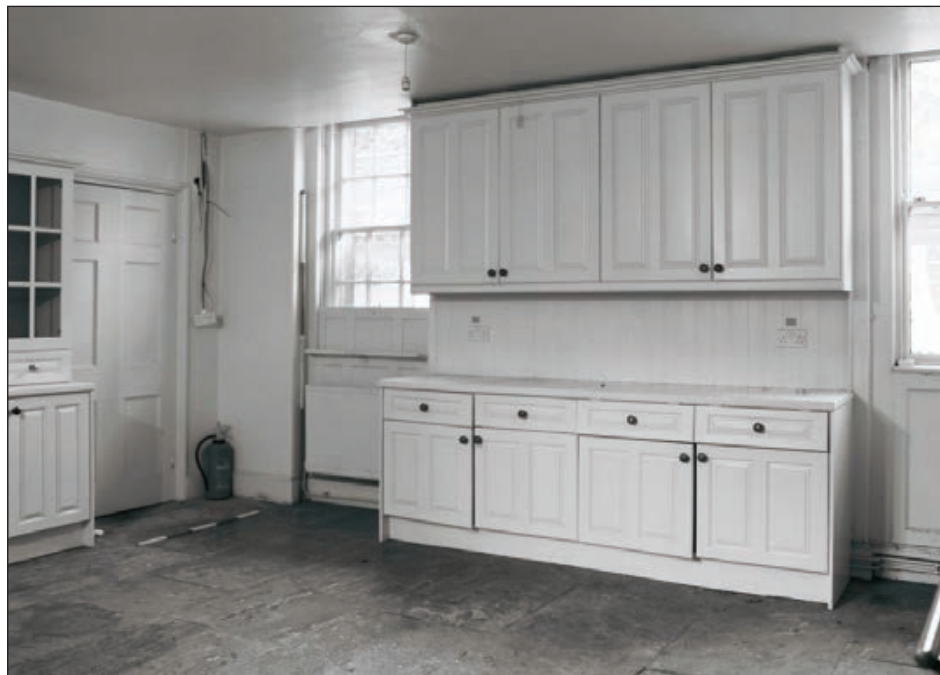
Plate 510: General view of G51, South Range - Agent's House (Film 59.03)

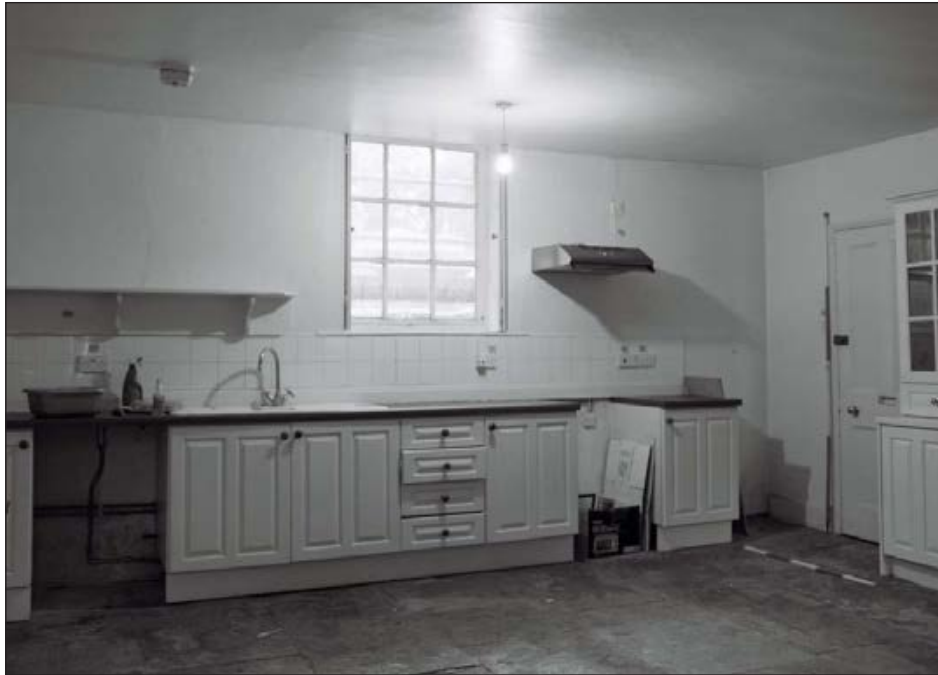
Plate 511: General view of G51, South Range - Agent's House (Film 59.05)

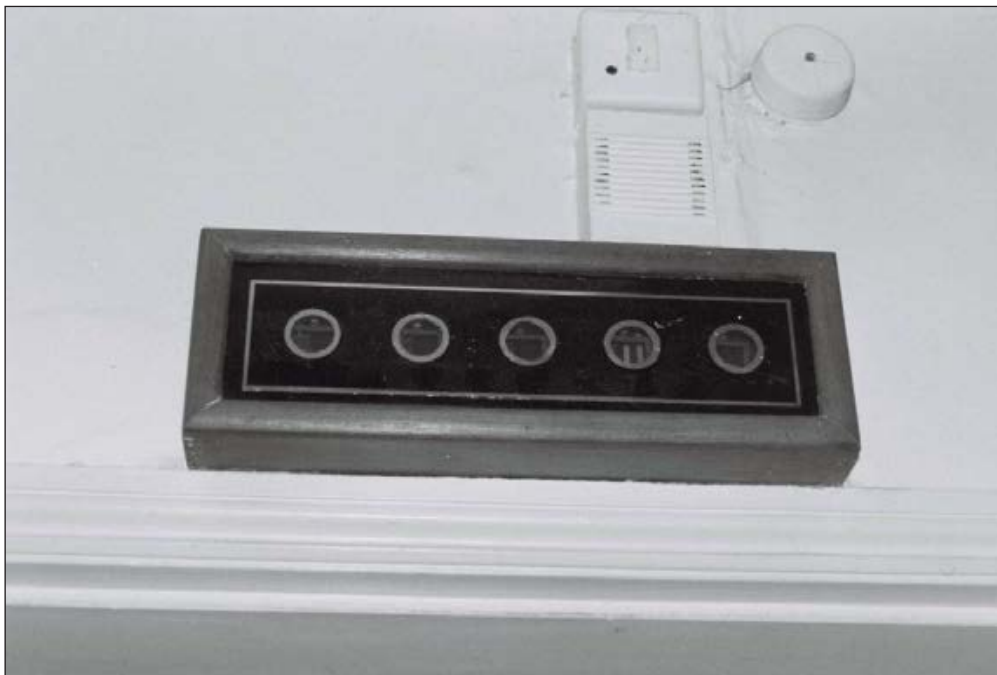
Plate 512: Detail of electric servant indicator board, above doorway with G50, G51 (Kitchen), South Range - Agent's House (Film 65.25)

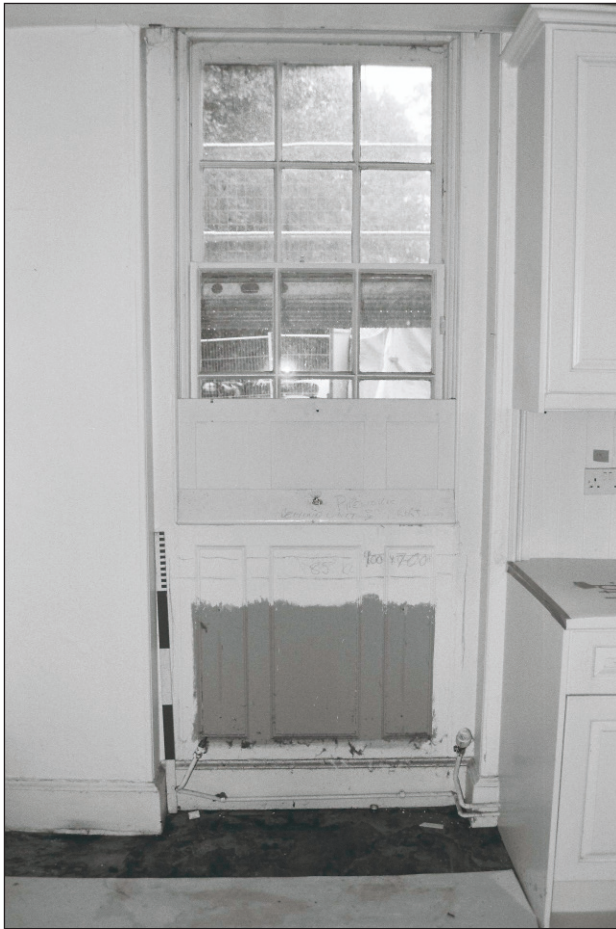
Plate 513: Detail of sash window with lifting shutter, east wall of G51, South Range - Agent's House (Film 65.29)

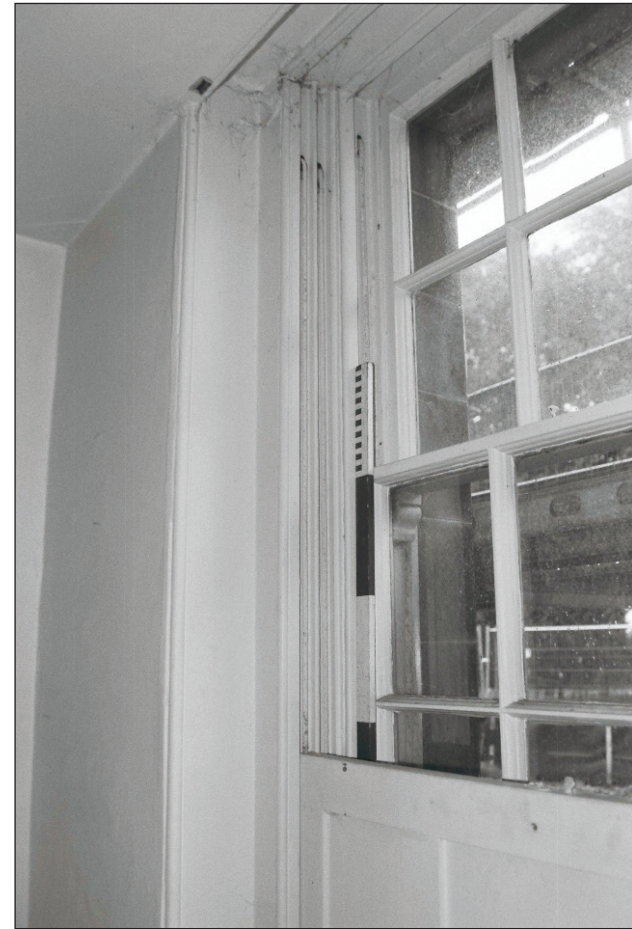
Plate 514: Detail of sash window with lifting shutter, G51, South Range - Agent's House (Film 65.27)
