NOSTELL PRIORY STABLES, NOSTELL, WAKEFIELD, WEST YORKSHIRE

Historic Building Recording and Structural Watching Brief

Planning Application Ref: 09/00701/FUL & 09/00705/LBC

72934.01_BDG_V0_4

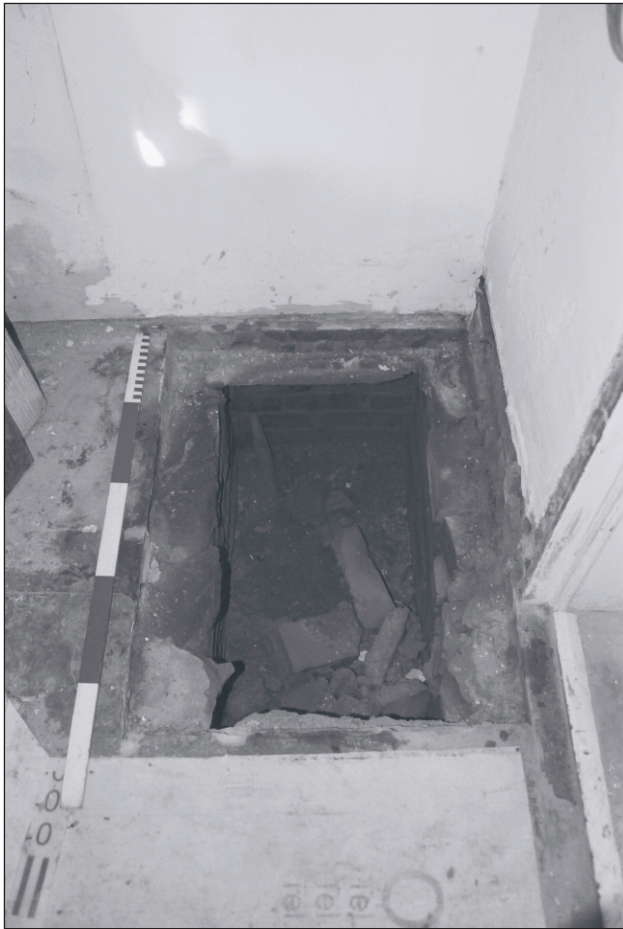
Plate 515: Detail of floor construction, G51, South Range - Agent's House - OB. 88 (Film 68.07)

- 5.4.42 Room G51 was the kitchen of the Agent's House, positioned to the north of G49 and G50. To the south was a central large fireplace which would have once housed a large range (**Plate 509**). To the east were two sash windows (**Plate 510**), the northernmost of which had retained its pull up shutter (**Plates 513, 514**). To the north were two doorways, one to the east which opened up into an understair pantry (G52), and one to the west which led to staircase G53. There was a single sash window to the west, centrally positioned within the room (**Plate 511**). Above the doorway to G50 to the south was an original electric servant indicator board (**Plate 512**). The floor was made of stone flags, resting on brick plinths running east-west across the room (**Plate 515**). Modern kitchen fixtures and fittings were present throughout the room.

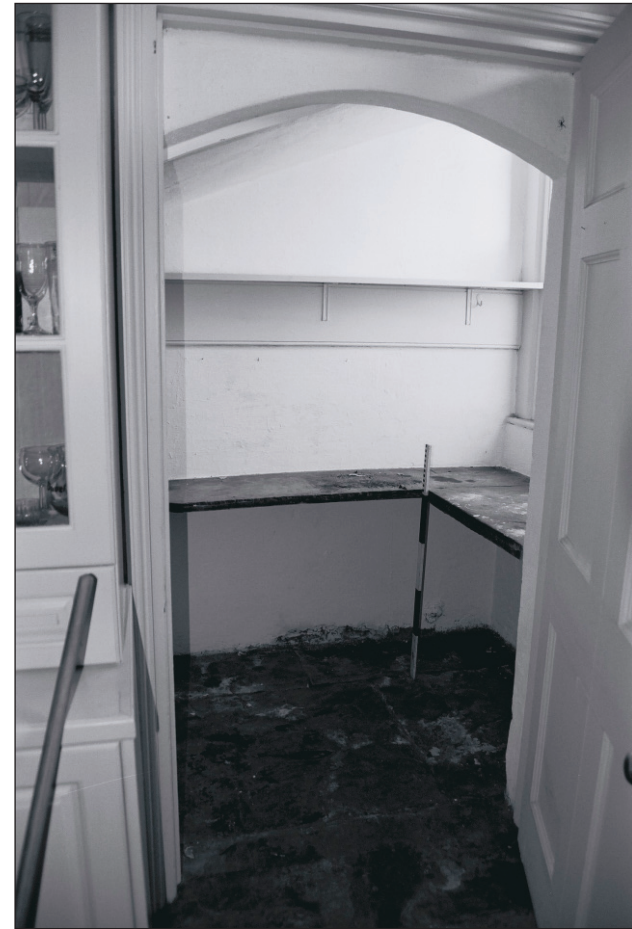
Plate 516: General view into G52, South Range - Agent's House (Film 43.03)

- 5.4.43 Room G52 to the north was a small understair pantry (**Plate 516**). It contained a sash window to the east (**Plate 517**), original stone shelving set into the walls, and additional timber shelves (**Plates 517, 518**). The sash window to the east was removed and the opening altered to a doorway. During these works, it was noted that the east wall was of two different phases to the north and south of the window (**Plates 519, 520**), with that to the north being of phase 6, whilst that to the south has a phase 5 core and phase 6 front.

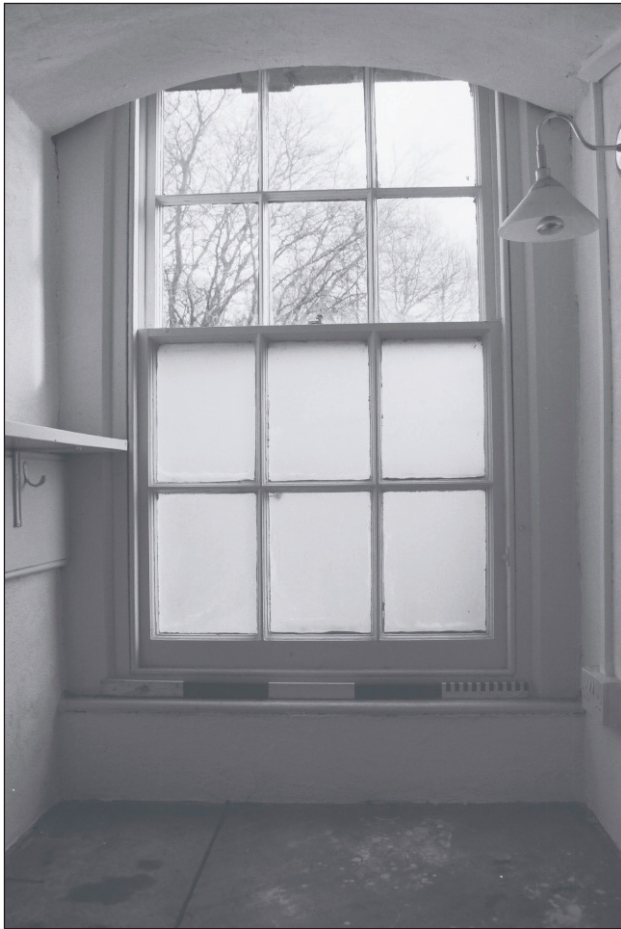
Plate 517: General view of G52, showing sash window in east wall, South Range - Agent's House (Film 44.35)

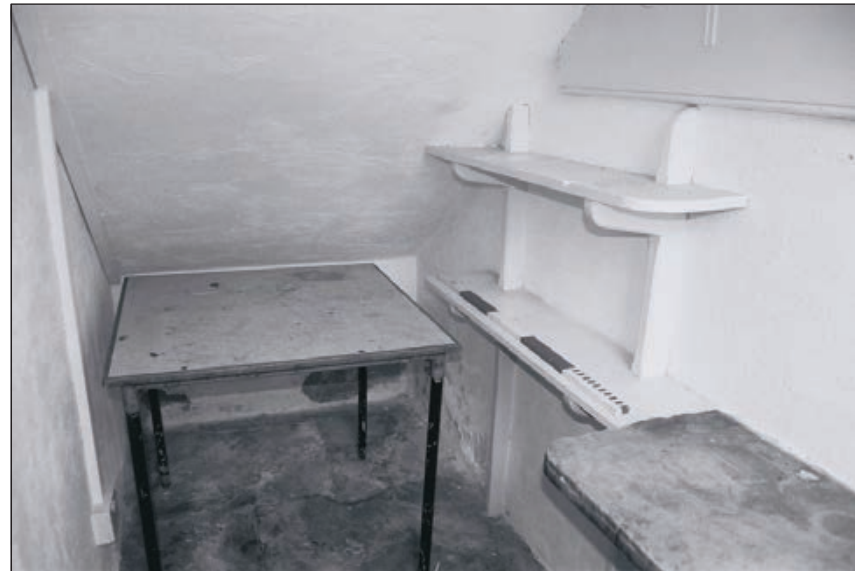
Plate 518: General view of G52, South Range - Agent's House (Film 44.34)

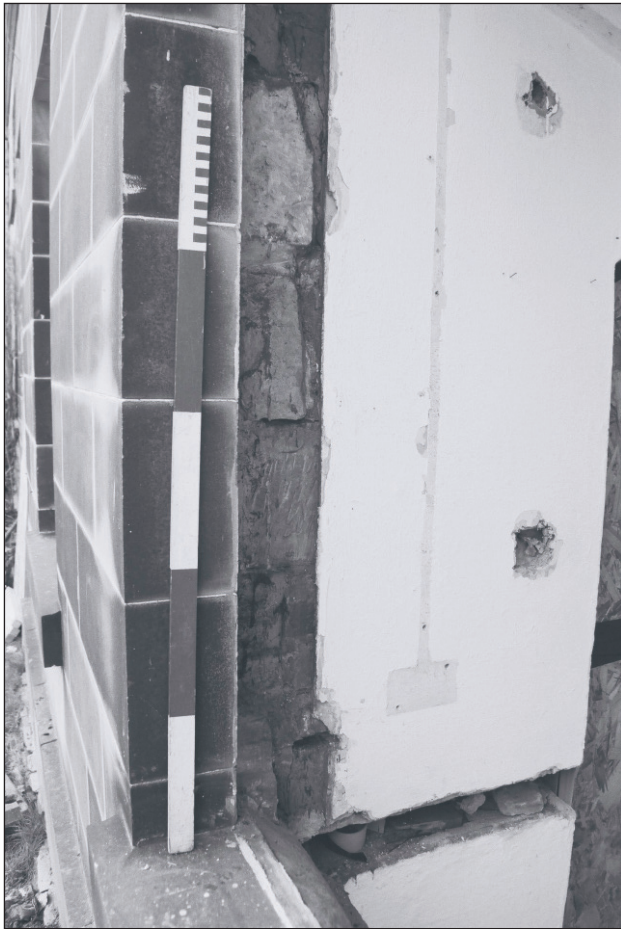
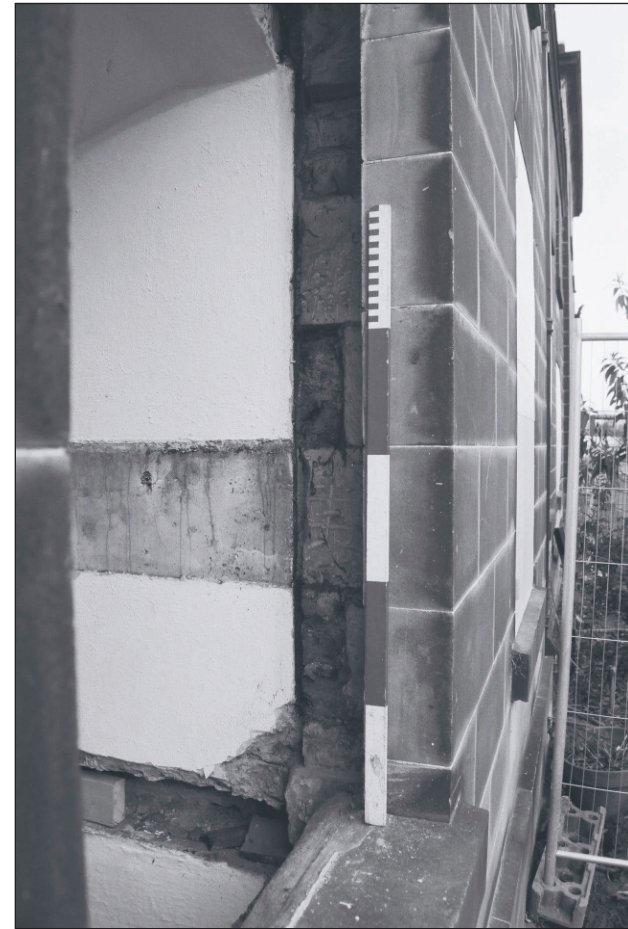
Plate 519: Detail of exposed wall fabric during insertion of door, G52, South Range - Agent's House - OB. 25 (Film 48.23)

Plate 520: Detail of exposed wall fabric during insertion of door, G52, South Range - Agent's House - OB. 25 (Film 48.29)

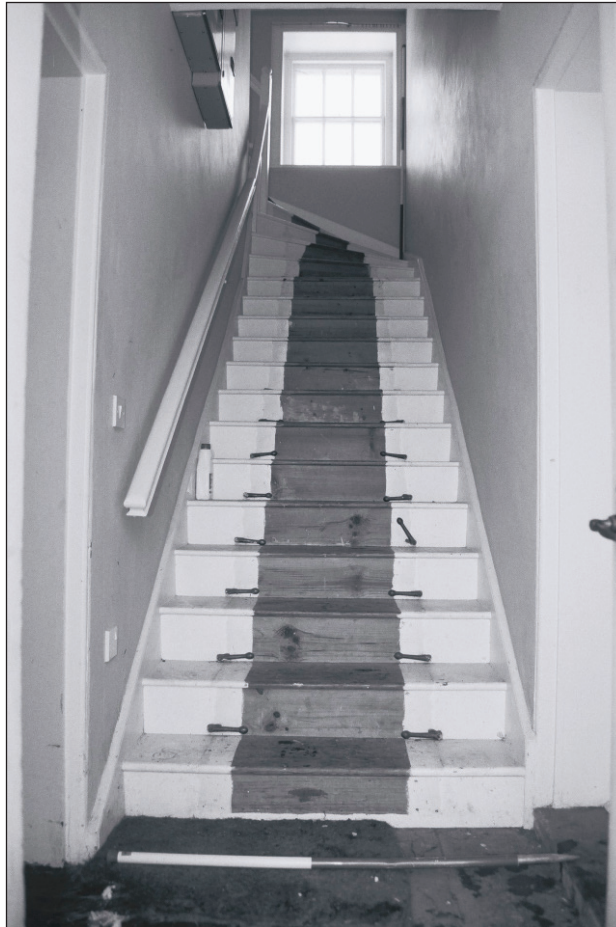
Plate 521: General view of G53, with stairs leading to F42, South Range - Agent's House (Film 22.30)

- 5.4.44 To the north of G51, and to the west of G52 was entranceway and staircase G53 (**Plate 521**). This provided access from the central courtyard to the ground floor of the Agent's House, room G54 to the north and the first floor of the East Range (**Figure 11**). It was observed that the floor above the entranceway was a later insertion with modern joists supporting room F42 above (**Plates 522, 523**)

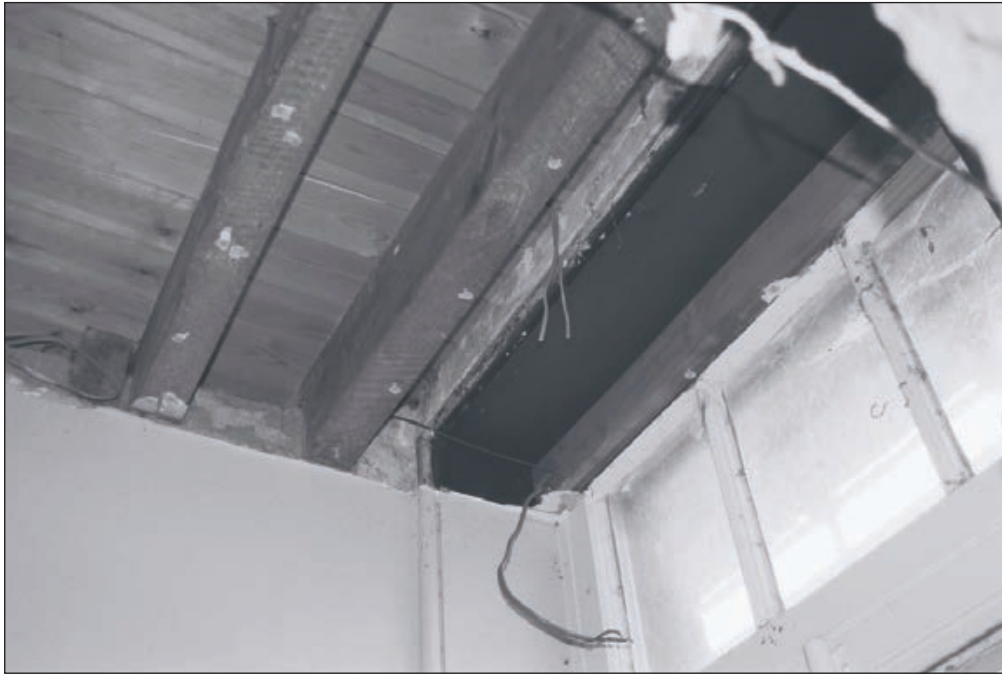
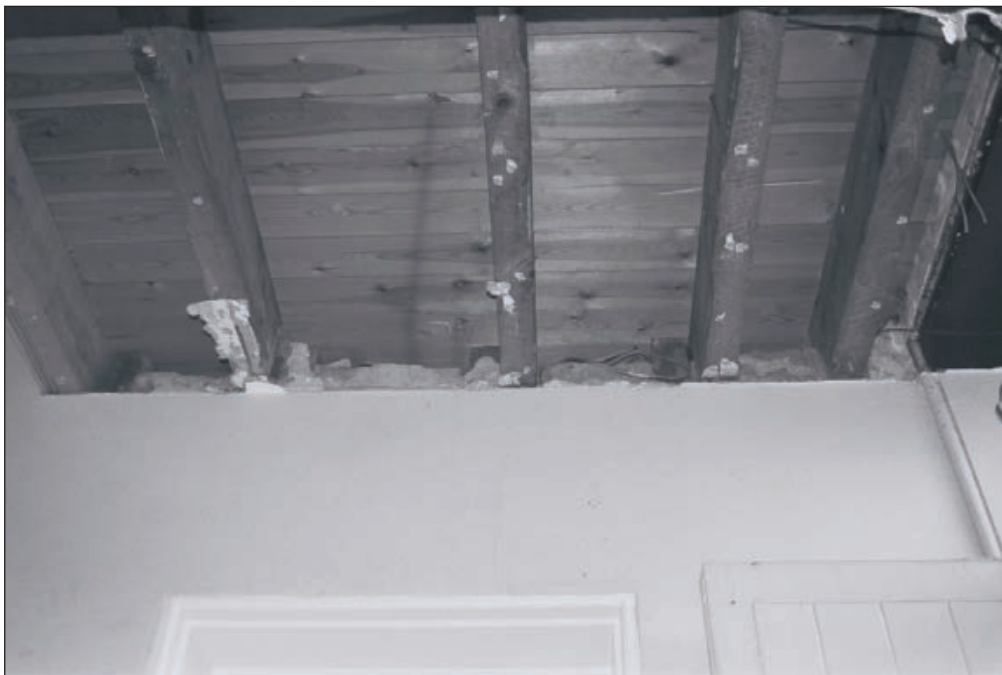
Plate 522: View of inserted modern joists for F41 above and position of removed inserted ceiling, G53, South Range - Agent's House (Film 46.05)

Plate 523: View of inserted modern joists for F41 above and position of removed inserted ceiling, G53, South Range - Agent's House (Film 46.07)

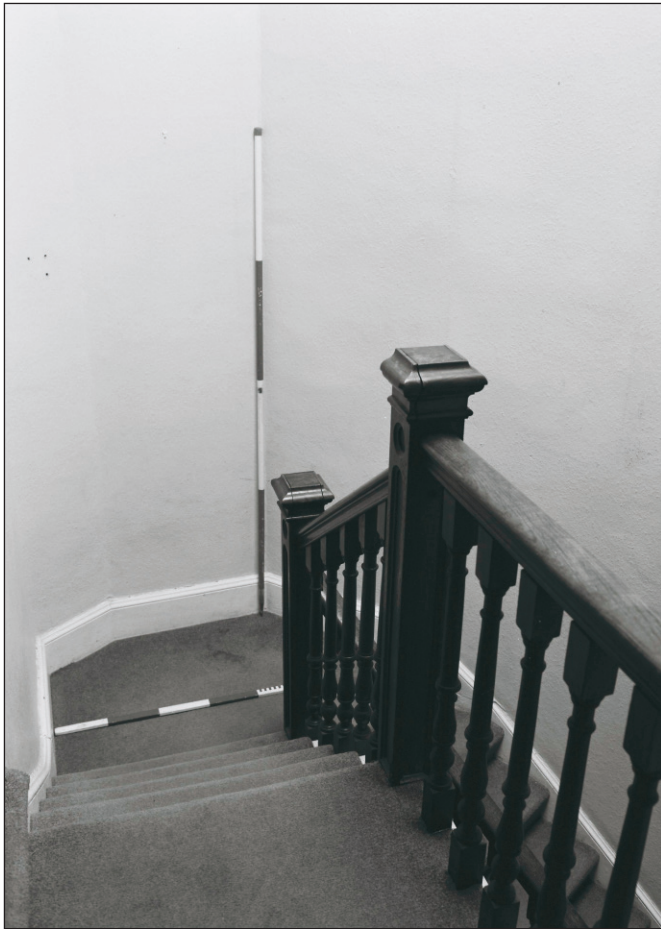
Plate 524: General view of staircase, F34 to G45, South Range - Agent's House (Film 64.07)

- 5.4.45 The first floor of the Agent's House, was accessed from the staircase in G45, leading to a first floor landing, F34 (**Plate 524**). To the east of F34, was an inserted opening, leading to F37 which contained inserted staircases of two phases (**Plate 525**), and led to F35 and F36 (**Figure 13**). Three treads and risers of the earlier phased staircase were removed, revealing the structure of the staircase (**Plates 526, 527**).

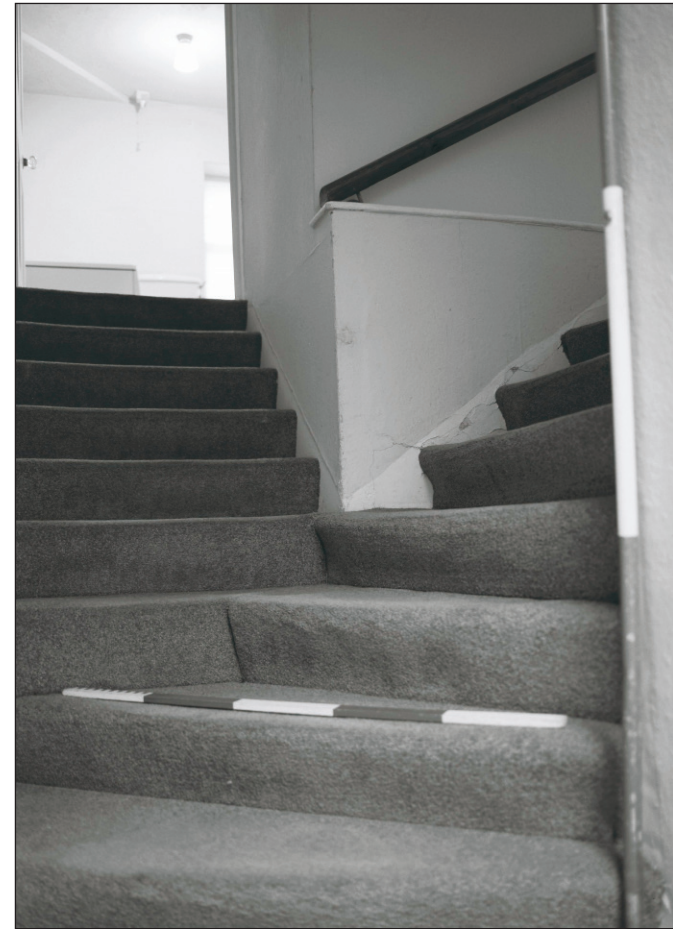
Plate 525: General view up staircase F37, South Range - Agent's House (Film 62.01)

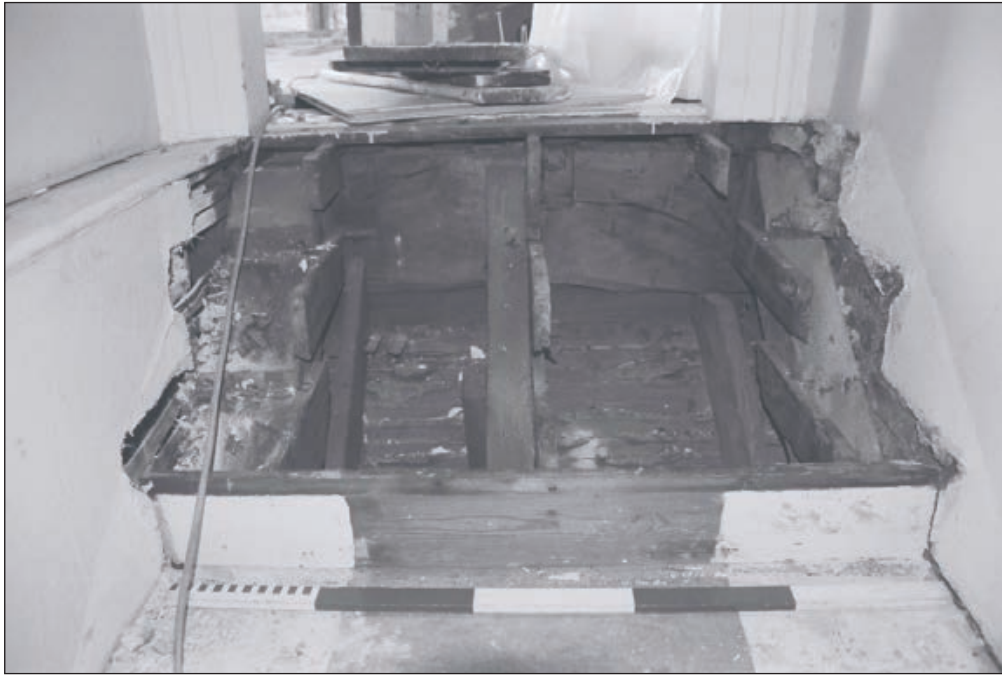
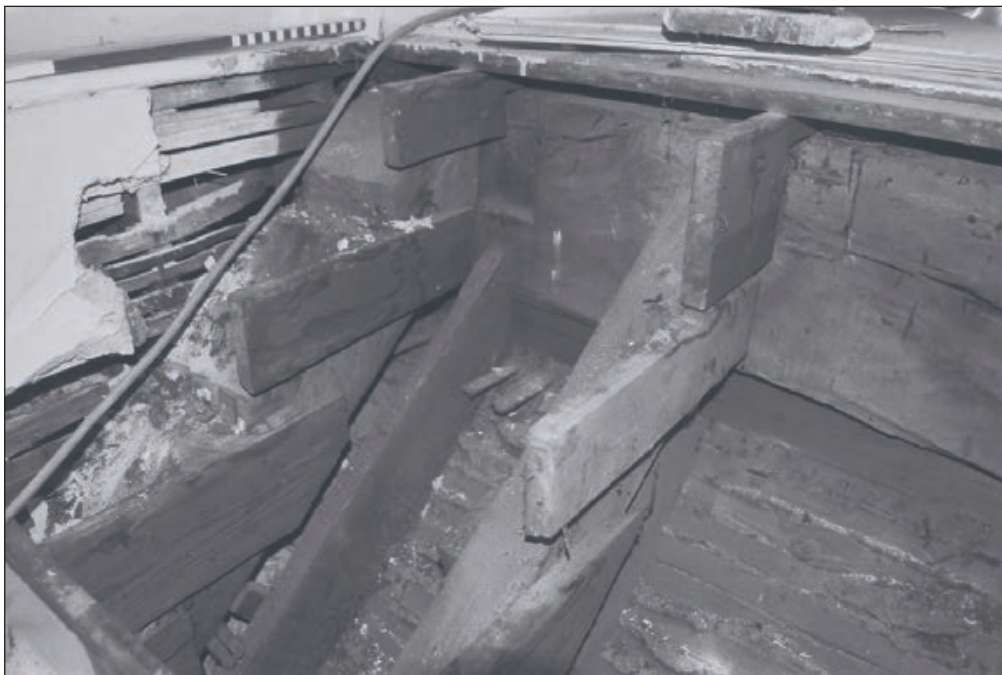
Plate 526: View of lifted stair treads exposing inserted staircase construction, F37, South Range - Agent's House - OB. 78 (Film 68.05)

Plate 527: View of lifted stair treads exposing inserted staircase construction, F37, South Range - Agent's House - OB. 78 (Film 68.01)

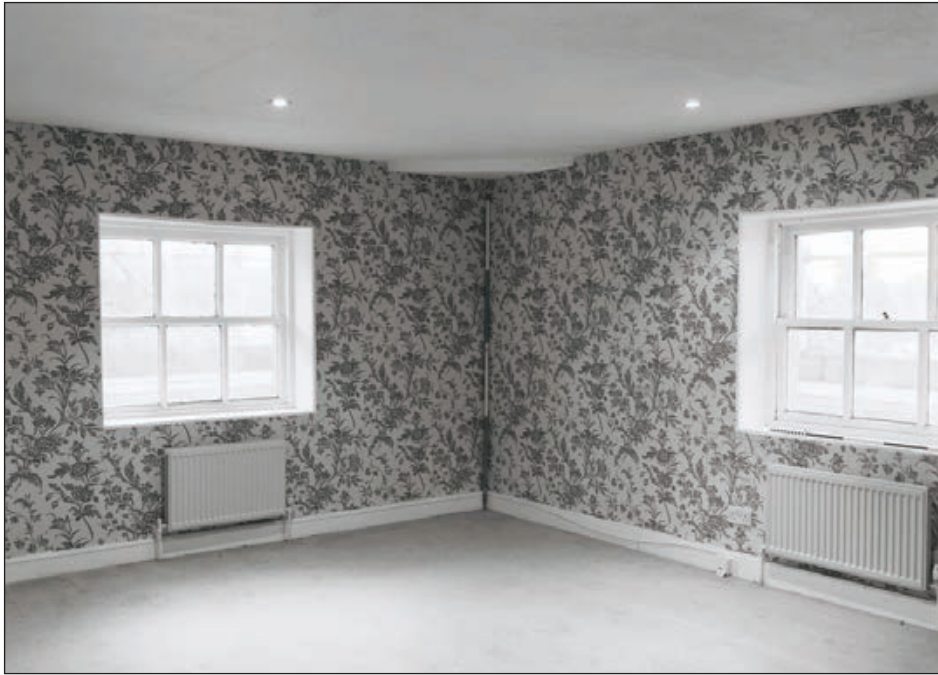
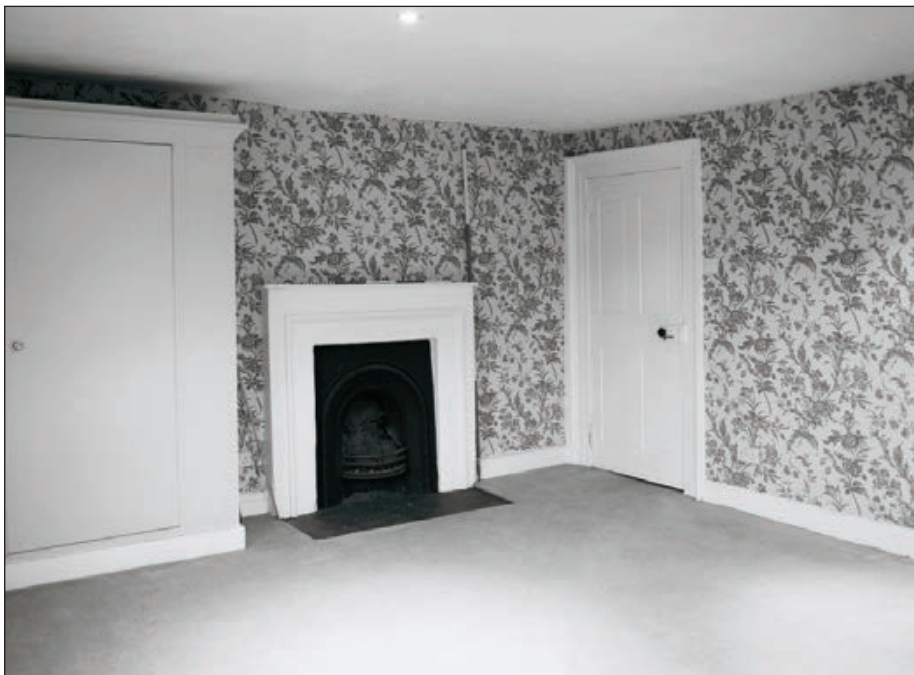
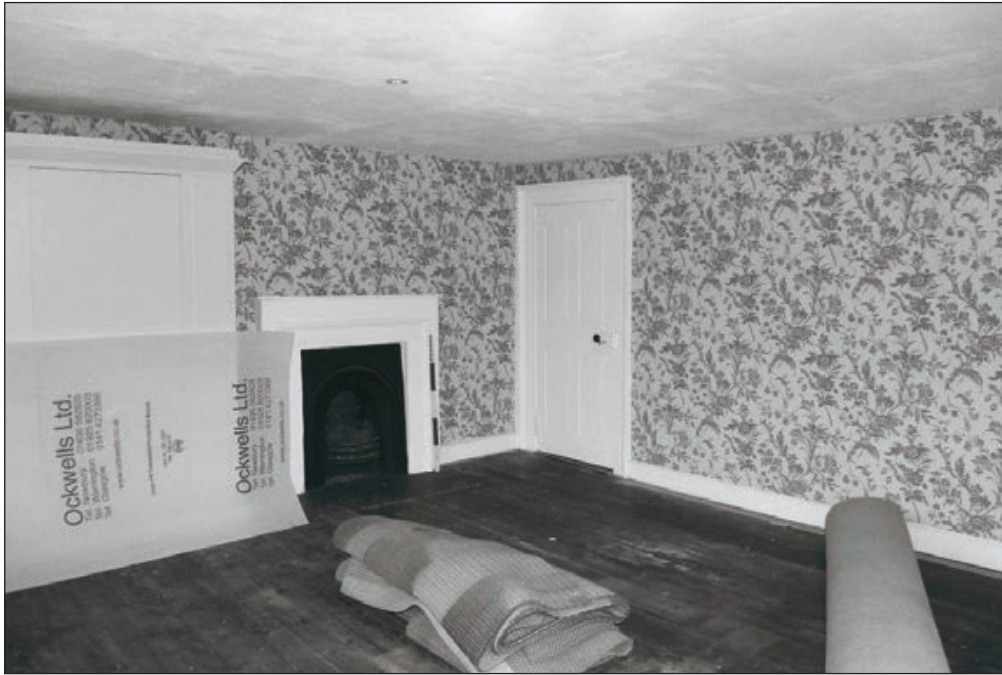
Plate 528: General view of F35, South Range - Agent's House (Film 63.01)

Plate 529: General view of F35, South Range - Agent's House (Film 62.07)

Plate 530: General view of F35, South Range - Agent's House - after carpet removal (Film 65.01)

- 5.4.46 At the top of the staircase, to the south of F37, was room F35. This was originally a single room with the adjacent F36. F35 was a square room with sash windows to the south and east (**Plate 528**) and fireplace to the west (**Plates 529-531**). The floor was covered with timber boards, beneath which original timber joists were carried on large timber beams running east-west across the room. These original beams and joists had sagged significantly in the middle of the room, and as a consequence later timbers had been placed on top of the joists (**Plates 532-534**). Attached to the underside of the joists and beams were timber battens supporting the lath and plaster ceiling of room G47 below (**Plate 534**). The room contained a timber panelled door to the north from F37, with latch and box lock (**Plates 535, 536**). A hatch within the ceiling of F36 showed the roof structure above F35 and F36 was of the same timber truss construction as that of the West Pavilion (**Plate 537**).

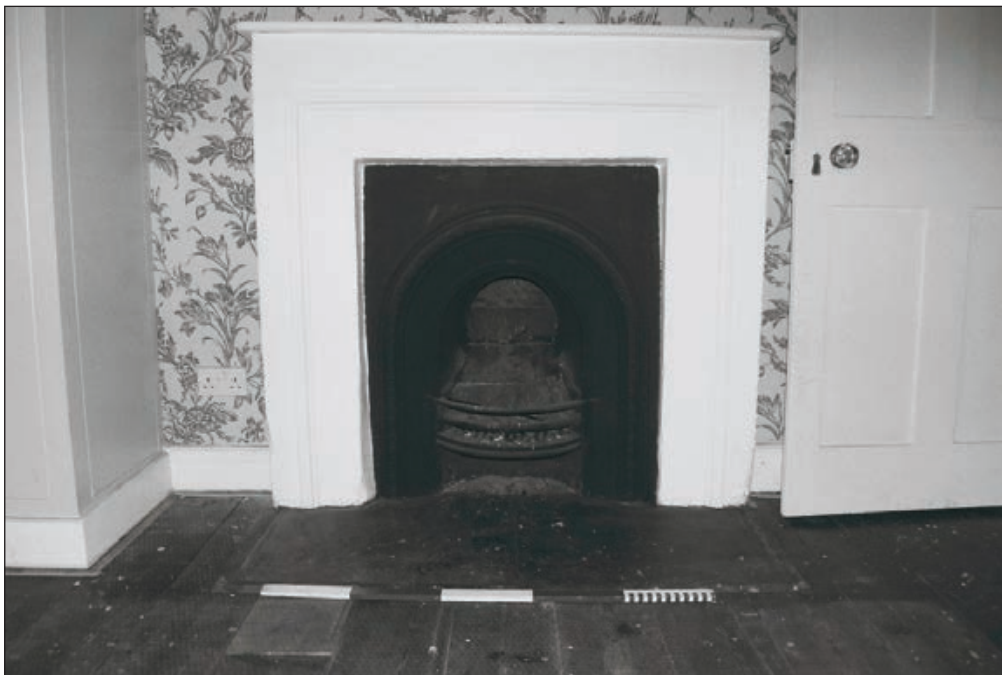
Plate 531: Detail of fireplace, F35, South Range - Agent's House (Film 65.08)

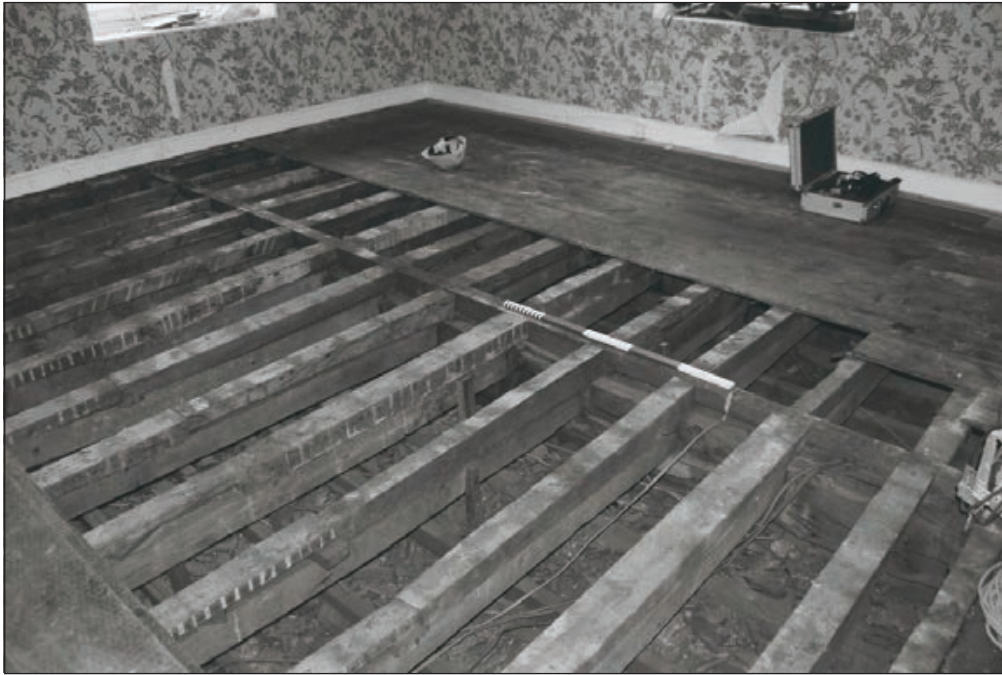
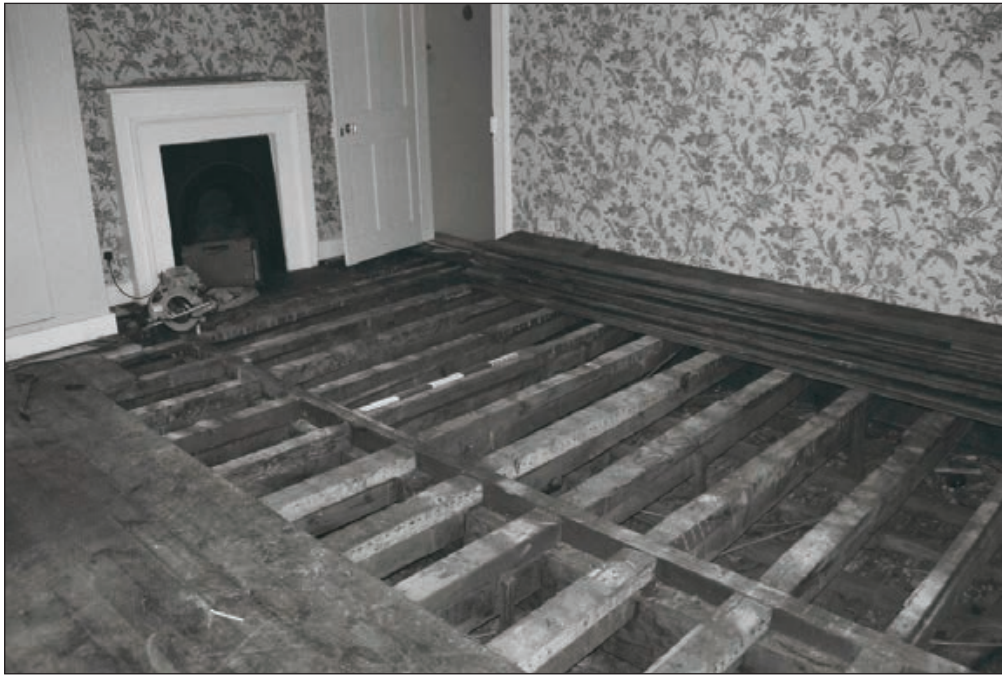
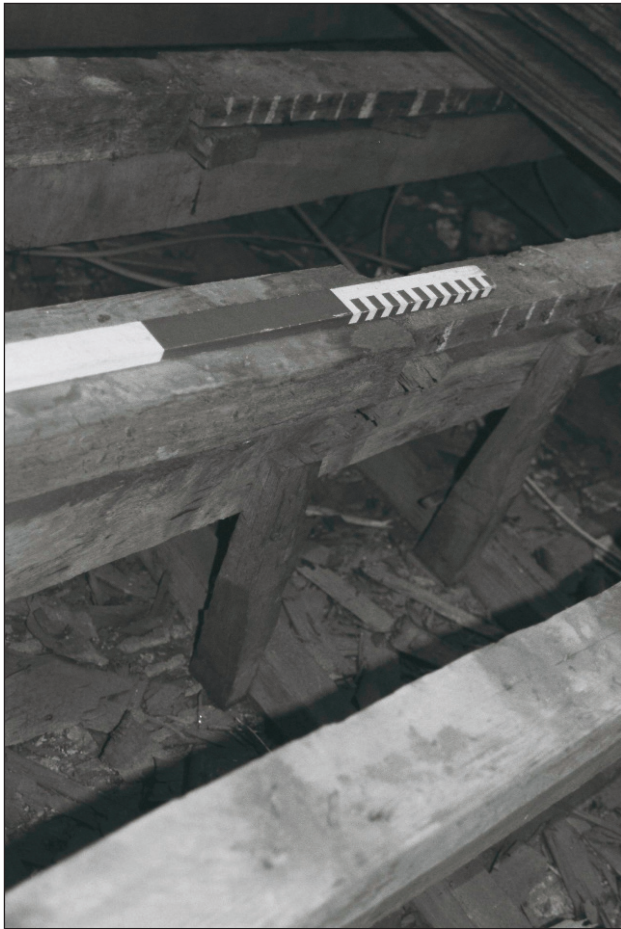
Plate 532: Detail of exposed timber floor and ceiling construction, F35, South Range - Agent's House - OB. 76 (Film 66.10)

Plate 533: Detail of exposed timber floor and ceiling construction, F35, South Range - Agent's House - OB. 76 (Film 66.19)

Plate 534: Detail of exposed timber floor and ceiling construction, F35, South Range - Agent's House - OB. 76 (Film 66.12)

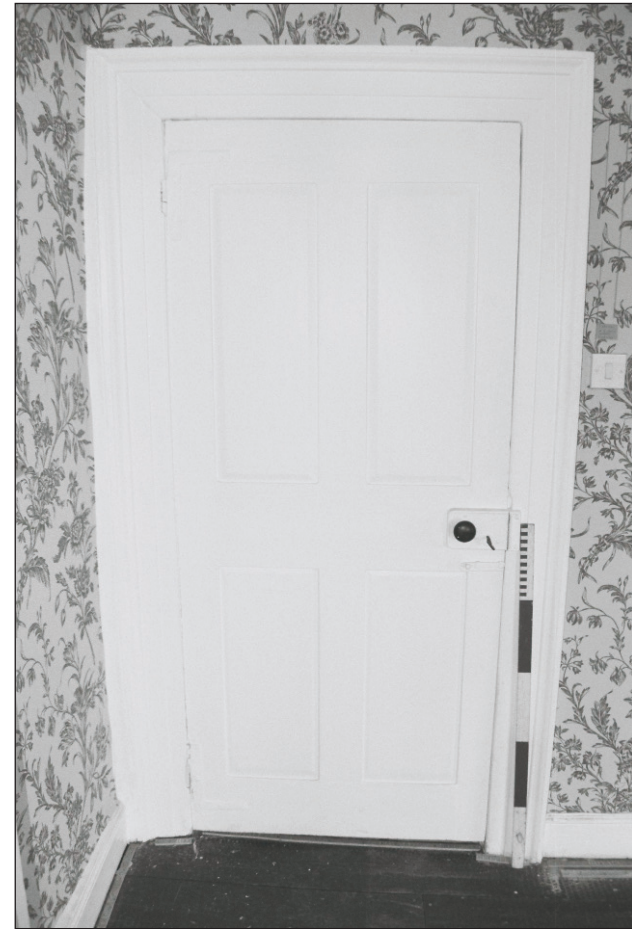
Plate 535: Detail of door, north wall of F35, South Range - Agent's House (Film 66.35)

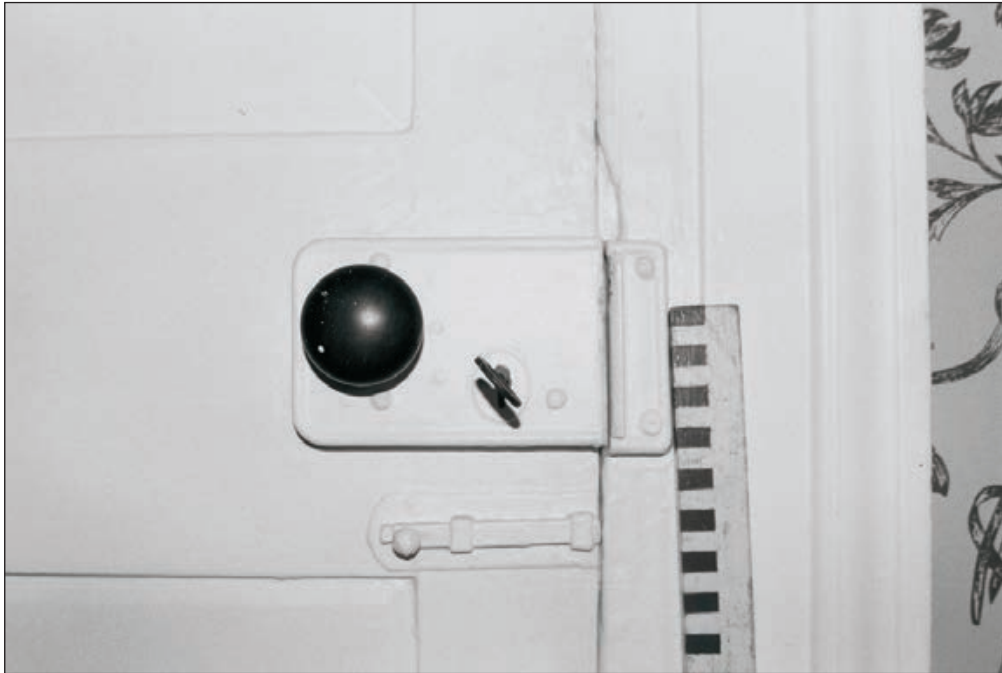
Plate 536: Detail of door furniture, F35, South Range - Agent's House (Film 66.34)

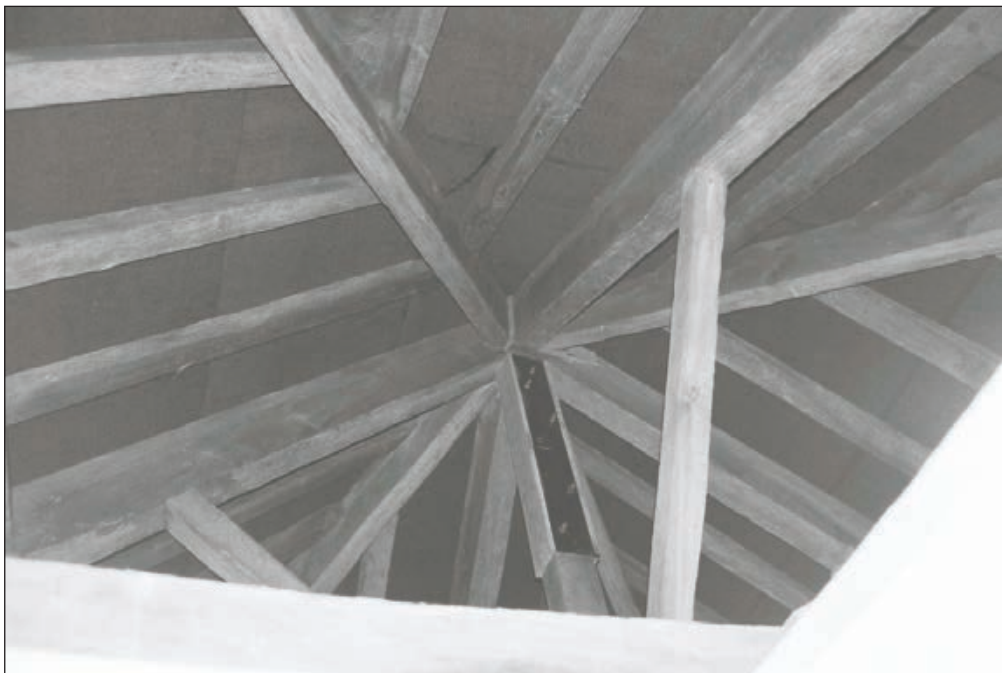
Plate 537: View of timber roof trusses above F35 and F36, South Range - Agent's House (Film 72.23)

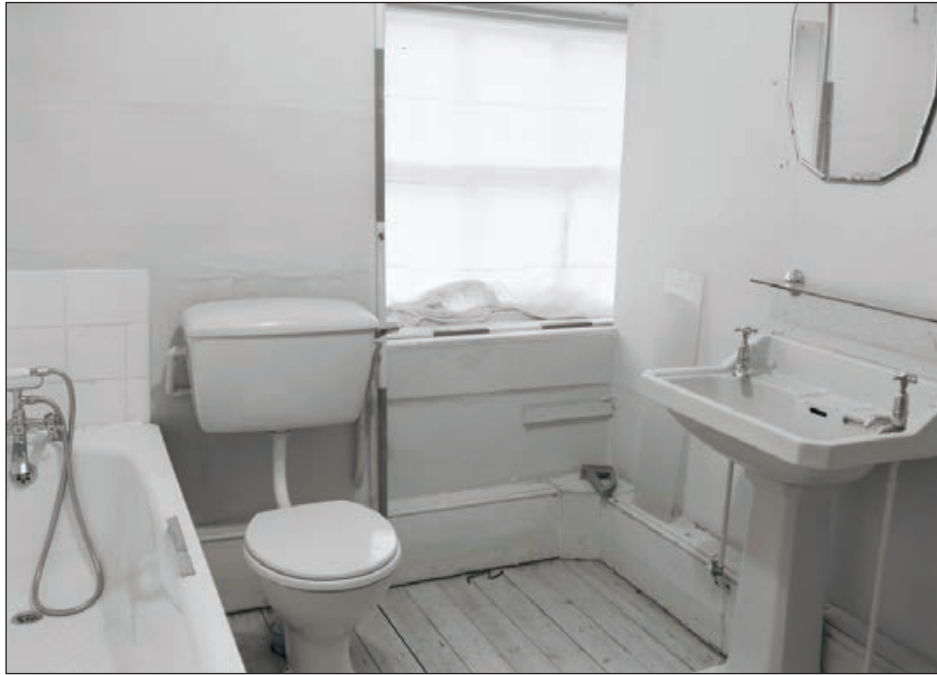
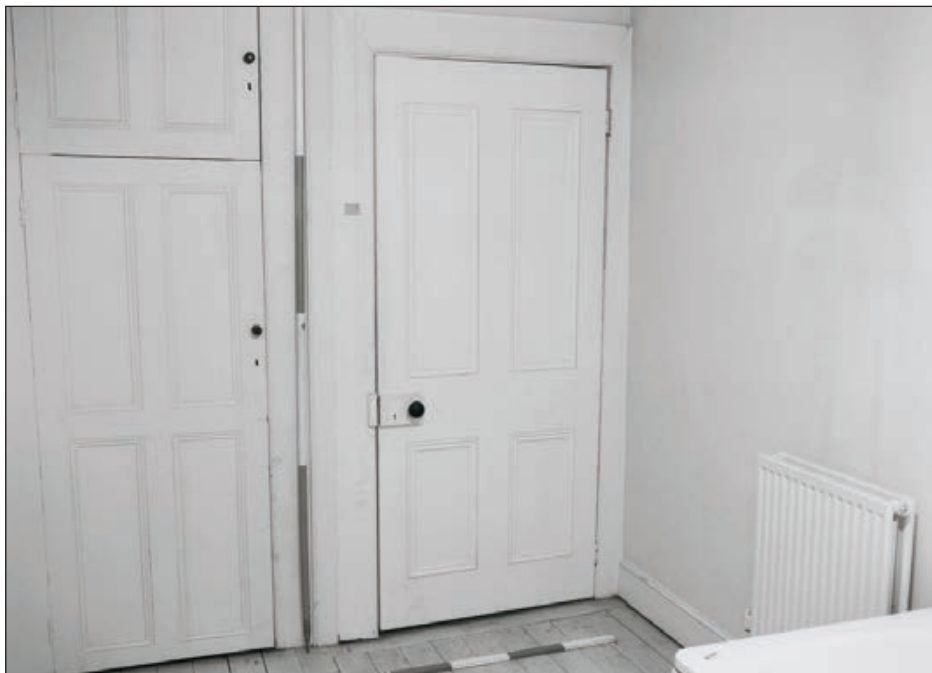
Plate 538: General view of F36, South Range - Agent's House (Film 62.05)

Plate 539: General view of F36, South Range - Agent's House (Film 62.03)

- 5.4.47 Room F36, to the north of F35, was a later partitioned bathroom with modern suite (**Plates 538, 539**). The floor construction was a continuation of that within F35, which was cut by the insertion of the staircase in F37 to the northwest (**Plates 540, 541**).

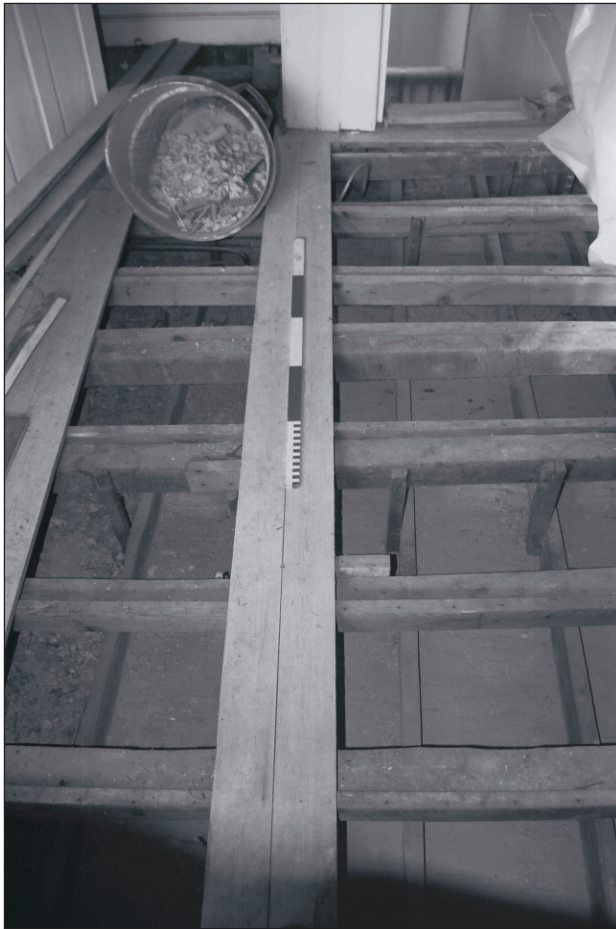
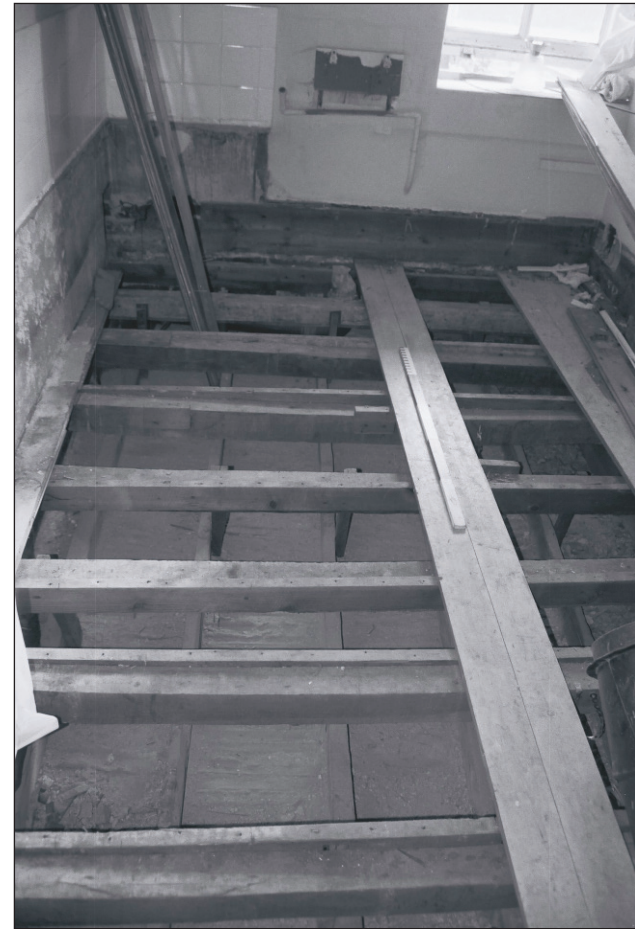
Plate 540: Detail of exposed timber floor and ceiling construction, F35, South Range - Agent's House - OB. 77 (Film 67.23)

Plate 541: Detail of exposed timber floor and ceiling construction, F35, South Range - Agent's House - OB. 77 (Film 67.25)

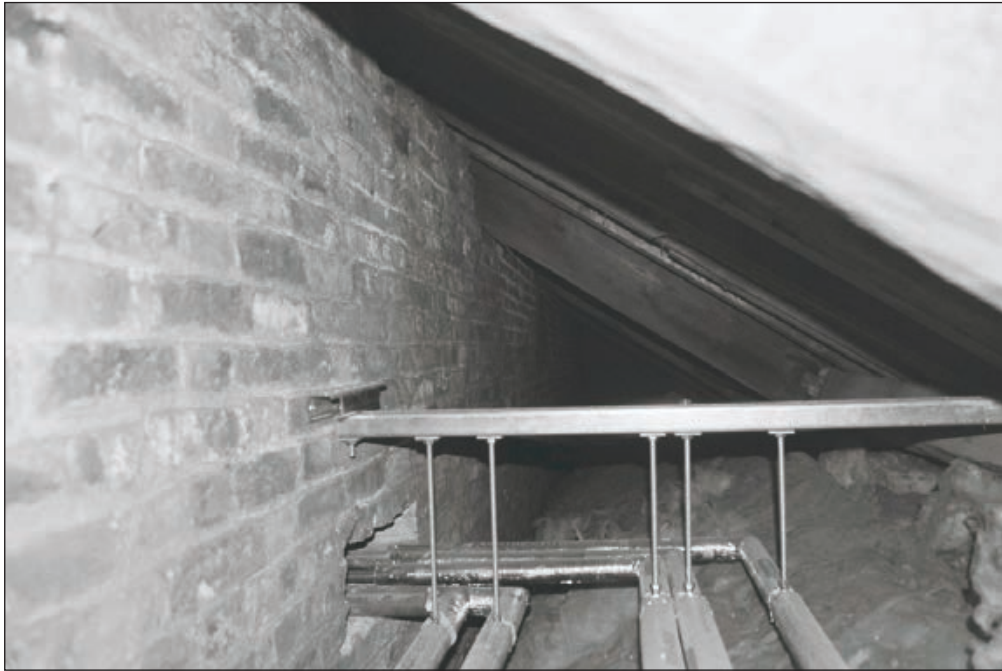
Plate 542: View of Roof Void 13 above G37-40 & G42-43 from F34/F39, South Range - Agent's House - OB. 102 (Film 72.32)

- 5.4.48 At the junction of corridors F34 and F39, an observation into Roof Void 13 above rooms G37-40 and G42-43, was made, showing a continuation of timber trusses from the adjacent Roof Void 14, and the structure of the arched timber ceiling of the former corridor below (**Plate 542**). The eastern end of Roof Void 13 had been altered due to the later modifications within the Agent's House, with the insertion of a corridor linking the first floor of the East Pavilion, with the first floor to the north. A lead lined water tank was also inserted into the northeast corner of Roof Void 13 (**Plate 543**).

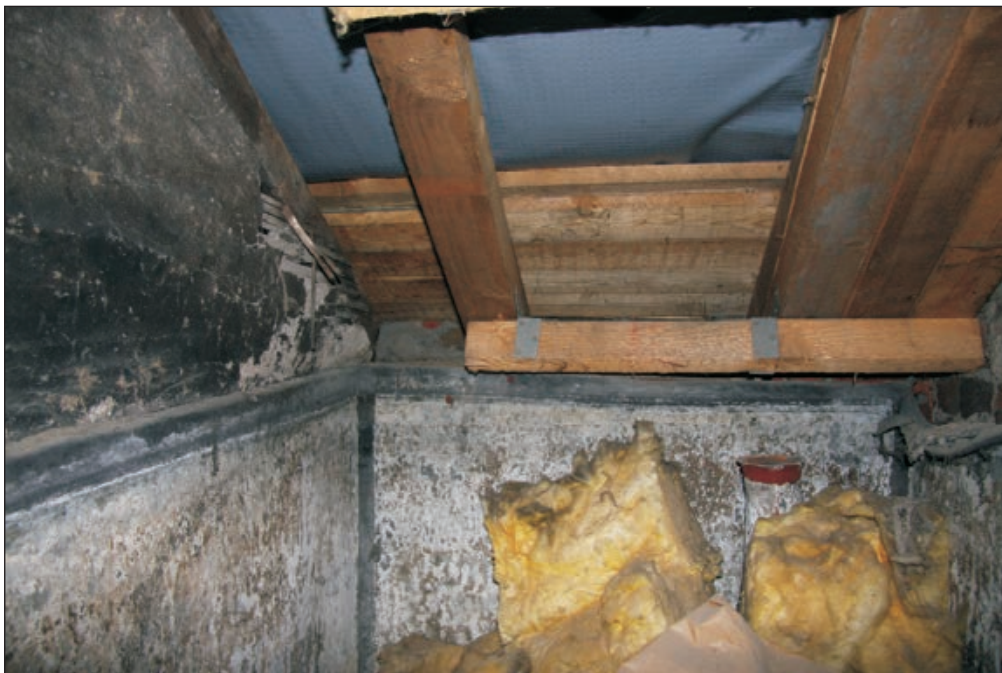
Plate 543: View into inserted tank within east end of Roof Void 13, above G43, from F34/39, South Range - Agent's House - OB. 103 (Film D. 25.08.11 4798)

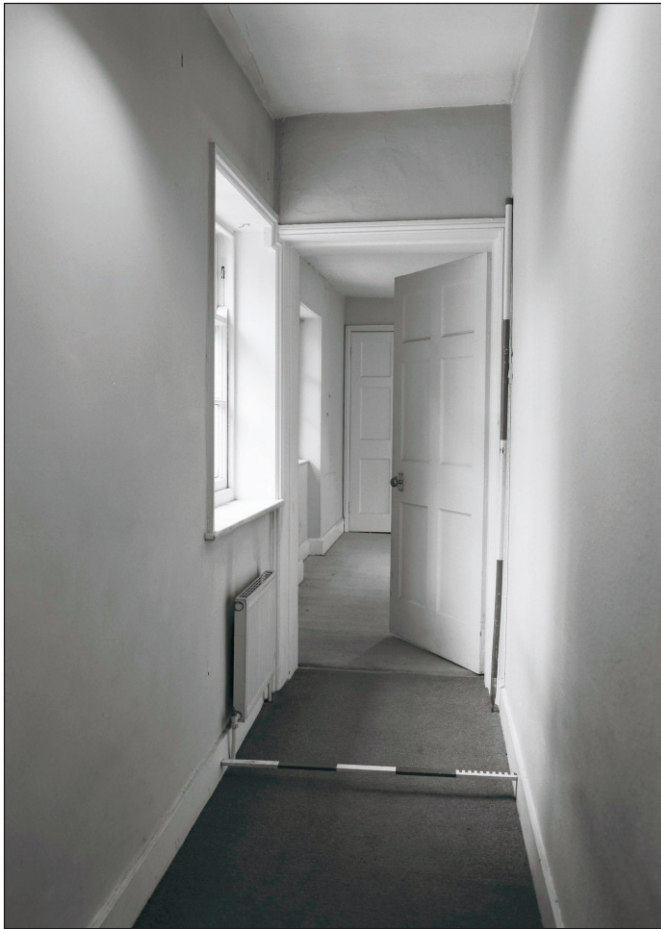
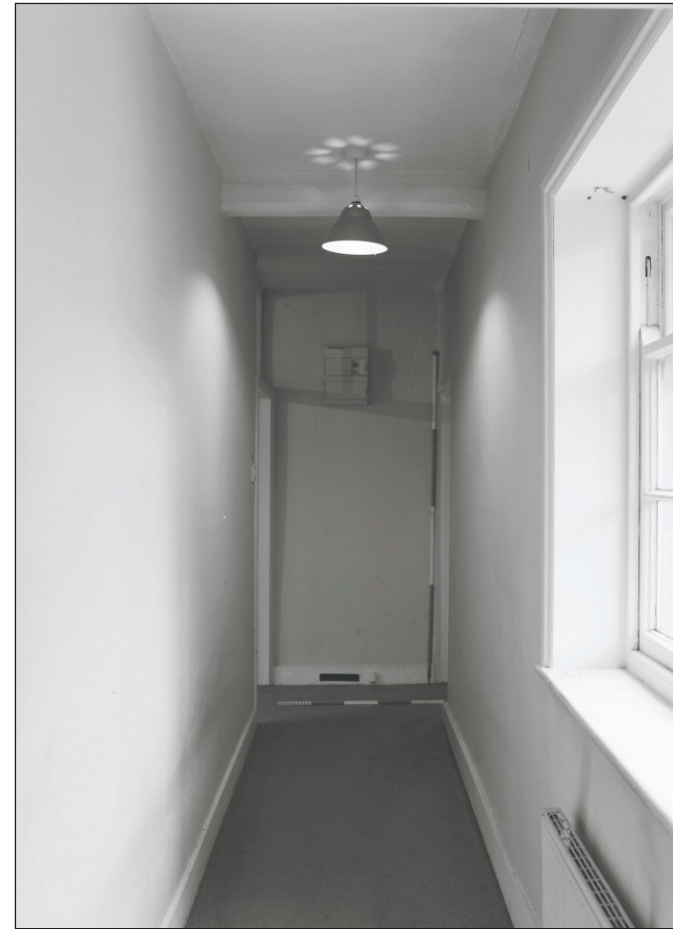
Plate 544: General view of corridor F39, South Range - Agent's House (Film 63.07)

Plate 545: General view of corridor F39, South Range - Agent's House (Film 64.05)

- 5.4.49 To the east of this was corridor F39 (**Plates 544, 545**), with sash window to the west, room F38 to the east and F40 to the north. Room F38 was a square room with fireplace to the north, and single sash window to the east (**Plates 546-550**), accessed from F39 to the southwest. The floor was constructed with timber floor boards on timber joists (**Plate 551**). A hatch within the ceiling of the room provided access to the roof space above, showing a timber King-Post roof structure with trenched and pegged purlins (**Plate 552**).
