NOSTELL PRIORY STABLES, NOSTELL, WAKEFIELD, WEST YORKSHIRE

Historic Building Recording and Structural Watching Brief

Planning Application Ref: 09/00701/FUL & 09/00705/LBC

72934.01_BDG_V0_4

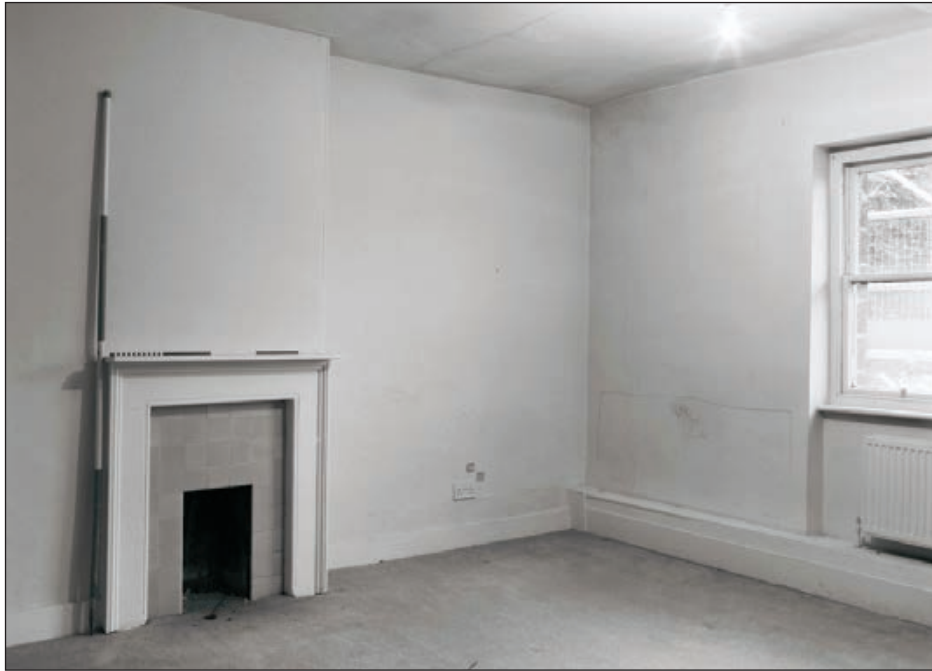
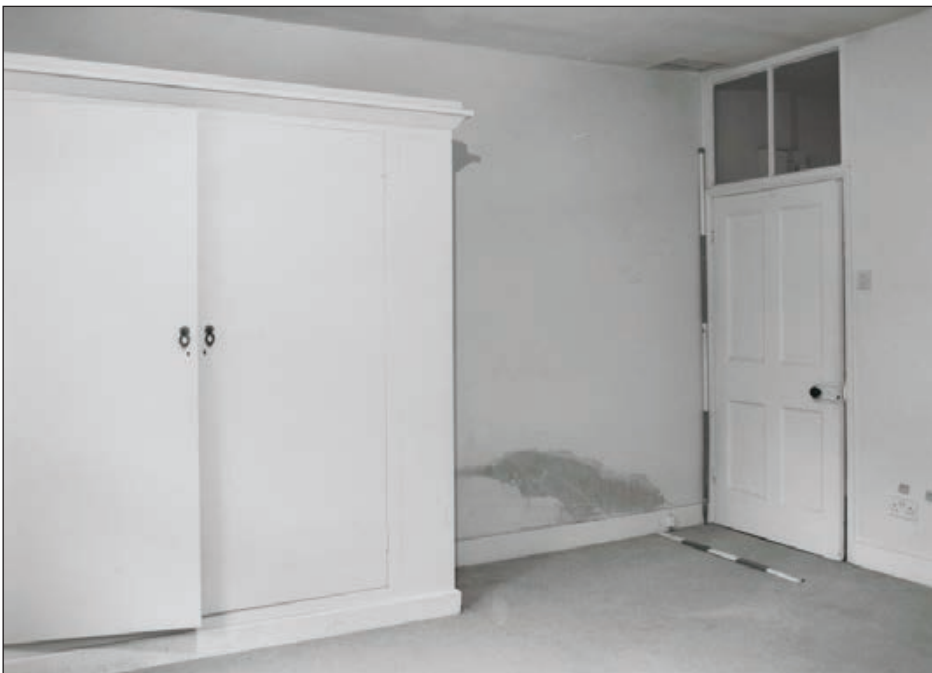
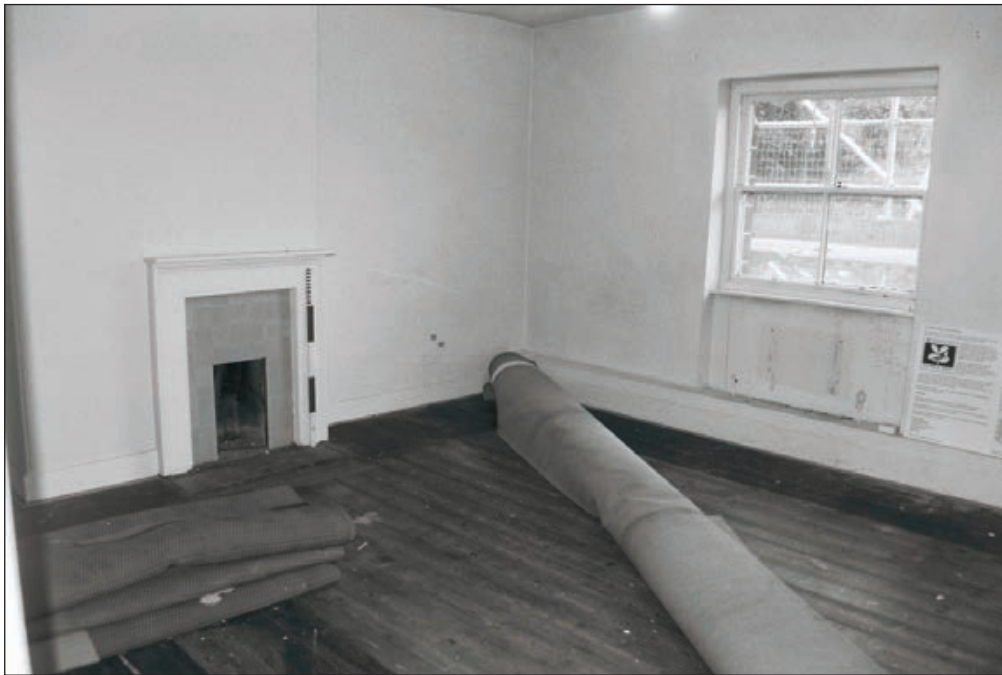
Plate 546: General view of F38, South Range - Agent's House (Film 63.03)

Plate 547: General view of F38, South Range - Agent's House (Film 63.05)

Plate 548: General view of F38, South Range - Agent's House - after removal of carpets (Film 66.31)

- 5.4.49 To the east of this was corridor F39 (**Plates 544, 545**), with sash window to the west, room F38 to the east and F40 to the north. Room F38 was a square room with fireplace to the north, and single sash window to the east (**Plates 546-550**), accessed from F39 to the southwest. The floor was constructed with timber floor boards on timber joists (**Plate 551**). A hatch within the ceiling of the room provided access to the roof space above, showing a timber King-Post roof structure with trenched and pegged purlins (**Plate 552**).

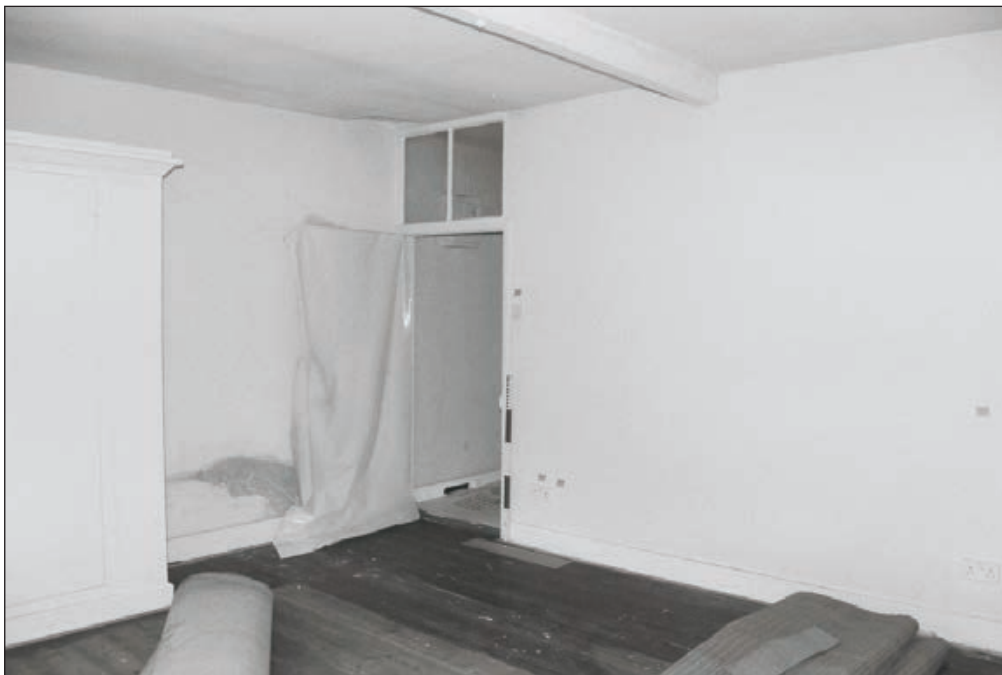
Plate 549: General view of F38, South Range - Agent's House - after removal of carpets (Film 66.29)

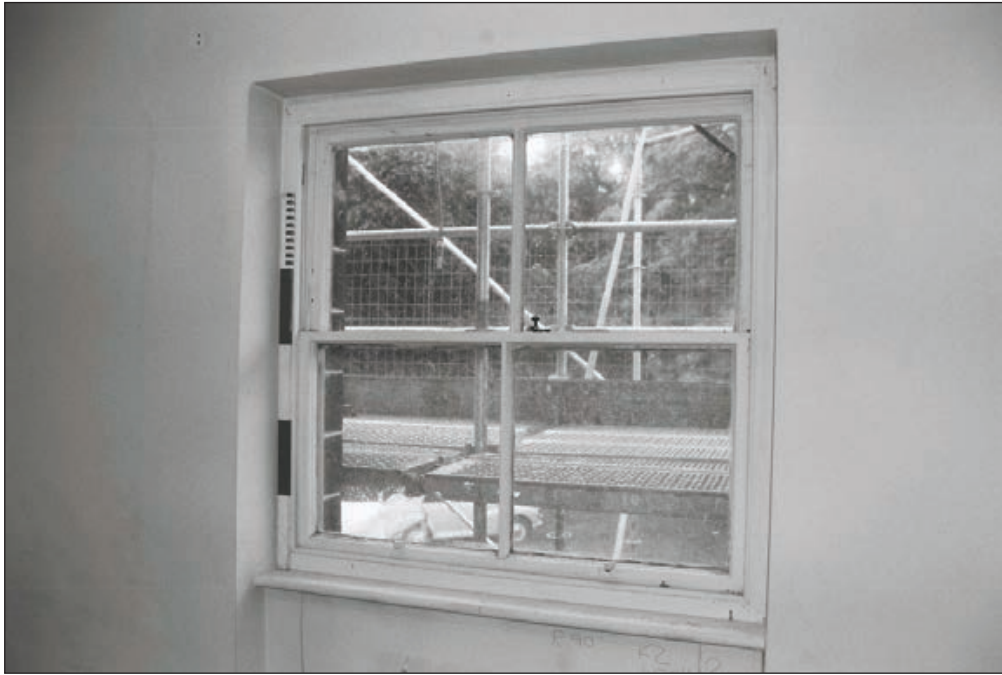
Plate 550: Detail of sash window, F38, South Range - Agent's House (Film 65.12)

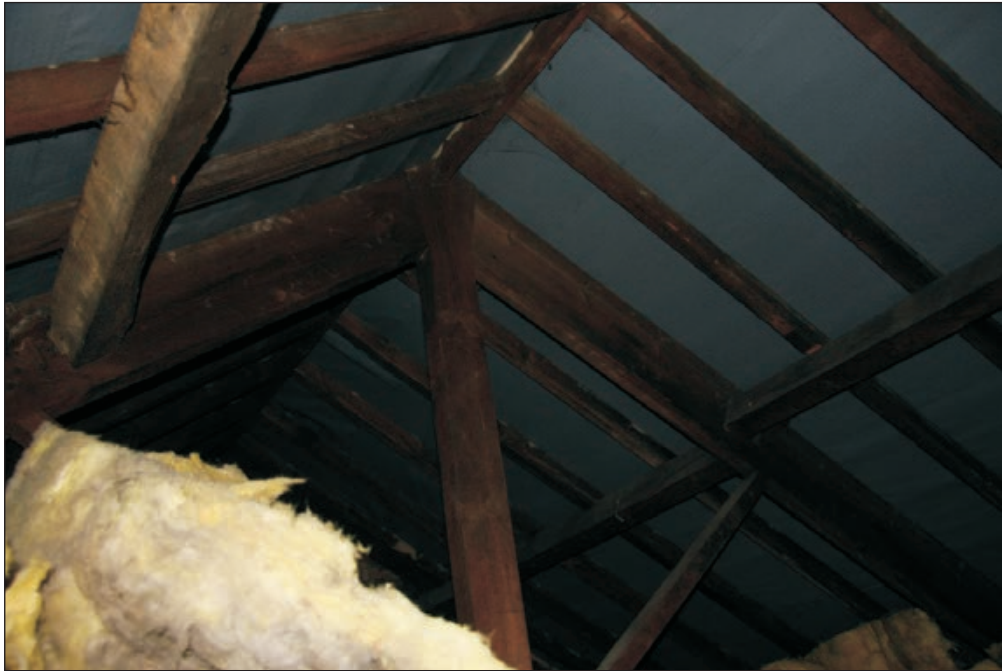
Plate 552: View of timber King-Post truss in roof above F38, South Range - Agent's House (Film D. 21.10.10 1860)

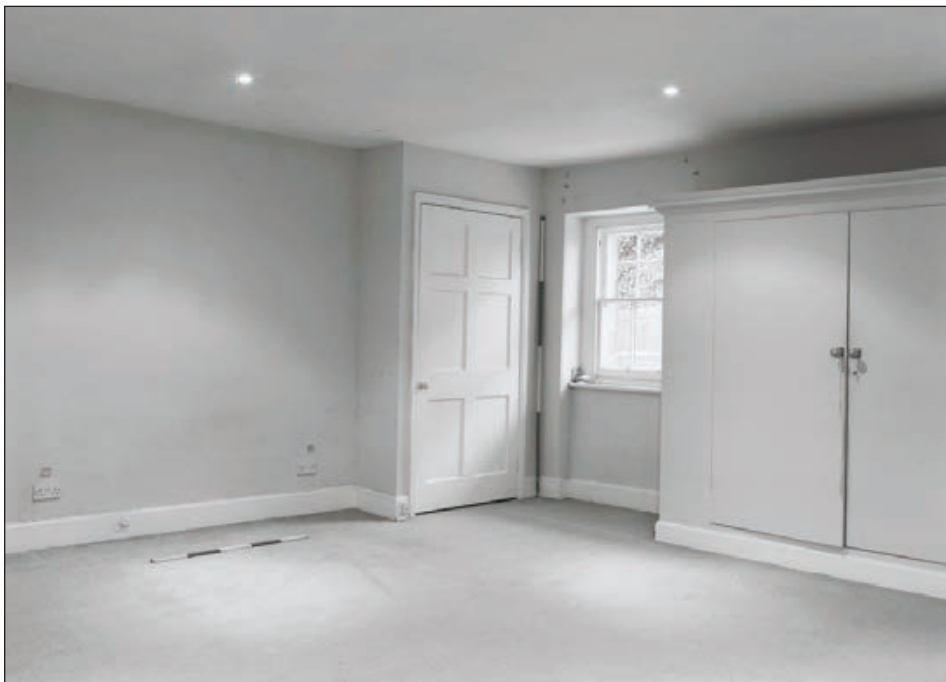
Plate 553: General view of F40, South Range - Agent's House (Film 63.09)

- 5.4.50 To the north, accessed from F39, was room F40 (**Plates 553-555**). This had several modern built-in cupboards, two sash windows to the east, and a single sash to the west. Within the south wall was a fireplace (**Plate 556**). The floor was constructed of timber joisting with noggins covered by floor boards (**Plates 557, 558**). The room also retained its original skirting (**Plate 559**). To the north of F40, was a small modern en-suite bathroom, F41 (**Plate 560**). This had been inserted above the staircase in G53 and F42. Although this was a modern insertion, evidence of blocked doorways within the north and south walls suggest that there had been a corridor linking the two first floors of the Agent's House and East Range, prior to the en-suite.

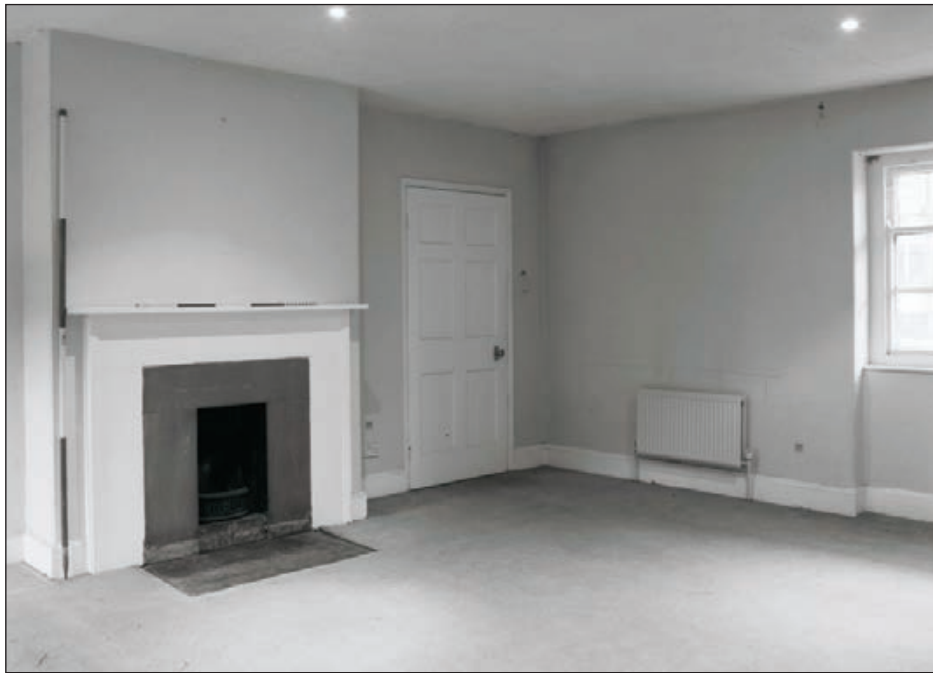
Plate 554: General view of F40, South Range - Agent's House (Film 64.01)

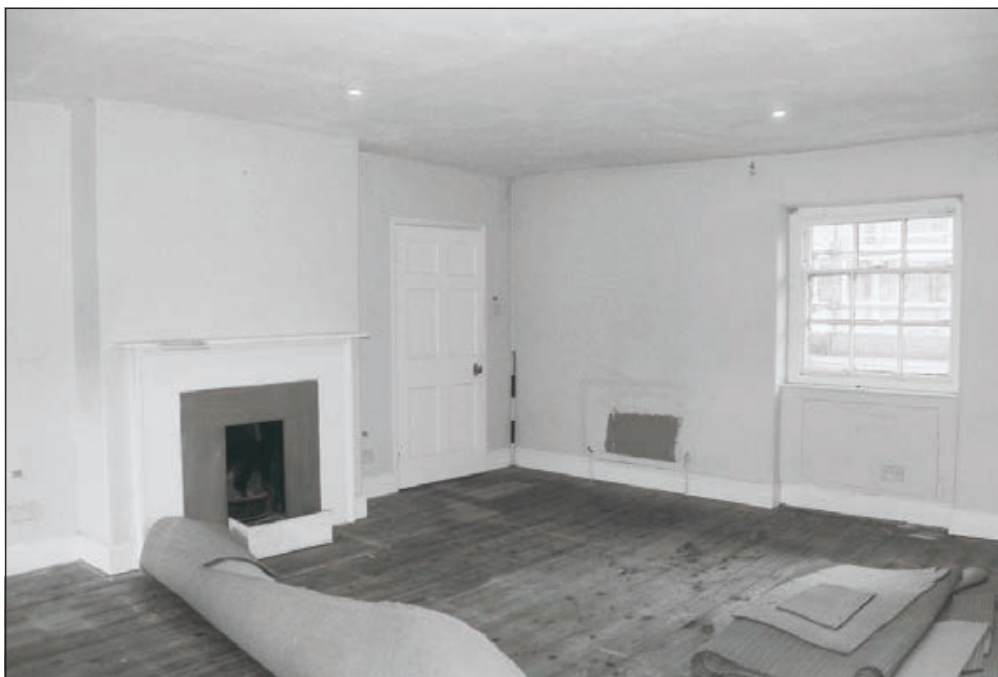
Plate 555: General view of F40, South Range - Agent's House - after removal of carpet (Film 66.26)

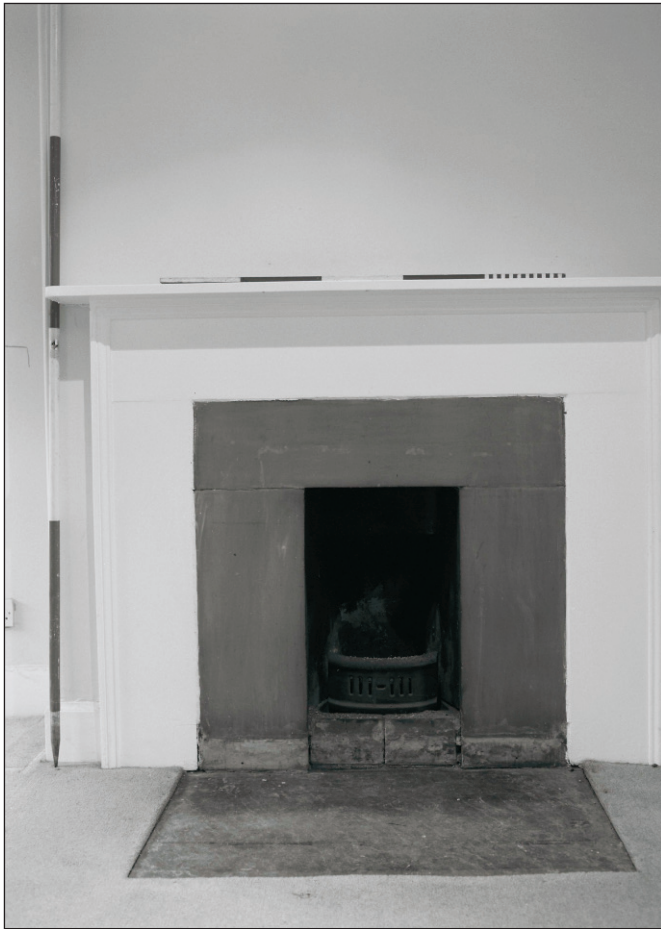
Plate 556: Detail of fireplace, F40, South Range - Agent's House (Film 64.03)

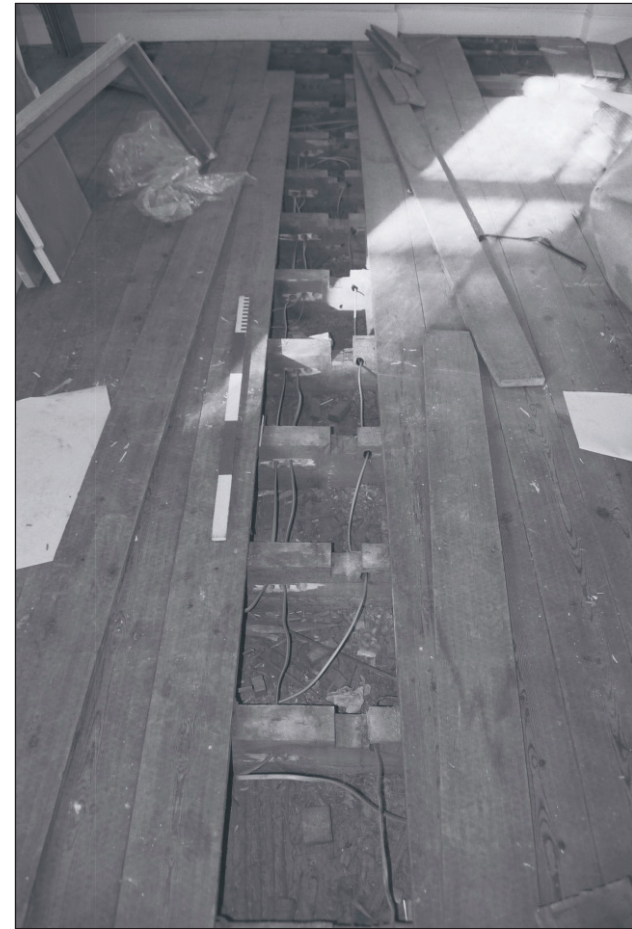
Plate 557: Detail of exposed floor joists, F40, South Range - Agent's House - OB. 82 (Film 67.31)

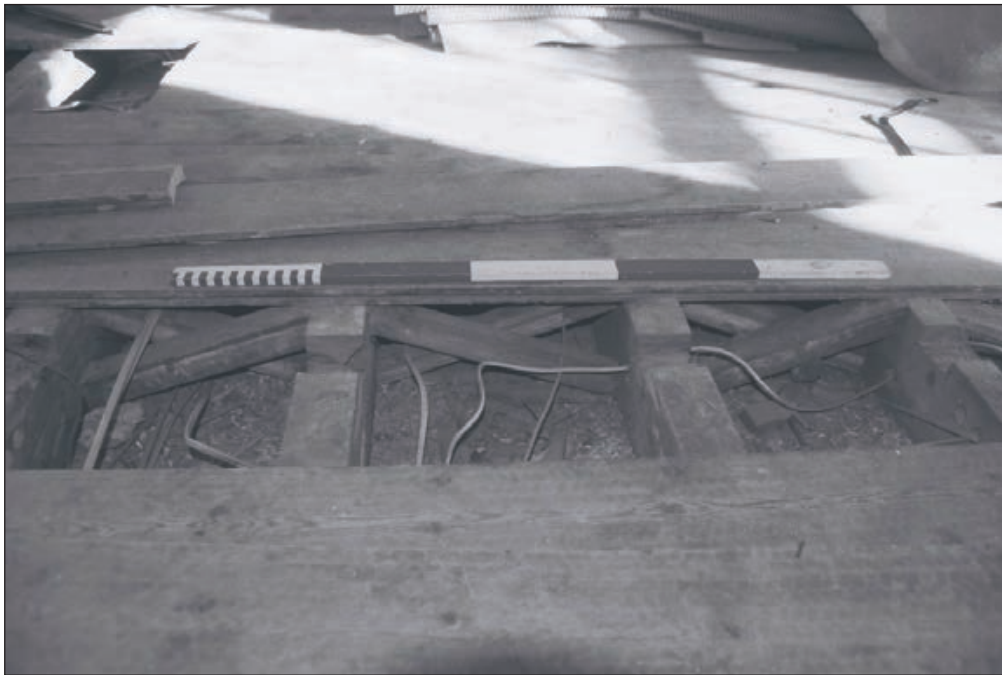
Plate 558: Detail of exposed noggins between joists, F40, South Range - Agent's House - OB. 82 (Film 67.27)

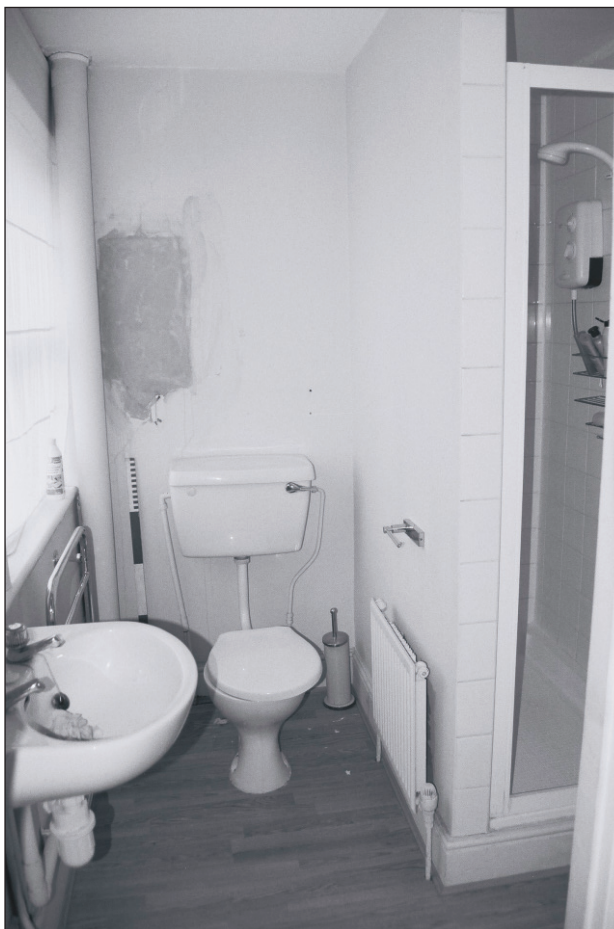
Plate 560: General view of F41, South Range - Agent's House
(Film 44.32)

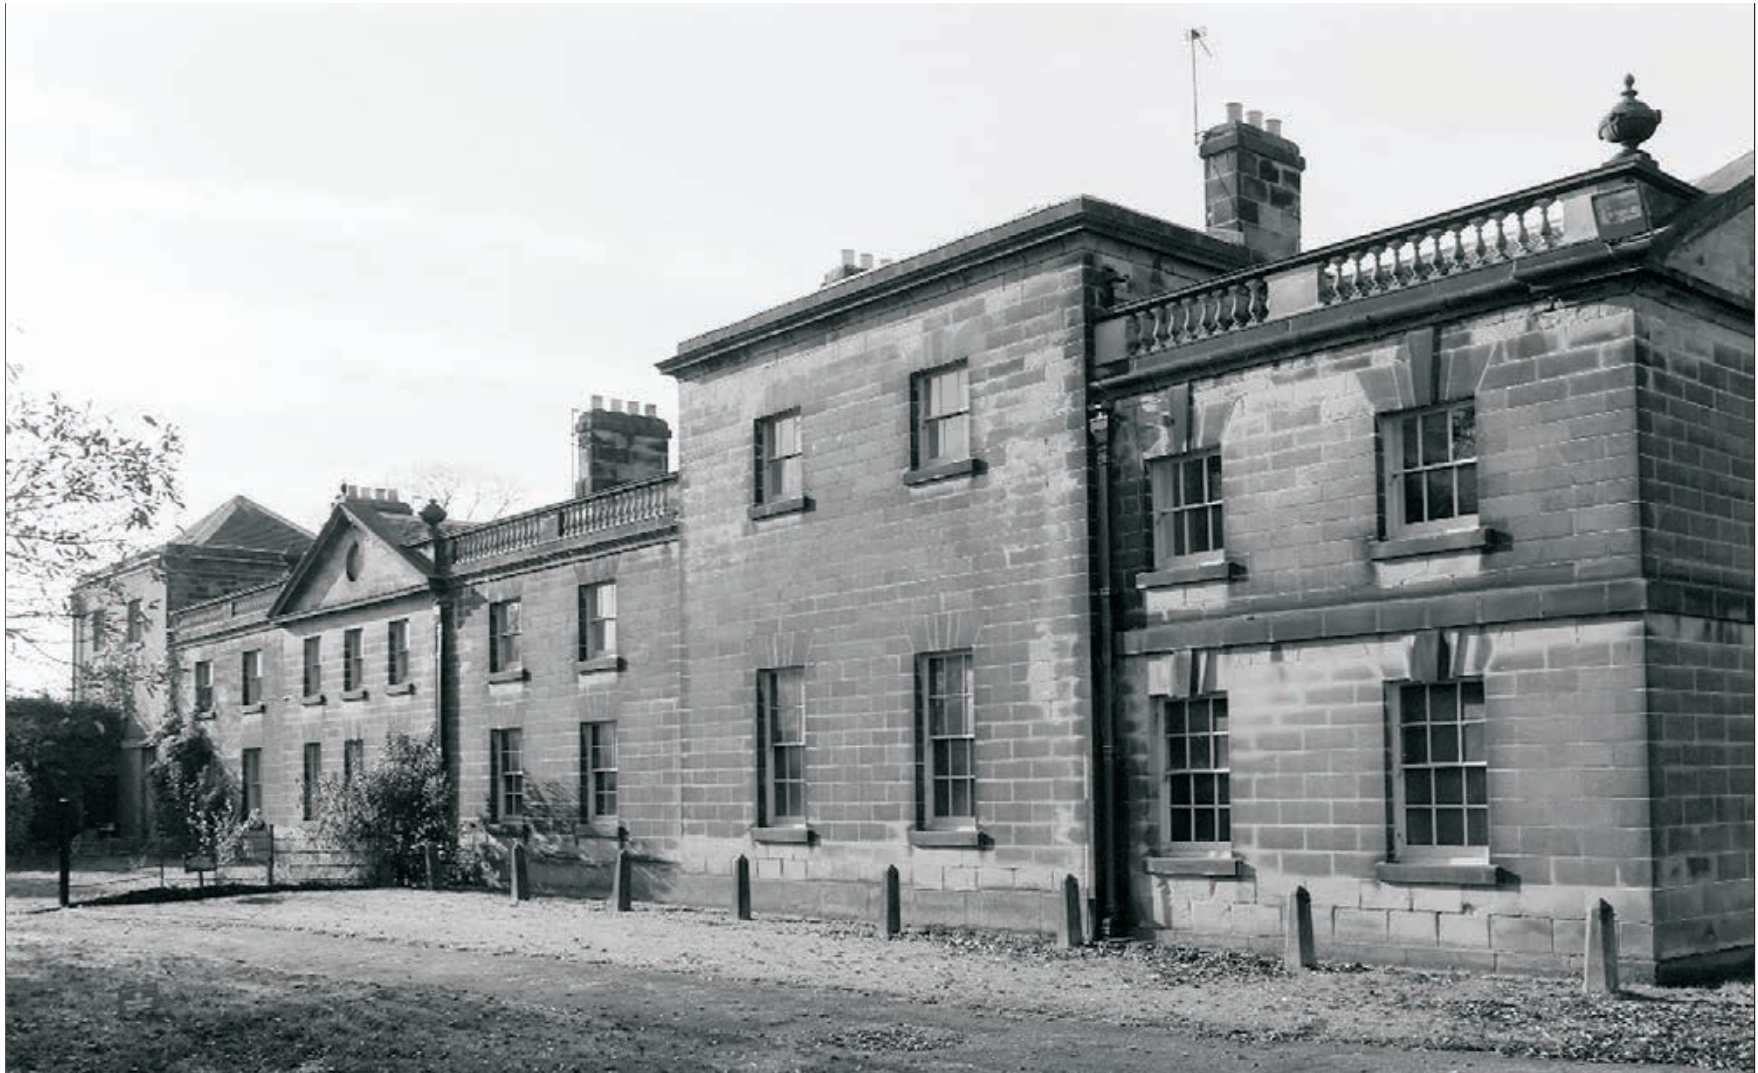
Plate 561: General view of the east elevation of the South, East and North Ranges, looking southwest (Film 01.06)

- 5.5.2 The northernmost two bays which form the east end of the North Range contained a blind and internally boarded window at ground floor and two small sash windows at first floor, all of which had segmental stone flat arched heads with accented key stone, and projecting stone sills. There was a continuation of the string course within the north elevation, dividing the ground and first floors, and the top of the elevation was finished with a stone balustrade (**Plate 561**).

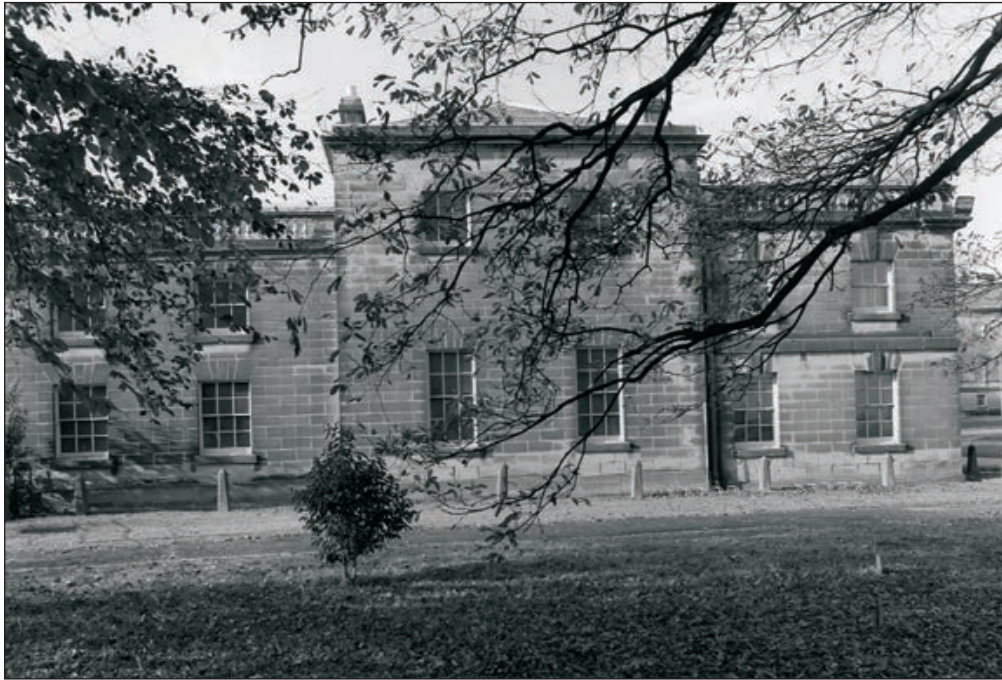
Plate 562: View of the north end of the east elevation of the North and East Ranges (Film 01.08)

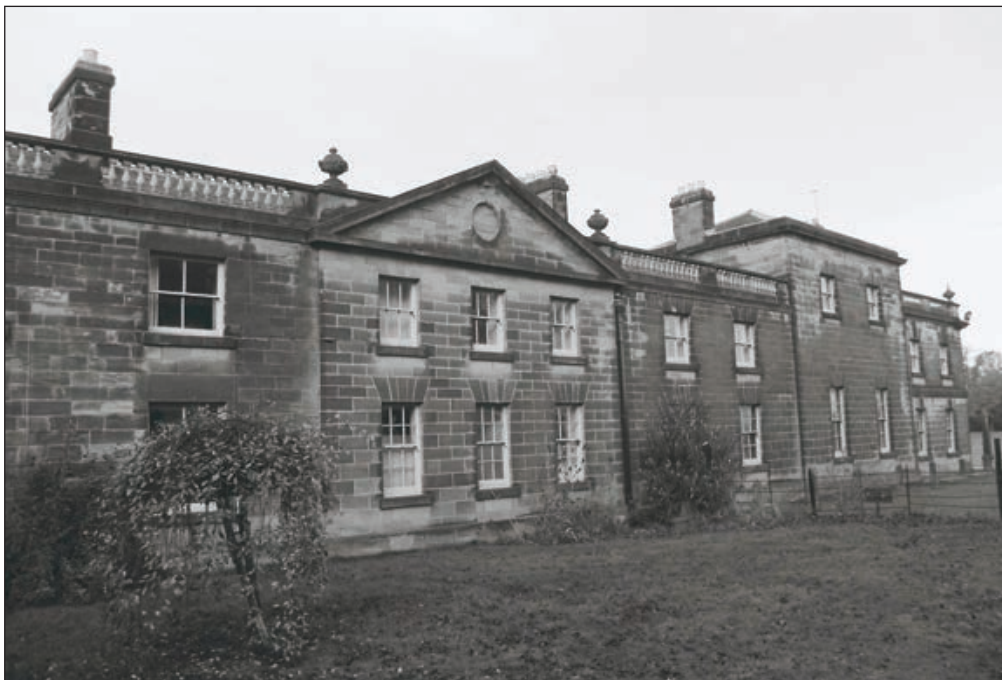
Plate 563: View of the east elevation of the South and East Ranges, looking northwest (Film 11.33)

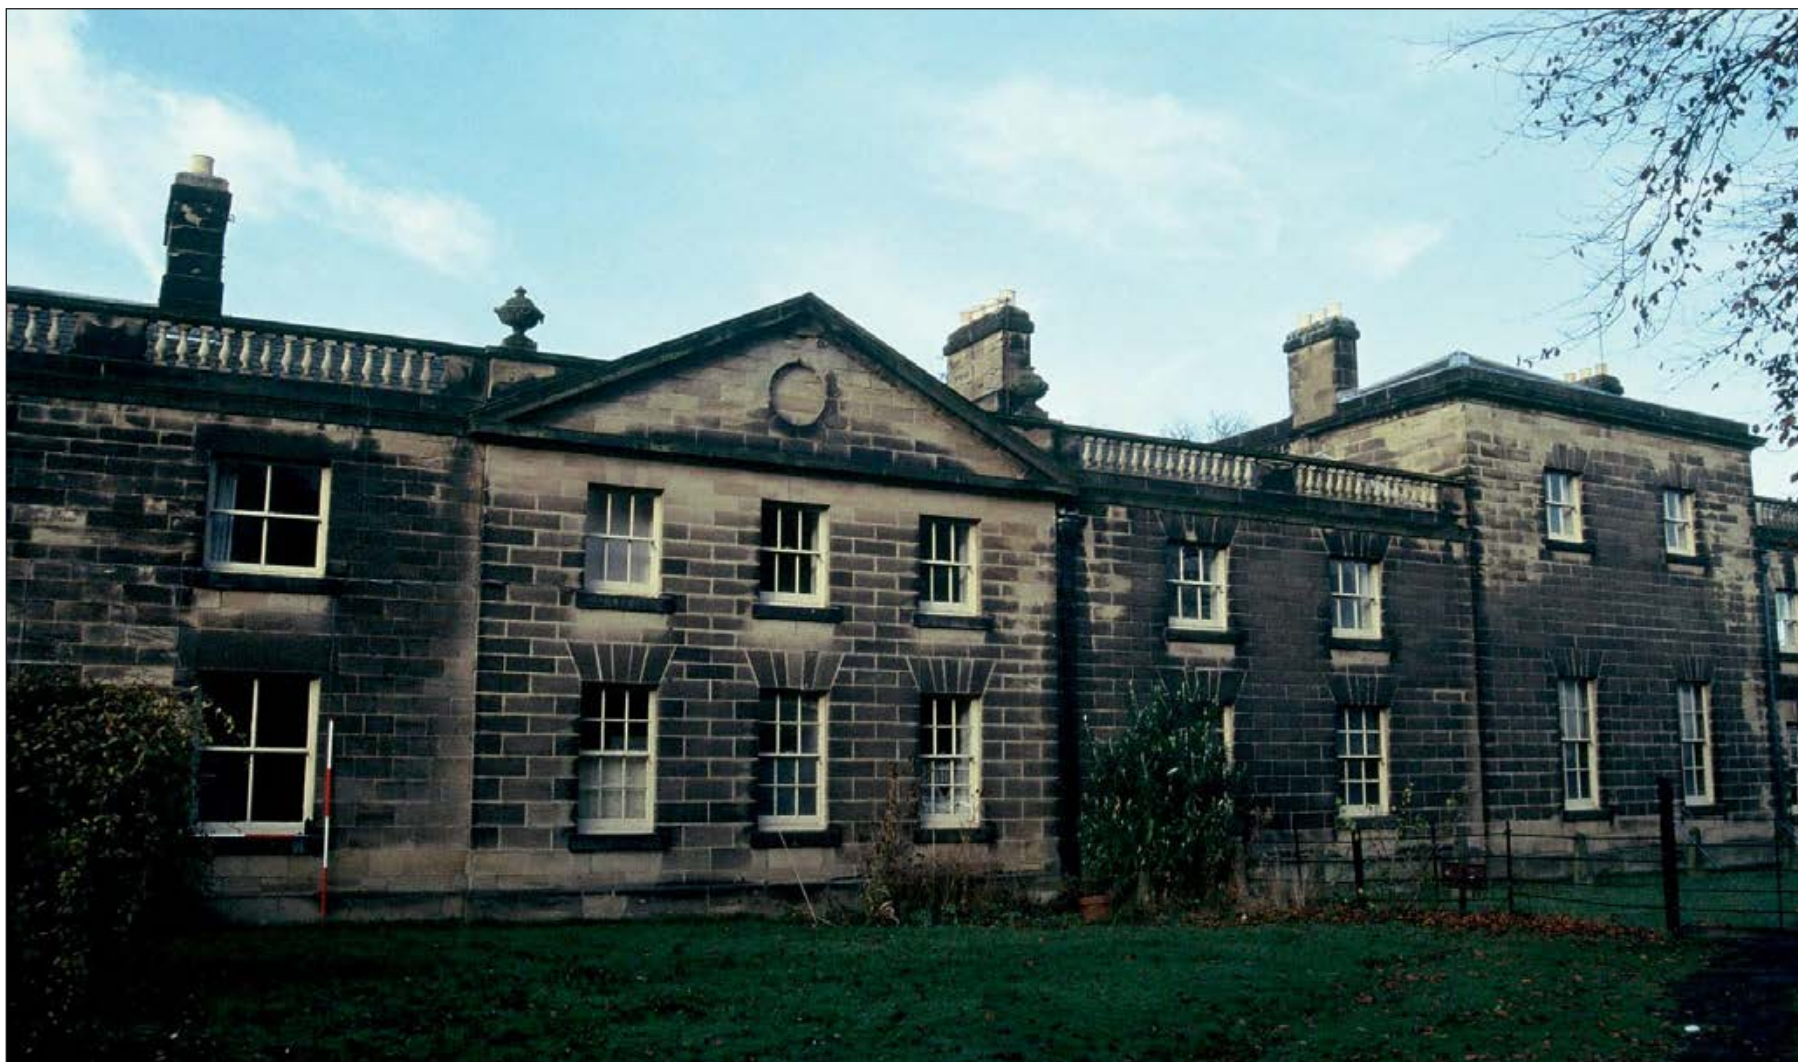
Plate 564: General view of the east elevation of the South and East Ranges, looking northwest (Film C.S.2.)

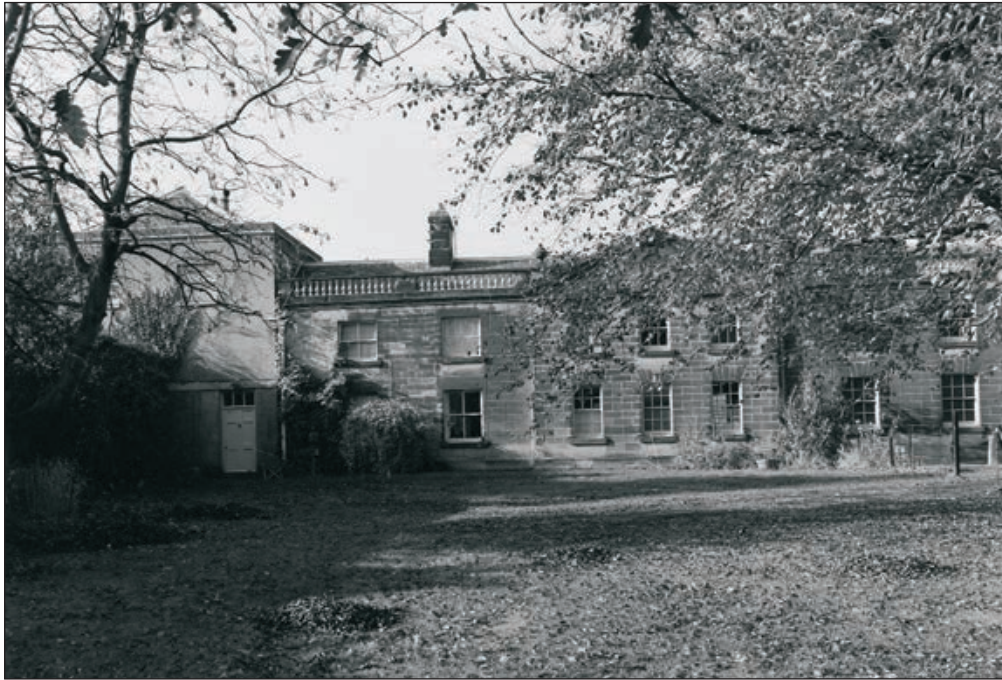
Plate 565: View of the south end of the east elevation of the South and East Ranges (Film 01.09)

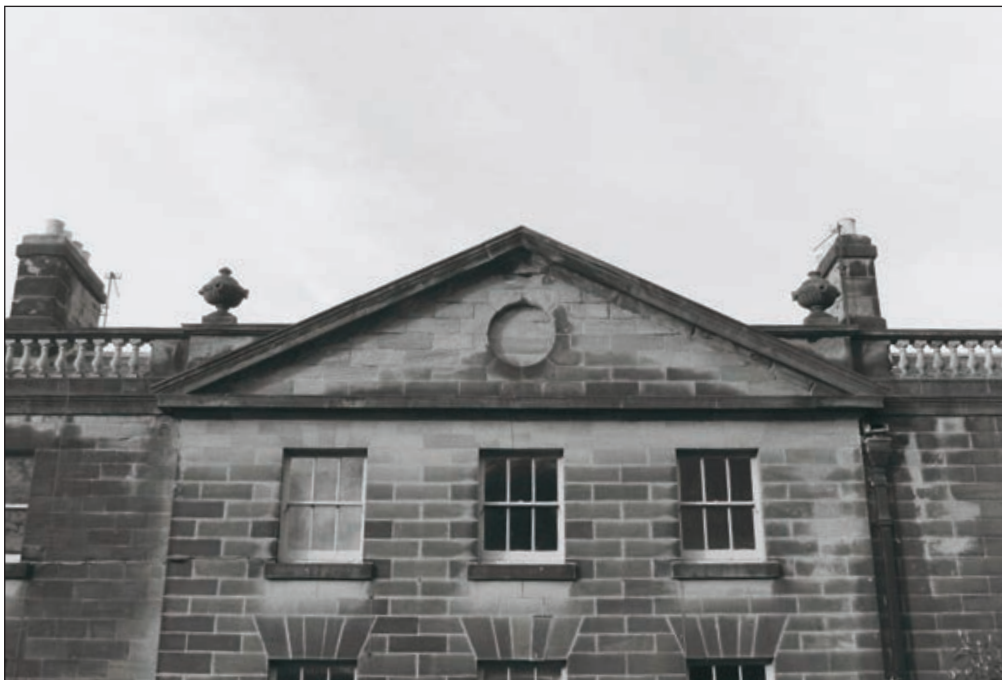
Plate 566: View of upper projecting pedimented section of the east elevation of the South and East Ranges (Film 12.02)

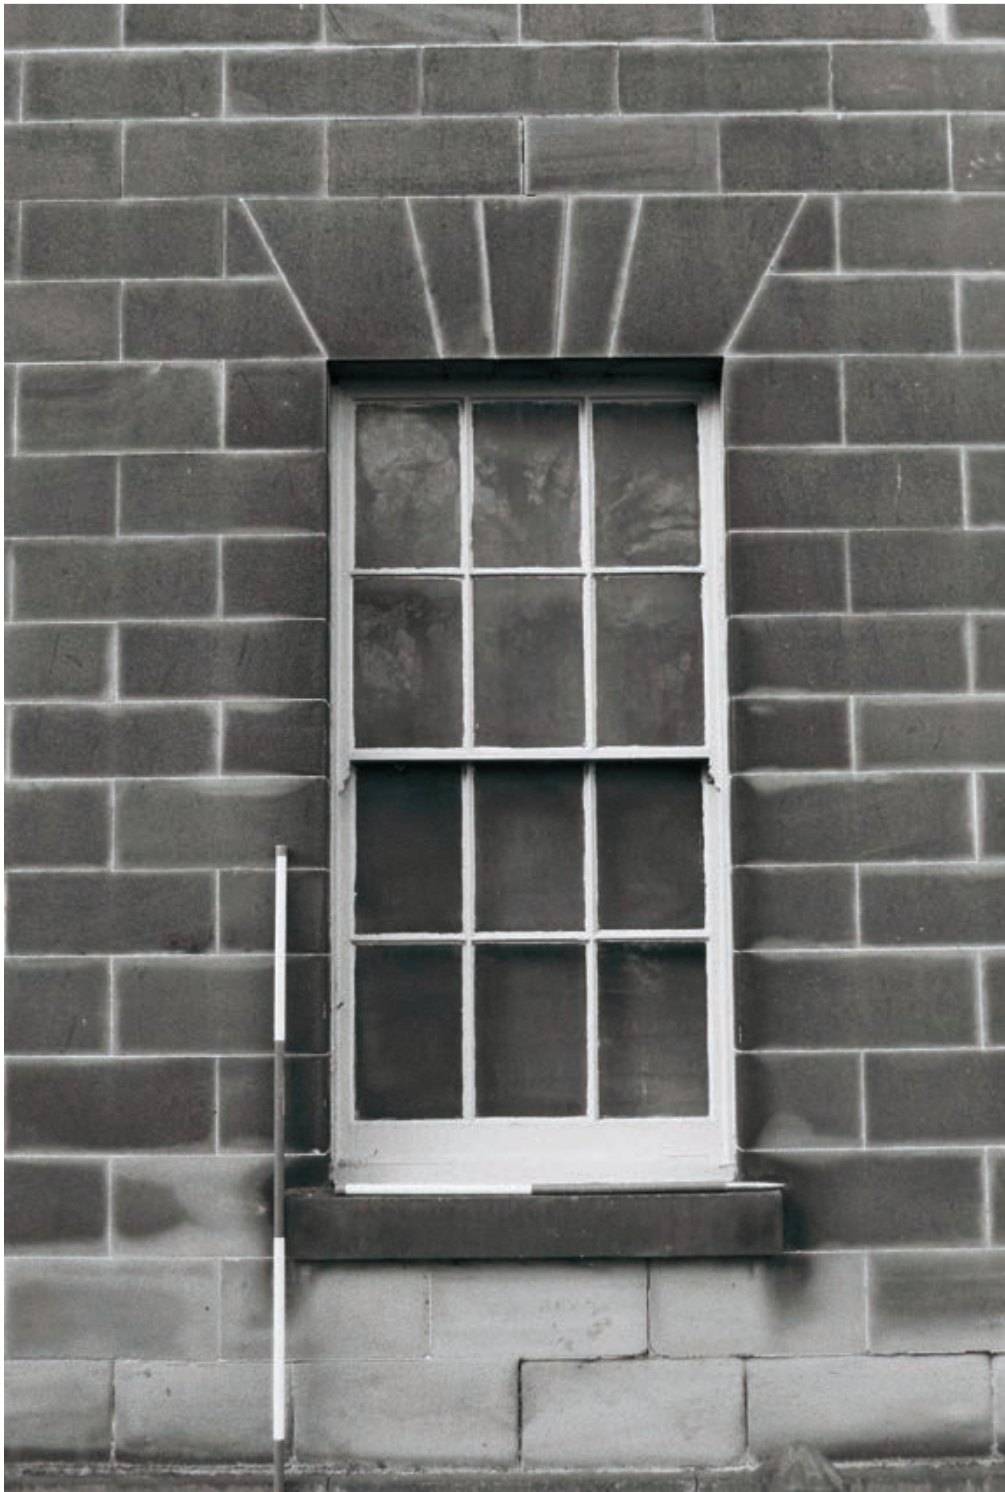
Plate 567: Detail of a 1905 blind window at the north end of the east elevation of the East Range (Film 11. 26)

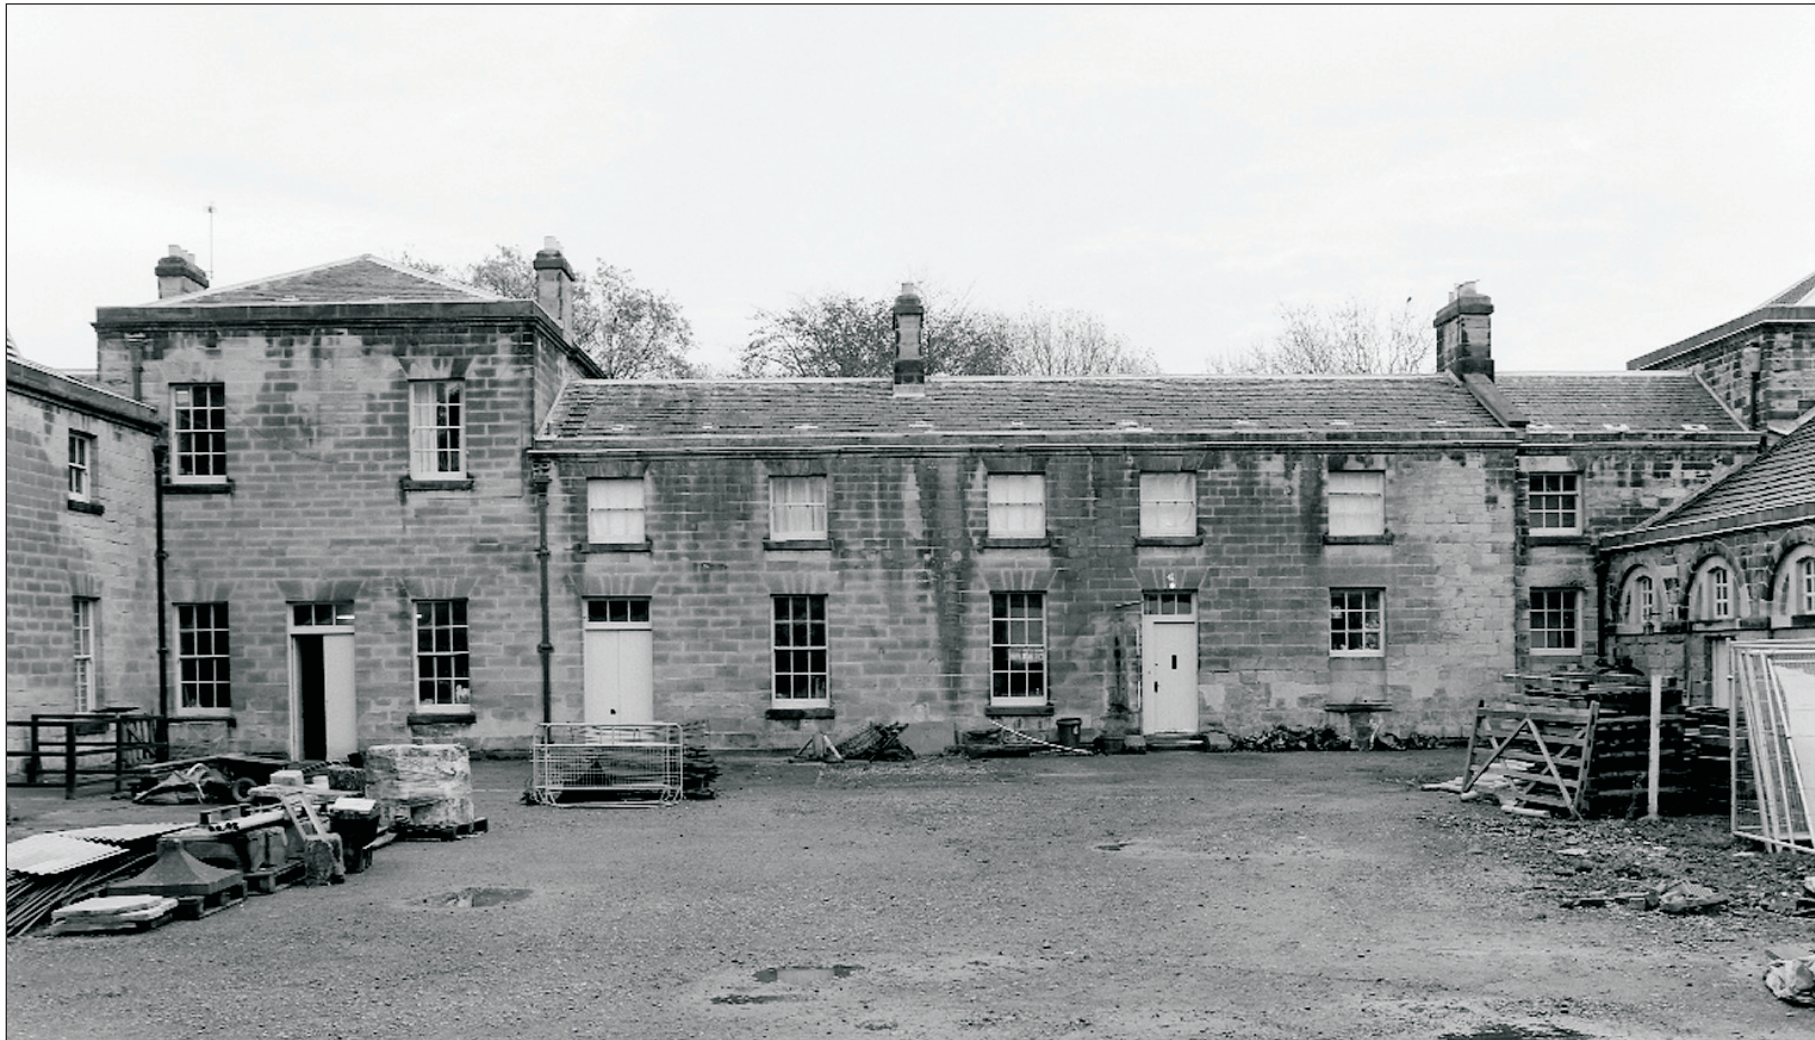
Plate 568: View of the west courtyard elevation of the East and South Range, looking east (Film 18.01)

- 5.4.17 The west elevation of the Agent's House (South Range), fronting the courtyard, encompassed the southernmost three bays of the elevation (**Figures 12 and 14 and Plate 568**). The southern bay was stepped back from the remainder of the elevation and contained a sash window within the upper half, whilst the lower half was blind at ground floor, and a sash window at first floor. At ground floor, the remaining two bays contained a further half blind half sash window (**Plate 369**) and a doorway leading into the Agent's House and the East Range. At first floor were two sash windows (**Plate 370**). The openings which were of phase 2 or 5 construction contained flush flat stone lintels, whilst those representing phase 6 construction had segmental stone heads (**Plate 658**).

taller structure had two sash windows at both ground and first floor, as well as a central double doorway at ground floor (**Plate 569**). The roof is a pyramidal design with stone tile covering (**Plates 568, 569**).

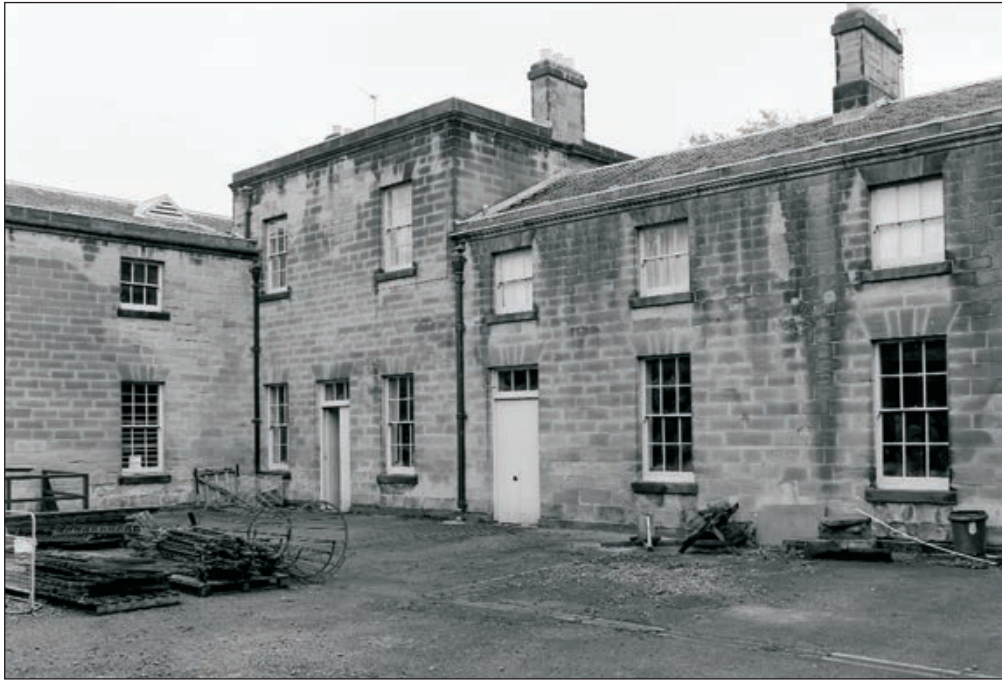
Plate 569: View of the north end of the west courtyard elevation of the Range, showing junction with the North Range, looking northeast (Film 17.09)

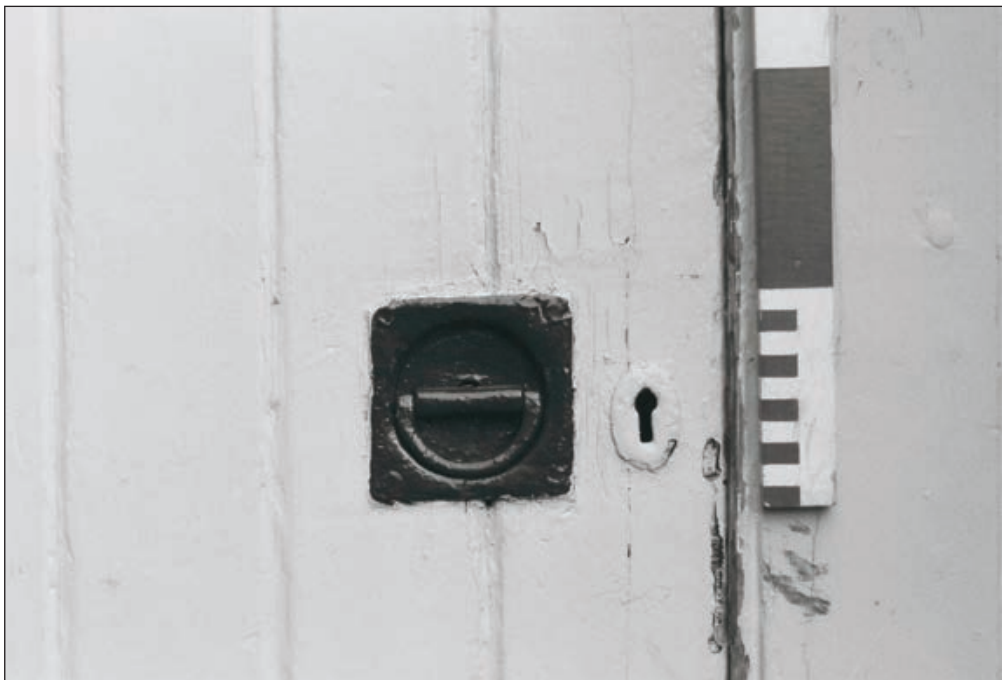
Plate 570: Detail of door furniture of the 1905 stable doorways at the north end of the west elevation of the East Range (Film 16.32)

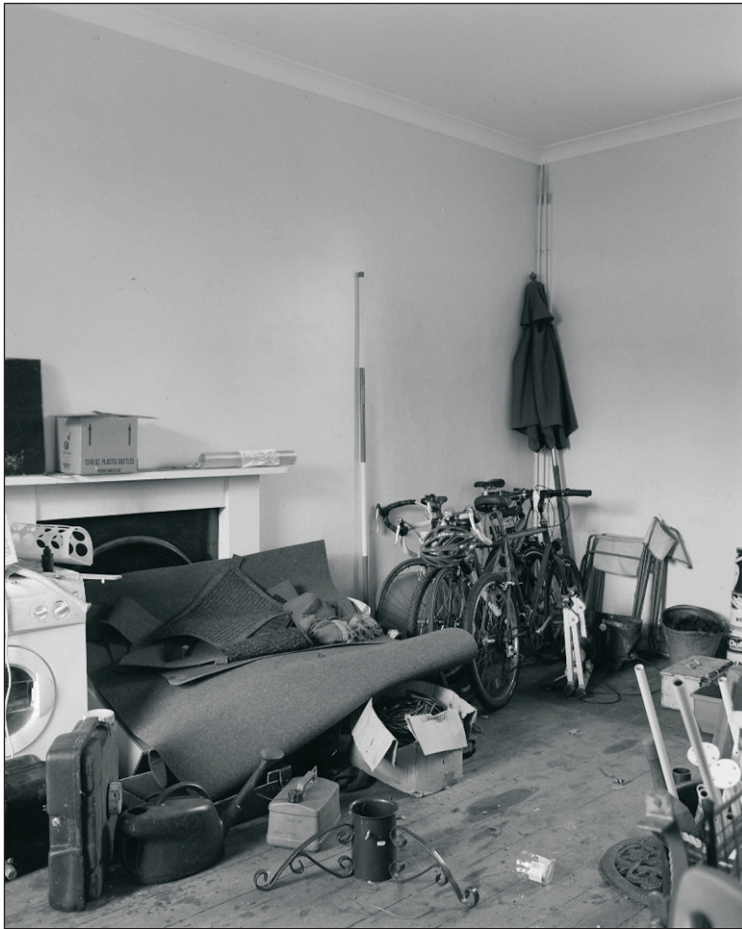
Plate 571: General view of G54, East Range (Film 19.09)

- 5.5.5 The ground floor contained room G54, accessed only from G53 to the south (**Figure 11**). This was a rectangular room with sash windows to the east and west, and a cast iron fireplace to the north (**Plates 571-573**). A simple coving was retained around the room, whilst the floor was constructed from floor boards laid on timber joists on top of brick supports (**Plate 574**).

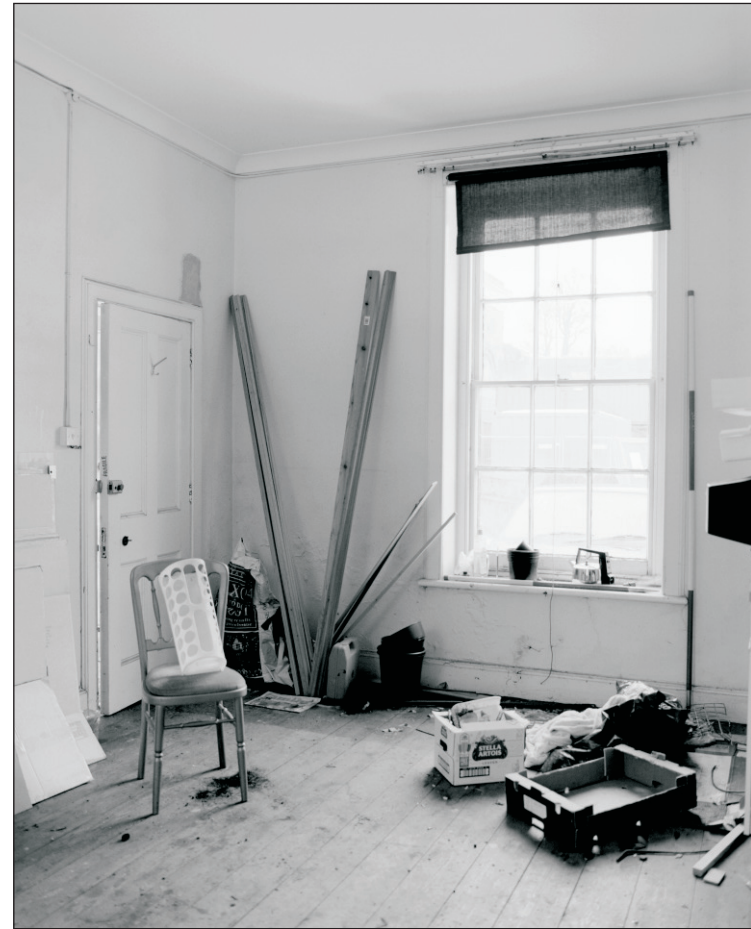
Plate 572: General view of G54, East Range (Film 30.06)
