NOSTELL PRIORY STABLES, NOSTELL, WAKEFIELD, WEST YORKSHIRE

Historic Building Recording and Structural Watching Brief

Planning Application Ref: 09/00701/FUL & 09/00705/LBC

72934.01_BDG_V0_4

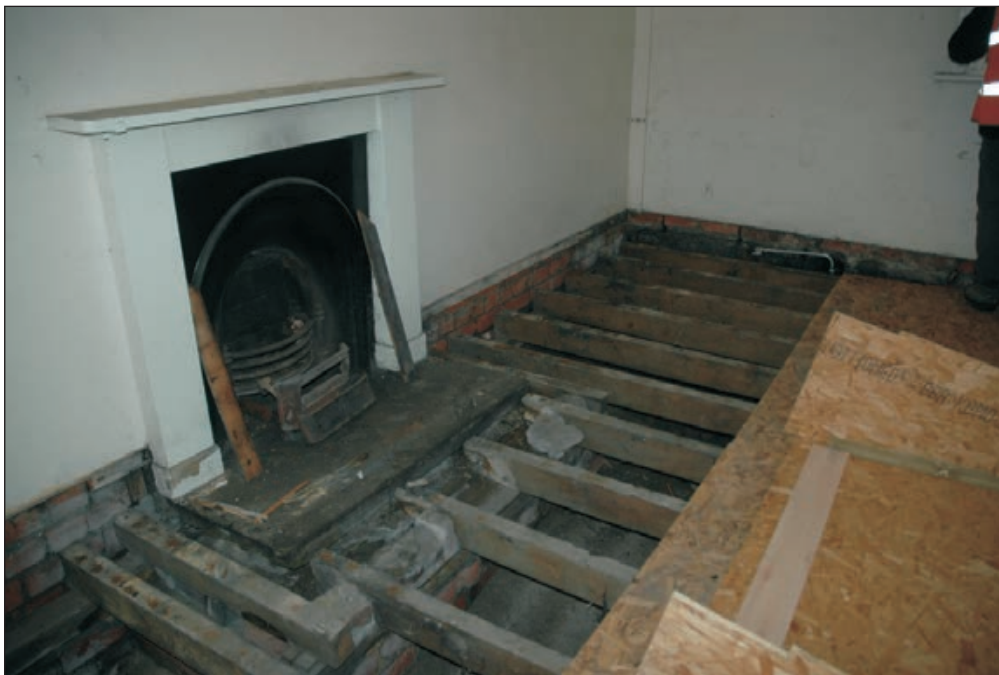
Plate 574: Detail of exposed timber joists, G54, East Range (Film D.03.03.10 7626)

- 5.5.5 The ground floor contained room G54, accessed only from G53 to the south (**Figure 11**). This was a rectangular room with sash windows to the east and west, and a cast iron fireplace to the north (**Plates 571-573**). A simple coving was retained around the room, whilst the floor was constructed from floor boards laid on timber joists on top of brick supports (**Plate 574**).

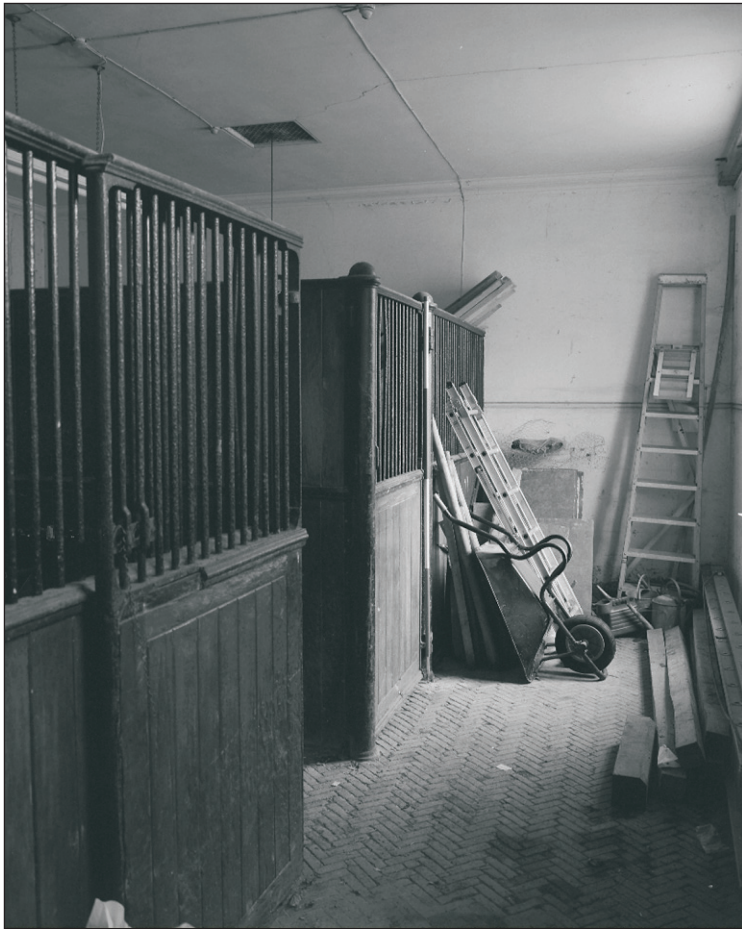
Plate 575: General view of G55, East Range (Film 19.06)

- 5.5.6 To the north were two rooms: G55 and G56. These each had two loose boxes within them (G55a & b and G56 a & b) (**Figure 11**). Room G55 (**Plate 575**), contained a doorway and window to the south, with recessed arched drain and tap positioned between the two within the wall (**Plate 576**). The loose boxes were essentially the same as those retained and previously described within G2 of the North Range. The floor was of brick in a herringbone pattern (**Plate 577**), and original moulded cornicing is retained, framing the ceiling (**Plate 578**). Of note were two designs of tether hooks within the loose boxes: one is a 'flower' shape; the other a 'star' shape (**Plates 579, 580**). A small section of the lower tongue and groove match boarding within the loose box was removed, exposing the internal brick construction of the east wall (**Plate 581**). At the west side of the south wall, an opening was inserted during the works. The removed plaster exposed the brickwork of the wall (**Plate 582**), and the detail of the moulded plaster dado around the room (**Plate 583**). Also undertaken as part of the refurbishment works was the removal of the west partition of the loose box. This included the removal of the cast iron column, the base of which had been firmly placed well below the floor level (**Plate 584**). The two former blind windows within the east wall were opened up during the works.

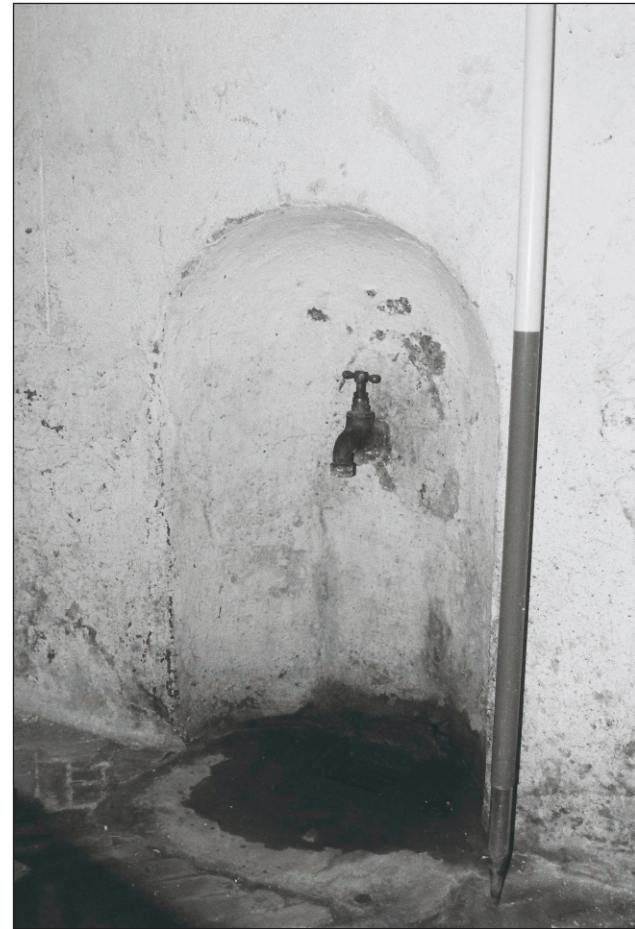
Plate 576: Detail of recessed drain, west wall of G55, East Range (Film 16.23)

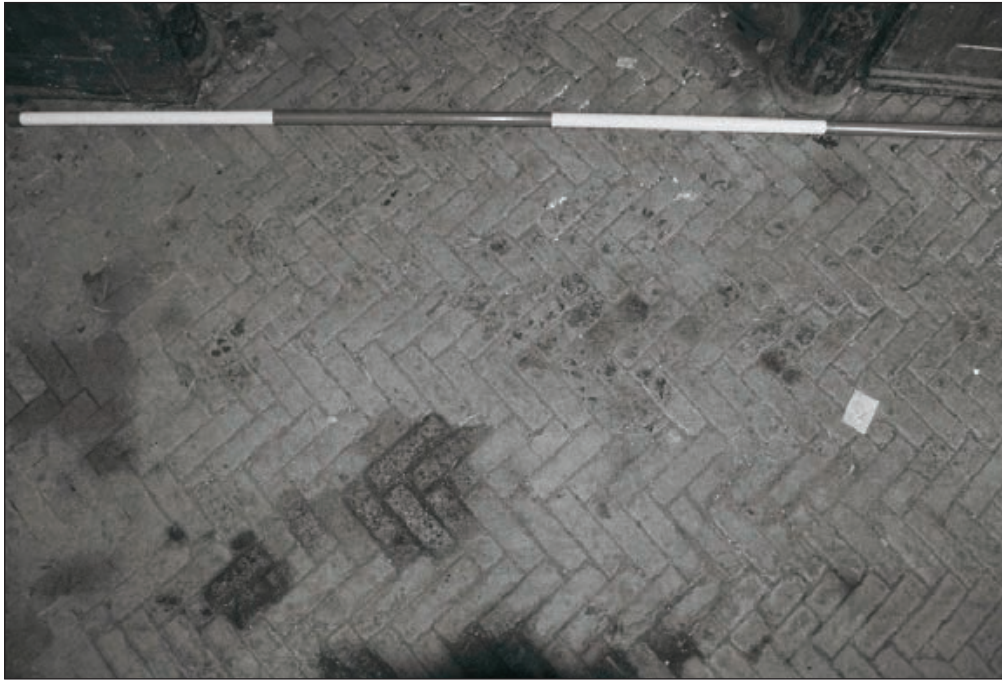
Plate 577: Detail of herringbone brick floor, G55, East Range (Film 16.20)

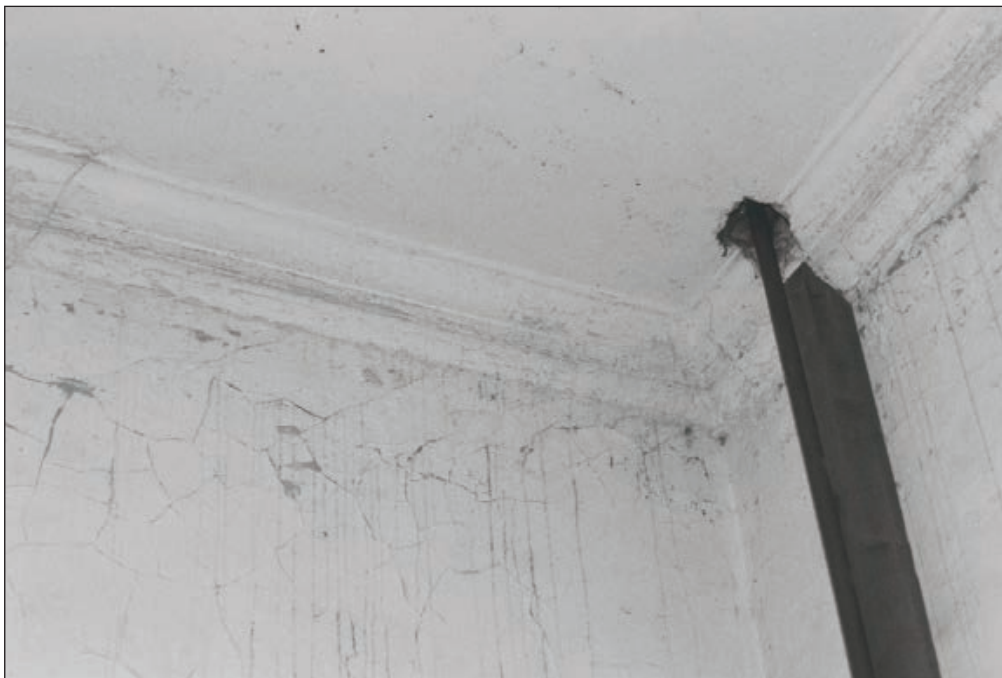
Plate 578: Detail of original cornice, G55, East Range (Film 16.26)

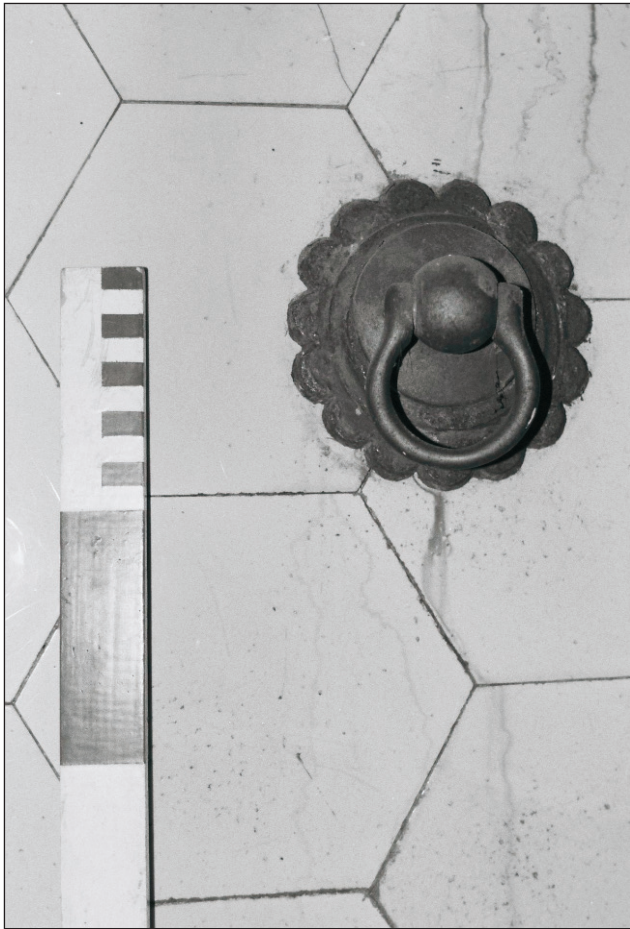
Plate 579: Detail of iron tether hook, G55, East Range (Film 16.25)

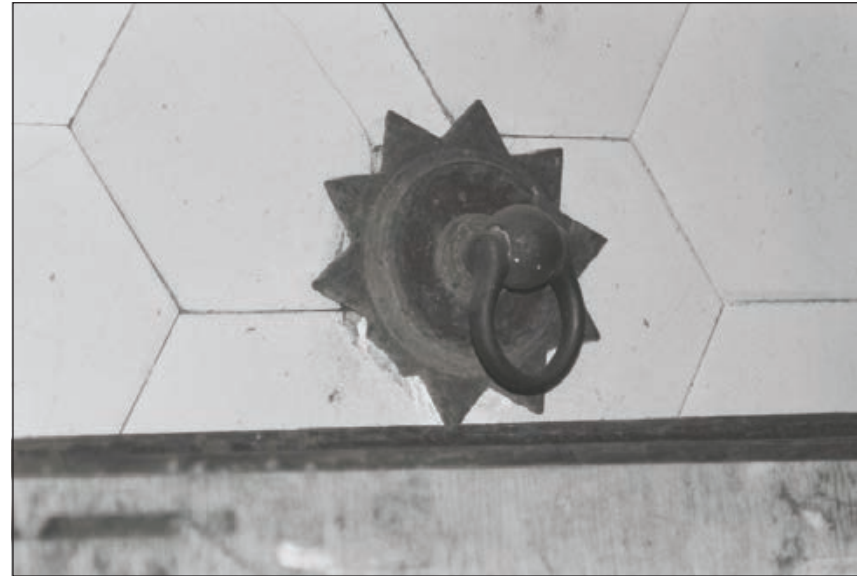
Plate 580: Detail of iron tether hook, G55, East Range (Film 16.29)

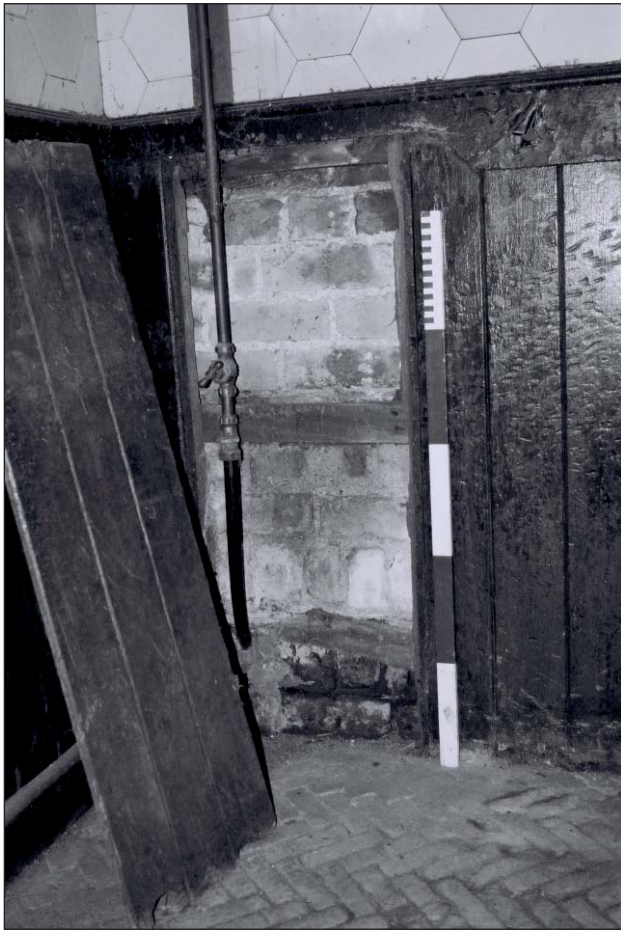
Plate 581: Detail of removed tongue and groove boarding, east wall of G55, East Range - OB. 12 (Film 43.5)

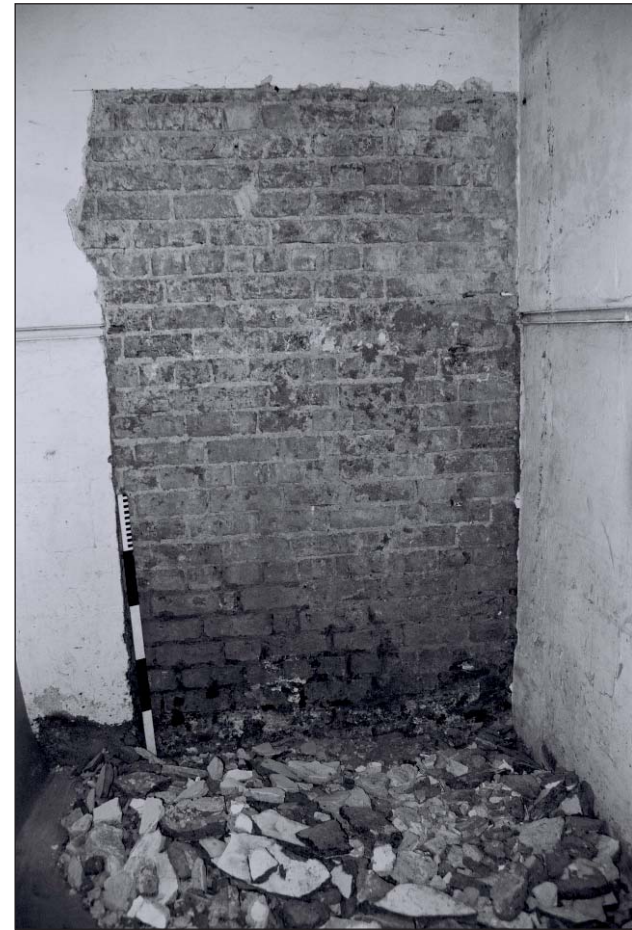
Plate 582: Detail of exposed brickwork, south wall of, G55, East Range - OB. 11 (Film 43.7)

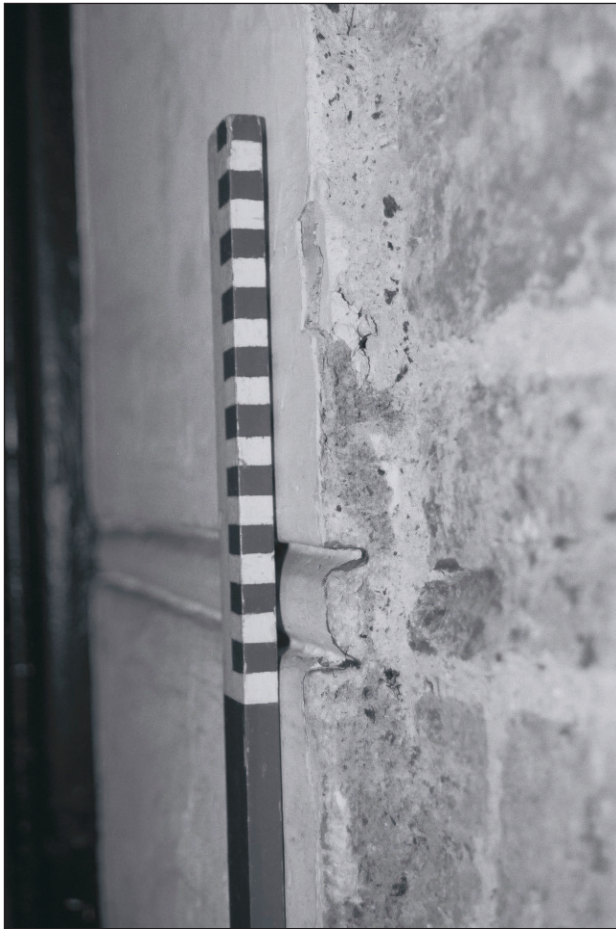
Plate 583: Detail of moulded wall plaster, G55, East Range (Film 45.33)

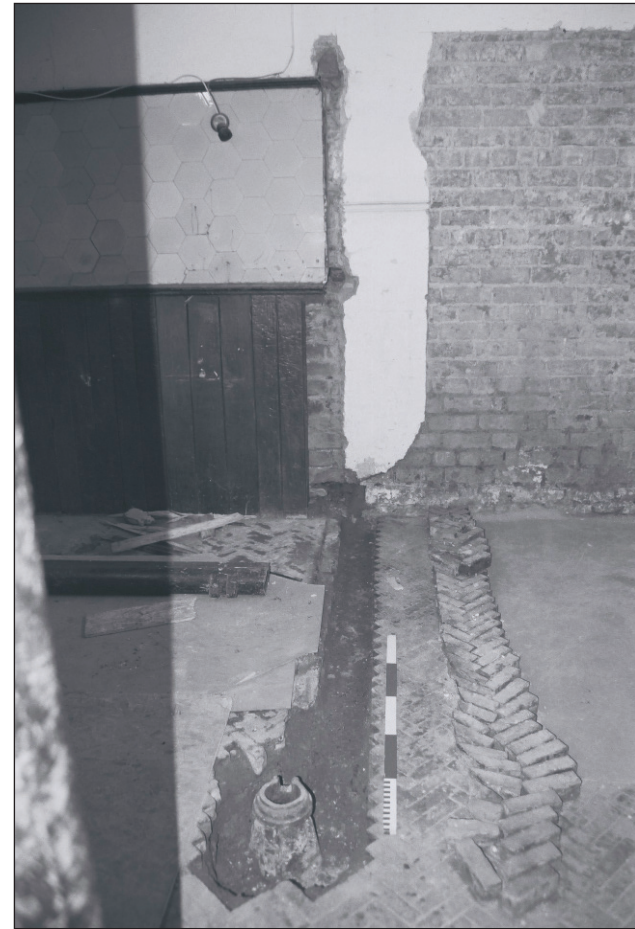
Plate 584: Detail of removed cast iron loose box column, partition and brick floor, G55, East Range (Film 45.25)

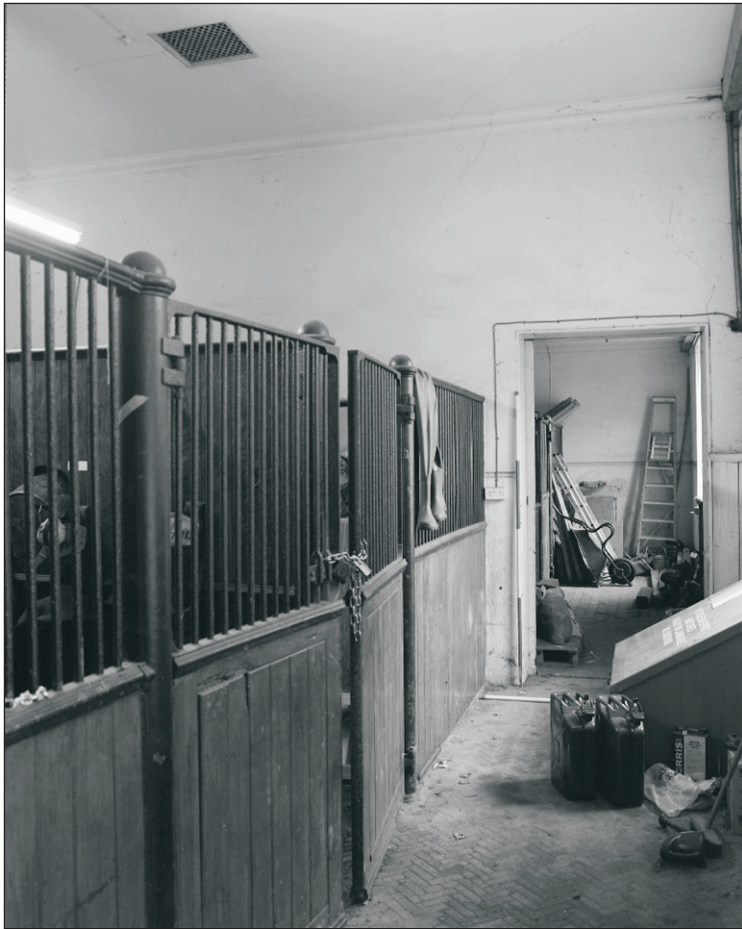
Plate 585: General view of G56, East Range (Film 19.01)

- 5.5.7 Room G56 to the north of G55, had internal access between the two rooms via a timber sliding door. G56 also contained two loose boxes, the same as those within G55 (**Plates 585-586**). There were two windows and a central door to the west, and a sliding door to the north, connecting the room with G1 in the North Range (**Plate 586 and Figure 11**). The former blind windows to the east were also opened up during the refurbishment works (**Plate 588**).

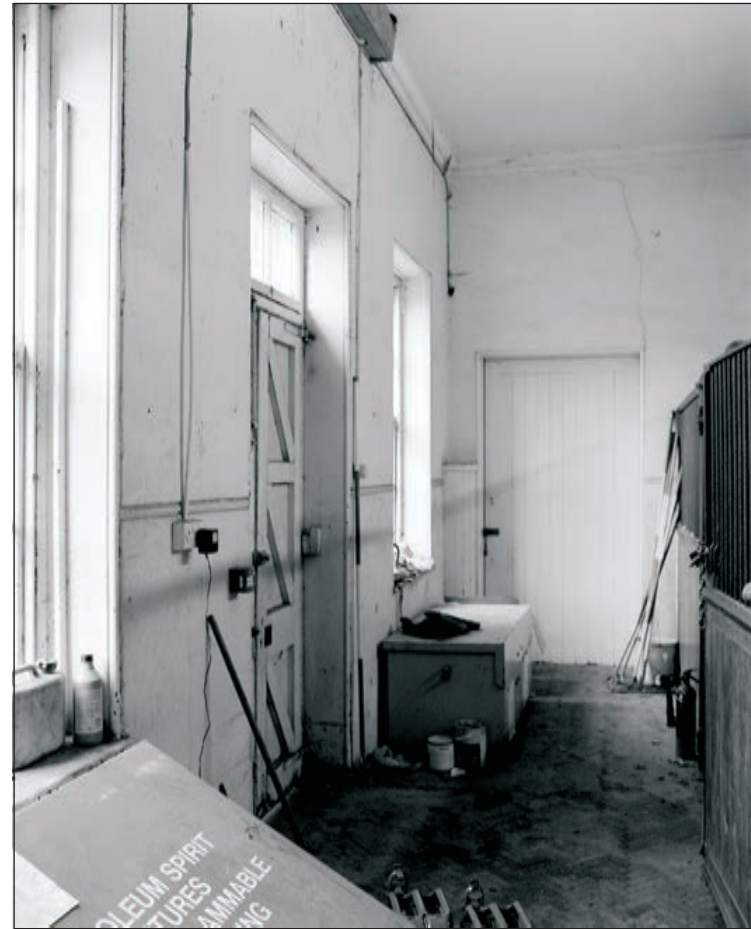
Plate 586: General view of G56, East Range (Film 19.03)

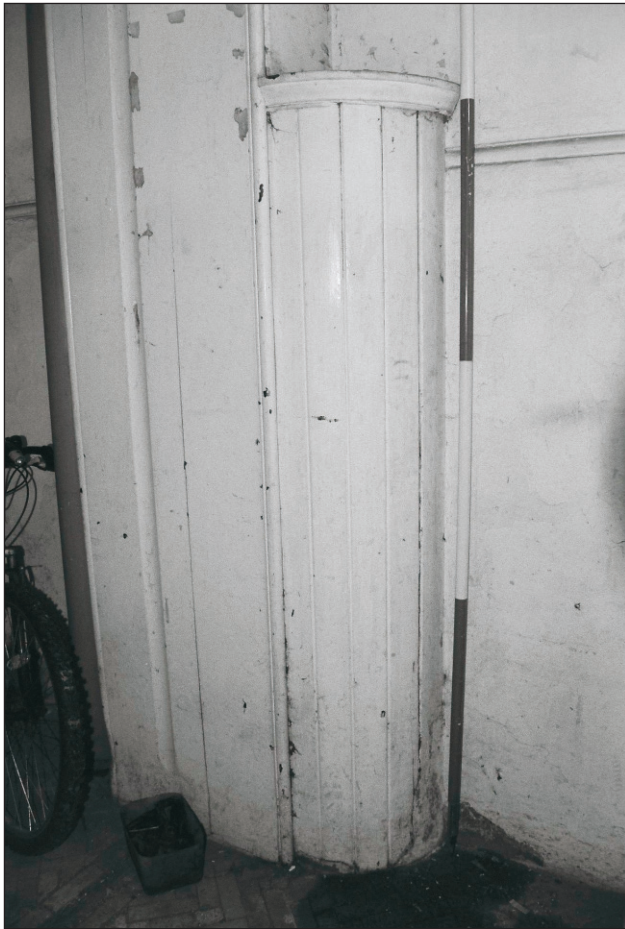
Plate 587: Detail of timber casing, south-west corner of G56, East Range (Film 16.31)

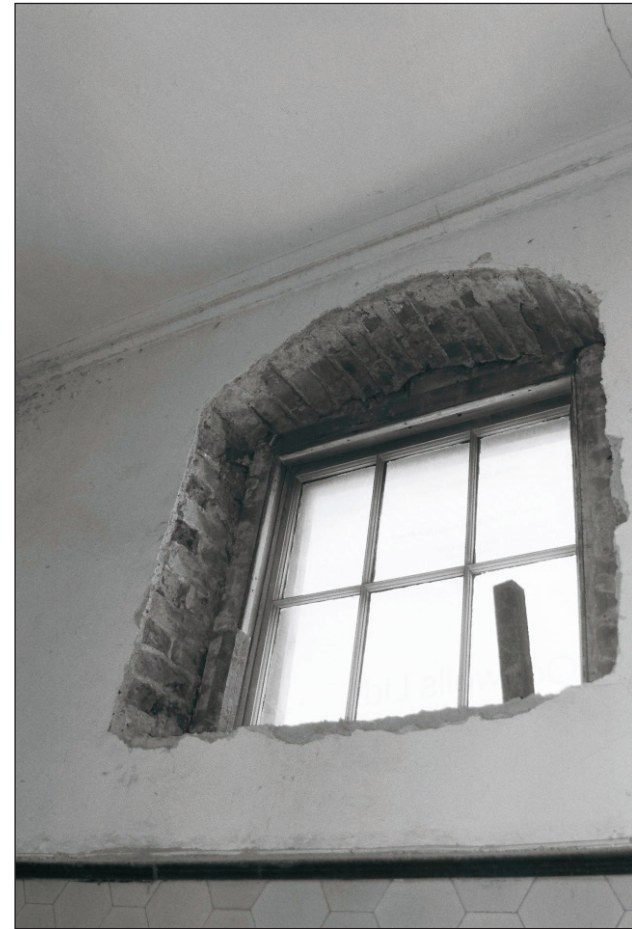
Plate 588: Detail of opened up former blind windows, east wall of G56, East Range (Film 52.25)

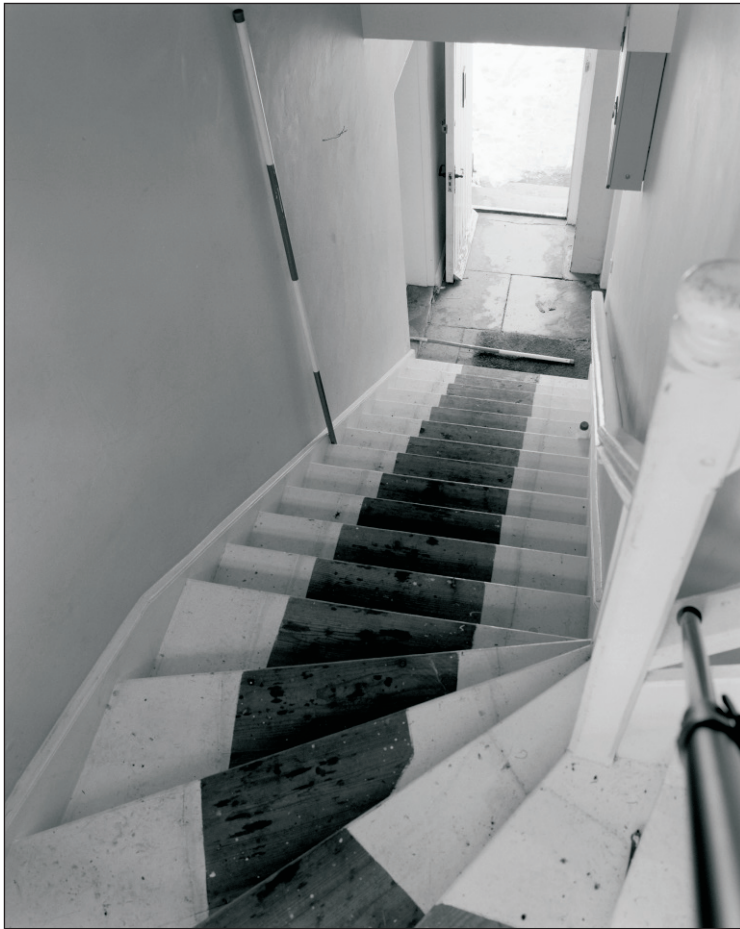
Plate 589: General view of staircase leading from F42 to G53, South/East Range (Film 30.01)

- 5.5.8 The access to the first floor of the east range was via the staircase in G53/F42 (**Plate 589**). The top of the balustrade of the staircase had been moved and altered, indicating the insertion of the doorway at the top of the stairs (**Plate 590**). The first floor of the East Range comprised a long corridor along the east side of the building (F44 and F50), with a change in floor level half way along (**Plates 591-592**). The floor throughout the first floor was limeash. Leading off from this corridor to the west were five main rooms (**Figure 13**). At the southern end was room F43, with windows to the west,

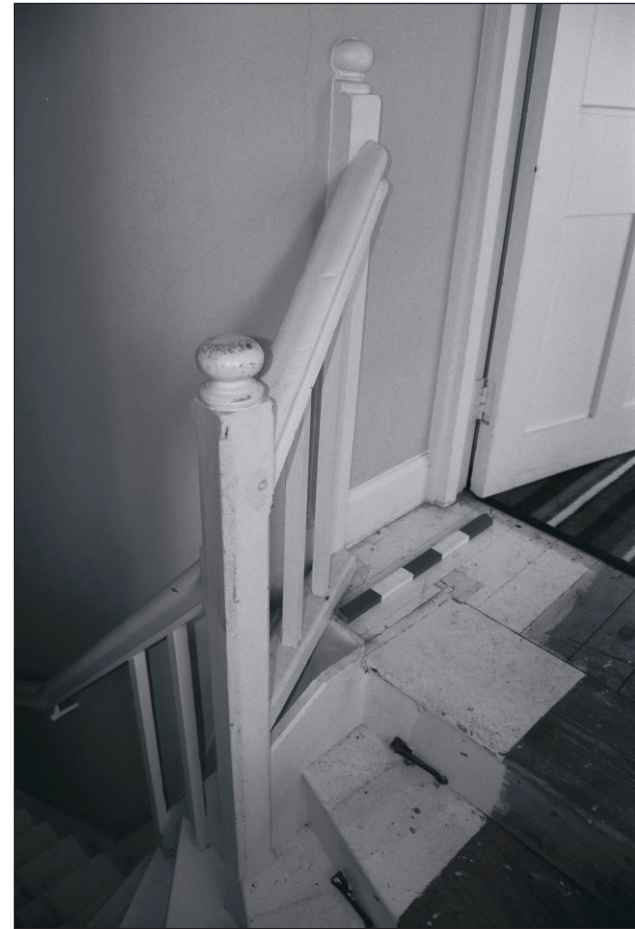
Plate 590: Detail of truncated and moved newel post at top of staircase, F42, East Range (Film 22.34)

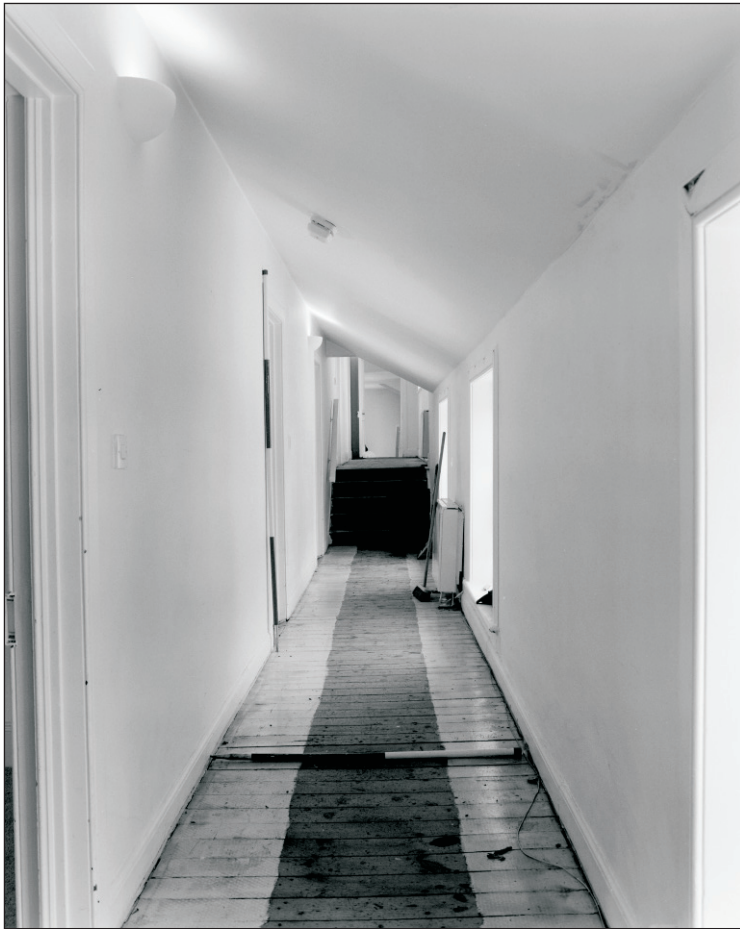
Plate 591: General view of corridors F44 & F50, East Range
(Film 29.10)

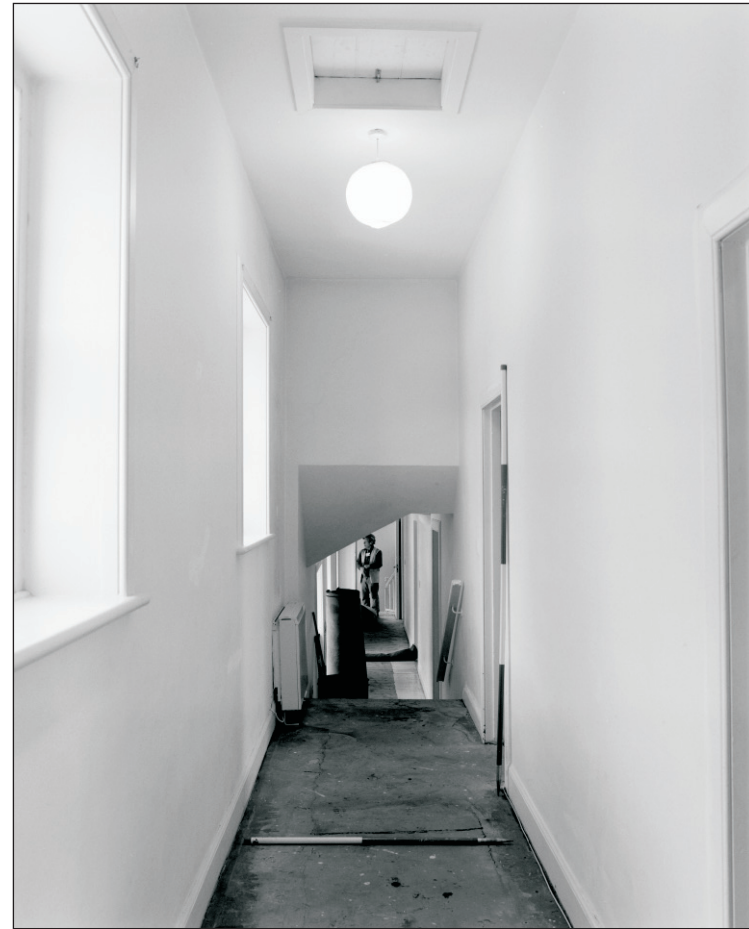
Plate 592: General view of corridors F44 & F50, East Range
(Film 28.01)

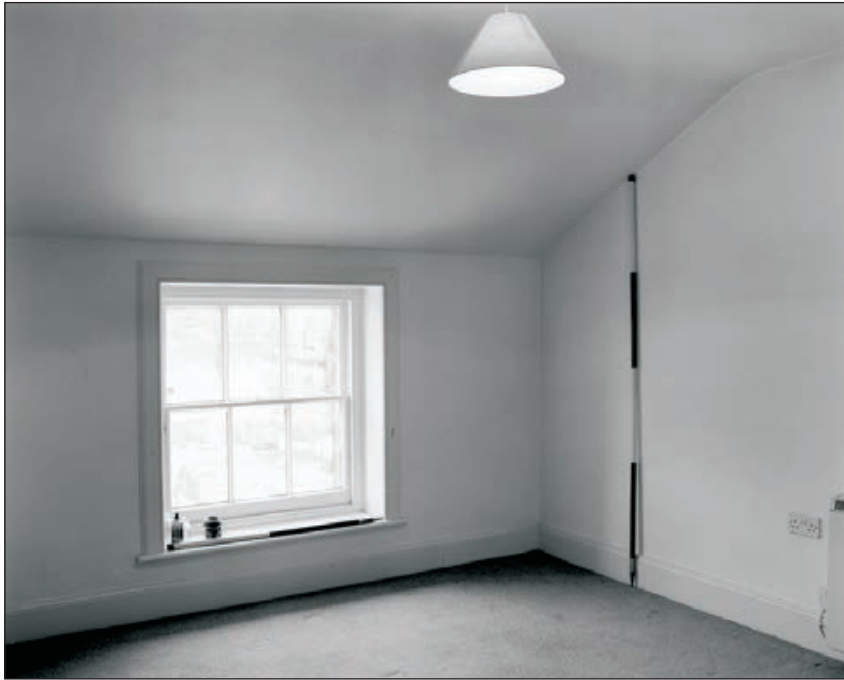
Plate 593: General view of F43, East Range (Film 29.05)

doorway to the east, and blocked fireplace to the north (**Plates 593-594**). Within the south wall at the west end was an exposed blocked doorway, which would have originally provided access to the first floor of the Agent's House to the south (**Plate 595**). Room F45 to the north contained a sash window to the west, doorway to the east, and a blocked fireplace with exposed hearth stone to the south (**Plates 596-598**).

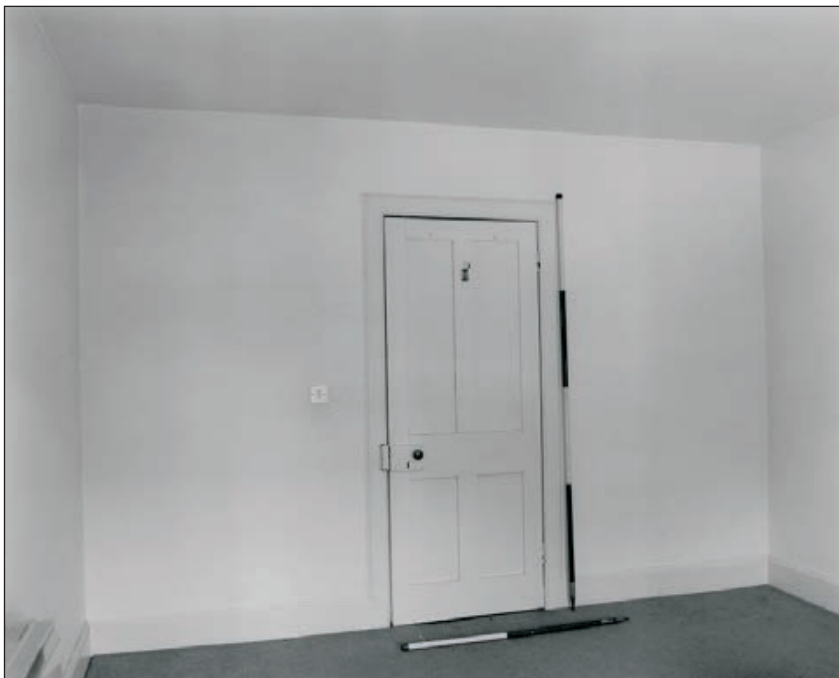
Plate 594: General view of F43, East Range (Film 29.07)

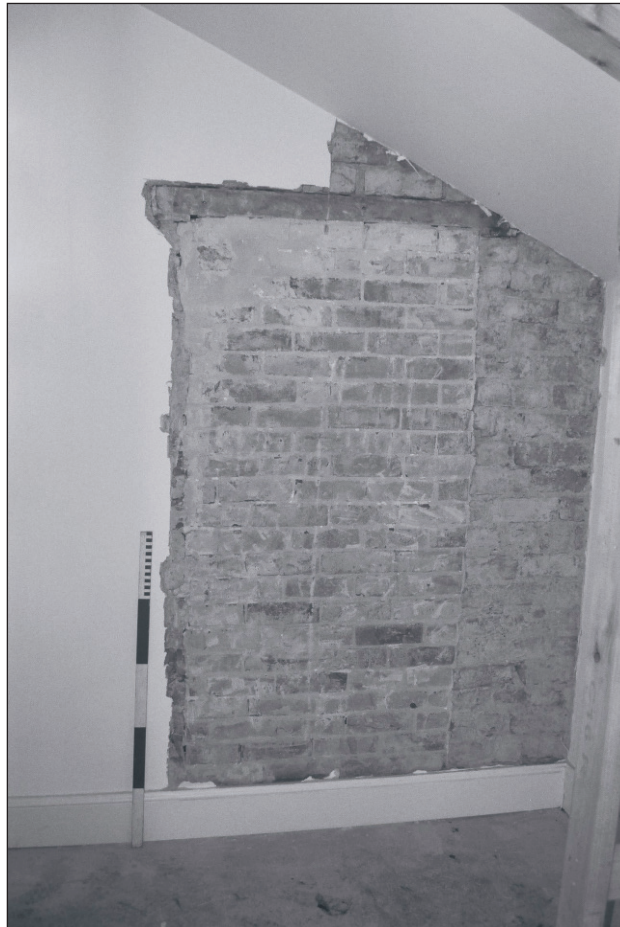
Plate 595: View of exposed blocked door within south wall of F43, East Range - OB. 06 (Film 46.02)

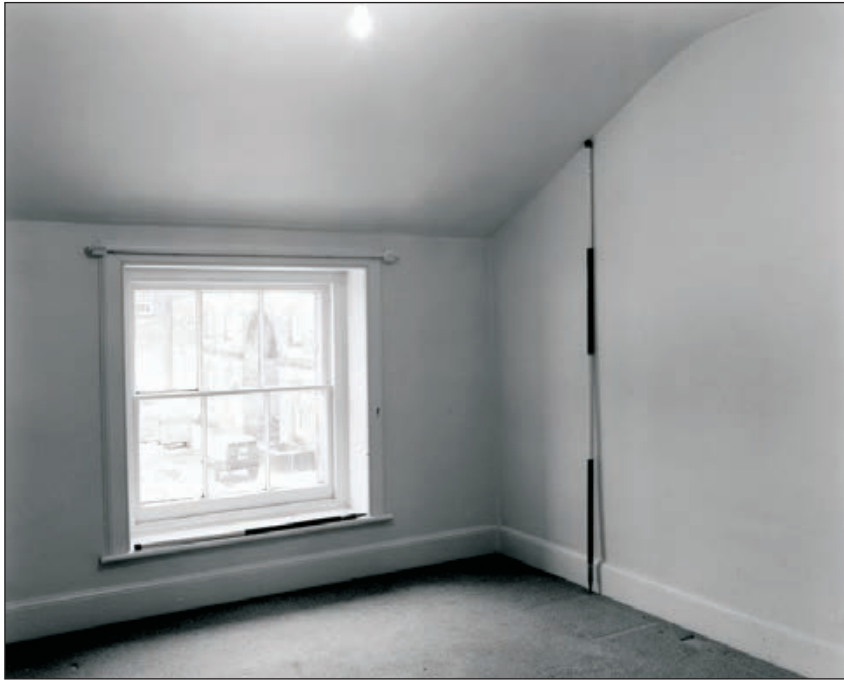
Plate 596: General view of F45, East Range (Film 29.01)

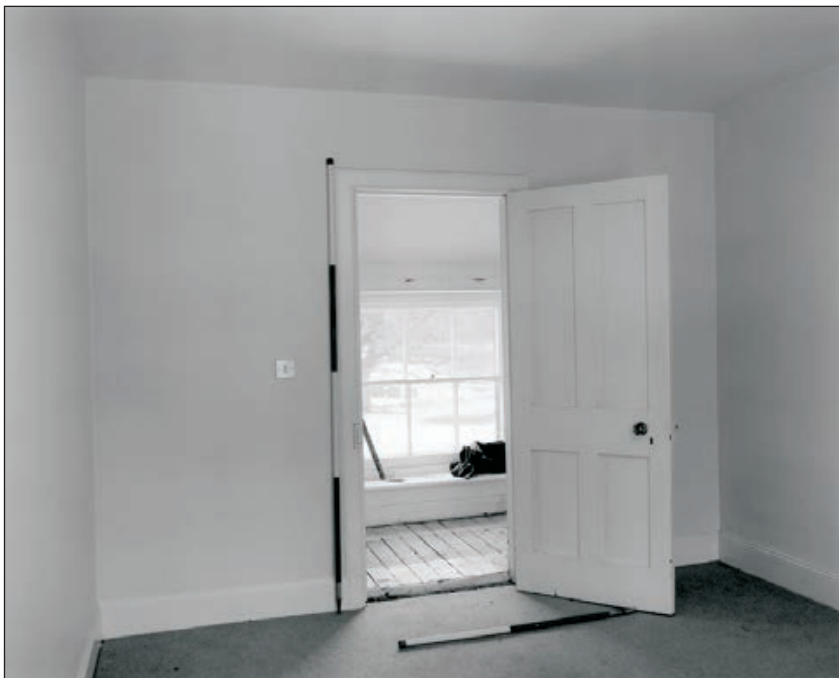
Plate 597: General view of F45, East Range (Film 29.03)

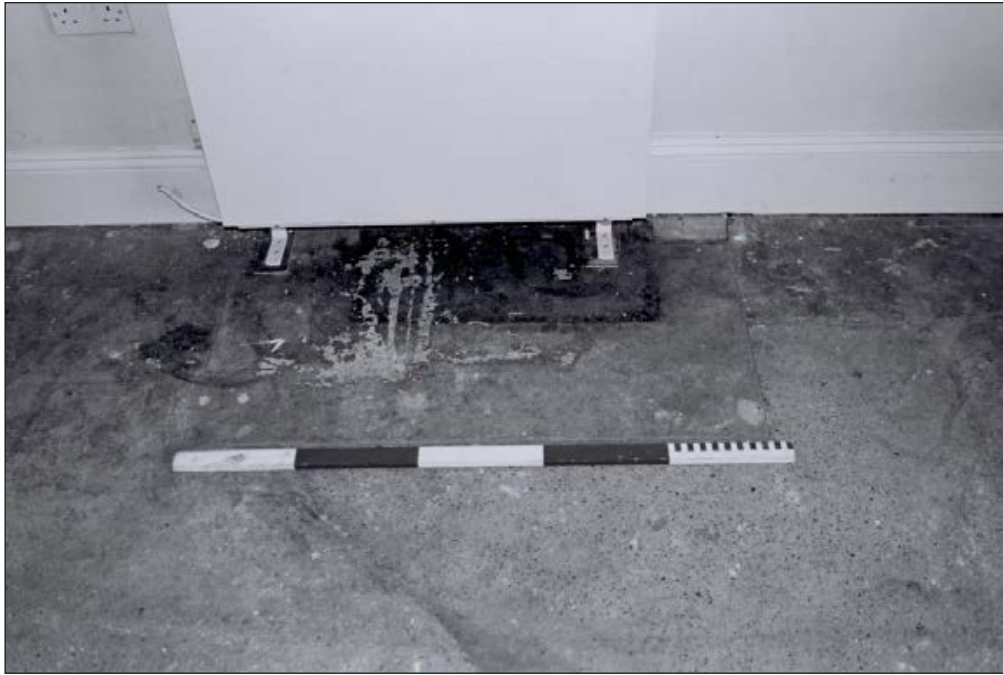
Plate 598: Detail of exposed hearth stone set in limeash floor of F45, East Range (Film 43.17)

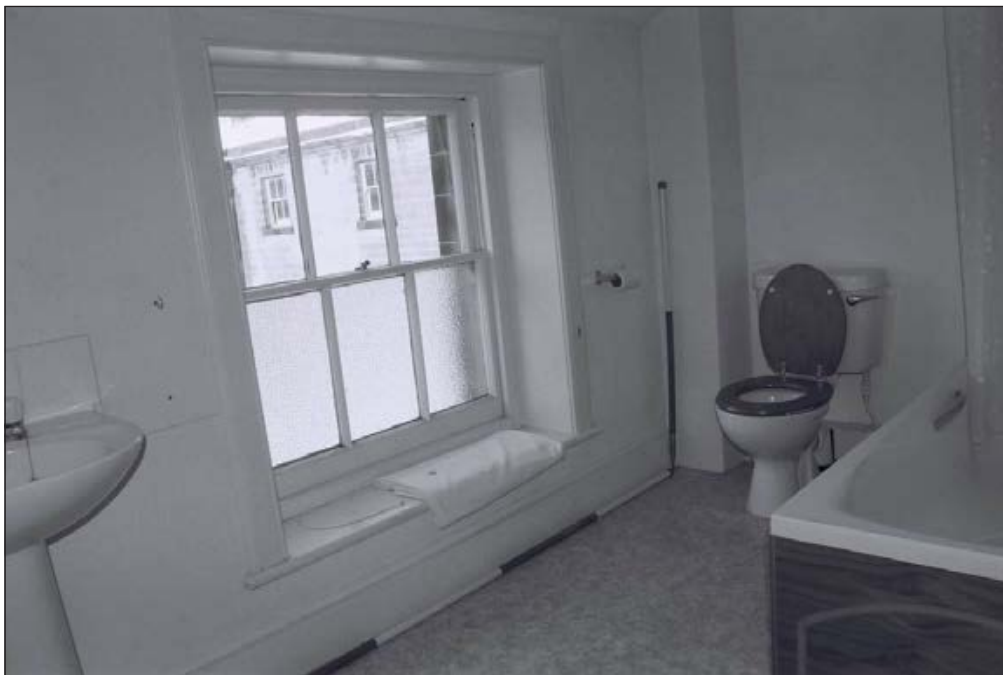
Plate 599: General view of F48, East Range (Film 21.11)

- 5.5.9 Rooms F46a and F46-F48 were all modern partitioned rooms creating a bathroom in F48 (**Plate 599**), a w.c in F47 (**Plate 600**), and small corridor and cupboard in F46 and F46a (**Plate 601**). This was originally a single room with window to the west, doorway to the east and fireplace to the north.

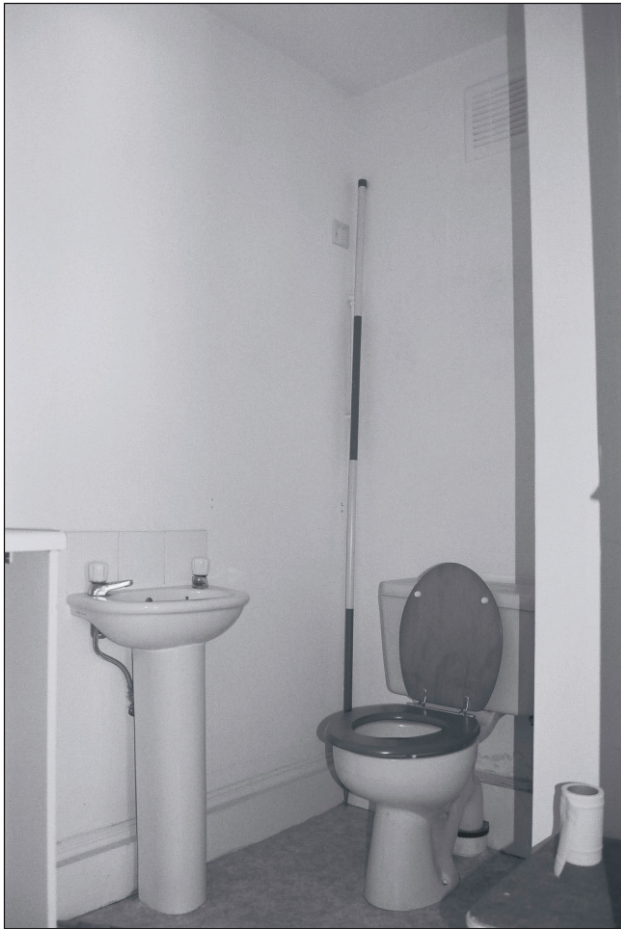
Plate 600: General view of F47, East Range (Film 21.12)

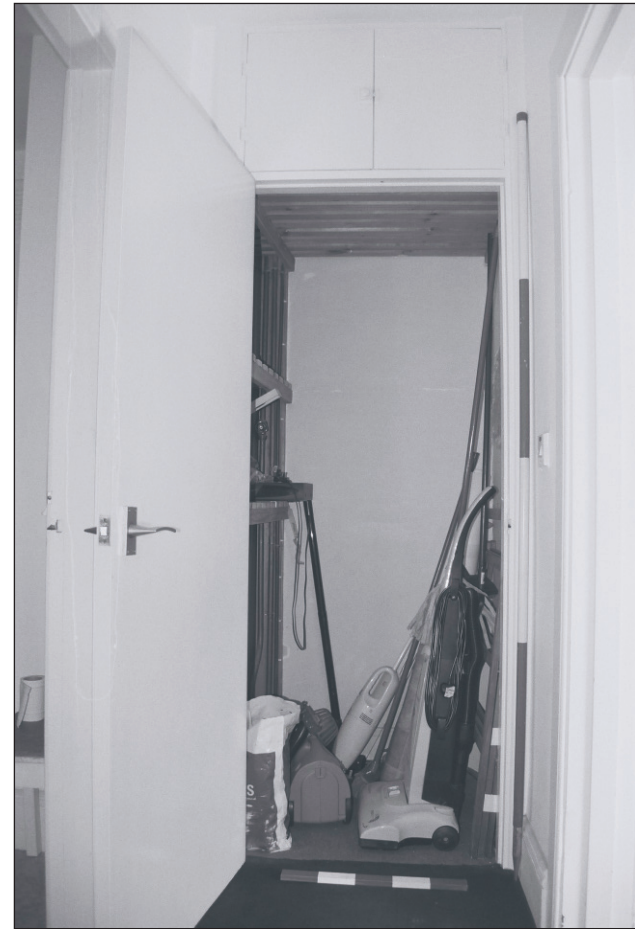
Plate 601: General view of F46a/b, East Range (Film 21.14)

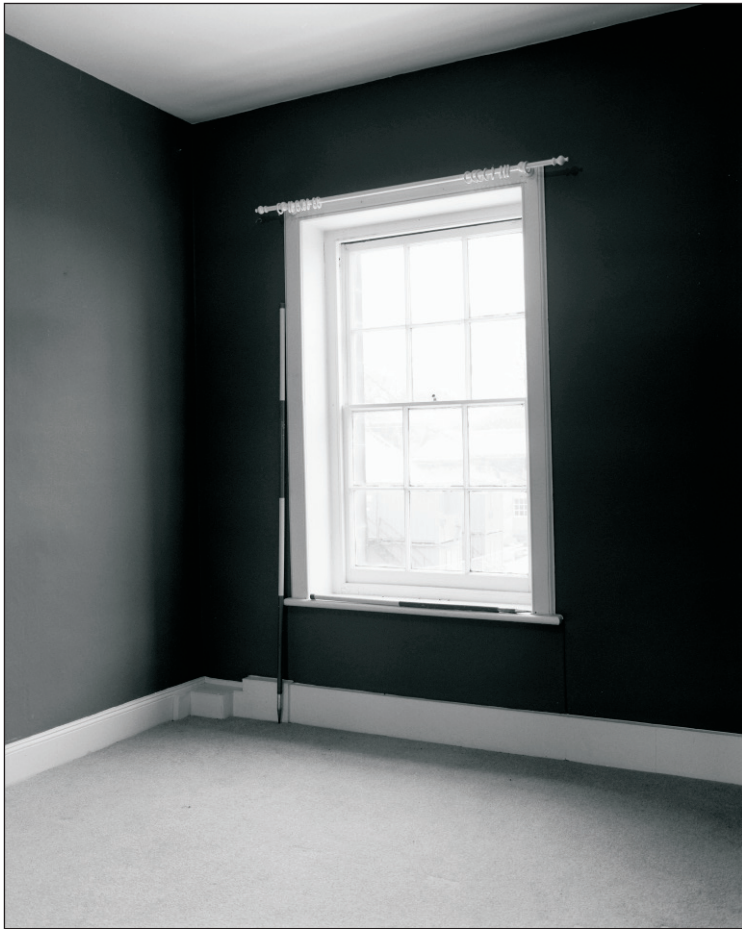
Plate 602: General view of F49, East Range (Film 28.03)

- 5.5.10 Room F49, again with essentially the same layout as room F45, contained a larger sash window to the west than the room to the south (**Plates 602-603**) and has a blocked fireplace to the south. F51 at the north end of the East Range, contained modern kitchen fittings, with large sash window to the west and doorway to corridor F50 to the east (**Plates 604-605**). The north end of F50 connects with F1 of the North Range, although room F1 is encompassed as part of the living quarters of the East Range (**Figure 13**). Viewed from a hatch within the ceiling of F50, was the roof void above the East Range. Timber King-Post roof trusses were observed making up the roof structure (**Plate 606**).

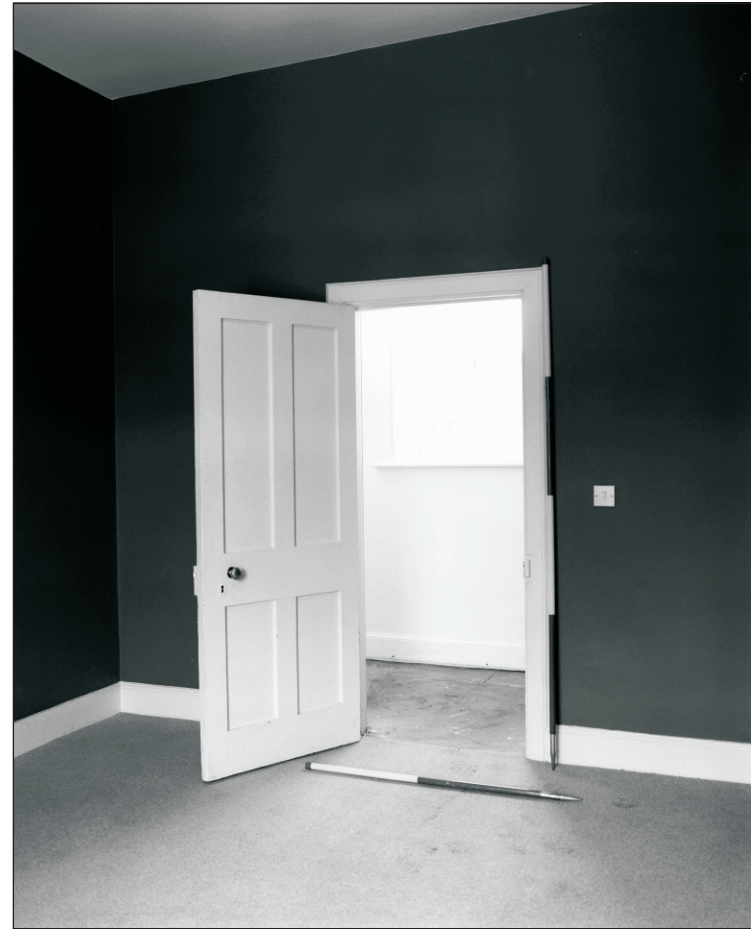
Plate 603: General view of F49, East Range (Film 28.05)

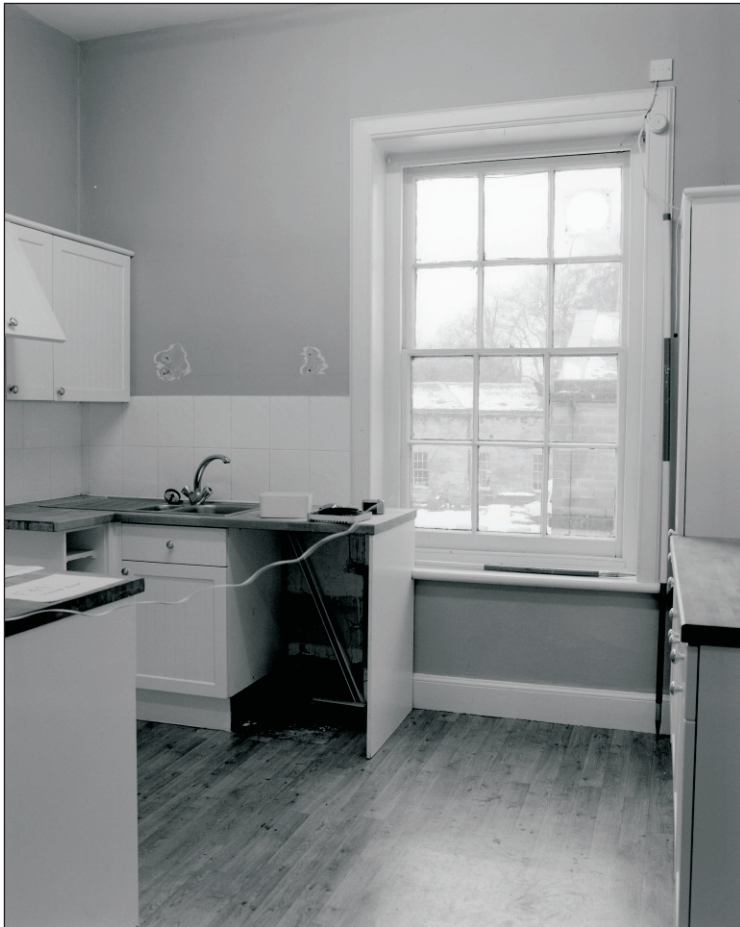
Plate 604: General view of F51, East Range (Film 27.08)

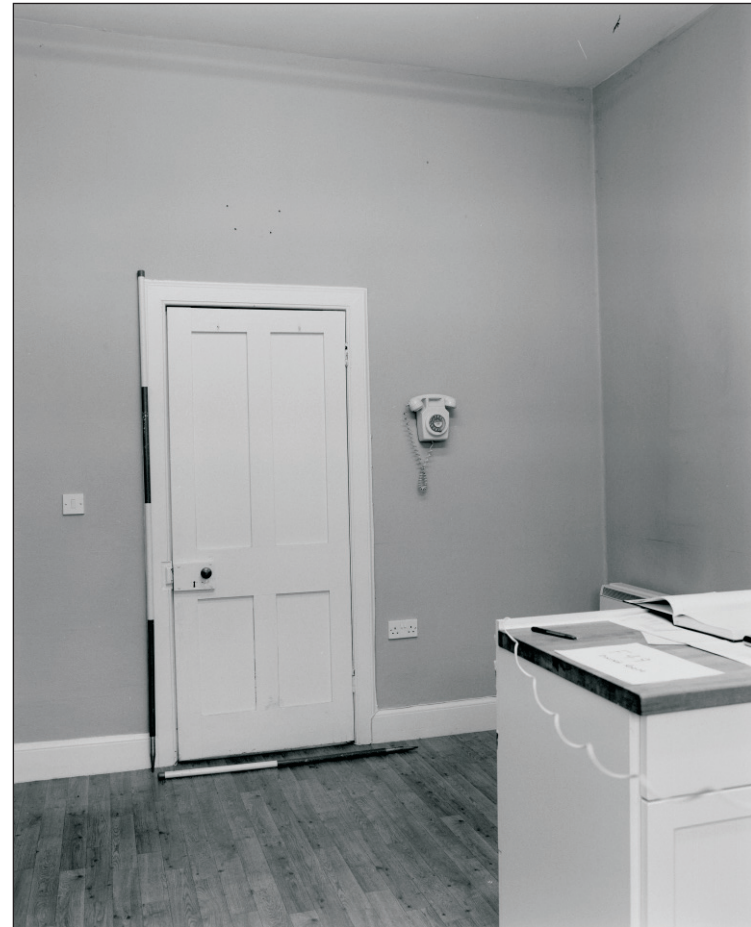
Plate 605: General view of F51, East Range (Film 27.10)

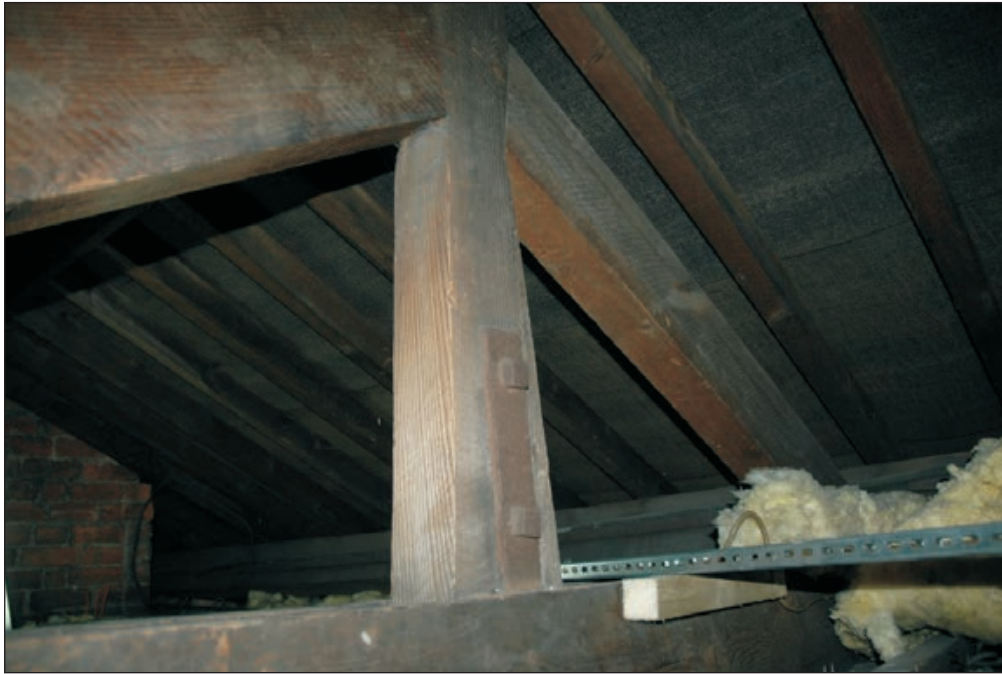
Plate 606: View of timber King-Post roof trusses above East Range, (Film D. 25.02.10 7488)
