Stonehenge Environmental Improvements Project

Assessment Report on Archaeological Mitigation

Planning ref: S/2009/1527/FULL
SMC ref: S00052419/S00031192
Ref: 76862.04
January 2016

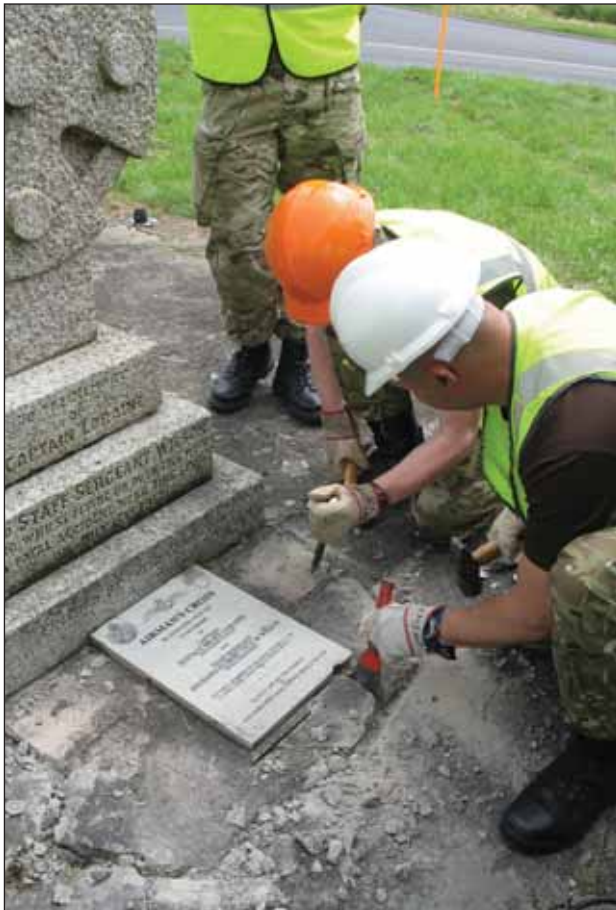
Plate 5: Lifting of the dedication plaque of the Airman's Cross memorial

5.2.7 The dedication plaque at the base of the memorial cross was successfully lifted whole by the Royal Engineers (Plate 5). It was bolted onto two sections of seating material, one of which is still attached to the plaque. A few of the letters were missing from the dedication.

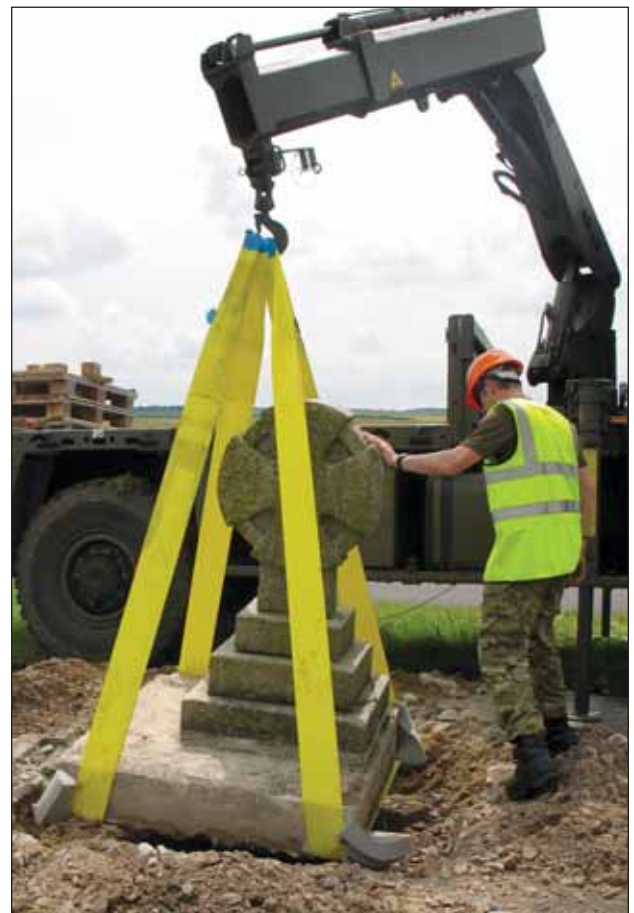
Plate 6: Lifting of the Airman's Cross

5.2.8 It was not possible to dismantle the monument before lifting (Plate 6). During the previous removal, the cross and top tier of its base had been separated from the bottom two sections of plinth. Initial attempts to remove the fixing material at the same point showed that whatever had been used when the cross was re-erected was far too hard to be loosened without risk of damage to the monument. The bottom plinth is firmly embedded in a large square of concrete.

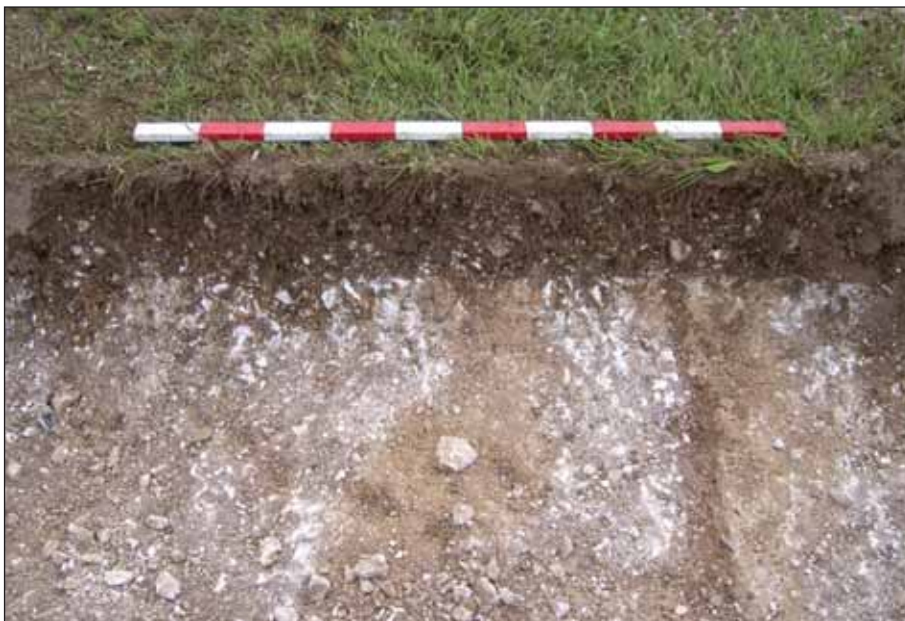
Plate 14: Section showing stratigraphy in Phase 2 area

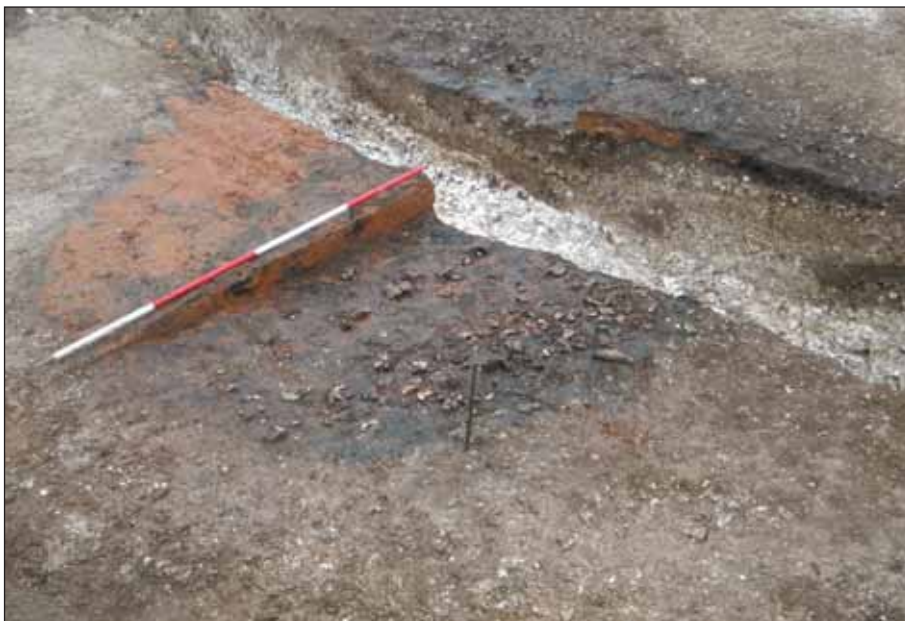
Plate 16: Burnt deposits in feature 10018, during excavation, viewed from the north-east

- 5.3.7 A sequence of three deposits (10003, 10004 & 10005), indicative of a substantial burning event (Plate 16), were recorded overlying deposit 10006. The upper fill composed of a thin very dark silty loam (10003) contained charcoal and burnt flint, and sealed a red, burnt, well-oxidised silty clay loam (10004) up to 0.19 m thick at the centre but thinning out to the sides. This overlay a thin very dark greyish brown silt loam (10005), indicative of a burnt or partially burnt turf-line. Considerable quantities of burnt flint were recovered from layers 10003 (983g), 10004 (4063g) and 10005 (4650g).

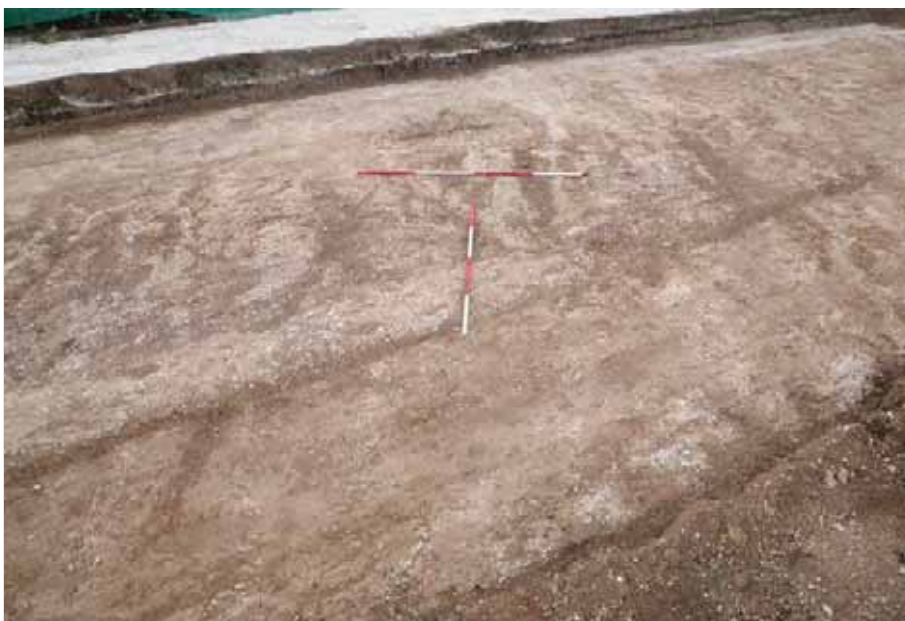
Plate 19: Periglacial features within the Avenue, and adjacent to the northern ditch

5.4.6 A number of linear features of periglacial origin, orientated approximately north-east to south-west were observed in the natural where the sub-base of the road had been completely removed (Plate 19); they were not mapped. These were also evident adjacent to and cut by the edges of the northern Avenue ditch (10078, below) (Fig. 8). They are visible in the sections of both Avenue ditches (Figs 7 and 8) as undulations in the upper, more degraded levels of the Chalk, filled with darker soil – eg, 10104 in ditch 10078, and 10102 in ditch 10068; it seems likely that layer 10120, recorded as a fill of Avenue ditch 10068, is in fact degraded Chalk natural.

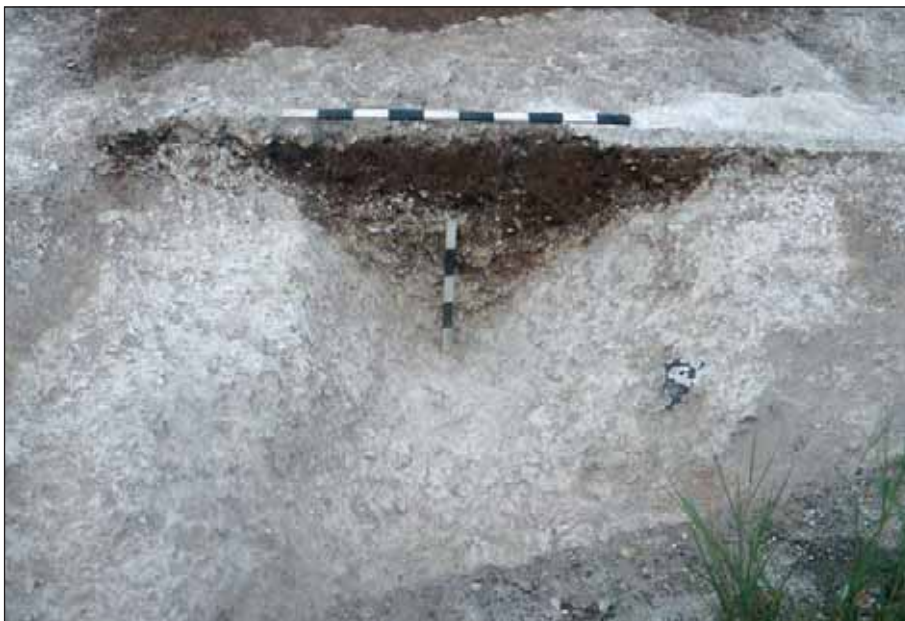
Plate 22: Section of the southern Avenue ditch, viewed from the south-west

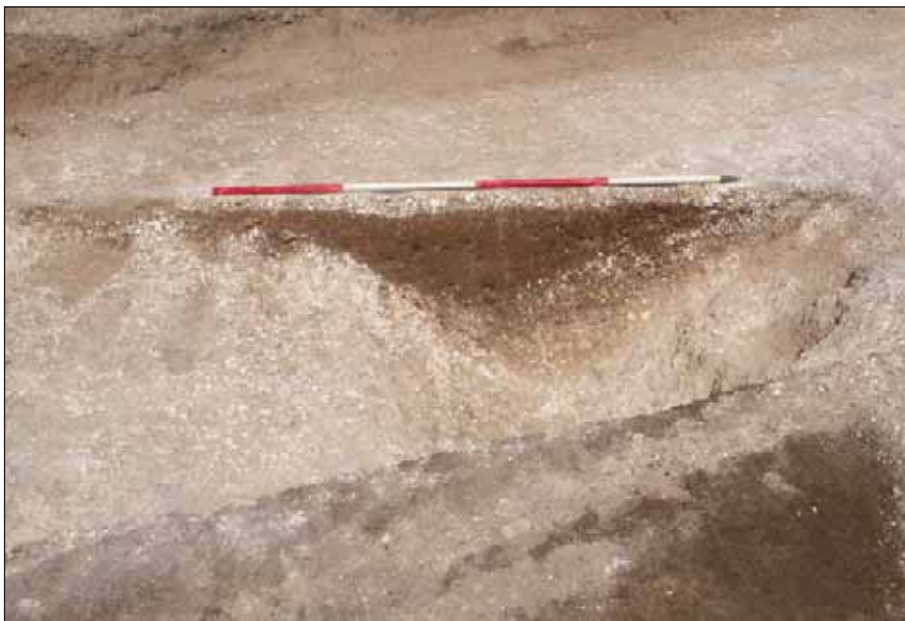
Plate 24: Section of the northern Avenue ditch, viewed from the south-west

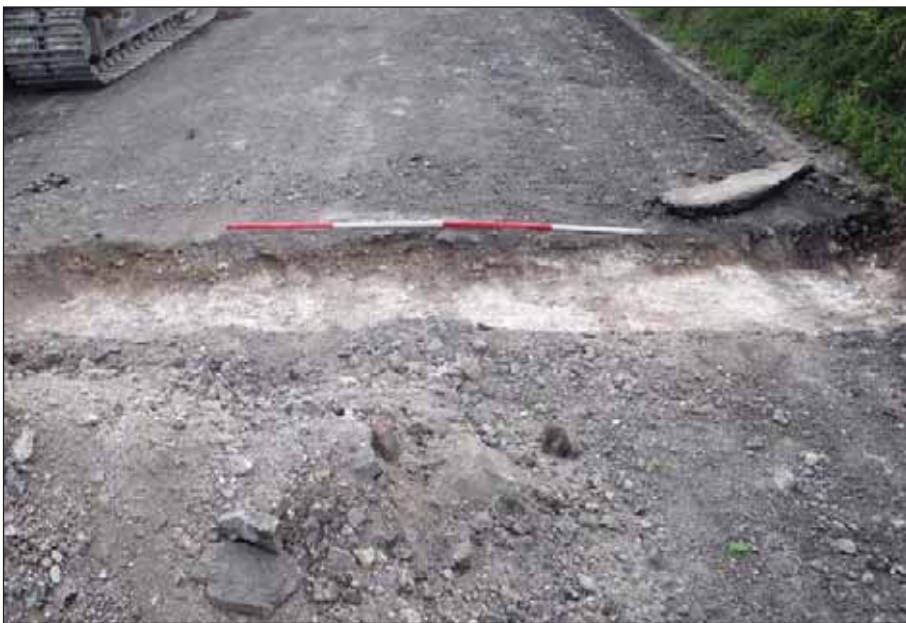
Plate 28: Section through road bedding layers

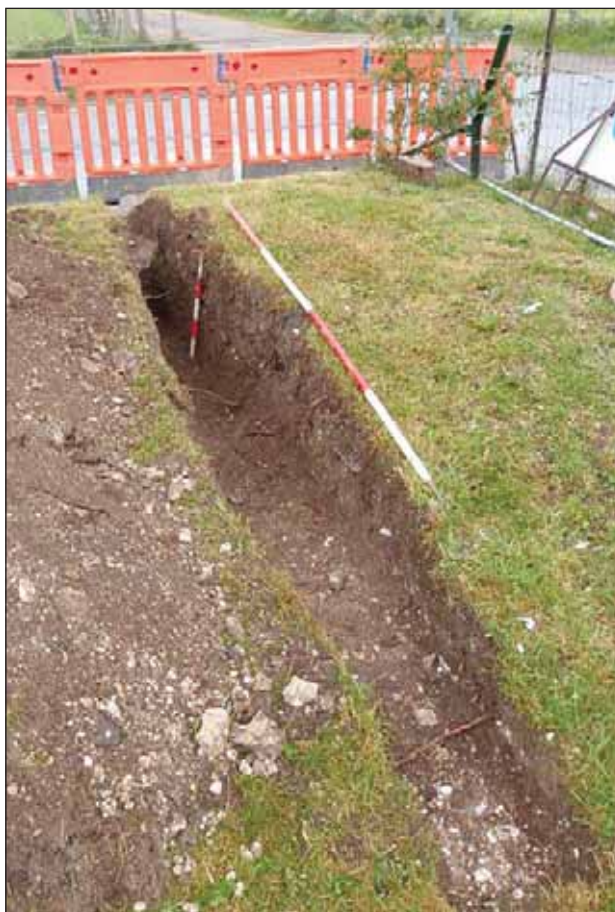
Plate 31: South-east facing section through roadside bank

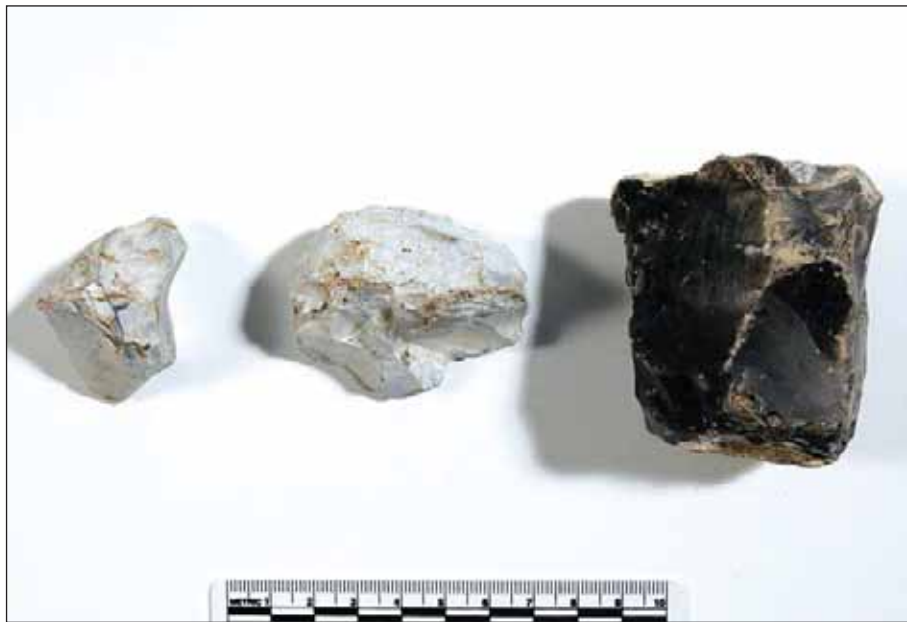
Plate 58: Fragments of multi-platform cores from the northern Avenue ditch 10078

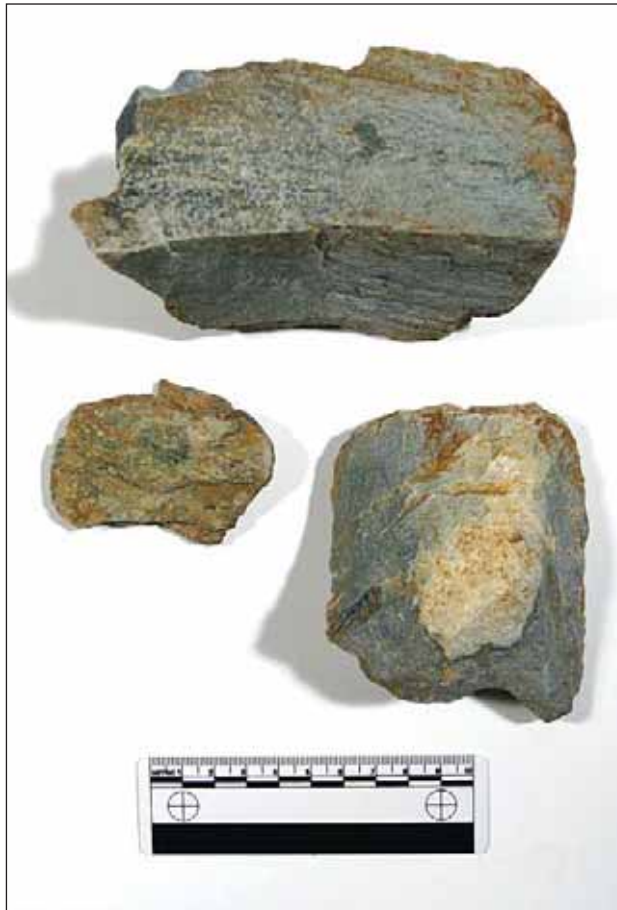
Plate 59: Stone pieces from the southern Avenue ditch 10068

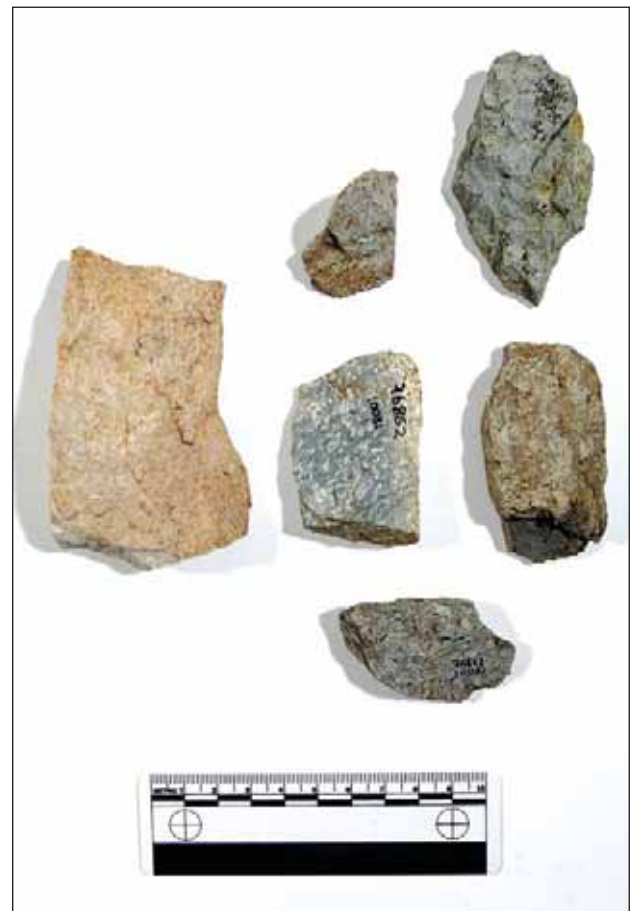
Plate 60: Stone pieces from the northern Avenue ditch 10078
