Holy Trinity Church, Bradford on Avon, Wiltshire

Archaeological Works Report

Ref: 105030.02
September 2014

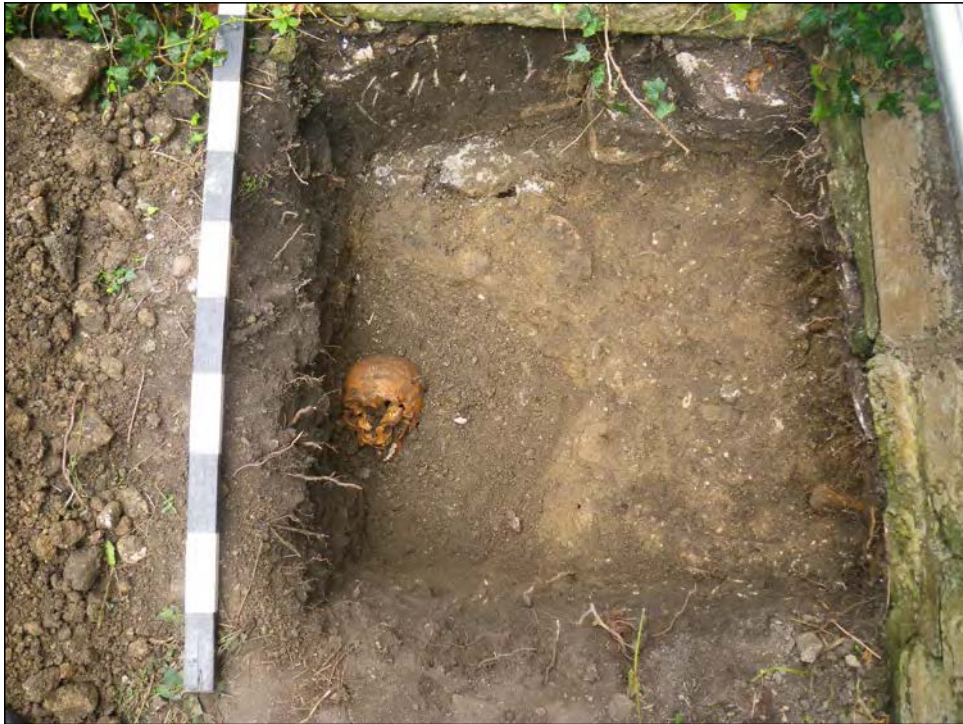
Plate 3

- 4.2.2 The earliest deposit in **Test pit 1 (Figure 3)** was an undated soil layer (**103**) that contained articulated and disarticulated human bone. This deposit extended beneath the churchyard boundary wall (**101**), and was cut by two graves (**105** and **107**). Grave **105** was an earth-cut east-west aligned, confined, supine inhumation burial (**106**), the skull of which was uncovered at a depth of 0.3m below ground level. Remains of the coffin included a silvered tin *depositum* plate (also known as a ledger), which covered the jaw and neck of the skeleton. A simple oval-section coffin grip was located above the skull. The coffin furniture is indicative of an 18th or 19th-century date. The skeleton sloped steeply down towards the feet, which suggests that it may be the uppermost of a series of stacked burials. Grave **105** was backfilled with silty clay loam **104**, which was in turn overlain by a 0.15m thick layer of dark greyish-brown friable sandy loam topsoil (**102**).

- 4.2.3 Shaft grave **107** was lined with ashlar oolitic limestone blocks (**108**), which were capped with a 2m by 0.8m wide ledger slab. Structure **108** was abutted by wall **101**, which was built without foundations, directly on top of soil layer **103**.

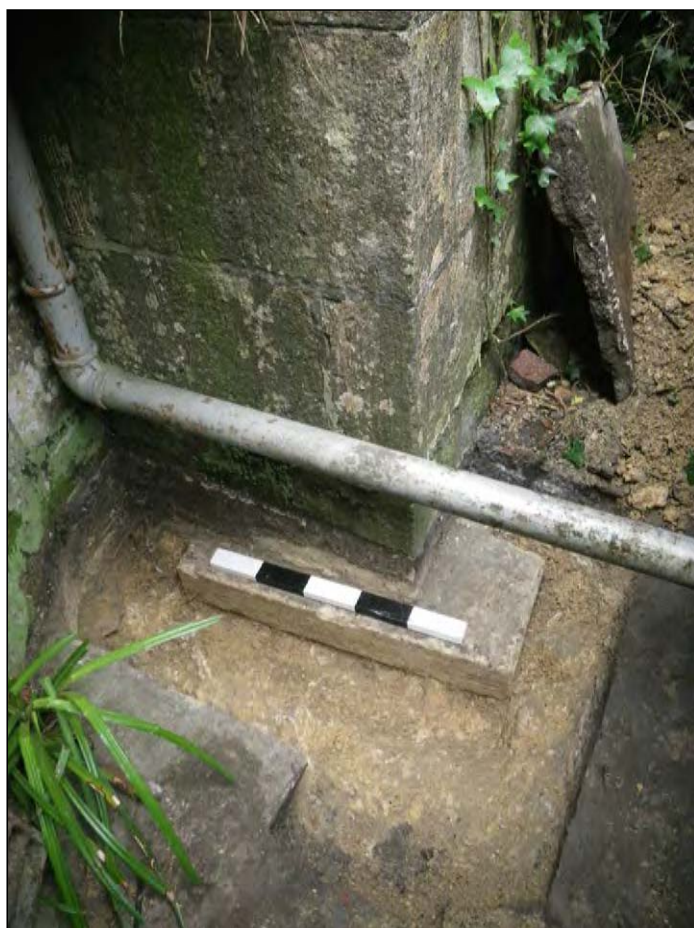
Plate 5

- 4.2.4 **Test pit 2 (Figure 4)** was excavated to investigate ground conditions and the foundations of the retaining wall (**202**) adjacent to Church Street. Limestone bedrock (**208**) was uncovered 0.32m below ground level. The foundations of the wall (**205**) were constructed directly on top of bedrock, and comprised blocks of ashlar oolitic limestone. Foundations **205** were overlain by a deposit of compressed limestone fragments, which were in turn overlain by greyish-brown clay loam (**204**). The present ground surface comprises limestone slab and brick paving (**201**).

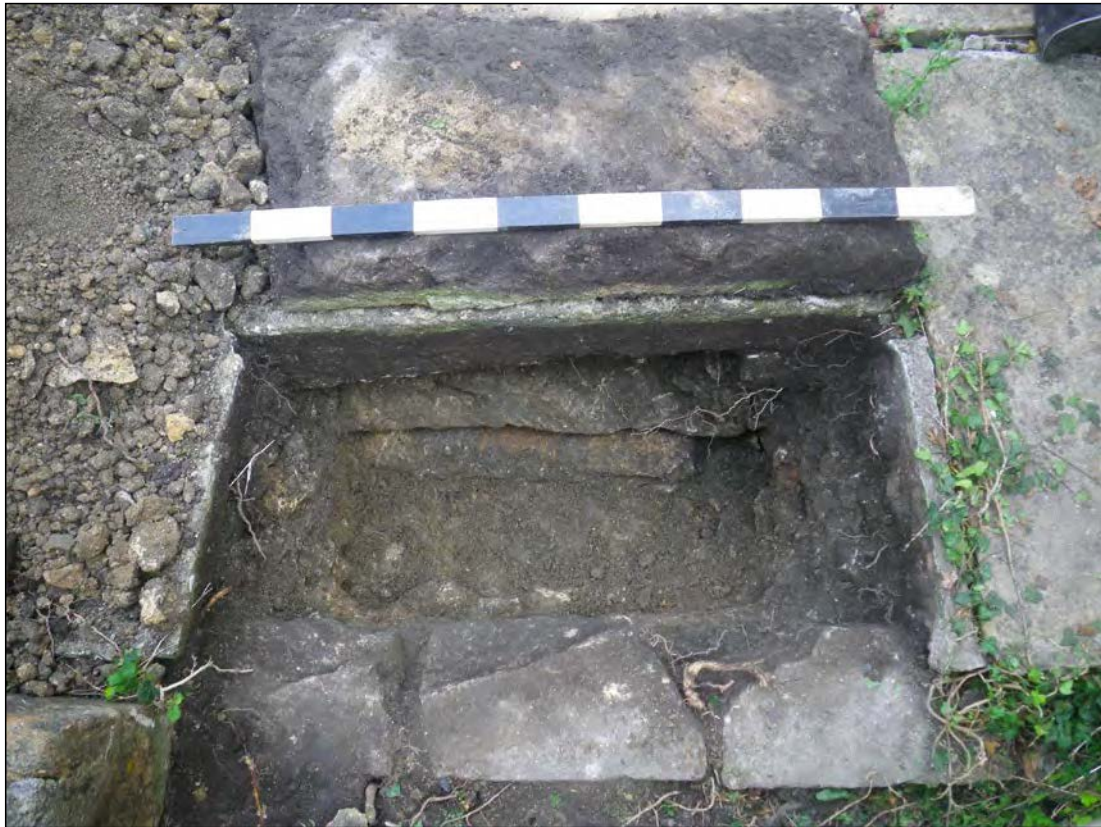
Plate 14: Section of Test pit 10

- 4.2.6 **Test pits 10 (Figure 11) and 11 (Figure 12)** were dug to determine if a probable burial plot marker was located over a burial vault or grave(s). The probable burial plot marker (**1001**) comprised a 0.26m high kerb (formerly topped by iron railings) surrounding a paved area. The southern edge of this structure comprised an ashlar oolitic limestone wall that also defined the southern edge of the raised terrace. Stone-lined burial vaults (**1003** and **1103**) were uncovered in both Test pits, and it is likely that there is a third burial vault between **Test pit 10** and the southern edge of the terraced area. Both vaults were capped with large stone slabs, which were covered by a layer of brownish-grey sandy loam (**1002** and **1102**). Some of the capping slabs over burial vault **1103** had collapsed into the underlying grave. No retaining wall was present north of the vault. A skull was partially uncovered in the north side of **Test pit 11** at a depth of 0.5m below ground level. The skull was left *in-situ* and it was not possible to determine if it was articulated or not.

- 6.1.4 Test pits 10 and 11 demonstrated that the kerbed and paved monuments to the north of the tower are indeed burial plot markers, which overlie stone-lined vaults, simply cut through earlier graveyard deposits containing disarticulated and possibly articulated burials. **Test pit 1** also shows that there are earth-cut burials in this area, at least one of which appears to be stacked, with articulated human remains lying only 0.3m below ground level.
