# 42 Kenavon Drive Reading, Berkshire

Archaeological Watching Brief Report

Accession Code: REDMG 2014.23
Planning Reference: 131280
Report Ref: 103240.02
November 2014

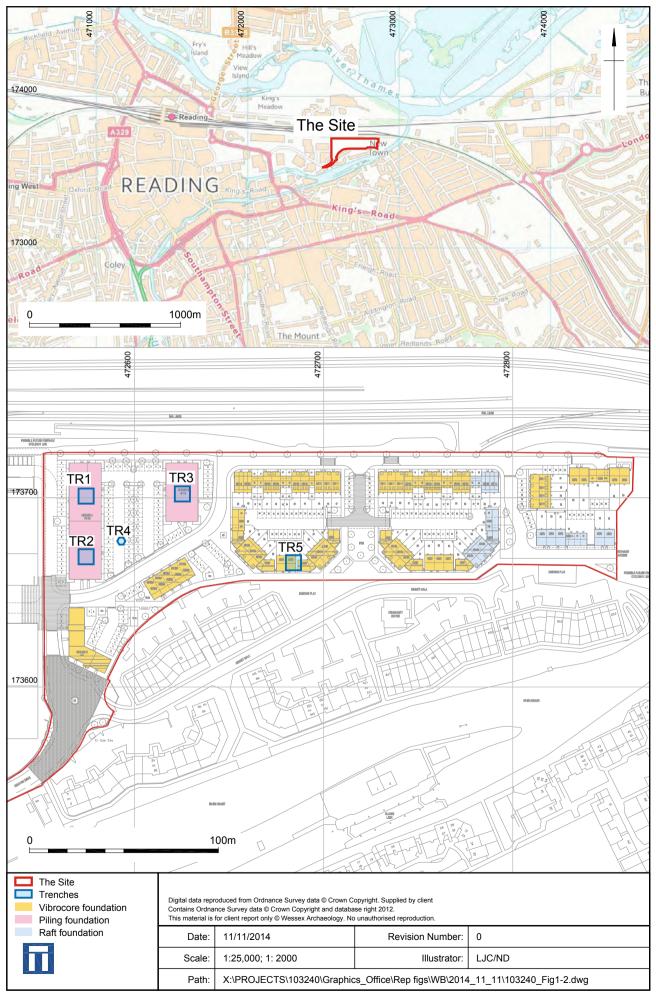
Site Location Plan showing approximate locations of trenches

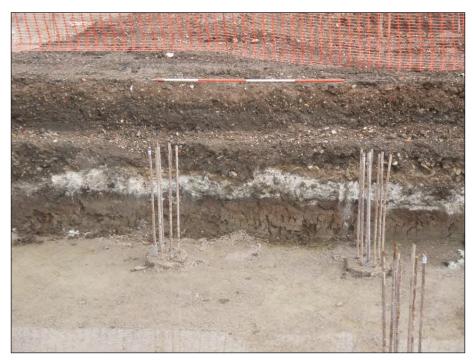
Trench 1		dimensions (m): c. 8 x 8 x 1.4	
context	description	on	depth bgl (m)
101	layer	made ground; light grey crushed concrete; distinct horizon	0-0.20
102	layer	made ground; dark grey brown clay, abundant subangular and subrounded flint, common subangular brick	0.20-0.80
103	layer	made ground; light yellow brown sand; common subrounded crushed concrete and gravel	0.80-0.95
104	layer	made ground; white clayey chalk	0.95-1.10
105	layer	made ground; light grey silty clay; possibly top of alluvium	1.10+
106	layer	concrete base	1.40+

Plate 1: South facing section of Trench 1

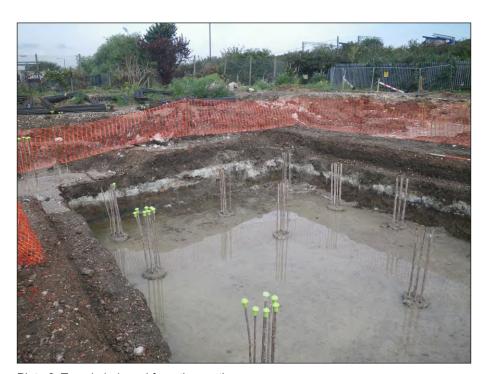
Plate 2: Trench 1 viewed from the south

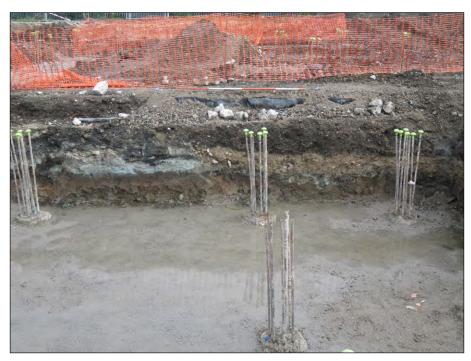
Trench 2		dimensions (m): c. 8 x 8 x 1.3	
context	description	on Control of the Con	depth bgl (m)
201	layer	made ground; dark grey brown clay, abundant subangular and subrounded flint, common subangular brick	0-0.60
202	layer	made ground; light yellow brown sand; common subrounded crushed concrete and gravel	0.60-0.90
203	layer	made ground; white clayey chalk	0.60-0.90
204	layer	made ground; light reddish brown clay	0.90+
205	structure	concrete base	1.30+

Plate 3: South facing section of Trench 2

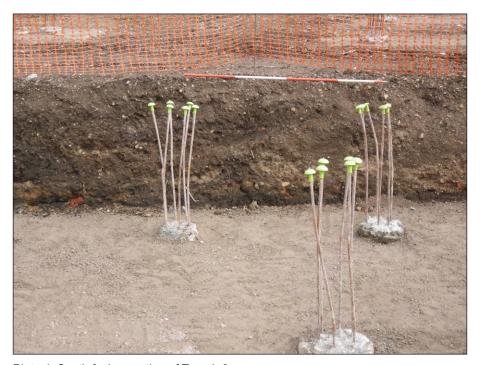
Trench 3		dimensions (m): c. 8 x 8 x 1.1	
context	description	n	depth bgl (m)
301	layer	made ground; dark grey brown clay, abundant subangular and subrounded flint, common subangular brick	0-0.70
302	layer	made ground; light yellow brown sand; common subrounded crushed concrete and gravel	0.70–1.00
303	layer	made ground; dark grey brown sandy clay, common subangular brick fragments	1.00+
304	structure	concrete base	1.10+

Plate 4: South facing section of Trench 3

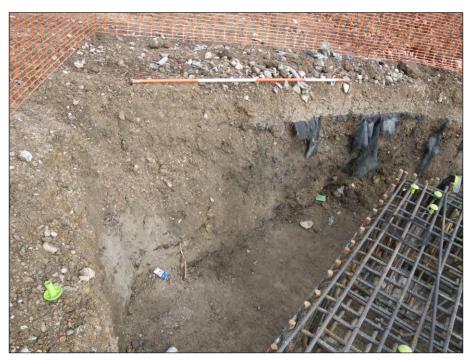
Trench 4		<b>dimensions (m):</b> <i>c</i> . 5 x 5 x 1.2	
context	description	n	depth bgl (m)
401	layer	made ground; light grey crushed concrete with terram beneath	0-0.20
402	layer	made ground; dark grey brown clay, abundant subangular and subrounded flint, common subangular brick	0.20–1.00
403	layer	made ground; light yellow brown sand; common gravel	1.00-1.05
404	layer	made ground; dark grey brown sandy clay, common subangular brick fragments	1.05+
405	structure	concrete base	1.20+
406	structure	steel crane base	?

Plate 5: South-east facing section of Trench 4

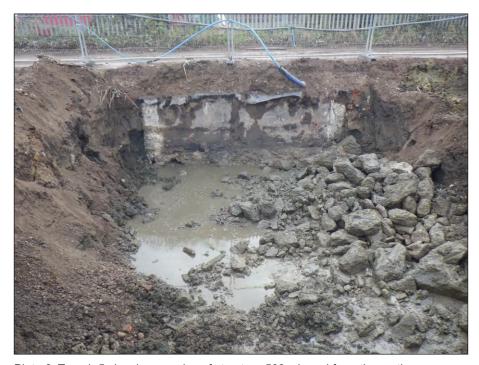
- determine if the structure continues further in this direction, or if it was partially subterranean, or completely free-standing.
- 4.3.3 The structure coincides with the south-east end of the main gasworks building (**Figure 2**).
- 4.3.4 Though conditions were not conducive to in-depth investigation, no distinctly natural deposits were observed in Trench **5**. Based on the riverine nature of the Site it is feasible that there was element of ground preparation (e.g. made-ground) to alleviate flooding risk prior to the gasworks construction, but the evidence is such that this remains supposition.

Trench 5		dimensions (m): 8 x 8 x 2.3	
context	description	on	depth bgl (m)
501	layer	made ground; mid brown silty sand, bricks, common subangular stone >0;08m, loose, distinct horizon; terram beneath	0-0.50
502	layer	made ground; dark grey brown silty sand, abundant subangular and subrounded stone >0;08m; loose, distinct horizon	0.50+
503	structure	concrete structure; c. 5m x 5m x 1.8m; roof pushed & pre-cast concrete 0.30m thick; base 0.5m thick; full of railway tracks ?reinforcing concrete slab; water table at base N.B dimensions for 503 are approximate and based on machine operator descriptions; the trench was unsafe to enter	0.50-2.30

Plate 6: Trench 5 showing remains of structure 503, viewed from the north
