Beer Wall Othery, Somerset

Archaeological Evaluation Report

Report Ref: 106060.03 Accession Code: TTNCN 92/2014 December 2014

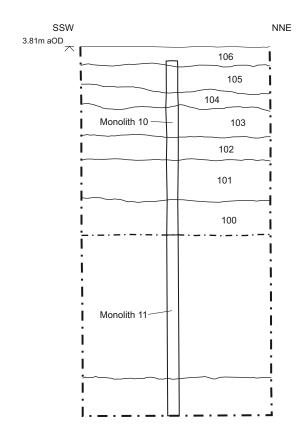
Section 1 - Trench 1: east facing section from showing Monoliths 10 and 11

6.2.1 Following the removal of 0.10m of turf and topsoil (106) a 0.15m thick alluvial clay deposit 105 (equal to 203 and 403) was revealed sealing interface deposit 104; a clay loam with common lenses of alluvial clay. Deposit 104 capped a series of four peat deposits; 103, 102, 101 and 101 which were recorded to a depth of 2m below the current ground surface, to c.1.86m aOD. Two monolith columns were taken from the exposed peat sequence in Trench 1 (Environmental Samples 10 and 11) (**Figure 2**, **Plate 1**). The results are provided below. No archaeological features were noted.

- 8.1.1 Two monolith samples, <10 & 11> were taken through peat deposits in Trench 1 (**Figure 2**). The sediment descriptions can be found in **Appendix 3**. These samples, forming a continuous 2m section, were described in the lab by a geoarchaeologist following Hodgson (1997).
- 8.1.2 The results mirror those from the upper core sequences, with woody fragments near the 2m mark (indicative of possible carr woodland).
- 8.1.3 The deposits have potential for good preservation of a range of palaeoenvironmental indicators; however in the absence of association with archaeological remains no further work is recommended on the samples.

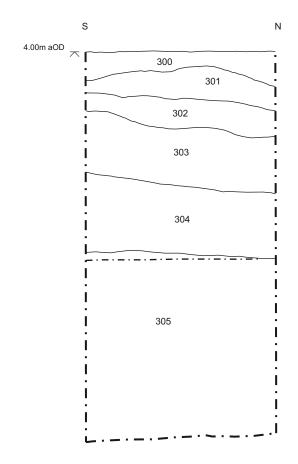
Section 2 - Trench 3: south-east facing section

6.4.1 Following the removal of 0.20m of current turf and topsoil (300) a 0.20m thick made ground layer (301 equal to 202) was revealed at the northern end of the trench. Adjacent to 301 was 308; a remnant of a roadside drainage ditch bank. The made ground layer sealed backfilled NNW–SSE aligned ditch 306; a probable drainage ditch or ream which was filled with lower fill 307 (0.30m thick) sealed by upper fill 302 (0.20m thick). The ditch cut through 0.45m thick peat layer 303, which in turn sealed peat layer 304 and 305; these were recorded to a depth of c.2m below the current ground surface to 2.07m aOD.

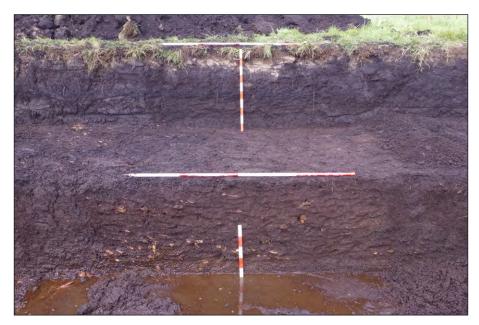
Plate 1: East facing section of Trench 1

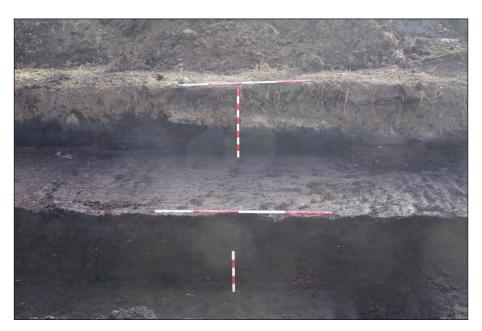
Plate 2: East facing section of Trench 2

6.3.1 Following the removal of 0.25m of current turf and topsoil (200) and further 0.20m of subsoil (201), a 0.25m thick modern made ground layer 202 (equal to 301) – composed of stiff orange clay and numerous modern finds (plastic, metal etc) was revealed at the southern end of the trench. The material was derived from the clearing out of an adjacent road side drainage ditch. Below 202 was a 0.25m thick light yellow grey alluvial deposit 203 (equal to 105 and 403) which capped a series of three peat deposits (204, 205 and 206) which were recorded to a depth of 2m below the current ground surface, to c.1.90m aOD (**Plate 2**). No archaeological features were noted.

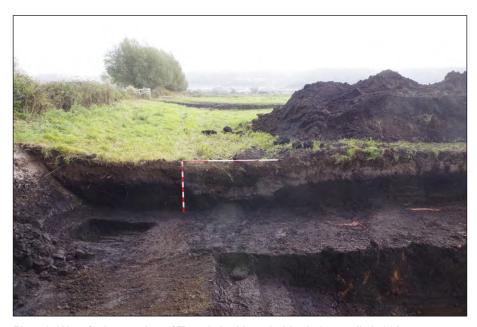
Plate 3: West facing section of Trench 3 with probable drainage ditch 306

306	Cut	NNW-SSE aligned ream at base of roadside ditch and bank. Extant prior to machine excavation. Filled by layers 302 & 307	0.4-0.75m				
307	Layer	Mixed deposit of reworked black brown peaty clay, orange brown stiff clay & fragments of alluvial clay.	0.2-0.5m				
308	Layer	Mixed deposit of stiff orange brown clay with Fe veins occasional CBM and stone. Forms bank parallel to roadside ditch.	0-0.5m

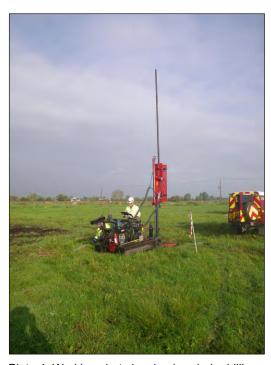
Plate 4: Working shot showing borehole drilling

- 4.1.7 A programme of geoarchaeological coring was undertaken concurrently during the groundworks. The boreholes were located 30m apart on a north-east to south-west aligned transect. Two boreholes were positioned to the south of the A372 and four to the north, as represented on **Figure 1**.
- 4.1.8 Core sampling was undertaken using a mechanical window-sampling rig (Terrier-type) retrieving 1m long sleeved cores of *c*.100mm diameter at specified locations.
- 4.1.9 The location of each geoarchaeological core was surveyed using a GPS and related to Ordnance Survey (aOD).
