# Henham Park Wangford With Henham, Suffolk

Archaeological Evaluation and Assessment of Results

Ref: 85204.01  
November 2014

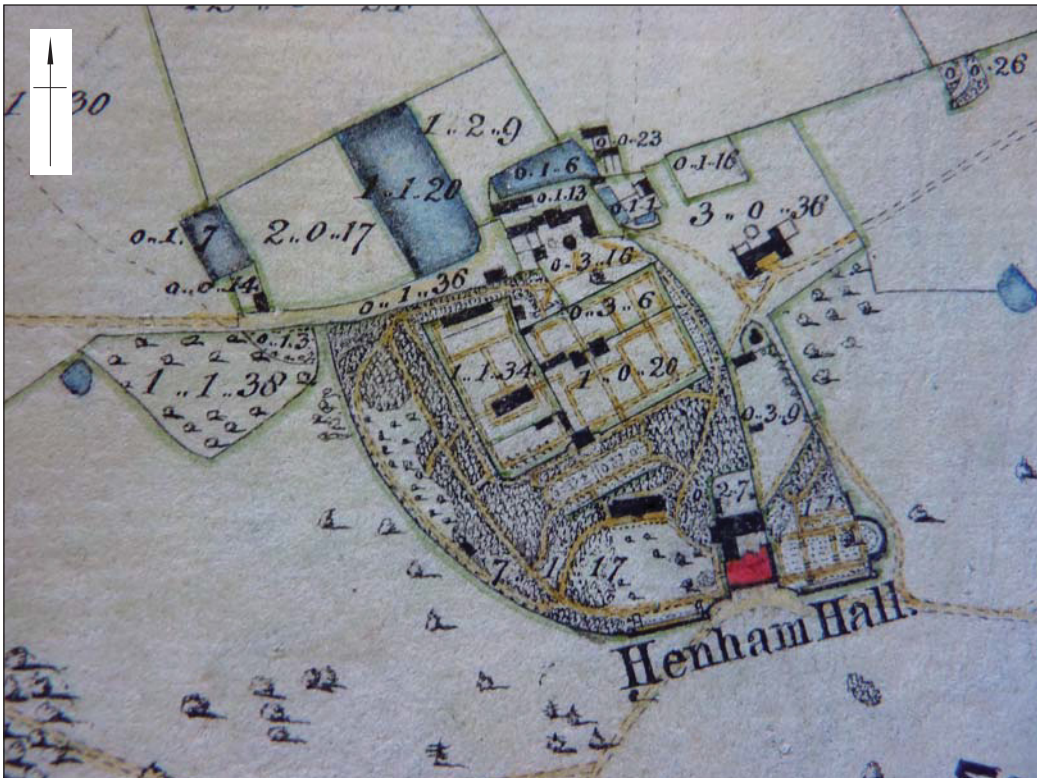
Plate 2: Detail from 1865 map by Stagoll (IRO ref. HA11/C9/70)

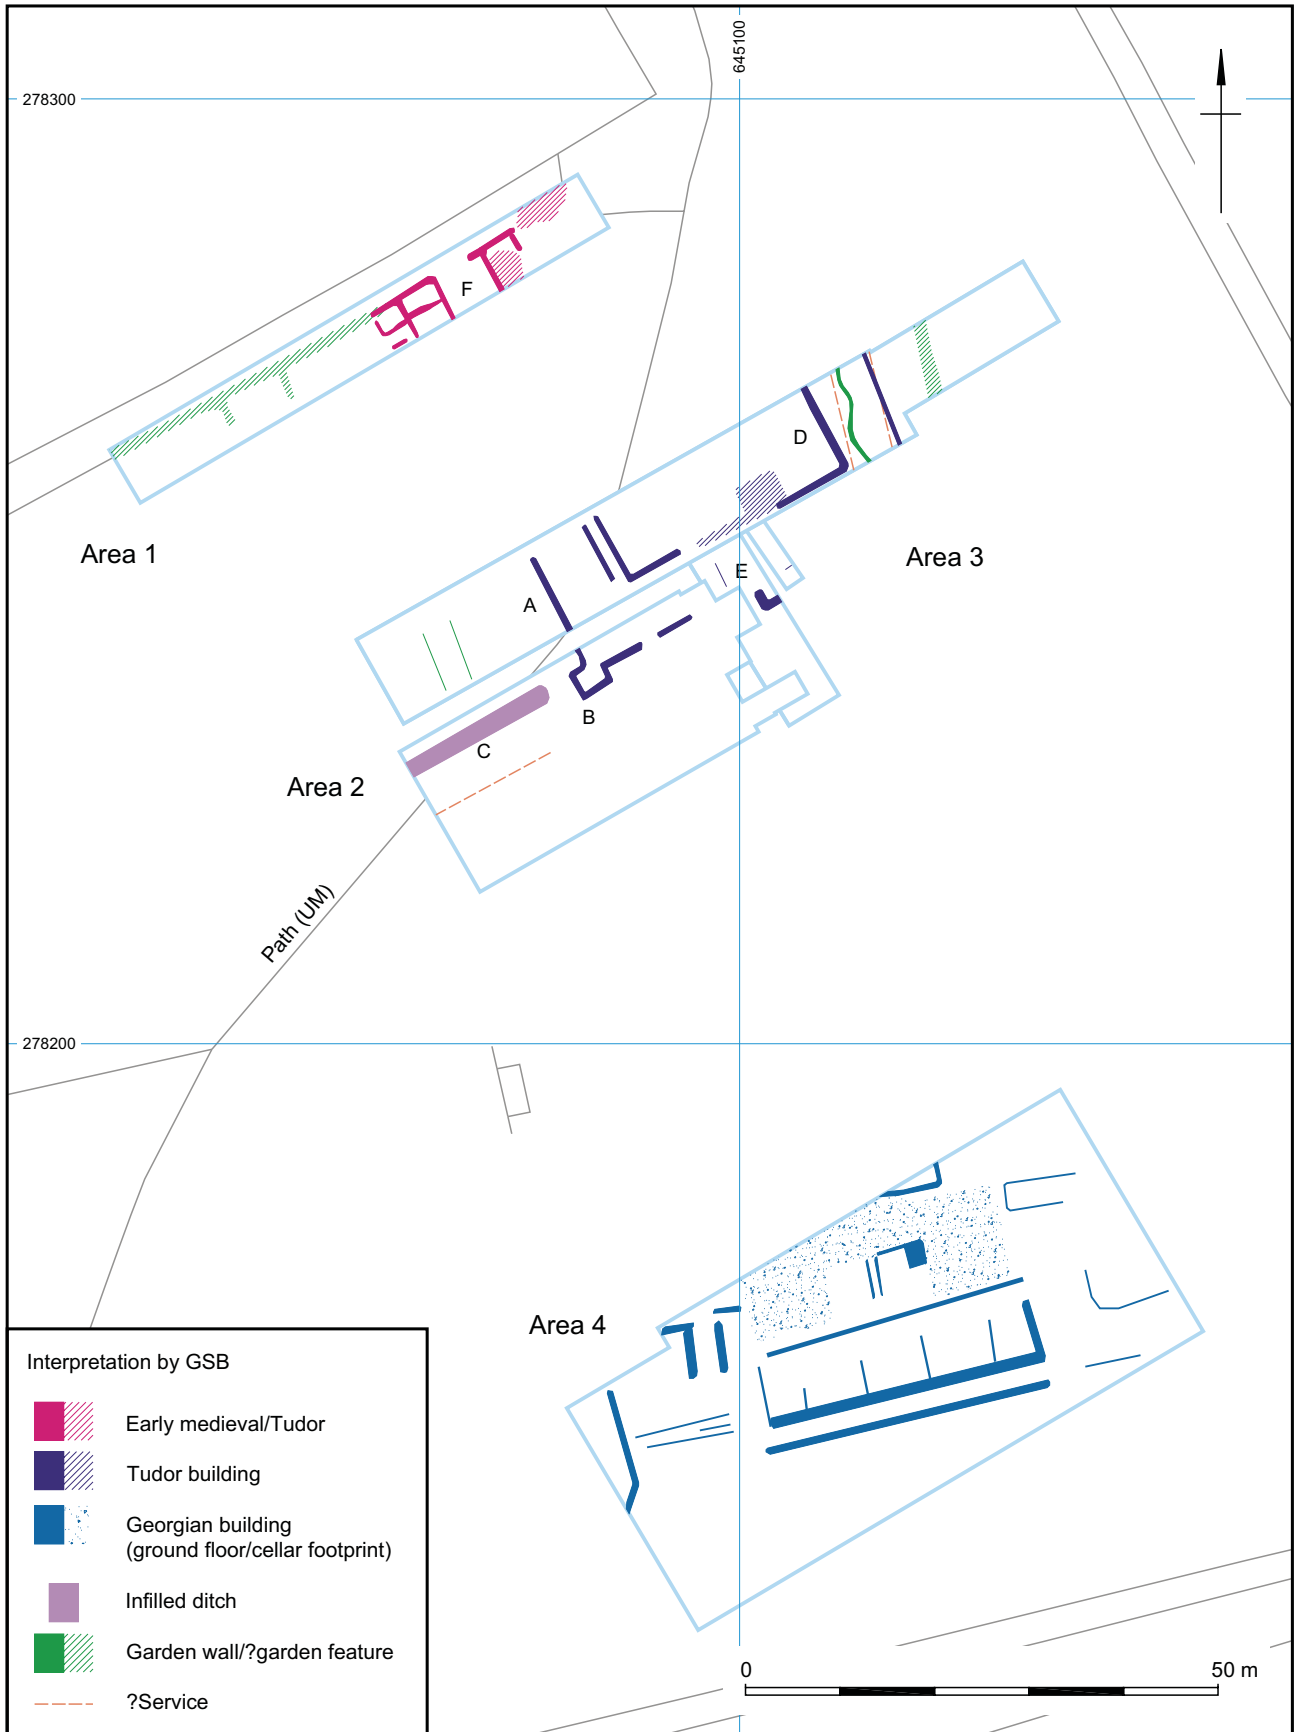
Figure 3

Ground penetrating Radar results

- 4.2.5 The western range [A] of the Tudor house's main court have been partially identified, with a south-western corner bastion [B] very clear. Beyond this to the west is what was thought to be another wall line [C] but, upon excavation, rather than being a solid foundation it was found to be a ditch back-filled with demolition material. The eastern range [D] is also discernible, as well as some reflectors [E] in the centre associated with the gatehouse; however the remainder of this structure was not surveyed due to trenching and spoil heaps.

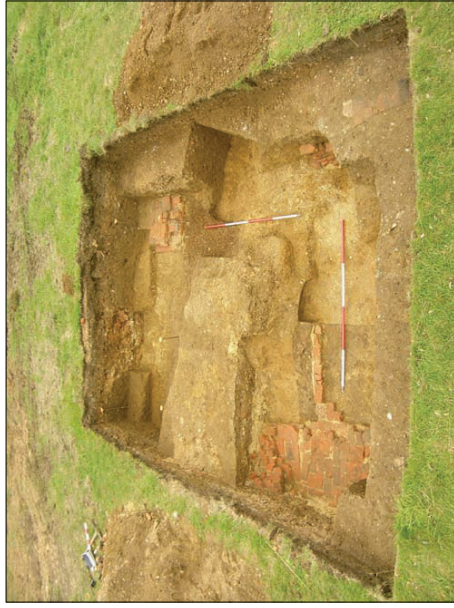
Plate 3: View of Trench 1, from the south-west

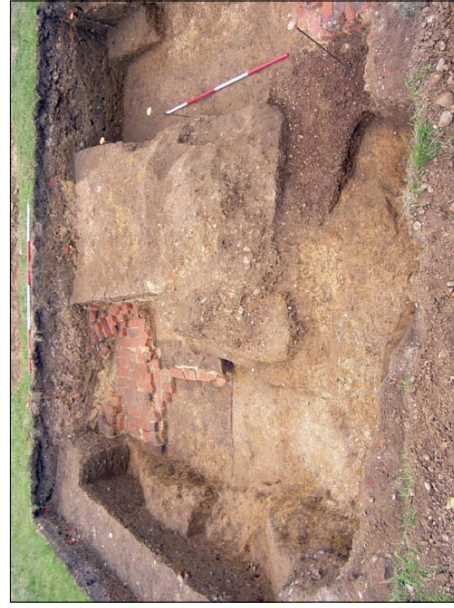
Plate 4: View of Trench 1; robber cuts 103 and 119, view from the south-east

- 4.3.11 A further robber cut (**119**) was also seen within the footprint of the tower. Slightly narrower than **103**, this would seem to represent the removal of an internal wall within the tower, perhaps associated with a staircase. Some traces of sand and brick at the base of the cut (**120**) are all that remains of the disturbed foundation, while above this was a deliberate backfill deposit (**121**) similar to that within **103**.

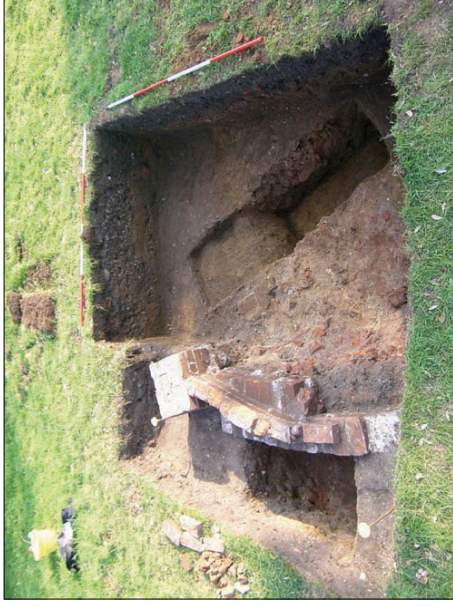
Plate 5: Trench 2, view from the north-east

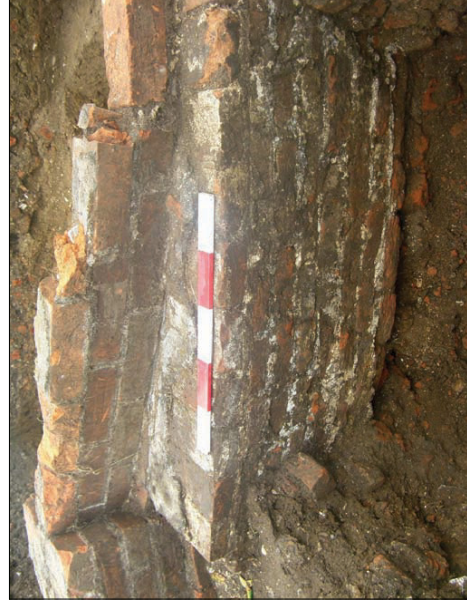
Plate 6: East-facing elevation of structure 210

- 4.3.18 Cutting both **206** to the west and made ground deposit **202** to the east was **209**, a construction cut for wall **210**. Wall **210** was of the type known as 'crinkle-crankle' or serpentine. These walls, often associated with growing fruit, normally date from the mid-18th century. An upstanding north-south aligned crinkle-crankle wall can be seen on the south-west side of the walled garden. The foundation for the wall **210** is markedly different from the intended visible extent, being constructed of re-used bricks probably derived from the earlier Tudor structure (**Figure 5, Plate 6**). The curving part of the wall by contrast uses bricks of different proportions (200 x 100 x 70mm or 8 x 4 x 2¾ inches), more consistent with 18th or 19th century brickwork.

210	<i>Structure</i>	Garden wall of crinkle-crinkle type. Red brick foundation utilising re-used 'Tudor' brick (23x10x6cm), eight courses on west side with three courses abutting on east side to support curve of wall. Three courses of single skin red brick (20x10x7cm) curving wall on this foundation. Pale grey-white mortar. 0.48m wide. Overlies 205.	0.72 high
211	<i>Structure</i>	Gate pillar or post, butts 210. Red brick (23x10x6cm) 4 courses high on 2 course foundation. Square in plan, 44x44cm. Pale grey-white mortar.	0.35 high
212	<i>Natural</i>	Natural sand, or could possibly be made ground or old subsoil. Dark yellow. <1% stone, rounded, <1cm. Compact. Occasional diffuse mottling. Overlies 213.	0.85-1.05 bgl
213	<i>Natural</i>	Natural sand. Mid-yellow with occasional mid-brown mottles and rare sandy clay mottles. Compact.	1.05+ bgl
214	<i>Structure</i>	Wall remnant; projects forward from main robber cut alignment so may be buttress. Composed of red brick (23x11cm) bedded with mid-yellow sand. Length 0.48m, width 0.20m. Height not fully exposed but thought to be only one course. Overlies 212.	0.04+ high

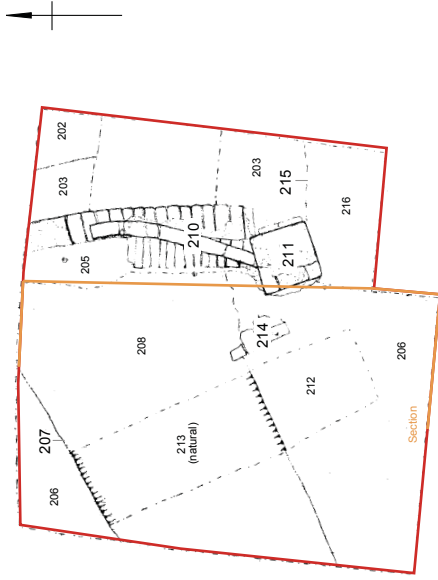
Section showing structures 210, 211 and features 215 and 217

- 4.3.20 The final deposits encountered were **203** and **204**; these similar and probably equivalent demolition deposits were banked up around wall **210** and pillar **211**, post-dating their use as garden features and levelling the surrounding area. Both deposits lie directly beneath the modern topsoil. A worn and residual Elizabeth I sixpence was found within layer **204** along with a sherd of early 18th century pottery.

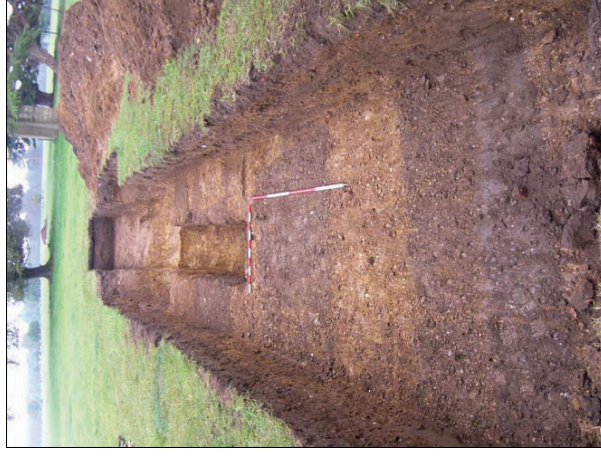
Plate 8: View of Trench 3, from the north-west

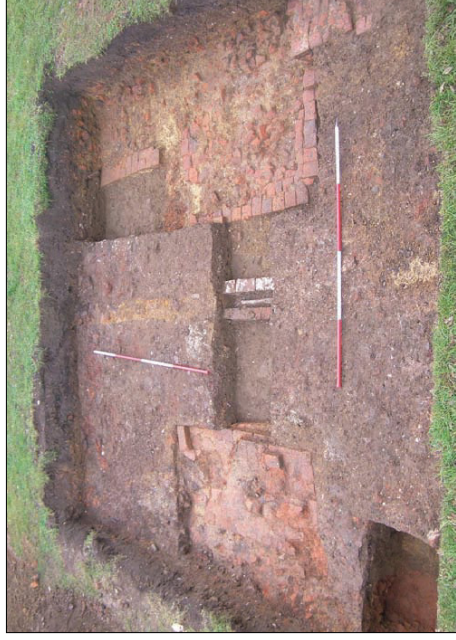
Plate 9: Trench 4, view from the south-east

- 4.3.25 Trench 4 was targeted on the gatehouse of the house and lay just over 15m to the north-east of Trench 1. As with Trench 1, the topsoil overlay a layer of mixed demolition debris (**402**). A late 17th century Charles II farthing was found within this debris.

- 4.3.26 A buried soil horizon was also discovered, numbered **407** and **412** in different interventions, which was cut by the construction cuts for the south-western and north-eastern sides of the gatehouse - **413** and **428** respectively. Pottery from this buried soil suggests a medieval date – a single post-medieval sherd from **412** is likely to be intrusive here. A sondage through **413** showed the lowest fill (**414**) to be entirely composed of brick rubble. This appears to have formed the foundation deposit. Within this early period of brick building, construction techniques were still used that were inherited from working with stone (Richard K Morriss *pers. comm.*), a form of technical skeuomorphism. In this manner, the wall appears to have been constructed with whole bricks as facing material (**422**) and a brick rubble core (**415**) (**Figure 7, Plates 9 and 10**). The facing bricks match the size and fabric of those in Trench 1 (230 x 110 x 60mm or 9 x 4¼ x 2½ inches).

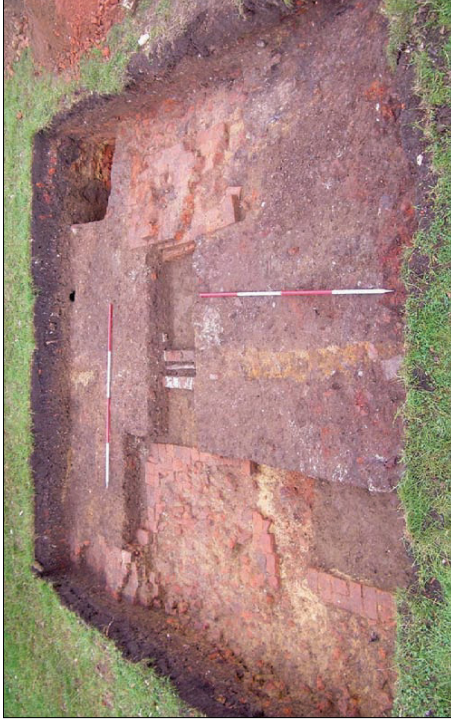
Plate 10: Trench 4, view from the north-west

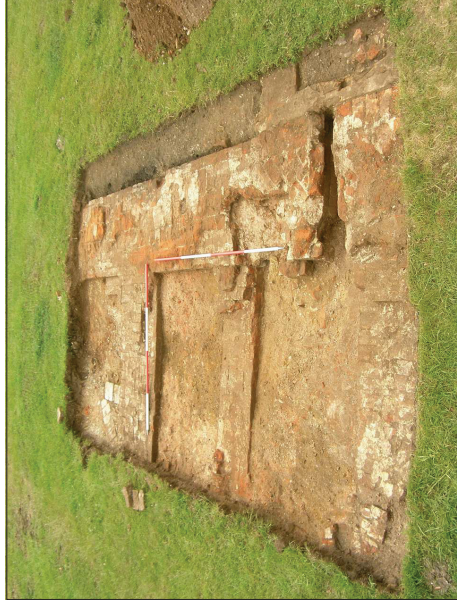
Plate 11: Trench 5, view from the north-west

- 4.3.36 Plans of the new house produced by James Wyatt in 1793 indicate that the trench is situated on the south-western edge of the 18th century house, with **502** forming the foundation for the external wall. The plans suggest that the southern part of the cellar storey was not used as rooms, as they lack the labels and door annotations shown within the northern part of the building. Wall **504** apparently formed the division between these cellar rooms and the foundations to the south. Walls **505** and **506** correspond to divisions within the ground floor above, where this area was divided into a water closet, strong closet and office. The position of the water closet, which lies above the northern end of the trench, explains the built-in drain **503** seen within wall **502**.

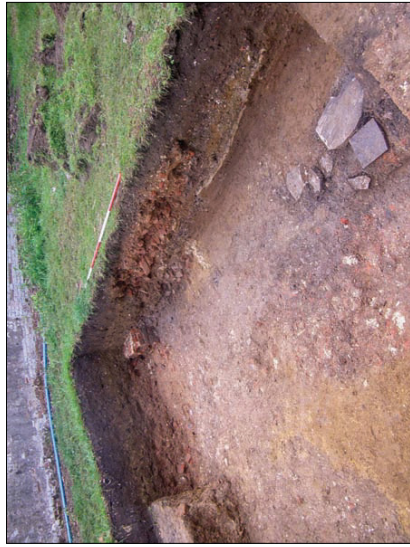
Plate 12: South-west facing section Trench 6, oblique view

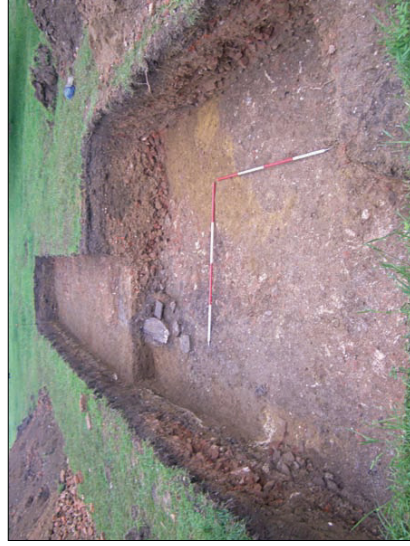
Plate 13: Trench 6, view from the north-west

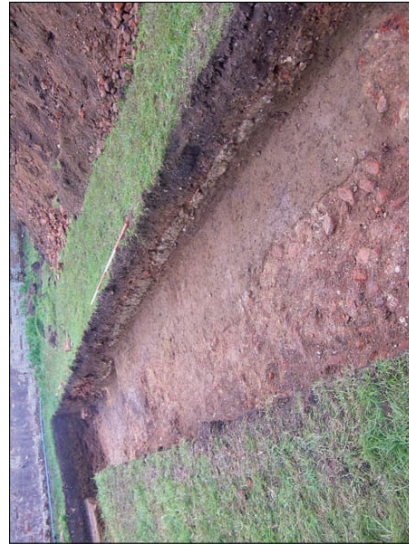
Plate 14: Trench 6, view from the south
