# Exeter Flood Defence Scheme Exeter, Devon

Archaeological Fieldwork Report

Ref: 105800.09  
March 2015

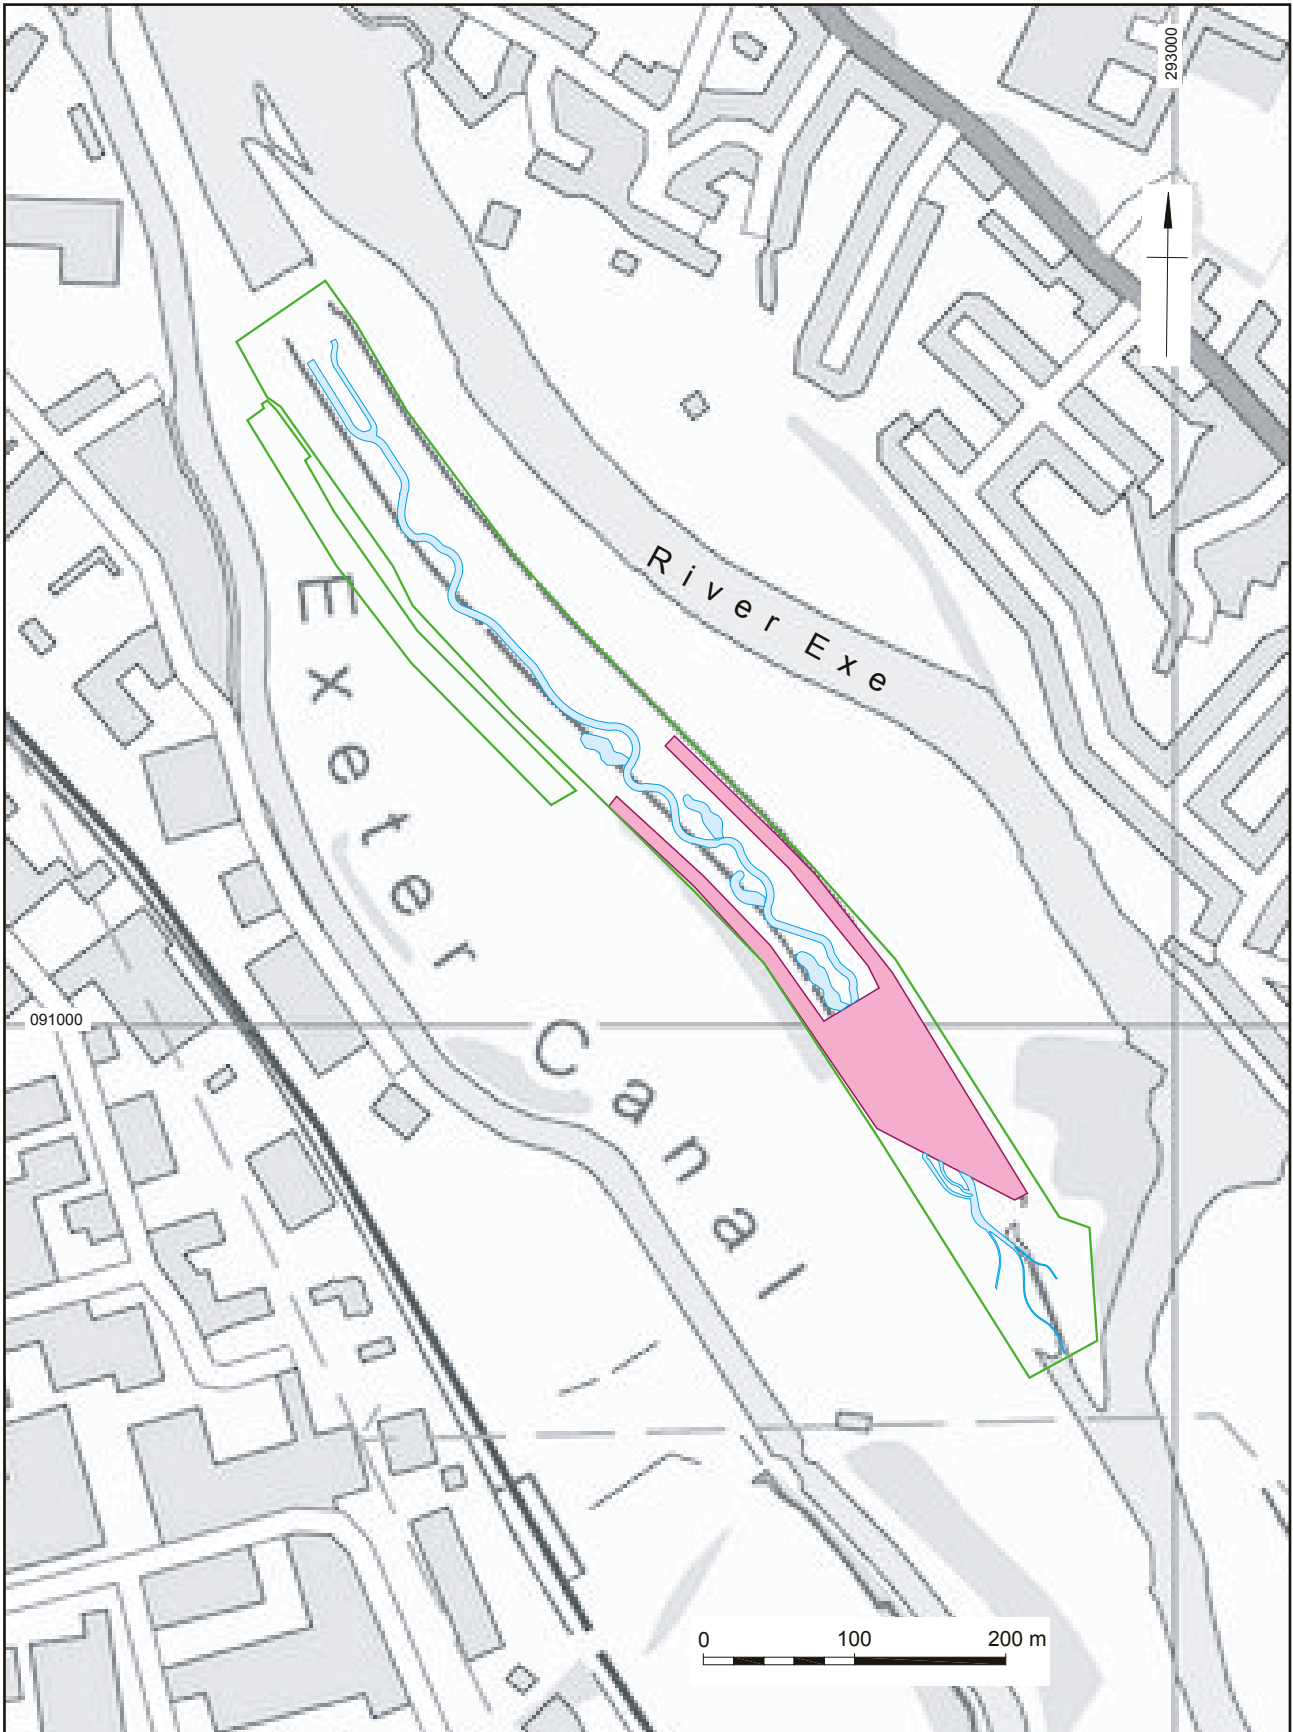
Figure 15

Watching brief: monitored area

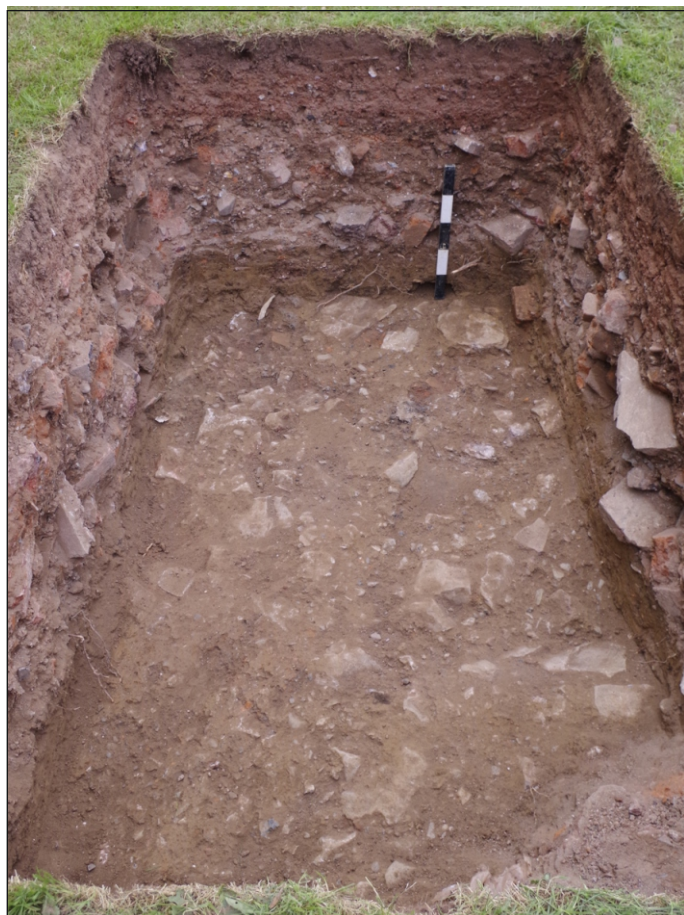
Plate 1: Zone 3 – adjacent to Exe Bridge Trench 1, viewed from the east

by the presence of live services and mature trees. Trench one encountered a heavily compacted (and virtually impenetrable) horizon (**Plate 1**) below 1m of successive layers of modern made ground. As excavation ceased at this level, no finds or features relating to the causeway (or associated structures) of the historic Exe Bridge were identified.

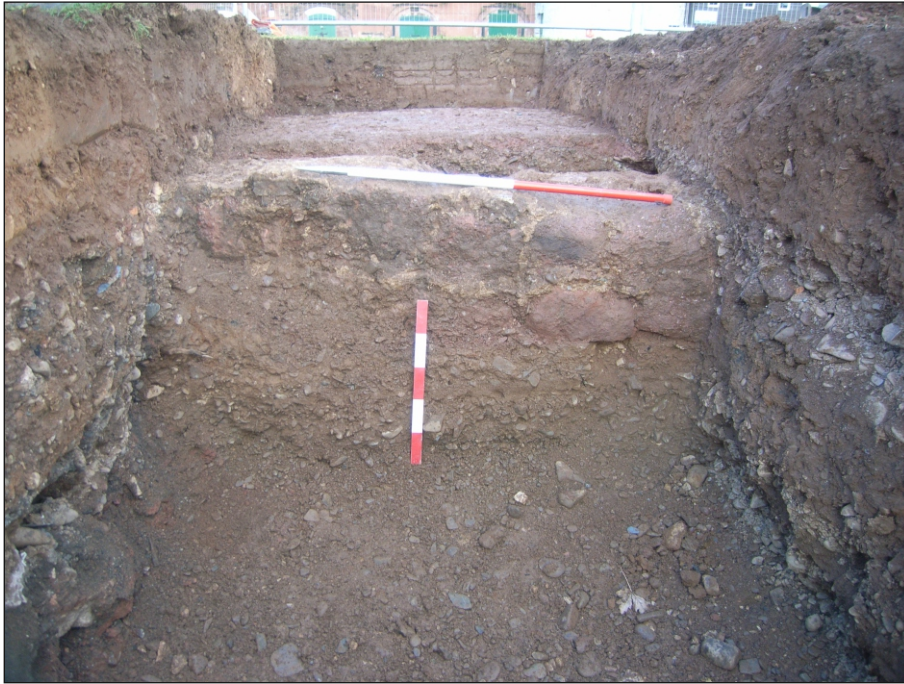
Plate 5: Zone 4 – Piazza Terracina Trench 5, wall 504 with alluvial deposits (right), viewed from the south-west

- 4.6.2 The wall foundation corresponds with the line of existing property boundaries, a boundary shown on the 1839 St Thomas Tithe map and the 1876 Ordnance Survey map and represents the footings of the limestone compound wall built in 1830 around both sides of the basin, for security and probably customs purposes.

- 8.1.9 Evaluation trenching to the north of the Canal basin, adjacent to Piazza Terracina (Trench 5) identified a wall foundation (**Plate 5**) that represents the footing of the basin compound wall of c. 1830, a standing section of which remains adjoining the North Warehouse. The wall foundation and other elements of the 19th century were found to be sealed beneath modern deposits. The wall foundation appears to have cut undisturbed alluvial silts and gravels. On this basis, the potential for surviving below ground archaeology on the Site is therefore assessed as **Moderate to High**.

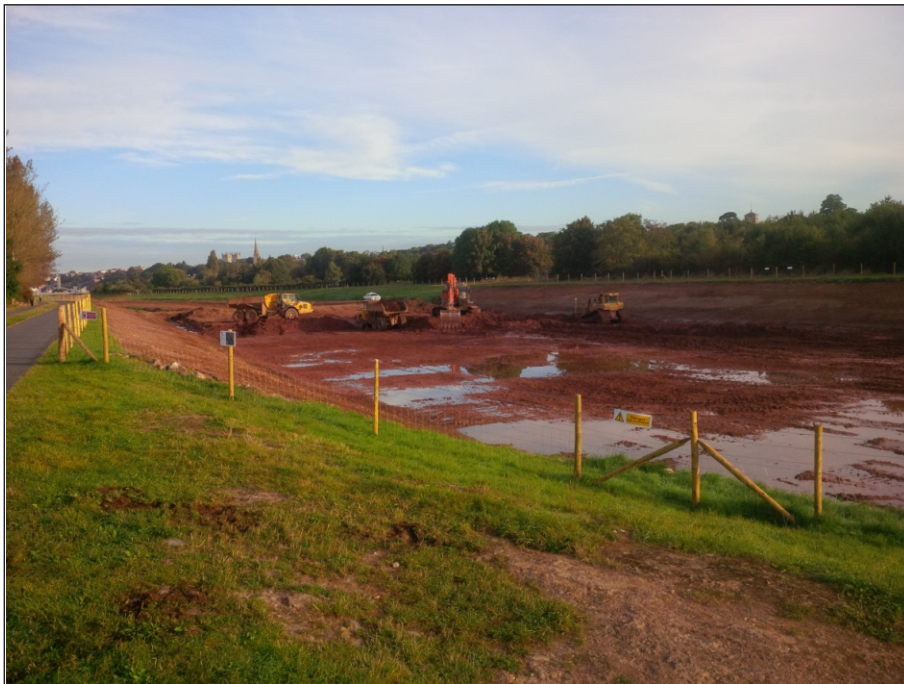
Plate 6: Watching brief area showing excavation methodology, viewed from the south

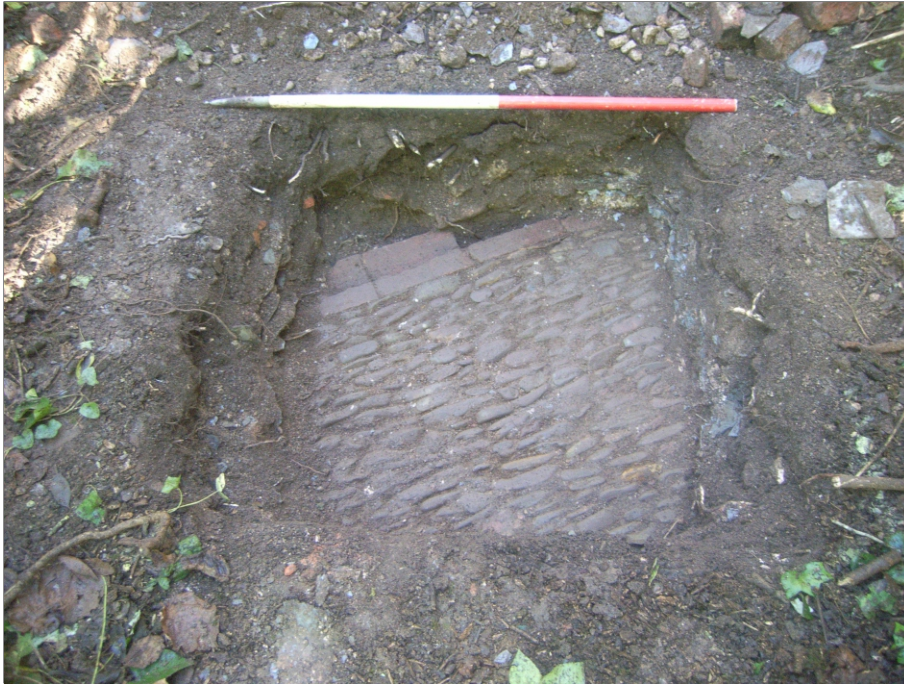
Plate 8: Zone 6 – Northbrook and existing Woodland Test Pit 5 cobbled surface from the south

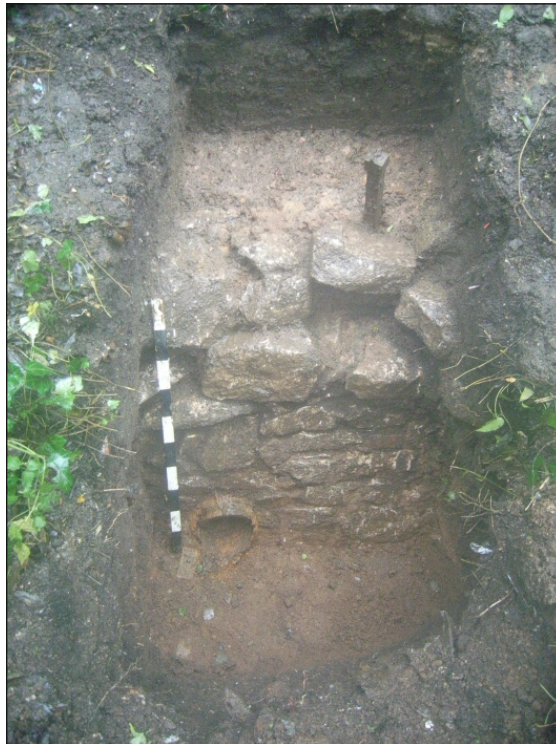
Plate 9: Zone 6 – Northbrook and existing Woodland Test Pit 12 north east facing wall of reservoir (1204)

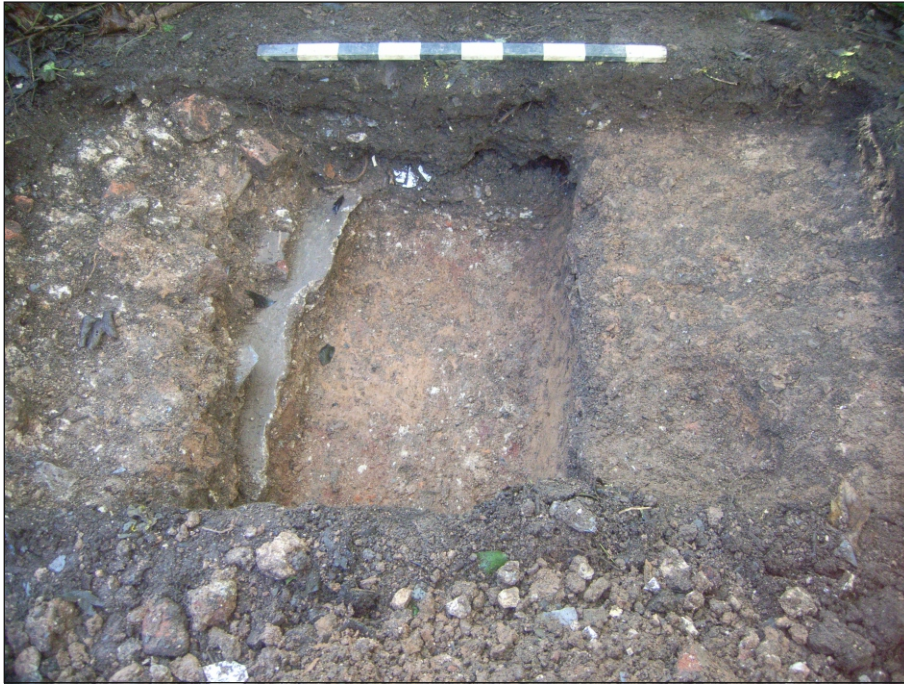
Zone 6 – Northbrook and existing Woodland Test Pit 13 robbed wall from the south west (1303)

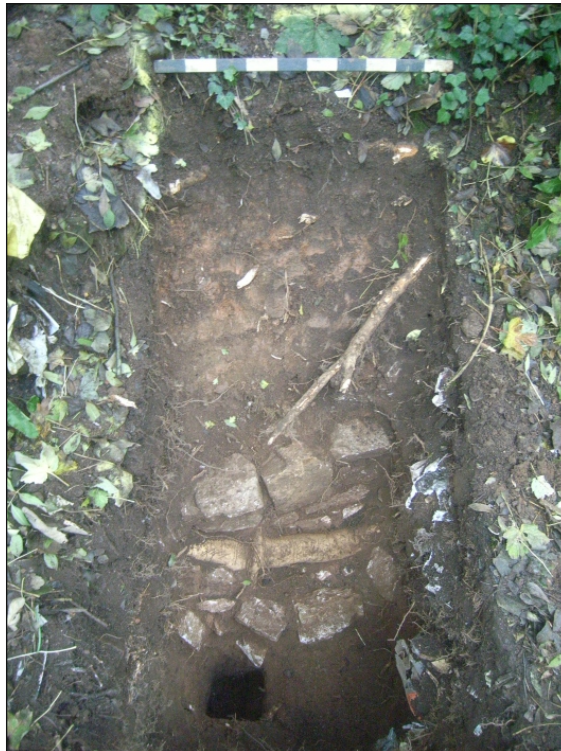
Plate 11: Zone 6 – Northbrook and existing Woodland Test Pit 26 wall of reservoir from the east (266)

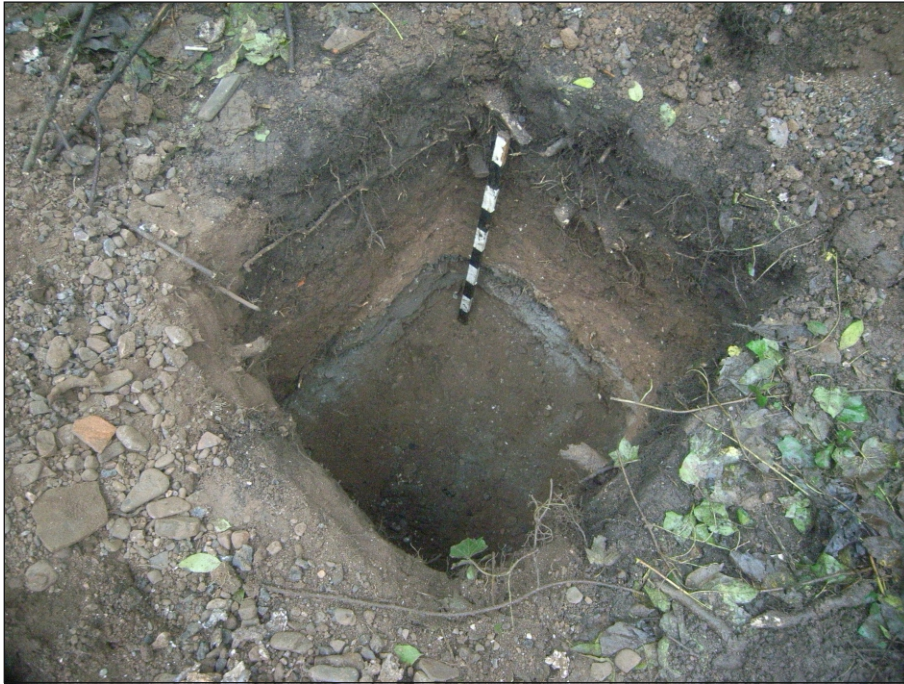
Zone 6 – Northbrook and existing Woodland Test Pit 16 demolition rubble to 1.20m from the south
