Lower Bredbury to Adswold Utility Work, Greater Manchester

Archaeological Watching Brief

Ref: 108810.02
October 2015

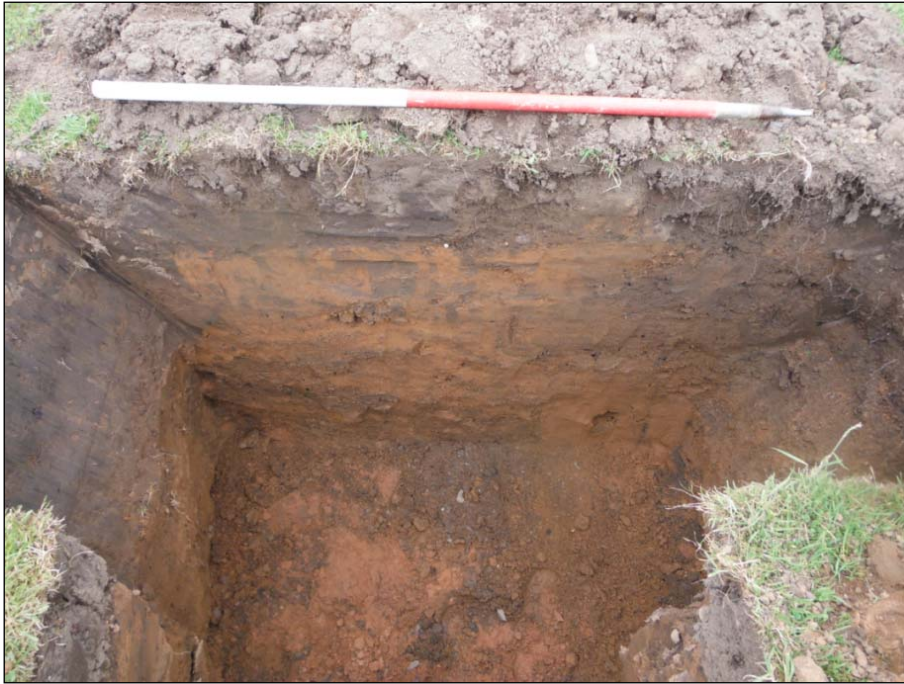
Trench 1		
Context	Description	Depth BGL (m)
101	Topsoil: mid greyish brown clay silt	0-0.3
102	Fill of 103: re-deposited tertiary fill. Mixed orange brown sandy clay	0-1.2+
103	Cut: cut for electrical services. N-S orientation, straight edges.	0-1.2+
104	Made ground: light brown clay with charcoal throughout	0.3-0.75
105	Natural: soft orange-brown sandy clay	0.75+

Plate 1: Trench 1 from south

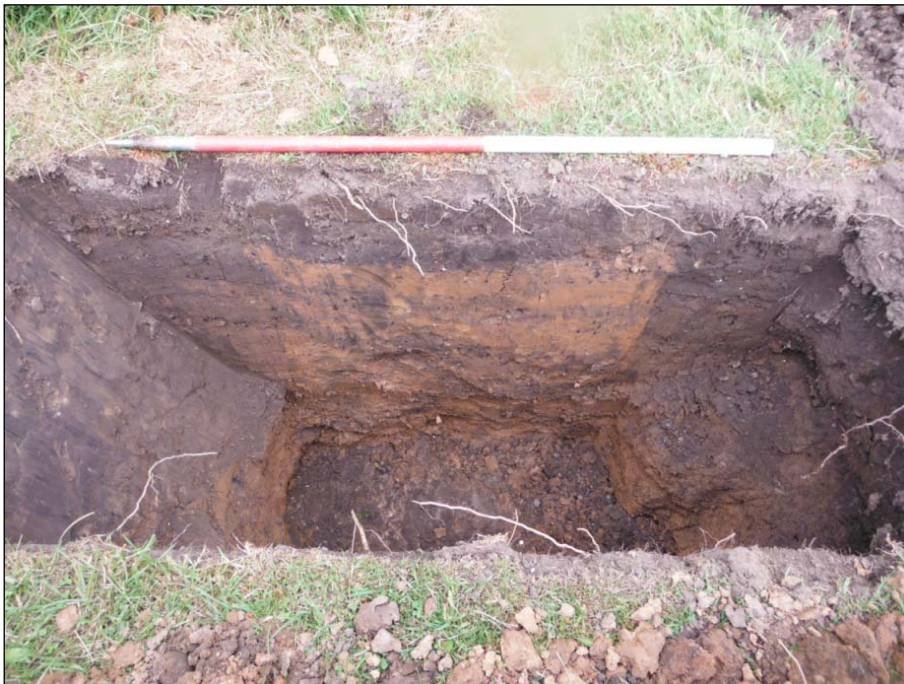
4.2.5 A deep (greater than 1.2m) straight-sided cut for existing services was seen in Trenches 1, 2 and 4 (e.g. 103). This was filled with re-deposited orange brown silt clay (e.g. 102).

Trench 2		
Context	Description	Depth BGL (m)
201	Topsoil: mid greyish brown clay silt	0-0.3
202	Made ground: light brown clay, firm, with charcoal and small nodules of orange clay	0.3-0.75
203	Natural: soft orange sandy clay	0.75+
204	Cut: n-s cut for services	0-1.2+
205	Fill of 204: orange brown silt clay	0-1.2

Plate 2: Trench 2 from south showing existing service cut

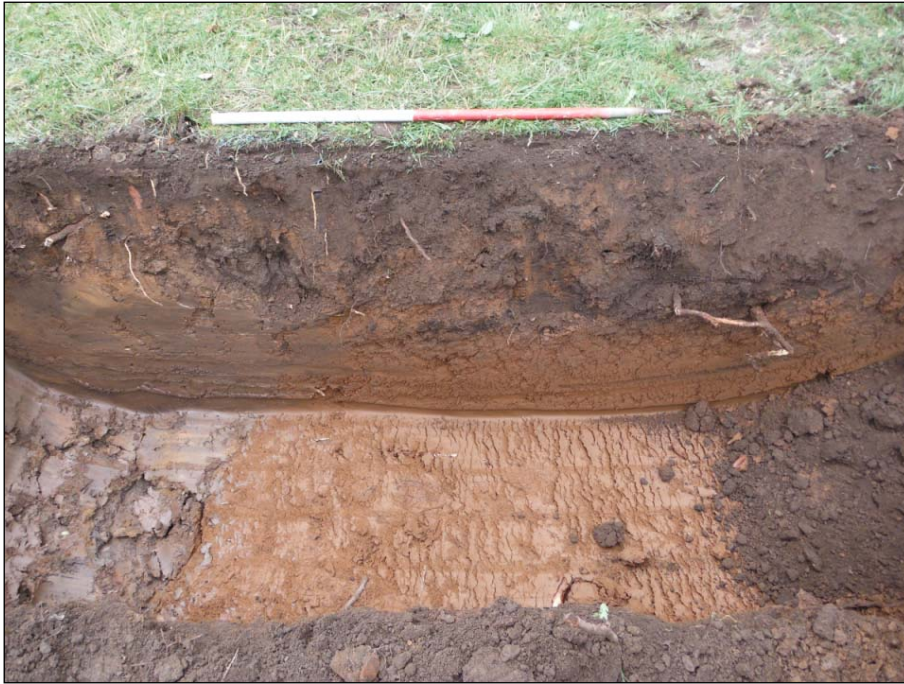
Trench 3		
Context	Description	Depth BGL (m)
301	Topsoil: mid greyish brown clay silt	0-0.2
302	Made ground: mixed orange-brown clay with charcoal	0-0.6
303	Natural: pale sandy clay with no inclusions	0.6-0.8
304	Natural: orange sandy firm clay	0.8+

Plate 3: Trench 3 from north

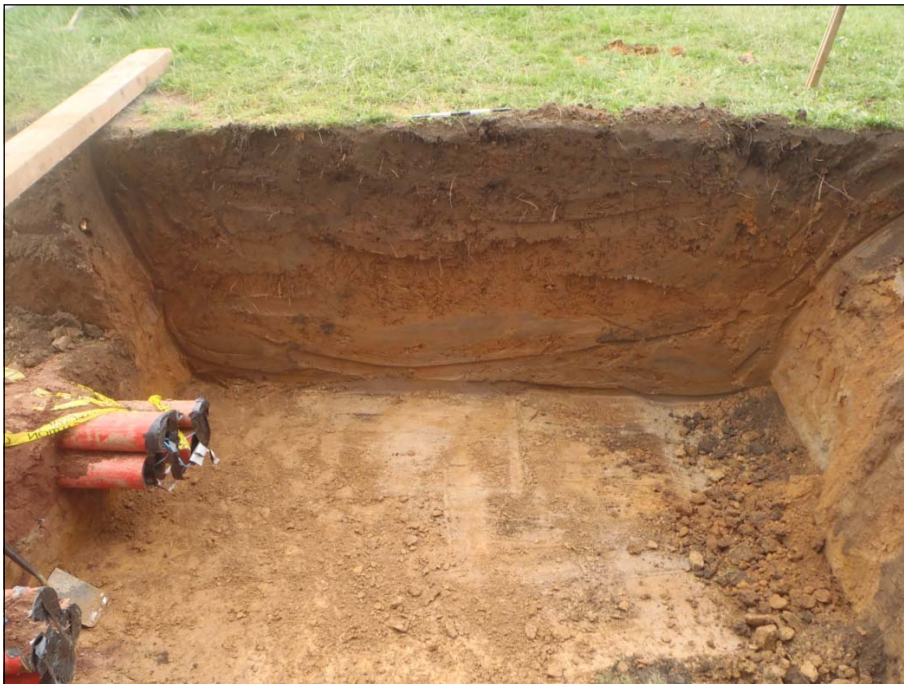
- 4.2.2 The deepest natural substrate was grey gravel and round stones (604), recorded at 2m below ground level (BGL). Above this, from around 0.7-2m, lay a firm clean orange sandy loam (e.g. 603).

Trench 6		
Context	Description	Depth BGL (m)
601	Topsoil: mid greyish brown clay silt	0-0.2
602	Made ground: mixed orange-brown clay with charcoal	0.2-0.7
603	Natural: orange loam. Gets gradually greyer towards base	0.7-2
604	Natural: gravel and round stones <0.08m in diameter. Just showing at base of trench.	2+

Plate 4: Trench 6 from north
