Car Dealerships, Meadowhall, Sheffield, South Yorkshire

Archaeological Evaluation - Final Report

Report reference: 74661.03

December 2010

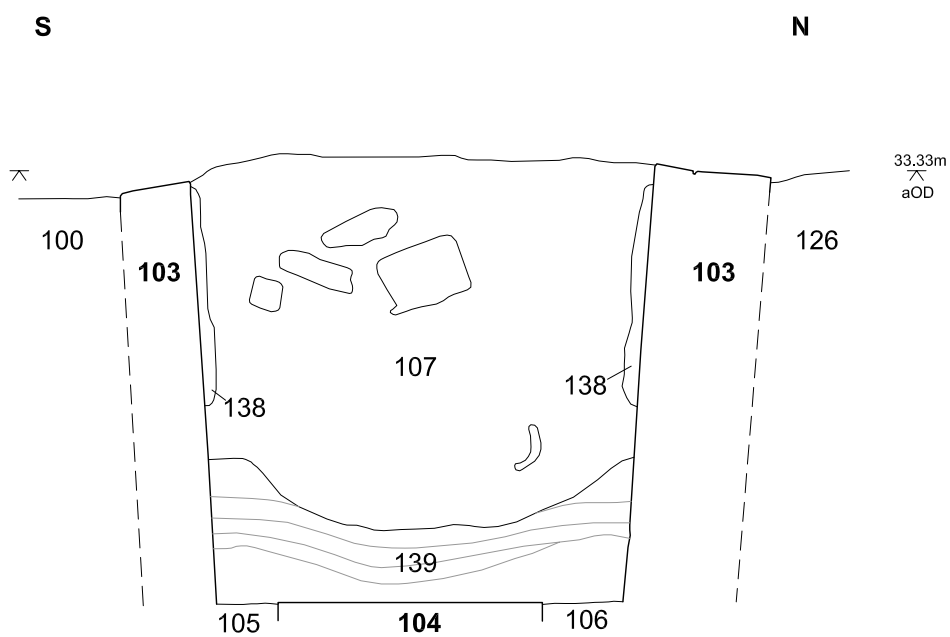
Figure 3

Section through structure 103

4.4.5 The upper part of Structure **103** was later backfilled with a presumed demolition deposit comprising loose, dark brown/black silty sand **107** containing brick, concrete rubble and timber, and fragments of metal and slag (**Figure 3**). Two graphite objects (**Plates 2 and 3**) recovered from this deposit may be derived from the dismantling or demolition of structures associated with the electric arc and induction furnaces (see section **5.2** below). Structure **103** had clearly been damaged during demolition and had originally been deeper/higher.

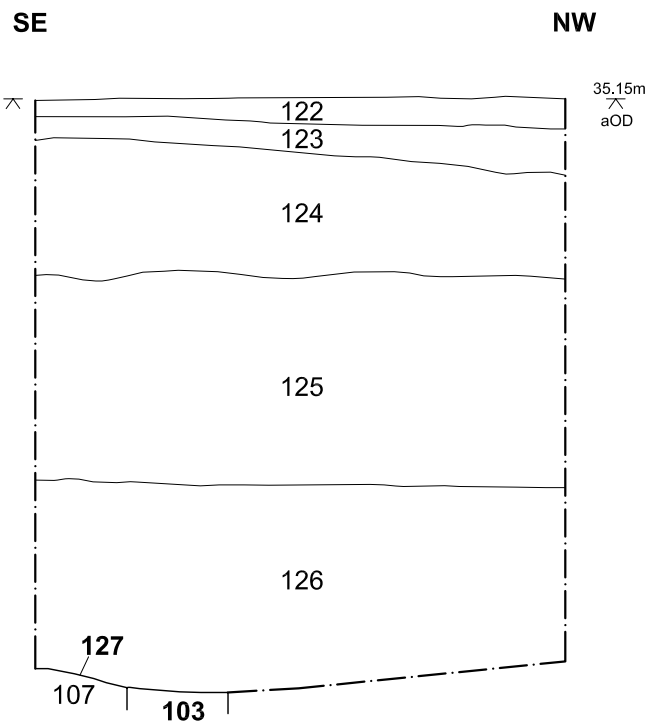
Figure 4

Section through overburden

4.6.1 The demolition of foundry walls and structures resulted in the distribution of debris **127** on a generally level plane (**Figure 4**). The demolition event was overlain by a 0.55m thick blackish brown deposit **126** containing frequent brick and concrete rubble with timbers, rubber and iron objects. This was overlain by a 0.6m thick layer of mid-bluish grey clay **125**, which in turn was overlain by a 0.3m thick layer of dark yellowish brown sandy silt **124**, representing made ground. A 0.12m layer of hardcore **123** underlay the bluish grey gravel **122** of the existing car park surface.

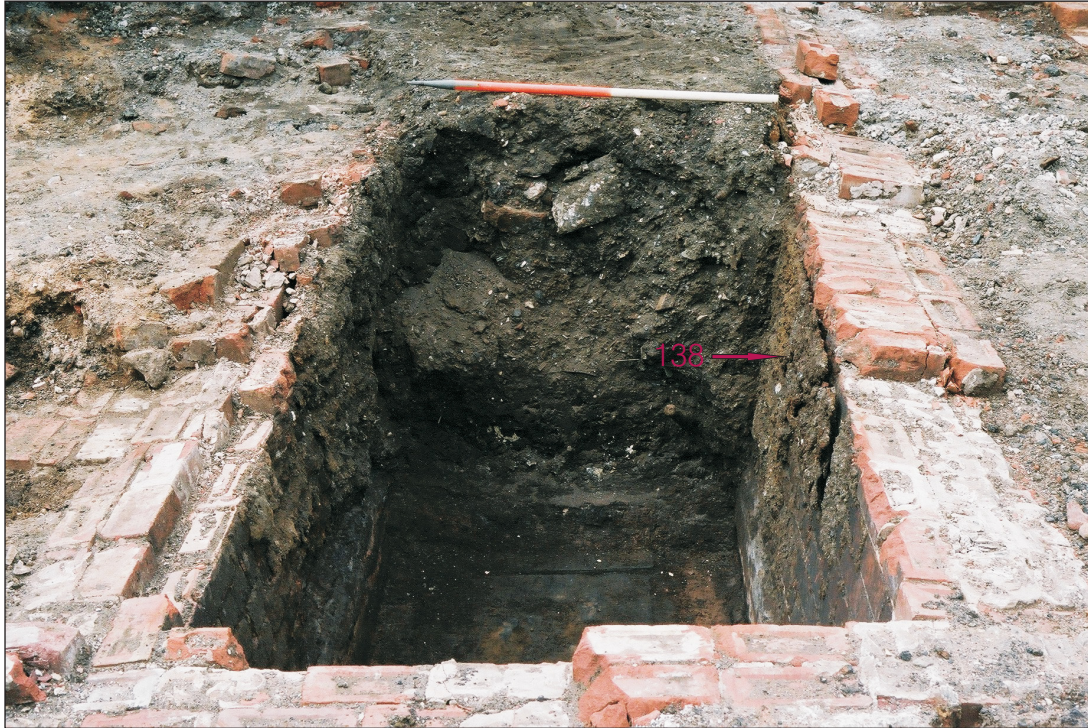
Plate 1: Structure 103 , showing metallic deposit 138.

- 5.3.4 Examination of the metallographic specimen revealed a very heterogeneous microstructure. The specimen appears to be made up from spheroidal and irregular shaped globules of steel. The microstructure of each globule is slightly different, and some are separated by thin layers of what appears to be silicate slag and/or possible ferrous oxides.

- 5.3.7 The sample analysed was removed from a deposit that was adhering to the lining what has been interpreted as a possible casting pit **103**. The lining of the upper half of the pit was covered with this metallic deposit/concretion. The level of sand and 'clean' brickwork found in the lower half of the pit suggests that it was approximately half filled with sand during use.
- 5.3.8 In the author's opinion, the 'casting pit' was probably being used to hold partially buried casting moulds, into which molten steel was poured. The splashes and spots from the teeming process appear to have accumulated and solidified on the lining of the pit over time. From the evidence available and potential variables involved, it is impossible to be precise on the time-scale of the deposition, or exact positioning of the casting moulds. However,

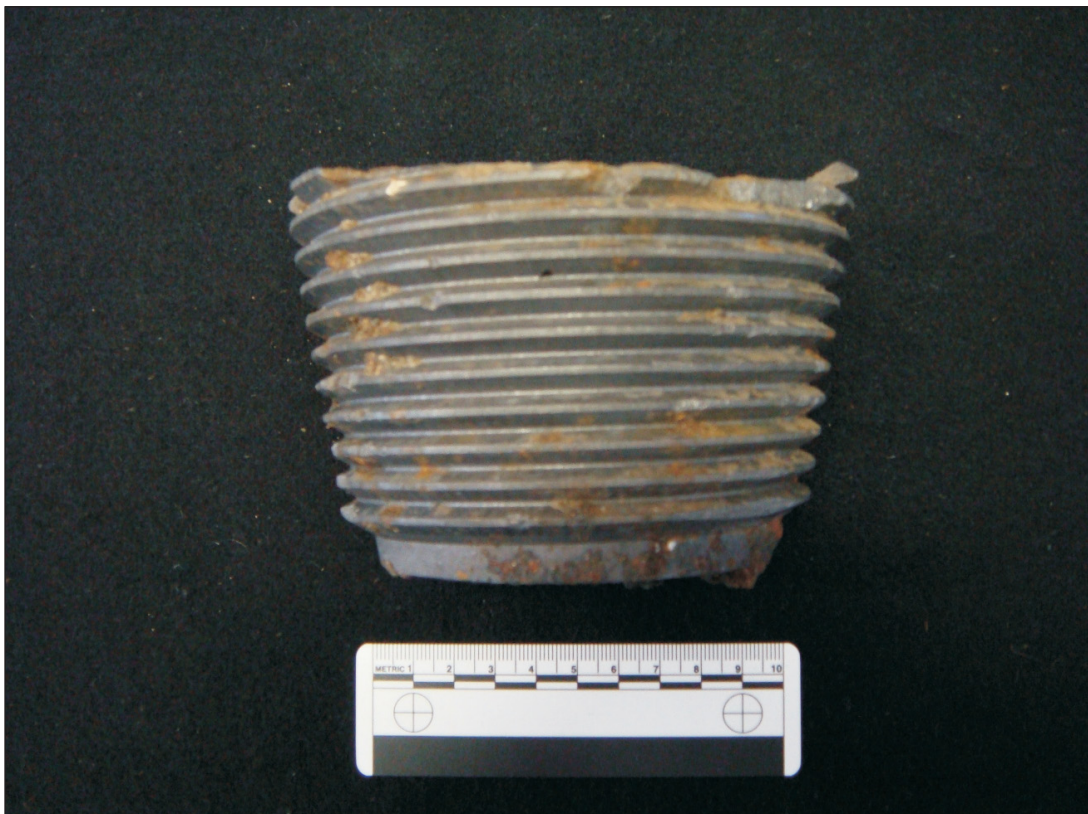
Plate 2: Screw threaded graphite object recovered from demolition deposit 107.

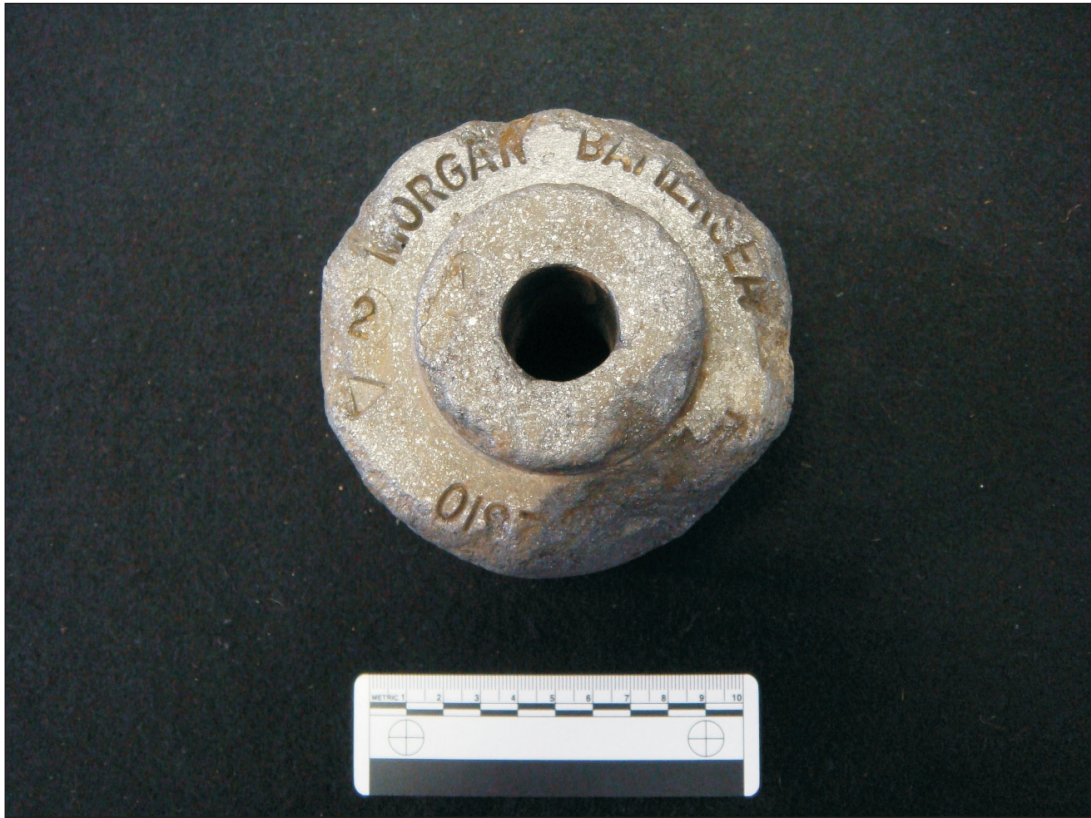
Plate 3: Screw threaded graphite object recovered from demolition deposit 107.

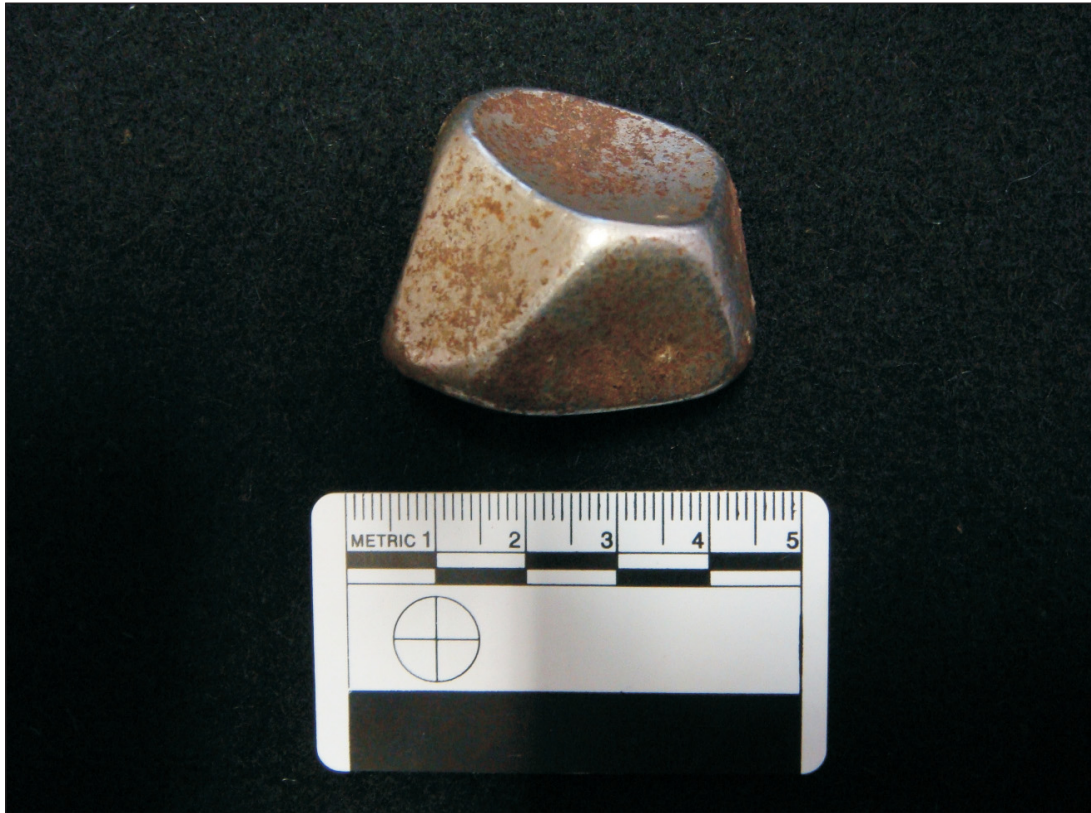
Plate 4: Unusually shaped 'nodule' of steel recovered from deposit 100.
