Chisbury Manor Ground Source Heat Pump Chisbury, Marlborough, Wiltshire

Archaeological Watching Brief Report

Scheduled Monument Consent Ref.: S00107896
Ref: 109340.01
July 2015

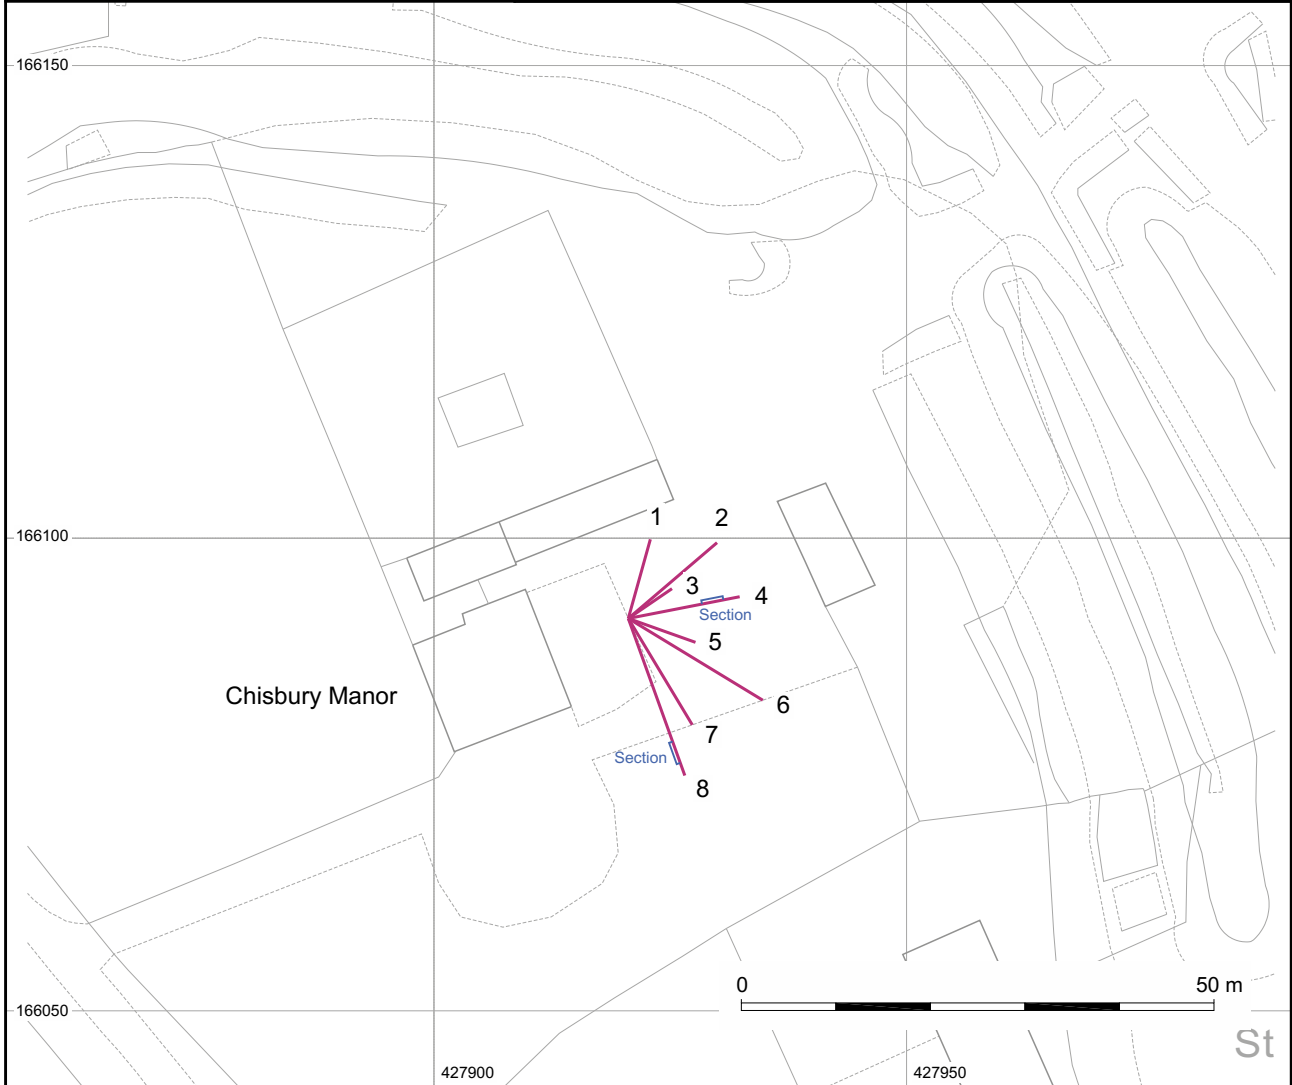
Figure 1

Site plan and location

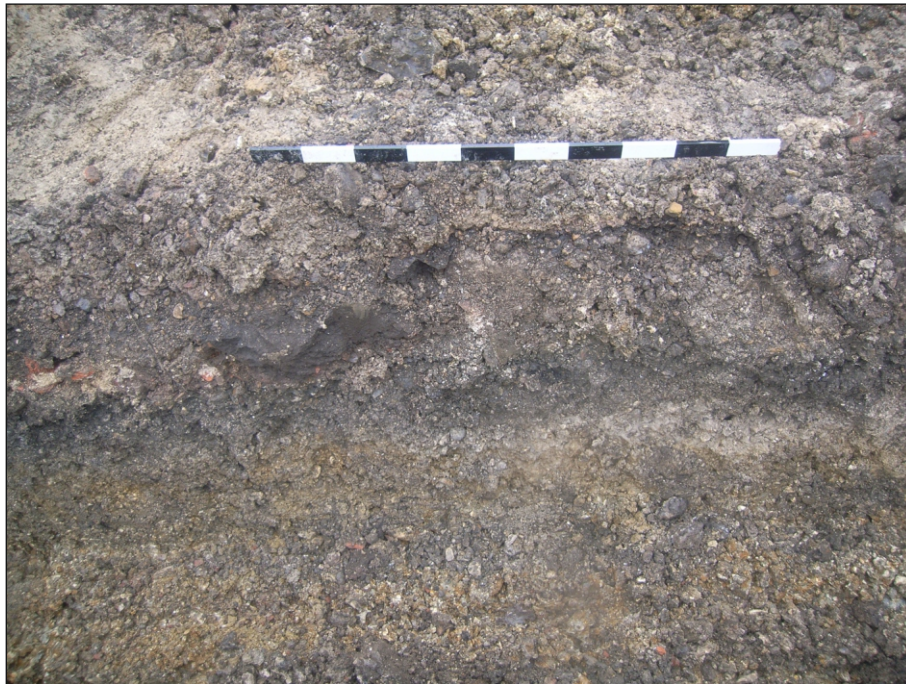
Section/test pit 8	dimensions (m): 0.50 x 1	
	land use: drive way and parking area	
category	description	depth (m) blg
Made ground	Made ground, rubble brick, mixed stone gravels	0-0.25
Buried soil	Buried soil. Possible garden soils 18 th C. Black silty clays	0.25-0.50
Natural	Mid to pale yellowy brown sub angular gravels, poorly sorted, mixed, pebble to pea sized. compact	0.50 +

Plate 1: East facing section showing stratigraphy at trench/test pit 8

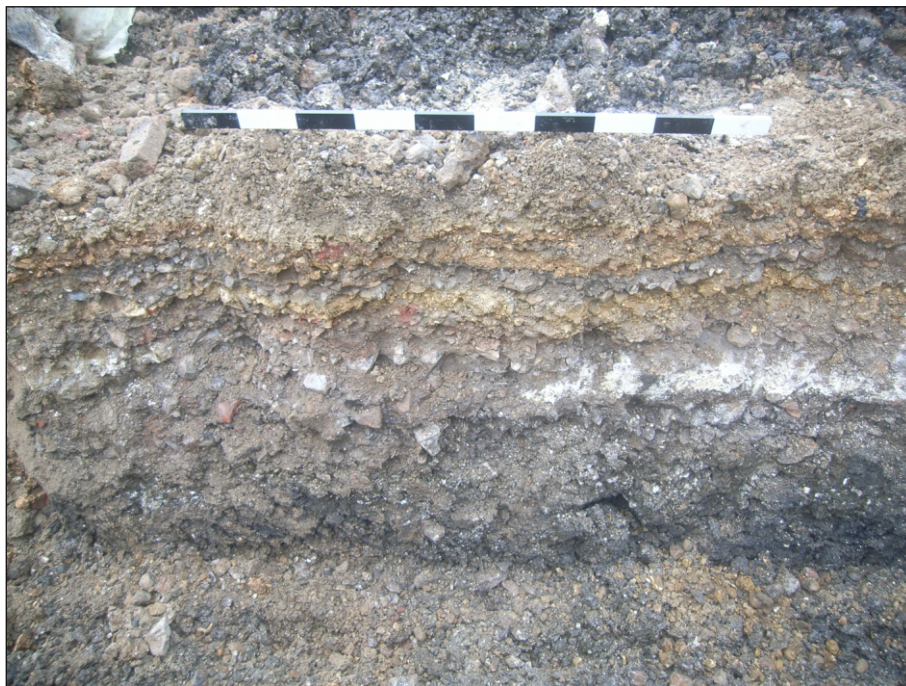
Section/test pit 4	dimensions (m): 0.30 x 0.90	
	land use: drive way and parking area	
category	description	depth (m) blg
Made ground	Pea grit, as part of the driveway and many layers of made ground, very mixed brick stone and gravels, occasional dumped brick.	0-0.30
Buried soil	Black silty clays, occasional sub-rounded gravels,	0.30-0.80
Natural	Mid to light brown gravels, poorly sorted pea to cobble sized.	0.80 +

Plate 2: South East facing section showing stratigraphy at trench/test pit 4

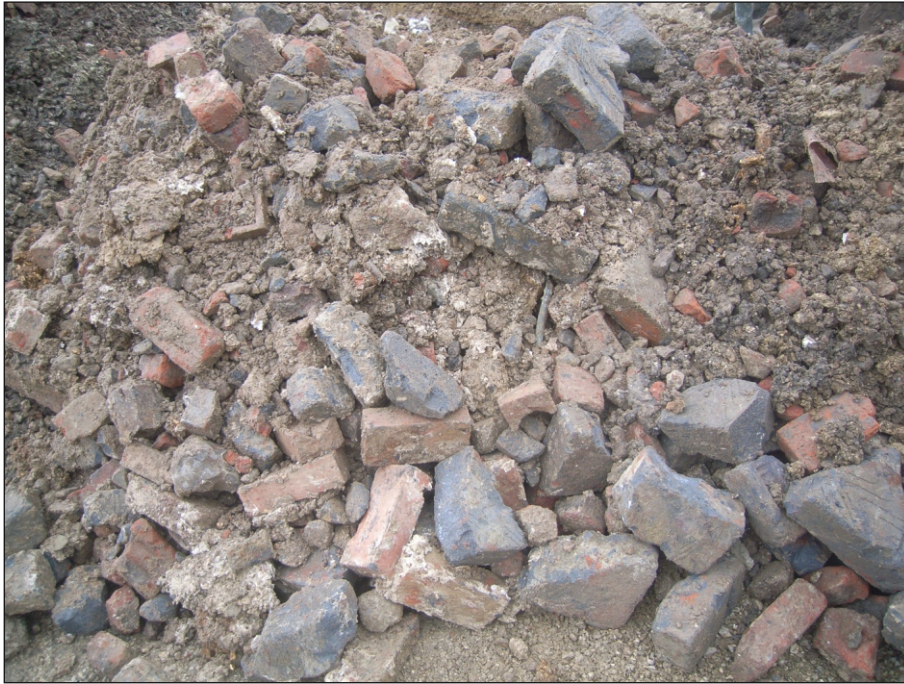
Plate 3: Brick and rubble up-cast
