Archaeological Strip, Map and Record and Watching Brief

Sheffield City Council Town Hall Pinstone Street Sheffield S1 2HH

Wessex Archaeology
Unit R6, Sheaf Bank Business Park
Prospect Road
Sheffield
S2 3EN

January 2016

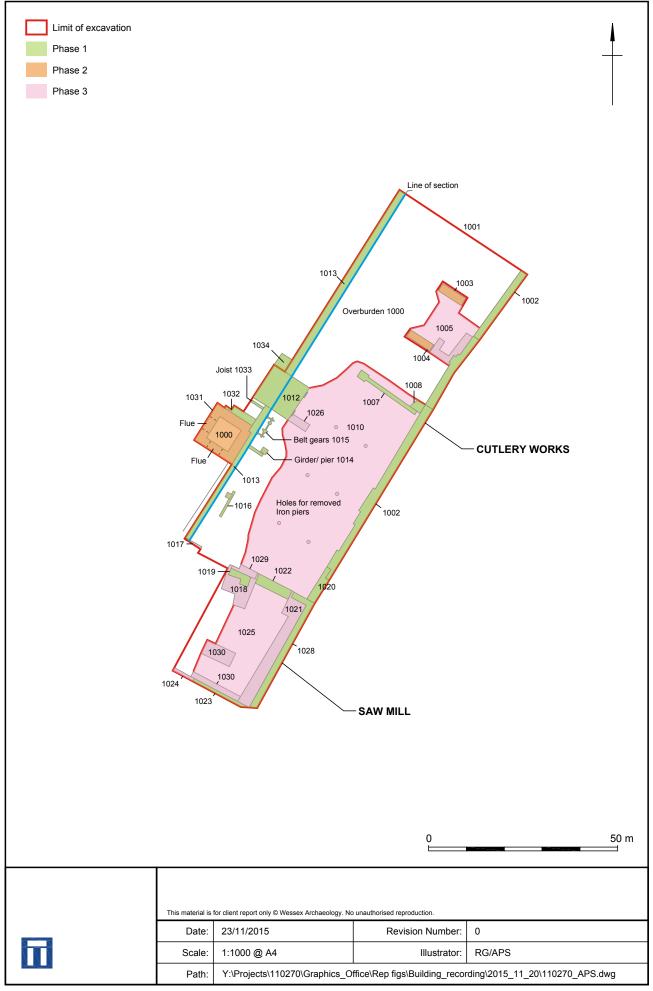
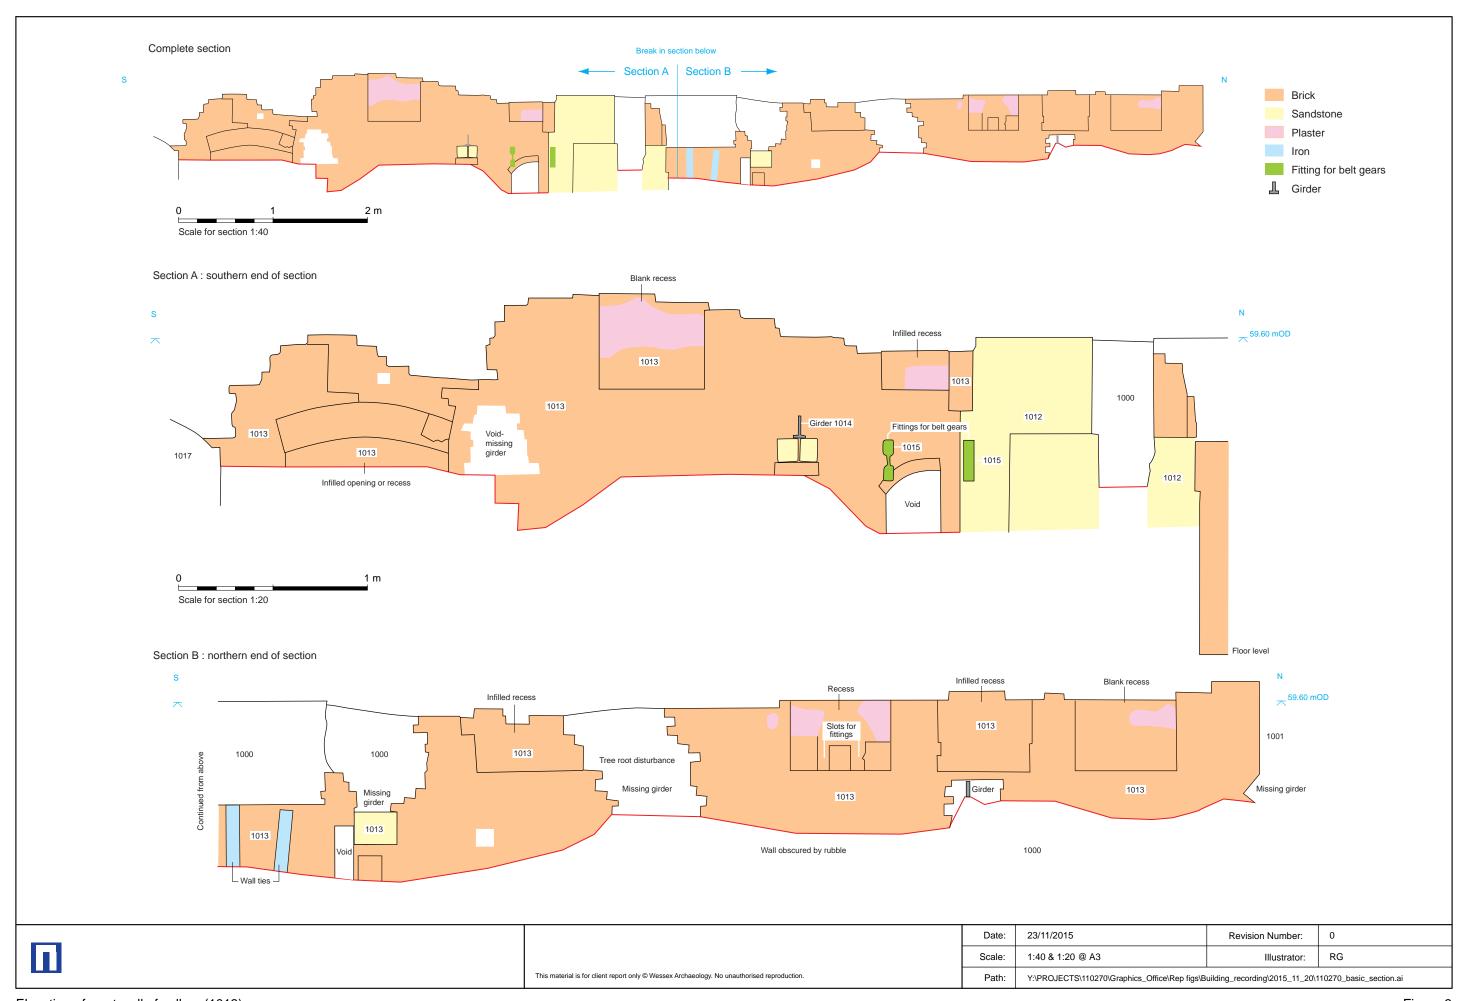
Plan of excavation Figure 2

- 4.2.2 The main area of excavation was focussed on a series of cellars adjacent to the Porter Brook River (**Figure 1**). In the north, several small rooms were partially exposed. In the centre, a large cellar was almost completely exposed, and in the south, an area had been modified in the 20th century. The northern and central areas originally formed part of the cutlery works as shown on historic mapping (**Figure 2**). However, the southern area was originally part of an adjacent sawmill and was remodelled in the 20th century to communicate with the cutlery works cellar. To the west of the cellars, partial structures were seen in plan suggesting that non-cellared buildings continued west beyond the exposed cellars.

- 4.3.2 Steel frame techniques were used to supplement the brick structure, with inverted "T" shaped girders used to support the ground floor (1014, Figure 2, Plate 1) and as part of the structure of the northern east-west wall (1001). These inverted "T" shape girders supported brick springers on either side that would have led to red brick vaulting supporting the ground floor above the excavated cellarage. Most of these girders had been removed (likely for scrap), but small truncated ends were occasionally seen and a pattern of voids in brick structures testified to the position of the rest. Circular steel piers with an external diameter of 0.135m (Plate 1) were used to support the girders, although in some cases these steel piers were replaced with red brick piers (e.g. where machine base 1016 prevented a steel pier being installed, Plate 2).

- 4.4.3 Some repairs in black ash mortar were performed on the main west wall (1013) as shown in Figure 2.
