Dillhorne Lane, Tickhill, Staffordshire

Archaeological Evaluation Report

Ref: 110840.01 September 2015

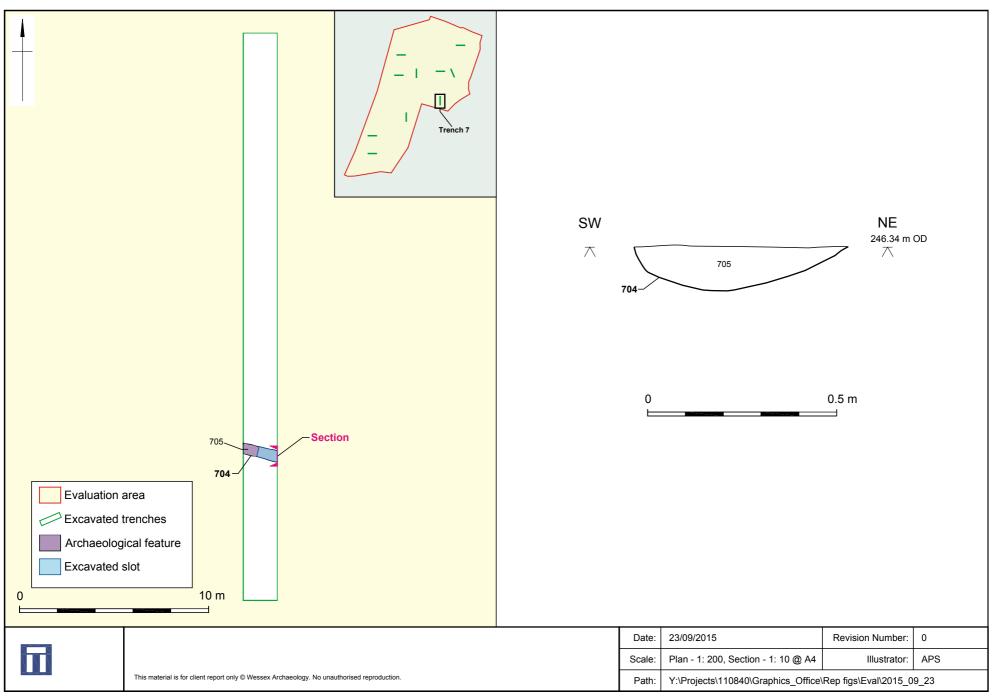
Trench 7, hedgerow 704 Figure 2

- 4.3.1 The backfilled remains of former hedgerow **704** was excavated and recorded in **Trench 7**, running on a north-west to south-east alignment (**Figure 2**; **Plate 8**). It measured 0.57m wide and 0.11m deep and was filled with a mid-grey sandy clay (**705**).
- 4.3.2 Trench 7 also contained a discrete deposit of blue-black highly vitrified material (706) sealed beneath the subsoil 702 (most likely redeposited) and above the natural geology 703. No subsoil was present in Trench 6 but a layer of similarly dark vitrified material was recorded that contained rubble fragments (602). The material is presumed to be a modern spread.

- 6.1.1 The evaluation identified traces of a former hedgerow **704** in **Trench 7**, and dumps of modern material in **Trenches 6** and **7**. Tree bowls were also identified and many of the trenches were cut by modern land drains.
- 6.1.2 None of the potential anomalies of archaeological origin were confirmed to be present during the archaeological evaluation.

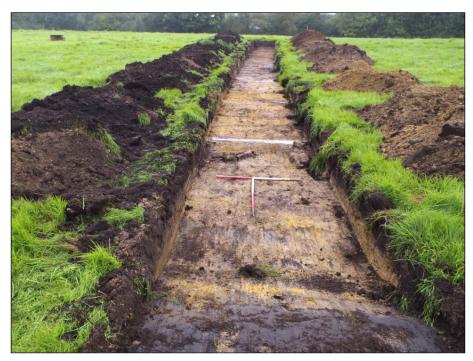
Trench 1	Dimensions: 30 x 1.8m	Max depth: 0.58m
Context	Description	Depth (m)
101	Topsoil – Very dark black brown clay silt with frequent small rounded pebbles	0 - 0.31
102	Subsoil – Light grey silty clay with occasional round pebbles	0.31 - 0.49
103	Natural – Patchy yellow brown and light grey sandy clay with frequent irregular pebbles	0.49+

Plate 1: Trench 1 looking west

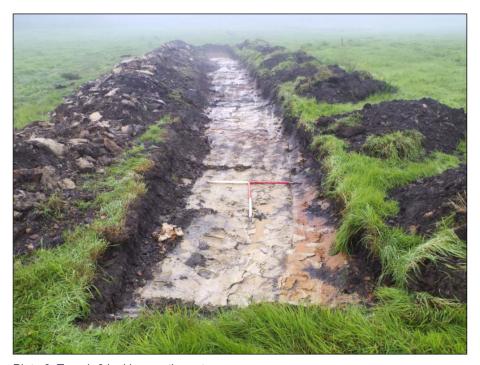
Trench 6	Dimensions: 30 x 1.8m	Max depth: 0.45m
Context	Description	Depth (m)
601	Topsoil – Dark brown clay silt with occasional small pebbles	0 - 0.23
602	Subsoil – Dark grey silty clay	0.23 - 0.34
603	Natural – Red brown and light grey mixed sandy clay with stone fragments	0.34+

Plate 6: Trench 6 looking south-east

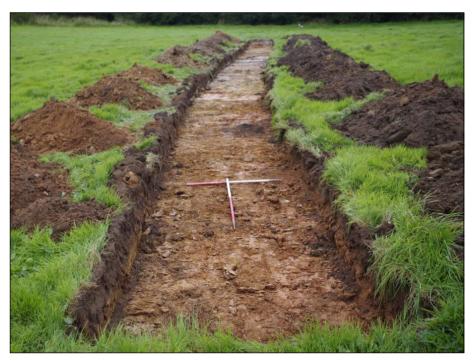
Trench 7	Dimensions: 30 x 1.8m	Max depth: 0.31m
Context	Description	Depth (m)
701	Topsoil – Dark brown clay silt with occasional small pebbles	0 - 0.15
702	Subsoil – Dark brown grey silty clay	0.15 - 0.26
703	Natural – Red brown and light grey mixed sandy clay with stone fragments	0.26+
704	Cut: Former hedgerow	0.26 - 0.37
705	Fill: Fill of former hedgerow 704. Mid grey sandy clay with abundant fragments of sandstone	0.26 - 0.37
706	Blue-black made ground	0.26

Plate 7: Trench 7 looking south
