# *South Australian* Geophysical Mapping Project

Survey Report and Site Plan

Ref: 108630.01  
September 2015

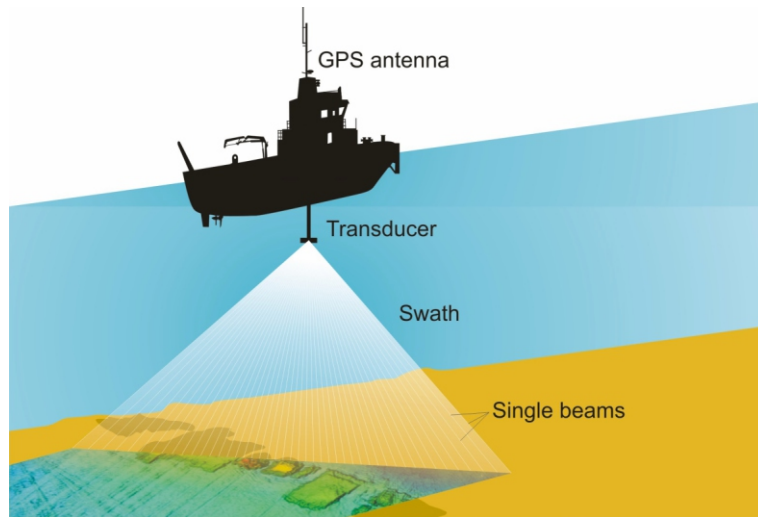
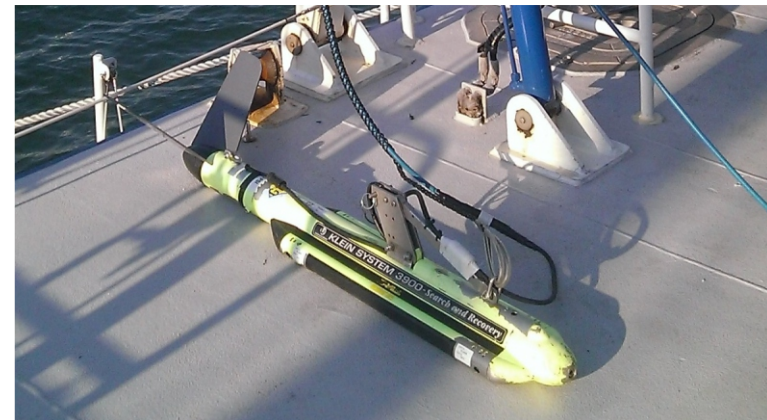
A. Acquisition of multibeam bathymetry data

B. Sidescan sonar towfish

C. Acquisition of sidescan sonar data

D. Details of sidescan sonar data acquisition

- 4.1.5 Multibeam, or swathe, bathymetry data is similar to data acquired using a normal boat echosounder as it is a measurement of water depth. An echosounder uses a single beam of acoustic energy that is sent down as a pulse from the transducer, is reflected from the seafloor and received back. The time taken, along with the sound velocity in seawater, is used by the equipment software to calculate the depth below the transducer. Multibeam bathymetry data are acquired by transducers using a fan-shaped array of hundreds of

beams. These cover a strip, or swath, of seabed (**Figure 3**). The water depth to the seabed for each beam is calculated. Data processing is used to reference these depths to a datum, typically chart datum or LAT for the UK.

- 5.1.2 Acquisition of sidescan sonar data is a standard methodology used for marine archaeology to detect items on the seabed. The data are acquired using a towfish which is towed behind a survey vessel (**Figure 3**). Elongated transducers, one on either side of the towfish, emit a high frequency pulse of acoustic energy. This pulse is emitted in a wide beam and reaches the seabed in a strip from near the towfish to a distance that is termed the range, i.e. furthest extent of the data to each side of the towfish. The range is specified by the user in the acquisition software. A shorter range (e.g. 40m) enables higher resolution data to be acquired but a longer range (e.g. 100m) enables a larger survey area to be covered more quickly as fewer lines of data are required. The seabed in a strip below the towfish is not covered by the data as the acoustic pulse does not reach here since the beam is angled outward.

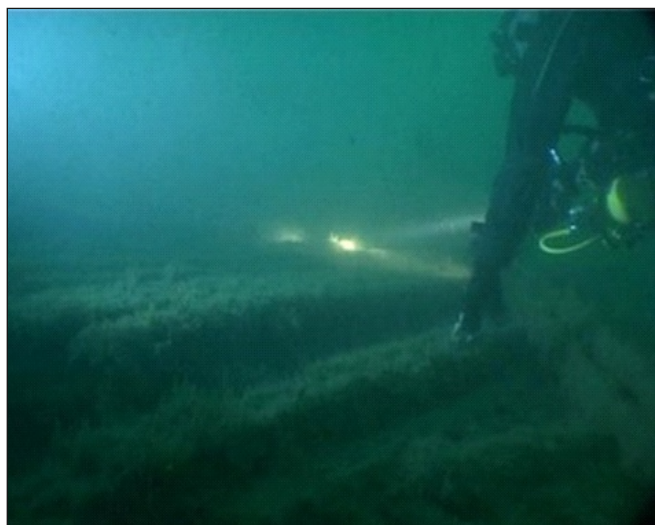
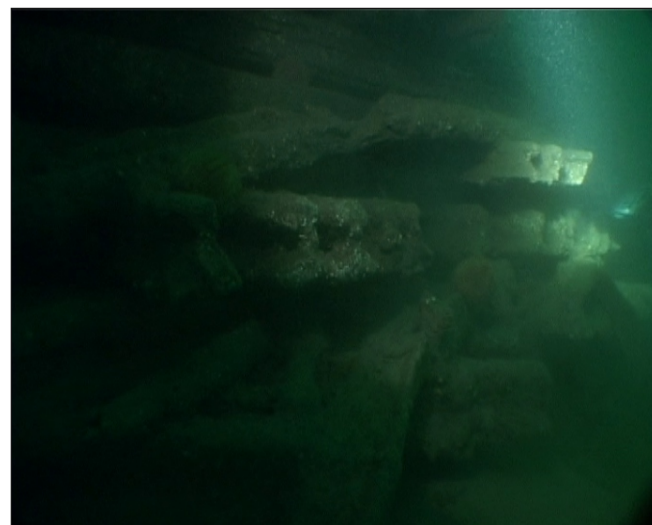
Plate 1: Diver on the rail stack

Plate 2: Rail stack

- 3.1.1 In the late 1980s members of Ilfracombe & North Devon Sub-Aqua Club (ILFSAC), alerted by a local fisherman, discovered a pile of railway lines (**Plates 1 and 2**) and some remains of a wooden vessel (**Plates 3 and 4**) in 45m of water on the edge of the Stanley Banks, approximately 3 miles northeast of Lundy (**Figure 1**). The wreck site was dived for some years without any research being undertaken to identify its origins.

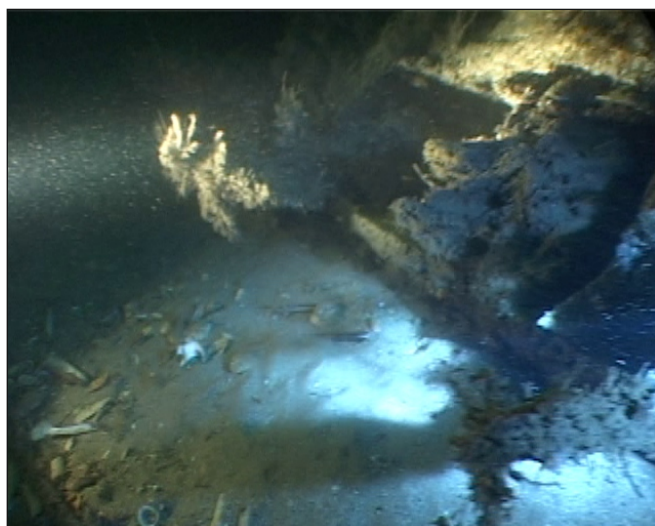
Plate 3: Remains of the hull

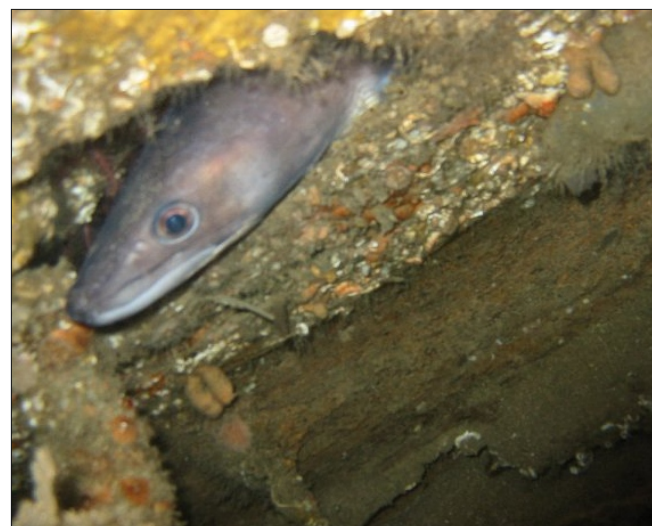
Plate 4: Conger eel by a frame and hull planking

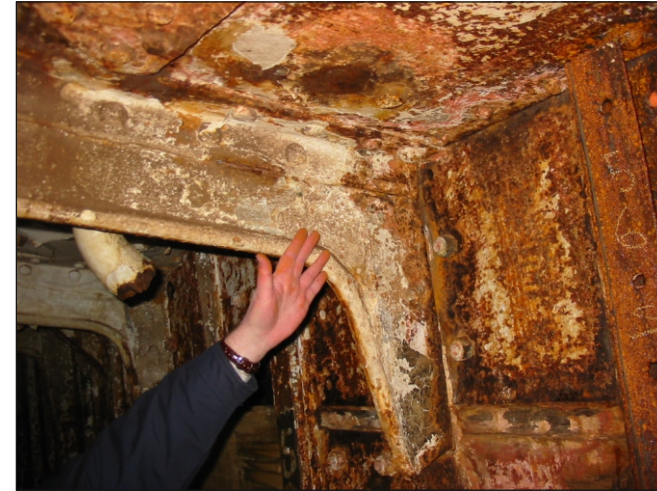
Plate 6: Iron knee (2005)

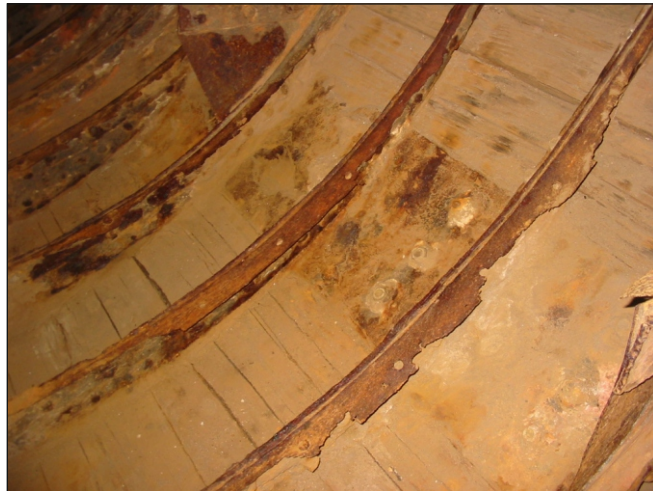
Plate 7: Interior of the hull, showing wooden planking and metal frames (2005)

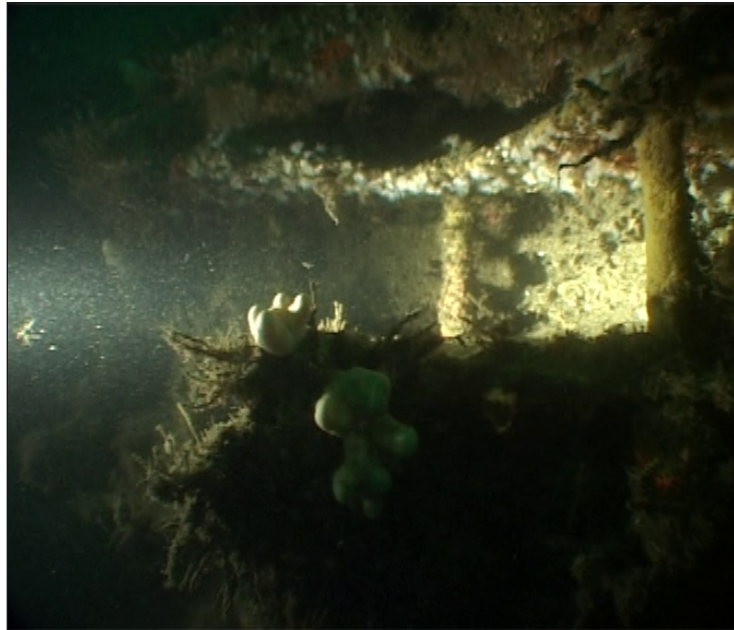
Plate 9: *South Australian* 'yellow metal' brass bolts

- 3.1.5 In the summer of 2005, Keith Denby, an ILFSAC diver, in the company of Dan Stevenson, an underwater video cameraman from the Clifton British Sub-Aqua Club, found and filmed

the bolts (**Plate 9**) and other significant structures on the wreck and the proof positive was obtained that the Stanley Banks railway line wreck was indeed the *South Australian*.

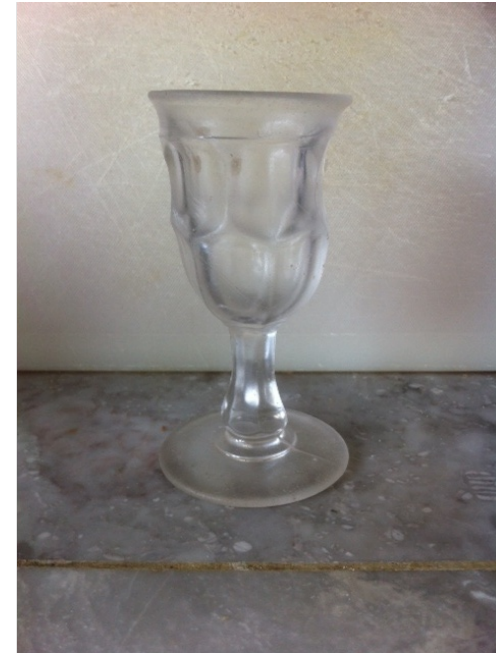
Plate 10: Wineglass from *South Australian*

- 3.1.6 With the task of positive identification of the *South Australian* achieved in 2005, ILFSAC have continued to explore the wreck site and diving technology has moved on even further with the use of closed circuit rebreathers using trimix diluent which give very long duration at depth without narcosis. This has allowed much greater exploration of the area of seabed surrounding the wreck and a number of things have been found. These include sections of the hull and frames, two anchors, a possible windlass and a large separated section of the wreck. An intact moulded wineglass was found on this separated section (**Plate 10**).

- 7.2 Known Objects Not Visible in the Geophysical Data**
- 7.2.1 ILFSAC report that there is a further area of wreckage 50m to 100m southwest of the rail stack - that is where Martin Davis found the wineglass (**Plate 10**). However, there is no evidence of any additional debris to the southwest of the rail stack in either the sidescan sonar data or the multibeam bathymetry data. It is possible that debris here has become buried by the seabed sediments and therefore was not able to be detected by the geophysical equipment at the time of the surveys. As the position of this additional area of wreckage is not known it has not been possible to add it to the site plan at this time.

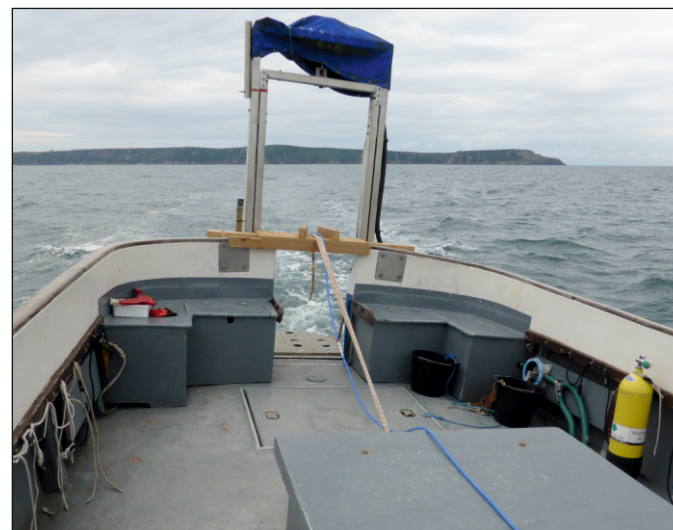
Plate 12: Sidescan sonar fish towed behind *Neptune*

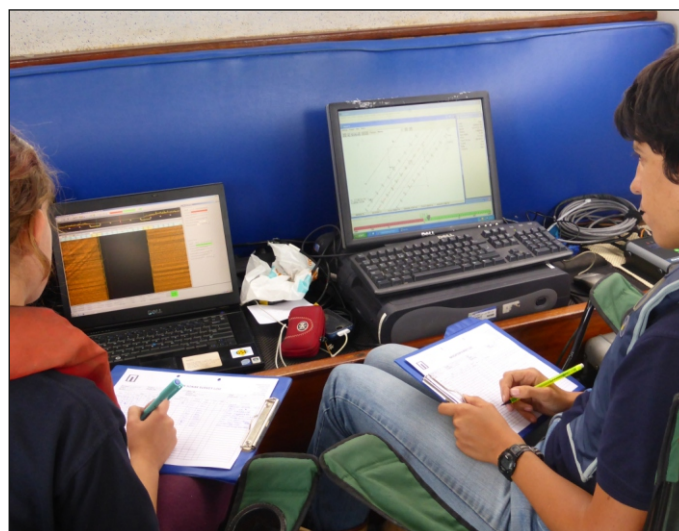
Plate 13: Data acquisition – sidescan sonar (left) and navigation (right)
