Great Martins, Shurlock Row, Reading, Berkshire, RG10 0PN

Archaeological Watching Brief Report

Planning Ref: 14/02872
Ref: 108270.01
October 2015

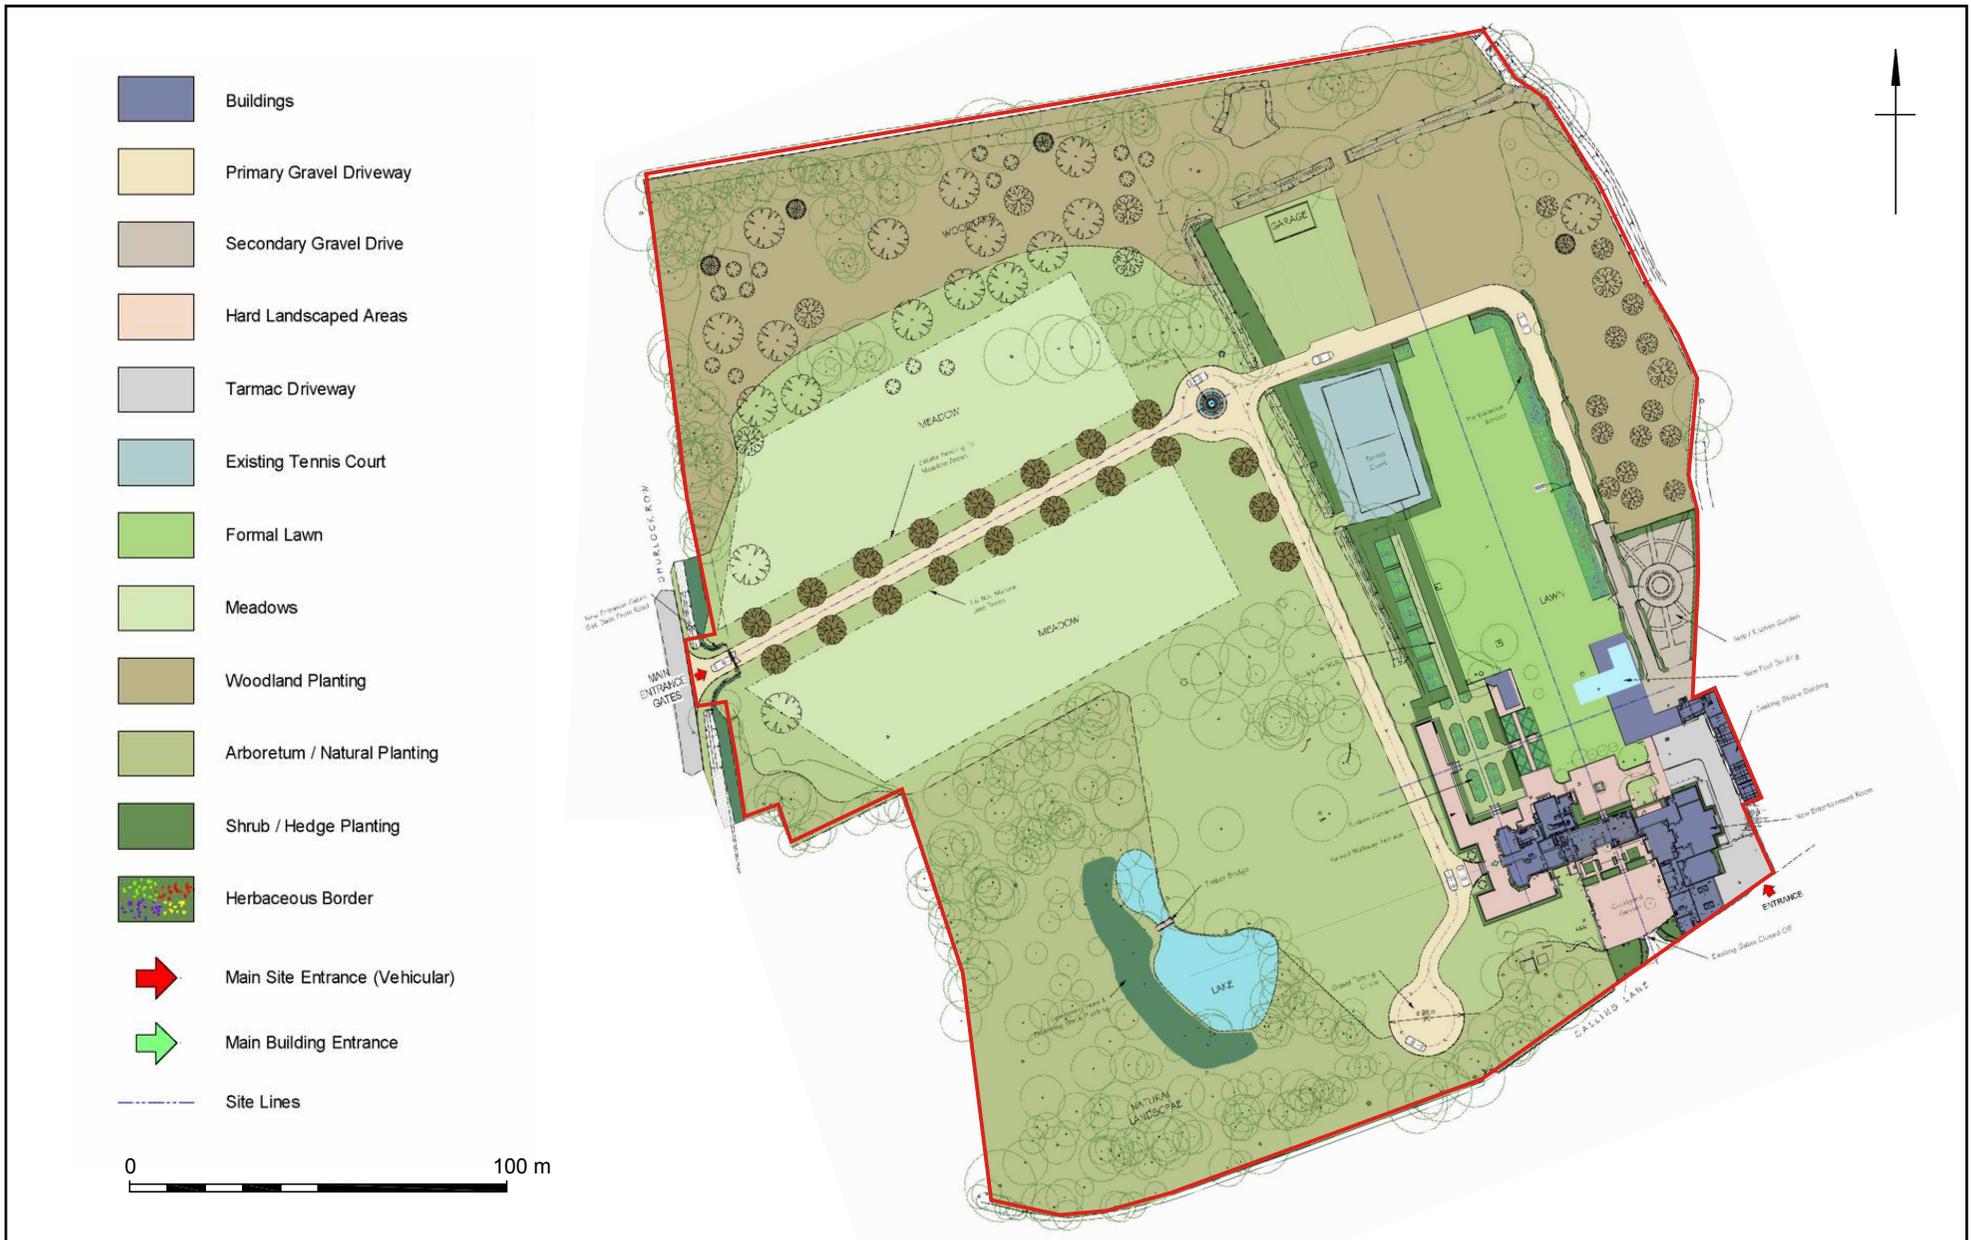
Figure 2

1.1.3 In September 2014 the Council for the Royal Borough of Windsor and Maidenhead received an application (ref: 14/02872) for a Change in Use of part of the grounds of Great Martins to form a new driveway layout and landscaping works – including the restoration of formal and sunken garden, alterations to an existing veranda and the creation of a sculpture walk (**Figure 2**).

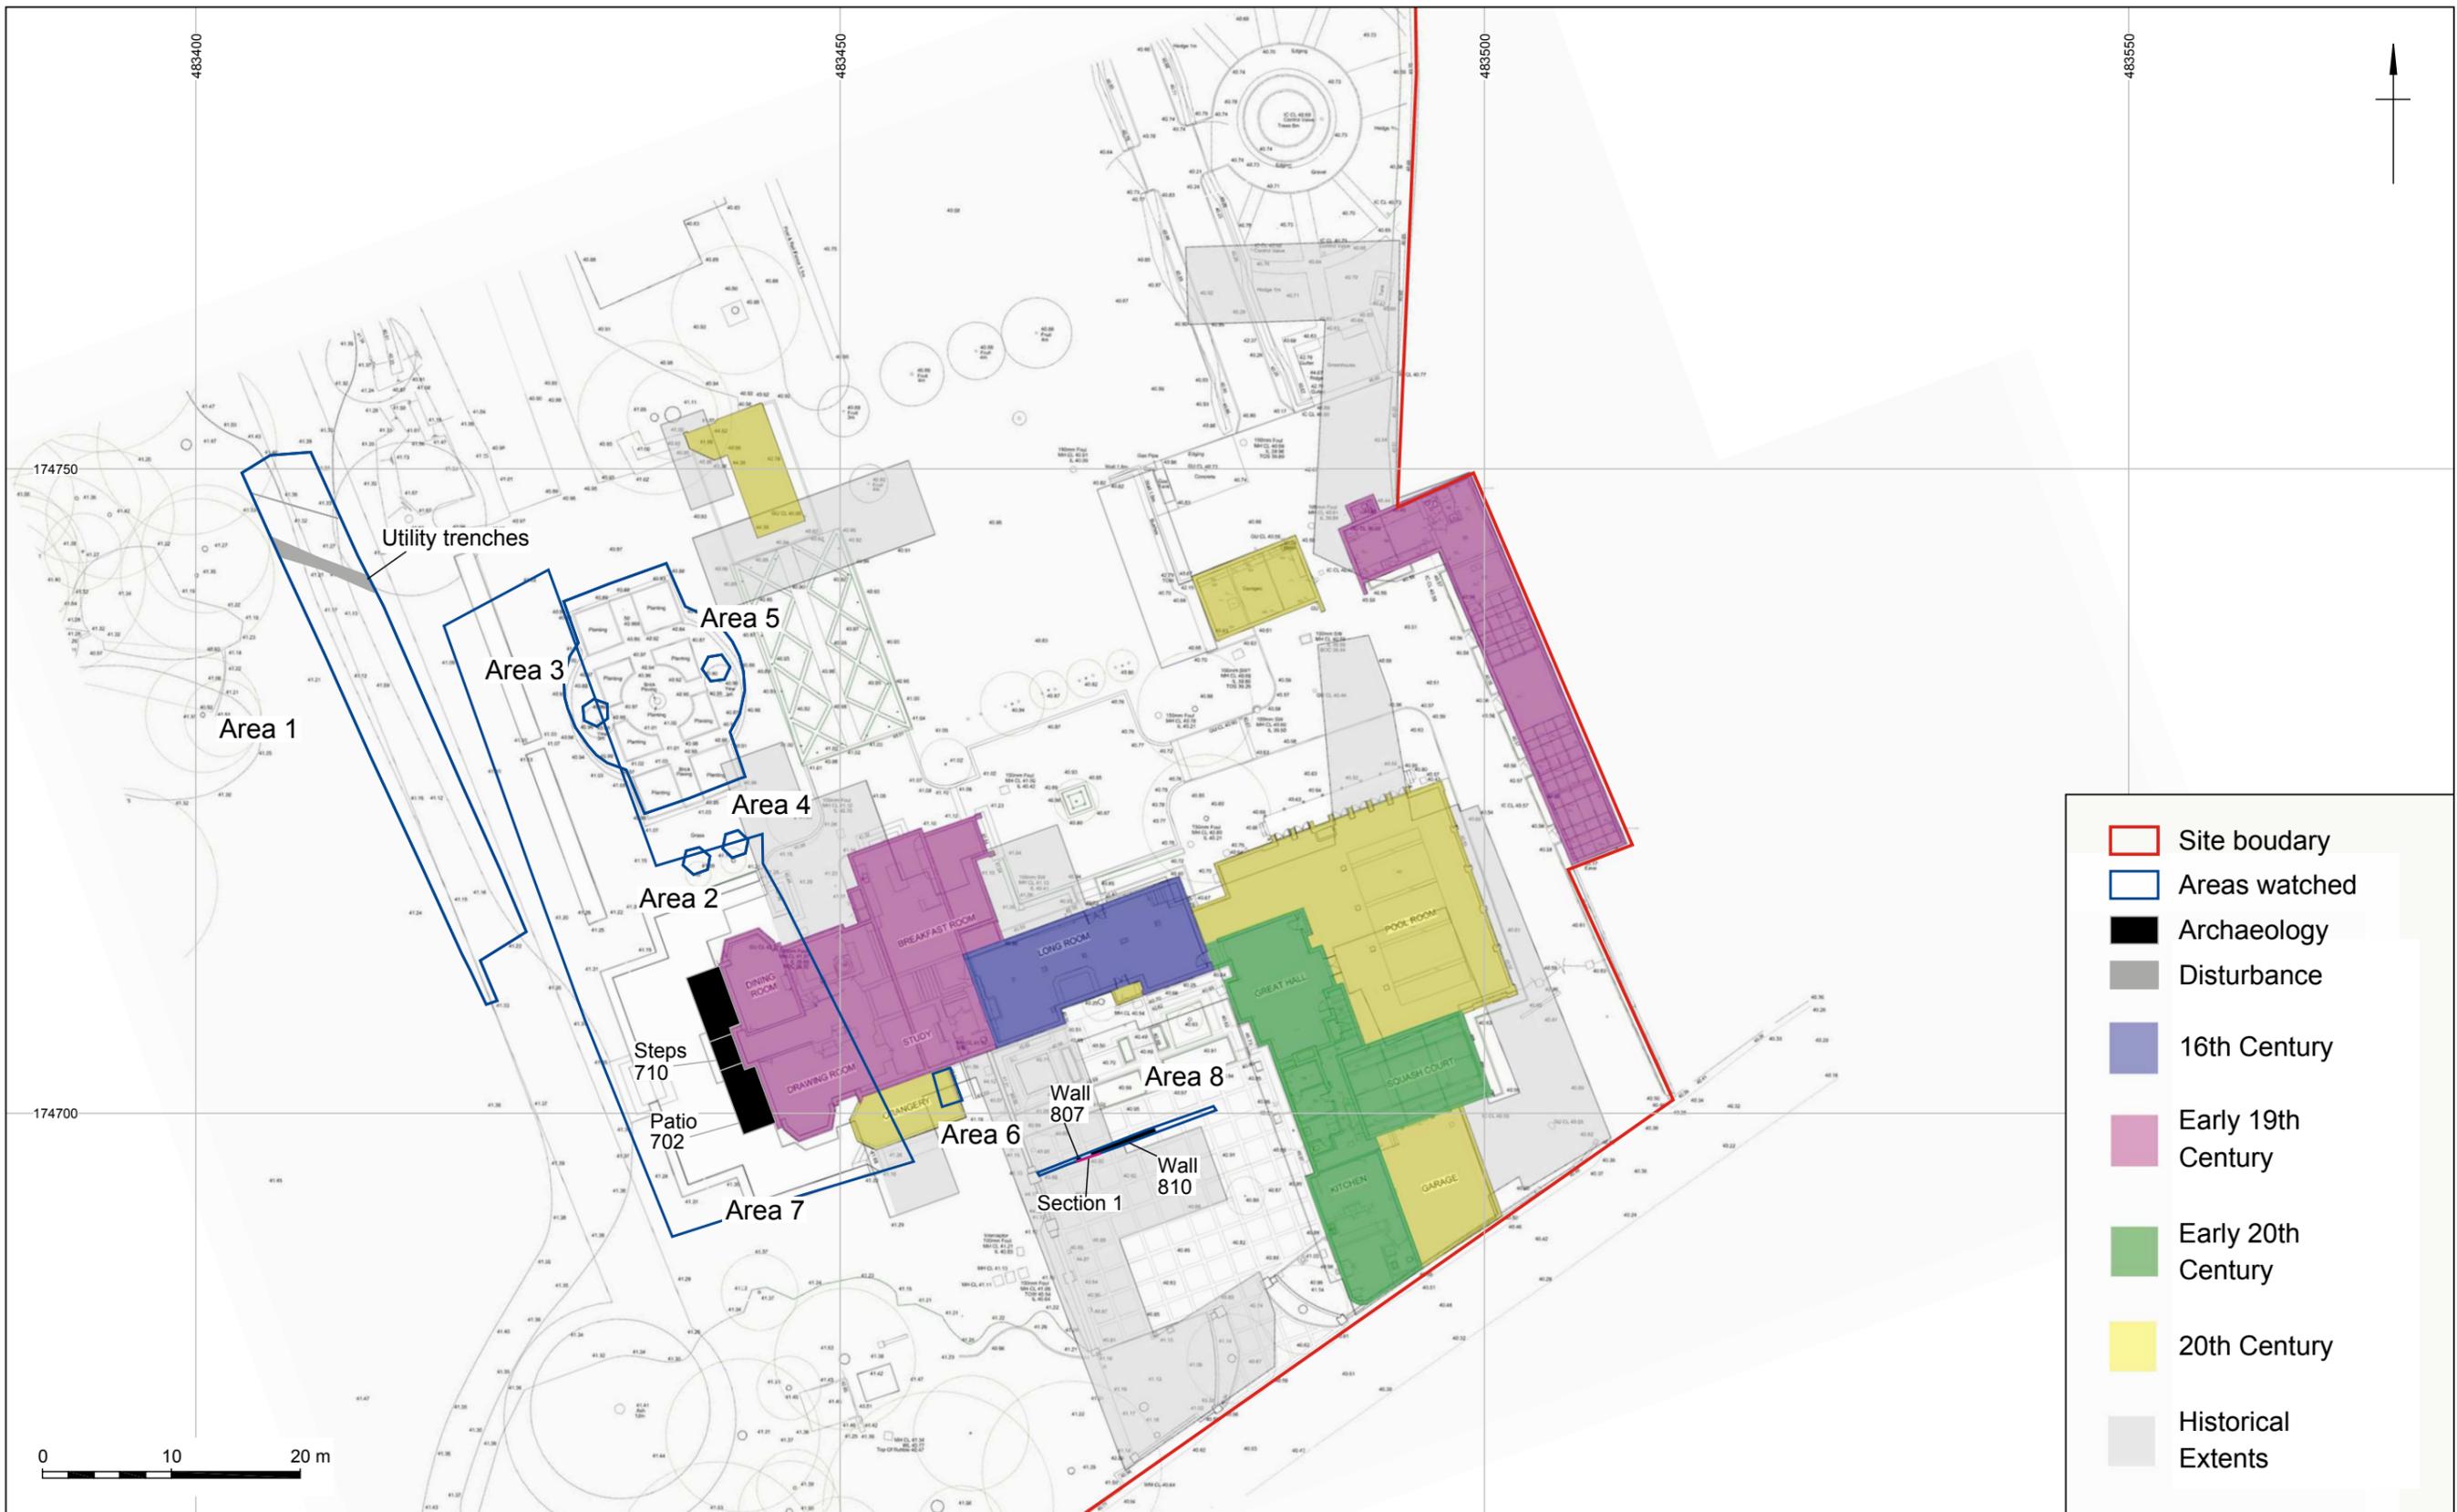
- 4.1.1 The watching brief was conducted within eight areas adjacent to the house comprising works associated with the driveway, formal garden, remodelling and services in the vicinity of the house complex (**Figure 3**).

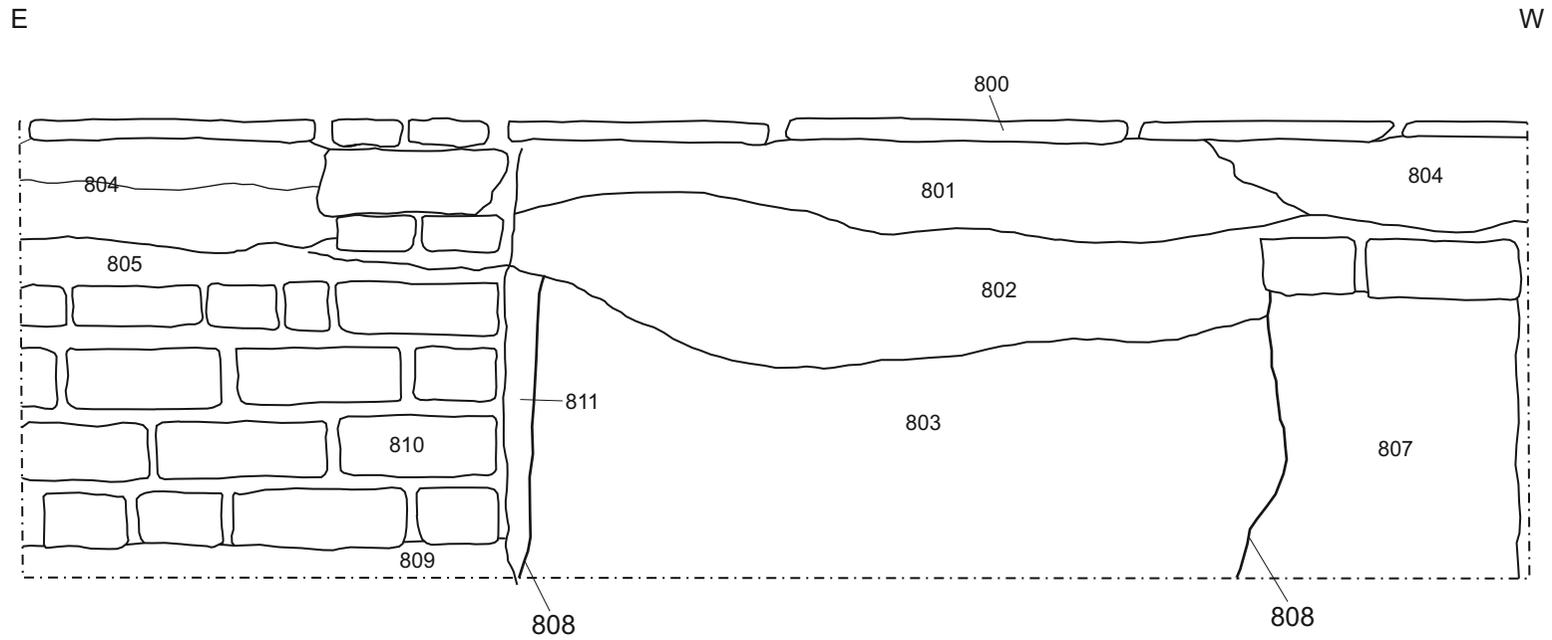
North facing sections of walls **807** and **810**

- 4.2.8 Here the earliest deposit exposed was a post-medieval levelling layer (**803**) which is likely to relate to earlier construction and occupation activity in and around the building complex. Cutting through this deposit were two foundation trenches for brick walls **807** and **810** (**Figure 4 and Plate 12**). The position of these walls, which were composed of red brick, suggests that they relate to the 19th century brewery buildings, which were demolished in the 20th century. The position of **810** correlates with an eastern projecting wing, visible on 19th century Ordnance survey maps. The location of **807**, within the building footprint, suggests it may be an internal division.

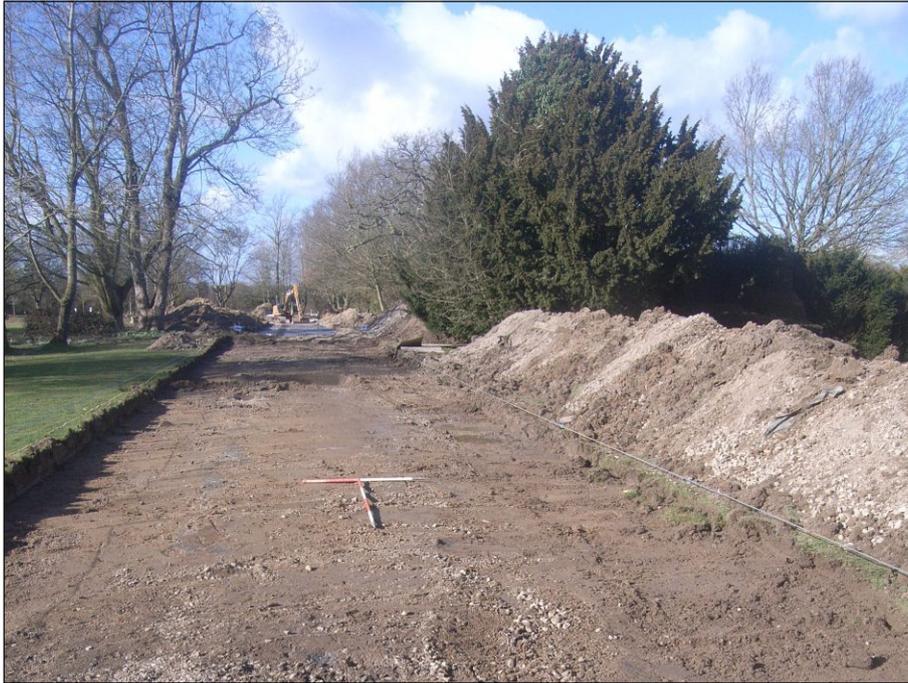
Plate 1: Area 1, view from the south-south-east

- 4.2.1 Ground reduction was undertaken for the new driveway to the west of the house (**Area 1**) (**Plate 1**). Here the ground reduction did not extend below the depth of the modern subsoil horizon (**102**) though a number of modern services were observed. It should be noted that the potential still exists for archaeological remains to exist below the subsoil horizon which have not been impacted by the current construction activities.
- 4.2.2 **Areas 2–5** comprised locations where trees were removed and relocated as part of the works within the formal garden (**Plate 2**). Here no archaeological features or deposits

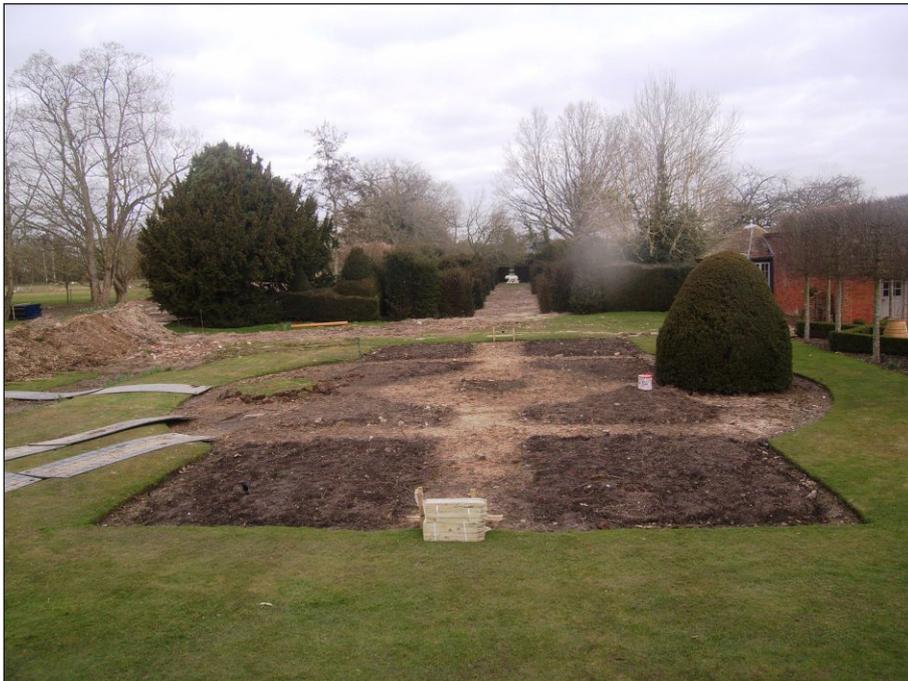
Plate 2: Working shot, formal garden, view from the south-east

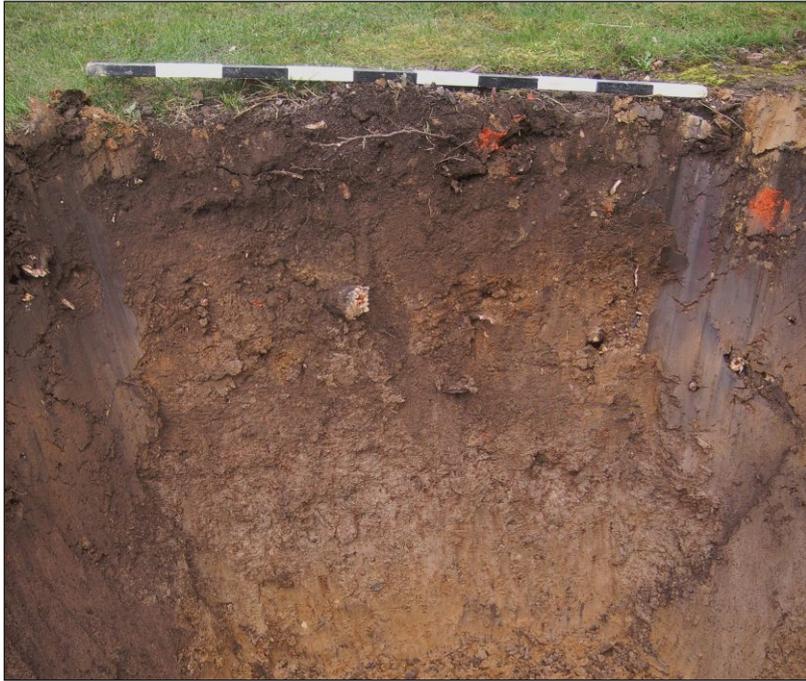
Plate 3: West facing section Area 4

were found though a layer of redeposited clay beneath the modern topsoil in **Area 4 (402) (Plate 3)** could relate to the 19th century or 20th century construction/ demolition activity. Brick rubble was also noted within and above the topsoil in **Areas 3 (301) and 5 (501) (Plate 4)**, this was also concluded to relate to 19th century or 20th century activity.

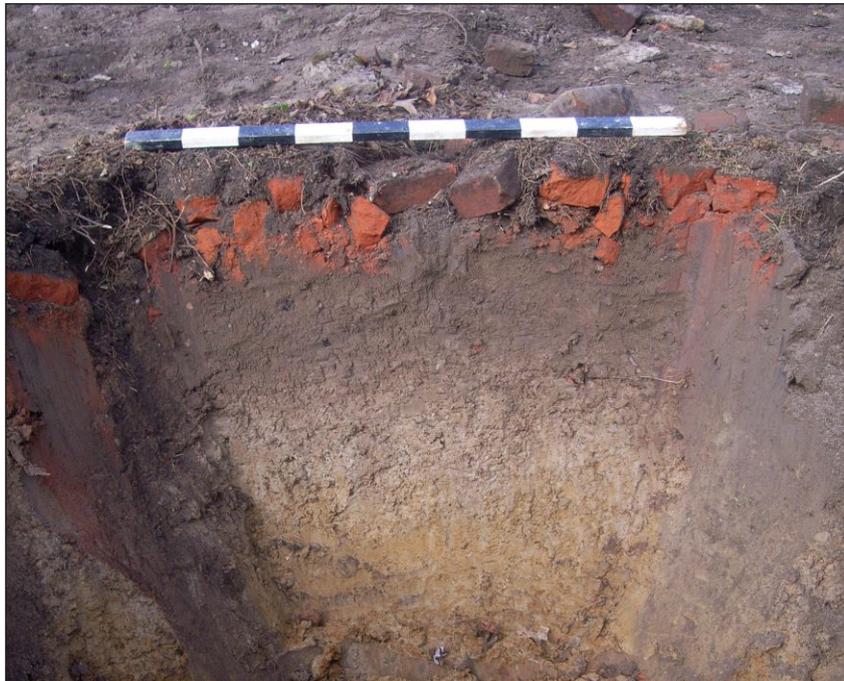
Plate 4: South-east facing section Area 5

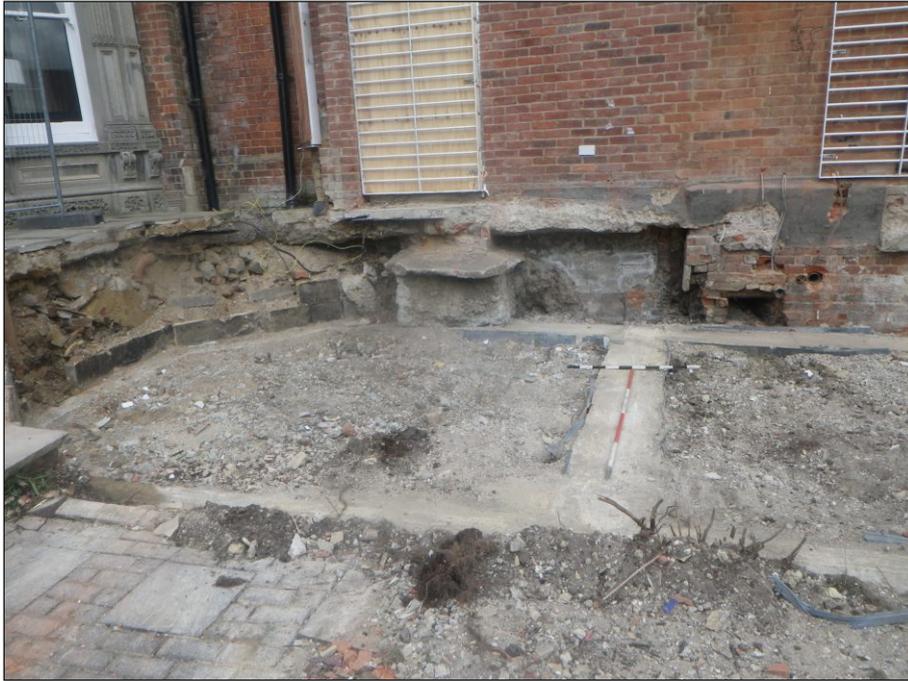
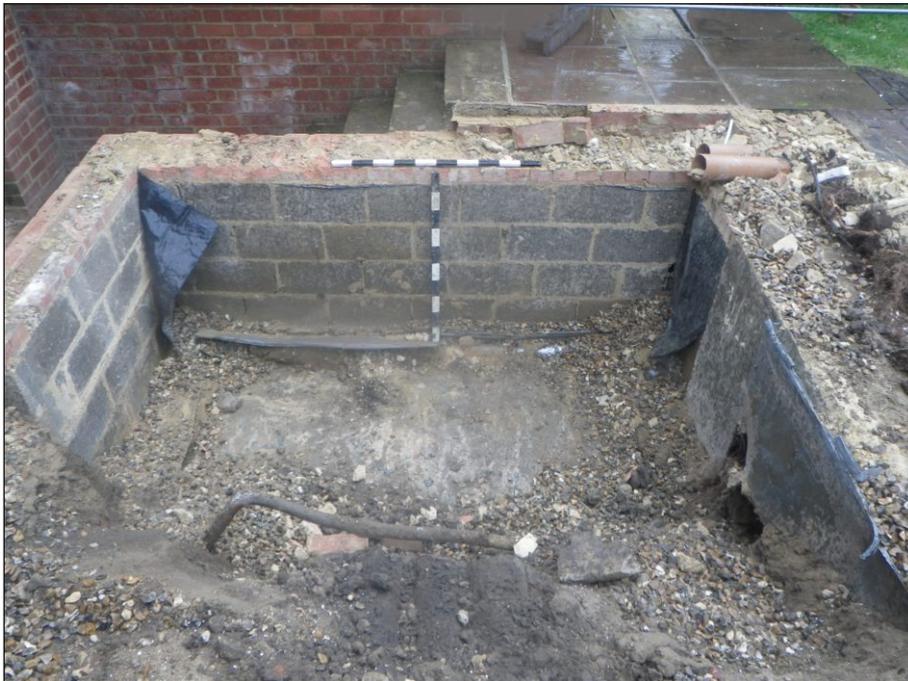
- 4.2.3 Located at the south-east end of the former orangery was **Area 6**. Excavation in this area only revealed elements of the 20th century structure (**Plates 5 and 6**).

Plate 5: Area 6, view from the south-west

Plate 6: North facing section Area 6

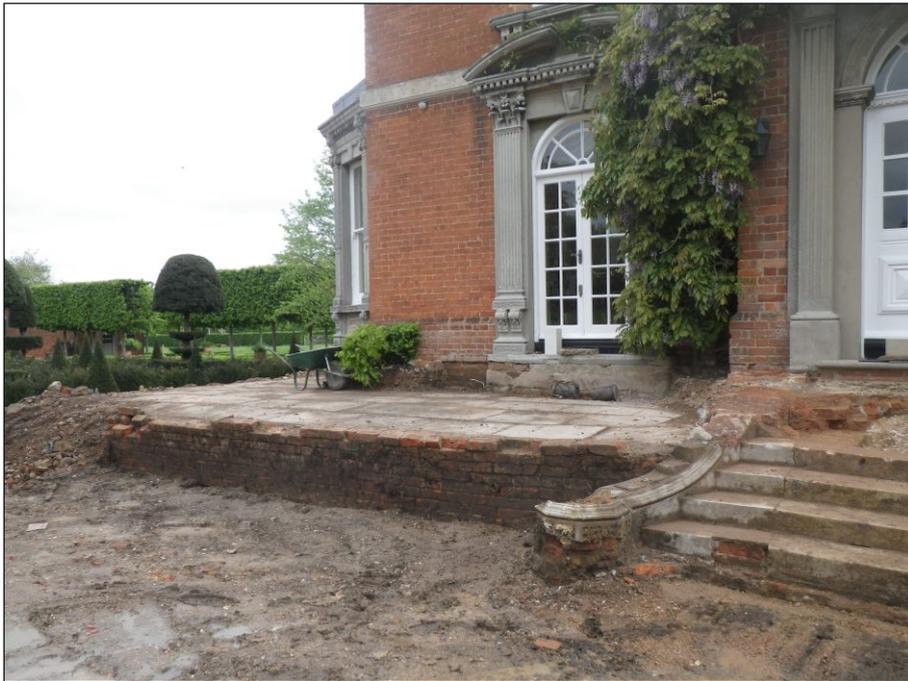
- 4.2.4 **Area 7** was located by the south-west frontage of the house where the existing raised patio was to be removed (**701**). Its removal located another earlier patio of concrete or compressed stone slabs (**702**) and surrounded with a red brick retaining wall (**705**). The footprint of this patio, whose style suggested it was of 1920s or 1930s construction, was less extensive than its successor and a flight of five steps led from the edge of the patio to the front door (**710**) (**Plate 7**).

Plate 7: Early 20th century patio 702 and steps 710, view from the south-west

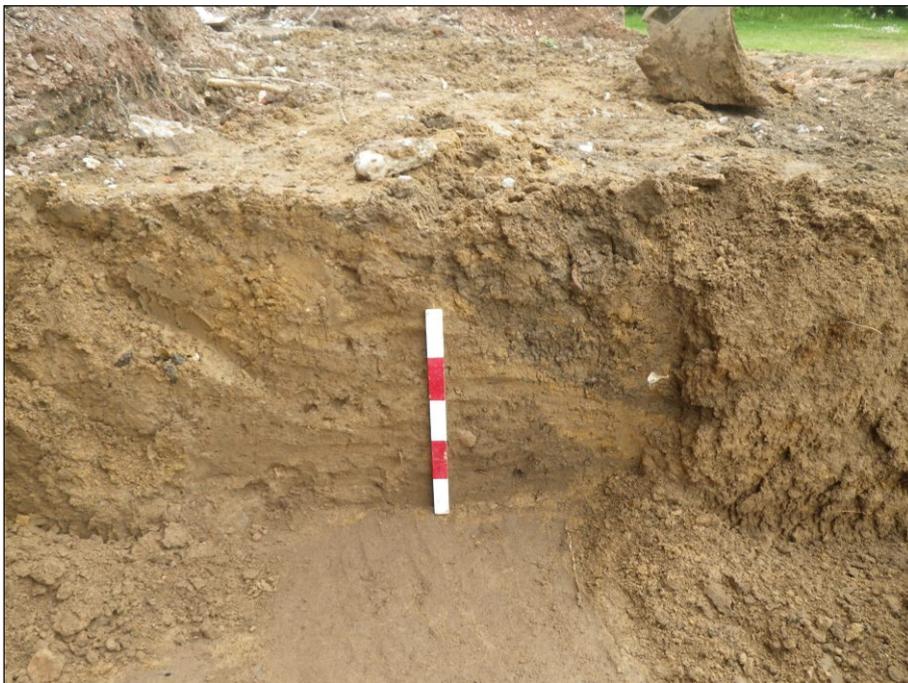
- 4.2.5 The ground within the patio area had been built up using a combination of redeposited natural and topsoil (**703**). Removal of this indicated that a short step bank had previously been present along the house frontage (**704**) (**Plate 8**). This overlay a buried topsoil horizon (**706**), though not dated the position of this deposit within the stratigraphic sequence suggests it is the post-medieval ground surface. Excavation did not continue below this depth.

Plate 8: North facing section showing bank 704, made ground 703 and buried soil 706

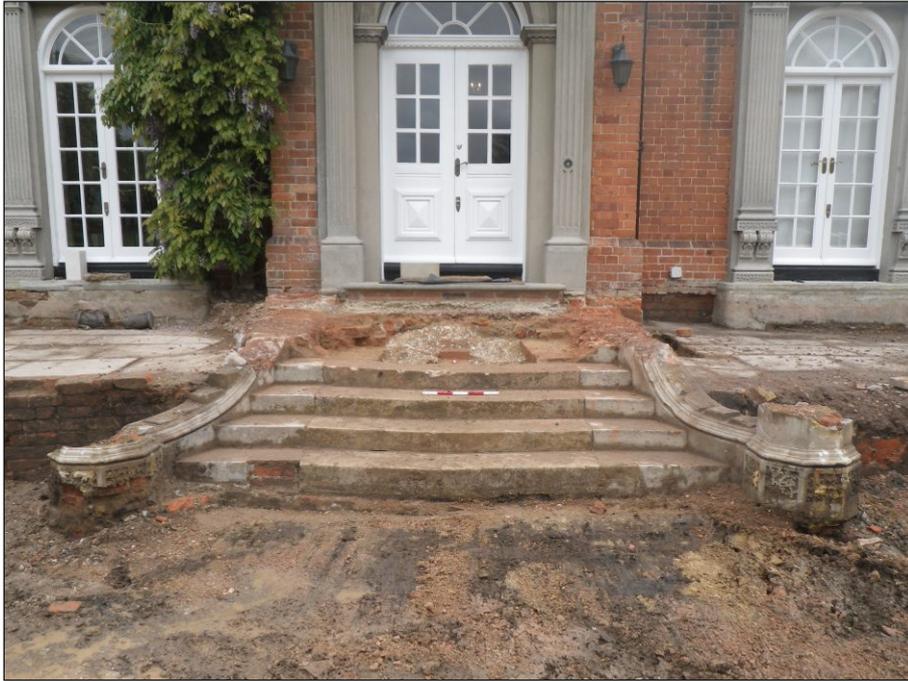
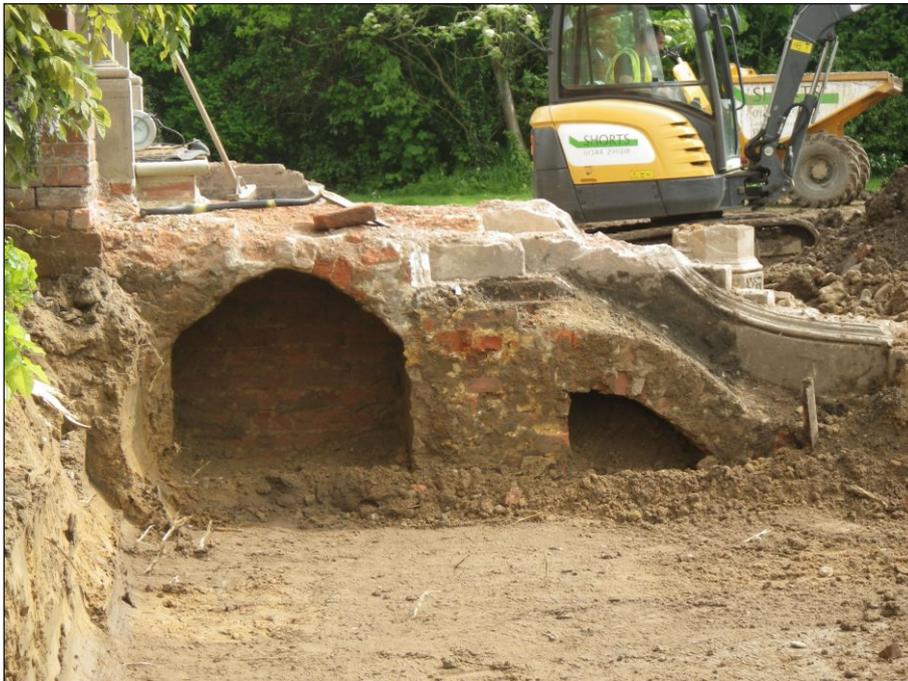
- 4.2.6 Removal of the patio (**702**) and associated deposits either side of the steps (**710**) (**Plate 9**) revealed that they were supported by brick arches (**708**) infilled with made ground (**707**) (**Plate 10**). A layer of rammed chalk was also uncovered below the front door step (**709**).

Plate 9: Entrance steps 710, view from the south-west

Plate 10: Brick support arches 708, view from the north

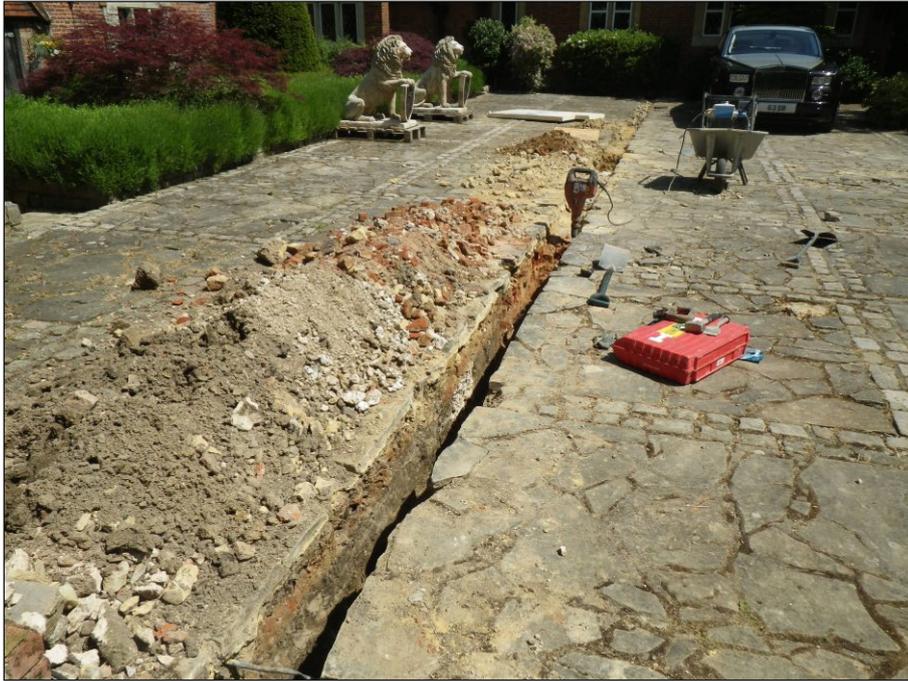
Plate 11: Area 8, view from the west

- 4.2.7 **Area 8** comprised a cable trench to the south-east of the 16th century part of the house (**Plate 11**). The modern ground level at this point is around 0.9-1.0 m higher than the ground level at adjacent to the 16th century building.

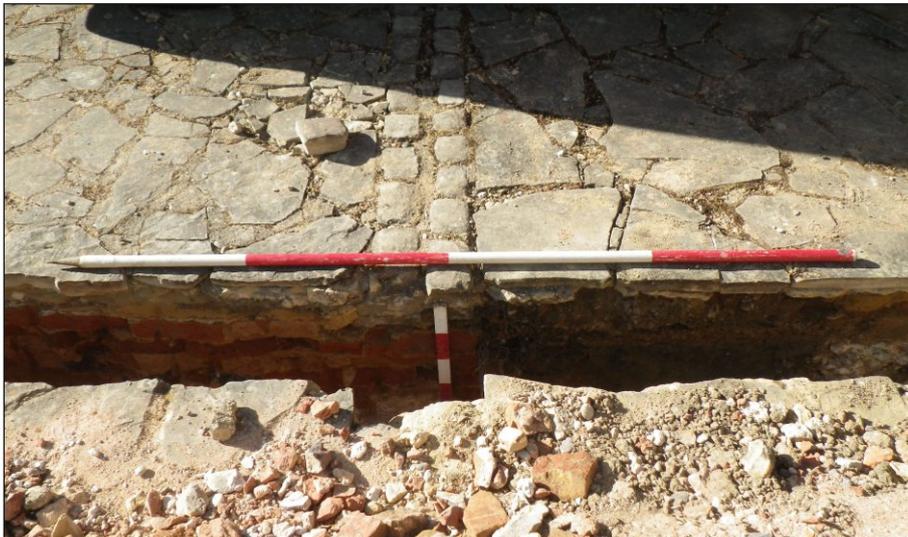
Plate 12: North facing section of walls 807 and 810
