Balt Moor Wall, Banklands Reservoir and Athelney Spillway, Athelney, Somerset

Archaeological Watching Brief Report

Museum of Somerset Accession number: TTNCM 27/2015
Sedgemoor District Council Planning Ref: 32/99/00005
WA Ref: 109040.01
November 2015

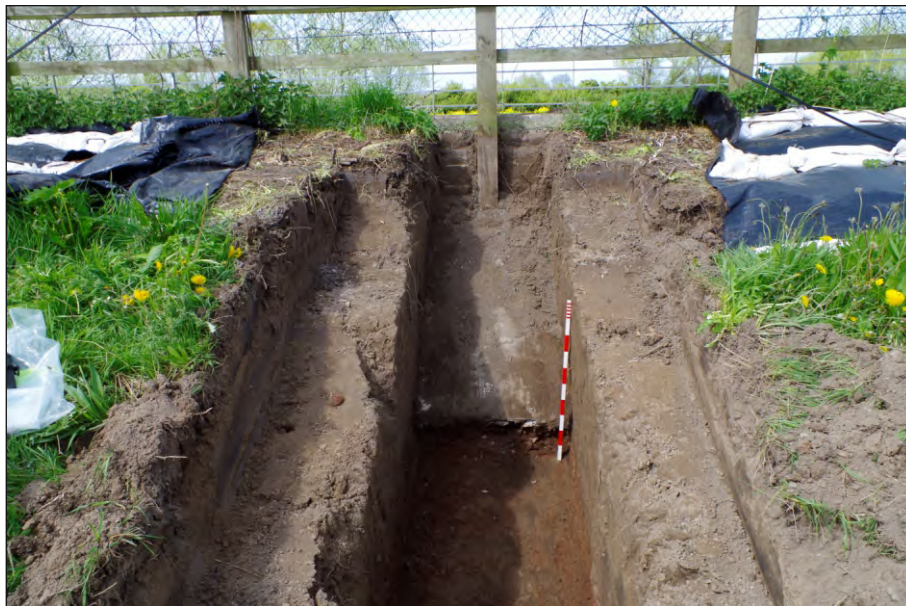
Plate 1: Test pit 1, showing typical deposit sequence to the south of Cuts Road, looking north

- 4.2.1 The excavation of four test pits (maximum depth 1.45 m) and the subsequent continuous piling guide trench along the south side of Cuts Road uncovered a brownish red silty clay bank deposit, the upper surface of which was recorded at 0.97-1.3 m below ground level (bgl), i.e. at 6.35-6.65 m aOD. A small quantity of mid-17th-century or later finds were recovered from this layer.
- 4.2.2 The bank layer was overlain by the modern concrete base for Cuts Road, which was in turn partially overlain and abutted by approximately 0.95 m of brownish grey sandy silt, which was sealed by 0.2-0.4 m of greyish brown topsoil.
- 4.2.3 **Plates 1-2** show a typical deposit sequence along the south side of Cuts Road; **Plate 3** shows the groundworks to the south of Willow Tree Cottage

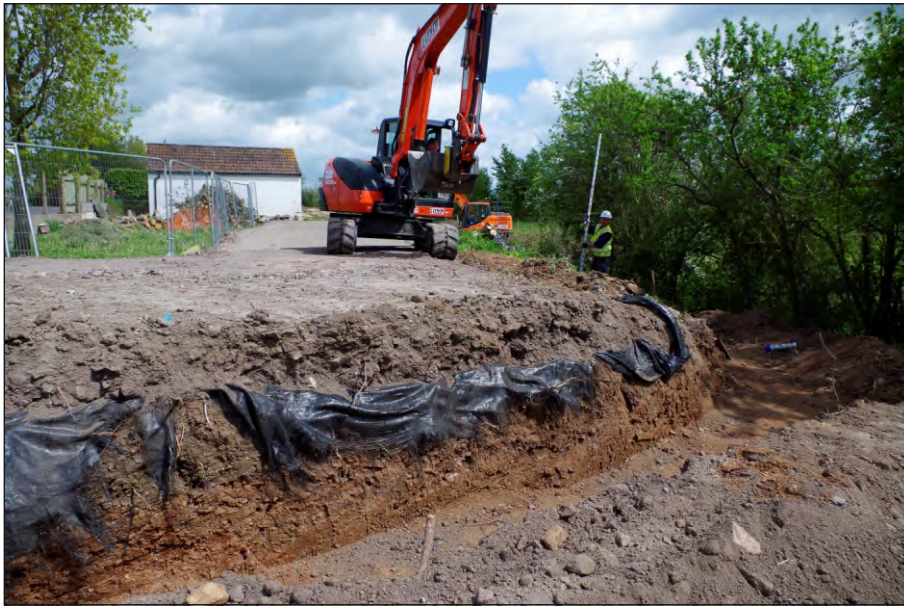
Plate 3: Excavation of sheet pile guide trench to the west of Willow Tree Cottage, looking north-east

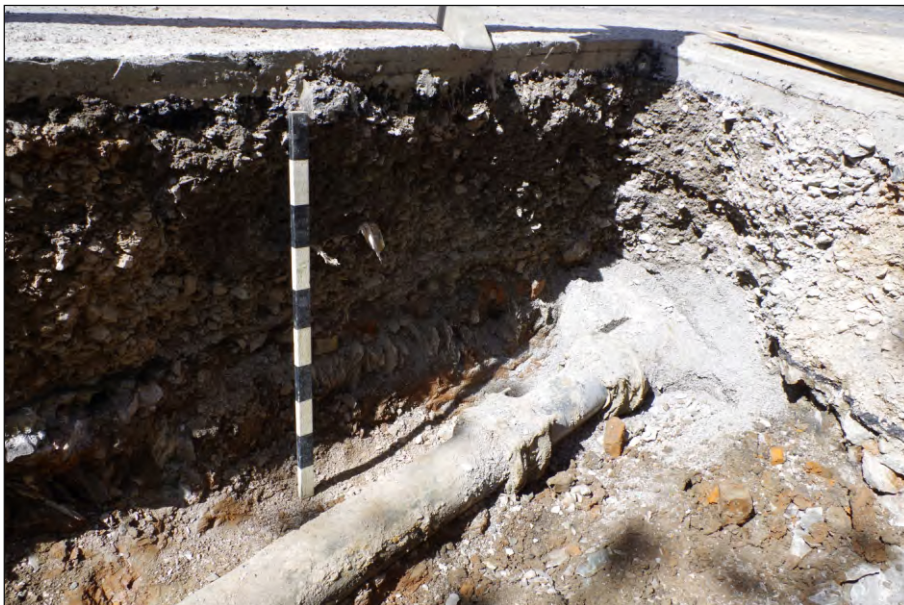
- 4.2.4 Trench 13 (maximum depth 1.1 m) was situated within the roadway to the east of Willow Tree Cottage. An undated deposit of compact red clay, **1308**, was uncovered at a depth of 0.94 m bgl (6.54 m aOD). Layer **1308** was overlain by 0.1 m thick pitched-stone road surface **1305**, which was in turn sealed by modern road make-up layers (**Plate 4**).

Plate 4: Trench 13, showing pitched-stone road surface 1305

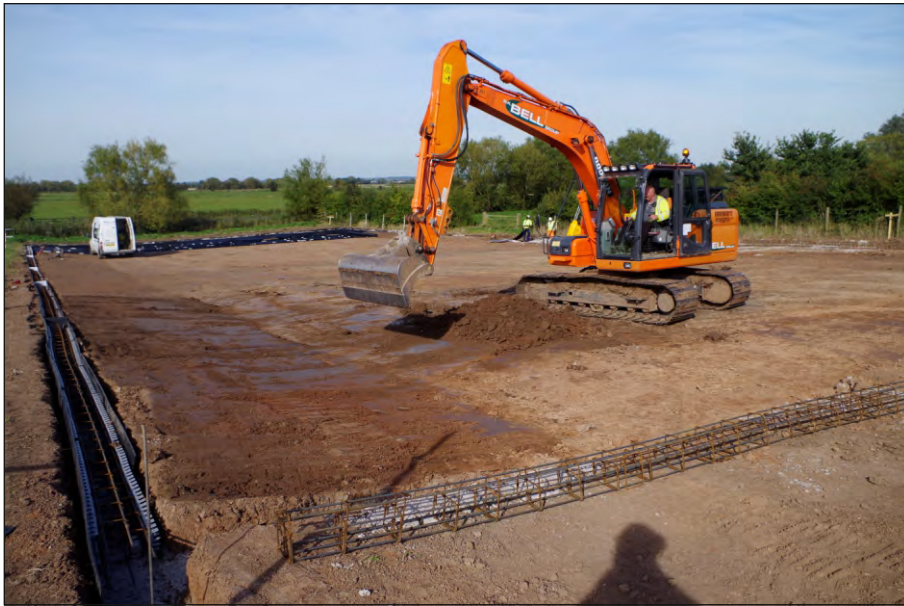
- 4.3.1 The re-profiling works at Athelney Spillway (**Plate 5**) revealed a sequence of over 0.55 m of modern subsoil, overlain by 0.09-0.12 m of imported topsoil.

Plate 5: Re-profiling works on the Athelney Spillway, looking north-east
