Portchester Castle Portchester, Hampshire

Archaeological Watching Brief

Ref: 108231.01
October 2015

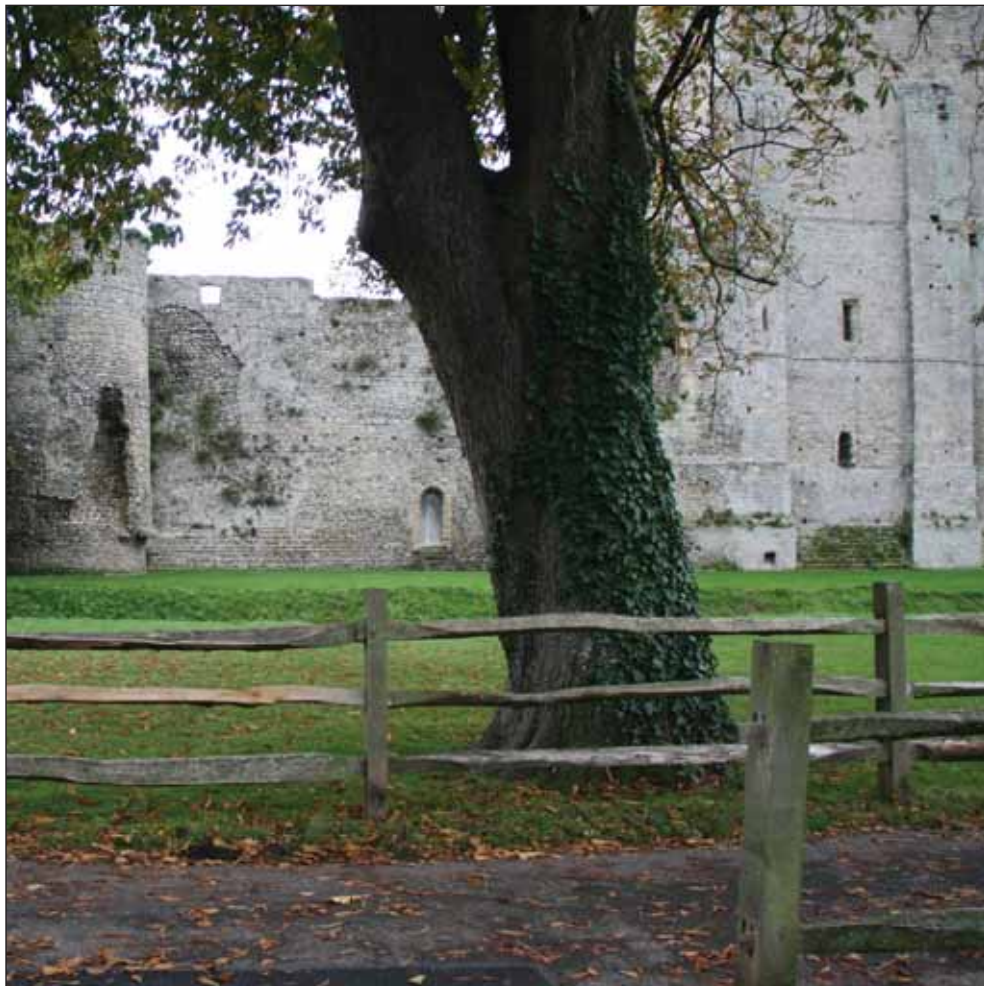
- Front Cover:** View of the fencing north of the north bastion tower, looking south
Plate 1: The excavated post hole on the fence line, looking south

- 3.2.1 The fence along the south side of the gravel footpath consists of square profile oak posts measuring 0.1 x 0.15 m in profile, approximately 2.6 m apart with three horizontal wooden staves linked between them (**Cover**).

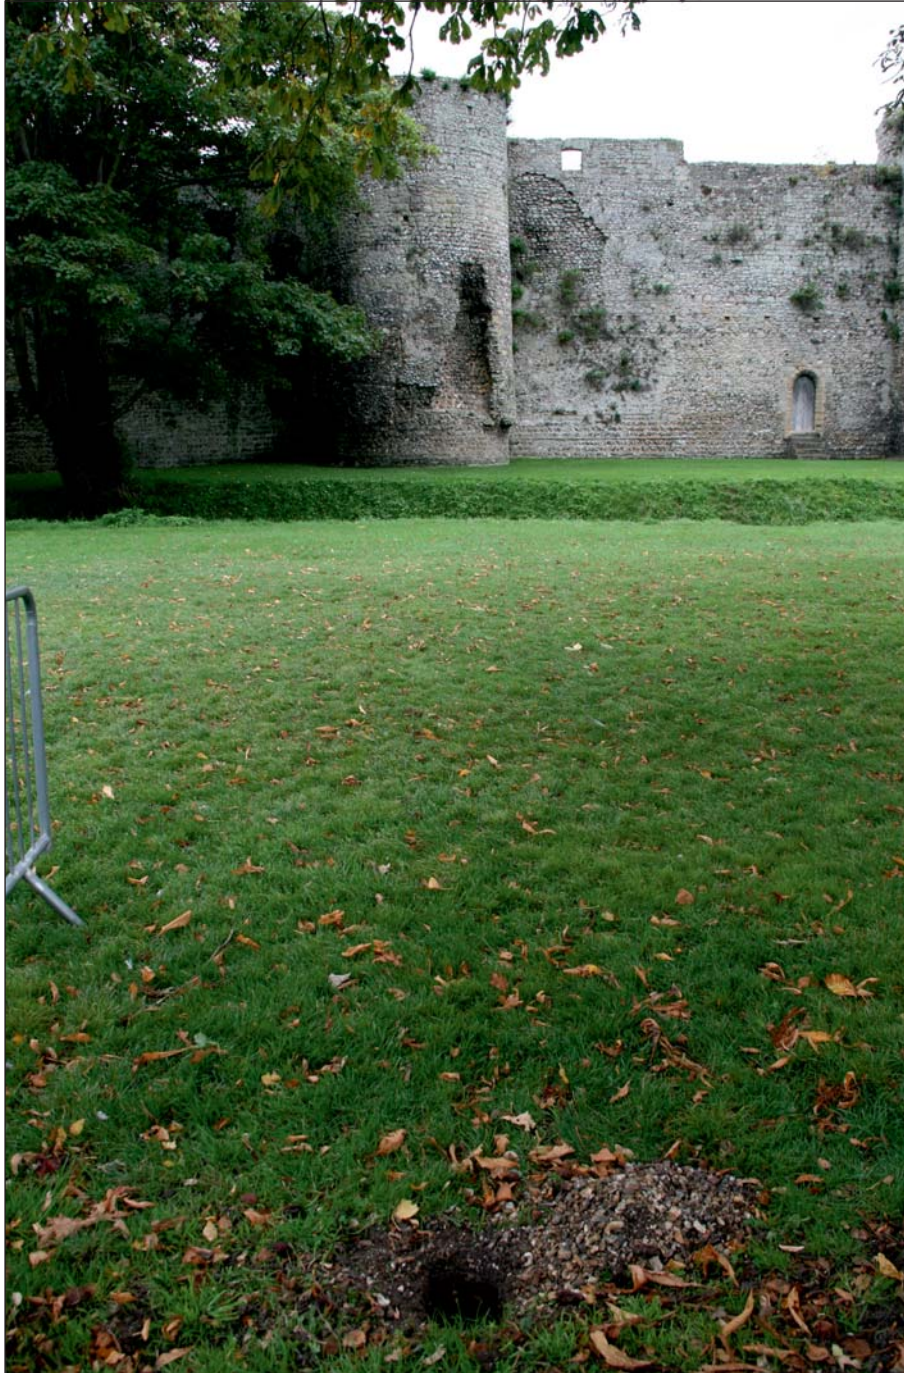
- 3.2.3 The post had been removed from the hole some weeks ago and the hole backfilled with beach pebbles. The pebbles were removed and the hole excavated down, to retrieve the rotted post base. The topsoil layer was observed to be 0.02 m depth from the ground surface and the deposit below was largely disturbed brown soil with tree roots. There was minimal disturbance and the deposit was photographed and recorded (**Plates 1 and 2**).

Plate 1: The excavated post hole on the fence line, looking south

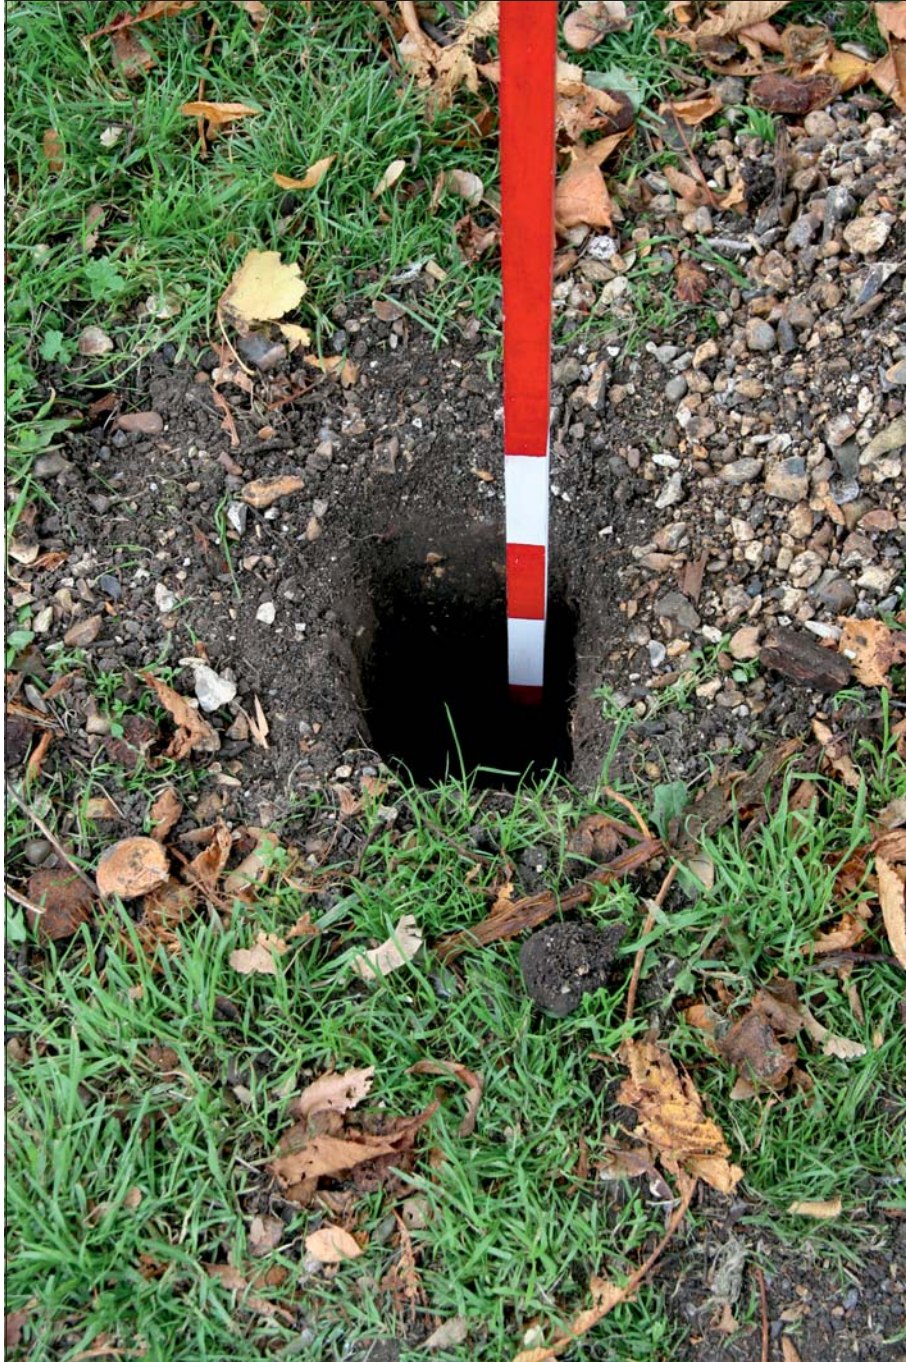
Plate 2: The excavated post hole with scale bar of 10cm and 50cm divisions, looking south

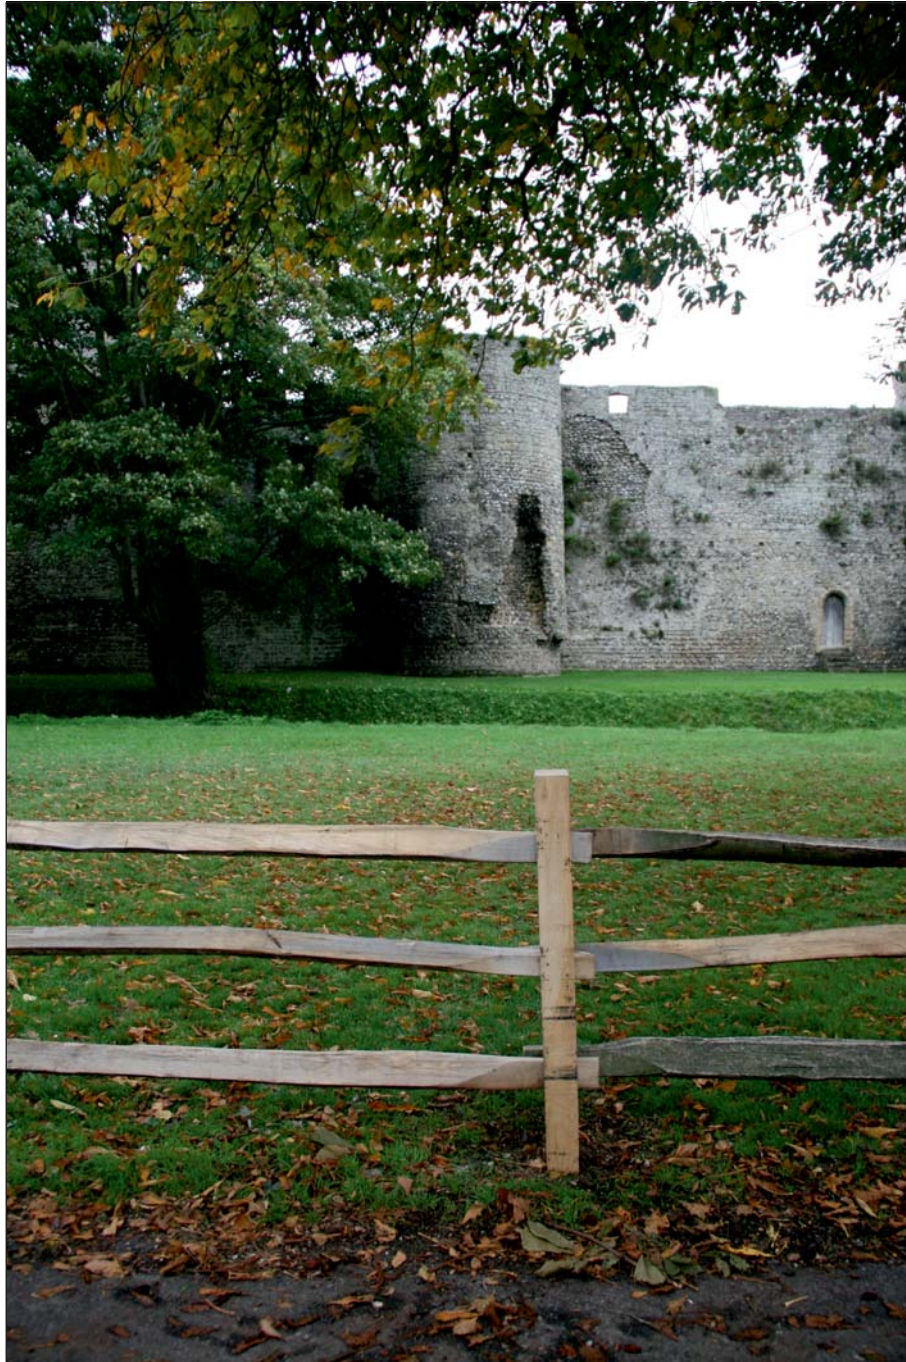
Plate 3: The repaired fence with installed replacement post and staves, looking south

- 3.2.4 Following the watching brief, a new fence post was inserted and staves were nailed into place (**Plate 3**).
