# Bishop's Waltham Palace Bishop's Waltham, Hampshire

Archaeological Watching Brief

Ref: 108231.02  
October 2015

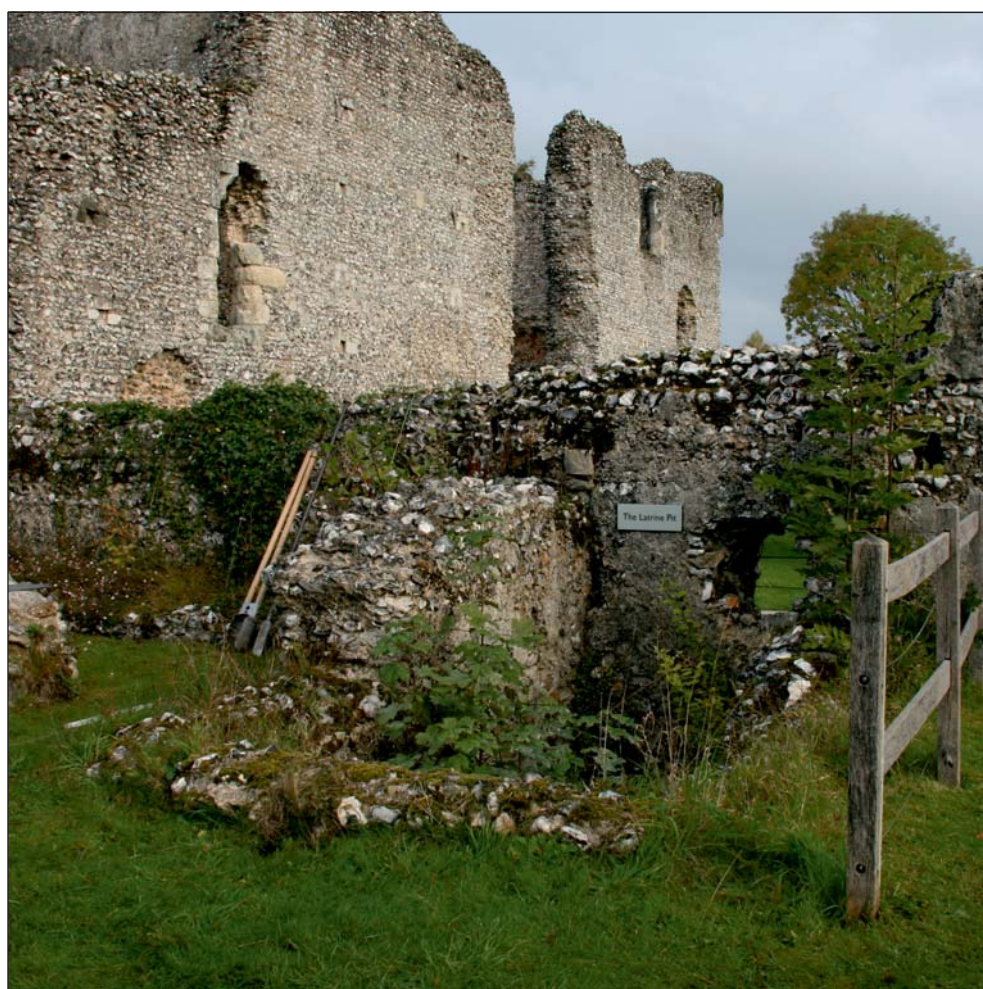
- Front Cover: The Latrine Pit and fencing, looking north-west  
Plate 1: Post hole 1 with scale bar of 10cm divisions, looking north  
Plate 2: Post hole 1 in front of east-west walls, looking north

- 3.2.1 The fence around the Latrine Pit consisted of square profile oak posts measuring 0.1 x 0.1 m in profile, with two metal wires linked between them and fixed to the 15th century east-west wall, with metal rings. The posts were situated approximately 1.3 m apart (**Cover**).

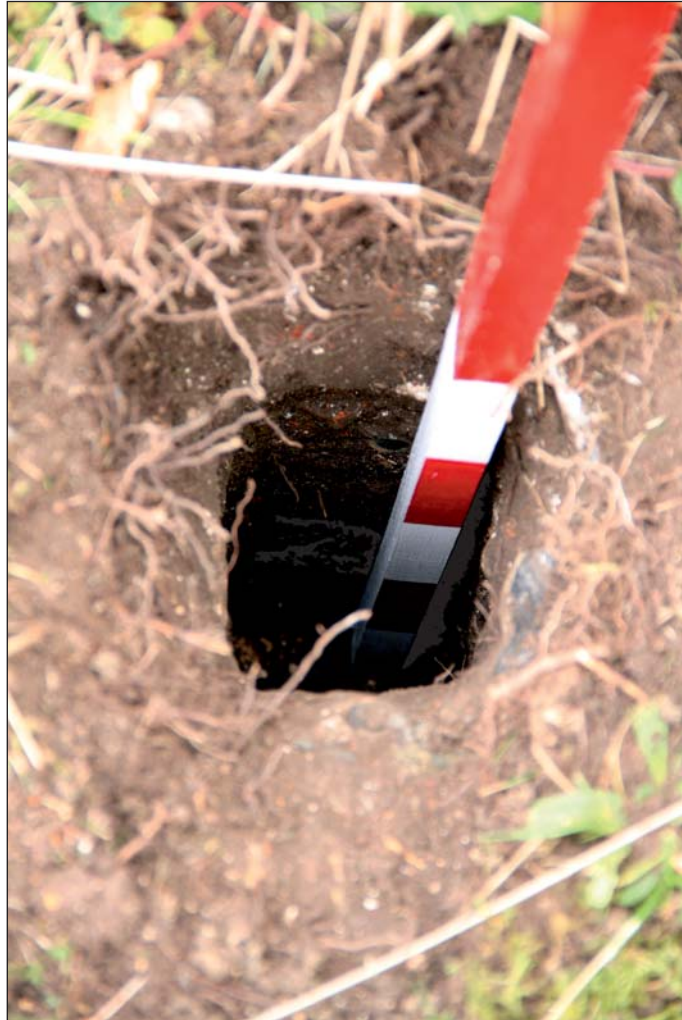
- 3.2.3 Post hole 1 was located adjacent to the 12th century east-west wall and the west wall of the Latrine Pit (**Plates 1 and 2**). The post hole was set beside the east-west wall and the turf layer was approximately 0.08 m thick. The next deposit that was encountered (context 003) was a mid-brown sandy silt containing flecks of ceramic building material (CBM) measuring less than 10 mm diameter, together with one larger fragment set into the north section, measuring approximately 10 x 25 mm. There are also flecks of chalk less than 5mm and two pieces of slate measuring 20 x 30mm. Two large flint nodules were also seen, approximately 100 x 600 mm in size. The post hole was excavated until the rotted post base was retrieved and the depth reached was 0.58 m below the ground surface.

Plate 1: Post hole 1 with scale bar of 10cm divisions, looking north

- 4.1.2 Post holes 1 and 2 revealed two fragments of ceramic building material, probably tile, which are likely to have been redeposited during the activities of excavation and fence post insertion over the course of the late 20th and early 21st centuries. However, their presence indicates that tile was used on the site. The 12th century east-west wall, the adjacent 15th century east-west wall and the Latrine Pit walls are all constructed of flint nodules, however, it is most likely that the ceramic tile fragments came from roofing tiles, which had become deposited over time. The mortar on the fragment from post hole 2 suggests that the fragment might have been used as a capping tile mortared into place, or incorporated into the build of a wall. The tile fragments were discarded as they were deemed non-diagnostic.

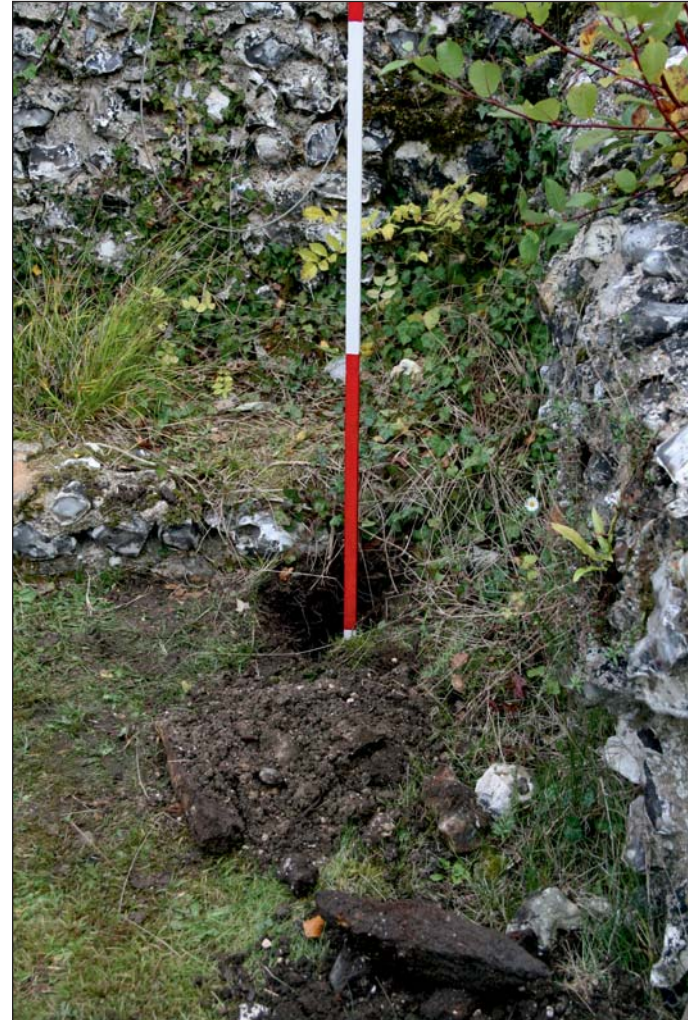
Plate 2: Post hole 1 in front of east-west walls, looking north

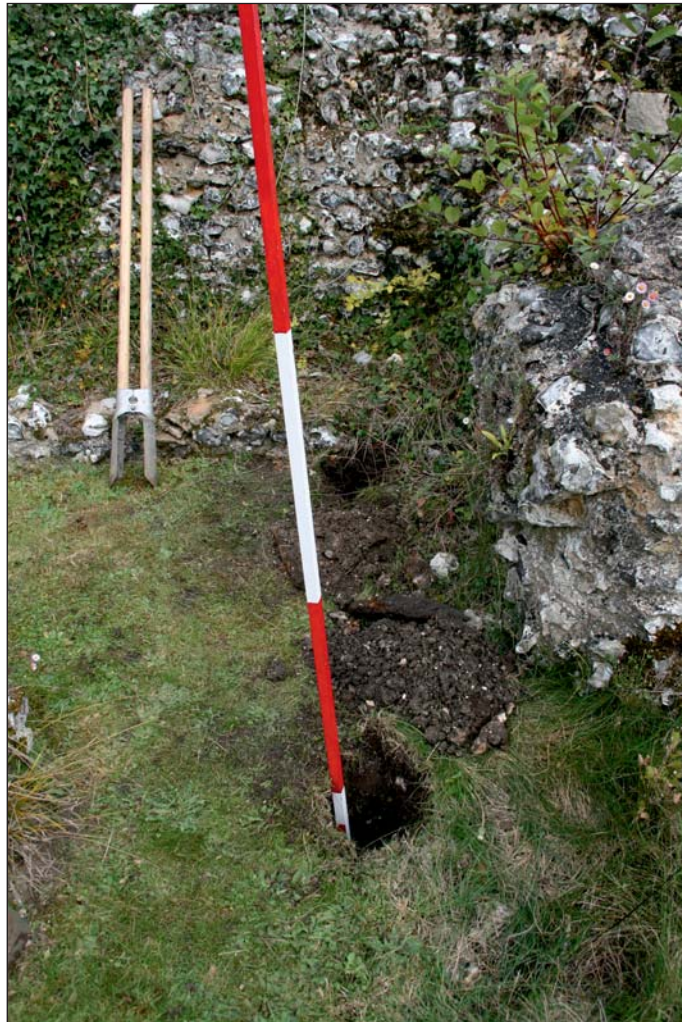
- 3.2.4 Post hole 2 was located approximately 1.5 m to the south of post hole 1 and included the turf layer to a depth of 0.08 m (**Plate 3**). The deposit below (context 005) was similar to 003 and contained a fragment of tile, with white lime mortar on both of the flat surfaces, measuring approximately 10 x 30 mm. The mortar on the surfaces may suggest that the tile fragment had been previously incorporated into a wall, possibly as a reused fragment or as a capping tile for a wall. Small natural flint fragments were seen approximately 10 x

20mm in size. The post hole was excavated until the rotted base was retrieved and reached a depth of 0.58 m below the ground surface.

Plate 3: Post hole 2, looking north

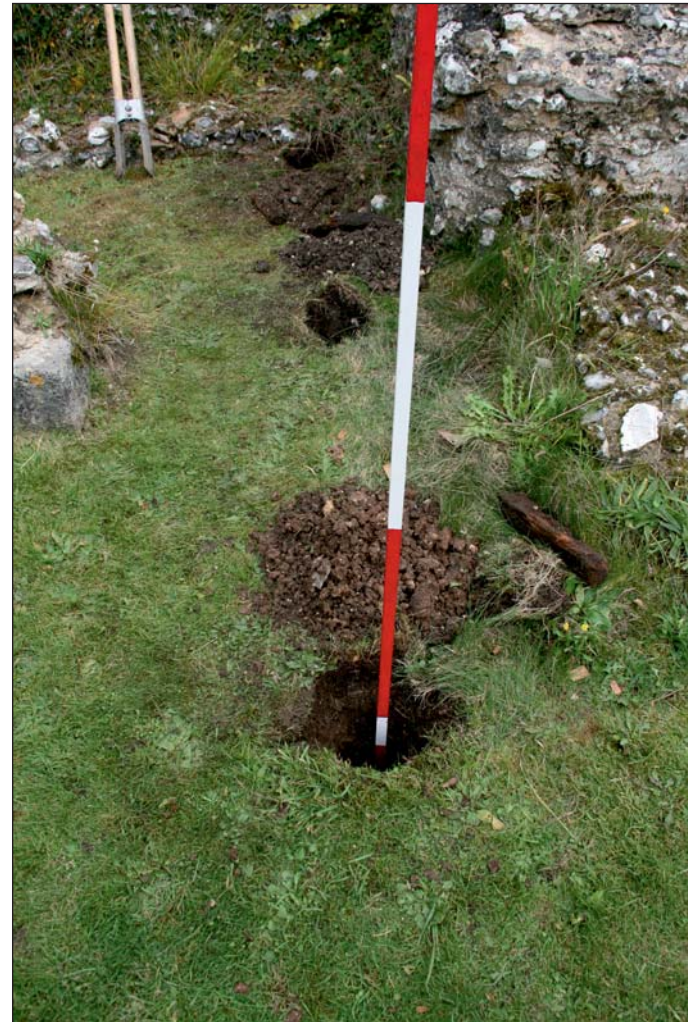
- 3.2.5 Post hole 3 is located 3.5 m south of the south face of the 15th century east-west wall (**Plate 4**). In similarity with the post holes 1 and 2, the turf layer was found to a depth of 0.08 m and the hole was excavated to a depth of 0.58 m. The deposit (context 007) matched 003 and 005 apart from containing no CBM fragments.

Plate 4: Post hole 3, looking north

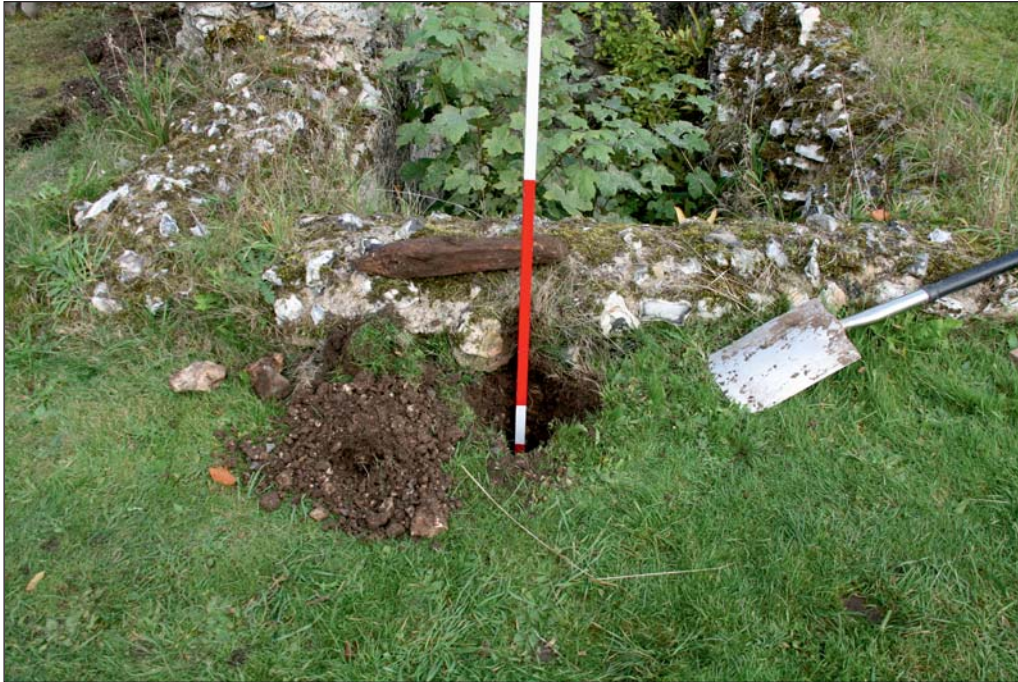
- 3.2.6 Post hole 4 was located approximately 1.8 m east of post hole 3 (**Plate 5**). The rotted post came out in one piece and therefore the hole was not excavated, leading to minimal disturbance of the deposit within. The deposit within (context 009) was similar to 007 and was present 0.08 m below the ground surface, to a depth of 0.58 m. As the hole was not excavated, the deposit was minimally disturbed.

Plate 5: Post hole 4, looking north

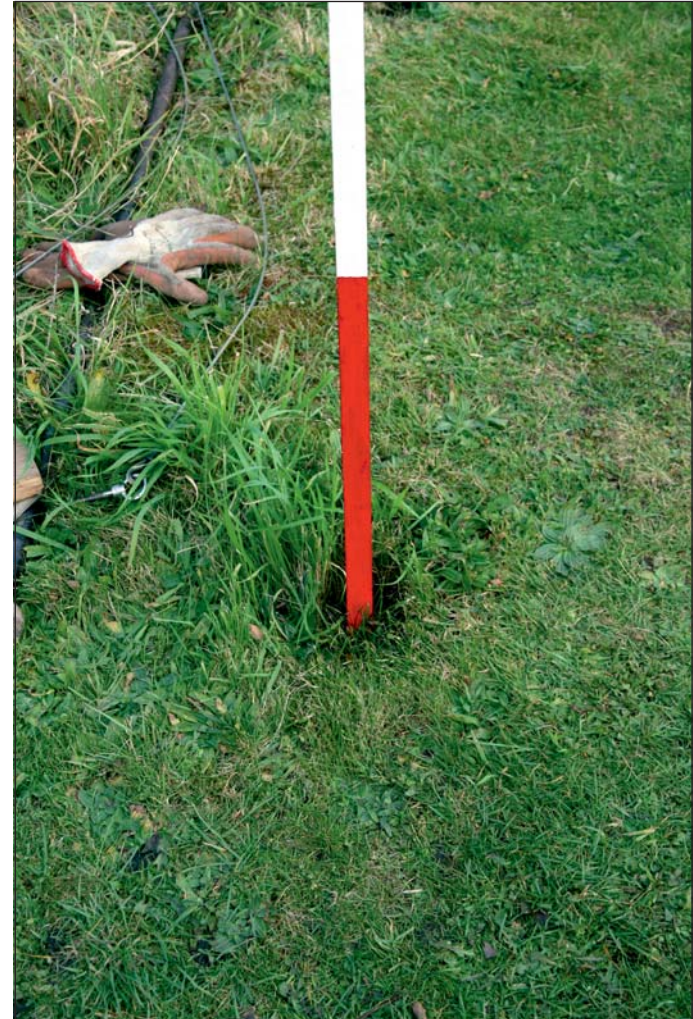
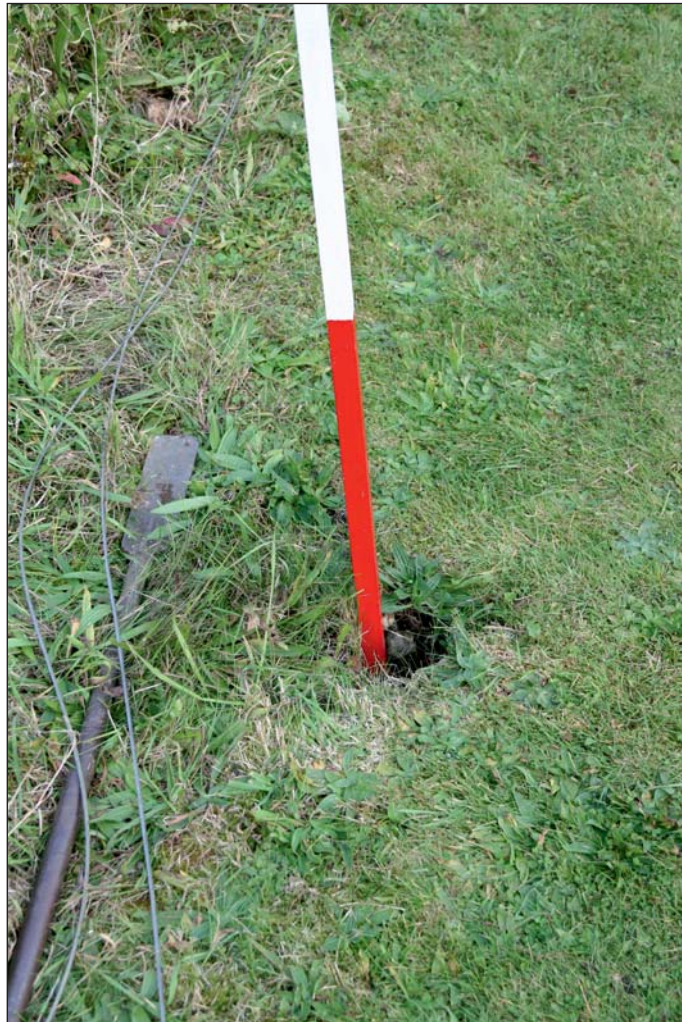
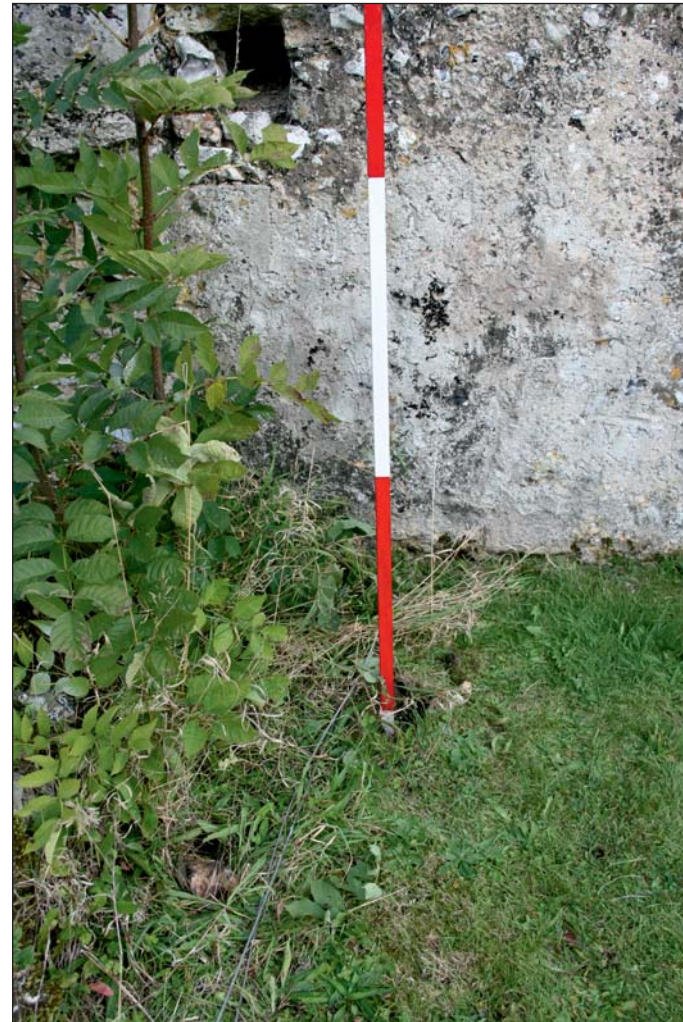
- 3.2.7 Post holes 5, 6 and 7 were located along the east side of the Latrine Pit, approximately 3.3 m east of post holes 1, 2 and 3 and directly opposite (**Plates 6, 7 and 8**, respectively). The wires fixed to the east-west wall were unscrewed and all three posts were lifted out of their holes in one go (**Plate 9**). Therefore there was minimal disturbance and the deposits within were not excavated, viewed or recorded.

Plate 6: Post hole 5, looking north

Plate 7: Post hole 6, looking north

Plate 8: Post hole 7, looking north

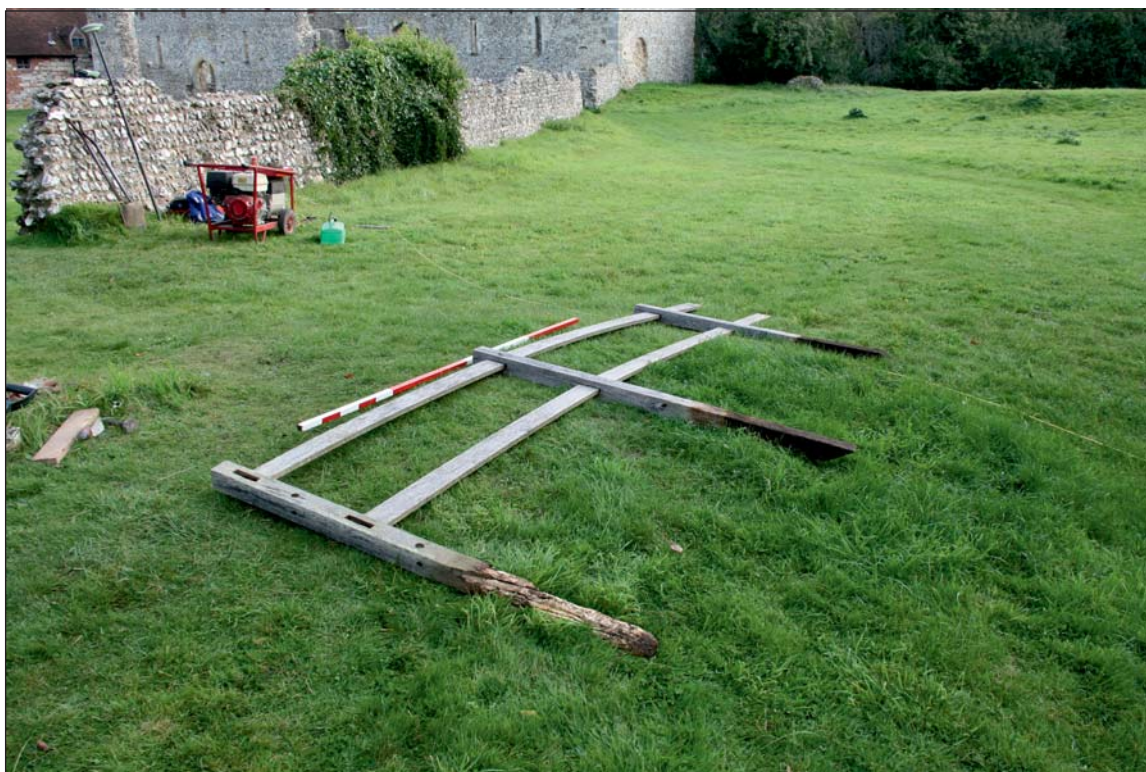
Plate 9: Removed fence posts from east side of Latrine Pit, looking east

- 3.2.8 Following the watching brief, the new fence posts were inserted in the old post holes.
