MOOR STREET, BRIERLEY HILL, DUDLEY

Archaeological Trial Trench Evaluation

Report reference: 85940.01

August 2012

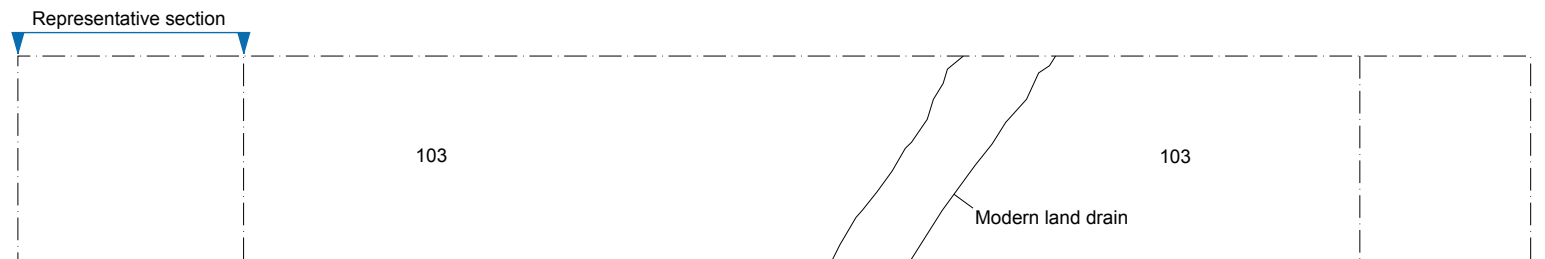
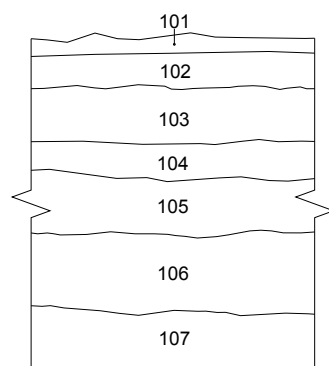
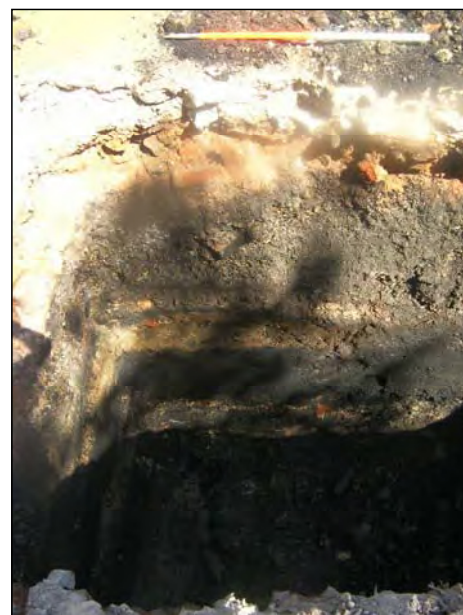
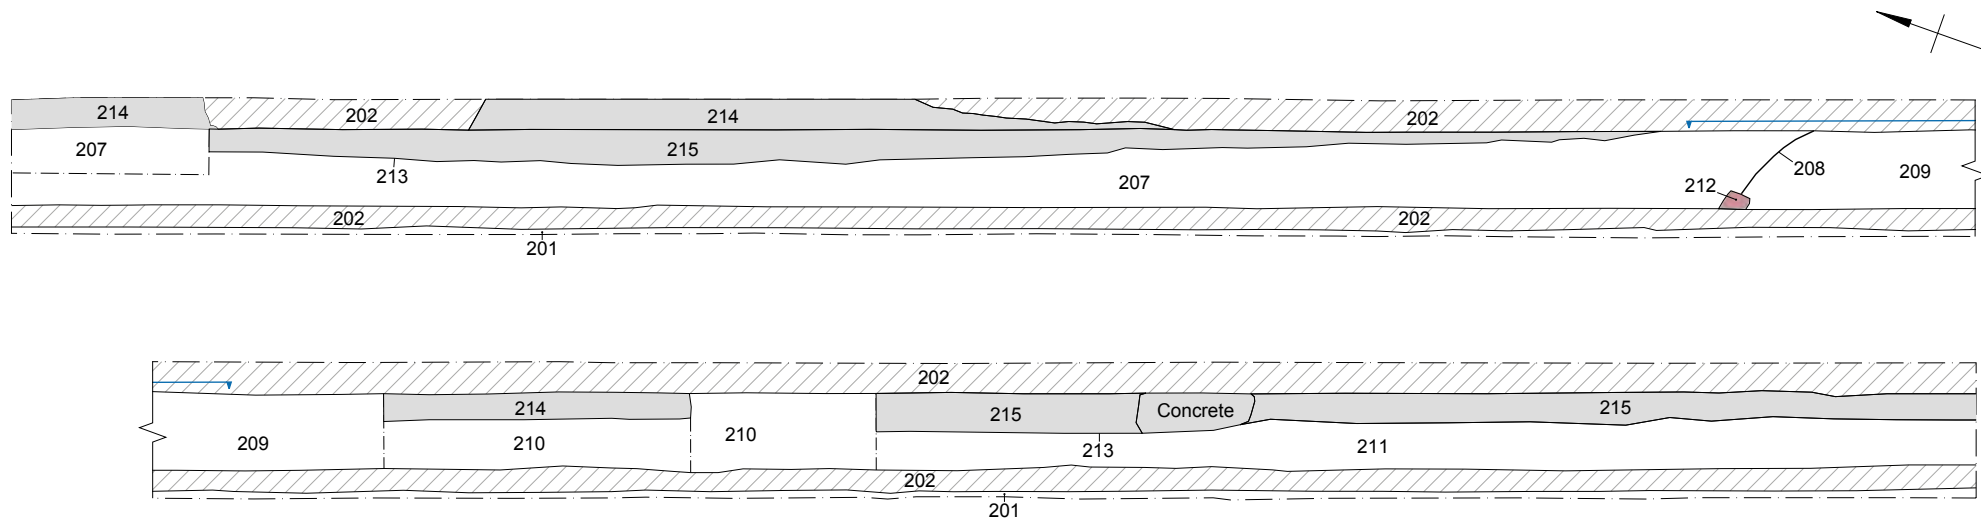
Trench 1 plan 1:100

Trench 1 representative section, west facing 1:80

Trench 1 representative section, looking east

- 5.2.1 Trench 1 (**Figures 2** and **3**) was excavated to a depth of 1m with a deposit of blackened clinker, cinder and ash (**103**) revealed throughout the trench (**Figure 3**), and overlain by the modern ground surface (**101** and **102**). Two sondages revealed deposits of mixed modern made ground (**104**, **105** and **106** – see **Appendix 1**), to a depth of 3.5m below the current ground level at each end of the trench (**Plate 1**). A black stained yellowish brown silty clay (**107**) was revealed at the base of the section, which may represent the interface with the natural geology.

- 7.1.1 The results from Trench 1 demonstrate that there is at least 3.5m of made ground in the northern part of the Site. The level of the natural geology (**117.85m AOD**) was considerably deeper (over 2m) than the average level of natural geology (**119.9m AOD**) revealed in Trenches 2, 3 and 4. The depth of made ground is most likely a result of the infilling of the quarrying marked on the 1884 OS historic map. Trench 1 as excavated lay beyond the footprint of the Moor Lane Glassworks. It is possible that remains survive on the street frontage, although the results from Trench 1 suggest that quarrying is likely to have destroyed any such remains following demolition of the building around 1870.

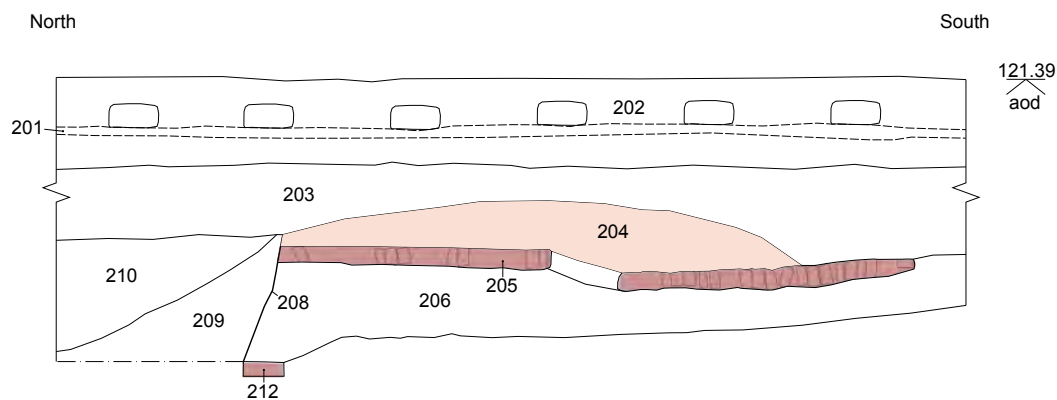
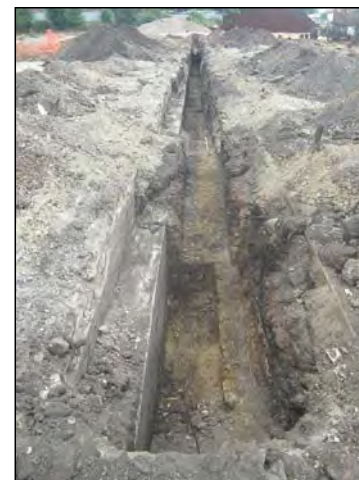
Trench 2 section, east facing 1:40

Trench 2, looking south 1:40

- 5.3.1 The natural clay (**207**) was encountered at a depth of 1.2m in the northern half of Trench 2. A foundation for an in-situ brick remnant of a heavily truncated wall foundation (**212**) was cut through the natural, and which aligned with structure **307** in **Trench 3** (see **5.4.5** below). A banded clay deposit (**206**) overlay wall **212**, and may have formed a levelling layer below a row of firebricks (**205**; **Figure 4**).

- 5.3.2 The firebricks (**205**) were overlain by a substantial domed deposit of pink clay **204** (**Figure 4**), which extended into **Trench 3** (see **316**). The southern section of this deposit, and the underlying fire bricks, were truncated by a large pit (**208**), which was filled with a mixed clay (**209**) and slag and clinker (**210**). Deposit **210** was overlain by 0.3m to 0.4m thick deposits of coal and clinker (**203** and **211**), which extended along the full length of the trench. Deposits **203** and **211** were overlain by levelling for the disused railway and sleepers (**201** and **202**; **Figure 4**).

- 5.3.3 The eastern half of the trench had been truncated by the insertion of a substantial modern concrete beam (**213** - **215**), which extended along the full length of the trench (**Figure 4**) and into Trench 3.

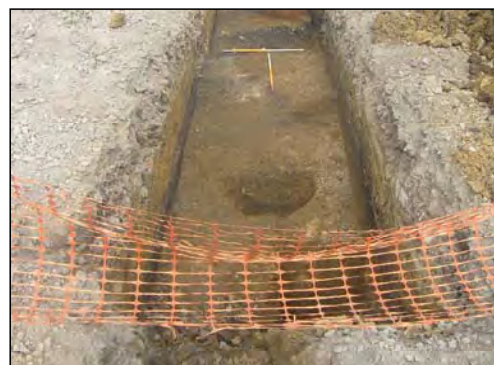
Feature 308, looking west

- 5.4.2 At the eastern end of the trench was a 0.8m diameter pit or posthole (**308**) with a single 0.5m deep fill (**309**). The fill was darker in the central portion, and was indicative of a post pipe (**Figure 5**).

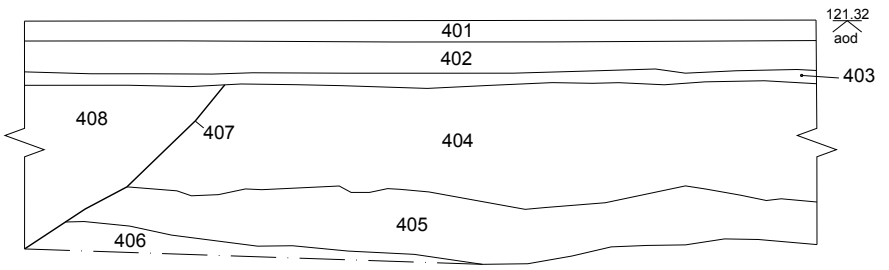
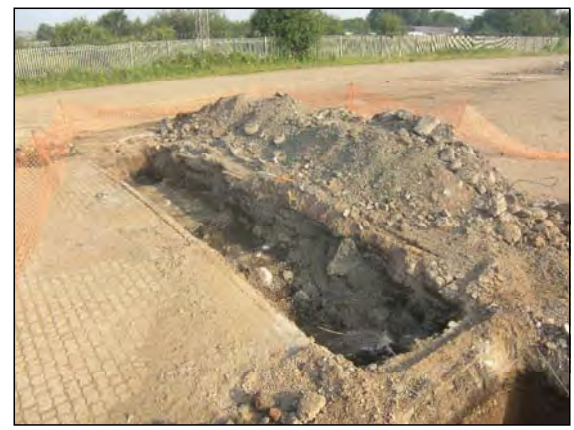
Trench 4 section showing feature 407, east facing 1:40

Trench 4, looking north-east

- 5.5.1 Trench 4 was located within an area of extensive ground disturbance, and the natural geology (**412**) was only partially observed at a depth of 1.45m below current ground level in the eastern half of the trench (**Figure 6**).
- 5.5.2 At the western end of the trench, a 2.75m deep sondage revealed a dump of sandy grit (**411**) that contained a high percentage of broken pottery (see **6.1** below). The deposit was at least 0.7m thick (**Figure 6**) and was of uncertain provenance.

- 5.5.3 Made ground deposits that were 1.85m thick (**405** and **406**) overlay deposit **411** (**Figure 10**). These deposits were cut by a large pit (**407**), which was filled with large lumps of broken concrete in a mixed sandy/silty clay (**408**; **Figure 6**).
- 5.5.4 In the eastern half of the trench a thin band of redeposited natural yellow clay (**409**) abutted a substantial concrete beam (**Figure 6**), the base of which was not exposed. The deposits were overlain by the bedding material (**403** and **402**) for the interlocking concrete sets (**401**) of the current ground surface.

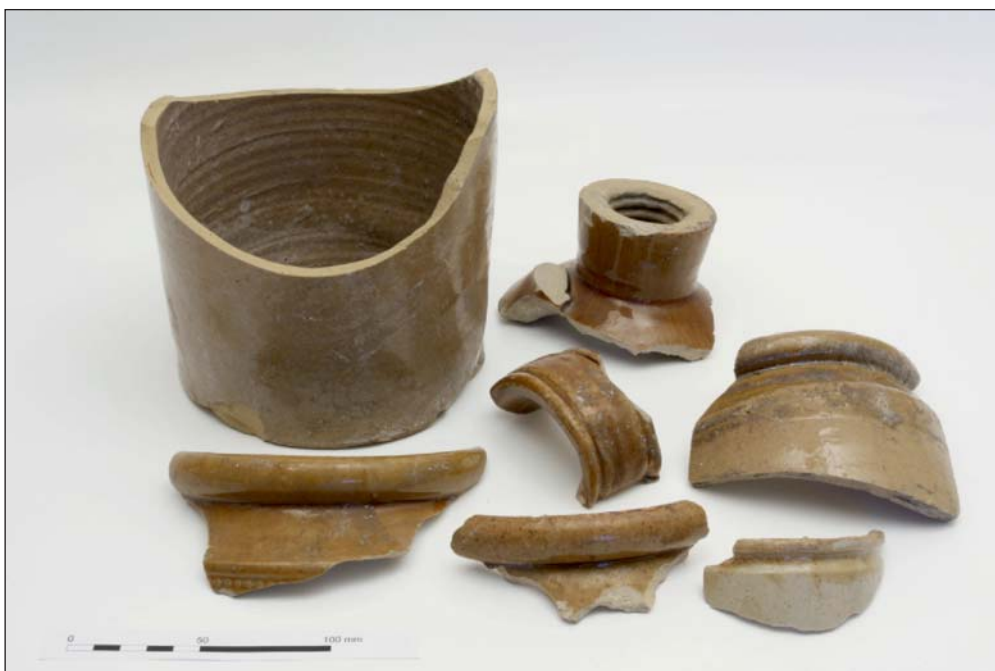
Plate 1: Stoneware from pottery dump 411.

- 6.2.1 With the exception of four sherds of refined whiteware (three of them transfer-printed), which probably represent domestic refuse, all of the pottery consists of stonewares with feldspathic glazes, some with an underlying yellow ochre dip on the upper part of the vessel. The sherds represent a range of storage vessel forms, although no complete vessels are present. At least four sherds exhibit firing faults, including probable underfiring (glaze not fused), warping, and breakage during firing, with glaze running over sherd breaks. These sherds are sufficient to identify this group as waste from stoneware production, although nearly all derived from made ground deposits and so cannot be regarded as being *in situ*.

6.2.4 Most of the pottery came from made ground deposits in Trenches 2, 3 and 4, the largest group from a deliberate pottery dump (**411**) in Trench 4 (**Plate 1**).

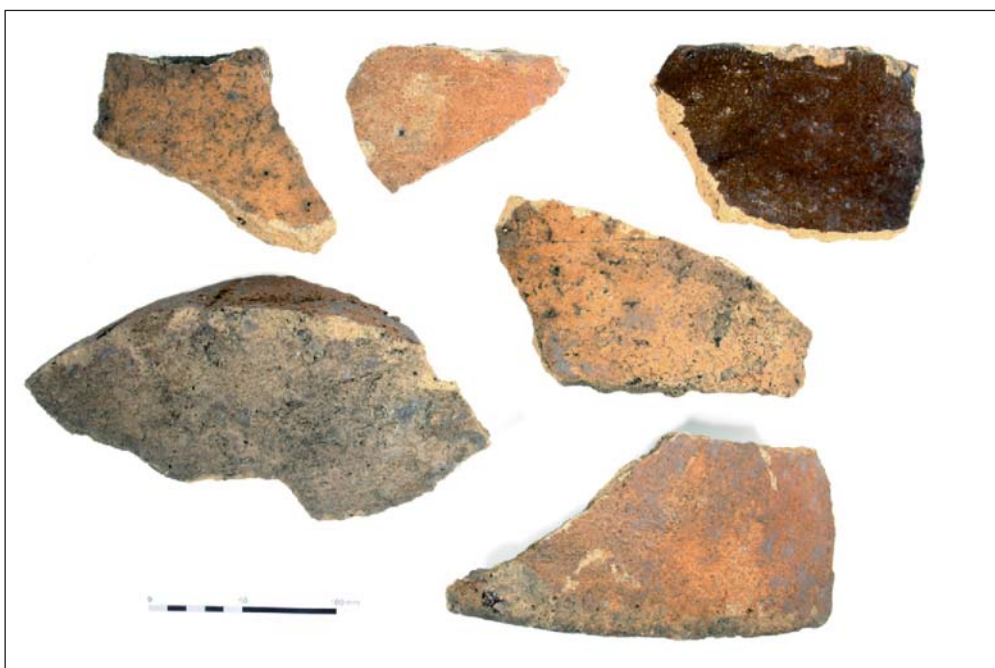
Plate 2: Flat-based saggars 314.

6.3.1 Nine fragments were identified as deriving from cylindrical, flat-based saggars, for containing and protecting fineware pots during firing (**Plate 2**). From measurable bases these appear to be around 400mm in diameter. Most fragments came from made ground in Trench 3, with one piece from made ground in Trench 1; the latter appears to derive from a smaller, thinner-walled vessel.
