Bramshill House, Bramshill, Hampshire

Archaeological Evaluation Report

Ref: 108640.08
November 2015

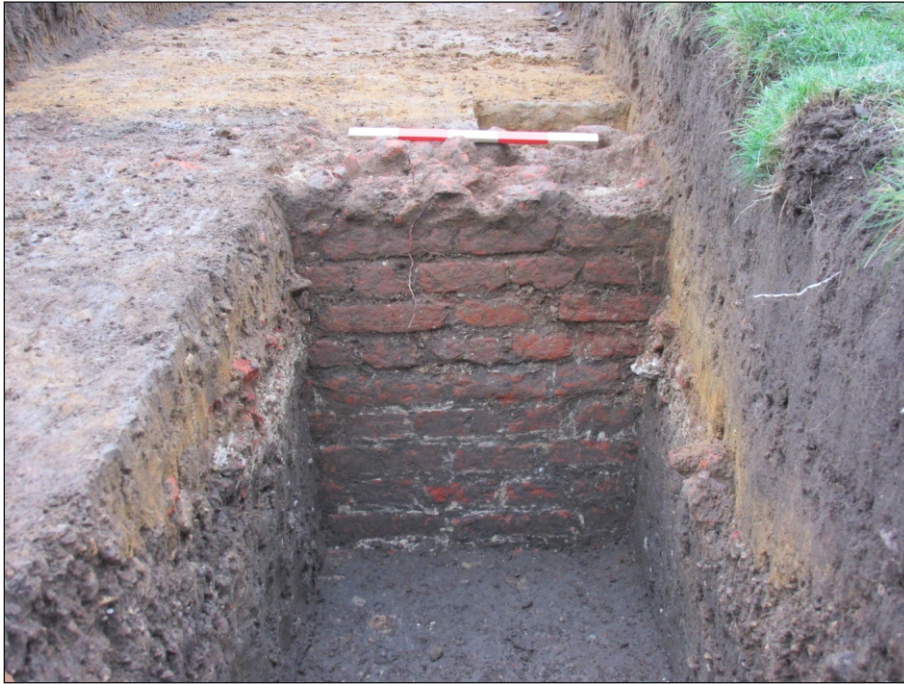
Plate 1: North-north-west facing elevation of wall 112

7.1.1 The trial trench evaluation has confirmed the position of the garden boundary wall (**112**) as predicted from the 1699 Justis survey and demonstrated its good state of preservation below ground with at least ten courses remaining; its full height was not revealed (**Plate 1**). The brickwork observed was consistent with a post-medieval date.

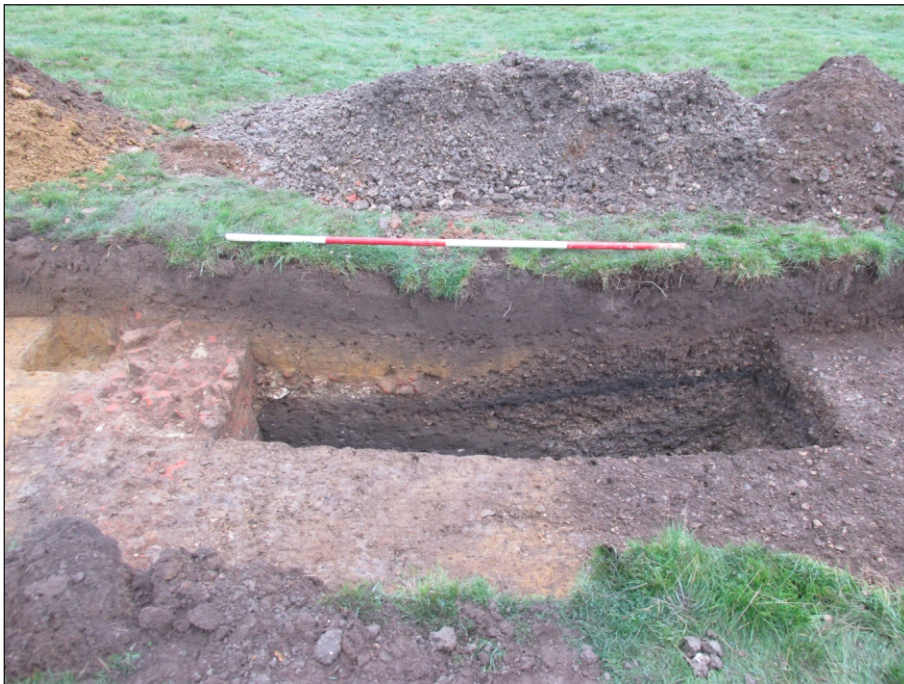
Plate 2: North-north-east facing section of wall 112 and feature 104

- 4.2.2 On the north-north-west side of the wall **112**, a series of deposits (**105-110**) butted against the north-north-western face of the wall (**Plate 2**). These deposits are assumed to represent the fills of a substantial cut feature **104**. Although the trench was extended slightly to the north-west, the extent of **104** was not visible in plan and the full depth of the feature could not be established within a slot positioned immediately against the north-north-western edge of the wall **112**, which was hand excavated to a maximum depth of 1.1m before excavation was halted for health and safety reasons. A sondage dug near the north-west end of the trench located the natural geology (**103**) at around 0.7 m below ground level (**Plate 3**), suggesting that the slope angle of cut feature **104** diminishes towards the north-west. Although its exact form could not be established, given its position **104** may represent a substantial ditch or boundary feature on a similar alignment to wall **112**. As the feature was not fully excavated, the exact stratigraphic relationships between the ditch and wall could not be determined: although the exposed deposits within **104** were seen to post-date the wall, it is possible that construction of the wall could post-date the original excavation of cut feature **104**.

- 7.2.4 A series of deposits (**105-110**) butting against the north-north-western face of the wall **112** (**Plate 2**) are thought to represent the fills of a substantial cut feature **104**, the extent of which could not be established within Trench 1. The stratigraphic relationships between the wall and adjacent feature could not be established with certainty: although the exposed deposits within **104** post-date the wall, construction of the wall could post-date the original excavation of the feature, which may be associated with establishment of the Italian Garden perimeter, or perhaps an earlier boundary ditch.

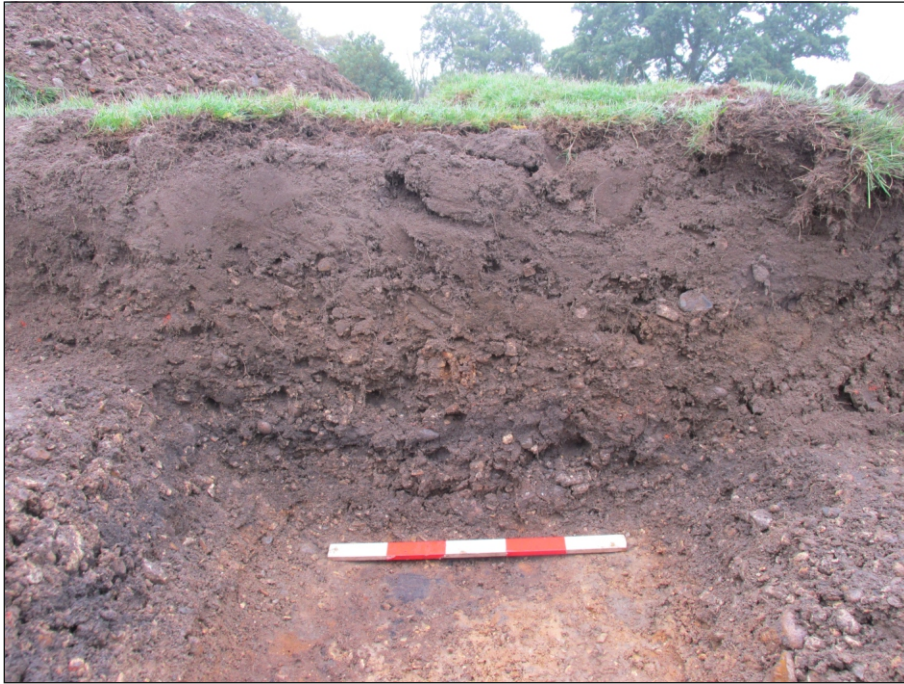
Plate 3: North-north-east facing section of 104 at north-western end of the trench

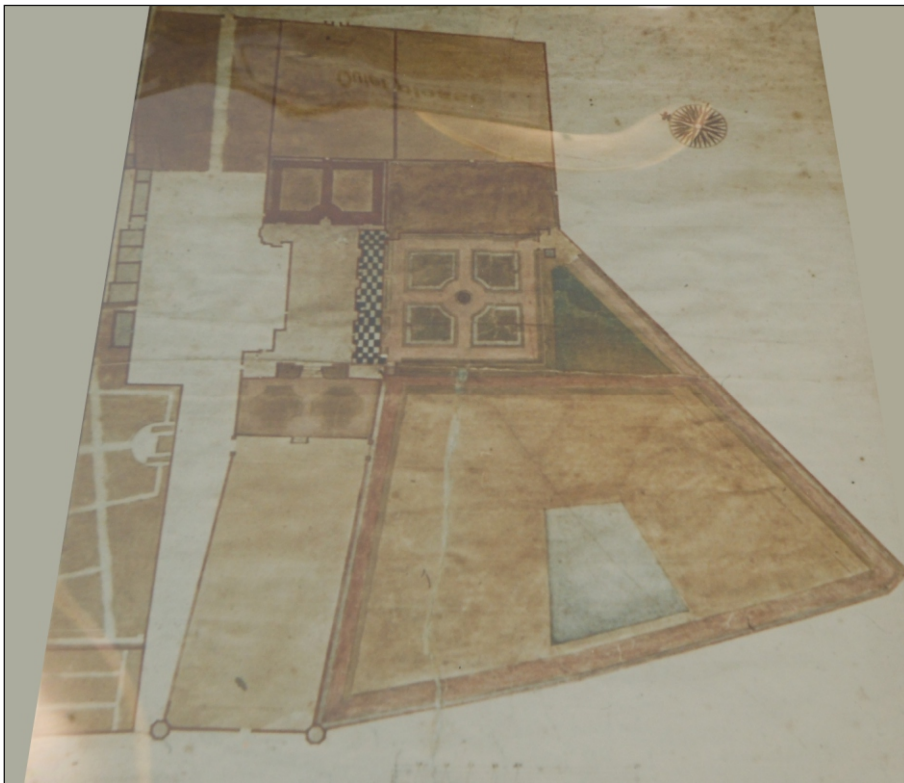
Plate 4: Garden plan of Bramshill 1715-16 (taken from a copy held in the HRO, ref. 133M84/3)

7.2.1 The projected line of the wall north-eastwards extends to a wide buttress just to the north-west of the rounded corner of the trocco (a kind of lawn bowls) terrace (**Plate 7**), believed to be of 18th century origin (HAHBR ID 31917). The terrace is depicted on the 1715-16 garden plan (HRO ref. 133M84/3) but without this pronounced rounded corner, perhaps

suggesting some later alteration to the structure (**Plate 4**): indeed, the early 18th century plan would seem to indicate a direct connection was intended between the terrace and the garden below.

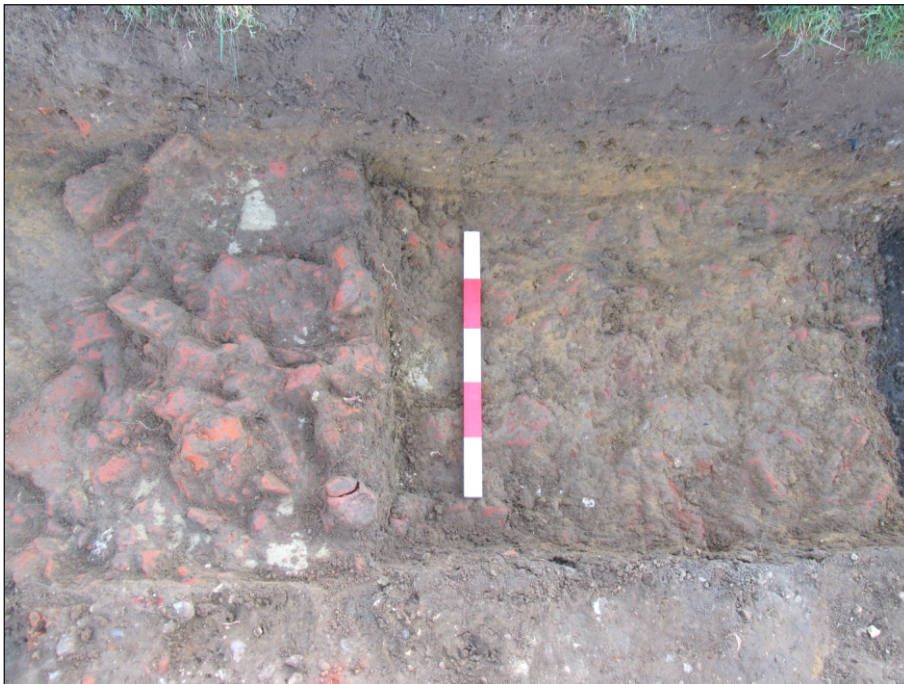
Plate 6: Mid excavation view showing brick rubble at the base of layer 110

- 7.2.3 On the innermost face of the wall (north-north-west) a layer of redeposited natural clay on a brick rubble base (**110**) appears to form a path along the postulated alignment of Lady Abney's Walk, thought to be associated with the 17th century garden but first specifically documented in 1756 (RCHME 1998, 8). A mortar-rich layer (**109**) beneath this suggests adjacent construction or demolition activity, although it clearly post-dates the original construction date of the wall.

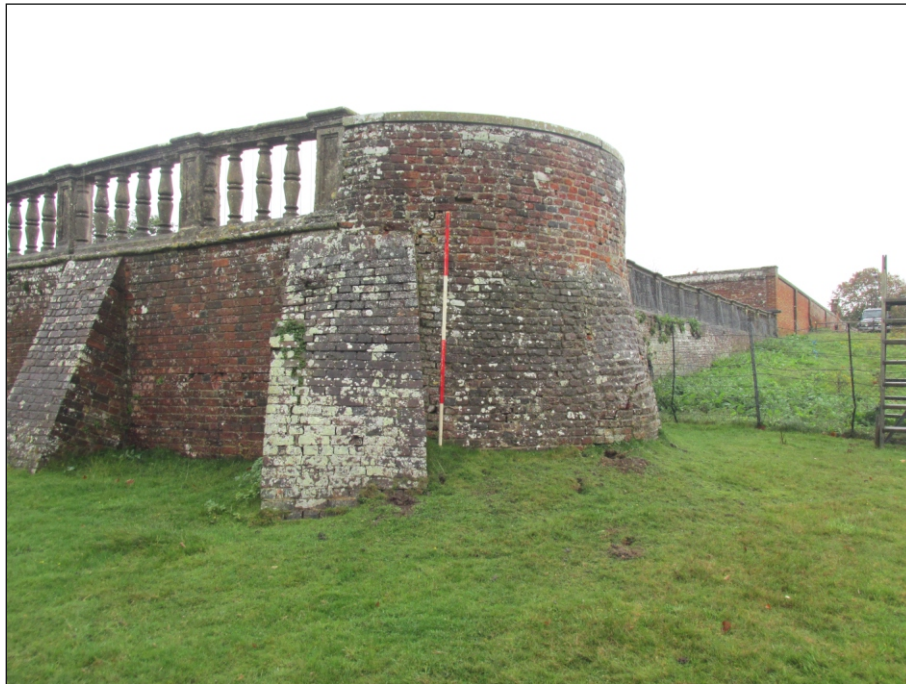
Plate 7: South-west corner and buttress of the trocco terrace

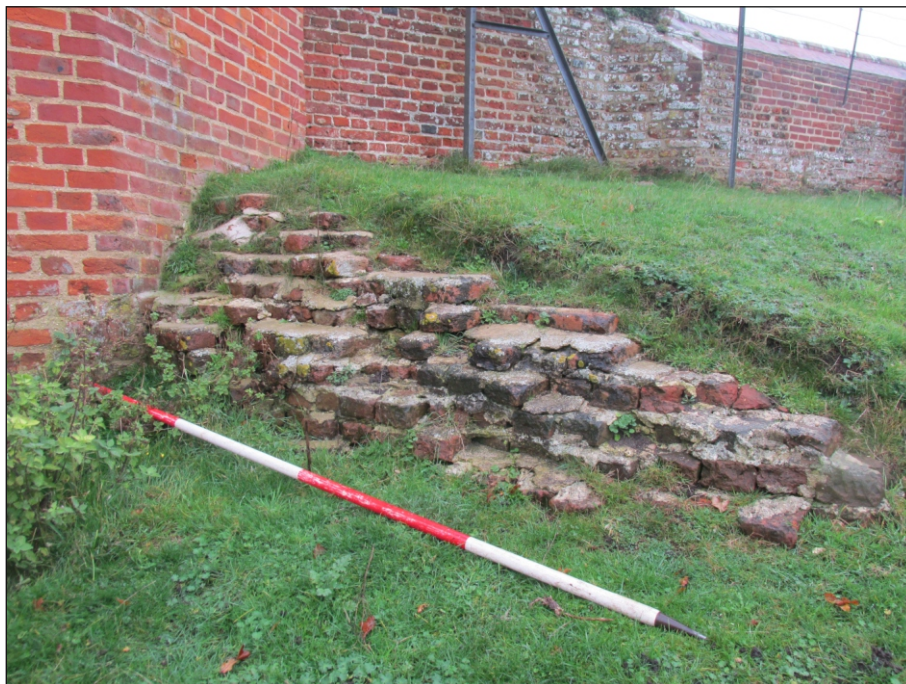
Plate 8: Brickwork visible at turret base, view from the south-west

- 7.2.2 The south-western boundary of the Italian Garden lies along the lower edge of the lake and remnants of wall visible adjacent to the southernmost turret here (list entry 1091939) (**Plate 8**) are assumed to be part of the contemporary wall as exposed in Trench 1.
