River Avon Restoration Works, Wilsford Wiltshire, SP4 7BP

Archaeological Watching Brief

Ref: 101462.02
December 2015

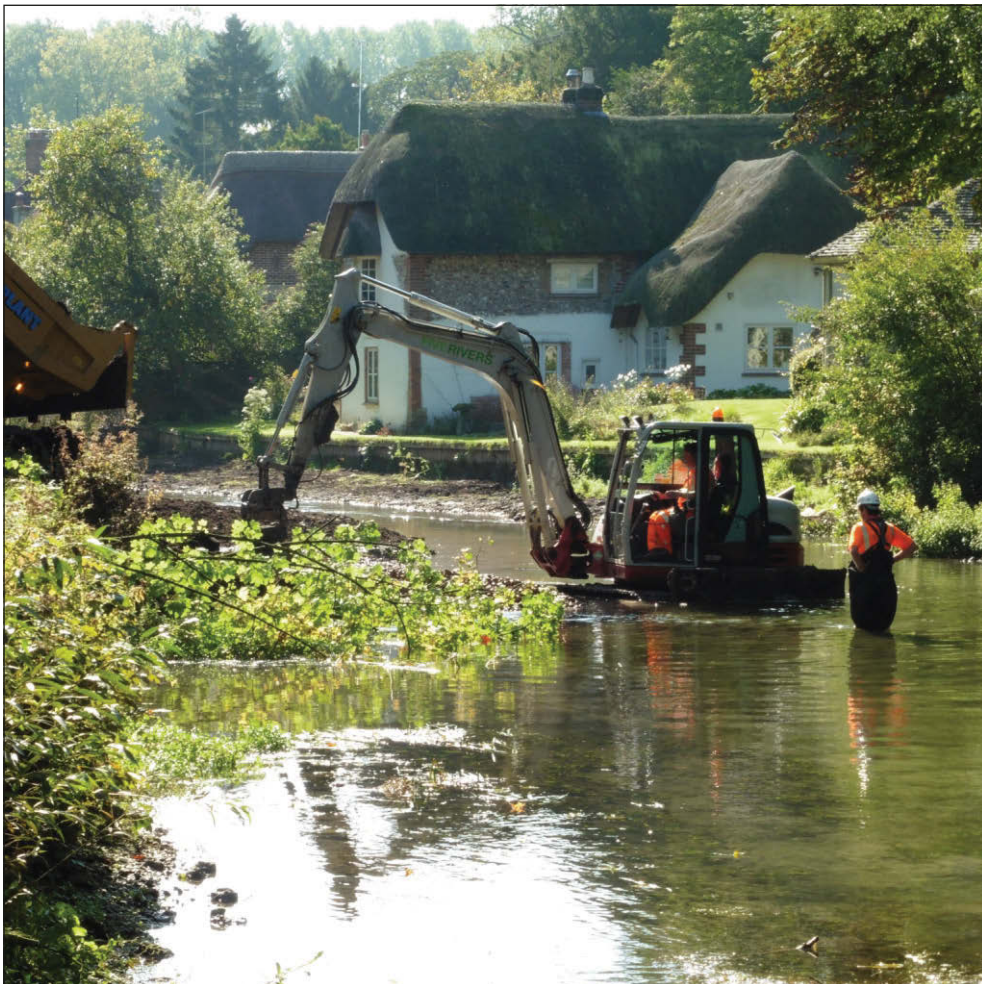
- Front cover** Five Rivers creating a berm on the east bank of the River Avon
Plate 1 Stratigraphic sequence in area of Shallow Scrape
Plate 2 Mechanical excavation of Shallow Scrape

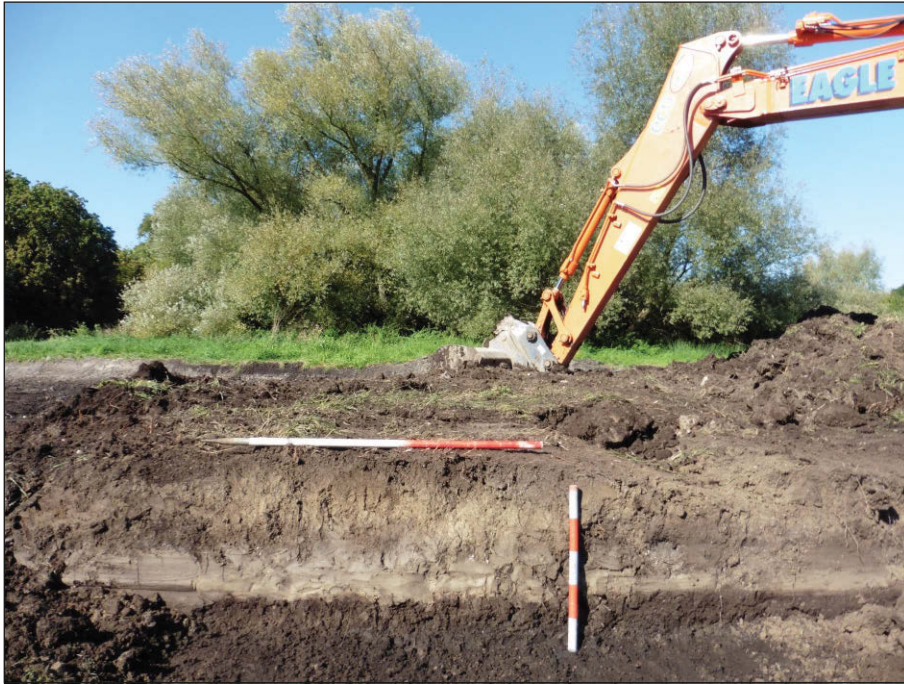
4.2.1 The stratigraphic sequence of natural deposits was consistent in the areas of the Shallow Scrape. The topsoil (**102**) was a blackish grey loam approximately 0.1 m thick. This overlay a whitish grey gritty silt (**103**) approximately 0.3 m thick, and identified as a probable flood deposit. Directly below was a 0.45 m thick layer of very pale grey clay alluvium (**104**). This sealed a dark brown peaty loam (**116**), approximately 0.1 m thick on average, and appears to be a preserved flood plain soil horizon. The horizon between the base of this deposit and (**105**), a blackish grey silty loam approximately 0.8 m thick on average, was very diffuse. Below was a pale grey to mid brown loamy sand with moderate grit inclusions (**106**) approximately 0.25 m thick overlying pale grey river gravels (**107**).

Plate 1: Stratigraphic sequence in area of Shallow Scrape

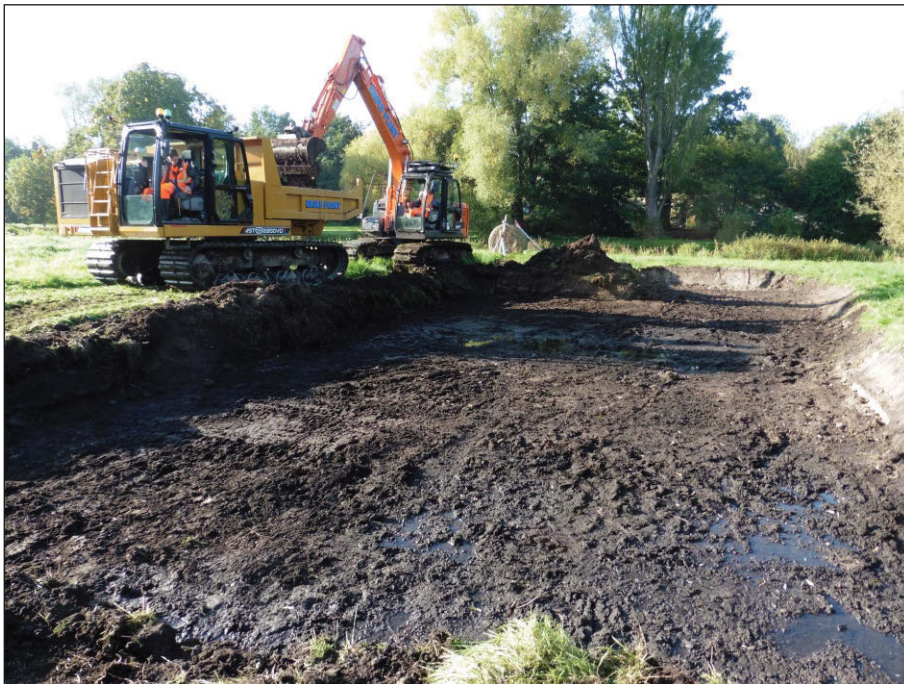
Plate 2: Mechanical excavation of Shallow Scrape
