# Merland Rise Recreation Ground, Tadworth, Surrey, Phase II

Archaeological Evaluation Report

Planning Ref: 13/01729/OUT  
Ref: 107840.02  
March 2016

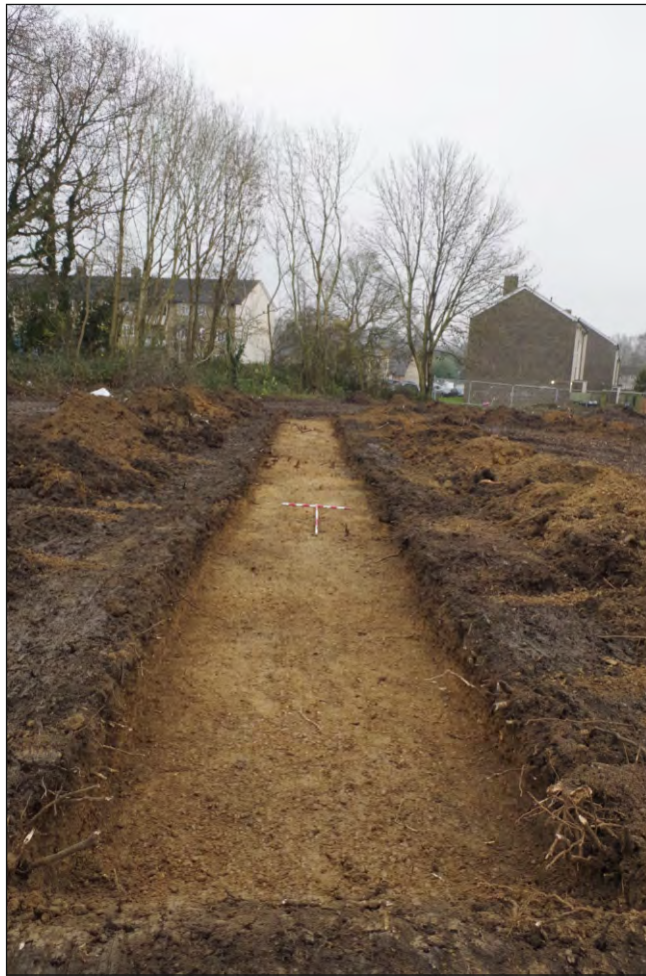
Plate 1: Trench 8, viewed from the North

5.3.2 **Trench 8** was located within the eastern extent of the Site and was excavated to a depth of 0.4m (171.29m aOD). Very dark grey silty clay topsoil, with abundant tree rooting (801) sealed a mid grey brown sandy clay with rare rounded flint inclusions and abundant tree rooting (802) which in turn overlay a light yellow brown sandy clay natural geology with abundant rounded gravel in patches and some pink brown clay patches (803).

5.3.3 The topsoil and subsoil were very loose and friable, suggesting that the area had been affected by bioturbation due to the planting of woodland landscaping. No archaeological finds or features were identified within this trench.

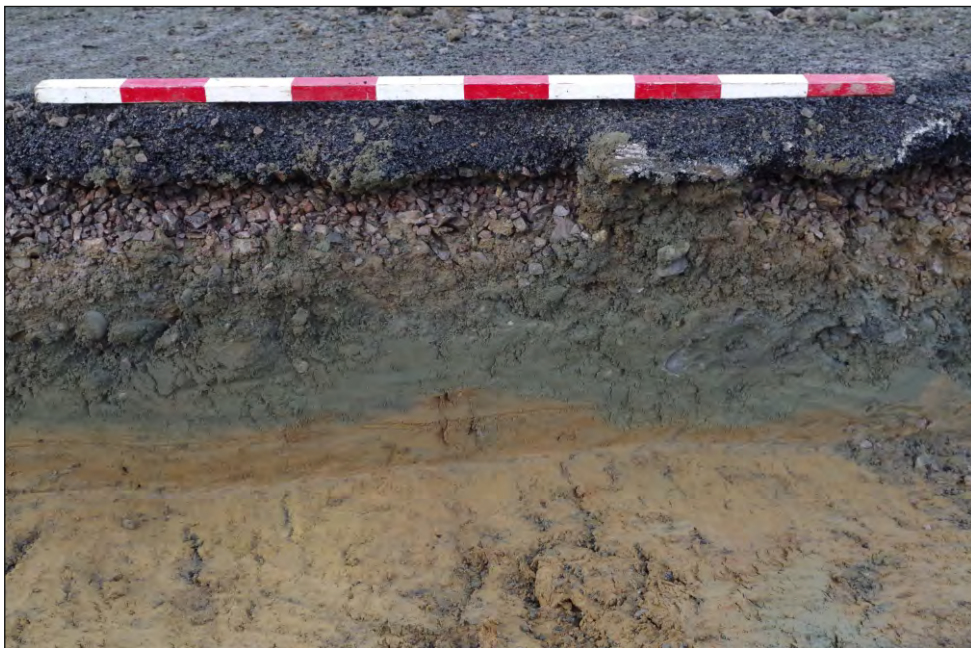
Plate 2: Trench 12, representative section viewed from the South

- 5.3.7 **Trench 12** was moved in order to avoid an extant tennis court. The mid yellow orange sandy clay natural, 1204 and reddish orange clay natural, 1205 were encountered at a depth of 0.42m bgl (169.46m aOD). These were sealed by a light greenish silty sandy clay alluvial deposit, 1203 which contained rare CBM inclusions and was in turn sealed by two layers of made ground, 1202 and 1201. No archaeological finds or features were identified within this trench.

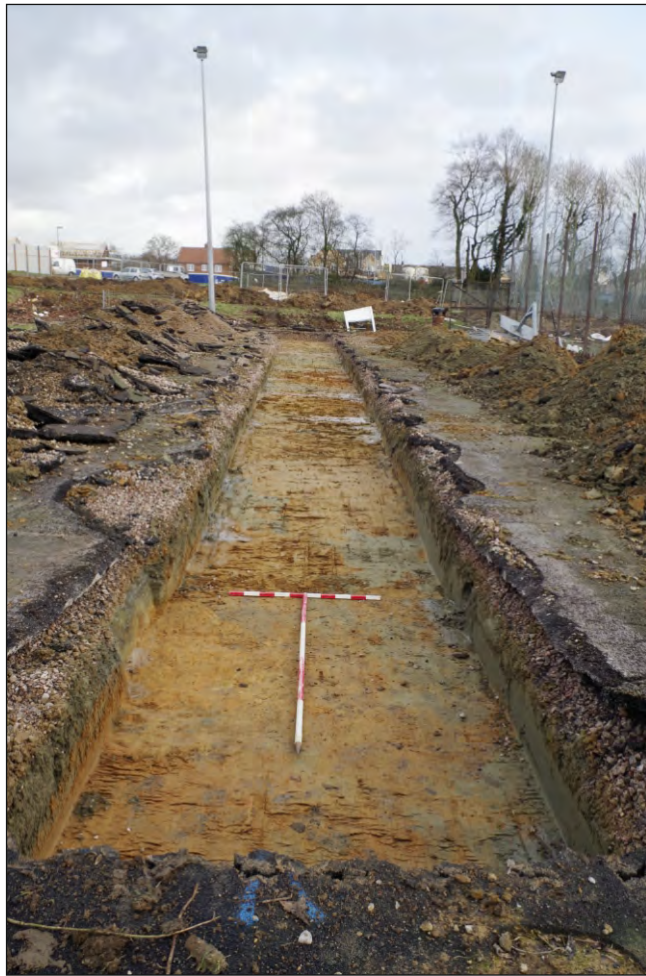
Plate 3: Trench 13, viewed from the East

- 5.3.8 **Trench 13** was relocated in order to avoid standing structures and street lights. The natural geology, 1304, which comprised dark yellowish orange sand with clay patches, was encountered at a depth of 0.57m bgl (169.44m aOD). This was sealed by an alluvial green silty clay (1303) with occasional CBM inclusions at depths between 0.32-57m bgl and overlain by two layers of made ground 1302 and 1301. No archaeological finds or features were identified within this trench.

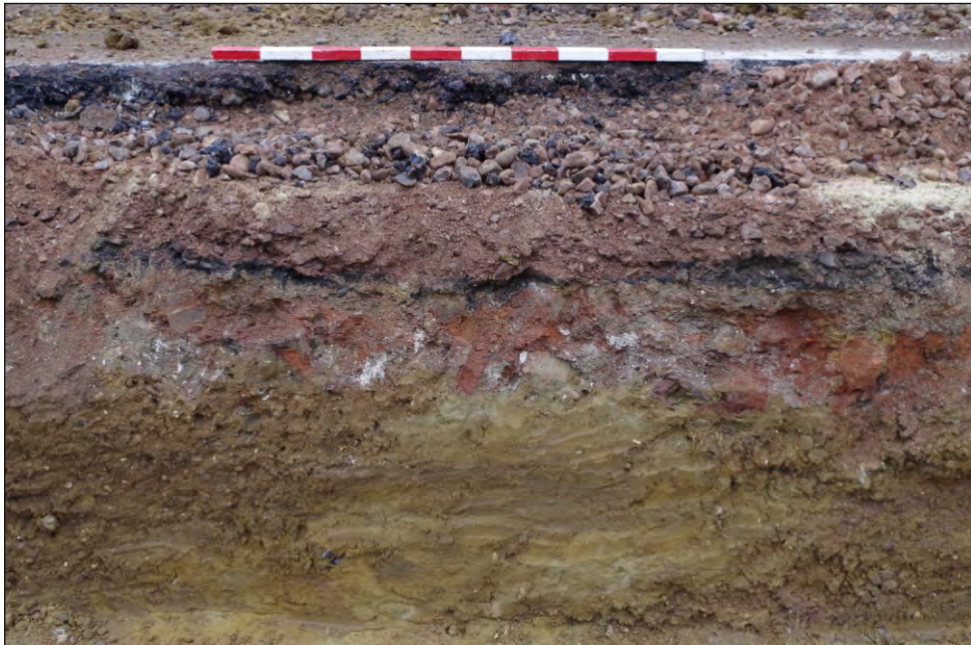
Plate 4: Trench 14, representative section viewed from the North

- 5.3.9 **Trench 14** located within the central area of the Site was relocated slightly to the south in order to avoid a chain link fence and steeply angled verge. The trench was not opened fully as asbestos was identified at 523318.4530, 157361.9570 (NGR). The site management was informed and the trench was immediately backfilled. The natural yellowish brown sand was identified 0.54m bgl (169.22m aOD), heavily truncated by modern activity. No archaeological finds or features were identified within this trench.

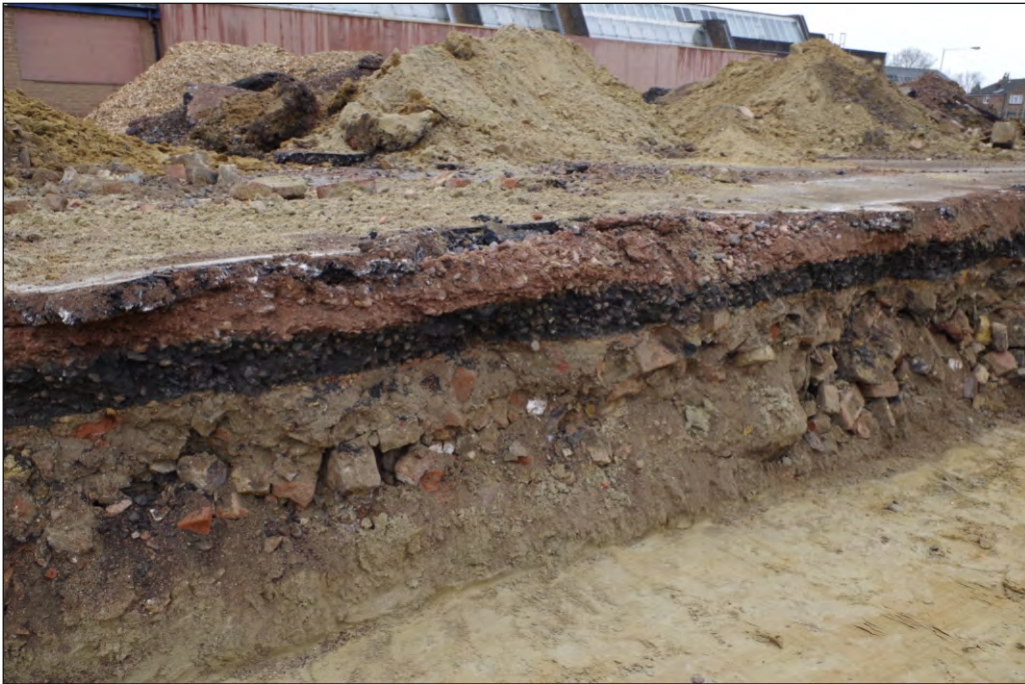
Plate 5: Trench 14, truncation viewed from the Northeast
