Land at former King George's Hospital Liphook, Hampshire

Archaeological Evaluation Report

Report reference: 65160.03

March 2007

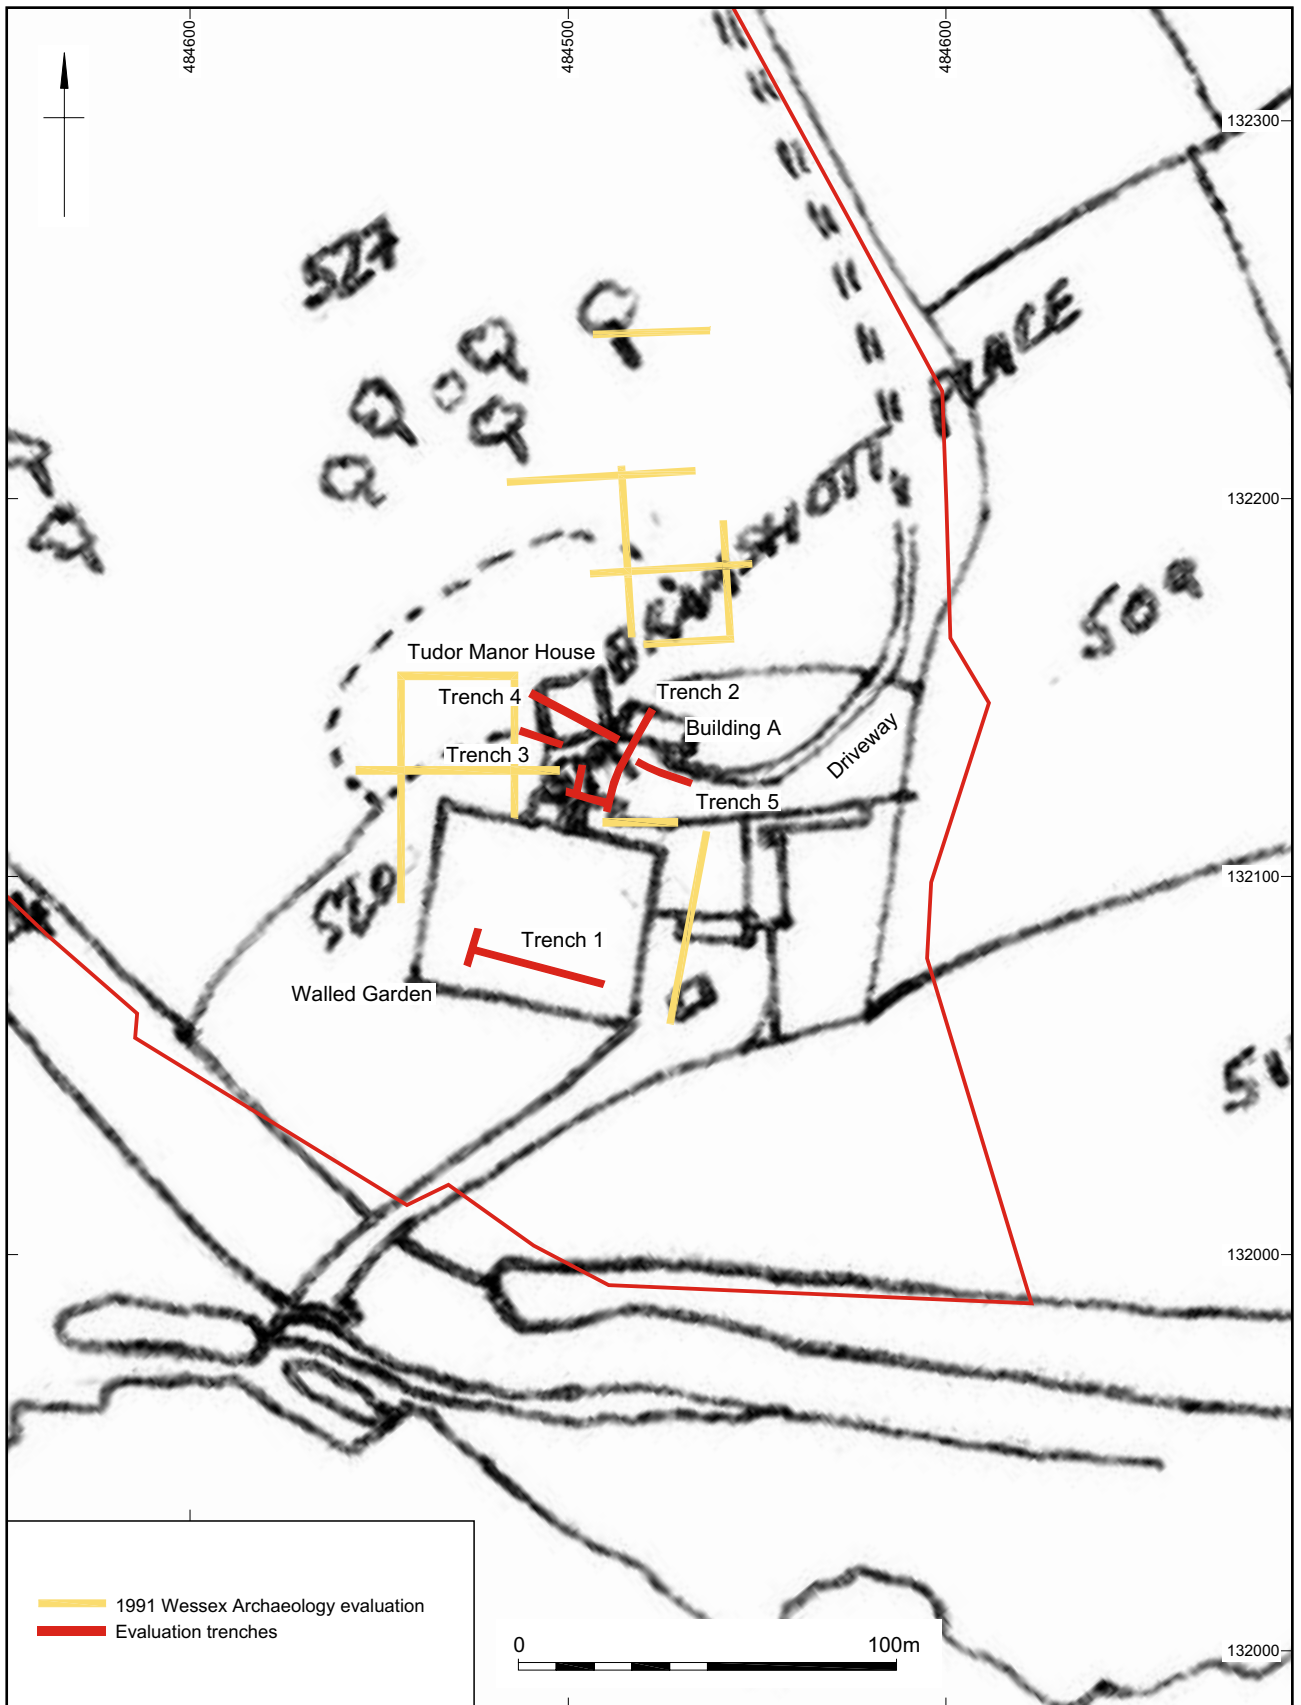
Figure 2

1846 Tithe Map showing location of evaluation trenches of 1991 and 2007

- 2.1.6 However, based on an analysis of the 1846 Tithe Map, the trial trenches may have missed the site of the Manor (**Figure 2**).
- 2.1.7 The first detailed map of the evaluation area is the Tithe Map of 1846. This shows what is believed to be the Tudor Manor House, called Bramshott Place, with a second building (marked A on **Figures 3 and 4**) immediately to the east. The drive from London Road approaches Building A, which was probably the coach house.

- 2.1.8 Also on the Tithe Map (**Figure 2**) is a range of presumed farm buildings to the southeast of Building A (and beyond the area evaluated for this report). A further range of buildings is shown along the walled garden, with a possible small walled enclosure to their west. The detail is not clear but a wall may have joined the walled garden and a corner of the Manor House

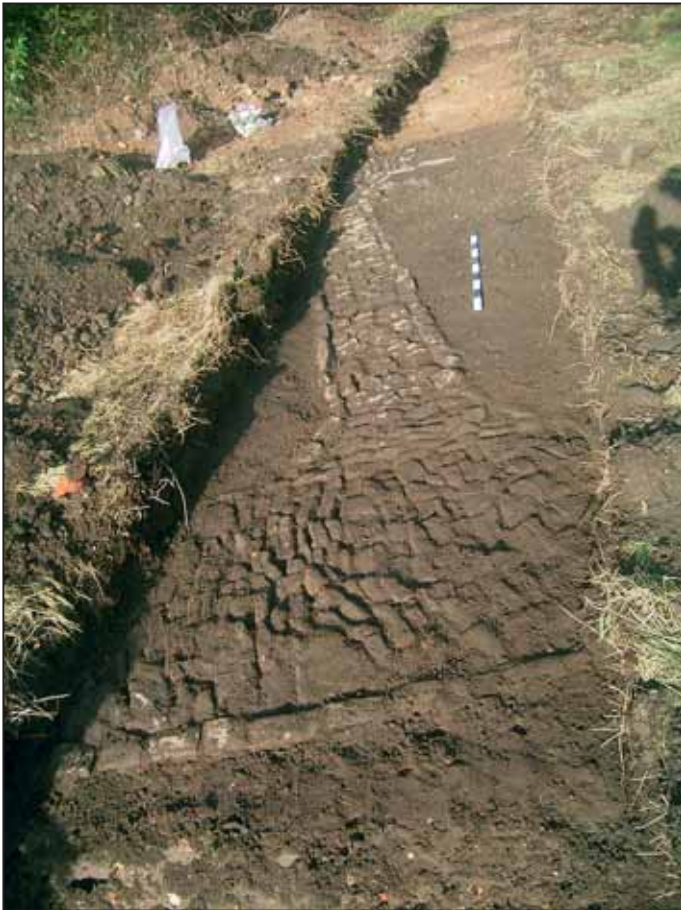
- 5.4.1 This area of cobbling extended 11m east to west and 5m north to south. It was best preserved in Trenches 2 and 5 forming a roughly east to west, 1.2m wide path edged with well laid sub-rectangular cobbles of *c.* 0.2m by 0.1m (**Plate 2**). The path had slightly less regular cobbles laid in lines running at right angles to the line of the path. A 3.5m long and 0.6m wide spur led north in Trench 2 and the heavily truncated cobbles **401** in Trench 4 show a continuation of the path to the west. All the cobbles were neatly laid although with suggestions of repairs and all were a dark, hard non-local stone. This area of cobbling corresponds with the path approaching Building A (**Figure 4**).

Plate 1: Cobbling 204

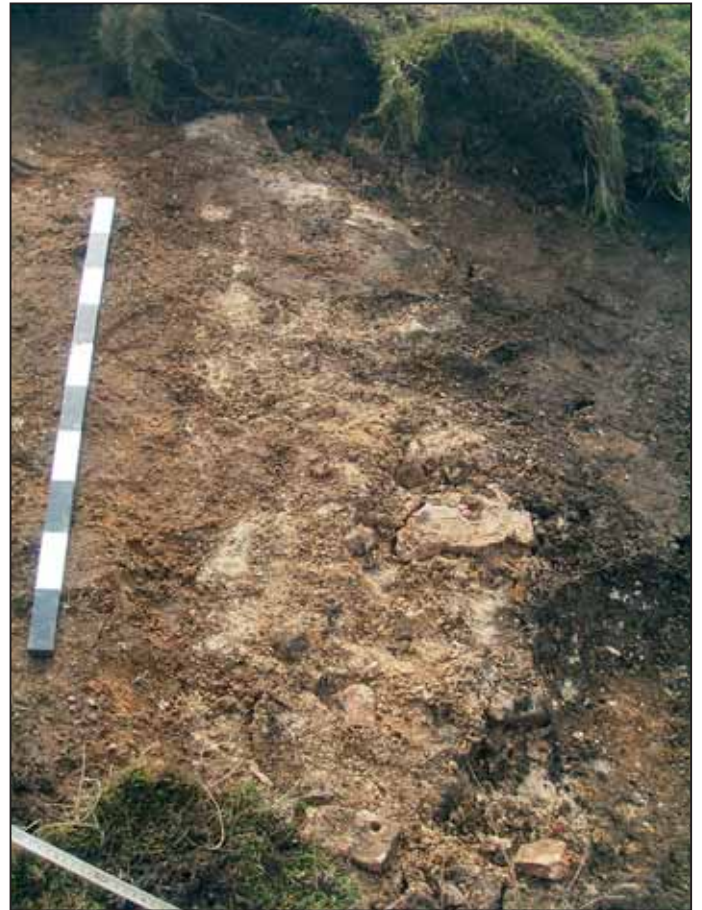
5.3.3 Near the western end of Trench 4 wall **406** ran north to south. Its 0.55m wide foundation comprised mortared sandstone blocks with a very flat upper surface (**Plate 1**). Wall **406** closely corresponds with the postulated western wall of the Tudor Manor House (**Figure 3**).

Plate 2: Wall 406

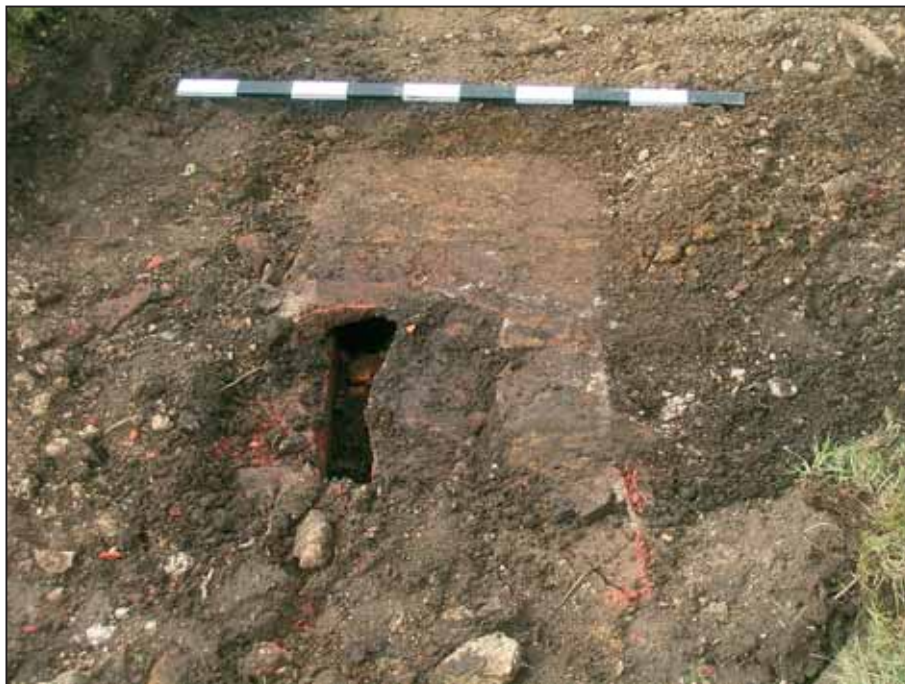
- 5.5.1 Brick built culvert **404** was 0.5m wide and 0.4m deep (**Plate 3**). Its base was lined with bricks, and the sides were formed of vertically pitched bricks. Two phases of use are shown by the presence of a ceramic 4 inch drain running within the culvert. The top was sealed with tiles. Culvert **404** was cut by wall **403**. Culvert **404** appears to be on the same alignment as the Manor House and lies close to the postulated position of the southern wall of the Manor House (**Figure 3**).

Plate 3: Culvert 404
