Church Walk, Ludlow Shropshire

Archaeological Watching Brief Report

Ref: 111960.03
November 2016

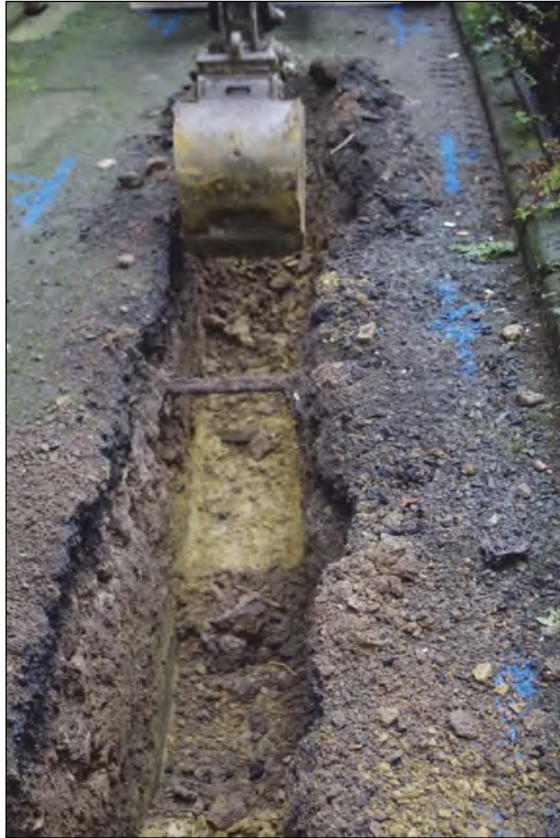
Plate 1: Excavation of Trench 1

- 4.1.1 The general stratigraphy of Trench 1 (Plate 1, Figure 2) comprised a layer of tarmac (101) 0.05 m thick overlying a very dark grey cinder crush layer of made ground (102) 0.08 m thick. This in turn overlaid a mid-reddish brown brick crush levelling layer (103) present between 0.13 m and 0.28 m below ground level (bgl). Stratigraphically below this was a dark reddish brown silty clay made ground (104) present between 0.28 m and 0.54 m below ground level. This made ground contained post-medieval pottery and is probably a build-up of soil relating to the properties along King Street to the south of the Scheme, which was established by 17th century. Below all these contexts was a mid-yellowish brown silty clay subsoil (105) which is the original church yard soil of St Laurence's (Plate 2).

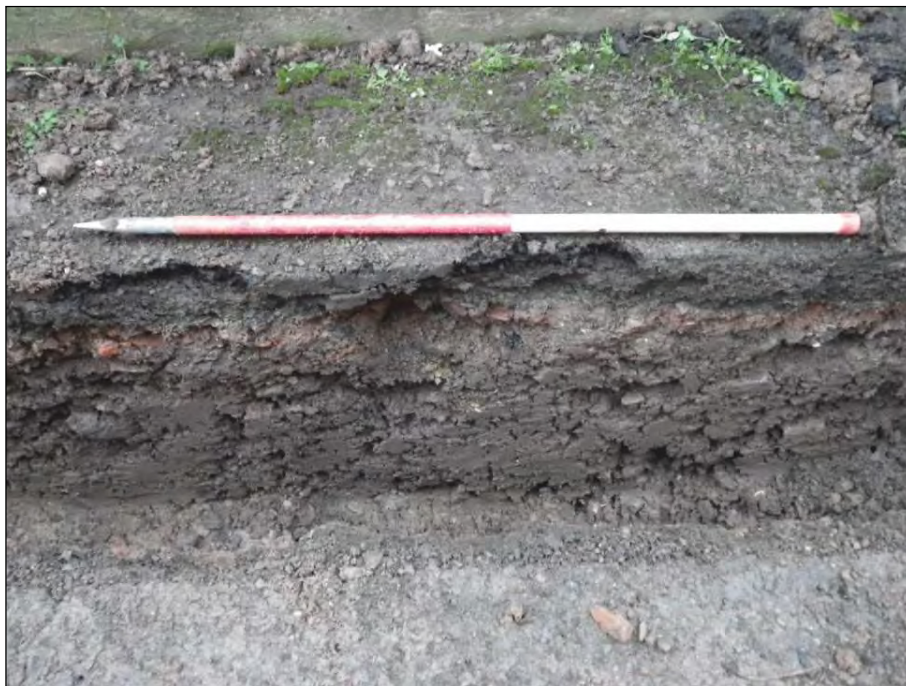
Plate 2: Representative section of Trench 1

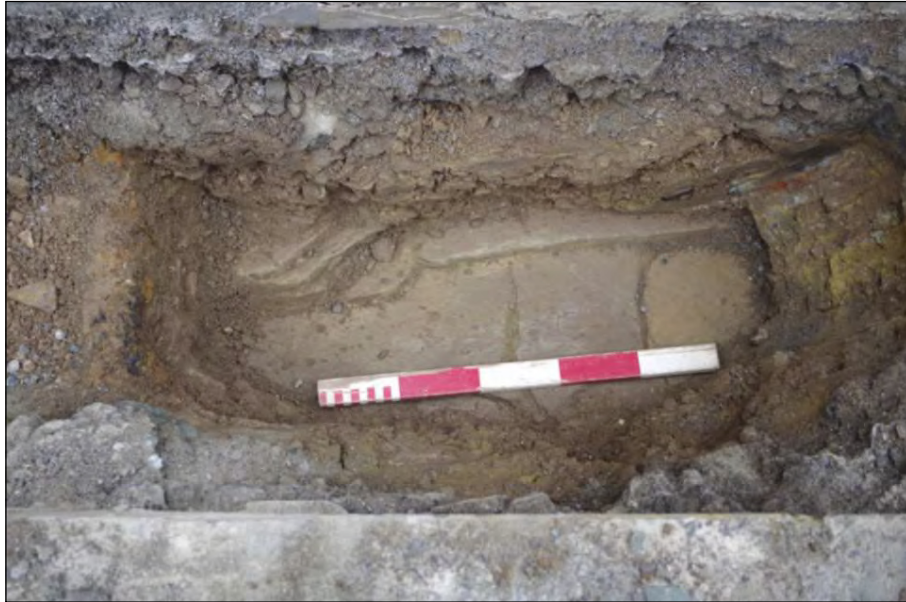
Plate 3: Sandstone paving (122)

- 4.1.3 An area of sandstone paving (122, Plate 3) was identified immediately to the south of the entrance to St Laurence's Church and bedded on a layer of yellow sand (126). This surface extended beyond the limits of the excavation.

7.1.2 An area of sandstone paving was identified within Trench 1 to the south of the south entrance to St Laurence's. It is possible that this represents an earlier paved area in front of the entranceway but the narrow dimensions of the trench make it difficult to confirm the exact nature and extent of this feature.

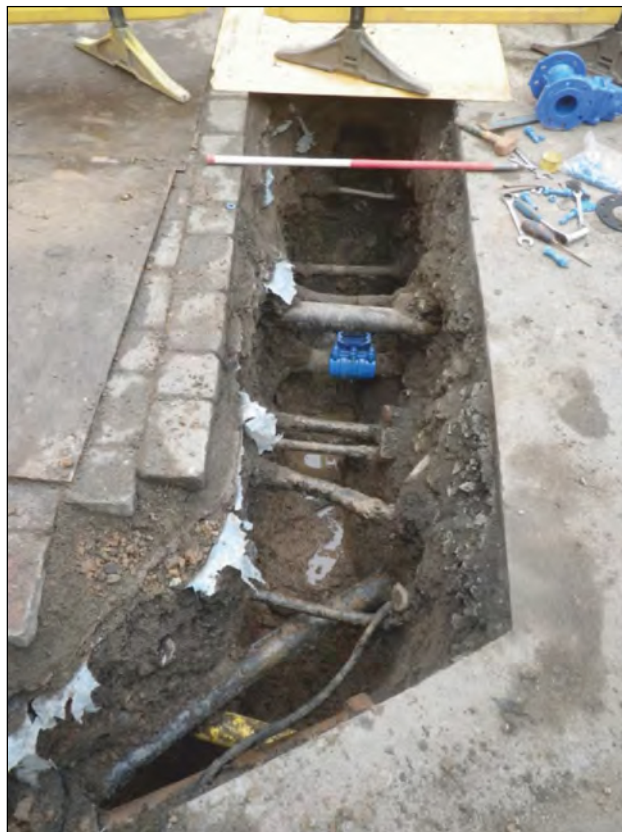
Plate 4: Overview of Trench 2

- 4.2.1 Trench 2 (Plate 4, Figure 2) was located at the western end of the Scheme and was excavated to locate the existing water main within College Street. The stratigraphy within this area of the Scheme was markedly different than that within Trench 1 and comprised a layer of tarmac (201) 0.1 m thick overlying a levelling layer of grey sub-angular medium gravel (202) 0.25m thick. This in turn overlaid a heavily disturbed mid greyish brown silty clay subsoil (203) 0.75m thick and formed through the excavation and reinstatement of numerous trenches for utilities along College Street.

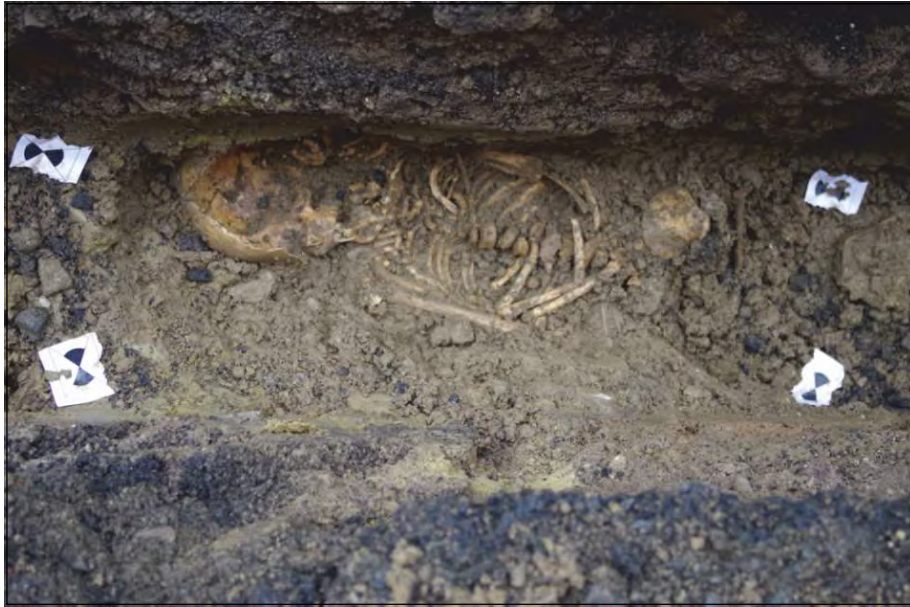
Plate 5: Skeleton 127

6.2.1 At least two skeletons (106, 127, Plate 5) appear to have been juveniles given the size and development of the skeleton. Skeleton 115 (Plate 6) appears to have been tightly bound within a shroud at the time of burial due to the angle of the clavicle and the position of the left humerus tight into the torso.

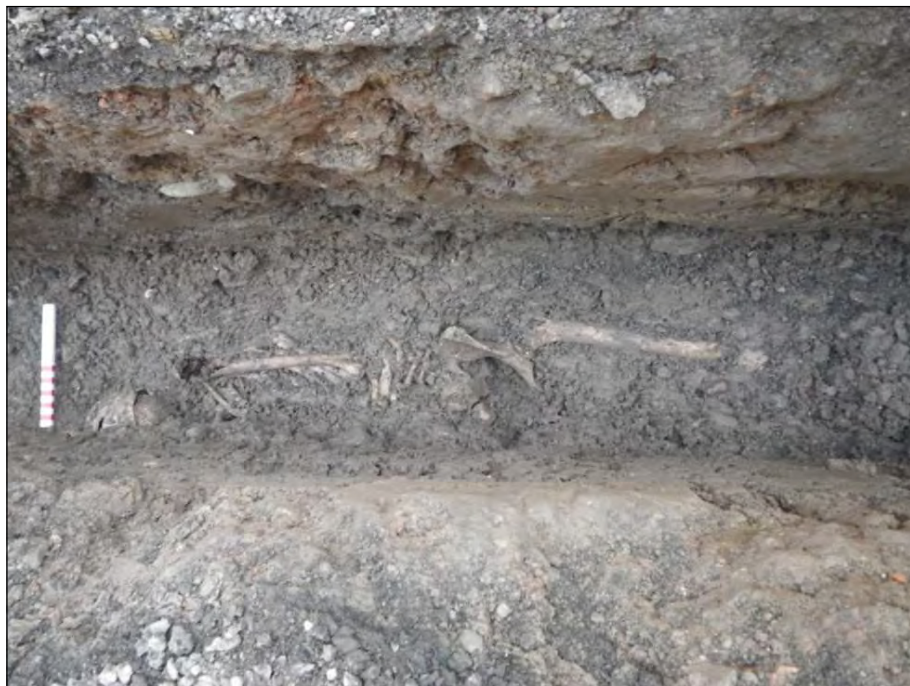
Plate 6: Skeleton 115

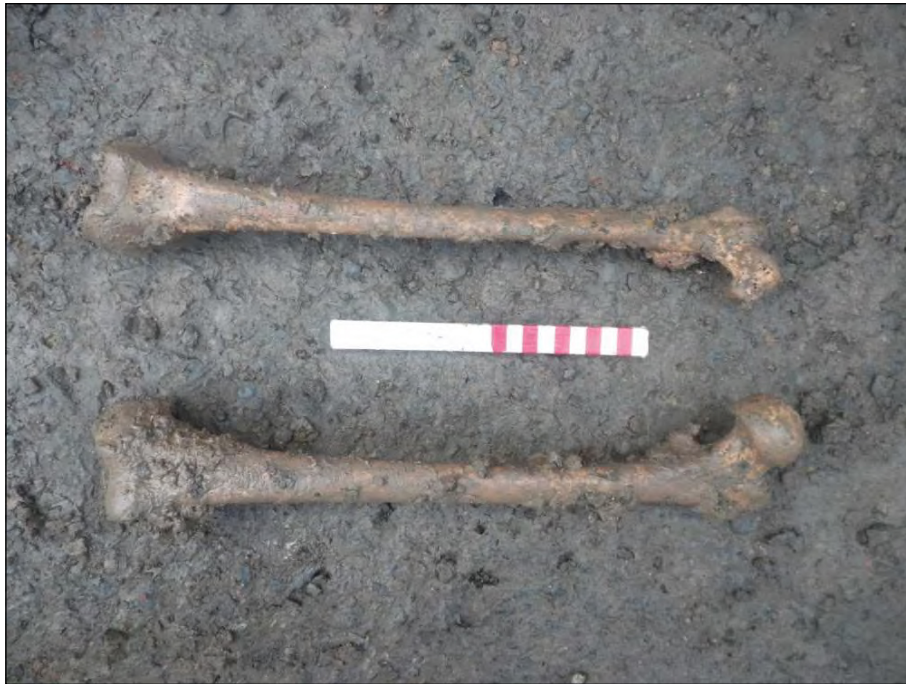
Plate 7: Femurs of Skeleton 112

6.2.2 The only pathology noted during excavation was on the right femur of skeleton 112 (Plate 7). The head of the right femur appears to be flattened medio-laterally and elongated superior-posteriorly indicating subluxation (dislocation) of the hip. The deformation of the femoral head appears concave and irregular, indicating necrosis due to disruption of the circulation. The hyper-vascularisation of the head and atrophy of the femoral shaft further suggests necrosis and associated loss of use of the right leg secondary to a dislocation or severe degeneration of the hip joint. Without the associated acetabulum it is difficult to verify any diagnosis, and bacterial diseases cannot be discounted because the lesion is uni-lateral (the left leg is not affected) and the rest of the skeleton is not available to determine the distribution of associated lesions.

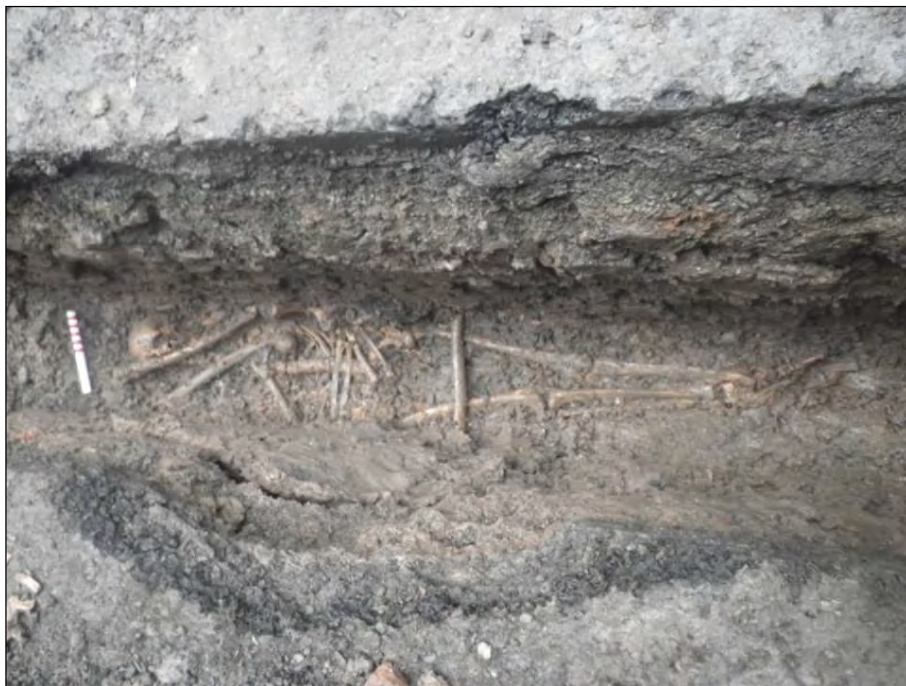
Plate 8: Skeleton 112

existing earlier burials. This is evident with skeleton 112 (Plate 8) which had disarticulated long bones lying across the chest and upper legs. It is probable that these were disturbed during the excavation of the grave cut (113) and reburied when the grave was backfilled.
